# Rim Drive Cultural Landscape Report Crater Lake National Park, Oregon

Stephen R. Mark  
Jerry Watson

USDI – National Park Service

2009

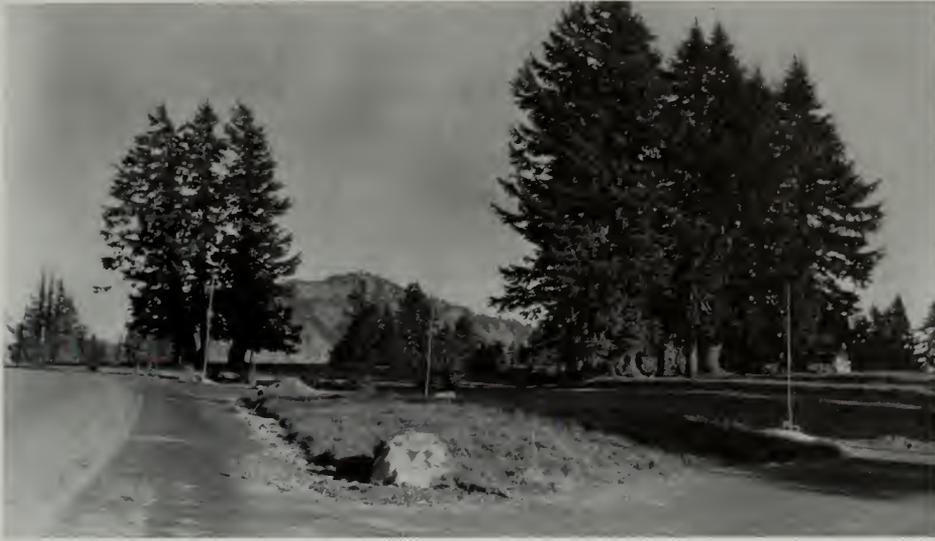
Road wye at the start of Rim Drive, looking east toward Rim Village, 1935. *Lange, NARA, RG 79, SB.*

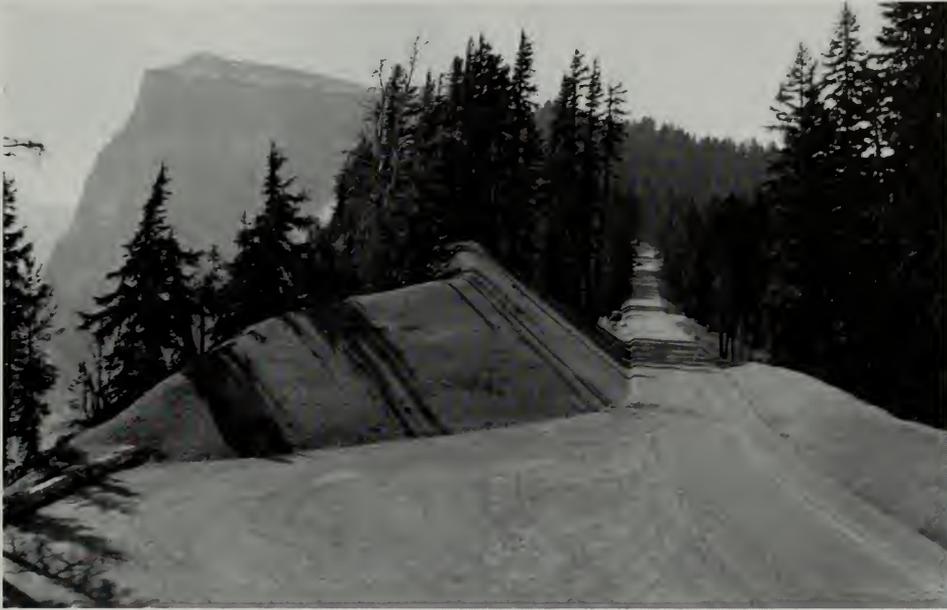
After development of a parking area above Steel Bay, 1936. Note the large bankslope at middle left. *Lange, NARA, RG 79, SB.*

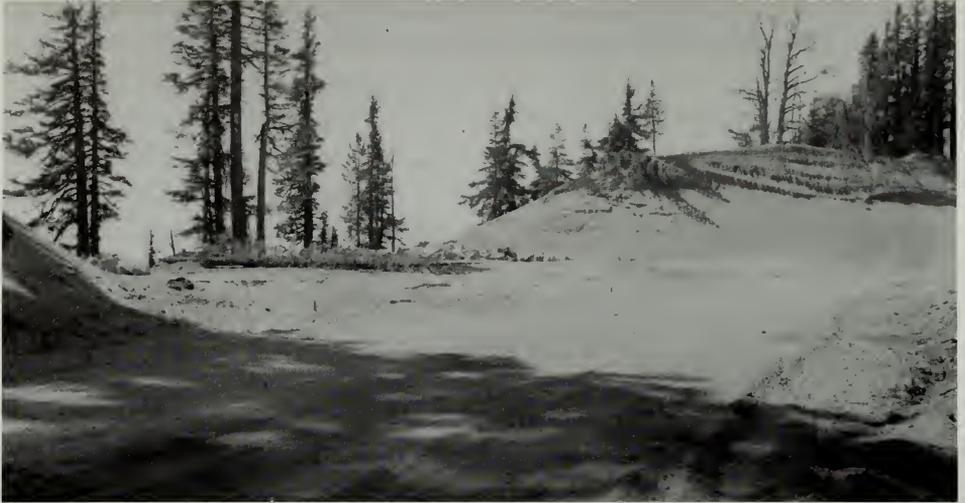
Parking area above Steel Bay in 1934 before landscape treatment. *Lange, CLNPMAC.*

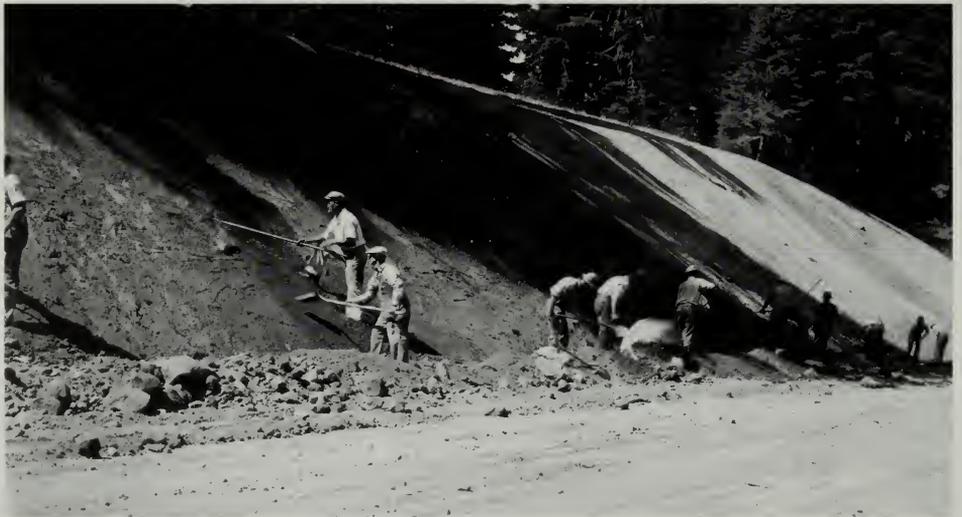
Finishing crew on slopes and ditches, segment 7-C, 1936. *Struble, BPR-FHWA.*

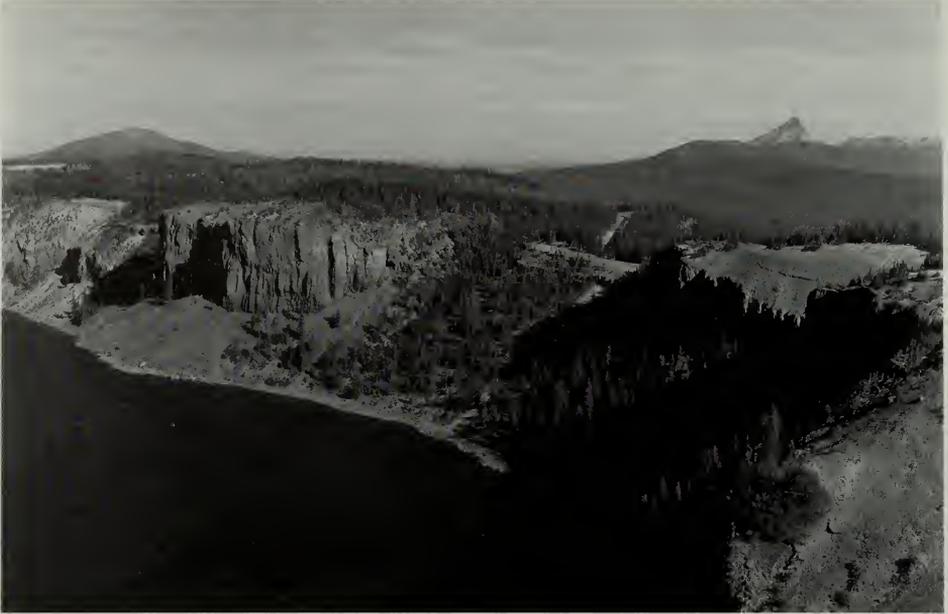
The Palisades as seen from Skell Head, about 1940. A portion of Rim Drive is visible below and to the left of Mount Thielsen. *National Park Service.*

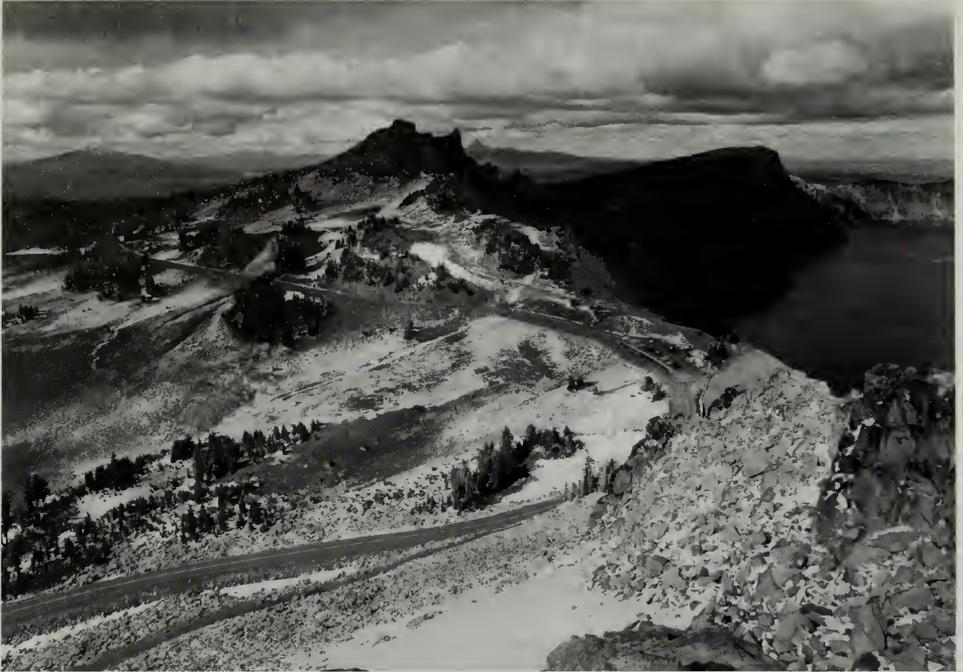
A section of the west Rim Drive as seen from the Watchman, 1999. *Jet Lowe, HAER.*

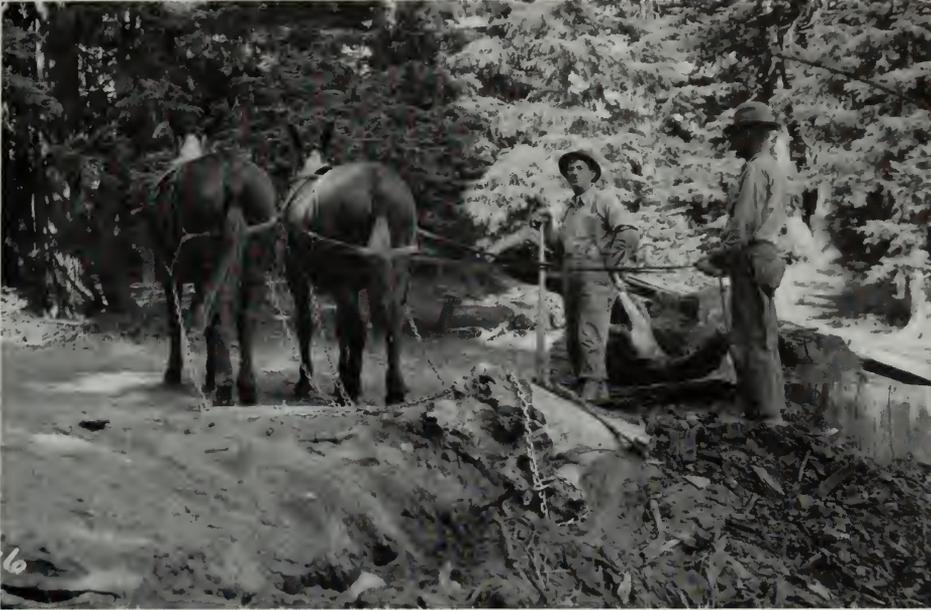
Team and hand labor method of grubbing road segment 7-B, 1933. *Sargent, BPR-FHWA.*

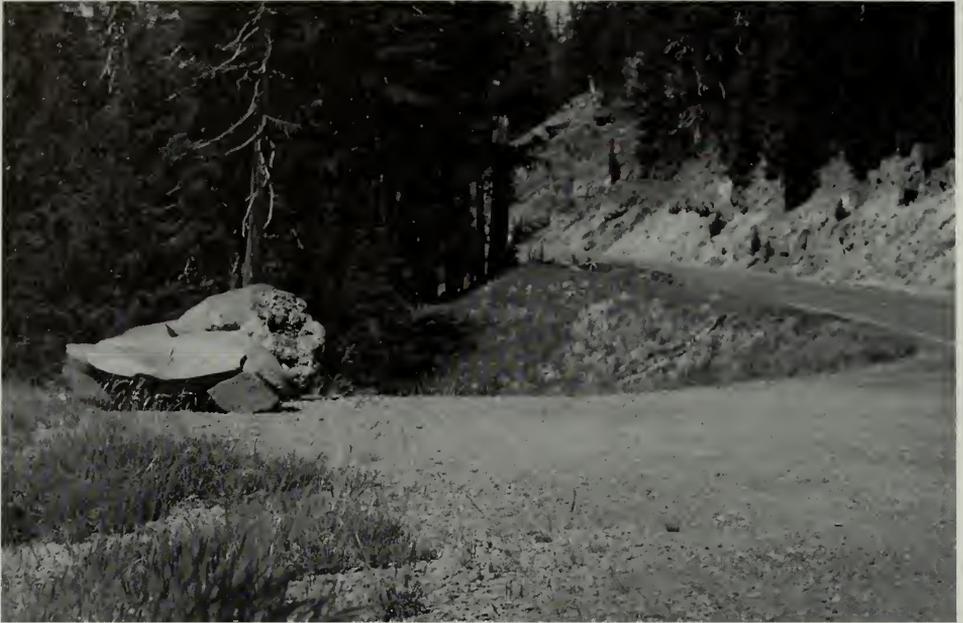
A flattened cut on the west Rim Drive used to collect rockfall and occasionally by visitors for parking. *Jerry Watson.*

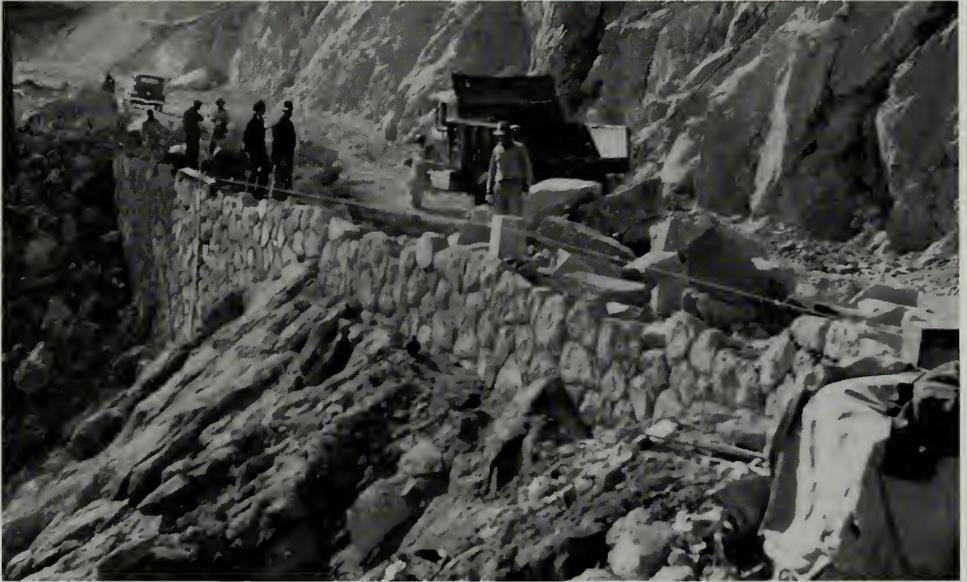
Building the retaining wall and guardrail at Scott Bluffs, 1934. *Doerner, NARA, RG 79, SB.*

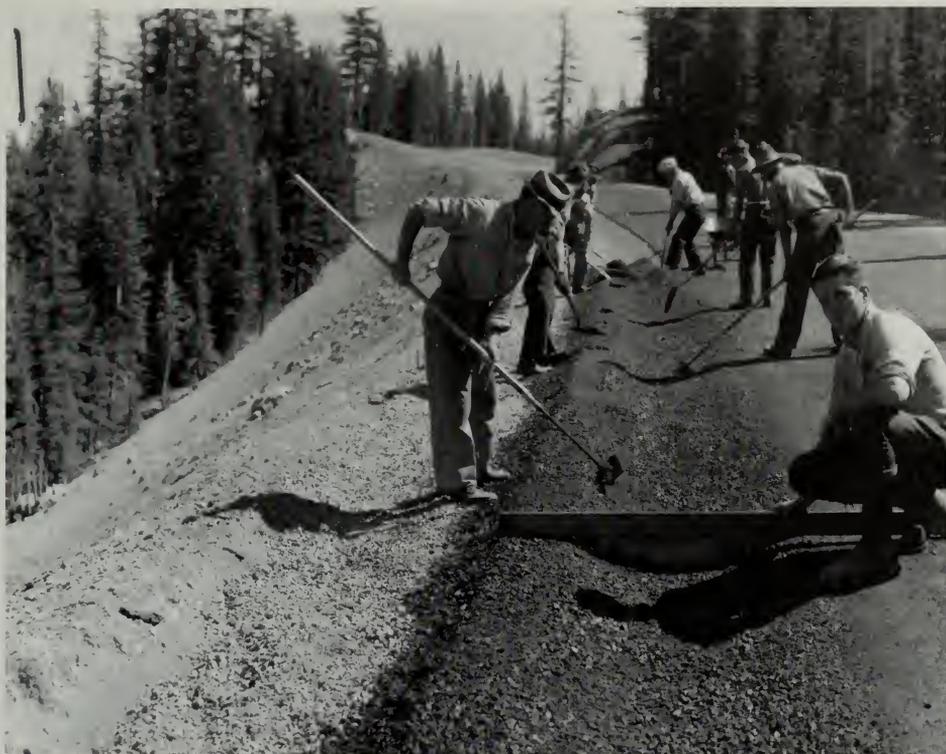
Laying and shaping a gutter section. Note template in foreground. *Struble, BPR-FHWA.*

**Bituminous ditches and walkways.** Away from the road surface and most parking areas, those who built Rim Drive used asphalt as part of the systems constructed for cross drainage in road segments 7-B and 7-C. As paved ditches or “gutters,” bituminous features conveyed water at a relatively shallow depth to drop inlets faced by asphalt. As a way of protecting the road margins, the bituminous ditch did not exceed two inches in depth of asphalt on any side but extended distances of a quarter mile or more.

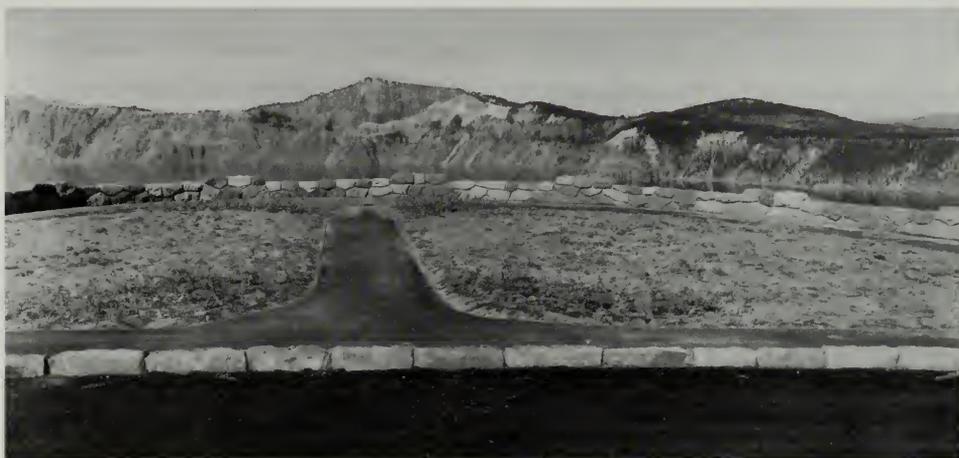
Detail of a portion of Skell Head parking overlook showing completed bituminous mat and sidewalks, 1938. *Struble, BPR-FHWA.*

Walkways, by contrast, are a pedestrian circulation feature that spanned the distance between curbs and masonry guardrail, as part of site plans from Francis Lange. This feature supplies a wearing course over an earthen base at what Lange referred to as “parapets,” or elevated walkways at Grotto Cove, Skell Head, Cloudcap, Cottage Rocks, Victor View, Reflection Point, Kerr Notch, and Vidae Falls.

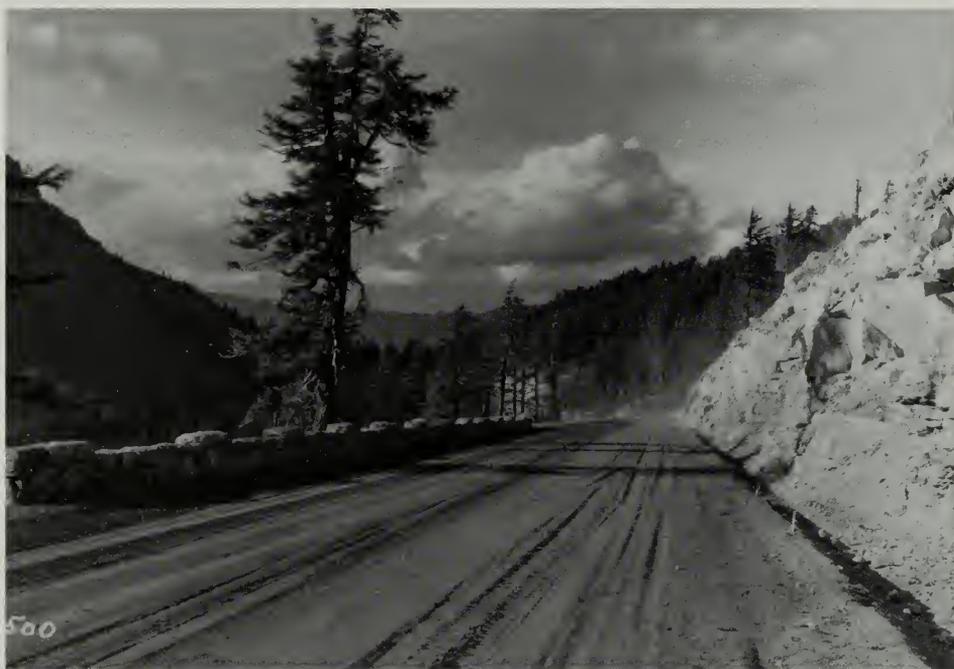
Graded road and masonry guardrail on Sun Grade, road segment 7-D, 1938. Note the "gutter line" at right. *Struble, BPR-FHWA.*

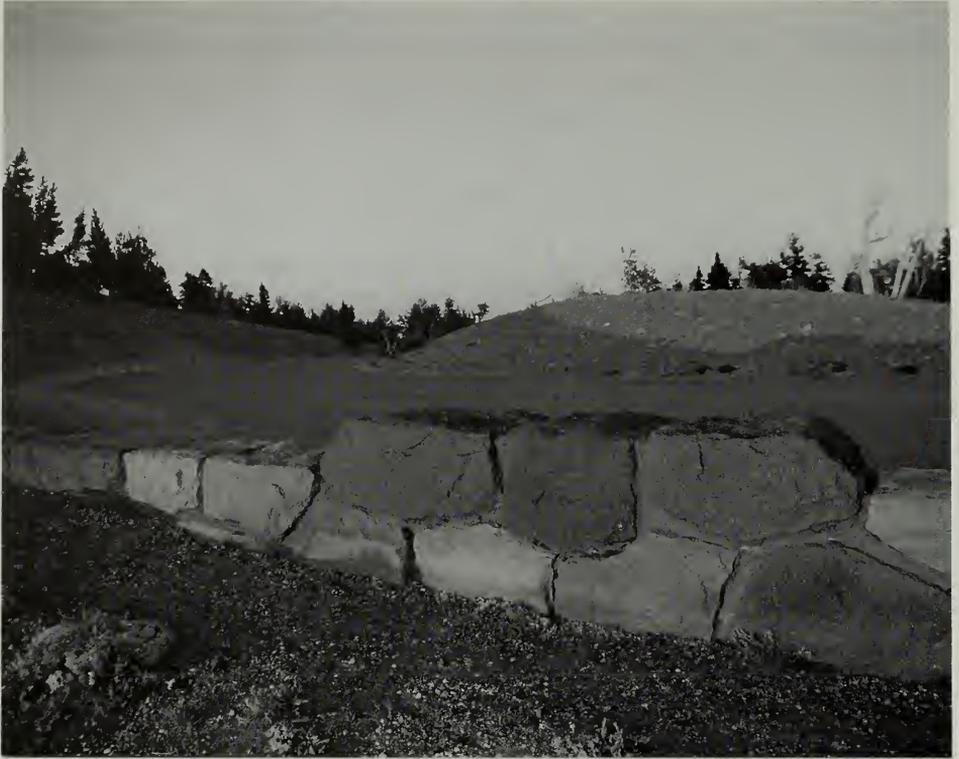
Masonry guardrail at the Cloudcap observation station, 2007. *Steve Mark.*

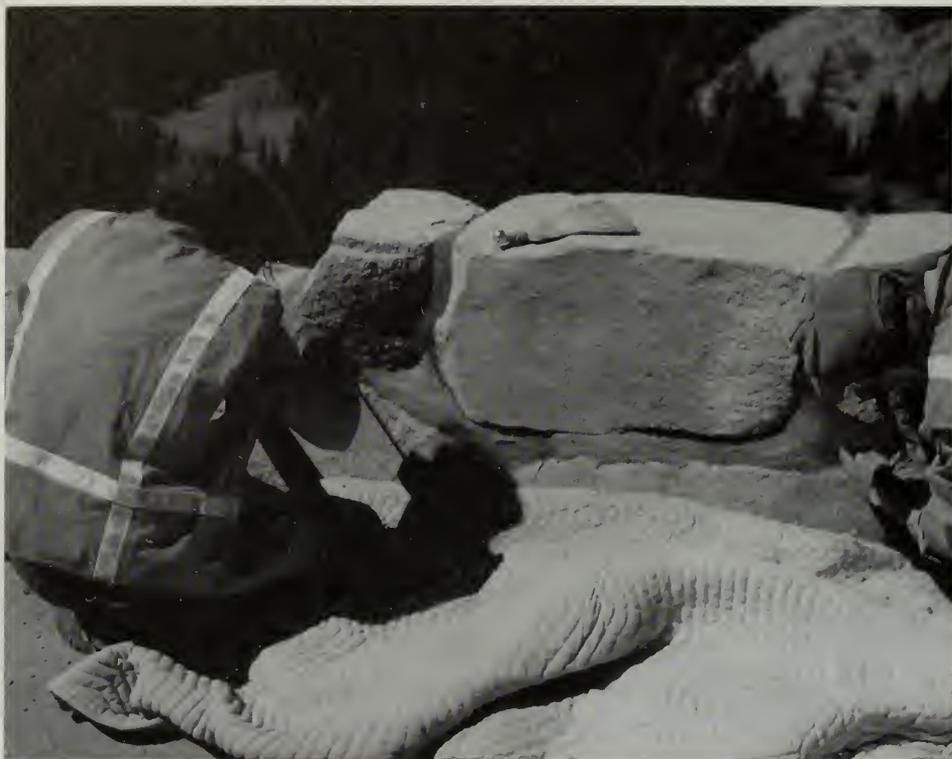
Repairing a portion of a masonry guardrail on west Rim Drive, 2002. *Jerry Watson.*

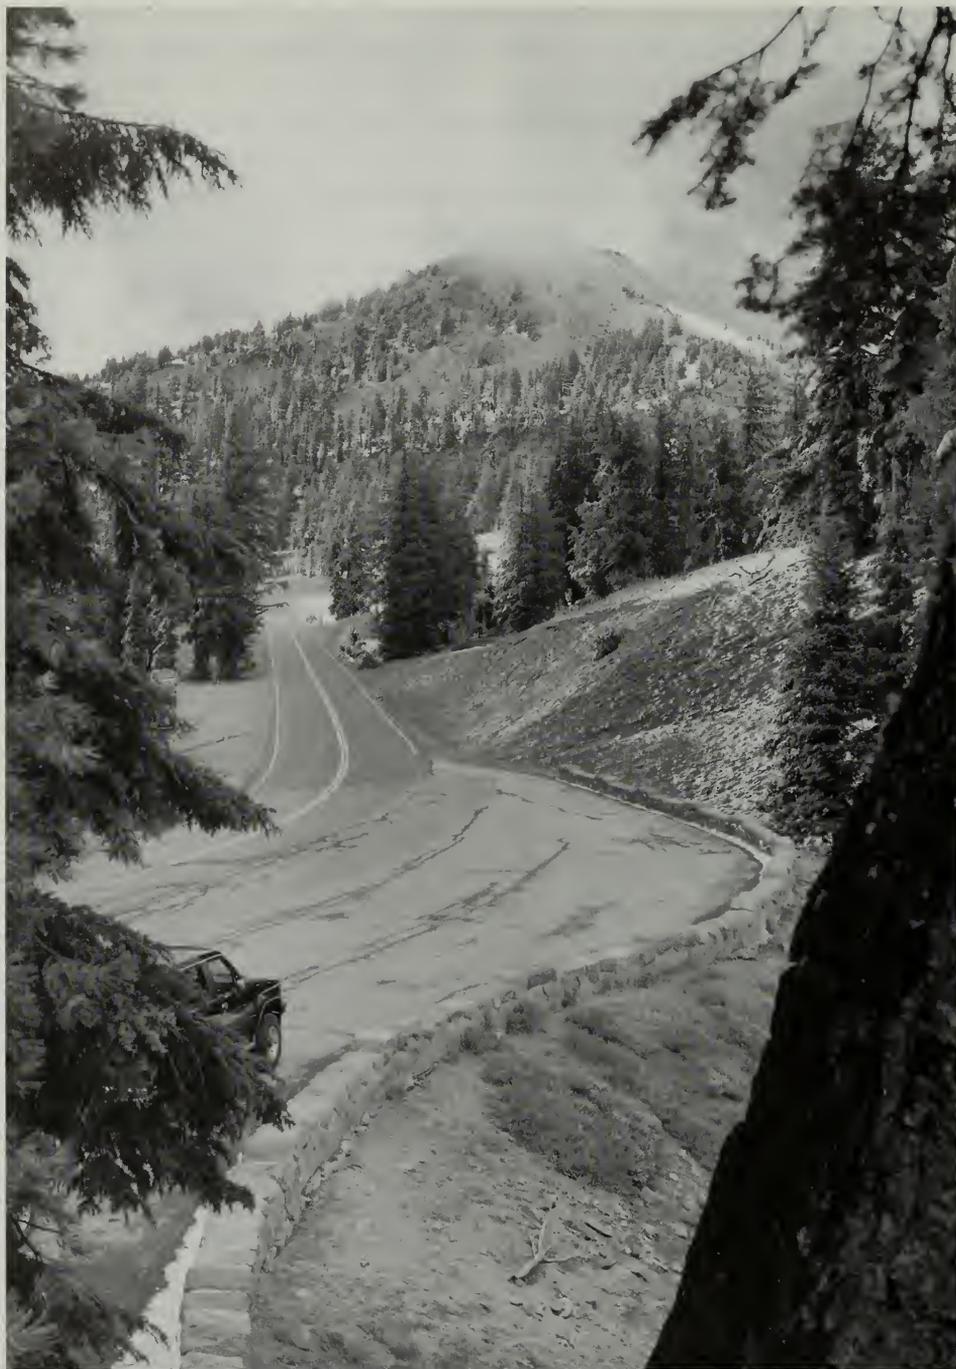
Wizard Island Overlook (substation 2-B) on west Rim Drive after a late summer storm, 1999.  
*Jet Lowe, HAER.*

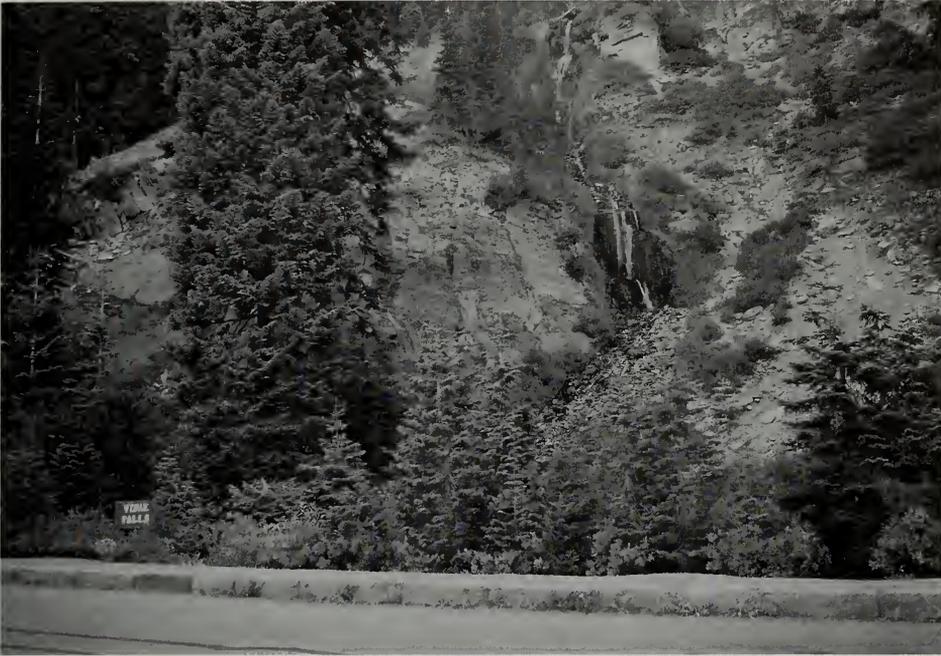
Portion of Vidae Falls parking area showing curb, original Civilian Conservation Corps sign, and planting on fill. *Steve Mark.*

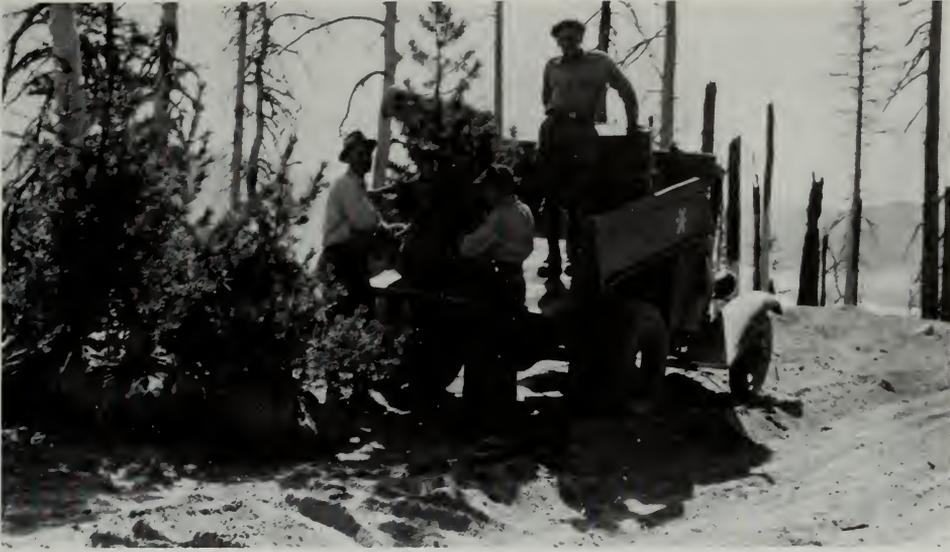
Crew moving trees for planting at road station 1039, Segment 7-B, 1935. *Lange, NARA, RG 79, SB.*

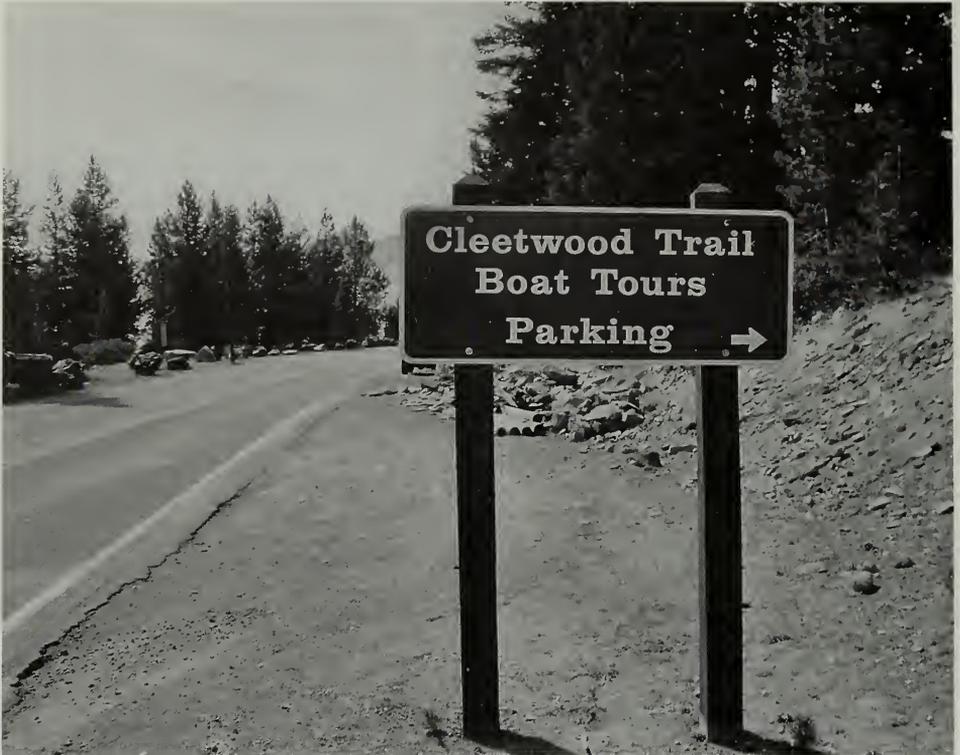
Sign near the Cleetwood Cove parking area, 2003. *Jerry Watson.*

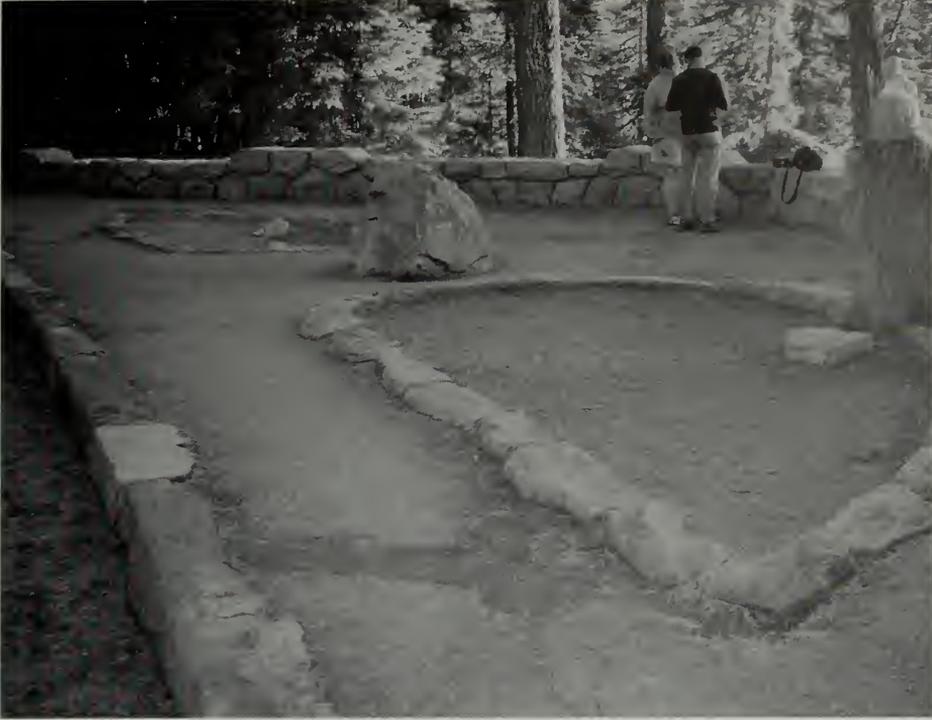
The fountain (at center) as it appeared in 2007. *Steve Mark.*

In regard to one of the parking overlooks (Kerr Notch), there is only one **drinking fountain** on Rim Drive, a feature similar to stone fountains located at Rim Village and Park Headquarters. Restoration of this fountain may not be feasible, since the spring located nearby has been capped, presumably in response to restrictions on open sources of drinking water.

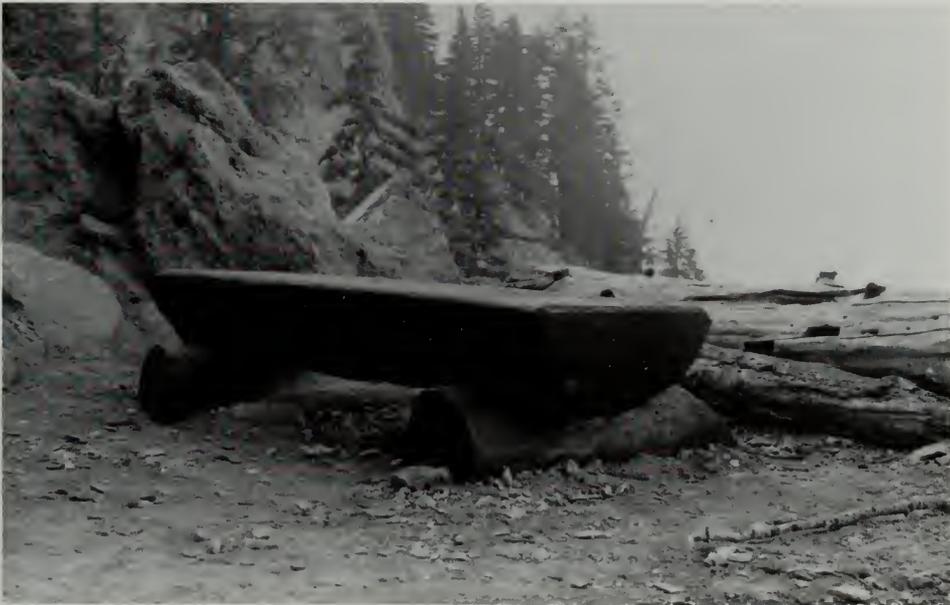
Bench placed on the Garfield Peak Trail by the Civilian Conservation Corps in 1937. *Lange, NARA, RG79, SB.*

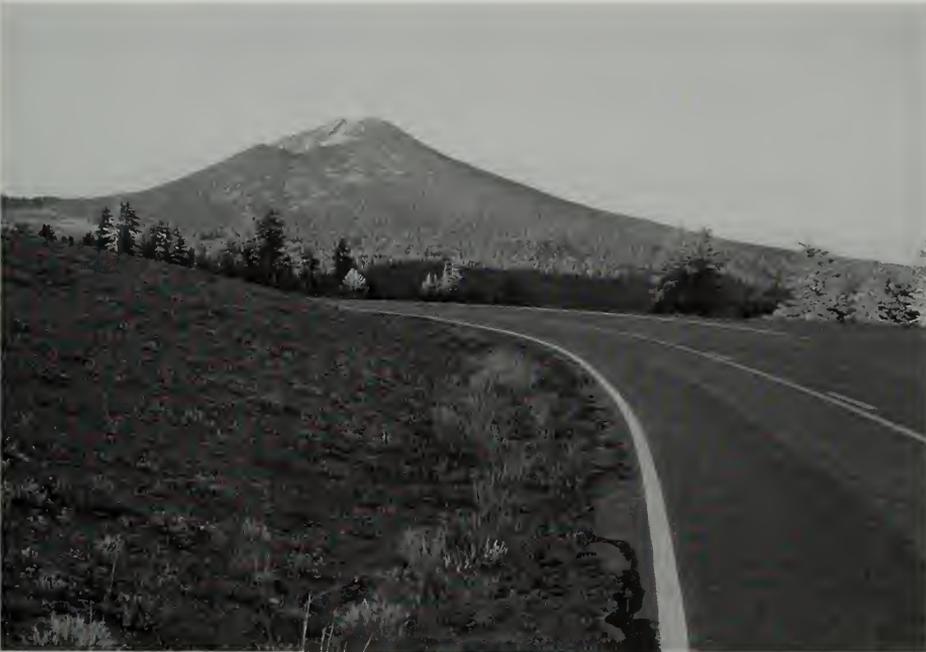
Section of east Rim Drive near the Dutton Ridge road summit, 2007. Note some sealing of cracks near the pavement edge. *Steve Mark.*

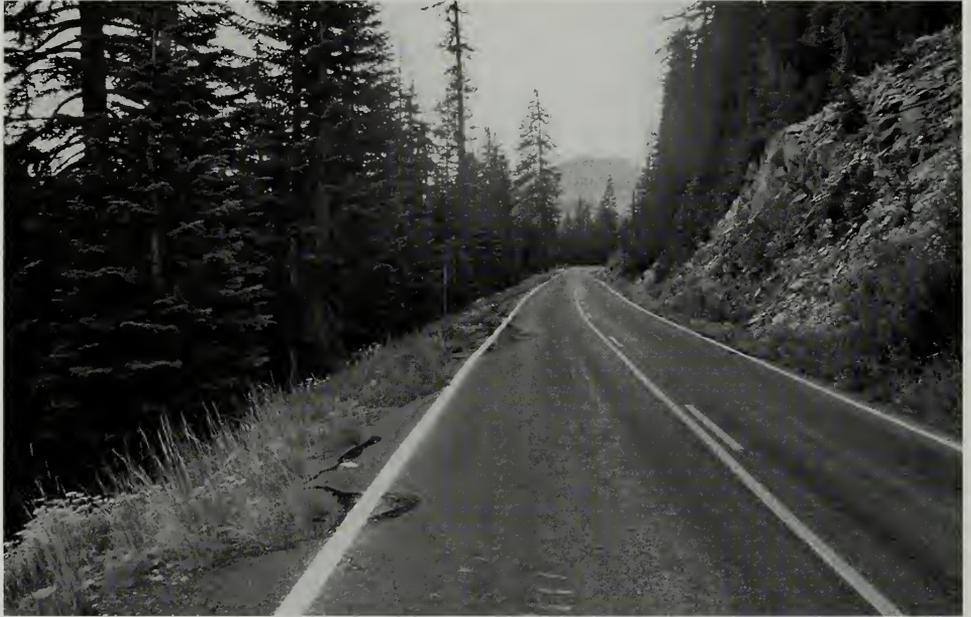
Section of east Rim Drive between Sun Notch and Vidae Falls, 2007. Some deterioration of the road is visible along its left edge. *Steve Mark.*

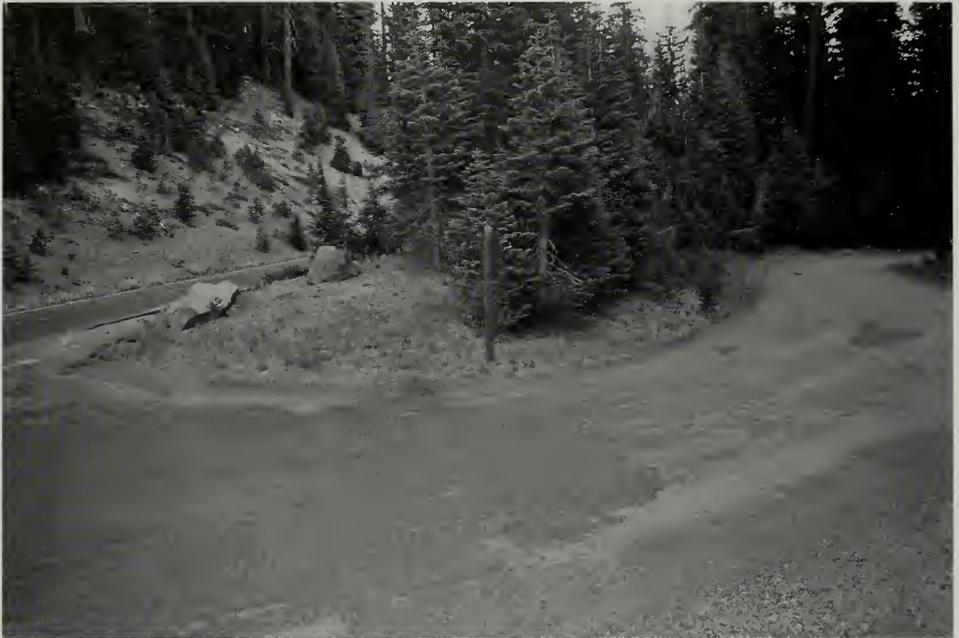
Bank slope separating east Rim Drive (left) from the road to Vidae Falls picnic area, 2007. *Steve Mark.*

Constructing bank slopes is generally more expensive, but may be effective at removing informal parking areas or stabilizing blowing pumice. An example of this treatment occurs overlooking Steel Bay in segment 7-B. By contrast, slope rounding is another less expensive way to transition from road to surrounding landscape and can be seen along Rim Drive where through cuts are shallow in relation to shoulders. A rounded bank slope, for example, was used to separate what was intended as the Sun Creek campground road from Rim Drive.

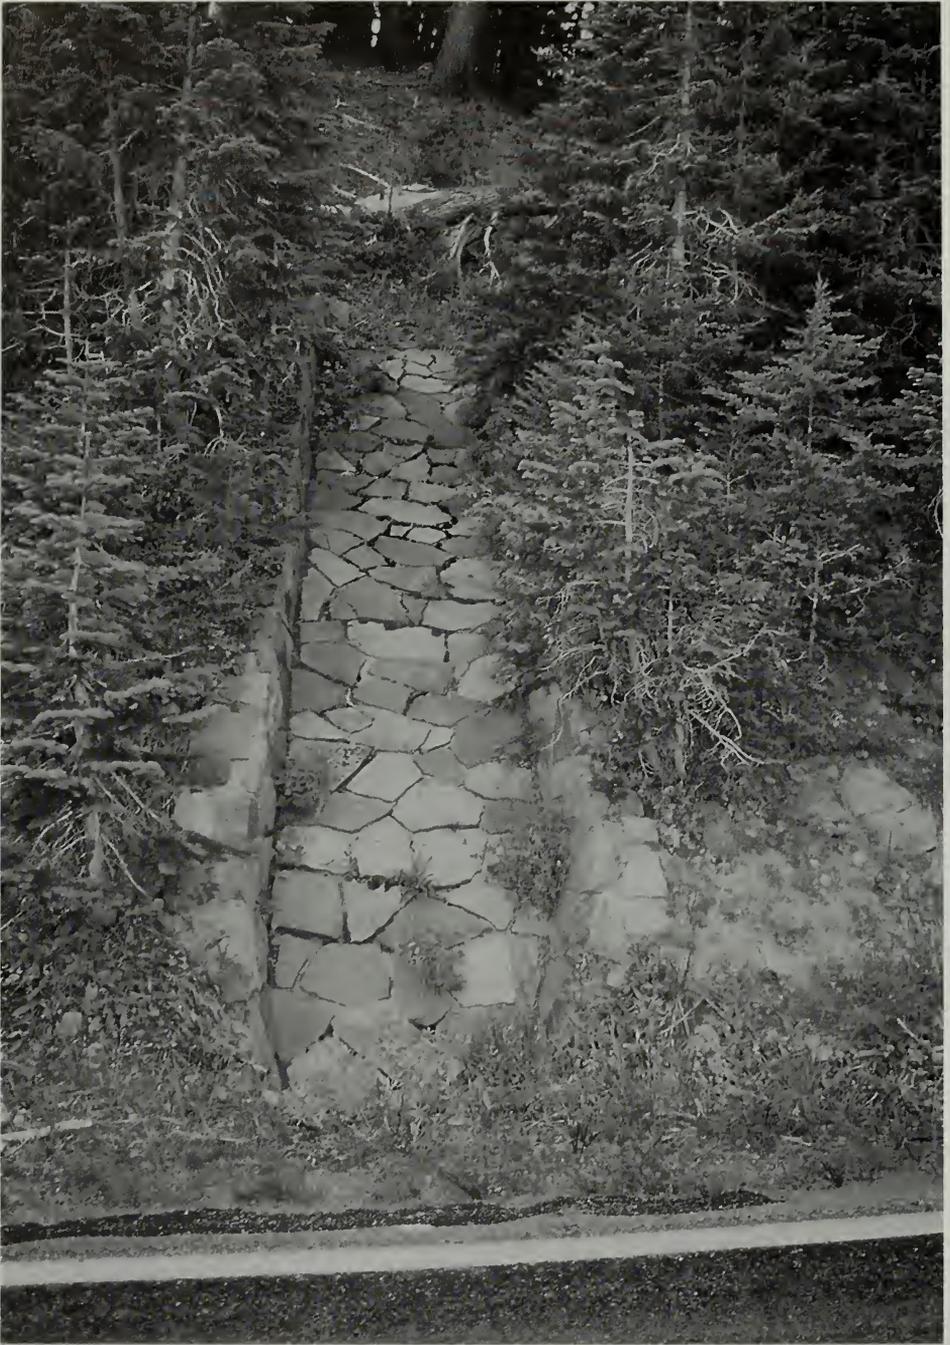
A spillway located at road station 242, segment 7-E, in 2007. *Steve Mark.*

Engineers designed the drainage system to transport water and discharge at a lower point than the Rim Drive’s sub-grade in order not to undermine the road structure. Ditches are thus placed parallel to the road to collect water before channeling it to drop inlets, culverts, and French drains. The BPR engineers designed a drop inlet for Rim Drive that was derived from a type previously installed on the Redwood Highway in northern California. Drop inlets catch water from paved ditches and then to a culvert often leading to the toe of a fill. In contrast to unlined earth

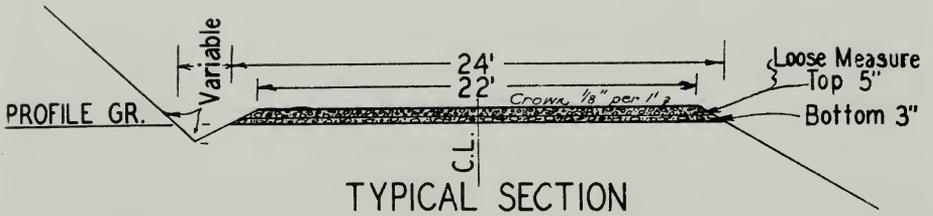
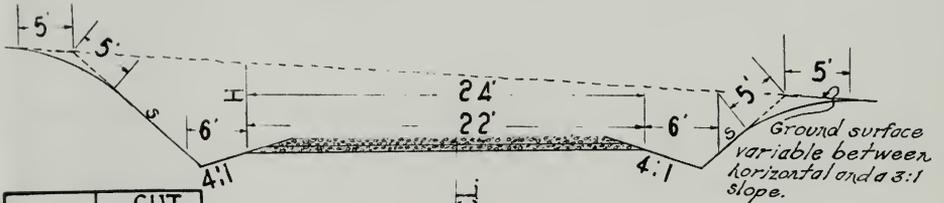
U.S. DEPARTMENT OF INTERIOR  
 NATIONAL PARK SERVICE  
 CRATER LAKE NATIONAL PARK - ORE.  
 PROJECT NO. 7A & 8 SURFACING & GUARD RAIL

Location Of Guard Rail		
Sta.	to	Sta.
10+63		11+48
12+41		13+06
55+40		59+90
115+75		118+50
290+10		292+10
299+00		303+00

ft	CUT SLOPE(S)
0+0.5'	2:1
5+0.8'	1 1/2:1
8+0.20'	1:1

SLOPE TREATMENT IN EARTH CUTS

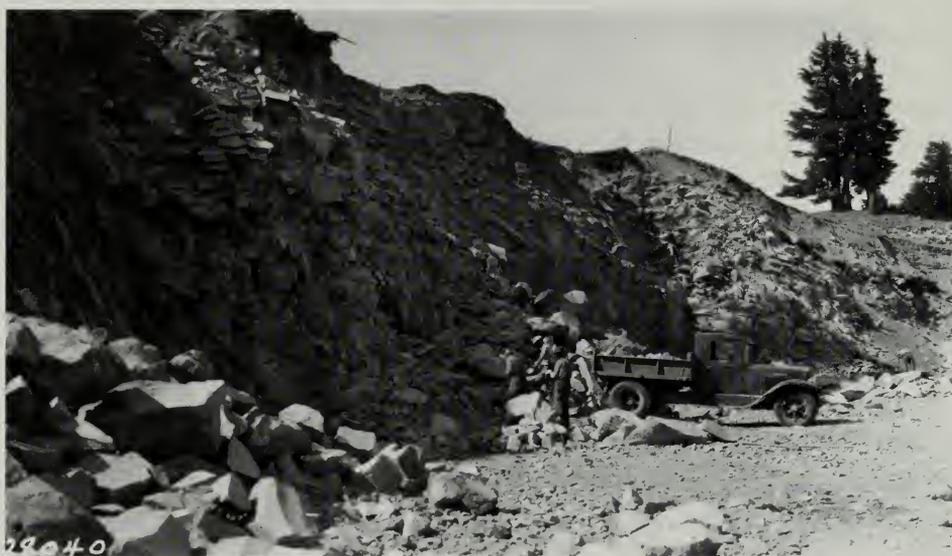
Men loading rock at substation 3-B in 1934. *Sargent, BPR-FHWA.*

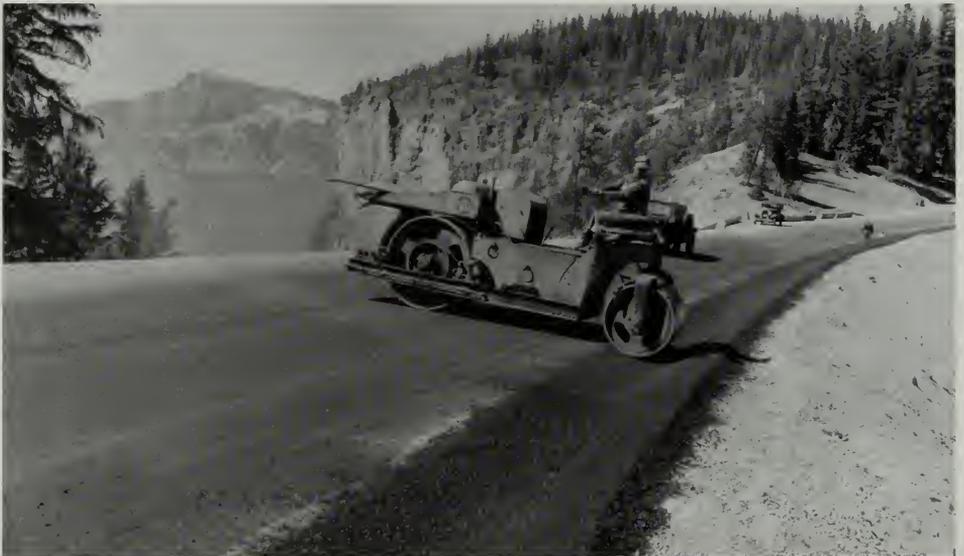
Rolling a gutter section in road segment 7-B. *Struble, BPR-FHWA.*

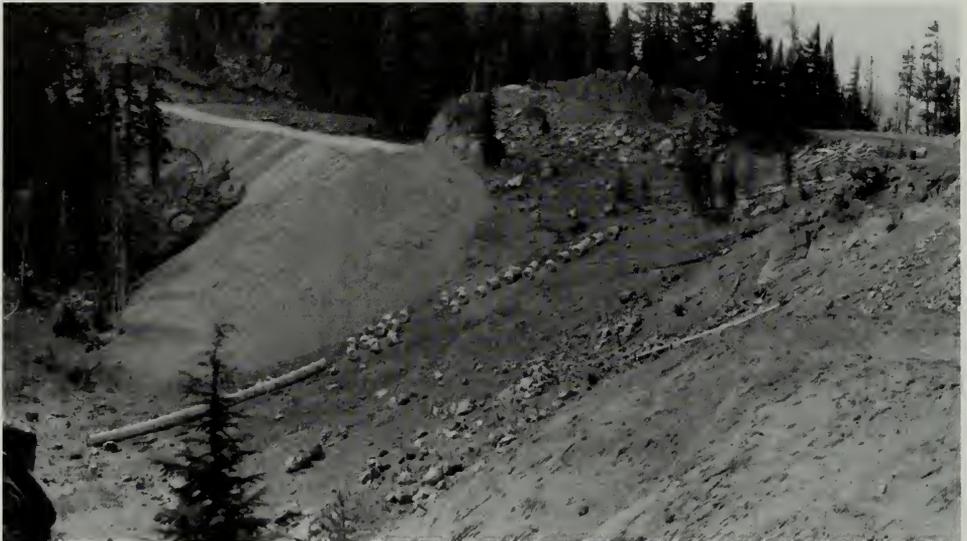
Partially assembled concrete pipe culvert near toe of fill, road segment 7-B, 1934. *Doerner, NARA, RG 79, SB.*

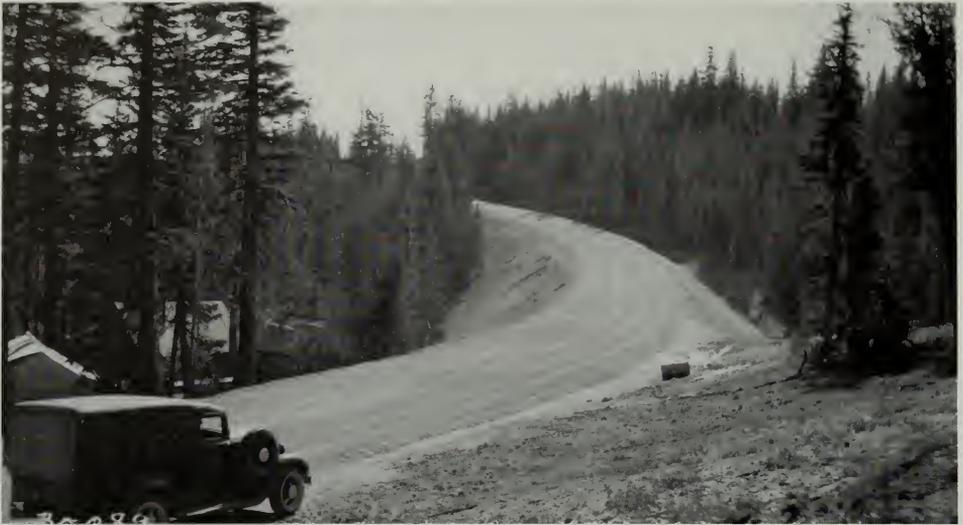
Heavy fill at Wineglass prior to surfacing. Contractor's camp at left. *Struble, BPR-FHWA.*

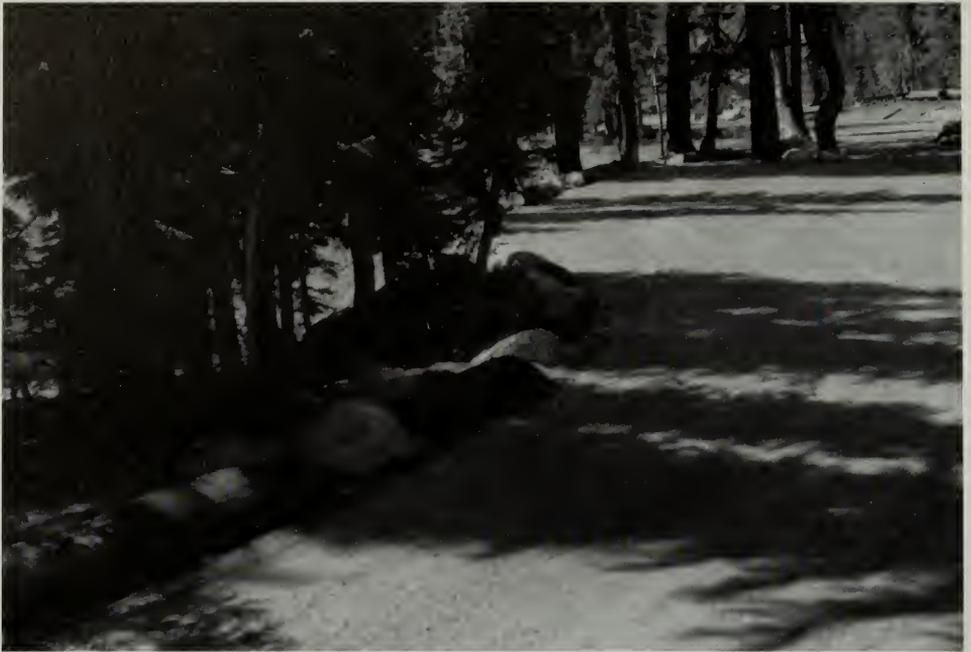
Log and boulder treatment at Kerr Notch, 1938. *Lange, NARA, RG79, SB.*

The original parking delineation on the side of this overlook facing away from the curb and masonry guardrail could be restored using the log and boulder treatment shown on Lange's site plan. Other restoration work could include repair of the drinking fountain and planting shrubs in the small bed adjacent to the fountain to discourage trampling by visitors. A historic locational sign should be restored, but reference to "Phantom Ship Overlook" (used in place of Kerr Notch) should be

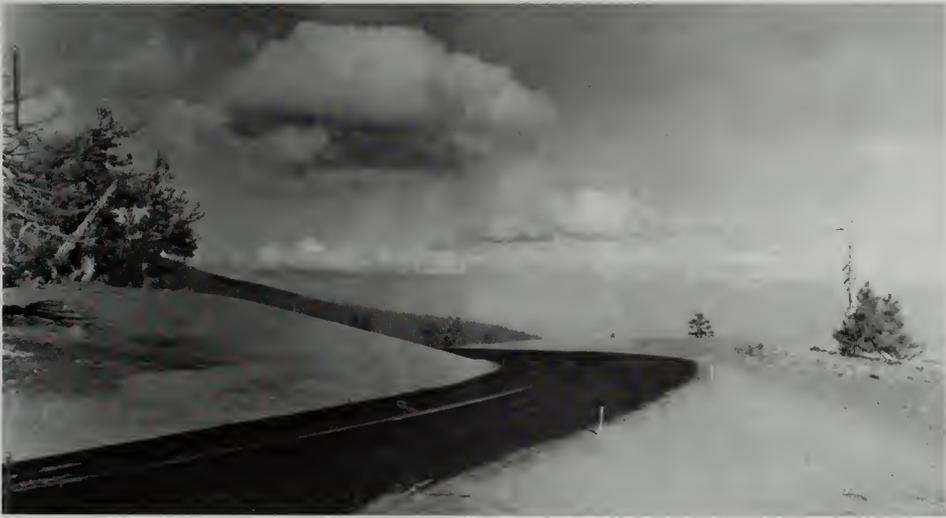
A portion of Rim Drive at the Dutton Ridge road summit looking east toward the Klamath Marsh, 1939. *Lange, NARA, RG 79, SB.*

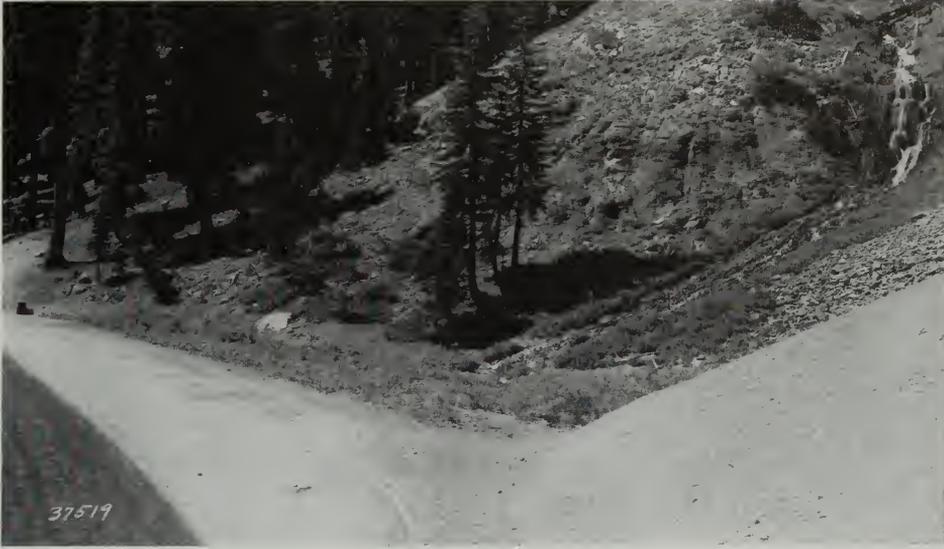
Vidae Falls, prior to placement of curb and walkway. Note drinking fountain at far left. *Struble, BPR-FHWA.*

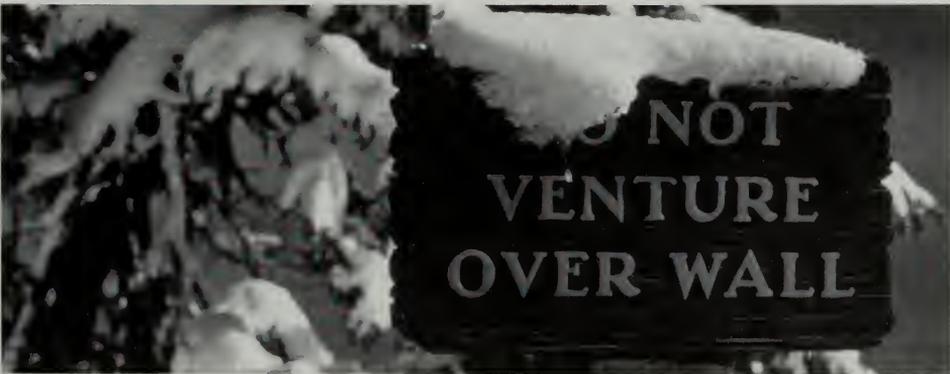
Warning sign placed by CCC enrollees at various places at the rim. *CLNPMAC 8885.*

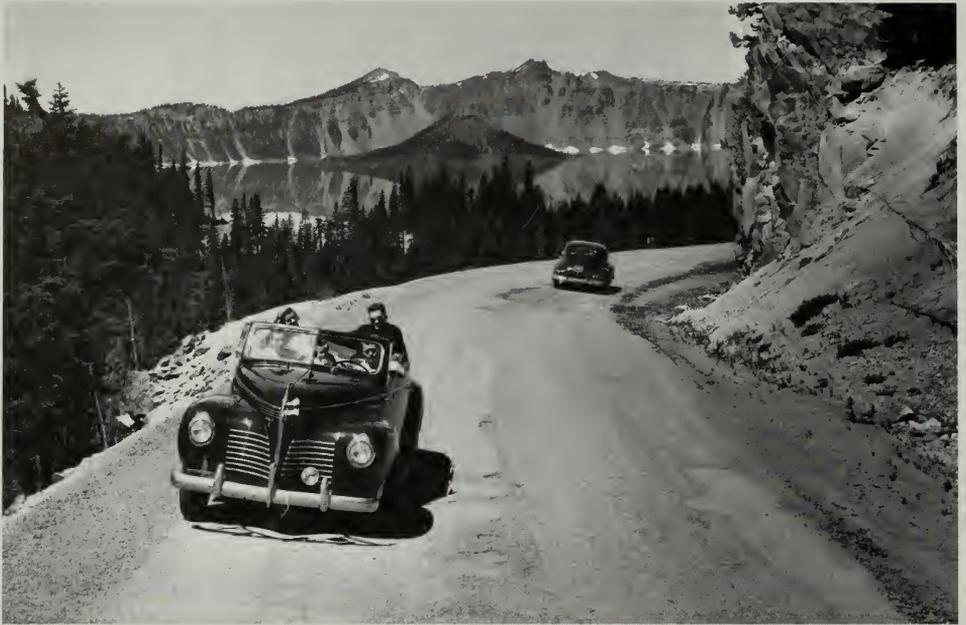
Oregon State Highway Commission publicity photo taken near Anderson Point, late 1940s. Note that the road surface is not paved but instead treated with oil. *Oregon State Archives.*
