# Rim Drive Cultural Landscape Report Crater Lake National Park, Oregon

Stephen R. Mark  
Jerry Watson

USDI – National Park Service

2009

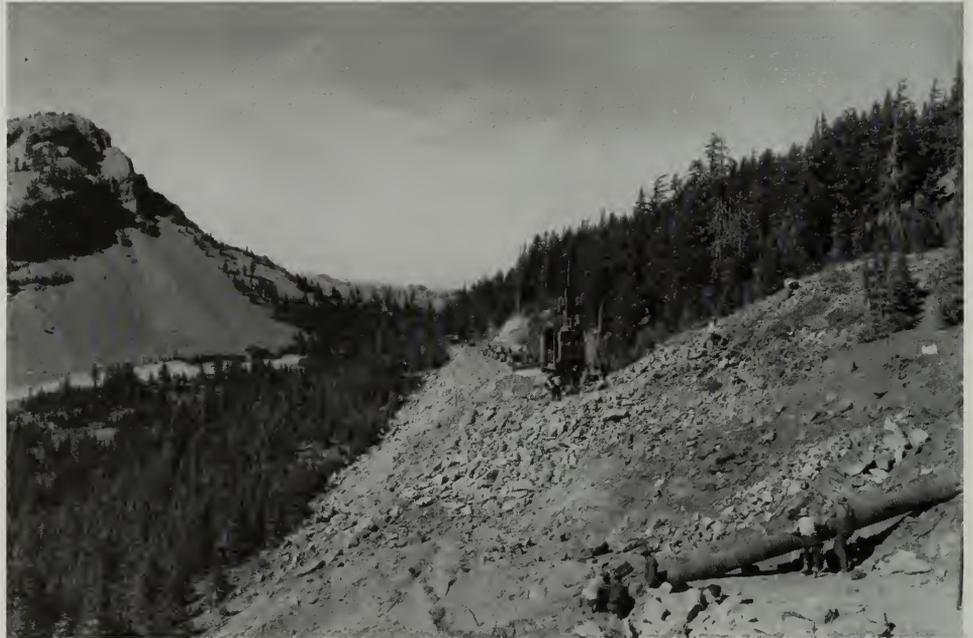
Culvert installation and rough grading on road segment 7-D (Sun Grade), 1937. *Struble, BPR-FHWA.*

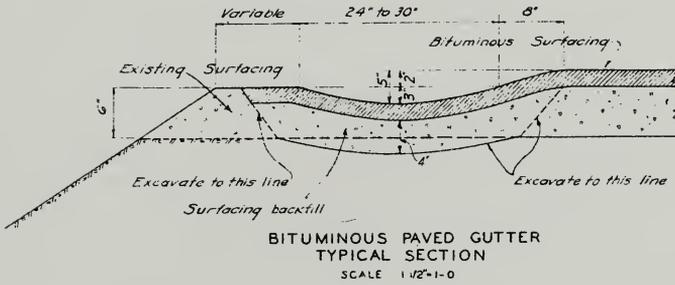
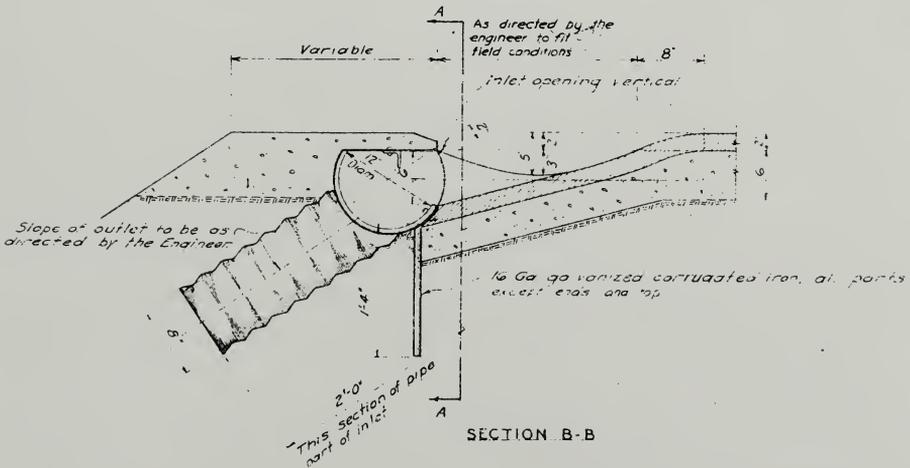
**SPILLWAY INLET & BANK PROTECTOR**  
SCALE 1/2"=1'-0"

BPR diagrams in Rim Drive paving contract (segments 7-B and 7-C), May 1938.

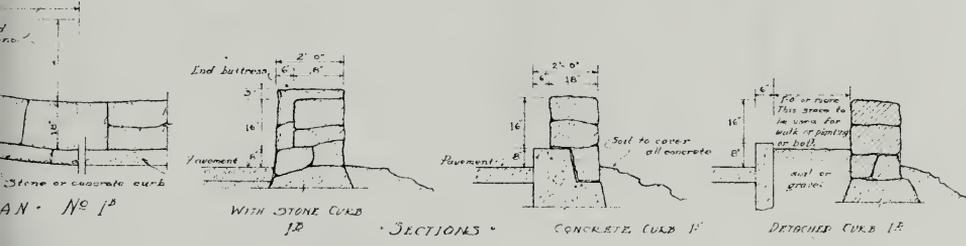
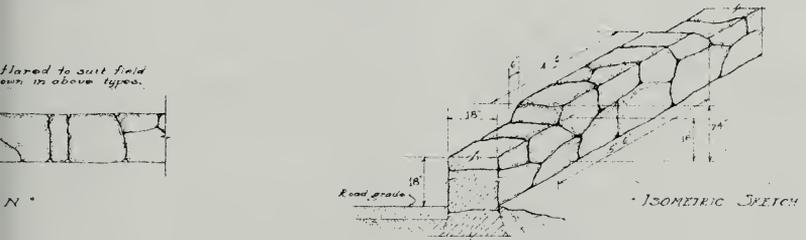
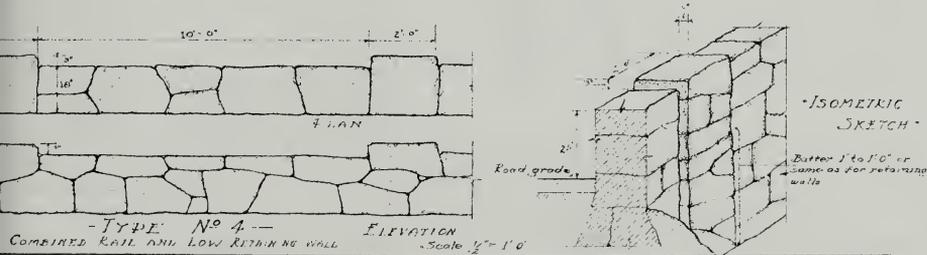
NPS drawing showing types of masonry guardrail, 1929. CLNPMAC 8899

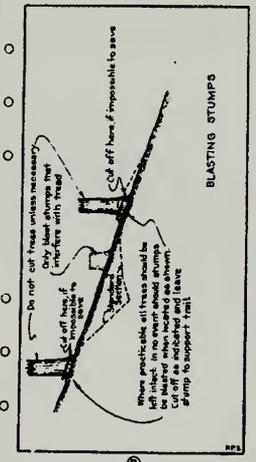
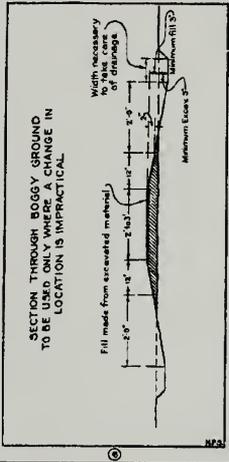
DEPARTMENT OF THE INTERIOR  
NATIONAL PARK SERVICE  
STANDARDS  
FOR  
TRAIL CONSTRUCTION  
OFFICE OF THE CHIEF ENGINEER  
SAN FRANCISCO, CALIFORNIA  
OCTOBER 1934

**SPECIFICATIONS FOR TRAILS**  
**Trail Section**  
 The trail will be of the standard 4'-0" width. The slope of the cut will vary according to the hardness of the ground on which the trail is constructed.  
 Any part or all of the width may be carried on a well built of large stones, the supporting ground being braced as necessary to afford a stable foundation.  
 Where necessary to retain material on a steep slope a dry random rubble wall may be built along the down hill side of the trail. When crossing talus slopes it may also be necessary to construct a suitable dry random rubble wall on the up hill side to retain slide material along the trail. Surface of trail on talus slopes should be covered with dirt or other fine material.

**Drainage**  
 Pipes, water breaks, culverts or traps should be provided where necessary for drainage water. Particular attention be paid to so locating the points for cross grade that shoulders or fills will not be used. Where suitable conditions do not exist or at which cross drainage must be provided trail surface and embankment must be equally protected by rip rap. A capacity of the precipitation and run off should be determined the type and spacing best suited conditions.  
 Generally speaking, dips or water lines to be preferred to culverts or traps. These latter two being considered only appropriate and necessary.  
 Drainage from switchbacks will not be done to prevent the discharge of a water into the trail below.

dry rubble wall must be a satisfactory and firm foundation. It has a slope toward the least 1" in 12". The outer face must have a better steeper face

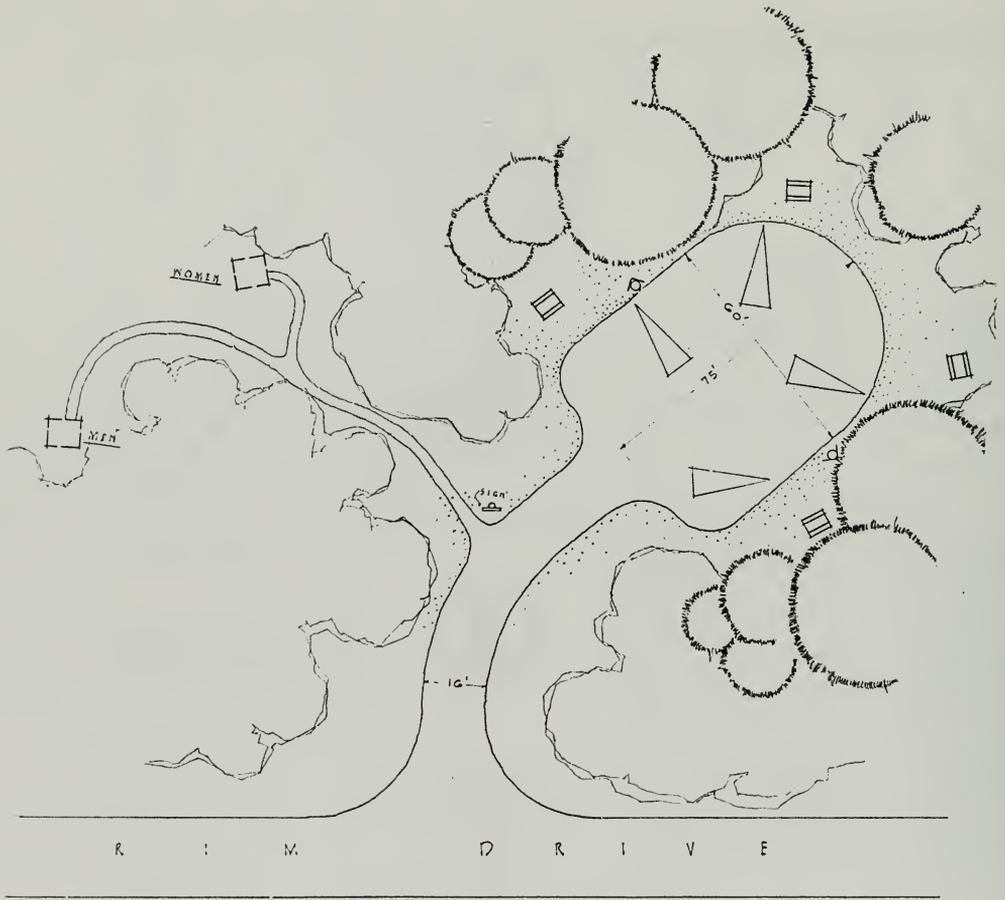
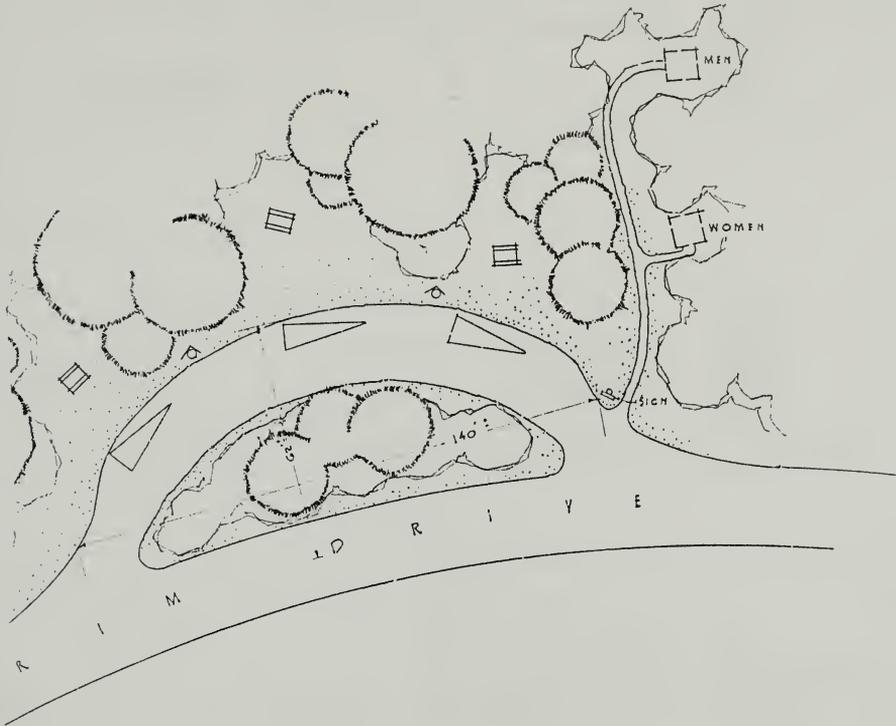
T Y P I C A L L A Y O U T S

Concept drawing for picnic areas on Rim Drive, 1957. CLNPMAC 8899

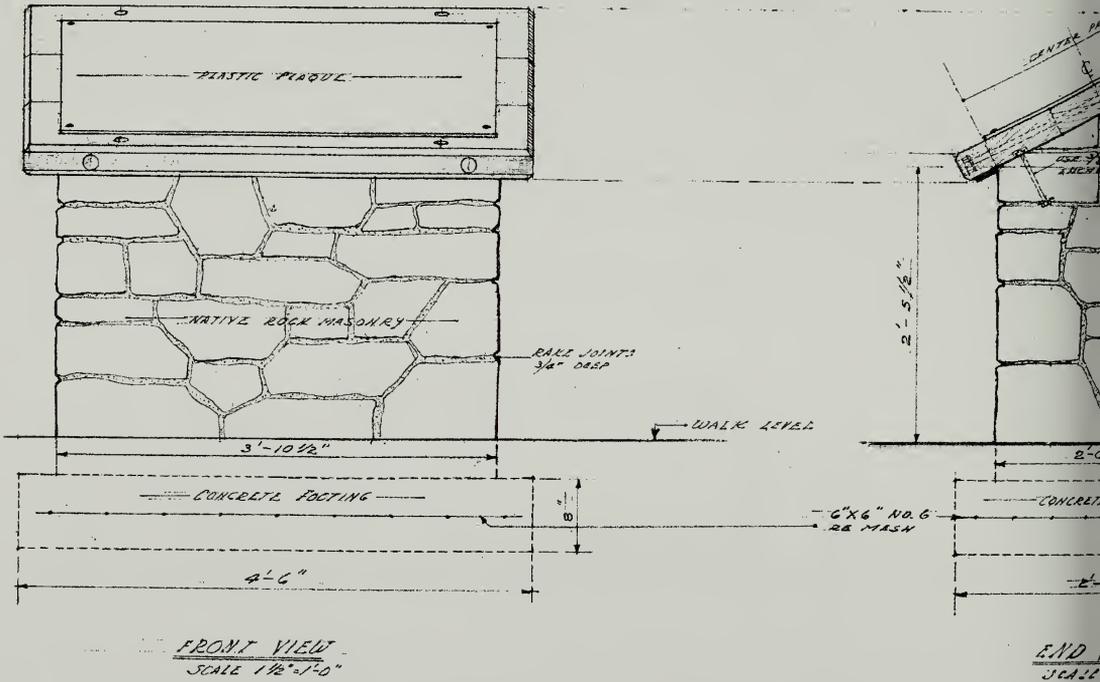
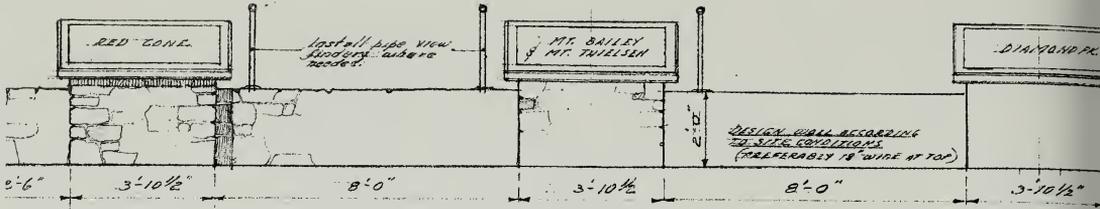
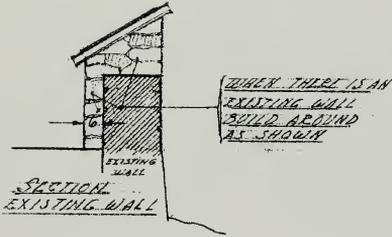
Stone masonry feature designed for use with wayside exhibits. Shown across the top is an elevation for the design at the Diamond Lake Overlook. CLNPMAC 8899.

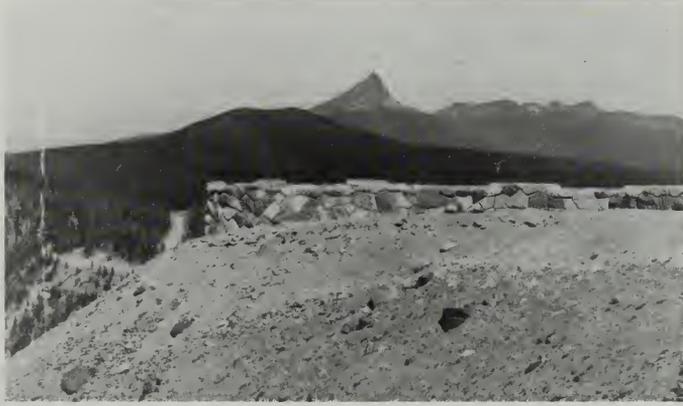
Completed parapet, 1938. Lange, CLNPMAC 10137.

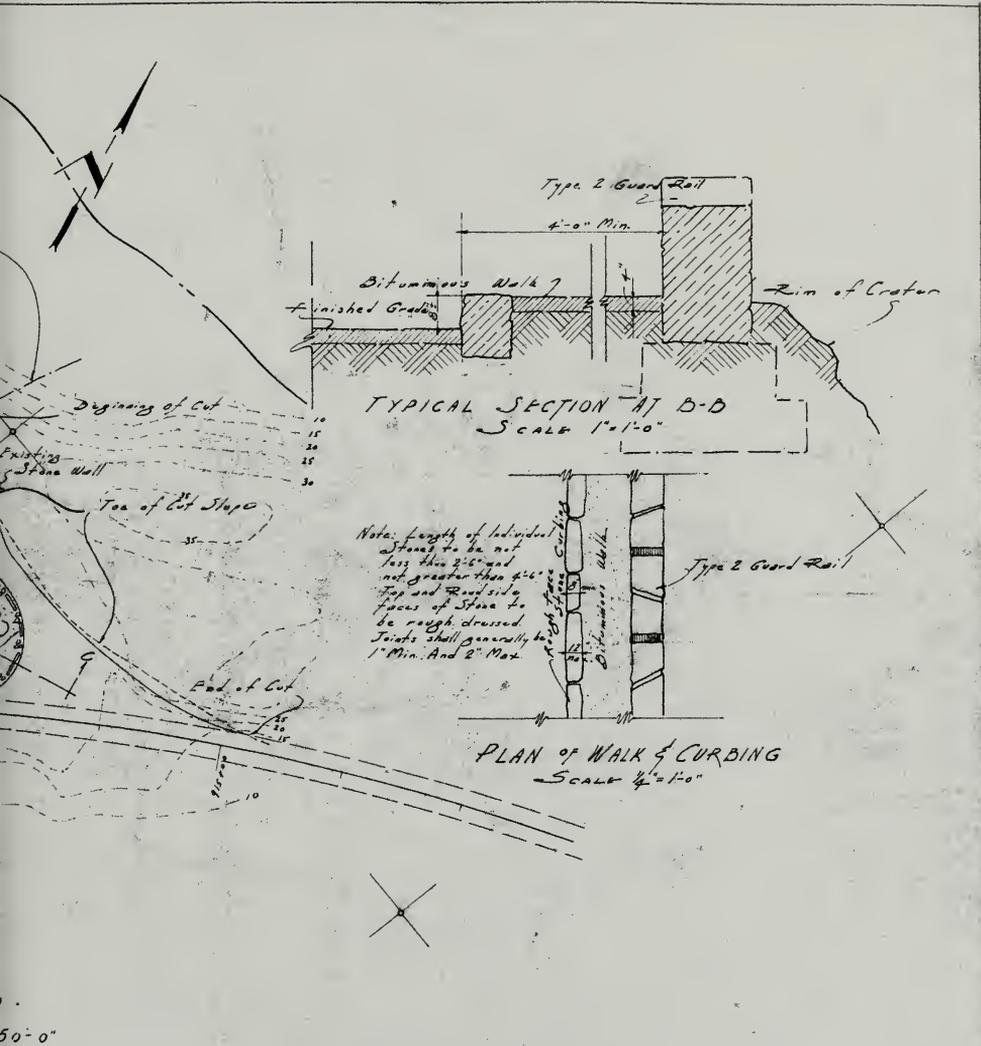
Skull Head Observation Station by Francis G. Lange, 1936. CLNPMAC 8899.

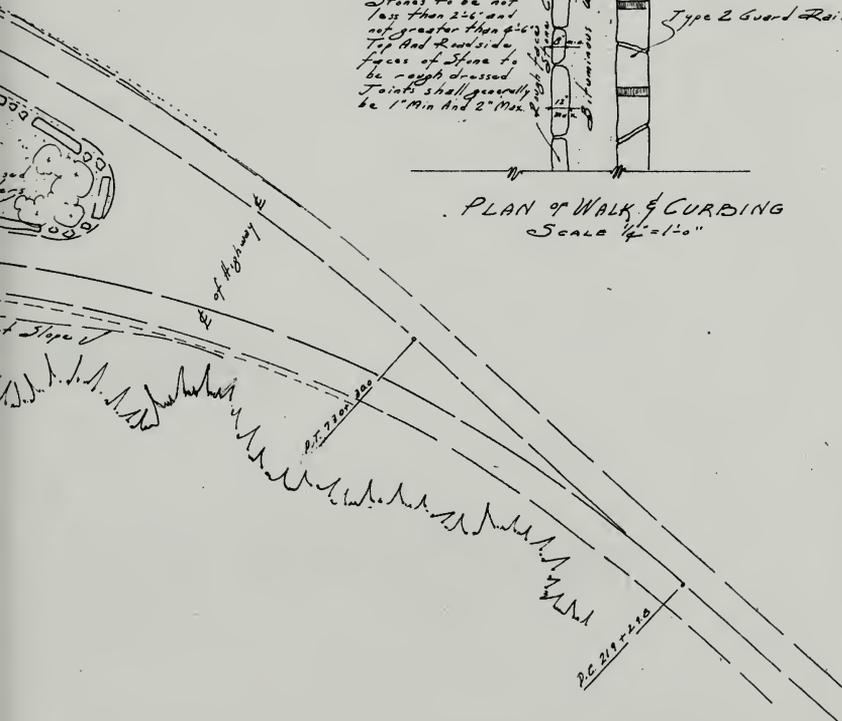
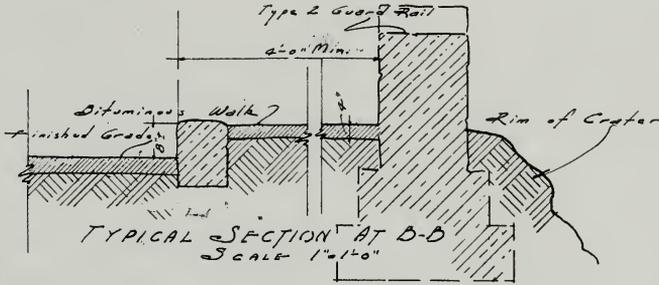
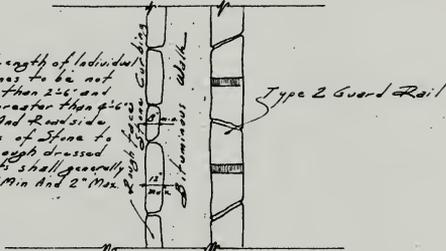
PLAN FOR  
 PARKING AREA AT CLOUD CAP  
 RIM OF CRATER F-01 UNIT  
 CRATER LAKE NATIONAL PARK  
 DRAWING OF PLANS & DESIGN  
 NATIONAL PARK SERVICE  
 November 30, 1936

Note: Length of individual Stones to be not less than 2'-6" and not greater than 3'-0". Top and Bottom of face of Stone to be rough dressed. Joints shall generally be 1" Min and 2" Max.

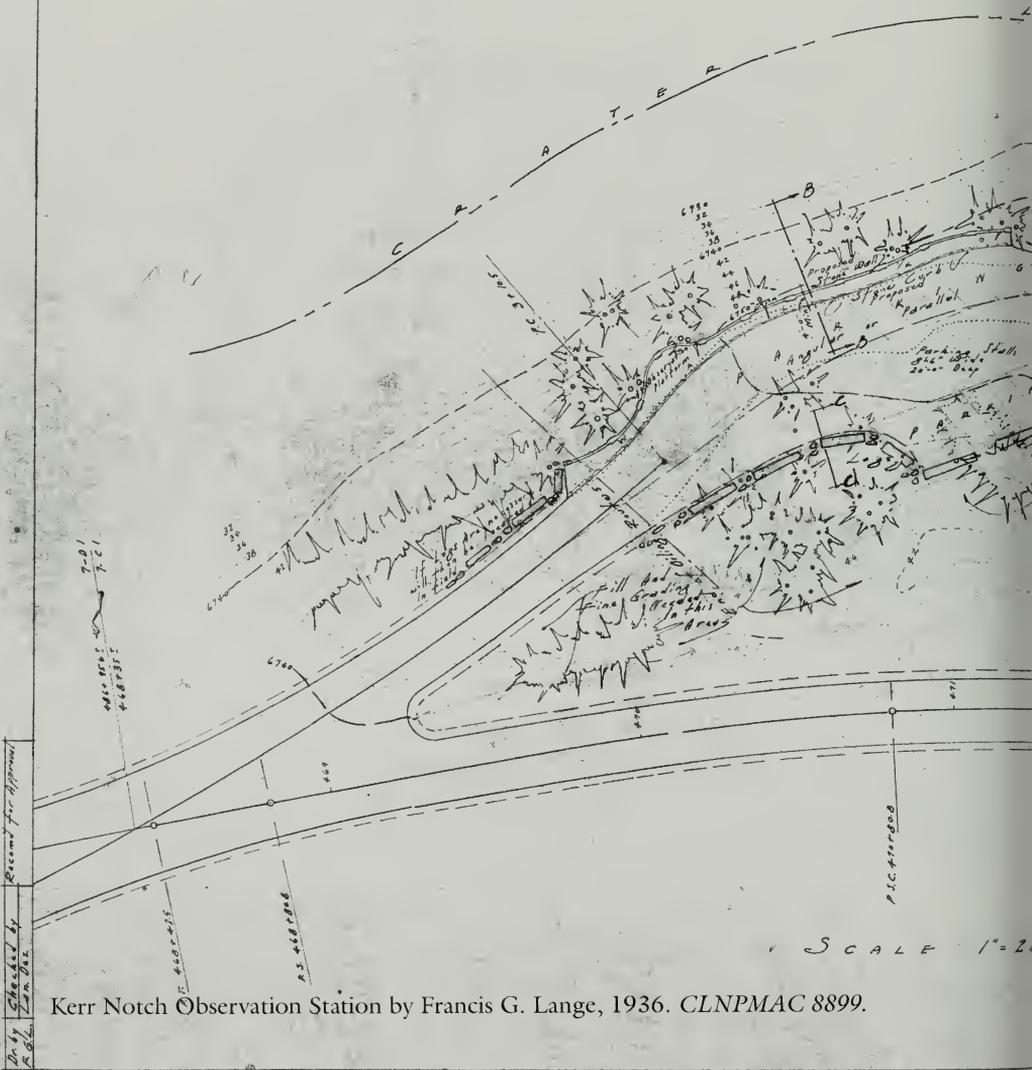
Kerr Notch Observation Station by Francis G. Lange, 1936. CLNPMAC 8899.

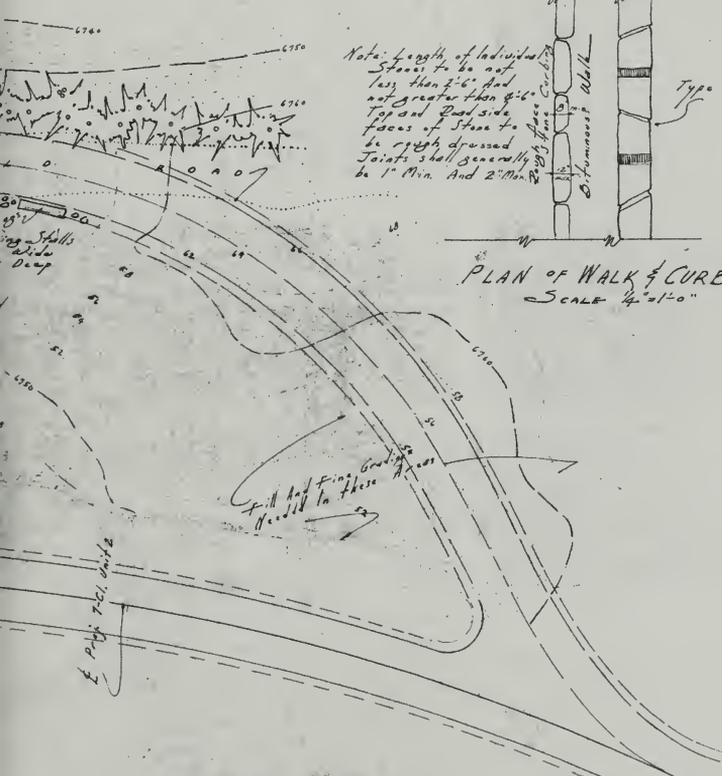
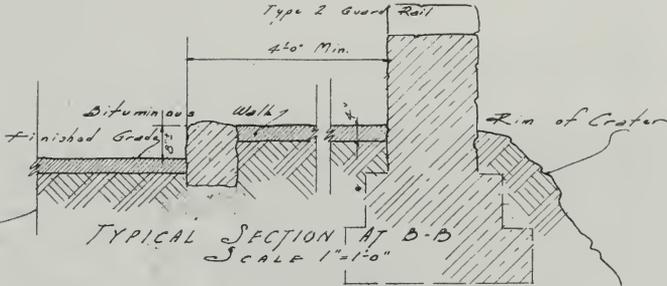
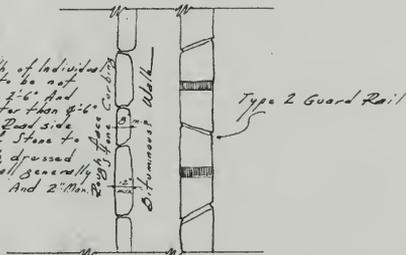
PLAN FOR  
PARKING AREA AT KERR NOTCH  
CALM ROAD PROJECT T.C.I. UNIT 2  
CRATER LAKE NATIONAL PARK  
BRANCH OF PLANS & DESIGN  
NATIONAL PARK SERVICE  
NOVEMBER 30 - 1936

Note: Length of individual  
Staves to be not  
less than 2'-6" and  
not greater than 3'-6"  
Top and End side  
faces of Staves to  
be rough dressed  
Joints shall generally  
be 1" Min. and 2" Max.

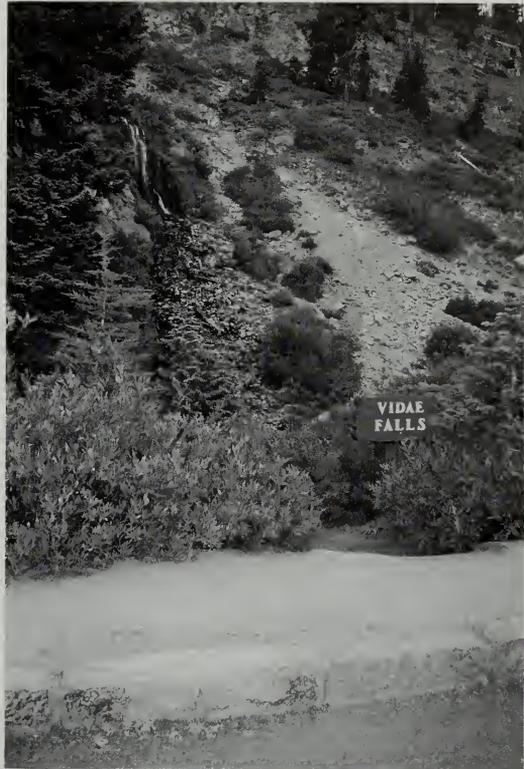
Vidae Falls Parking Area by Francis G. Lange, 1939. Plan view shows location of irrigation lines for plantings on fill. CLNPMAC 10137.

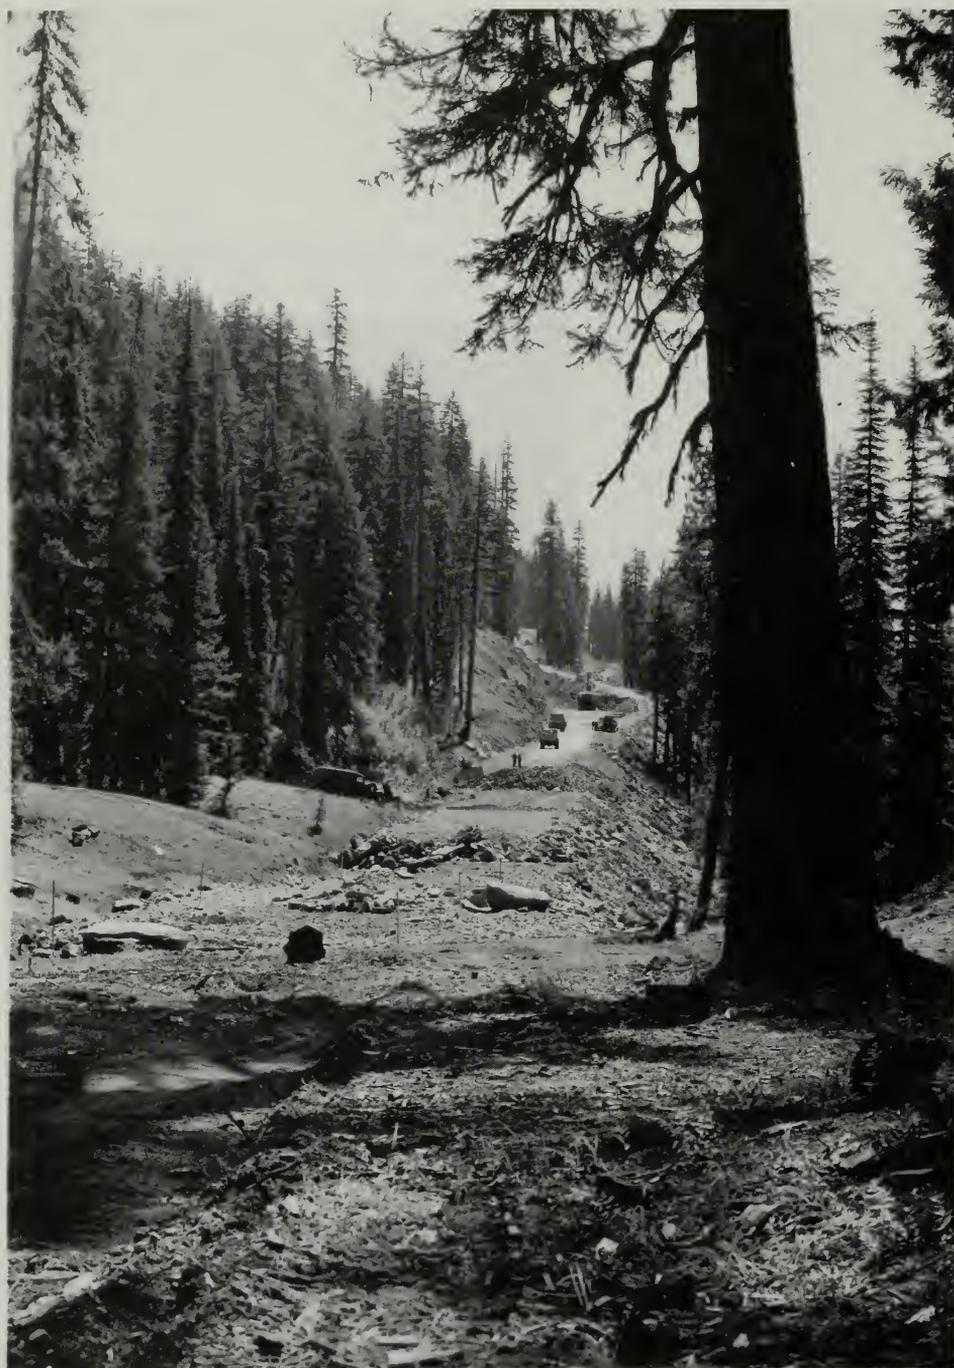
Road construction east of the Castle Crest Wildflower Garden, 1939. *Struble, BPR.*
