Technical Preservation Services
Preservation Assistance Division
National Park Service
U.S. Department of the Interior
Washington, D.C.

Interpreting the Secretary of the Interior's Standards for Rehabilitation

Volume II

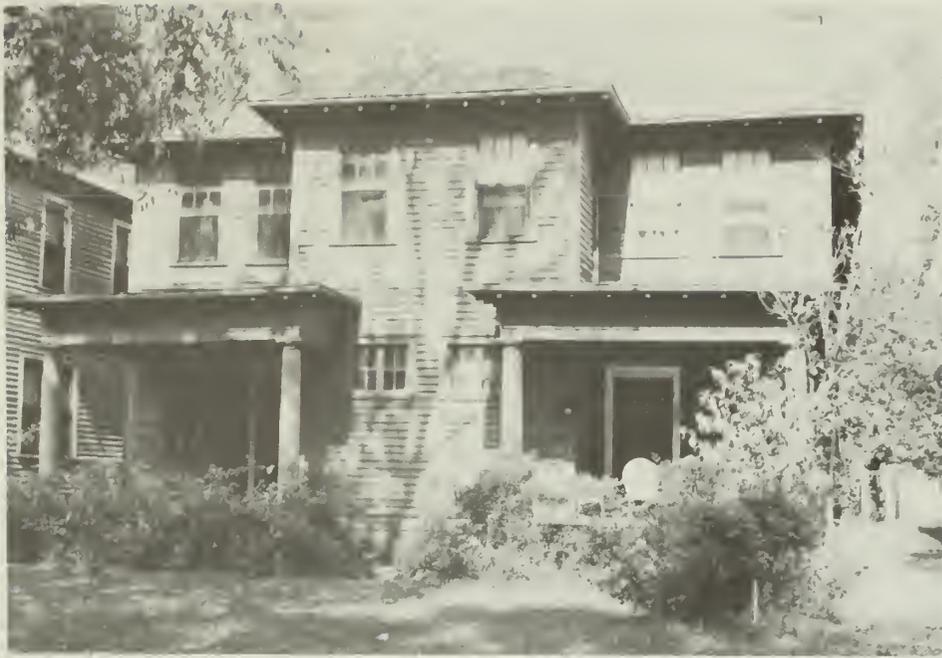
1. Prior to rehabilitation, the historic twin porch design and center projecting bay were strong architectural features.

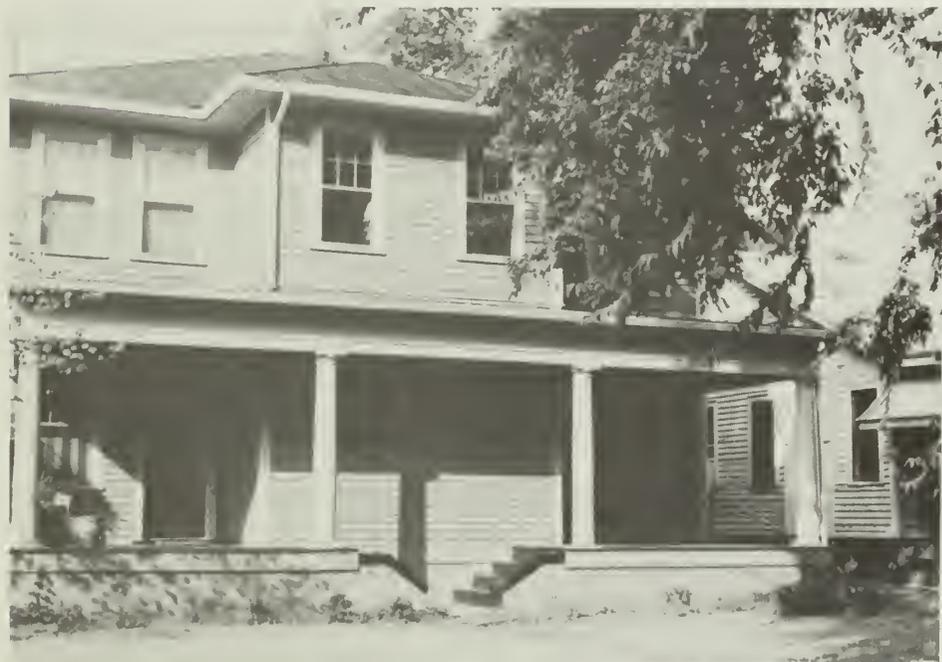
2. In connecting the two historic porches, the twin porch design was lost; a strong horizontal element was created by the large continuous porch; and the sense of a duplex building was diminished. To obtain certification, the owner agreed to restore the porch.

The sole justification for the porch alteration was the need to alleviate water accumulation at the steps. Traditionally, such porch roofs were pitched away from the steps and the building in order to properly shed water; the owner should have thus repaired the porch and added gutters and downspouts, as necessary, to correct the water problem.

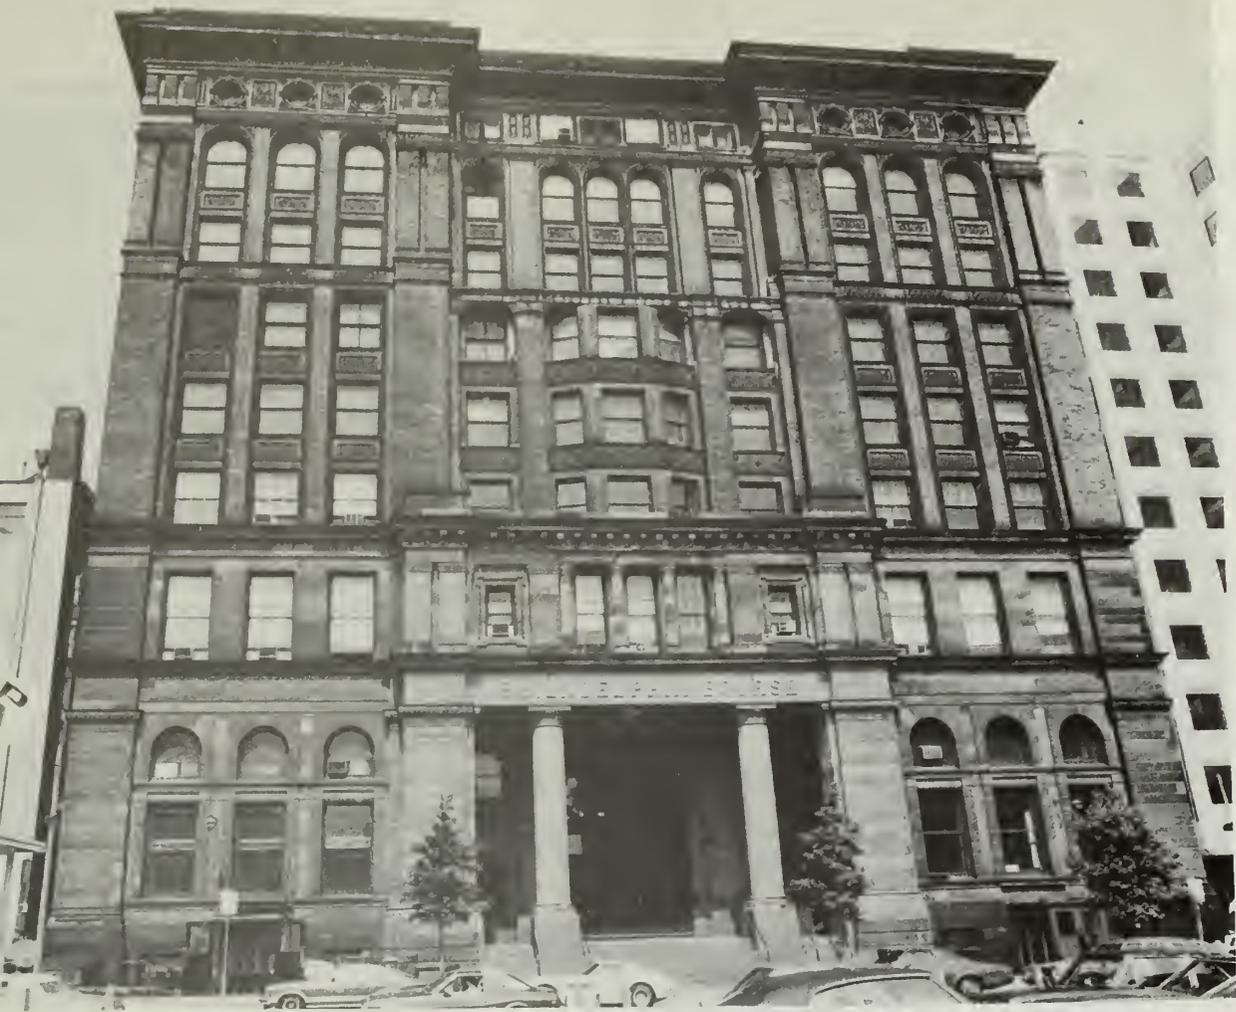
1. East elevation showing wooden vestibules flanking main entrance, added c. 1920.

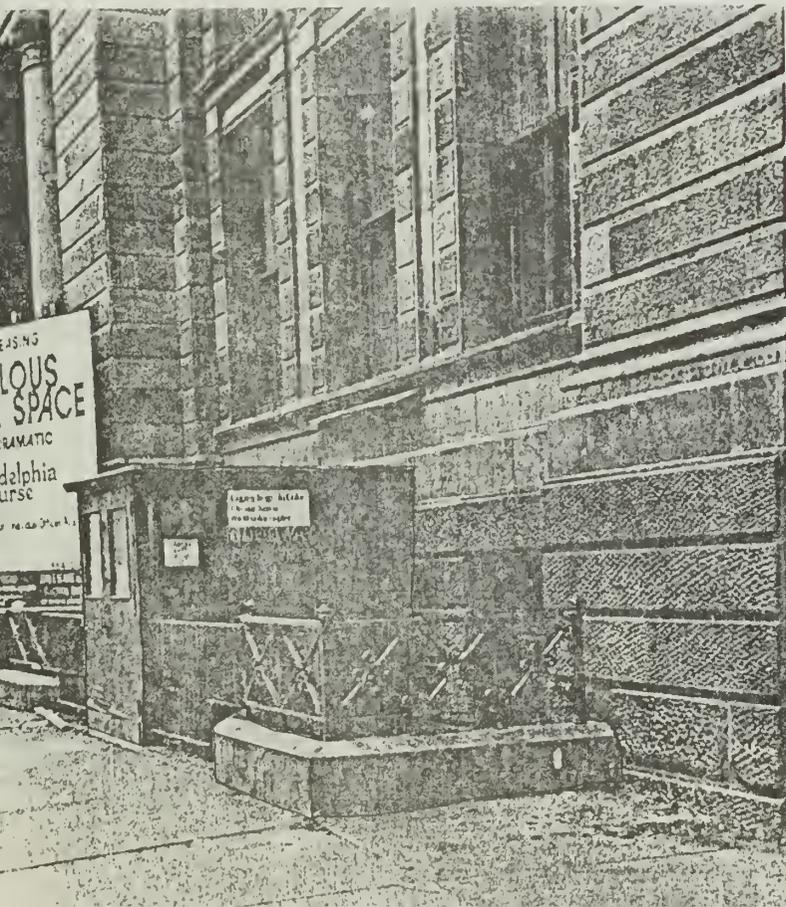
2. Deteriorated condition of vestibule.

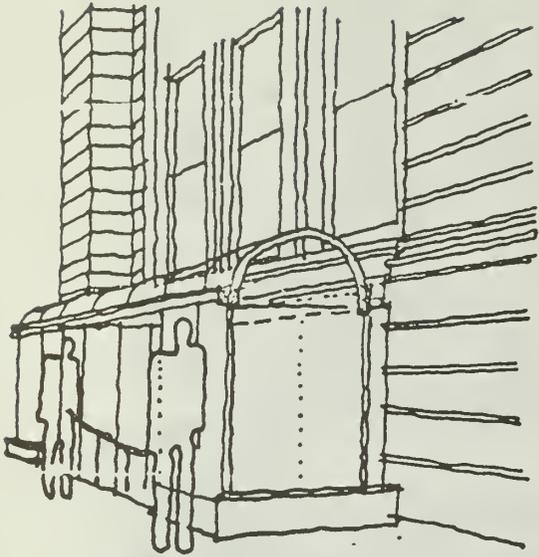
3. Initial canopy design was not approved by NPS because its height obscured the first floor windows.

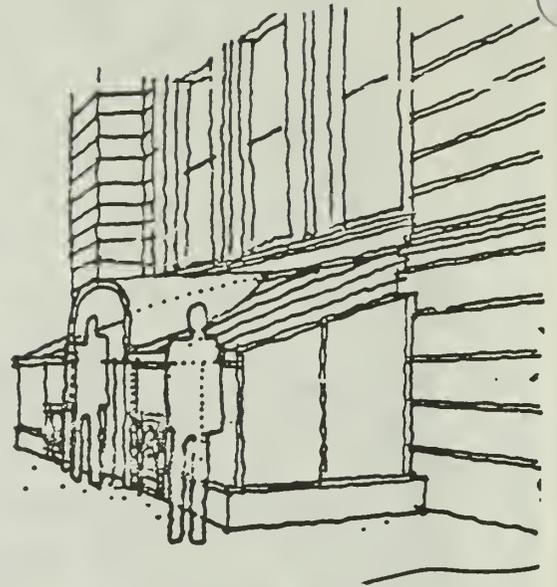
4. Revised canopy design met the NPS height condition but introduced potential pedestrian safety problems.

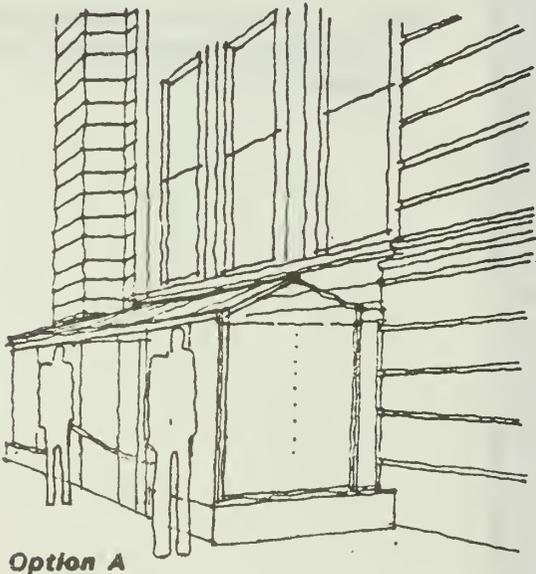
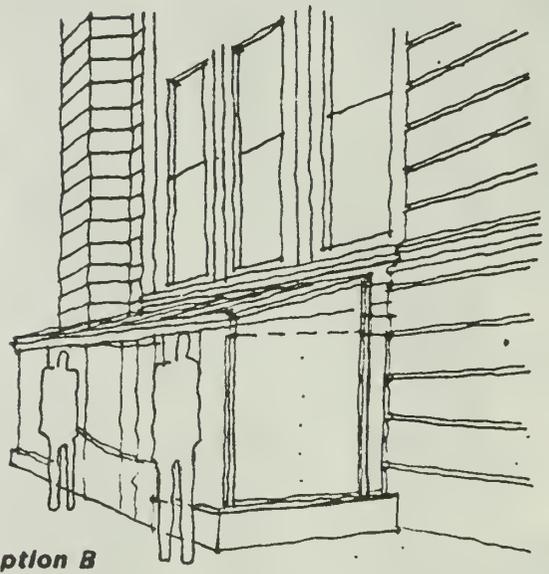
5. Final canopy designs (Option A and B), both of which NPS approved. The Option A design was ultimately constructed.

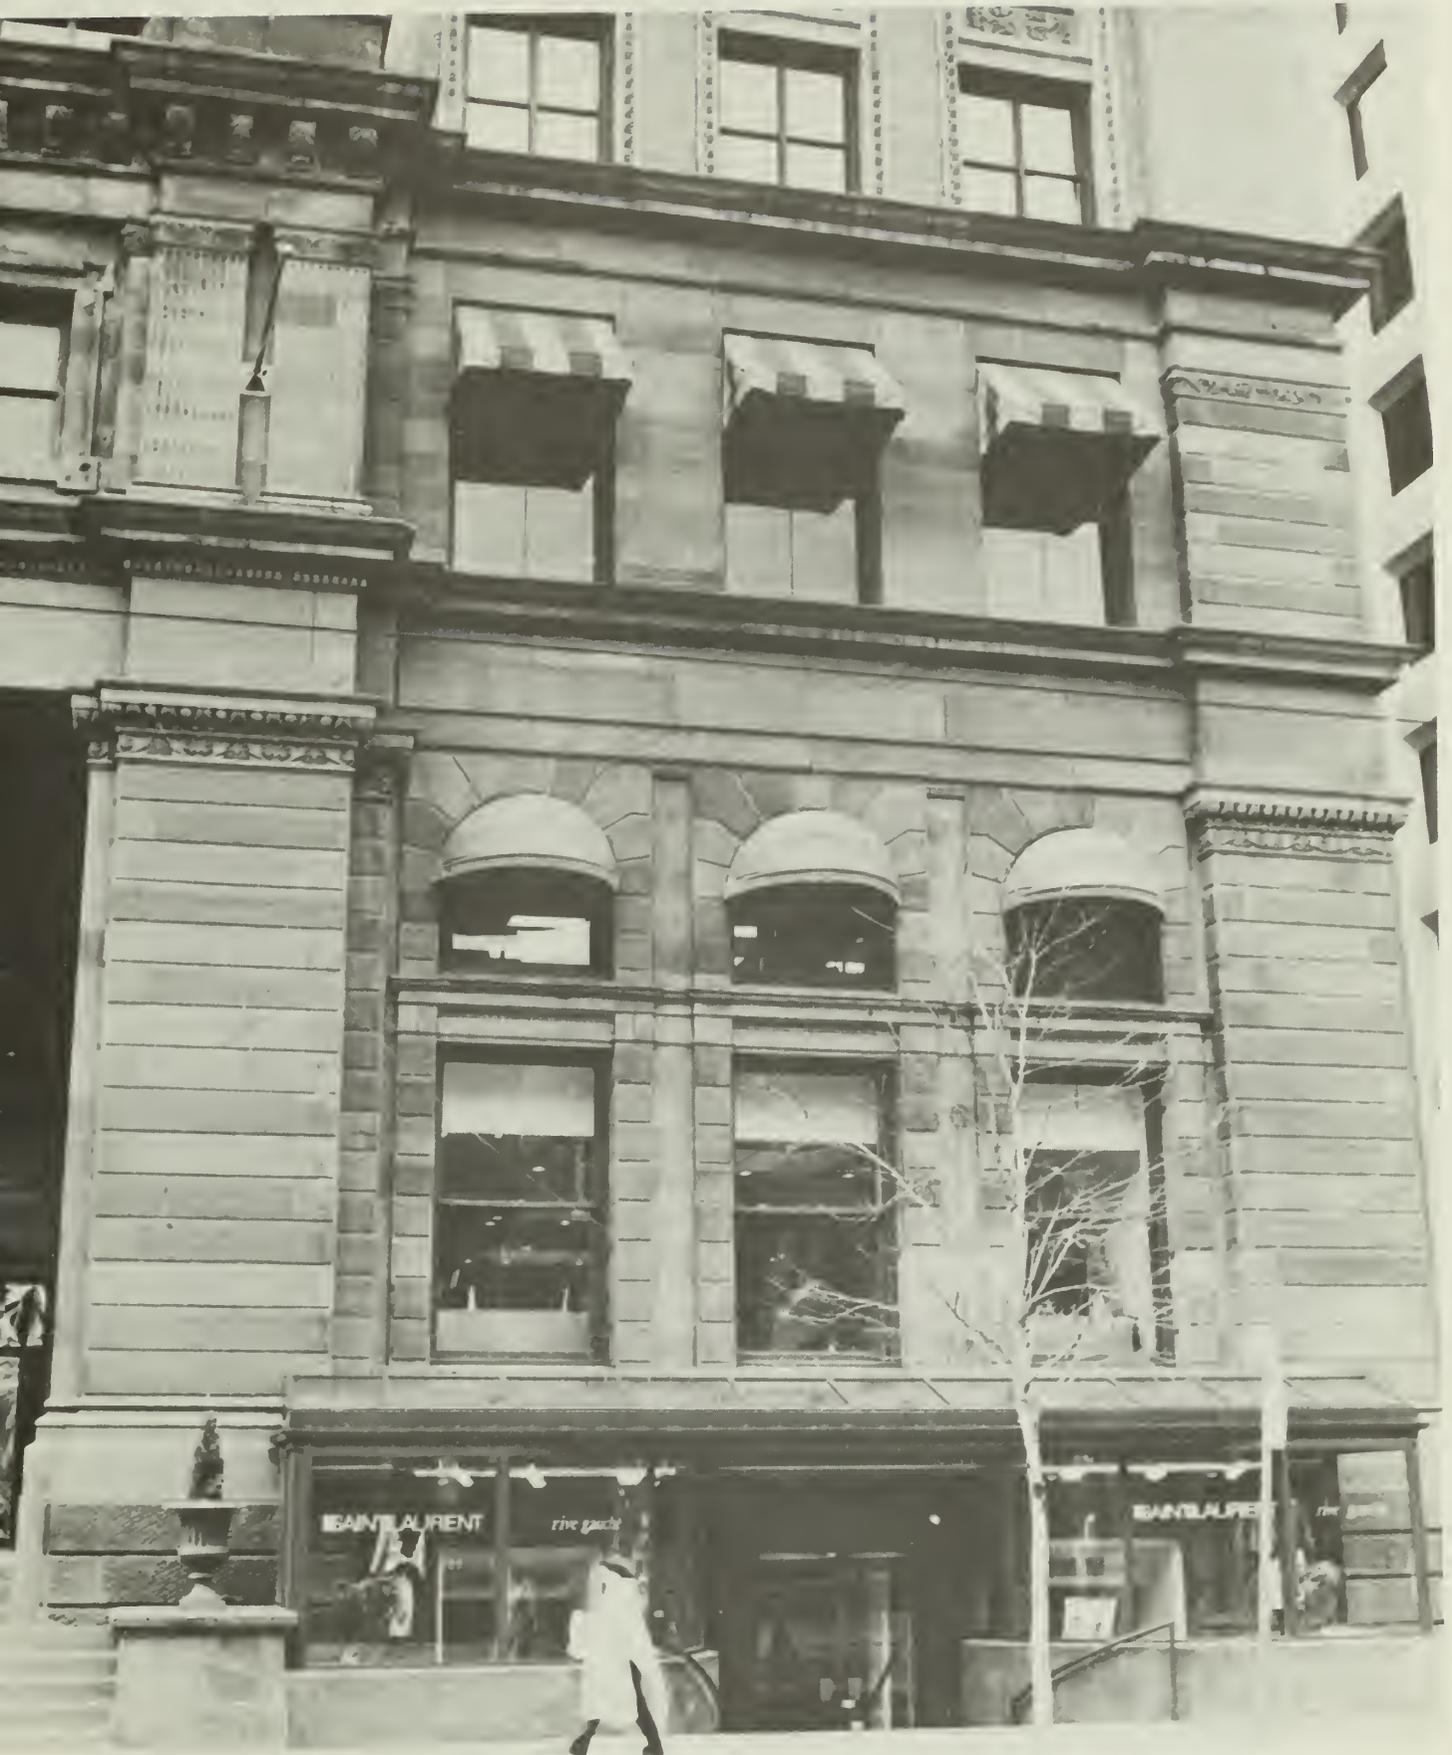
6. The Option A entrance canopy in place.

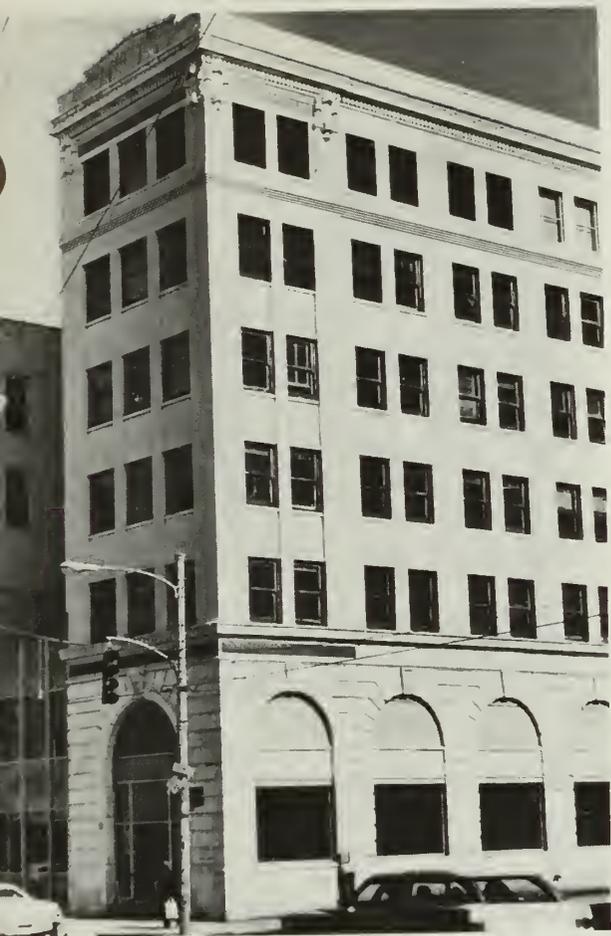
1. The original windows were of clear glazing and were of a one over one pane configuration.

The owner was further advised by NPS that the original double-hung wooden windows were typical of the time in terms of technology and design consideration and for the building were a significant feature. As such, the windows should have been repaired and if that was not practical, the replacement units should have matched the configuration of the original double hung sash and the reflective qualities of the glass. Representatives from both the state historic preservation office and the NPS regional office inspected the completed project and observed major changes in the design and the reflective qualities of the windows. With the new dark tinted glass and dark trim finish, the windows now appear as dark voids, contrasting with the white glazed brickwork. The denial of certification by the regional office was sustained on appeal by the owner.

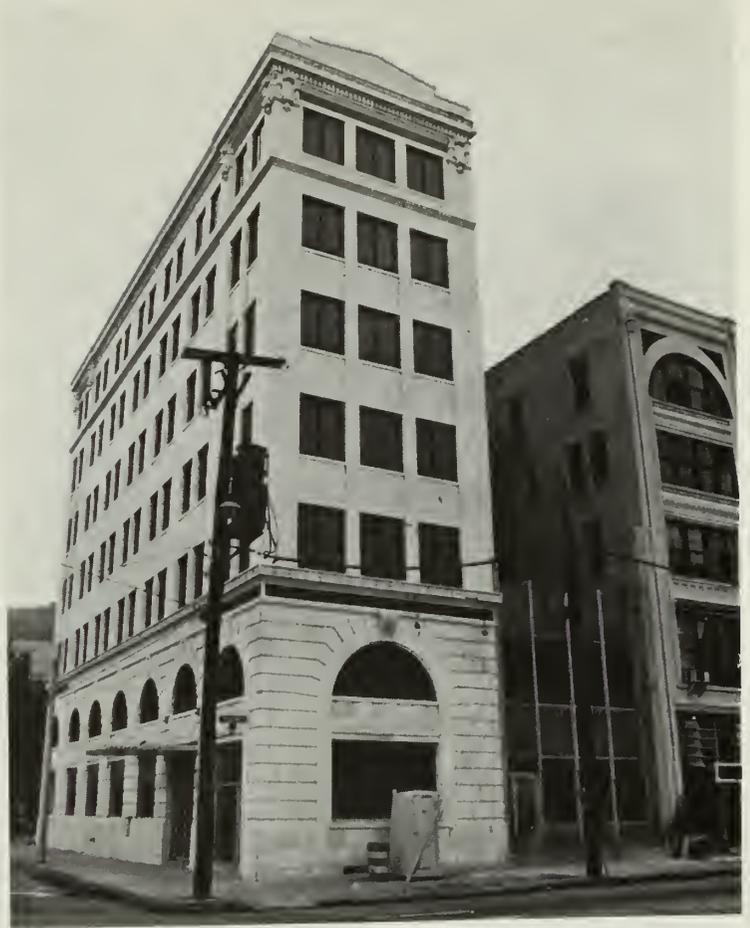
2. New windows with dark tinted glass and a vertical division on the upper floors were not in keeping with the character of the building.

In the course of rehabilitating the building for mixed commercial and residential use, the double-hung clear-glazed wooden windows were removed (and stored) and replaced with metal windows with a single vertical division created by a meeting rail. In addition, a dark tinted glass was used in place of the original clear glazing (see illus. 2 and 3). The change in the design and the use of dark tinted glass gave the new windows a strong contemporary look not in keeping with the historic character of the building. Upon submitting a certification application, the owner was advised that the window alterations did not meet numbers 2, 5, 6 and 9 of the Secretary's Standards.

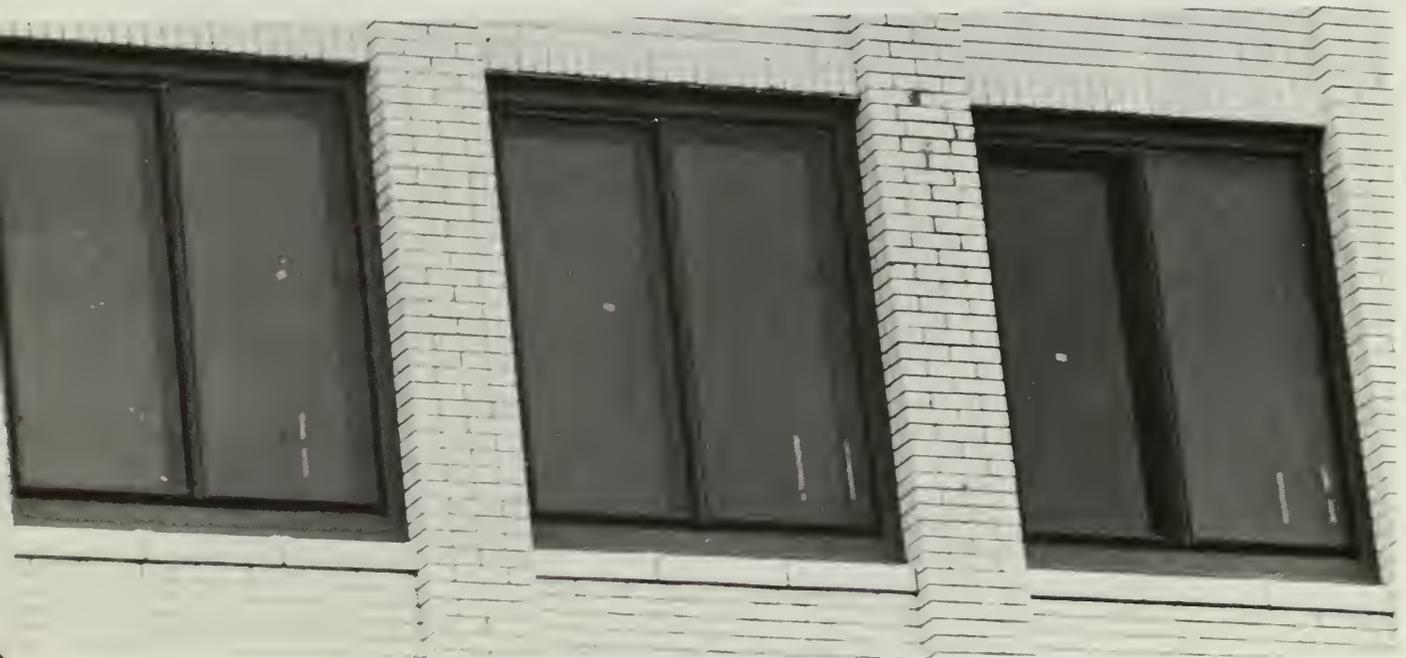
3. Close-up view shows the vertical division used in the new windows.

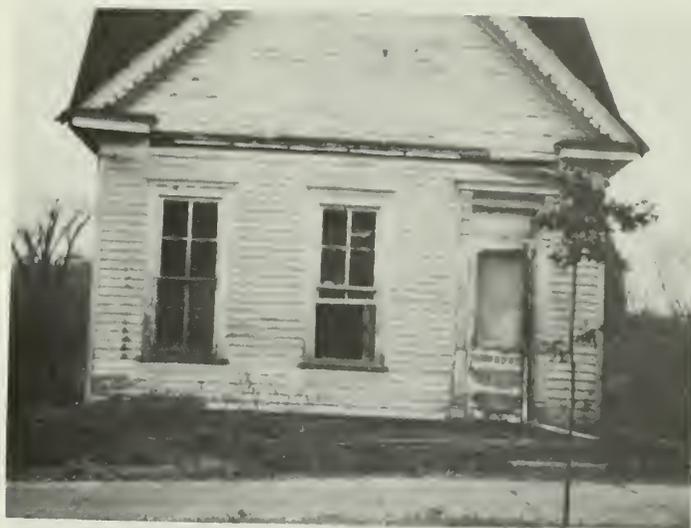
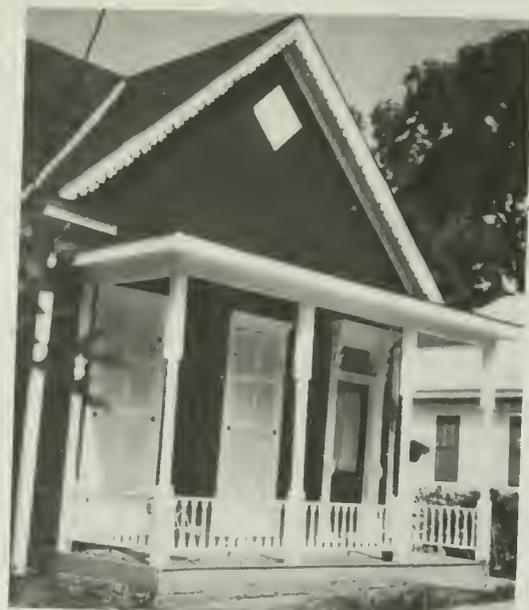
4. The 1880s cottage was in deteriorated condition prior to rehabilitation. Ghost marks of missing porch are evident. The original 2 over 2 windows had survived on the front and were to be repaired according to the plans submitted to NPS for prior review.

5. In the course of rehabilitation the owner elected to remove the original windows and install new ones in a historic design which extended to the first floor. Full-length blinds were also added.

Plans for the rehabilitation of a small late nineteenth century cottage, located in a historic district in the South, were submitted prior to undertaking the work. After the determination was made by NPS that the proposed work met the Standards, the owner elected to revise the plans to include the removal of the two original first floor windows and subsequent replacement with floor-to-ceiling windows (see illus. 4 and 5). Upon completing the work and requesting final certification the owner was advised by NPS that the introduction of the new sash and exterior shutters which extend to the porch floor created a design feature that never existed in this particular structure and gave the building an inappropriate historic appearance. Moreover, NPS indicated to the owner that this particular type of window generally was found in buildings of an earlier period in that area.

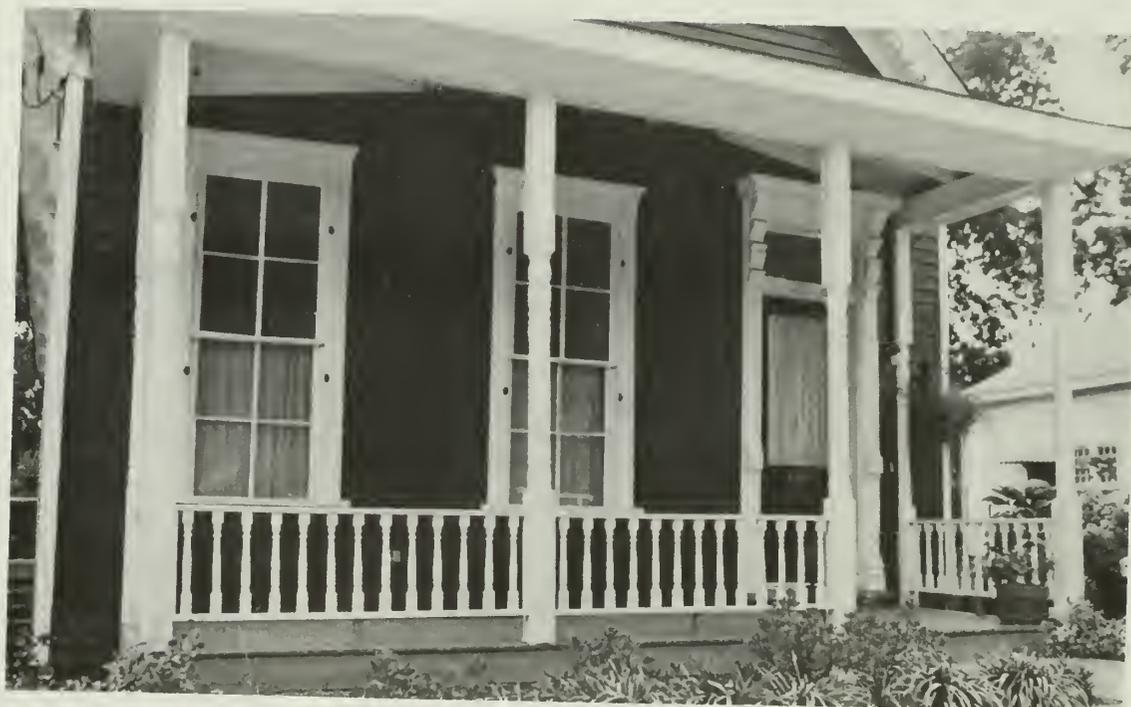
6. After the work was determined not to meet the Standards because of the window alterations, the owner proceeded to reinstall the original ones and thus obtained certification.

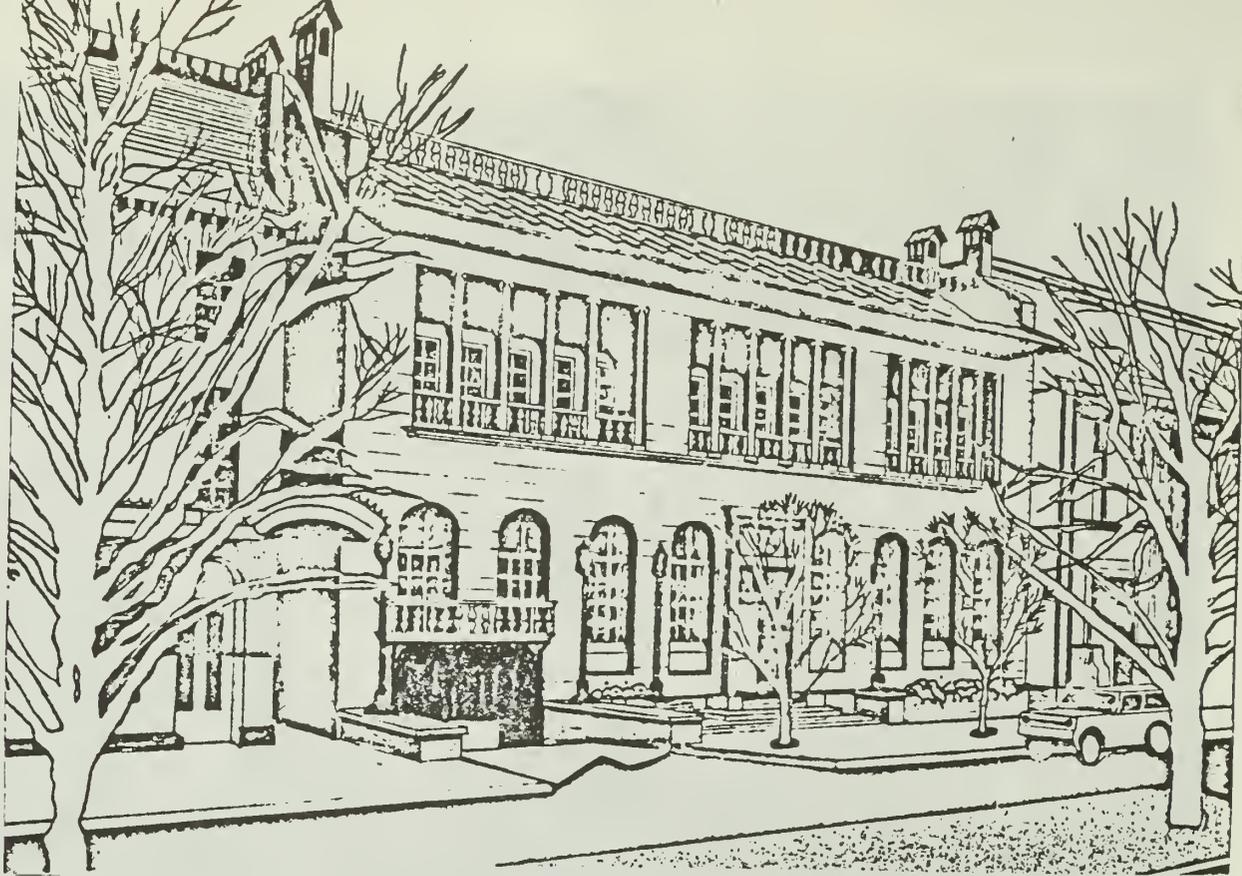
3. The original parking entrance proposed for the facade. The balustrade over the entrance was intended to serve as a visual "connector" to similar original features on the facade. The library slated for partial demolition is located behind the proposed entrance.

The introduction of the garage entrance on the principal facade alters the character of that well-detailed, Second Renaissance Revival-style facade. Not only does it result in the demolition and removal of historic material of significance, but it would also interrupt the rhythm and balance that is characteristic of this symmetrical facade (Standard 2). In addition, significant architectural features of the library--the bookcases, fireplace mantel, and decorative frieze--would be lost if the garage entrance is constructed as proposed (Standard 5). The Standards recommend a compatible use for a building that requires minimal alteration (Standard 1). Parking which requires a major opening on a principal facade cannot be considered a compatible use requiring minimal alterations. It is irreversible and destroys the form and integrity of that facade. The essential form and integrity of the structure should be unimpaired should alterations be removed in the future (Standard 10). While this office recognizes the arguments presented on the parking issue, the rehabilitation still must be consistent with the historic character of the structure and the Standards.

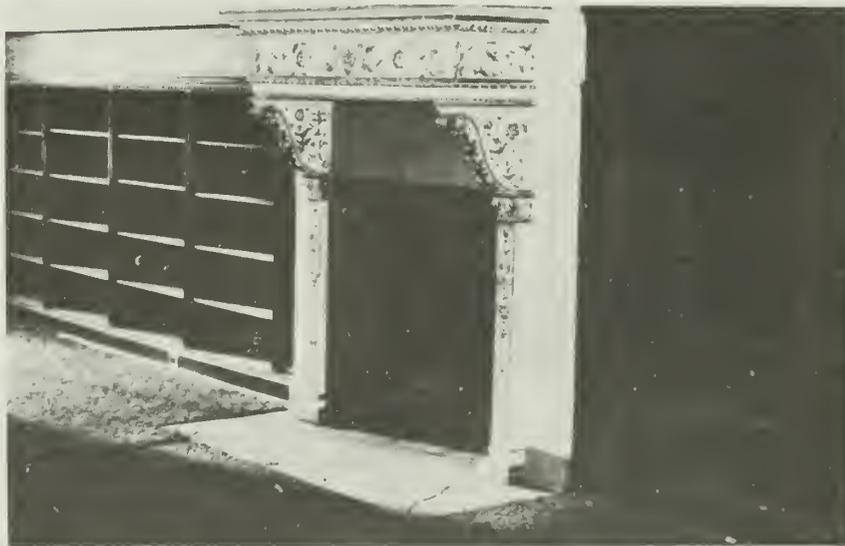
4. The parking entrance through the library would have necessitated removal of the fireplace and bookshelves.

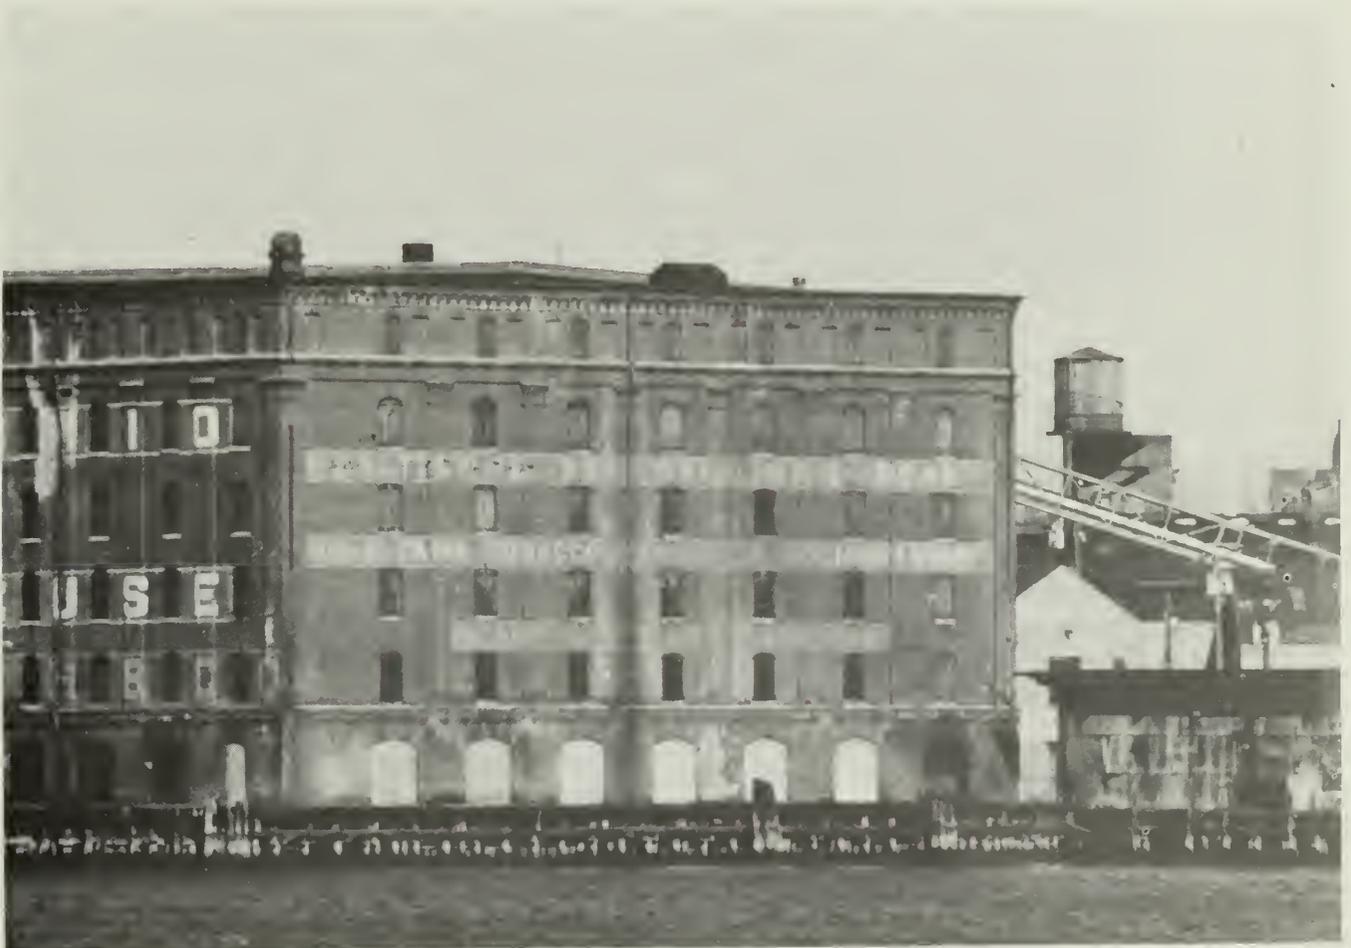
1. The existing south elevation of the 1890s warehouse building with its alternating bands of pilasters and window openings. The size of the openings decreases as the building progresses from the base to the top floor. The brickwork was quite sophisticated for a warehouse structure.

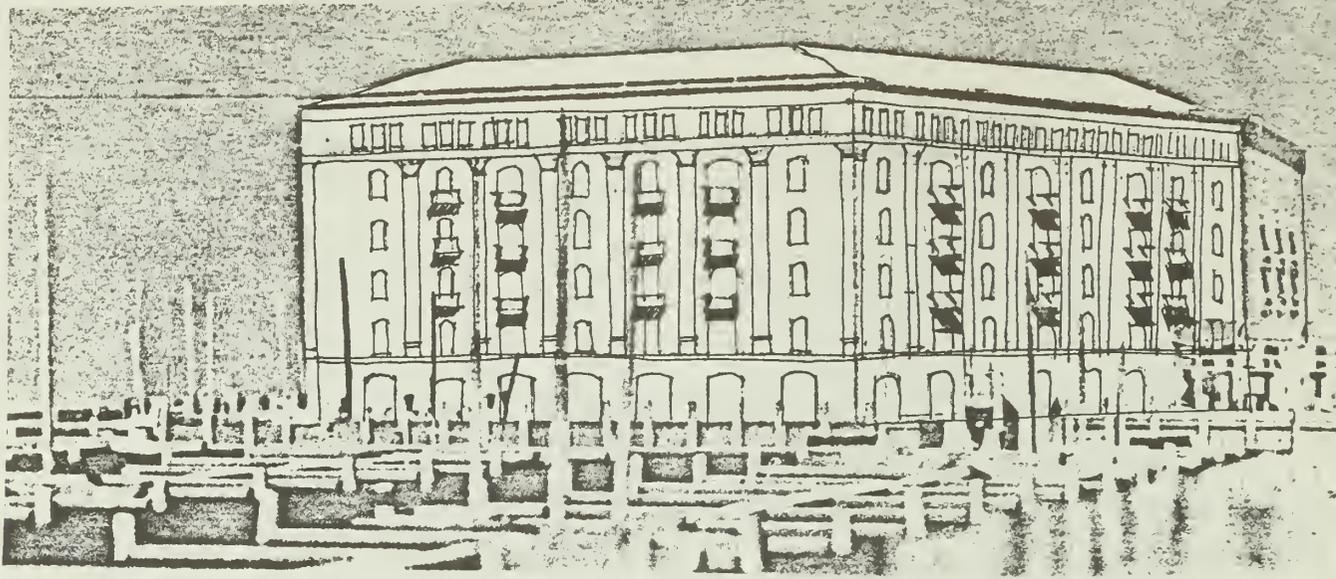
2. The proposed south elevation with bands of projecting balconies. The window openings would be widened or lengthened in order for each of the 204 apartment units to have one balcony. Not only would the windows be altered in selective bands, but the proposed balconies would create deep shadow lines on the facade. While the owner felt that the balconies were a reversible feature that could be removed in the future, the hearing officer determined that both the visual clutter of the balconies and the change in the hierarchy of the window openings did not meet the Standards.

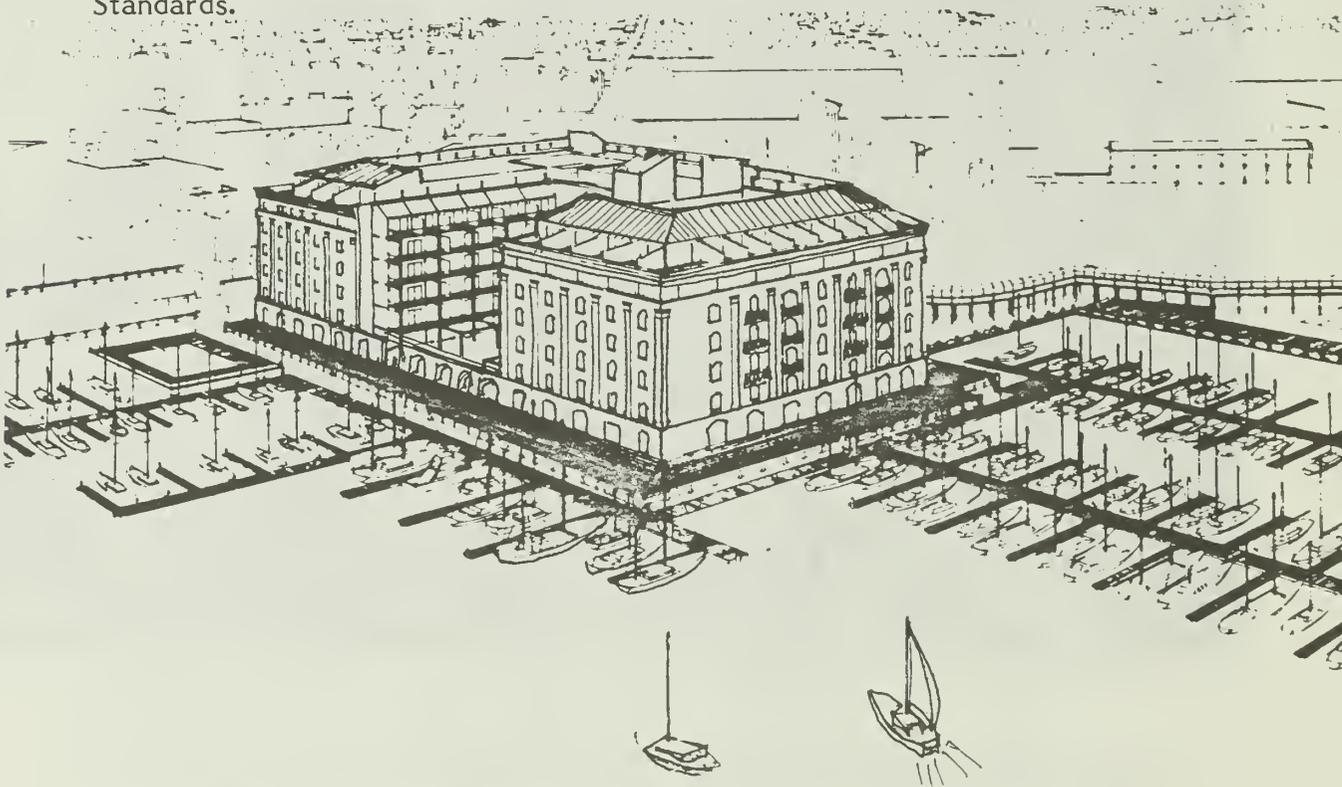
3. Perspective view of the proposed changes shows the large courtyard and the removal of seven bays of the waterfront facade in order to provide a water view for 85% of the apartment units. The hearing officer determined that the loss of significant original historic material and the drastic change in character created with the new "U" shaped plan did not meet the Standards. The projecting balconies and widened windows were also cited as not meeting the Standards. The setback rooftop addition, however, was not a concern as it would not have been visible from the street level of the historic district.

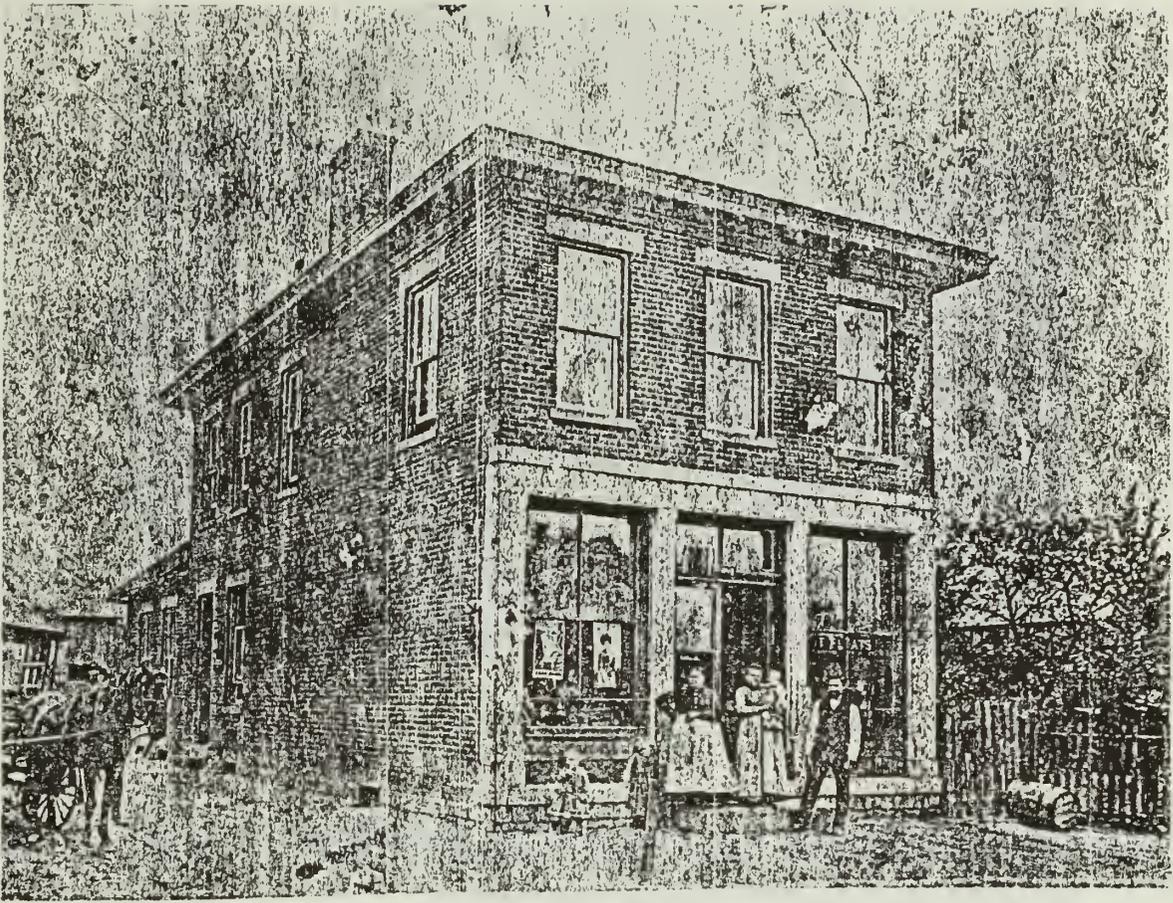
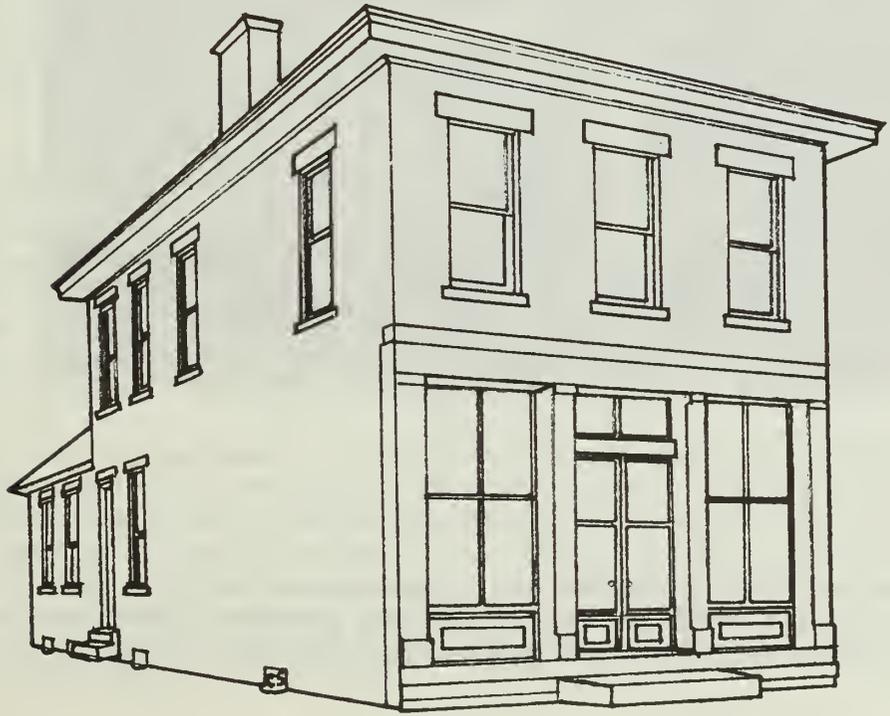
1a. and 1b. Historic photograph (1a) showing original three-bay storefront building (ca.1880-1890). With minor alterations, this storefront survived until most recent rehabilitation. Side door led to second floor apartments. Drawing (1b) shows the building's main features clearly.

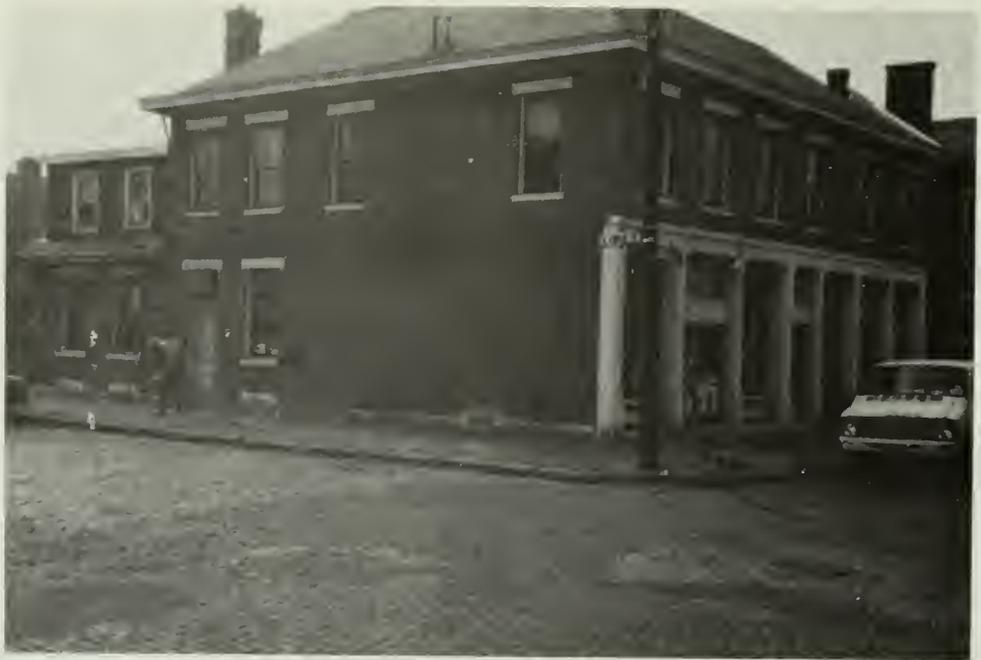
2a. and 2b. Building as it looked after ca. 1900 enlargement. Two identical storefronts (double doors flanked by window bays) were separated by a bay containing a single door.

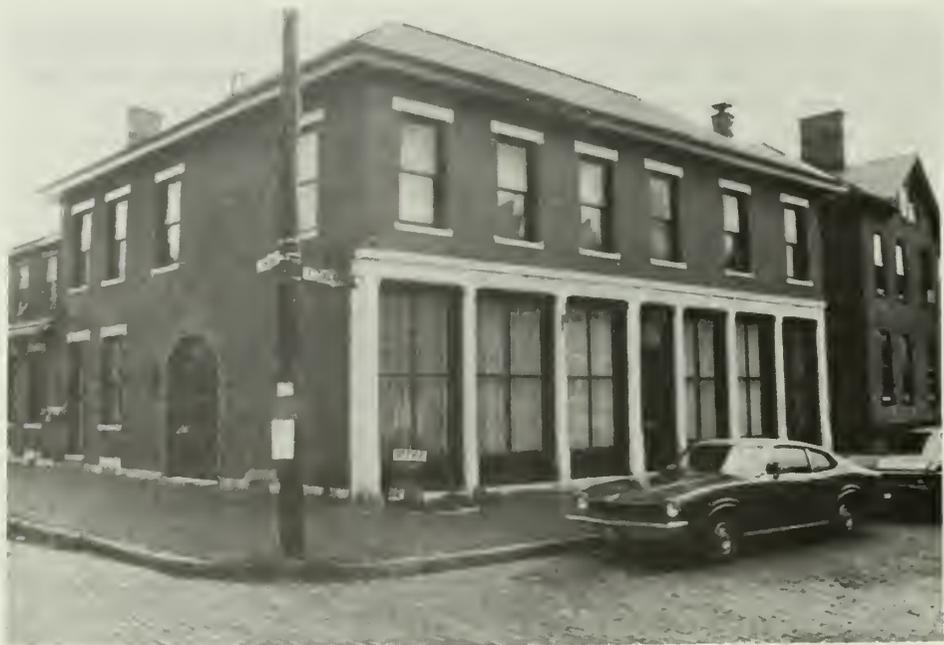
3a. and 3b. After rehabilitation. Double doors on the front have been replaced with windows, an arched side entrance has been cut, and the former side entrance has been replaced with a window.

In the most recent rehabilitation, which converted the building to office space, the owners replaced the two sets of double doors with windows copied from those existing in other bays of the storefronts. To accommodate ground floor offices, an arched entrance was added to the side elevation (see illus. 3). The design for this doorway echoed an interior doorway and an arched entrance on a neighboring building. The original side entrance was replaced with a window.

Upon appeal, the decision of the regional office was sustained. The chief appeals officer noted that the "two entrances were an important part of the commercial character and architectural detailing of the storefront facade." Furthermore, the "functional relationship of the storefront facade to the partially blank wall on the ground floor of the /side/ facade also reflected the commercial use within this portion of the building." The new entrance on this facade introduced a major new design element into the "strong rectilinear character of the building." This change further diminished the importance of the storefront to the structure.

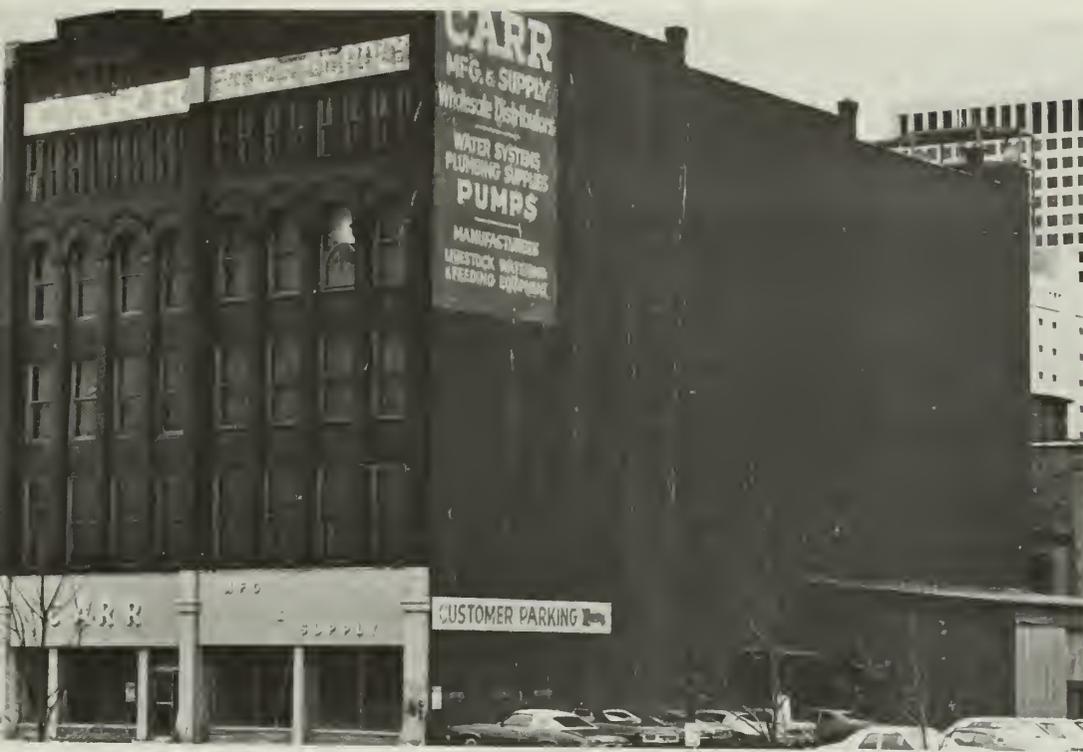
1. North and west facades of warehouse.
The 1960's storefronts are non-significant.

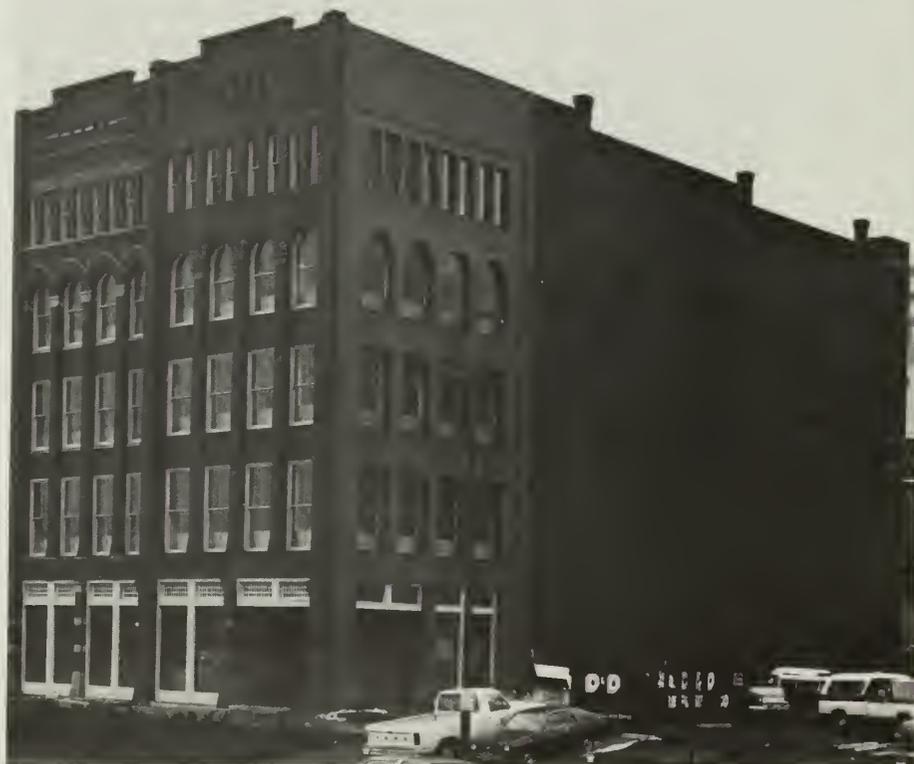
2. New windows and entrance on west facade. Certification was conditional upon owner adding a wooden column in center of westernmost storefront.

The rehabilitation, developed in close cooperation with the State, incorporates the new window openings into the rebuilt section of the west wall. The new windows are similar in size, shape, and rhythm to the windows on the primary north wall but the brickwork, sash, and glazing are clearly contemporary. The new brickwork is a slightly different color from the original and flush around the new windows rather than projecting; the sash is aluminum and a different color from the original, and the glazing is single-light. In rehabilitating the north facade, the owner carefully repaired the existing 2-over-2 wooden double-hung sash (see illus. 2).

The non-significant 1960's storefronts were removed and replacement storefronts were constructed, although the new use of the building might not include retail on the first floor. The replacement storefronts incorporate new matching brick and stone piers and new wooden windows and multi-light transoms. The newly constructed west wall also incorporates two "storefront bays" but uses a less decorative brick pier and plain transoms in order to continue the differentiation between the historic north facade and the contemporary section of the west wall. The entrance was moved from its 1960's location in the center of the north facade to the northwest corner of the building. Access is through open storefront bays from both the north and west which create a recessed entrance at the corner of the building (see illus. 2).
