Technical Preservation Services
Preservation Assistance Division
National Park Service
U.S. Department of the Interior
Washington, D.C.

Interpreting the Secretary of the Interior's Standards for Rehabilitation

Volume II

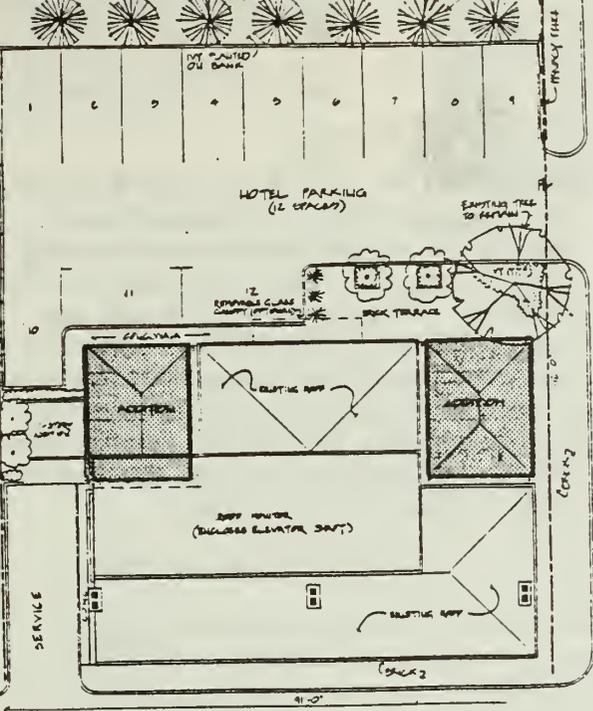
Illustration #1. Site Plan

The proposed two rear additions would change the plan from a "T" shape to a deep rectangle. In order to preserve the characteristic proportions of the Federal era, circa 1809, plan, it was determined that the new additions read as separate structures and not as a continuation of the historic structure.

In reviewing the initial application, the State office made note of several important aspects of the project that would require redesign. As a Federal era design, the pair of town houses was distinguished by narrow, one room deep "T" shaped plans. The state felt that the infilling of this plan should not give the appearance of earlier mid-Georgian plans that were heavier in mass and proportion. As such, the State recommended that the new additions read as separate structures connected to the historic resource, thereby preserving the original sense of the Federal plan. In addition, the new construction should be attached to the historic building with a minimum of damage to historic fabric so that if, in the future, the additions were to be removed, the basic form and integrity of the historic structure would remain.

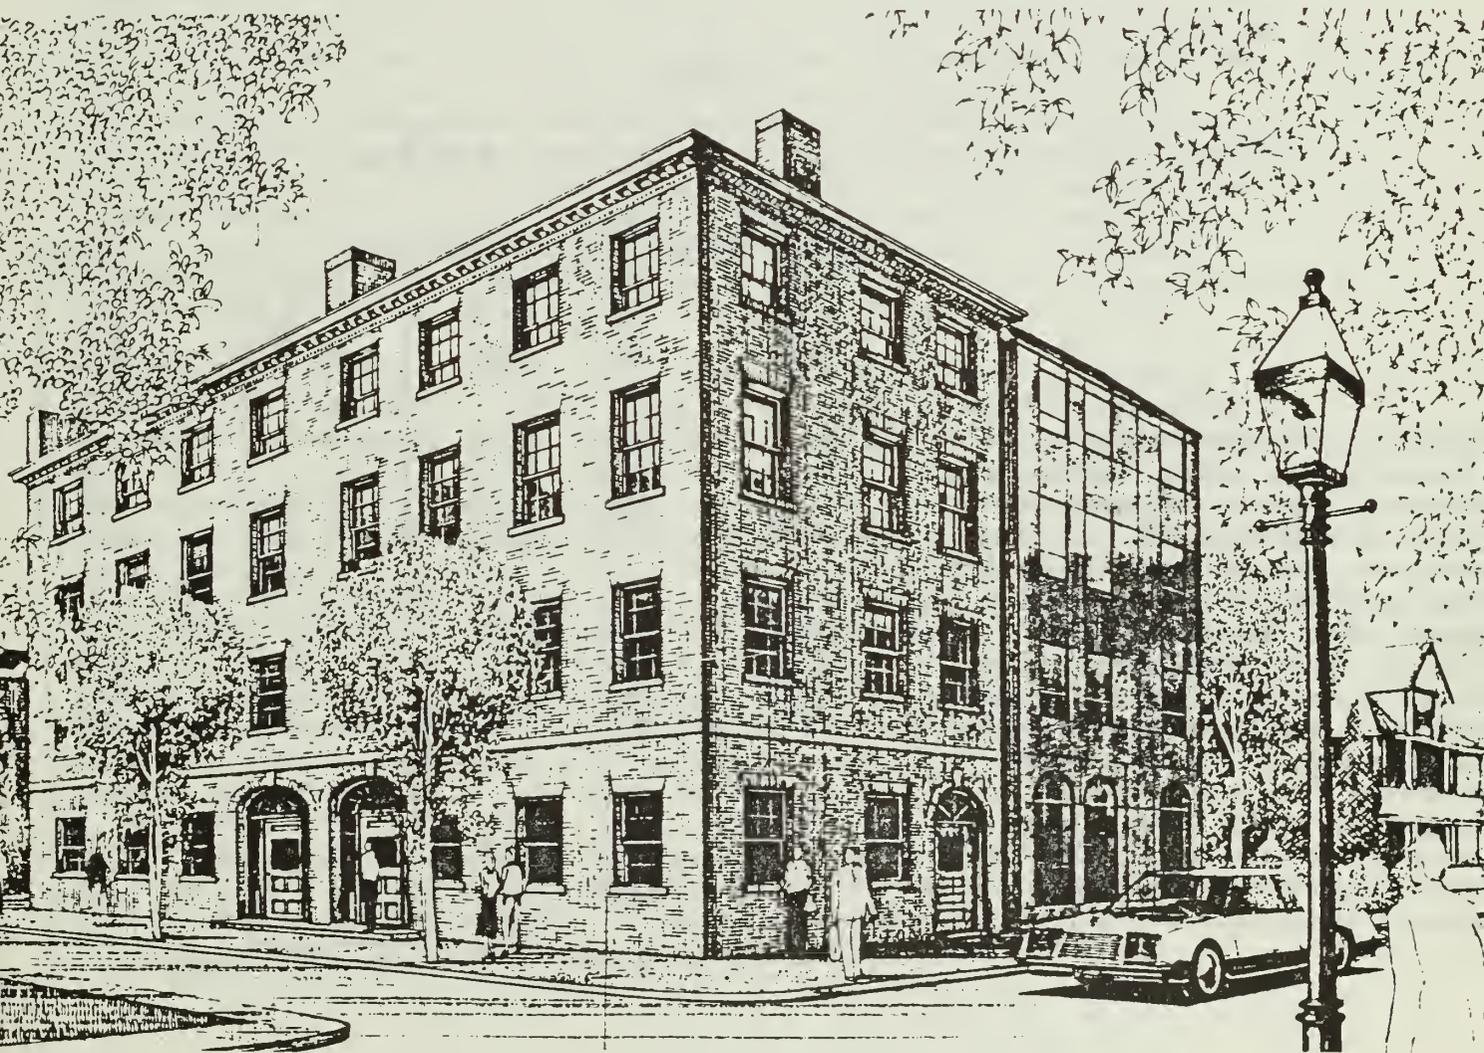
Illustration #2. PERSPECTIVE VIEW. The revised design treated the rear addition as a modern pavilion to clearly differentiate it from the historic structure.

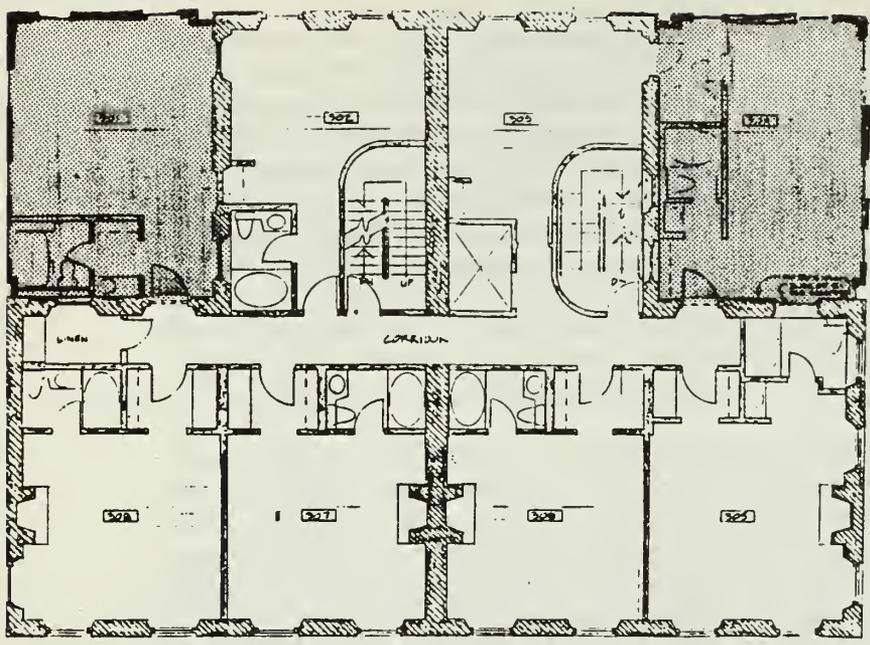
Illustration #3. TYPICAL FLOOR PLAN. The proposed infill plan (shaded) would respect the historic materials by leaving the original rear walls exposed within the new addition. The existing window and door openings would be left in place, as much as possible. In addition, recessed panels would be used as a connector infill between the original building and the additions in order to clearly differentiate the new construction from the historic structure.

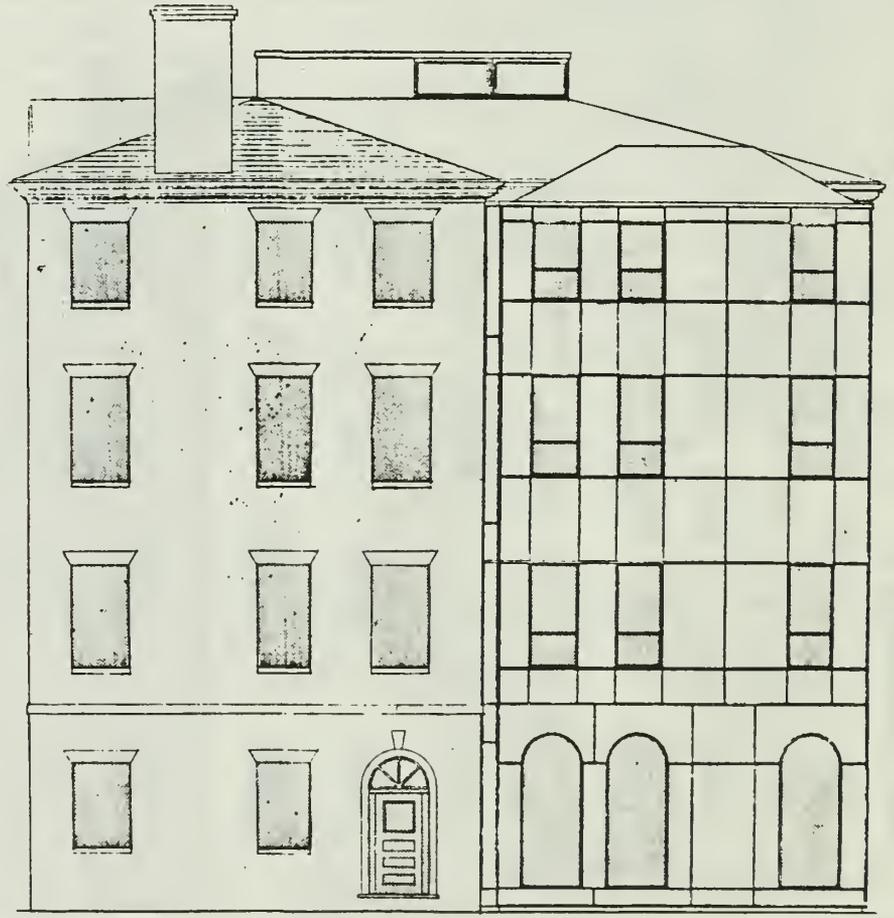
Illustration #4. ELEVATION
 The new 4 story addition visible from the street would be compatible in scale and proportion with the historic structure. The pattern of window and door openings in the new addition would reflect the rhythm in the historic facade. The use of a modern panel system, as opposed to detailed brickwork, would clearly separate the new construction from the historic resource. The use of a separate hipped roof for the addition would retain the scale of the property and would eliminate damage to the historic roof and cornice.

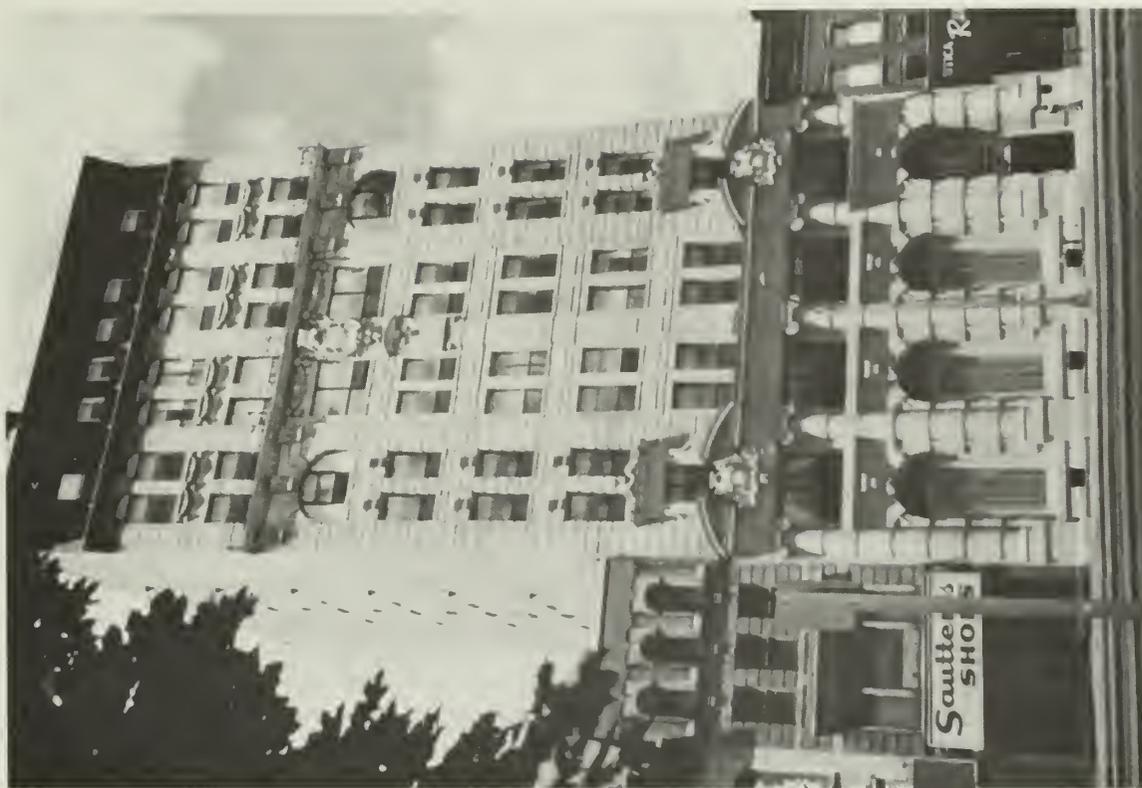
AFTER

Replacement sash now feature a lower meeting rail. The side lights in the arched windows were also replaced with fixed single pane glazing. The top floor is in a shadow; it was not altered by the project work.

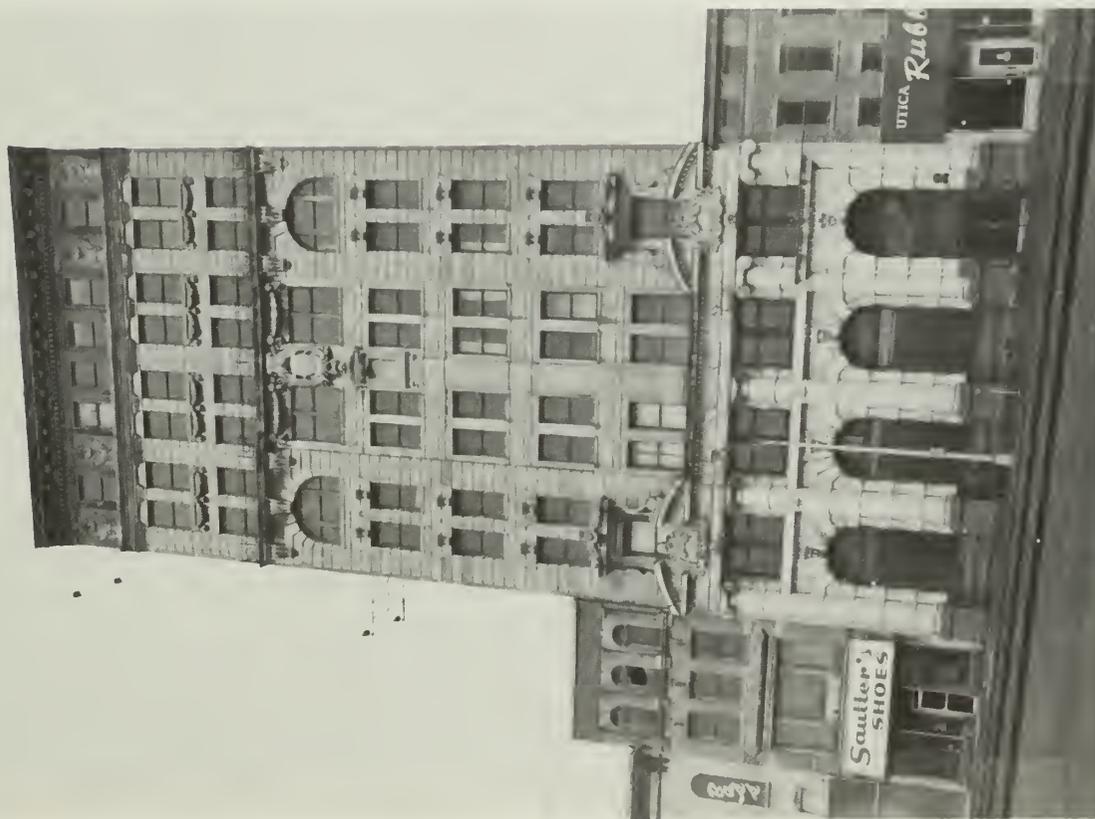
BEFORE

Original double hung window sash featured a mid-level, horizontal meeting rail.

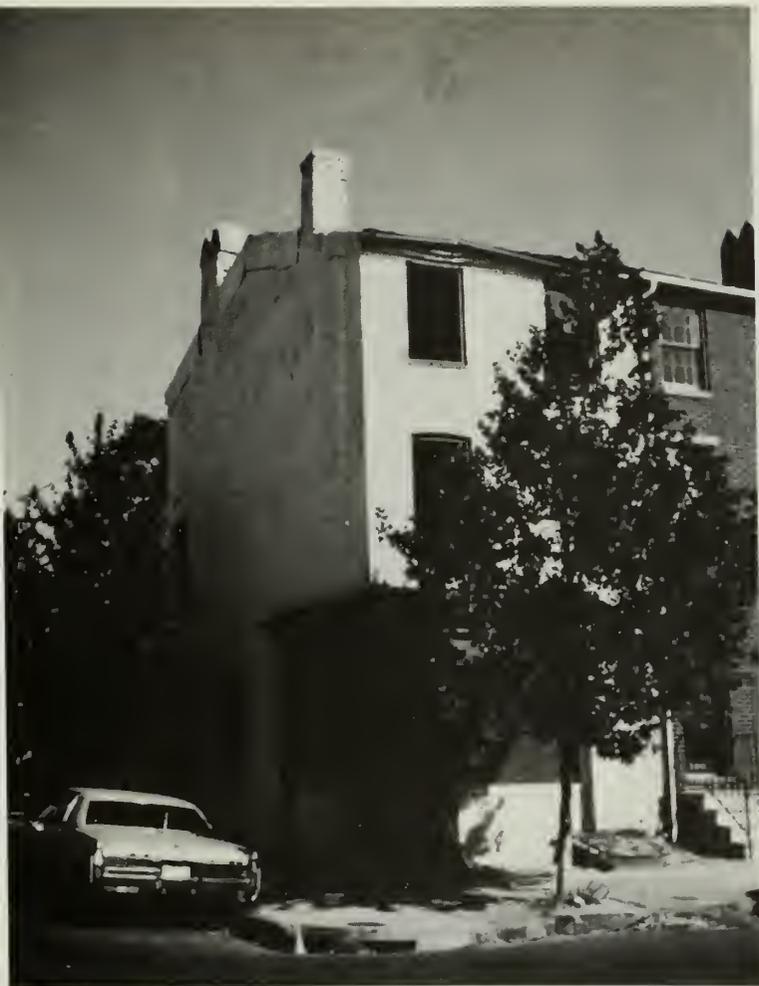
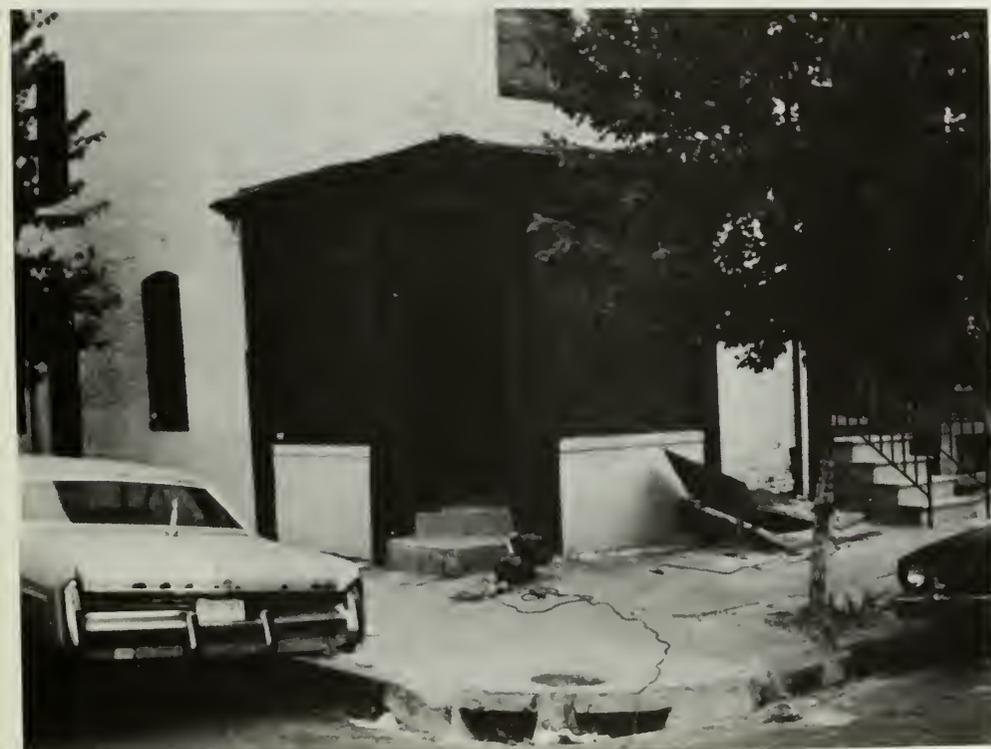
Example One

1. and 2. Before rehabilitation. The corner grocery store had its original diagonal entrance and flanking plate glass windows. Although the storefront remained intact, the base had been filled with brick and the plate glass boarded over.

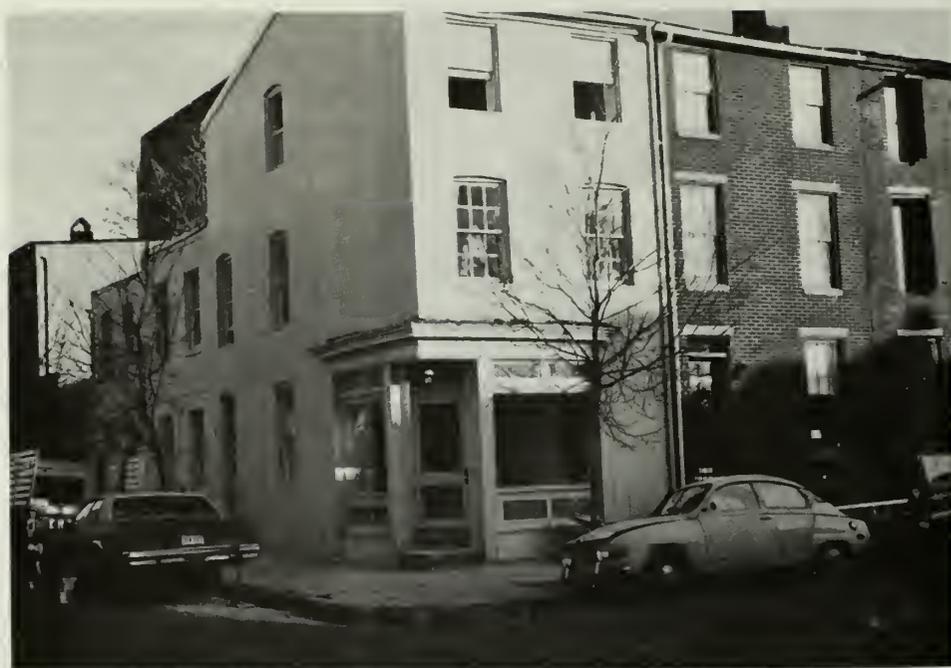
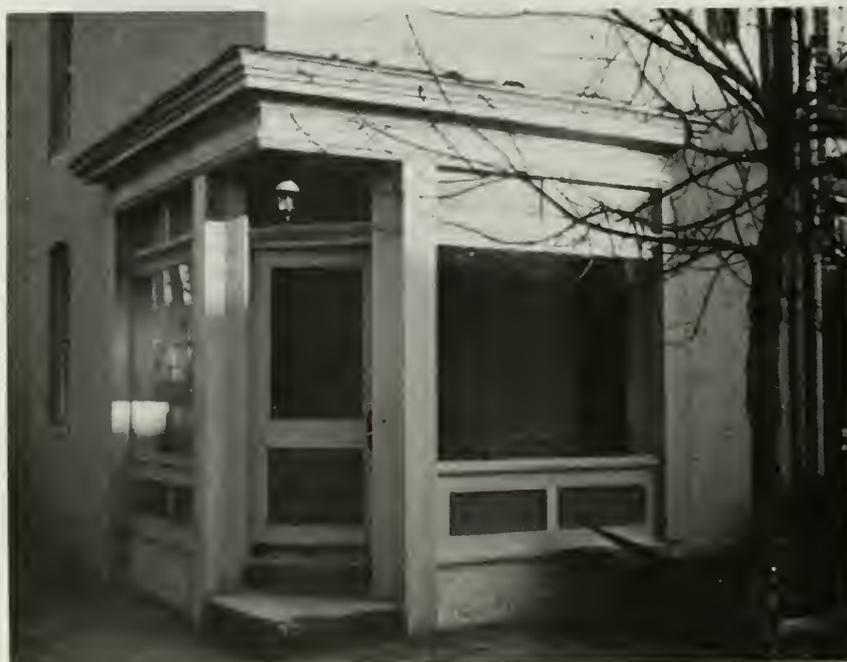
Example One.

3. and 4. After rehabilitation. In rehabilitating the original storefront, the owner installed plate glass in the large openings and transoms and replaced the brick infill with wooden panels. By retaining significant architectural features, the commercial character of the building was retained.

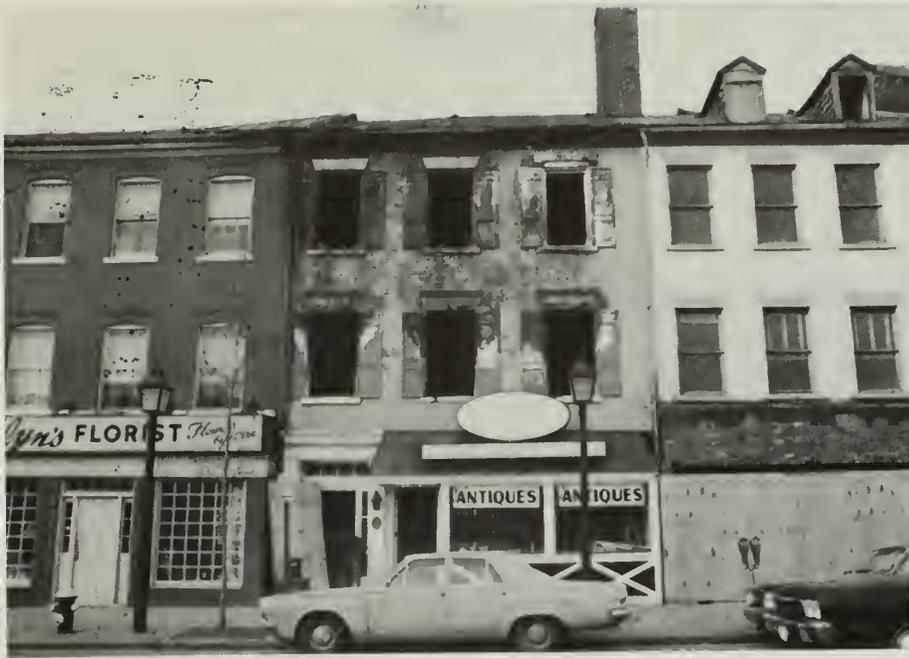
Example Two.

5. Before rehabilitation. The early 1800's rowhouse, although damaged by fire, retained its storefront. It is seen here as an integral part of a row of commercial structures.

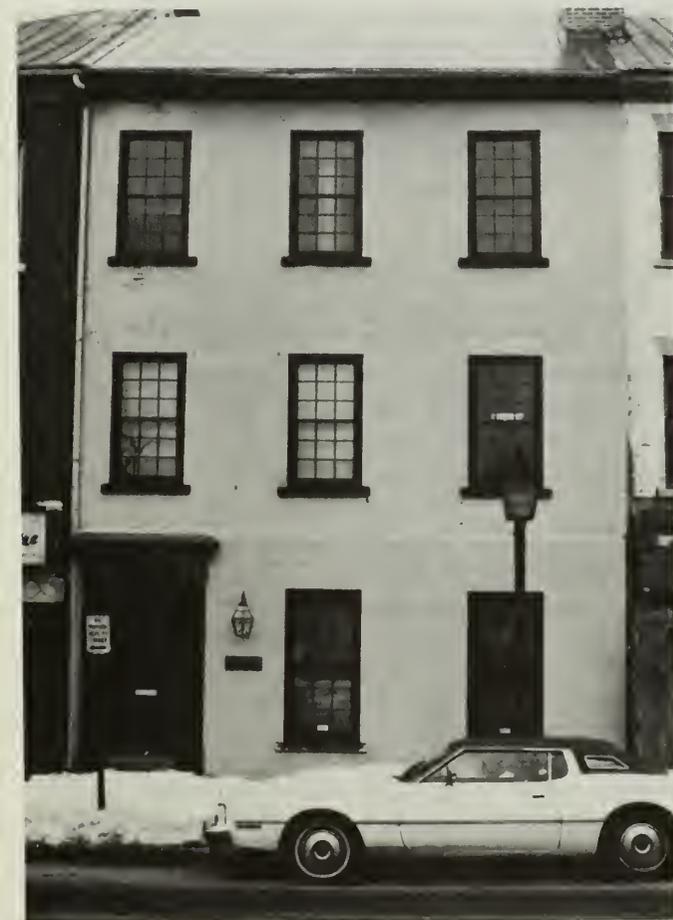
Example Two.

6. After rehabilitation. The building exhibits residential scale windows and door openings on the ground floor. This alteration results in a loss of the building's commercial character and an interruption in the commercial row.

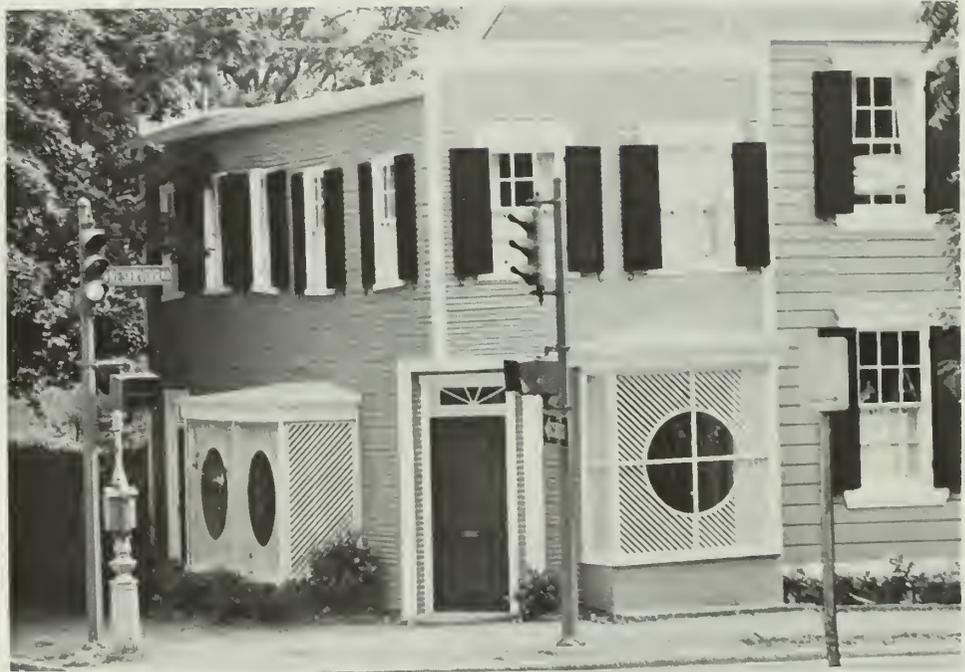
Example Three.

7. Wood lattice installed inside the display windows increases privacy from the street without sacrificing the commercial character of the building.

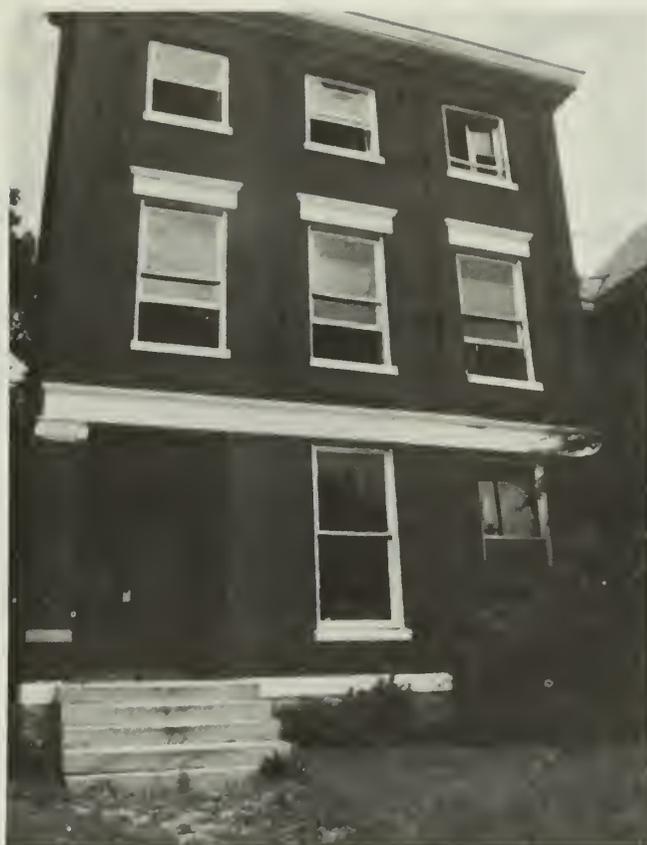
1. The townhouse, with its simple detailing, pictured before rehabilitation. The owner's proposal for exterior work was considered to be in conformance with the Secretary's Standards.

In order to convert the residence into four modern apartment units, both exterior and interior work was necessary. The owner's rehabilitation proposal for the townhouse exterior included cleaning the masonry with low-pressure water; limited tuckpointing; replacing a severely deteriorated cornice with one which would match the existing in material and detailing; replacing a later front door with one milled to the dimensions of the original; and replacing unrepairable window sash with new sash, reusing the historic wood frames. All of this exterior work was considered to be in conformance with the Secretary's Standards.

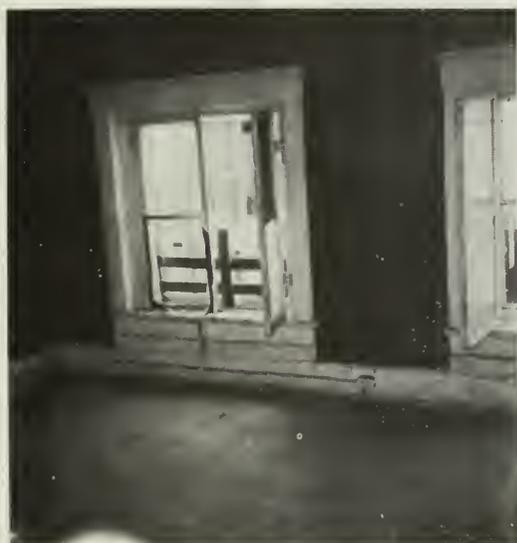
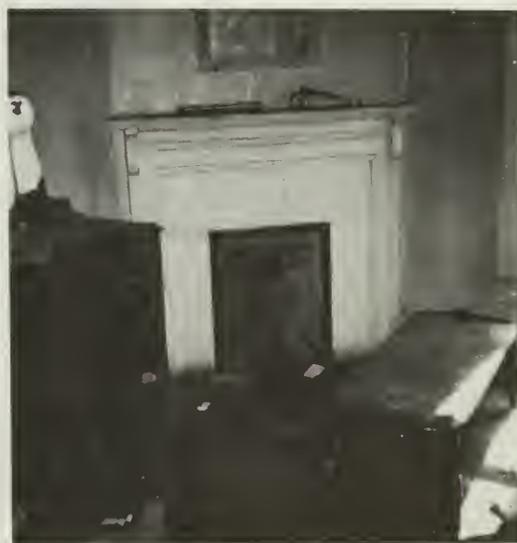
2. Modest interior detailing, such as window and baseboard trim, and diagonally placed mantels contribute to the historic character of the 1894 townhouse and thus should have been preserved to the greatest extent possible.

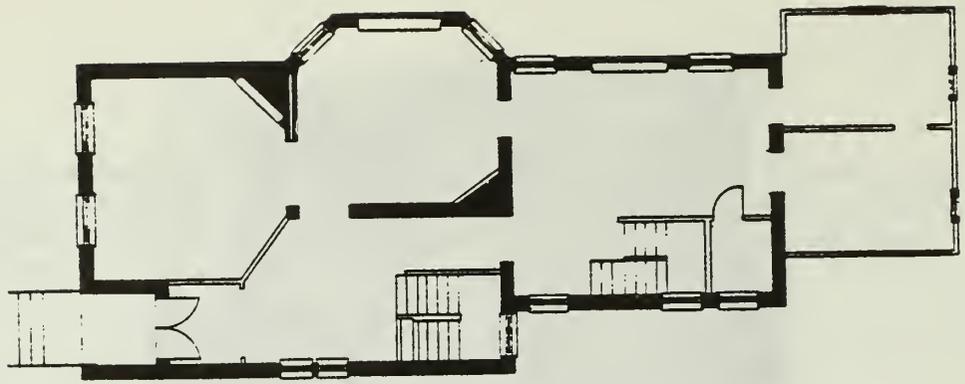
EXISTING FLOOR PLAN

3. A floor plan with side entrance and stair hall, and front parlor containing diagonally arranged partitions, chimney and mantel were identified as important in defining the historic character.

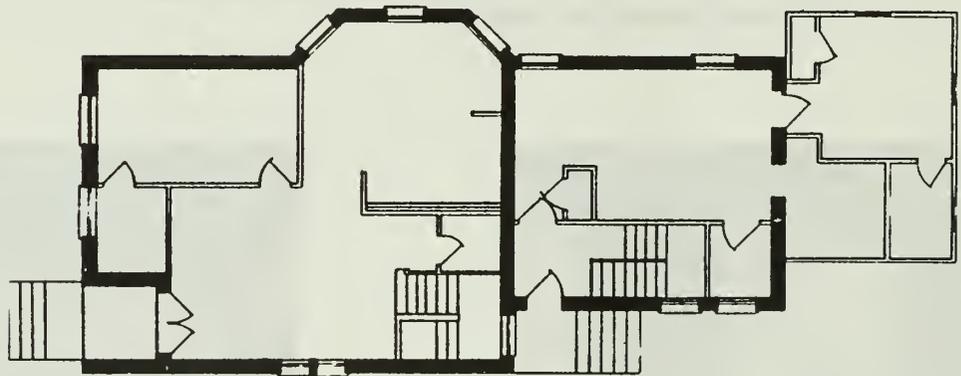
PROPOSED FLOOR PLAN

4. Interior work involved demolition of existing partitions as well as relocation of the living area to the historic entrance and stair hall space (see illus. 3). The rearrangement of rooms led to removal of corner mantels, baseboards, and door and window trim (see illus. 2). Because the character-defining interior spaces, features, and materials were not sufficiently preserved, the entire project failed to meet the Standards, despite qualifying exterior work.

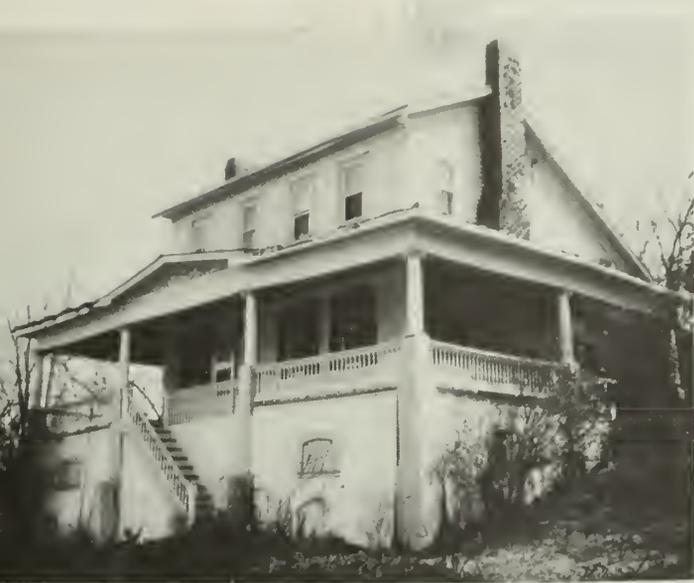
5. An 1830 structure with its large 1910 wrap-around porch characterized by columns resting on brick piers, highly decorative central pediment and turned balustrade. The porch was in a deteriorated, but still repairable, condition prior to rehabilitation work.

The intent of the rehabilitation work on the residence was to restore the building to its original 1830s appearance--the rationale for such work being largely predicated on the owner's assessment of the 1910 features. Because the porch was determined by the owner to be severely deteriorated and thus unrepairable, he felt preservation would require a prohibitively expensive dismantling and reconstruction of the piers, as well as total replacement of the roof (see illus. 6). As a result of this assessment, the porch was demolished. New front stairs and a covered stoop were then constructed on the primary facade to its 1830's appearance (see illus. 7). Interior work--including opening up of original fireplaces, removal of later inappropriate panelling, and repairs and repainting of doors and door trim--was also undertaken and completed as part of the project.

Finally, the Region agreed with the State in the final review that the porch as it existed at the time of the rehabilitation was deteriorated, but that its condition did not warrant removal. Because it was a character-defining feature that should have been retained and repaired, its removal violated Standards 2, 4, 5, and 6. A secondary issue in the denial was that the design for the new entry was not based on either photographic or physical evidence and was, therefore, conjectural. This treatment violated Standard #3.

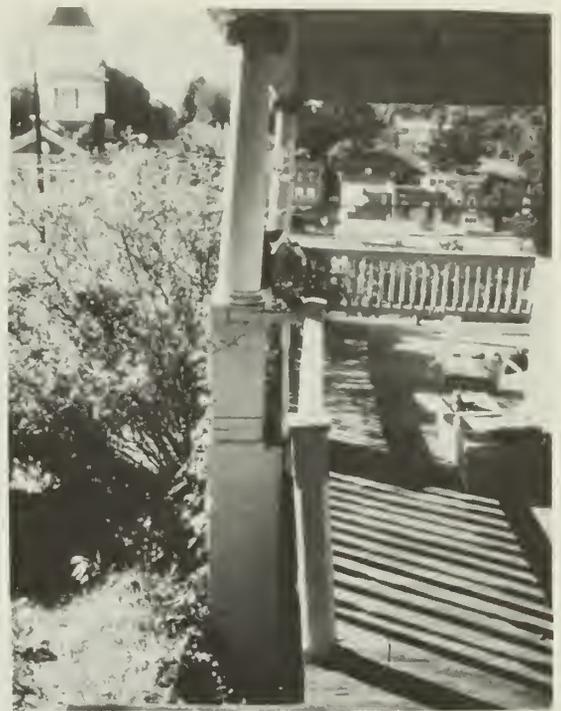
6. A detail of the 1910 porch shows structural problems that need to be corrected. The owner assessed the 1910 front porch as unreparable, which led to its removal.

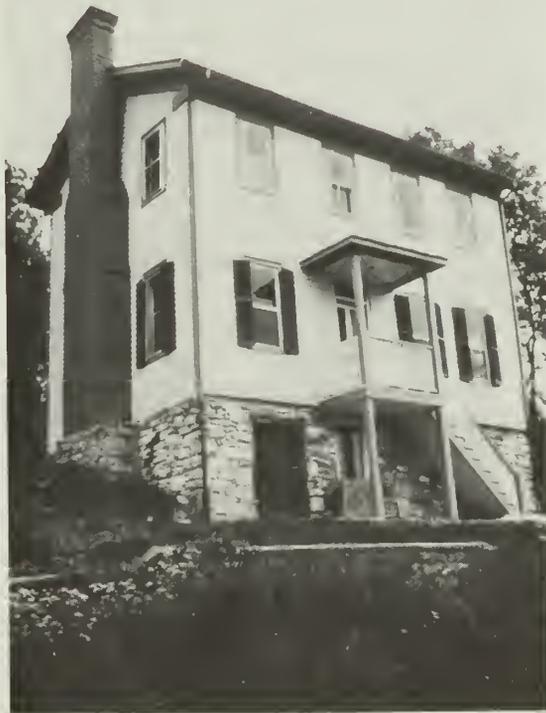
7. The replacement front porch--conjectural in design--was constructed after demolition of the historic porch. NPS concluded that because the 1910 porch was an important character-defining feature and was repairable, it should have been retained. The project was denied certification of rehabilitation for tax benefits.

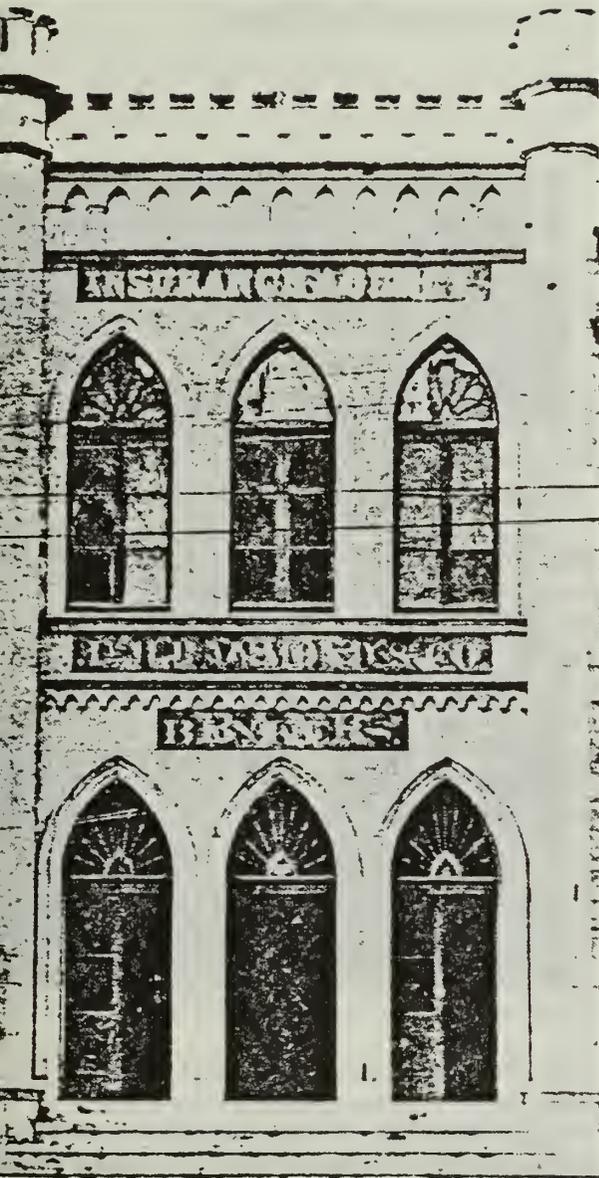
1. This historic photograph shows the 1870s building constructed of limestone and featuring Gothic detailing.

Application: A ca. 1870 stone Gothic Revival structure (see illus. 1) was being rehabilitated for re-use as an office building. A 1967 "modernization" of the building's facade for retail use had involved installation of a stucco false front on the upper level of the building. When the false front was subsequently removed as part of the new work, the owner found that the castellated stone at the top of the building had been removed; the historic decorative bands had been chipped away to permit installation of the stucco work; the window sills and jambs were damaged; and several holes had been bored into the stone to anchor the false front. Stone on the ground level of the building had been removed as the result of a 1950s installation of an aluminum and glass entry and merchandise and display area (see illus. 2 and 3).

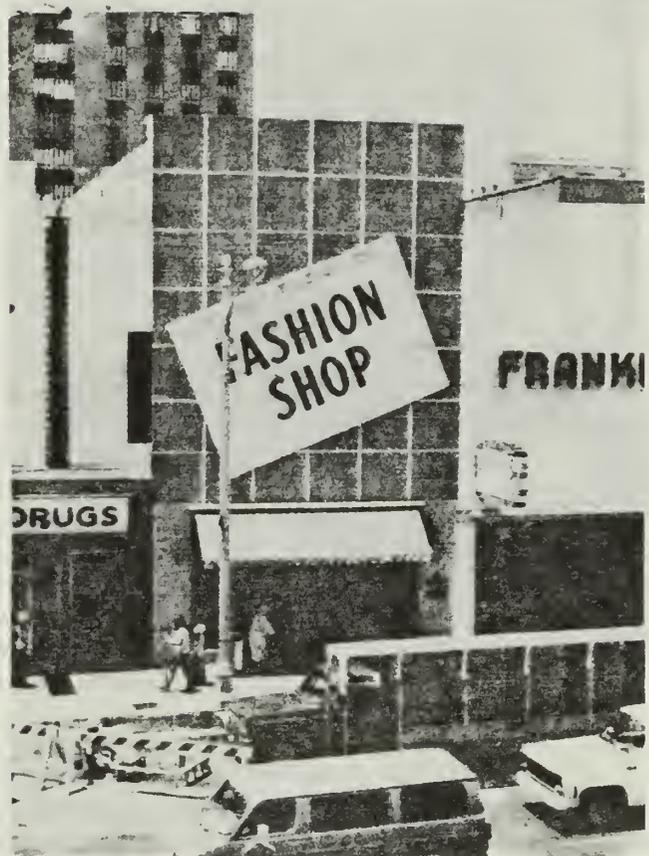
2. A 1967 storefront alteration involved installation of a stucco false front on the upper levels; stone at the ground level had been removed as the result of the installation of an aluminum and glass entry in the 1950s.

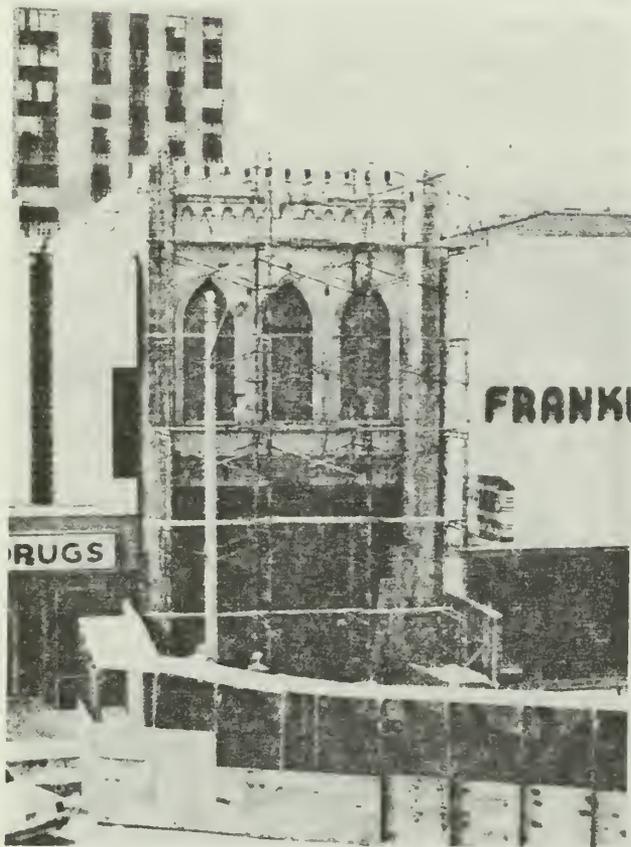
3. When the 1967 storefront was removed, the owner assessed overall damages to the upper and lower levels and felt total replacement of the limestone facade was necessary to restore the historic appearance.

Based on his evaluation of the overall damages to the stone as a result of the combined alterations, the owner concluded that the entire facade was essentially beyond repair and that partial replacement of the historic material would not be possible without leaving a splotchy, uneven facade--an appearance he felt was unacceptable. The report specifically cited the unavailability of matching limestone, potential structural consequences of replacing only the damaged stone, and the high cost of repair over replacement. As a result of this assessment, the owners elected to demolish both damaged and intact historic limestone from the primary facade by cutting it back to a depth of 5 inches, then re-build the facade with an all new stone veneer in order to achieve an even, uniform appearance (see illus. 4).

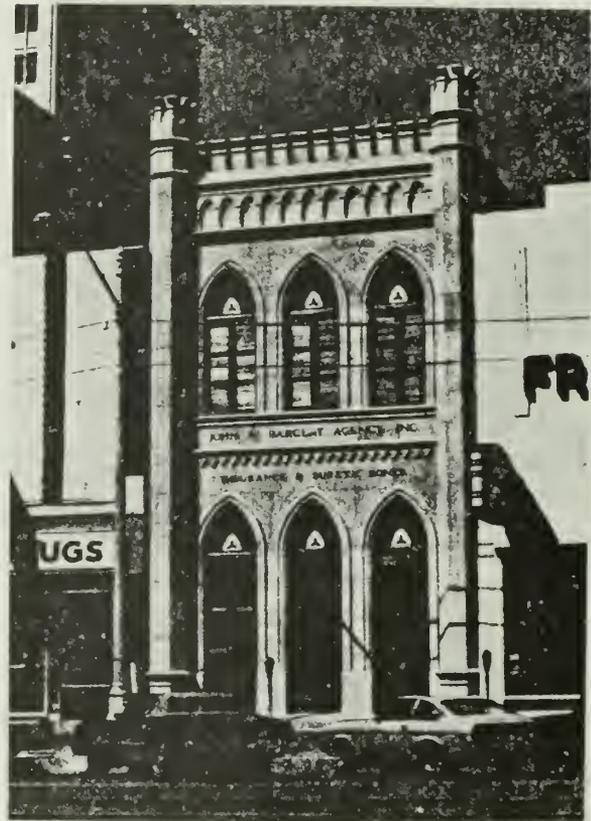
4. This photograph shows a totally reconstructed facade using all new material. NPS recommended denial of the project for tax benefits because it determined that the damaged upper level could not be repaired. An unacceptable loss of historic material on a significant facade was specifically mentioned in the denial letter.

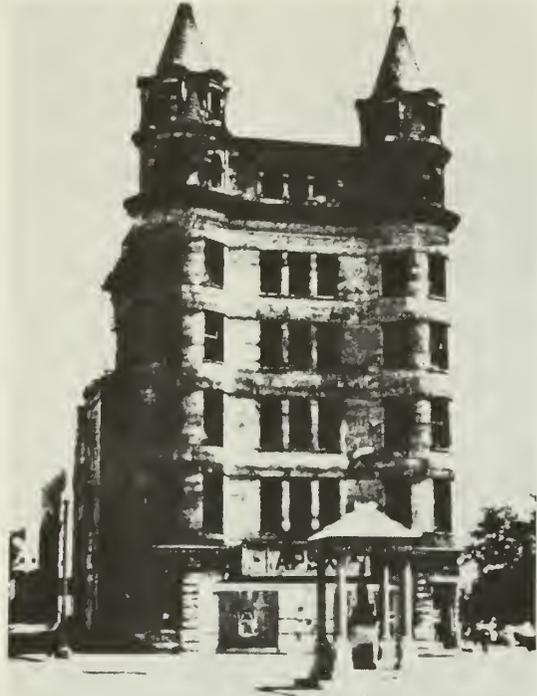
1. This photograph of the west elevation shows the 1880 addition of flush ashlar brownstone above the rough-cut brownstone of the first floor. Because the historic brownstone on this wall was basically sound, only repainting was required.

Application: An 1860s rusticated ashlar brownstone commercial building, altered in 1880 with the addition of a flush ashlar brownstone facade on the west, was purchased for rehabilitation for office use (see illus. 1). The building had been derelict and vandalized for several years--in addition to the total lack of maintenance--and, as a result, was severely damaged and deteriorated. Within the three exterior walls (south, west, and north), which consist of 14-inch thick loadbearing masonry of two wythes of brick faced with brownstone, the mortar was failing between the brick and the stone. The brownstone was spalling on both the north and south walls, with the condition much worse on the north (see illus. 2 and 3). The building had been painted in the past, possibly in an effort to stop water penetration. On the interior, the majority of the distinguishing architectural detailing had been removed as a result of deterioration,

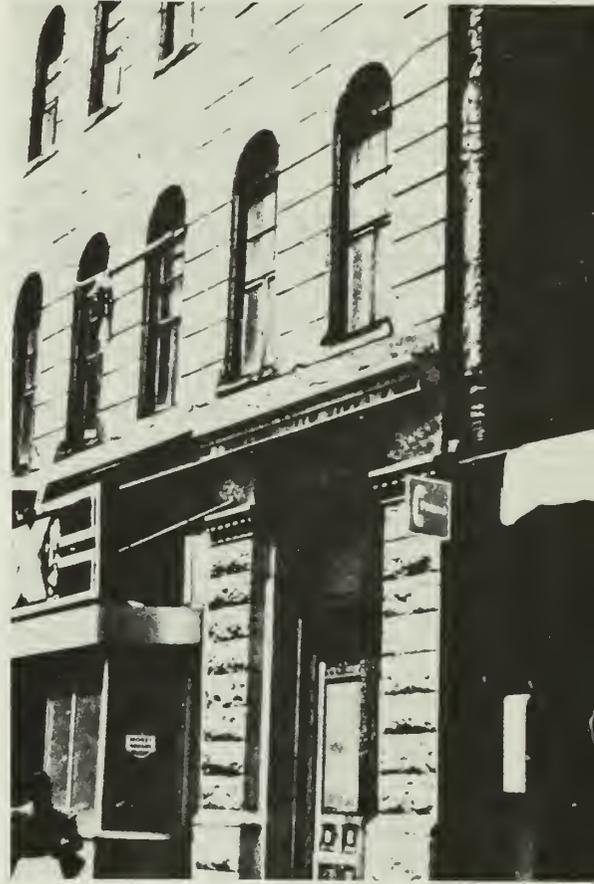
2. The brownstone of the south wall was not as deteriorated and could be retained in place and structurally strengthened by stainless steel pins tying cementitious patches to the sound stone beneath. Limiting the patching to the beveled edges of the stone blocks where the greatest amount of deterioration had occurred was considered a sensitive preservation solution because it left the historic material both intact and visible.

Subsequently, two structural engineers sought ways to preserve more of the historic material. It was confirmed that the north and south walls were out-of-plumb. To ascertain the reason for the apparent structural problems, more holes were bored so that the condition of the walls could be thoroughly investigated. The findings were that the north wall had lost its loadbearing capacity because of the advanced deterioration of the stone, brick, and iron anchors; however, the engineers' solution was to rebuild the wall only from the second floor up rather than the entire wall as initially proposed. Since the materials were not salvageable, the replacement wall would be all new materials. Cast-stone over concrete block was selected as a compatible substitute material with the facing cast-stone to simulate the historic brownstone. The re-evaluation of the structural and preservation problems of the building led to the conclusion by the architect and engineer that the south wall could be retained in place with the use of stainless-steel pins tying cementitious patches to the sound brownstone beneath. The bulk of the patching would be at the beveled edges of the ashlar blocks where the worst erosion had occurred, leaving the majority of the historic material intact and visible.

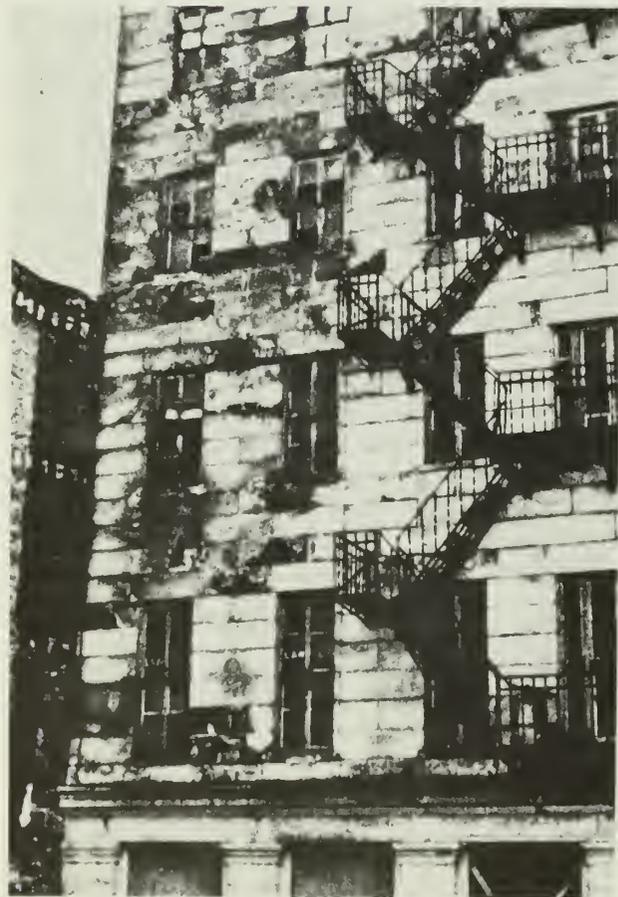
3. Badly spalling brownstone on the north, and less visible, wall was for the most part unsalvageable. Replacement walls were constructed from the second story up, a solution that assured maximum retention of historic material while making the building structurally sound for the new use.

An initial structural assessment led to a proposal to rebuild the north and south walls. The structural engineer felt that the original construction technique--tying the interior brick to the facing brownstone with iron strap anchors--was inadequate. Further, the deficiency of the walls had been aggravated by water penetration into the cavity between the brick and the stone, which had caused the iron anchors to rust. The recommendation to rebuild both walls was based primarily on a few test holes bored in the walls for investigation of the condition of the materials, particularly the metal anchors; and on the fact that both walls were out-of-plumb by about two inches. However, because this proposal--along with planned interior alterations for modern office use--involved such a substantial loss of historic material, the National Park Service determined that if the project proceeded as proposed, the resulting building would be substantially new construction. Therefore, despite the seriously deteriorated condition of the materials, NPS found that the work, as proposed, would violate Standards 2, 3, and 6.

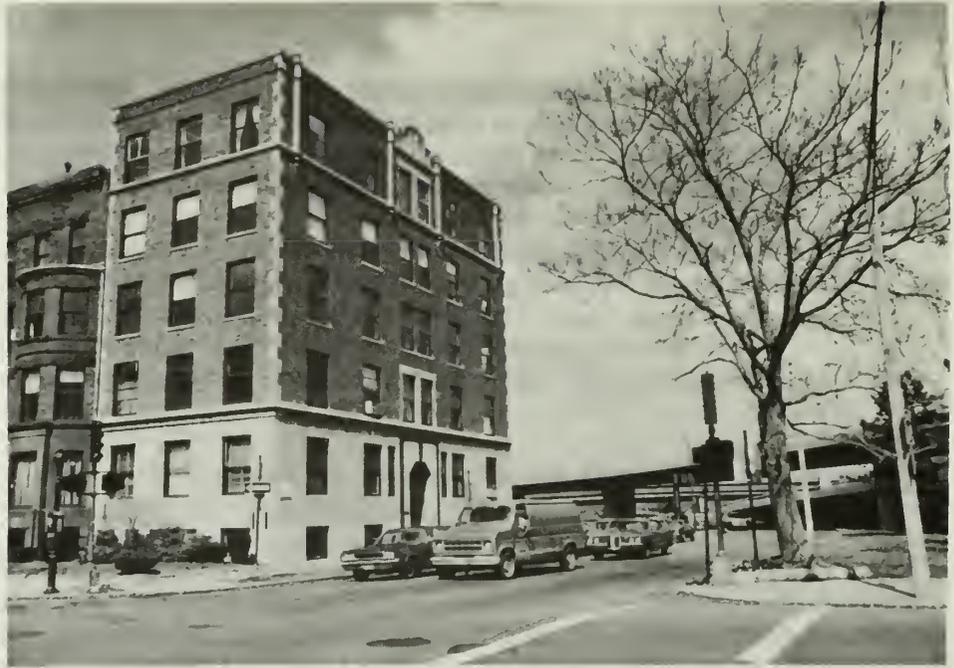
1. This 20th century building served as an anchor at the end of the small historic district and had three highly visible facades. Note how the location, design, and even the color of the wooden sash and frames matched that of the adjacent older properties.

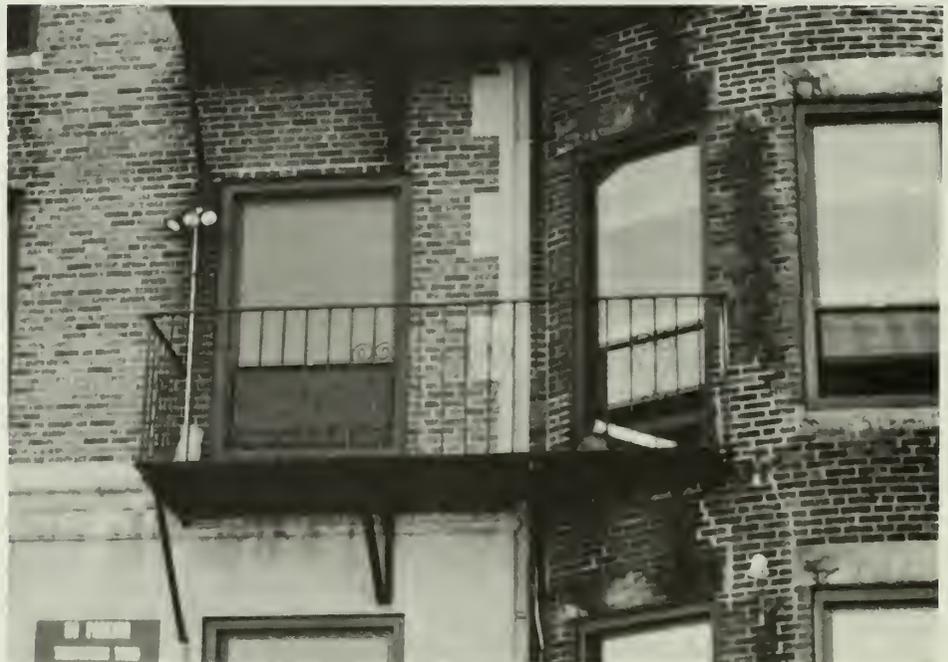
2. This is a close-up view of the contemporary window units which were installed. They had flat framing detail, bronze-anodized finish, tinted glass, and a lowered meeting rail.
