Technical Preservation Services
Preservation Assistance Division
National Park Service
U.S. Department of the Interior
Washington, D.C.

Interpreting the Secretary of the Interior's Standards for Rehabilitation

Volume II

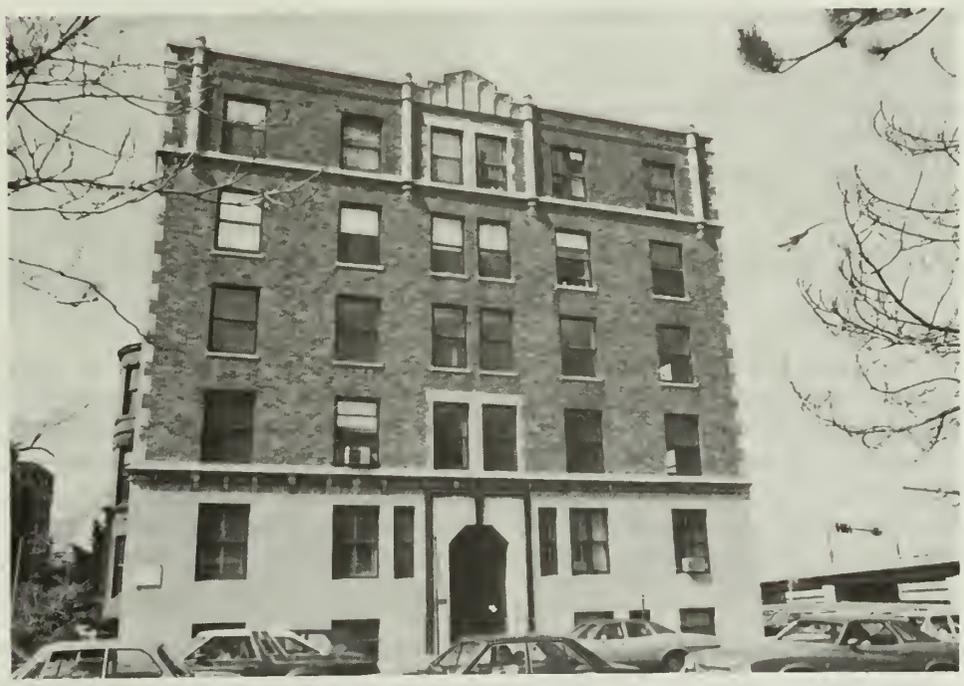
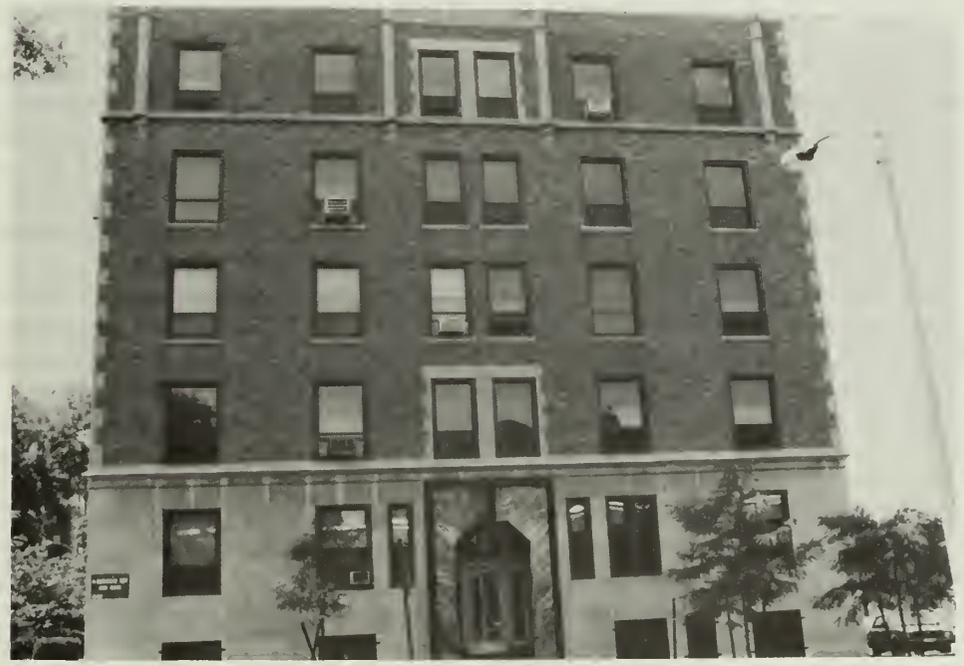
3. Below is a comparison view of "before" and "after" rehabilitation which shows the impact of the window changes. While relocation of the meeting rail was the most pronounced alteration, the tinted glass, lack of trim around the frames, increased width of the anodized aluminum frames, and loss of other detail were cited in denial of the project for preservation tax benefits.

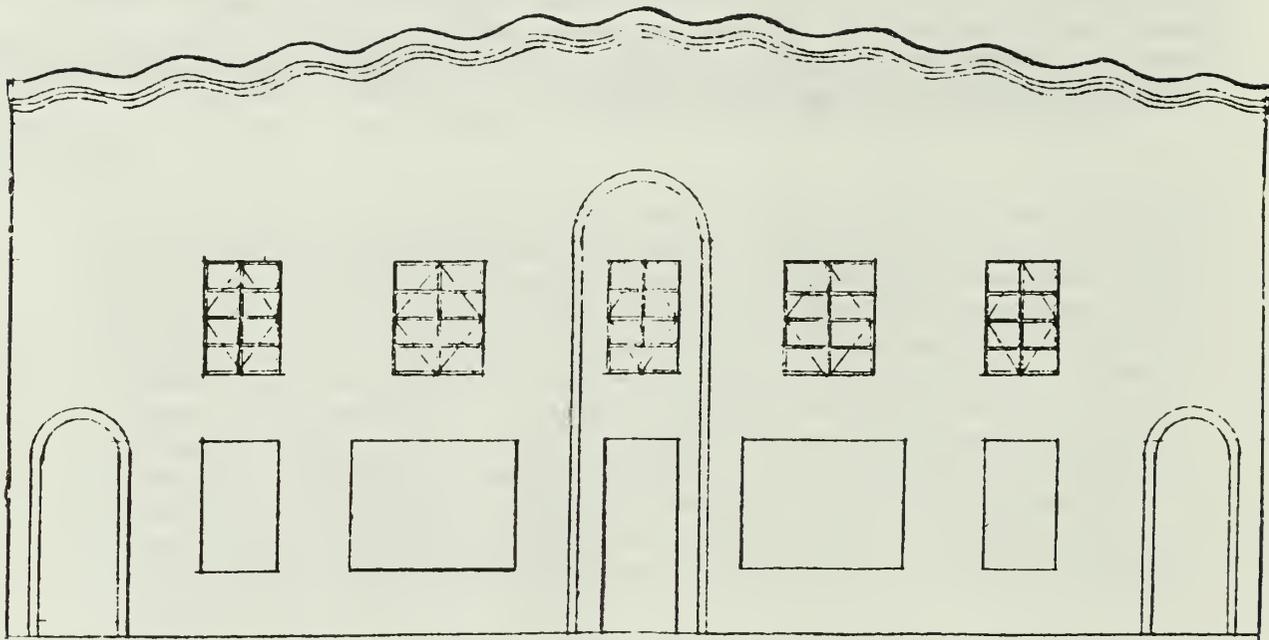
1. This drawing points out the historic form of a small-scale Spanish Colonial Revival building with a waved parapet cap and symmetrical window and door openings.

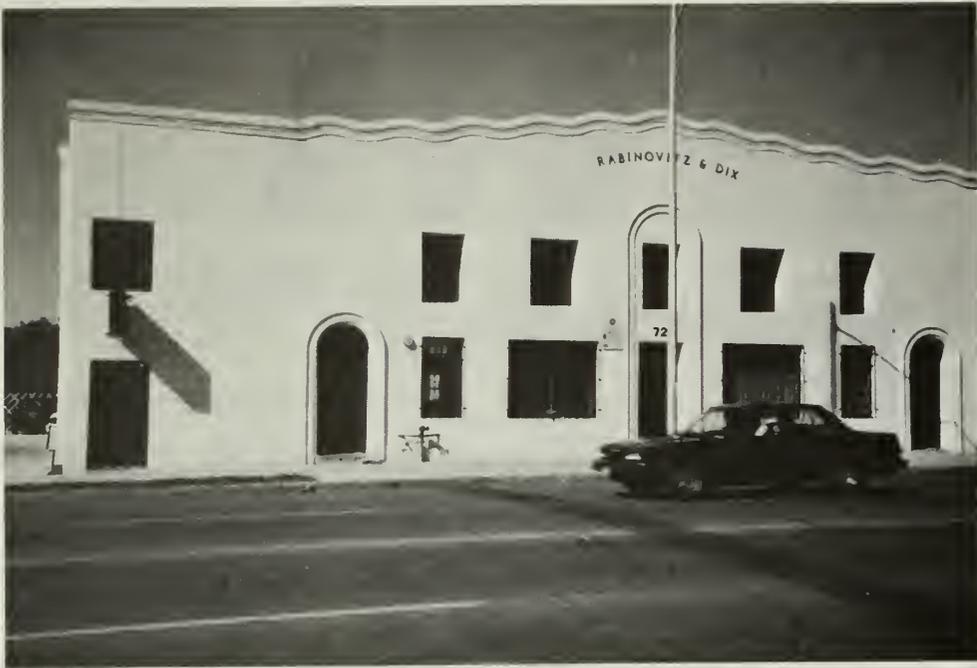
2. This view of the southeast corner of the primary elevation shows the new addition that enclosed an existing stair. The addition extends from the termination of the historic building, which is defined by the waved parapet cap.

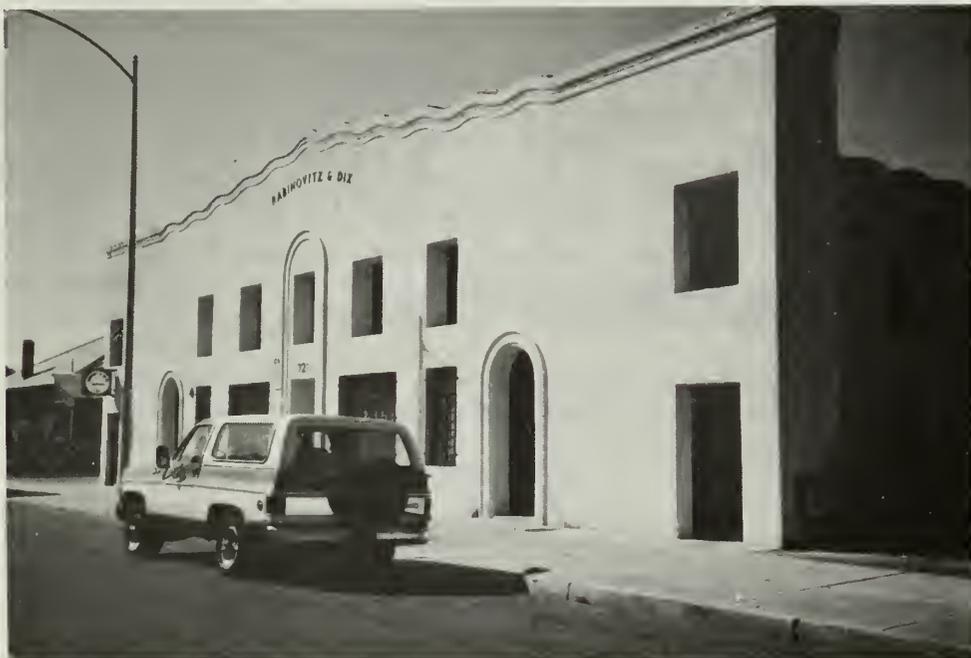
3. This view of the northeast corner of the primary elevation shows the added wing wall that was built to visually balance the new addition on the southeast corner. Again, the addition extends from the end of the historic building, as defined by the waved parapet cap. Both additions increased the total length of the historic building by one-third and made indistinguishable what was historic and what was new construction.

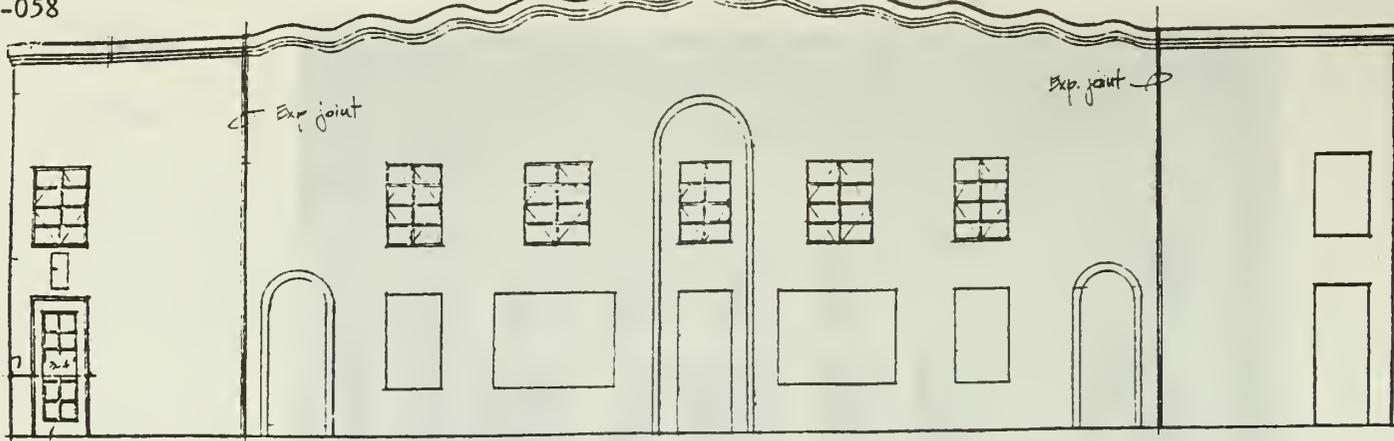
4. Scheme "A" was proposed by the developer to make the project meet the Standards. This change in the design would simply have provided expansion joints to show the difference between the historic building and the new additions. The proposal was rejected.

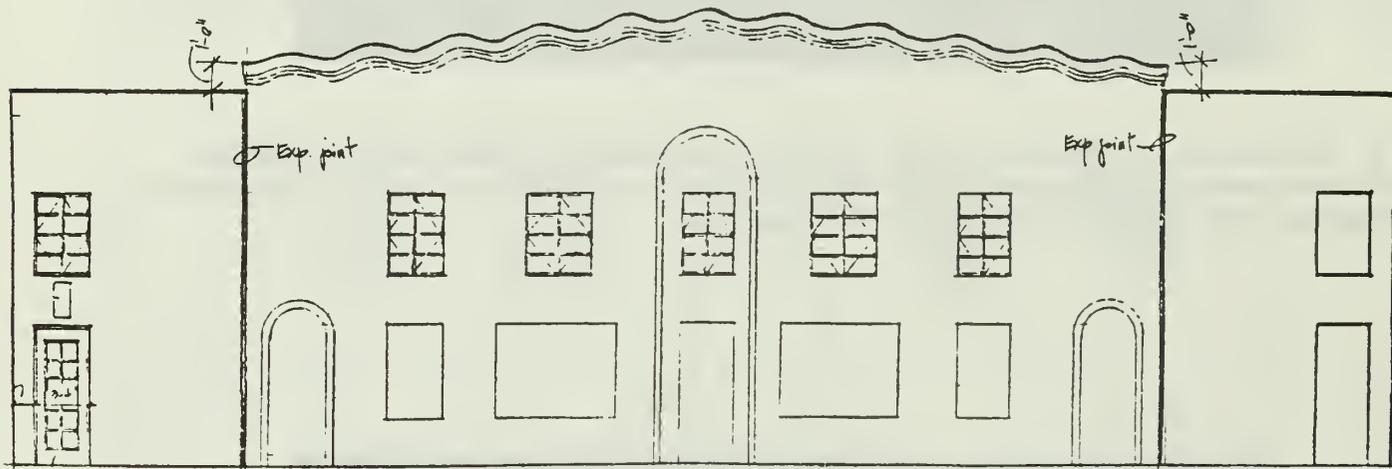
5. Scheme "B" was also offered by the developer as a means of making the project meet the Standards. Part of this design change was acceptable--the lowered parapet on the stair enclosure. The total scheme was rejected, however, because the nonfunctional northeast wing wall, even though differentiated in height, still unnecessarily expanded the historic form of the building. It also created a symmetry at a scale that never existed historically.

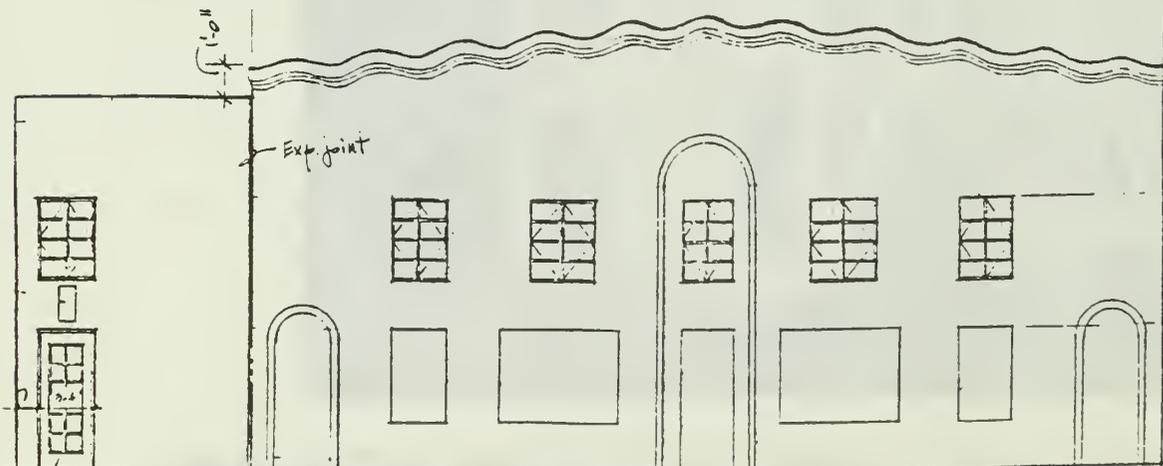
6. Scheme "C" represents those changes to the design that would have to be made to bring the project into conformance with the Standards. The Chief Appeals Officer specifically listed as requirements for certification a widened expansion joint; demolition of the northeast corner wing wall; lowering the parapet on the stair tower; and further distinguishing the new addition from the historic facade by use of a different paint color.

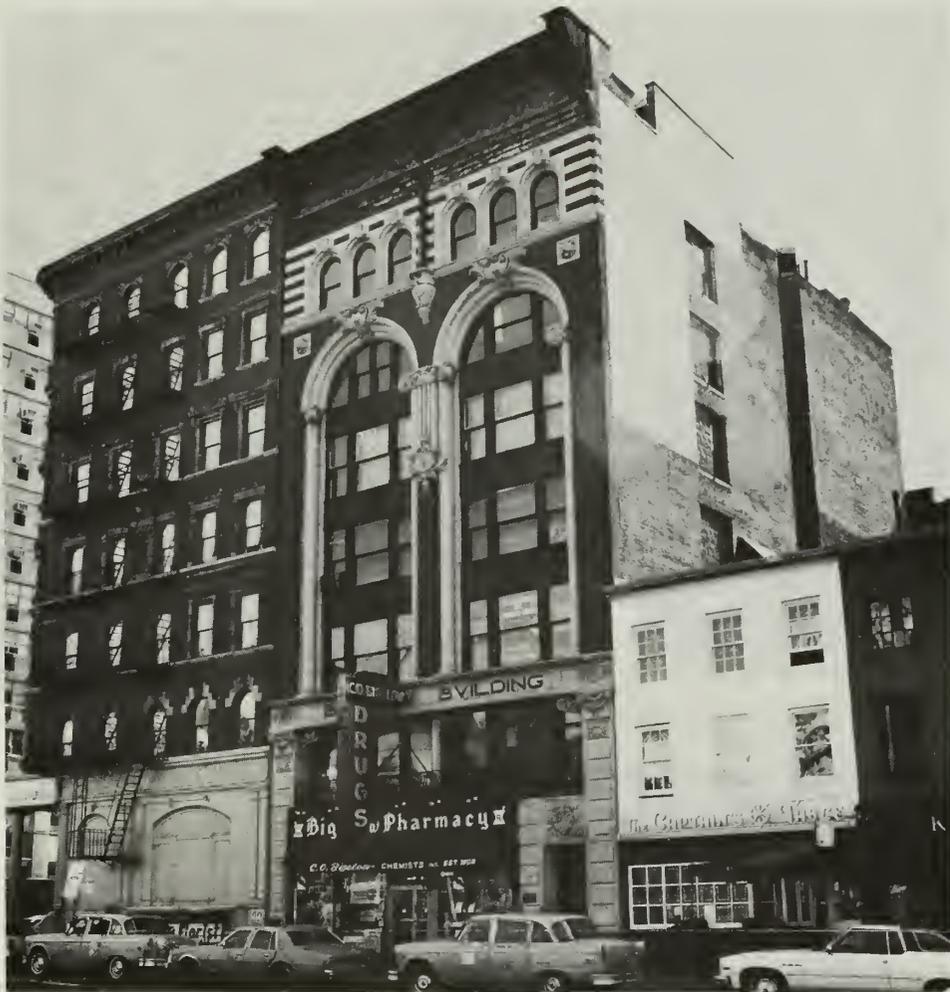
1. Rehabilitation project work on an early 20th century building focused upon meeting health and safety code requirements for the new use.

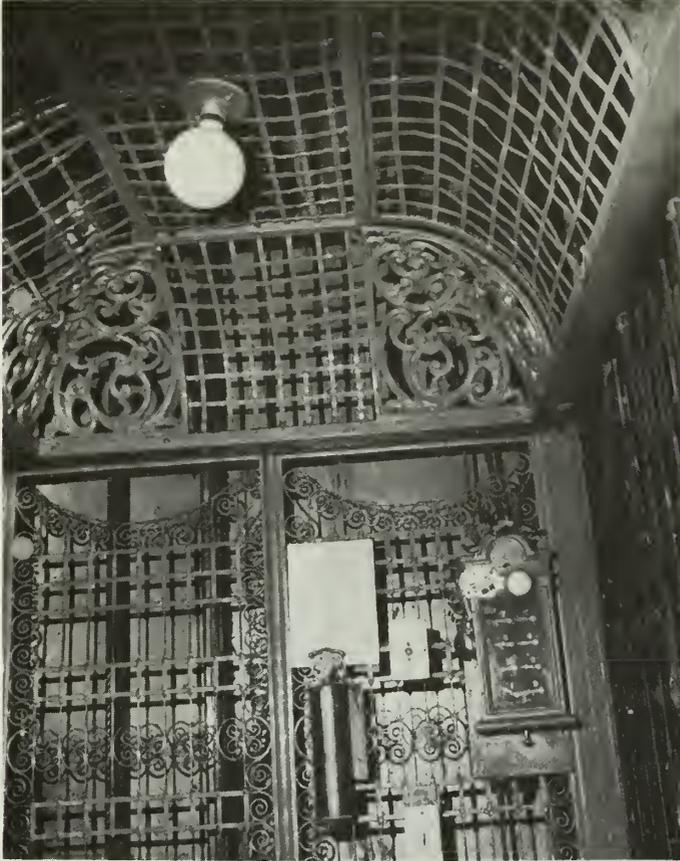
2. This shows a detail of the open dome, manually-operated elevator with its highly decorative iron grill work. Because an enclosed cab was required by State law, the historic elevator was found to be in violation of ANSI building code standards. The consulting engineer thus recommended its removal and replacement with a modern elevator.

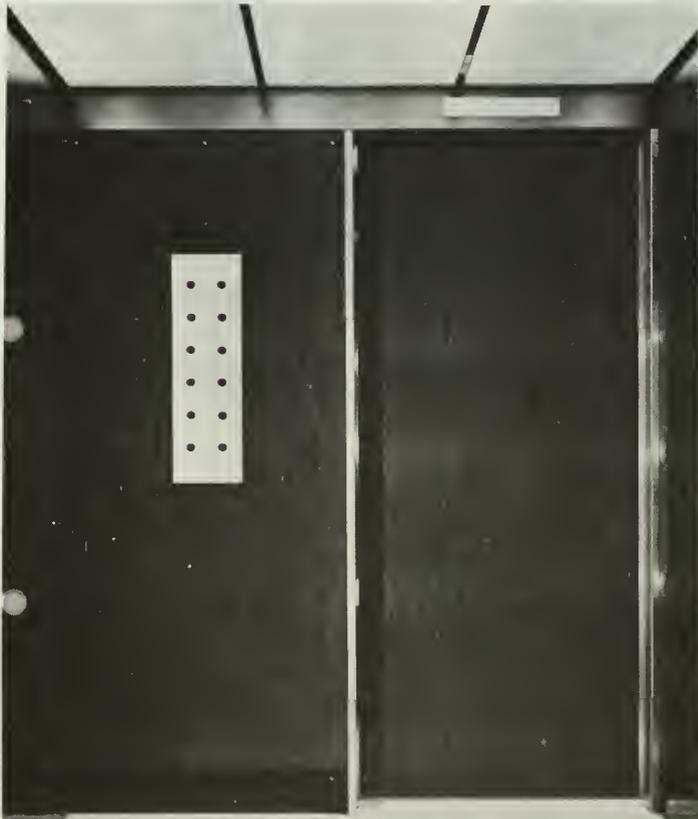
3. The replacement cab featured an enclosed cab and hollow metal shaft doors, in accordance with health and safety codes. Removal of the 1916 elevator eventually led to project denial because the historic elevator was deemed a significant interior feature and, thus, its retention and preservation were necessary to meet minimum preservation requirements.

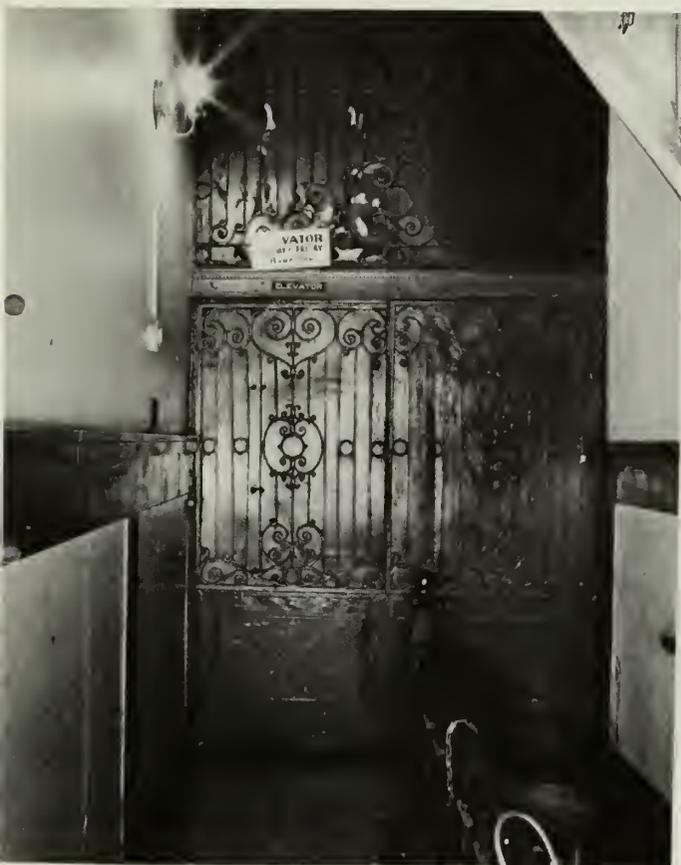
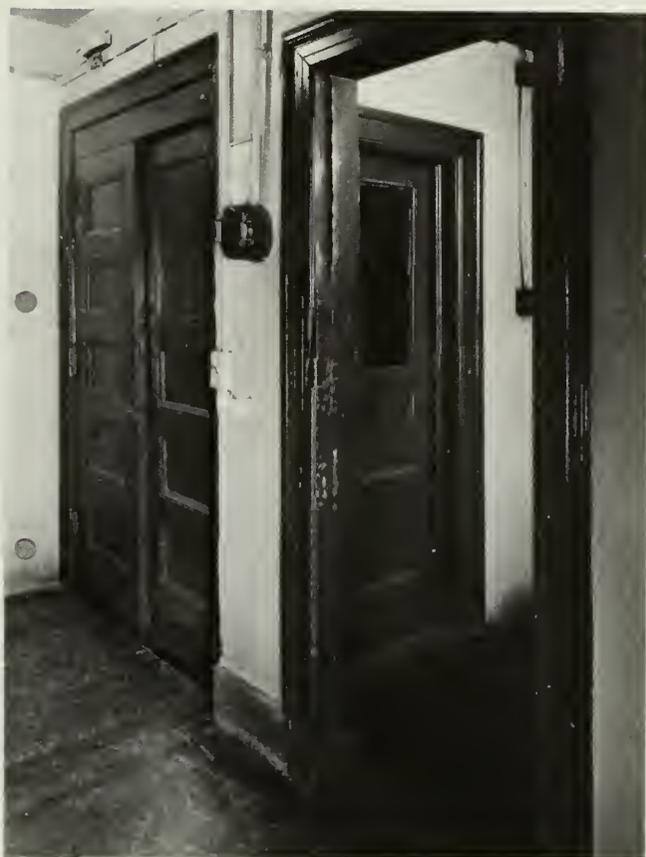
4 and 5. The decoratively detailed elevator doors in the lobby (left) were to be removed as part of the code-required elevator replacement as well as the simpler, panelled doors on floors 3-7 on the west side (right).

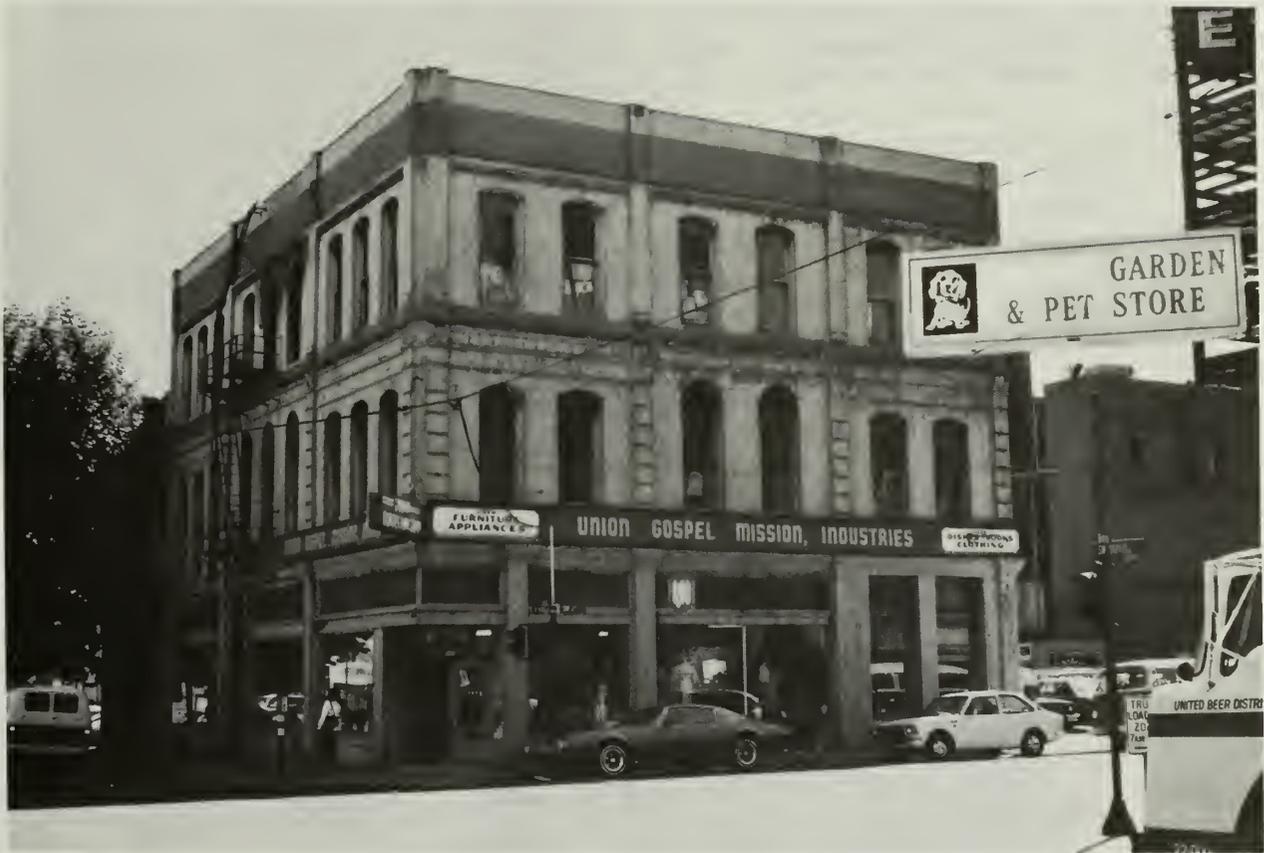
1. The building prior to rehabilitation was a three-story structure prominently located on a corner site in a National Register district noted for late 19th century commercial structures. Originally built in 1884 as a two-story brick building, a third floor was added in 1890, the building was stuccoed and an elaborate projecting cornice was applied. The cornice was lost in the mid-twentieth century and the building suffered a serious fire on the third floor prior to the rehabilitation.

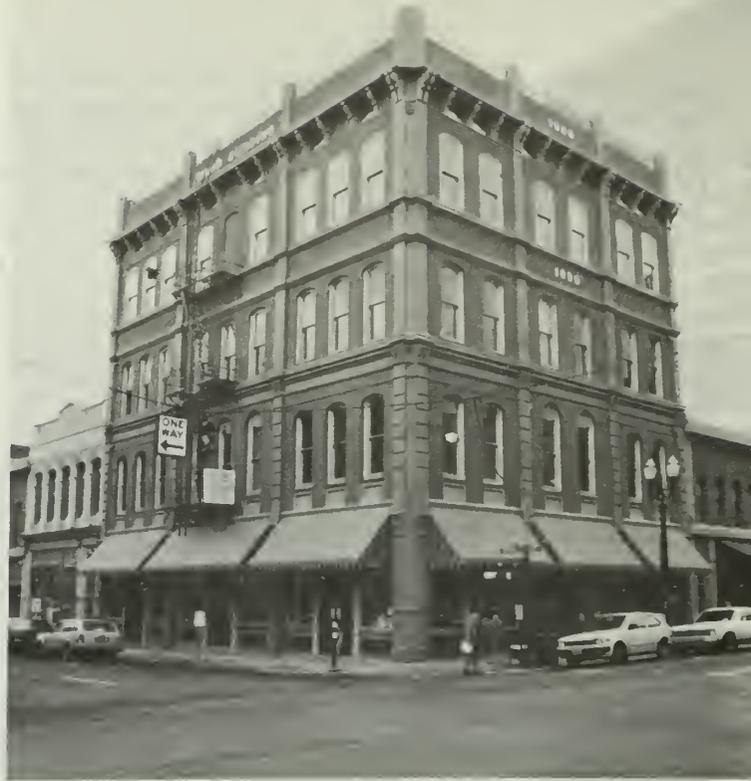
2. The historic building received a one and a half story addition to accommodate eight loft bedroom apartments over the retail and office space. Note the change in scale and the dramatic vertical emphasis as a result of the new rooftop addition. As the overall mass, scale and proportional relationships of the building were significantly altered, the project was denied certification.

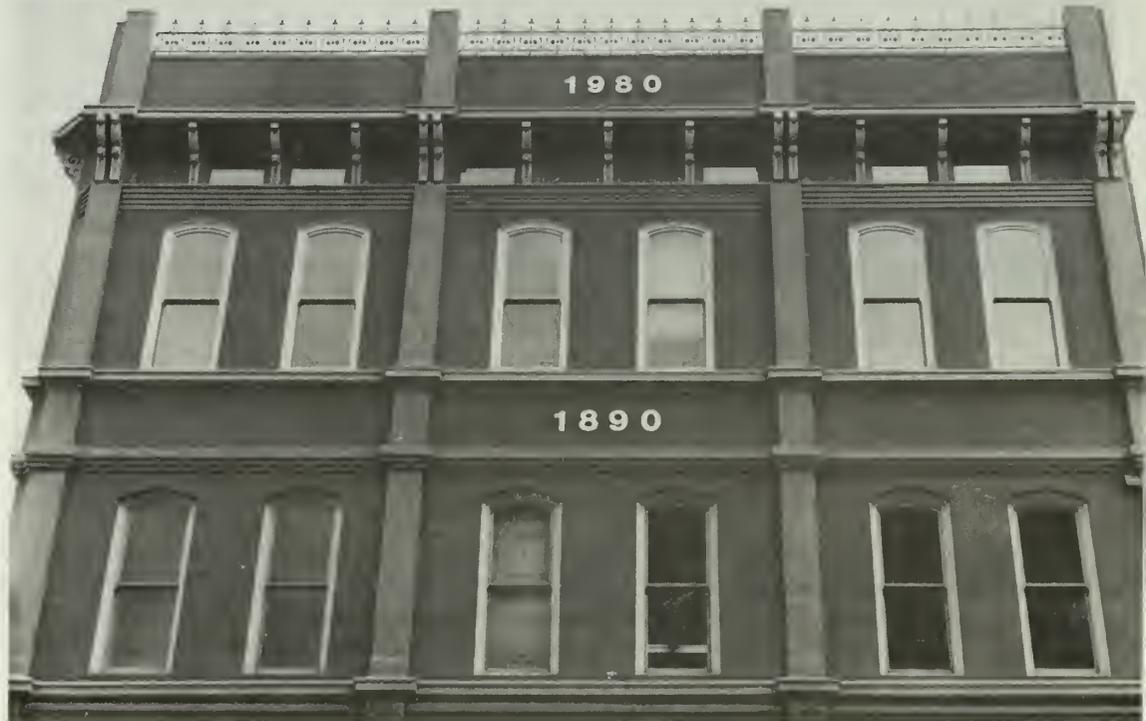
3. The new rooftop addition is not differentiated from the historic resource except by the use of applied dates. The addition is flush with the exterior walls and has adopted historicized features including wrought iron cresting, bracketed cornice, jack-arch windows, pilasters and beltcourses. In this case, however, the addition so altered the scale and massing of the building, that even if the addition had been contemporary in design, it could not have been certified.

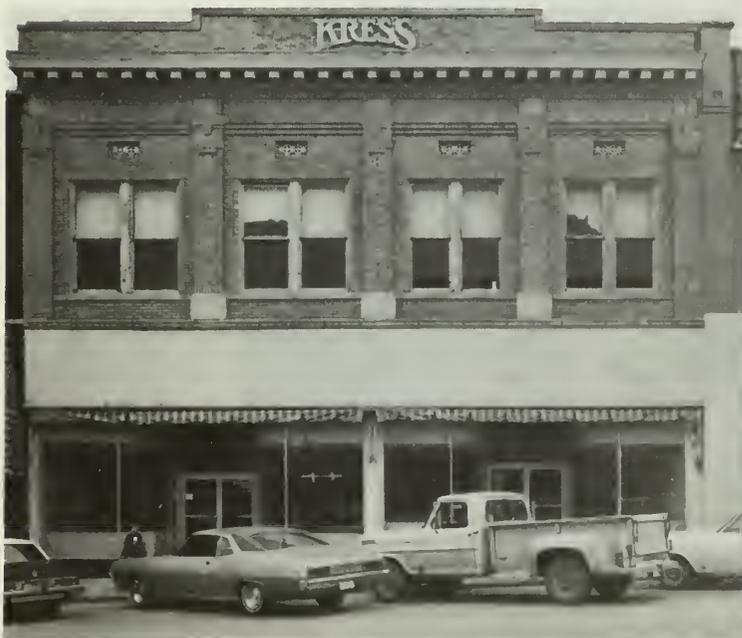
1. Prior to rehabilitation, the 1930s Kress Company storefront had survived in place with nice curved entrances although the transoms had been covered over.

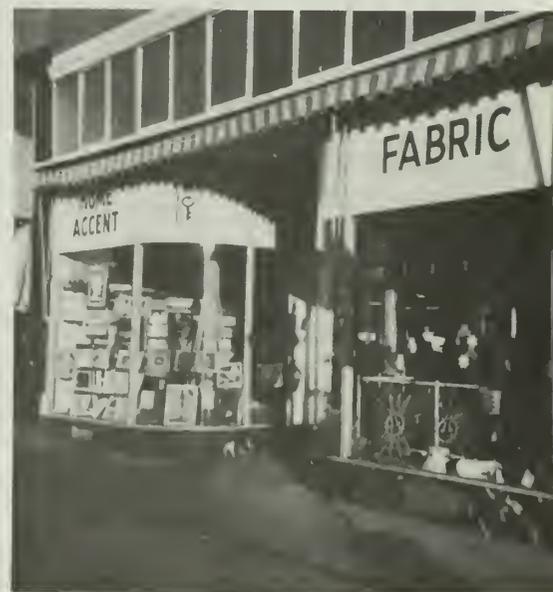
2. Very little change to the 1930s storefront had occurred prior to rehabilitation as evidenced by this historic photograph.

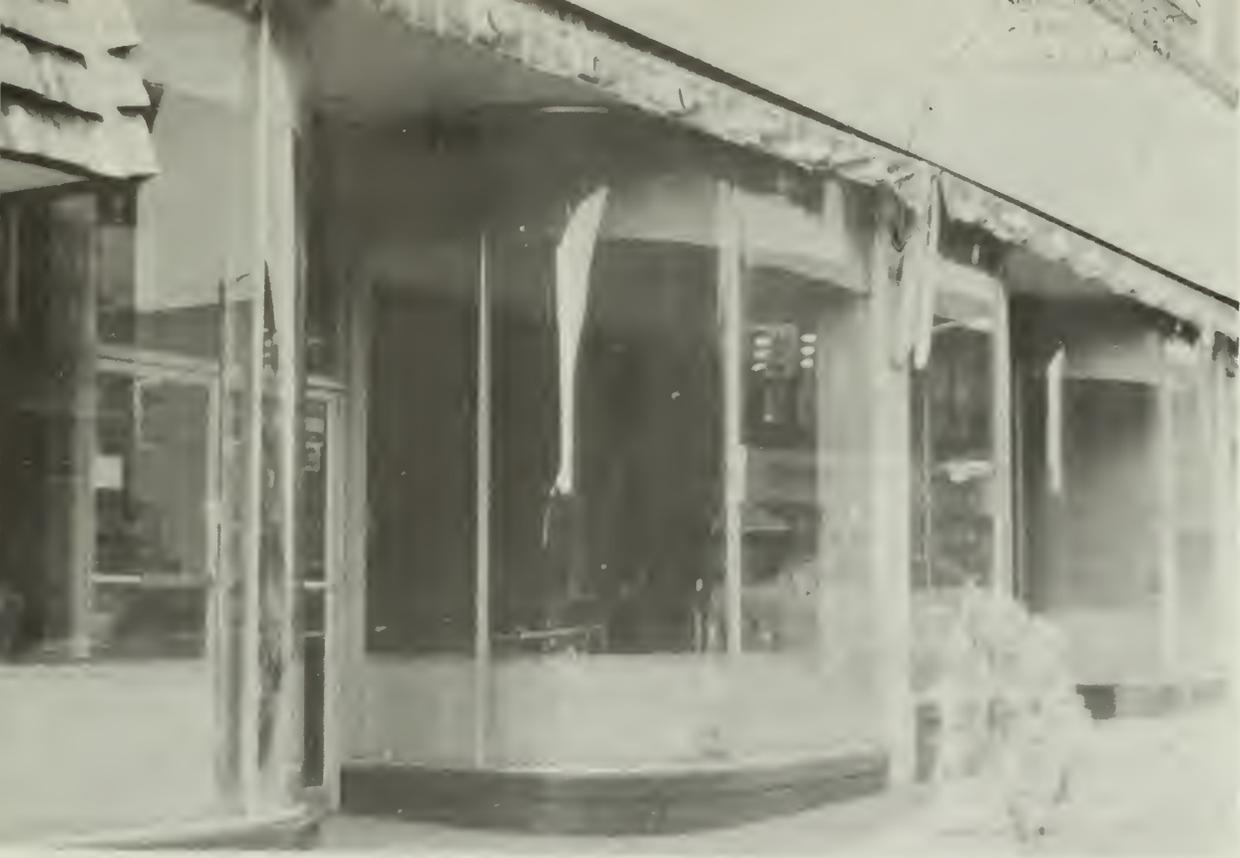
3. The entire storefront was replaced following breakage, during rehabilitation of one of the curved sheets of glass. Expediency and difficulty in locating a manufacturers of curved glass were cited by the owner as reasons for the change.

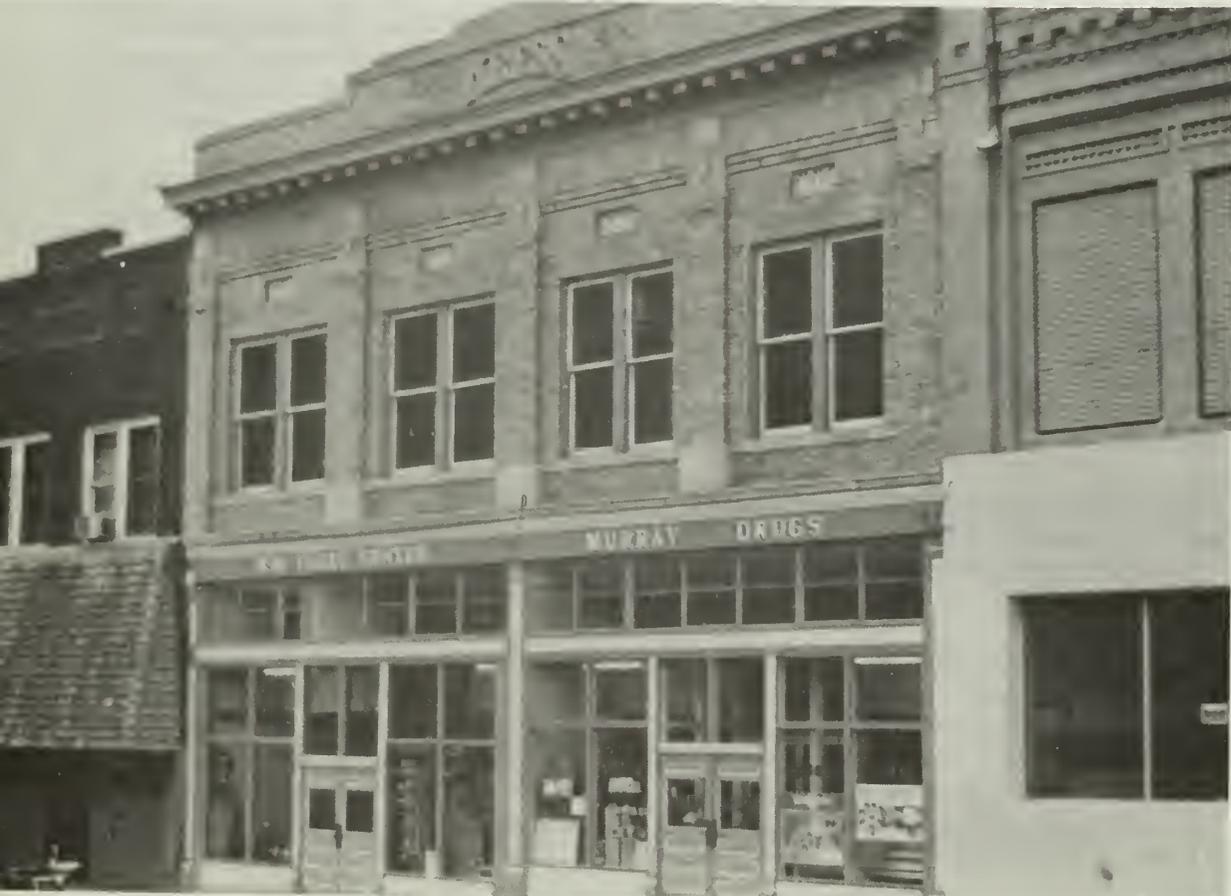
4. View of storefront after rehabilitation showing conjectural appearance of the original storefront — note inappropriate detailing of the transoms and small size of the doors.

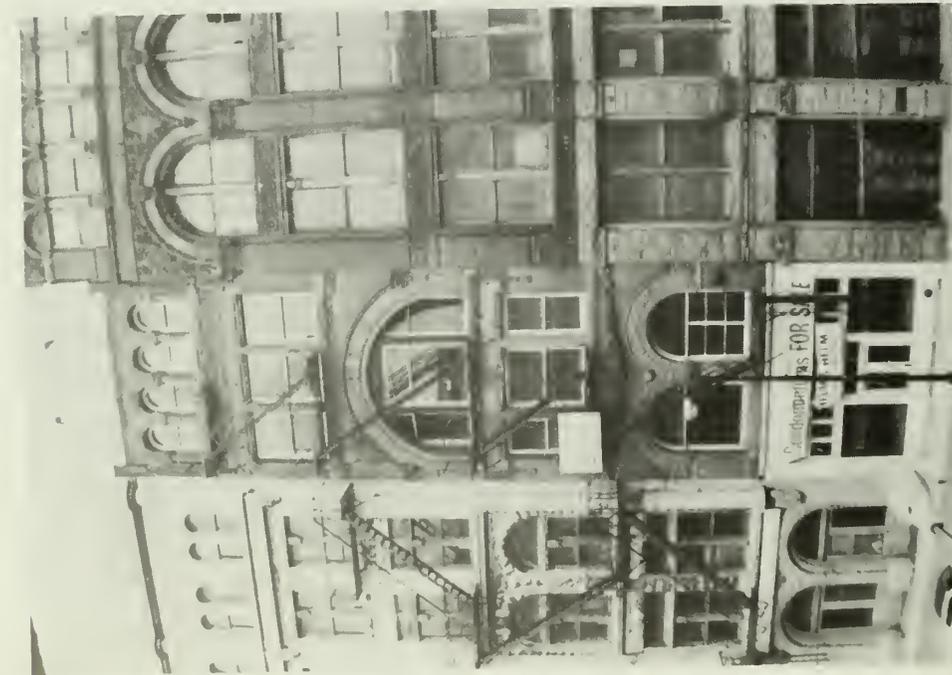
1. Overall view of the 1890s building and ca. 1930-1940 alterations to the original storefront. While the twentieth century storefront alterations were considered to be of "nice design," they were not significant stylistically or in material and craftsmanship.

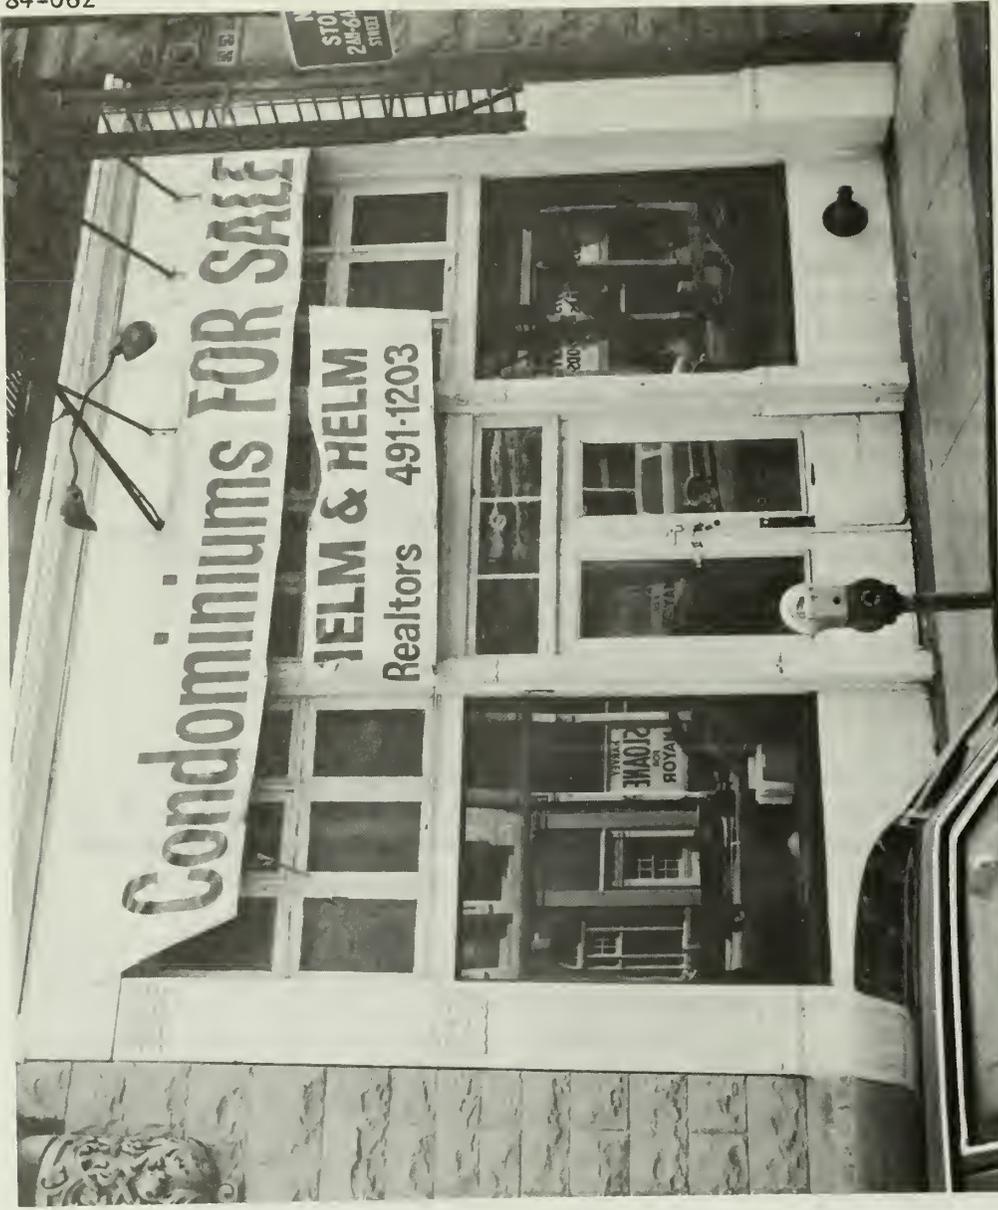
2. The owner removed the nonoriginal elements of the storefront, including plain concrete block kick panels beneath the display windows, standard non-decorative woodwork and glazing in the transoms and display window sash, and the unadorned double doors. Although the proposal was denied by the region, it was ultimately overturned on appeal. The Chief Appeals Officer concluded that the later storefront elements did not display any special significance, and could thus be removed. The original portions of the storefront--the distinctive cast-iron columns, pilasters, and cornice--were retained, preserved, and integrated into a compatible, contemporary storefront design.

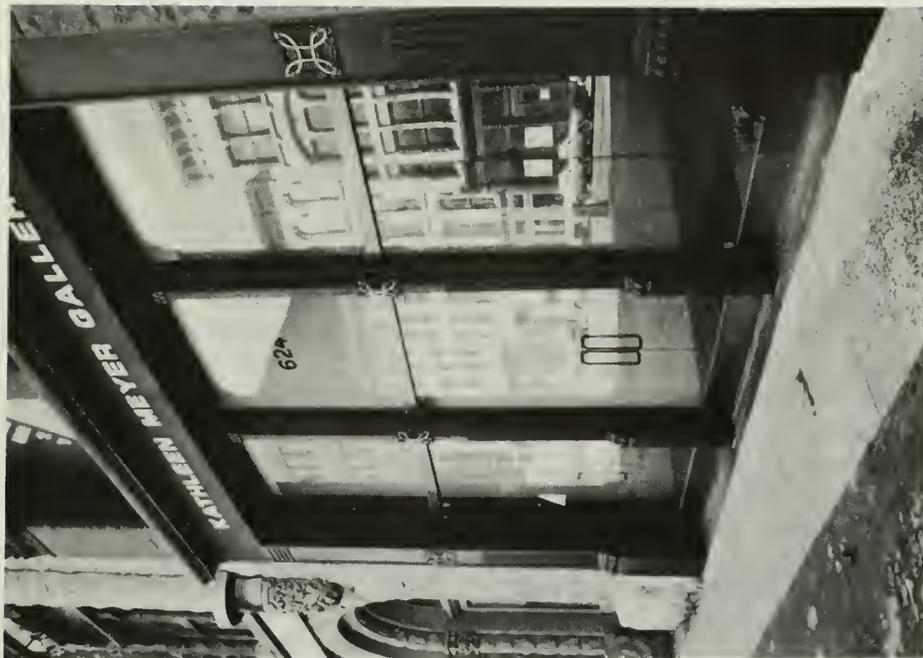
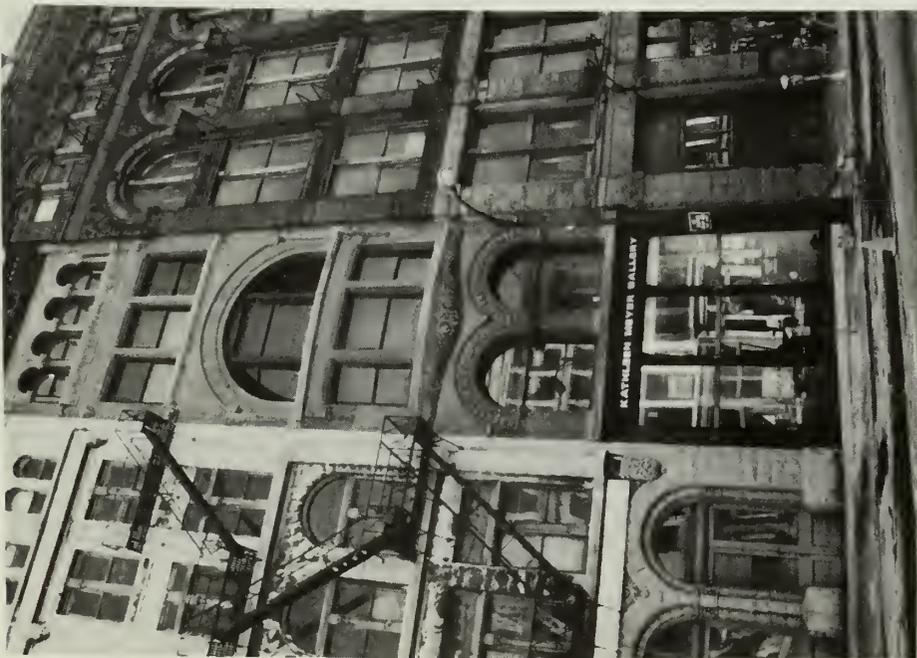
3 and 4. Overall and detail views, after installation of the compatible new storefront features. Note the 1930s-1940s features have been replaced, while the new design successfully retains the 3-bay division defined by the decorative cast-iron columns and cornice. The original cast-iron storefront elements have been painted dark brown as well as upper level window trim and cornice.

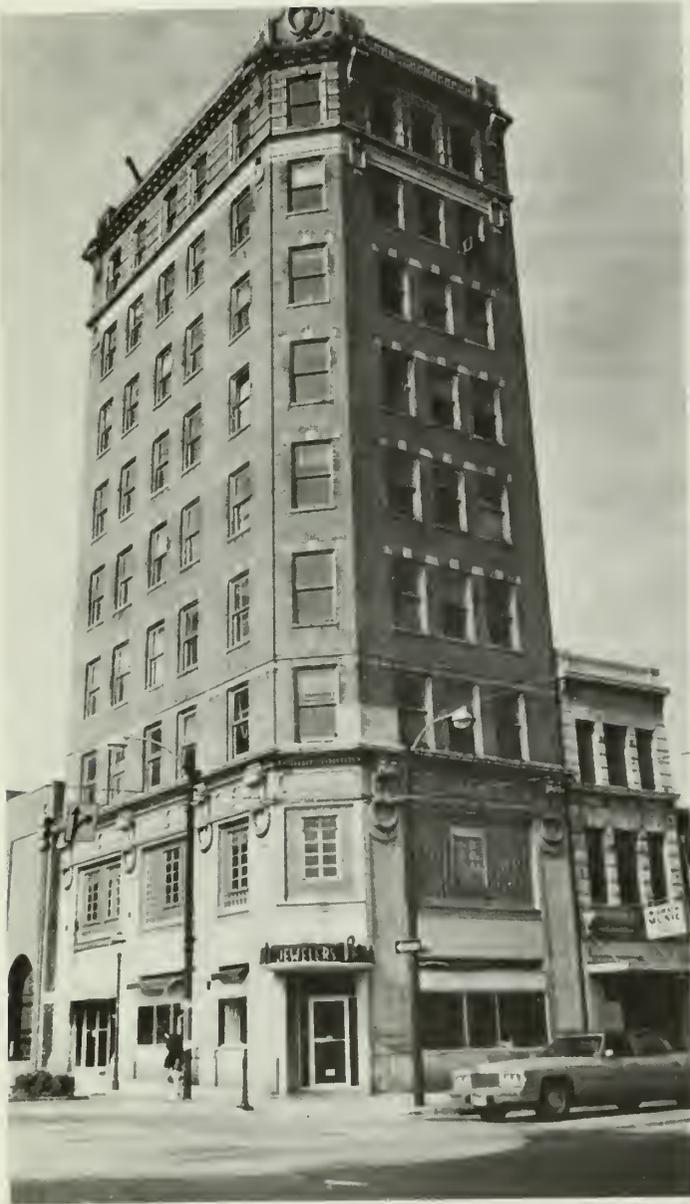
1. Nine story bank and office building before rehabilitation. Note uniformity of brick color.

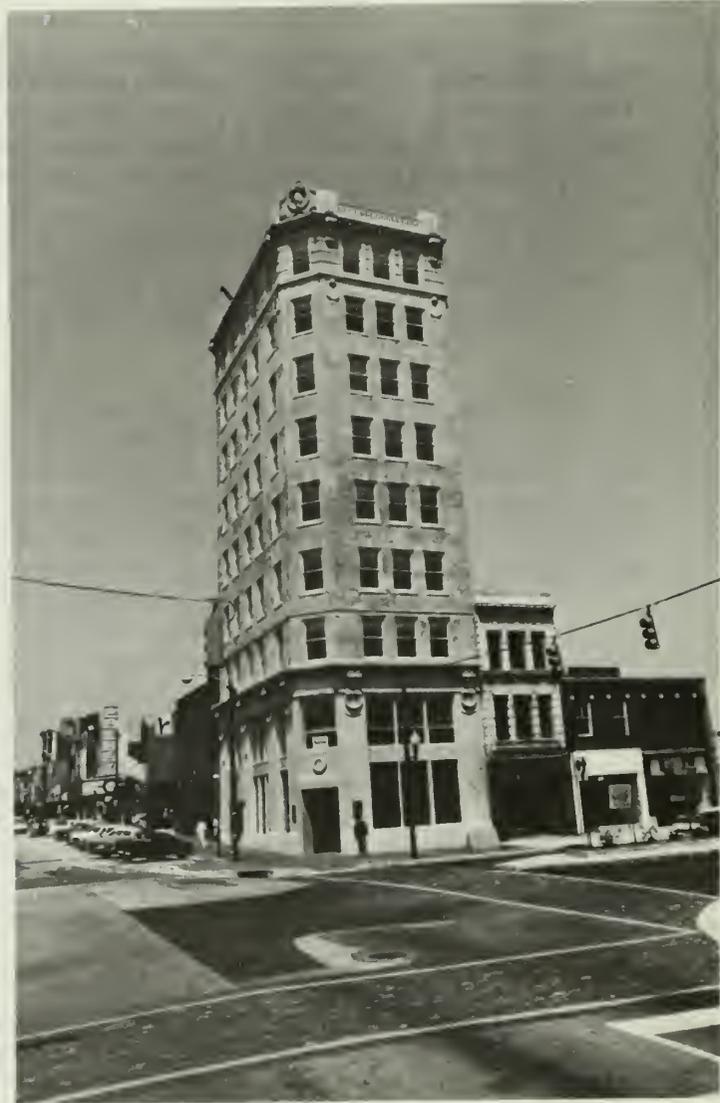
2. Office building after chemical cleaning showing splotchy and discolored brick.

When the completed project was submitted to the National Park Service for final review, however, it was denied certification on the basis of the cleaning techniques which had resulted in "severe discoloration and splotching of the brick surfaces" (see illus. 2). The region's denial letter went on to say: "The brick was apparently cleaned with an inappropriate chemical cleaner which was not adequately tested before its use, contrary to the recommendations contained in the Secretary's Guidelines for Rehabilitating Historic Buildings. Although the physical damage to the brick was not documented, the region felt that the visual change to the brick surface was sufficient to deny the project, citing violation of Standards 7 and 2.

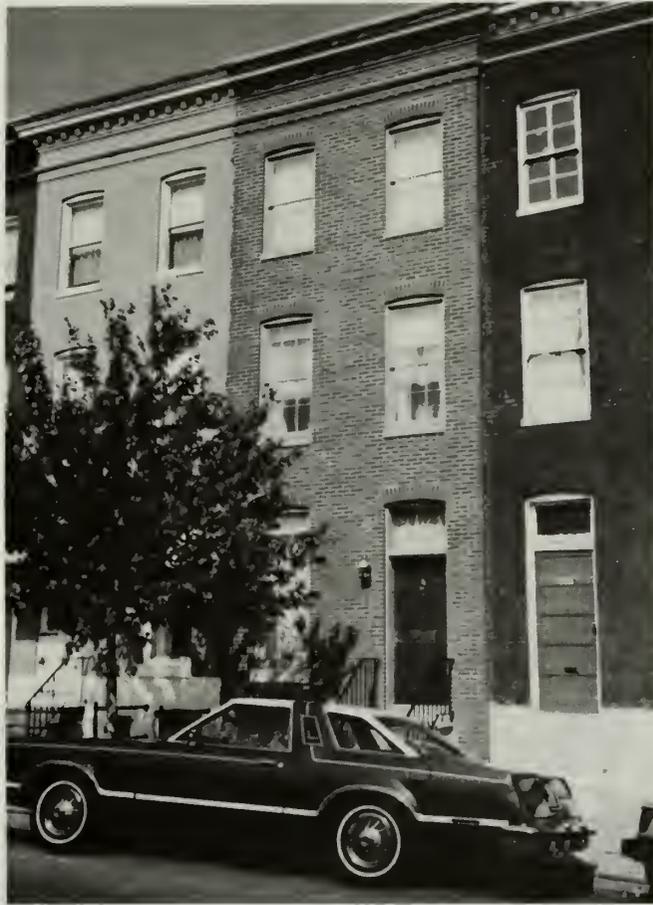
3. Brick rowhouse in center after paint removal using sodium hydroxide stands out conspicuously from its still painted neighbors.

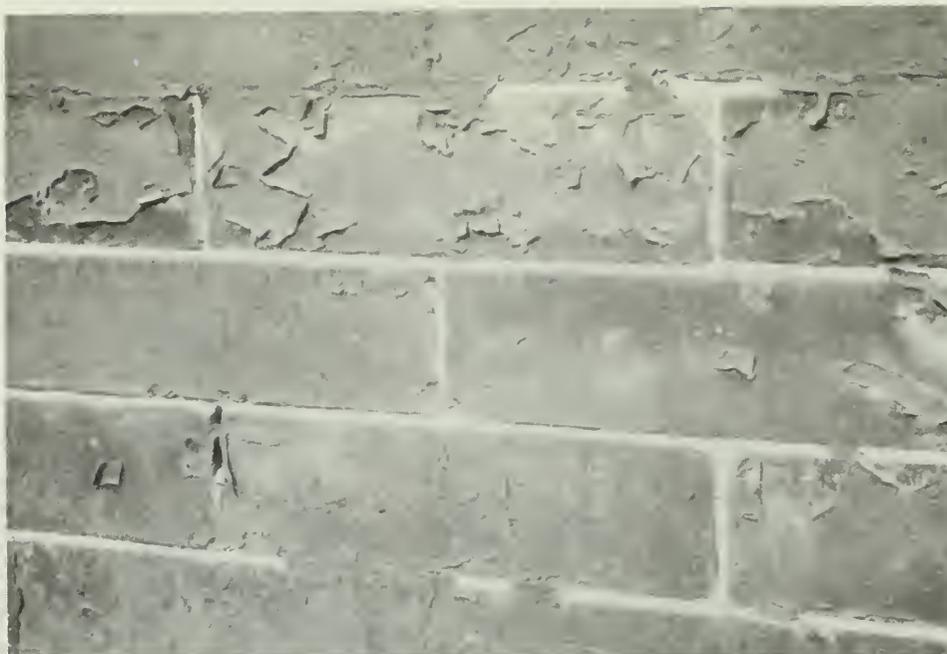
4. Close-up view of uncleaned partially painted wall with original paint. Note relatively smooth surface of this brick on identical house on same block

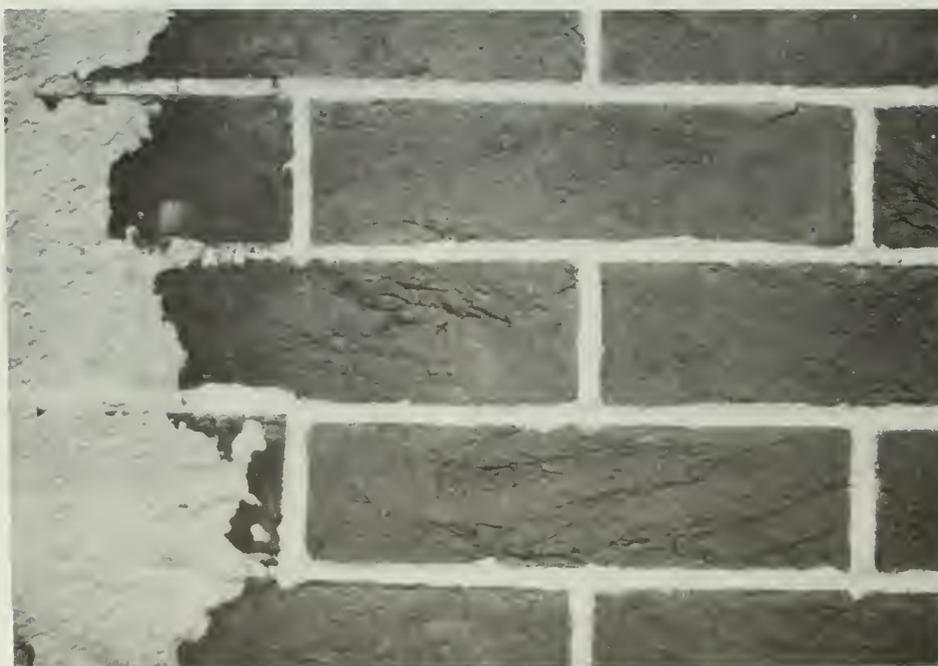
5. Close-up view of chemically cleaned brick showing deep ridges and newly abraded texture.
