Technical Preservation Services
Preservation Assistance Division
National Park Service
U.S. Department of the Interior
Washington, D.C.

Interpreting the Secretary of the Interior's Standards for Rehabilitation

Volume II

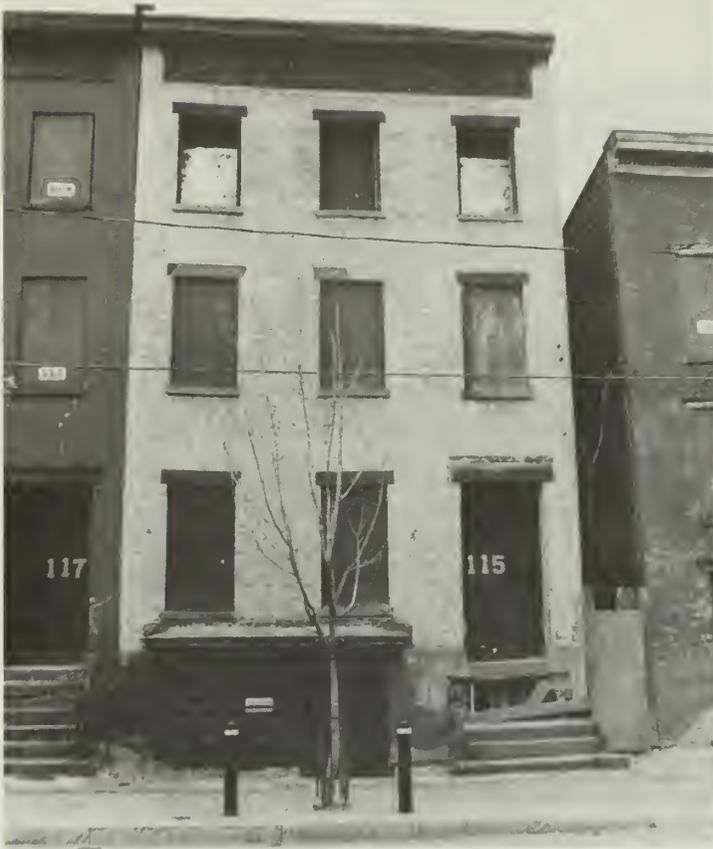
1. Although photographic documentation submitted with the Part 1 application showed some deterioration and loss on the primary elevation, NPS determined that the building exhibited sufficient "integrity" to qualify as a certified historic structure.

Application: A deteriorated, three-story, three-bay wide brick structure built in 1843 was certified in the Part 1 application as contributing to the significance of the registered historic district--a 13 block area of 19th century Federal and Greek Revival structures (see illus. 1,2,3,4).

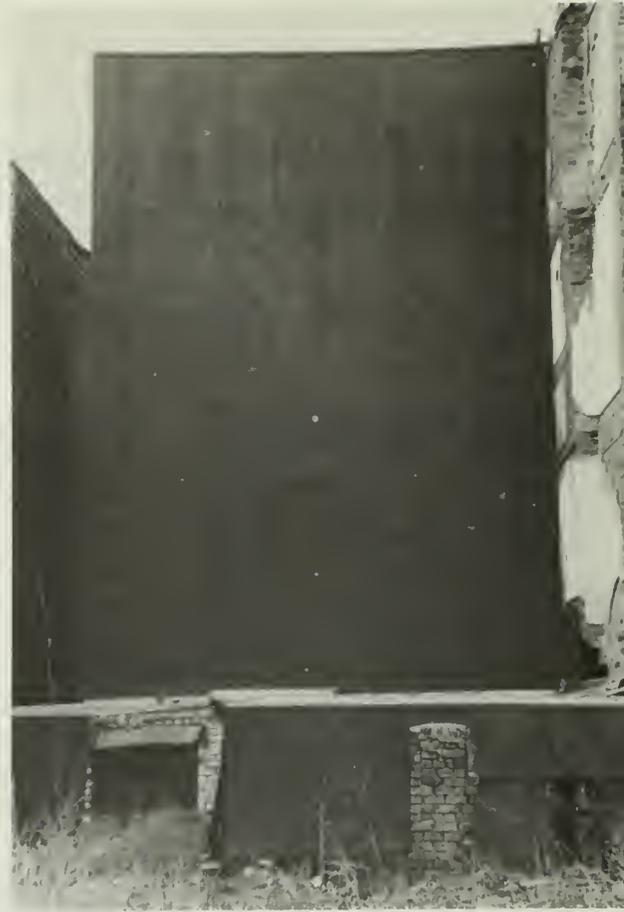
2. Limited demolition at the rear of the building had already occurred and protective boards had been applied.

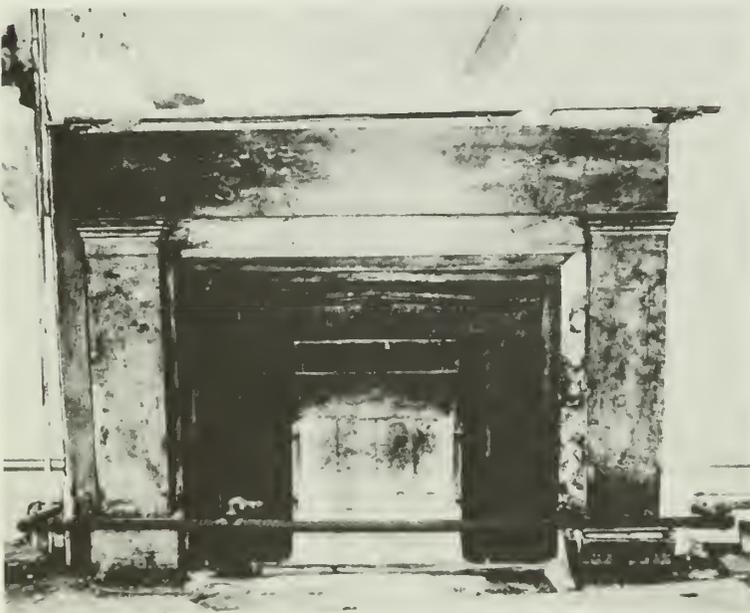
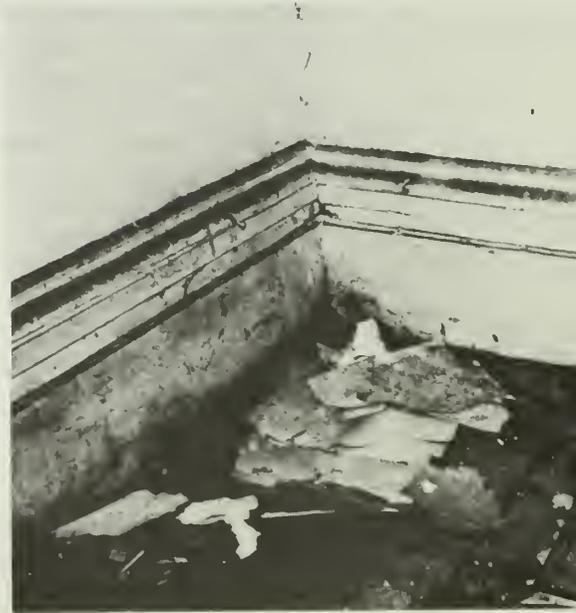
3, 4. The interior, with intact trim and mantels helped define the character of this simple, mid-19th century structure.

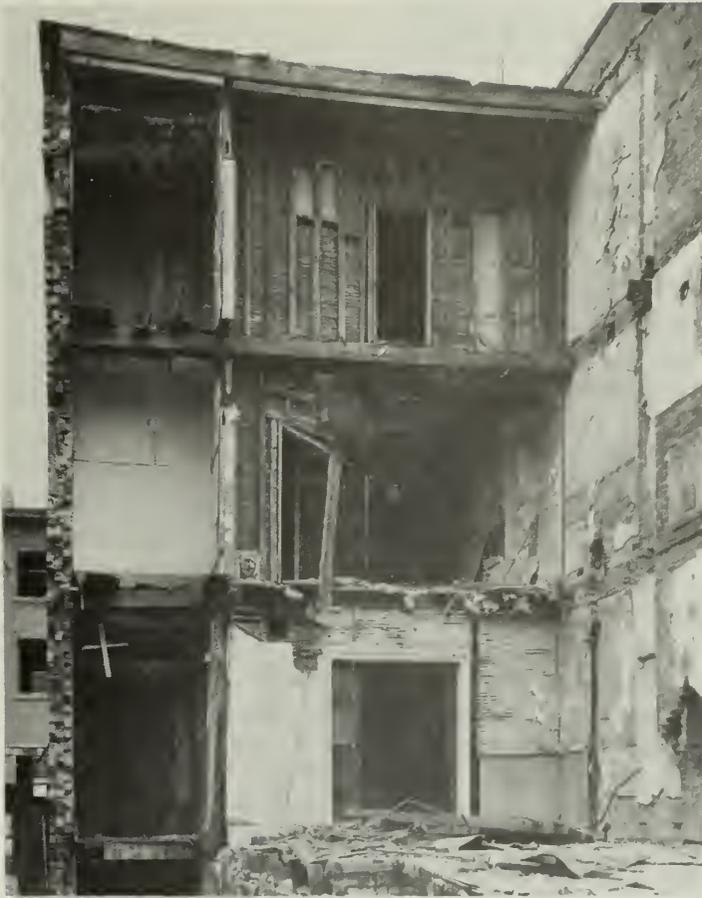
5. Crucial to the decertification of the structure were additional photographs documenting the condition of the rear of the building prior to rehabilitation. After removal of the boards, this new information showed that barely 1/3 of the building remained.

The new photographic documentation that you submitted shows that barely one-third of the building was standing at the time rehabilitation work commenced. As a result of the building's extremely deteriorated condition, significant architectural features are too deteriorated to be preserved on the remaining portion of the building. In addition, nearly all interior finishes are to be replaced and rebuilt using new materials. As a result of the new information, we have determined that No. 2 of the "Standards for Evaluating Significance Within Registered Historic Districts" has been met (e.g., the structure does not contribute to the significance of the district) and, therefore, the building cannot qualify as a "certified historic structure." This decision supersedes the earlier decision...Since the building does not qualify as a "certified historic structure," in accordance with Department of Interior regulations, the project is not eligible for certification of rehabilitation.

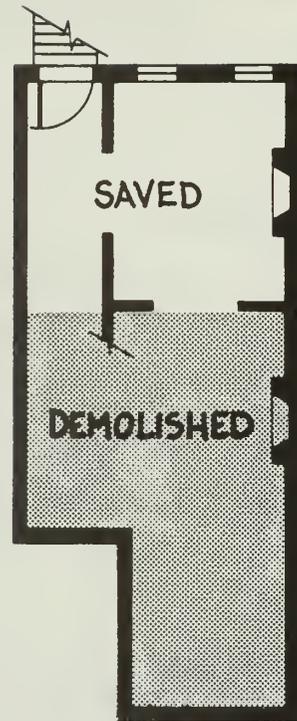
6. The plan indicates the extent of material loss that had occurred prior to rehabilitation, including exterior and interior features.

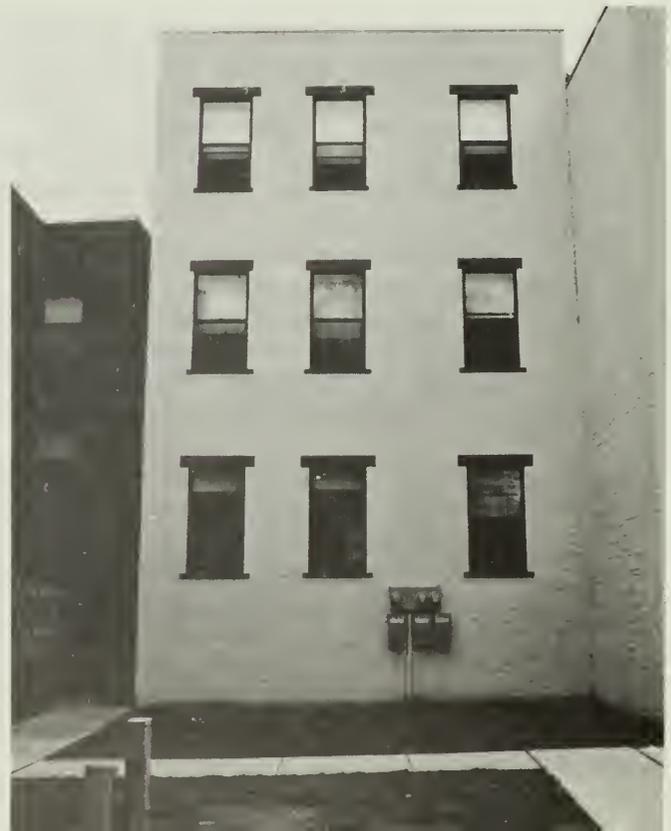
7. The rear of the building and major portions of the interior required extensive replacement of historic material with new material.

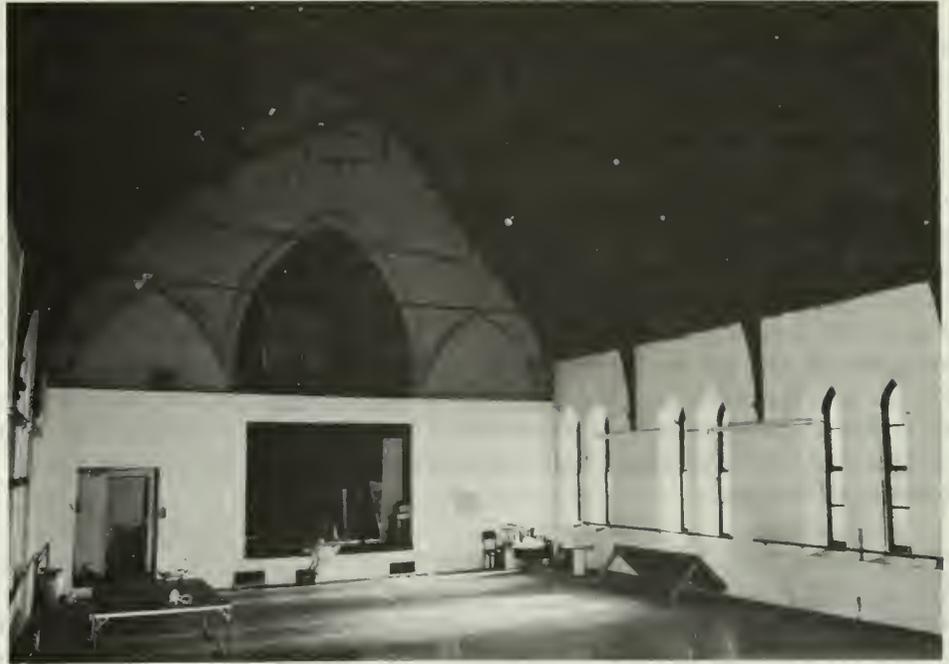
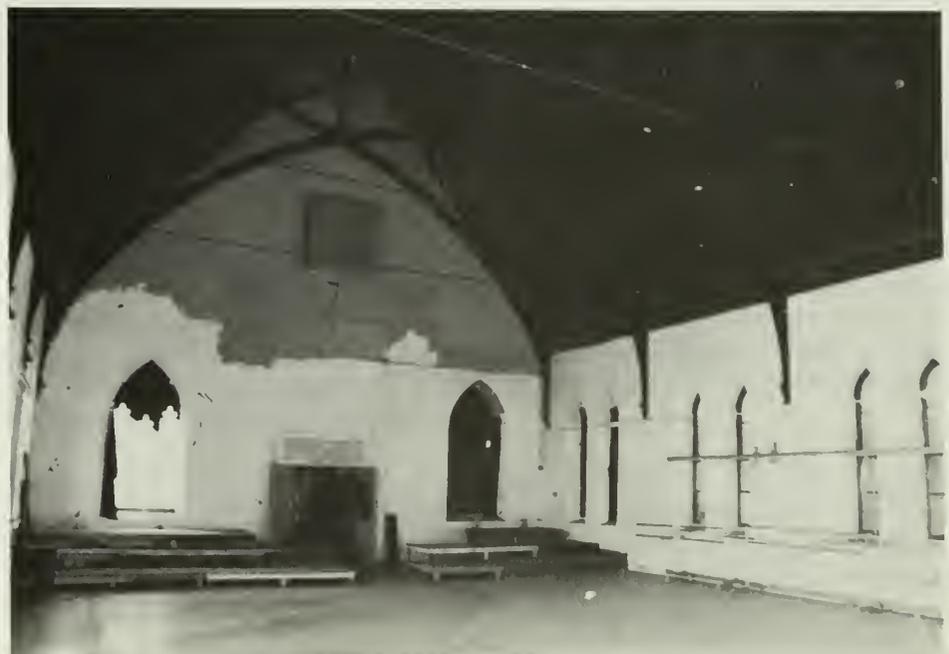
1 and 2. Interior of the church at the time rehabilitation planning commenced. Remaining features include regularly spaced windows, roof structure and exposed scissor trusses, original floor to ceiling height. Only the church furnishings had been removed.

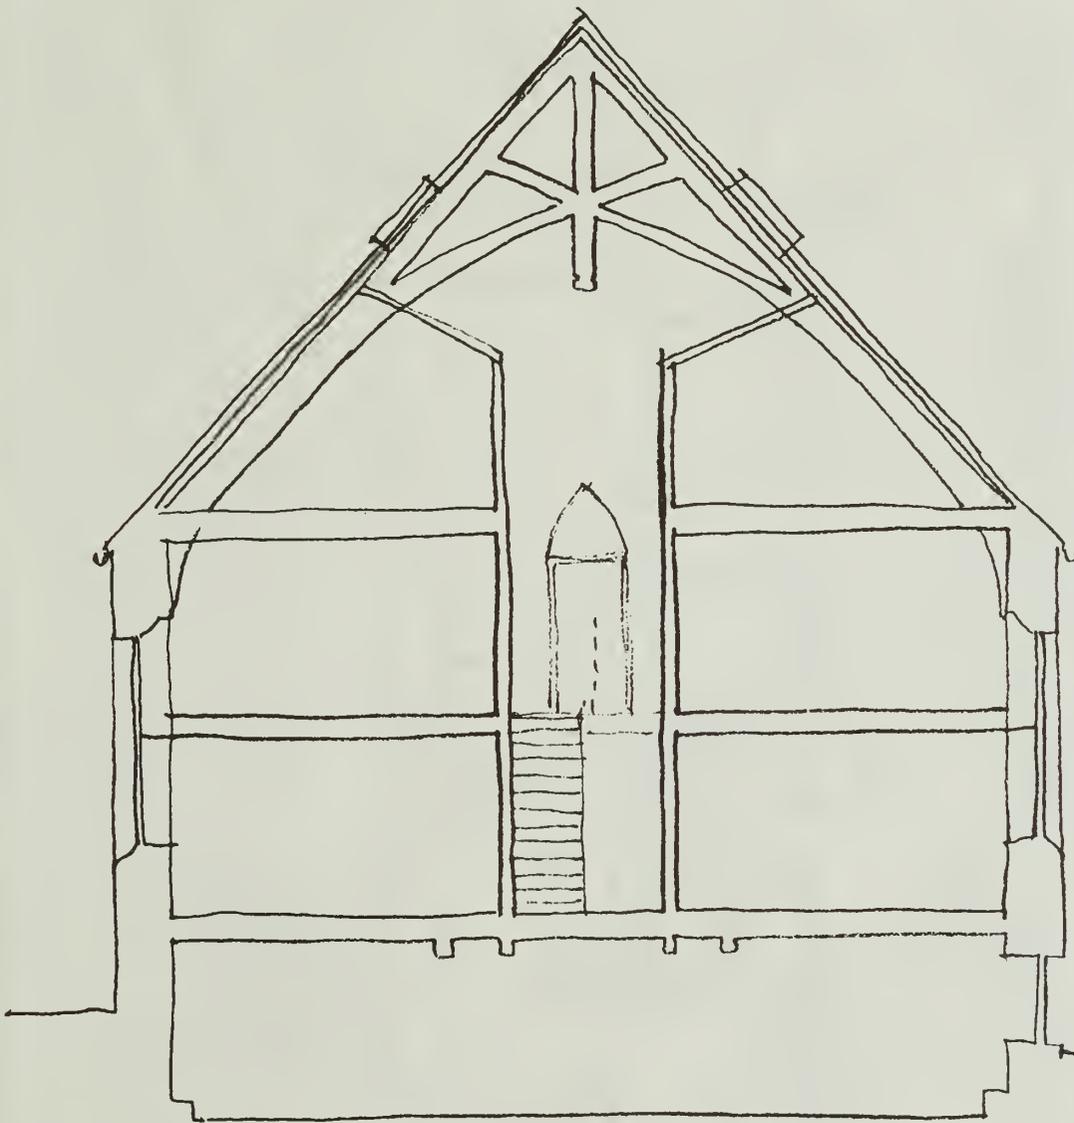
SECTION THROUGH STAIR HALL

3. Section showing proposed insertion of two floors and a hallway within the sanctuary.

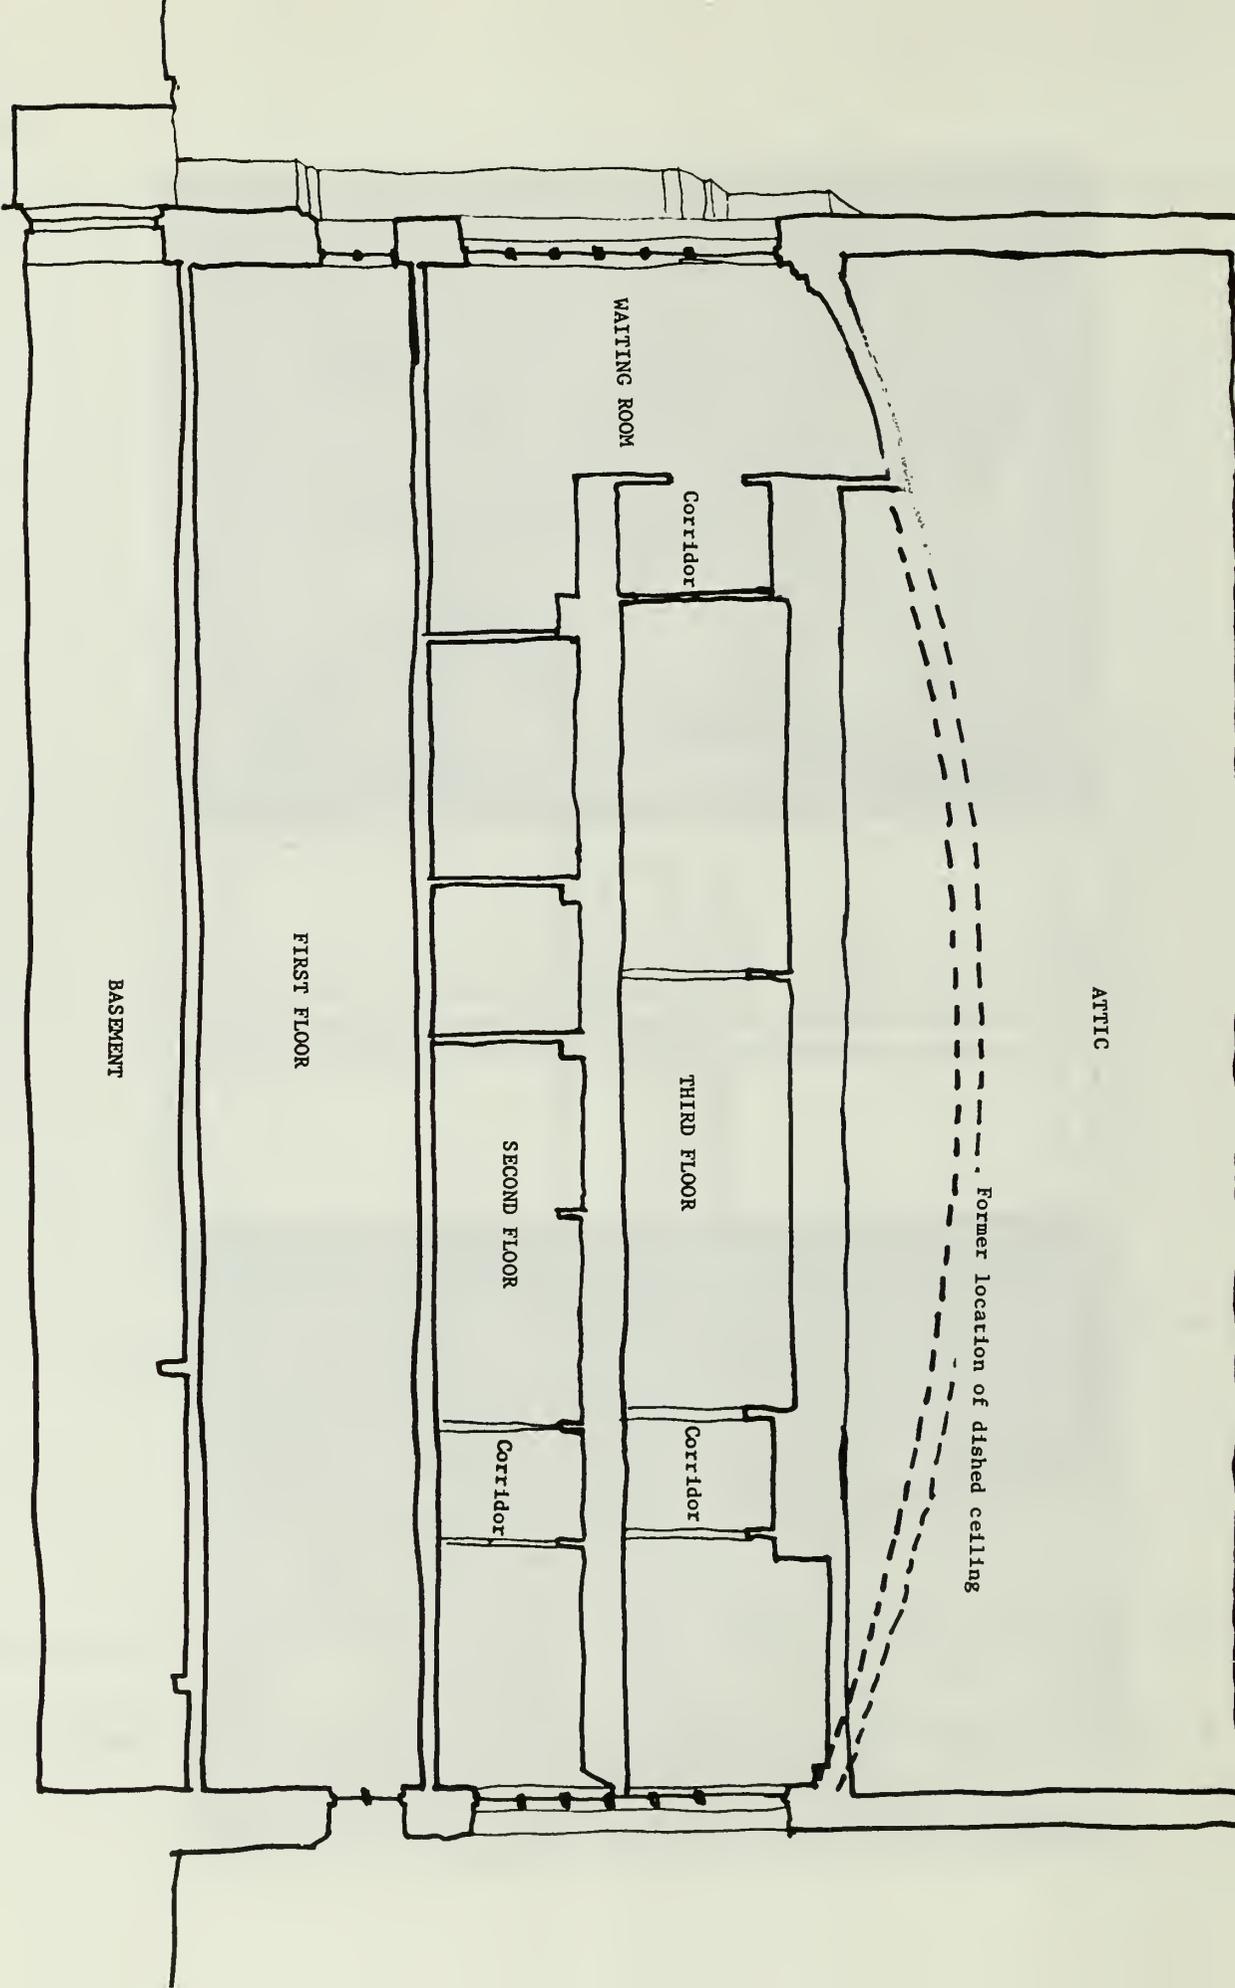
4. Section of Octagon sanctuary space with proposal to add floors and partitions for the new use as offices. Two-story waiting room with reconstructed plaster details on left of sketch.

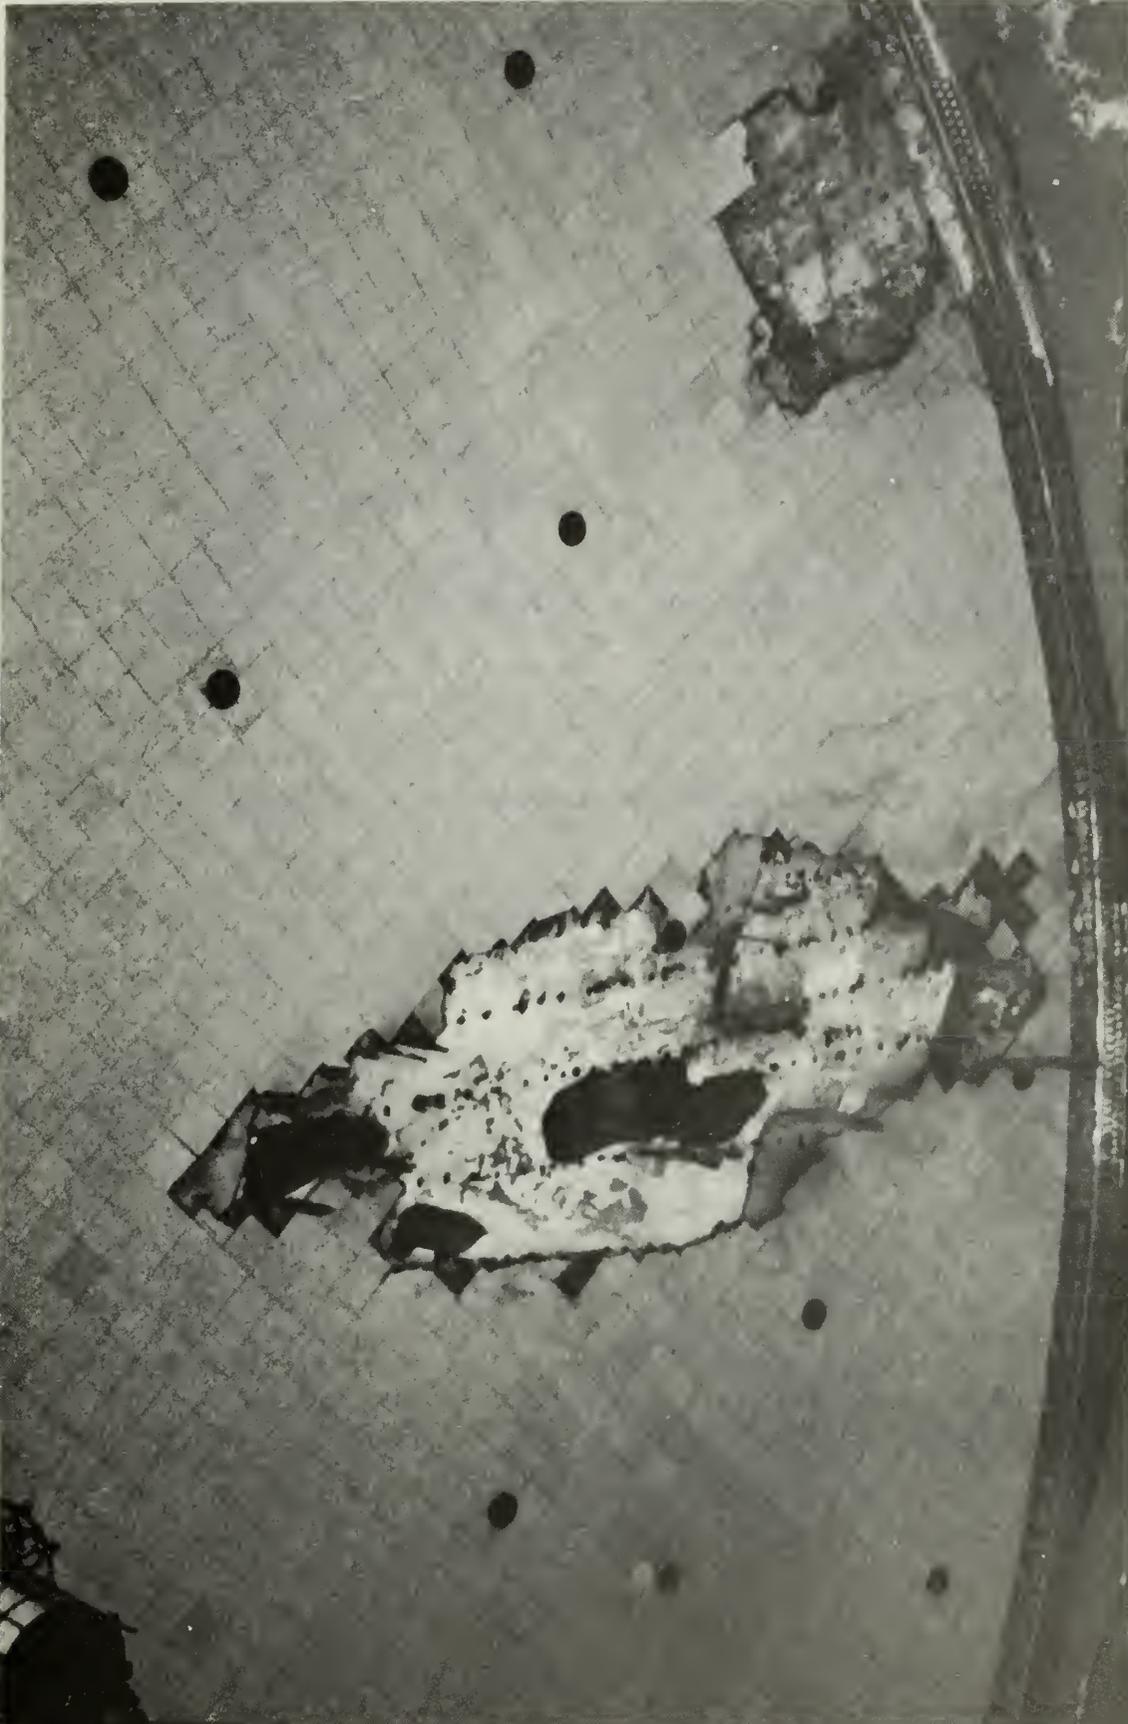
5. Damaged ceiling, due to moisture from roof leaks, buildup of pigeon droppings above, and lack of heat.

In appealing the regional denial, the owners stated that the dished ceiling plaster and lath (as well as the applied acoustical tile) would have to be removed, as they were soaked with water from the numerous roof leaks, and had a thick layer (as much as one foot) of pigeon excrement above. Further, due to water penetration and freeze-thaw cycles, the decorative plaster on the sanctuary walls was severely damaged and so unstable as to be unable to withstand even the slightest impact.

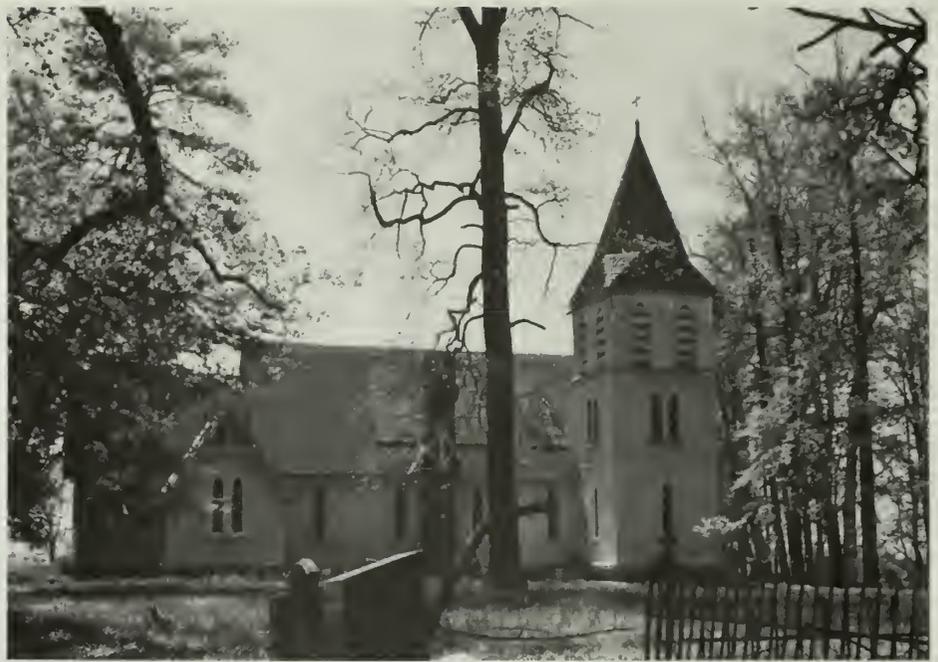
5. North elevation showing new skylights inserted in nave roof after rehabilitation.

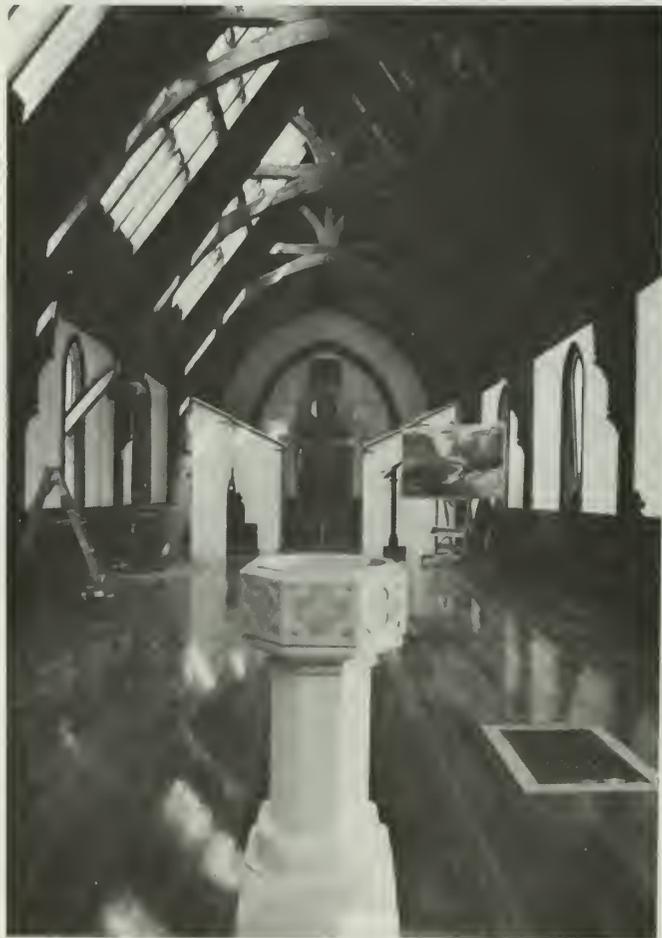
6. View of nave looking east. Note the 2 new sheds in front of and on either side of spiral stairs in center of sanctuary arch leading to mezzanine.

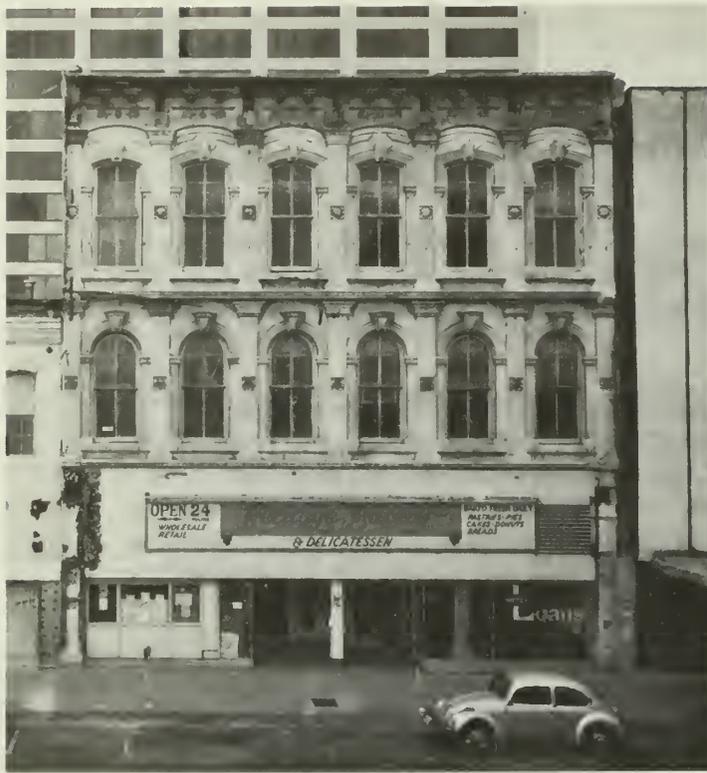
1. At the outset of rehabilitation, an 1866 limestone building was missing its ornamental cornice; and the ground level storefront had been extensively altered.

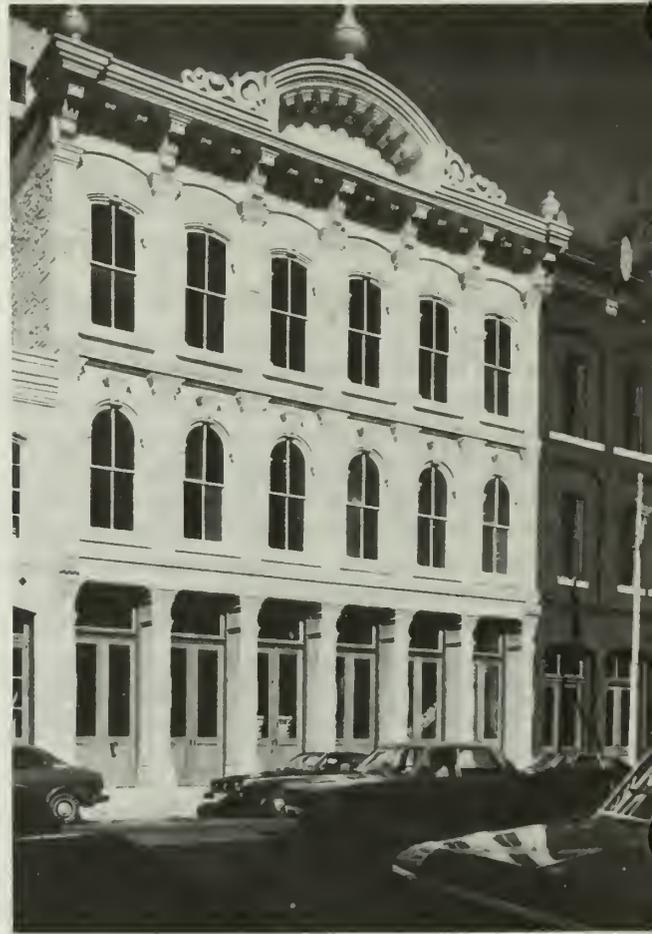
3. In addition to restoration of the storefront using matching materials, this photograph of finished work shows an acceptable use of substitute material (in this case, fiberglass) to fabricate the missing pressed metal cornice.

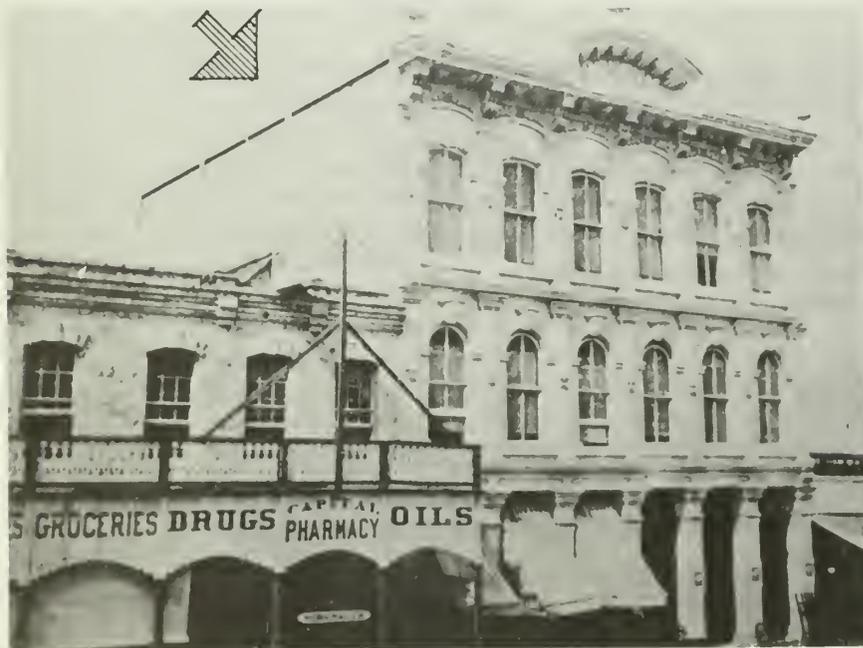
2. Based on the availability of this and other photographic documentation, the owners were able to accurately restore both the cornice and the storefront to their historic configuration.

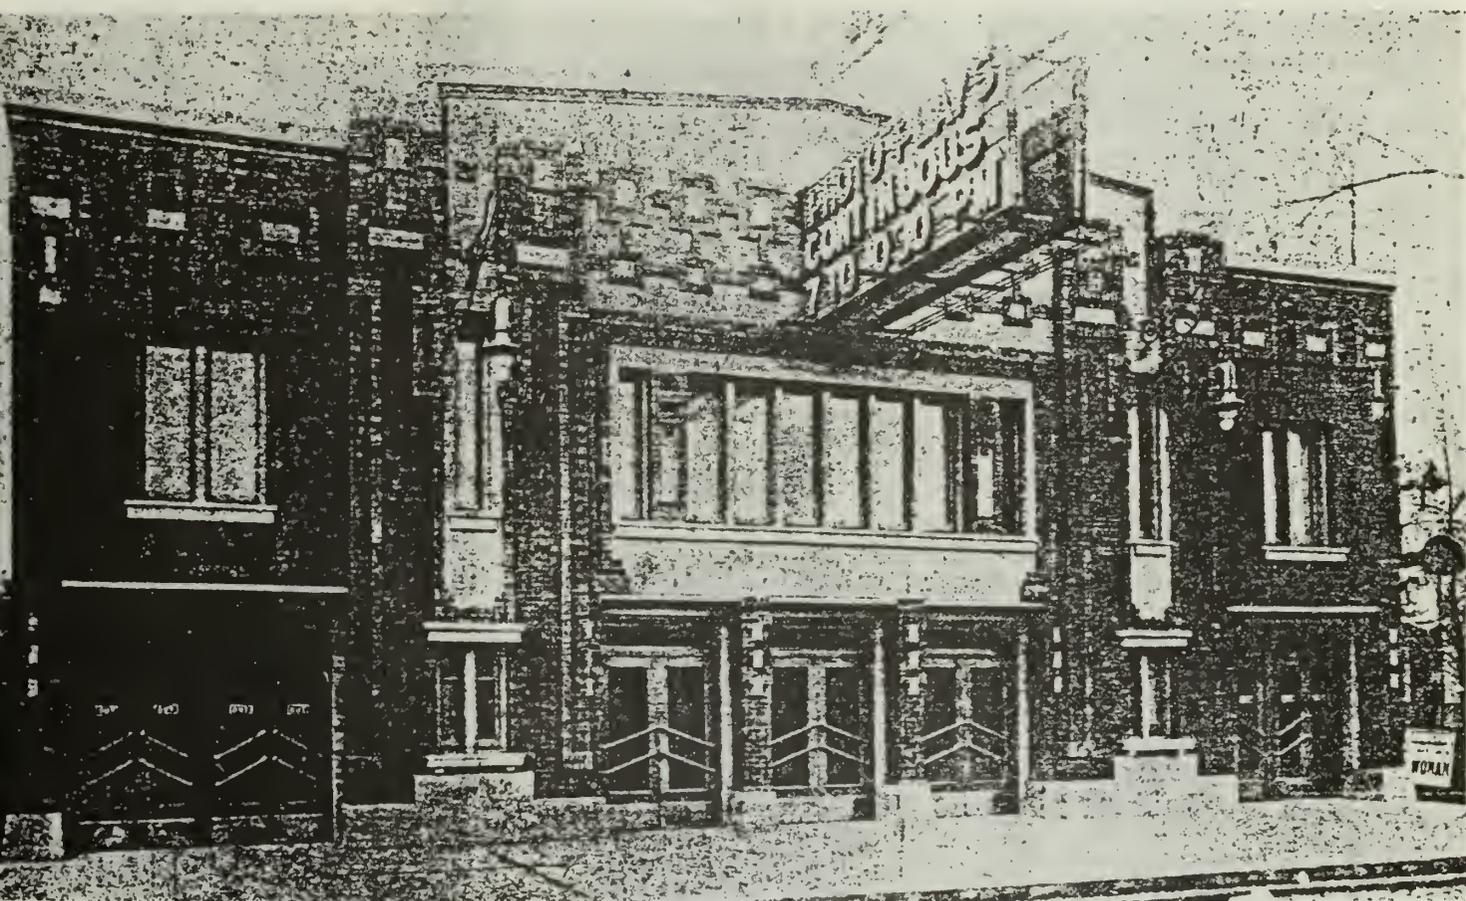
4. Historic photograph of the theatre's facade as it appeared in 1913. Note the glazed wooden double doors, repetitive features that, together with the distinctive rectangular openings themselves and the patterned brickwork, define the architectural character of the building.

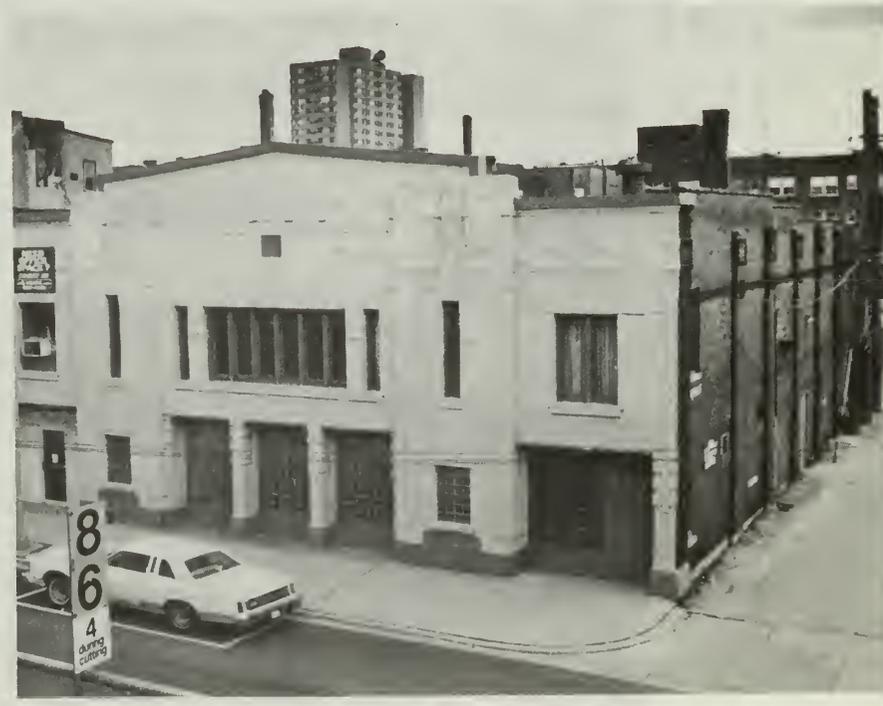
Theatre building as it appeared at the commencement of rehabilitation. The wooden doors had been removed in an earlier "renovation" and the openings filled-in with glass block. In addition, the masonry was painted a uniform gray. The stone sills cover a 22-inch-thick concrete floor inside.

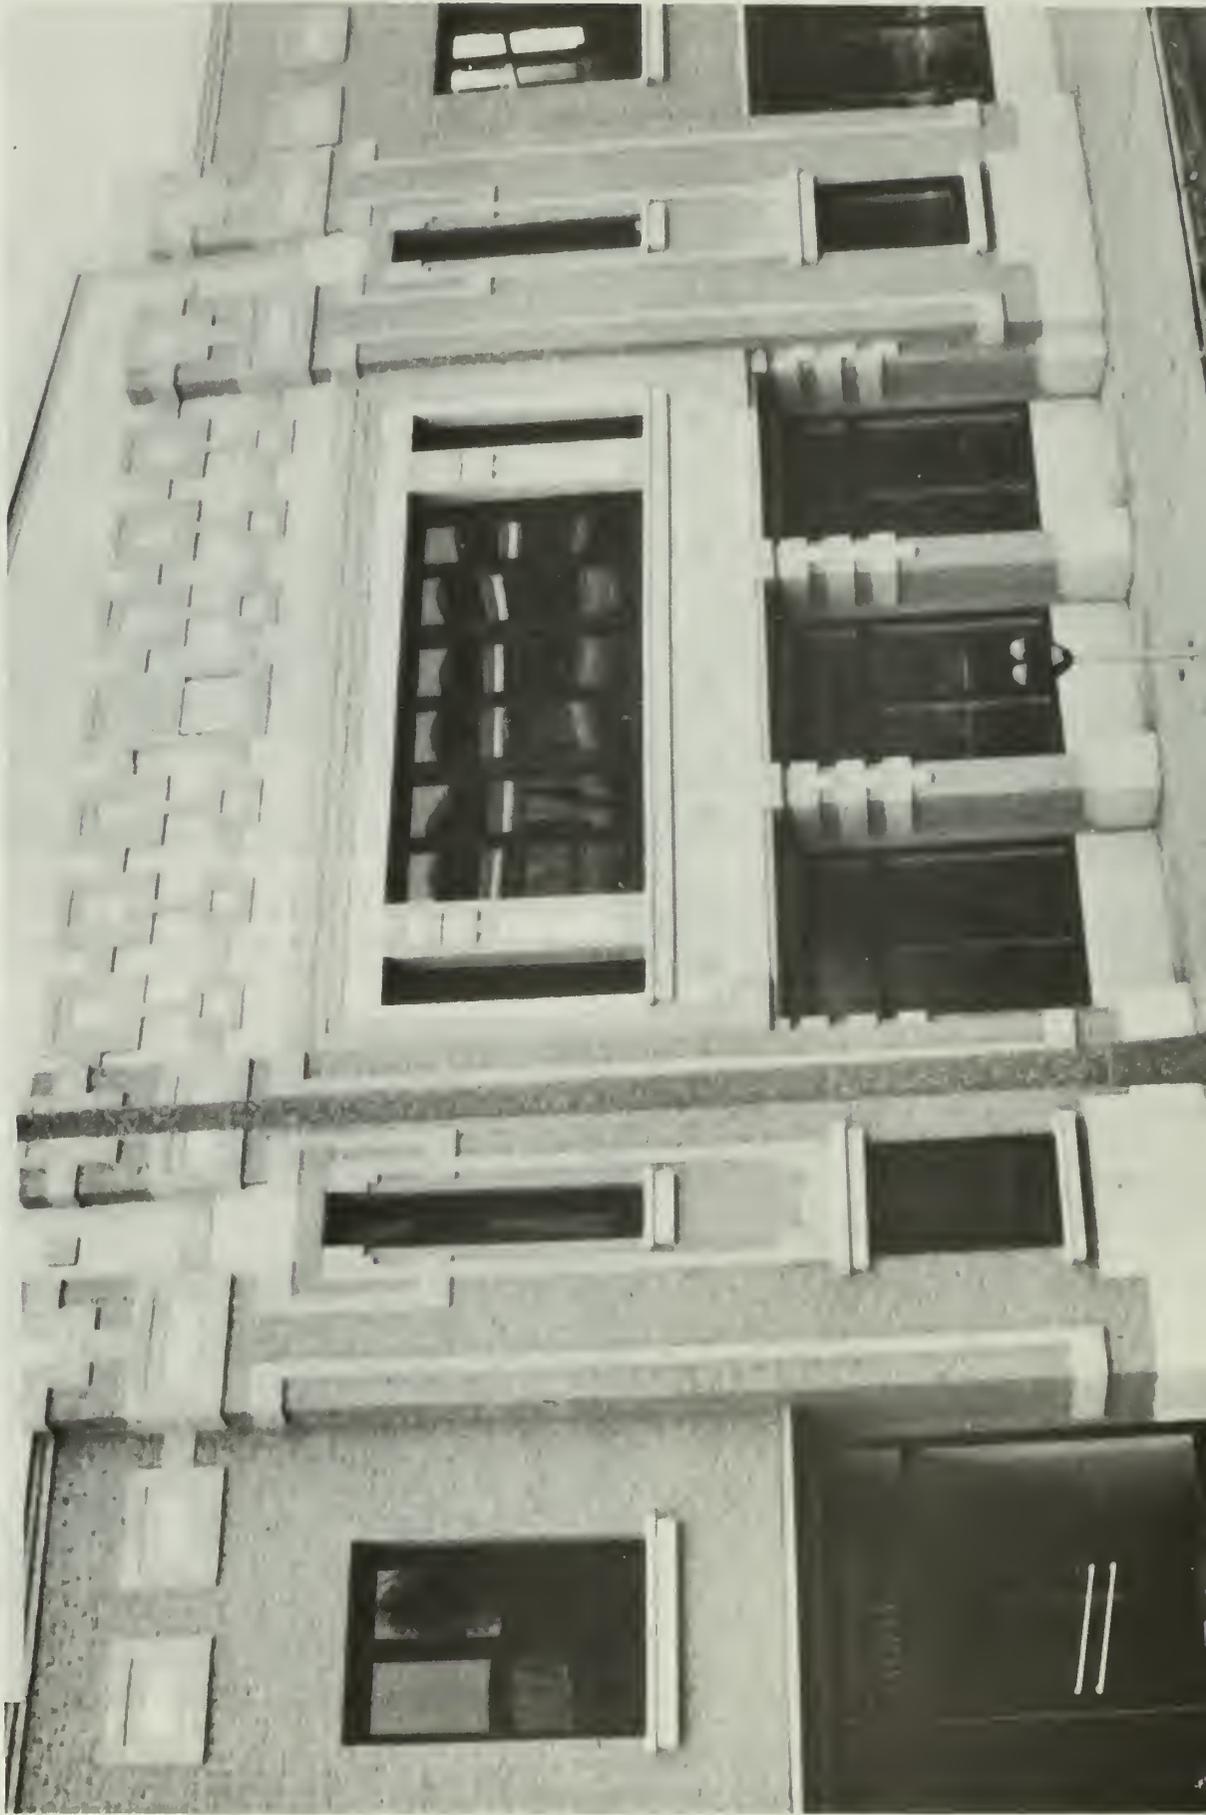
6. Rehabilitated facade. After removing the nonsignificant glass block infill, the owners elected not to restore the wooden double doors, but instead, to install new, simply detailed steel windows that respect the regularized openings. The brick has been painted to approximate the original colors so that the patterning is again evident.

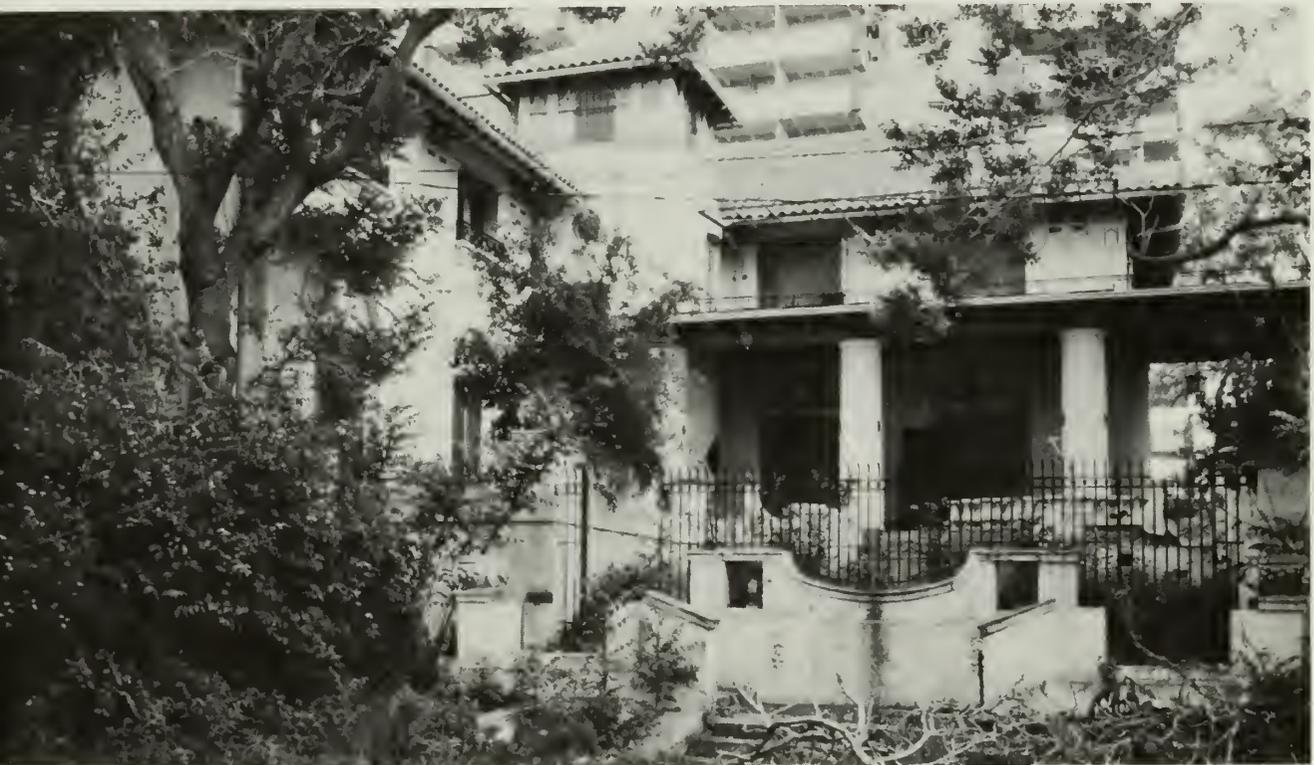
2. View of the rear of the house before rehabilitation began. There is a rear terrace with a pergola and a small walled garden with ornamental walls and an iron fence.

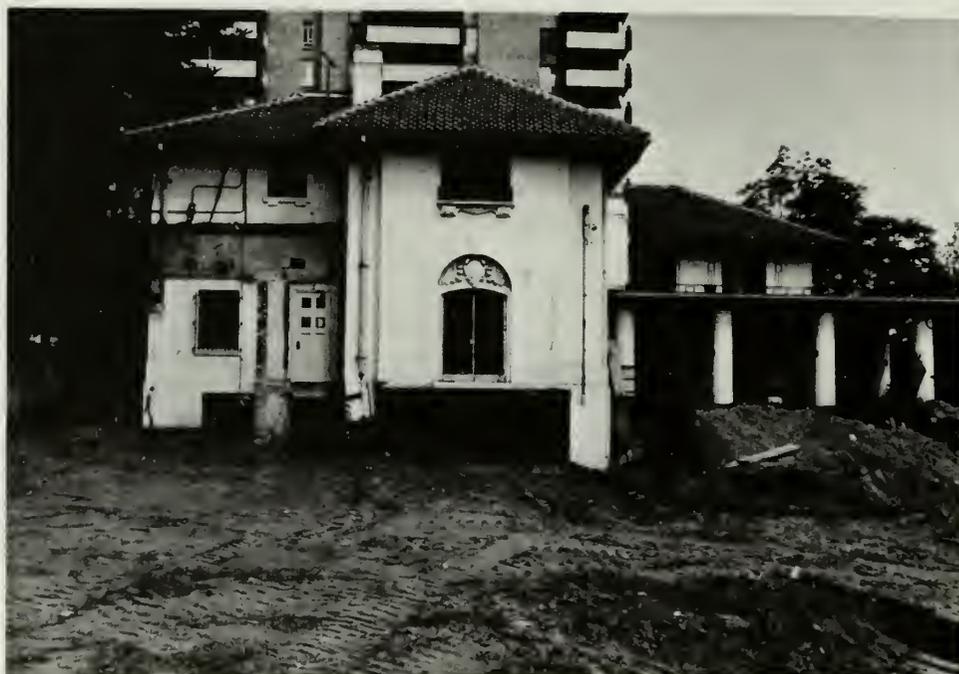
3. Rear of the house after garden was cleared but before construction began.

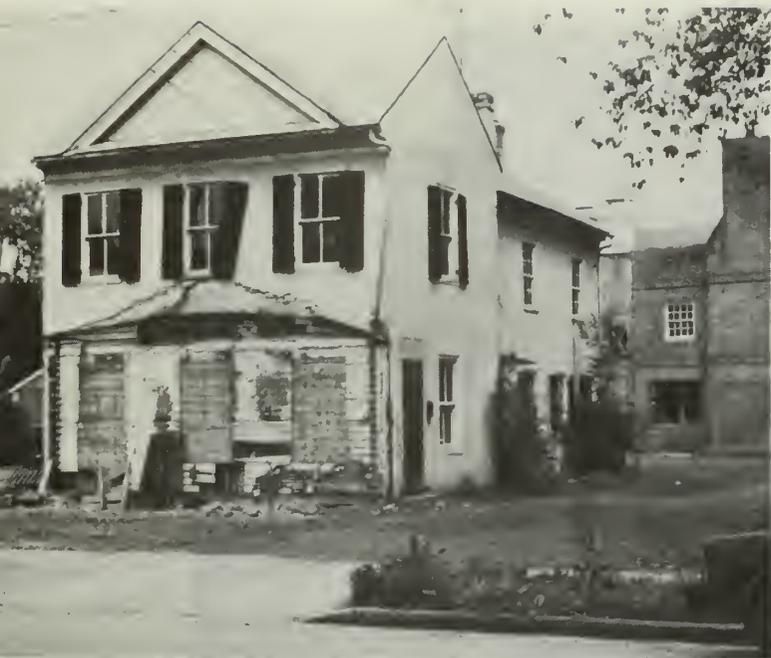
1. Front and side elevations of a ca. 1865-1870 wood frame building prior to rehabilitation. Stucco had been applied over the exterior wood at a later date and had caused rotting and termite infestation of historic wood. The building was certified as meeting Part 1 integrity requirements in its deteriorated and damaged condition.

Application: The first case is a two-story frame house with lap siding built ca. 1865-1870. Photographs of the exterior prior to rehabilitation revealed a combination of damage, deterioration, and previous alterations (see illus. 1). Specifically, lap siding had been inappropriately covered with stucco. A later front porch, nonsignificant front and rear additions, and an exterior metal staircase leading to the second floor had all been removed. Finally, the building's interior had lost the majority of its historic features due to earlier insensitive renovations. In spite of exterior and interior losses and change, the building had been certified as meeting Part 1 integrity requirements because the essential form and detailing was sufficiently intact to convey historic significance within the district.

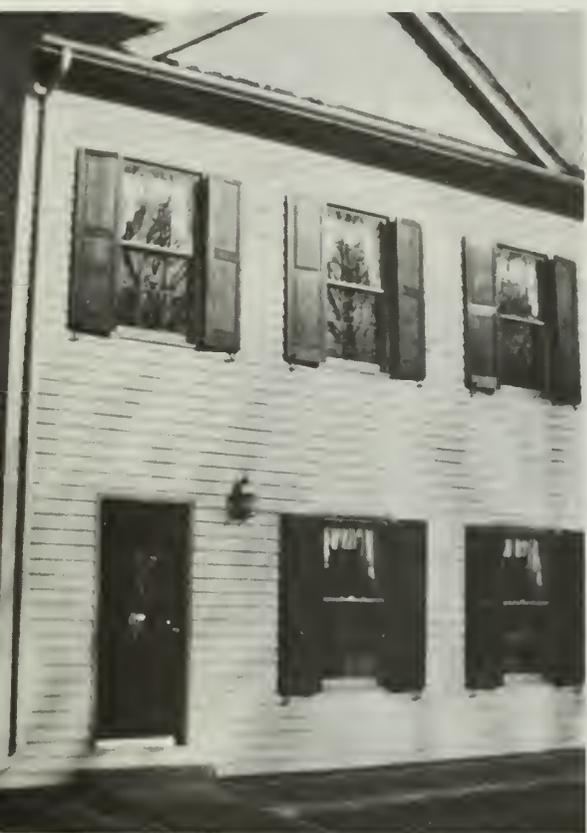
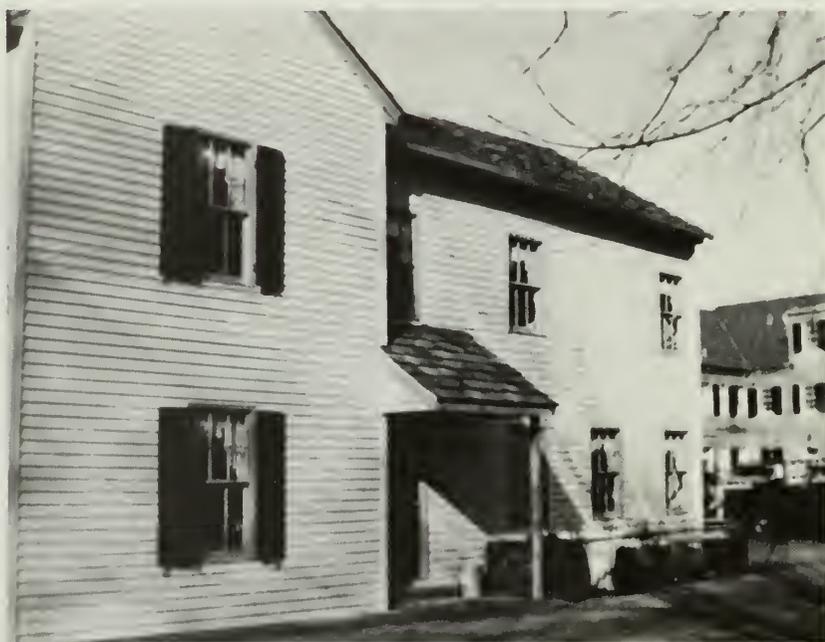
2, 3. The same building shown after rehabilitation is essentially new construction. Rather than targeted replacement of deteriorated materials, the owner replaced all of the siding, roofing, windows, sills, shutters, and trim. Some of the replacement features, such as the use of thick, cedar shakes on the roof and side porch were considered inappropriate. The owner was denied Part 2 certification on appeal. As a result of material loss during rehabilitation and the earlier loss of interior features and spaces, the Part 1 certification was also withdrawn because the building could no longer meet integrity requirements.

At the same time, other historic wood features were removed and replaced, including roofing, window sash, sills, lintels, shutters, and wood trim (see illus. 2,3). Again, justification for replacement was based on extreme deterioration. When the State office reviewed the project, it recommended denial primarily based on undocumented replacement of exterior wood. Also, some of the replacement features were felt to be inappropriate, such as the heavy roof shakes. The region concurred with the State evaluation and the project was subsequently denied for nonconformance with Standards 2 and 6. The denial letter from the Regional Director strongly emphasized the unnecessary introduction of new material:
