Technical Preservation Services
Preservation Assistance Division
National Park Service
U.S. Department of the Interior
Washington, D.C.

Interpreting the Secretary of the Interior's Standards for Rehabilitation

Volume II

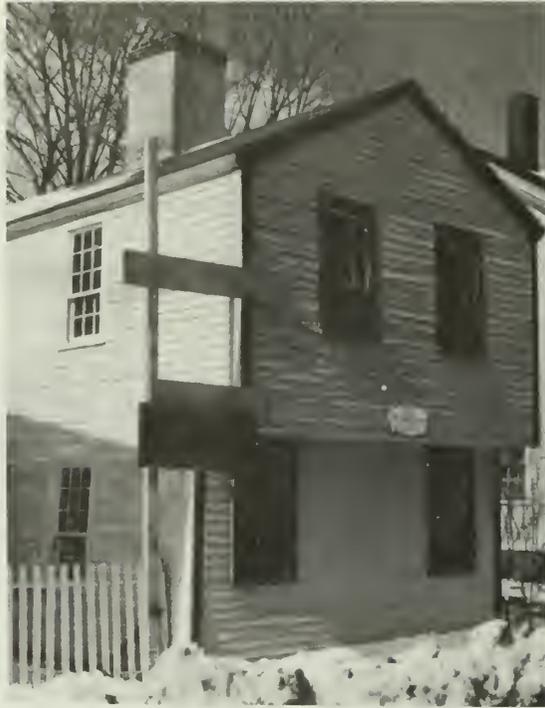
4. A ca. 1769 building was certified in the Part 1 application in its existing condition, which involved extensively deteriorated exterior wood clapboarding, sheathing and window sash. On the interior, some original framing members were intact, while others were repaired or replaced.

In a second case, another "contributing" wood frame building, built ca. 1769, was rehabilitated by the present owner as a single family rental home. The building had been used historically for a variety of purposes, including a warehouse, residence, store, and post office. In the Part 2 application, the owner provided both general elevation photographs as well as detailed photographs of existing conditions, and ongoing and completed work (see illus. 4 , 5). Both exterior and interior work was photographically documented and submitted with a narrative explaining what was original, what was added later, what could reasonably be preserved, and what needed to be replaced. Because the owner's architect believed that exterior wood features were not repairable, extensive replacement of exterior work was already underway as

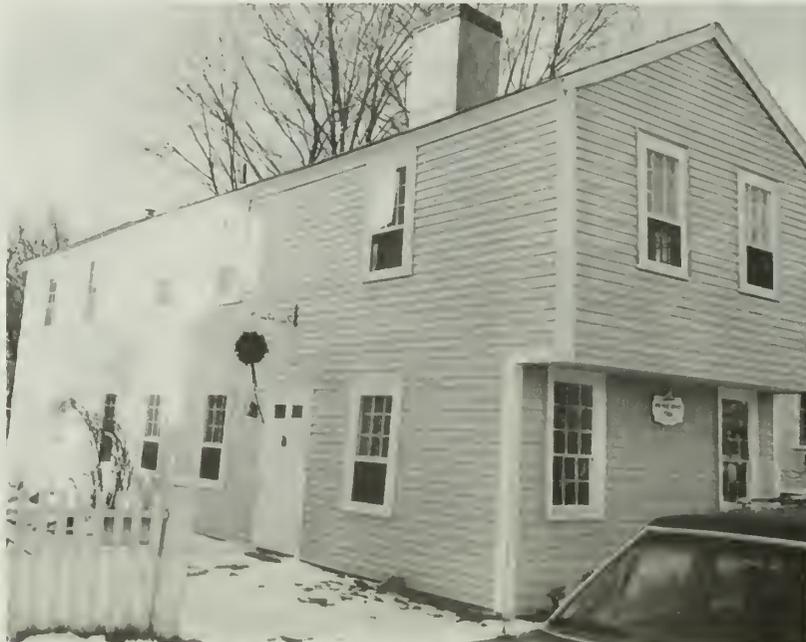
5. Completed exterior work shows the extent of replacement of deteriorated exterior wood materials and features. All siding and sheathing was replaced with new wood. Window sash and frames are also new. The applicant documented areas that needed to be replaced because of extensive deterioration as well as those portions, such as the cornice molding, that could be retained and preserved.

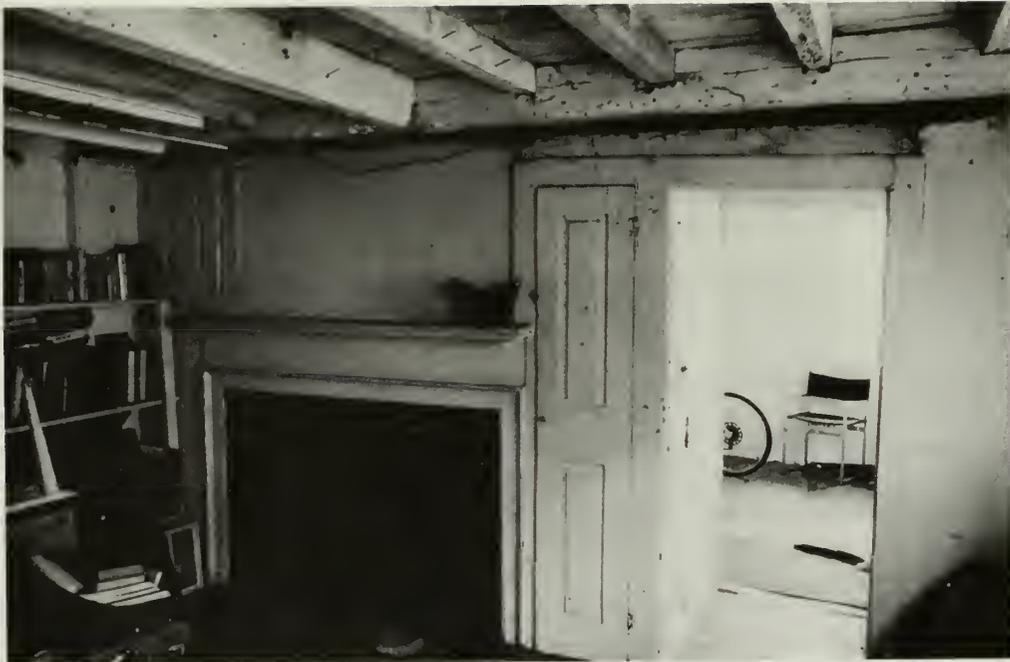
6. An early pegged-braced structural system, fireplace with bee-hive oven, and cupboards are shown. If the extant, significant interior had not been factored into the evaluation to offset extensive loss of exterior materials, overall preservation requirements for Part 2 would not have been satisfied.

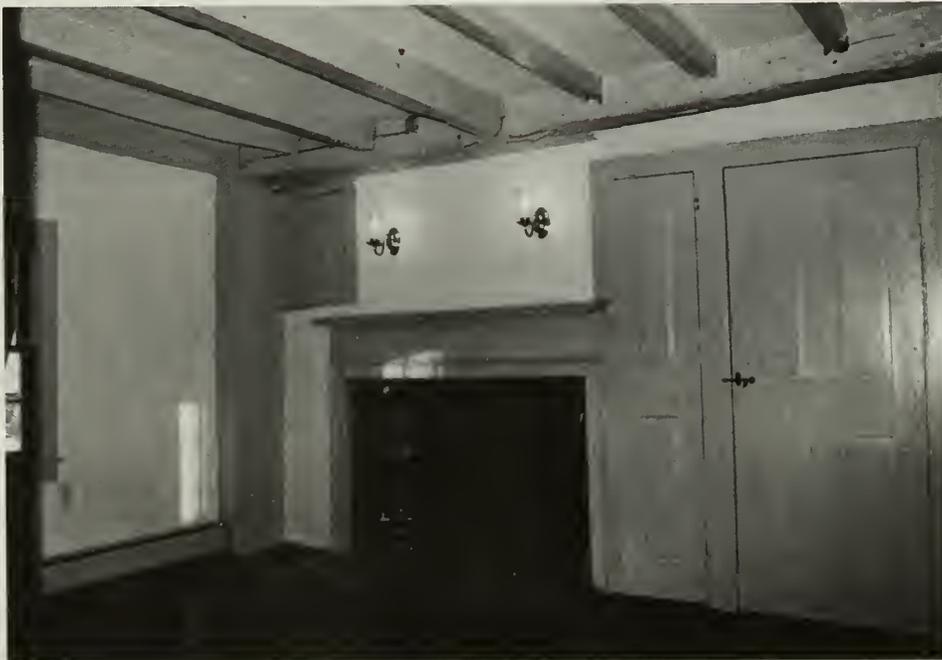
7. The same room shown above after completion of the work. On appeal, it was concluded that the building's highly significant interior, including materials, features, spaces, and an early structural system had been identified prior to rehabilitation, then carefully retained and preserved.

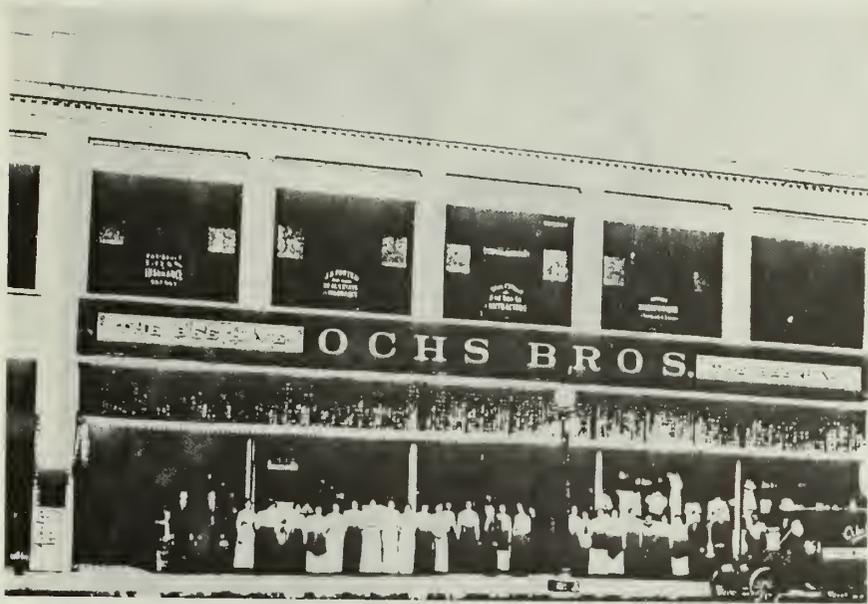
1. Early 1900s photograph of the Ochs Building shows the storefront in its historic design prior to a series of renovations, the last of which totally obscured the facade.

Application: Part 1 certification was requested for a two-story masonry building in a historic district. A photograph of the 1908 department store (see illus. 1) was submitted together with photographs of the existing appearance. In its current condition, however, it did not convey historic, architectural, or cultural

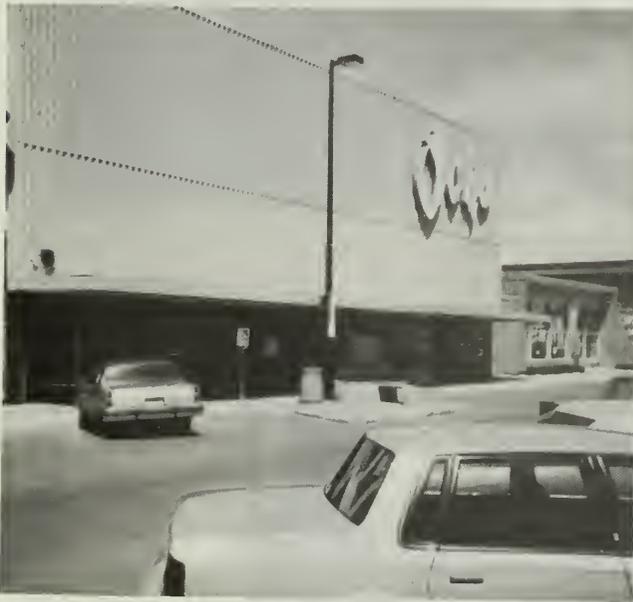
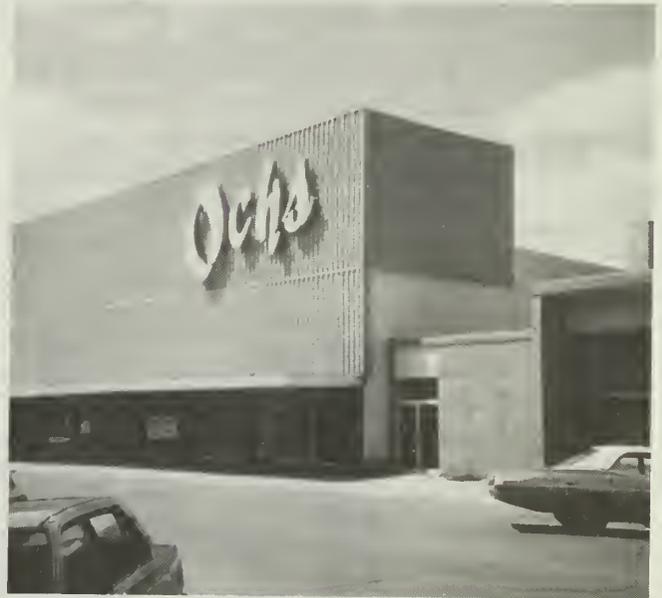
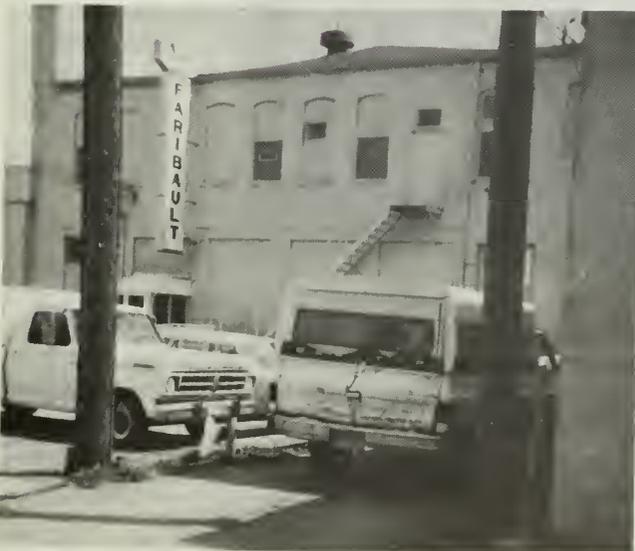
2, 3, 4. The department store shown as submitted for Part I evaluation, with a false front obscuring the primary elevation and enamelled metal squares covering the secondary elevation. A photograph of the rear elevation showed a portion of the building's historic material that had not been obscured. This elevation, however, was not of any particular architectural or historic significance.

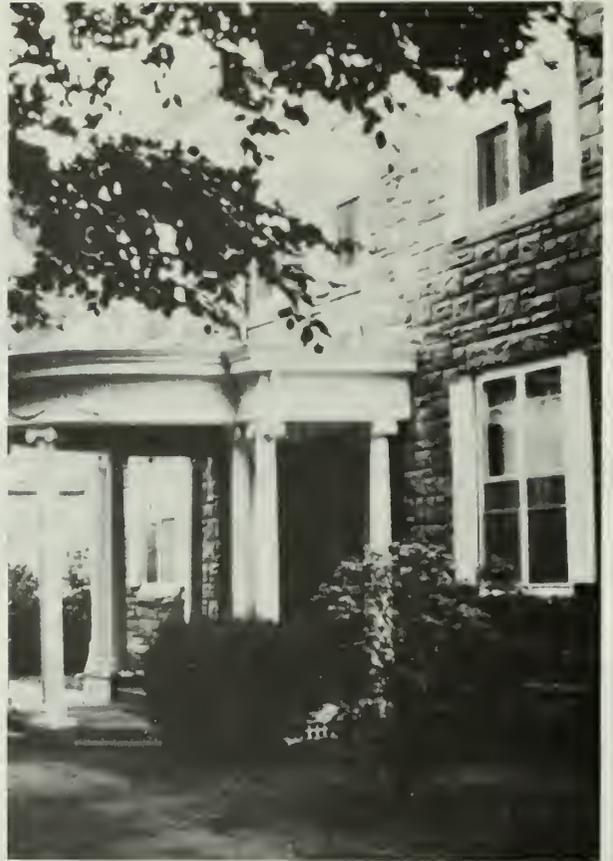
5. A photograph of a portion of the primary facade reveals a highly decorative porch, but also shows the nonhistoric concrete veneer, and aluminum sash and shutters.

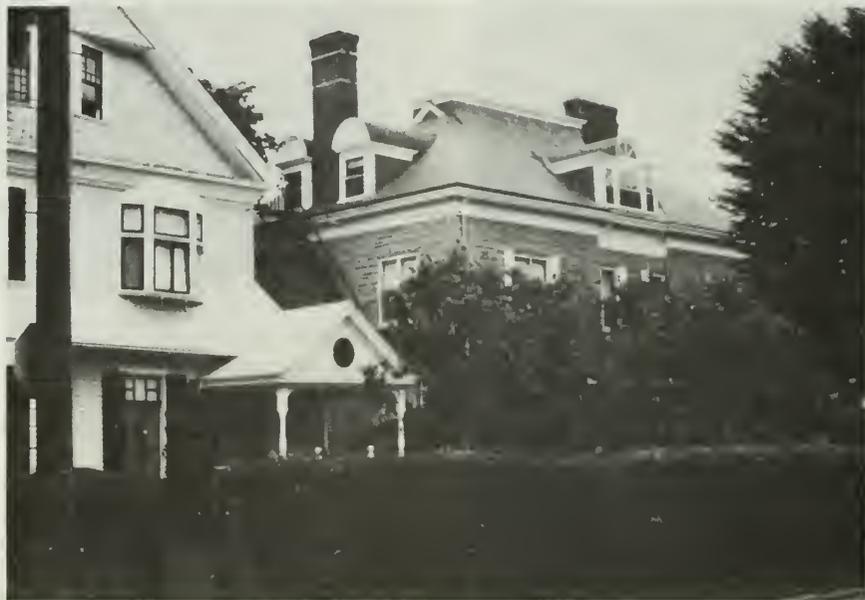
6. The building is shown here on the right in relationship to another building in the district. Although the historic wood sheathing has been obscured with formstone that is heavy and gray in appearance, the surviving physical characteristics of the rest of the building were sufficient to convey historic and architectural significance. This includes the roof shape and materials, and a decorative cornice and portico. Part 1 was issued. In the rehabilitation, the concrete veneer was simply patched and retained as part of overall work.

In a second case, an owner submitted a Part 1 and Part 2 application with photographs of a 2 1/2 story, hip-roofed, frame and masonry building in a tree-lined district of similarly scaled residences. Photographs and a narrative explained that the building had been covered with a concrete veneered covering, and that the wood window sash and shutters had also been replaced with new aluminum "features" (see illus. 5). It was acknowledged in the application that these changes to the building did not contribute to its overall architectural appearance and historic integrity. Documentation also included several photographs of the interior showing raised paneling, parquet floors, tiled fireplaces, and intricate plaster cornice moldings and, in fact, the application emphasized the interior's significance.

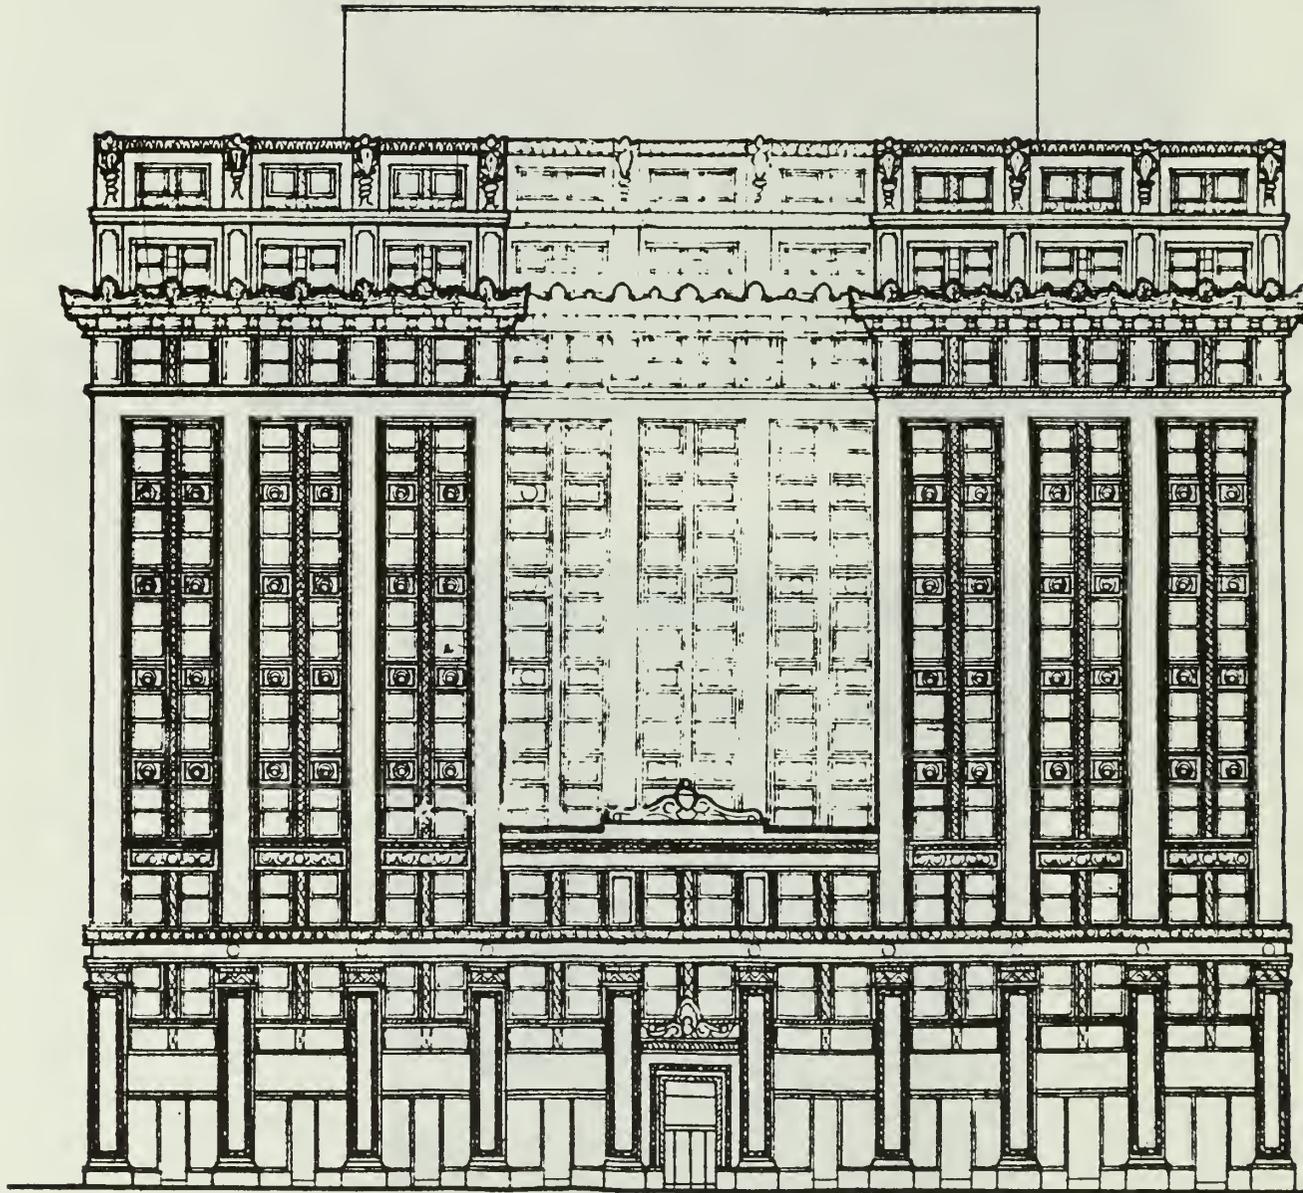
3. The proposed rooftop addition, like other designs submitted, would have obscured the appearance of the character-defining cornice against the sky.

Upon appeal by the owner, the denial was affirmed by the Chief Appeals Officer, who noted that "the two-story addition... would extend to the plane of the wall, thereby drastically reducing and weakening the prominence of the cornice." The "marked appearance of the cornice against the sky," he continued, is "virtually unique" in the city, and is the "overriding character-defining feature of the building."

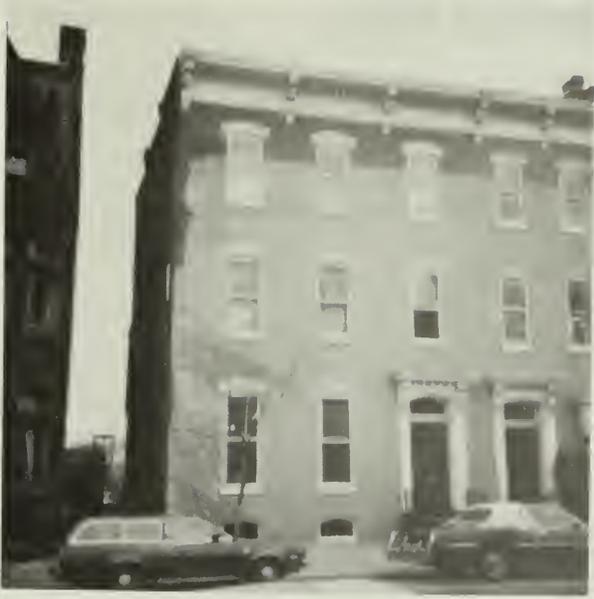
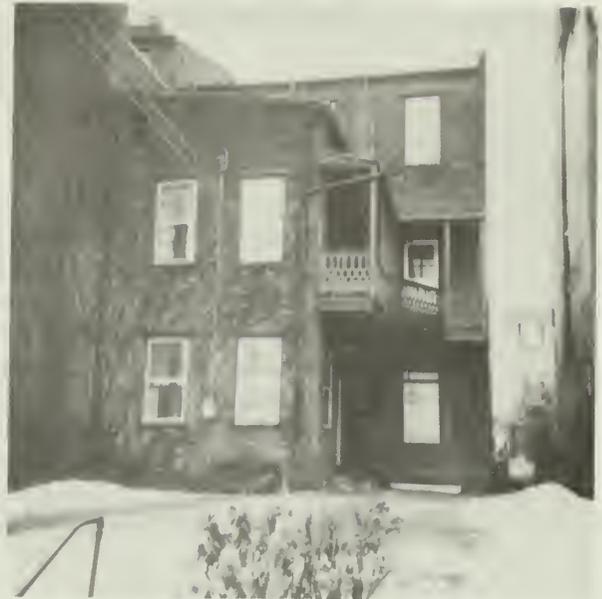
1, 2. The 3-story brick rowhouse, front and rear elevations, prior to conversion into a dress shop. Although many rear elevations are not particularly distinctive, this one featured a second story gallery and brick kitchen wing that were characteristic of the rear elevations of other residences in the district. Demolition of the wing and gallery preceded construction of a massive new addition that interrupted the former visual unity of the neighborhood.

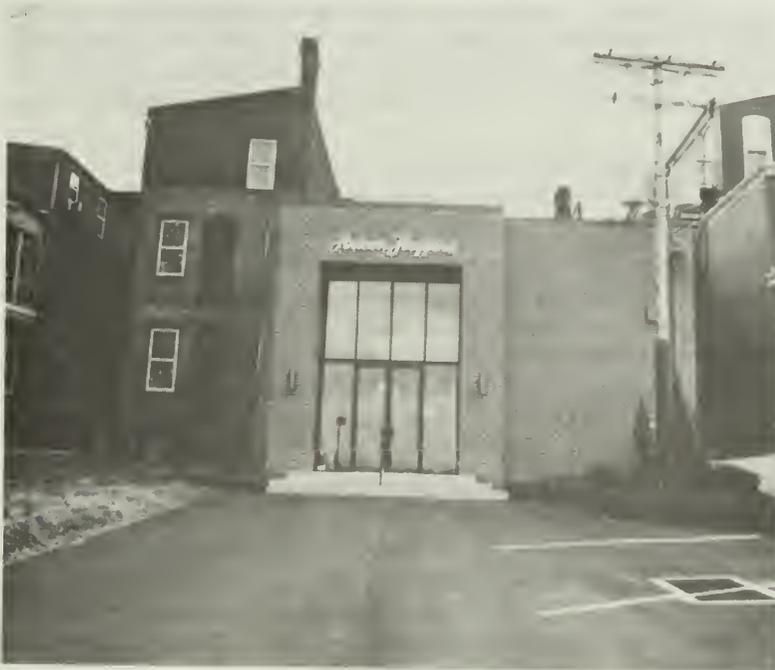
3. Completed work, rear elevation. The project was denied, largely based on demolition of the rear wing and porch and construction of a large addition that changed both the exterior form and interior plan.

Rehabilitation of the building essentially involved work to convert the residence into a dress shop. The owner felt that the existing interior space was inadequate for the retail operation, and, as a result demolished the historic rear ell and two-story porch preparatory to building a much larger addition in its place (see illus. 3).

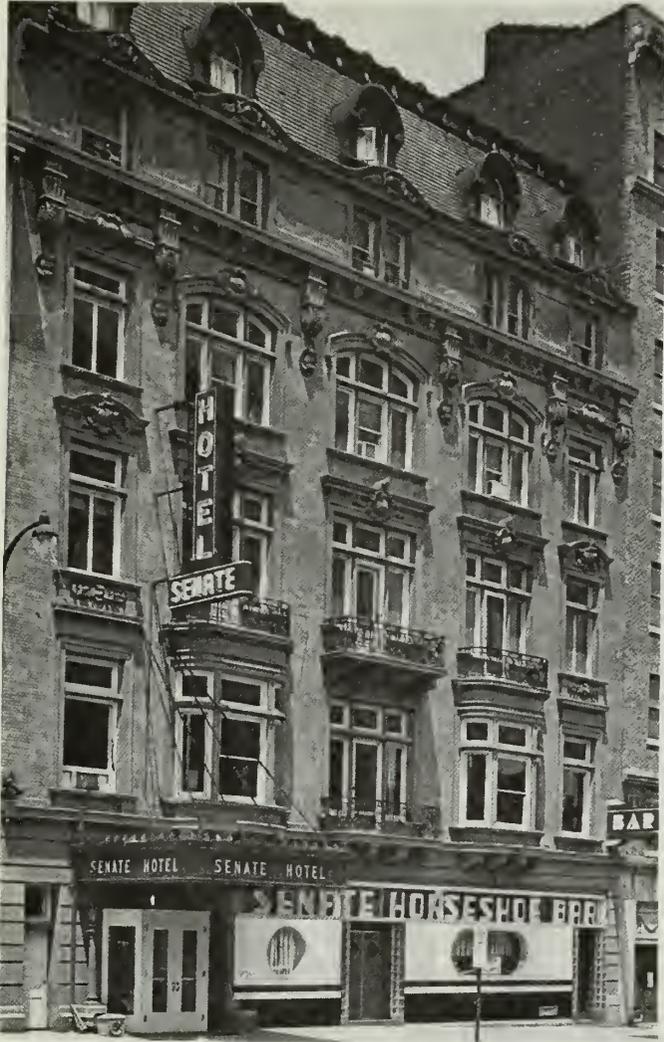
1. The 1906 hotel before rehabilitation. Note the Art Moderne facade and copper marquee on the first floor.

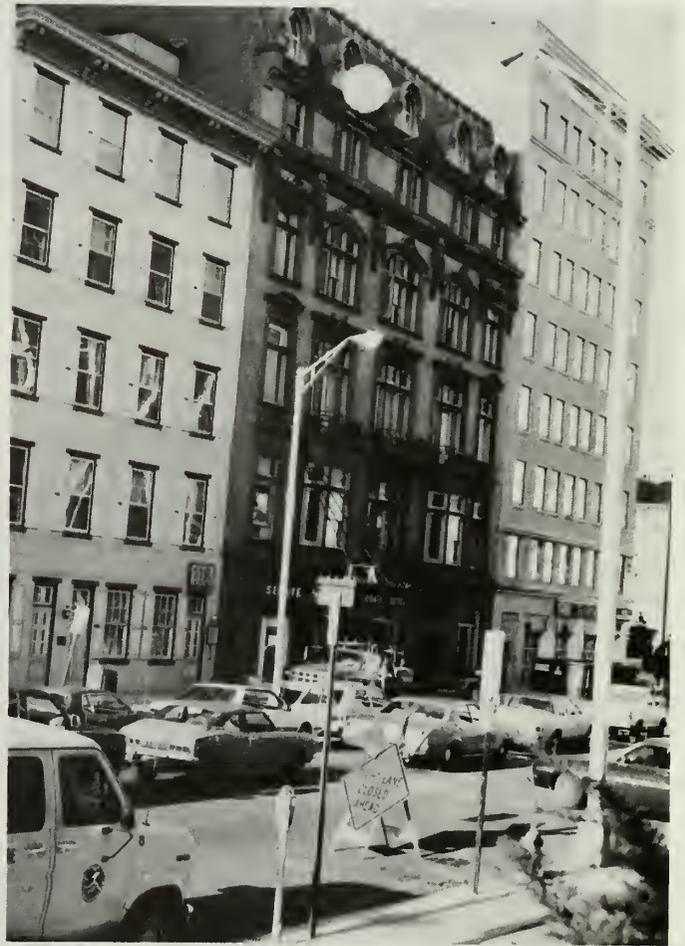
2. During rehabilitation into an office building the first floor is being reconstructed according to the original architectural drawings.

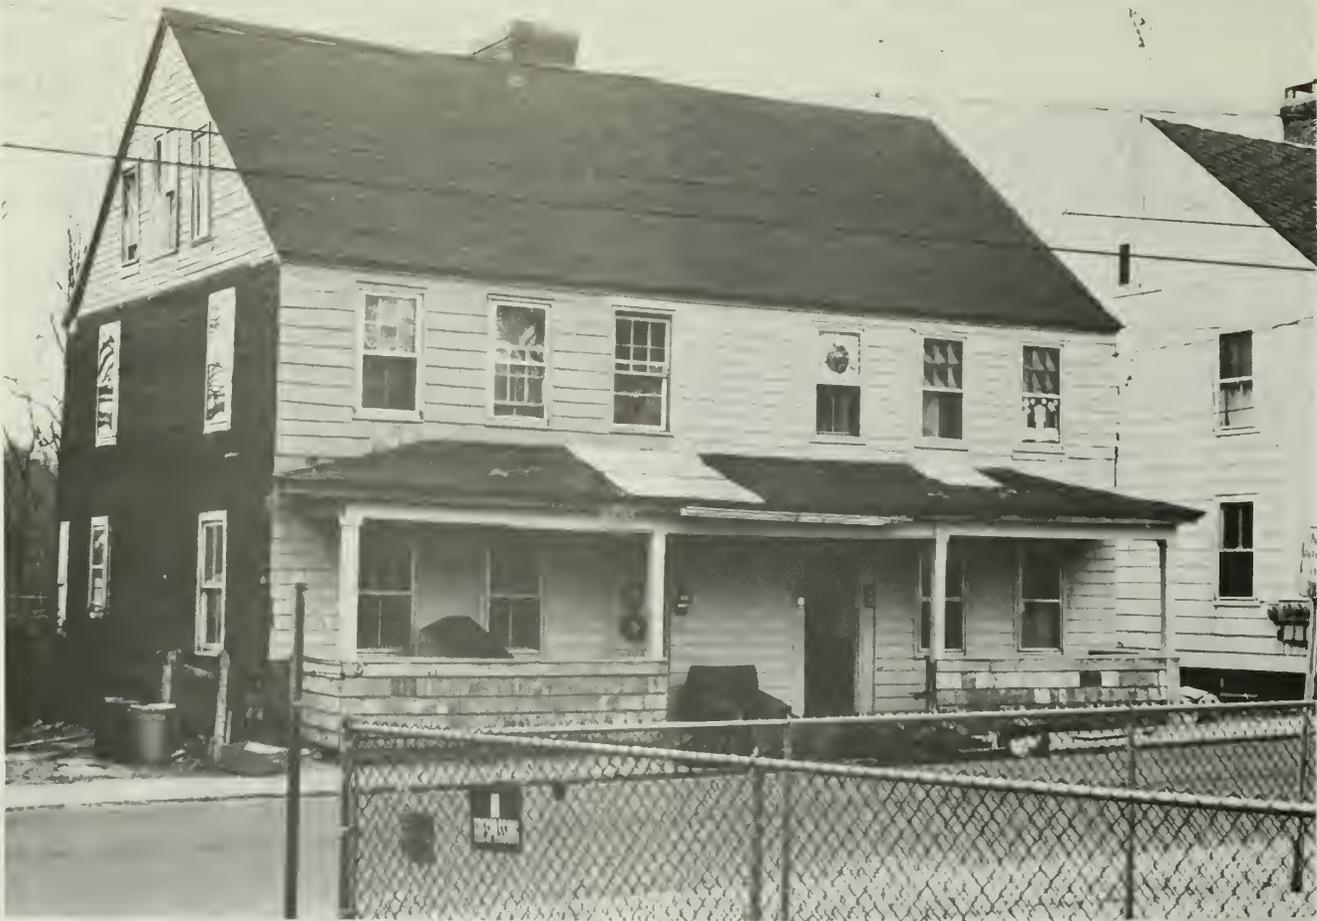
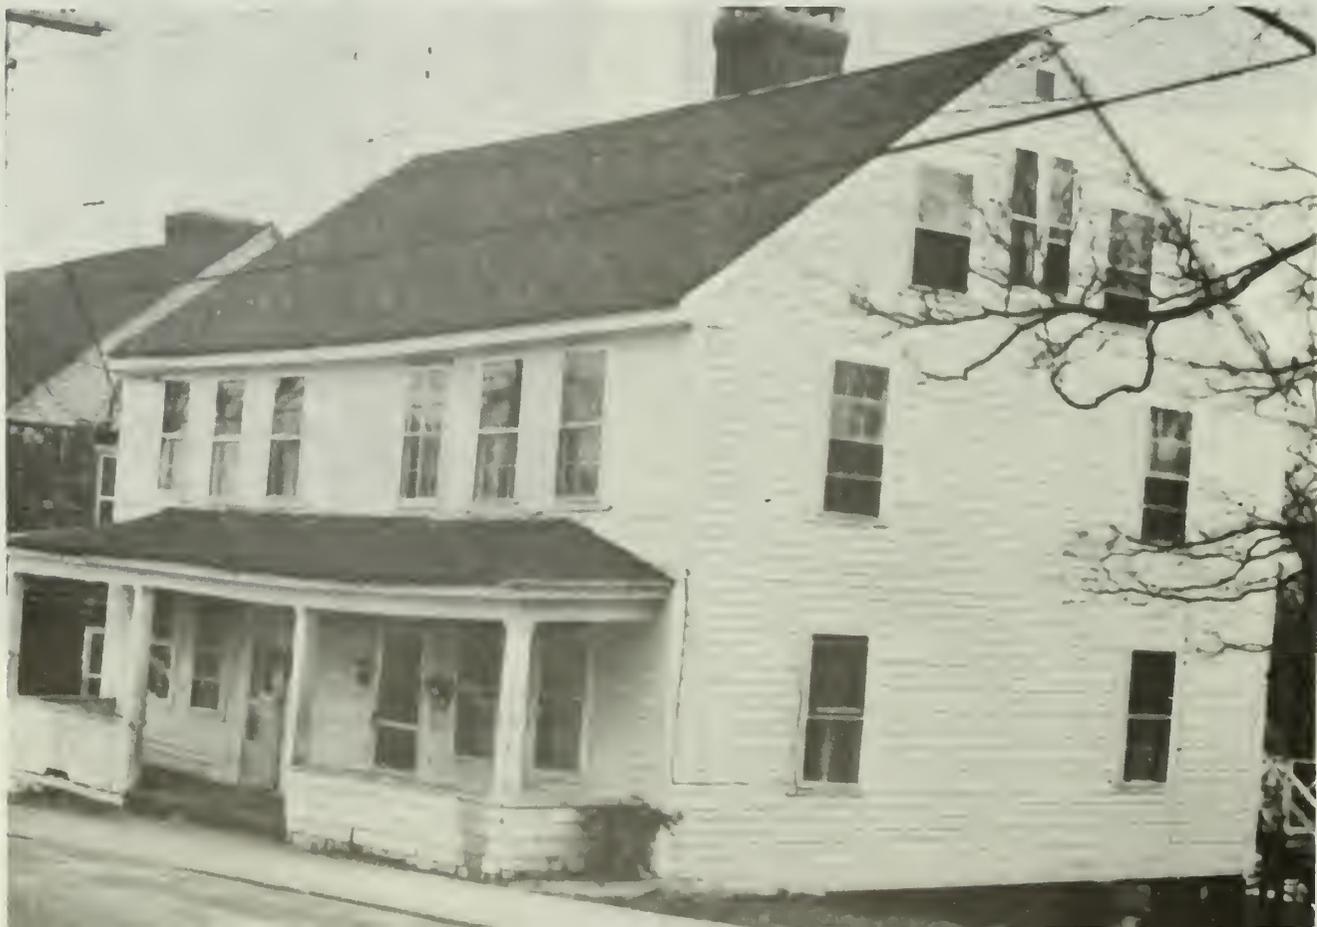
3-4. The two houses before rehabilitation. Because the porches were added after the historic district's period of significance, their removal was one option.

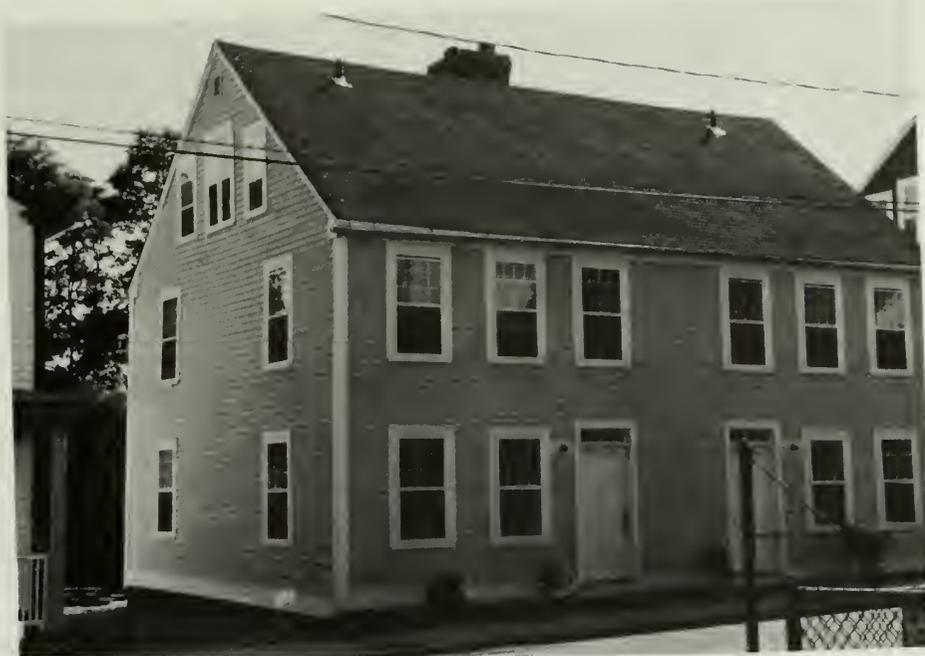
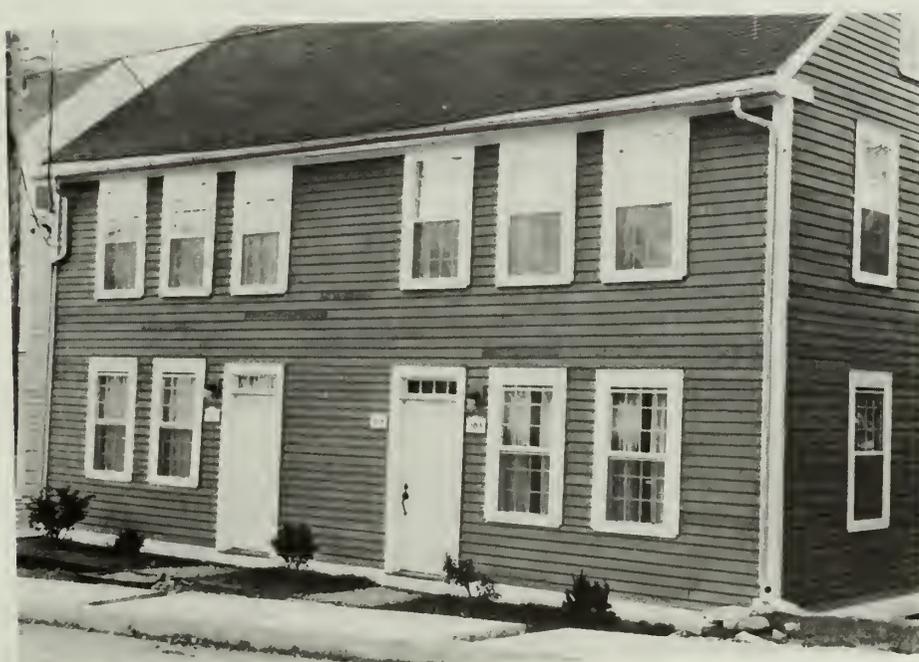
5-6. The two houses after rehabilitation, their porches removed to reveal the original early nineteenth-century character. (Twelve over twelve window replacement was based on remaining original sash still extant in several of the third floor windows.)

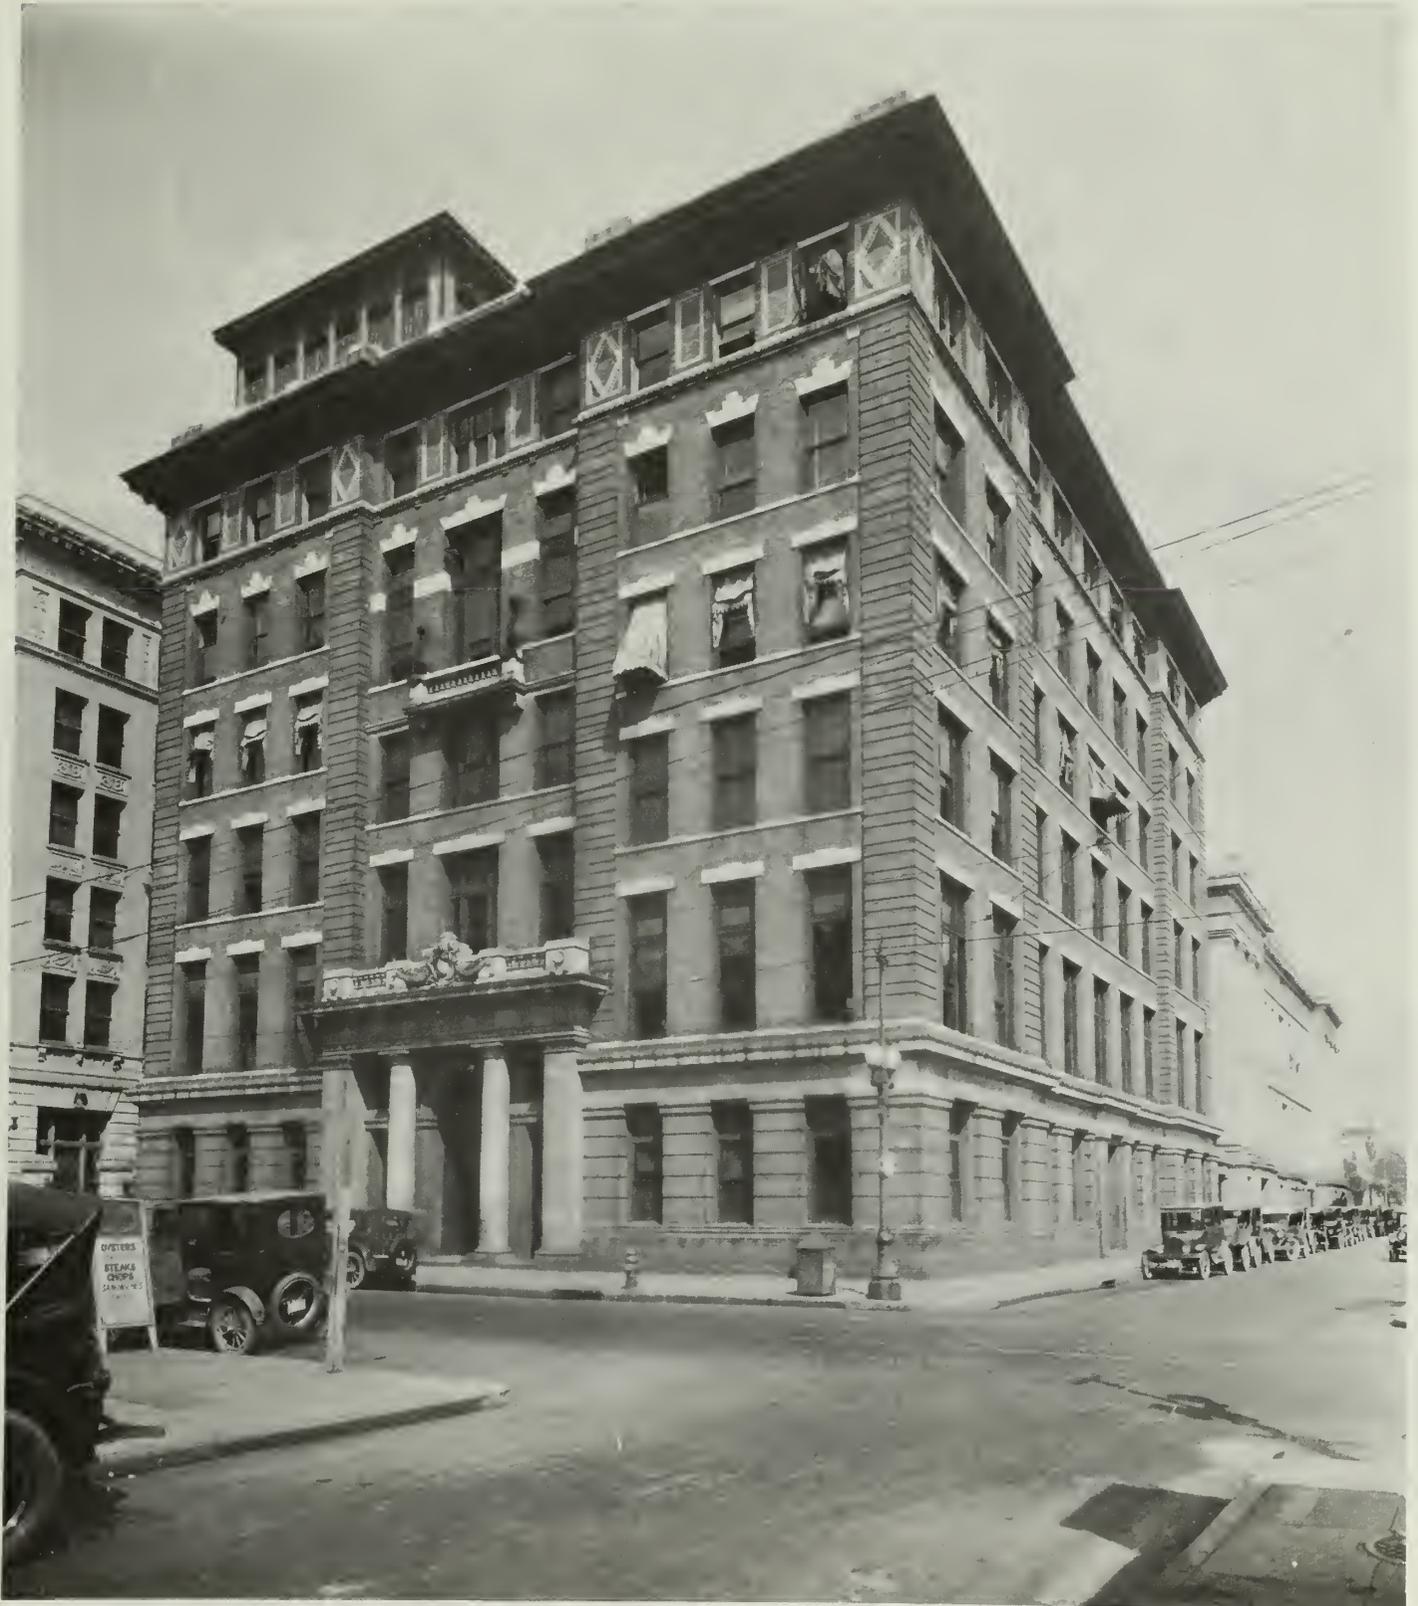
1. This former City Hall, shown here in a 1925 photograph, has changed little over the years on the exterior with the exception of an old rooftop addition off to the left. The building has a prominent corner location and is highly visible not only at the intersection of two busy thoroughfares but also from down the streets as well.

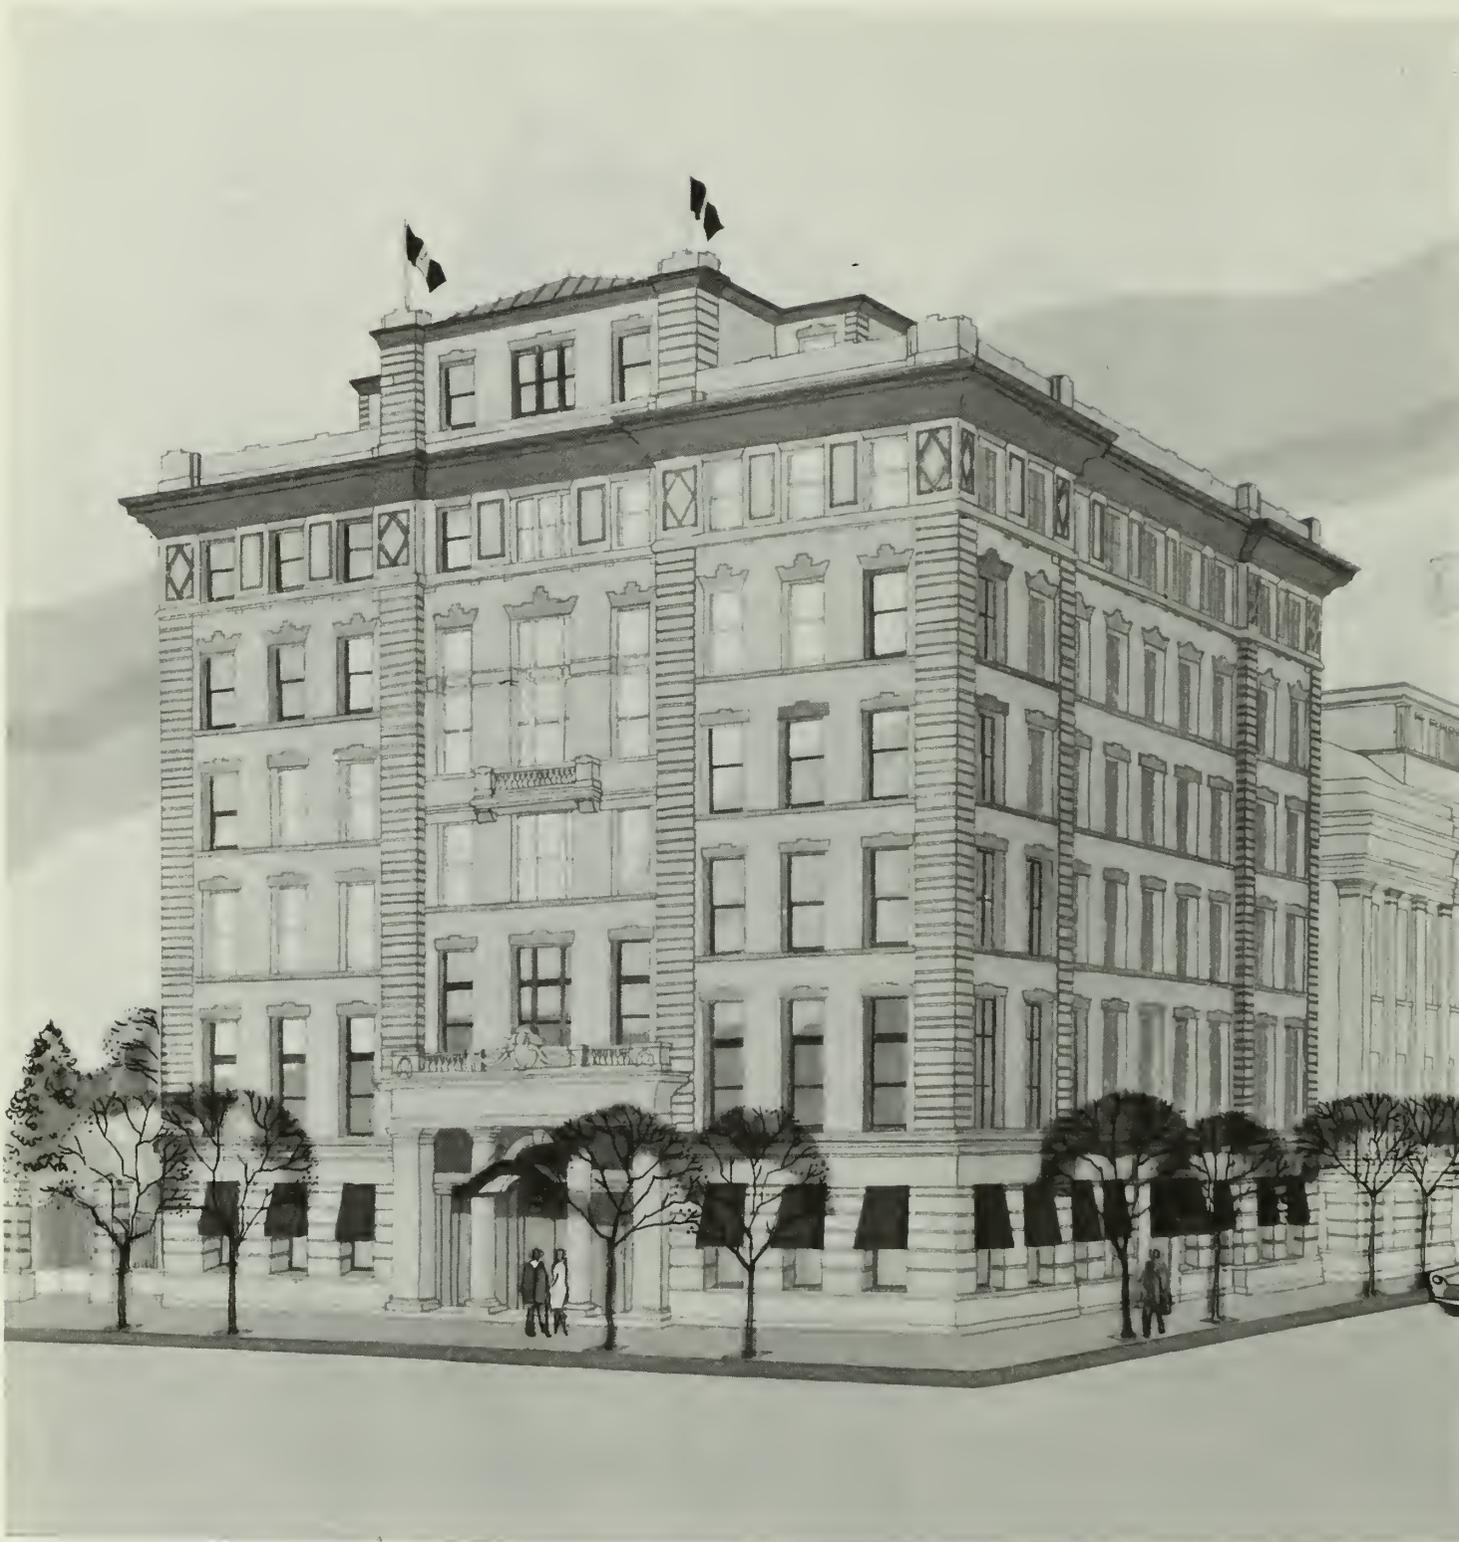
2. The proposed penthouse addition with the three bay portion across the front was determined not to meet the Standards for Rehabilitation. The change in the form of the building; the conscious attempt to tie the addition to the historic building through use of replicative detailing; and the alterations to the historic roof balustrade, were all factors cited by the National Park Service.

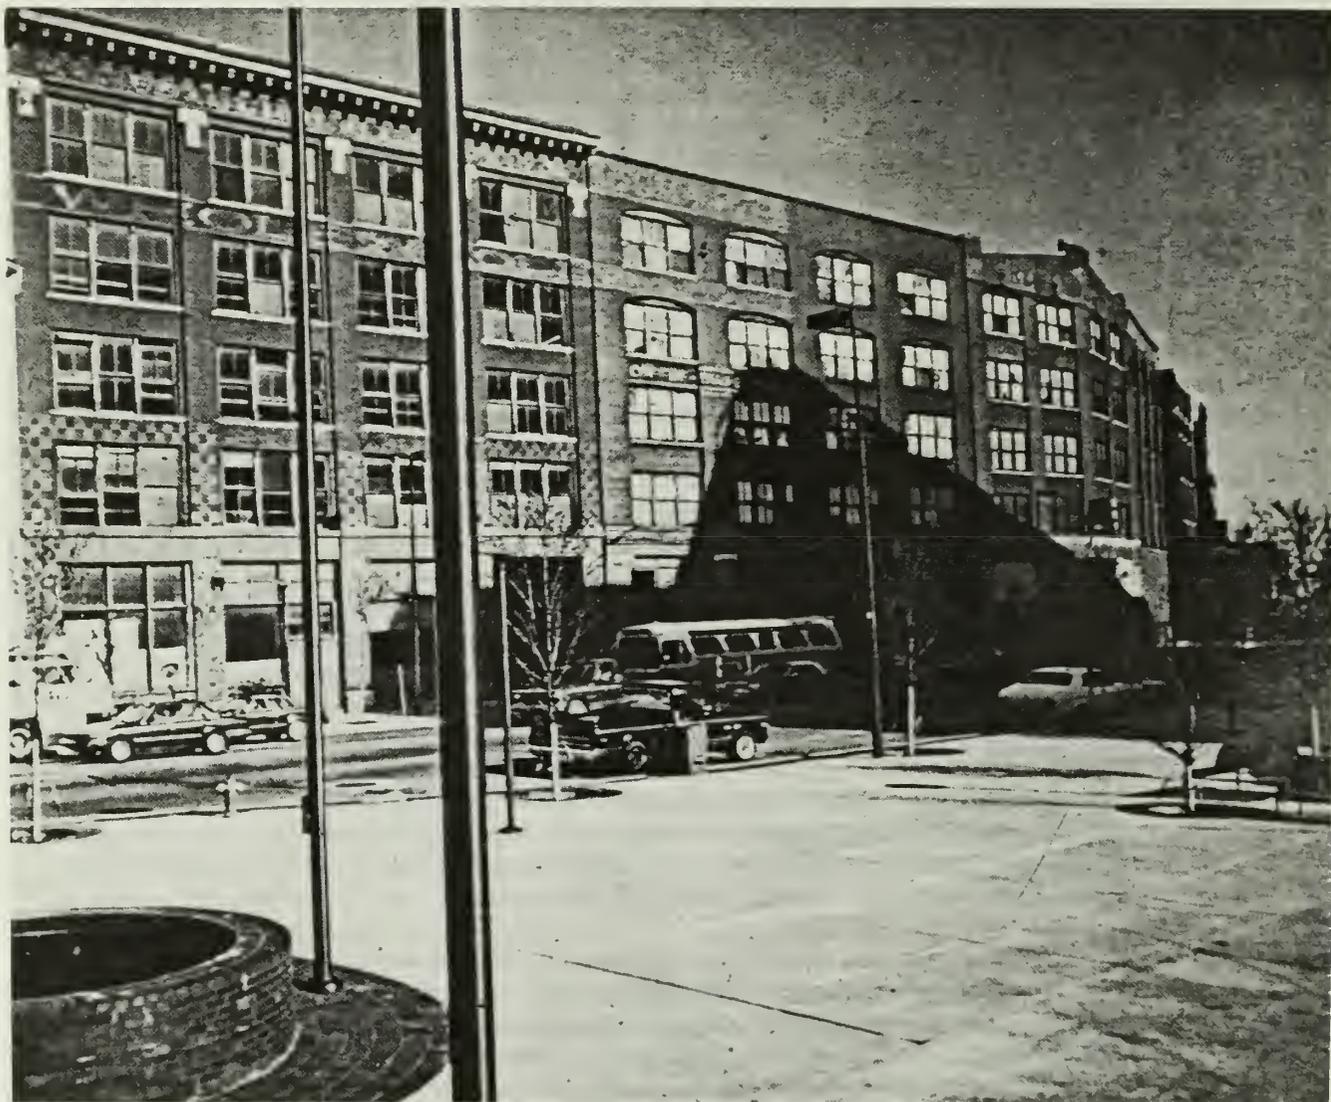
1. Case No.1: This view is looking south along the major street. Note the bend in the warehouse row as the buildings follow this road. This two block row of eight buildings is the last remaining row of industrial warehouses in the city.

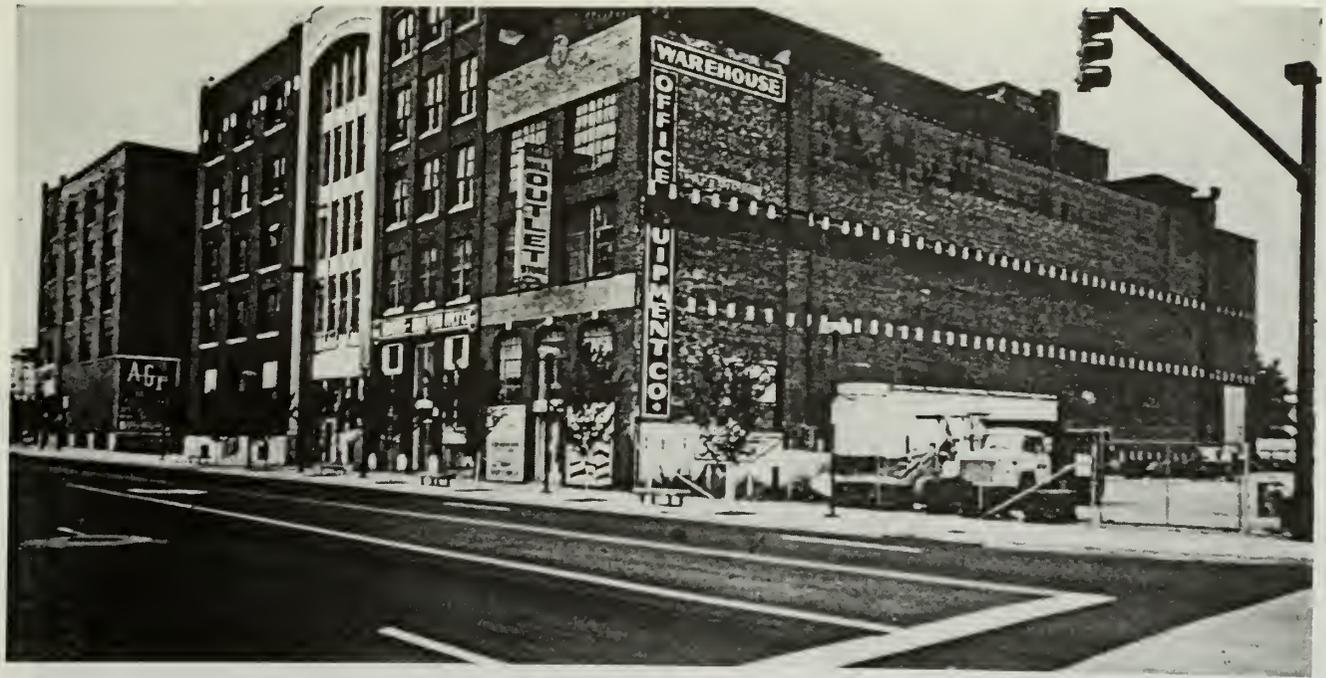
2. This view of a portion of the historic district is looking north. Note the road which divides the district into two blocks. This is the site of the proposed new addition and "pedway."

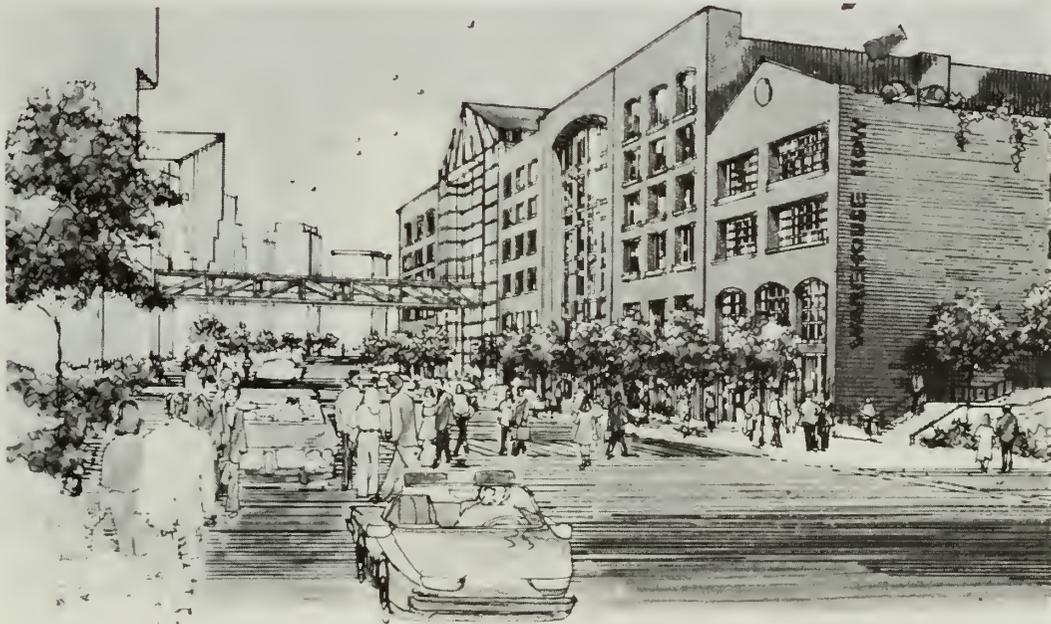
3. This artist's rendering, looking south, shows the proposed "pedway" connecting a public plaza across the street to the renovated warehouses. This new horizontal element, visually intrudes on the historic panoramic vista of the warehouses and was a cause for denial of certification. The glass enclosure over a historic street was a separate cause for denial.
