Technical Preservation Services
Preservation Assistance Division
National Park Service
U.S. Department of the Interior
Washington, D.C.

Interpreting the Secretary of the Interior's Standards for Rehabilitation

Volume II

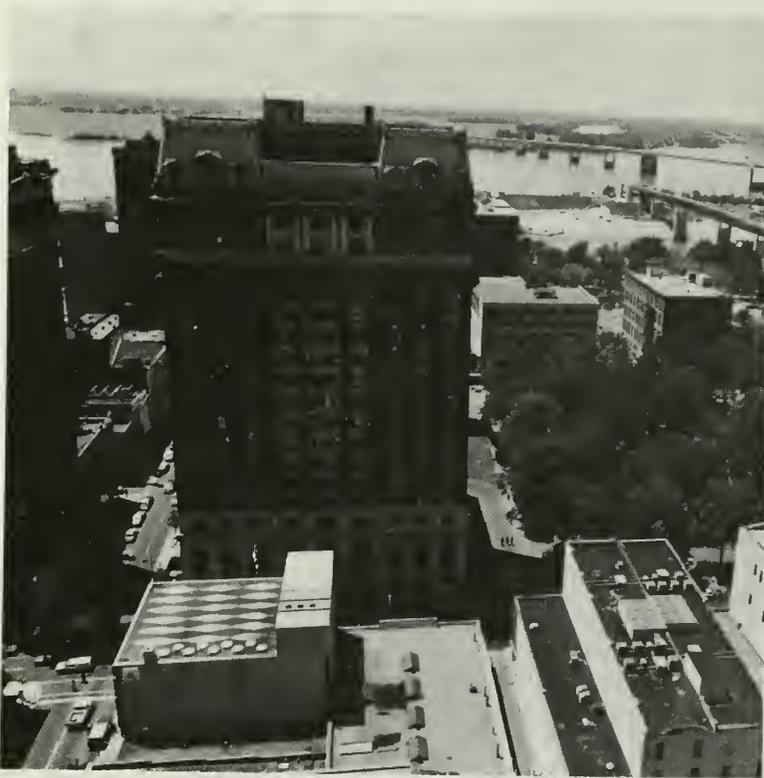
4. Case No.2: This 20-story building is individually listed as well as being located within a registered historic district. The proposed "pedway" would enter the arched window in the limestone base four bays from the corner closest to the park.

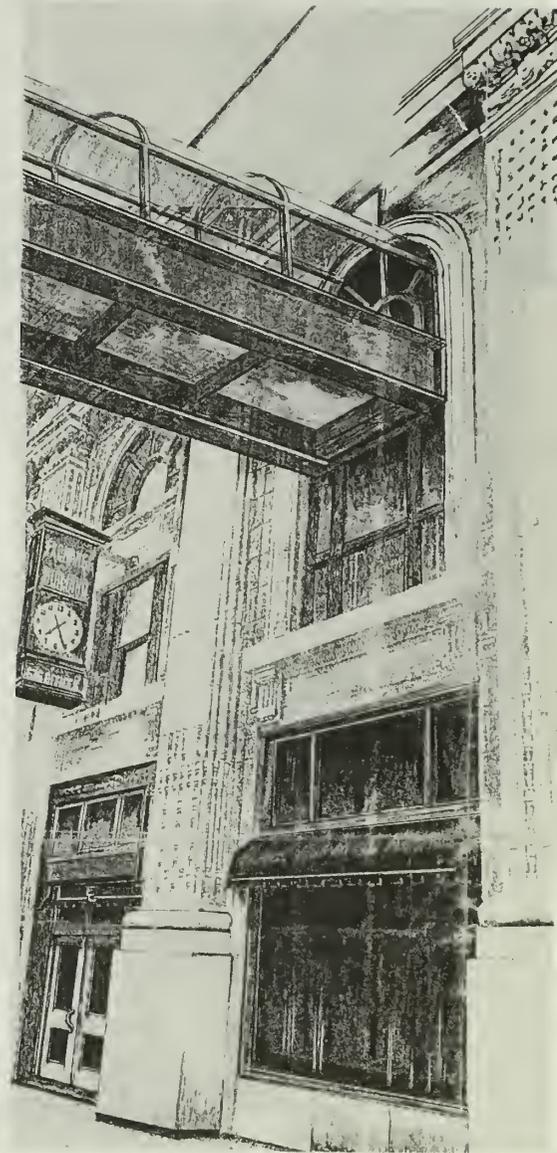
5. This rendering of the proposed "pedway" shows that the architect took great care to reduce the loss of historic materials. The project, however, was denied certification as a result of the drastic change this elevated bridge would have on the formal facade of this significant architectural resource.
