# Beached Shipwreck Archeology: Case Studies from Channel Islands National Park

Submerged Resources Center  
Professional Reports  
Number 18

Submerged Resources Center  
Intermountain Region  
National Park Service

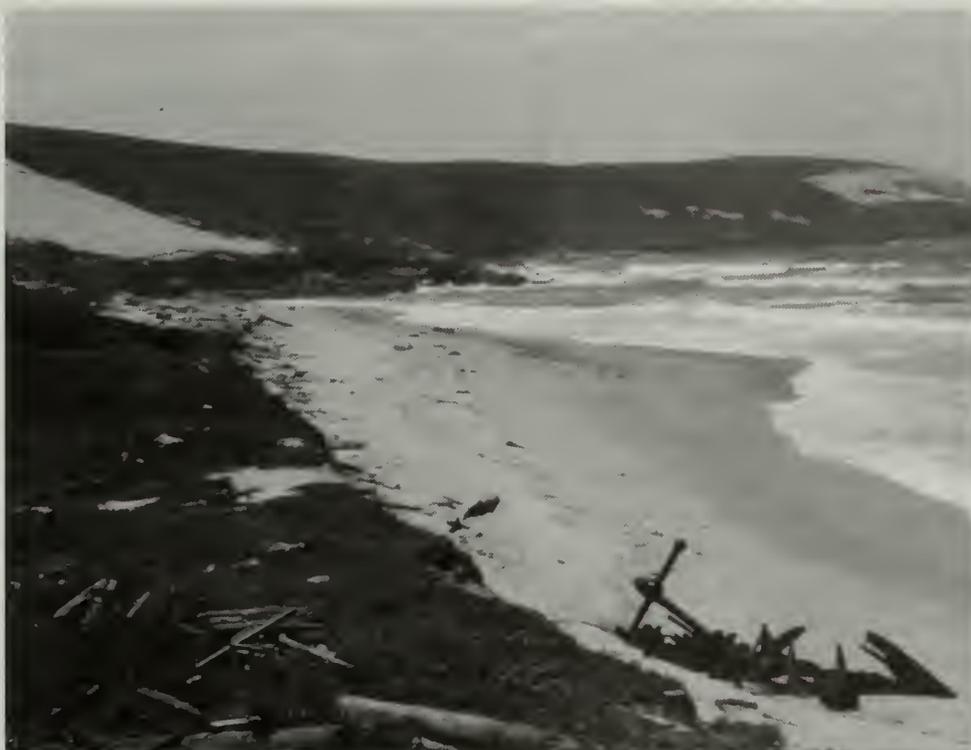
**Figure 1.2.** *Comet* site exposed in Simonton Cove in 1984. NPS photo by Reed McClusky.

National Park Service (NPS) personnel have known about the *Comet* site, located in Simonton Cove, San Miguel Island, since at least 1977 when the first documented site exposure occurred. The next recorded exposure was in 1984, when an NPS ranger took several photographs of *Comet's* exposed remains (Figures 1.2, 1.3 and 1.4). Although an anchor and capstan are clearly visible in the photographs, insufficient hull structure was exposed then to allow identification of specific features. Between 1984 and 1999, the site

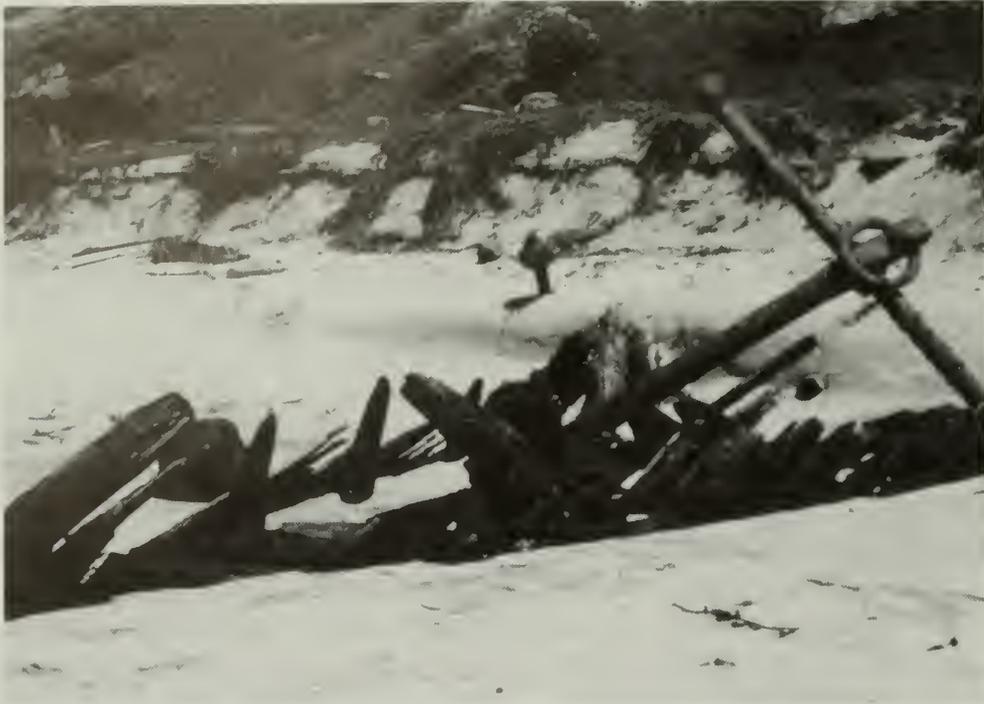
**Figure 1.3.** *Comet's* timbers and anchor exposed in 1984. NPS photo by Reed McClusky.

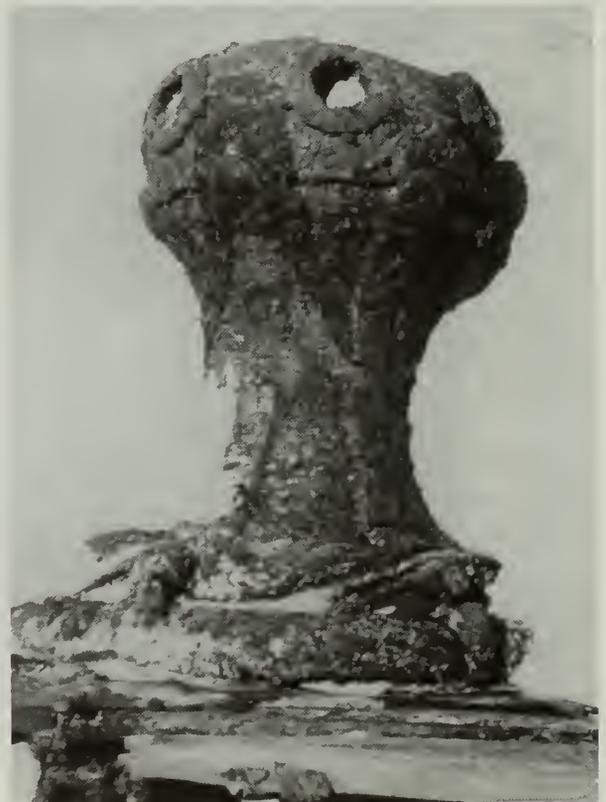
**Figure 1.4.** *Comet's* capstan in 1984. NPS photo by Reed McClusky.

Although investigators presumed the exposed remains were from *Comet's* bow (based on the anchor and capstan in the 1984 photographs), they were unprepared for just how intact and well preserved the site is. The hull remains observed include *Comet's* nearly

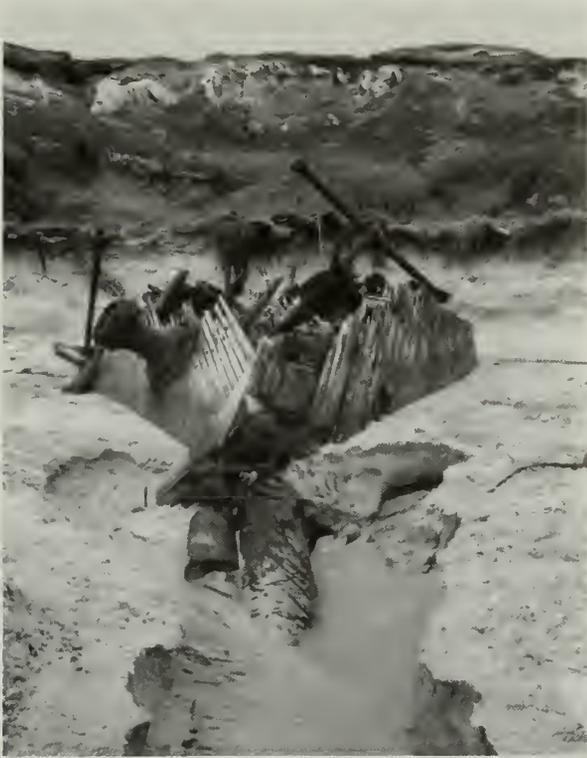
**Figure 1.5.** *Comet* site in April 1999, looking straight towards the bow, which is canted to the left in this photo. The forecastle deck is to the left, port side outer hull planking to the right and the bowsprit is in the bottom of the photo. NPS photo by Matt Russell.

intact bow from the break of the forecastle deck forward (Figure 1.5). The bow section is heeled to starboard; consequently, much of the port side has been exposed and is now deteriorated. But the starboard side, including the starboard half of the forecastle and main decks, is largely intact with machinery still mounted in its original location. Although only the bow section was observed during this project, this section of *Comet's* hull is the most intact and well-preserved Pacific Coast lumber schooner documented in the archeological record. Only one other intact section of lumber schooner hull has been recorded on the West Coast, which was a small section of the side of

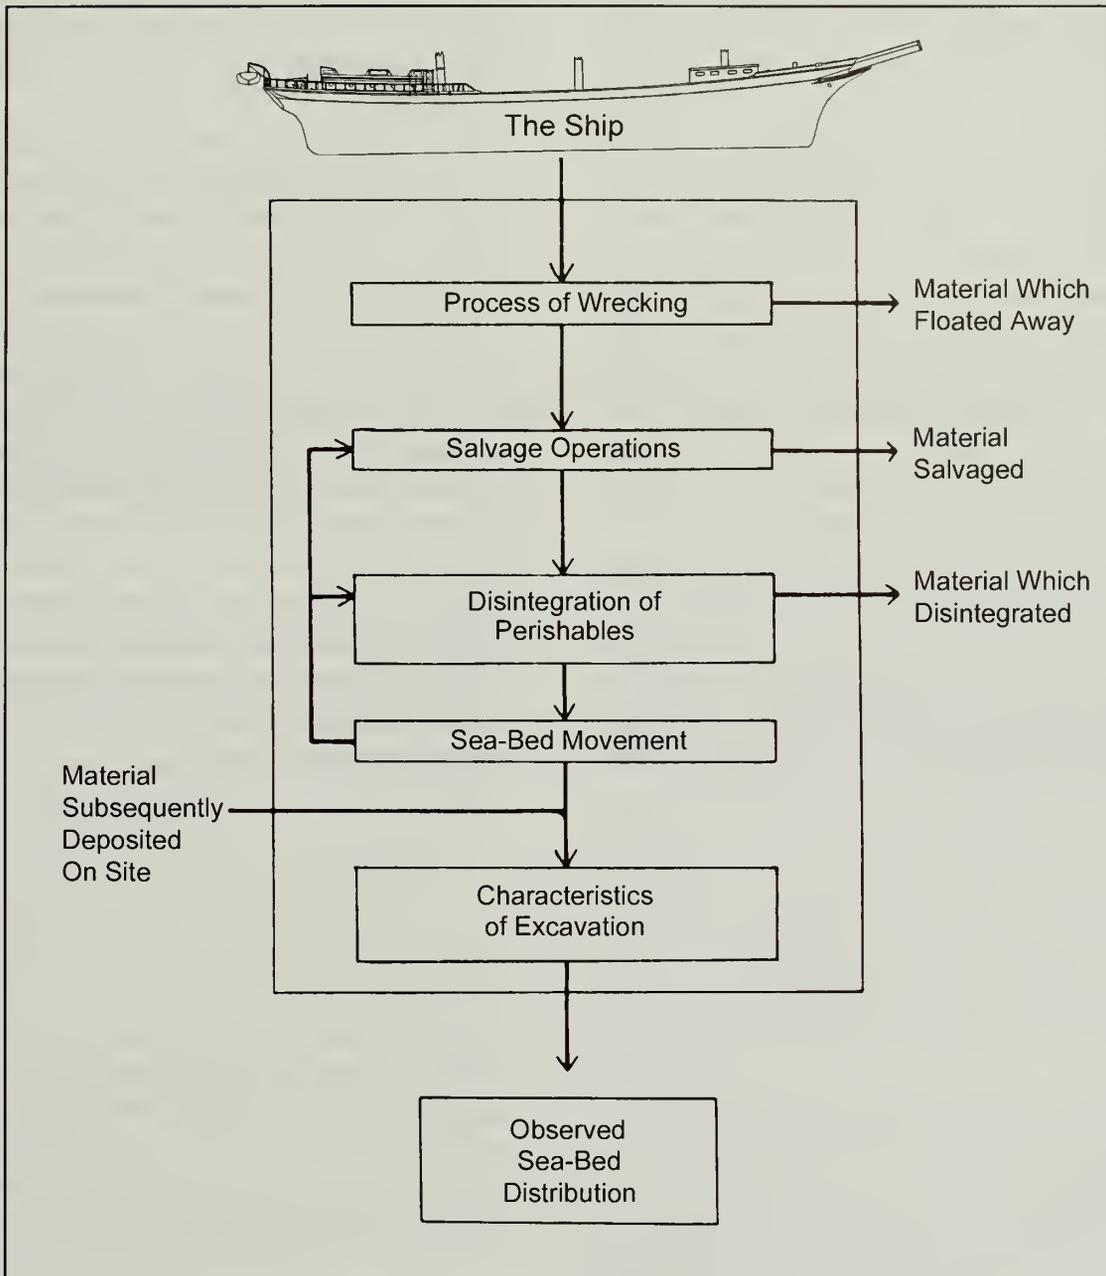
Figure 1.6. Shipwreck site formation processes based on Muckelroy (1978:158).

disintegration of perishables, sea-bed movement, and deposition of intrusive materials (Figure 1.6). A close examination of site formation processes at work on these three shipwrecks has contributed a more complete understanding of the archeological record.

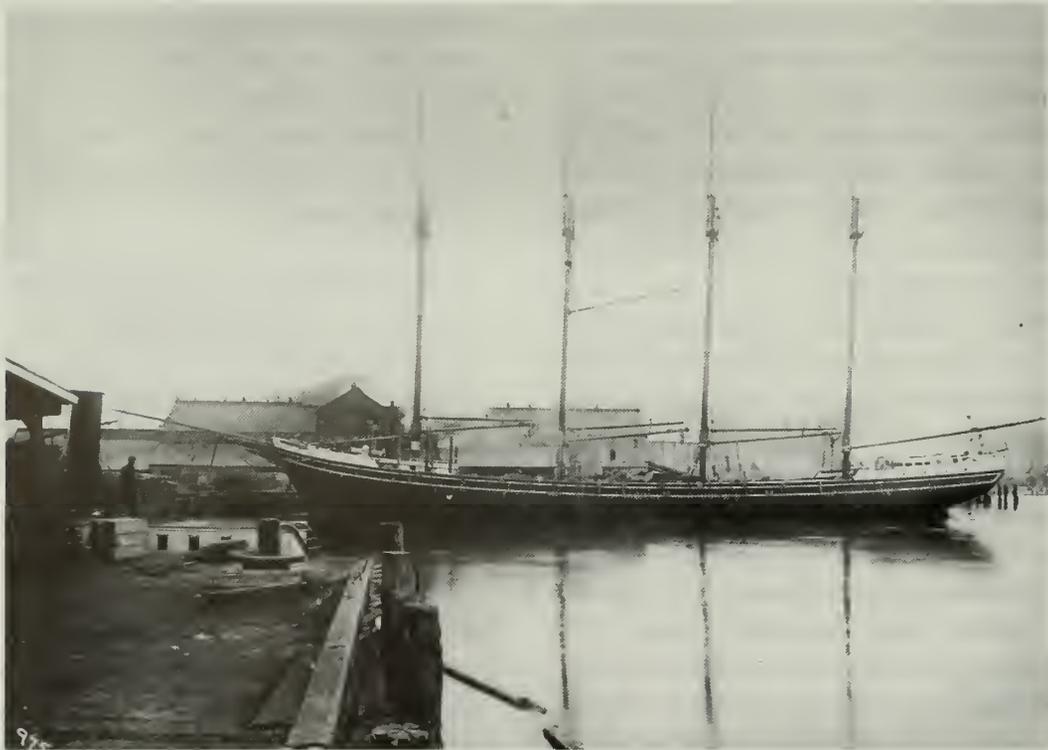
**Figure 2.1.** Schooner *Watson A. West* at an unknown port. *Watson A. West* was also built by the Hall Brothers. Photo courtesy of San Francisco Maritime NHP.

A distinctive vessel-type emerged for lumber transportation: the Pacific Coast lumber schooner, whose design was influenced by Pacific Coast environmental conditions and the requirement to carry an all-lumber cargo (Figure 2.1). The lumber schooner carried the raw material of California development. It delivered the basic construction material, which laid the foundation for nearly all California's metropolitan centers, making the vessel regionally significant as the primary cargo carrier.

Along with a distinct hull design, West Coast lumber schooners also had a unique schooner rig. Known as "baldheaded" schooners, they often carried only their gaff sails, preferring to run without topsails because "in the long beat to windward of the return trip there were no gafftopsails to shift when tacking" (Weinstein 1978:20). Many lumber schooners were "terns," or vessels with masts of equal height (Bauer 1988:271) (Figure 2.1). Some schooners were

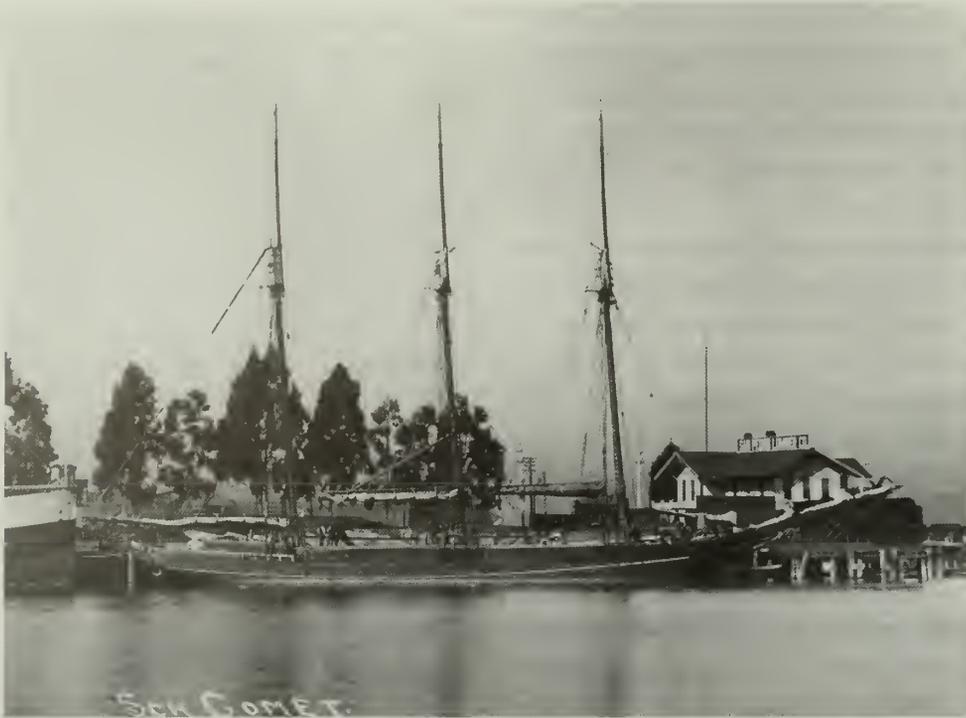
**Figure 3.3.** Schooner *Comet* docked at San Pedro, California. Photo by William Phelps, courtesy of San Francisco Maritime NHP.

The schooner *Comet* was launched from the Hall Brothers’ Port Blakely yard in October 1886 (Figures 3.3 and 3.4). Once again, the original contract for the vessel survives, giving a complete record of construction. *Comet* had a length of 136.0 ft. on the keel, 144.6 ft. overall, with a breadth of 35.2 ft., a depth of 11.4 ft., and registered 429.74 gross and 408.26 net tons (JPSL:Hall Brothers Shipyard Contract Number 49, 1886; NA 1886:RG 41:Registry 18). Like *Dora Bluhm*, it had one deck, three masts, a billet head and an elliptic stern (NA 1886:RG 41:Registry 18). It was constructed entirely of Douglas fir, again with the exception of the stempost and sternpost, which were “hardwood (JPSL 1886).” *Comet* was entirely iron fastened, with the addition of 1¼-in. locust treenails on the outer hull planking. The vessel was also equipped with a centerboard, and, like *Dora Bluhm*, had bow and stern ports for loading and unloading lumber. During construction, *Comet* was “salted from lower edge of wales to deck.” The rest of the fitting out and furniture was exactly the same as *Dora Bluhm*, down to the 24 in. windlass purchase and Number 3 capstan. For this vessel, the Hooper Brothers of San Francisco and C. F. S. Lass of Oakland agreed to pay \$30,000 in US Gold Coin, over four installments (JPSL 1886).

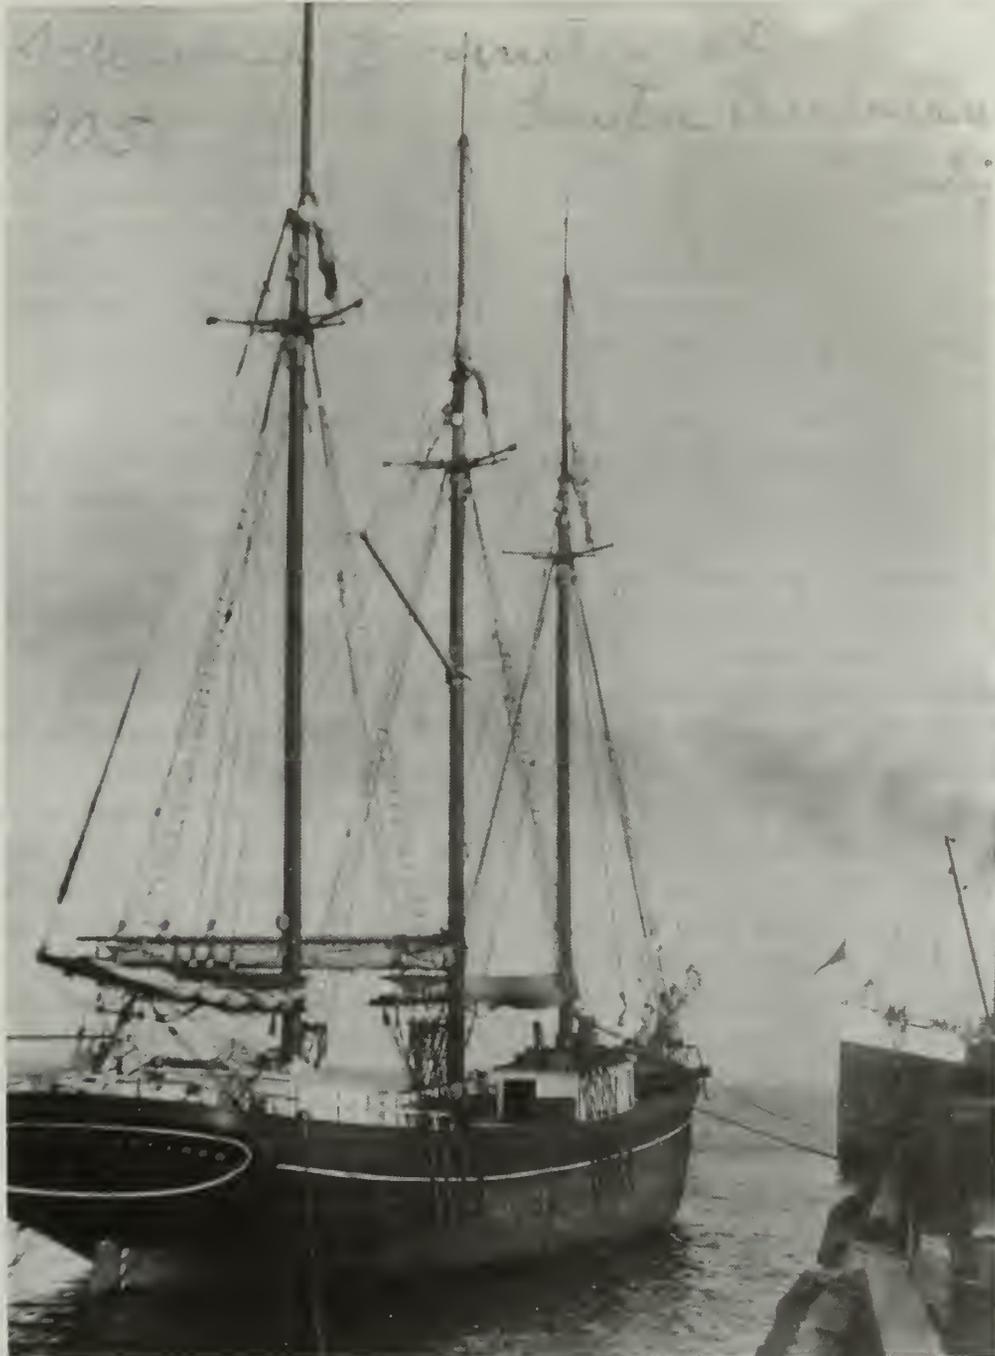
**Figure 3.4.** *Comet* at Santa Barbara, California, 1904. Photo courtesy of San Francisco Maritime NHP.

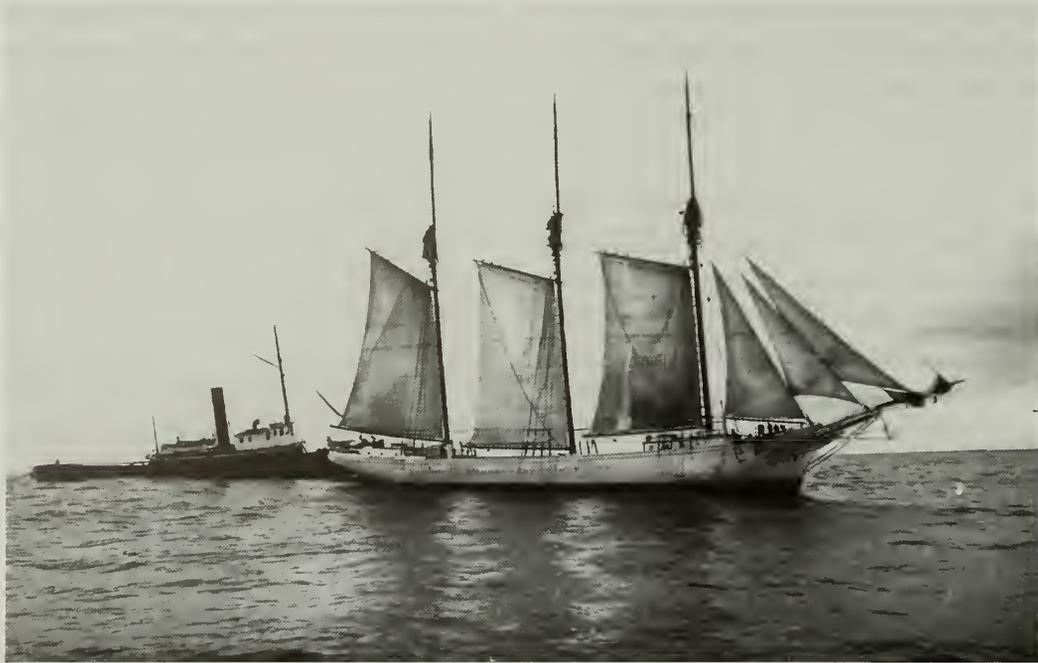
**Figure 3.5.** The schooner *J. M. Colman* about 1900, photographed off Cape Flattery or in the Straits of Juan de Fuca. *J. M. Colman* was built by the Hall Brothers Shipyard, who also built *Comet*. Photo by Hiram Hudson Morrison, courtesy of San Francisco Maritime NHP.

The Hall Brothers launched the schooner *J. M. Colman* in April 1888 (Figures 3.5 and 3.6). The vessel measured 157.0 ft. long, 37.0 ft. in breadth, 11.3 ft. deep, 471.95 gross tons, and 448.36 net tons. Like the other two schooners, it had one deck, three masts, a billet head and an elliptic stern (NA 1888:RG 41:Enrollment 43). It was built for J. J. McKinnon of San Francisco, who was the sole owner. Unfortunately, *J. M. Colman*'s original contract has not been located, but a hand-written ledger sheet indicates the vessel was originally known as Hull Number 56, and was built for \$33,286.84 (JPSL, Hall Brothers Shipyard Ledger Sheet Number 56, 1888). *J. M. Colman* was one of the largest three-masted schooners built on the coast, registering only 13 gross tons less than the largest, *W. F. Jewett* (Haller and Kelly 1990:22). The first master of *J. M. Colman* was C. H. Atwood (NA 1888:RG 41:Enrollment 43).

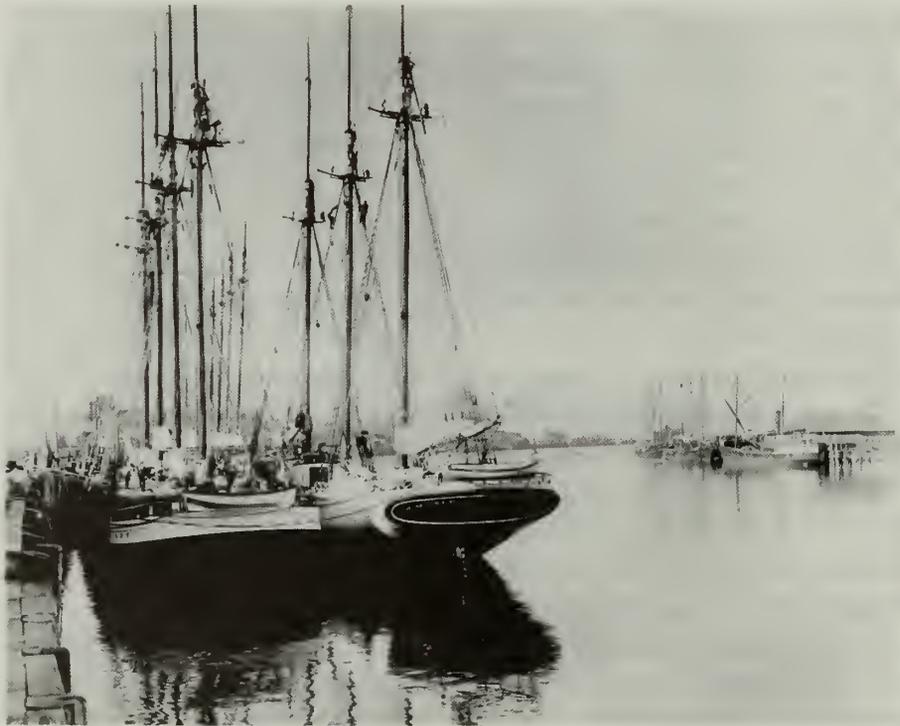
**Figure 3.6.** *J. M. Colman* in port at San Pedro, California. Photo courtesy of San Francisco Maritime NHP.

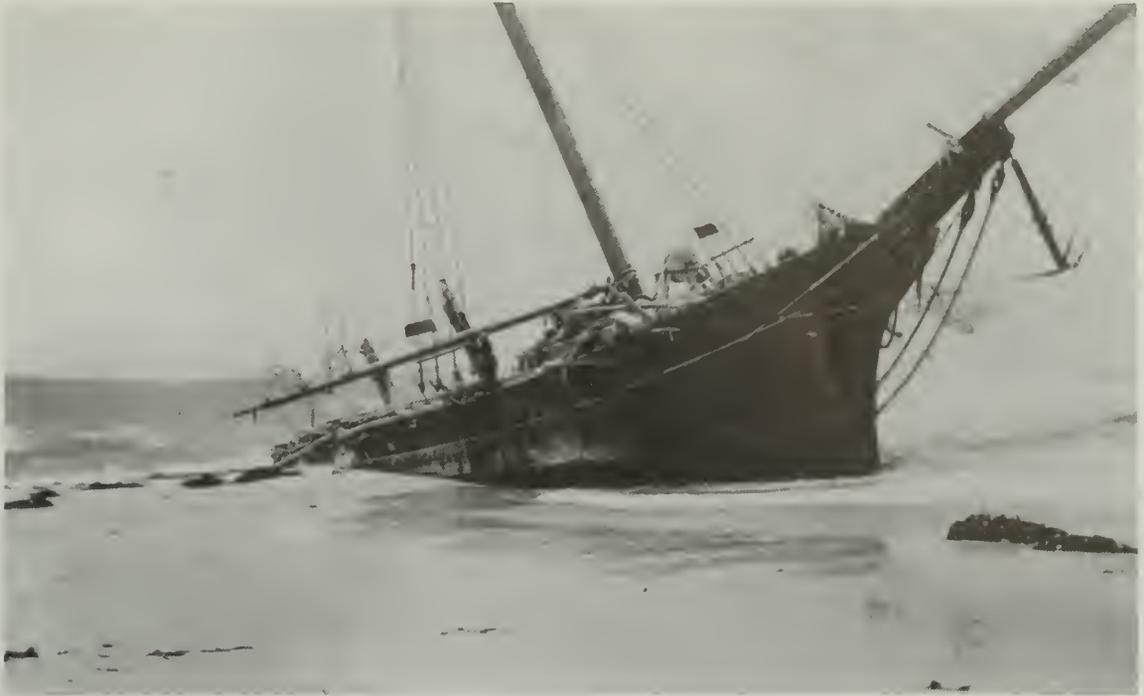
**Figure 3.9.** *Comet* aground in Simonton Cove, San Miguel Island. Photo courtesy of Santa Barbara Museum of Natural History.

As discussed above, a series of photographs were taken of *Comet* sometime after the wreck and before the vessel broke up. These undated photos, from the Santa Barbara Museum of Natural History's collection, show the schooner lying broadside to the surf with its port side to sea (Figures 3.9–3.11). The vessel is firmly embedded in the sand, probably between the

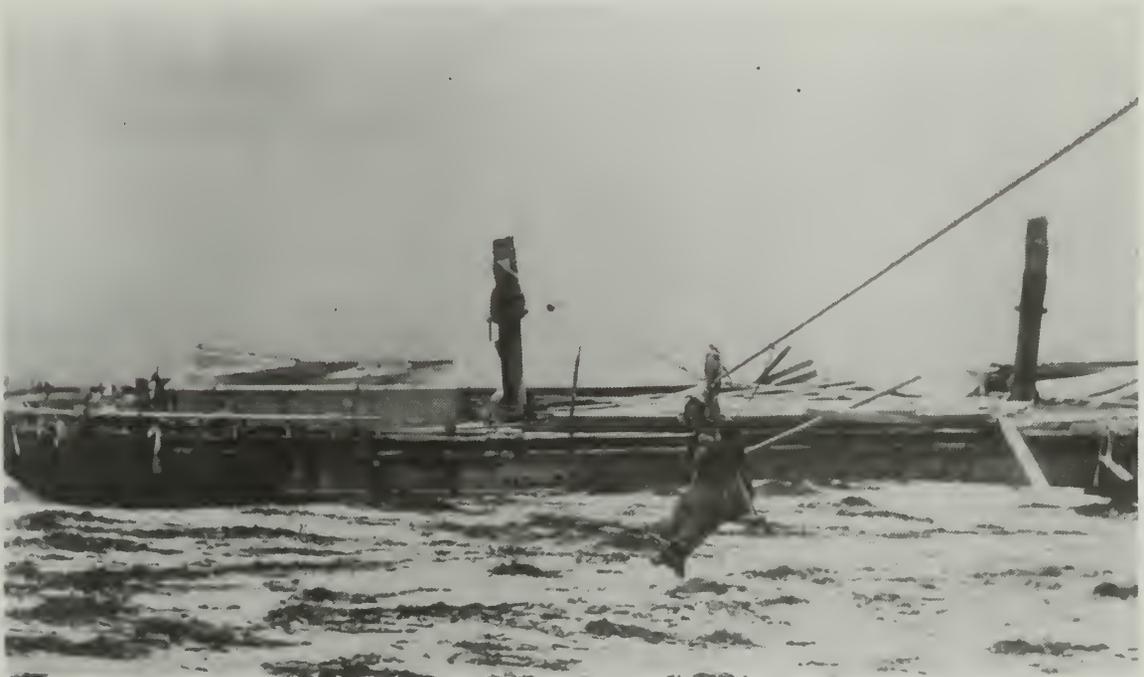
**Figure 3.10.** *Comet* aground in Simonton Cove, San Miguel Island, with unidentified woman. Photo courtesy of Santa Barbara Museum of Natural History.

uses. Salvage alone cannot explain, however, why only the bow is present today. Observation of site layout suggests a series of events that led to the wreck's present condition. The last known historical photographs of *Comet* (see Figures 3.9–3.11) show the vessel laying broadside to the shoreline, somewhere between high and low tide. Subsequently, *Comet's* bow broke away from the rest of the hull at a point just aft of the forecastle deck and forward of the forward deckhouse (Figure 4.105). It is possible the stempost/keel joint broke, but the pointers kept the bow structure to aft of the forecastle deck together. The pointers crossed and were fastened into multiple frame pairs, including all the cant frames, and would have provided reinforcement to help bind them together (Figures 4.85 and 4.86).

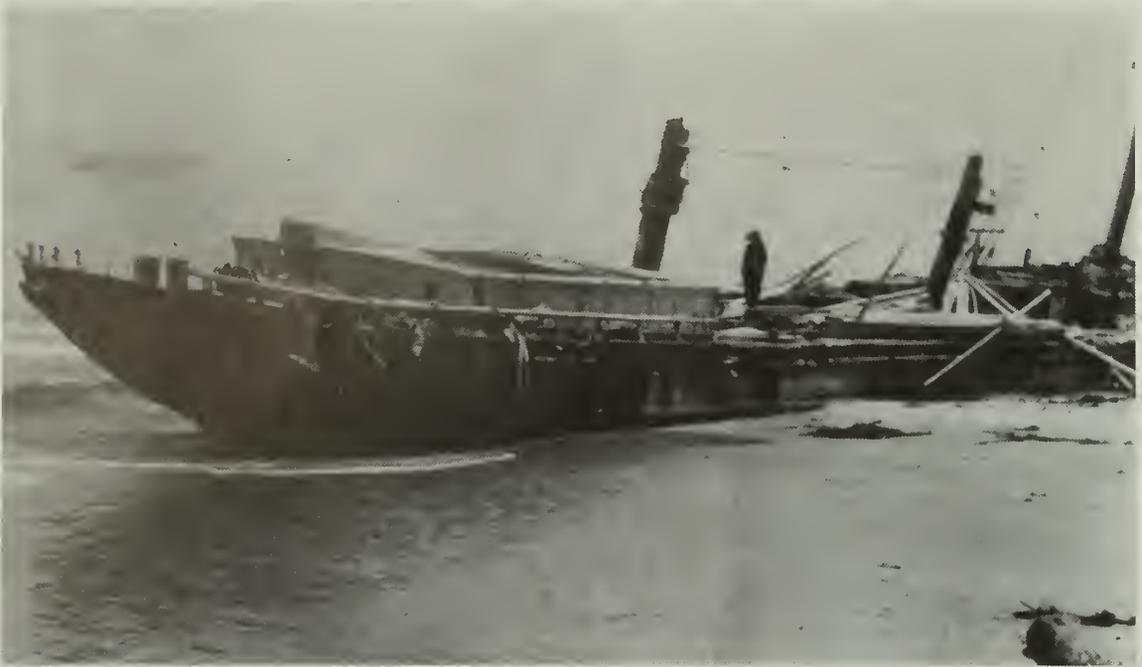
**Figure 3.11.** *Comet's* stern, aground in Simonton Cove, San Miguel Island. Photo courtesy of Santa Barbara Museum of Natural History.

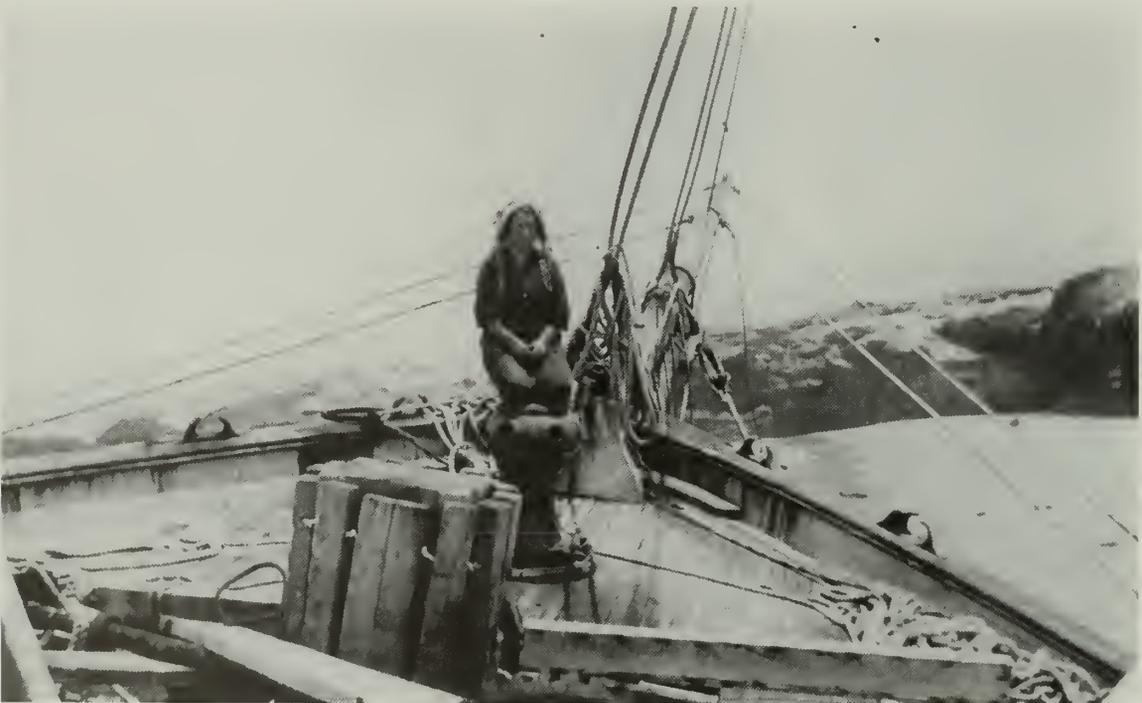
**Figure 3.12.** Unidentified woman on *Comet's* forecastle deck. Photo courtesy of Santa Barbara Museum of Natural History.

mean high- and low-tide lines. The foremast is still standing, but the main- and mizzenmasts are gone. Two photographs, taken from just forward of the foremast looking forward, show a man and woman standing on *Comet's* bow (Figures 3.12 and 3.13). These photographs are the key evidence in identifying wreckage in Simonton Cove as *Comet*. In the background of the photographs is an easily identifiable rock formation that is east of the wreckage in Simonton Cove today (Figure 3.14). Therefore, with the help of these historical photographs, a positive identification of the *Comet* wreck site can be made.

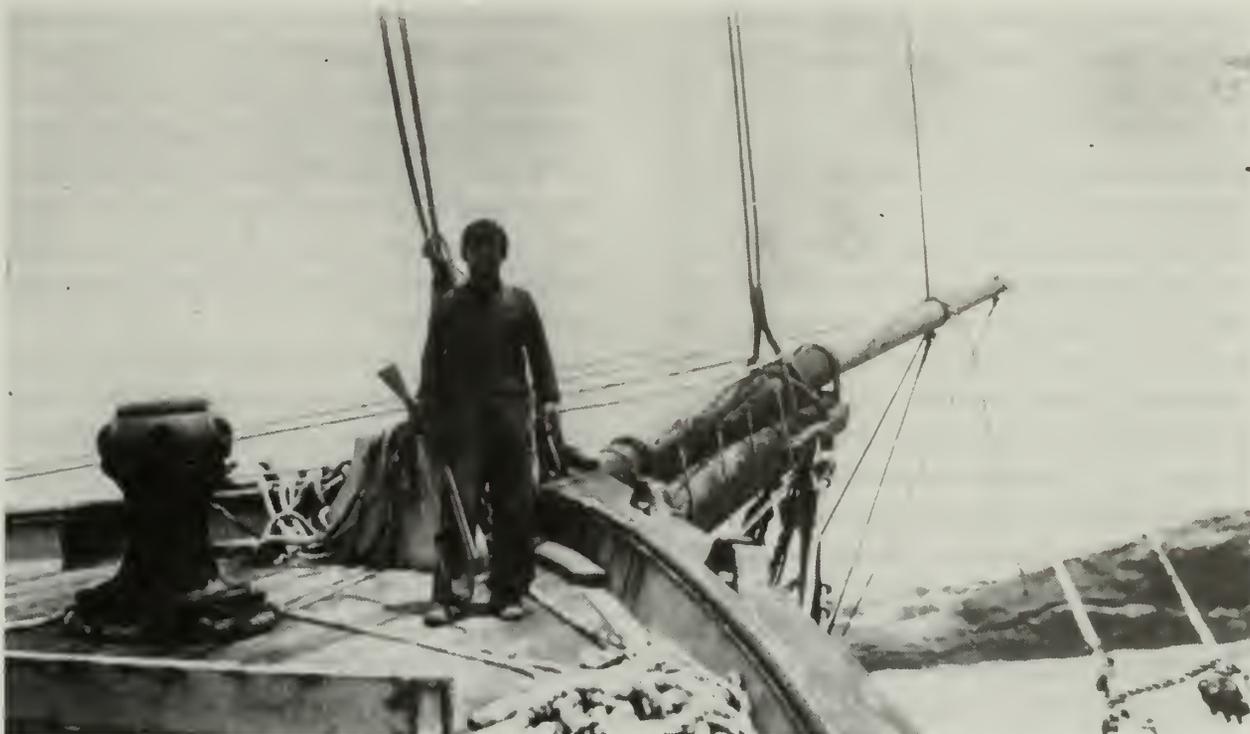
**Figure 3.13.** Unidentified man on *Comet's* forecastle deck. Note the capstan which is still mounted in the same location today. Also, note the rock ledge in the background which can be compared to Figure 3.14. Photo courtesy of Santa Barbara Museum of Natural History.

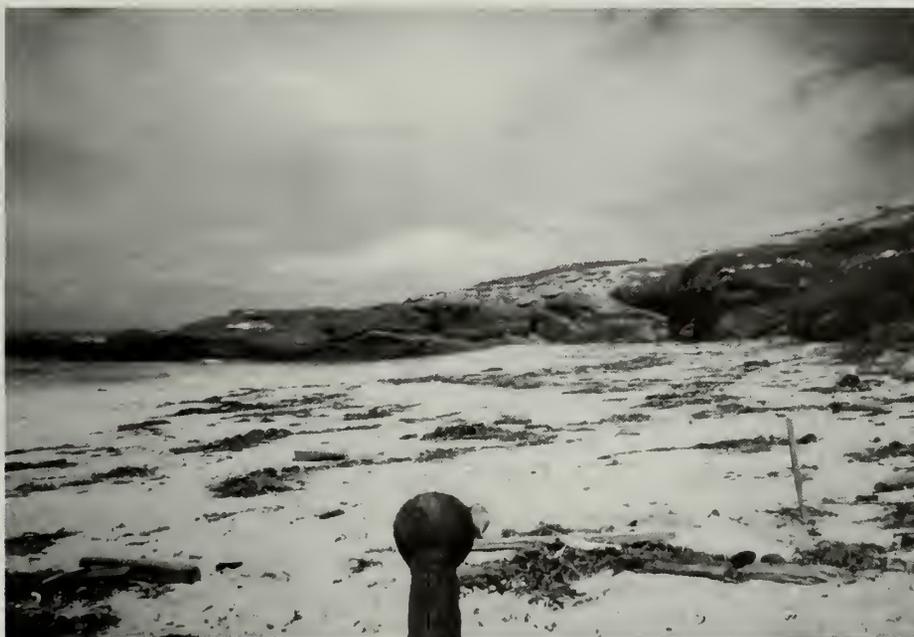
**Figure 3.14.** Anchor stock sticking out of the sand in Simonton Cove in the 1980s. Compare the rock ledge in the background to Figure 3.13. NPS photo by Don Morris.

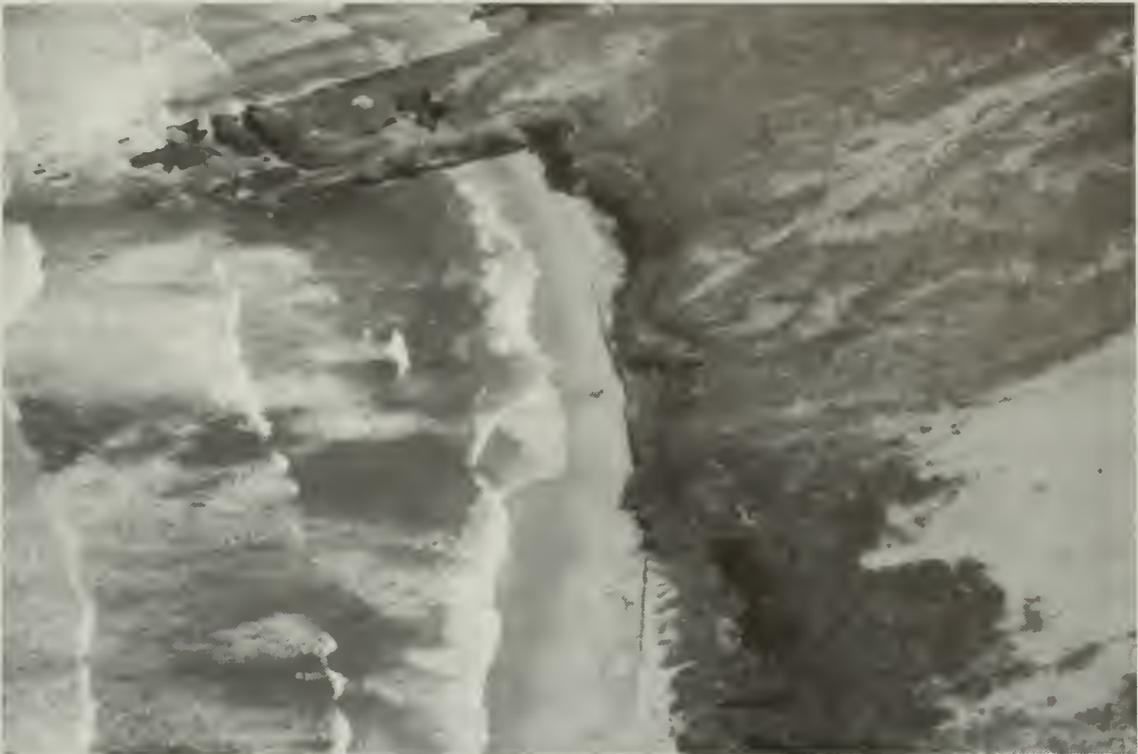
**Figure 4.3.** Aerial view of *Comet* site in Simonton Cove. *Comet* bow wreckage is on the beach in the center of the photograph. Photo courtesy of Robert Schwemmer.

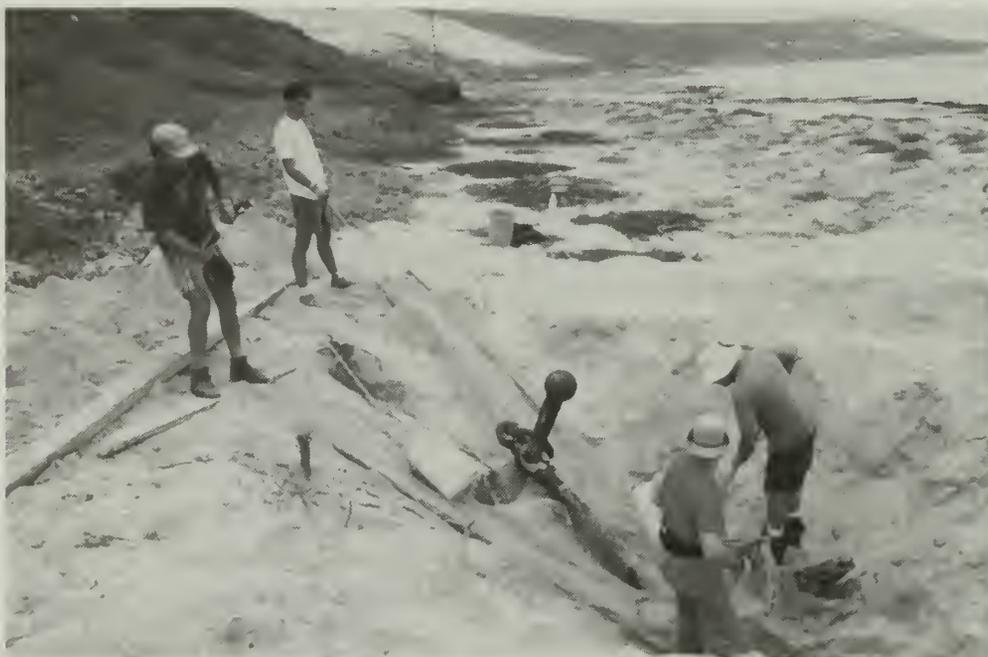
**Figure 4.6.** Volunteers working to expose *Comet* wreckage in October 1993. Just the tip of the anchor stock was exposed before digging began. NPS photo by Matt Russell.

Four volunteers arrived on October 19, 1993, and work began that afternoon. The tip of the anchor stock was used as a starting point for sand overburden removal. Project personnel and volunteers spent October 20–21, 1993, excavating (Figure 4.6). The anchor was

uncovered, along with a few timber ends, and nothing more. Although the timbers located are certainly from *Comet*, no details could be recorded because the unstable walls of the hole kept collapsing as the timbers were exposed. In total, about 21 cu. yds. of sand were removed from a hole 21 ft. in diameter at the top and 7 ft. deep. The few remains uncovered indicated this site could not be exposed without mechanical excavation and shoring. Barring landing a backhoe, *Comet* would have to wait for detailed recording until naturally uncovered.

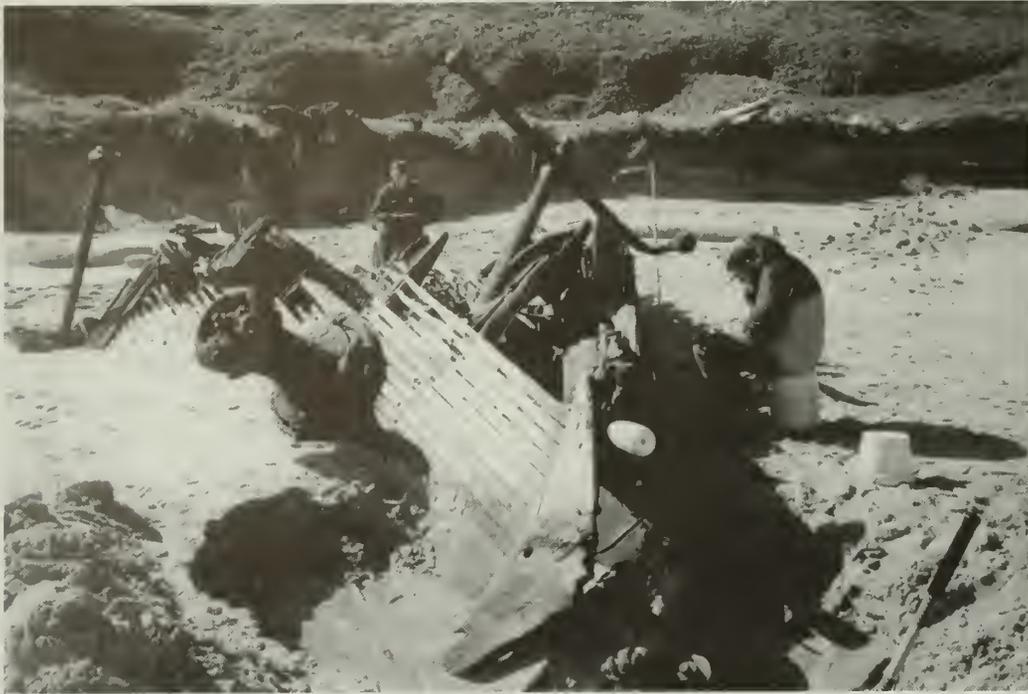
**Figure 4.7.** Archeologists mapping *Comet's* bow section. NPS photo by Don Morris.

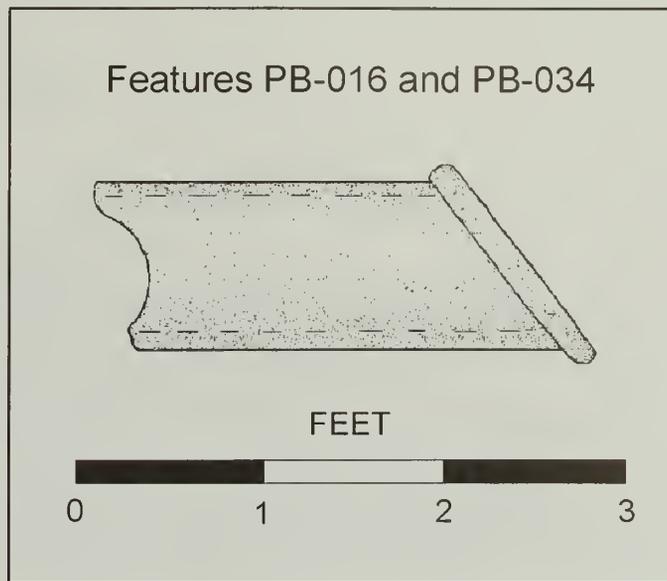
**Figure 4.8.** Features PB-016 and PB-034 are two identical hawse pipes. Drawing by Matt Russell.

The most diagnostic objects in the intertidal zone are two hawse pipes, features PB-016 and PB-034, of identical dimensions (Figures 4.8 and 4.9). Hawse pipes were located on each side of a vessel's bow and allowed the chain cable to pass through the hull. Hawse pipes are distinguishable from mooring pipes (which allowed mooring lines to pass through the main deck bulwarks on the main deck) and chain pipes (which allowed the chain cable to pass through the main deck into the chain locker) by their

length and their sloping outer faces, which must conform to a bow's compound curves. PB-034 is located 50 ft. 6 in. northwest of PB-016. The two hawse pipes have the same dimensions, which, combined with proximity, indicate they came from the same vessel. The pipes have an overall length of 2 ft. 11 in., an outside diameter of 11 in. and an inside diameter of 9 in.

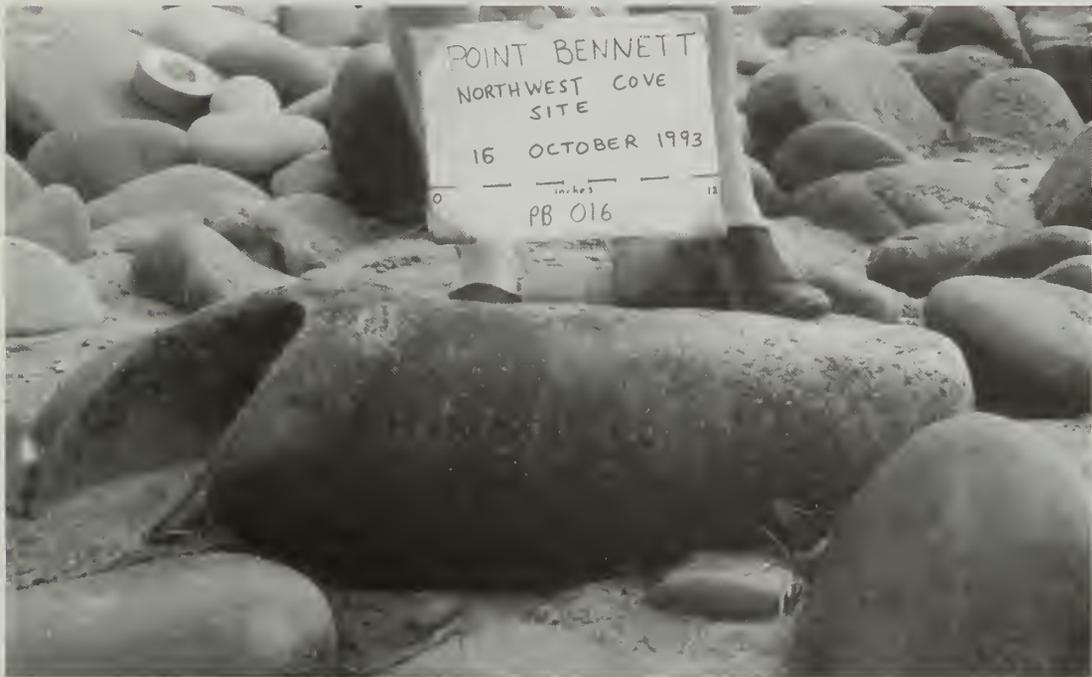
**Figure 4.9.** Hawse pipe (feature PB-016). NPS photo by Adriane Neidinger.

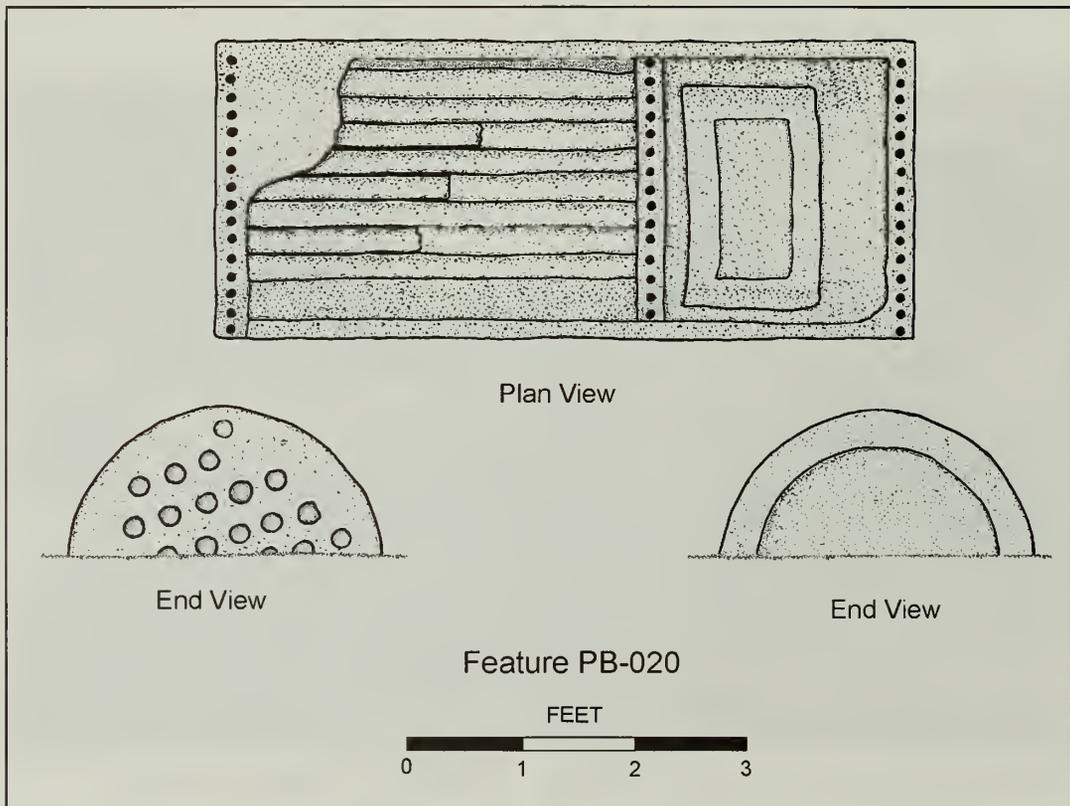
**Figure 4.10.** Donkey boiler (feature PB-020). Drawing by Matt Russell.

Feature PB-020 is another readily identifiable object, a steam donkey engine boiler (Figures 4.10–4.12). It is a cylinder

approximately 6 ft. 6 in. long and 3 ft. in diameter, its interior filled with 2¾-in. diameter tubes for about two-thirds of its length. Donkey engines, or “steam donkeys” as they were known, were found aboard coastal lumber schooners after the early 1880s (Cox 1974:231) and were used for a variety of purposes, including loading and unloading cargo, hoisting the sails and running the ship’s pumps. The donkey engine was usually located in the forward deckhouse, as in the coastal lumber schooner *C. A. Thayer*, built in 1895 by Hans D. Bendixsen and now on display at San Francisco Maritime National Historical Park. Like *J. M. Colman*, *Comet* and *Dora Bluhm*, *C. A. Thayer* is a three-masted lumber schooner and very similar in size and configuration to the Hall-built schooners.

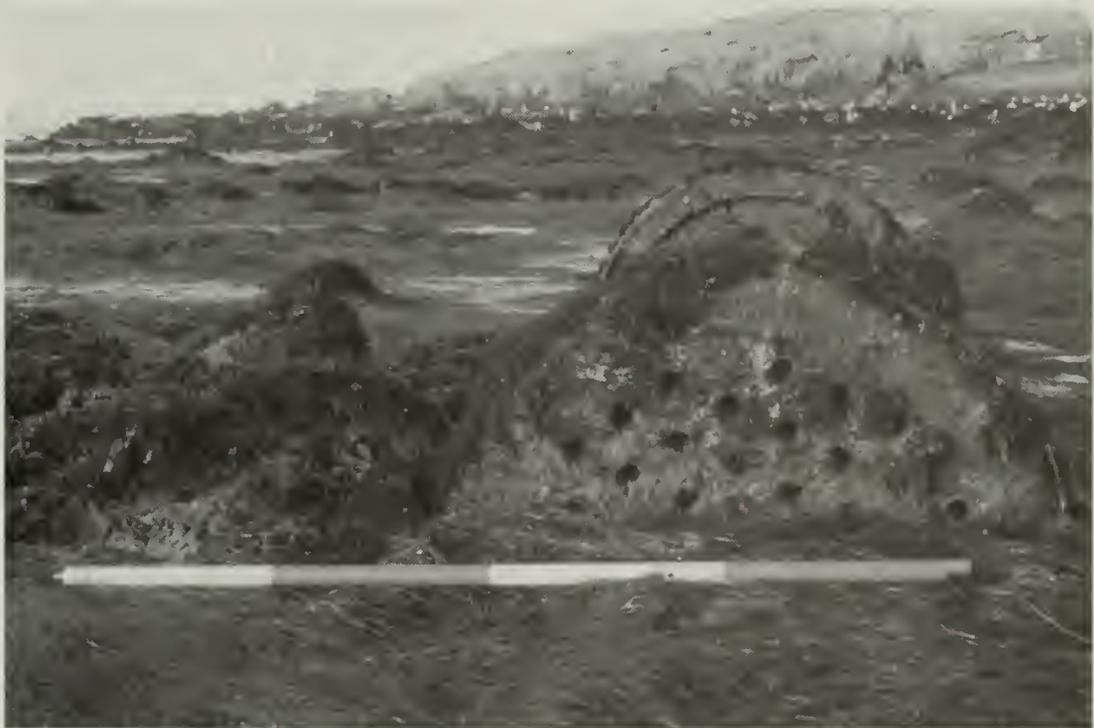
**Figure 4.12.** End view of the donkey boiler. NPS photo by Adriane Neidinger.

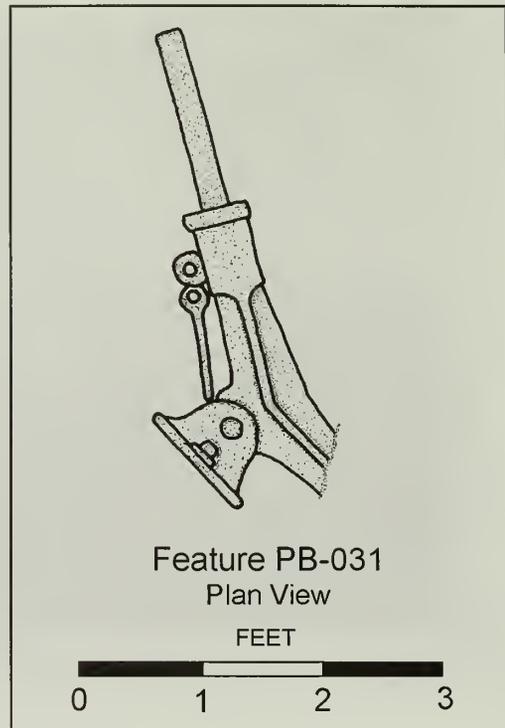
**Figure 4.13.** Crosshead mechanism from a pump-brake windlass (feature PB-031). Drawing by Matt Russell.

Another intertidal-zone object identified is PB-031, which is the crosshead mechanism of a hand-operated, pump-brake windlass (Figures 4.13 and 4.14). An example of this mechanism can also be seen on board *C. A. Thayer*, where it is mounted on the forecastle deck, directly forward the sampson post above the windlass. The crosshead was attached to the windlass by connecting rods that passed through the forecastle deck and were connected to the windlass purchase rims (de Kerchove 1961:614). Removable handles were inserted into the crosshead and the up-and-down motion supplied by two seamen rotated the purchase rims, which turned the windlass. This is the same type of windlass and mechanism recorded on *Comet* (see below). Feature PB-031 is partially obscured by encrustation and marine growth, but a portion of one of the removable handles is present. The overall length of the piece is 4 ft. The base of the crosshead mechanism was secured to the forecastle deck with two 1-in. diameter iron fasteners. The base is about 10 in. square and 6½ in. tall, which is similar to the crosshead mechanism found on *C. A. Thayer*.

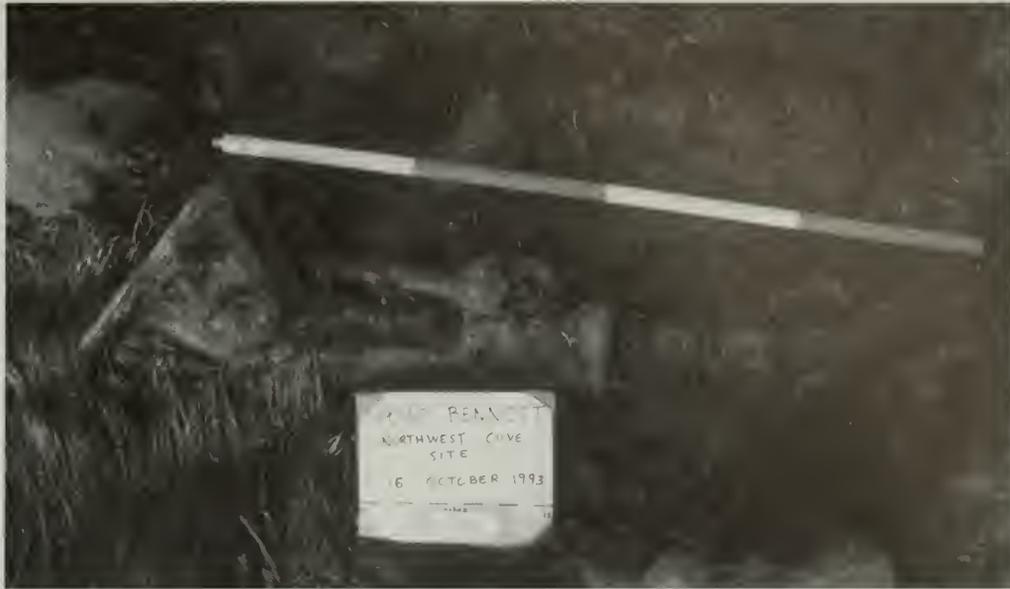
**Figure 4.14.** Crosshead mechanism from a pump-brake windlass. See Figure 4.96 for a similar mechanism. NPS photo by Adriane Neidinger.
