# Beached Shipwreck Archeology: Case Studies from Channel Islands National Park

Submerged Resources Center  
Professional Reports  
Number 18

Submerged Resources Center  
Intermountain Region  
National Park Service

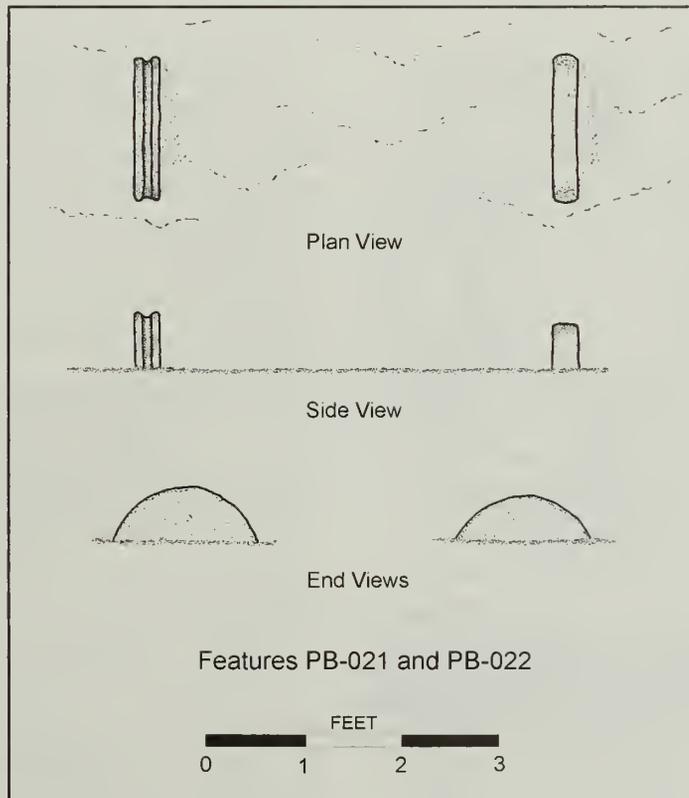
**Figure 4.15.** Part of the drive mechanism from a donkey engine (features PB-021 and PB-022). Drawing by Matt Russell.

At least seven of the remaining intertidal zone features are either from a windlass, a donkey engine, or a messenger chain system that linked the two. A messenger chain used a series of chains, gears and shafts to connect a steam donkey engine to the windlass, pumps, auxiliary warping heads and other hoisting gear. *Comet* was equipped with a messenger chain system to drive its windlass (see below). Feature PB-021/022 (actually a single object) is likely part of a donkey engine (Figures 4.15 and 4.16). PB-021/022 are two circular iron pieces sticking upright out of the bottom, 4 ft. apart, and connected by a shaft that could not be exposed (which is why they were given separate feature numbers). The circular iron pieces are 1 ft. 6 in. in diameter. One of them (PB-021) is featureless, while the other (PB-022) is grooved

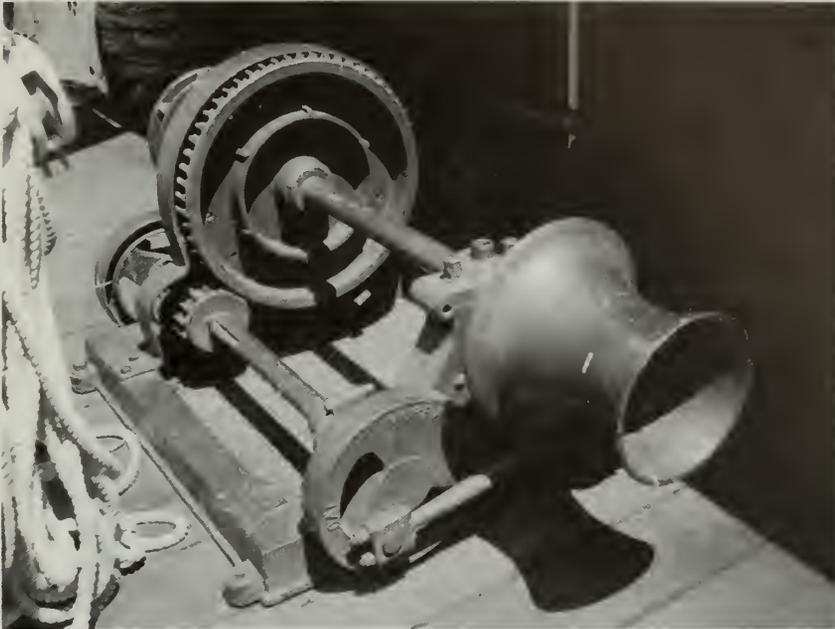
**Figure 4.17.** Windlass from *Falls of Clyde* in Honolulu, Hawaii. The smaller mechanism to the left is similar to features PB-021 and PB-022. NPS photo by Matt Russell.

along the edge. Although positive identification is difficult, this feature is probably the drive spindle of a steam donkey engine (Figure 4.17).

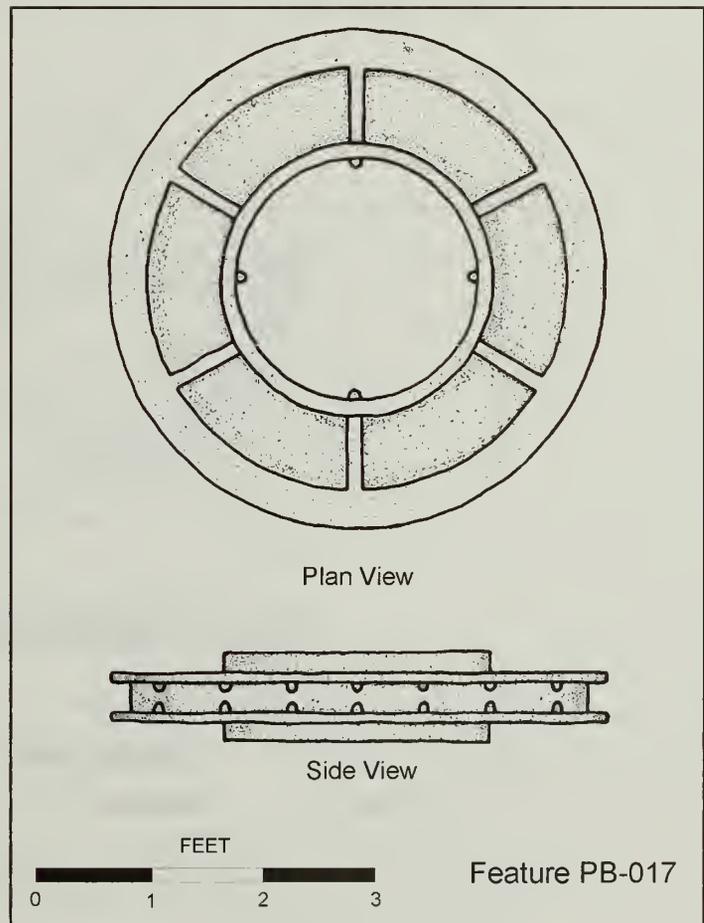
**Figure 4.18.** The widely-spaced teeth on this feature's outer edge indicate it is part of a messenger chain system that ran the windlass from a donkey engine. Drawing by Matt Russell.

Features PB-017, 018 and 023 are all similar objects and part of a vessel's windlass or messenger chain system. PB-017 is an iron ring with an outside diameter of 4 ft. 4 in., an inside diameter of 2 ft. 1 in., with a thickness of the main part of the ring 5 in. An inner flange adds 2 in. in thickness to either side (Figures 4.18 and 4.19). PB-018, also an iron ring, has an outside diameter of 3 ft., an inside diameter of 2 ft. 2 in., and is 4 in. thick (Figures 4.20 and 4.21). PB-023 is a solid circular iron object 2 ft. 1½ in. in diameter and 4 in. thick (Figure 4.22). All three features have edges notched for gears. Edges of PB-018 and PB-023 have closely spaced gears, while the edge of PB-017 has teeth spaced about every 7 in. Feature PB-018 is likely the purchase rim of a windlass (Figure 4.23). The 7-in.-spaced teeth of PB-017 are from the messenger chain system that ran this machinery.

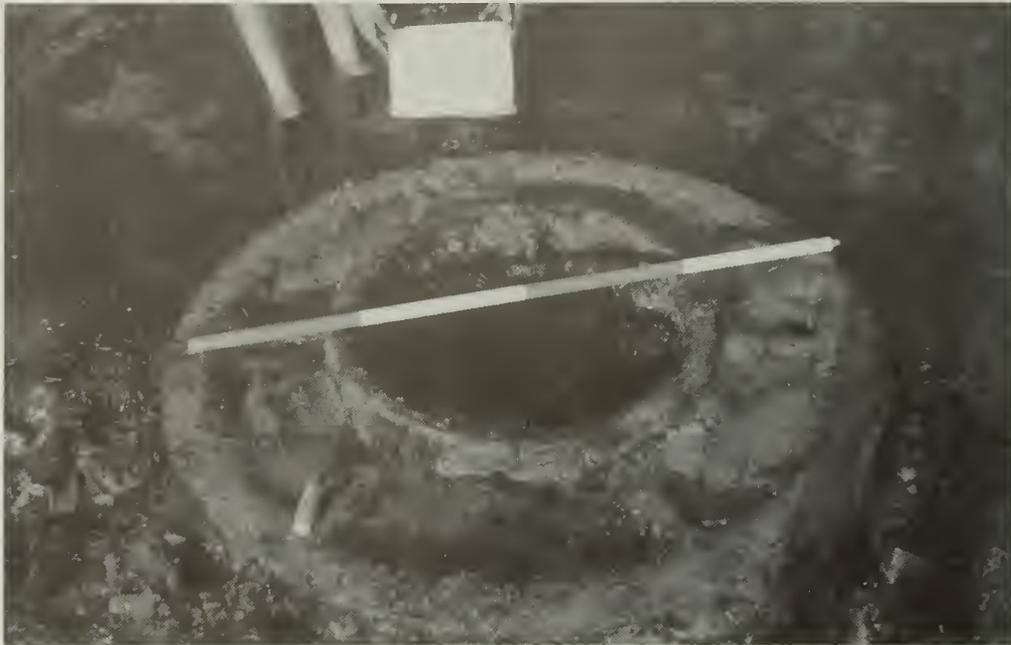
**Figure 4.19.** Iron ring from a windlass messenger chain system (feature PB-017). NPS photo by Adriane Neidinger.

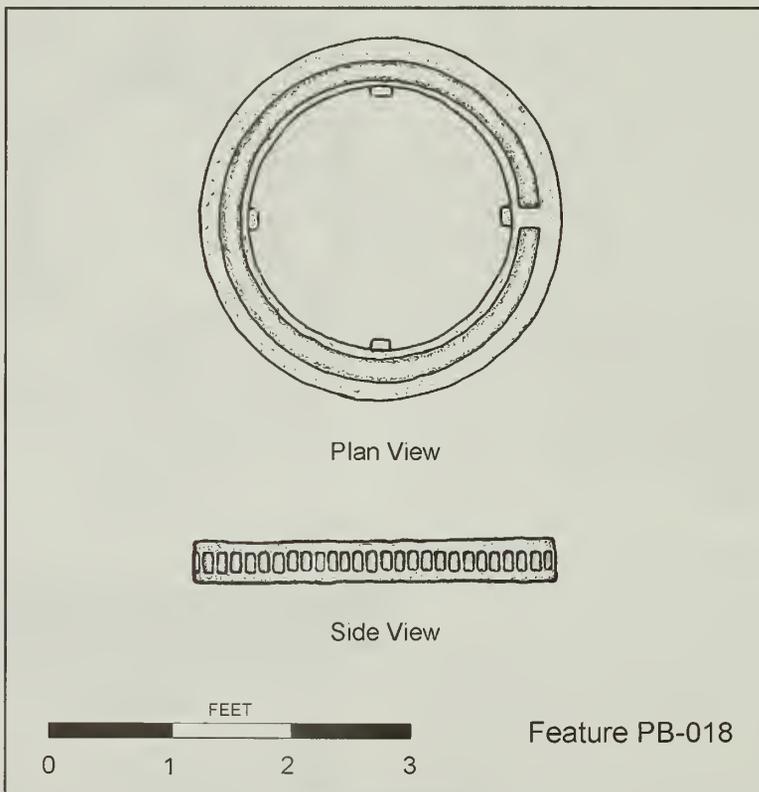
**Figure 4.20.** Purchase rim from a pump-brake windlass. Drawing by Matt Russell.

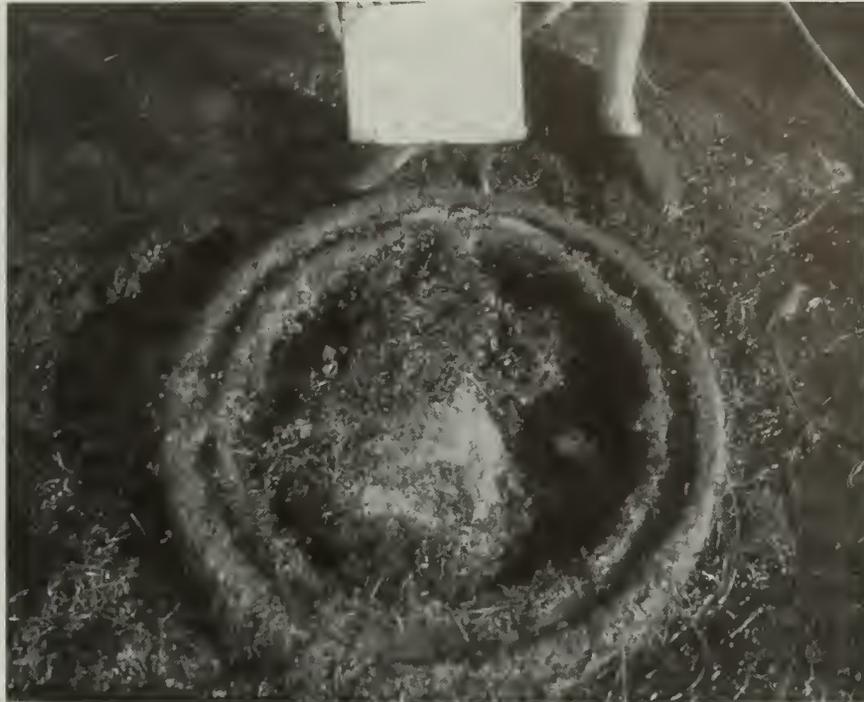
**Figure 4.21.** Purchase rim (feature PB-018). NPS photo by Adriane Neidinger.

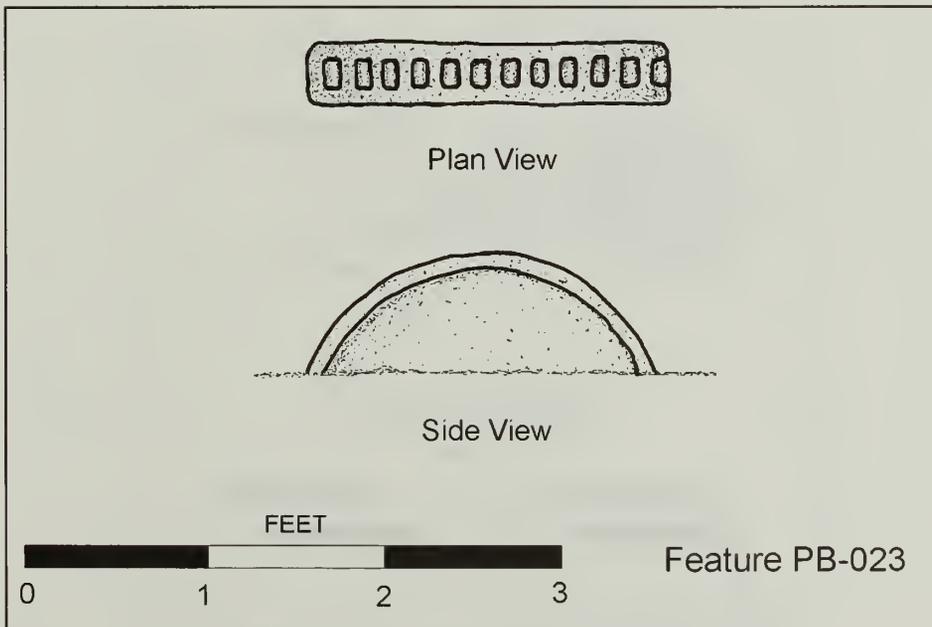
**Figure 4.22.** Unidentified windlass element (feature PB-023). Drawing by Matt Russell.

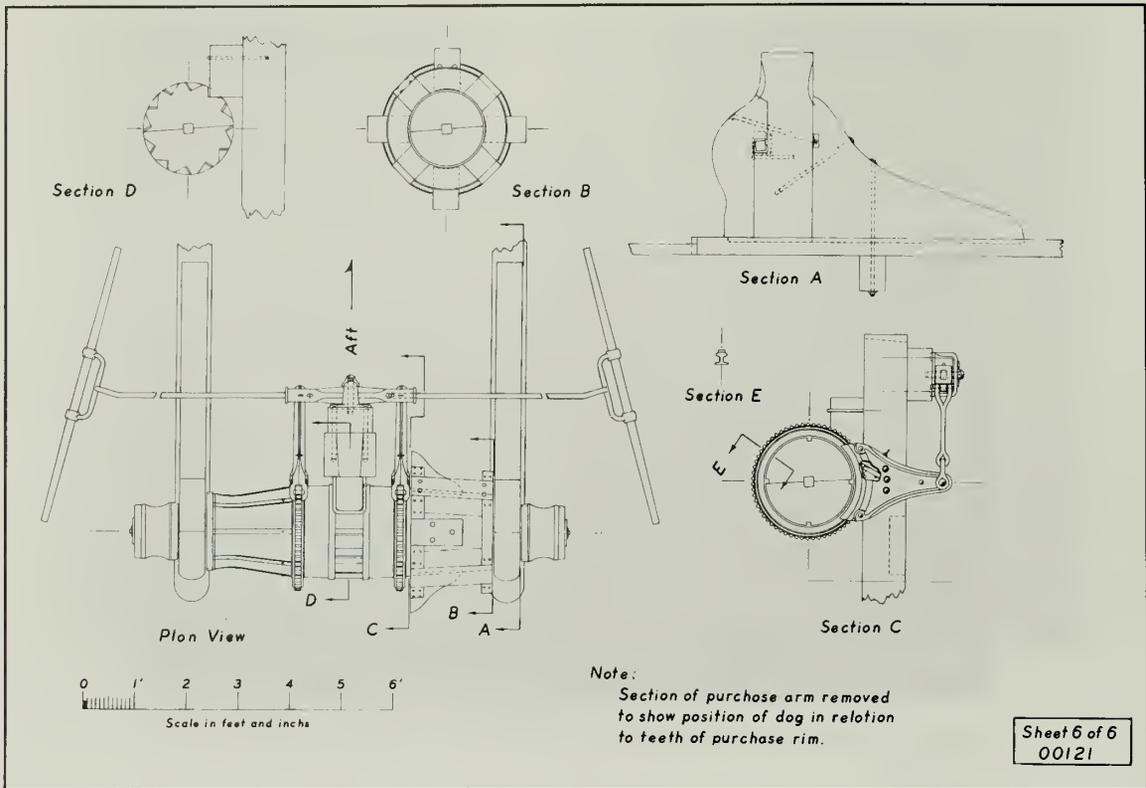
**Figure 4.23.** Feature PB-018 is a purchase rim, pictured here in Section C with the purchase arm attached. Note the four teeth on the inside of the rim that match those on feature PB-018. Drawing from the Smithsonian Institution.

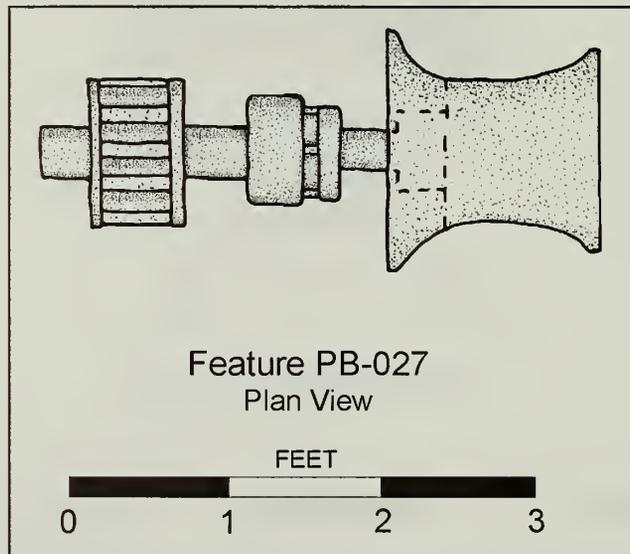
**Figure 4.24.** Unidentified windlass element with the warping hub (feature PB-027). Drawing by Matt Russell.

Features PB-026, 027 and 029 are also likely parts to either a windlass or a donkey engine. Both PB-027 and PB-029 contain warping hubs and geared mechanisms on shafts, likely parts from the windlass, a deck winch or the donkey engine (Figures 4.24–4.27). PB-027 is 3 ft. 9 in. long, and PB-029 is 2 ft. long. The warping hubs on each are identical, 1 ft. 4 in. long and 1 ft. in diameter at their narrowest point. Feature PB-026 has a large, circular geared mechanism 1 ft. 10 in. in diameter, and a smaller circular object 1 ft. 5 in. in diameter (Figures 4.28 and 4.29). The teeth on the latter's edge are spaced on 7-in. centers, same as PB-017, which is also from the messenger chain system (Figure 4.30).

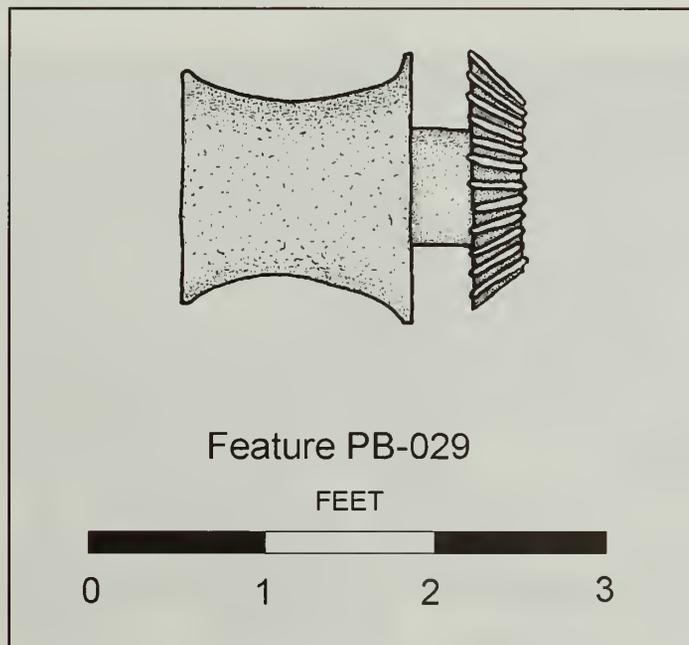
**Figure 4.26.** Another unidentified windlass element (feature PB-029). Drawing by Matt Russell.

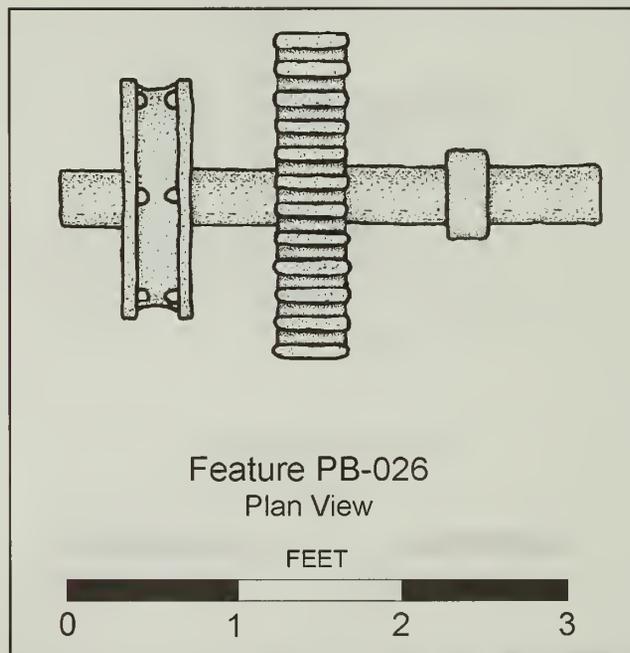
**Figure 4.28.** Unidentified windlass element with widely-spaced teeth for the messenger chain on the left. Drawing by Matt Russell.

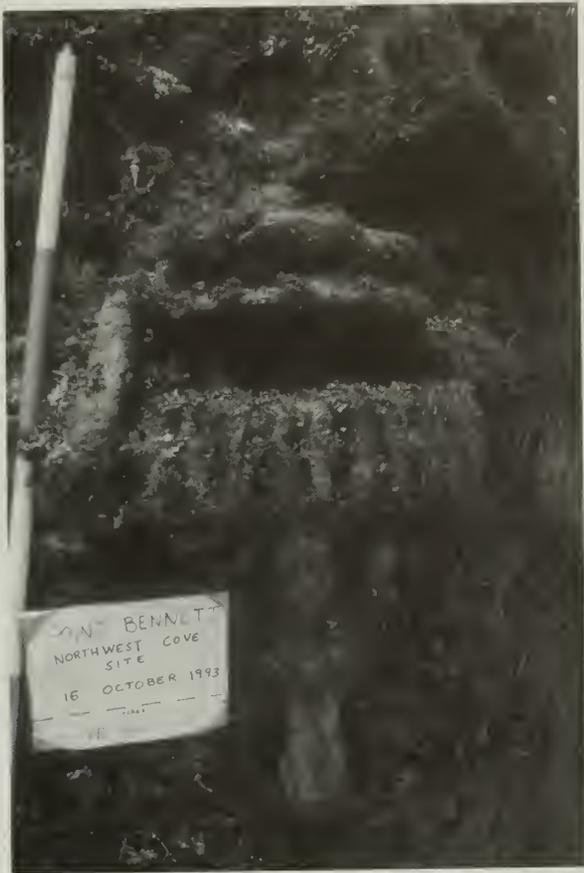
**Figure 4.29.** Feature PB-026 with the messenger chain gear at top. NPS photo by Adriane Neidinger.

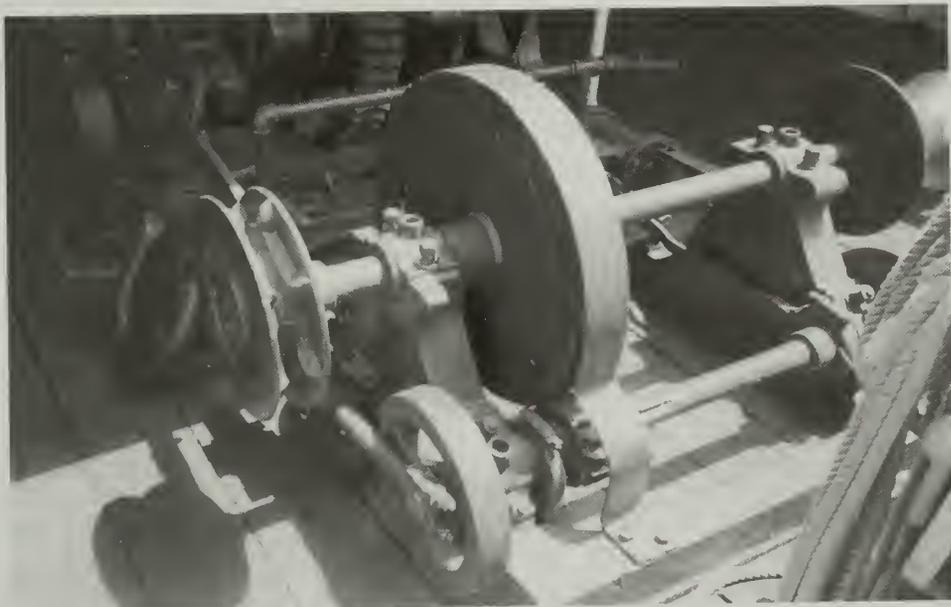
**Figure 4.30.** Windlass from *Falls of Clyde* in Honolulu, Hawaii. Note the gear to the left in the photograph that is from the messenger chain system. NPS photo by Matt Russell.

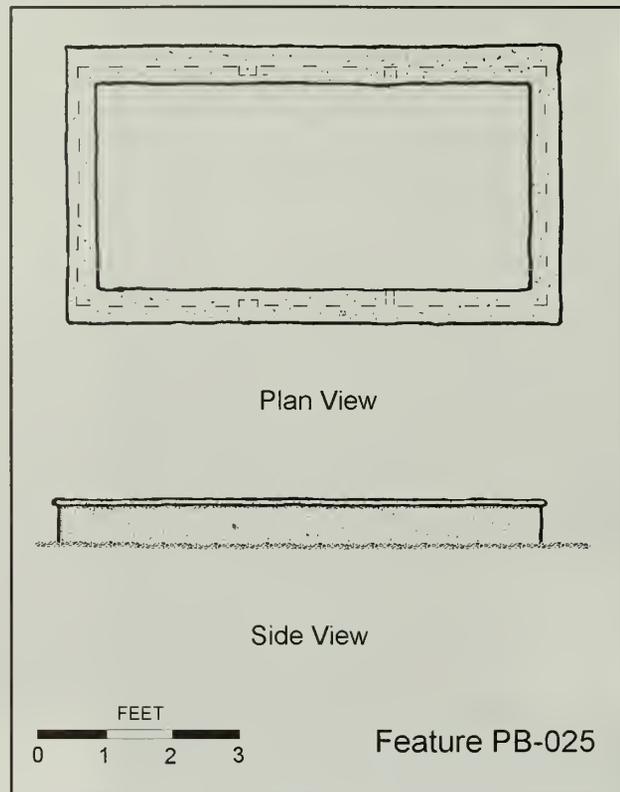
**Figure 4.31.** Machinery mount for the donkey engine (feature PB-025). Drawing by Matt Russell.

PB-025 is a large, rectangular-shaped iron feature encrusted to the seabed. It has an outside length of 7 ft. 2 in. and an outside width of 4 ft. 1 in. The inside length is 6 ft. 4 in., while the inside width is 3 ft. 1 in. The object is 8 in. high (Figures 4.31 and 4.32). At first glance, the object appears to be some sort of hatch coaming, which is unlikely because cargo hatches on

ocean-going vessels would have been much larger and constructed of wood. Feature PB-025 is probably the machinery mount for the donkey engine.

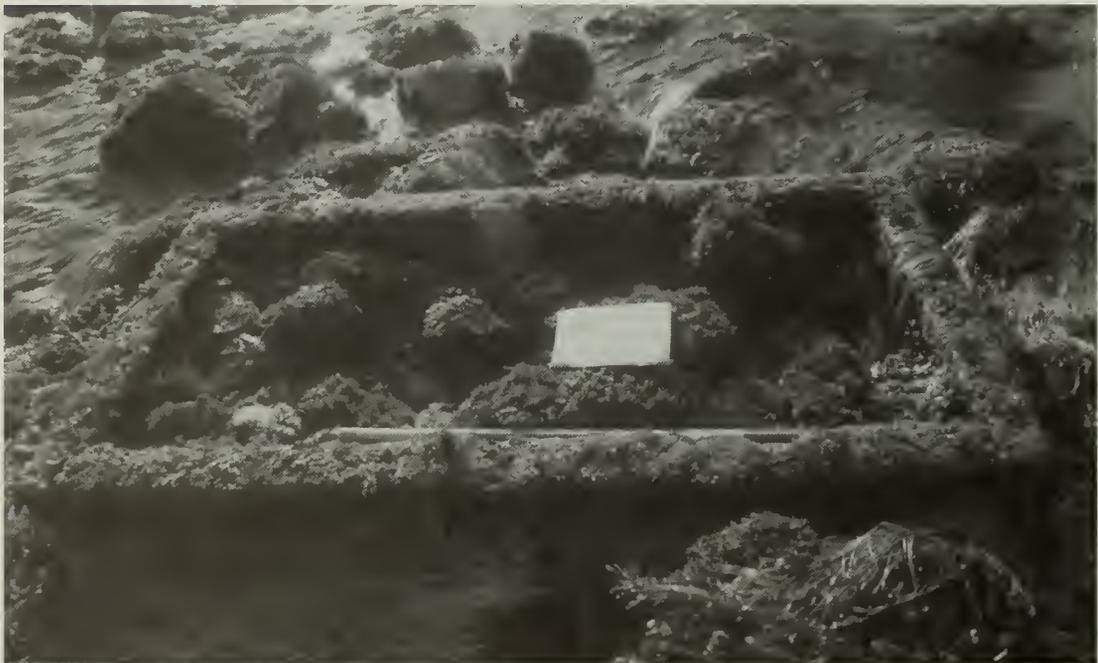
**Figure 4.32.** Feature PB-025. NPS photo by Adriane Neidinger.

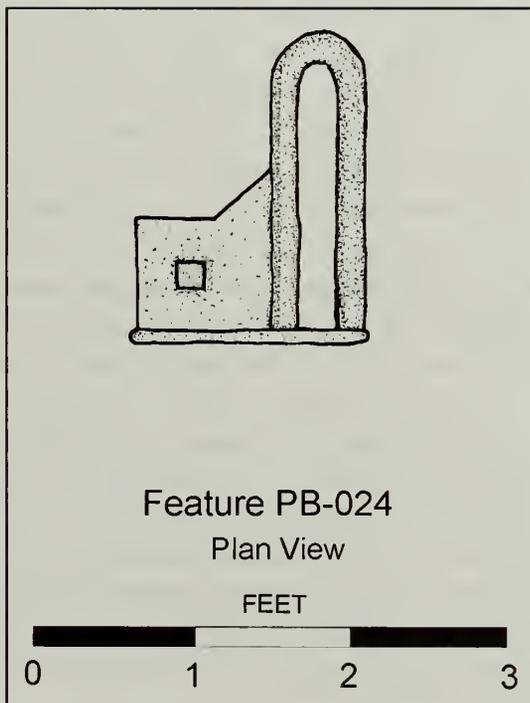
**Figure 4.33.** Unidentified object (feature PB-024). Drawing by Matt Russell.

The remaining six intertidal features could not be conclusively identified. Feature PB-019 is a deteriorated piece of wood firmly embedded in the bottom, probably attached through the encrustation of various iron fasteners or fittings. Feature PB-024 is an oddly shaped iron object with rough dimensions of 1 ft. 11 in. x 1 ft. 6 in. The main attribute is a U-shaped piece of iron attached to a base (Figure 4.33). The object was only drawn in two dimensions because it is encrusted into the bottom and surrounded by thick marine growth. Heavily encrusted, feature PB-028 appeared only as a small ferrous lump covered with marine growth and no details could be observed. A scale drawing was not produced. Feature PB-030 is an iron block 2 ft. 4½ in. long,

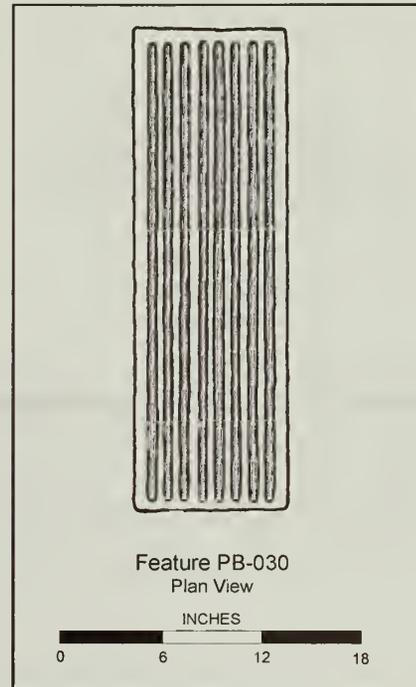
**Figure 4.34.** Unidentified object (PB-030). Drawing by Matt Russell.

9 in. wide and 4½ in. thick (Figure 4.34). The top (exposed) surface has shallow grooves ½ in. wide and ½ in. apart running lengthwise for the whole width of the piece. A group of three iron fasteners concreted onto the rocks make up feature PB-032. Their lengths are 9 in., 1 ft. and 1 ft. 3 in.; the two shorter ones are approximately 1-in. diameter; the longer is about 1½ in. in diameter. Feature PB-033 is a small, half-moon-shaped iron object 2 ft. 1 in. long across its base, just over 9 in. wide at the broadest point, and 1½ in. thick (Figure 4.35). The top surface has six shallow grooves running lengthwise that are ½ in. wide with ¾-in. spaces between them. The bottom surface of the object is smooth.

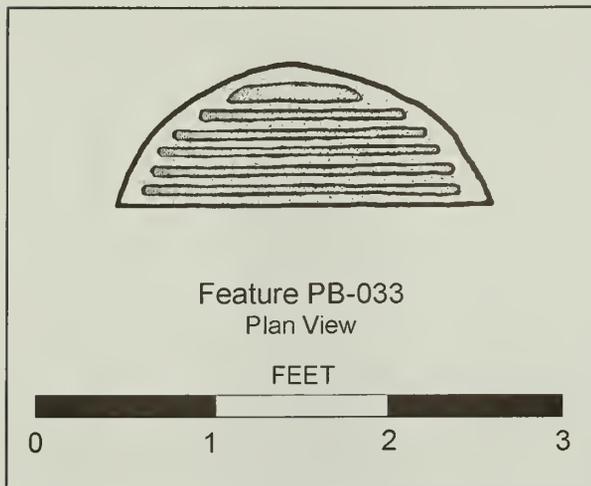
**Figure 4.35.** Unidentified object (feature PB-033). Drawing by Matt Russell.

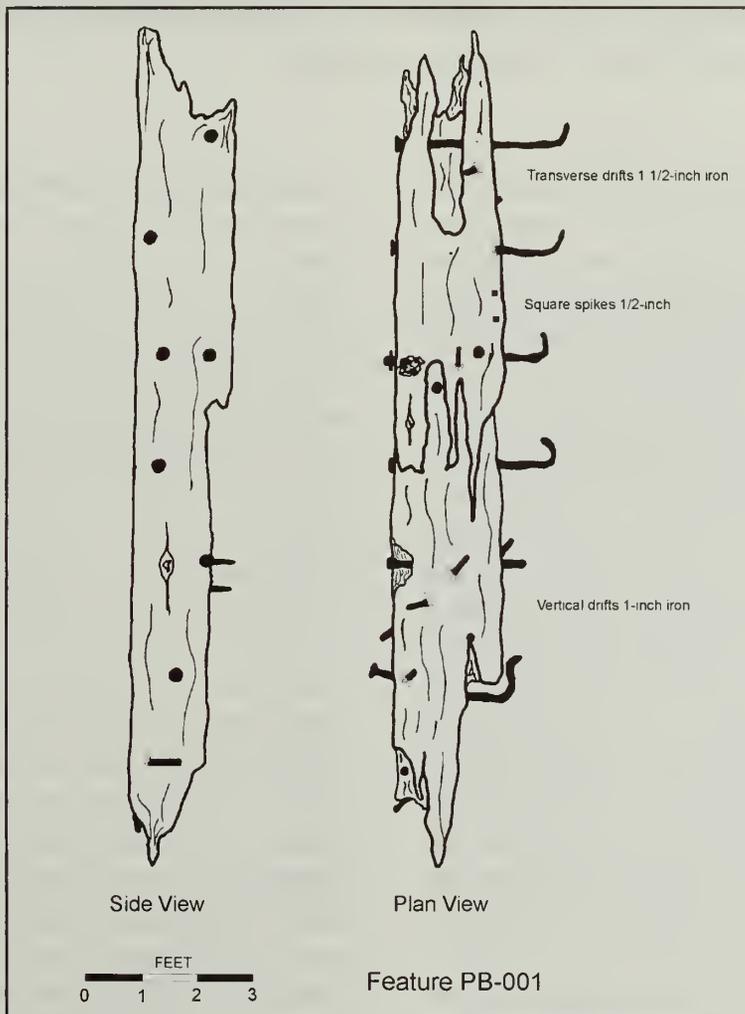
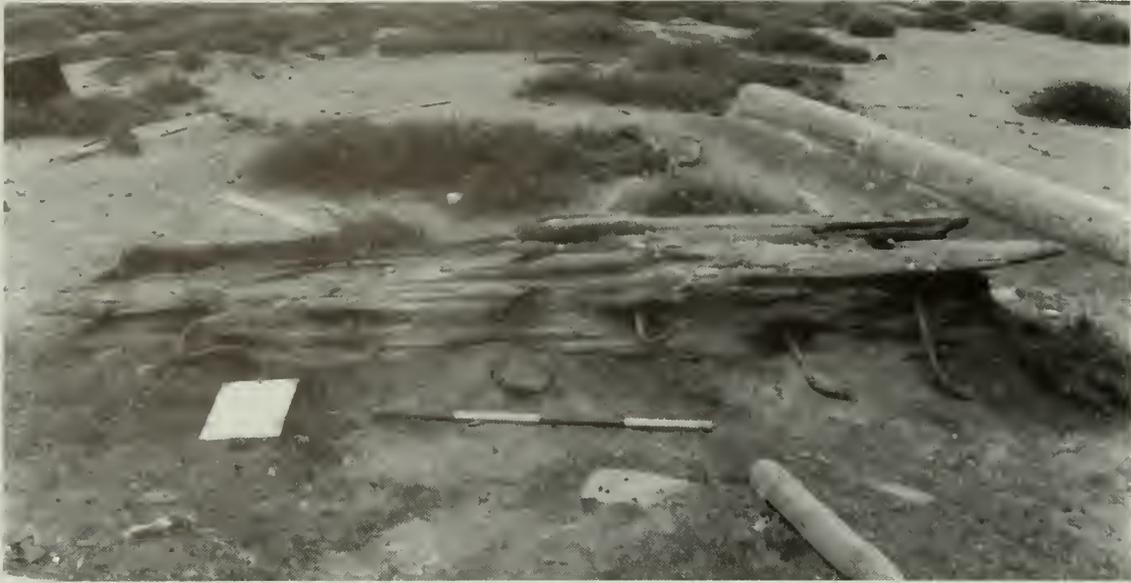
**Figure 4.36.** Keelson element with iron fasteners (feature PB-001). Drawing by Matt Russell.

Figure 4.37. Feature PB-001. NPS photo by Matt Russell.

in. (Figures 4.36 and 4.37). Both ends are broken off, so it is impossible to determine the element's original length. All extant surfaces are badly worn and deteriorated, so sided and moulded dimensions are approximate. The element's most conspicuous characteristics are size and number of iron fasteners. There are six large, iron drift pins driven through and protruding from the side. These drifts are approximately 1½ in. in diameter (though exfoliating badly) and range in length from 2 ft. 2 in. (broken) to 4 ft. 2 in. long spaced an average of 2 ft. apart. There are also nine 1-in. diameter

iron drifts and five spikes ½ in. square protruding from the timber's top surface. All are broken off close to the surface.

The element's size and fasteners make it likely this feature is part of a structural member from an ocean-going vessel. Furthermore, because of the element's large size and configuration of iron fasteners, it is most likely PB-001 is a portion of a vessel's centerline structure. The lack of rabbet, fasteners driven through both axis of the piece, and the observation that the large drifts were first driven through this piece and then, probably, into

another makes it impossible for this piece to be a portion of a keel. On the other hand, these same characteristics are consistent with a piece of a main, sister, rider or assistant keelson, which now rests on its moulded face. The element's western face, from which the large iron drifts were driven, is likely the top, or sided, surface. If PB-001 is a piece of the main keelson, then the six 1½-in. diameter drifts were probably driven through this piece, through the floors and into the vessel's keel. If it is from a sister keelson, then the large drifts were probably driven through this timber into the floors or first futtock of the vessel. If this timber is from a rider or assistant keelson, then the large iron fasteners were probably driven through the piece into the main or sister keelson. In all cases, the 1-in. diameter fasteners driven through the opposite axis of the timber edge-bolted this timber to its adjacent keelson component, indicating multiple keelson elements.

*Comet's* contract specifies that iron fastenings 1¼ or 1 1/8 in. in diameter be used to fasten the keelson. Because *J. M. Colman* was larger than *Comet*, 1½-in. iron drifts to fasten the keelson would be consistent. Another possibility is that the expansion caused by the corrosion process of the iron fasteners made the 1½-in. measurement larger than the original diameter. In either case, these fasteners reflect probable association with *J. M. Colman*.

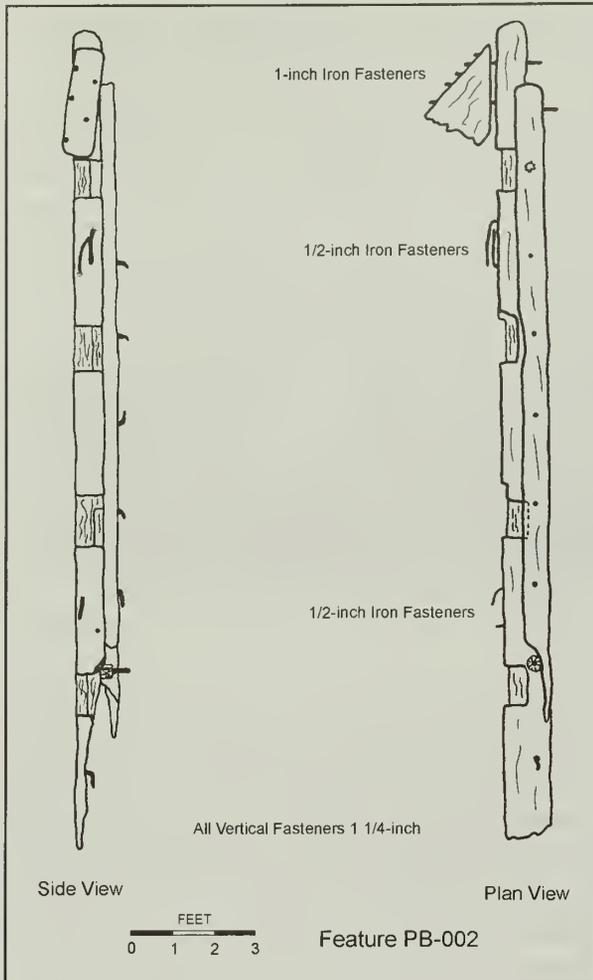
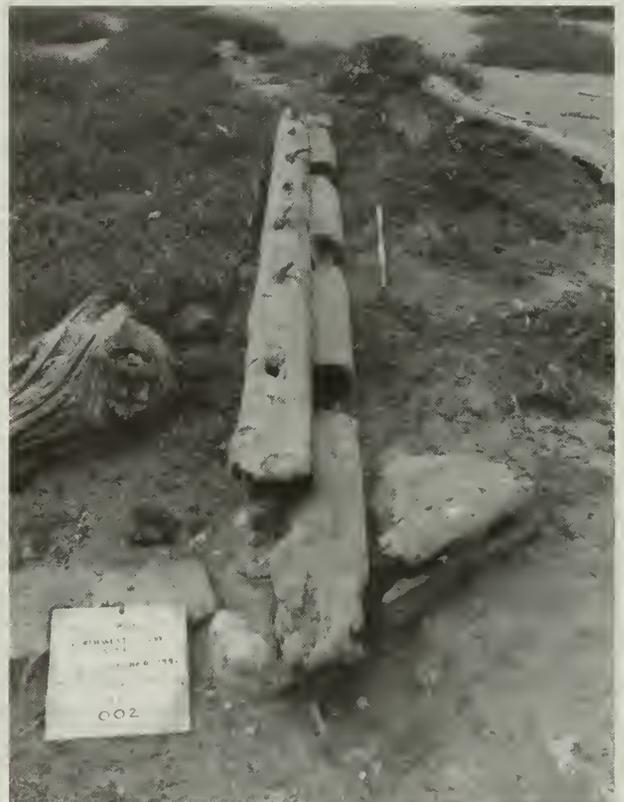
**Figure 4.38.** Feature PB-002. This fragment is possibly part of a deck clamp or shelf. Drawing by Matt Russell.

**Figure 4.39.** Feature PB-002. NPS photo by Matt Russell.

Another feature that is likely a scantling piece from a large, ocean-going vessel is PB-002 (Figures 4.38 and 4.39). This fragment consists of three wooden components: two long, rectangular pieces, one on top of the other, and a small trapezoidal piece fastened to the bottom timber. Also present are numerous iron fasteners. The bottom timber's total length is 19 ft. 8 in., it is 1 ft. 2 in. wide and 8 in. thick. This piece contains four mortises cut into its west side, which measure between 10 in. and 1 ft. 1 in. long, 3½ in. high, and 5½ in. deep. The mortises are indented about 1½ in. from the side. The top timber, which was originally fastened to the bottom piece with eight 1¼ in. in diameter iron drift pins spaced 2 ft. on center, is 15 ft. 6 in. long, 8 in. wide, and 4 in. thick. On the feature's north end, a trapezoidal piece 2 ft. 2 in. long, 1 ft. 7¾ in. wide, and 8 in. thick is fastened to the lower timber with five iron, 1-in. diameter drift pins. In addition to these fasteners, the fragment also has two pairs of additional ½-in. diameter drifts in its west face.

Attributes of this feature suggest identification as a deck clamp or shelf. The mortises, spaced on 4-ft. centers, would have received the deck-beam ends. Deck beam spacing corresponded to frame spacing, so that the end of each deck beam rested against a frame (Desmond 1919[1984]:105). Generally, a vessel framed on 2-ft. centers would have a deck beam for every other frame, with deck beam spacing not exceeding 5 ft. (American Shipmasters'

Association 1879:23). The trapezoidal piece was a reinforcing chock, butted between the clamp and the deck beam.

There are several problems with this interpretation, however, and several questions to be answered before it can be wholly accepted. First, the mortises extend only about half the width of the bottom timber. Normally, the deck beam rests on the full width of the clamp, not just half. Second, a main-deck clamp would have been firmly fastened to the vessel's frames with large through-bolts driven from the outside and clinched (Desmond 1919[1984]:104). There is no evidence of any large fasteners or holes coming through the bottom timber transversely. Third, between the mortises, evidence of more reinforcing pieces like that found on the end of the feature would be expected. However, there are only two pairs of ½-in. fasteners, nothing like the five 1-in. drifts

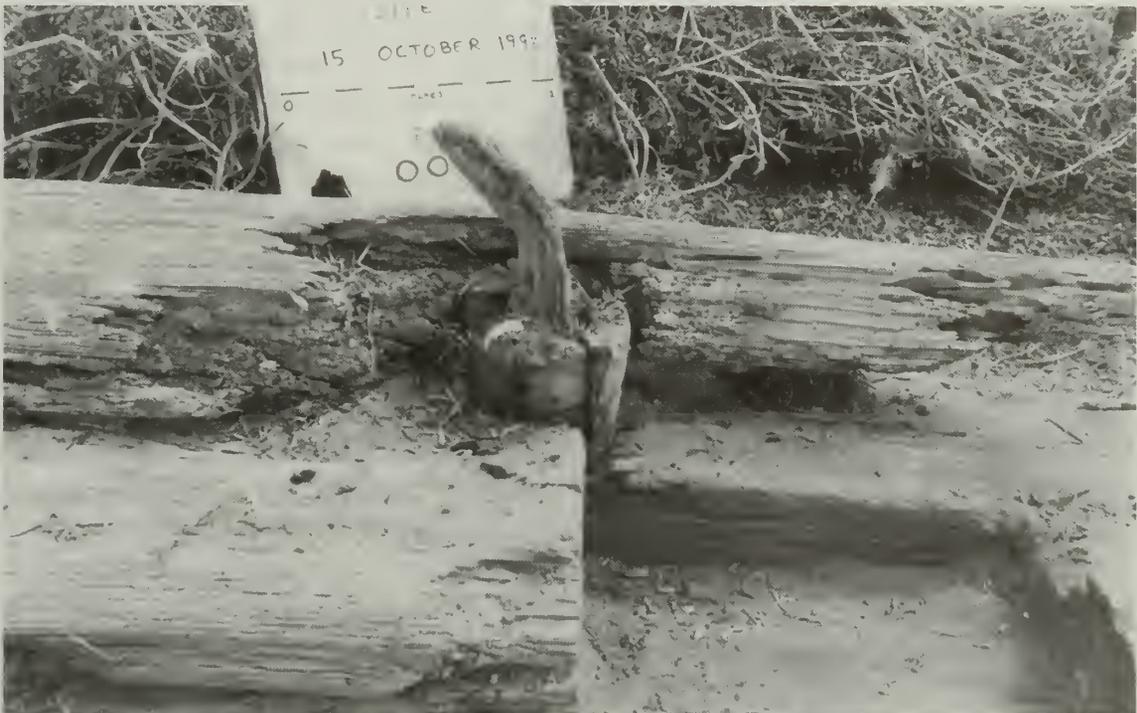
**Figure 4.40.** Iron fastener driven through an oak plug on feature PB-002. NPS photo by Matt Russell.

Finally, one of the most puzzling aspects of this fragment is that at least two of the vertical 1¼-in. fasteners joining the top timber to the bottom timber are driven through oak plugs (Figure 4.40). Only two could be examined, so it is possible that the remaining fasteners were also driven through plugs. Research into this practice has been inconclusive. It is unknown if this represents an effort to strengthen the bonding of these two timbers, or if this is evidence of a repair meant to replace a corroded fastener or possibly to augment wood that had deteriorated around the fastener. This may represent a peculiar and undocumented practice of the Hall Brothers. Identification as a portion of a deck clamp or shelf should be viewed as tenuous, especially when considering association with *J. M. Colman*.

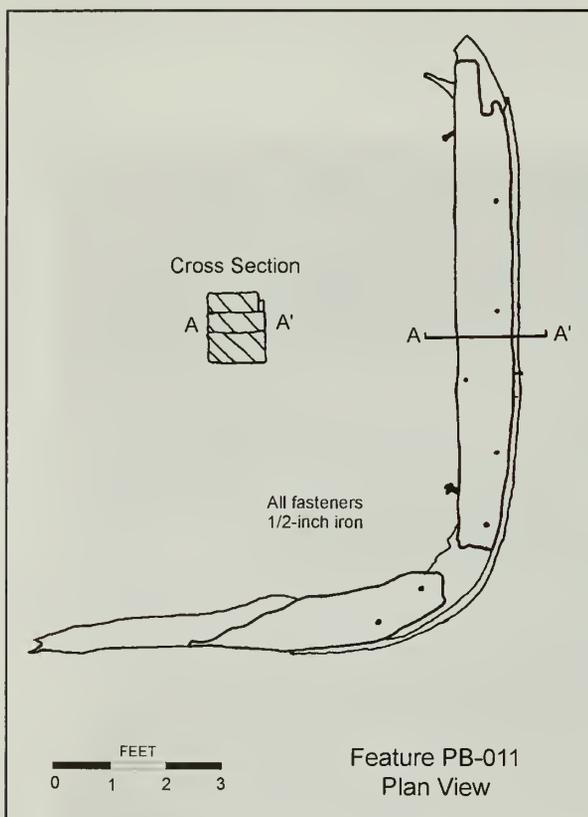
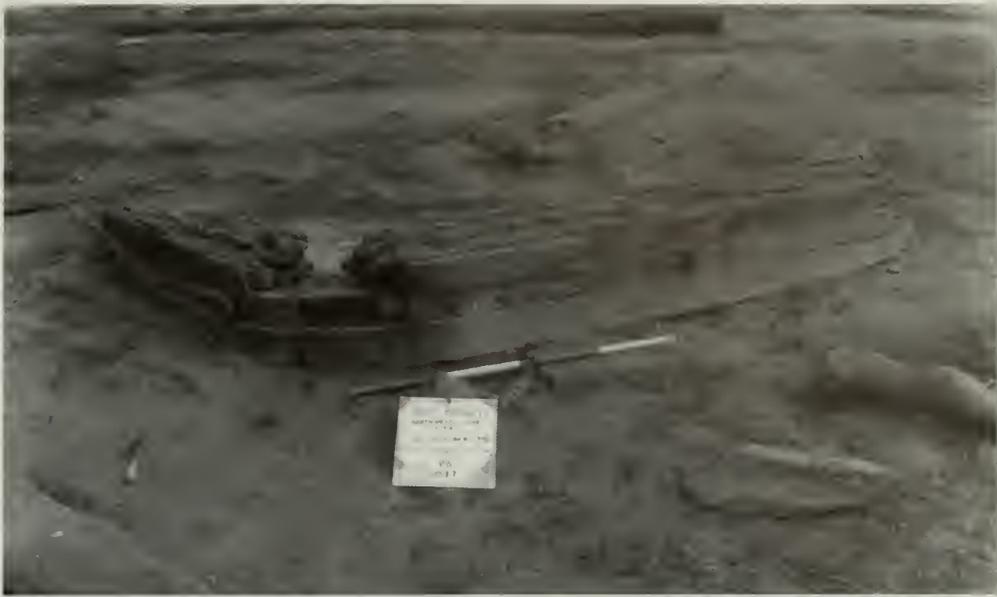
**Figure 4.41.** Plan view of feature PB-011, possibly part of a hatch coaming. Drawing by Matt Russell.

**Figure 4.42.** Oblique view of feature PB-011. NPS photo by Matt Russell.

Features PB-011 and PB-014, constructed in the same manner, likely represent pieces of a wooden hatch coaming (Figures 4.41–4.44). The two fragments each have three layers of timbers, fastened together with ½-in. diameter, round iron fasteners. Originally, the structure was either U-shaped or, more likely, rectangular with rounded corners. PB-011 is sitting upright, with the three layers stacked, while PB-014 is laying face-down with the three layers side by side.

Feature PB-011's bottom timber is 6½ in. thick, the middle timber is 5 in. thick, and the top timber is 7 in. thick, giving PB-011 a total height of 18½ in. Each of the timbers is 1 ft. wide. Feature PB-011 is roughly L-shaped, with the longest side 11 ft. long, and the shorter 8 ft.

Each layer of wood on feature PB-011 is faced on the outside edge with thin, horizontal planks ¼ in. thick. These are nailed to the main timbers with ¼-in. round nails. Wood species analysis identified these planks as *Quercus virginiana* or live oak. The main timbers were Douglas fir. It could not be determined if PB-014 included similar planks because the side they would have been attached to was face-down. The plank nailed to the top layer of PB-011 is only 4¼ in. wide, so it extends only about half the thickness of that timber. This, in effect, leaves a 2¾-in. deep, 1¼-in. wide rabbet around the outside of the structure's top face.

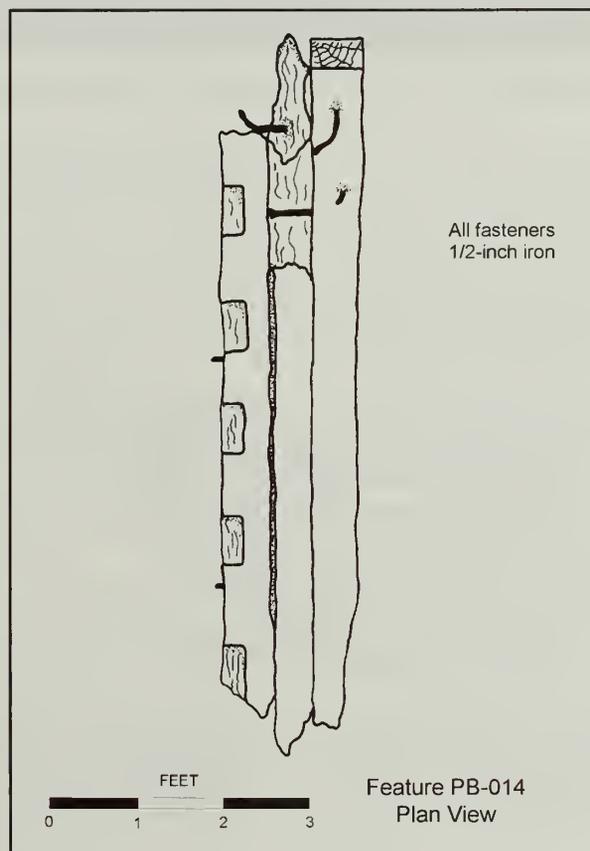
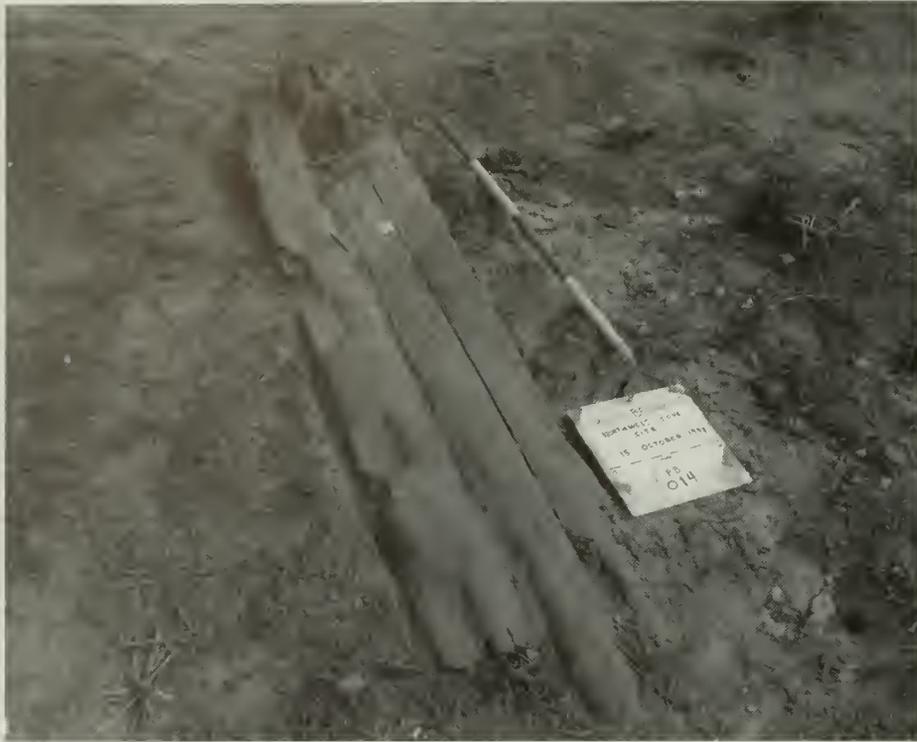
**Figure 4.43.** Plan view of feature PB-014, likely part of the same coaming as feature PB-011. Drawing by Matt Russell.

**Figure 4.44.** Feature PB-014. NPS photo by Matt Russell.

long; both ends are broken. The end of the longer side exhibits the beginning of a curve before the fracture. Feature PB-014 shows the beginning of a curve on one end before it is broken off, as well. In the one intact curve on PB-011, the two timbers forming the bottom layer meet in the middle of the curve. The timbers of the two top layers are joined in the curve by a chock. Feature PB-014 has shallow mortises along what would be the inside edge of the top timber, if it were standing upright. These mortises are 6 in. long, 3 in. wide with a maximum depth of 1½ in. The shorter length of PB-011 exhibits identical mortises on its inside face, suggesting that PB-014 was originally connected to PB-011 opposite their shorter length.

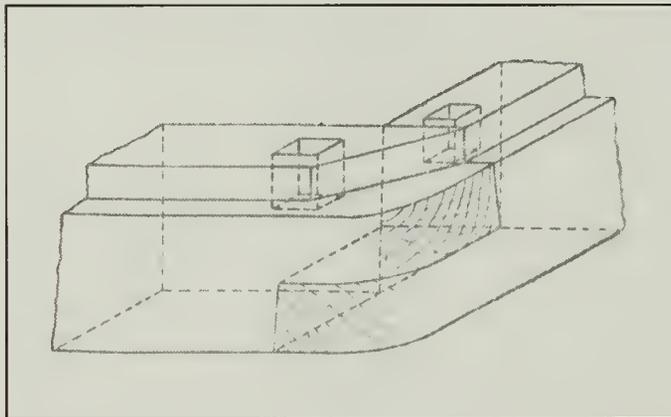
**Figure 4.45.** Hatch coaming depicted in Curtis 1919:200.

Positive identification of these fragments is difficult, but attributes are consistent with a hatch coaming, or deck structure coaming of a large vessel. Both hatch and house coamings resembling this structure are depicted in W. H. Curtis *The Elements of Wood Ship Construction* (1919:131, 152, 199, 201)(Figure 4.45). There is evidence to support this speculation and problems with this possibility, as well. In addition to the similarity to the structures depicted in Curtis, mortises cut into the top, inside edge of PB-014 and the shorter length of

PB-011 support the possibility of the structure being a hatch coaming. Hatch coamings contained a number of removable beams that criss-crossed the opening of the coaming. These beams, the transverse ones called strongbacks and the longitudinal ones called, simply, fore-and-aft beams, supported the hatch cover. These supports were necessary because the hatch cover had to support a great weight of deck cargo, particularly on lumber schooners where much of the cargo was carried on deck. These beams were supported on their ends by mortises cut into the coaming. One problem with this identification is that the hatch coaming would be securely fastened to the hatch framing with closely spaced, large, iron through-bolts (Curtis 1919:133). PB-011 has only five ½-in. diameter vertical fasteners along its entire 11-ft. length. It is possible, however, that either the lowest or the lower two layers were securely fastened to the hatch framing, and then the top layer fastened to them, thereby hiding the large through-bolts.

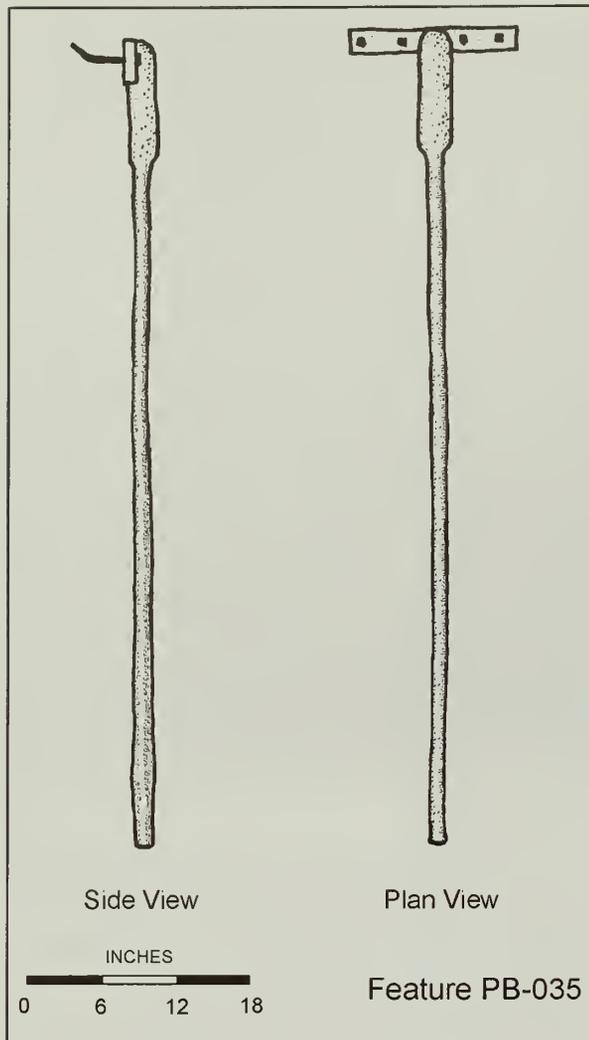
**Figure 4.46.** Unidentified object (feature PB-035). Drawing by Matt Russell.

As mentioned earlier, a single, unidentified iron piece, feature PB-035, was recorded above the high-tide line at Northwest Cove (Figure 4.46). This feature is a 4 ft. 8 in. long, 1¾-in. square iron bar, which ends in a 2-in. diameter, 10-in. long round portion. Connected to the bottom of the round end is a 1 ft. 3 in. x 3½-in.

rectangular piece, so that the whole object forms a “T.” This rectangular piece has four ½-in. square spikes through it. This object has not been identified.

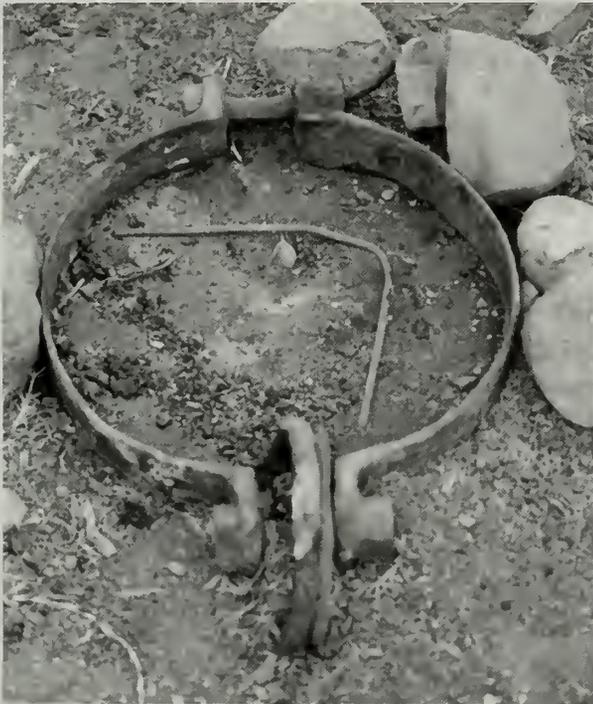
**Figure 4.47.** Iron mast-band used as a fire ring at Cluster Point. This object has since disappeared. NPS photo by Don Morris.

just south of Cluster Point. At that time it was being used as a fire ring, and it has since disappeared (Figure 4.47).

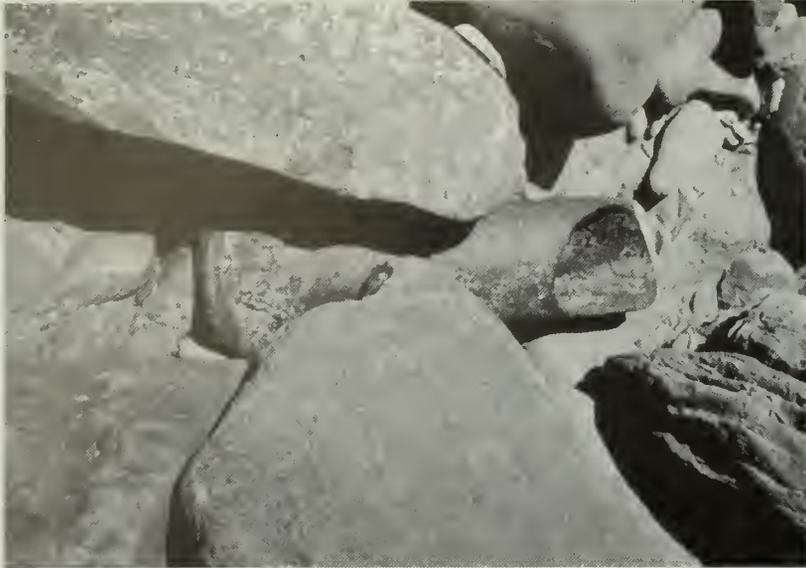
**Figure 4.48.** Hawse pipe located near Cluster Point. NPS photo by Don Morris.

The second feature reported by Morris is an iron hawse pipe measuring 3 ft. 5 in. long, with an external diameter of 9½ in. Originally located in the rocks to the south of Cluster Point, it could not be relocated during the present study (Figure 4.48). According to the tables found in Desmond (1919[1984]), a vessel of 300 tons (*Dora Bluhm* registered 330 gross and 315 net tons) required a hawse pipe measuring 11½ in. in diameter. This hawse pipe appears to be more appropriate for a vessel of approximately 150 tons (Desmond 1919[1984]:157), but this does not discount association with *Dora Bluhm*. It has already been demonstrated that dimensions were sometimes altered from published rules, as long as overall strength was not compromised.
