# Beached Shipwreck Archeology: Case Studies from Channel Islands National Park

Submerged Resources Center  
Professional Reports  
Number 18

Submerged Resources Center  
Intermountain Region  
National Park Service

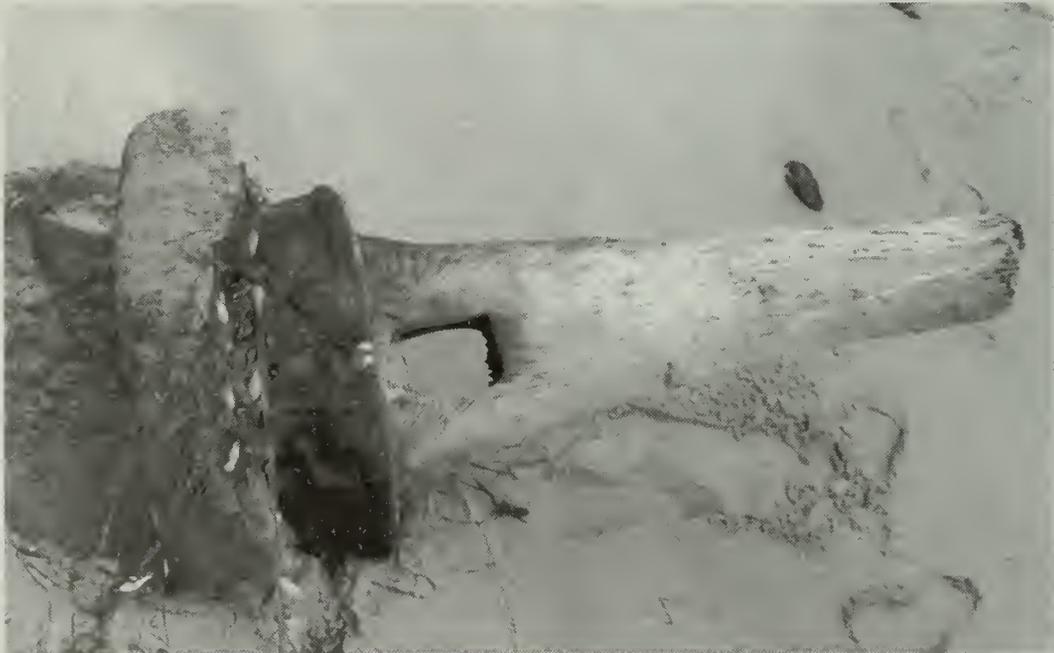
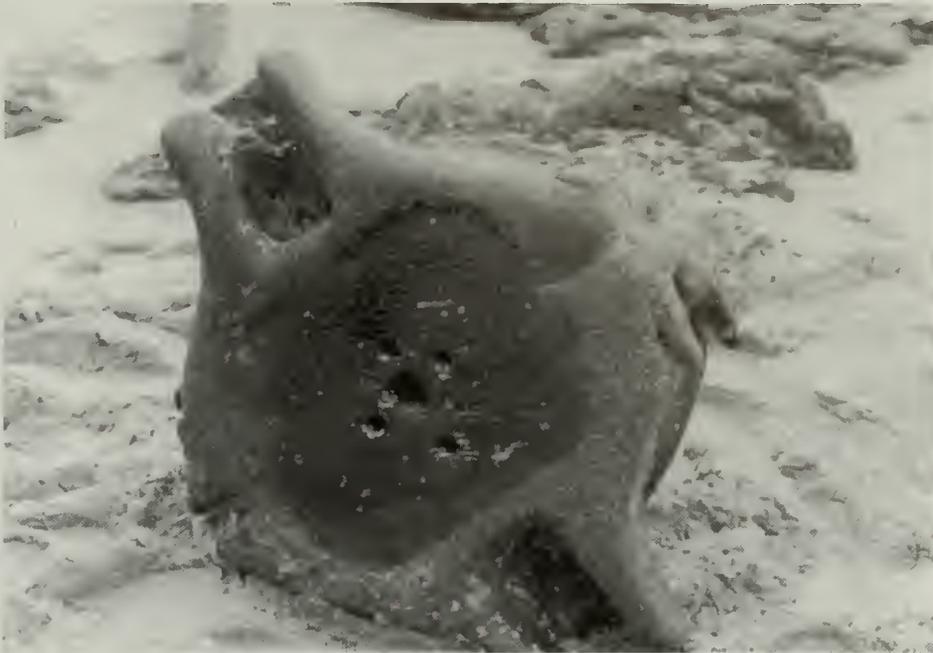
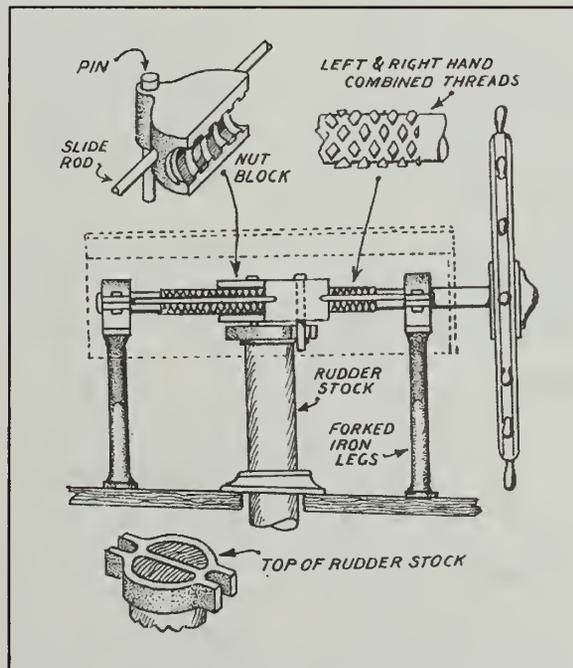
**Figure 4.49.** Portion of a rudder stock with the iron yoke that attached it to diamond-cut screw steering gear. NPS photo by Don Morris.

**Figure 4.50.** End view of the yoke attached to the end of a rudder stock. NPS photo by Don Morris.

**Figure 4.51.** Top of rudder stock depicted with yoke that attached it to a steering gear (from Campbell 1974:127).

The third feature has been identified as the top of a rudder stock, which bears the yoke that attached it to a diamond-cut-screw steering gear (Don Morris, personal communication 1993; Figures 4.49–4.51). It consists of a worn wooden piece 12 in. in diameter clamped into an iron yoke, which is 10 in. wide. The iron yoke is composed of halves, connected by two iron fasteners on each side. Although there is no size comparison available, there are two pieces of evidence that support a *Dora Bluhm* association. First, the original contract for this schooner states that it was equipped with a diamond-cut-screw steering gear (JPSL 1883). Second, although not sampled for species identification, field observations by Morris indicate that the wooden portion of the feature, the top of the rudder stock, was hardwood, possibly oak. These two clues make this feature's association with *Dora Bluhm* likely. Unfortunately, this feature disappeared from the beach shortly after Morris recorded it in October 1988.

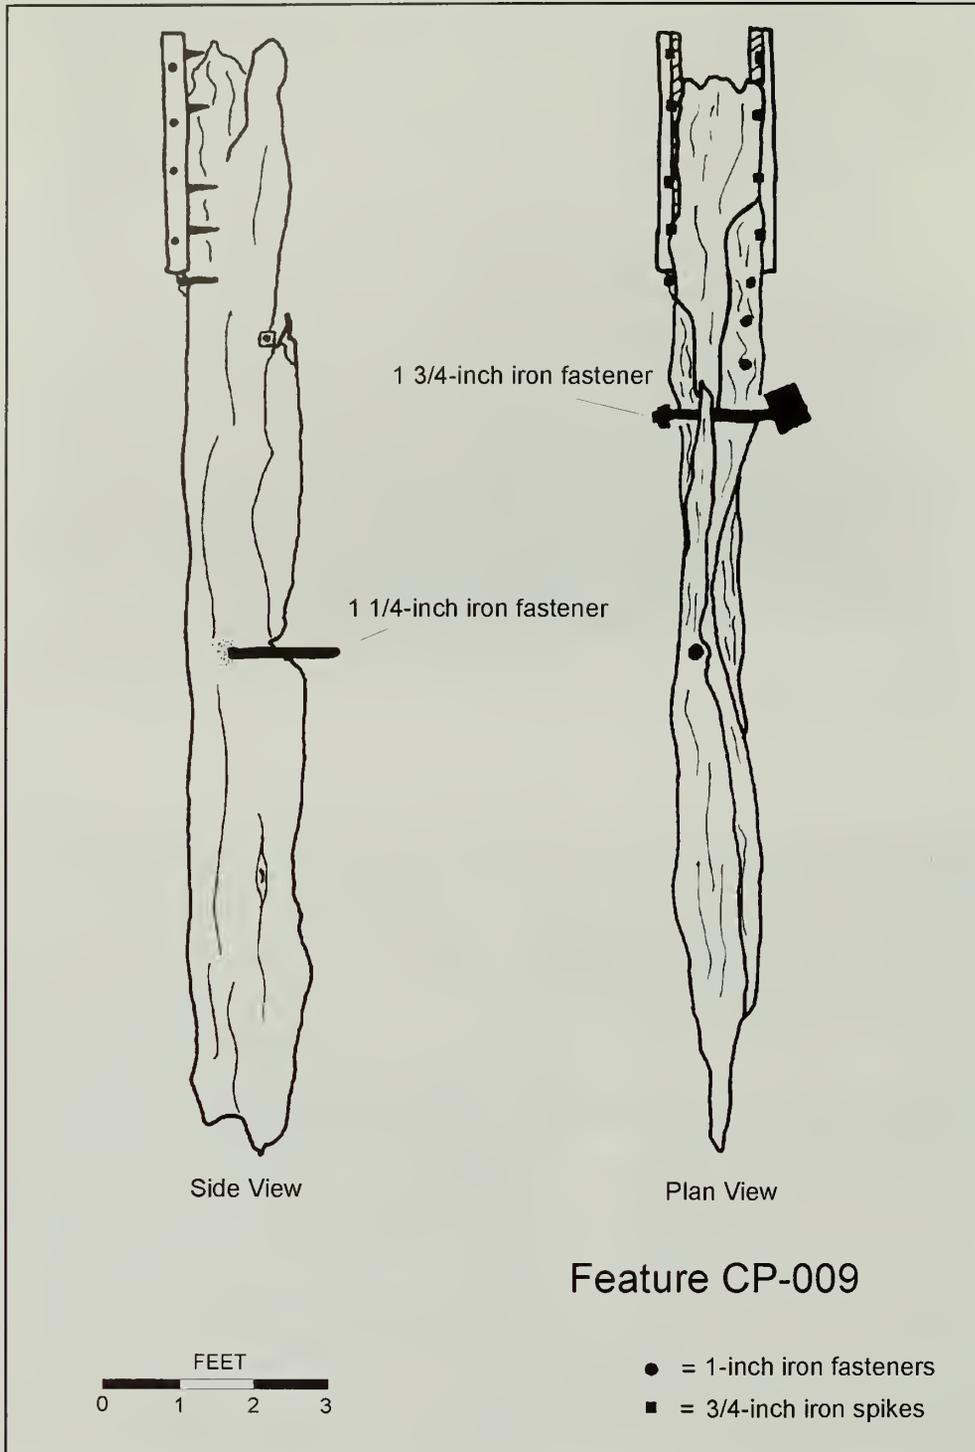
**Figure 4.52.** Feature CP-009, likely not part of *Dora Bluhm*. Drawing by Matt Russell.

The remaining discussion focuses on features recorded during 1993 fieldwork. All 22 elements and fragments analyzed and sampled were Douglas fir, so none could be discounted immediately, as with the Northwest Cove site (Puseman 1994:6–7). One timber, however, feature CP-009 (Figure 4.52), has a wooden component identified as a member of the Fabaceae family, probably ironwood (Puseman 1994:6–7). This is not a wood usually used in ship construction. The ironwood pieces are two narrow planks 3 ft. 2 in. long, 3½ in. wide and 3½ in. thick, which are fastened to either side of a large, extremely deteriorated Douglas fir timber measuring 14 ft. 8 in. x 17 in. x 16 in. As found, the ironwood planks are fastened along the timber's bottom edge, on the western end.

Four horizontal spikes, driven from the outside face and four vertical spikes, driven from the bottom, fasten each piece. Each iron spike is countersunk into the ironwood, and plugged with an ironwood plug. The main Douglas fir timber contains four vertical 1-in. diameter drift pins grouped near the ironwood planks; one 7/8-in. square spike; one 1¼-in. diameter vertical drift pin; and one horizontal 1¾-in. diameter bolt with a 1¾-in. square nut on one end, and a 6-in. square spacer on the other. The latter fastener's function is unknown, but it is not consistent with common late-nineteenth-century ship construction. This fastener arrangement, coupled with the relatively few fasteners in a timber this size and the unusual ironwood pieces, make this fragment's association with *Dora Bluhm* unlikely.

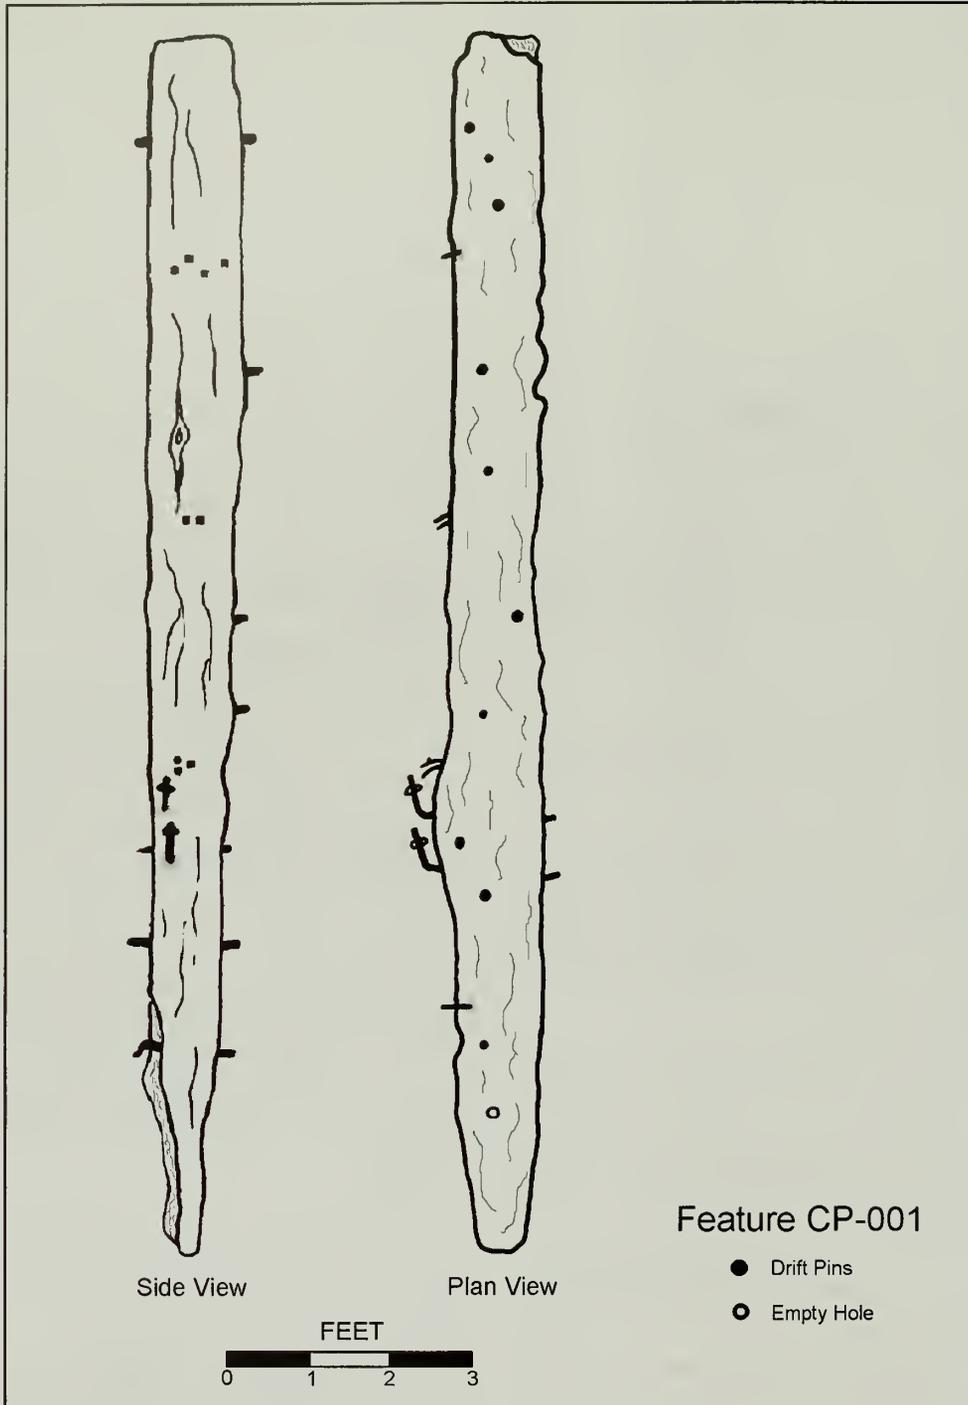
**Figure 4.53.** Keelson element with iron fasteners (feature CP-001). Drawing by Matt Russell.

Of the nine structural members, features CP-001, 010 and 012 are all similar Douglas fir elements with large, iron fasteners (Figures 4.53–4.55). The first (CP-001), heavily abraded and worn, is 14 ft. 10 in. long, with maximum dimensions of about 15 in. x 13 in. Both ends of the element are broken; original length is indeterminate. There are ten vertical, iron drift pins along its length, and there is an empty hole for an eleventh. Six drift pins are 1¼ in. in diameter (though slightly expanded by

corrosion), four measure 1 in. diameter, and the empty hole is 1 1/8 in. diameter. These fasteners are grouped roughly in pairs (including the empty hole): the paired pins are approximately 1 ft. apart, and the pairs are about 2 ft. apart. One pair has an additional 1-in. diameter drift between them. These vertical fasteners are broken close to the timber on both sides. In addition to the vertical fasteners, there are several transverse drift pins and spikes including four ½-in. square spikes and two ¾-in. diameter drift pins with 2-in. diameter (possible) clinch rings on one end. The two drifts are paired and 9 in. apart. The drifts protrude from the timber 7 in. on the ends with the clinch rings. There is no other evidence of fasteners on the timber's side faces.

The original contract for *Dora Bluhm* aids interpretation of these timbers. The contract specifies the main keelson was to be sided 16 in. and moulded 16 in., while the sister keelson was to be sided 12 in. and moulded 18 in. (JPSL 1883). If features CP-001, 010 and 012 are keelson elements, then, based on sided and moulded dimensions, CP-010 could be either part of the main or sister keelson, while CP-001 and 012 could only be part of the main keelson (taking into account some deterioration). Assistant and rider keelsons are not mentioned in the contract.

In addition to specifying timber dimensions, the contract required the keelson to be fastened with 1 1/8-in. iron fasteners. In all likelihood, all 1¼-in. measurements for the fasteners in CP-001, 010 and 012 are greater than the original measurement because of expansion caused by iron deterioration. This observation is supported by the single 1 1/8-in. diameter hole found on CP-001, which is assumed to be unaltered. Therefore, it is likely that the 1¼-in. diameter fasteners recorded on all three timbers were originally 1 1/8-in. iron fasteners. This does not,

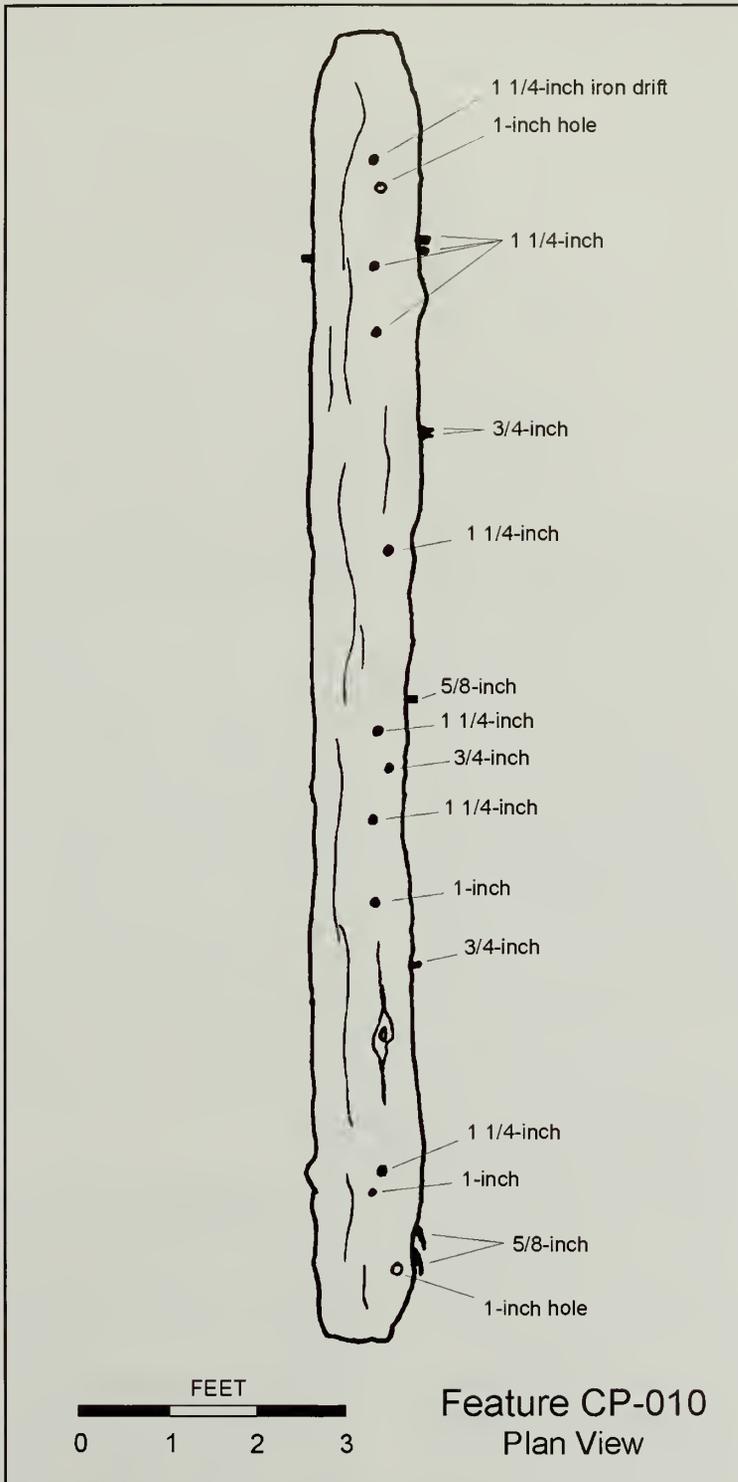
**Figure 4.54.** Keelson element with iron fasteners (feature CP-010). Drawing by Matt Russell

Feature CP-010 is 14 ft. 9 in. long (broken at both ends), with maximum dimensions of 15 in. x 11 in., though somewhat deteriorated, and contains ten vertical iron drift pins along its length, and holes for two more. These fasteners (and holes) include seven 1¼-in. diameter pins, four 1-in. diameter pins, and a single ¾-in. diameter pin. The element also contains transverse fasteners: a pair of 1¼-in. diameter drift pins; a pair of ¾-in. diameter drifts; a single 5/8-in. diameter drift; another, single ¾-in. diameter drift; and a pair of 5/8-in. diameter drifts. There is no discernible pattern to fastener spacing.

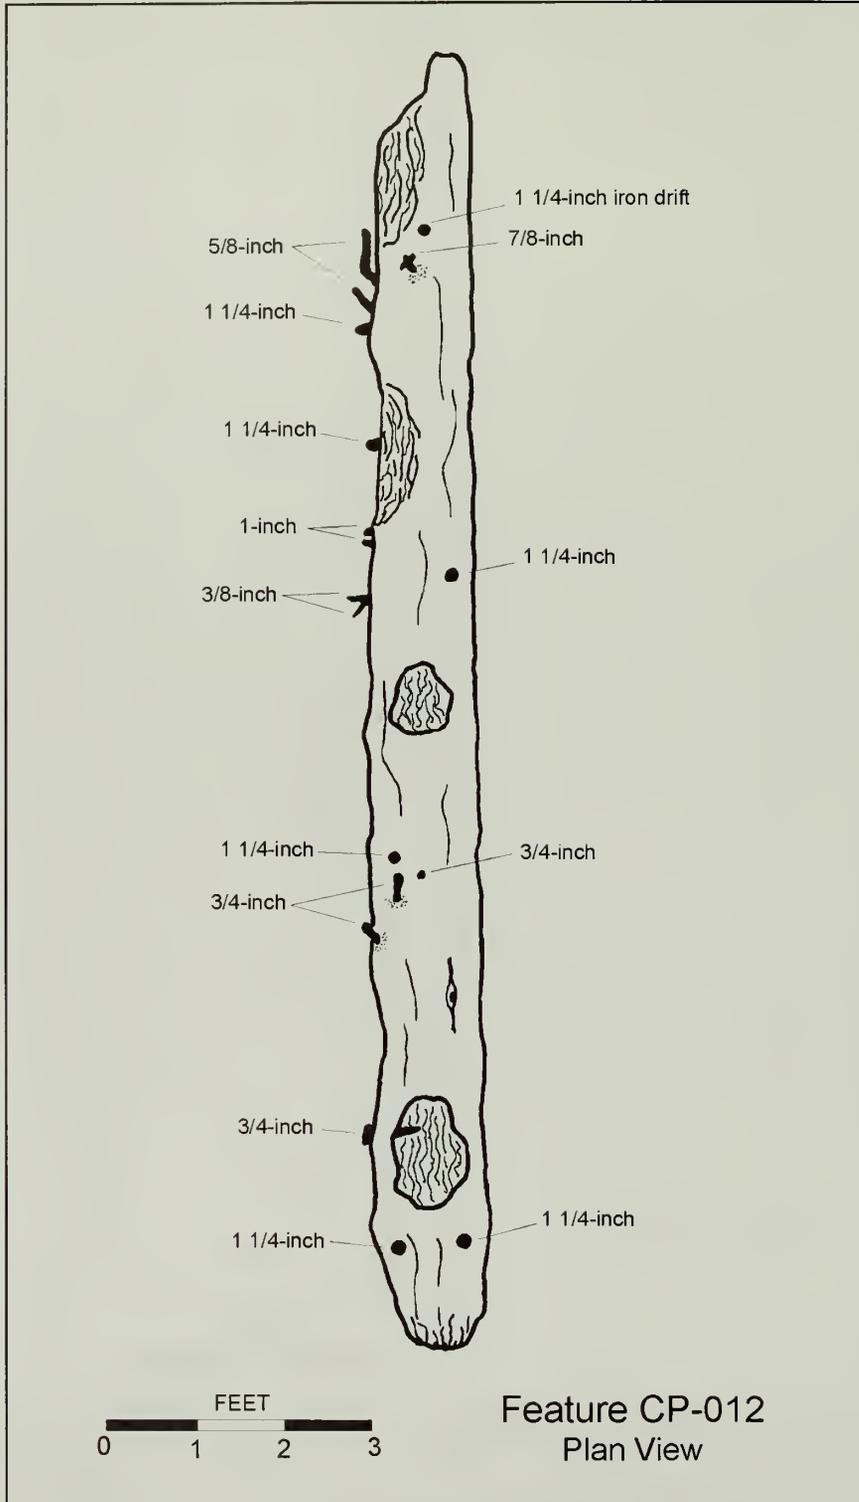
**Figure 4.55.** Keelson element with iron fasteners (feature CP-012). Drawing by Matt Russell.

Feature CP-012 is a similar element, measuring 14 ft. 3 in. long (broken at both ends), with maximum dimensions of 14 in. x 13 in., again with some deterioration. The most conspicuous features of this element, besides the fasteners, are two large holes penetrating all the way through the timber, apparently caused by some kind of differential deterioration. There are no large fasteners in or around these holes, so it is unknown if the deterioration was centered on iron drift pins, as seen in feature PB-001. Like the two previous features, CP-012 has

several vertical, as well as transverse, iron fasteners. The vertical fasteners include five 1¼-in. diameter drift pins, three ¾-in. diameter drifts, and a single 7/8-in. diameter bolt with a 1-in. square nut on the end. The transverse fasteners consist of two 5/8-in. diameter round drifts, two 1¼-in. diameter drifts, two 1-in. diameter drifts, two 3/8-in. diameter round spikes, and a single ¾-in. diameter round drift.

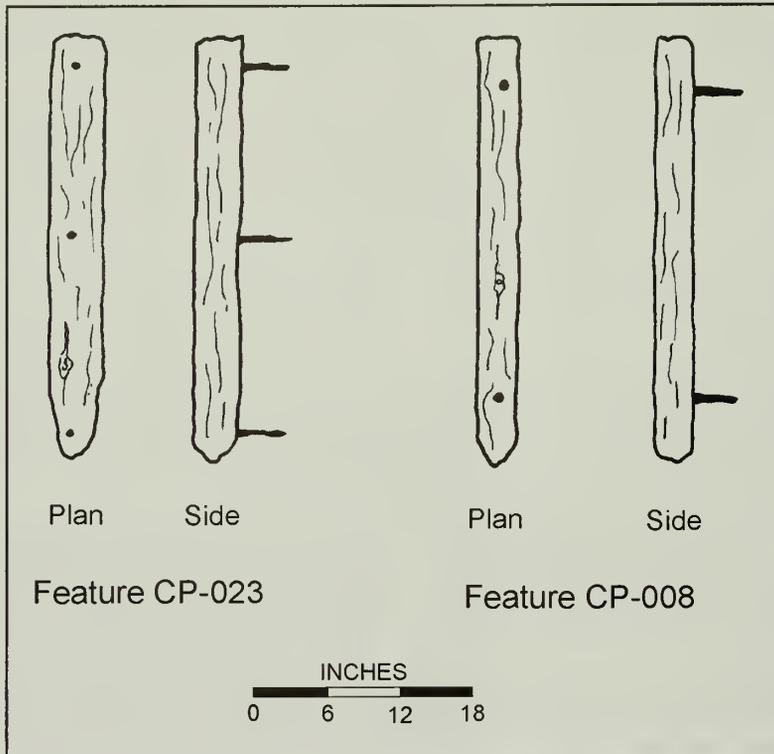
**Figure 4.56.** Deck planking elements with iron fasteners. Drawing by Matt Russell.

Two features that may represent small portions of structural members are features CP-008 and CP-023 (Figure 4.56). Both features are 3 ft. long and nearly square in cross-section. Feature CP-008 is 3½ in. wide and 3¼ in. thick; all its faces are extremely worn. It contains two round spikes 2 ft. 2½ in. apart. One is ¾ in. diameter and the other is 7/8 in. diameter, though both are exfoliating badly. Feature CP-023 is slightly more than 4 in. wide and 3 7/8 in. thick; all its faces are also very worn. It contains three iron spikes, all ½ in. diameter. The first and second spikes are spaced 1 ft. 2 in. apart, and the second and third are 1 ft. 5 in. apart.

*Dora Bluhm's* contract calls for 4-in. x 4-in. main-deck planking (JPSL 1883). With deterioration taken into account, either element could be a piece of main-deck planking. Fastener spacing cannot be used as an indicator for identification of these features because it is possible that spikes were fastened into carlins or lodging knees and not only into deck beams. The fasteners may have been countersunk and plugged, which is typical practice for main-deck planks; the plugs have since disappeared and the face deteriorated enough to hide traces of countersinking. It is probable that features CP-008 and CP-023 represent portions of the main-deck planking of *Dora Bluhm*.

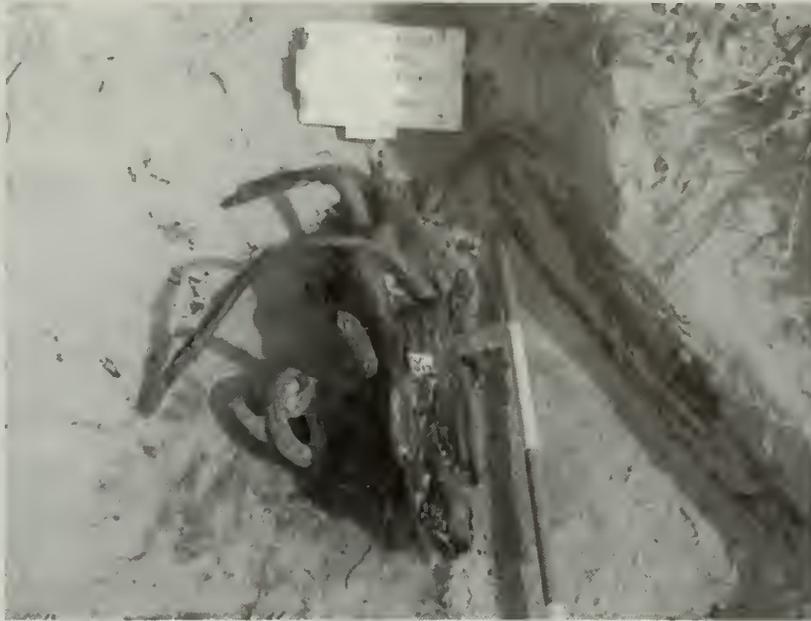
**Figure 4.57.** Unidentified element with large iron fasteners. NPS photo by Matt Russell.

Feature CP-017 is also a structural member from a large, wooden sailing vessel (Figure 4.57). The extremely deteriorated wood element is 3 ft. 4 in. long, 7 in. wide and 10 in. thick. It contains, however, five 1½-in. diameter iron drift pins (the longest 3 ft. long), and a 2-in. diameter iron eye-bolt with a 6½-in. outside diameter ring attached. The eye-bolt and ring represents a tie-down point, which could have been placed in many locations on the vessel. The five fastener's original measurements were considerably smaller, accounting for expansion caused by iron corrosion. The largest fasteners required in the *Dora Bluhm* contract were 1 1/8-in. drifts for the keel, keelson, stempost and sternpost. Feature CP-017 likely represents a small portion of any of these components.

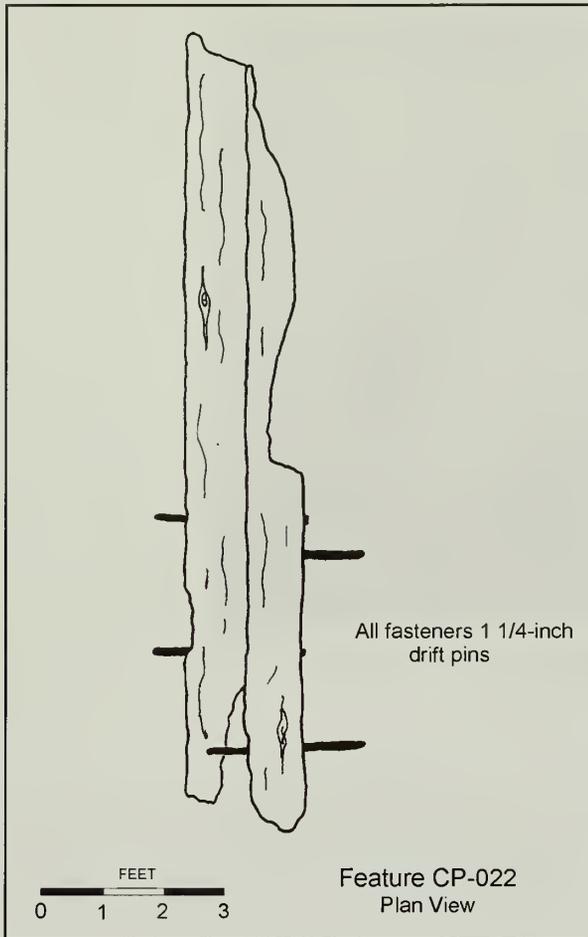
**Figure 4.58.** Fragment of the centerboard trunk (feature CP-022). Drawing by Matt Russell.

Another probable structural member of *Dora Bluhm* is CP-022 (Figure 4.58). This

fragment is composed of two timbers, each with an original width of 12 in. and surviving lengths of 12 ft. 10 in. The timbers are edge-bolted together with four 1¼-in. diameter drift bolts. The four fasteners originally edge-bolted at least two more timbers to the two surviving pieces, one on each side. The timbers have a present thickness of 5 in., but the undersides are extremely deteriorated, so they were originally thicker. The fasteners are slightly expanded, so they were probably originally 1 or 1 1/8 in. diameter.

to every frame. Another possibility, since *Dora Bluhm* was built with a centerboard, is that feature CP-022 is a portion of the centercase. The vessel's contract specifies the centercase was to be constructed of 8-in. thick timber and fastened with 1-in. iron (JPSL 1883). With the severe deterioration on the underside of this feature, these timbers may have originally been 8 in. thick. The fasteners also may have originally been 1 in. diameter. Furthermore, the centercase would have been entirely edge-fastened, which CP-022 clearly displays (Barkhausen 1990:11–12). This feature can be distinguished from the centerboard itself, which would have been more heavily fastened. Therefore, feature CP-022 is most likely a portion of the centercase, or centerboard trunk, of *Dora Bluhm*.

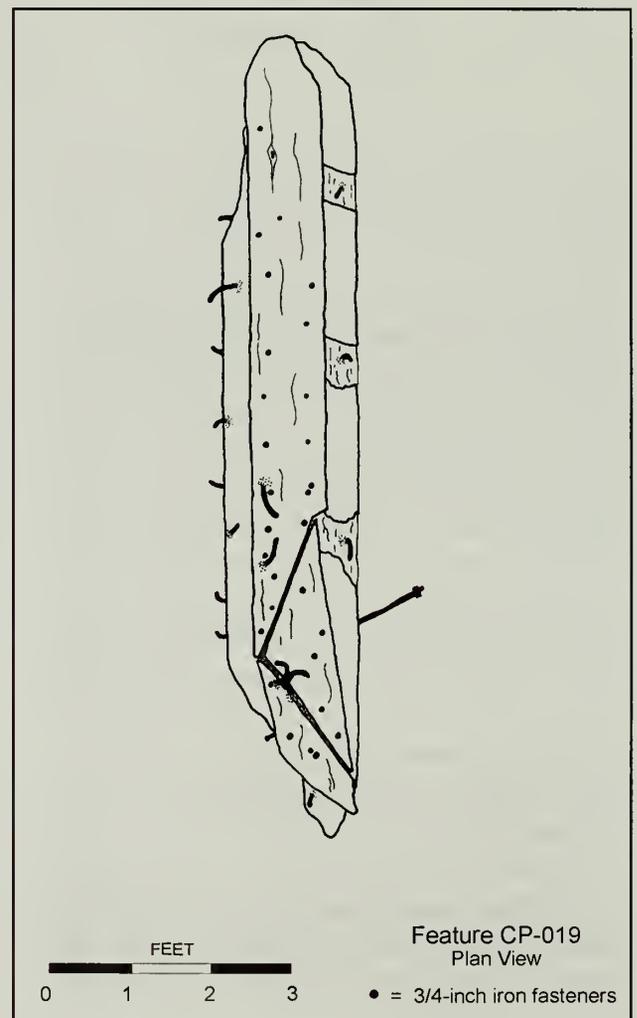
**Figure 4.59.** Feature CP-019. Drawing by Matt Russell.

Feature CP-019 is an oddly shaped fragment that exhibits characteristics that are clearly from a large, wooden vessel (Figure 4.59–4.60). The feature is sizable and contains 47 iron fasteners,

all of which are  $\frac{3}{4}$ -in. diameter round drifts. The fragment is composed of two pieces: a large, lower timber with three mortises along one edge, and a top portion made up of three different sections. These segments include a long element joined to a smaller element by a triangular chock. These three sections are fastened to the lower timber by 33 fasteners. The bottom part of the feature is 9 ft. long, 18 in. wide and 12 in. thick. The top timbers are  $10\frac{1}{2}$  in. wide and 3 in. thick. Like most of the other features, both ends are broken, so original length and configuration is unknown.

*Dora Bluhm's* contract does not go into sufficient detail to identify this feature based on the size of fasteners alone. This is clearly a unique piece, however, and could not have been incorporated into very many places on a sailing vessel. In addition, its size and number of fasteners denote a major structural function. The mortises suggest beams were fitted into the side of the timber, making that piece a deck shelf.

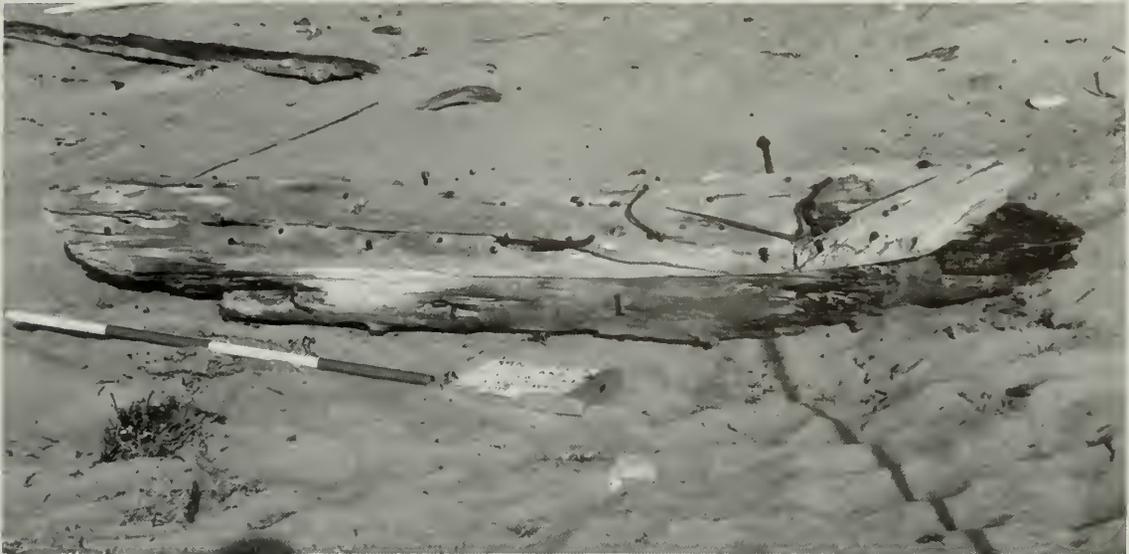
**Figure 4.60.** Feature CP-019. NPS photo by Matt Russell.

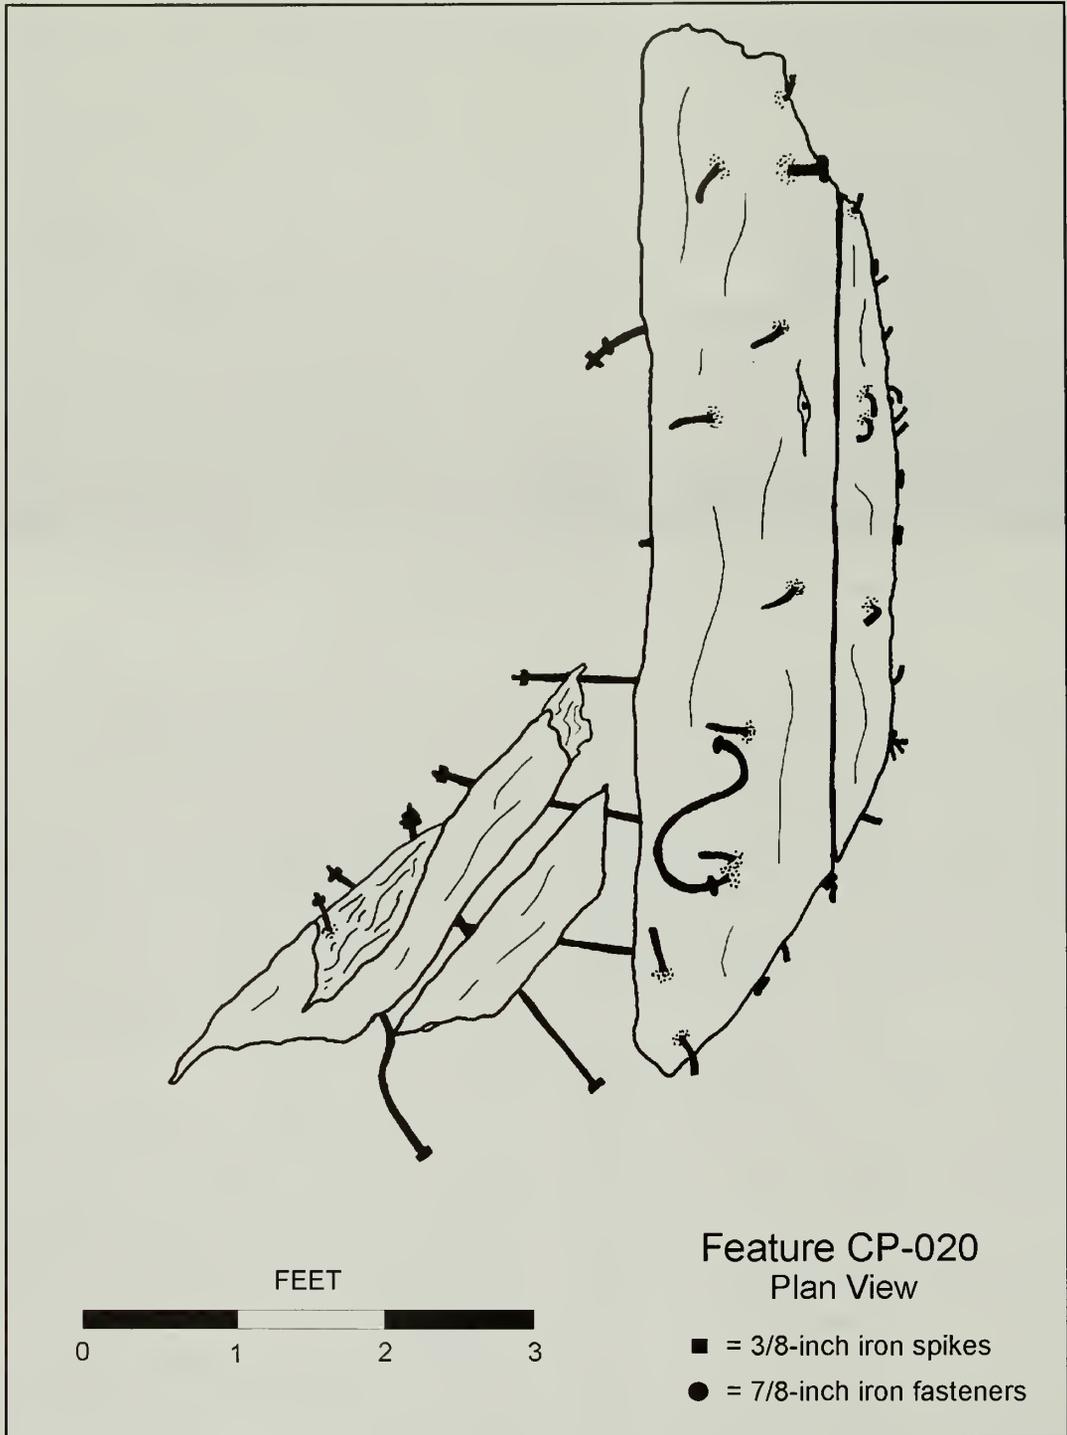
Figure 4.61. Feature CP-020. Drawing by Matt Russell.

The last structural member discussed is feature CP-020 (Figure 4.61–4.62). It is a relatively flat fragment with a uniform thickness of  $8\frac{1}{2}$  in. The main timber is 7 ft. 3 in. long (though broken at the ends) and 1 ft. 9 in. wide; a smaller 4-ft. x 1-ft. 4-in. fragment is fastened to it at an angle. The feature contains nineteen  $\frac{3}{8}$ -in. square spikes and seventeen  $\frac{7}{8}$ -in. diameter drifts. Timber and fastener configuration suggest this piece represents a portion of the “rim” of a large, wooden vessel, while the smaller fragment attached to it is a component known as the anchor stock (Curtis 1919: 66). The rim circled the stern of the vessel

and formed the knuckle line, or main-deck line. The rim was generally composed of three sections joined by two chocks called anchor stocks. The upper ends of the stern frames ended at the bottom of the rim, and the solid work was directly above it. It was a major stern structural element.

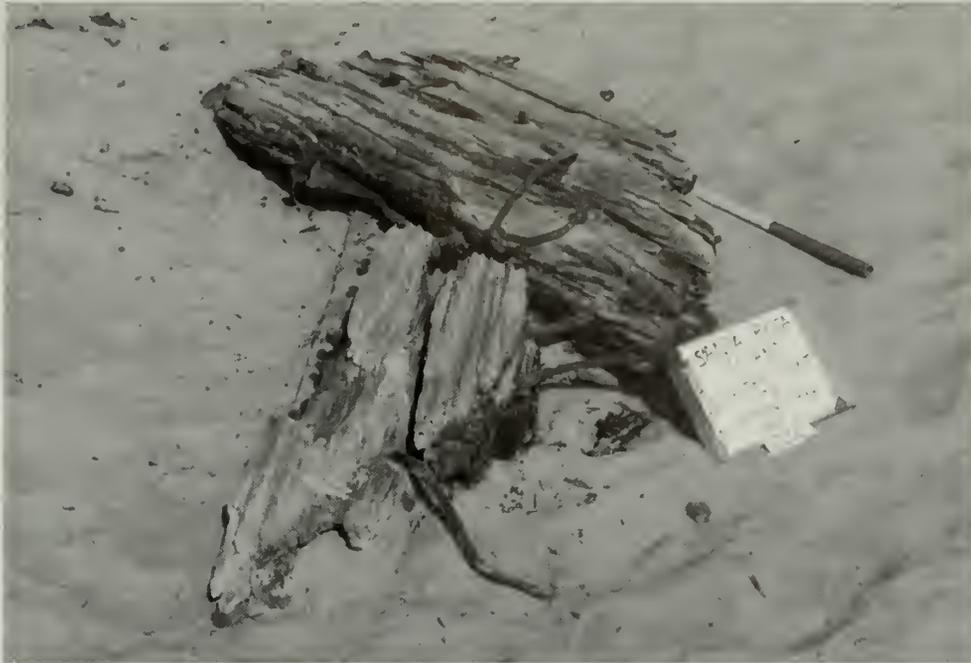
**Figure 4.62.** Feature CP-020. NPS photo by Matt Russell.

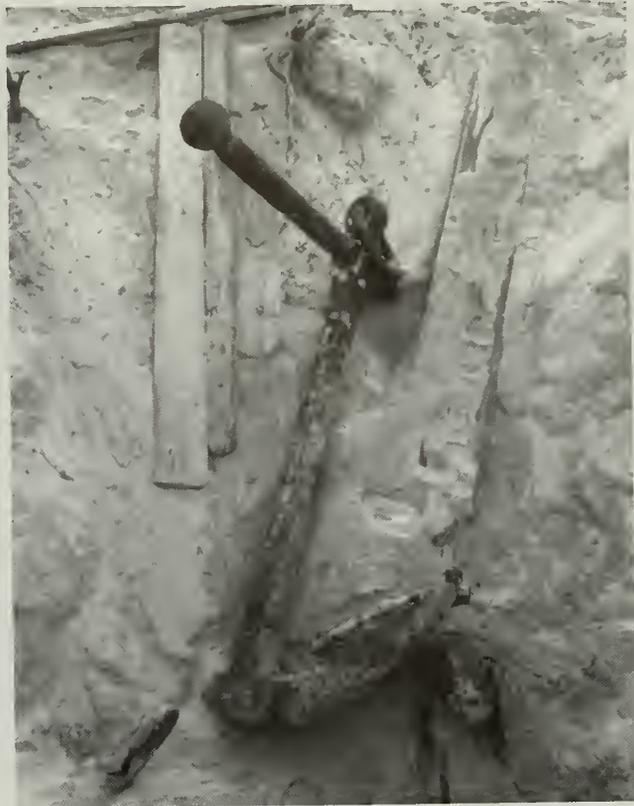
**Figure 4.63.** *Comet's* anchor after exposure in 1993. NPS photo by Matt Russell.

Although 1993 fieldwork exposed little of *Comet's* remains, it was possible to completely expose and record the anchor. *Comet's* anchor is iron with a collapsible iron stock (Figures 4.63–4.65). The anchor is fitted with a ring, but no cable is present. Overall length is 7 ft. 11 in.; stock length is 7 ft. 9½ in. Anchor arms are 3 ft. long, with 5 ft. 6 in. between palm tips. The palms measure 1 ft. 3¾ in. wide x 1 ft. 6 in. long, and 1¼ in. thick.

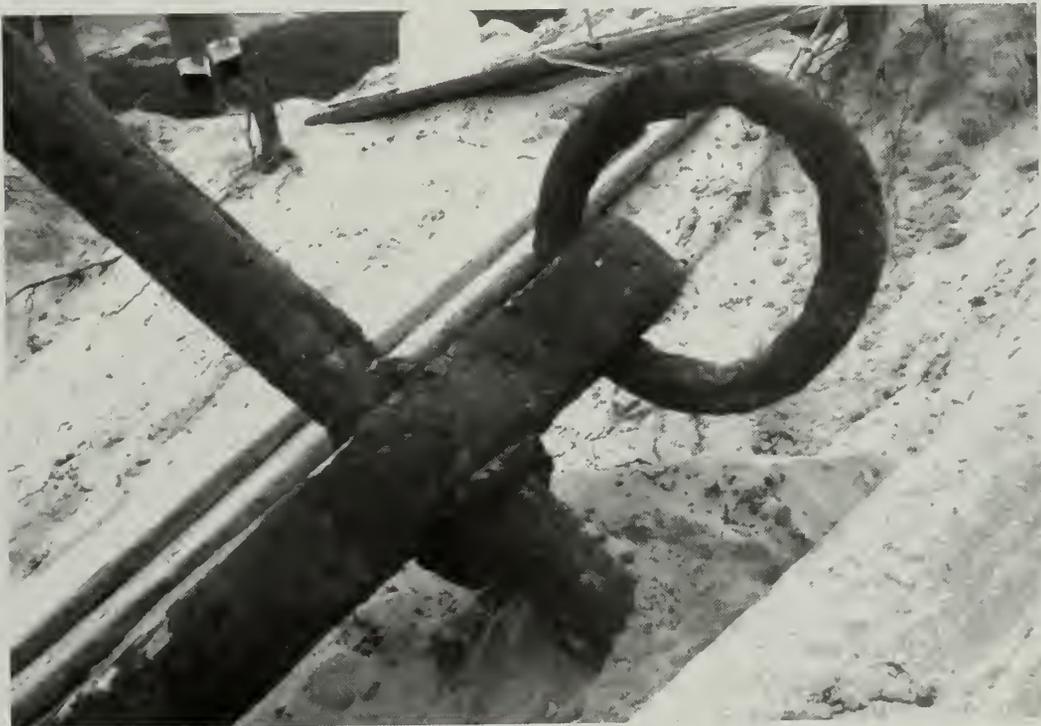
**Figure 4.64.** *Comet's* anchor ring. NPS photo by Matt Russell.

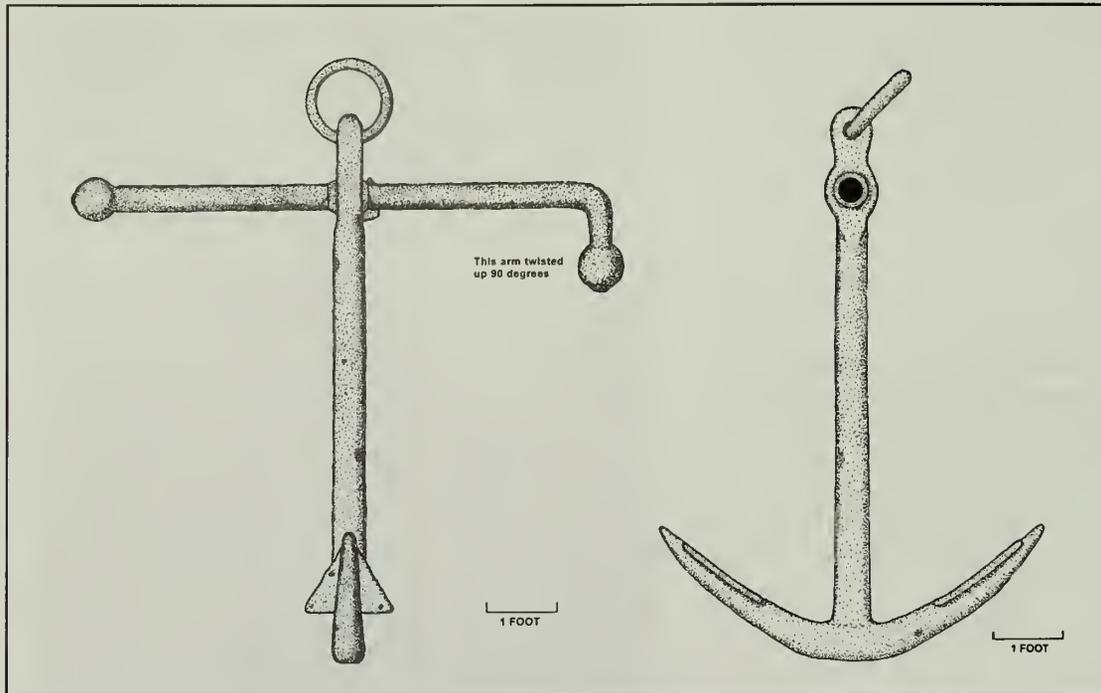
**Figure 4.65.** *Comet's* anchor. Drawing by Matt Russell.

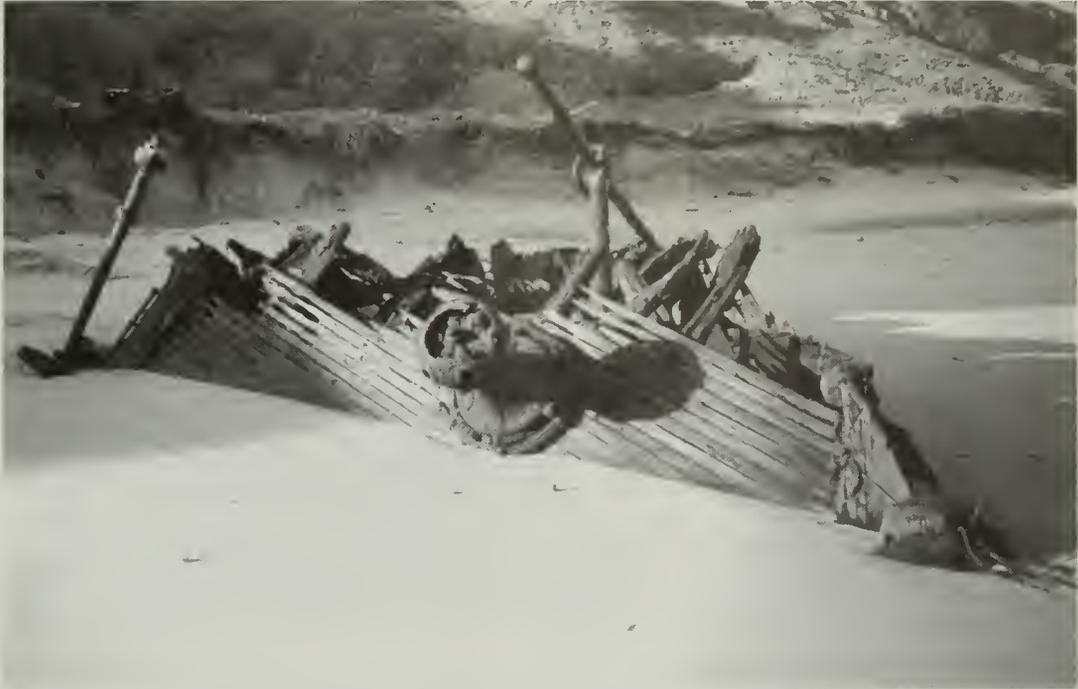
**Figure 4.66.** *Comet's* bow section looking down at forecastle deck. NPS photo by Matt Russell.

approximately 10 m x 8 m. The nearly intact bow section points out to sea on a heading of 317° magnetic, and the bow is heeled 55° to starboard and tilted down 20°. Much of the bow's port side has been worn away by natural deterioration (Figures 4.66–4.69).

The starboard side of the forecastle deck is intact from the bow to the deck's aft end above the windlass (Figure 4.80; also Figures 4.66 and 4.69). Forecastle deck remains are supported by five deck beams; the three forward-most beams are 5½ in. sided, and the two aft beams,

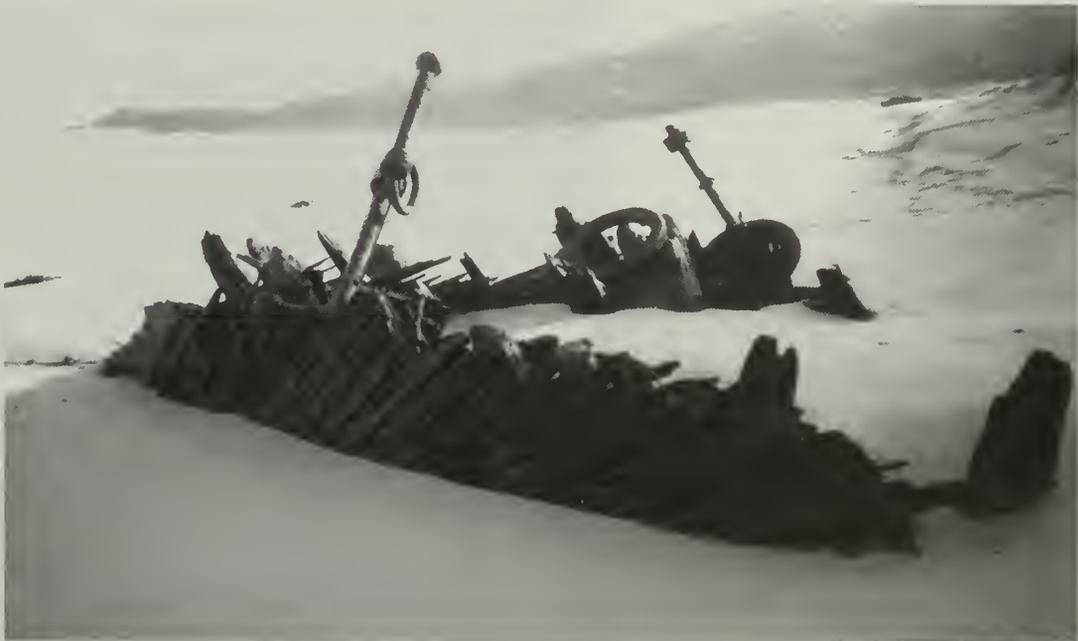
**Figure 4.67.** *Comet* site in April 1999, looking at the port side outer hull timbers. NPS photo by Matt Russell.

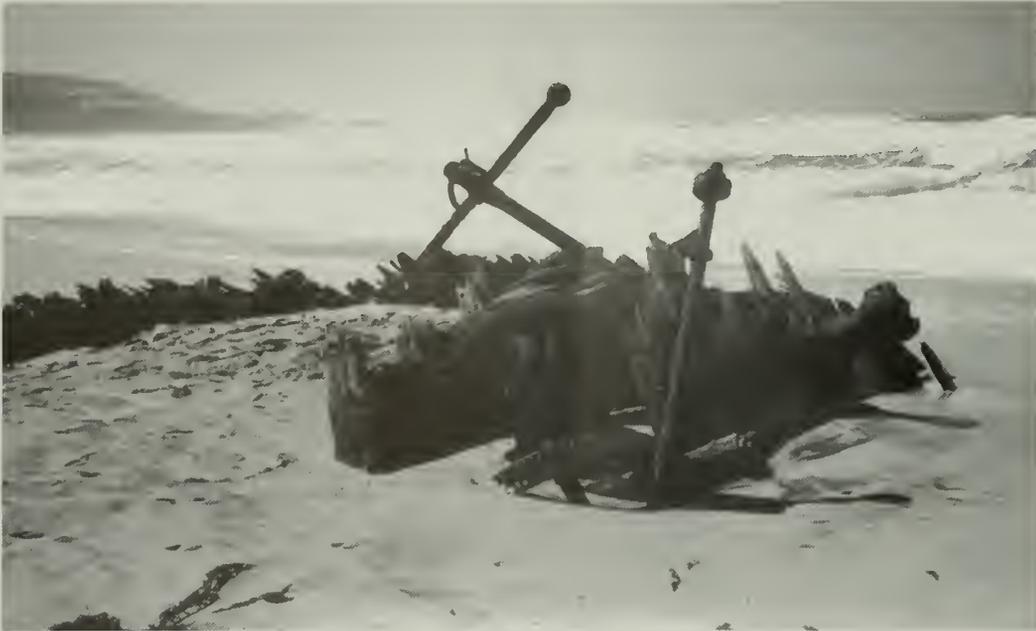
**Figure 4.68.** *Comet* site in 1999, looking towards the windlass (mounted on the main deck) in the center of the photo, with the capstan (mounted on the forecastle deck) to the right. NPS photo by Don Morris.

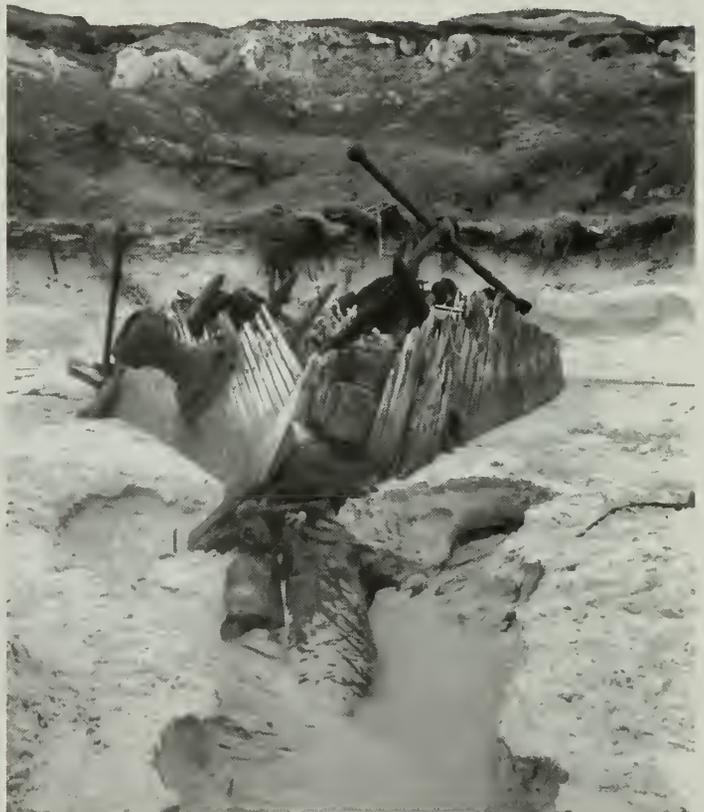
**Figure 4.69.** *Comet* site in April 1999, looking straight towards the bow, which is canted to the left in this photo. The forecastle deck is to the left, port side outer hull planking to the right and the bowsprit is in the bottom of the photo. NPS photo by Matt Russell.

As noted above, *Comet*’s bowsprit is intact and in its original position (Figures 4.69, 4.70 and 4.75–4.77). On a wooden sailing vessel, the bowsprit, a spar that projects forward from
