# Beached Shipwreck Archeology: Case Studies from Channel Islands National Park

Submerged Resources Center  
Professional Reports  
Number 18

Submerged Resources Center  
Intermountain Region  
National Park Service

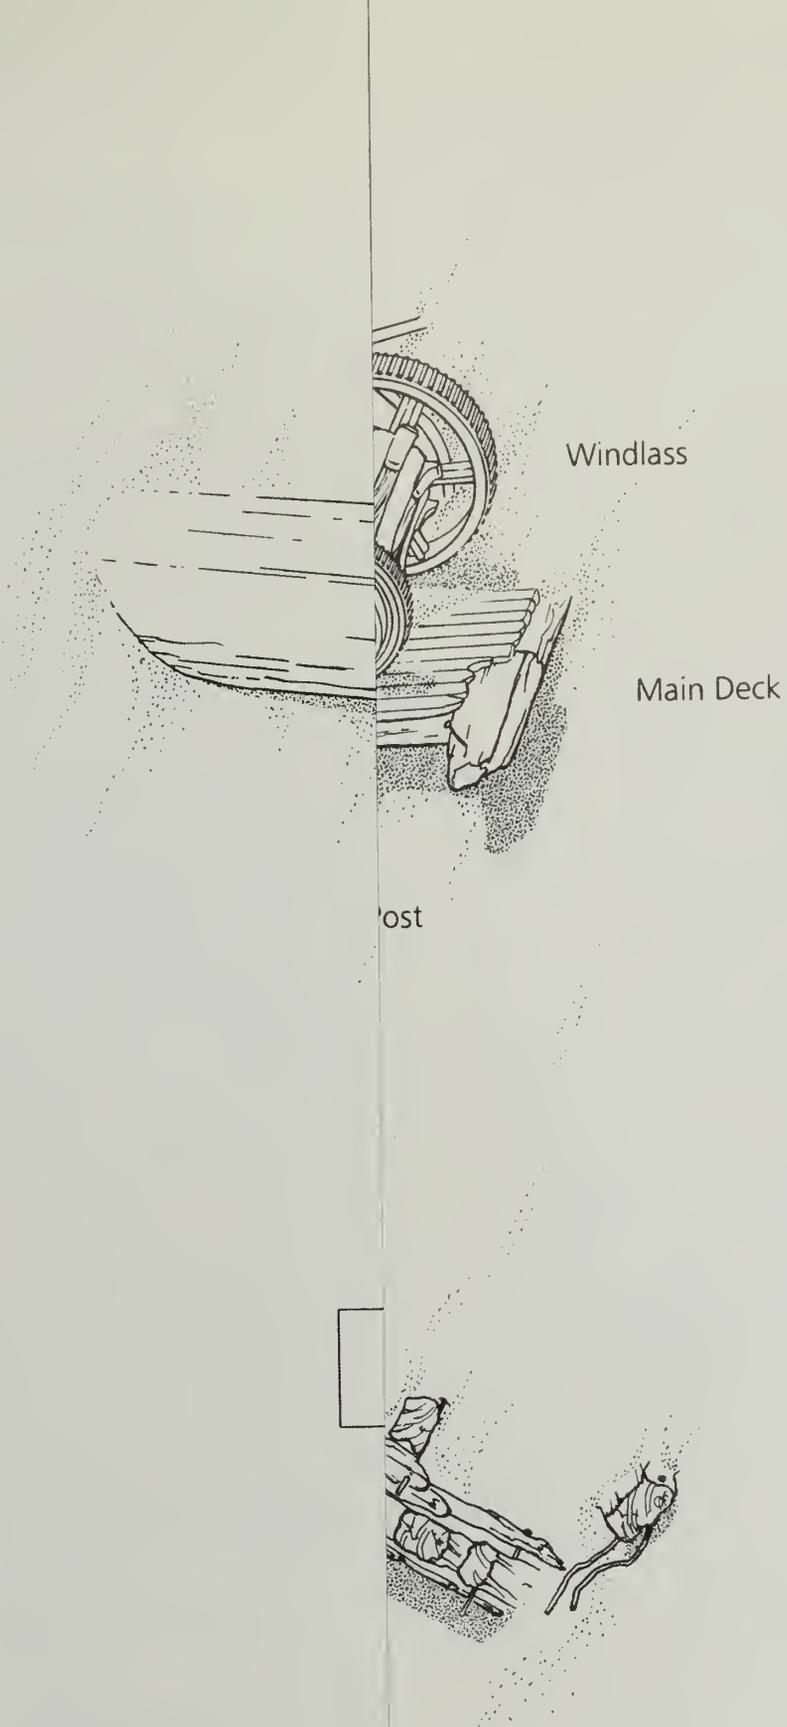
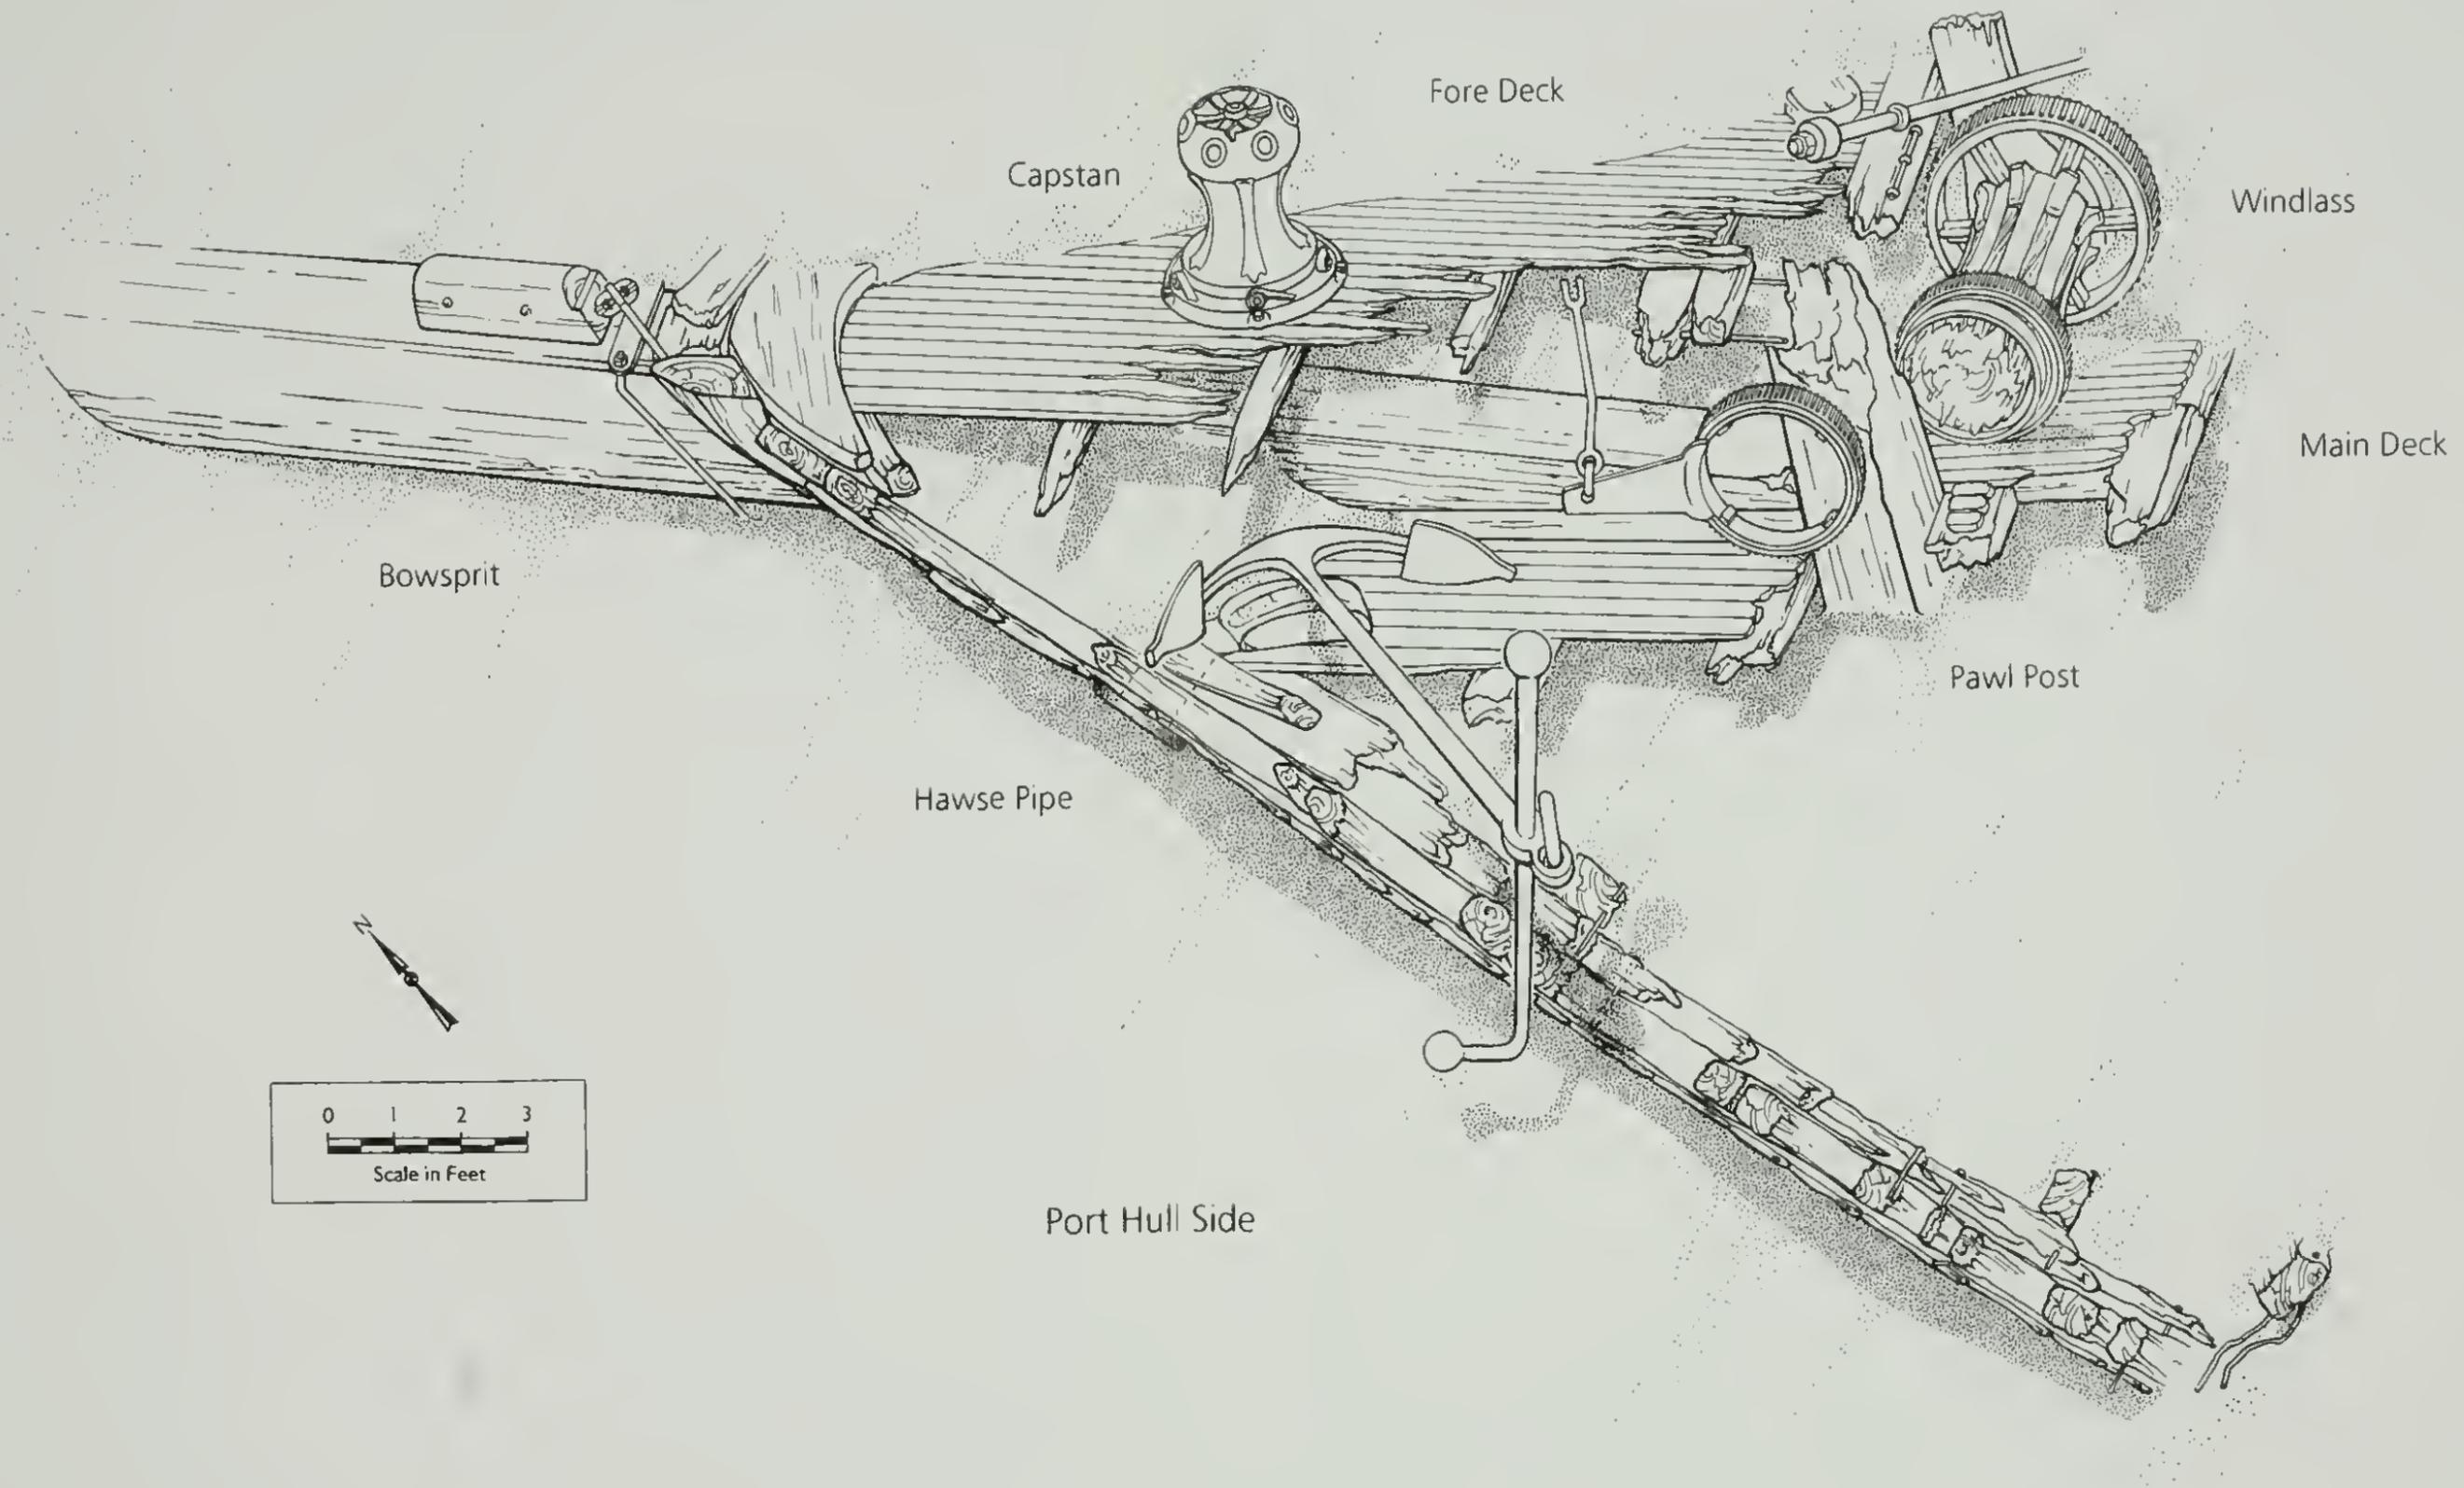
Figure 4.70. *Comet* site plan. Field drawing

Figure 4.70. Comet site plan. Field drawing by Matt Russell; final drawing by Robert Turner.

Nearly all *Comet's* original bow structure and related features are represented on the site (Figure 4.70). Exposed structural elements include port-bow framing and outer-hull planking; the partially intact forecastle deck and forecastle-deck beams; the partially intact main deck and main-deck beams below the forecastle deck; the pawl post (sometimes called a pawl bitt or Samson post) extending through the main deck and broken off at the forecastle-deck level; the bowsprit, extending from where it is stepped into the pawl post's forward face to about 19 ft. forward of the bow; the forecastle- and main-deck deck-hooks and waterway hooks; and several bow pointers. Other features present

The final structural members discussed are two timbers in the site's southwest corner, rising vertically out of the sand inside the ceiling planks (Figure 4.70). At the deepest exposure, about 2 ft. of these timbers were visible. The aft-most timber measures 1 ft. 2 in. x 9 in., and has two 7/8-in. diameter iron fasteners in it. The forward-most of these two timbers measures 11 in. x 7 in. These structural timbers are likely pointers, placed in the bow and stern angled down diagonally in their normal upright position (Figures 4.85 and 4.86). According to Curtis (1919:101), pointers are used to “. . . furnish additional stiffening to the hull at the locality where the pointer is placed, to aid in resisting panting movements and stresses, and . . . to add additional strength against torsional strains such as are experienced at the ends of a ship when rolling heavily at sea.” Pointers are fastened at a 45° angle atop the ceiling planks and into the cant frames, and they extend from the lower part of the hull upwards to the first, or in *Comet's* case, main deck (*Great Lakes Register*

As noted above, *Comet*’s bowsprit is intact and in its original position (Figures 4.69, 4.70 and 4.75–4.77). On a wooden sailing vessel, the bowsprit, a spar that projects forward from

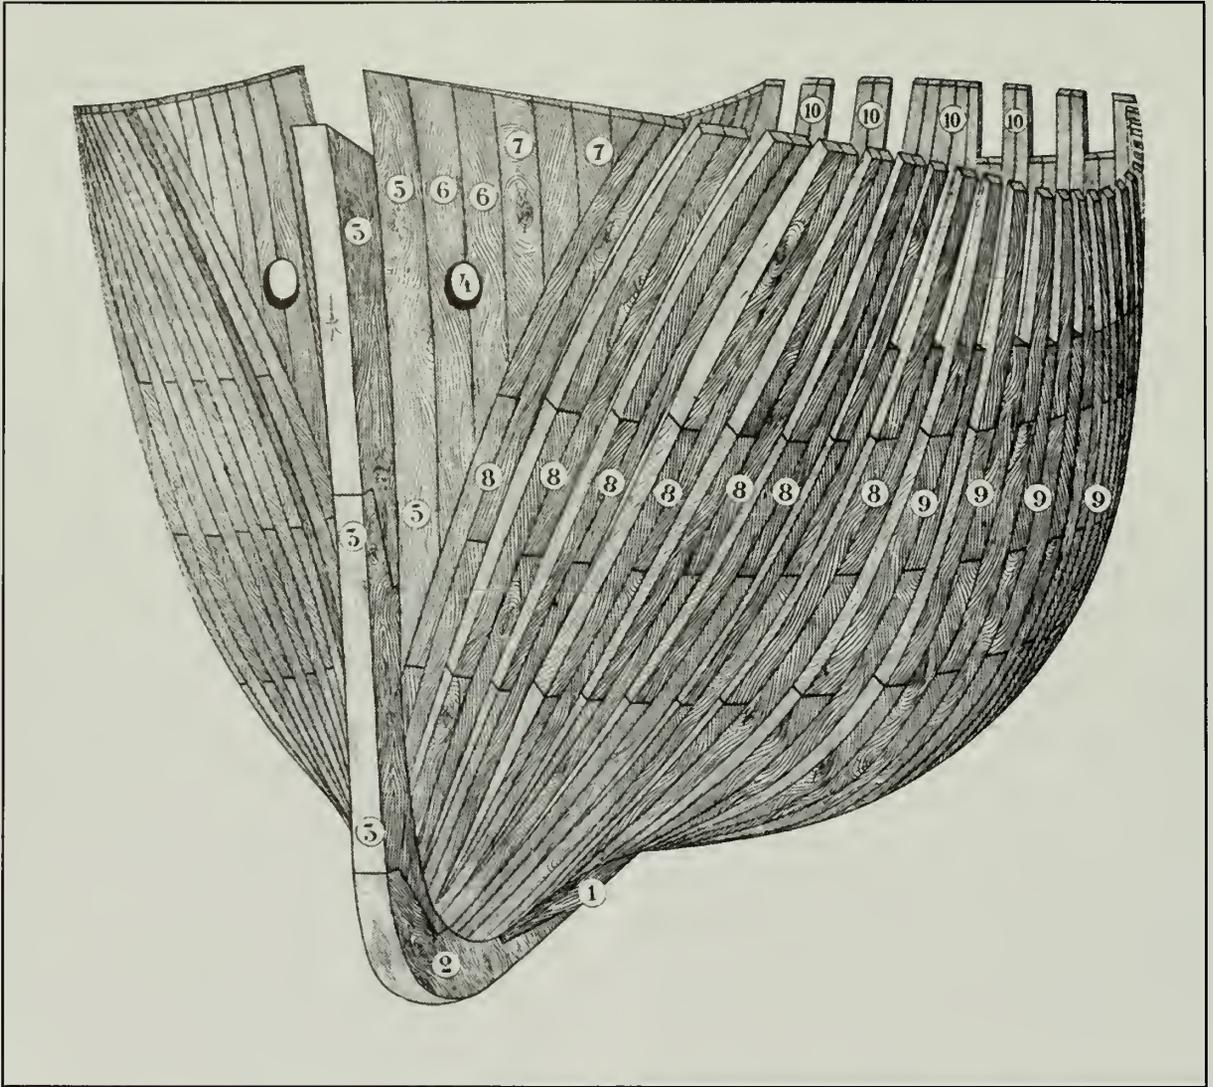
**Figure 4.71.** Bow framing, including sternpost (3), knighthead (5), hawse timbers (6) and cant frames (8) (from Paasch 1977:plate 5).

Bow framing in a wooden vessel of this period includes cant frames, hawse timbers, knightheads, and the stempost (Figures 4.71–4.73). Cant frames are frame pairs, made up of futtocks and top timbers (futtock heels are notched into the bow deadwood, so there are no floors) that are rotated forward of perpendicular to the keel to create the vessel's bow form. Forward of the cant frames are hawse timbers, which solidly fill the space between the cant frames and knightheads. A vessel's hawse pipes pass through the hawse timbers, which provide a solid foundation for fastening the hawse pipe flanges. The knightheads are timbers located on both sides of the stempost and extend above it to support the bowsprit, which rests atop the stempost and between the knighthead timbers (Desmond 1919[1984]:50, 55).

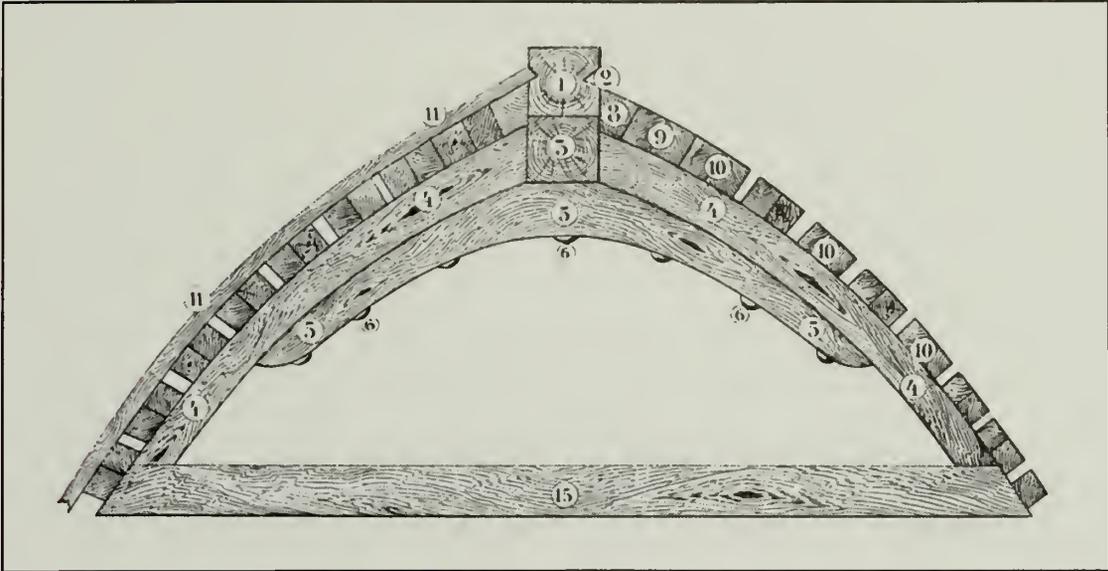
**Figure 4.72.** Bow framing, including stempost (1), knighthead (8), hawse timbers (9) and cant frames (10). Additional features observed on *Comet* include the deck hook (5), deck beams (15) and outer hull planking (11) (from Paasch 1997:plate 15).

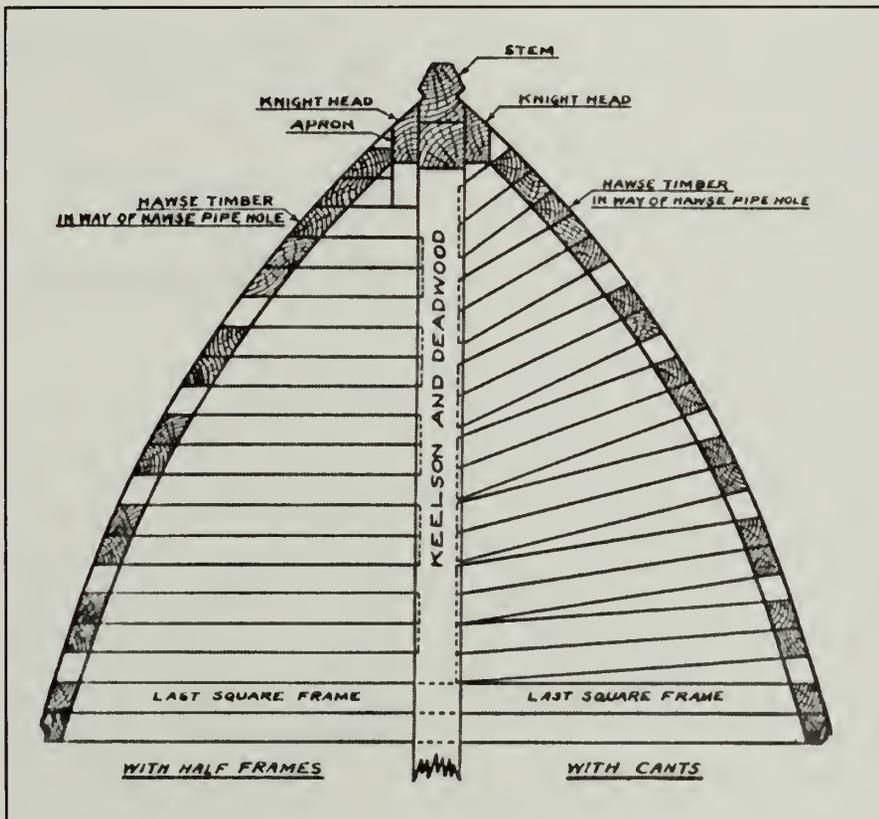
**Figure 4.73.** Bow framing, showing difference between cant frames and half frames (Curtis 1919:58).

Although it was difficult to verify because of limited access and complex angles involved, the five frame pairs are most likely all cant frames as opposed to half frames (Figure 4.74 and see Figure 4.73). At their greatest exposed dimension, each frame measured 9½ in. sided and 10 in. molded. Each frame's molded dimension at the top, approximate main-deck level, was 8 in. *Comet's* contract specifies frames as sided 10 in. and molded 13 in. at the keel and 6½ in. at the deck (JPSL 1886). *Rules for the Construction of Wooden Vessels* stipulates a 400-ton vessel built of "yellow fir" should have top timbers (frames at deck-level)

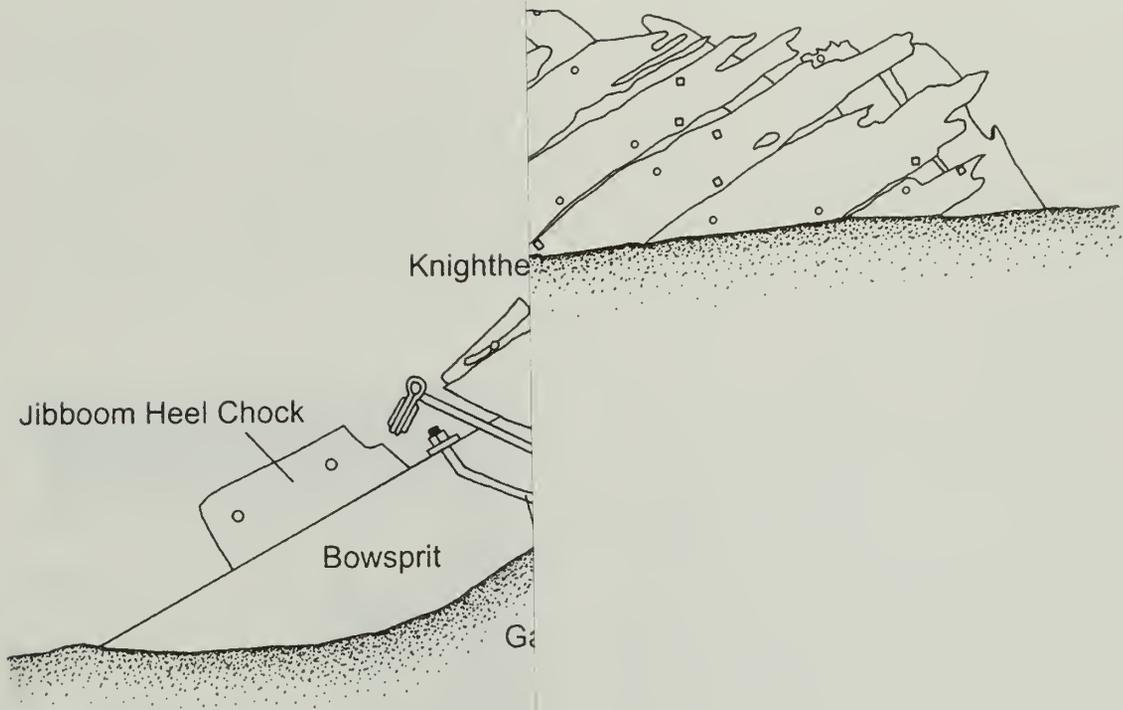
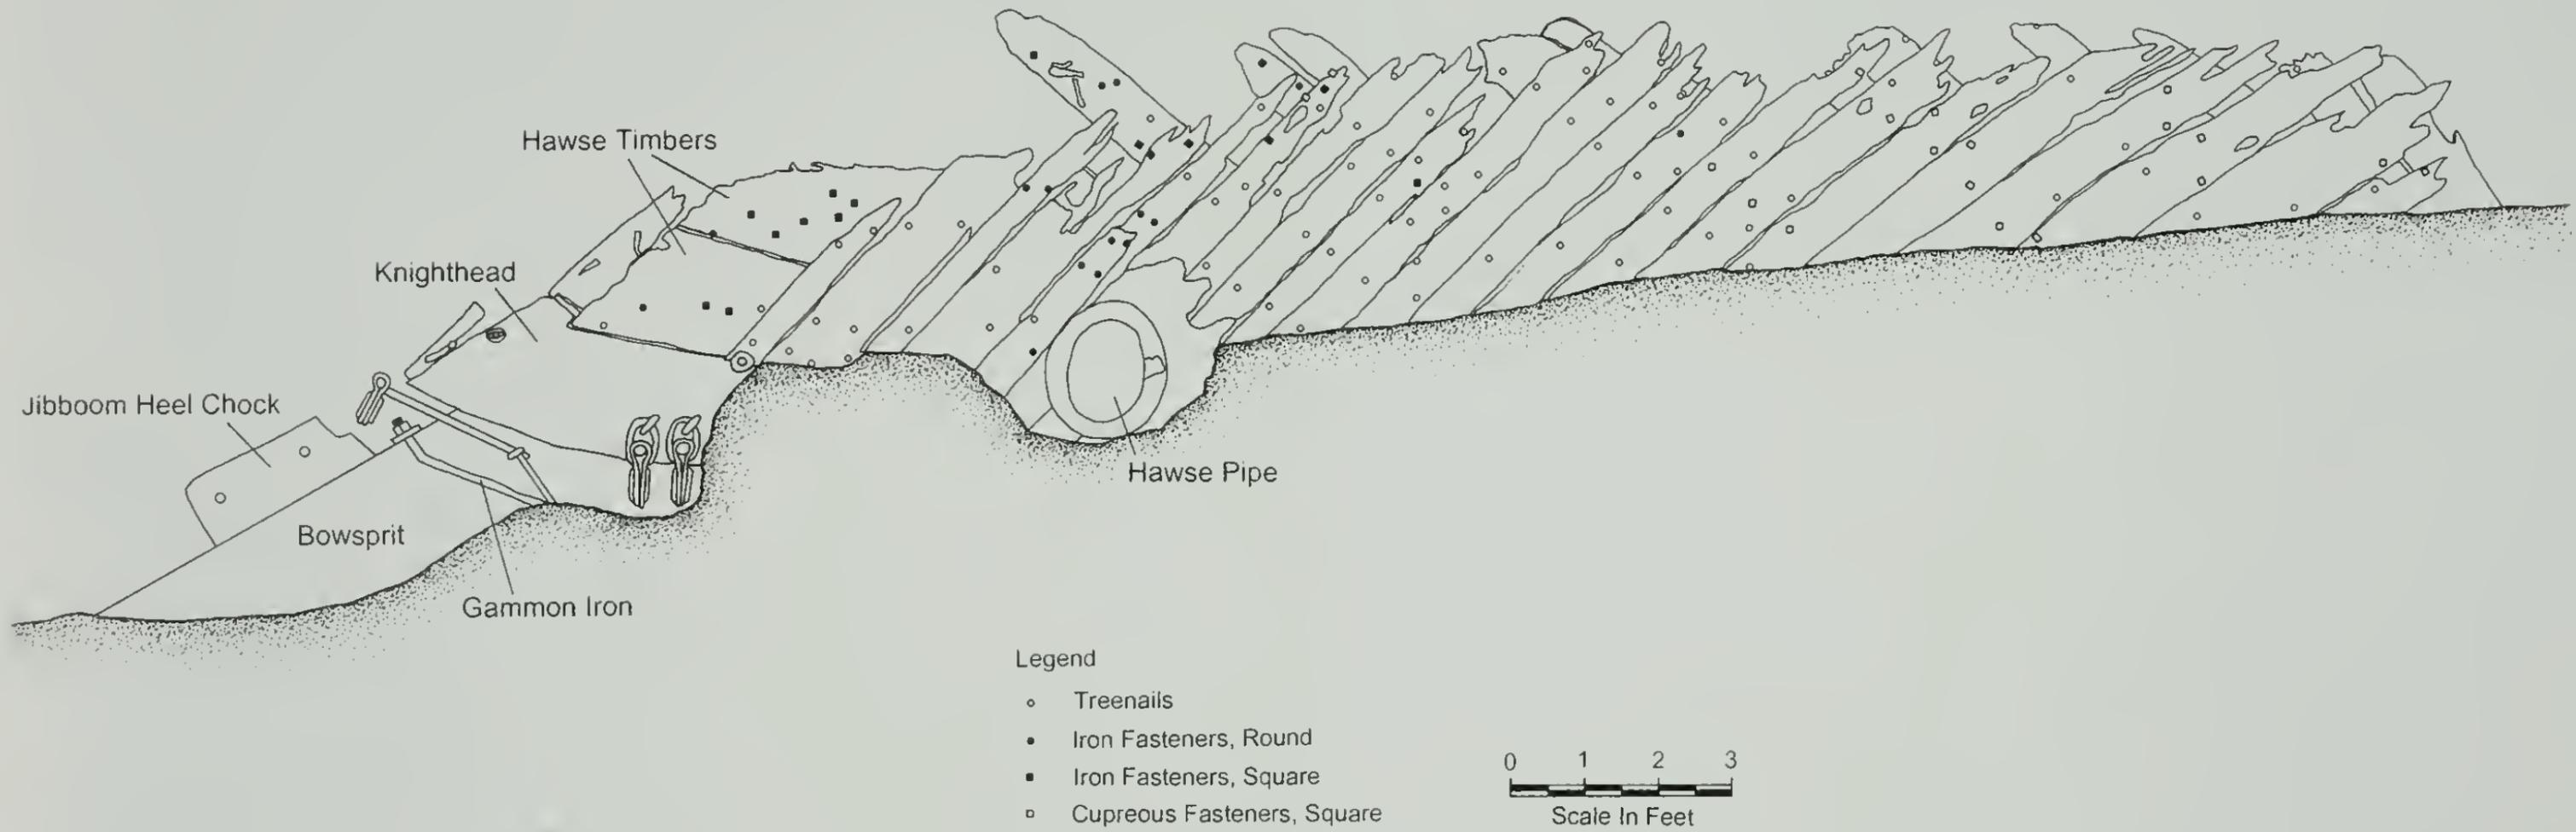
Figure 4.74. Comet port elevation drawing

**Figure 4.74.** *Comet* port elevation drawing. Drawing by Jim Bradford; inked by Nancy Lamm.

Forward of the frame pairs are two hawse timbers, or hawse pieces (Figure 4.75; see Figure 4.74). These timbers “. . . close the openings between forward cant frames from the knightheads aft as far as necessary to give good solid fastening for hawse-pipe flanges. The lower ends of hawse timbers are bolted to the apron and the several hawse timbers are edge-bolted together . . .” (Desmond 1919[1984]:55). The hawse pieces are 6 in. molded and 2 ft. sided, though their sided dimension appears to narrow over their length, and the aft hawse piece is eroded on its aft side, making an accurate original sided dimension difficult to measure. The top edge of the hawse pipe is located 5 ft. 5 in. below the upper surface of the hawse timbers.

Forward of the hawse timbers is the port-side knighthead (Figures 4.76 and 4.77; see Figure 4.74). The knightheads strengthen the bowsprit and support the hooding ends, which are the forward ends of the outer hull planks (Desmond 1919[1984]:50). The knighthead is rhomboid in shape, with each side varying slightly between 1 ft. 2 in. and 1 ft. 3 in., and its shape narrows and curves over its length. Neither hawse timbers nor knightheads are mentioned in *Comet's* contract, but the *Rules for the Construction of Wooden Vessels* states that knightheads and hawse timbers should have double the sided dimension of the frames (American Shipmasters' Association 1879:xxi). *Comet's* hawse timbers are sided more than double the frames' sided dimensions, and the port knighthead, if measured on the diagonal, also follows this specification. The starboard knighthead and stempost were buried in the sand beneath the bowsprit and neither was observed.

A total of 21 outer hull planks were recorded, varying in width from 5 in. to 1 ft. 2 in. and from 1 to 2 in. thick (Figure 4.74). *Comet's* contract states planking should be 4 in. thick, while *Rules for the Construction of Wooden Vessels* specifies it should be 3½ in. thick (JPSL 1886; American Shipmasters' Association 1879:xxviii). Erosion likely accounts for the difference between *Comet's* outer hull planking thickness and the thickness recorded in historical documents. Outer hull planks were fastened to the frames with a combination of treenails, round iron fasteners, and square iron and cupreous spikes, which conforms to outboard fastenings specified in the contract (JPSL 1886). Two strakes overlay the outer hull planking directly above the hawse pipe, creating a double layer of planking. This feature is undocumented in contemporary historical records, and how common a construction practice this was in Pacific Coast lumber schooner shipbuilding is unknown. The ends of eight ceiling planks were

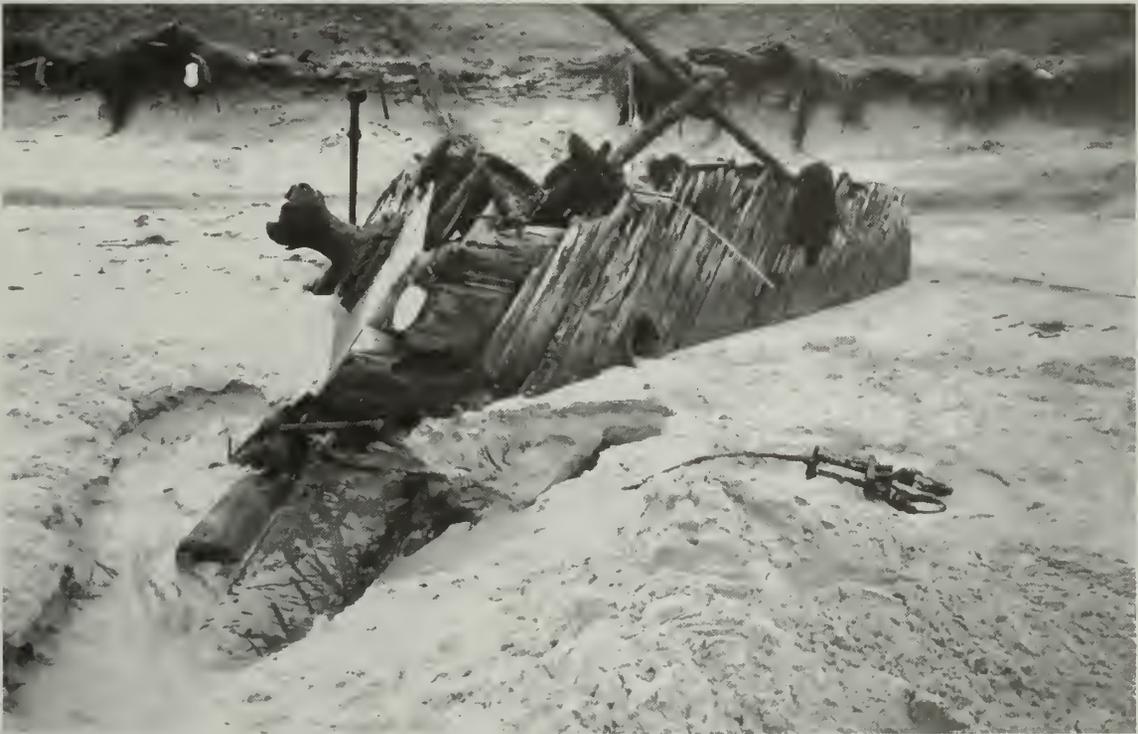
**Figure 4.75.** *Comet's* bow. The hawse timbers are in the center with the white float on them. The hawse pipe is visible at the sand-line, to the right of the hawse timbers. In the right foreground is an unattached rigging element. NPS photo by Matt Russell.

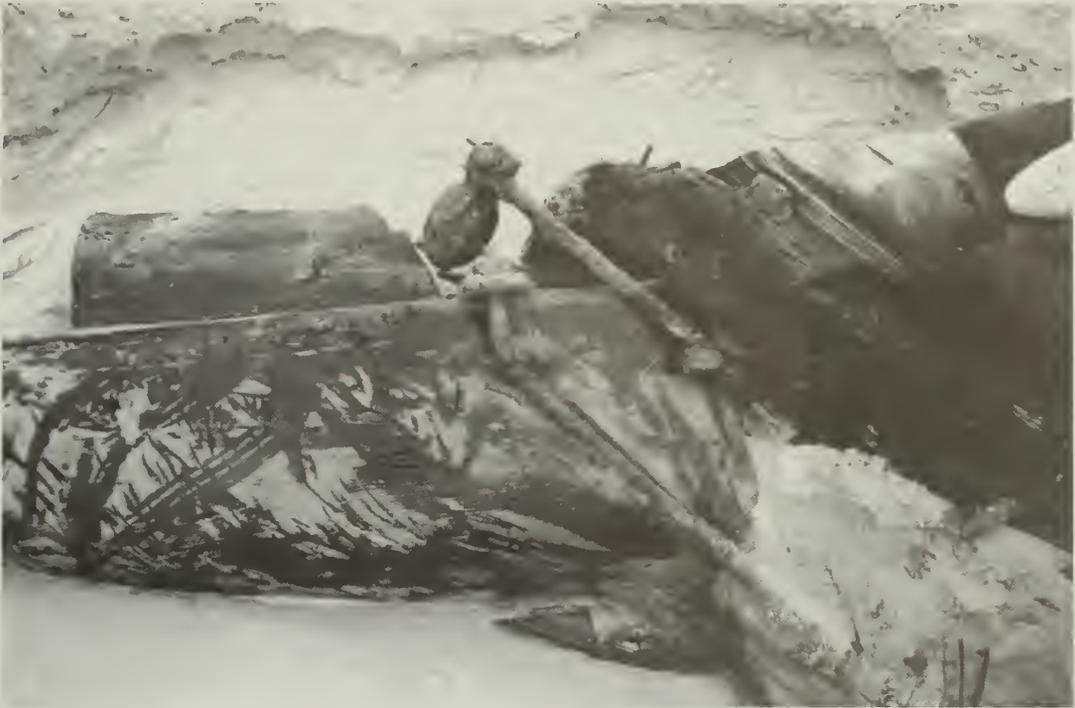
**Figure 4.76.** The port knighthead is the large timber on the right side of the photograph. The bowsprit extends horizontally to the left in the photo with the jibboom heel chock on top; also visible are the gammon iron and a single bull's-eye that held the foremast stay.

Just forward of the knighthead, set up around the bowsprit, is the gammoning or gammon iron (Figures 4.76 and 4.77). The gammoning secures the bowsprit to the stempost and counters the upward lift of the foremast stays. Before the late-nineteenth century, gammoning consisted of rope or chain lashed over the bowsprit; later it was replaced by an iron band, which could be tightened with nuts and bolts (de Kerchove 1961:323). Chapelle (1973:479) depicts gammon iron consisting of iron straps for both the horizontal (across the bowsprit’s upper surface) and vertical (down the bowsprit’s sides and bolted to the stempost) components (Figure 4.87; see Figure 4.84). *Comet* has 5-in. wide x 1-in. thick iron strap across the bowsprit’s upper face secured by 1½-in. diameter, round iron bar stock on either side of the bowsprit to the stempost. The top of the bar stock is threaded and tightened to the strap with 2¾-in. hex nuts. The point where the bar stock attaches to the stempost was buried and could not be documented.

Located on the bowsprit’s upper surface, just forward of the gammon iron, is the jibboom heel chock or block, also called the jibboom saddle (Figures 4.76 and 4.77) (Chapelle 1973:359, 368, 503; de Kerchove 1961:408; Underhill 1958:33). This is a small wood block that supported the jibboom heel. The jibboom is a spar located on top of and attached to the bowsprit that extends forward of it (Figures 4.84 and 4.87)(de Kerchove 1961:408).

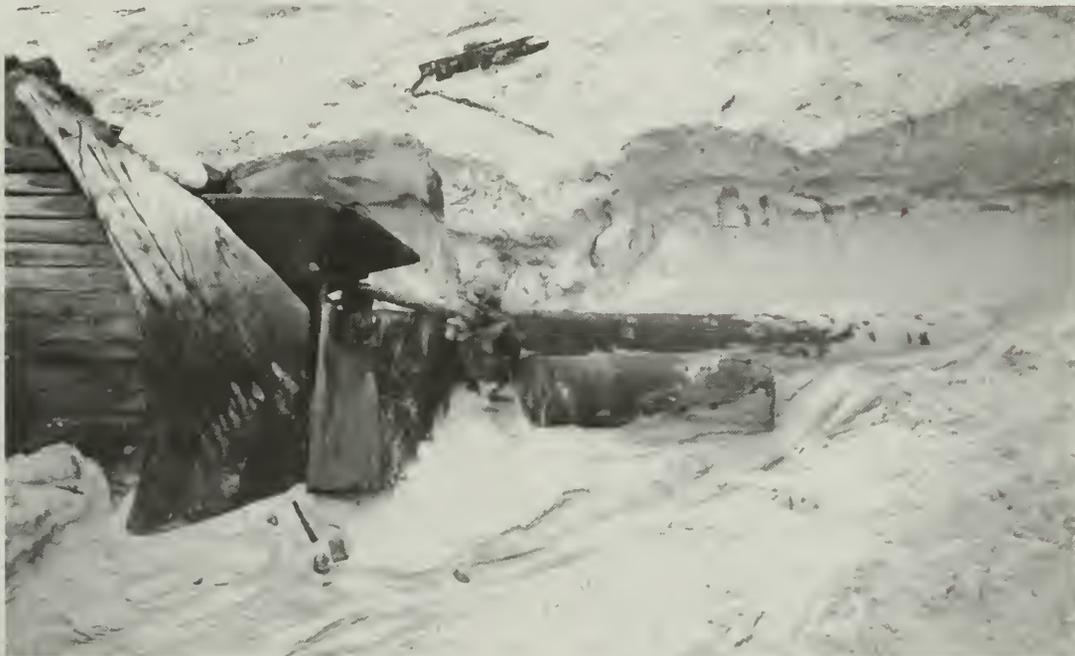
**Figure 4.77.** Top view of *Comet's* knighthead (to the lower right of the white float), bowsprit and jibboom heel chock. NPS photo by Matt Russell.

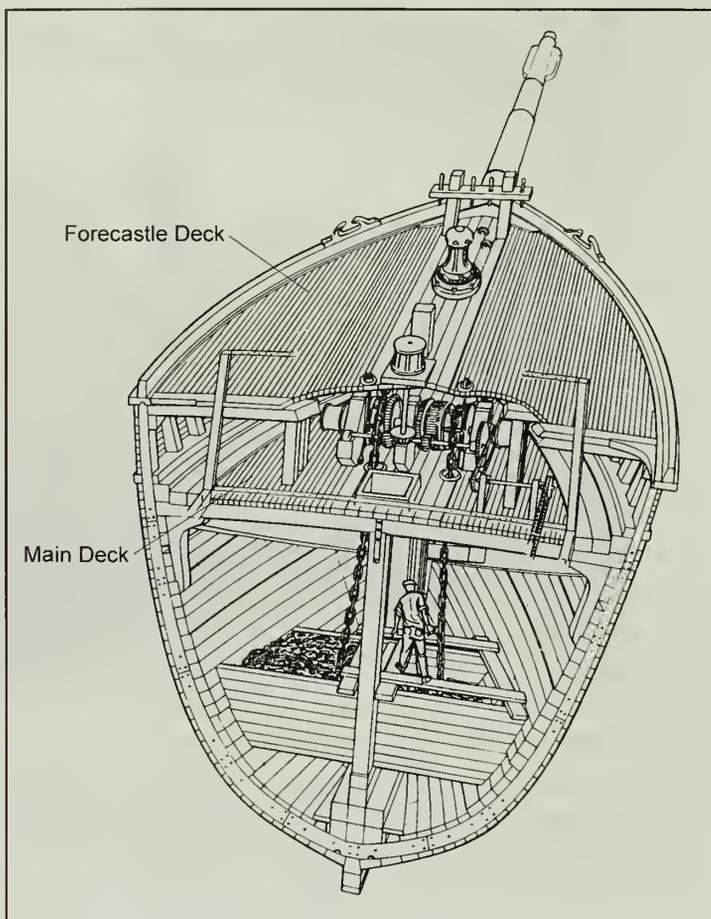
**Figure 4.78.** Bow section of a wooden-hulled schooner showing main deck, forecastle deck and location of windlass (from Greenhill and Manning 1995:90).

Both the main deck and forecastle deck are intact and in place from the centerline starboard, though almost the entire port half of each deck has deteriorated due to natural erosion (Figure 4.78). Four main-deck beams are visible supporting remnants of the main deck. Exposed ends of each deck beam are eroded, but dimensions vary from 10 to 13 in. wide and 7 to 9 in. thick, indicating the deck beams were originally at least 1 ft. 1 in. wide x 9 in. thick. Deck beams are specified in *Comet's* contract as being sided 14 in. and molded 11 in. (JPSL 1886), which matches reasonably, taking into account timber erosion. This again exceeds the 10½ in.-sided dimension specified in *Rules for the Construction of Wooden Vessels* (American Shipmasters' Association 1879:xxviii). Although not noted in the literature, possibly larger deck beams were used because of the large deckloads lumber schooners were required to carry. Thickening deck beams would have increased ship construction costs minimally, but returns on this small investment would have accrued throughout the vessel's operational life. Two deck beams are located directly fore and aft of the pawl post, a third is located 1 ft. 4½ in. aft of the beam butting the pawl post's aft face, and the fourth is located 2 ft. 10¾ in. forward of the

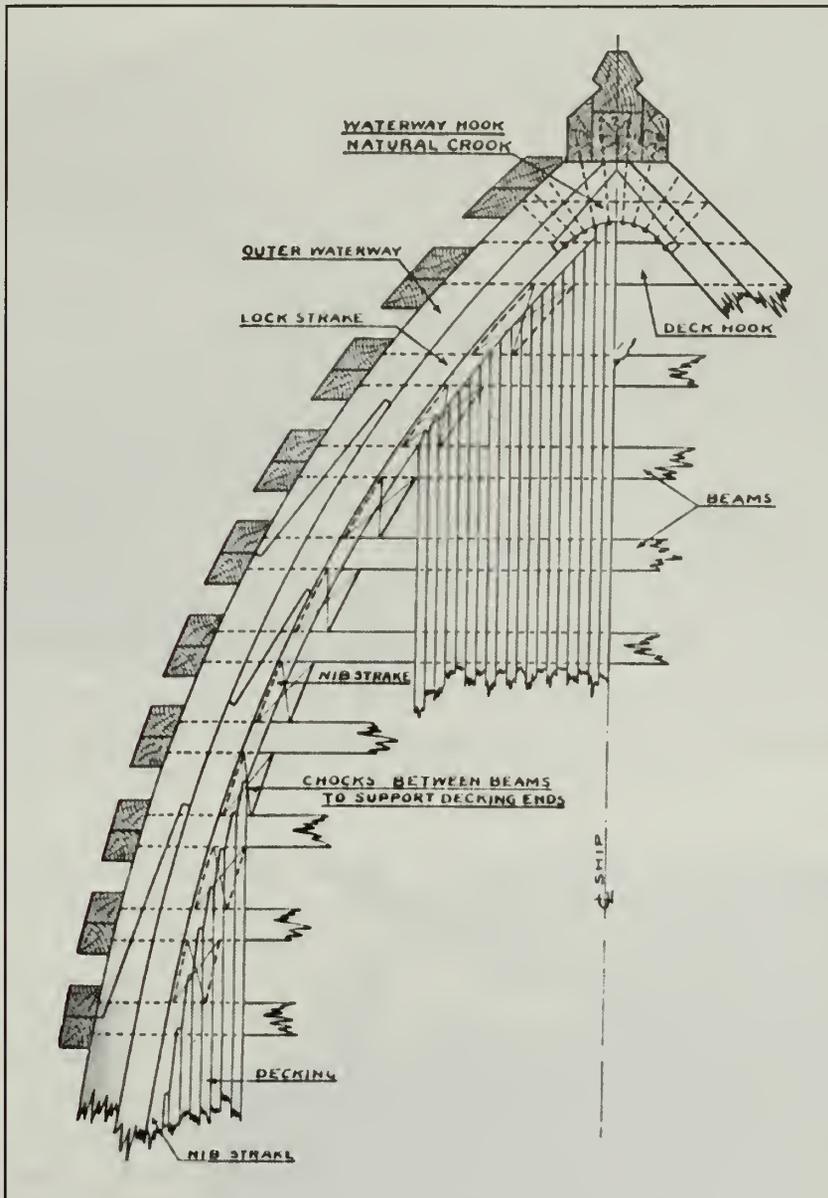
**Figure 4.79.** Planking details, showing deck and waterway hooks (from Curtis 1919:146).

in. long with 7/16-in. square shanks and 13/16-in., four-faceted heads, and are countersunk and plugged with 1-in. diameter wooden plugs. A main-deck hook and main-deck waterway hook are present in the bow, and the forward ends of the main-deck planks rest on and are fastened to the main-deck hook and butt against the main-deck waterway hook, which follows the typical practice (Figure 4.79)(Curtis 1919:134–135, 144–145). As with the deck clamps, waterway strakes are no longer present.

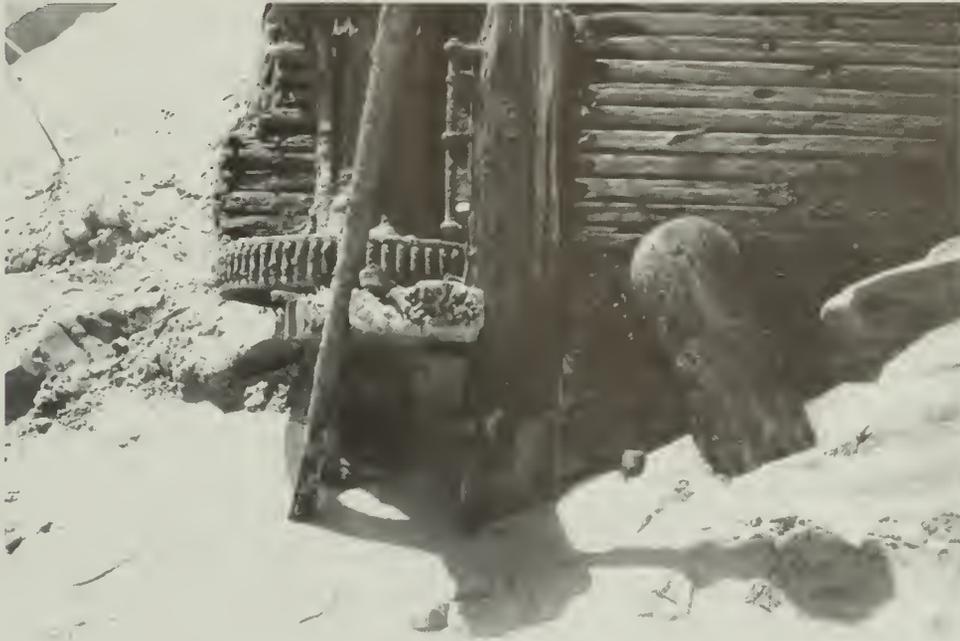
**Figure 4.81.** Top view of the aft end of the forecastle deck. The aft-most forecastle deck beam is the vertical timber in the center of the photo. The windlass is to the left, mounted on the main deck below; the starboard cathead is the angled timber to the right. NPS photo by Matt Russell.

fore- and aft- the pawl post, are sided between  $9\frac{1}{2}$  and  $10\frac{1}{2}$  in. Like on the main deck, port clamps are absent. Thirty fore-castle-deck planks are exposed; all 3 in. sided x  $2\frac{1}{2}$  in. molded. Each plank is fastened with a single boat spike at its forward end, a single boat spike at its aft end (for complete planks), and a single boat spike in each deck beam. Fore-castle-deck spikes are  $5\frac{1}{4}$  in. long with  $5/16$ -in. square shanks and  $11/16$  in., four-faceted heads and are countersunk and plugged with 1-in. diameter wooden plugs. Deck plank forward ends are resting on and fastened to the fore-castle-deck hook and are butted against the fore-castle-deck waterway hook (Figure 4.77). Again, like the main deck, waterway strakes are gone. Complete deck plank aft ends are resting on and fastened to a recessed shelf notched into the forward edge of the aft-most fore-castle-deck beam (Figure 4.81). Fore-castle deck beam and

The aft end of the starboard cathead was visible attached to the forecastle deck (Figures 4.80 and 4.81). A cathead is a wood beam that projects out over port and starboard bow to support the anchor before releasing or while retrieving or stowing (Figure 4.89) (de Kerchove 1961:132)—when the anchor ring has been hoisted up to the cathead, it has been “catted.” *Comet's* cathead is a solid timber, 11<sup>1</sup>/<sub>4</sub> in. wide x 5 in. thick with an exposed length of 2 ft. 7 in. A 3<sup>3</sup>/<sub>4</sub>-in.diameter, 1-in. thick iron ring is fastened to its upper surface at the lowest exposure, 2 ft. 7 in. from the aft end. No other details about the cathead were observed because most of its length was buried.

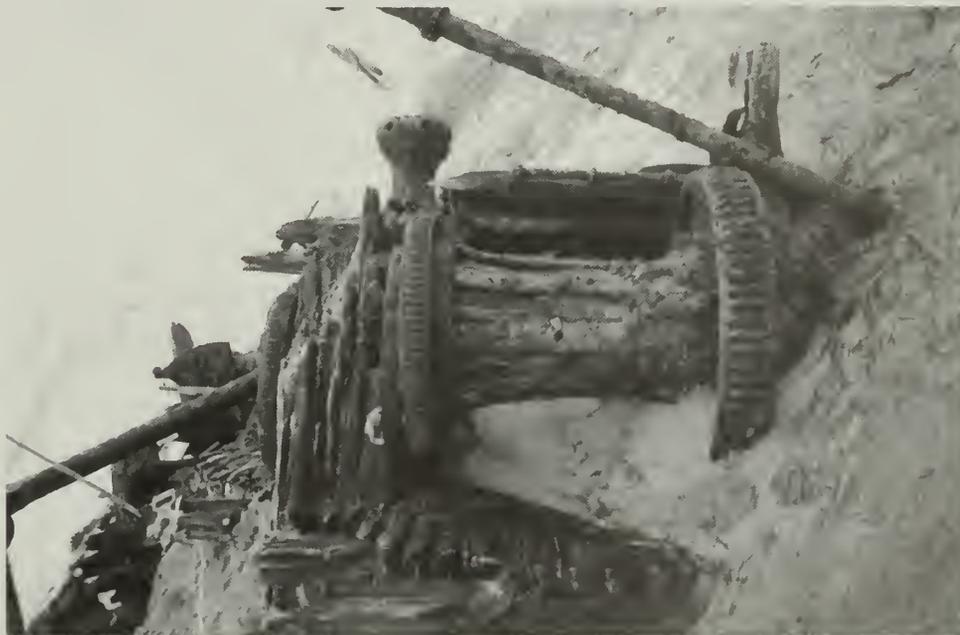
**Figure 4.82.** Photograph taken from the perspective as if the viewer were standing on the main deck looking forward. The pawl post is to the left of the windlass. NPS photo by Matt Russell.

The pawl post, sometimes called the pawl bitt, Samson post or heel bitt when the bowsprit is stepped into it, is present from fore-castle-deck level to the main-deck level, where it is buried in the sand (Figures 4.82–4.84). The pawl post is a solid timber, usually stepped into the keelson or bow deadwood, which extends upward and ends above fore-castle-deck level (Chapelle 1973:368–370; de Kerchove 1961:91; Underhill 1958:88). In *Comet*, the pawl post served two purposes: 1) the bowsprit's inboard end, called the heel, is stepped into the pawl post's forward face; so the pawl post serves as a major reinforcing member for the bow rigging; and 2) the windlass pawl was mounted on the pawl post's aft face, though neither the windlass pawl nor pawl rim are present on site. The pawl post

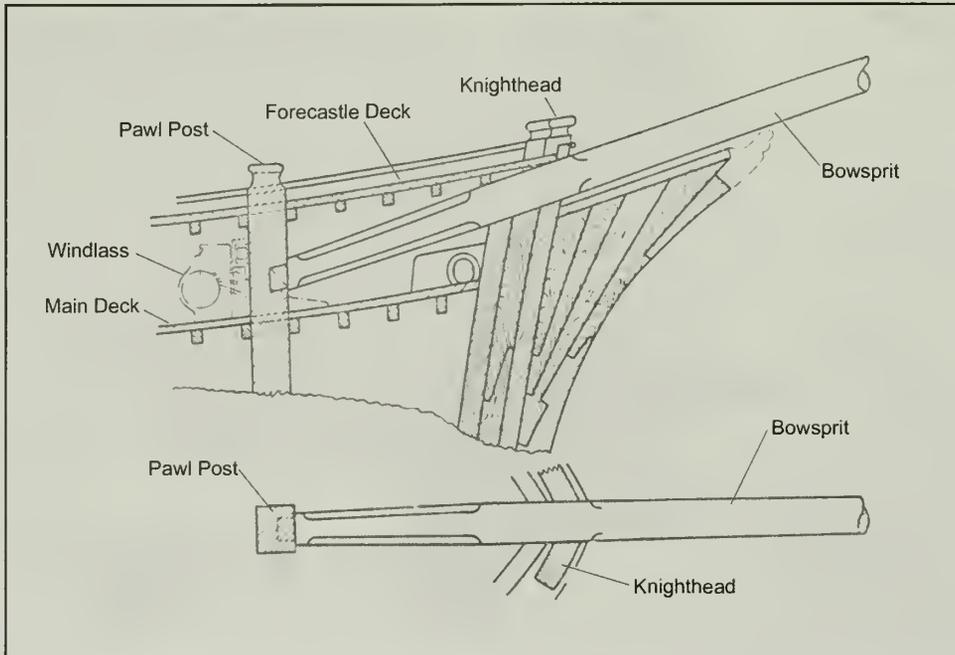
**Figure 4.83.** Schooner bow section showing the bowsprit stepped into the forward face of the pawl post (after Underhill 1958:88).

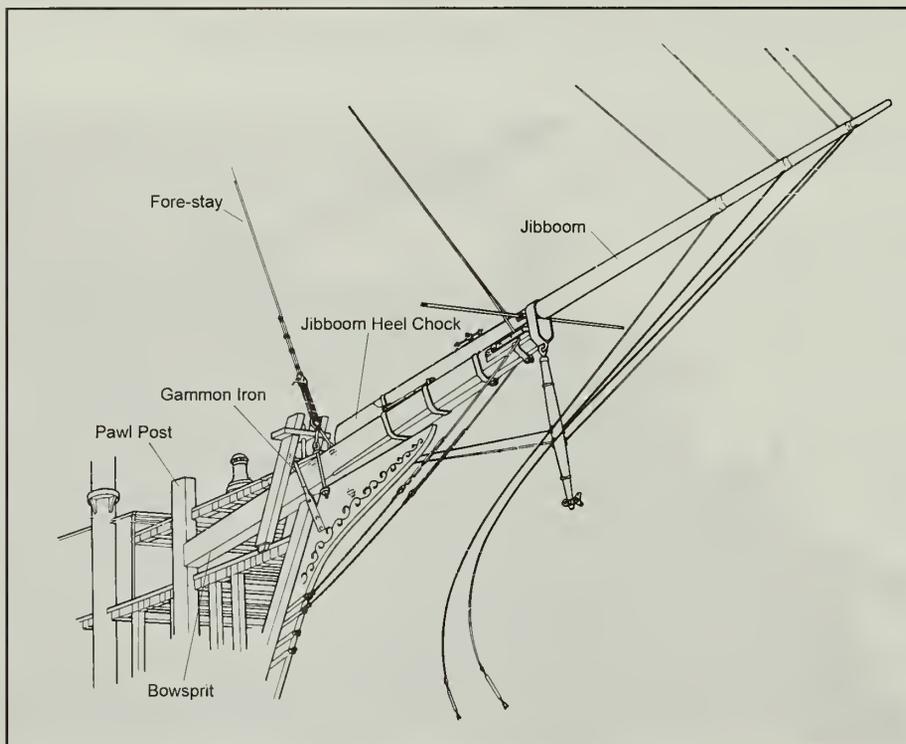
**Figure 4.84.** Schematic of a schooner bow-section, showing the bowsprit stepped into the pawl post, the jibboom, jibboom heel chock, gammon iron and fore-stay (after Greenhill and Manning 995:113).

the bow, serves two main purposes: 1) to extend the head sails forward, balancing the sail plan by counteracting the effect of the after sails; and 2) to support the foremast, which is fastened to it with stays (Figure 4.84) (de Kerchove 1961:90). *Comet*’s bowsprit is formed from a single, large timber, most likely Douglas fir.

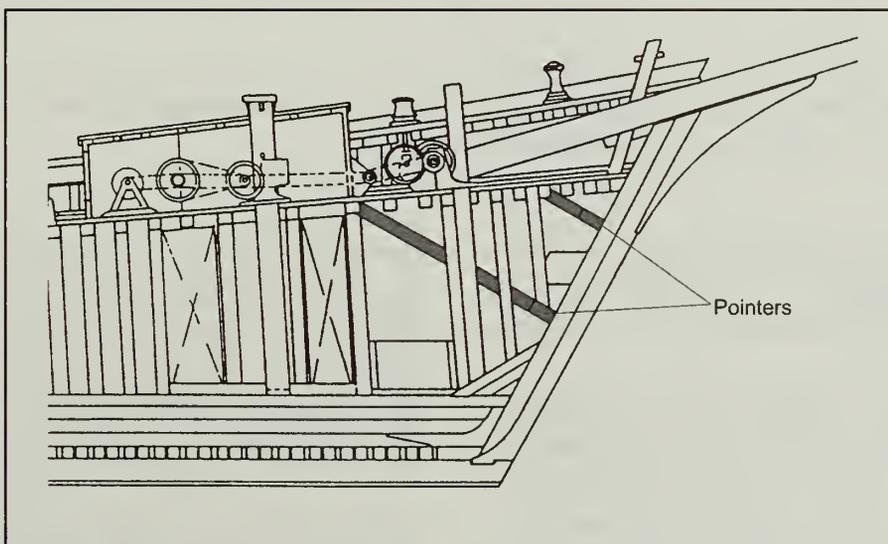
**Figure 4.85.** Bow pointers in a wooden-hulled schooner (after Greenhill and Manning 1995:63).

uses. Salvage alone cannot explain, however, why only the bow is present today. Observation of site layout suggests a series of events that led to the wreck's present condition. The last known historical photographs of *Comet* (see Figures 3.9–3.11) show the vessel laying broadside to the shoreline, somewhere between high and low tide. Subsequently, *Comet's* bow broke away from the rest of the hull at a point just aft of the forecastle deck and forward of the forward deckhouse (Figure 4.105). It is possible the stempost/keel joint broke, but the pointers kept the bow structure to aft of the forecastle deck together. The pointers crossed and were fastened into multiple frame pairs, including all the cant frames, and would have provided reinforcement to help bind them together (Figures 4.85 and 4.86).
