# Beached Shipwreck Archeology: Case Studies from Channel Islands National Park

Submerged Resources Center  
Professional Reports  
Number 18

Submerged Resources Center  
Intermountain Region  
National Park Service

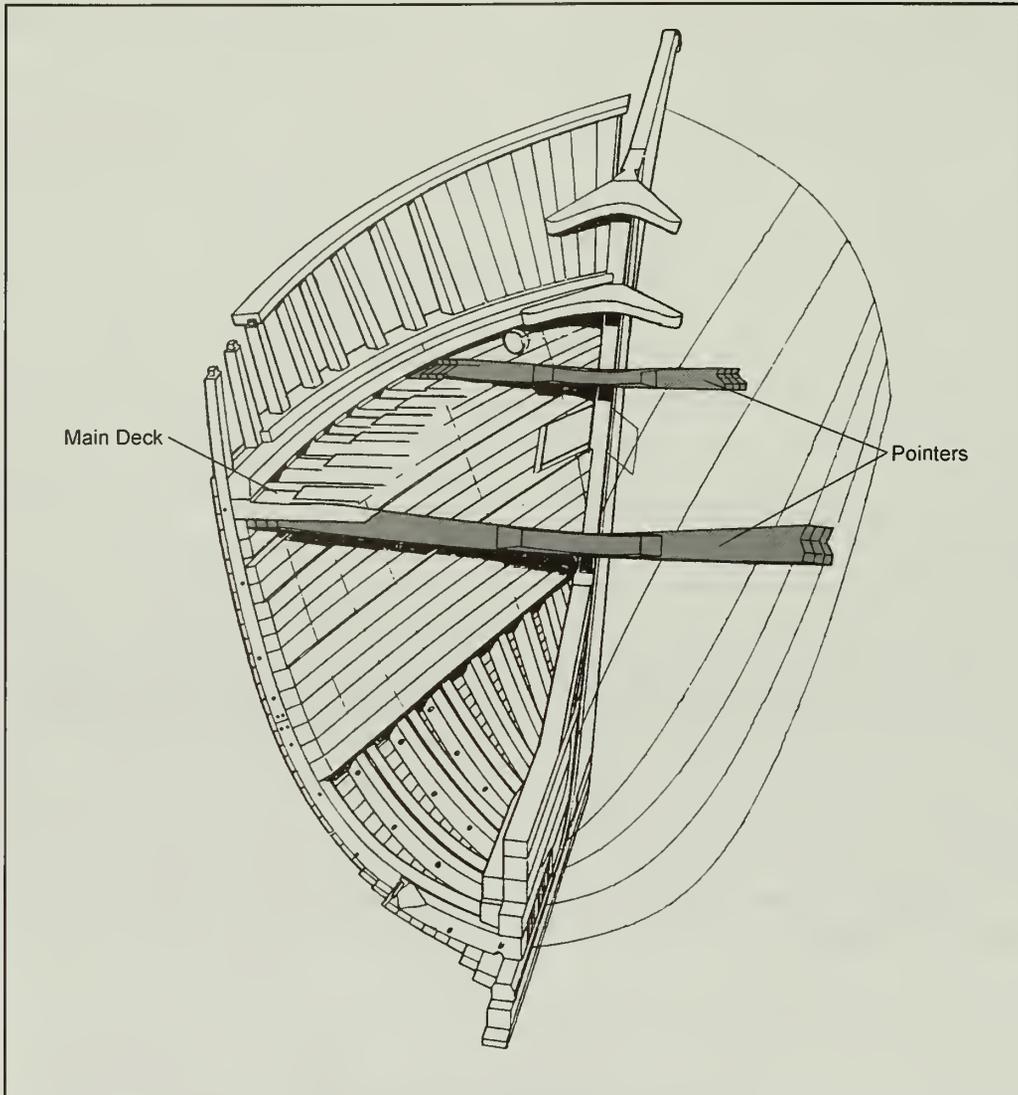
**Figure 4.86.** Schematic showing location of bow pointers in a wooden-hulled schooner (after Greenhill and Manning 1995:70).

uses. Salvage alone cannot explain, however, why only the bow is present today. Observation of site layout suggests a series of events that led to the wreck's present condition. The last known historical photographs of *Comet* (see Figures 3.9–3.11) show the vessel laying broadside to the shoreline, somewhere between high and low tide. Subsequently, *Comet's* bow broke away from the rest of the hull at a point just aft of the forecastle deck and forward of the forward deckhouse (Figure 4.105). It is possible the stempost/keel joint broke, but the pointers kept the bow structure to aft of the forecastle deck together. The pointers crossed and were fastened into multiple frame pairs, including all the cant frames, and would have provided reinforcement to help bind them together (Figures 4.85 and 4.86).

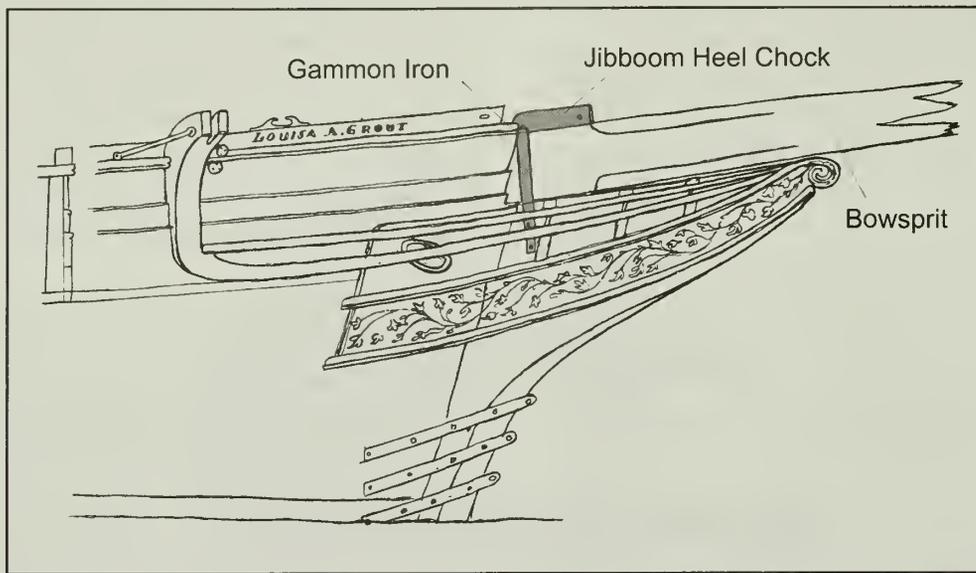
**Figure 4.87.** Vessel bow section showing location of the gammon iron and jibboom heel chock (after Chapelle 1973:359).

Located on the bowsprit’s upper surface, just forward of the gammon iron, is the jibboom heel chock or block, also called the jibboom saddle (Figures 4.76 and 4.77) (Chapelle 1973:359, 368, 503; de Kerchove 1961:408; Underhill 1958:33). This is a small wood block that supported the jibboom heel. The jibboom is a spar located on top of and attached to the bowsprit that extends forward of it (Figures 4.84 and 4.87)(de Kerchove 1961:408).

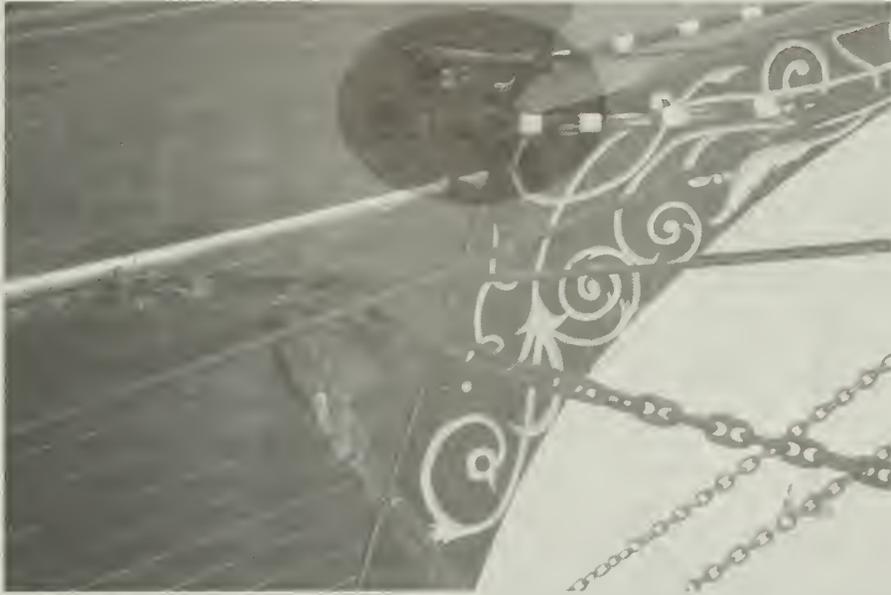
**Figure 4.88.** Bull's eye above and forward of the hawse pipe (at the top-center of photo) support the bowsprit guys on *C. A. Thayer* in San Francisco Maritime National Historical Park. NPS photo by Matt Russell.

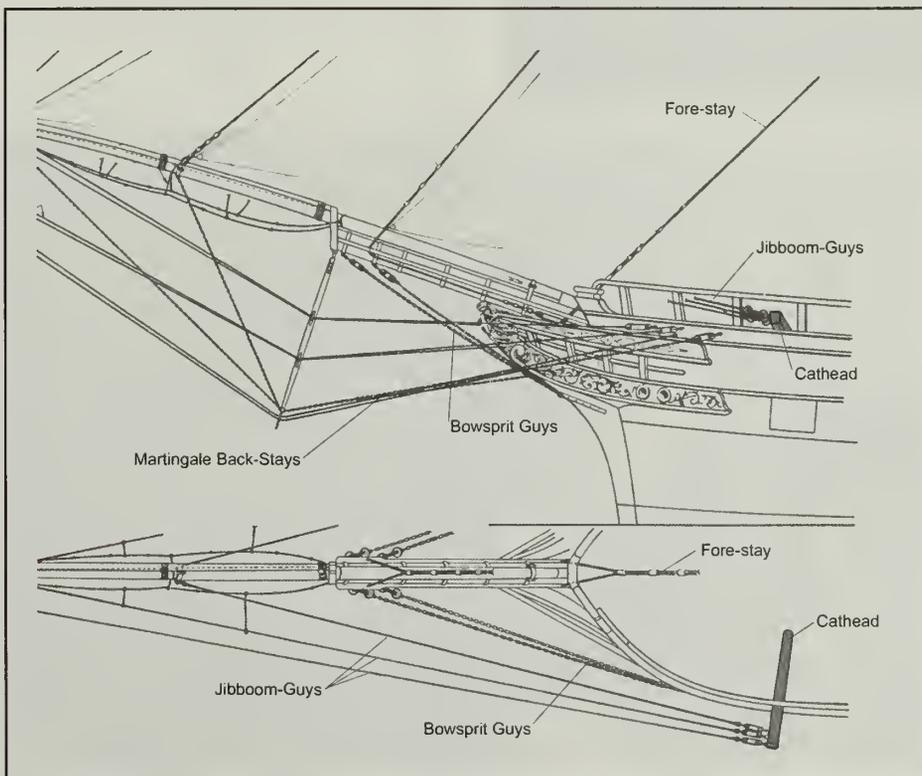
**Figure 4.89.** Bow rigging elements found on *Comet* site (after Underhill 1958:64).

This is most likely one of the attachment points for the fore-stay, which supported *Comet's* foremast. *C. A. Thayer* has identical bull's eyes supporting its foremast in the same location. Underhill (1958:64) also depicts a similar forestay configuration (Figure 4.89).

the attachment point for the inner- and outer-jibboom guys, or shrouds (Figure 4.89) (Underhill 1958:64). Chapelle (1973:398) notes that “as long as the schooners carried jibbooms the jibboom shrouds were set up with hearts, or small deadeyes, and lanyards on the foresides of the catheads.” *C. A. Thayer* has similar, though not identical, rigging elements on the foresides of its catheads, which support the jibboom guys (Figure 4.92). In addition, historical photos of *Comet* wrecked in Simonton Cove give indirect evidence for this identification. Although the photos do not show the cathead or this particular element, they depict the jibboom guys coming to a point that can only be on the foresides of the catheads (see Figures 3.12 and 3.13). The iron hooks are called jib stay hooks (Greenhill and Manning 1995:103), and the iron rod was a brace between the cathead and the rail (Chapelle 1973:398). The rod’s angle identifies this object coming from the port, rather than the starboard, cathead.

The aft end of the starboard cathead was visible attached to the forecastle deck (Figures 4.80 and 4.81). A cathead is a wood beam that projects out over port and starboard bow to support the anchor before releasing or while retrieving or stowing (Figure 4.89) (de Kerchove 1961:132)—when the anchor ring has been hoisted up to the cathead, it has been “catted.” *Comet's* cathead is a solid timber, 11<sup>1</sup>/<sub>4</sub> in. wide x 5 in. thick with an exposed length of 2 ft. 7 in. A 3<sup>3</sup>/<sub>4</sub>-in.diameter, 1-in. thick iron ring is fastened to its upper surface at the lowest exposure, 2 ft. 7 in. from the aft end. No other details about the cathead were observed because most of its length was buried.

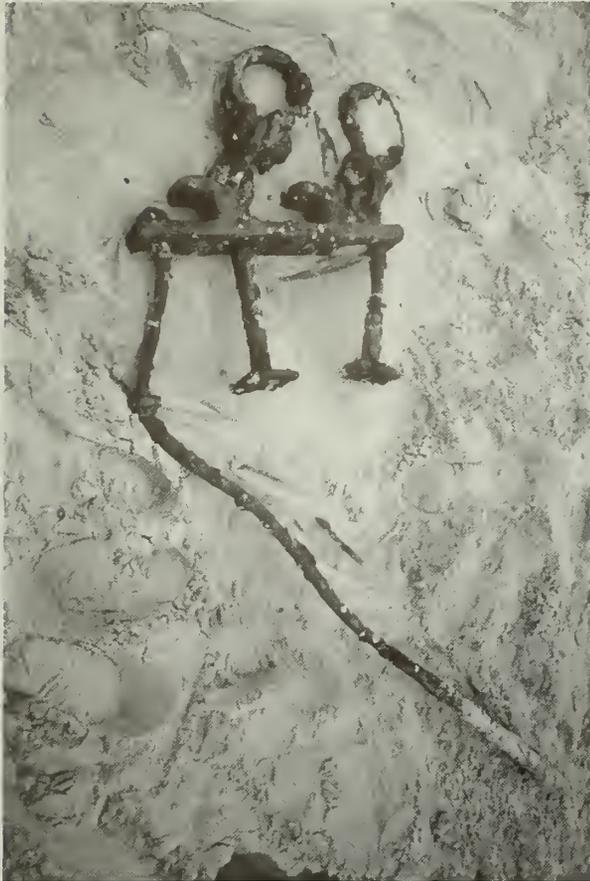
**Figure 4.90.** Rigging element off *Comet's* port bow. NPS photo by Matt Russell.

Located off *Comet's* port bow is an unattached iron rigging element (Figure 4.90 and 4.91; also Figure 4.75). It consists of a 4 ft. 3 in.-long iron rod with a 5 in. long x  $2\frac{1}{2}$  in. wide x  $\frac{1}{2}$  in. thick plate on one end, attached to an  $11\frac{1}{2}$ -in. long x  $\frac{3}{4}$  in. diameter iron fastener that is attached to a 1 ft.  $6\frac{1}{2}$ -in. long x 1-in. thick iron plate. The plate is pierced by two 1 ft. 3-in. long x 1-in. diameter eyebolts, each of which has an iron ring attached to an iron strop from a bull's eye or deadeye (the wooden block is no longer present), similar to those described above. In addition, the iron plate has two iron hooks cast as part of its upper surface. Although documentary research could not identify the element's proper name, its function was identified. This object was originally fastened to the foreside of the port cathead and provided

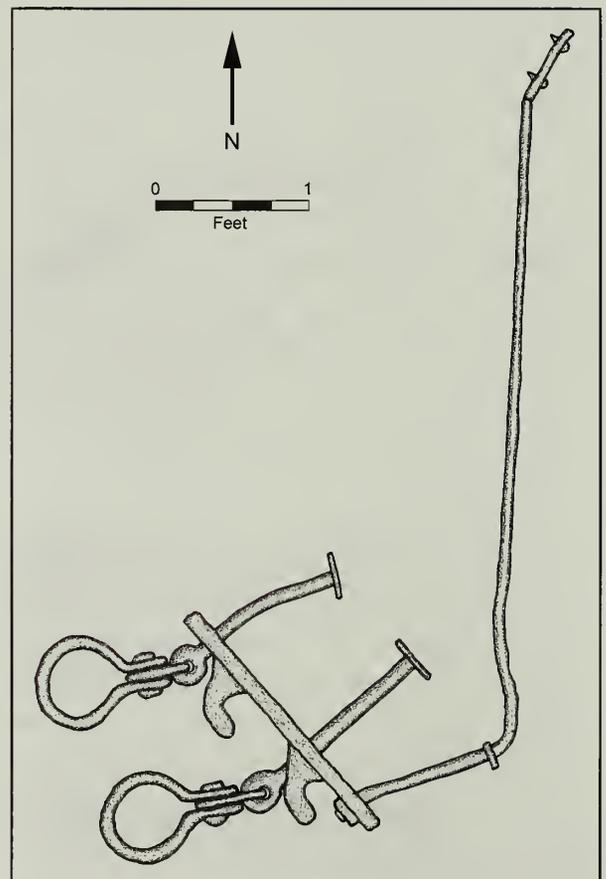
**Figure 4.91.** Rigging element from port cathead that secured the jibboom guys. Drawing by Matt Russell and Don Morris.

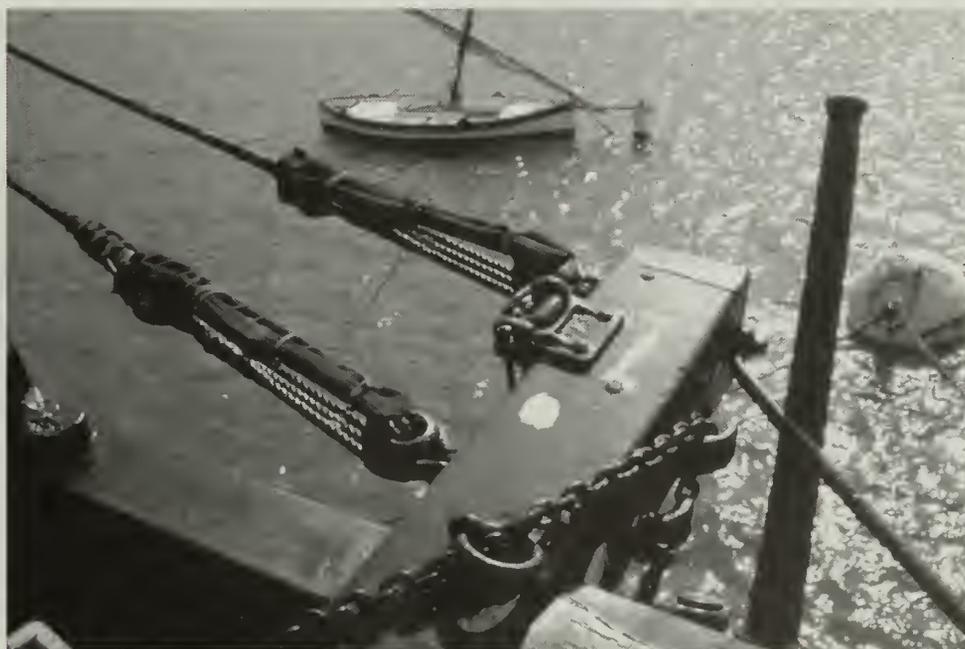
**Figure 4.92.** Rigging element supporting jibboom guys on forward side of *C. A. Thayer*’s cathead. NPS photo by Matt Russell.

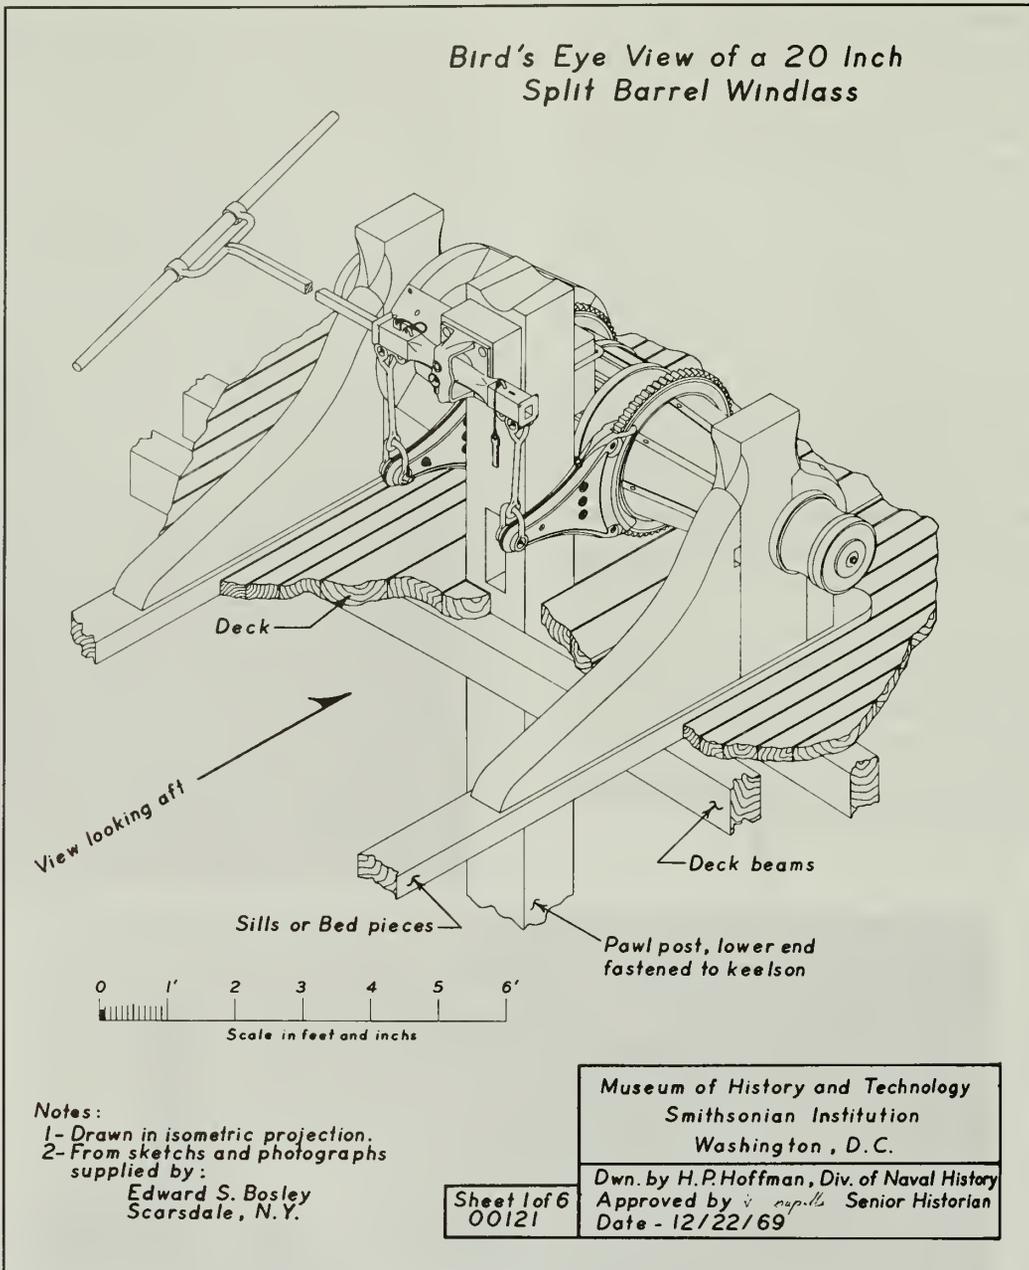
**Figure 4.93.** Pump-brake windlass. Drawing from the Smithsonian Institution.

*Comet*’s windlass is a type generically known as an “Armstrong Patent”, or pump-brake, windlass, which was introduced during the 1840s, quickly replacing older models employing handspikes. Pump-brake windlasses, which used purchase levers and pump handles, remained in use into the twentieth century (MacGregor 1984:88). Chapelle (1973:677) refers to this type of windlass as a “wooden, or log, windlass, with pump-brake ironwork” (Figures 4.93).

On this windlass type, a pawl mounted on the aft face of the pawl post engaged either teeth cut into the center of the windlass barrel or an iron pawl rim mounted on the windlass barrel, which prevented the barrel from reversing direction (Figure 4.93) (Chapelle 1973:677; Paasch 1890:Plate 70). Neither the pawl nor a pawl rim is present on the *Comet* site, possibly indicating the pawl engaged teeth cut directly into the windlass barrel rather than a pawl rim. An auxiliary warping drum, or gypsy head, was present outside each carrick bitt (Figure 4.95). Only the starboard half of the windlass barrel remains intact, including the starboard purchase rim and arm, the starboard carrick bitt supporting the windlass, and the starboard warping drum outside it. Much of the windlass's port-side ironwork is present, however, laying loose on the main deck against the bowsprit's port side, including the port purchase rim (Figure 4.97), arm and rod; four iron whelps from the port-side windlass barrel; a single large iron fastener with a diamond-shaped rove that held

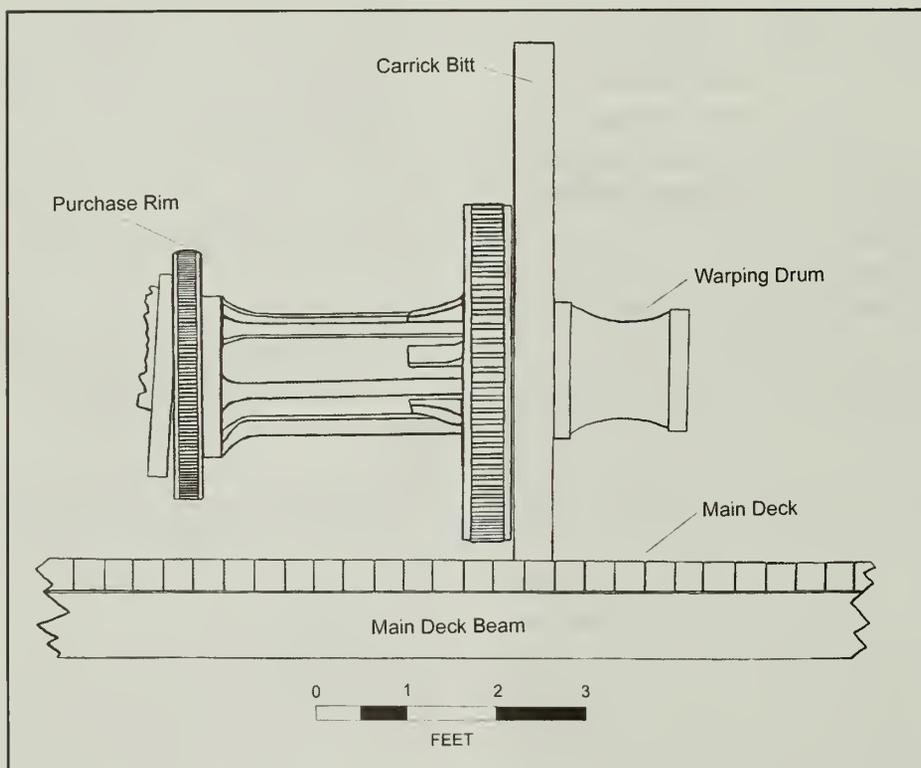
**Figure 4.95.** *Comet's* windlass, elevation view looking forward on main deck. Drawing by Jim Bradford and Matt Russell.

*Comet's* windlass is mounted on the schooner's main deck, just aft of the pawl post (Figure 4.94 and 4.95). The windlass has a wooden barrel with iron whelps supported by hardwood carrick bitts. It was worked with two iron purchase rims (with 1 ft. 11½ in., or 23½ in., inside diameter) and purchase arms connected by iron purchase rods to a pivoting rocker, or crosshead, mechanism that was originally mounted above the windlass on the forecastle deck (Figure 4.96)(Chapelle 1973:669–680; Paasch 1890:Plate 70). Just forward of the pawl post at forecastle-deck level are two fasteners and the remains of a block that supported the crosshead on the forecastle deck. On either side of the pawl post are openings in the forecastle deck where the purchase rods connected the windlass purchase arms to the rocker on the forecastle above (Figure 4.80).

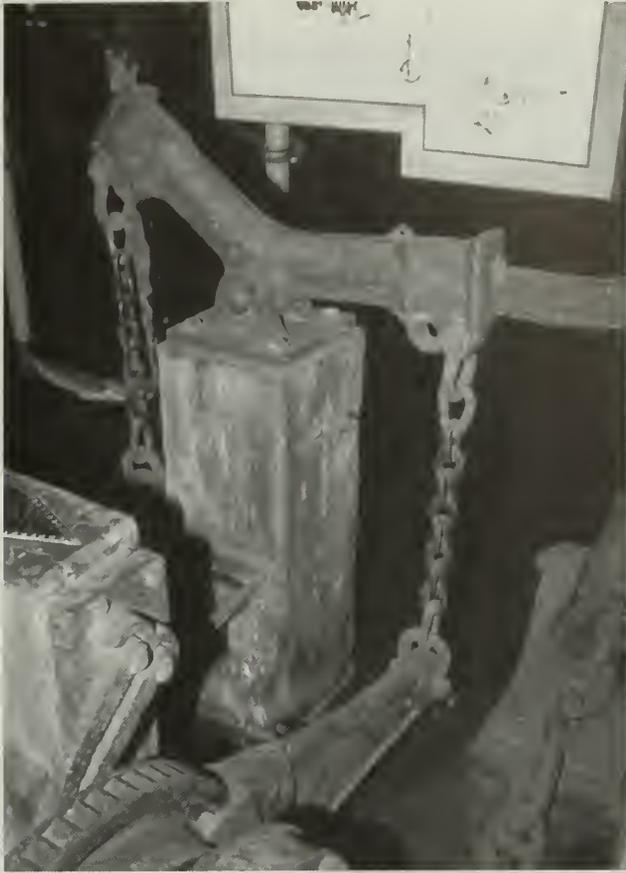
**Figure 4.96.** Pivoting rocker, or crosshead, mechanism connected to a windlass purchase arm with chain. *Comet* was equipped with a similar windlass type. NPS photo by Matt Russell.

Included in the iron material located on the main deck are an eyebolt fastened into the bowsprit's port face with another eyebolt attached to it, some small link chain with 2-in. long x ½-in. diameter links, 10 loose iron fasteners and an iron bar measuring 3½ to 4 in. square x 3 ft. 9½ in. long. The fasteners are probably from the windlass's port side, the link chain is possibly from the messenger chain or connected the purchase arm with the rocker (Figure 4.96) and the iron bar is possibly part of one of the pump-brake hand levers.

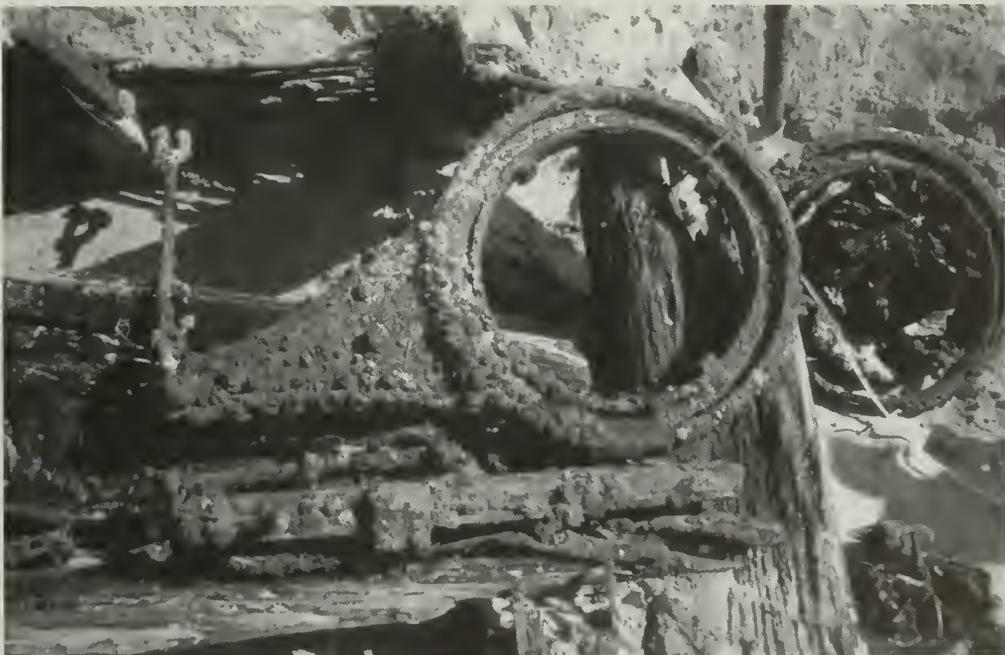
**Figure 4.97.** *Comet*'s port windlass purchase arm and windlass hardware on the main deck laying against the port side of the pawl post and bowsprit. NPS photo by Don Morris.

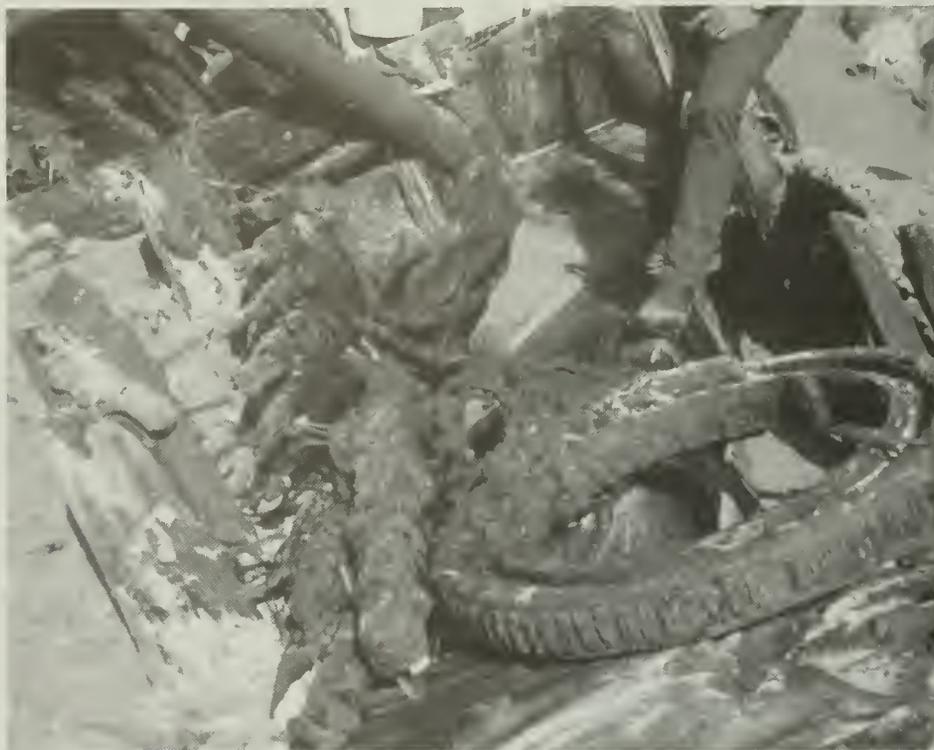
**Figure 4.98.** *Comet's* port windlass hardware laying on the main deck. NPS photo by Don Morris.

the port-side carrick bitt, cheek and knee together (an identical fastener is still in place on the starboard side); and the rocker base plate with two fasteners that held it to the forecastle deck (Figure 4.98).

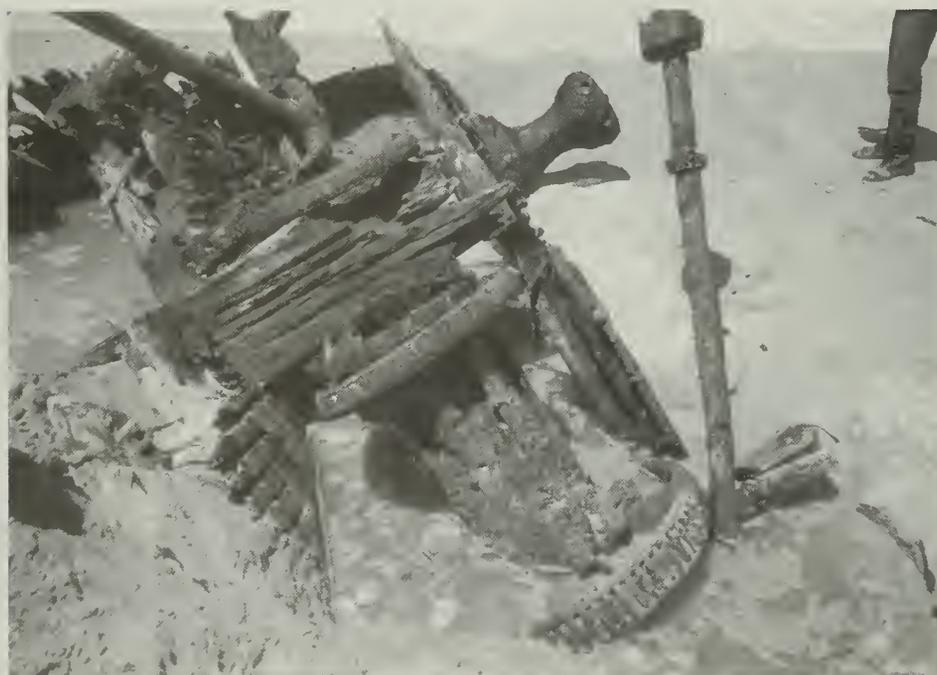
**Figure 4.99.** *Comet's* windlass and the iron shaft sticking out of the sand on the right side of the photograph. NPS photo by Matt Russell.

On the windlass's starboard end, just inside the carrick bitt, is a 3 ft. 6½-in. diameter gear that is not integral to the primary workings of the windlass. In addition, an upright iron shaft with some heavily encrusted bands that may have been gearing is sticking out of the sand near the windlass's starboard end (Figure 4.99; see Figure 4.95). This is part of a messenger chain system for driving the windlass by an endless chain from a donkey engine. Figure 4.100 depicts a similar arrangement, with a geared shaft mounted above the windlass articulated to a large gear on the windlass's outside end. A similar system is depicted in drawings of *Bertha L. Downs*, another late-nineteenth century schooner (Figure 4.101) (Greenhill and Manning 1995:79–81, 90). Essentially, a messenger chain system was used to run several pieces of machinery off a single donkey engine. Using a system of shafts, gears and chains, a donkey engine could power the windlass, pumps, auxiliary warping heads and other hoisting equipment. As discussed in Chapter 3, *Comet* was probably not originally equipped with a donkey engine, but one was added in the 1890s.

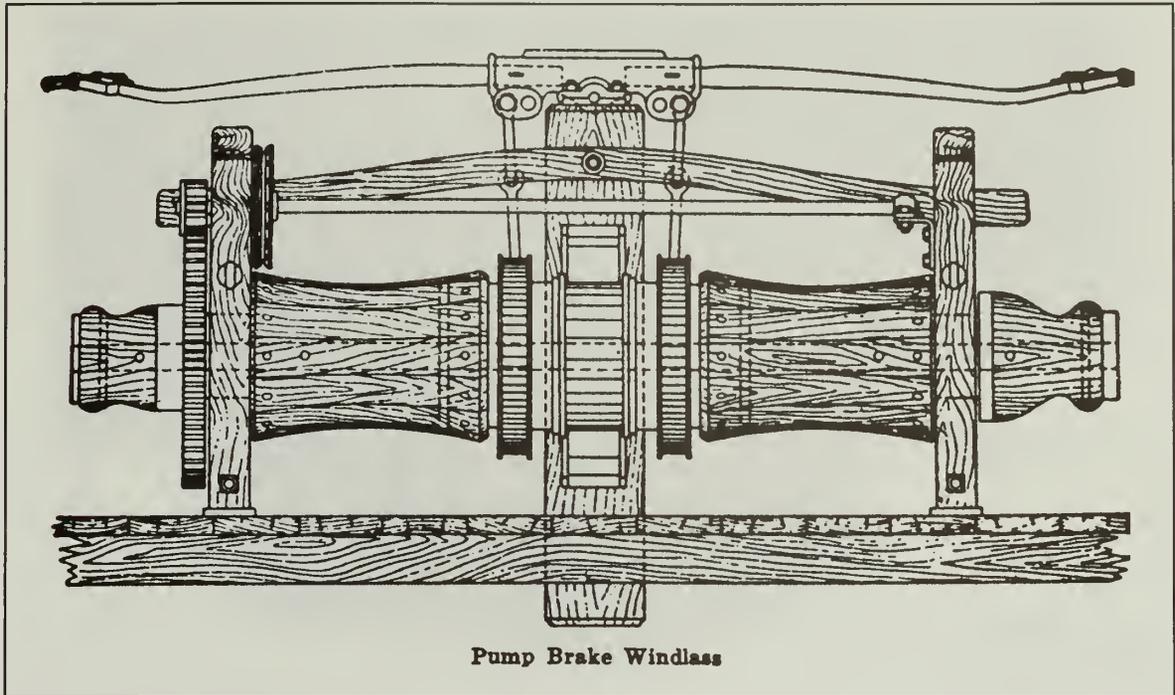
**Figure 4.100.** Windlass nearly identical to *Comet's* windlass, including the gearing (in this case on the port side) for the messenger chain system.

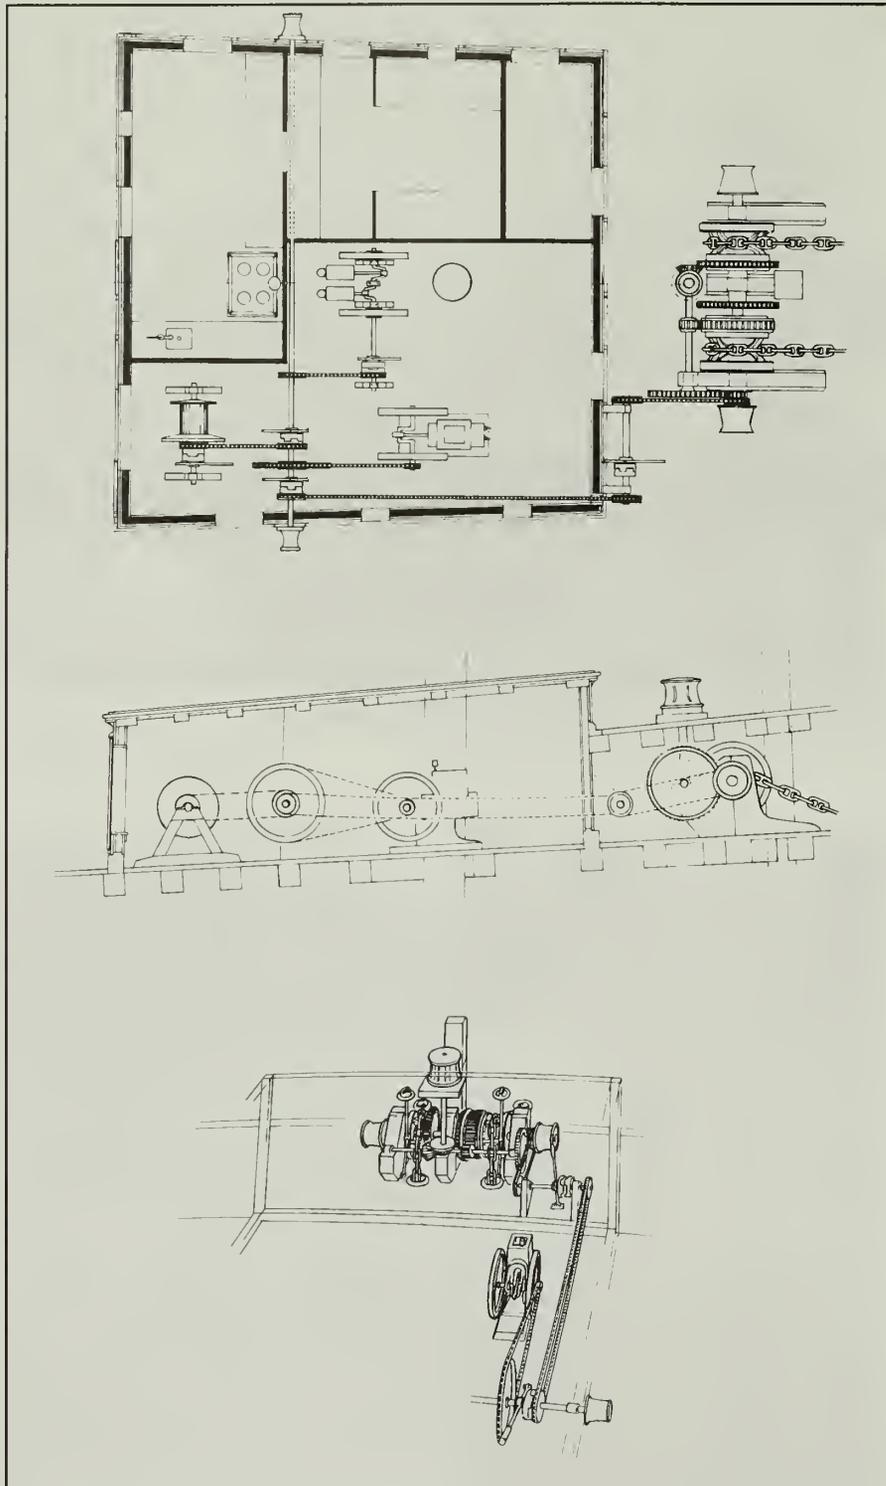
**Figure 4.101.** Messenger chain-driven windlass system (from Greenhill and Manning 1995:79 and 90).

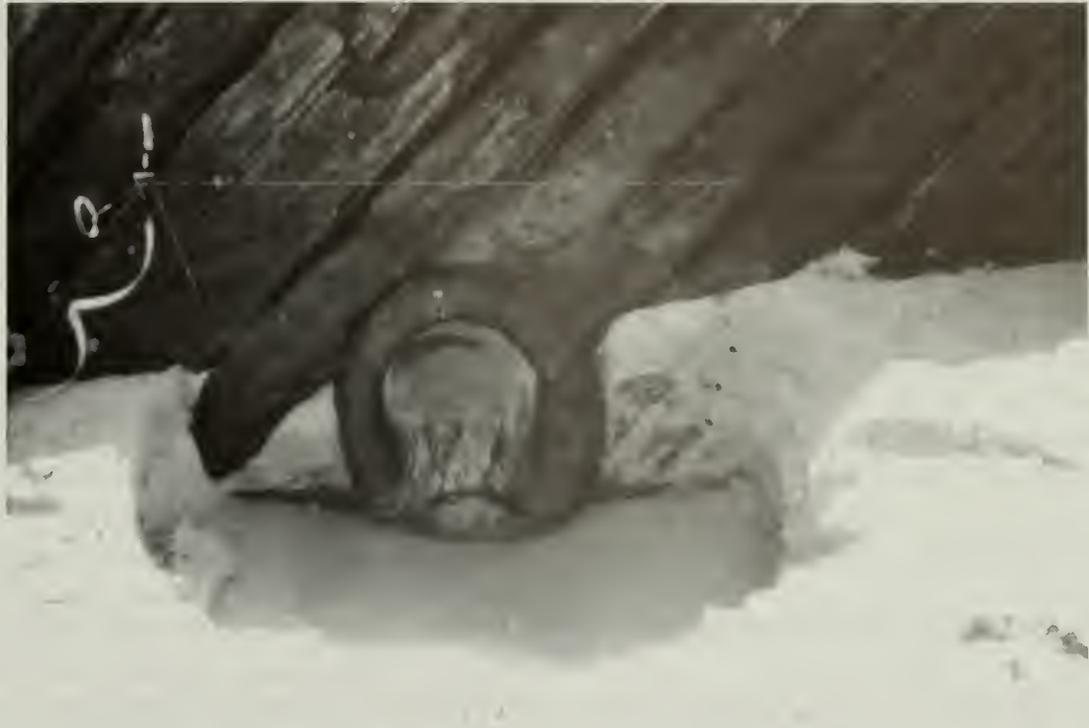
**Figure 4.102.** *Comet's* port-side hawse pipe. NPS photo by Don Morris.

The port hawse pipe is in place, piercing the port hull at main-deck level (Figure 4.102). The hawse pipe provided an opening for the anchor chain cable to pass through the bow to the windlass, and from the windlass into the chain locker. The hawse pipe is a flanged iron pipe with an outer face angled to fit the shape of the outer hull. The flanged opening is 1 ft. 5 in.

long x 1 ft. 6 in. wide, and the hawse pipe has an 11-in. interior diameter. Doing the same kind of analysis as above for the hawse pipes in Northwest Cove gives a different result. Using the same tables in Desmond (1919[1984]), a 400-ton vessel should carry a 1 1/8 in. diameter chain cable, which requires a 10<sup>3</sup>/<sub>4</sub> in. hawse pipe. This matches very well with *Comet's* 11-in. inside diameter hawse pipe. This complicates the identification of the shipwreck in Northwest Cove.

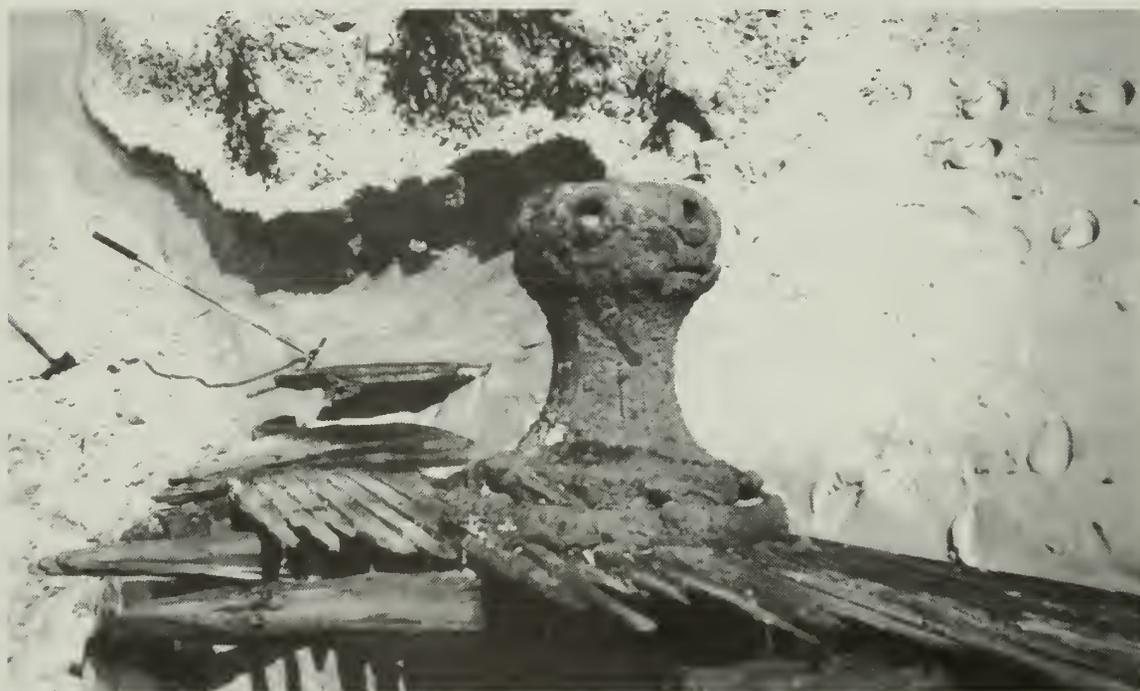
**Figure 4.103.** *Comet's* capstan, mounted in the center of the forecastle deck. NPS photo by Don Morris.

A hand-powered capstan is mounted in the center of the forecastle deck (Figures 4.103 and 4.104). It is not linked to the windlass, so is not technically part of the ground tackle. It was used for warping only, including such tasks as handling lines and assisting with raising sail (Campbell 1974:135). The capstan is 2 ft. 10 in. tall, with a 2-ft. 8-in. diameter base and 1 ft. 8-in. diameter head. This is presumably the "#3 capstan" specified in *Comet's* contract.

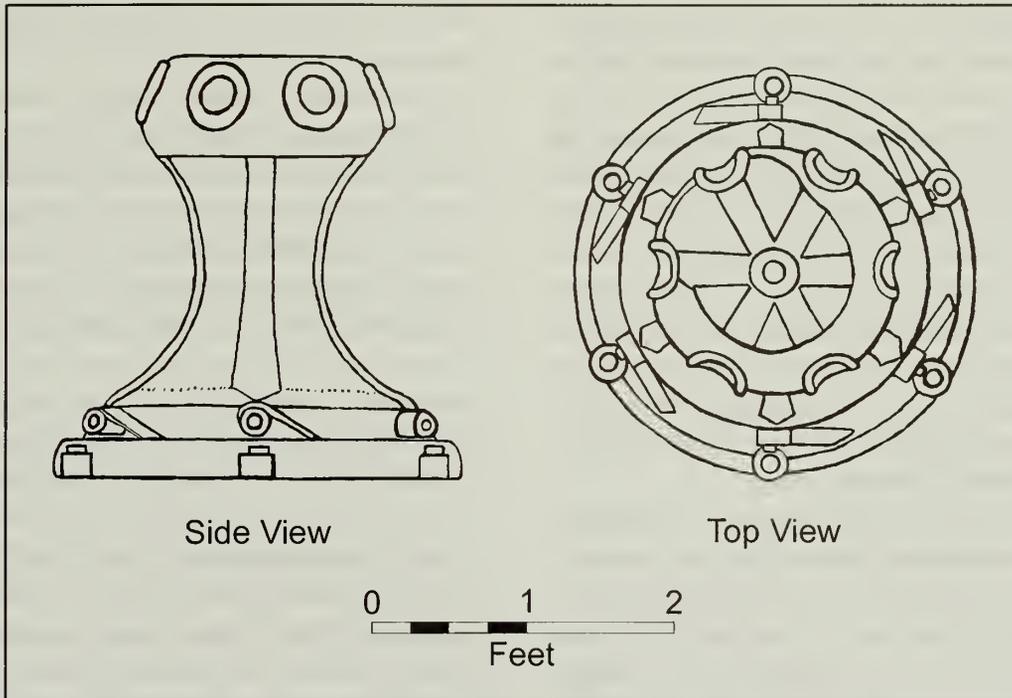
**Figure 4.104.** *Comet's* capstan. Drawing by Jim Bradford.

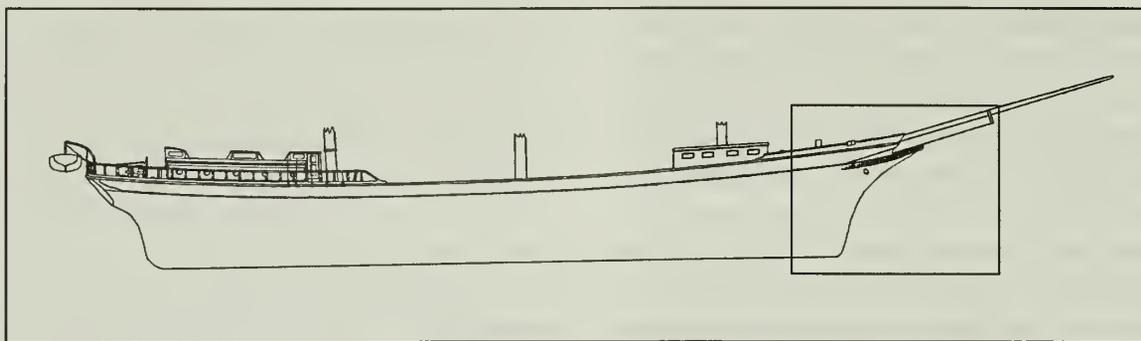
**Figure 4.105.** Area of *Comet's* preserved hull.

The majority of *Comet's* hull cannot be accounted for in the archeological record. Only about 10% of the hull was observed during this project. Significant natural forces worked to break the hull and separate the bow, but the location of the remainder of the hull is unknown. It is possible it is still buried elsewhere on the beach in Simonton Cove or was transported offshore and settled into the sediment. Alternatively, it could have gradually broken up and the pieces floated off into the Santa Barbara Channel. Further research, especially terrestrial
