Historic Lighthouse Preservation Handbook

1997

PD-375

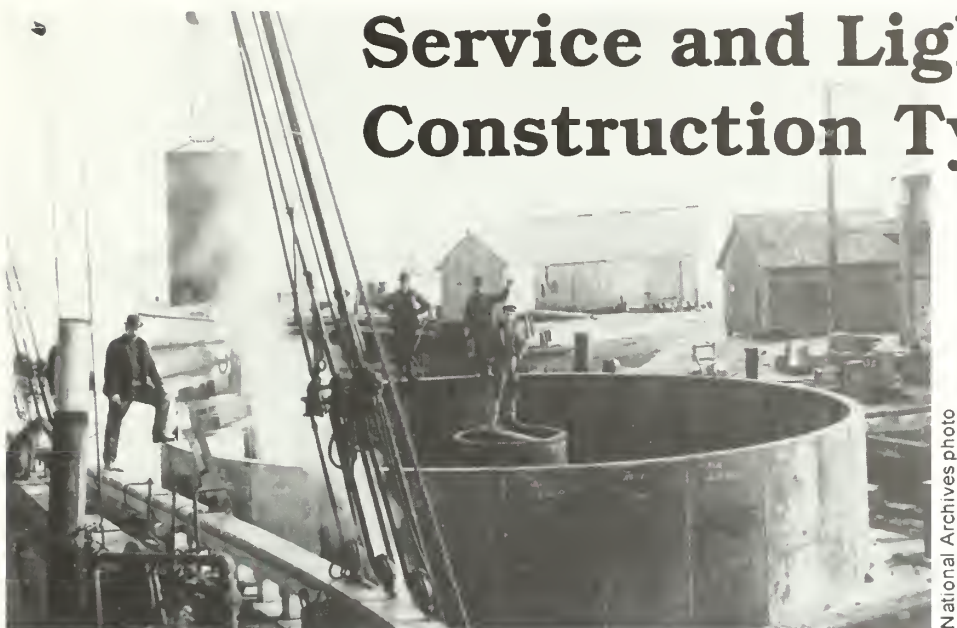
Figure 1. Assembly of Point No Point Lighthouse caisson at Solomons, Maryland, before being transported to site in Chesapeake Bay.

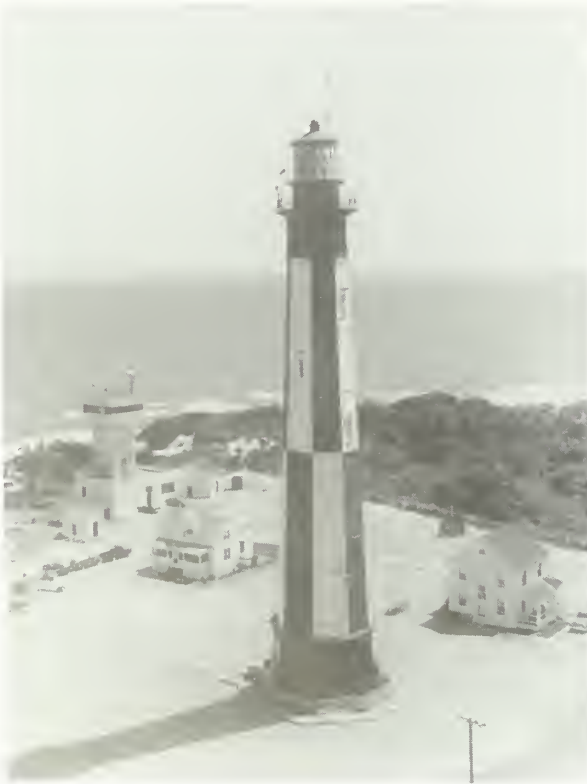
Figure 4. Cape Henry Light Station, cast-iron tower, Fort Story, Virginia.

Cast-iron-plate tower: Cast iron was lighter than stone or brick, relatively inexpensive, strong, watertight, and had a slow rate of deterioration. The second Cape Henry Lighthouse (1881), Virginia, is the tallest cast-iron-plate tower in the United States at 163 feet. Steel and wrought-iron plate was also sometimes used. This construction type was capable of being dismantled and moved; examples include Cape Canaveral, Florida and Hunting Island, South Carolina.

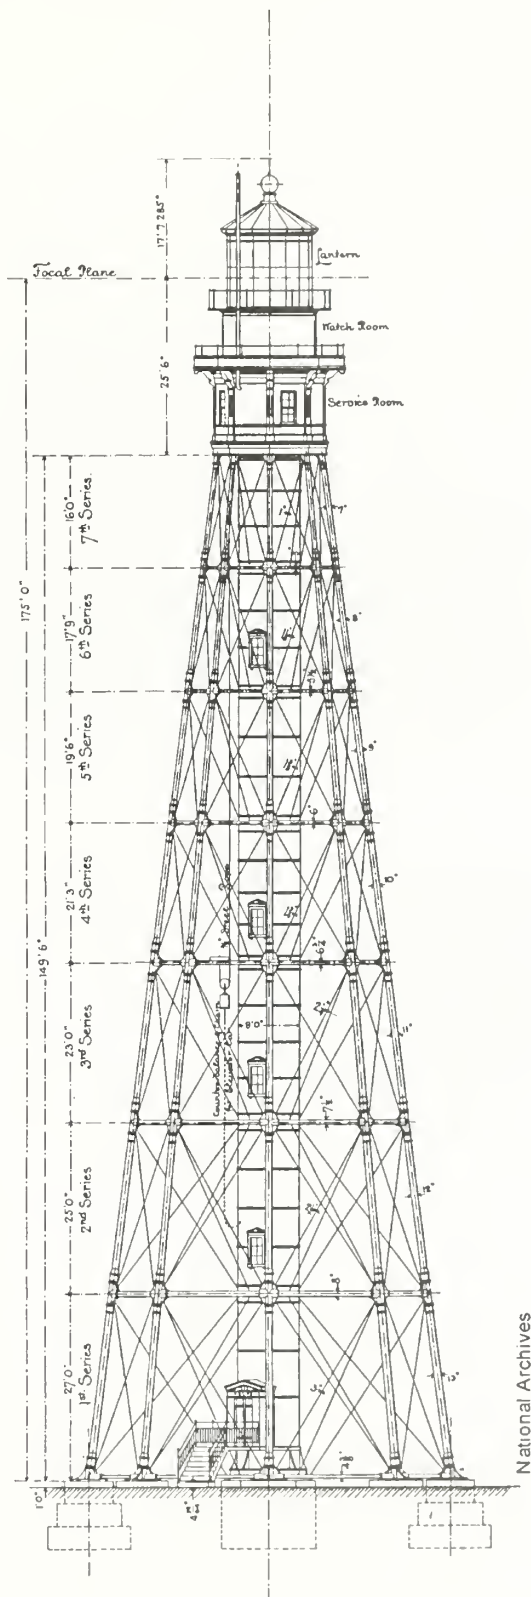
Figure 5. Construction drawing for Cape Charles Lighthouse, Virginia, an onshore skeletal tower.

Skeletal tower: Onshore skeletal towers were built of metal and were typically constructed on concrete foundations. Offshore skeletal towers were also built of metal and typically constructed with straight or screwpile foundations (discussed below). Manitou Island Lighthouse (1861) and Whitefish Point Lighthouse (1861), Michigan, both built from the same plan, are the earliest onshore skeletal towers built in the United States. Like the cast-iron-plate tower, skeletal towers could also be dismantled and moved.

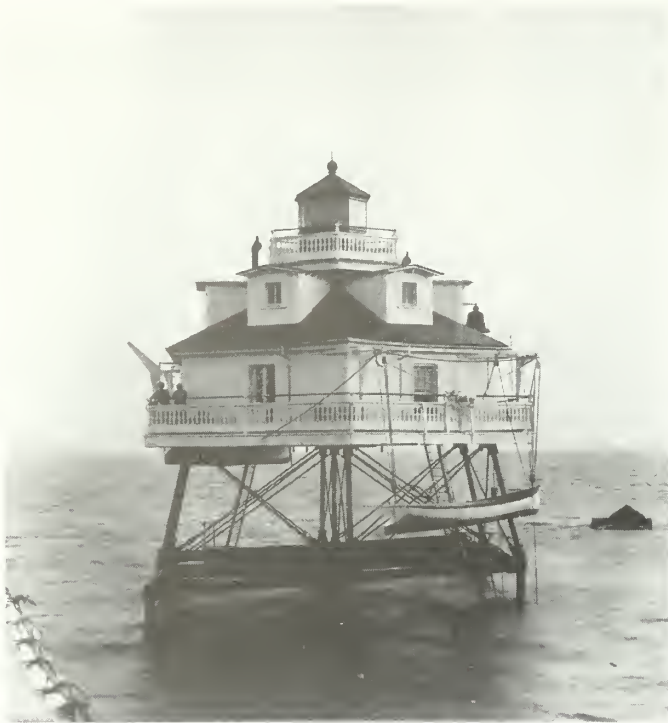
Figure 6. Thomas Point Shoals Lighthouse with screwpile foundation located in Maryland's Chesapeake Bay; shown here in 1885.

Screwpile: To increase the holding power of the pile, a screw-like flange was fastened to the bottom of the pile and wound like a screw into the substrate. There are two principal screwpile type lighthouses, 1) low spider-like foundations for rivers, bays, and sounds, and 2) tall offshore coastal towers. Perhaps as many as 100 spider-like screwpile lighthouses were built throughout the Carolina sounds, the Chesapeake Bay, Delaware Bay, along the Gulf of Mexico, and one even at Maumee Bay (1855) on Lake Erie in Ohio. Thomas Point Shoals Lighthouse (1875), Maryland, is the oldest extant, unmoved, spider-like screwpile lighthouse in the United States. The first of the tall skeletal screwpile coastal towers built in the United States was Carysfort Reef Lighthouse (1852), Florida, which still stands. A few offshore screwpile skeletal tower lighthouses built on coral reefs used foot plates or disks to help disperse the weight of the tower. Examples in the Florida Keys include Carysfort Reef Lighthouse (1852), Fowey Rocks Lighthouse (1878), and American Shoal Lighthouse (1880).

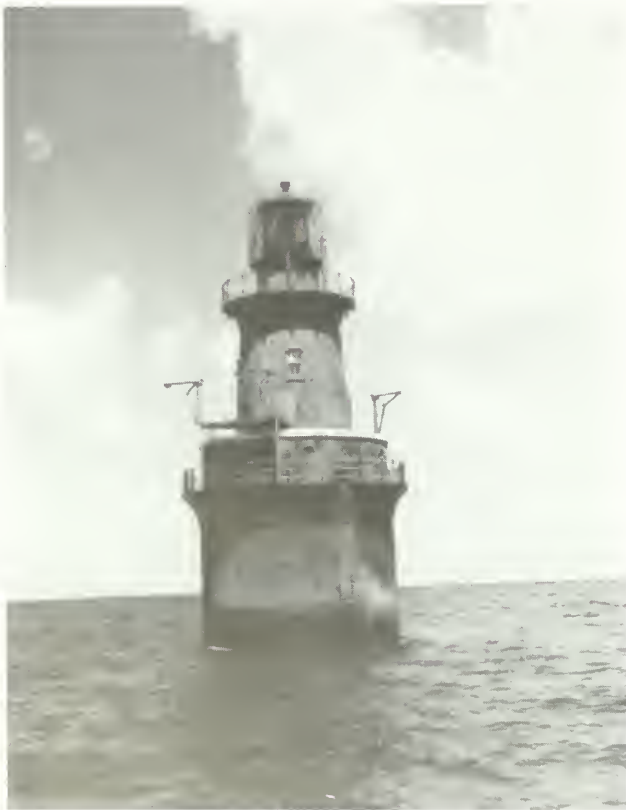
Figure 7. Sabine Bank Lighthouse with caisson foundation in Texas.

Caisson: Caisson foundations were best suited for unconsolidated bottoms composed of sand or mud. The caisson lighthouse type used a large cast-iron cylinder, which was sunk on the bottom and filled with rock and concrete to form a foundation. The caisson foundation was sturdier and better able

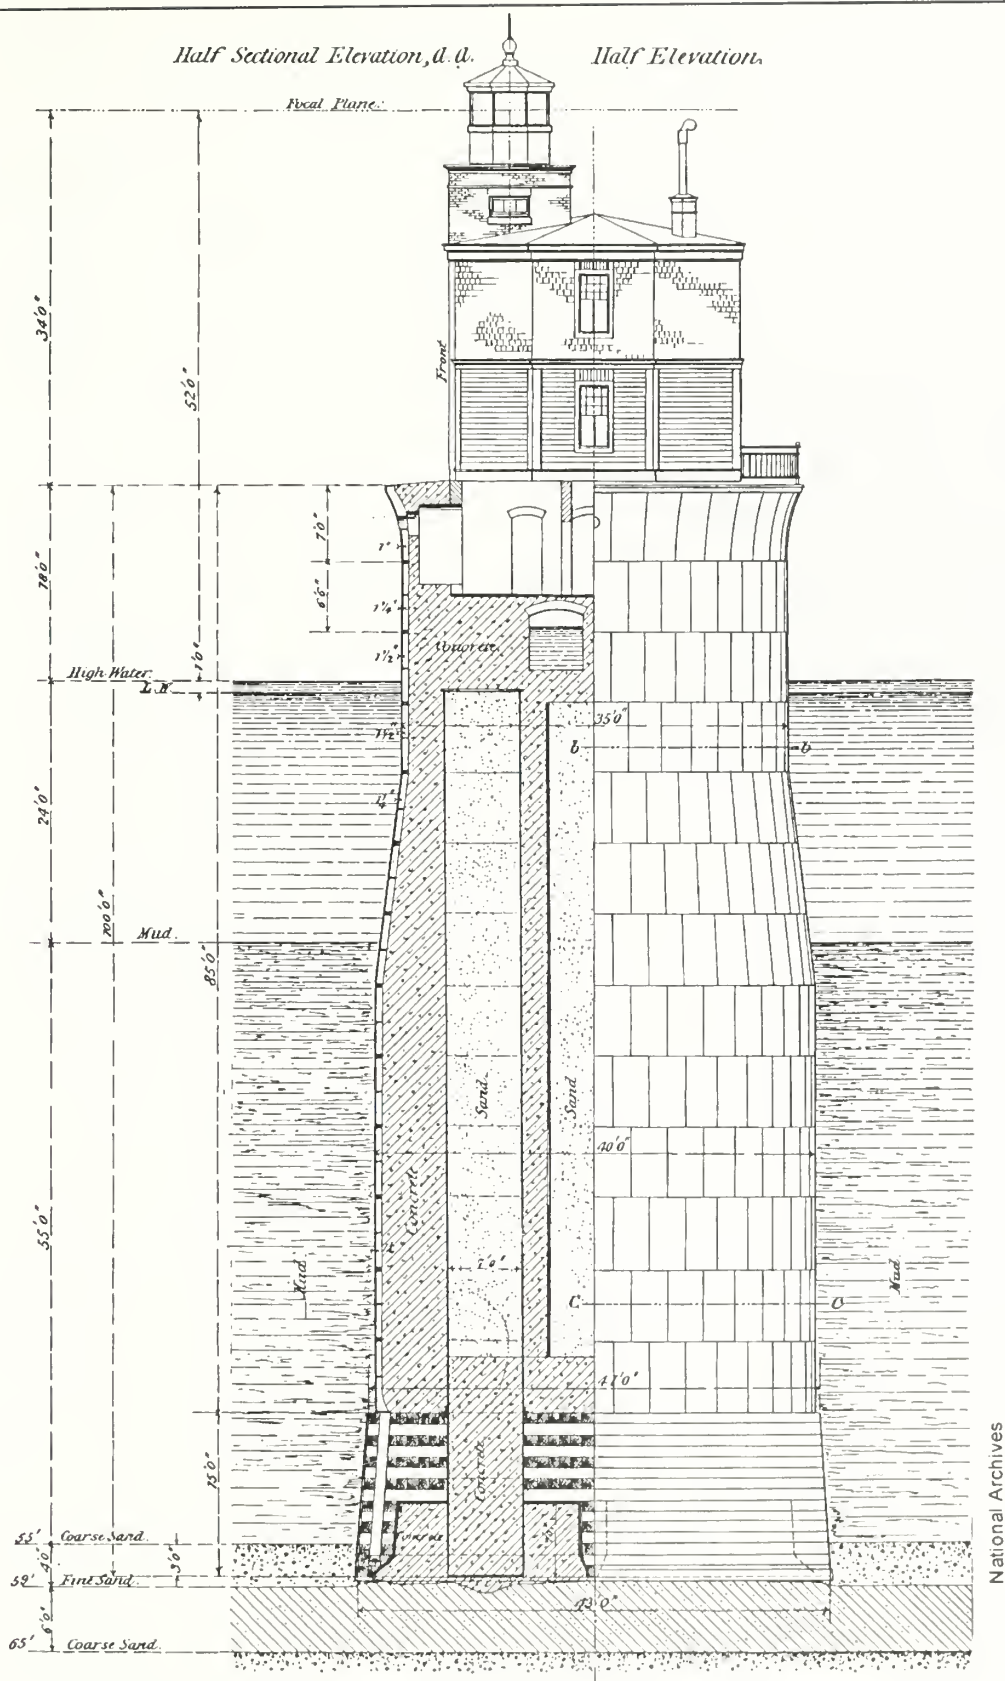
Figure 8. Construction drawing detailing the caisson foundation for Baltimore Lighthouse in Maryland's Chesapeake Bay.

to withstand heavy stress than the pile foundation lighthouses, so it is not surprising that caisson lighthouses were built in areas where moving ice was a hazard. The Craighill Channel Lower Front Range Lighthouse (1873), Maryland, is an early surviving example. Where bottoms were harder, contained rocks, and/or needed greater depth of penetration into the substrate, the pneumatic process was used. The substrate within the caisson was removed and the caisson allowed to sink further into the bottom. Eleven pneumatic caisson lighthouses were built in the United States. The Sabine Bank Lighthouse (1905), Texas, is the most exposed, located 15 miles offshore in the Gulf of Mexico—the only successful caisson south of the Chesapeake Bay.⁶

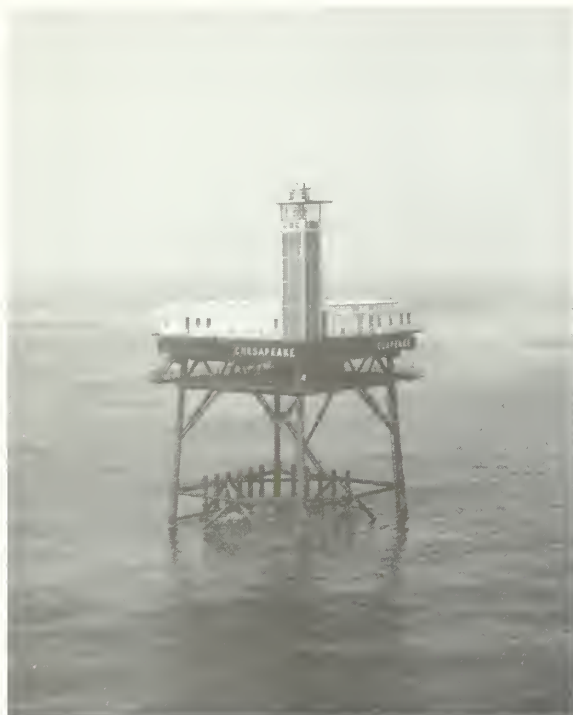
Figure 9. Chesapeake Light Station, Texas tower at entrance to Chesapeake Bay.

Texas Tower Type: A relatively recent technological development in lighthouse construction was the Texas tower type which replaced exposed lightships offshore. These so-called Texas towers were adaptations modeled on the offshore oil drilling platforms first employed off the Texas coast. The first Texas tower lighthouse in the United States was the Buzzards Bay Light, located in Buzzards Bay, Massachusetts, and commissioned on November 1, 1961. It has been extinguished and may be dismantled. A total of six Texas tower lighthouses have been constructed.

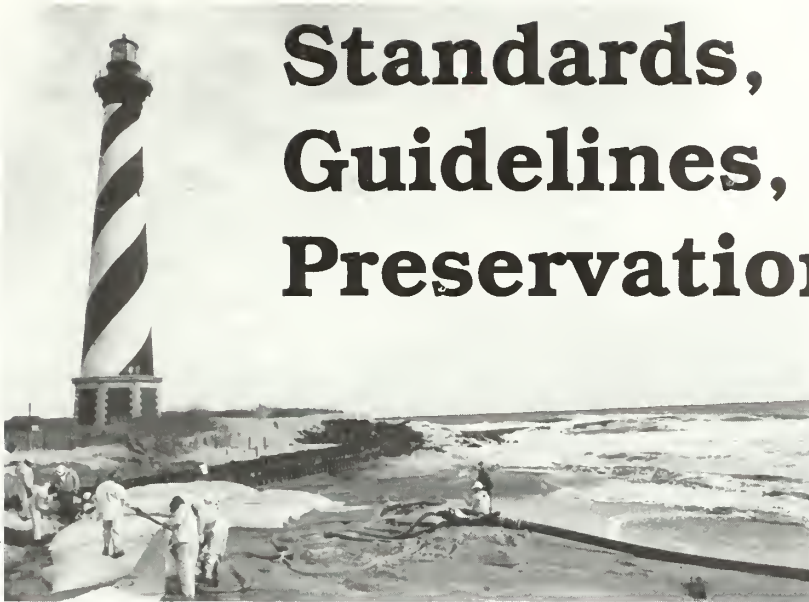
Figure 1. Sandbags are used to protect Cape Hatteras Lighthouse, Buxton, North Carolina, from further shoreline erosion.

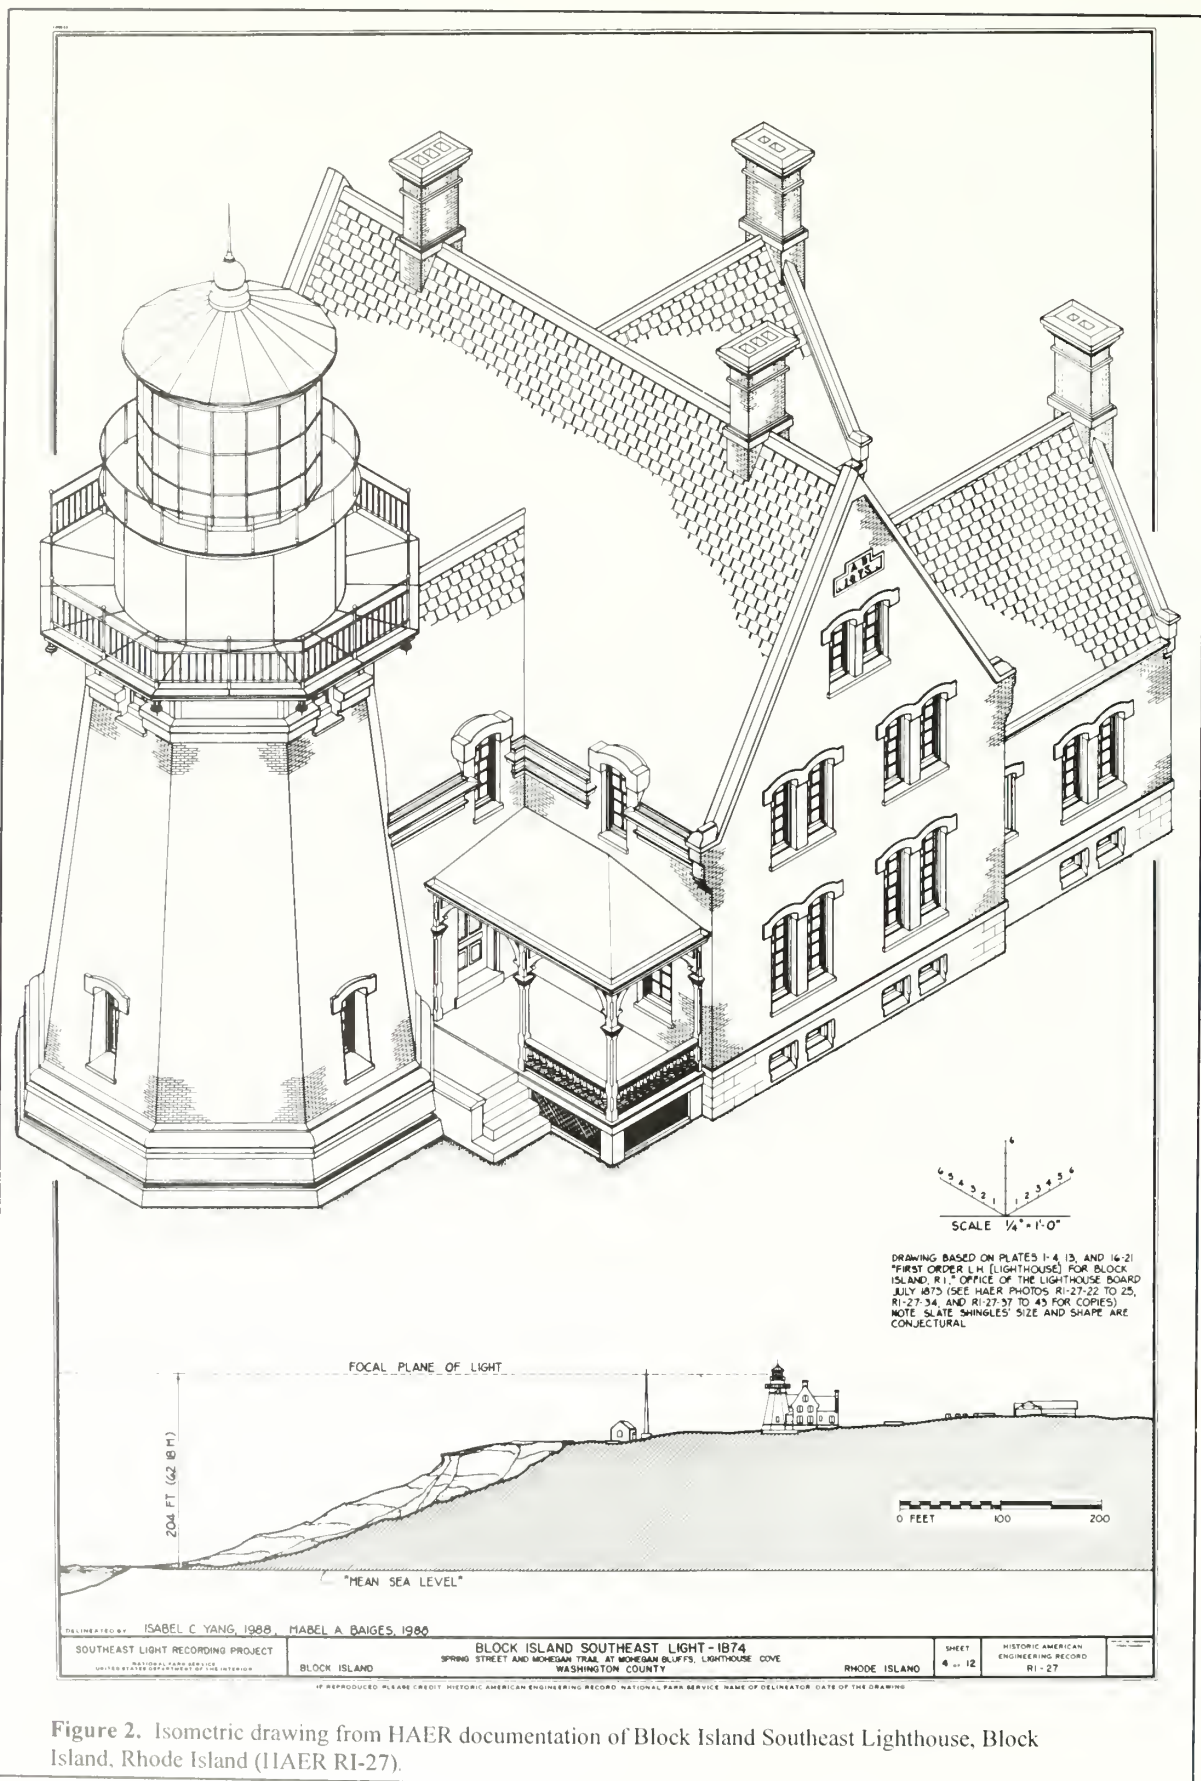
Figure 2. Isometric drawing from HAER documentation of Block Island Southeast Lighthouse, Block Island, Rhode Island (HAER RI-27).

In many cases, the first step in the preservation of a lighthouse, or any historic property, is documentation. The existing site should be recorded with drawings, photographs and historical and descriptive reports to define the characteristics and significance of that site. The HABS/HAER program of the National Park Service was created in 1933 to develop this type of documentation, establishing a standardized collection of the American-built environment, held for perpetuity within the Prints and Photographs Division of the Library of Congress. All materials are produced to archival standards and specific formats that assure a consistent

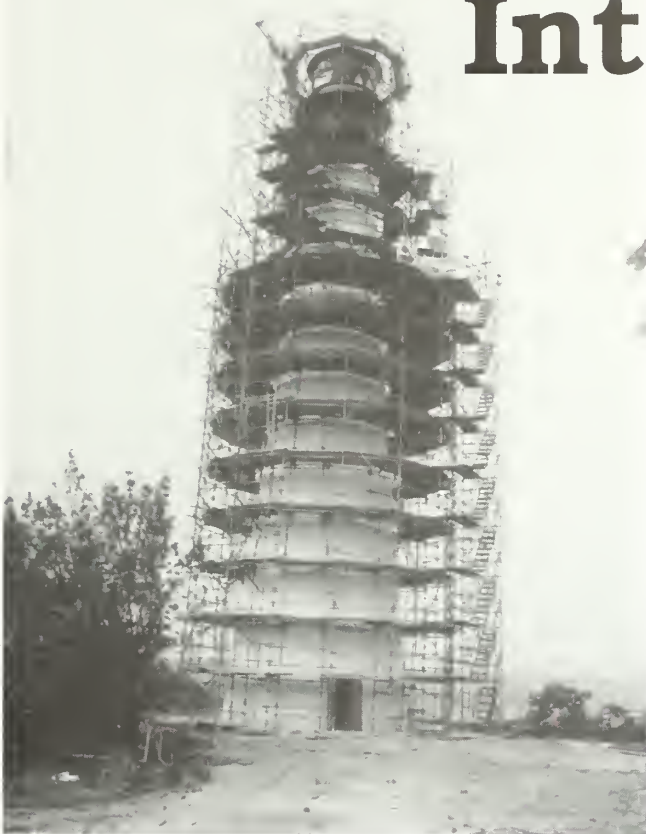
Figure 1. Brick replacement in 1996 restoration at Cape Florida Lighthouse on Key Biscayne, Florida.

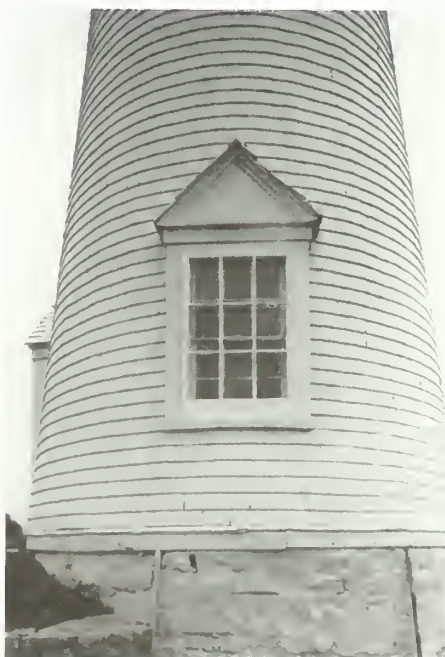
Figure 2. Stone masonry foundation in a 38-foot-tall wood-frame lighthouse in Maine.

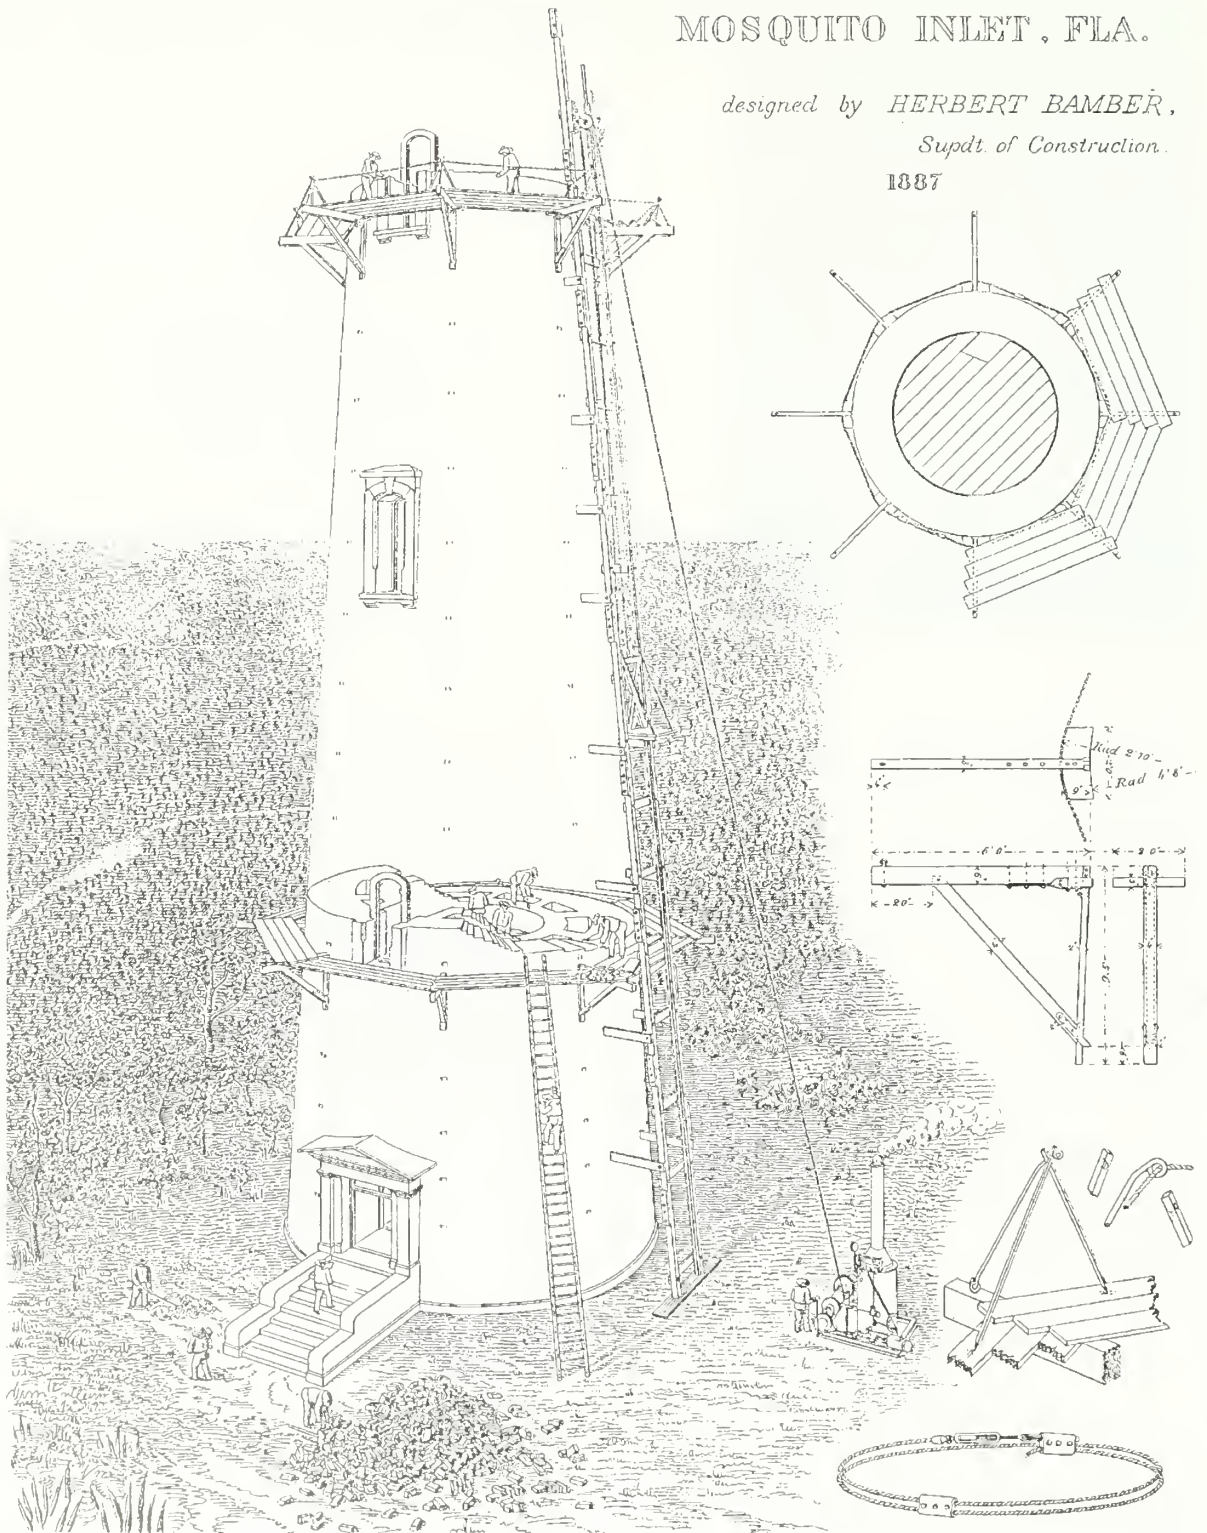
Figure 3. This construction drawing for Mosquito Inlet Lighthouse, Florida, shows the voids or cavities in the walls of tall masonry towers.

Masonry lighthouses are typically constructed in one of two configurations: solid wall or hollow cavity wall. Shorter towers tend to be solid-wall construction because the cross section of wall can be thin enough to support the lantern and interior stairs as well as economical to build. Tall towers are typically constructed with radiating cavities or voids. The exterior of the tower is the frustum of a cone while the interior is typically a cylinder. From the cylinder are radiating walls that tie into the exterior walls and create voids or cavities. The voids in the wall structure save weight while at the same time do not compromise the strength of the wall. The voids are typically vented to encourage air movement through the internal cavities. This ventilation system should be preserved and maintained.

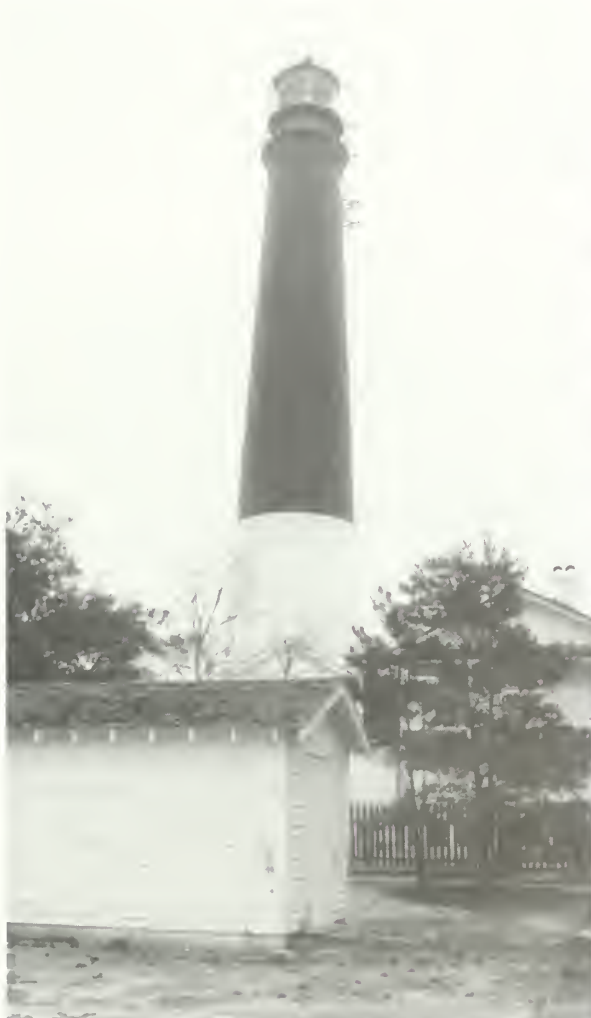
Figure 4. Brick masonry construction in the 171-foot-tall Pensacola Lighthouse in Florida.

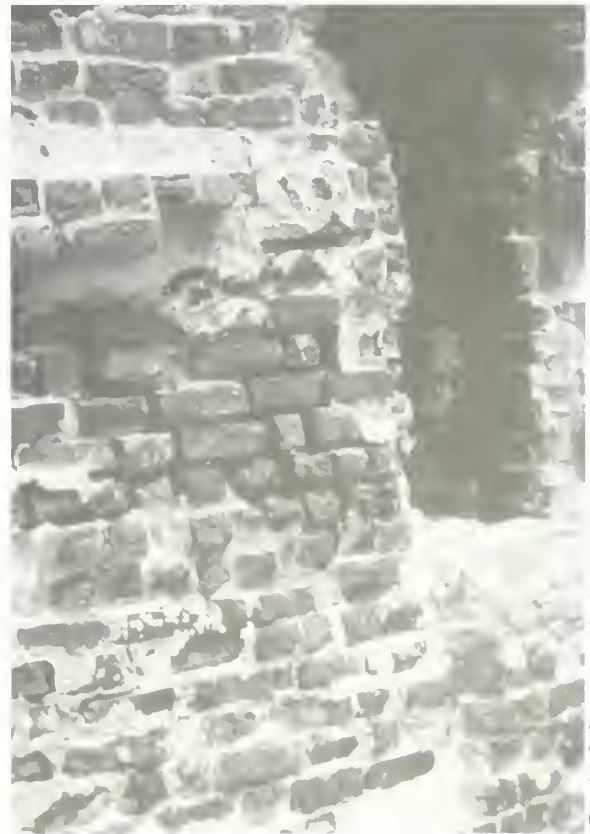
Figure 5. The coating that once protected the soft bricks of this lighthouse was not maintained; the severe deterioration required the replacement of nearly 25,000 bricks.

In some instances the vulnerable, softer masonry surfaces were not covered with a protective coating, or the protective coating was not maintained and the masonry has since deteriorated. In these cases the protective coating needs to be reinstalled after the required repairs are made, or the masonry may need to be consolidated by a qualified architectural conservator.

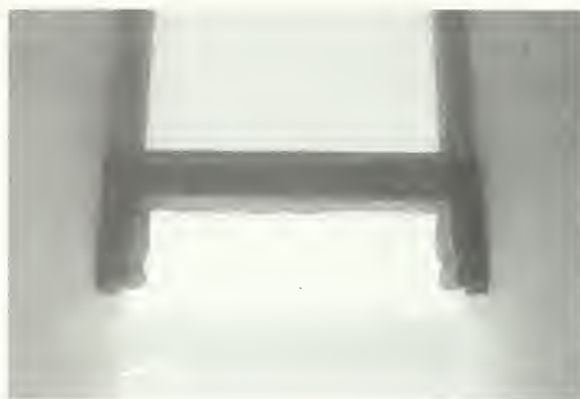
Figure 6. The once crisp edges of this decorative granite lintel have been eroded by constant high winds and airborne sand.

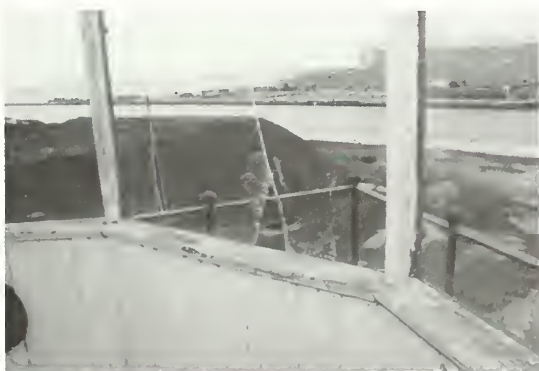
Figure 7. Lantern glass with holes and/or cracks should be replaced as soon as possible to minimize water infiltration. If immediate replacement is not feasible, the glass can be temporarily patched.

- **Lantern glass:** Lantern glass, frames, and roofs must be weathertight before mothballing. Refer to the **Lantern** section of this handbook for more information concerning weatherproofing lantern components.

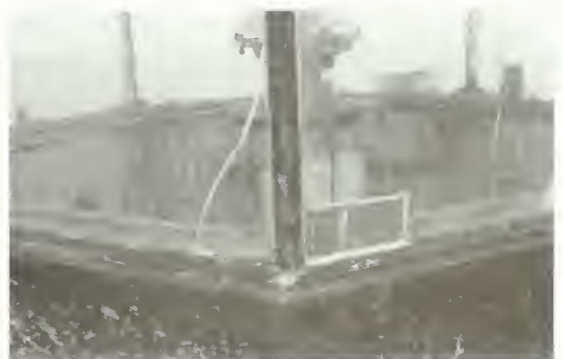
Figure 8. Detail of an acceptable temporary repair to a lantern glass using a piece of painted sheet metal that has been adhered to the glass with a high quality, exterior grade caulk. This type of temporary repair will prevent water from entering the lantern and therefore help avoid further damage. This fix should be considered only as an interim treatment until replacement of the lantern glass.

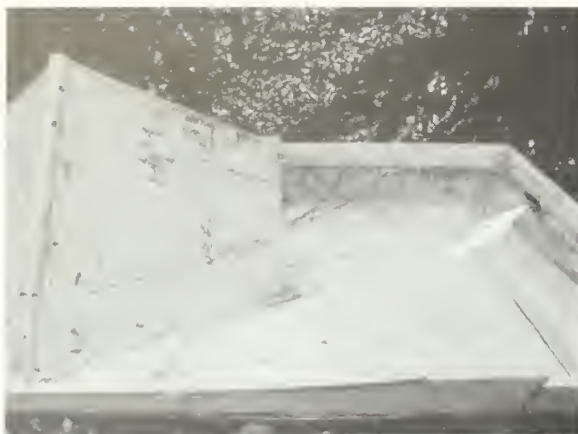
Figure 9. View of built-in gutter system on a mansard-style roof; the arrow indicates where a fist-size hole exists. This hole allows water to enter the interior of the lighthouse.

- **Built-in gutter systems:** All rainwater gutter systems (lantern roofs, or other tower roof forms) should be cleaned and checked for holes. All holes and non-functioning gutter system components should be repaired. For more information refer to the discussion on roofing in the **Lantern** section of the handbook.

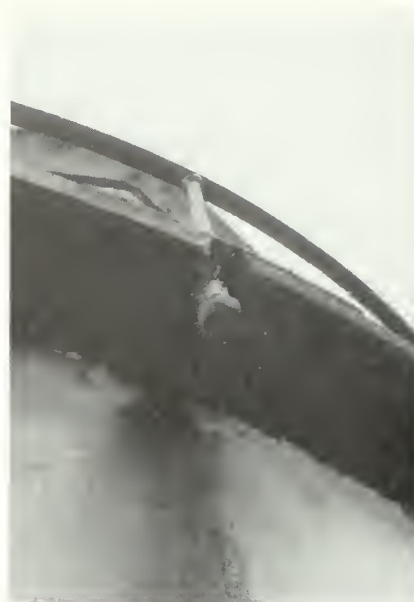
Figure 10. View of underside of gallery deck; the streaks on the stucco indicate that water is passing between the deck plates and possibly entering the masonry wall.

- **Gallery decks:** In most masonry lighthouses gallery decks are cast iron, sheet-metal-covered wood, stone, or concrete. These decks are generally laid directly on top of the masonry wall structure. The decking should be sloped away from the lighthouse to shed the water away from the structure. If the decking material is not weathertight, moisture can enter the interior cavity of the masonry wall. See Figure 10 for signs that a gallery deck is failing. Refer to the **Lantern** section of this handbook for more information concerning the weatherproofing of gallery decks.

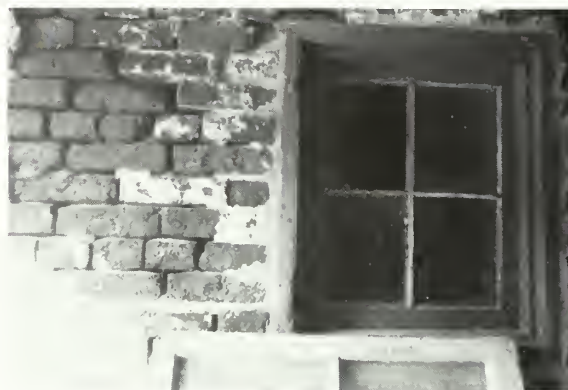
Figure 11. Detail of severely eroded brick and painting.

- **Loose or eroded mortar joints:** If pointing between masonry units is loose, cracked, eroded, or is completely missing, moisture will penetrate (see Figure 11). In order to prevent this infiltration, all pointing that is in disrepair must be removed and the affected joints repointed. For more information refer to the discussion on repointing under the **Repair** treatment in this section of the handbook.

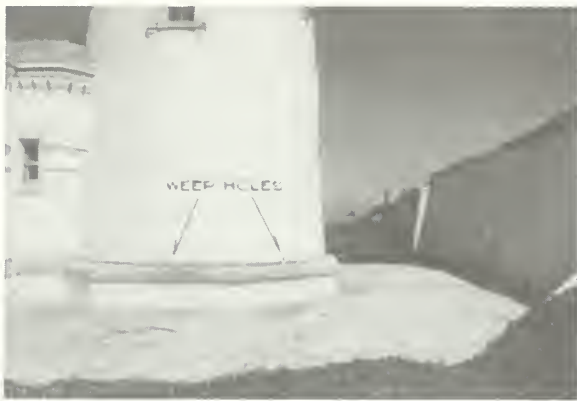
Figure 12. Typical masonry lighthouse weep hole locations. Each weep hole provides drainage for each individual cavity within the masonry wall.

- **Weep and vent holes:** If the walls have cavities between the interior and exterior walls, weep holes may exist at or near the base of these walls. Weep holes typically range in size from small slits to large brick headers. These holes allow any moisture that has entered the cavity between the walls to drain out. These openings must be kept clear in order to provide sufficient drainage of the cavity. In some instances the walls may have vent holes (larger than weep holes) that allow the movement of air through the cavities or voids. Typically vent holes open into the interior. These openings must be kept clear in order to provide sufficient ventilation (see Figure 12).
- **Protective coatings:** Lighthouses were often painted as a protective measure and for identification as a daymark. As part of a

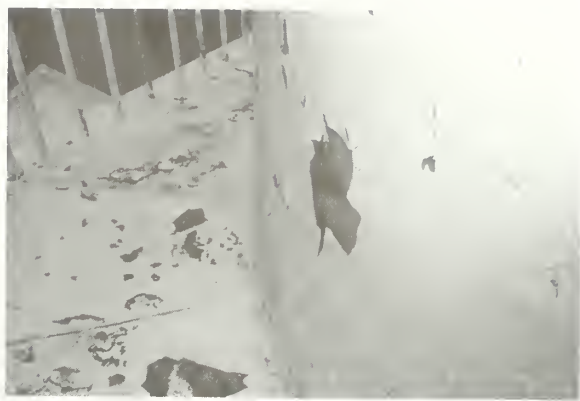
Figure 14. Detail of failing paint, a problem which should be addressed during stabilization and protection. In this particular case, spot painting may be all that is required to maintain a weatherproof protective coating.

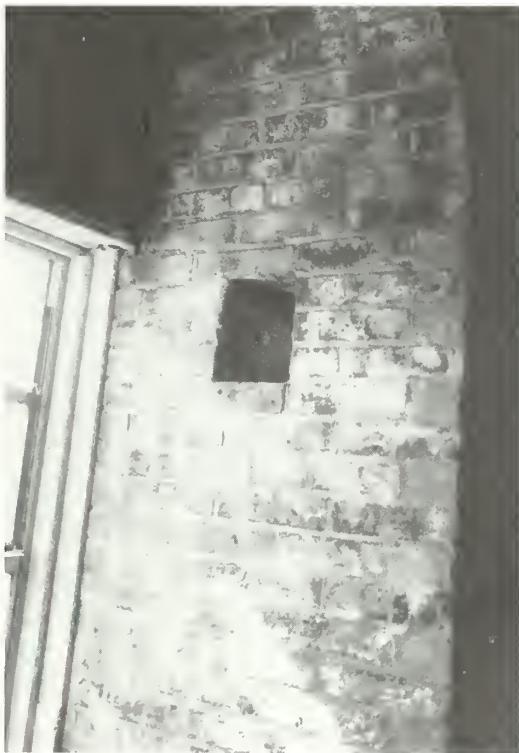
Figure 13. Vent hole located in the window well of a brick lighthouse.

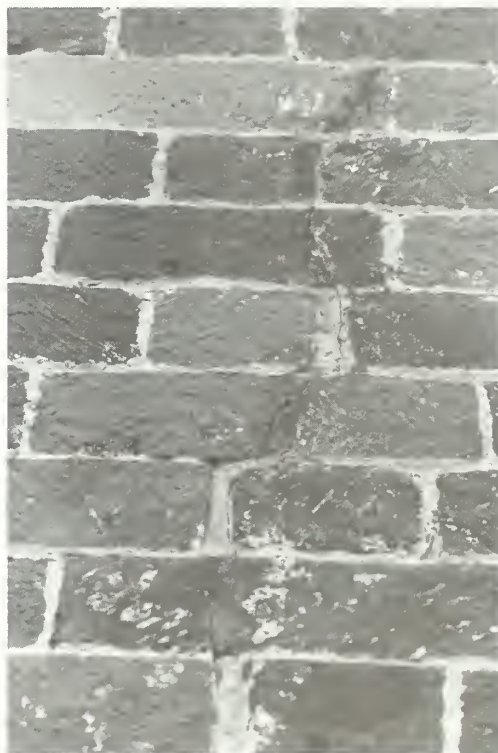
Figure 15. Cracks such these in a sandstone lighthouse should be monitored for movement prior to treatment.

- **Open cracks in walls:** Cracks in exterior masonry walls indicate that movement has occurred, either caused by shrinkage (in the case of stucco) or by settlement or mechanical impact. Cracks should be monitored to determine if movement is still occurring and

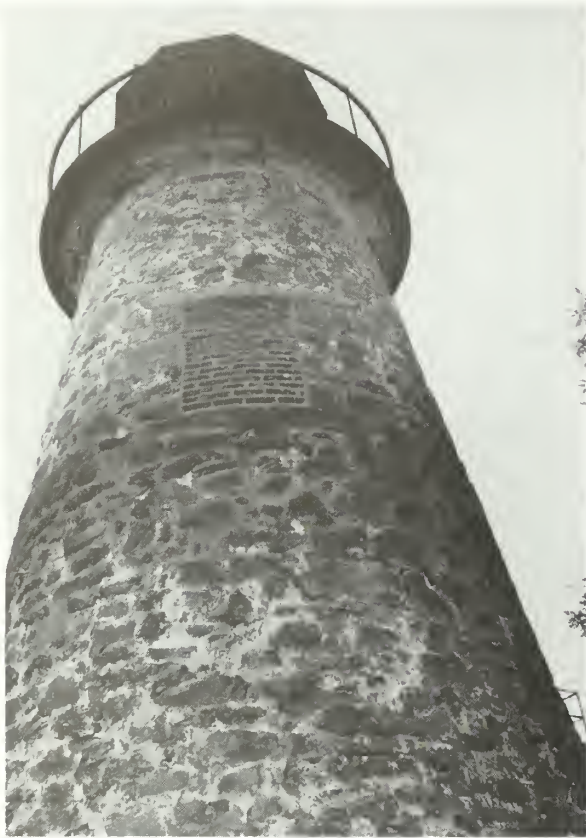
Figure 16. An example of a reversible masonry stabilization treatment for the window opening that has prevented structural deterioration and moisture infiltration.

‘mothballed’ period. If funds are insufficient to make structural repairs, structural stabilization should be performed as a less expensive temporary alternative. Temporary blocking in of window and door openings and installation of interior or exterior shoring or bracing are all stabilization methods. Figure 16 illustrates a window opening that has been stabilized with brick infill. Brick is a historic stabilization method in stone masonry construction. If this method is used, the

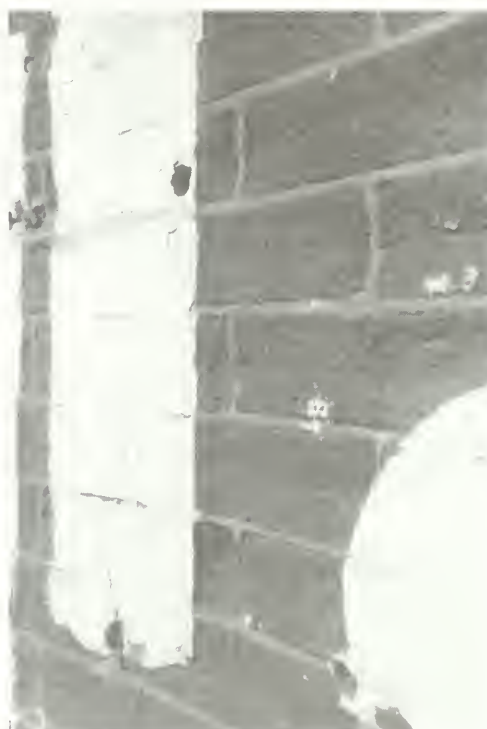
Figure 17. Deeply eroded brick as a result of sandblasting. The white areas are where electrical components were attached to the wall at the time of sandblasting.

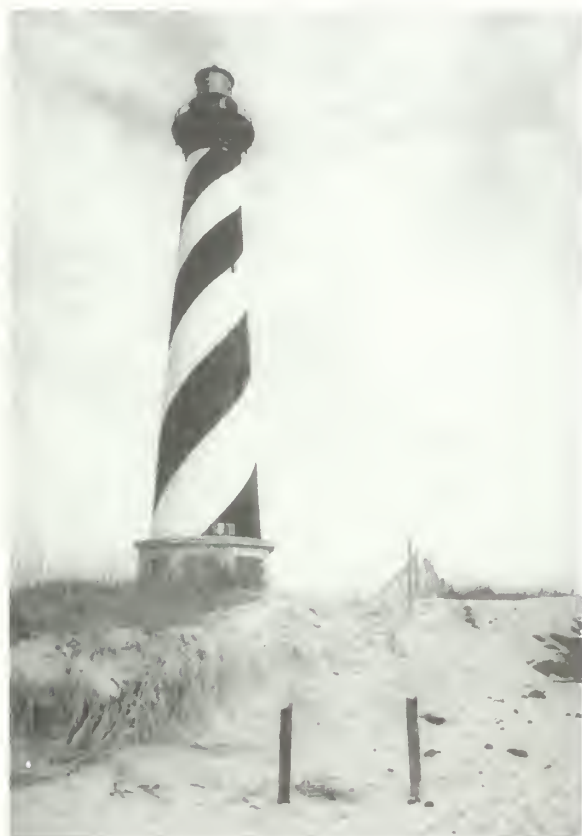
Figure 16. Daymark patterns are a character-defining feature and should be preserved.

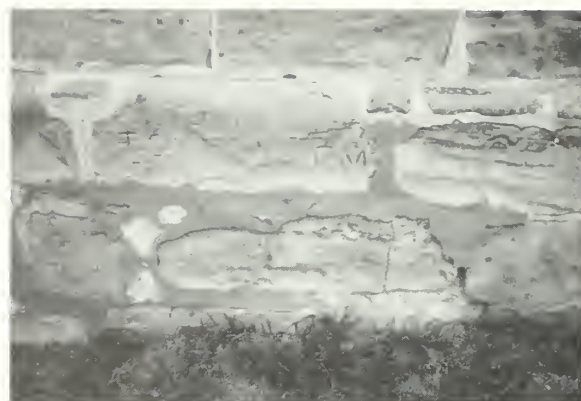
Figure 19. The use of hard portland cement mortar and sloppy pointing technique have aided in the deterioration of this soft sandstone wall.

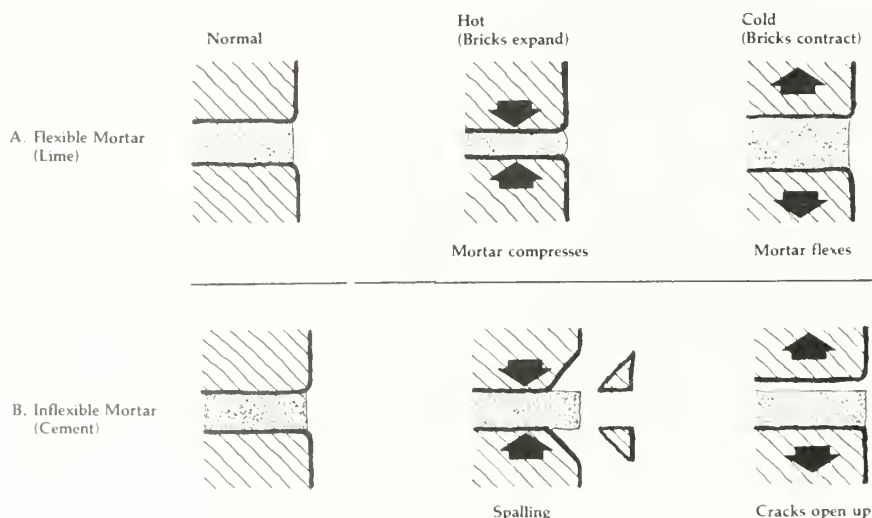
Figure 20. Diagram showing the behavior of lime-based mortar and cement-based mortar during relative temperature changes of the surrounding masonry. (Source: NPS *Preservation Briefs 2, 1980*)

When repointing joints in historic lighthouses, special care must be given to the matching of the strength of the replacement pointing mortar with that of the original pointing mortar. Historically, softer lime-based mortars were used for pointing. If the compressive strength of the original mortar cannot be readily determined, i.e., the lighthouse had been improperly repointed with a hard portland cement based mortar, the mortar should be matched to the compressive strength of the brick on stone. For more information on repointing historic lighthouses refer to NPS *Preservation Briefs 2: Repointing Mortar Joints in Historic Brick Buildings*. These softer mortars were flexible enough to expand and contract with the expansion and contraction of the masonry units which made up the wall structure.

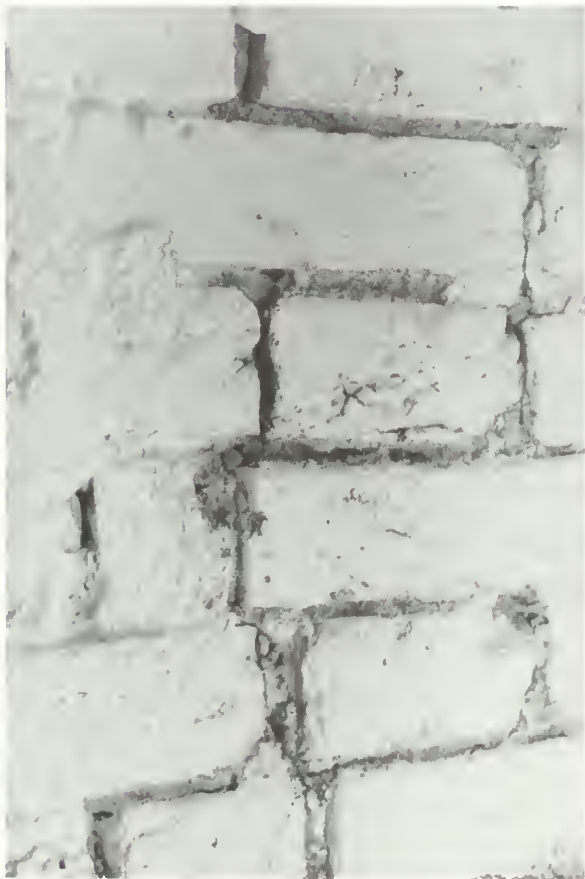
Figure 21. Detail of eroded pointing.

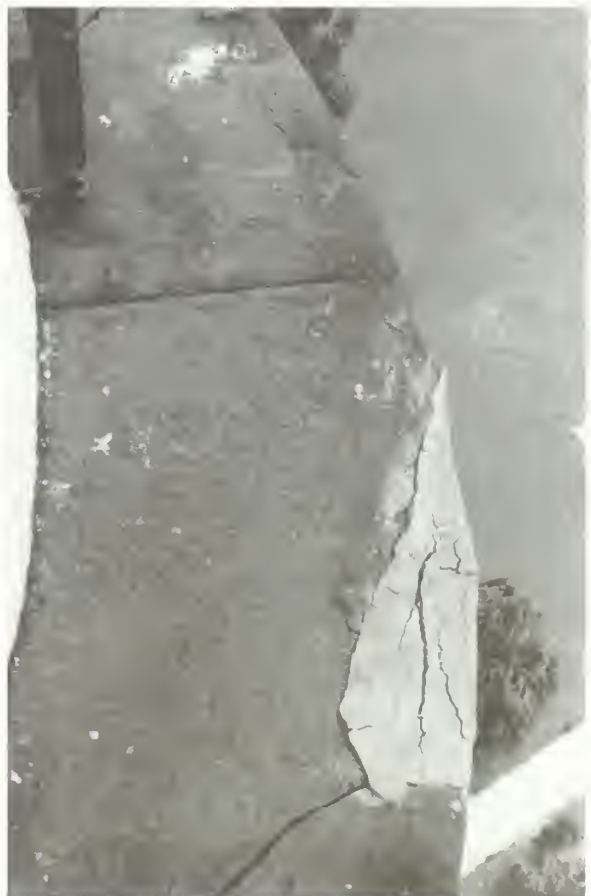
Figure 22. A failing repair made to a stone gallery deck using a simulated stone material. A stone dutchman repair should have been used.

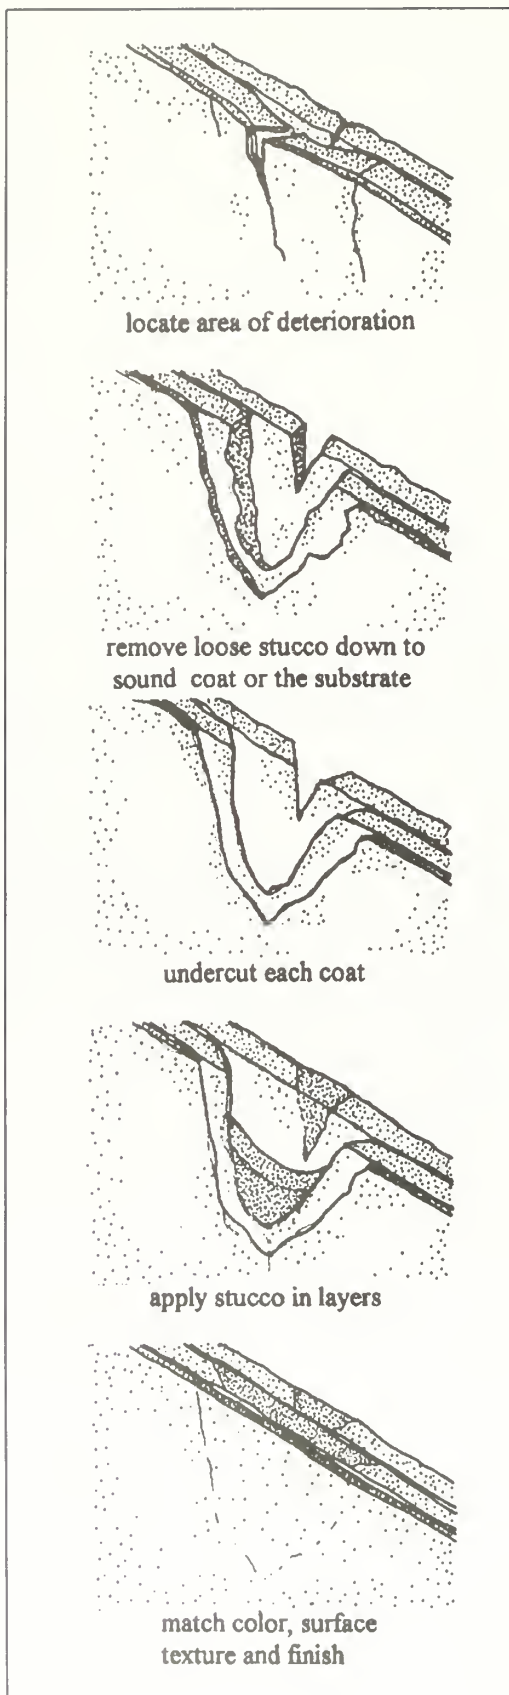
Figure 23. The five basic steps of stucco repair; each layer of stucco must be patched separately. (NPS drawing)

- Remove previous patches that do not match texture, color, or strength of the original stucco.
- Undercut the repair boundaries to create a dovetail-shaped mechanical bond between the old and new stucco.

- Test new stucco in an inconspicuous location and allow test samples to weather as long as possible, ideally for one year. Matching the original material will probably require a number of test samples.

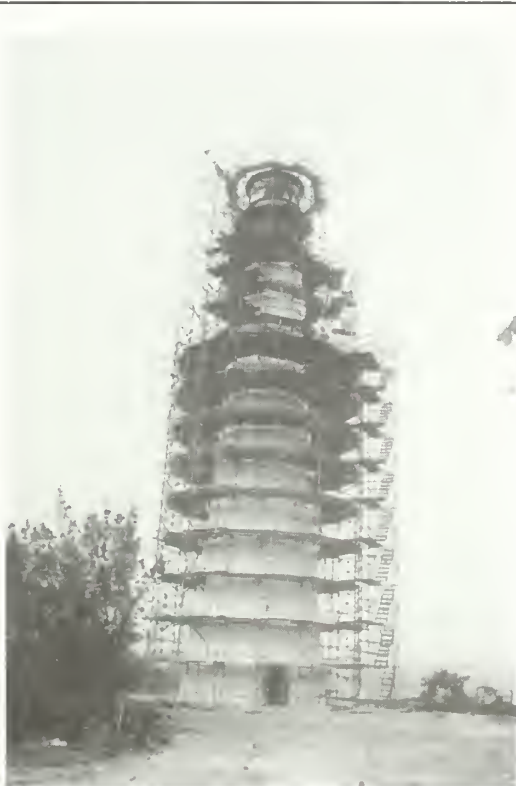
Figure 24. Cape Florida Lighthouse with scaffolding used during the 1996 restoration. The white coating on the tower is the lime mortar wash applied to help protect the damaged brick and to restore the tower to its 1846 appearance.

To protect the historic bricks from further deterioration, the exterior of the tower was coated with a sacrificial lime mortar wash. Protection of the soft masonry is vital to

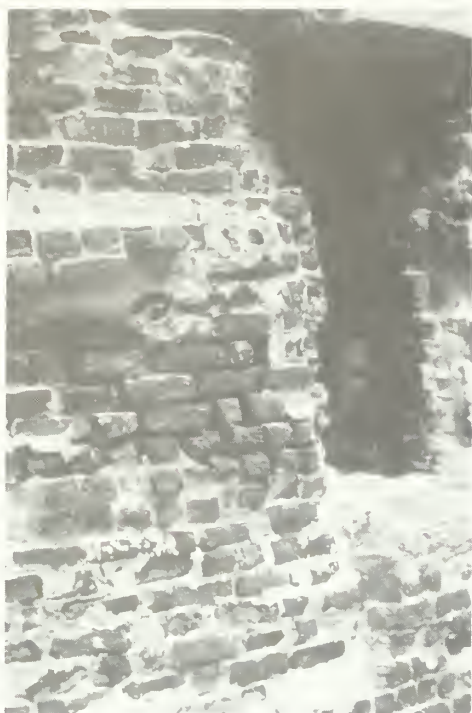
Figure 25. View of the lower portion of the tower showing the more severe deterioration. Note that a large percentage of the first brick wythe is missing or has been removed. The white areas are remains of a portland-cement-based parging applied in the late 1960s in an effort to protect the deteriorating bricks.
