Historic Lighthouse Preservation Handbook

1997

PD-375

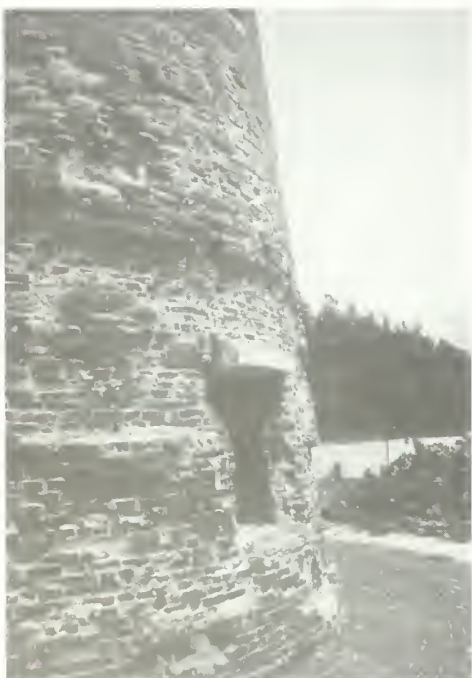
Figure 26. View of the lower tower window; note the depth of the brick deterioration at the window openings. The face of the protruding granite lintel above the window opening represents the face of the original wall.

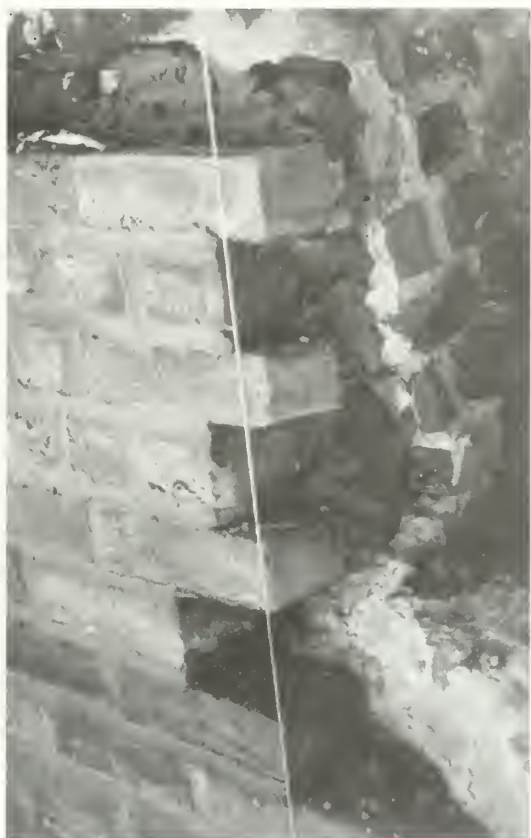
Figure 27. View of repairs being made to the exterior wall. A new brick wythe is being installed where bricks were missing, using mortar that matches the strength of the new and historic bricks. Masonry anchors are used to attach the new wythe to existing wall. The deteriorated mortar joints in the extant wall were repointed with a matching mortar mix.

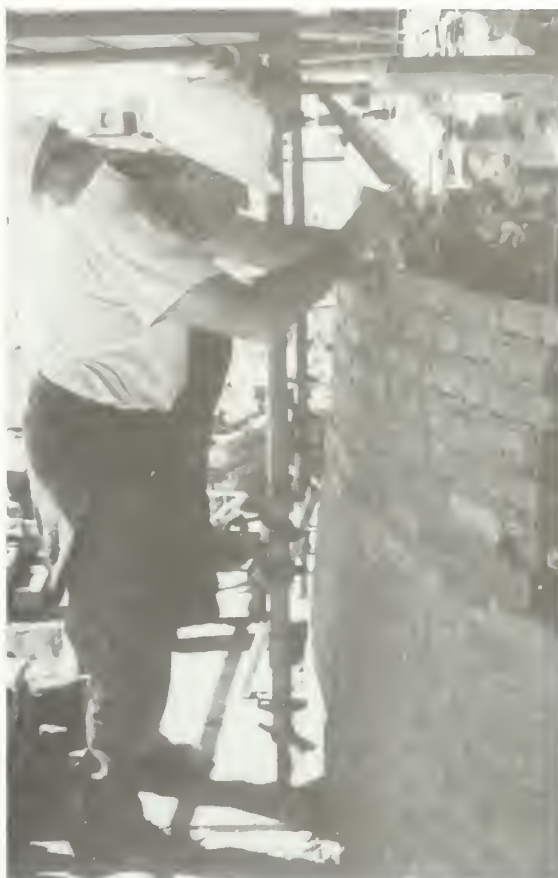
Figure 28. Here a mason is implementing repairs to the exterior wall. The missing bricks were replaced with in-kind materials: the bricks match the historic bricks in size shape and strength. The mortar joint sizes are also being made to match the historic in size, color, and texture, as demonstrated in this photo. The vertical strings over the brickwork define the wall plane, so when the mason places the bricks, they maintain the taper of the conical tower.

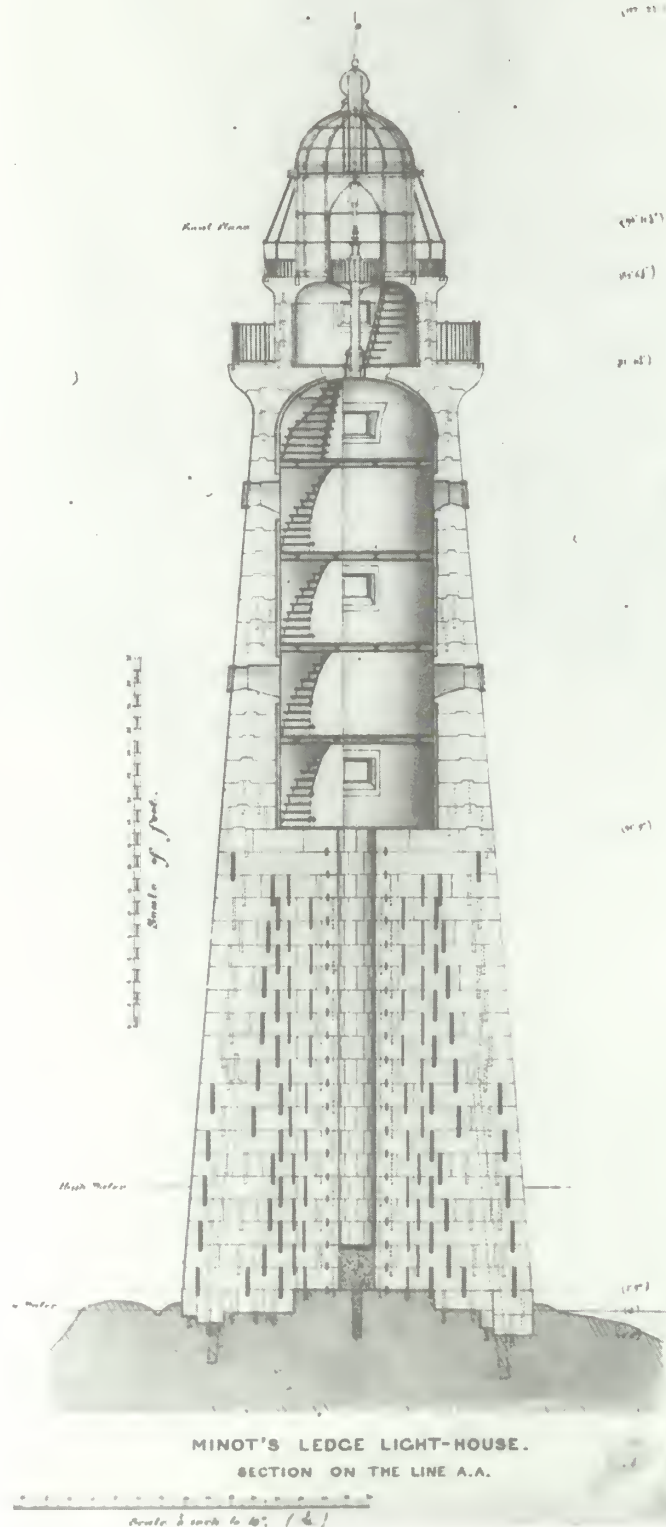
Figure 29. Cross section for 114-foot Minots Ledge Lighthouse.

On August 31, 1852, Congress approved the erection of the second and still standing lighthouse on the “Outer Minots rock.” This time the design chosen was one of interlocking granite blocks. The plans consisted of a masonry tower in the form of a frustum of a cone, solid for the lower 40 feet of its 114-foot height. Because the ledge was exposed only at low tide and on calm days, the work was very slow. Tides were found to be right only “six times during any one lunation, three at full moon and three at the change.” It took three years to prepare the ledge for the first course of granite masonry which was cut and test assembled on nearby Gulf (later called Government) Island, near Cohasset, where the government acquired 7.3 acres of farmland for a staging area for the building of the second lighthouse. Here stone-sheds were erected for the stone cutters and a perfectly flat pavement prepared so the stones once cut could be pre-assembled for correct fitness. Granite from Quincy was chosen as being “finest of grain, toughest and clearest of sap.” An iron scaffold was erected on the ledge for the safety of the

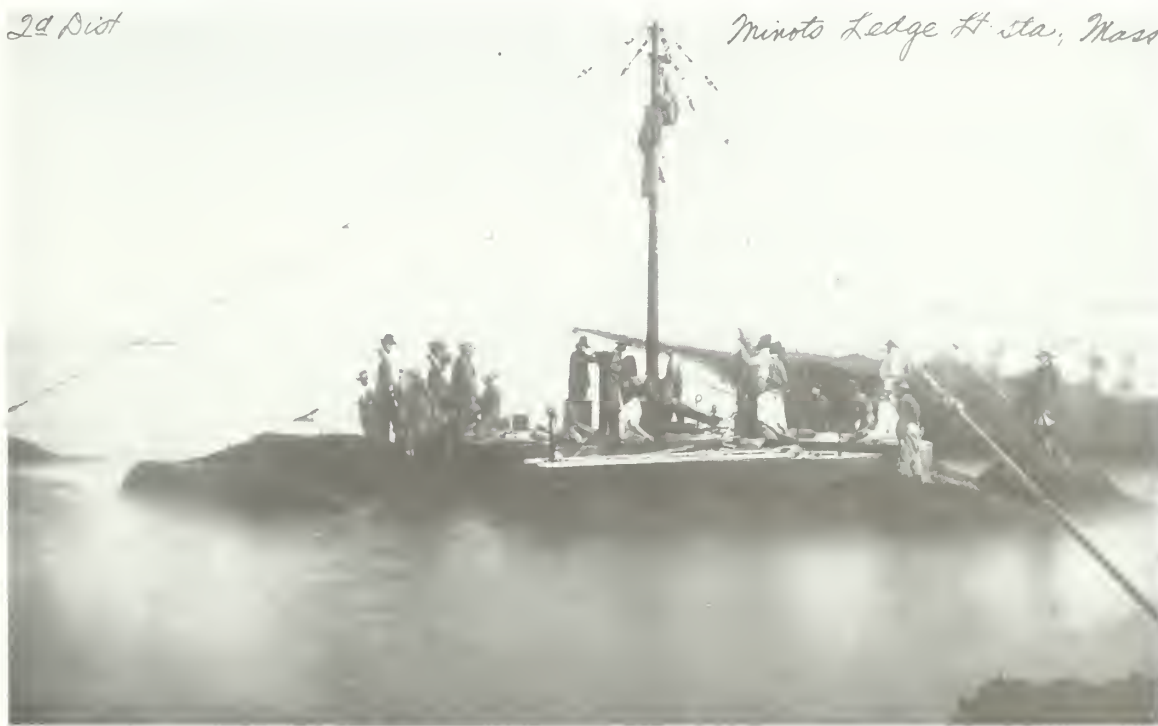
Figure 30. Workers on a calm day, completing the first course of granite block for the foundation of Minots Ledge Lighthouse, 1858

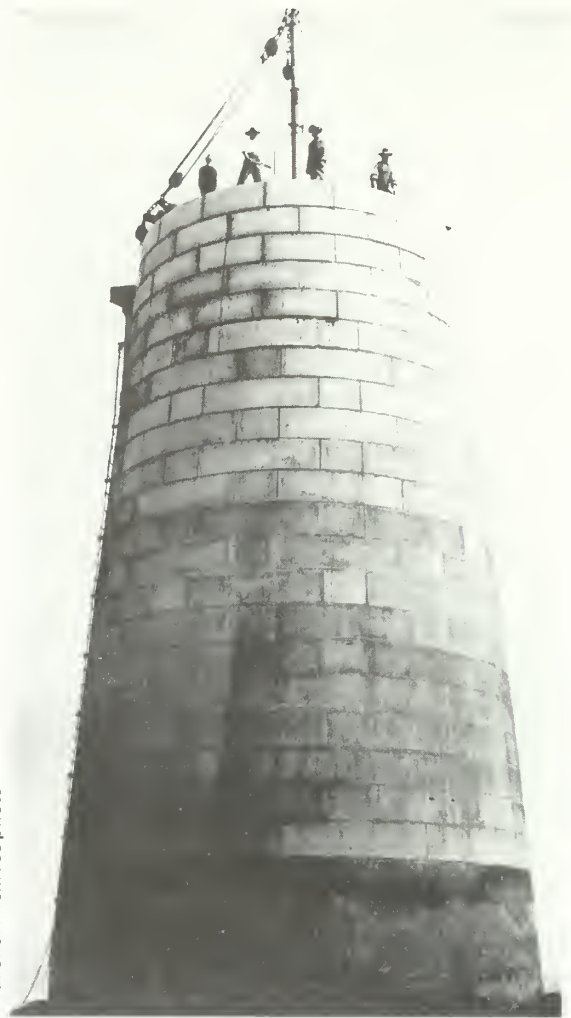
Figure 31. Work on Minots Ledge Lighthouse as it progressed just above the entrance level which is visible on the left. The tower below this level was essentially solid.

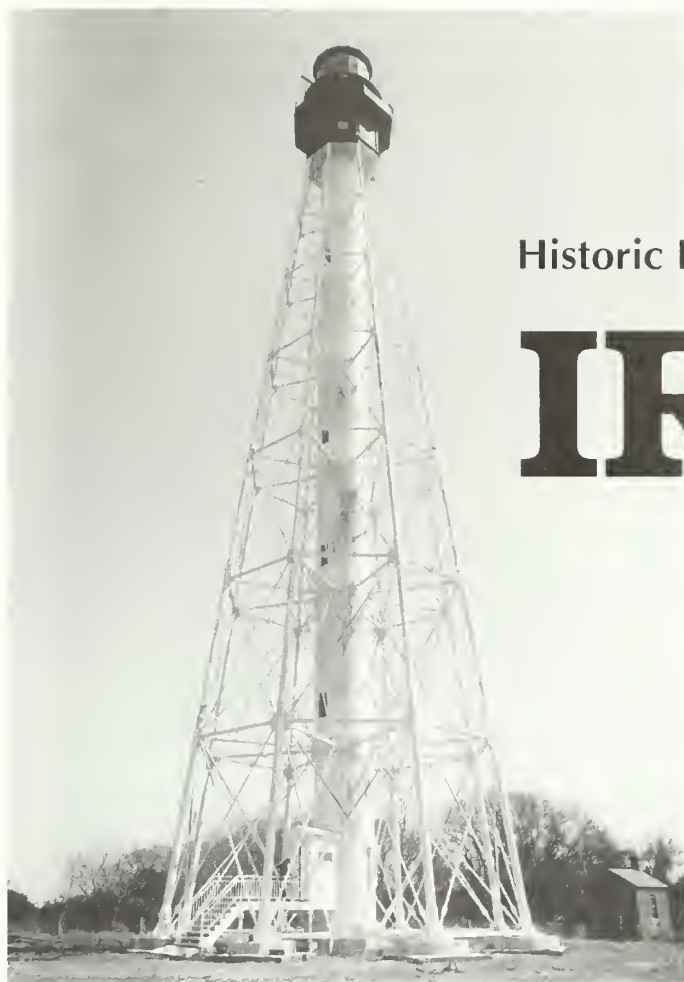
Figure 1. Cast-iron-and-steel skeletal 191-foot-tall tower at Cape Charles, Virginia

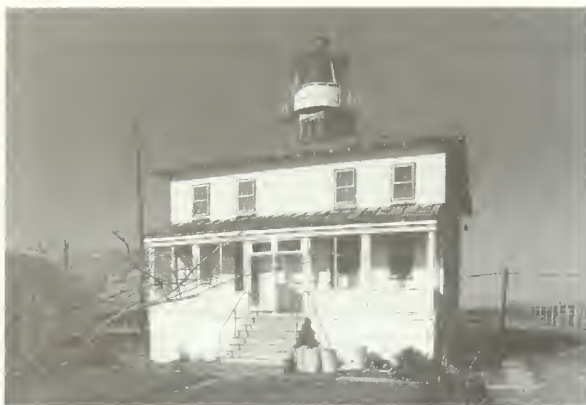
Figure 2. Example of a keeper's quarters fitted with a prefabricated cast-iron-and-steel lantern.

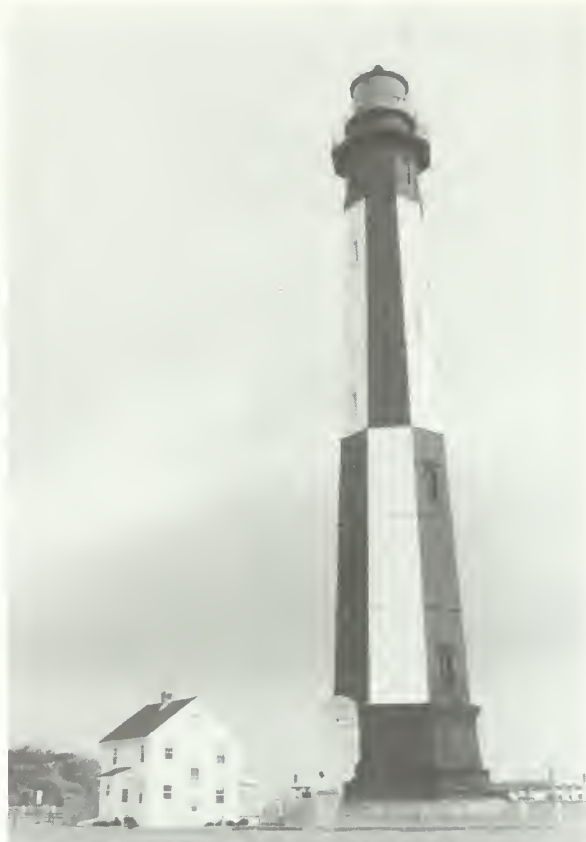
Figure 3. Example of an all-cast-iron construction "sparkplug" caisson-style lighthouse.

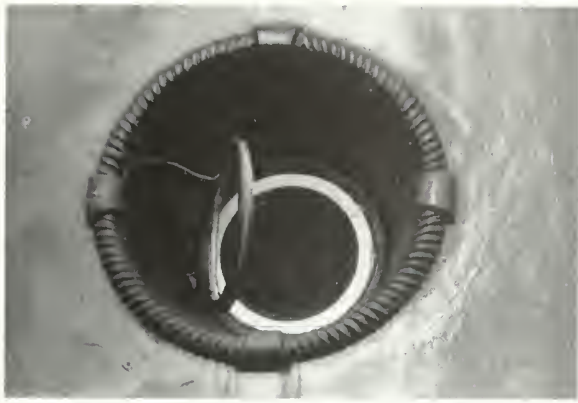
Figure 5. A view of decorative-rope nautical-style cast-iron window surrounds on Cape Canaveral Lighthouse.

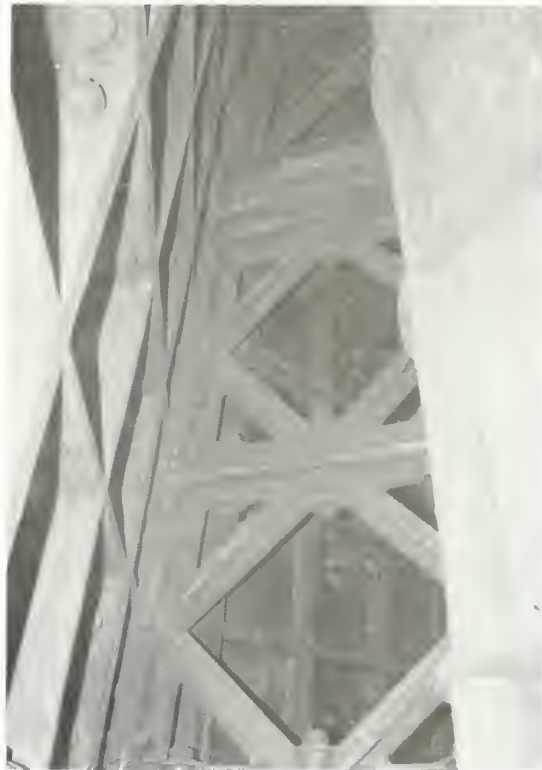
Figure 6. A view of the inner cavity and skeletal structure of the Cape Henry Lighthouse.

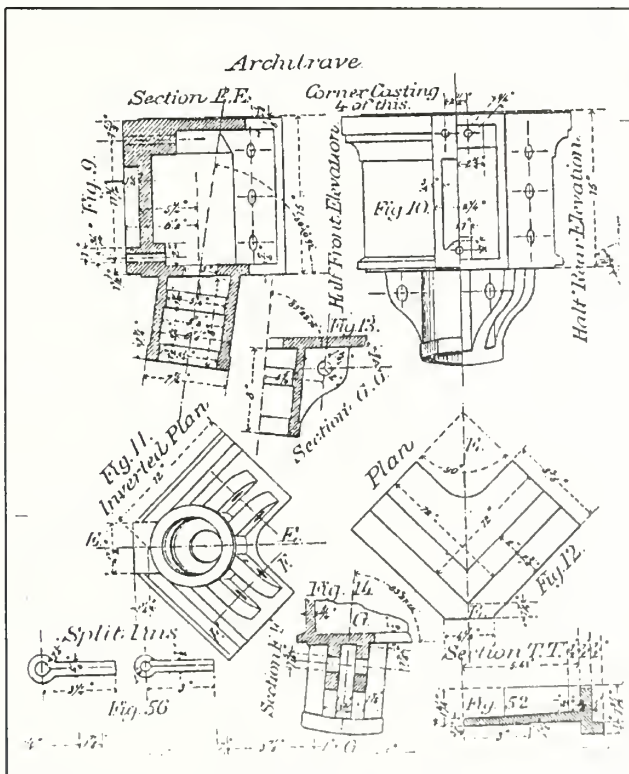
Figure 7. Shop drawings used for the production of cast-iron lighthouse parts for a screwpile lighthouse.

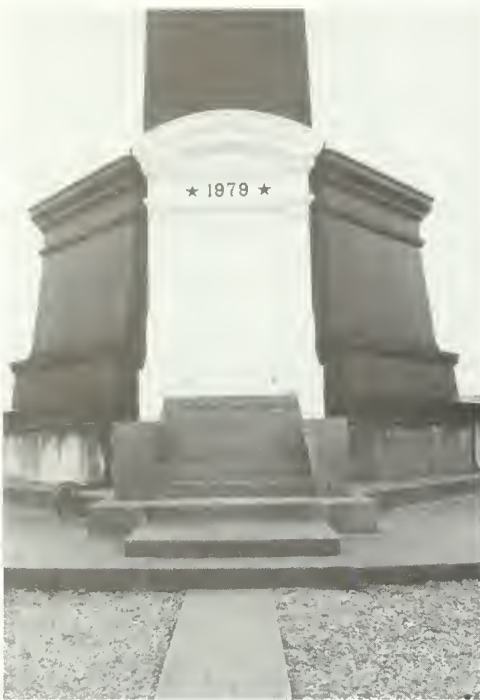
Figure 8. An example of the level of detail achieved with cast-iron construction.

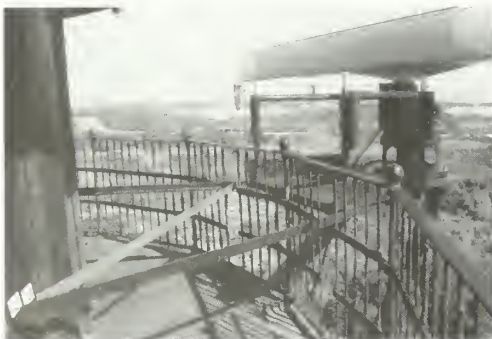
Figure 9. A modern range finder attached to the gallery deck using modern steel members.

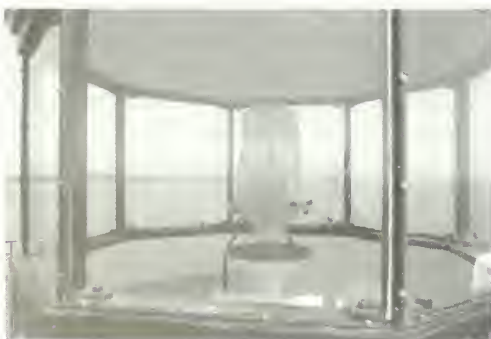
Figure 10. Close-up of a lantern glass frame: note the use of stainless steel bolts; the lower clamps are also stainless steel that have been painted black.

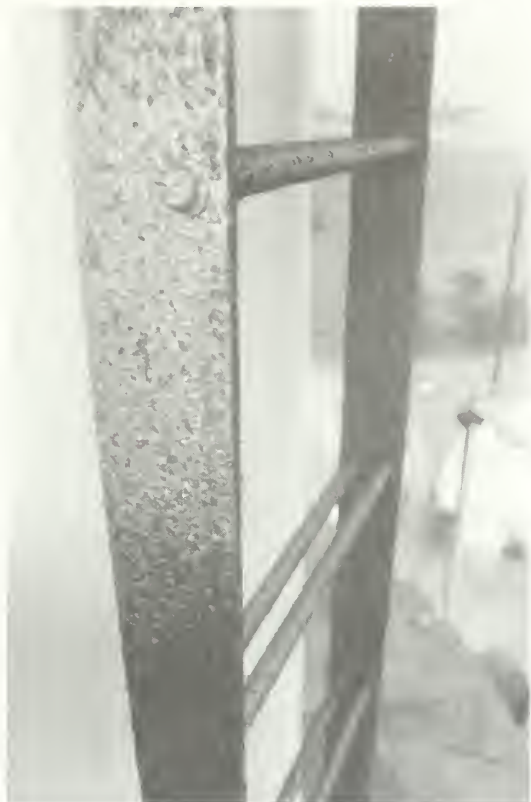
Figure 11. Detail view of a steel ladder that has been uniformly attacked by corrosion.

- **Uniform attack** is where the iron component corrodes evenly where exposed to corrosive agents.
- **Pitting** is the localized corrosive attack on the iron component.
- **Selective Attack** can occur where an iron component’s composition is not homogeneous and certain areas are attacked more than others.

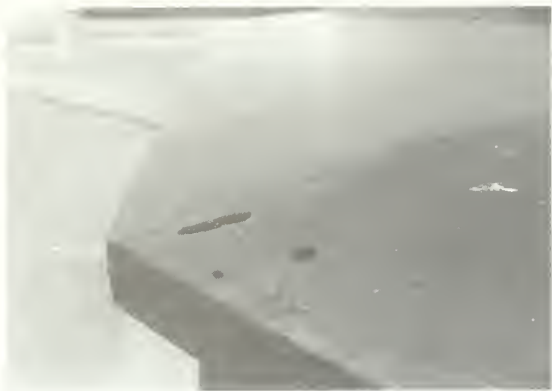
Figure 12. Close-up of localized corrosion or pitting where the corrosion has eaten through the cast iron.

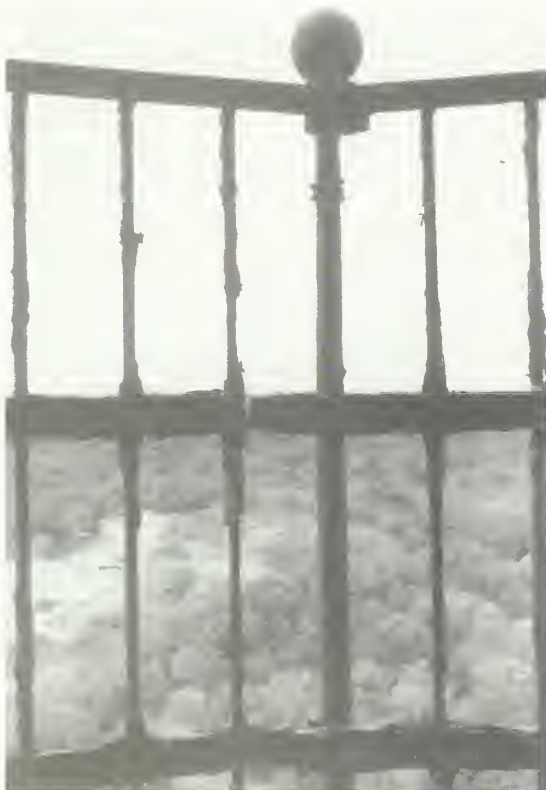
Figure 13. View of a steel railing where corrosion has occurred in distinct locations either because of variations in composition or localized failure of the coating system.

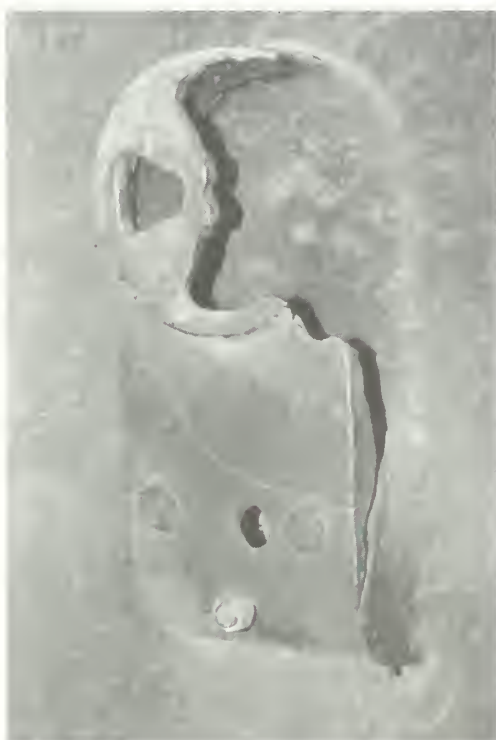
Figure 14. Nearly 30% of this ventilation shroud has been lost to two forms of abrasion: first, sand or grit blasting abraded away a majority of the material; second, human touch has smoothed the once rough surface.

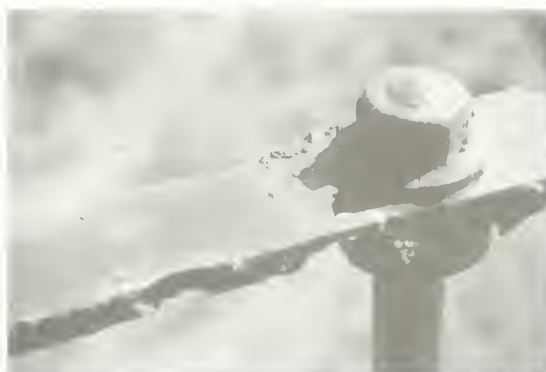
Figure 15. As corrosion attacked this steel handrail, wind and airborne sand eroded the loose and flaking surface rust.

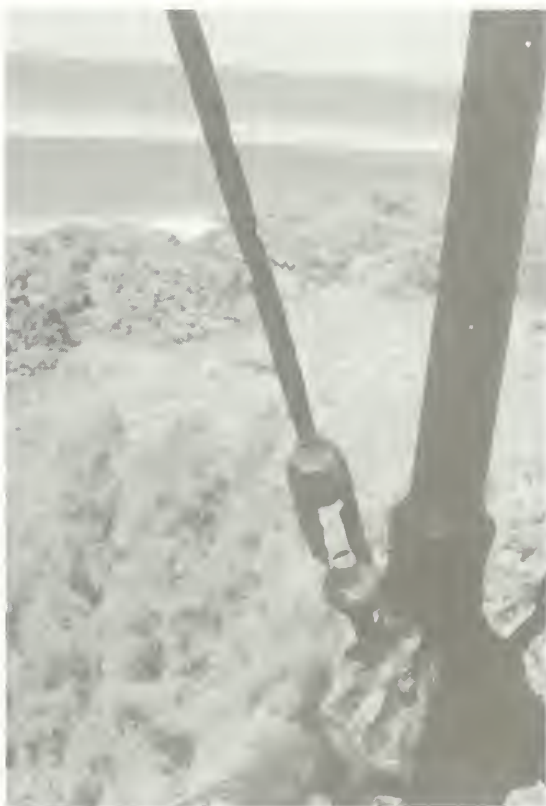
Figure 16. As corrosion attacked this steel turnbuckle, wind and airborne sand eroded away the flaking rust.

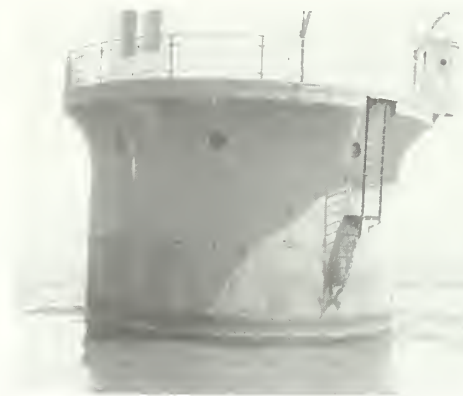
Figure 17. The cyclic pressure of the different rates of expansion and contraction of the exterior cast-iron plates and the interior brick lining of the caisson-style lighthouse has caused the cast-iron plates to fatigue and crack.

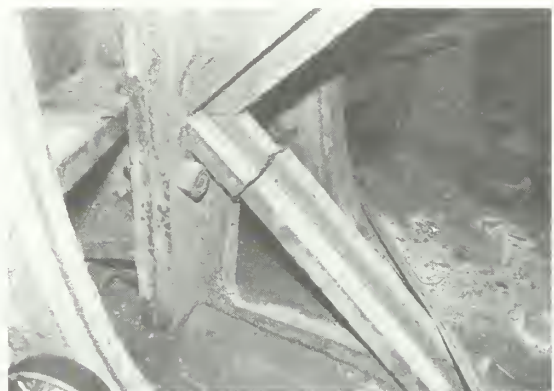
Figure 18. The internal structural skeleton of this lighthouse is cracked because of overloading possibly during assembly.

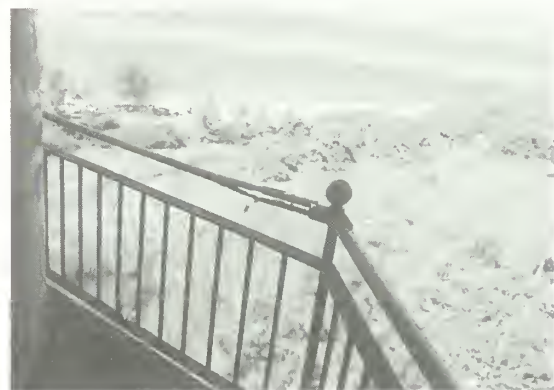
Figure 19. This handrail has been damaged by rust-jacking; rusting began between the two pieces of flat bar stock that formed the rail.

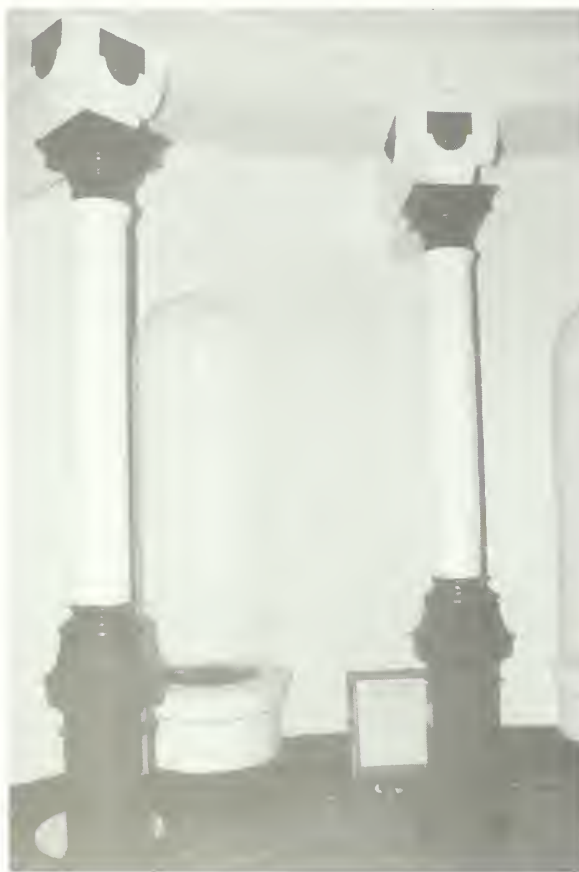
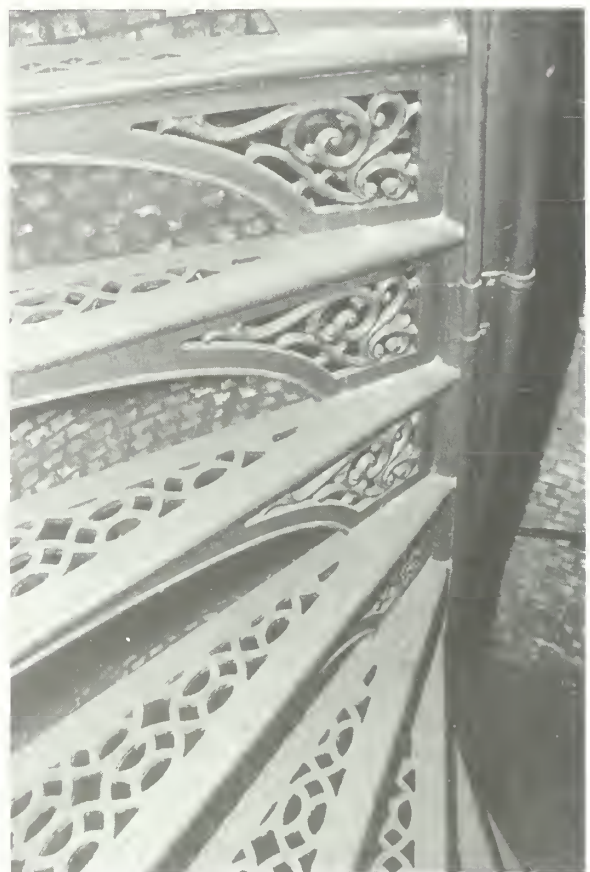
Cast-iron and steel features such as gallery deck brackets, handrails, skeletal structures, pilasters and door pediments, window architraves, as well as textured, finished surfaces such as raised diamond pattern non-skid surfaces, are important in defining the historic character of the lighthouse (see Figures 20 and 21). It is essential that the character-defining features are retained during any treatment. It should also be noted that while cast iron is among the most durable of historic building materials, it is also the most susceptible to damage by improper maintenance or repair techniques and by harsh or abrasive cleaning methods. Therefore, all treatment should be executed using the gentlest means possible. In Part V., **Beyond Basic Preservation**, examples of treatments that are considered rehabilitation and restoration are illustrated and discussed.

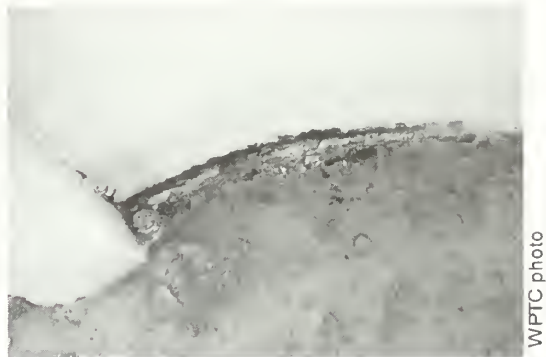
Figure 22. Interior of a sheet-iron parapet wall that is rusting from the inside to out along the lantern room door. This is the result of water entering the interior cavity of the parapet wall.

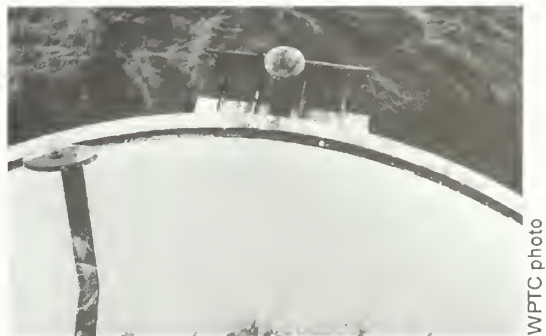
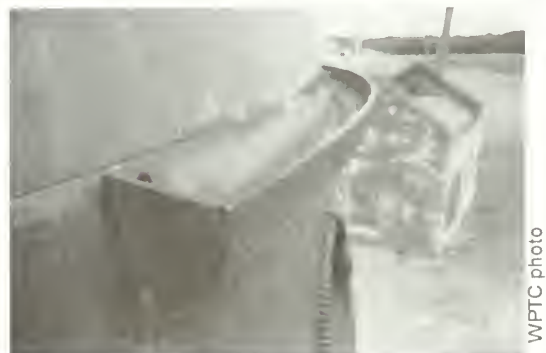
Figures 23 and 24. Two types of gutters found on iron lighthouses; the gutters must be in proper working order and checked regularly during the mothballing period.

- **Built-in guttering systems:** In order to prevent water from entering the interior cavity of double-wall iron or brick-lined iron wall systems, all rain water guttering systems (lantern roofs, or other tower roof forms) should be cleaned and checked for holes. It is imperative that all holes and non-functioning gutter system components are repaired. For more information refer to the discussion on roofing in the **Lantern** section of the handbook.

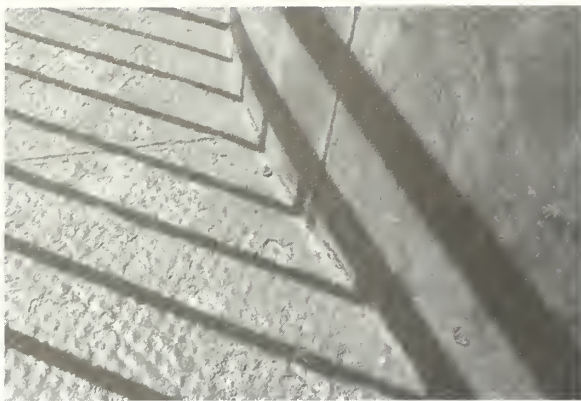
Figure 25. The seams between the deck and wall plates of this lighthouse were not properly sealed; as a result the areas collected water and began to rust.

- **Gallery decks:** The seams between cast-iron gallery deck plates must be made weathertight. If rust is already present, this must be removed and the affected areas primed and painted. The joints should be sealed with a high quality

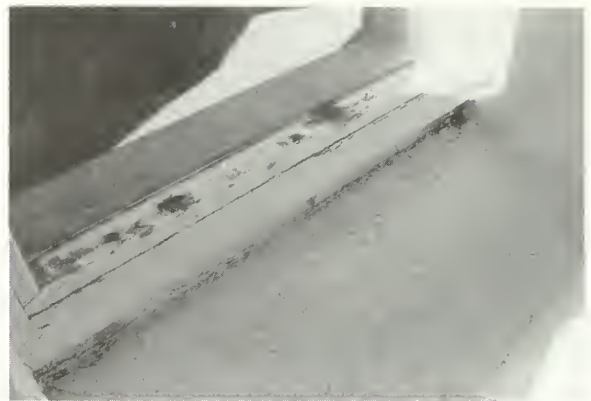
Figure 26. This steel casement window frame was not sealed properly and as a result has begun rusting from the inside out.

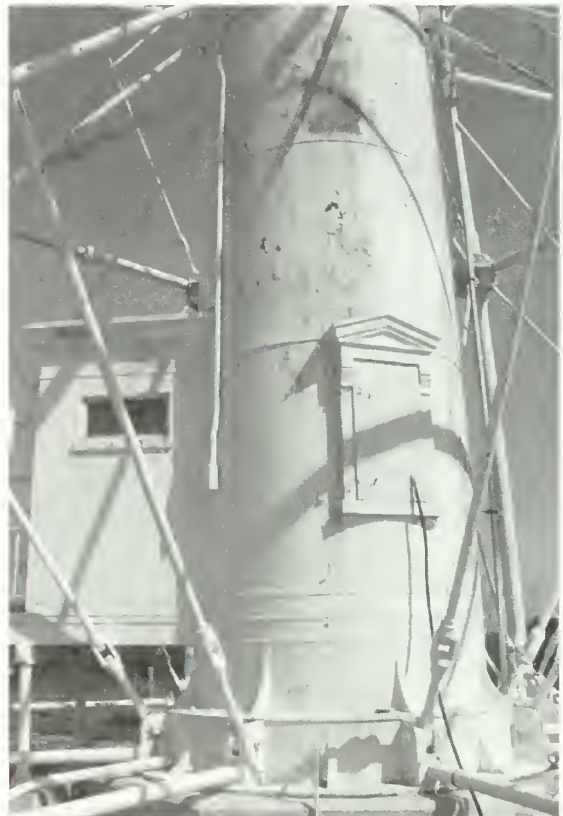
Figure 27. Blistering paint, as pictured here, should be removed and the affected areas properly primed and painted.

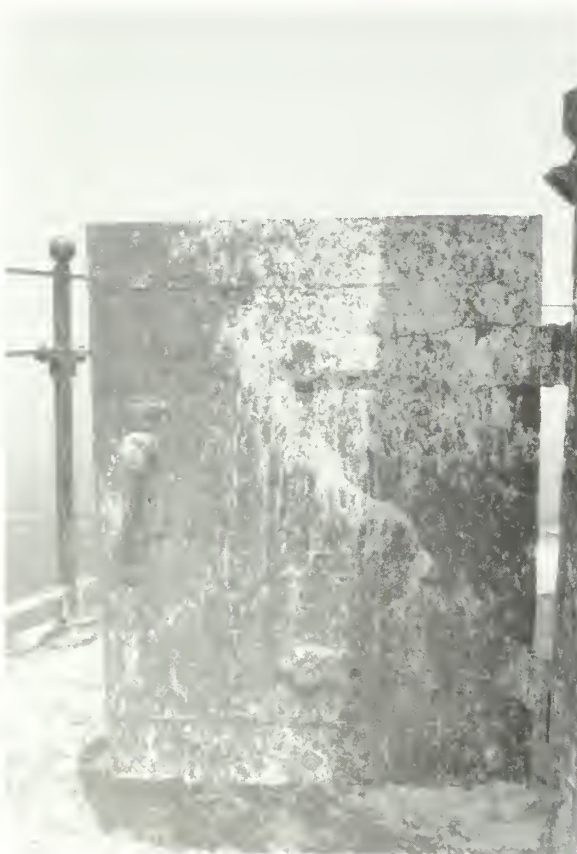
Figure 28. Surfaces such as this sheet-steel-covered parapet door that are covered with seagull guano should be thoroughly cleaned before mothballing and should be checked and cleaned once a year during the mothballing period.

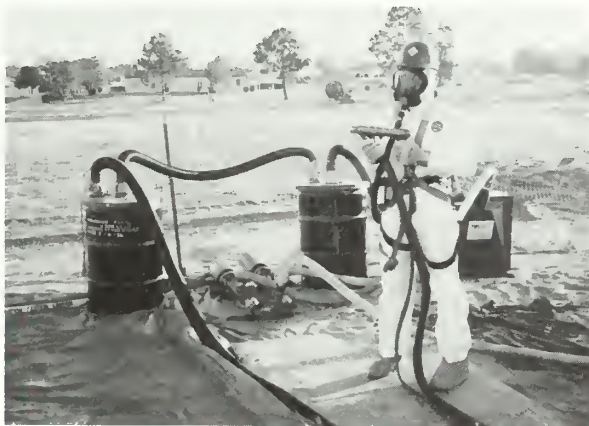
Figure 29. Worker dressed in full personal protective gear. The full-face-shield self-contained respirator provides both respiratory and eye protection. The worker is wearing protective coveralls, gloves, and boot covers to prevent lead dust contact. The harness is part of a full protection system. He is holding a pneumatic needle gun that is hooked to a two-stage HEPA (High Efficiency Particulate Air) filtered vacuum system.

outfitted with dust-collection hoods with vacuum hookup. As with any paint removal procedure, personal protective equipment required for health protection should be worn. Typical personal protective equipment includes eye/face protection, respiratory protection, gloves, coveralls, hard hat, and protection from falling if working 6 feet or higher above the ground (see Figure 29).

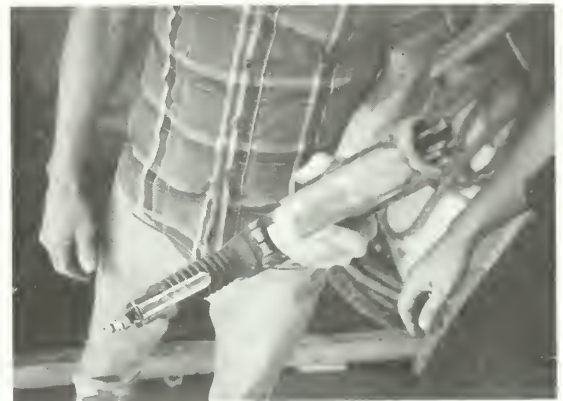
Figure 30. Close-up of a pneumatic needle gun. This tool works well for hard-to-reach and detail areas. The needle gun can be pressure-controlled to minimize impact on the iron substrate. This figure shows the vacuum-shroud connection on the right and air-hose connection on the base of the pistol-grip handle on the left.

Figures 30 through 33 are paint removal tools used during the Sand Key Lighthouse rehabilitation. Sand Key Lighthouse is located in open water off the coast of Key West. The paint being removed contained lead; therefore it was essential that all debris be contained for proper disposal.

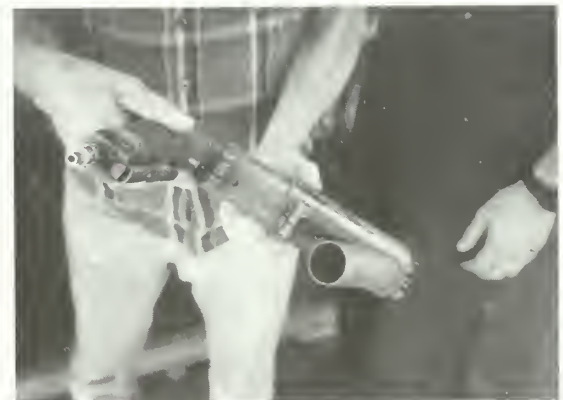
Figure 31. The gun is activated by squeezing the lever on the rubber pistol grip. The amount of air pressure controls the speed and impact of the pulsating needles against the iron substrate. The needles can be seen protruding from the vacuum shroud.

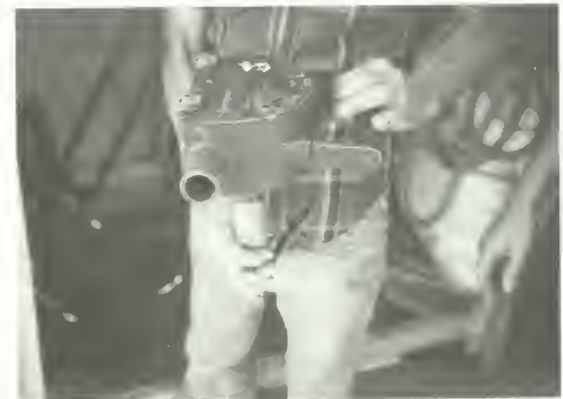
Figure 32. Close-up view of a pneumatic flush-plate tool. During the Sand Key Lighthouse rehabilitation this tool was used for all flat surfaces and for removing paint from the light-tower columns. The rollers located at the top and bottom of the shroud guide the tool over the flat and curved surfaces. The amount of air pressure controls the speed and impact of the rotating head against the iron substrate. To contain the paint dust and chips, the shroud has been outfitted with a vacuum hookup.

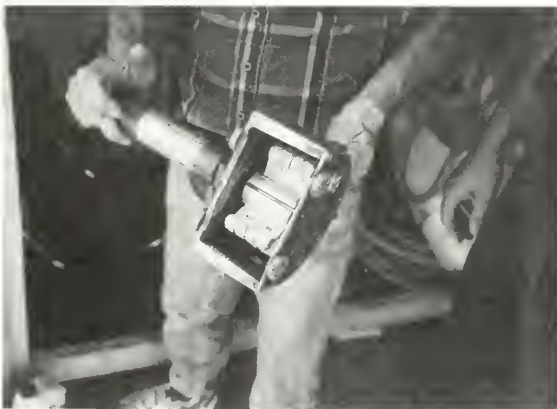
Figure 33. Close-up of the studded flaps mounted on the rotating head. To use the tool, it is held against the face of the iron member and as the studded flaps spin they “slap” the surface and “knock” the paint off the iron.

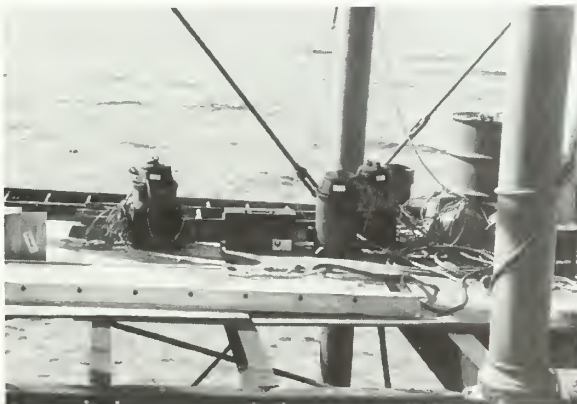
Figure 34. The small vacuums used at Sand Key Light are shown in this photo. Each vacuum has a HEPA filtration system to ensure that no lead dust escaped into the atmosphere. The conditions at Sand Key Lighthouse made the use of a large central vacuum system impractical. Using portable vacuums allowed for paint removal at numerous locations at any one time.

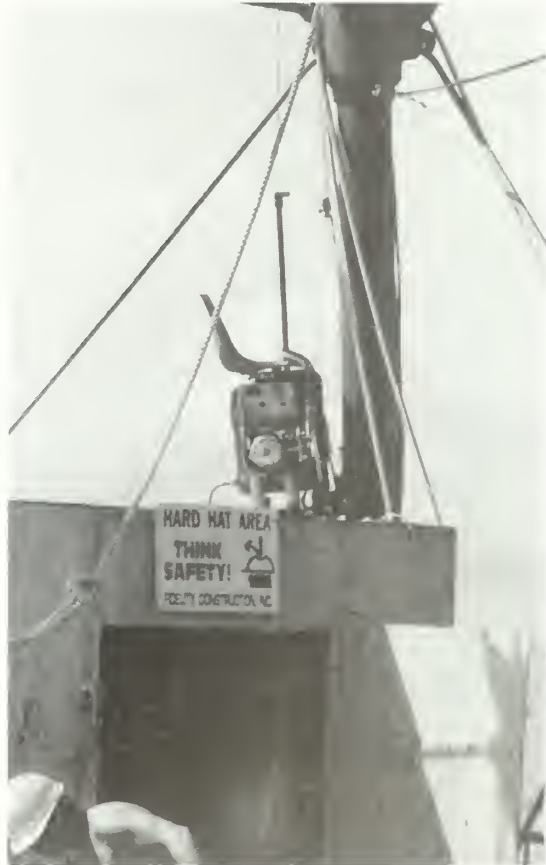
Figure 35. This motorized chair was used to hoist workers as they removed paint from the cast-iron columns at the Sand Key Lighthouse. The chair's motor is attached to a hoist, so the chair actually climbs a cable that has been strung alongside the column.

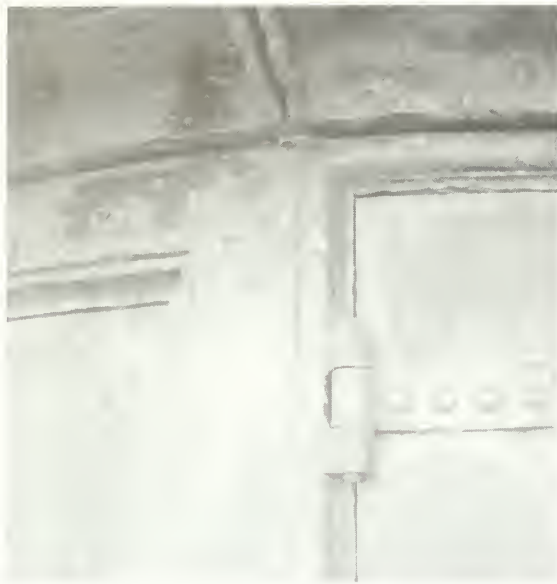
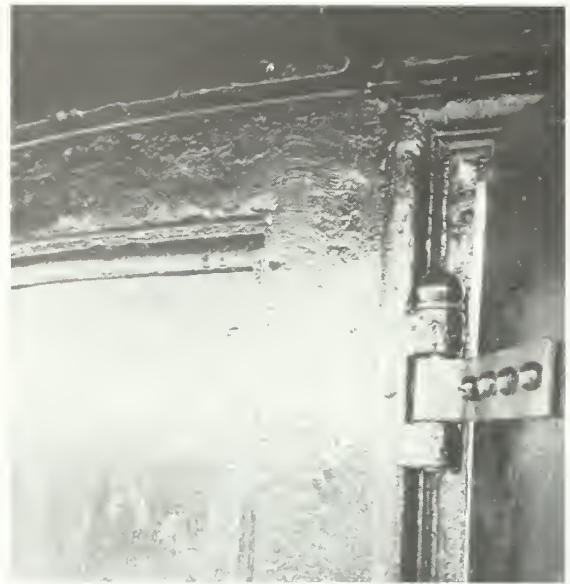
Figures 36 and 37. The left image shows the condition of the iron exterior service room wall before rehabilitation. The right image shows the same area after power hand tool cleaning and coating. The crescent shaped scars in the iron are from the arc of a grinding wheel.

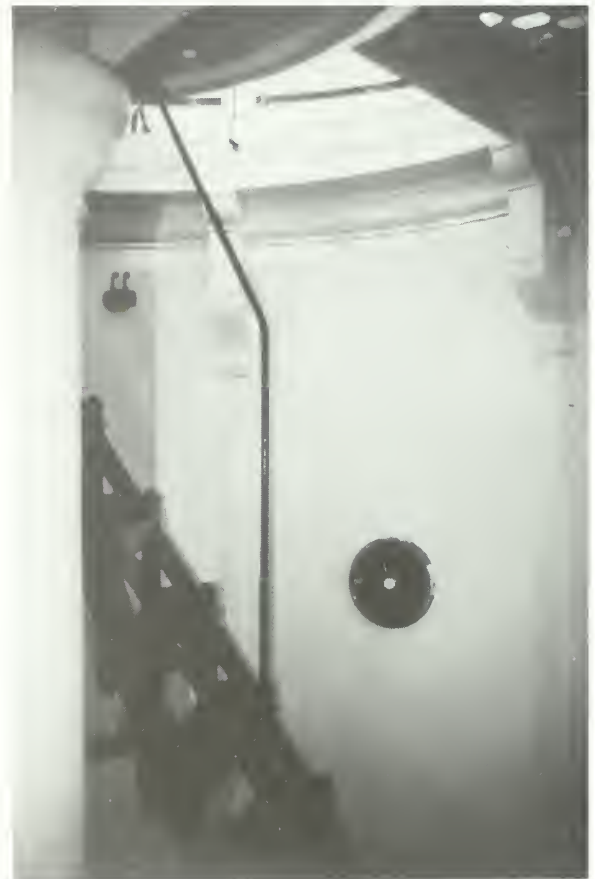
Figure 38. Service room bracket after chemical cleaning.

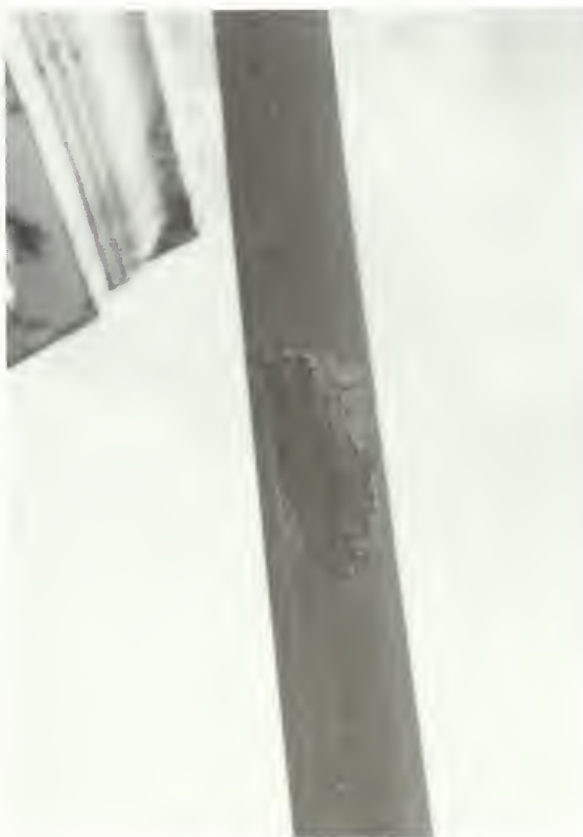
Figure 39. The finish on this tension rod failed and localized corrosion (rust) has formed. The rust is exfoliating in layers that are trapping moisture and causing corrosion to occur deeper and deeper into the tension rod. The result is pitting that will compromise the strength of the tension rod. If the area had been touched up in time, the corrosion might not have formed.

The effective protective life span of an existing paint or coating can be greatly increased by routinely touching up areas of deterioration. A small break in the protective finish can lead to accelerated corrosion of the underlying iron (see Figure 39). Areas where the paint or coating has been damaged by mechanical impact or blistering has occurred should be addressed immediately. These areas should have all loose paint and rust scale removed using one of the recommended methods

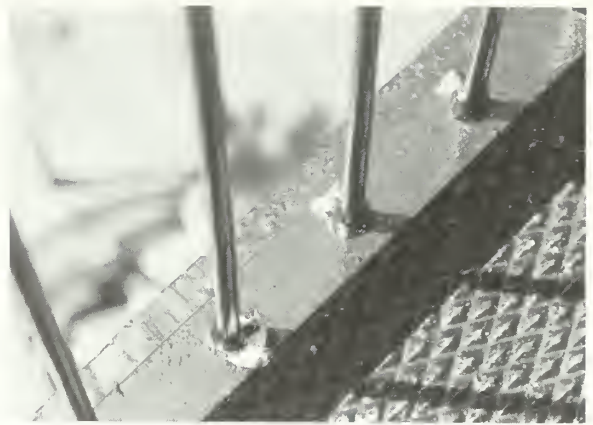
Figure 40. The paint on this stainless steel replacement gallery deck has begun to peel less than three months after it was painted. This could have been prevented if the stainless steel parts were first cleaned and then lightly glass-bead blasted.

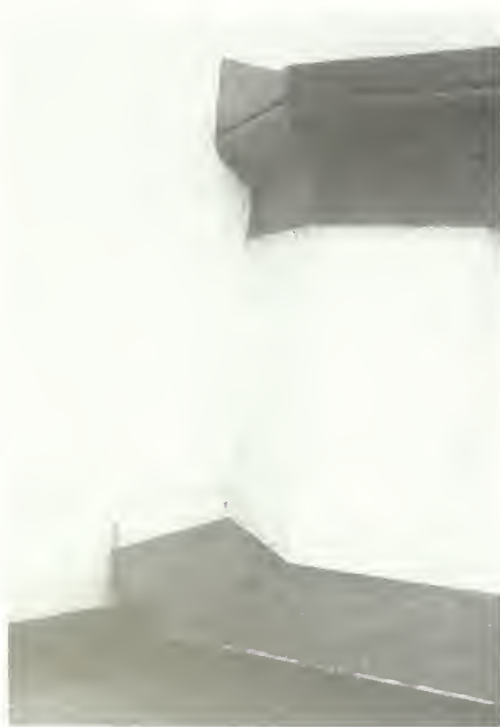
Figure 41 (left). This masonry lighthouse has been detailed with a two-tier cast-iron water table (the iron portions are painted black). Rust-bleed is occurring along lower edge of the upper tier.

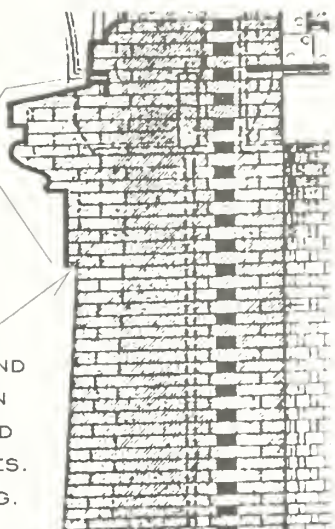
Figure 43.

CAST IRON BELT COURSE

RAKE OUT LOOSE PAINT, MORTAR, AND RUST SCALE. PRIME AND PAINT IRON AND MASONRY (IF PREVIOUSLY PAINTED OR REQUIRED BY SEALANT) SURFACES. SEAL WITH A HIGH QUALITY CAULKING.

This condition can easily be remedied if the following issues are addressed during the preservation treatment of the lighthouse. During any repairs or repainting, all masonry and iron surfaces must be cleaned of all loose paint and rust scale. All mortar that has been placed between the masonry and the iron should also be removed. The mortar helps trap moisture against the iron. Once the joint is clean, all exposed iron must be coated with a rust-inhibiting primer and top coat to provide a barrier between the iron and the mortar. The void created by the missing mortar should be filled with a new mortar mixture that matches the strength of the historic mortar (for more information on the matching of mortar strength refer to the **Masonry** section). When filling the open joint with the mortar, hold the mortar back about 1 inch. The joint should then be filled with a ½-inch-diameter polyethylene foam backer rod. To seal the joint, use a high quality silicone or urethane caulking. (Some caulks may require a painted surface to adhere to brick; therefore, the surface of the brick that will come in contact with the caulk may have to be painted before the caulk is applied). Ideally, the caulking depth should equal the joint depth up to a ½ inch. The profile on the caulking should be slightly concave to shed water. Refer to Figures 43 and 44 for more details.

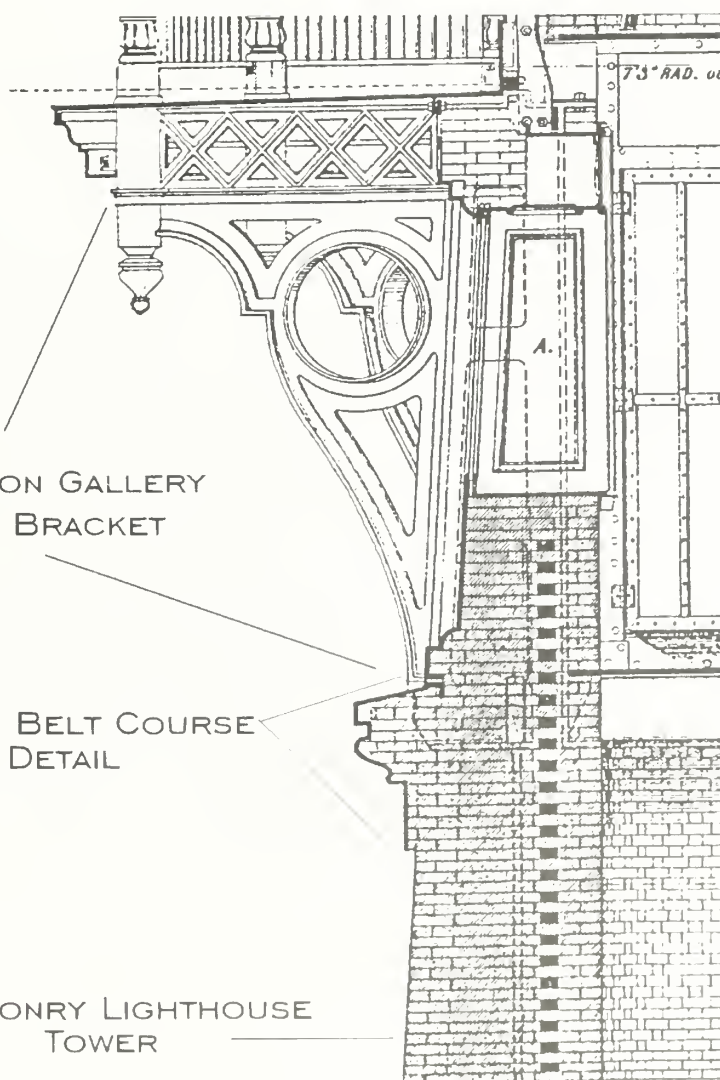
Figure 44.

CAST IRON GALLERY DECK BRACKET

CAST IRON BELT COURSE
SEE DETAIL

MASONRY LIGHTHOUSE TOWER

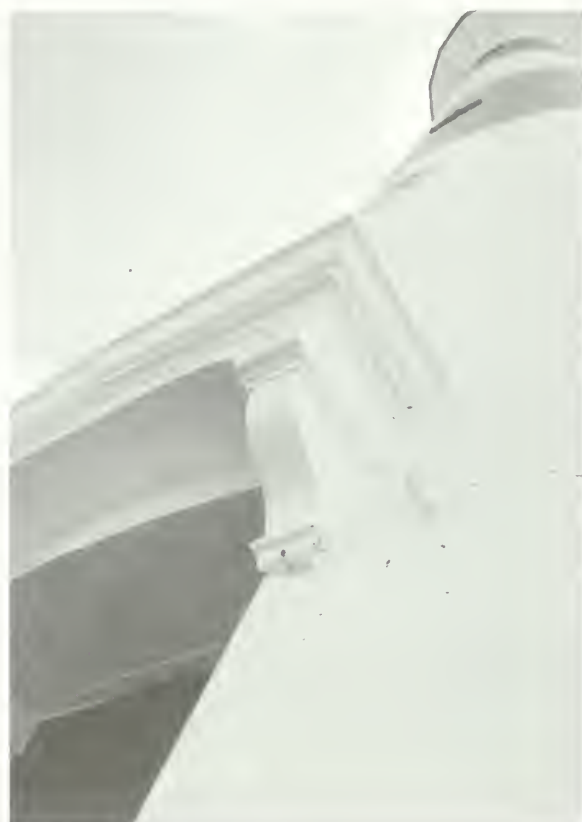
Figure 45. Within three months after painting, the rust began to bleed through this weep hole on the bottom of this pediment bracket. Two lessons are to be learned from this condition: 1) keep weep holes open to allow any water that may have entered the casting to escape, and 2) keep joints around applied castings sealed; apparently this was not done and water has entered the hollow cavity of the pediment, causing rust to form inside.
