Historic Lighthouse Preservation Handbook

1997

PD-375

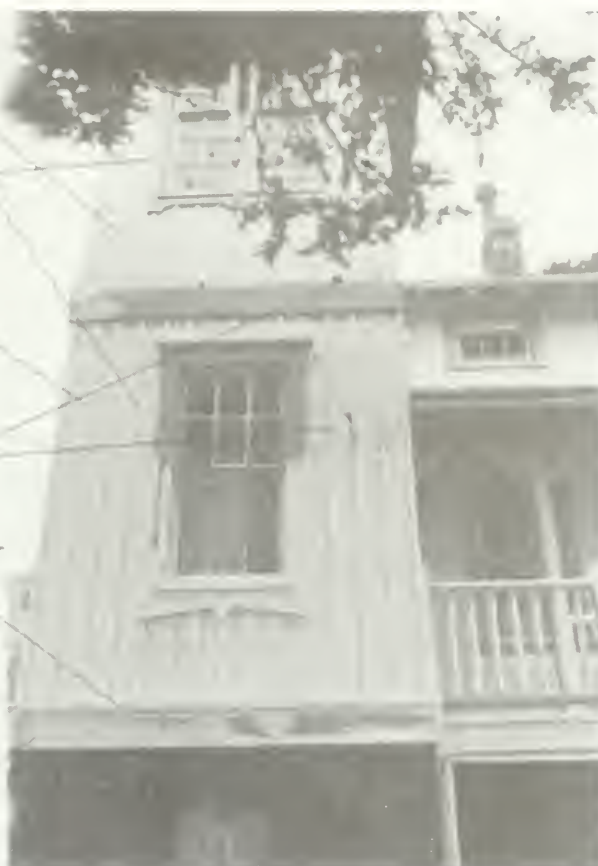
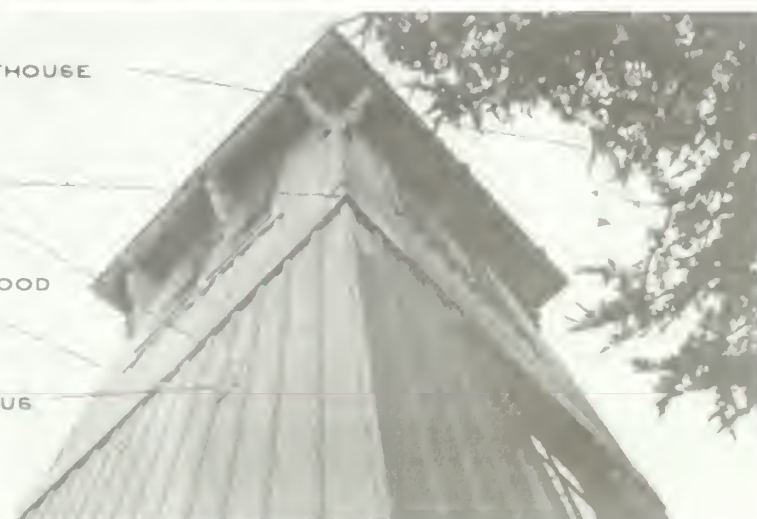
Figures 3 and 4.

CHECK FLASHING AT
WATER TABLE

CHECK JOISTS FOR
ROT WHERE THEY
REST ON THE
FOUNDATION

TREE CLOSE TO LIGHTHOUSE
TOWER

PATCHES OF BARE WOOD

EVIDENCE OF PREVIOUS
REPAIRS

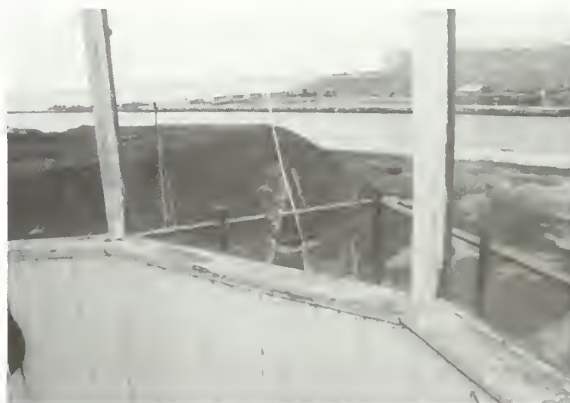
Figure 5. Storm glass with holes should be replaced as soon as possible to minimize water infiltration. If immediate replacement is not an option, the storm glass can be temporarily patched.

- **Lantern glass:** Lantern glass, frames, and roofs must be weathertight before mothballing (see Figure 5). Refer to the **Lantern** section for more information concerning the weatherproofing of the lantern components.
- **Built-in guttering systems:** All rainwater guttering systems (lantern roofs, or other tower roof forms) should be cleaned and checked for holes. Water entering the structure will cause premature deterioration of internal structural components. For more information refer to the discussion on roofing in the **Lantern** section.
- **Gallery decks:** In most wooden lighthouses gallery decks are wood covered in sheet metal. These decks are generally laid directly on top of

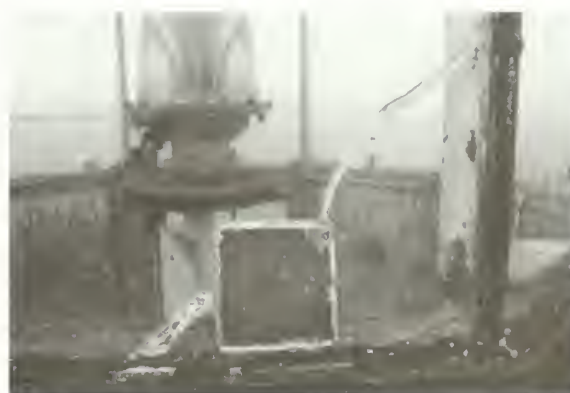
Figure 6. An acceptable temporary lantern glass repair made using a small piece of sheet metal and caulking.

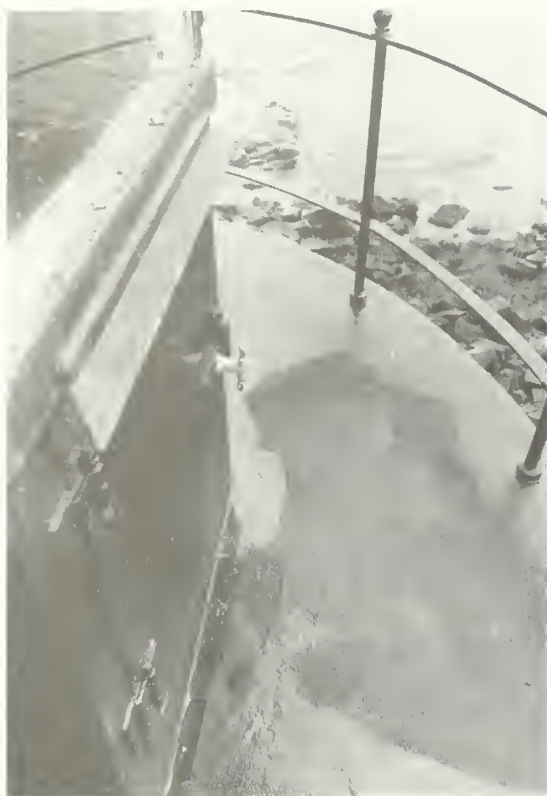
Figure 7. Ponding is occurring on this gallery deck near the base of the lantern parapet wall. This ponding has led to an active leak that occurs even during light rain conditions. A condition such as this should be remedied before the mothballing period.

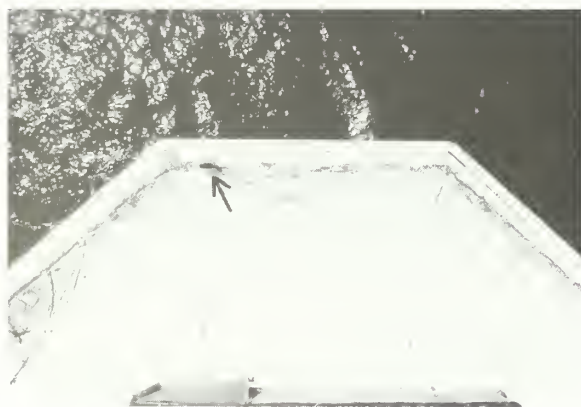
Figure 8. View of a wood-framed lighthouse roof; the arrow indicates where a large hole (approximately 2 by 4 inches) is present in the built-in gutter system. Water entering this hole has caused extensive damage to the interior wood framing members and wood interior wall paneling.

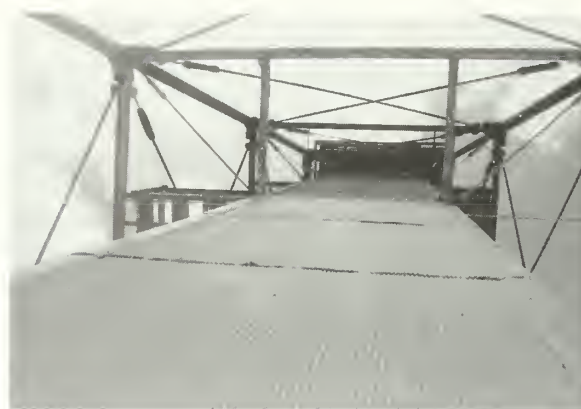
Figure 9. If the exterior of the wooden tower has been covered with another sheathing material like this corrugated metal, all joints in the exterior sheathing should be made completely weathertight; at this particular lighthouse, deterioration of interior wood framing members was caused by moisture infiltration.

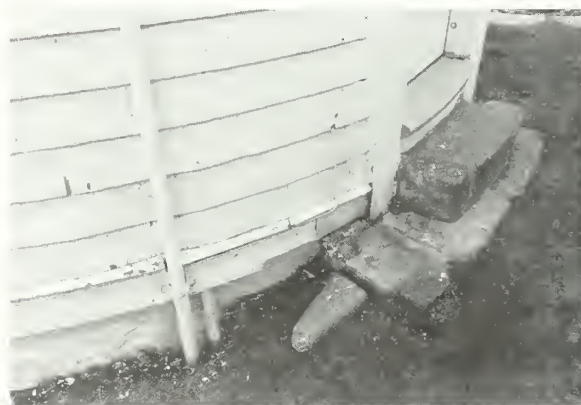
Figure 10. This door sill has a positive slope to ensure proper drainage; the joint where the door surround meets the shingles should be checked for gaps and recaulked if necessary.

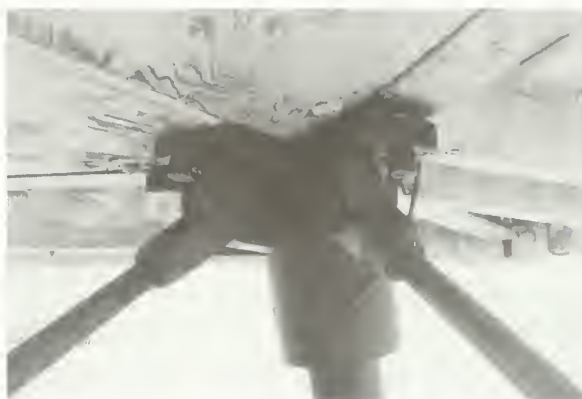
Figure 12. View of underside of a screwpile lighthouse. Although these bare wood surfaces are not directly exposed to rain, they are susceptible to mist and condensation moisture; and because there is no exposure to direct sunlight, the surfaces are seldom dry. For adequate protection during the mothballing period, these surfaces should be painted.

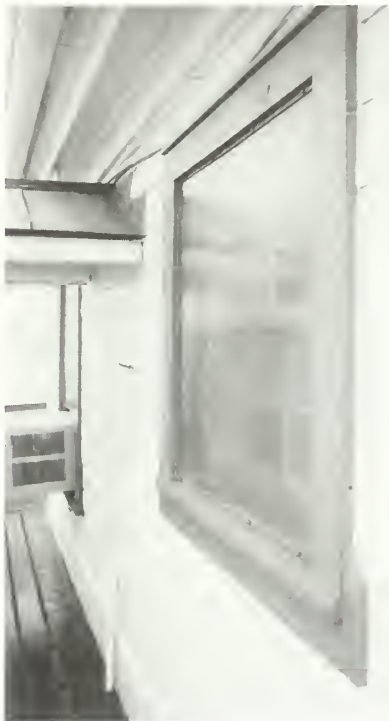
Figure 13. This image shows a Class I paint condition: virtually no deterioration, only some soiling and possible salt buildup resulting from the open-water location of the lighthouse.

Class I: Generally no paint removal—dirt, soot, pollution, chalking, mildew etc., (see Figure 13).

Recommended Treatment: This condition presents a problem only if the surface is to be painted over. If not removed, the surface deposits can be a barrier to proper adhesion and cause peeling. Most surface matter can be loosened by a strong, direct stream of water from the nozzle of a garden-type hose. Stubborn dirt and soot will need to be scrubbed off using a 1/2 cup of household detergent in a gallon of water with a medium soft-bristle brush. (For the removal of mildew add 1 cup of bleach to the non-ammoniated detergent.) The cleaned surface should be thoroughly rinsed and permitted to dry before further inspection to determine if repainting is necessary.

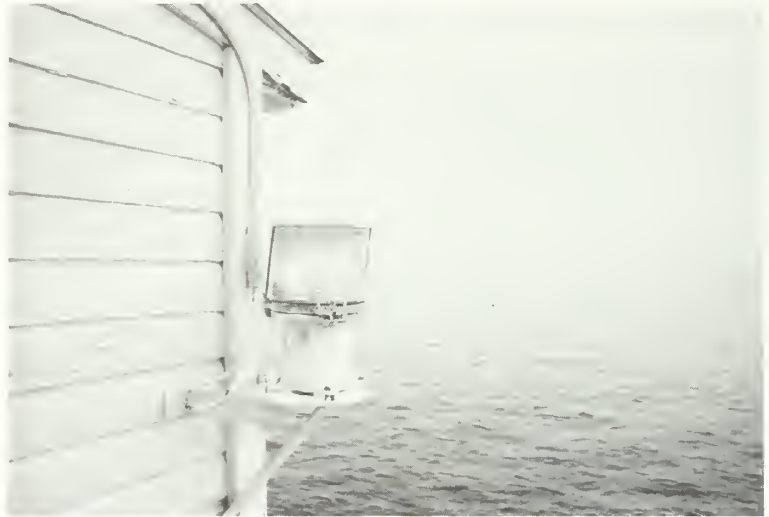
Figure 14. View of Class II paint condition: this example happens to be on the same lighthouse as the Class I condition shown in the previous image; multiple paint conditions can exist on the same lighthouse. In this example, only spot paint removal and repainting will be required to remedy the condition.

Class II: Generally limited paint removal—crazing, intercoat peeling, solvent blistering, wrinkling (see Figure 14).

Recommended Treatment: Crazing can be treated by sanding the surface by hand or mechanically, then repainting. Although hairline cracks may tend to show through the new paint, the surface will be protected from moisture penetration.

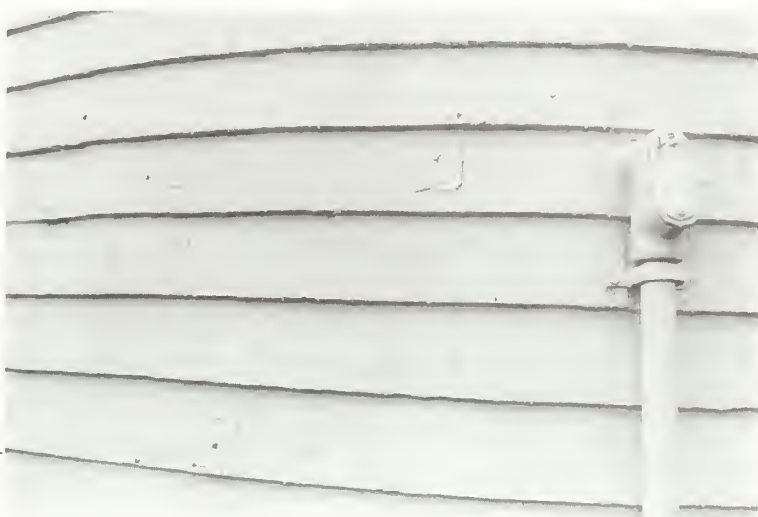
Figure 15. View of Class III paint condition: in this case the cracking, peeling, and alligatoring have been caused by excessive paint layer build up.

Class III: Exterior surface conditions generally requiring total paint removal—peeling, cracking/alligatoring (see Figure 15).

Recommended Treatment: If cracking and alligatoring are present only in the top layers, they can probably be scraped, sanded to the next sound layer, then repainted. If cracking and/or alligatoring have progressed to bare wood, however, and the paint has begun to flake, it should be totally removed. Methods include scraping or paint removal with the electric heat plate, electric heat gun, or chemical strippers, depending on the particular area involved. Bare wood should be primed within 48 hours, then repainted.

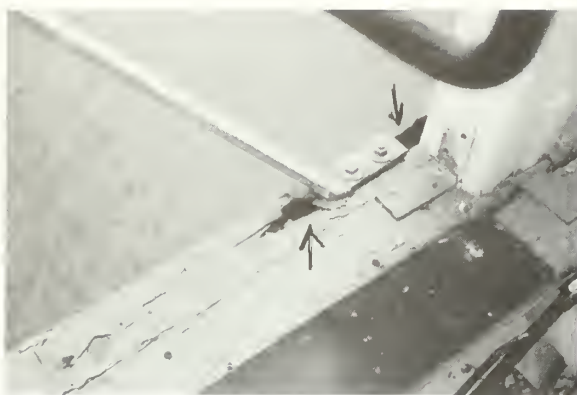
Figure 18. The wooden structural member that this bracket is attached to is extensively deteriorated. This condition is a prime example of deterioration that can be repaired by cutting back the rotted wood to a sound substrate, then fitting the void created with a wooden 'dutchman' or infill that matches as closely as possible the grain orientation and wood species as the existing member. Once the dutchman has been glued, and if needed, doweled in place, then the affected area should be properly primed and painted. This technique is affordable and incurs only minimal damage to the existing historic materials.

Deteriorated portions of wood can be effectively repaired using like-kind splices. Splicing of a wood member is required when a portion of the wood component, i.e., handrail, has been damaged or has deteriorated and only that portion needs to be removed and a new section attached in its place. The replacement member should match the existing members in species and grain orientation and in any existing shape or profile. The new member can even be made from matching salvaged stock. All deteriorated material should be removed and the end where the replacement member will be attached should be cut on a diagonal to increase the gluing surface area.

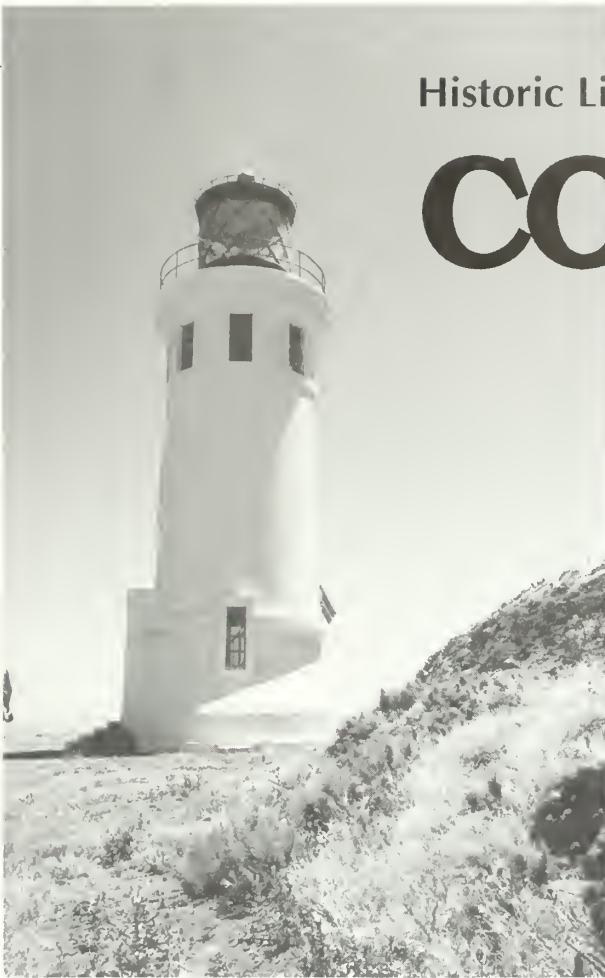
Figure 1. Anacapa Island Lighthouse is a reinforced concrete lighthouse located on a highly exposed island off the California coast. Concrete was chosen because of its ability to withstand the high winds, harsh climate, and seismic activity of this exposed location.

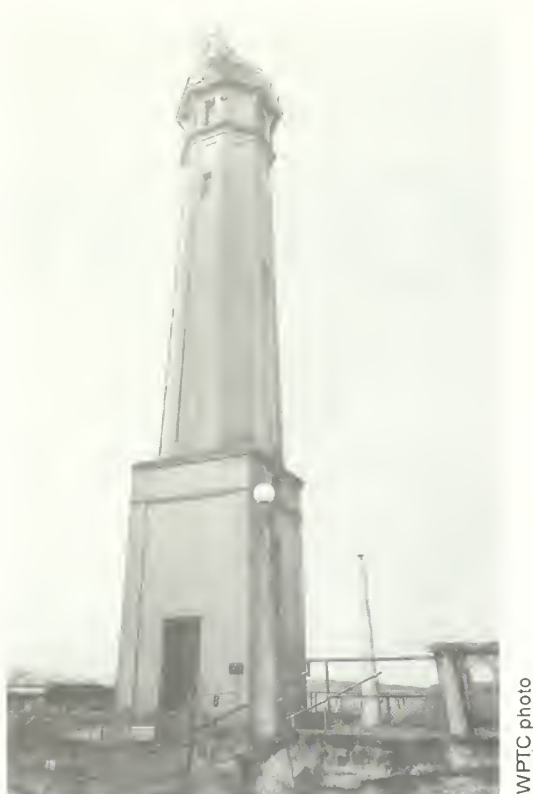
Figure 2. View of the Alcatraz Island Lighthouse. Reinforced concrete was chosen for this lighthouse location for its ability to withstand earthquakes.

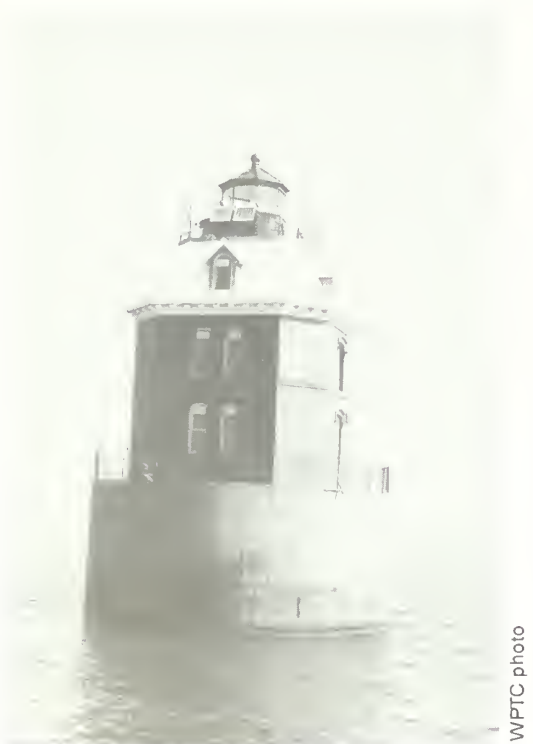
Figure 3. For the construction of this caisson-style lighthouse, unreinforced concrete was used as ballast to sink the cast-iron caisson foundation deep into the mud on the bottom of the Chesapeake Bay in Maryland.

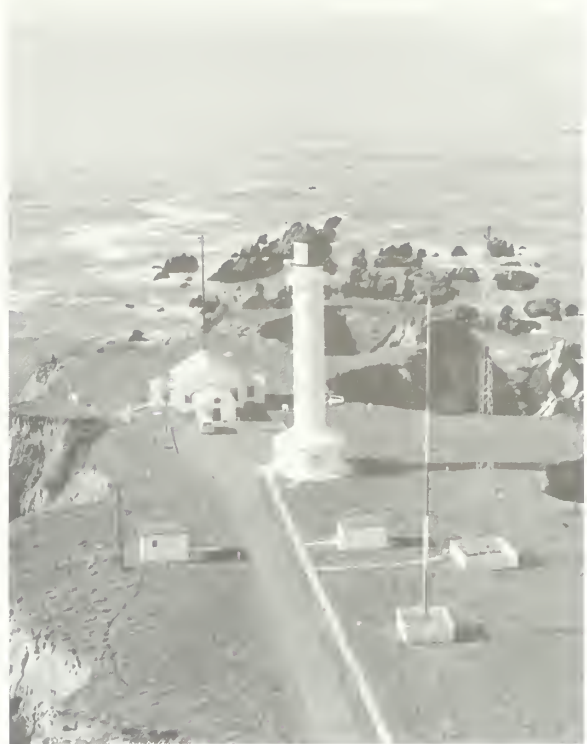
Figure 4. The first reinforced concrete lighthouse, Point Arena Light Station in California.

Concrete¹ is the fourth most common lighthouse construction material. The 1908 Point Arena Lighthouse, the first reinforced concrete lighthouse in the United States was constructed in response to the search for an earthquake-proof construction material. (The Point Arena Lighthouse is located within 10 miles of the San Andreas Fault.) The Point Arena Lighthouse, however, was not the first lighthouse to use concrete in its construction. Caisson-style

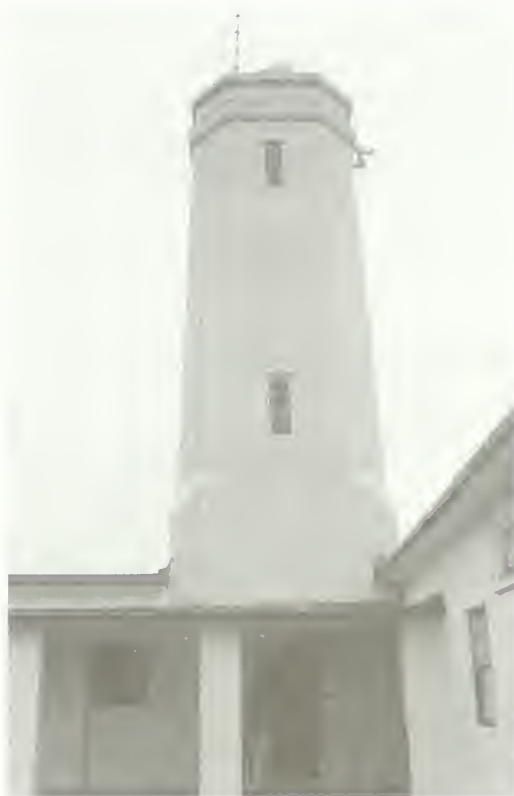
Figure 5. St. John's River Lighthouse, Mayport, Florida, was constructed of reinforced concrete for its economy and low maintenance.

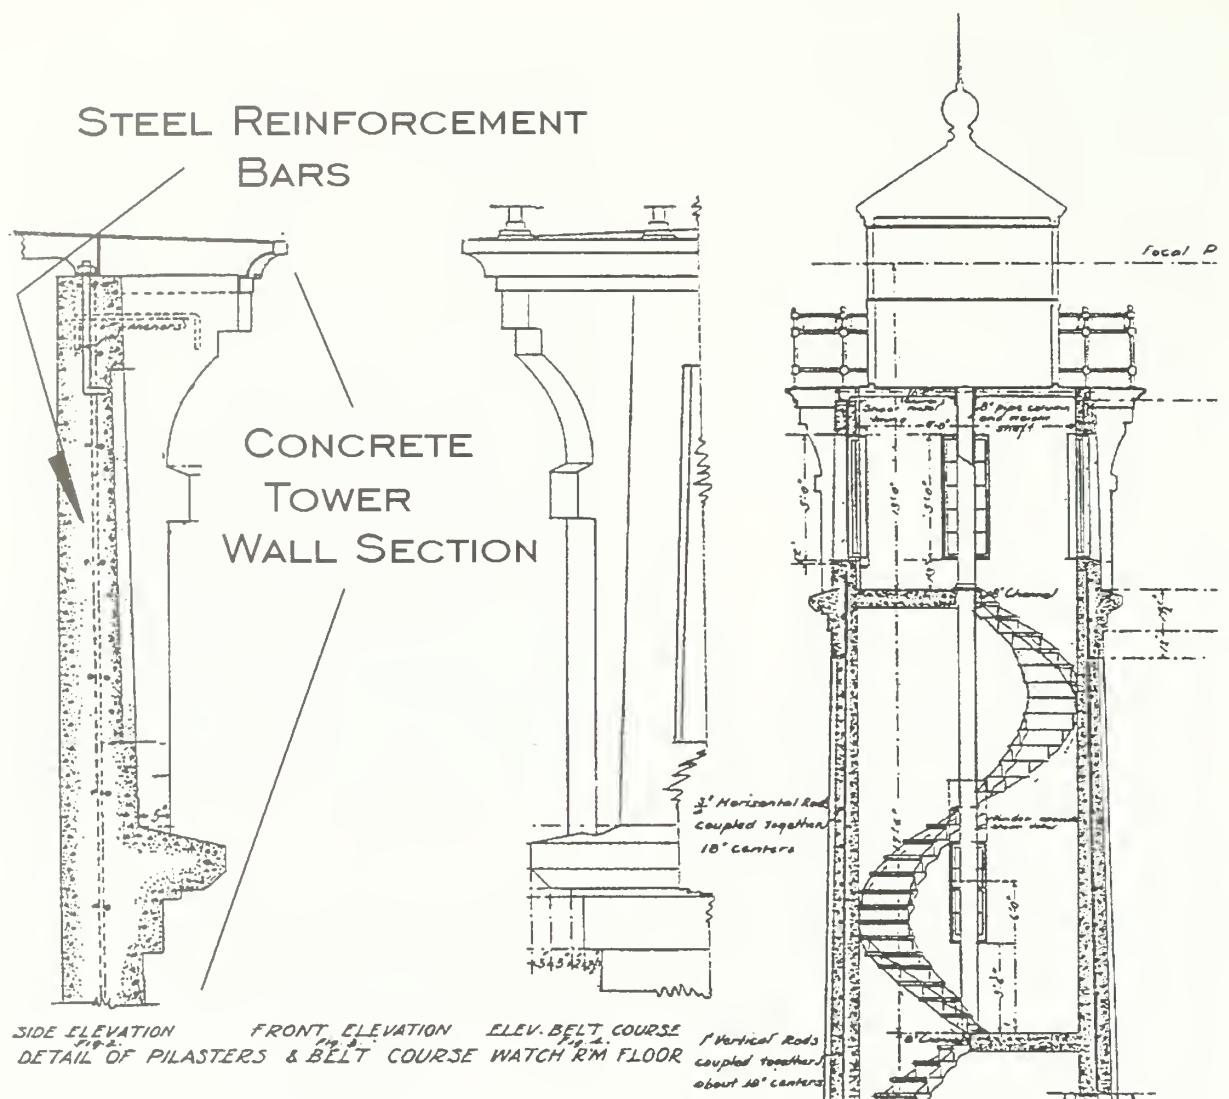
Figure 6. Image showing the placement of reinforcing bars in concrete lighthouse construction. (Image courtesy of CEU Oakland)

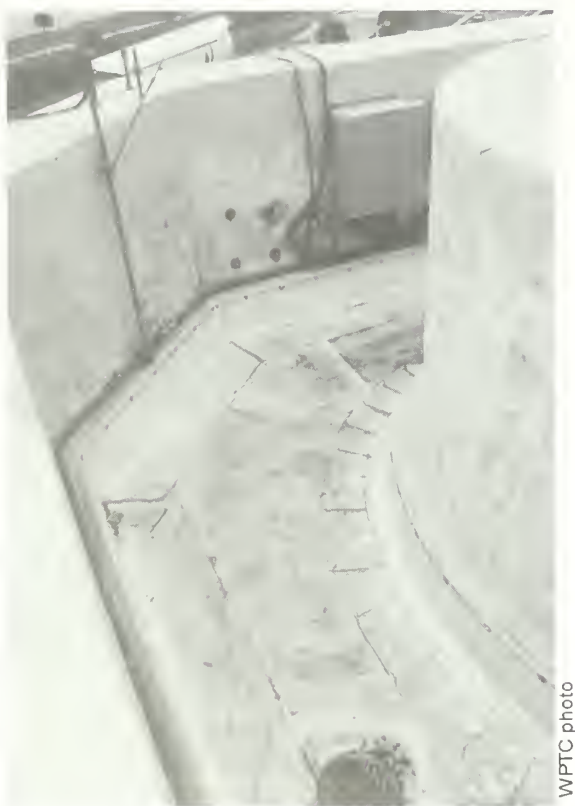
Figure 7. The concrete gallery deck on this concrete lighthouse has been covered with a rubber membrane. This covering should be checked regularly for leaks.

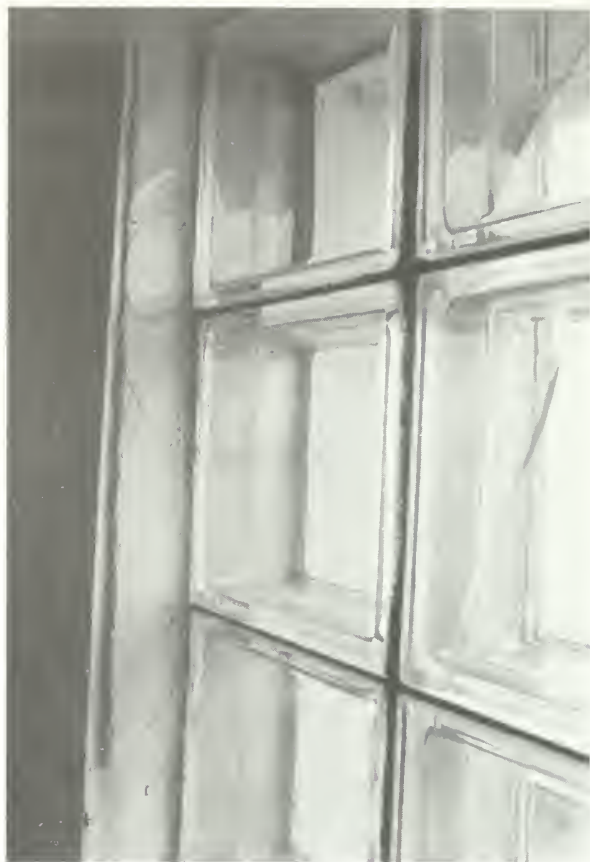
Figure 8. Close-up view of a glass-block window in a concrete lighthouse. The joint where the glass block meets the concrete wall should be caulked to prevent moisture infiltration.

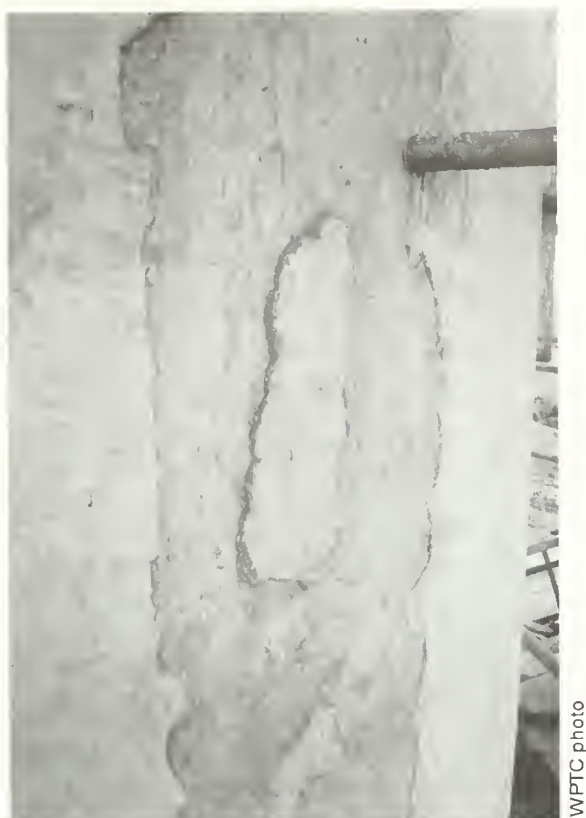
Figure 9. Patches of spalled concrete: familiar with lighthouse preservation the one pictured here should be repaired to protect the underlying concrete structure.

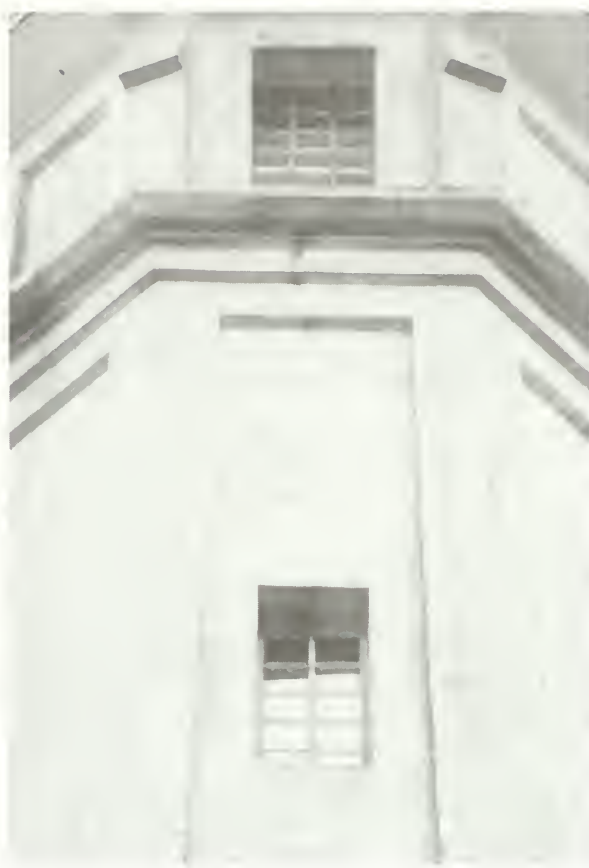
Figure 10. Cracks like the one here, extending down from the belt course of this concrete lighthouse, should be monitored for movement before any patching is performed.

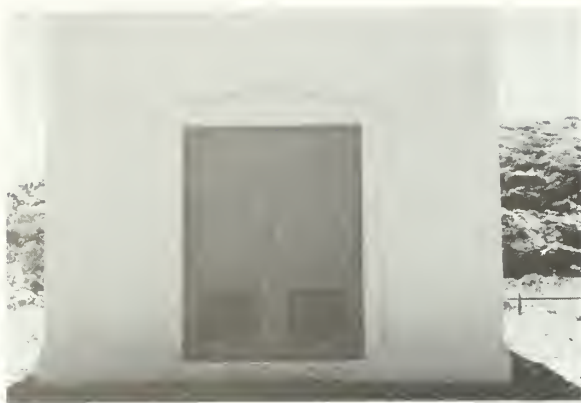
Figure 11. These replacement lighthouse doors have screened louvers that cover approximately 25% of the door opening to maximize air exchange.

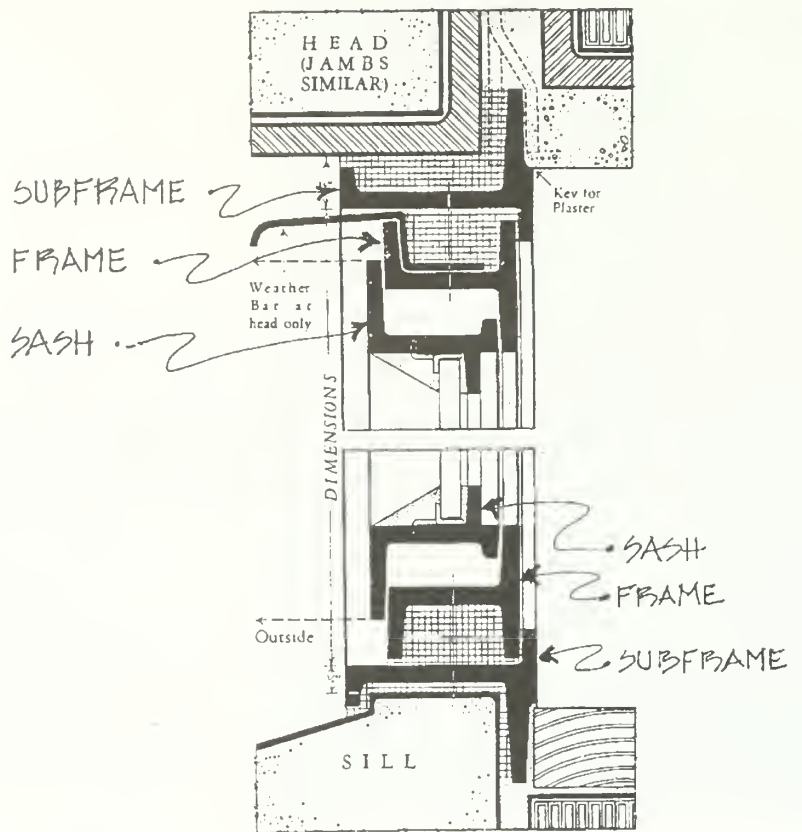
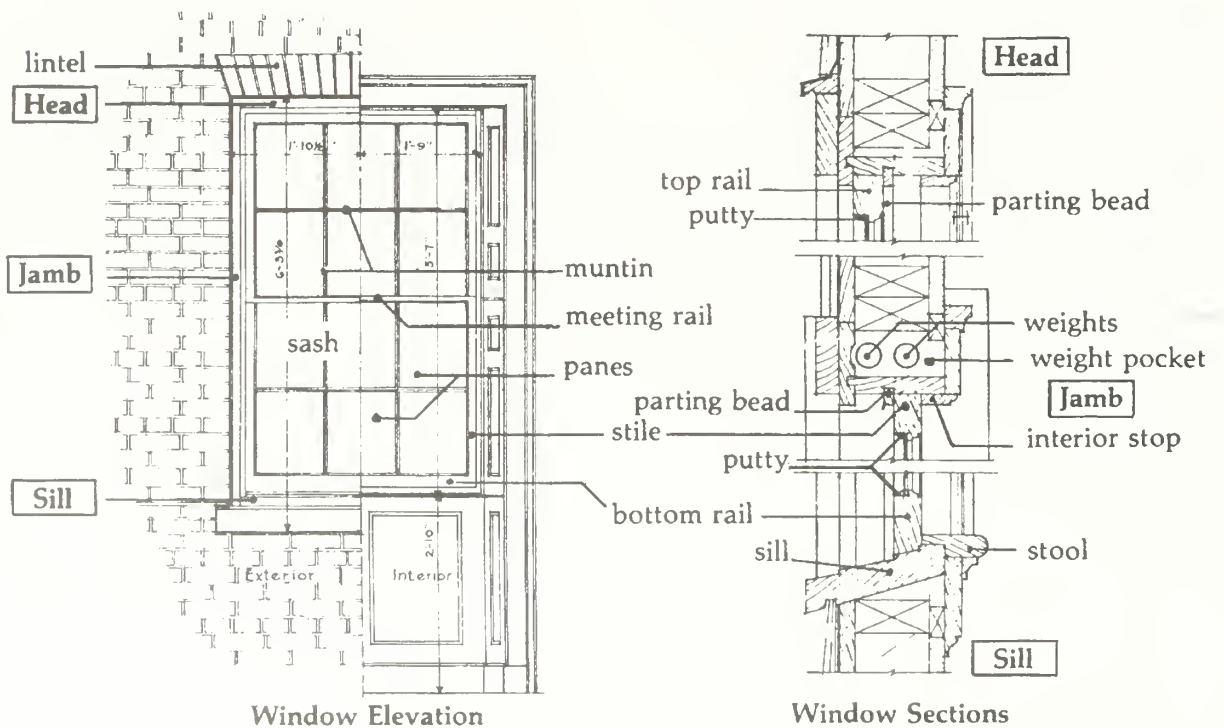
Figures 2 and 3. Wood and metal window details (source: *The Window Handbook*).

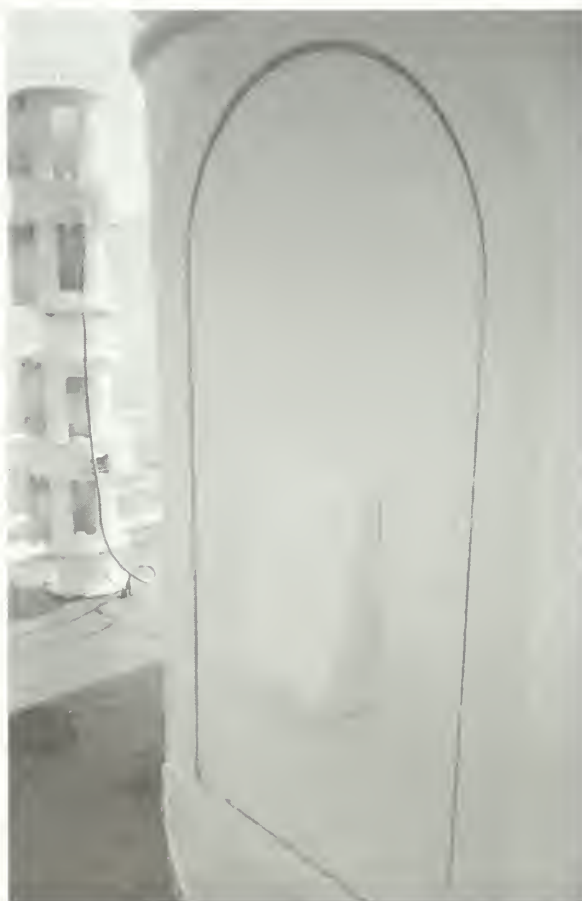
Figure 4. A good example of a blocked window using a metal panel fitted with a hooded vent. For more adequate ventilation, the vent should be larger.

- There are a number of ways to insert vented plywood panels into window openings to avoid damage to frame and sash. One common method is to bring the upper and lower sash of a double-hung unit to the midpoint of the opening and then to install pre-cut plywood panels on the inside face of the window using long carriage bolts anchored into horizontal wooden bracing, or strong backs (see Figures 4 and 5).

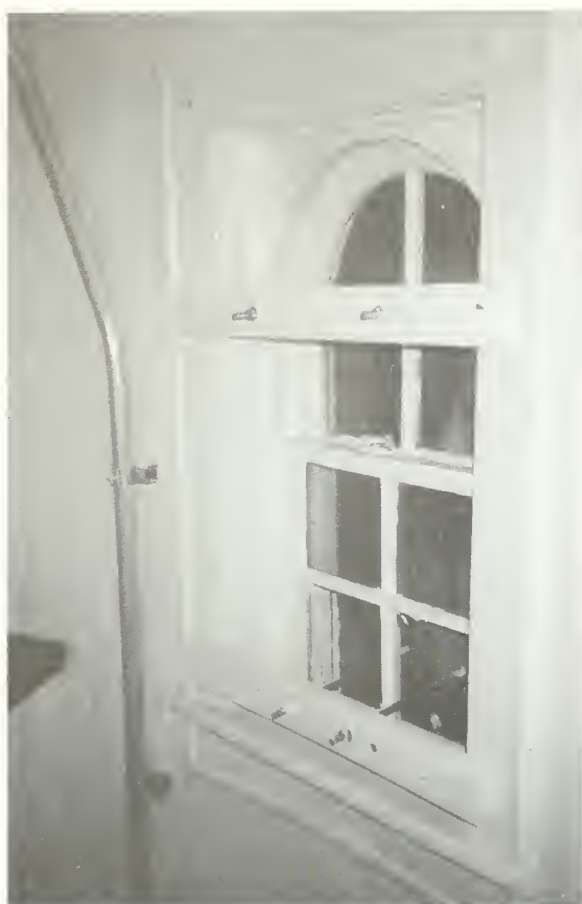
Figure 5. Interior view of the blocked window. If possible, a better solution would have been to raise the lower sash and lower the upper sash and pass the bolts through the openings.

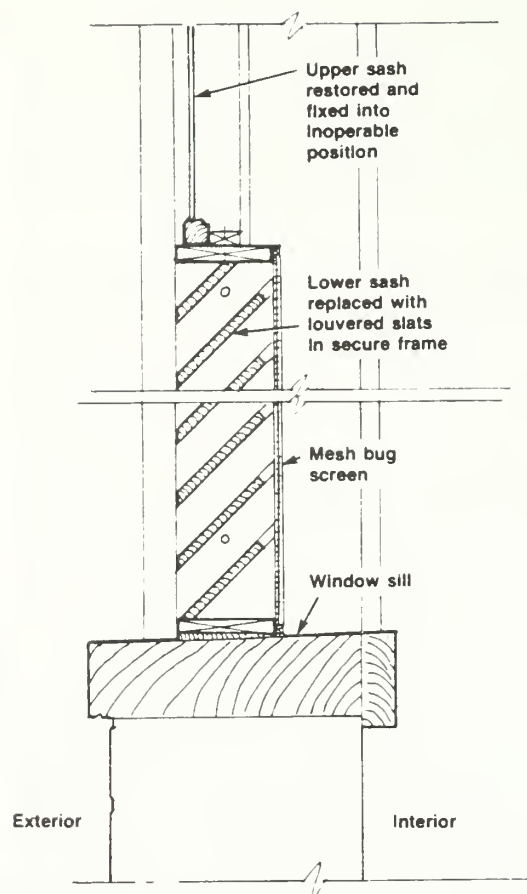
Figure 6. Detail of wood louver system designed to be inserted into lower sash opening after sash has been carefully removed. (Drawing by Thomas Vitanza, WPTC)

(To provide adequate ventilation, the louvered opening should have an area that is approximately half of the original sash opening.) When using this treatment, the sheeting must be ventilated to ensure that condensation, which could accelerate the deterioration of the window, does not build up between the panel and the window.

- The type of ventilation should not undermine the security of the building. The most secure installations use custom-made grills well anchored to the window frame, often set in plywood security panels. In upper-level windows vents formed using heavy millwork louvers set into existing window openings are another possibility (see Figure 6).

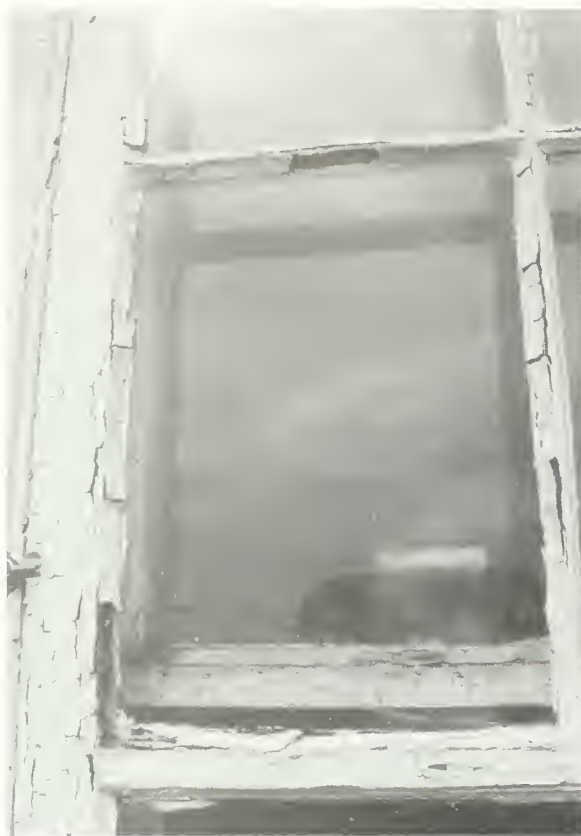
Figure 7. Deteriorated glazing putty and peeling paint on a multilite wood sash.

- Figures 7 through 9 illustrate forms of deterioration typical to lighthouse windows. All of these conditions are repairable and do not require total replacement. The following guidelines are intended to aid in the repair of such deterioration.

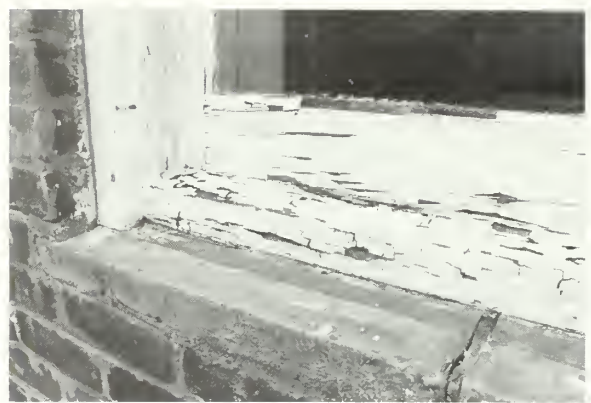
Figure 8. Deterioration of the bottom rail and sill on a wooden double-hung window.

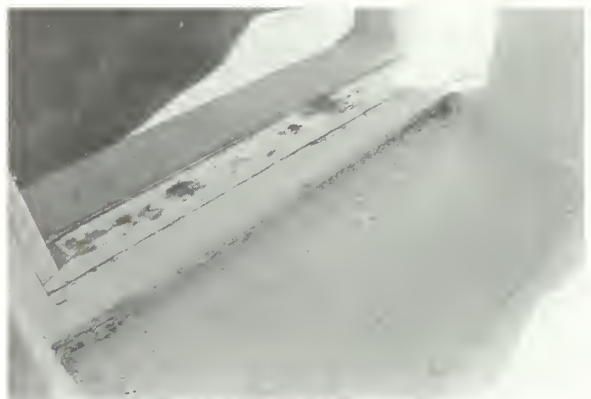
Figure 9. Rust occurring on the inside of the steel channel that forms the sill of this metal casement window.

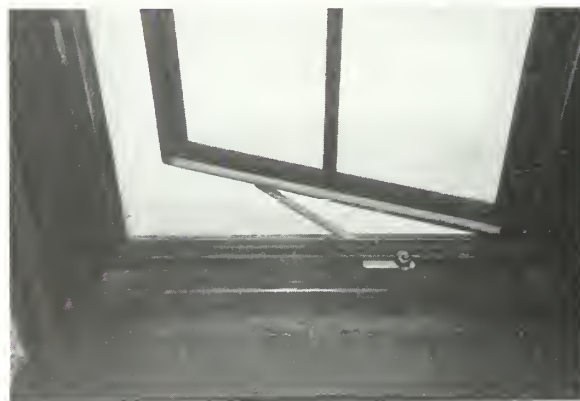
Figure 10. Close-up of a recently restored replacement metal window at Cape Hatteras Lighthouse. Now that the repair work is done, all that this window needs is the hardware lubricated and periodic maintenance to remain in operable condition for the next 50 years. At the time of this lighthouse restoration, it was discovered that the original windows were not repairable and funds were not available to replicate the original cast-iron frame design. The original windows were more like a shutter, constructed in two parts, hinged at both sides and meeting in the middle. The new landing windows were installed as a temporary measure until additional funds are available.

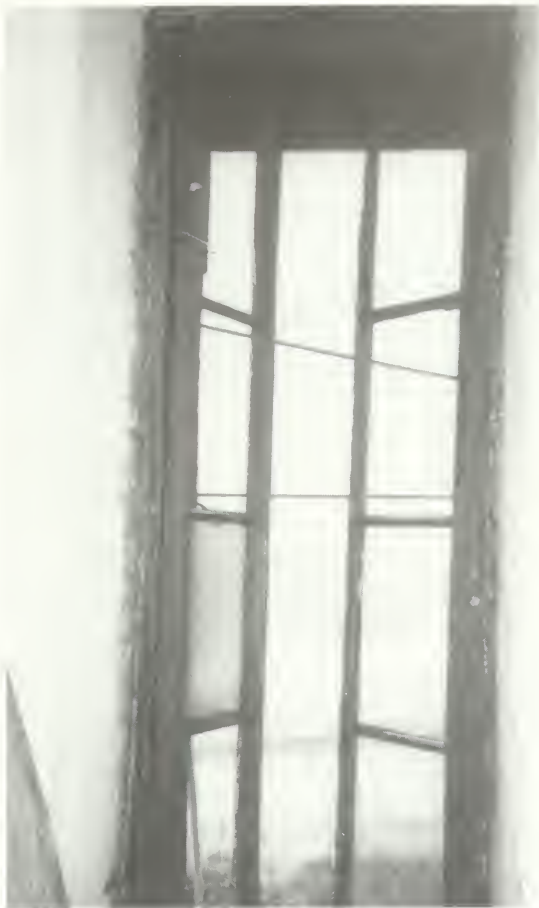
Figure 11. Example of a metal casement window in a lighthouse dating from the 1870s

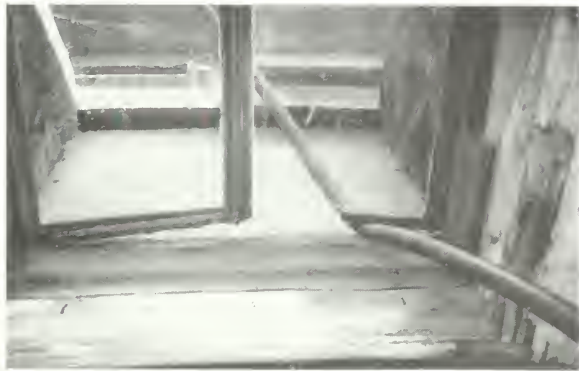
Figure 12. Close-up of severely deteriorated bottom rail of the same window in Figure 11. This condition can be repaired by splicing a new piece of sash

cut the end diagonally to match the existing member; then drill aligned holes in both members for reinforcing dowels.

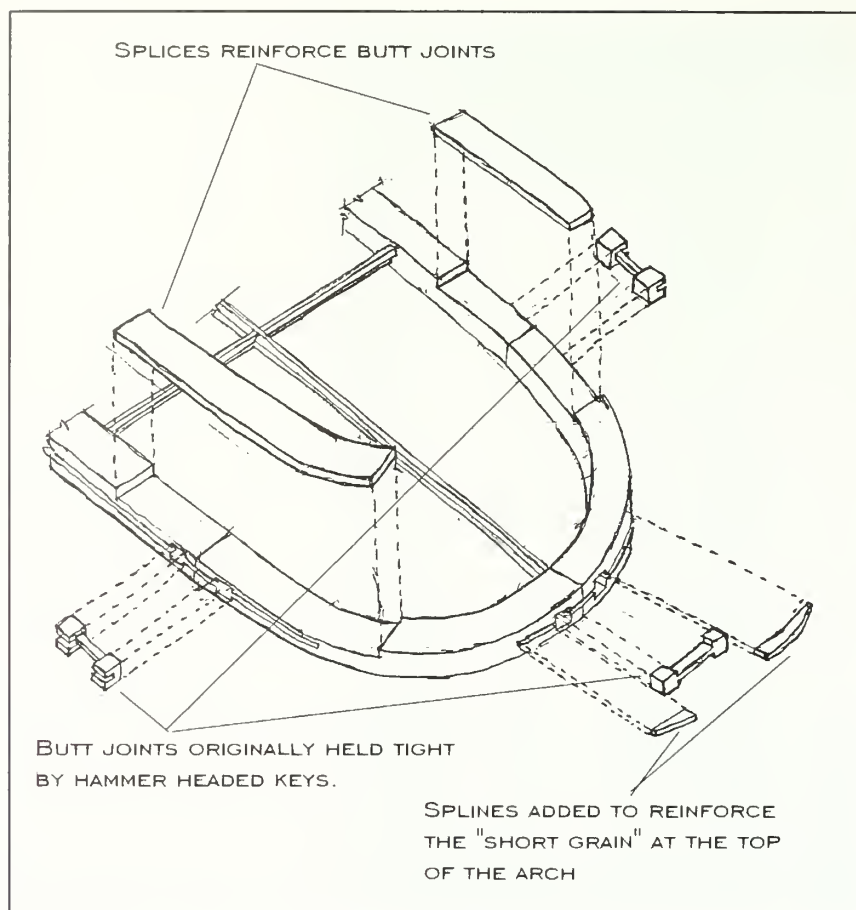
Figure 14. A wood window splice repair. (Illustration by Eric Ford, WPTC)

Deteriorated portions of wood windows can be effectively repaired using like-kind splices or dutchmen. Splicing of a wood member is required when a portion of the window, i.e., a frame rail, has been damaged or has deteriorated and only that portion needs removal and a new section attached in its place. All deteriorated material should be removed, and the end where the replacement member will be attached should be cut on a diagonal to increase the gluing surface area. The replacement member should match the existing members in grain orientation and in any existing shape or profile. The new member can even be made from matching salvaged stock. To attach the new member,

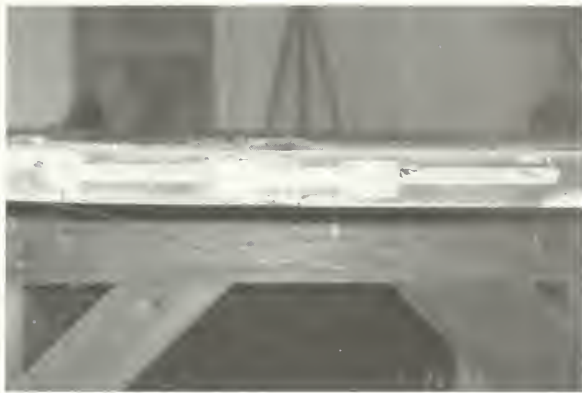
Figure 15. This window sash frame was repaired with traditional (replacement wood hammerhead key) and modern epoxy filler (material to left and right of the hammer head key) techniques.

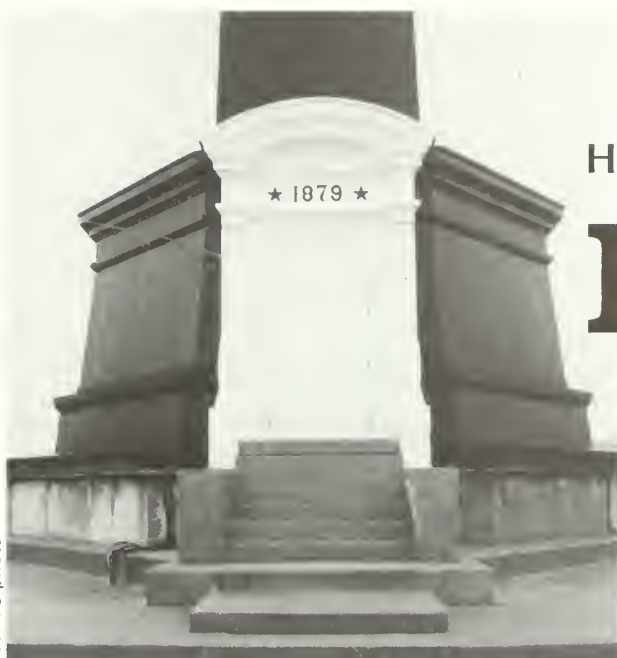
Figure 1. Close-up of large, double-leaf, wood-frame and panel doors at the Cape Henry Lighthouse (second tower), Fort Story, Virginia.

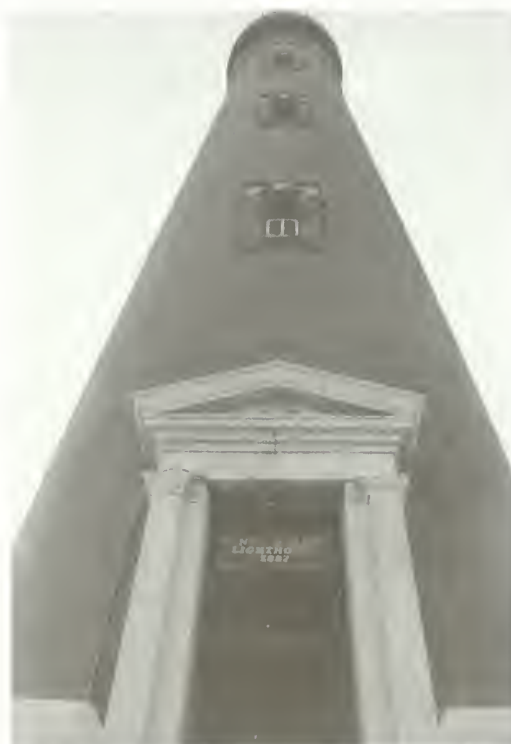
Figure 2. View of the neoclassical doorway at the Ponce De Leon Inlet Lighthouse, Florida.

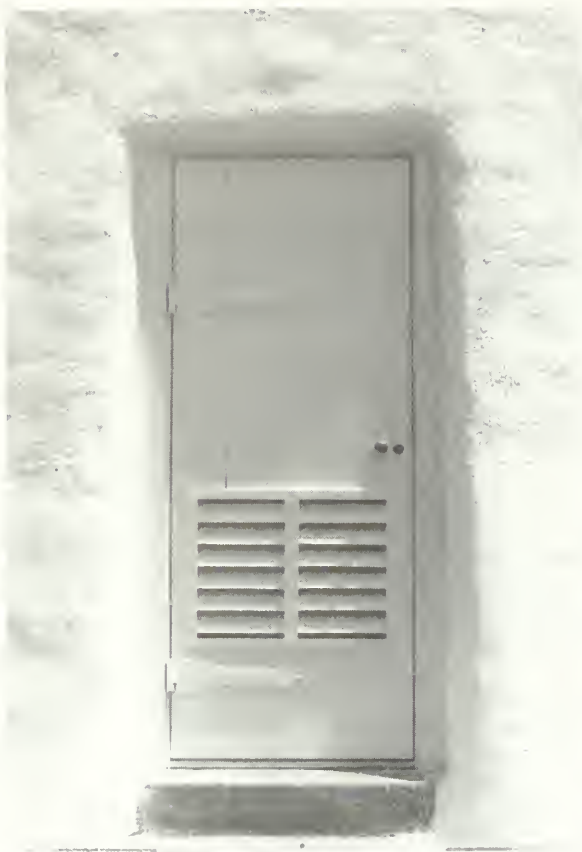
Figure 3. View of the simple pre-Civil-War-style replacement plank door at the Ocracoke Lighthouse, North Carolina.

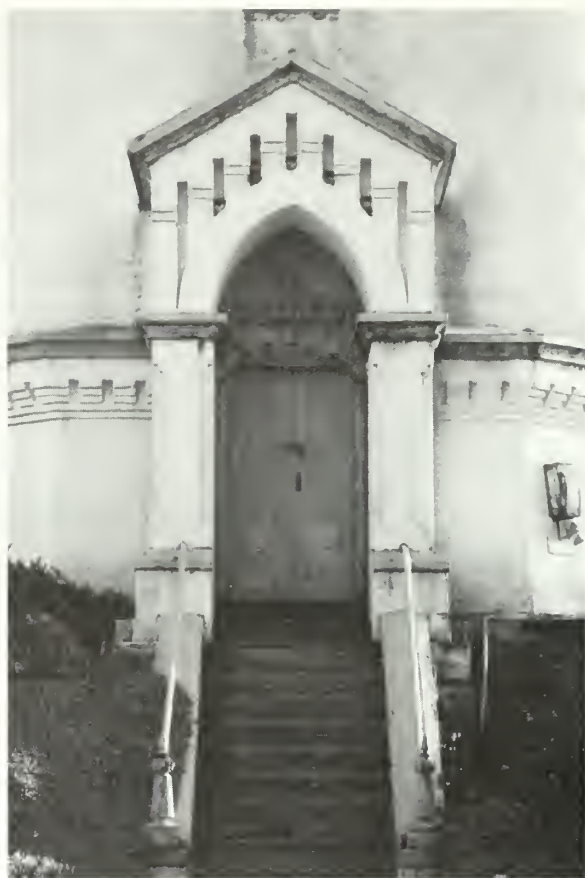
Figure 4. View of gothic revival style entrance at Piedras Blancas Lighthouse, California.

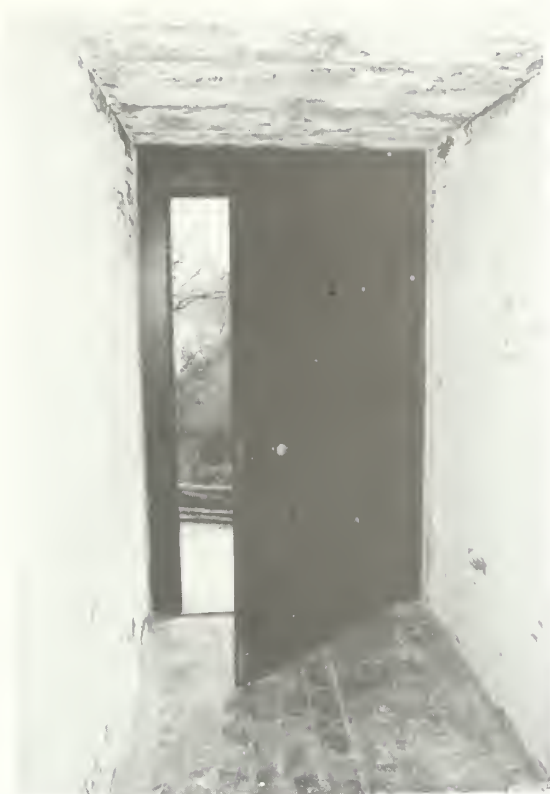
Figure 5. View of the large, single-leaf, wood-plank door at the Cape Henry Lighthouse (first tower), Fort Story, Virginia.

- **Wood plank door:** A door of one or two leaves that is constructed of two layers of tongue and groove wood planks that run vertically on the exterior side of the door, and typically run horizontally or diagonally on the interior. The planks are typically fastened by clinch nailing (nails that are driven through the outside of the door and bent over on the inside). The door is usually reinforced with horizontal 'battens' at the hinge locations; a diagonal batten may run from the top batten to the bottom batten. Such a door is typically hung on strap hinges; however, butt hinges may have been used. This construction method is used to limit the exposure of the end grain in the boards to the top and bottom of the door.

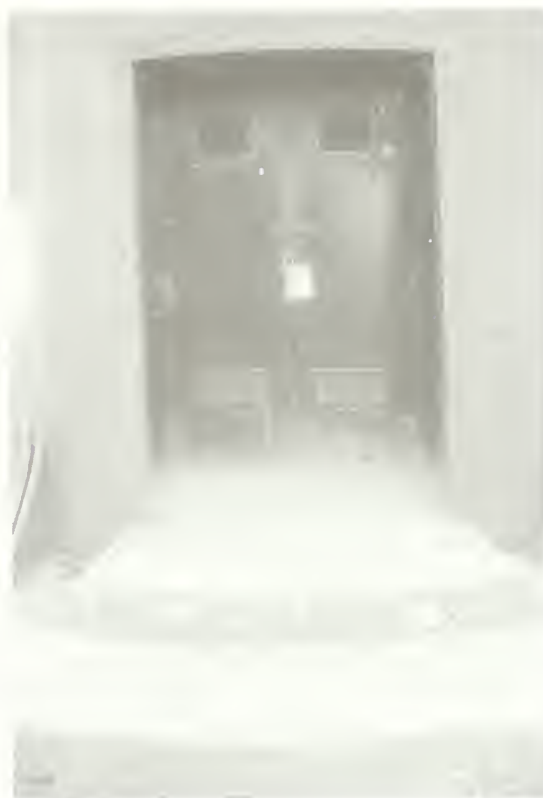
Figure 7. Another variation on the double-leaf, sheet-iron door configuration at the Cape Canaveral Lighthouse, Florida.

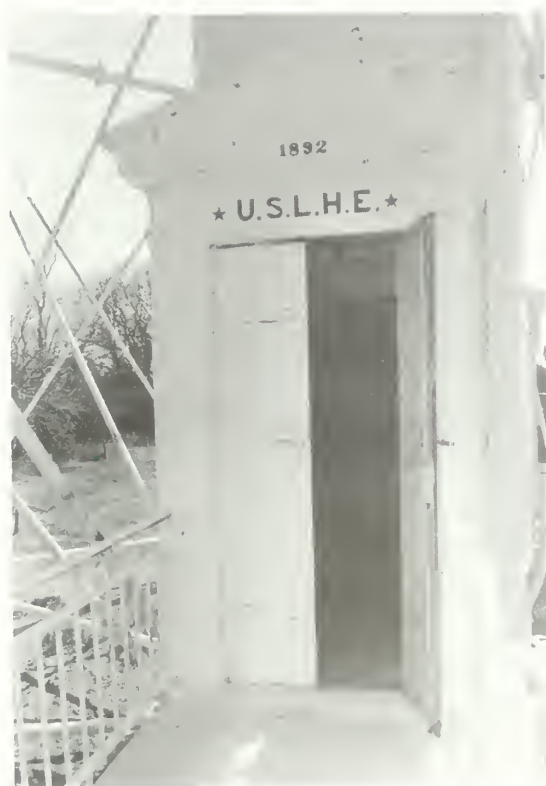
Figure 6. Close-up of the neoclassical, double-leaf, sheet-iron door at the Cape Charles Lighthouse, Smith Island, Virginia.
