Historic Lighthouse Preservation Handbook

1997

PD-375

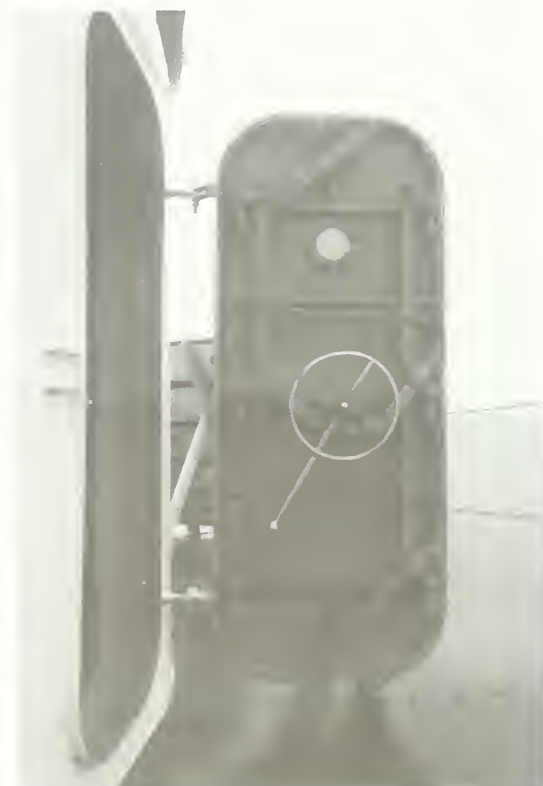
Figure 8. An example of a typical watertight 'ship' style door at Los Angeles Harbor Lighthouse, California.

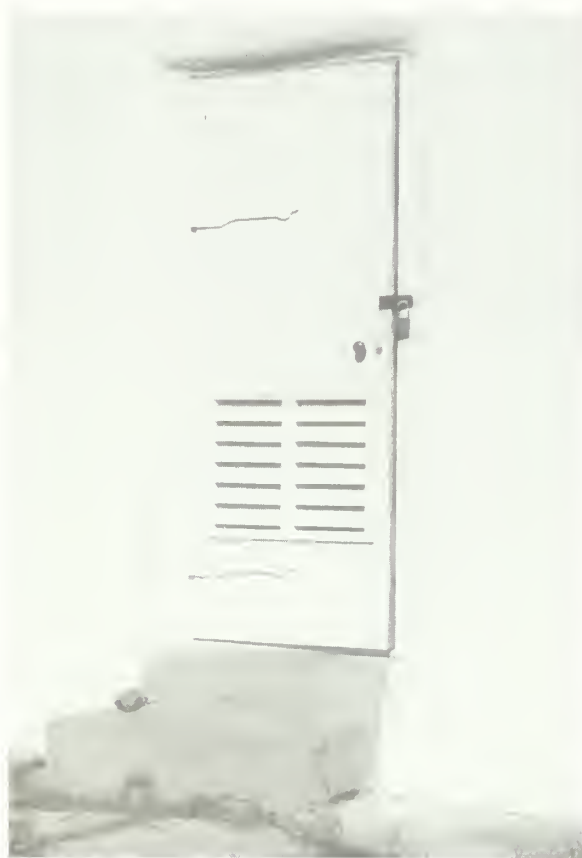
Figure 9. View of the Ocracoke Lighthouse five years after replacement; note rust streaks from nails. This condition indicates the paint coating has degraded to the point where moisture has permeated the surface.

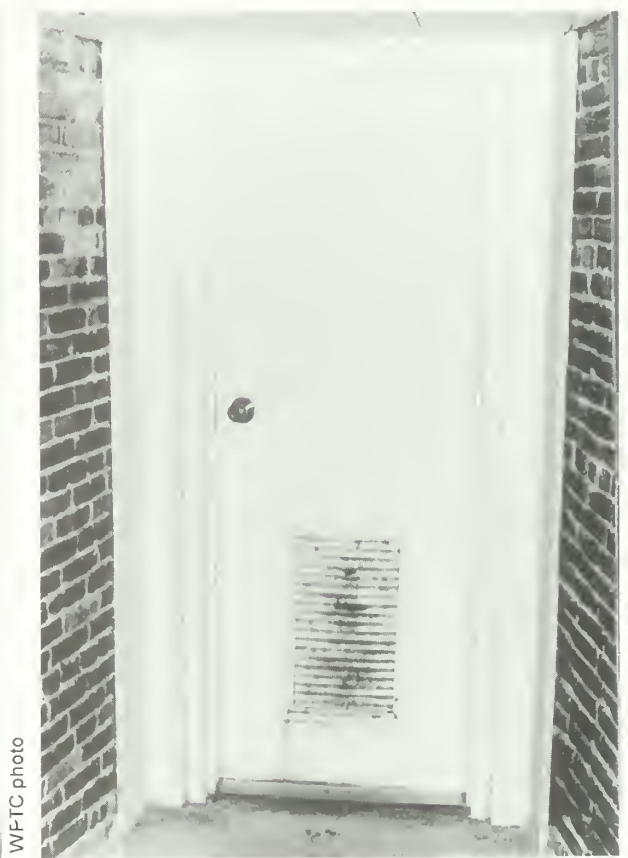
Figure 10. Interior view of the modern metal door at the Ocracoke Lighthouse before its replacement; corrosion like this should be removed and the affected areas treated with a rust-inhibiting coating system.

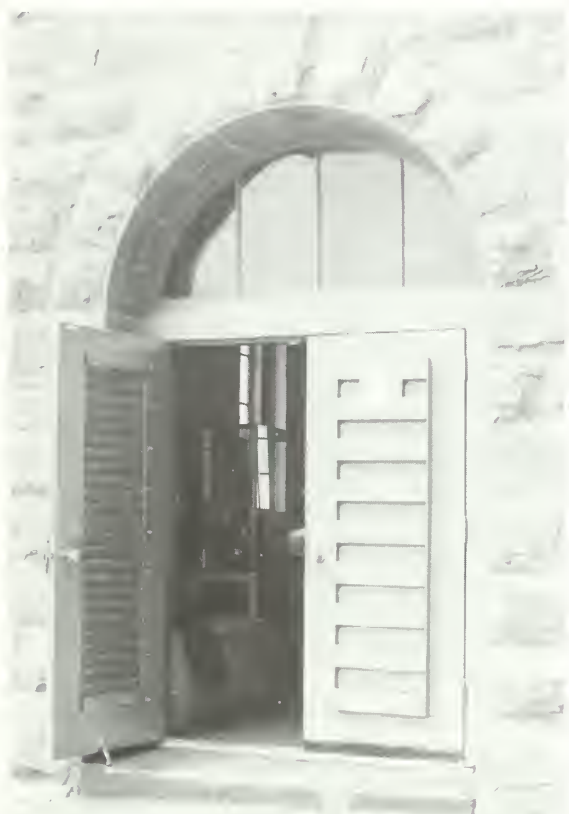
Figure 11. These louvered doors have been installed at Point Sur Light Station for security and ventilation. Note the baffles on the exterior and the screened louvers on the interior.

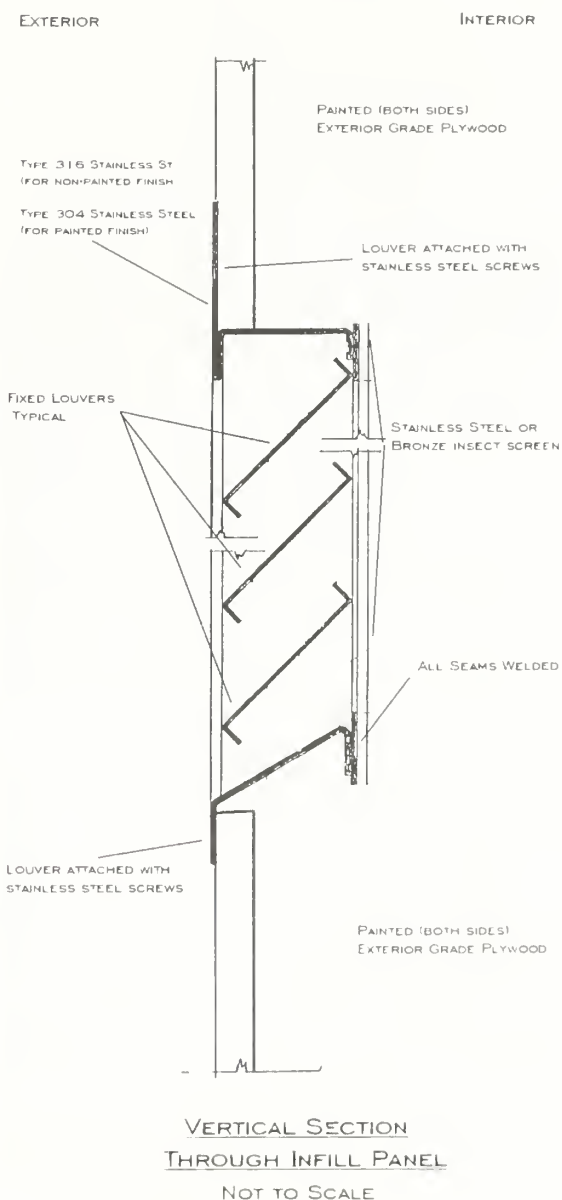
Figure 12. Typical detailing of a "storm proof" louver for temporary lighthouse doors. (WPTC image adapted from drawing from USCG-CEU Oakland Archives)

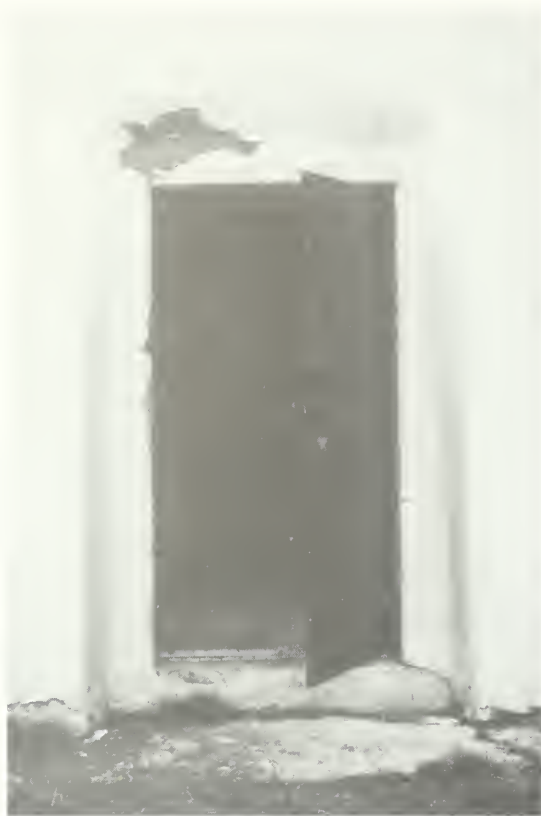
Figure 13. Site-built steel door at the Turkey Point Lighthouse; this solution was chosen because of the remote location and repeated break-ins. Note exterior stiffeners and shroud over the hasp and lock.

Site-built, fabricated steel door: This door consists of a steel 'C' channel frame set into the existing opening that is lag-bolted to the existing door frame. On the outside of this frame, the door leaf is connected by welding the hinges to both the frame and door leaf. The door leaf should overlap the opposite door frame to facilitate the installation of an eye that will pass through a slot in the door leaf to facilitate a lock. A steel shroud big enough to facilitate lock operation with a key, but prevent bolt cutters from reaching the lock, should be welded over top of the eye slot. If the lighthouse is not in an area that is to being wave swept (i.e., if the lighthouse is located on a breakwater or pier), the door should be fitted with screened louvers that are approximately 25 percent of the total door area. The louvers

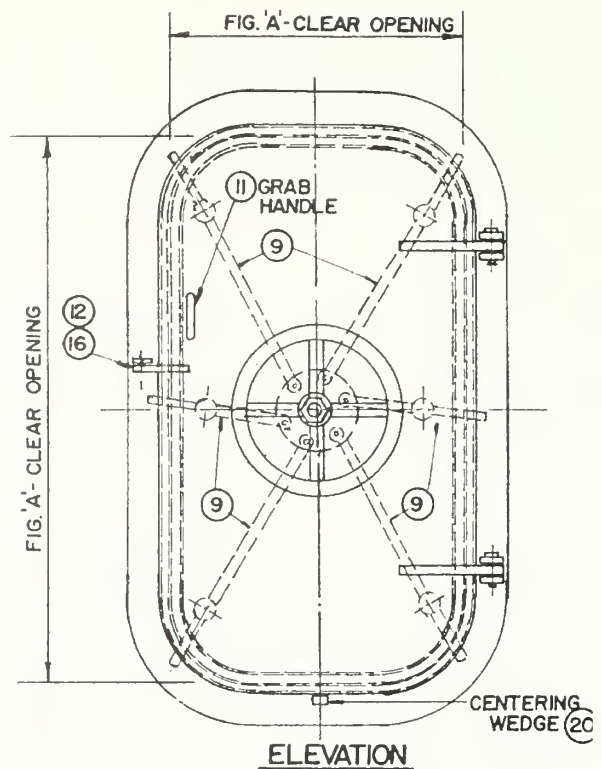
Figure 14. A shop drawing depicting the parts of the watertight 'ship' style door. (Drawing courtesy of Cen-Tex Marine Fabricators)

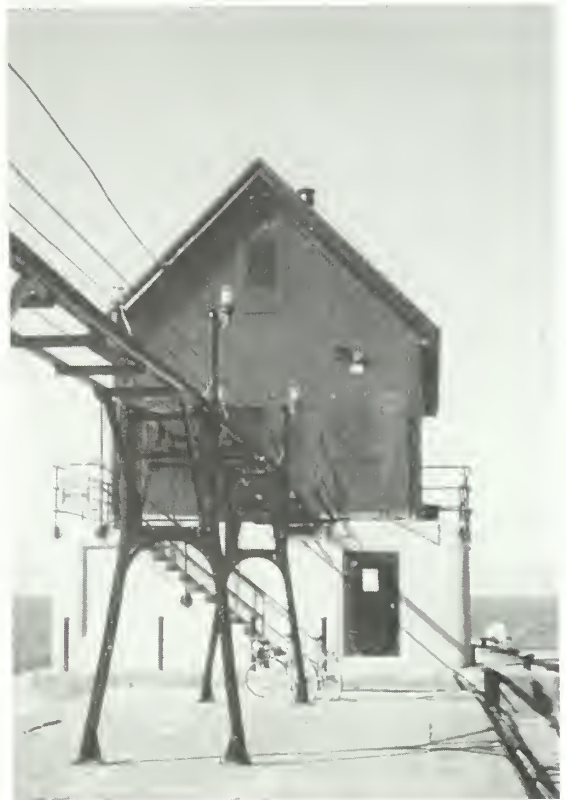
Figure 15. View of watertight 'ship' style door installation on the Grand Haven South Pierhead Front Range Light, Grand Haven, Michigan.

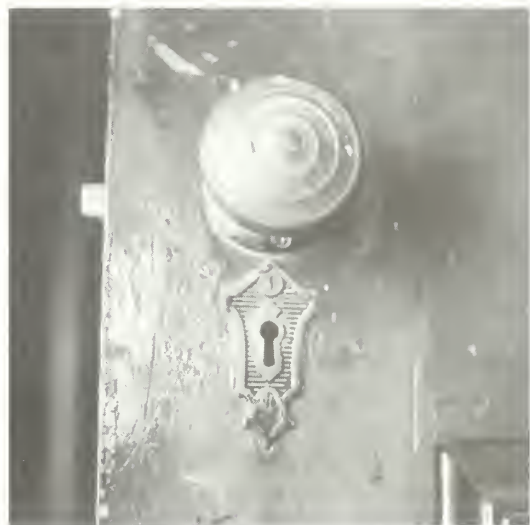
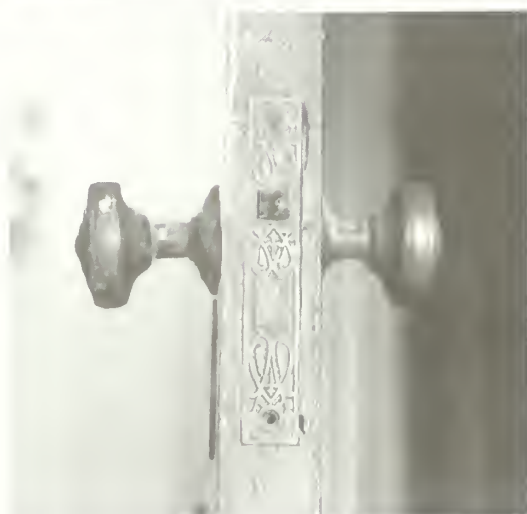
Figures 16 and 17. Examples of decorative door hardware found in late 19th-century lighthouses.

Historic lighthouse door hardware is not only functional but also significant in defining the character of the historic door. Lighthouse door hardware such as door knobs, hinges, keyhole escutcheons, and even strike plates were often decoratively detailed with motifs of the architectural style of the lighthouse. When preserving historic lighthouse doors, the existing hardware should be retained. When repairs are made to the door, the hardware should be removed for protection or protected in place to avoid any damage that may be incurred during the repair process. If the hardware is removed, label each piece to

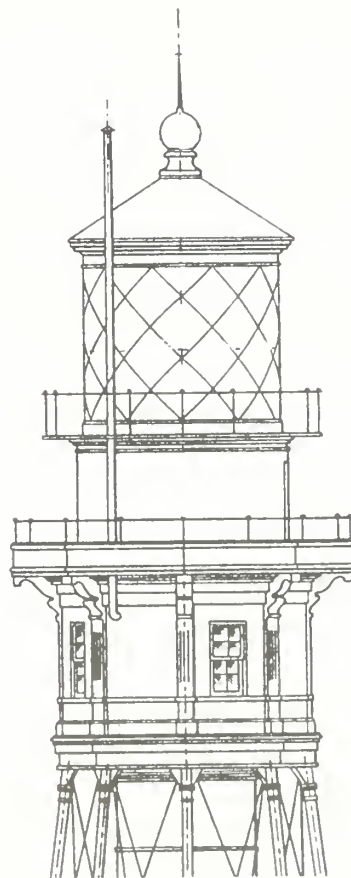
Figure 2. Original construction drawing of the first-order Cape Fear Lighthouse showing the lantern above the service/watch room.

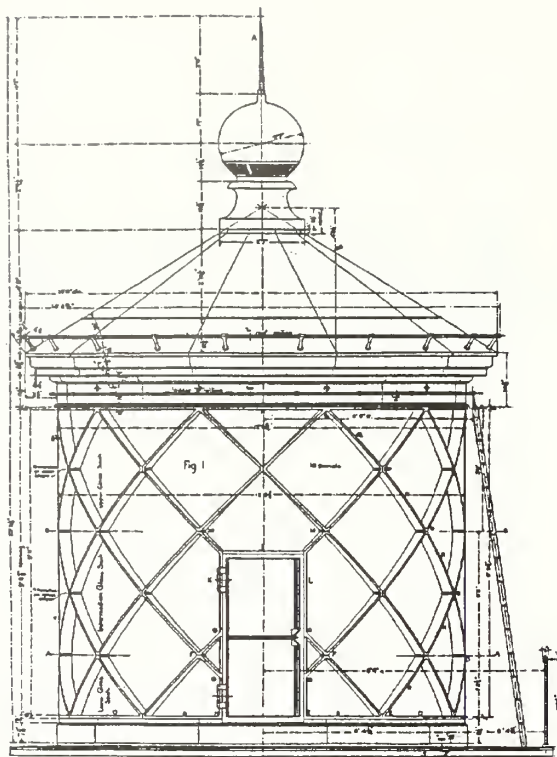
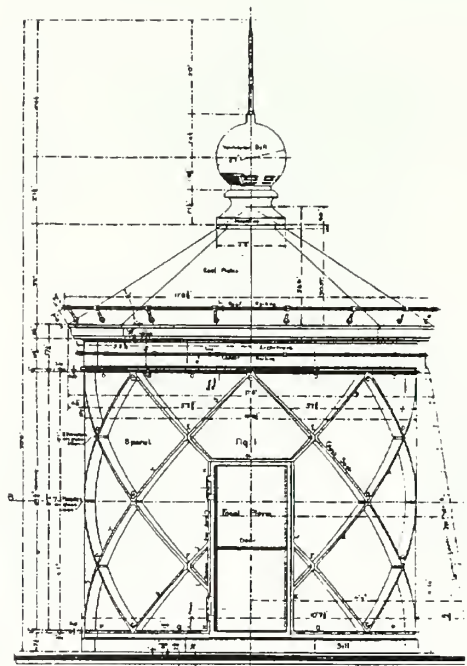
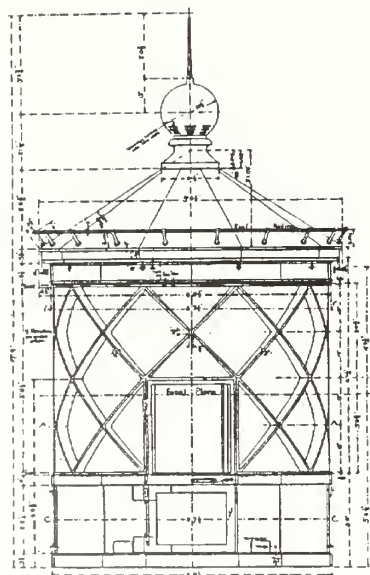
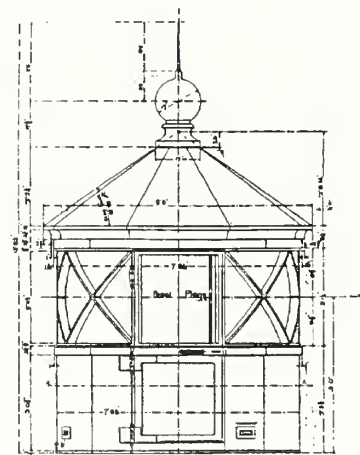
Figure 3. Illustration of the four standard lantern sizes used by the U.S. Lighthouse Establishment in the first half of the 20th century. Drawing assembled by WPTC from images dated 1898 and 1903 courtesy of USCG CEU Oakland.

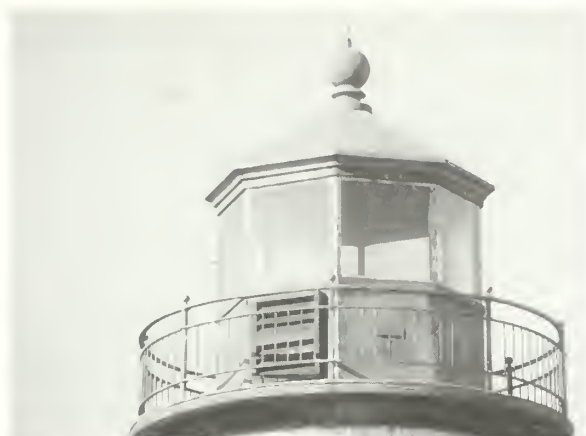
Figure 4. Close-up of the fourth-order lantern at Coquille River Lighthouse in Oregon.

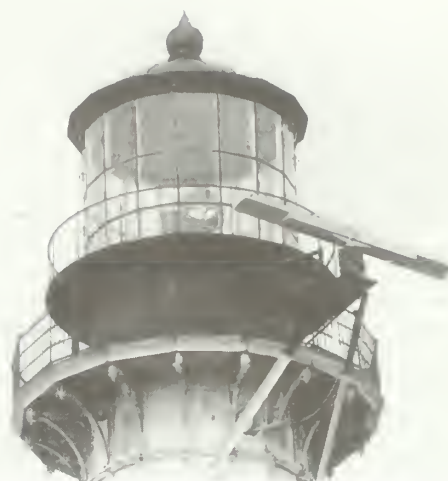
Figure 5. Close-up of the first-order lantern at Cape Canaveral in Florida.

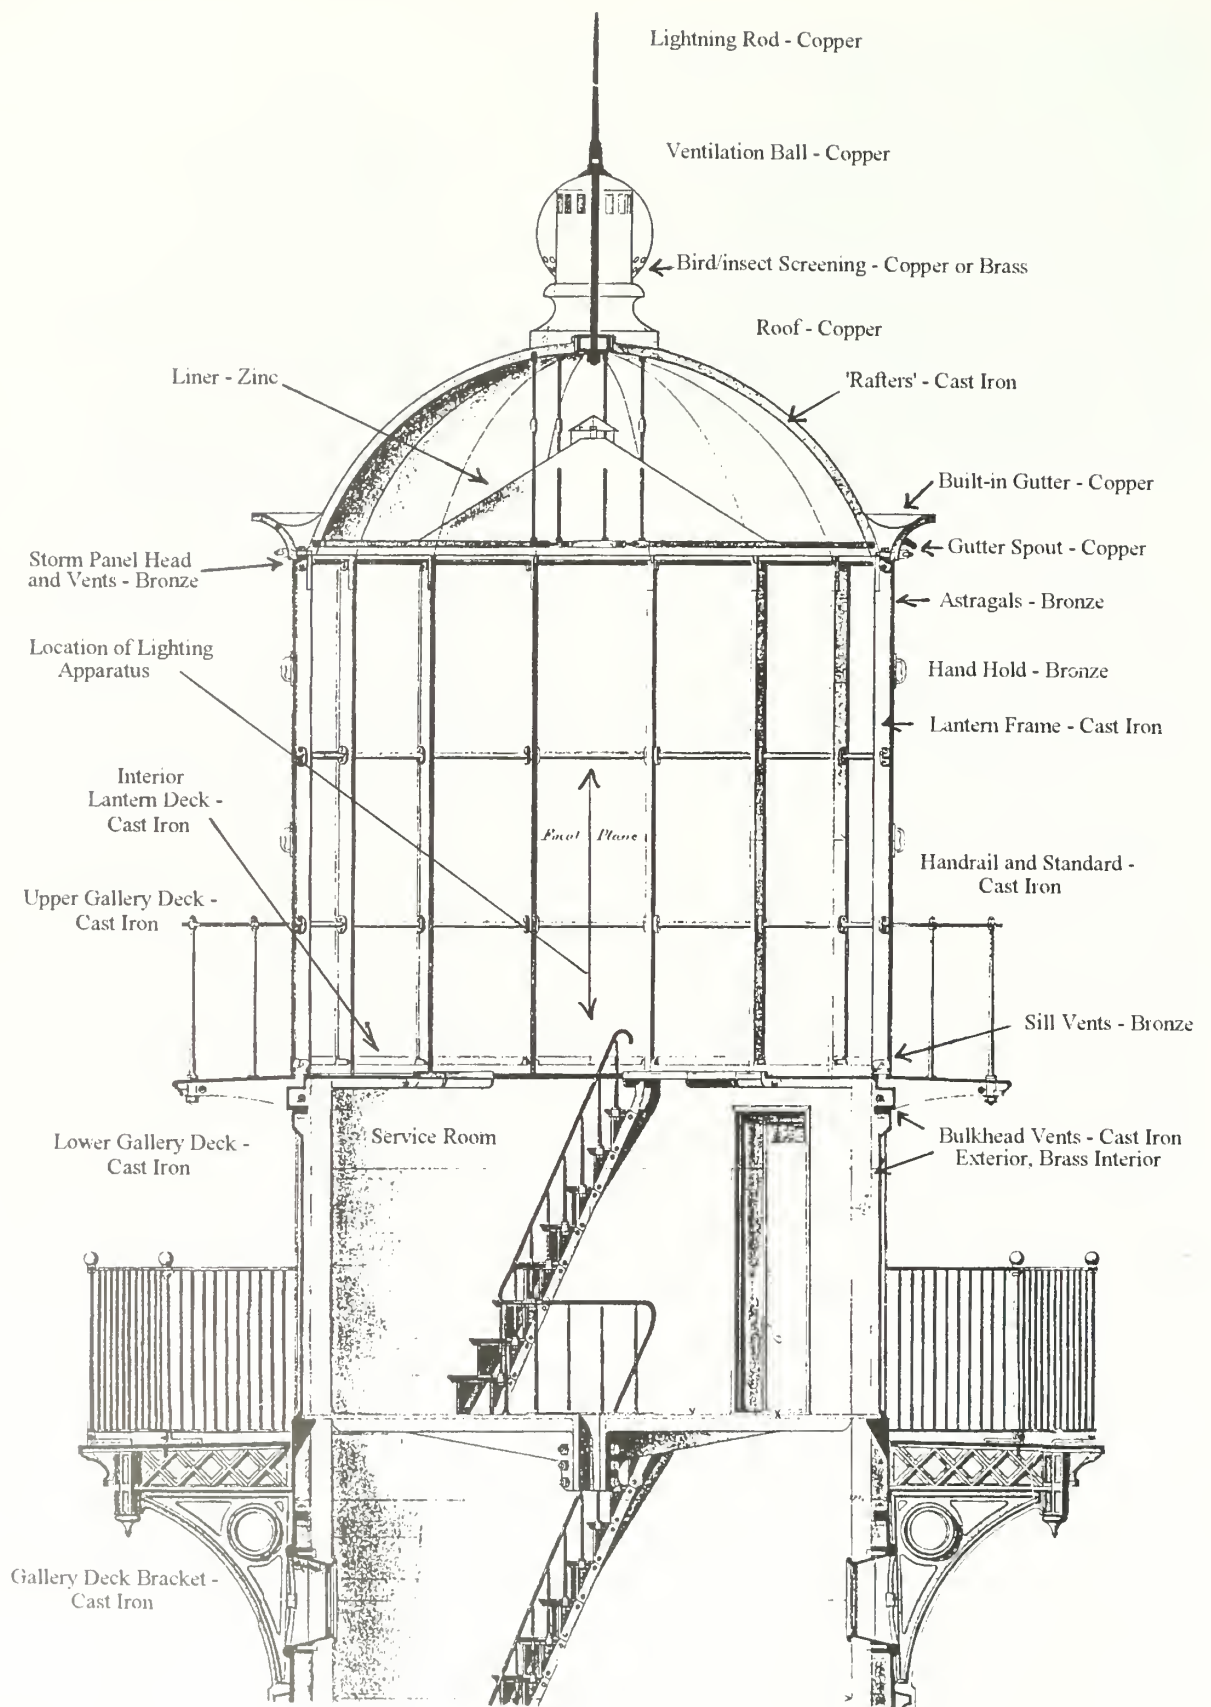
Figure 6. Diagram of a typical first-order lantern; the parts are similar to second- and third-order lights. (Diagram based on USLHS drawing in the National Archives)

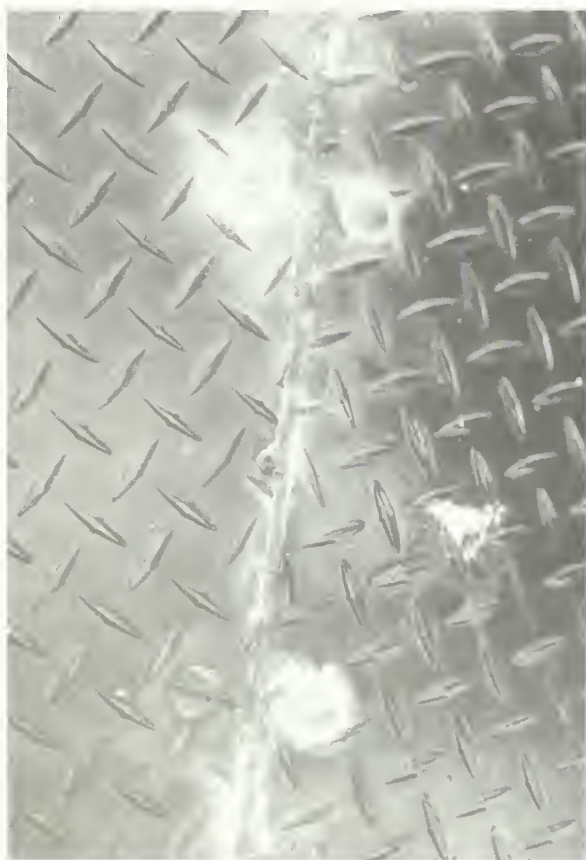
Figure 7. The white chalky residue around the steel bolt heads on this aluminum deck is the by-product of the corrosion occurring at these connections.

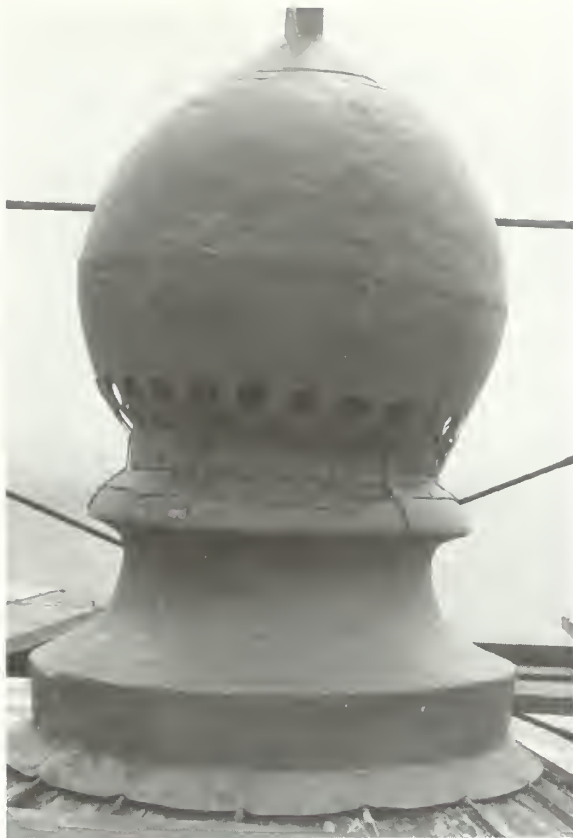
Figure 8. Despite the fact that this first-order lantern ventilation ball has been repaired several times, it still provides adequate lantern ventilation.

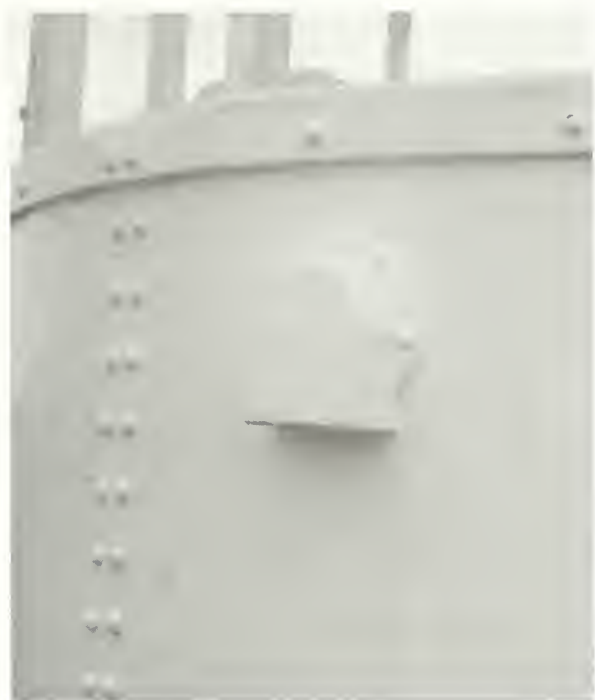
Figure 9. An example of a parapet-wall-mounted vent on a fourth-order lantern.

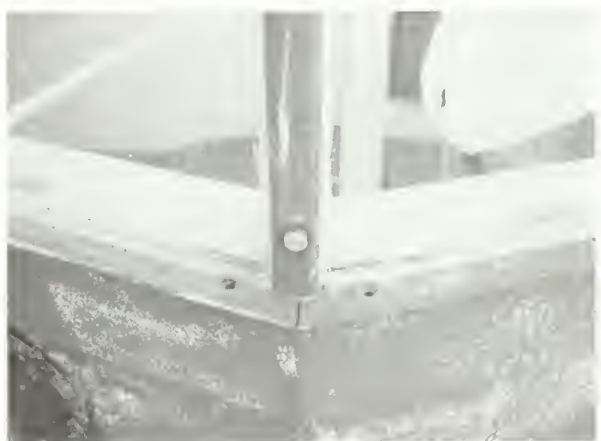
Figure 10. Close-up of missing clamp bolts; these bolts should be replaced to keep this area weather tight.

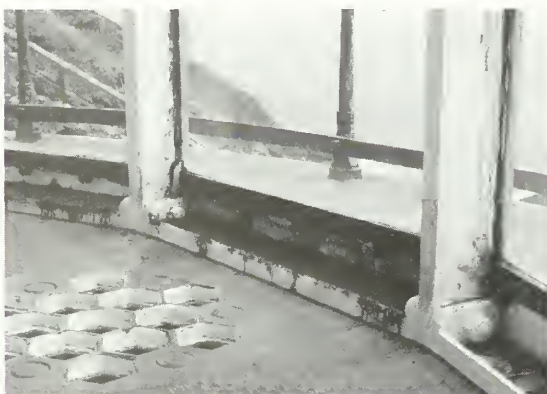
Figure 11. The water that has collected in this lantern sill is causing the iron lantern glass frame (the vertical members in the center of the photo) to rust and corrode.

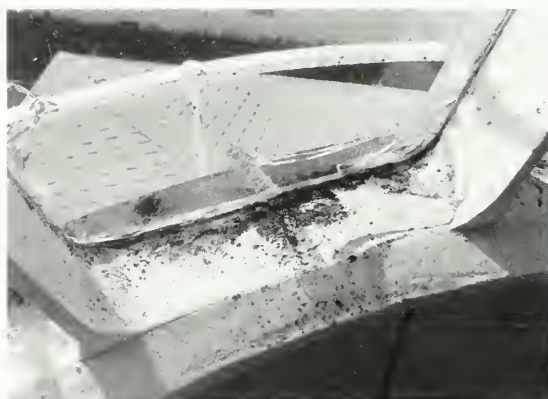
Figure 12. The glass in this lantern has been cracked by the rust-jacking that is occurring along the iron frame.

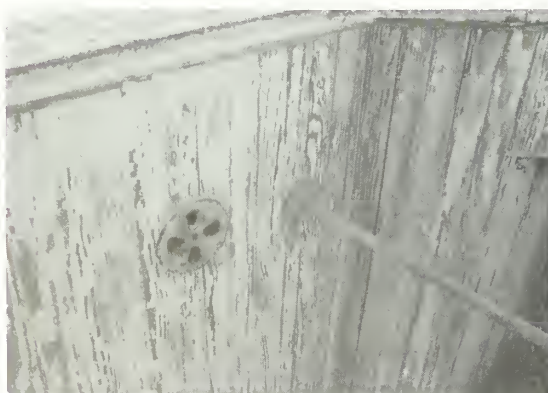
Figure 13. The paint coating that once protected this lantern parapet wall has failed.

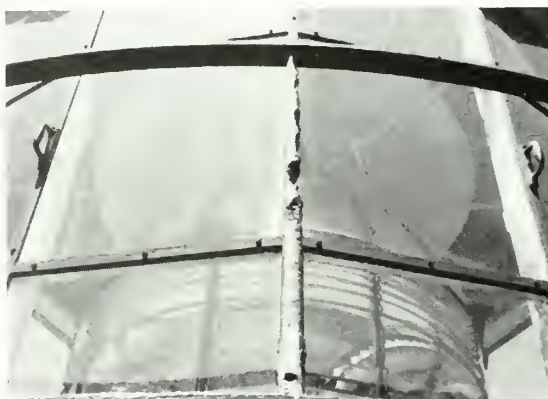
Figure 14. Wind and airborne sand have accelerated the deterioration of this lantern gallery deck handrail

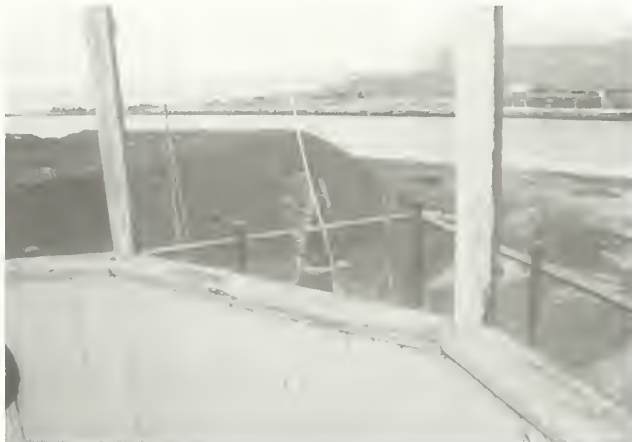
Figure 16. This lantern glass has been damaged by rock-throwing vandals. The resulting hole is allowing rain and insects to enter the lantern.

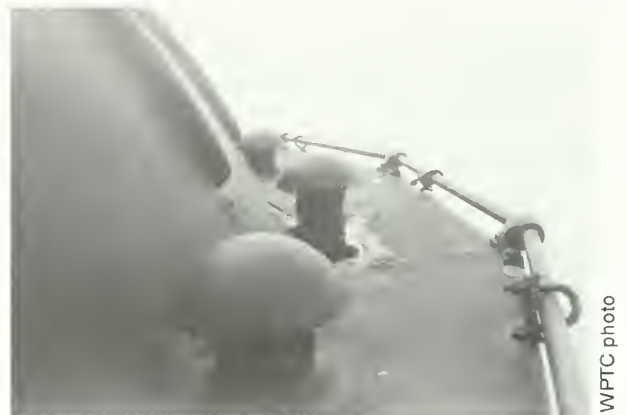
Figure 17. Roof vents such as these should be inspected for leaks and maintained during the mothballing period. This shroud-style vent allows air to pass while preventing rain from entering.

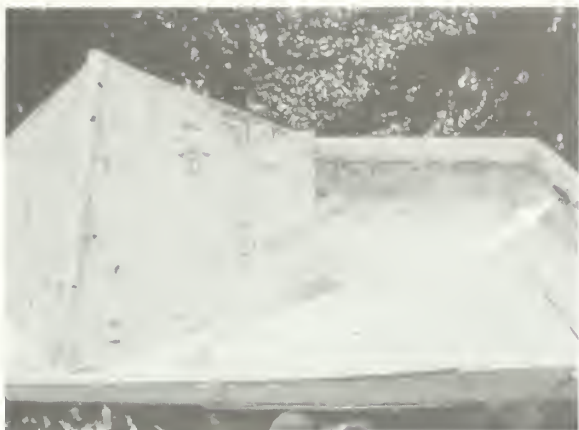
Figure 18. View of built-in gutter on a caisson lighthouse; arrow indicates fist-size hole. This condition must be treated before mothballing.

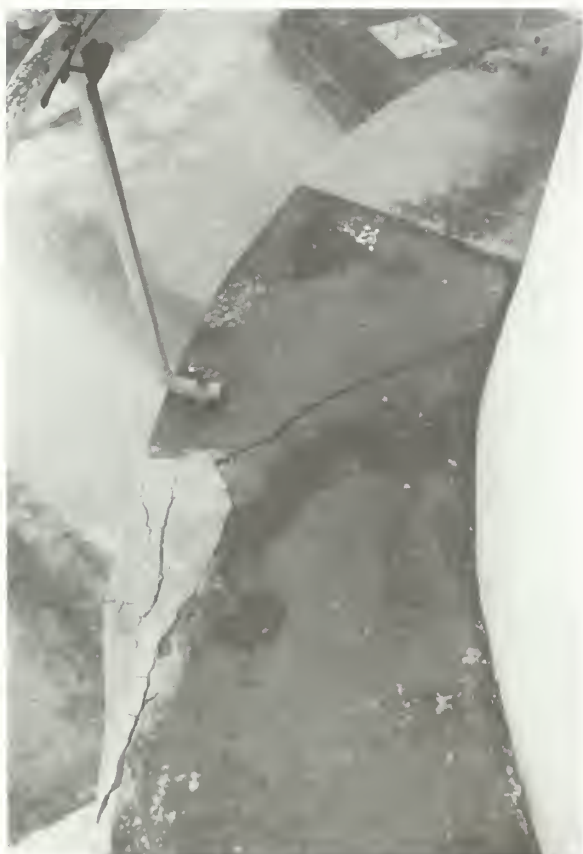
Figure 19. The repair made to this stone gallery deck has begun to deteriorate; moisture penetration is occurring. This condition should be addressed before mothballing.

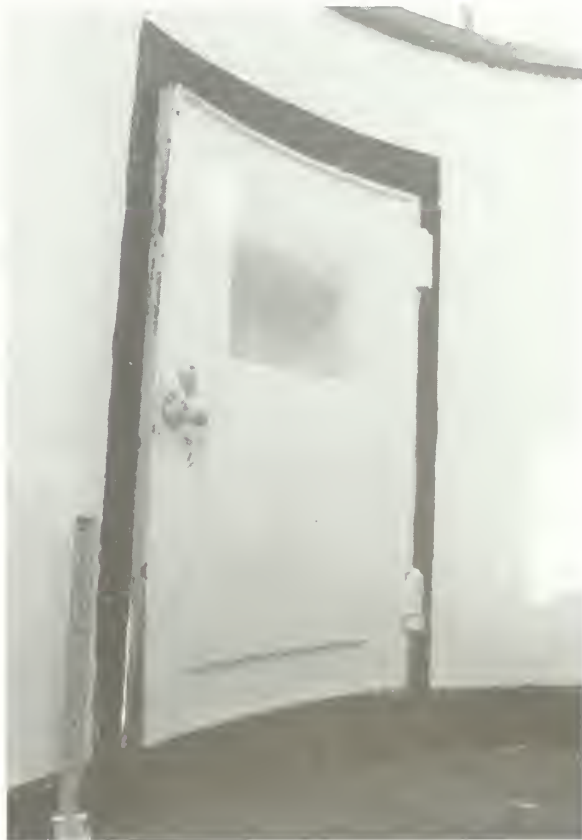
Figure 20. Close-up of a vented parapet hatch in a fourth-order lantern. The hatch should have a good seal and still remain operable. The built-in vent should also be kept open to maximize ventilation of the lantern and tower.

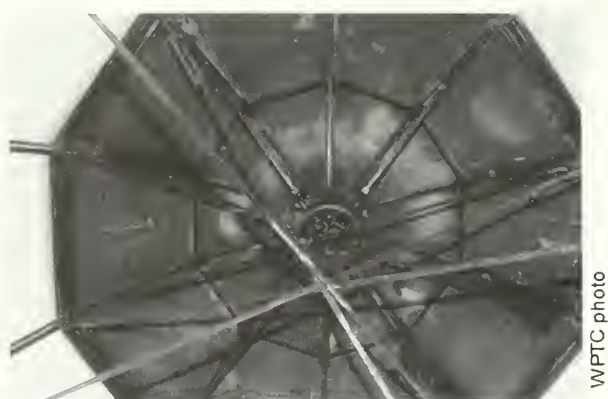
Figure 21. The diagonal tension rods in this empty lantern were installed to brace the lantern against lateral loading caused by high winds.

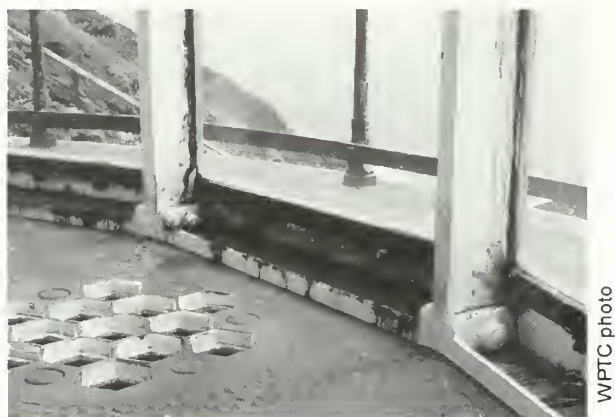
Figure 22. Close-up of sill vents in a first-order lantern. The vents should be kept open during the mothballing period to maximize lantern and tower ventilation.

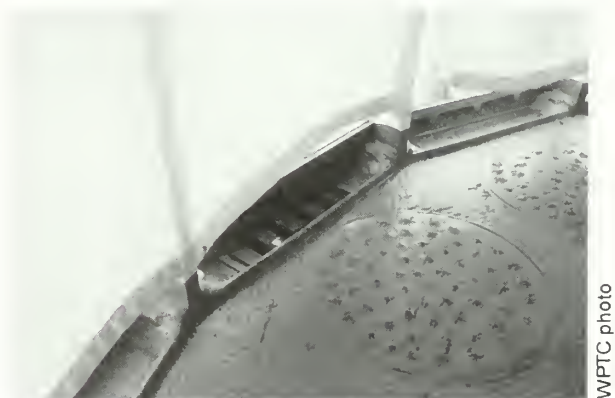
Figure 23. As part of the lantern mothballing treatment the lantern glass sill vents should be kept open (except in extremely damp climates) to allow for the free flow of air through the lantern.

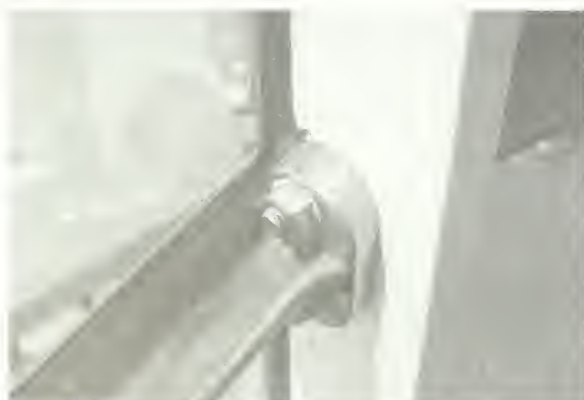
Figure 24. The stainless steel through bolts used to join this bronze sash bar to the vertical lantern post is isolated from the bronze using a nylon washer as a barrier.

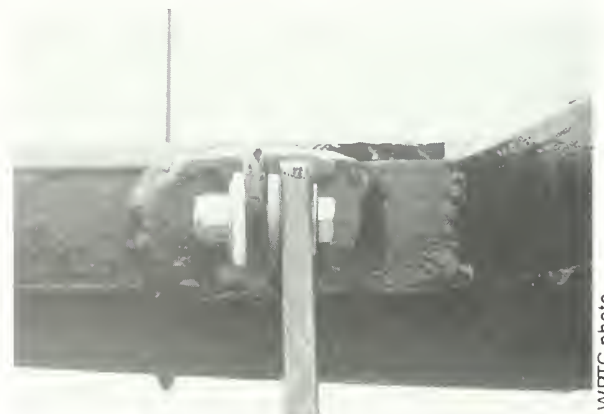
Figure 25. This is a view of a typical dissimilar metal isolation solution; the steel ladder post (vertical member in the center of the image) is isolated from the aluminum lantern gallery deck with nylon washers. The bolt chosen for this application is made from Type 316 stainless steel.

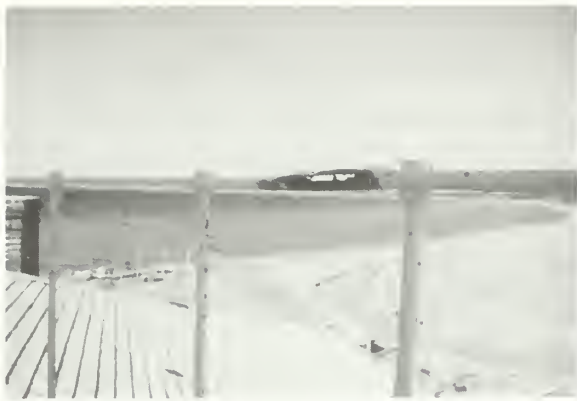
Figure 26. Detail of handrail that is being deformed by rust-jacking.

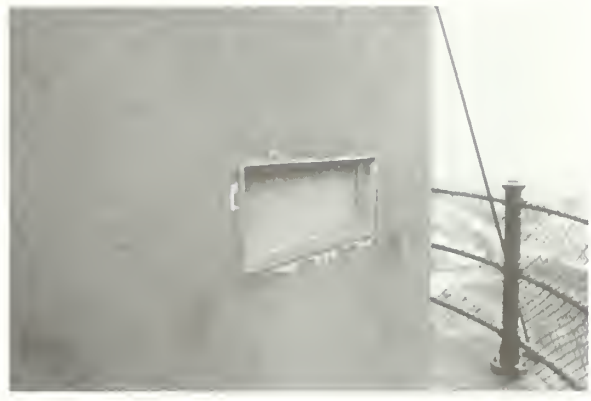
Figure 27. This lantern vent opening has been covered with a fine stainless steel screen that prevents insect infiltration while maximizing air movement through the vent and into the lantern.

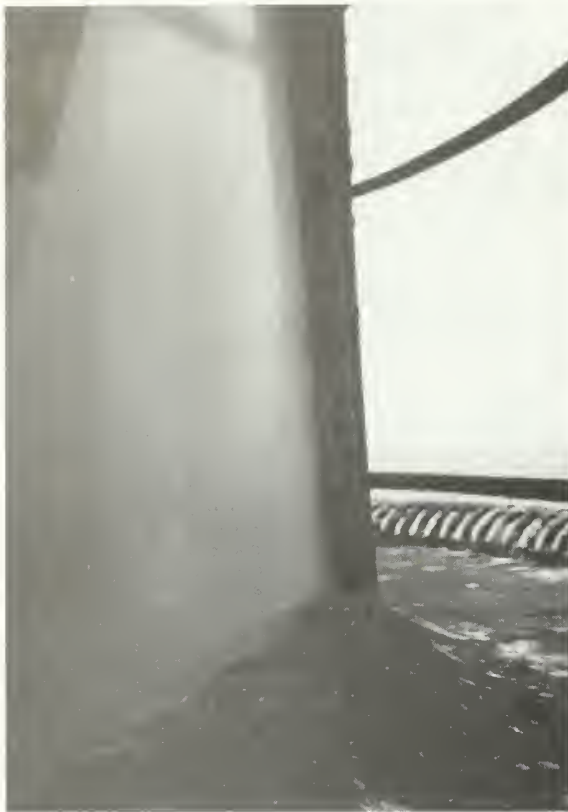
Figure 28 (top left). Close-up view of severely hazed Lexan replacement panel. Note the limited visibility caused by only ten years of sunlight and salt air exposure.

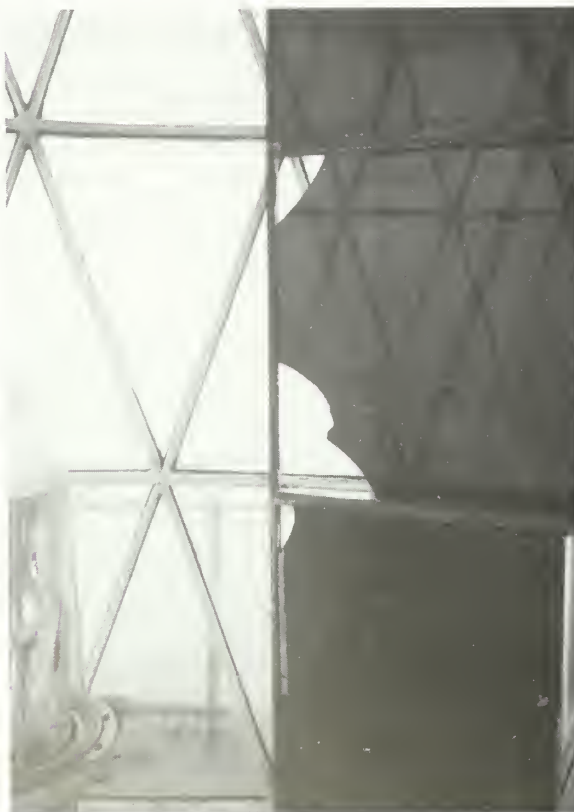
Figure 29 (bottom left). Looking out through severely hazed Lexan panels, note the limited amount of light transmission; this greatly hinders the effectiveness of the aid to navigation. If the panels are not replaced, the degradation may continue and diminish the light transmission, ultimately rendering the aid to navigation ineffective.

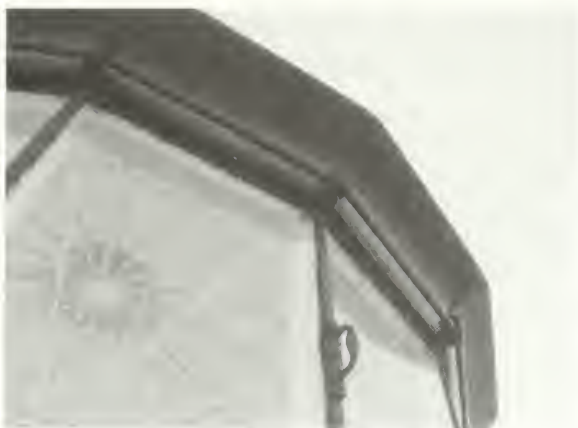
Figure 30. Close-up of a first-order lantern that retains its lantern glass; note the clarity.

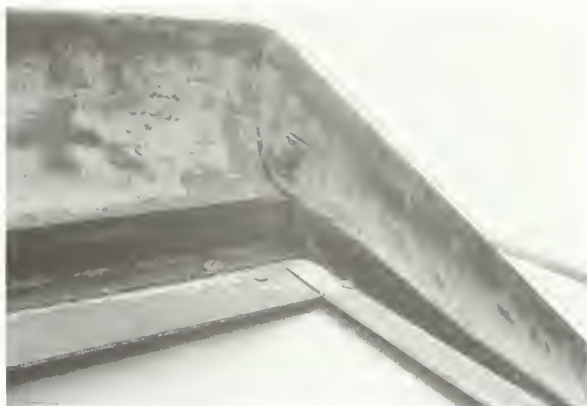
Figure 31. View of built-in gutter spout on a copper roof.

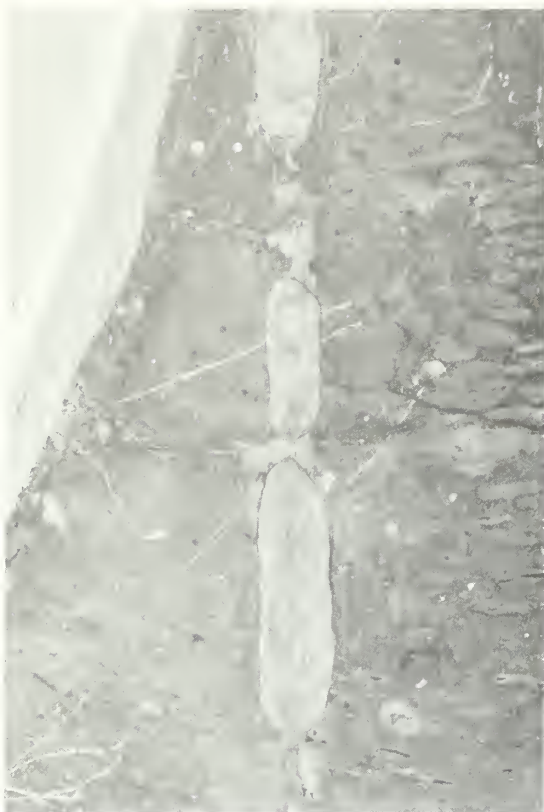
Figure 32. This sheet-copper-covered lantern gallery deck has been repaired several times by soldering sheet copper patches over the holes. This method of repair, if performed properly, greatly increases the life span of the roof covering.

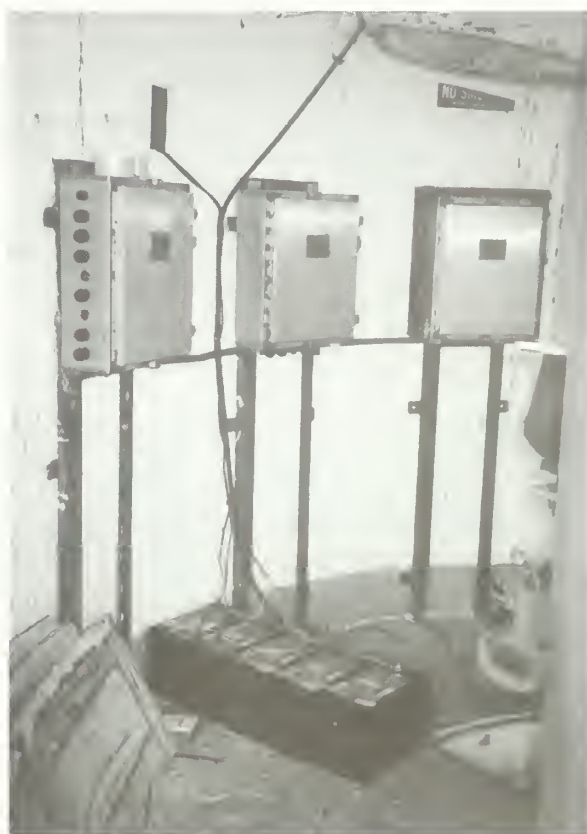
Figure 33. To minimize damage to historic wood beadboard panelling, these new panels should have been installed on a sheet of plywood attached to the historic wood beadboard panelling in four locations. These batteries stored on the floor should be in containment boxes in case the batteries leak.

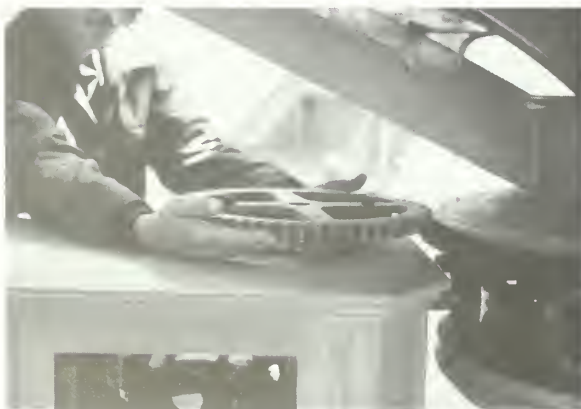
Figure 34. When this first-order classical lens was converted to AC power, the original drive gear (pictured here) was the crank used to wind the clockworks.

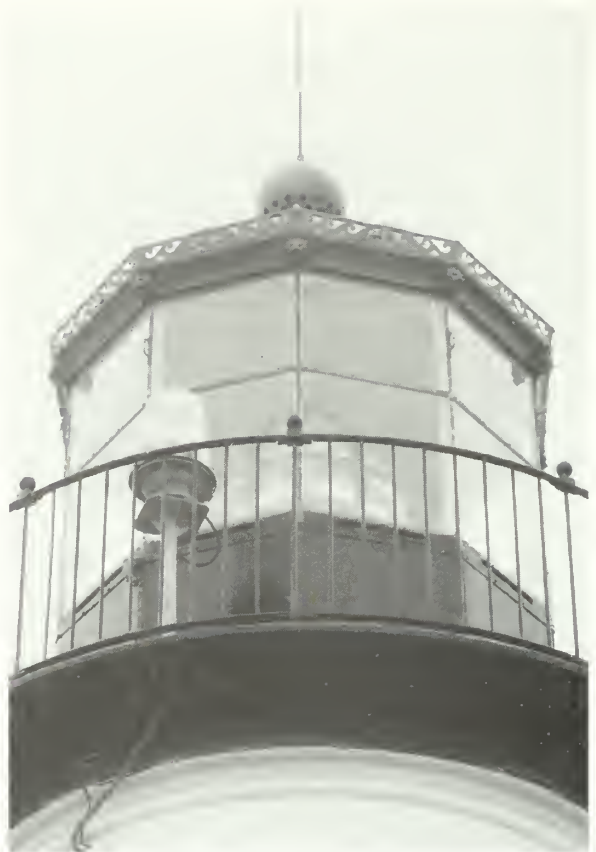
Figure 35. This is an acceptable auxiliary light installation. The light is mounted on an aluminum pedestal that has been bolted to the replacement aluminum deck.

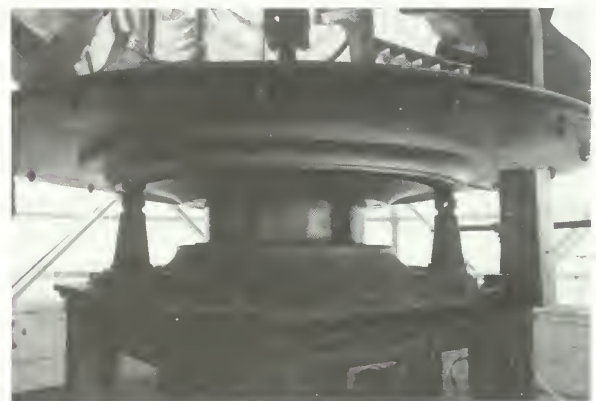
Figure 36. This c. 1926 lens was designed to be AC powered; the original lens jacks are still in place. The three jacks (the third is obscured by the brass bearing cover) were used to lift the lens assembly so that bearings could be serviced.

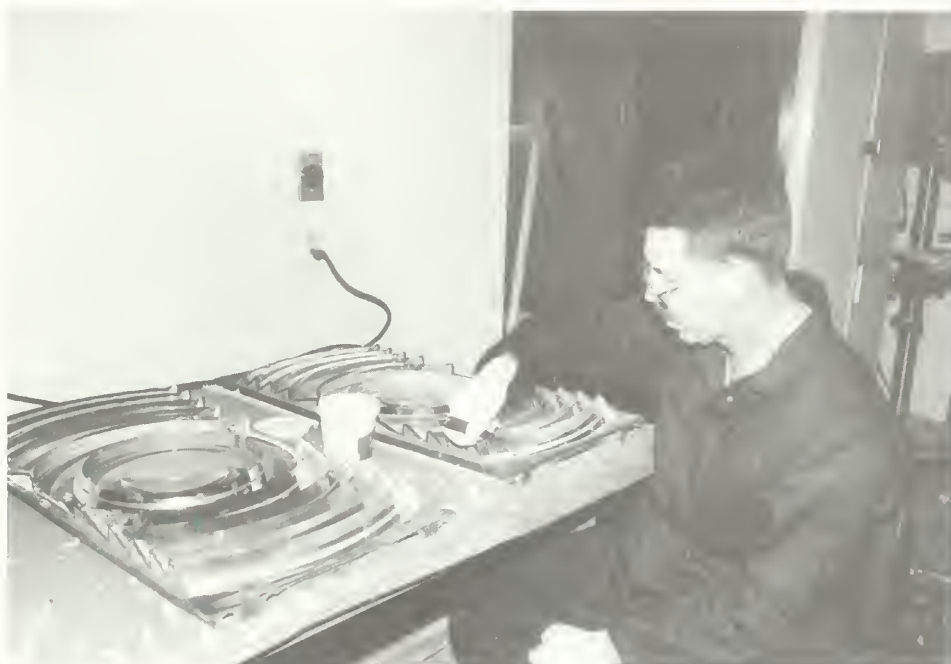
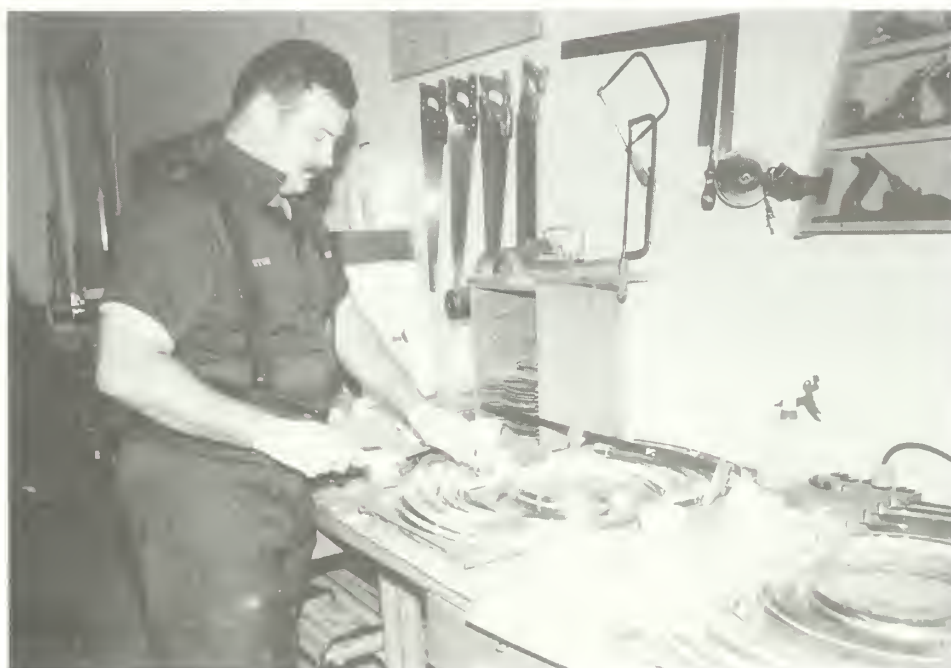
Figures 37 and 38. Joe Cocking (above) and Nick Johnston (below) restore a classical lens at the U.S. Coast Guard Exhibit Center.

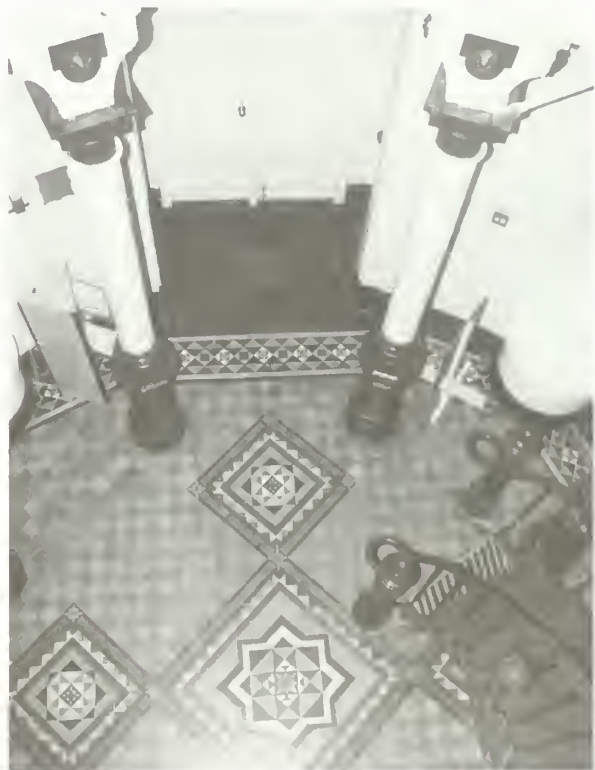
Figure 3. Highly decorated interior of the Cape Henry Light Station (second tower), Fort Story Virginia

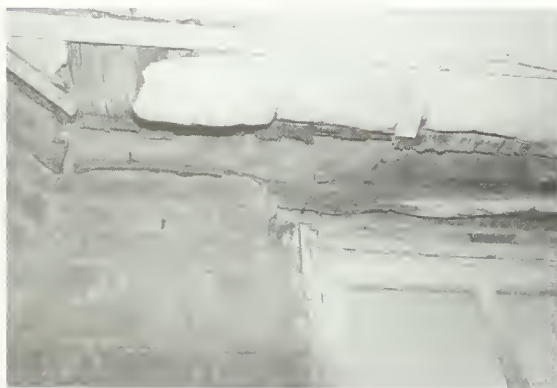
Figure 4 (left). Extensive interior finish deterioration in a lighthouse that had holes in the roof which were not repaired.

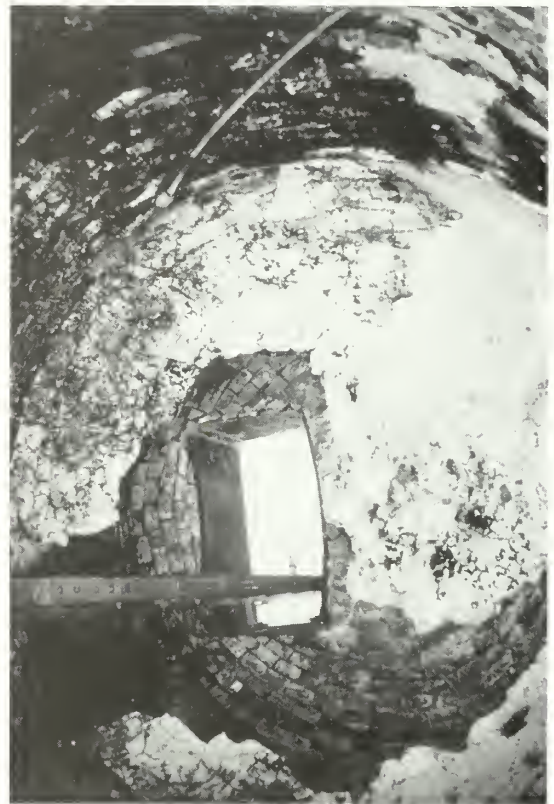
Figure 5 (above). Excessive condensation buildup in this lighthouse caused the interior plaster finish and some mortar joints to fail.
