Historic Lighthouse Preservation Handbook

1997

PD-375

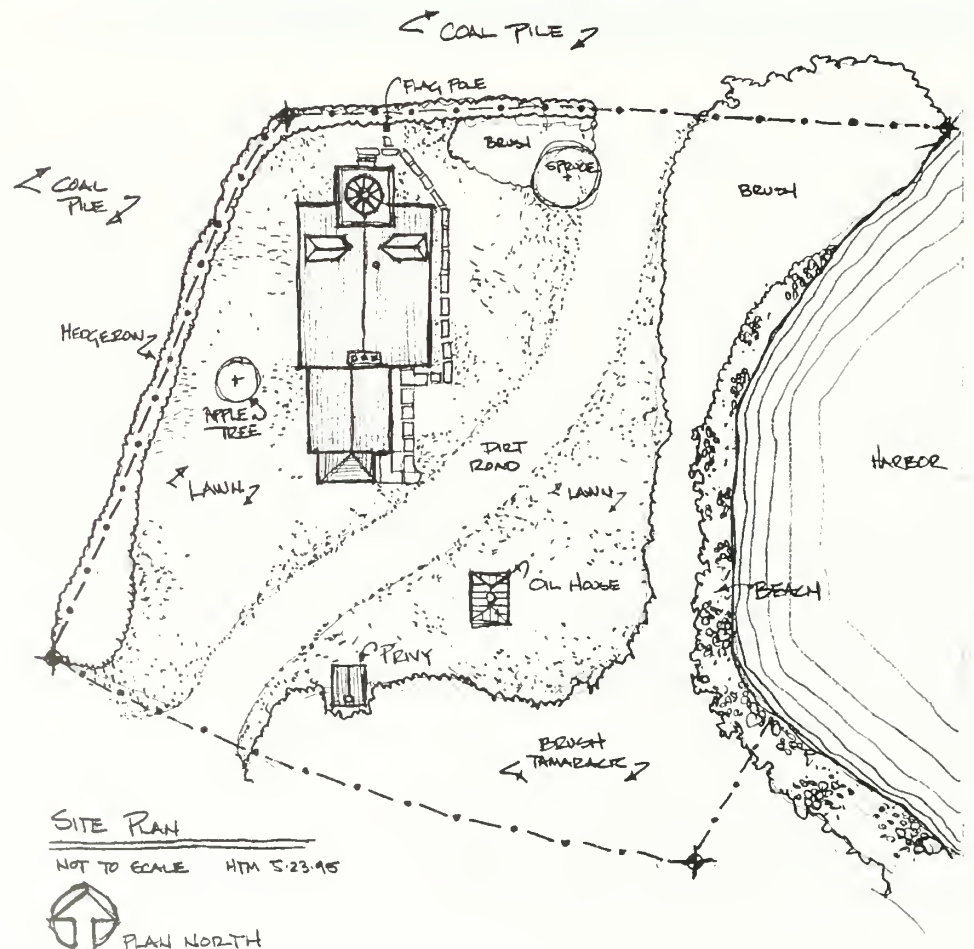
Figure 5. A simple sketch site plan records the relationship of a light station's buildings and features. This type of recordation should be dated and filed with the lighthouse maintenance records. (WPTC drawing by H. Thomas McGrath)

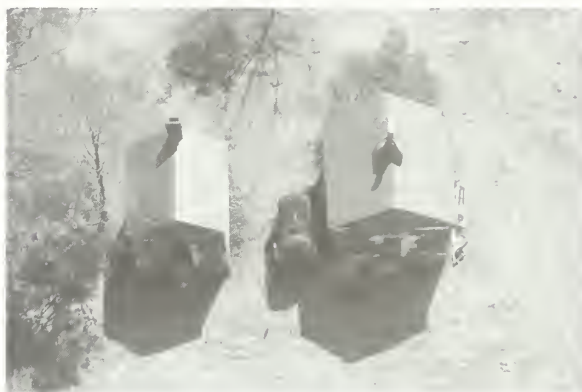
Figure 7. The relationship of this oil house (right) and generator building (left) show the variety of structures associated with a manned light station.

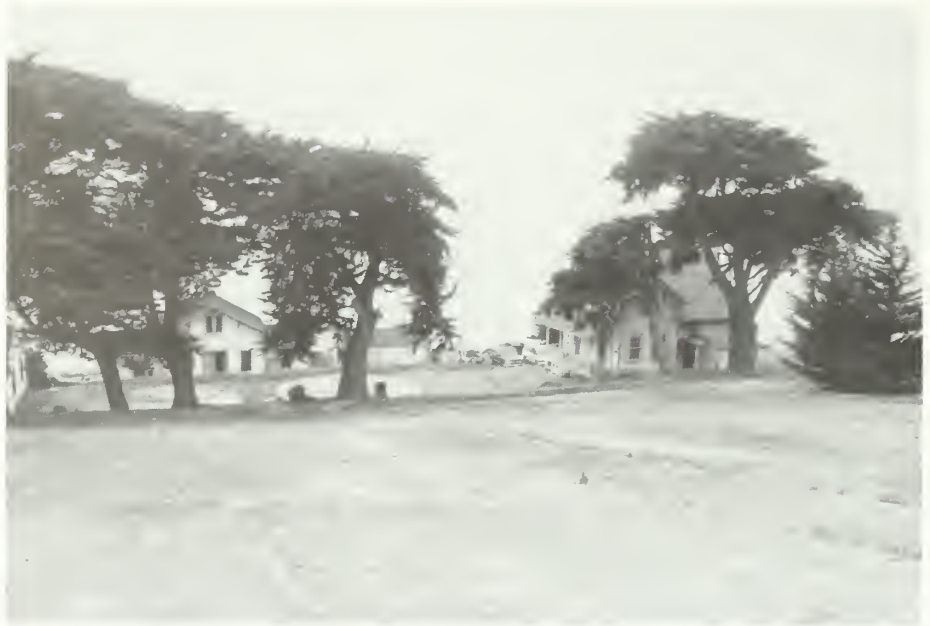
Figure 9. View of a highly intact historic light station in California. All principal structures that made up the light station are intact including the large concrete rain water catchment (in the foreground) and the below-grade wood cisterns (just the lids are visible in the center of the photo) used to store the rainwater to produce steam for the fog signal. The preservation of a site at this level of integrity is essential to understanding the relationship of the light station buildings and their contribution to the station's overall operation.

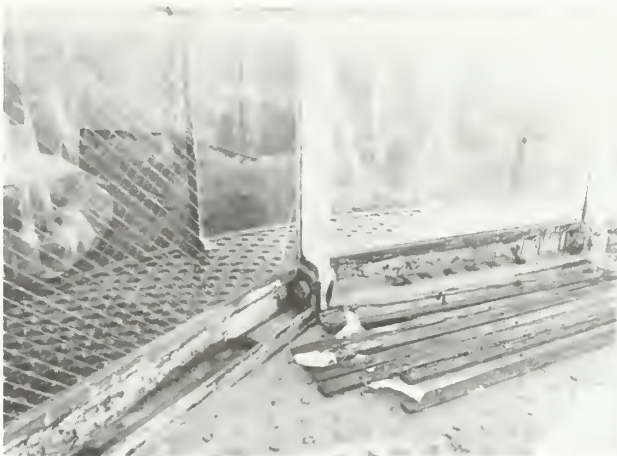
Figure 10. Oblique of the interior of the lantern room with exterior bronze astragals stored in the foreground before cleaning and removal of the extent wire-glass panels.

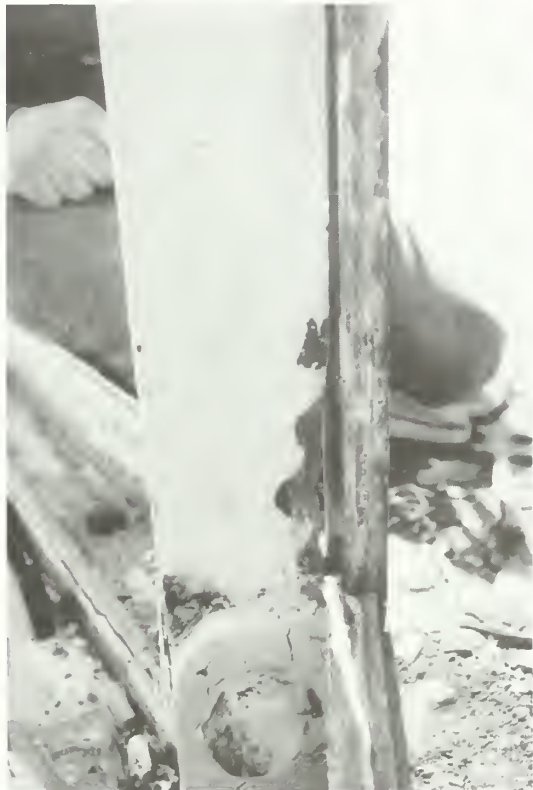
Figure 11. The extent of the damage to the cast-iron column through exfoliation can be seen in profile after the removal of loose rust and the lower bronze mullion.

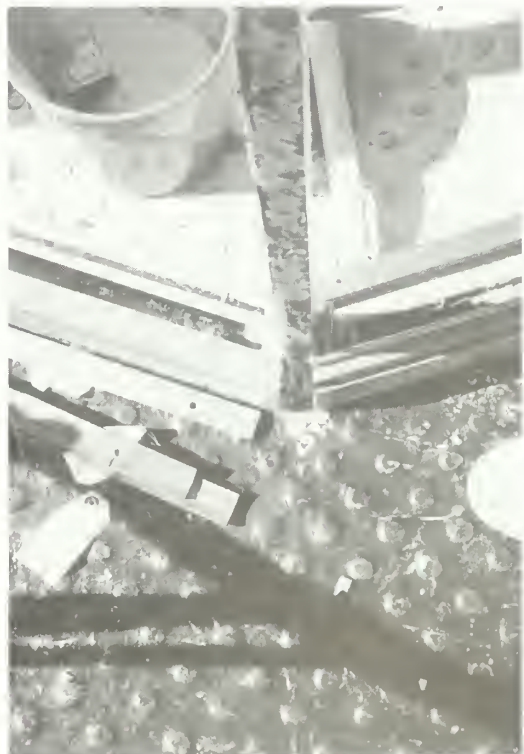
Figure 12. Detail of the bronze sill when the lower mullion is removed; the fastener is re-tapped and the cast-iron column is treated with a rust converter. Note that the bronze astragals have been cleaned and are ready to accept the glazing system.

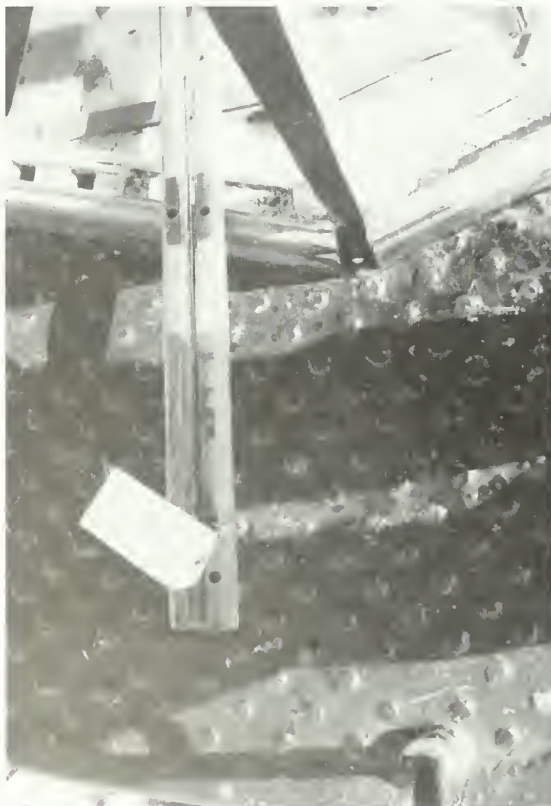
Figure 13. This detail of the bronze sill shows the location of the new lower fastener before its removal and resetting with the lower bronze mullion.

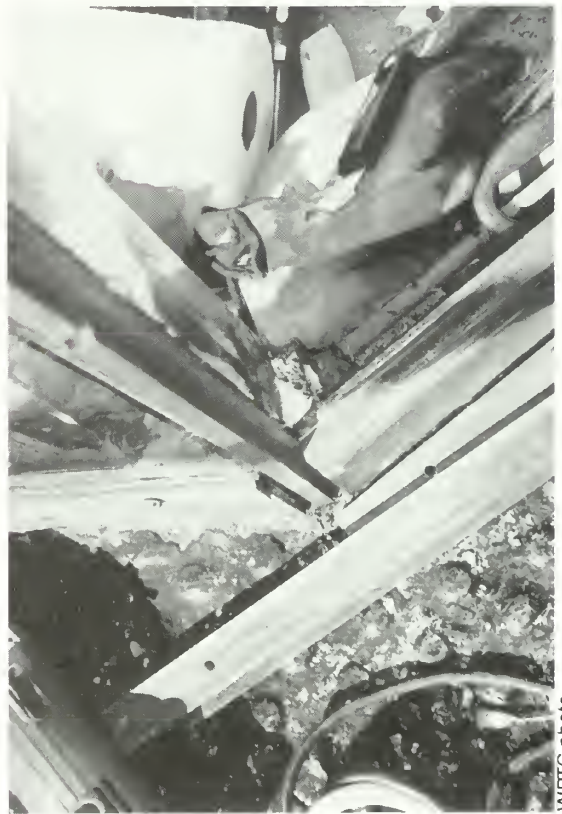
Figure 14. Following placement of the restored bronze mullion, the fenestration is ready to receive the new glazing system.

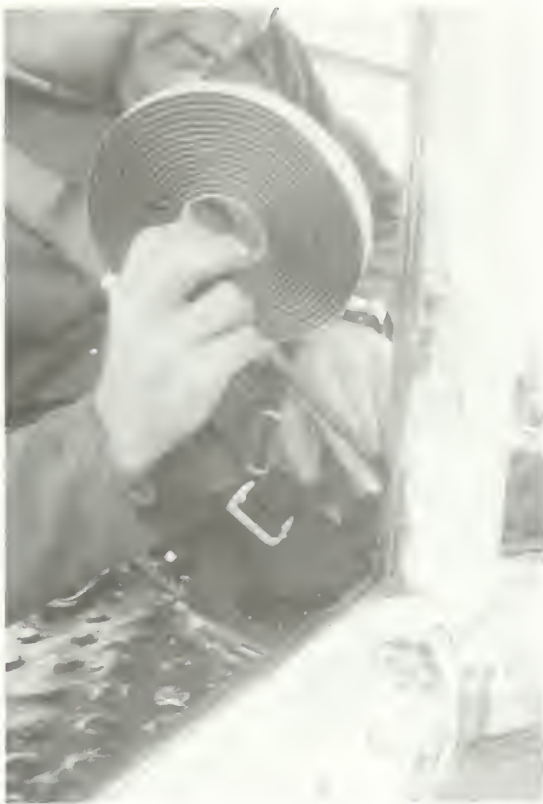
Figure 15. The polybutyl sealant tape was placed on all receiving surfaces on the plane of the interior face of the glass and on the inside faces of the exterior astragals.

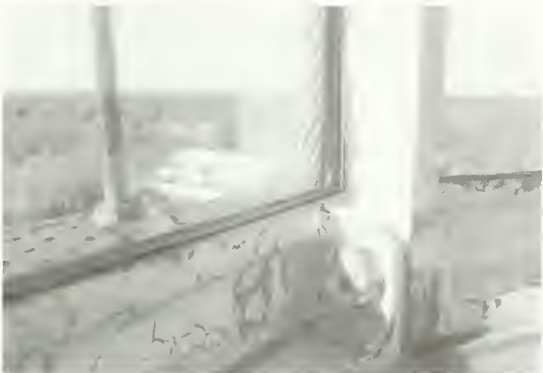
Figure 16. This detail shows the new glazing system in place with associated cast-iron post and bronze sill available to receive additional cleaning and paint removal.

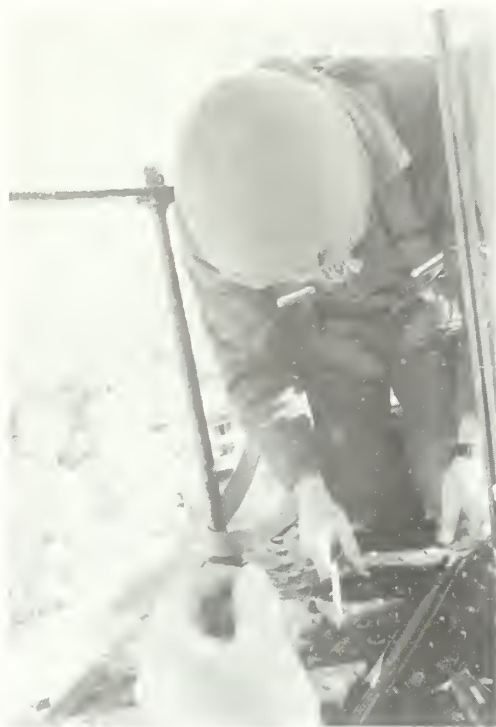
Figure 17. Note the detailing of the finished exterior astragal in place and the polybutyl sealant tape visible in profile.

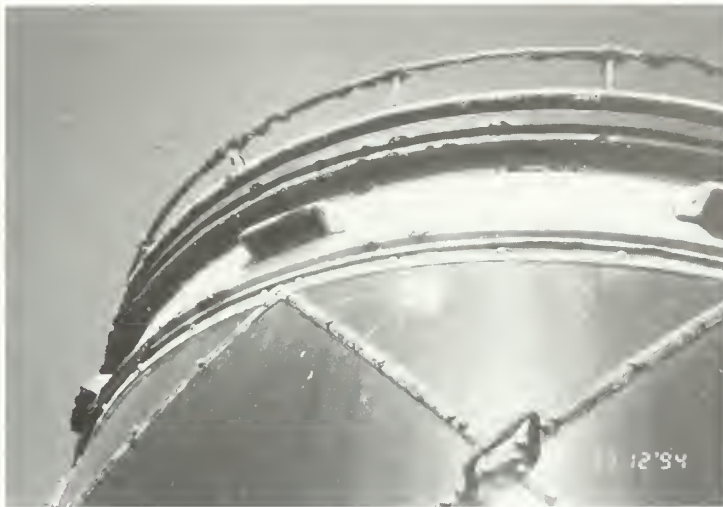
Figure 18. Close-up of the deteriorated conditions of the Anacapa Island Lighthouse before rehabilitation.

Civil Engineering Unit Oakland's Facility Inspection Team originally identified the need for this rehabilitation during an inspection of the lighthouse in 1992. The entire lighthouse was in such poor condition that it was labeled the worst lighthouse on the West Coast (see Figure 18). The inspection team initiated the paperwork that identified both the need for the rehabilitation and funds. Although most large Coast Guard projects normally take five years before being funded, Anacapa was in such poor condition that it was given a high priority; design work started within two years. In late 1994 the architect assigned to the project made his first site visit. The architect determined that the best way to repair the badly deteriorated cast-iron lantern house was to remove it from the concrete tower via heavy-lift helicopter and transport it to the mainland for overhaul. Further investigation, however, disclosed several insurmountable obstacles; he was forced to consider a more conventional but far from easy onsite rehabilitation of the entire lighthouse. The following scope of work was identified and budgeted for \$325,000:

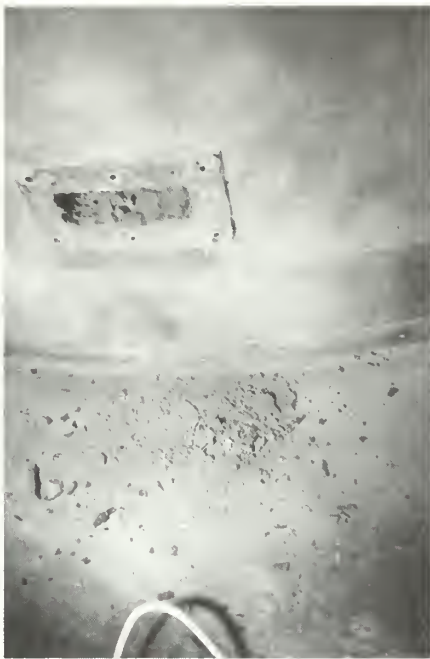
Figure 19 (left). Buildup of rust in parapet wall vents.

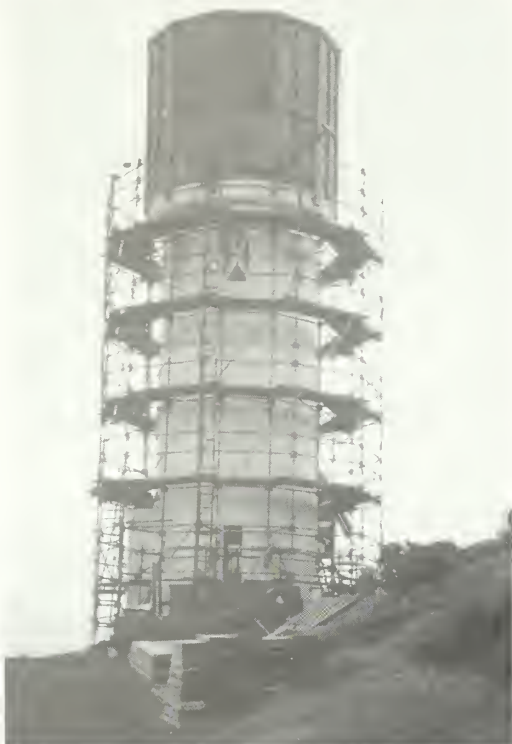
Figure 21. View of the plywood lantern enclosure and scaffolding.

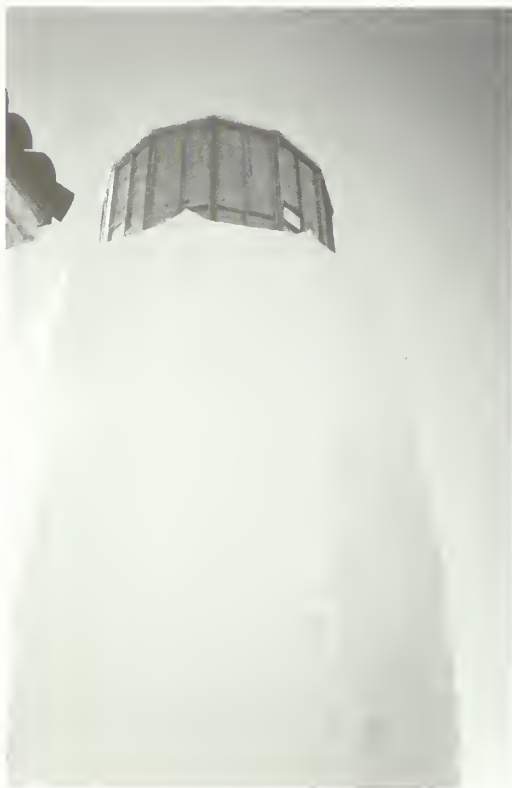
Figure 22. View of the lighthouse scaffolding covered with shrink wrap to contain all hazardous materials and protect workers from severe weather.

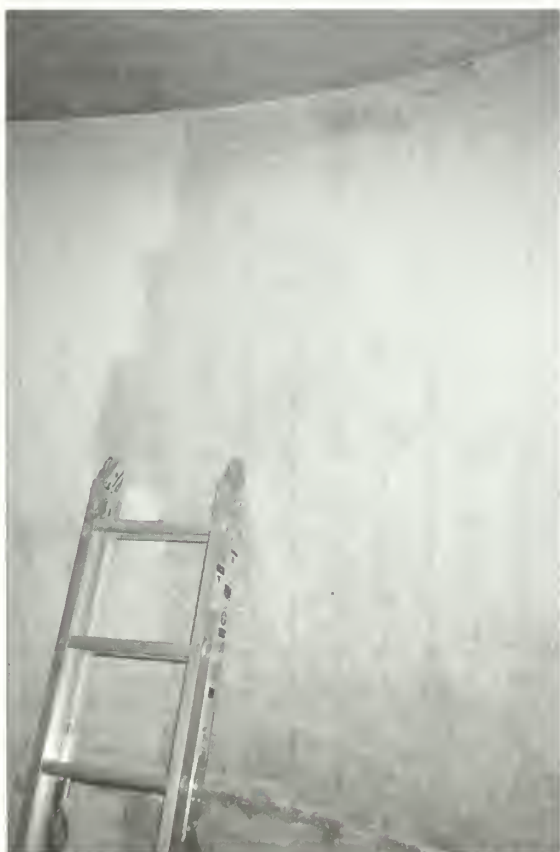
Figure 24. The interior paint was effectively removed using needle gun scalers, without damaging the concrete as evidenced by the visible impressions of the formwork boards.

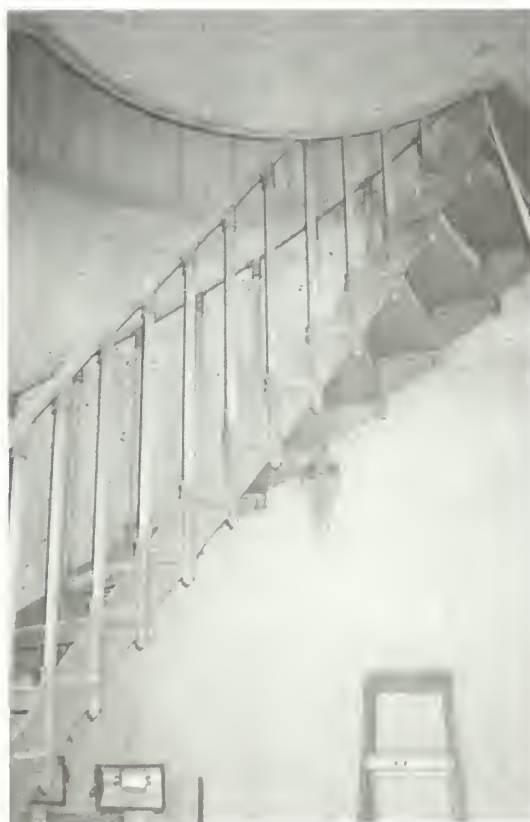
Figure 25. After the cast-iron stairs were blast-cleaned, they were rinsed to remove all traces of lead dust; flash rust immediately formed (as seen in this photo). Before painting, this light rust was removed with wire brushes.

expected and did not pose a problem (see Figure 25). All surfaces were then wire brushed, prepped, and primed by a three-man team who only prepped what they could prime within an hour. Although the primer used was designed for use over flash-rust, we did not want to chance a coating failure.

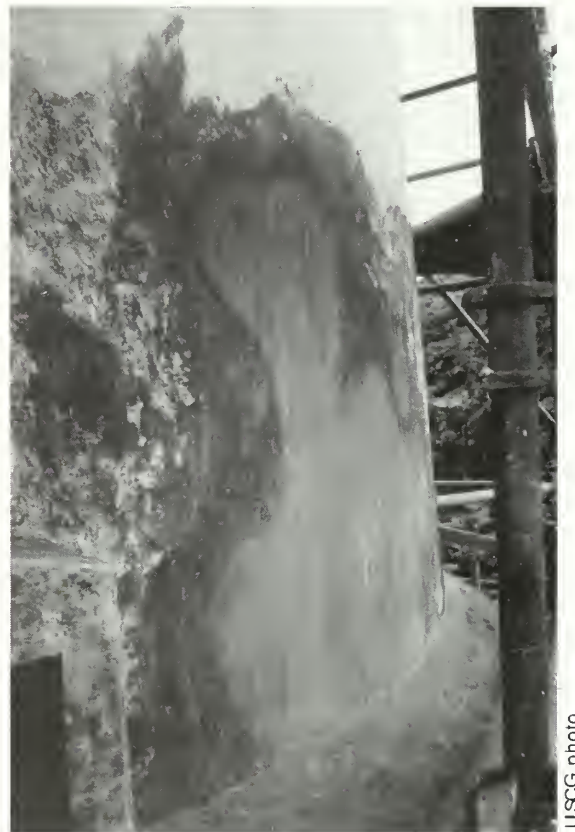
Figure 27. The areas where the loose mortar finish coat was removed were repaired with a two-part mortar patch. The final texture on the patch was tooled to match the historic wall surface. The patch was completely invisible after the tower was painted.

The 3/8-inch white mortar finish coat that had been applied over the exterior concrete when the light was built in 1932 was not identified in any of the original drawings. As a result, no one looked during the work site visit for signs of delamination. After the scaffolding was in place, however, several areas were found to be loose between the 10- and 30-foot elevations. The foreman became concerned that other unidentified delaminated areas would fall out after the job was complete and ruin his work. The foreman inspected the entire tower and found an additional 100 square feet of delaminated mortar. After receiving approval to repair any bad mortar, he personally chipped away all the loose mortar and applied a two-part masonry patch material. The repair work was of such high quality that the patches were unnoticeable when the tower was repainted (see Figures 26 and 27).

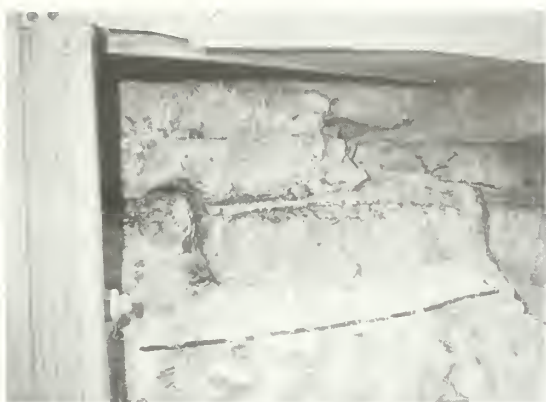
Figure 28. Close-up of the damaged concrete gallery deck after the loose concrete has been removed and before the damaged concrete was repaired using pressure-injected epoxy grout.

One major area of concern was the concrete gallery deck located outside the lantern. This deck had considerable damage in two areas without any evidence of the cause. The outer rebar showed signs of corrosion but the damage went 18 to 24 inches deeper into the concrete. Since freezing was not an issue, the cause of the damage was at first unknown. Closer examination revealed signs of an explosion inside the concrete, and we noticed bolt patterns for two old antenna mounts directly above the area. We determined lightning to be the cause. There was no practical way to dig out the

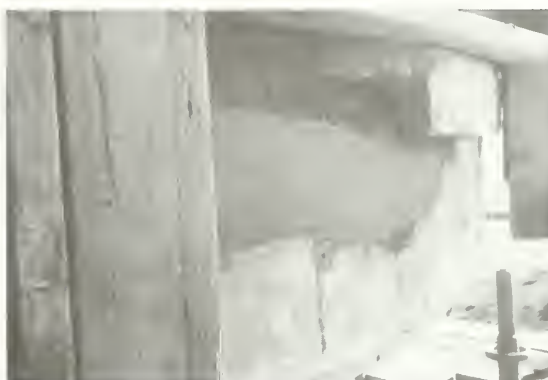
Figure 29. The first application of the mortar patch material to the damaged concrete.

broken concrete; the project was already over budget. We decided to do a pressurized epoxy injection and fill all the voids. The area was prepped and pumped full. The outer three inches were left unfilled so the two-part mortar patching compound could be used to restore the damaged area (see Figures 29 and 30).

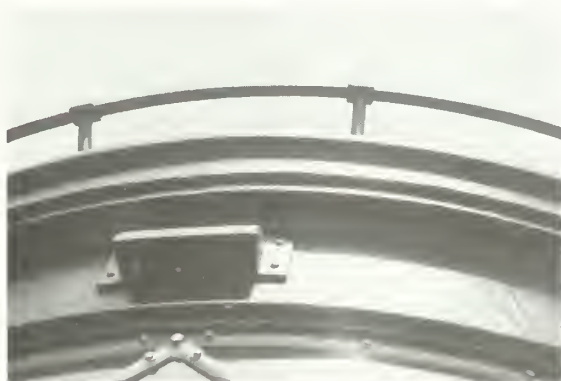
Figure 31. Close-up of the finished metal work on the lantern.

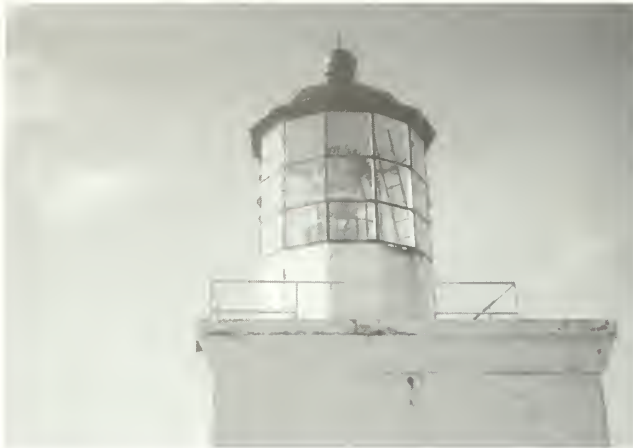
Figure 33. Point Bonita Lighthouse before rehabilitation; note missing gallery deck and holes below between the bottom of the lantern glass and top of the service room wall.

The poor condition of Point Bonita was first noted by the Officer in Charge of the San Francisco Aids to Navigation Team (ANT). His request prompted a site visit to Point Bonita in January 1993 to conduct a facility assessment and provide advice on how to repair the structure (see Figure 33). The original plan was to stop the water from entering the lighthouse and let Civil Engineering Unit (CEU) Oakland do the overall renovation in a couple years. But further investigation indicated the need for more immediate repairs, using self help-funding and the ANT personnel. The project soon grew into a full renovation that took six months and \$75,000 to complete.

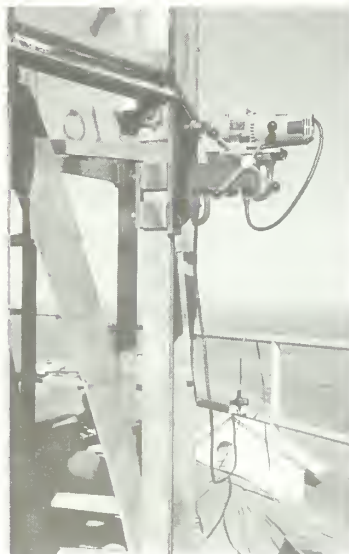
Figure 35. Jig used to bore holes in the gallery bracket tenons.

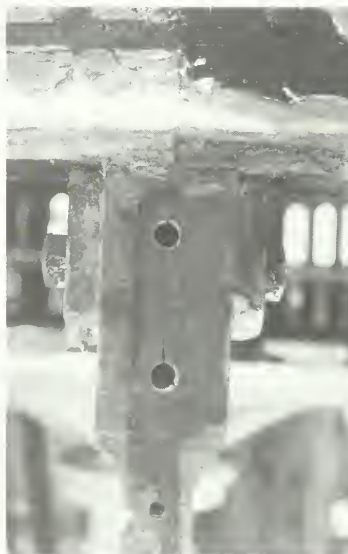
Figure 36. View of the gallery bracket tenons after the holes have been drilled. The tenon on the right connected to the exterior gallery; the tenon on the left is part of the interior gallery deck bracket. The 'v' that has been stamped in the end of the left tenon is an assembly identification mark.

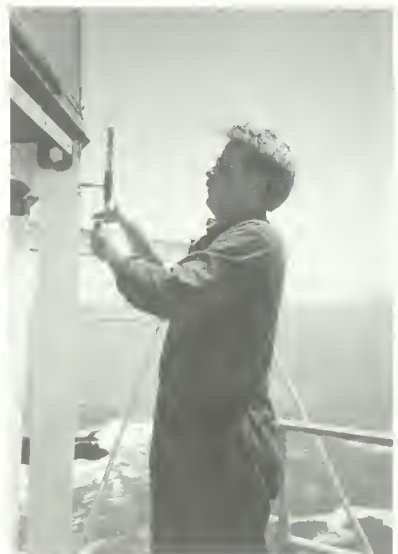
Figure 37. After drilling, threads were cut into each hole using a hand-operated tap.

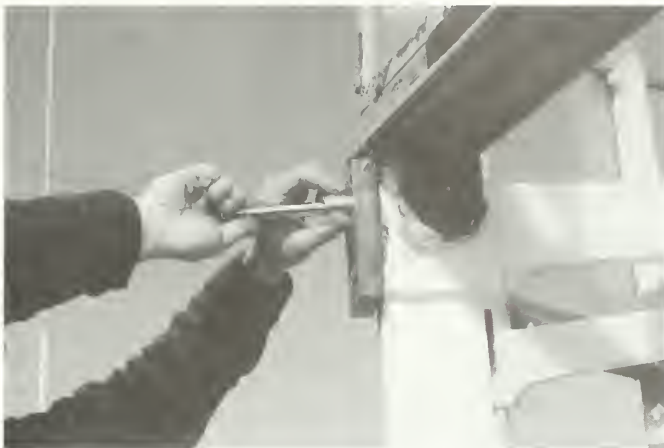
Figure 38. To provide a plumb mounting surface for the gallery deck, each mounting surface was covered with Belzona (a two-part metal paste); then the mounting plates were installed and tightened until they were plumb. The excess Belzona can be seen oozing near the middle of the plate.

Investigative demolition followed. The original gallery deck had been removed in the 1960s, but no details were available on how it was performed. First removed was the fiberglass cloth that sealed the watchroom panels to the lantern room and covered the areas of the original gallery deck brackets. Fortunately, the old brackets had been cut off above the wide base flange with a torch, leaving the tenons from the original brackets intact inside the cast-iron lantern frame (see Figures 34 and 36). Removal of the remaining tenons from the frame and fabrication of new gallery deck brackets duplicating the originals proved impractical because the tenons were rusted tight and pinned in place. The tenon was therefore used as an anchor. The old base flange flush with the frame was cut using a portable metal-cutting bandsaw and the area ground flush. A special jig was designed for the magnetic drill press; two holes were then drilled and tapped directly between each set of tenons (see Figures 35, 36, and 37). A one-inch-thick mild steel mounting plate consisting of two recessed bolt holes and four tapped holes was then put in place. (304 S/S might have been an even better choice; the mild steel is holding up well, but may become a maintenance problem if the lighthouse isn't properly maintained.) The two recessed holes allowed the plate to be bolted to the lantern frame and the new bracket bolted directly over the two base bolts. The area beneath the plate was covered with a 1/8-inch layer of Belzona Metal filler to ensure there would be no voids and to act as a leveling compound (see Figure 38). The bolts as well as the plate were covered with a releasing compound (Vaseline)

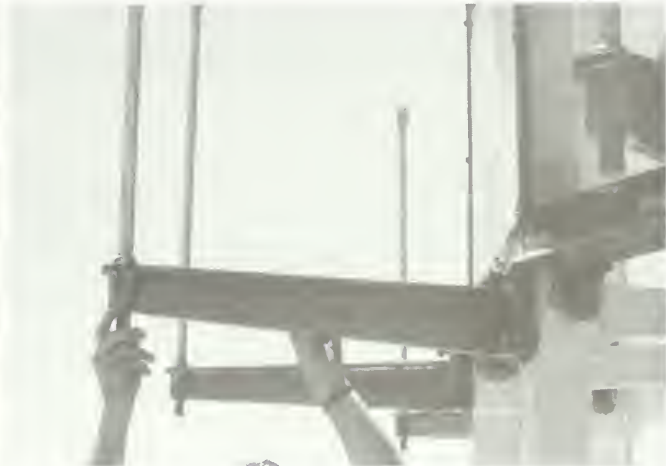
Figure 40 (above). The new gallery deck brackets after installation.

fabricated to match the original cast-iron brackets details. (This is another area where 304 S/S might have been better.) The stanchions were made of 1-inch 304 S/S round stock and 1-inch 316 S/S bolts. The bolts had a 1-inch diameter and 1/4-inch-deep recess machined in the head to ensure the bolts were properly aligned during welding. Custom 1-inch 316 S/S acorn nuts were then purchased to secure the stanchion to the brackets and the handrails. With the brackets and stanchions in place, the 3/8-inch flat bar handrails were then drilled, scribed, and fitted (see Figure 40).

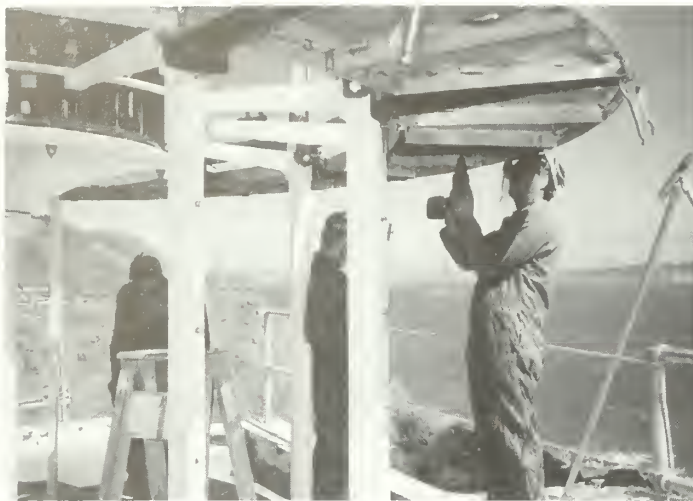
Figure 41. Final fitting and installation of the new aluminum deck plate.

with no signs of dissimilar metals reacting. S/S diamond plate, might however, avoid any future problems (see Figure 41).)

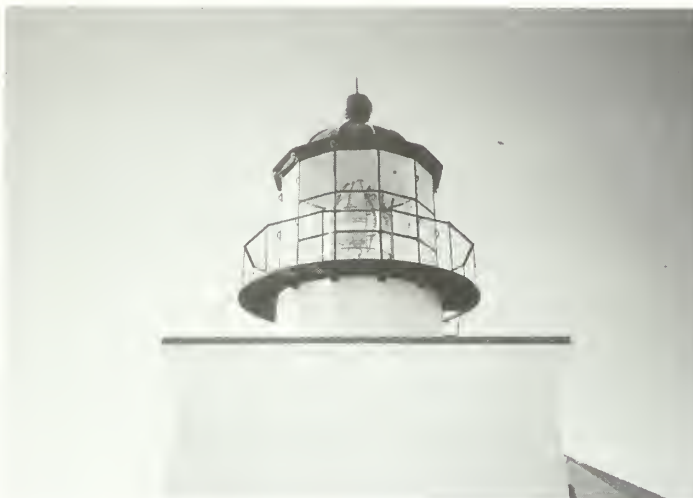
Figure 42. View of the Point Bonita Lighthouse after the gallery deck replacement.

on lighthouses understands dissimilar metals or even how to ensure that materials are properly reinstalled (see Figure 42).

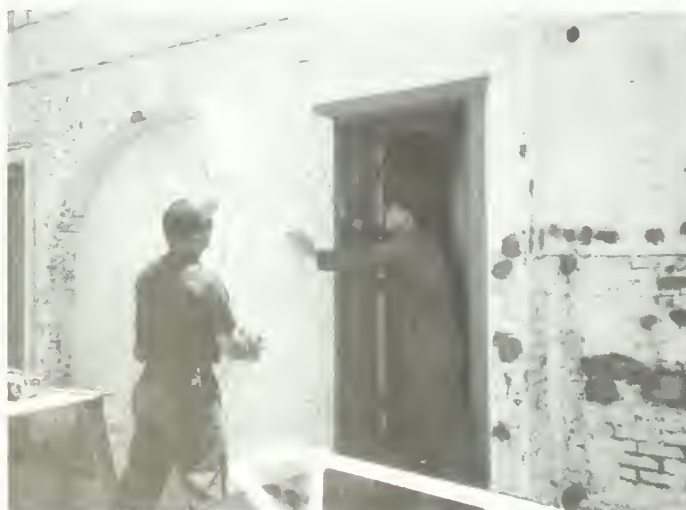
Figure 43. Installation of the new exterior wood storm door.

The exterior storm doors were also easy to duplicate. The pictures were clear and showed one door open and one closed. Both exterior doors were made of 1- by 6-inch tongue-and-groove redwood and fastened together using S/S carriage bolts, nuts, and washers. After the doors were test fitted, they were disassembled, primed, painted, and reassembled. These doors have held up extremely well and have given no trouble (see Figure 43).

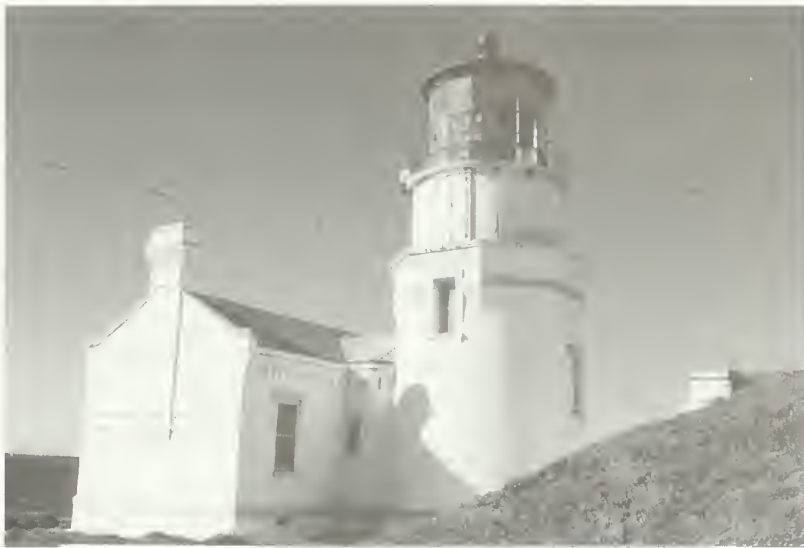
Figure 44. *Before the rehabilitation.* Note the doors at the watch room. A new louvered panel will be installed for added ventilation.

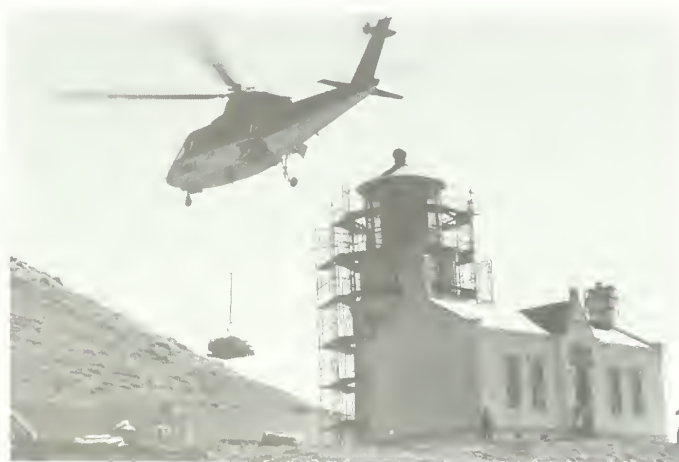
Figure 45. *Staging the work.* Note the temporary location of the auxiliary light on the fog signal building chimney.

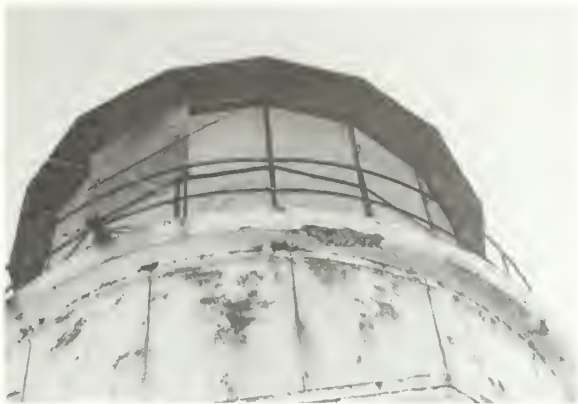
Figure 46. *Lighthouse lantern before rehabilitation.* Note the missing ladder rails and the severe rust on the lantern cornice and lower watch room panels. The badly spalled concrete gallery deck was installed in 1947 and is not original.

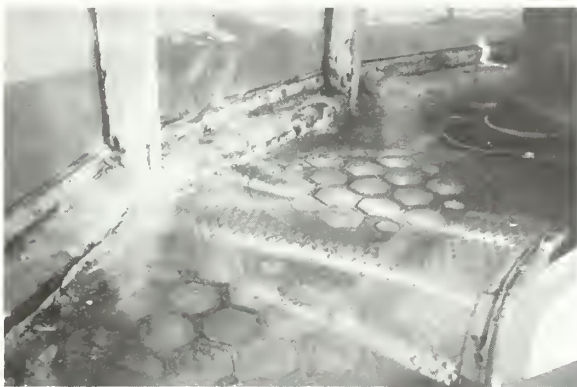
Figure 47. *Lantern room before rehabilitation.* Note the lower sill channels filled with concrete. This shortsighted 'repair' method blocked the ventilators and caused condensation to spill out on the deck, effecting rust and further damages below.

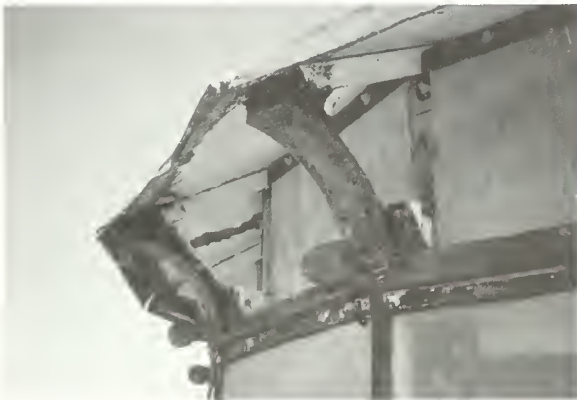
Figure 48. *Reconstructing the cornice.* The cornice plates were removed to expose the corroded cast-iron brackets and top channels. New brackets were cast in bronze, and the top sill channels were fabricated in stainless steel. Note the plywood 'curtain' erected for weather protection and shoring the lantern roof during reconstruction.

heavy rain washed out portions of the road, which cut off access for over a week. A special plywood 'curtain' was erected in the lantern room with clamps to protect the classical lens from the weather and shore up the lantern structure during reconstruction.

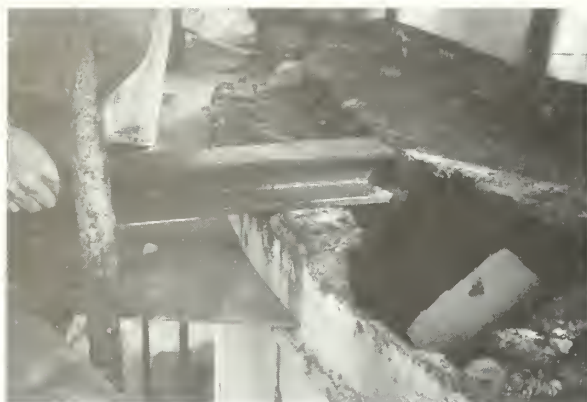
Figure 49. *Reconstructing the gallery deck.* After removing the existing concrete, remnants of the original cast-iron deck were found.

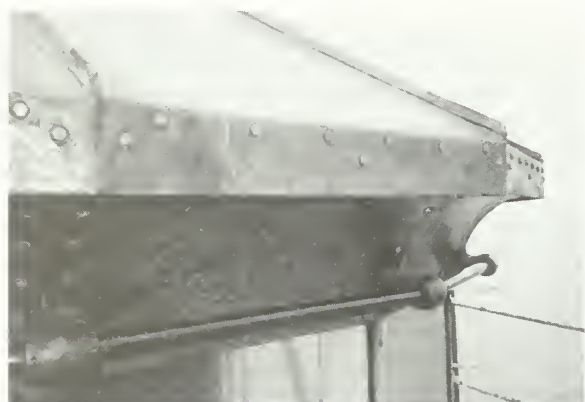
Figure 50. *Lantern cornice after rehabilitation.* Replacing the original steel cornice plates with copper eliminated the dissimilar metals problem.

Although surface rusting was the main problem at the lantern, some of the deterioration was caused by galvanic reaction between dissimilar metals. Dissimilar metal problems were eliminated by replacing the original deteriorated cast-iron cornice plates and brackets with copper and bronze. The original copper roof dome was then stripped of its paint and allowed to naturally patina. Besides low maintenance, the other advantages of copper are its flexibility to withstand strong winds, building movement, and wide temperature changes. In other areas, neoprene gaskets, felt or teflon tape, thick epoxy primers, and bituminous paints were used between dissimilar metals to prevent future corrosion.

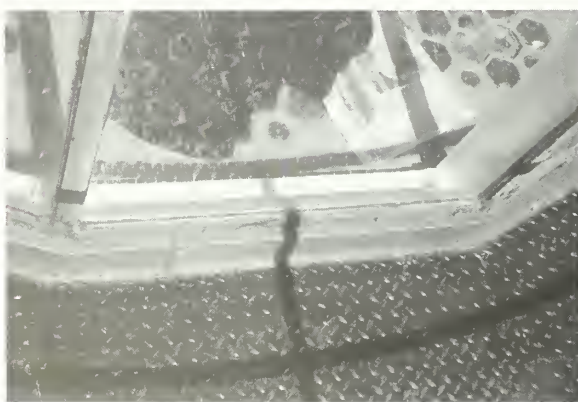
Figure 51. *Lantern galley deck after rehabilitation.* The new gallery deck was fabricated with stainless steel diamond plate and carefully flashed with copper at the lantern room. The interior lower sill channels were rebuilt to catch condensation from the glass.

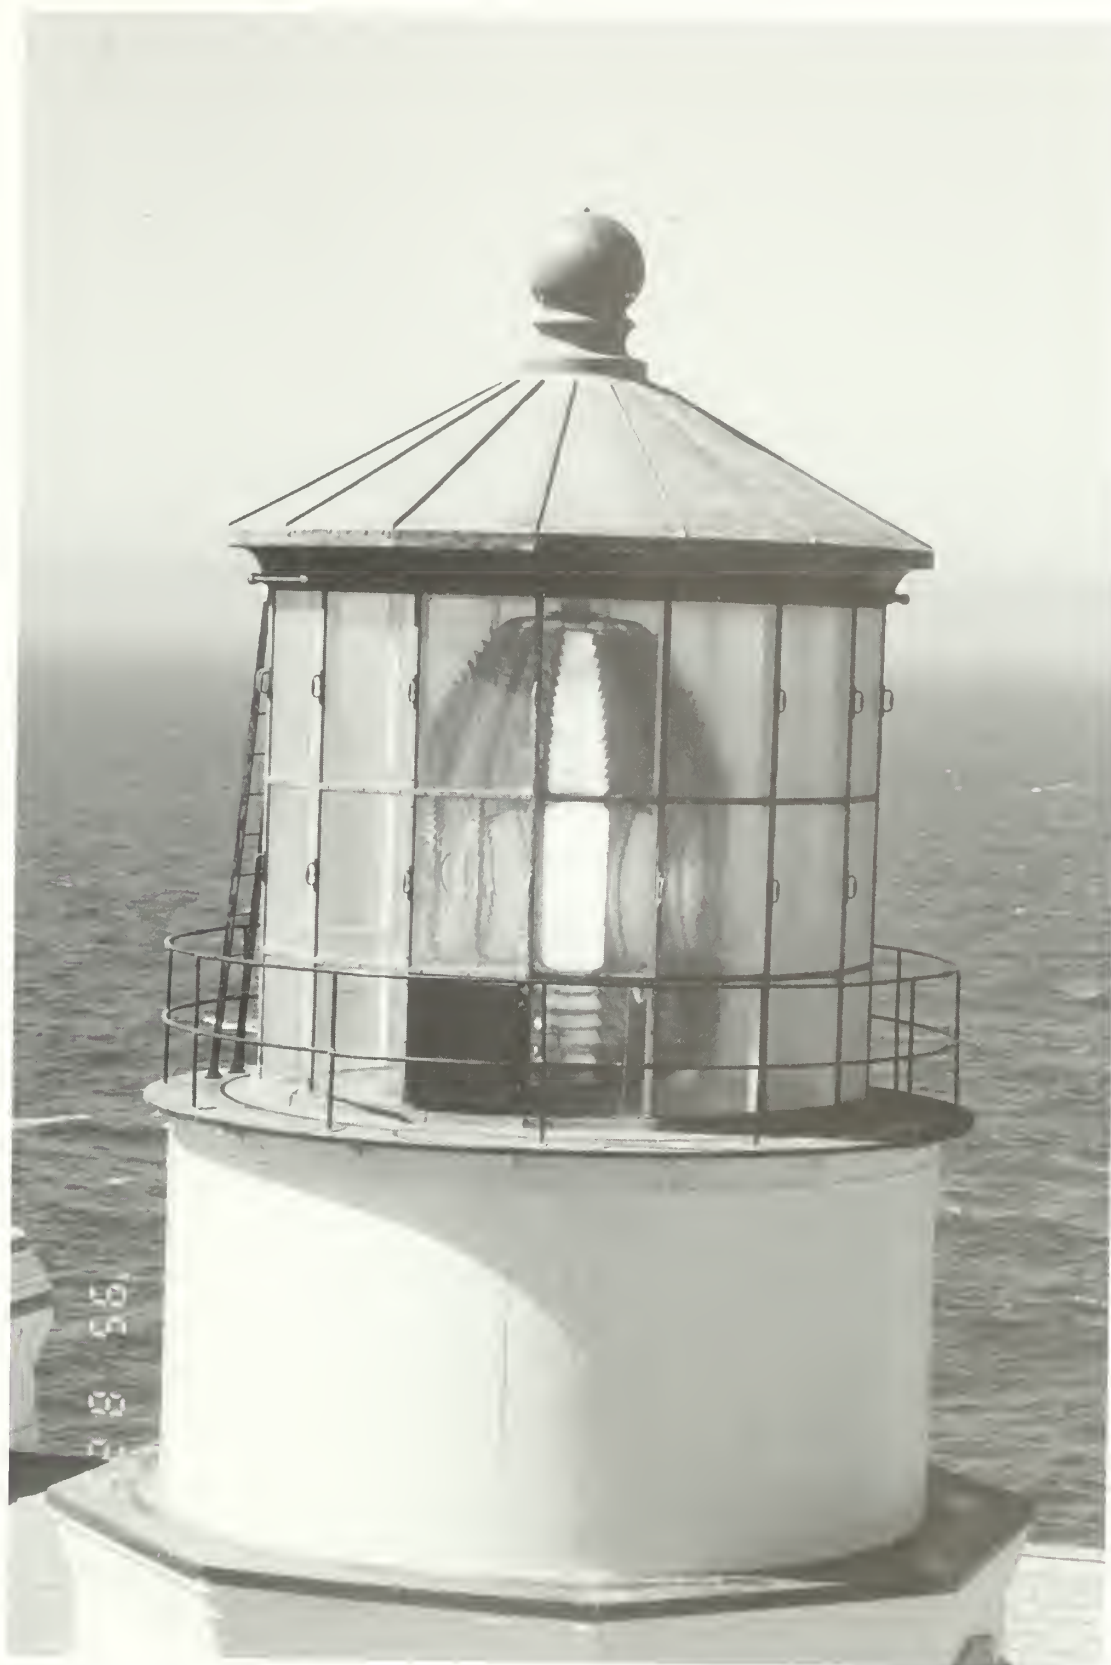
Figure 52. *Light tower lantern after rehabilitation.* The nonferrous metalwork at the lantern room is left unpainted and allowed to naturally patina, thus saving maintenance costs.

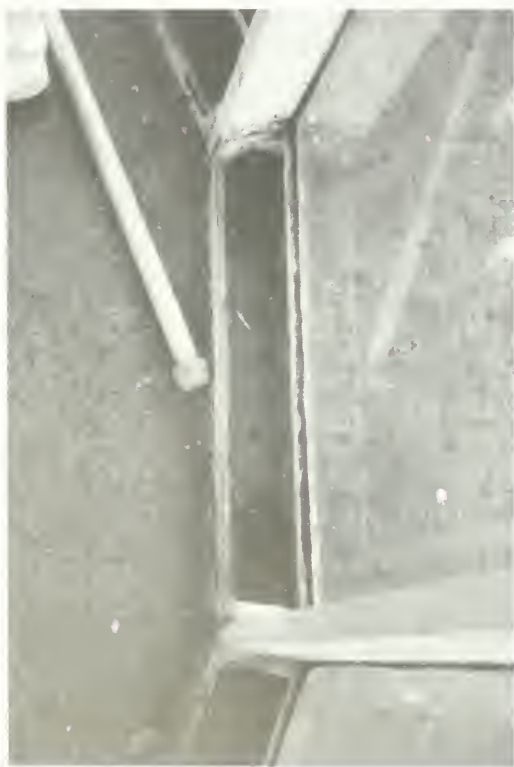
Figure 2 (left). Condition of the bronze sill sitting on the lantern deck inside the lantern room. The sill is wedged between two vertical cast-iron stiles, which are anchored into the masonry below.

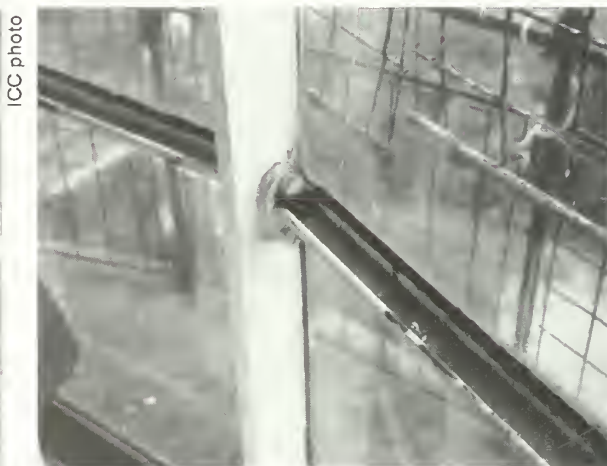
Figure 3 (above). Horizontal mullions run in between the stiles and serve to keep the stiles straight and frame the individual pieces of glass. Before restoration, the mullions and sills had been bolted in place over 140 years.

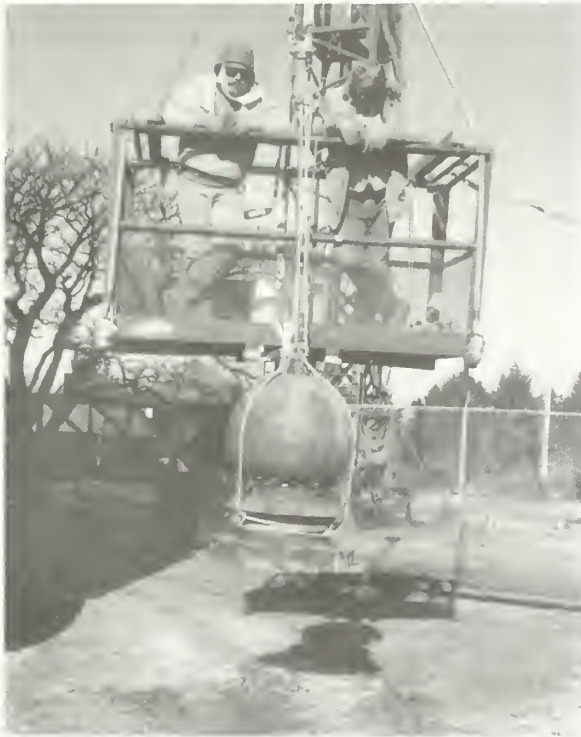
Figure 4. The first step in removing the roof was to take off the vent ball. The vent ball not only serves as a lightning rod but also provides ventilation to the glass in the lantern room, limiting condensation.

system of cantilevered beams that concentrated the load on the brick column of the tower. A lifting jig was designed and installed underneath the roof, and the roof was disconnected from the window wall system.

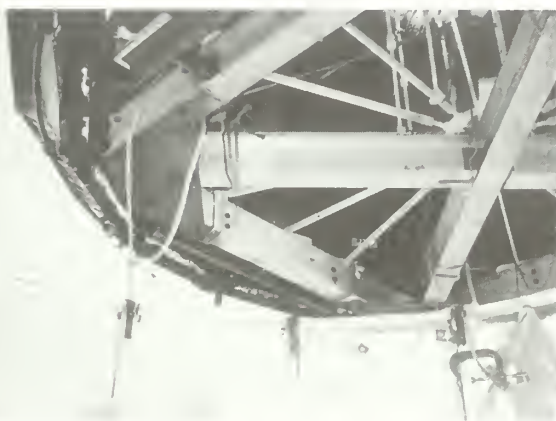
Figure 5. As the roof is being removed from the lighthouse, the tie rod system, supported by ICC's aluminum roofing frame, is visible. This frame was designed to fully support the roof and alleviate any stress or strain on the roof during the lift. Protruding down from the roof are the ends of the rafters which connect to the top of the stiles.

In Buffalo, extreme care was required to restore the roof without compromising dimensional integrity of the 16 tie rods and 16 roof rafters. The roof would be reinstalled in the same position, mating in 16 individual points, bolting together in 48 individual machined holes. The roof measured over 13 feet in diameter; restoration included replacement of the original cornice brackets that held the roof to the window wall and kept the shape of the copper. A 1/16-inch difference at each location would add up to a one inch deviation, preventing the roof from fitting.

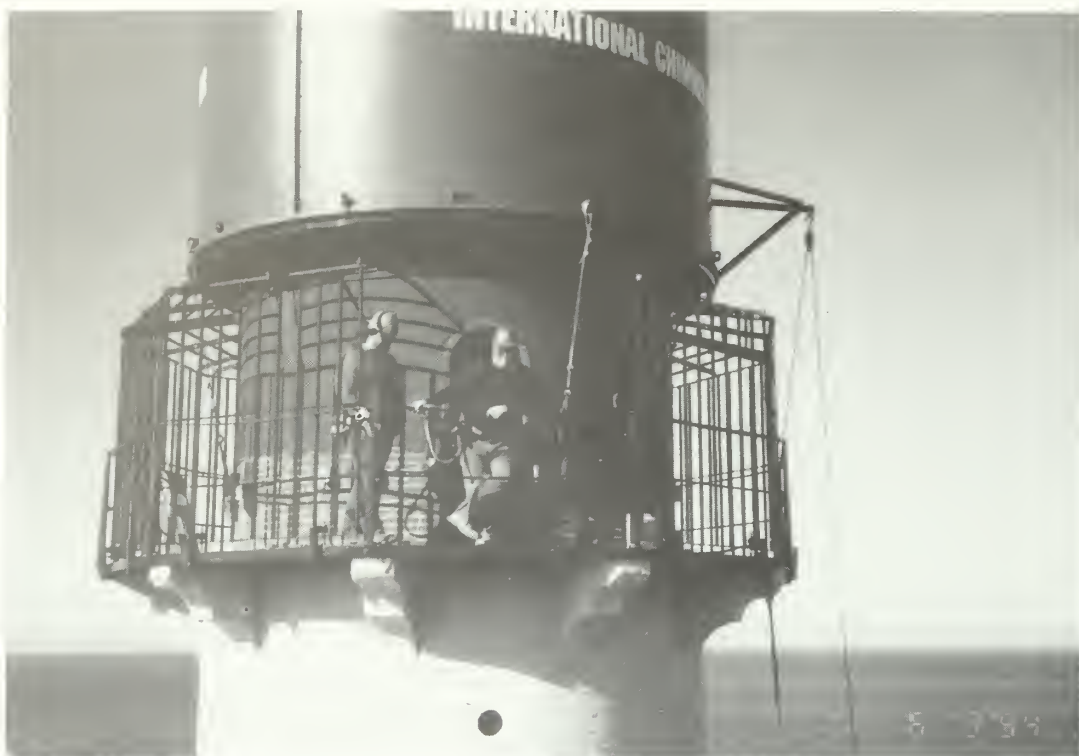
Figure 6. During the restoration, this 'Campbell Soup Can' was installed over the lantern room in order to protect restoration efforts from the environment.

Necessity is truly the mother of invention. The job was replanned to include disassembly of the roof only and rework of the lantern in the field. A large temporary steel enclosure, affectionately referred to as the 'soup can', was fabricated to fit over the window wall system and allow craftsmen to work in relative comfort during the coldest winter in Cape May history. The temporary steel enclosure, designed to accommodate both interior lighting and ventilation, was installed on a

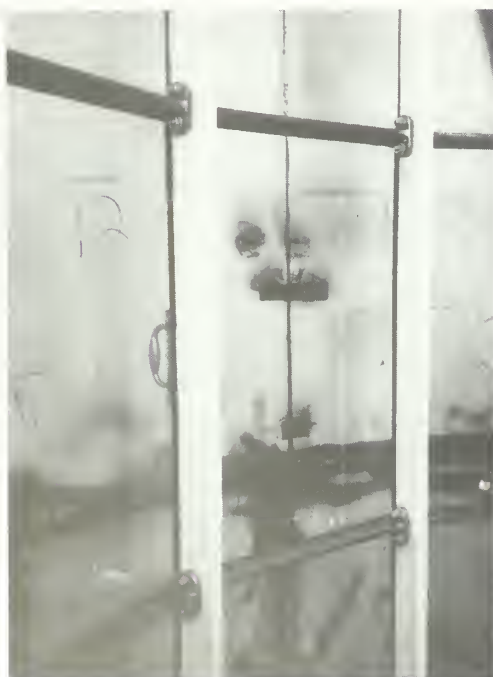
Figure 7. Inside the lantern room, the mullions have been reworked and reattached to the stiles. New stainless steel bolts have been used to prevent corrosion and teflon tape has been used as a gasket between the bronze and the cast iron. Teflon washers also separate the bronze from the stainless steel bolt.

In June 1994, all preparations were complete for reassembly of the lantern room and roof system. The matched, marked pieces were carefully refitted with new stainless-steel hardware and teflon tape which acts as an isolator between the dissimilar bronze and cast-iron metals. In the 19th century, little was known about the chemical reaction between dissimilar metals. When a copper-based metal is placed in contact with a ferrous-based metal, an anode-cathode reaction occurs, similar to a battery. This changes the molecular structure of the ferrous metal, causing corrosion.

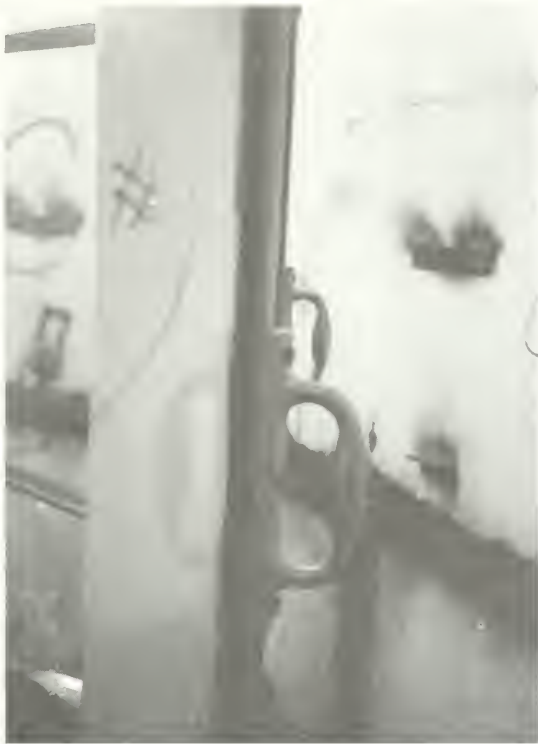
Figure 8. New hand holds were replicated to replace missing pieces. These exactly match the originals.
