Historic Lighthouse Preservation Handbook

1997

PD-375

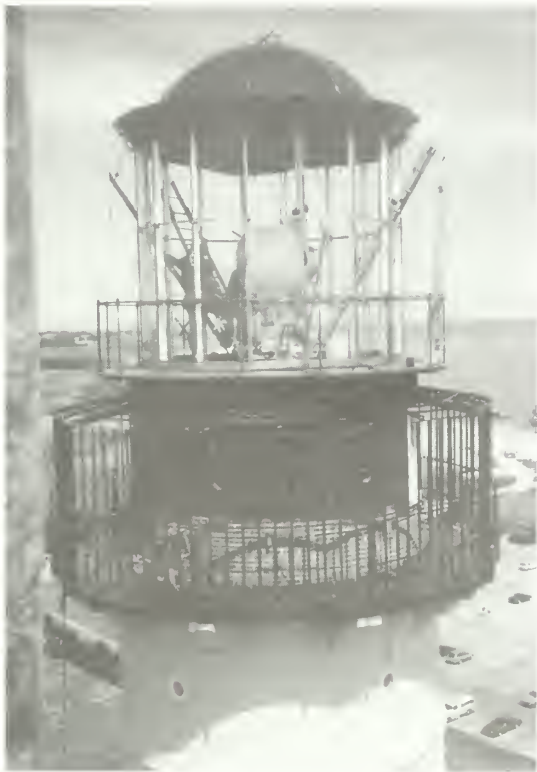
Figure 9. The refurbished roof is replaced on the lantern room. The fit is almost exact.

Meticulous preparations were made on the ground and in the air for the lift. The refurbished roof was centered as close as possible to the center line of the lighthouse and turned to allow for the proper fit in its original position. ICC's craftsmen were perched on ladders waiting for the roof to be hoisted. When all was ready, the signal was given and the lift began. The roof was centered above the window wall and began its descent. The result was anticlimactic. The roof came down exactly into position as if sucked in by a giant magnet. The major portion of the restoration was complete.

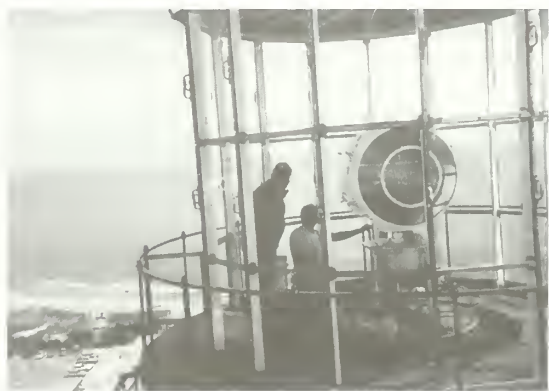
Figure 10. All glass is now in place and final preparations are made for the reopening.

New safety glass was installed on the window wall system, and the 'soup can' was no longer needed. A relatively calm wind would be required to remove the enclosure and set down the newly refurbished roof. On the June 4, 1994, conditions appeared favorable. The enclosure was lifted and, for the first time in five months, the efforts of the craftsmen were revealed. The newly lacquered bronze mullions, glazing bars, and sills gleamed in the bright early summer sun.

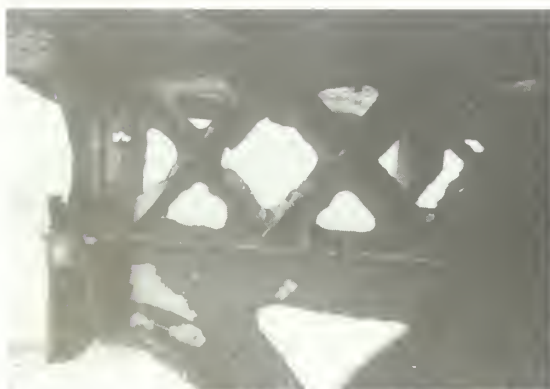
Figure 12. Some brackets were so deteriorated that they were totally exposed to the elements.

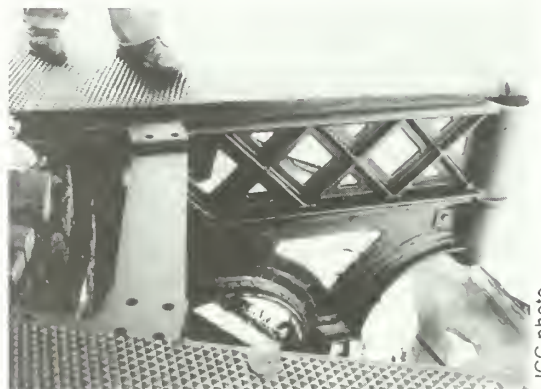
Figure 13. After the most severely deteriorated portion of the brackets were removed, new cast-iron pieces were made and installed; and new deck plates installed.

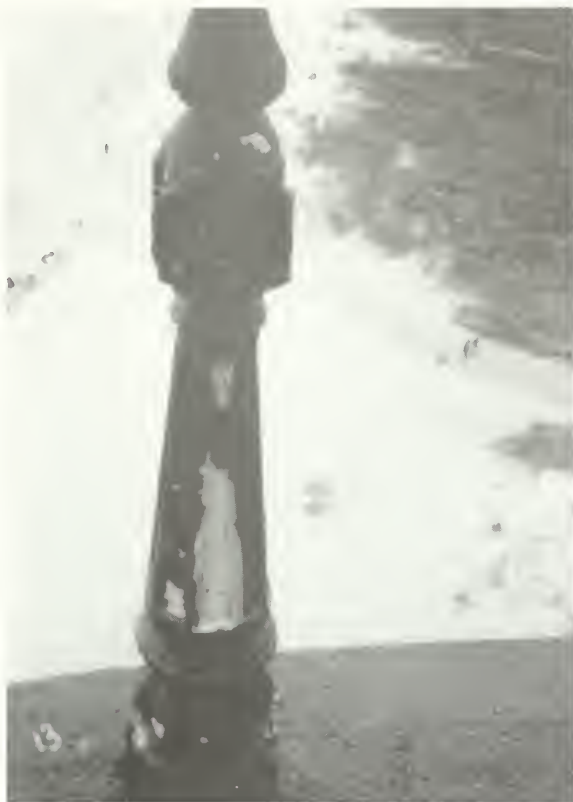
Figure 14. The handrail assembly has been removed and the ornate cast-iron post is ready for removal.

When repairs were completed to the Bonner Bridge, exterior work could begin. A 7-foot-wide, circular work deck was placed below the large gallery deck. This afforded access to the complete hand rail system and deck plates. The hand rail components were carefully removed, as were the deck plates. The surviving pieces of deck plate were so deteriorated that accurate measurements could not be made. The deck was recalculated and a template made of the theoretical size and shape of the new deck plates. This was custom-fitted to each individual bracket, revealing that the lighthouse was slightly out of round. Measurements were taken for each individual section, which required custom casting, machining, and fitting of each individual section of plate. The brackets supporting the plate were reworked, and individual components recast. The belt course holding the brackets together below was removed, the masonry underneath repinned, and the cast belt course reinstalled. Deteriorated masonry was carefully cut out and repainted, as was the granite pedestal at the base.

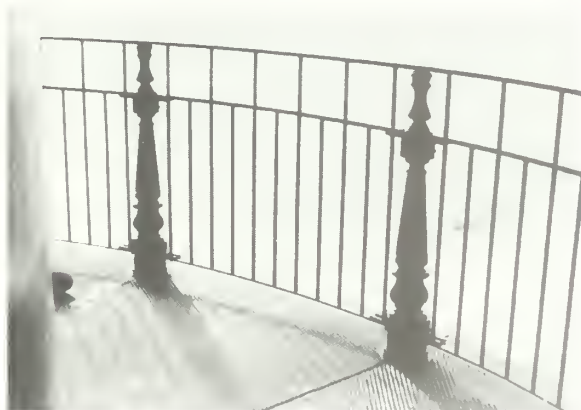
Figure 15. A replica handrail is installed.

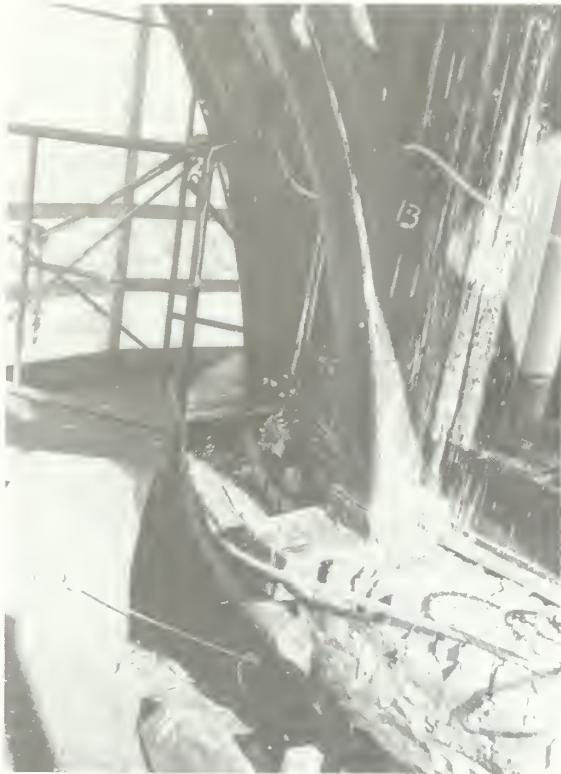
Figure 16. At the base of the brackets, the cast-iron belt course is removed, exposing deteriorated masonry below.

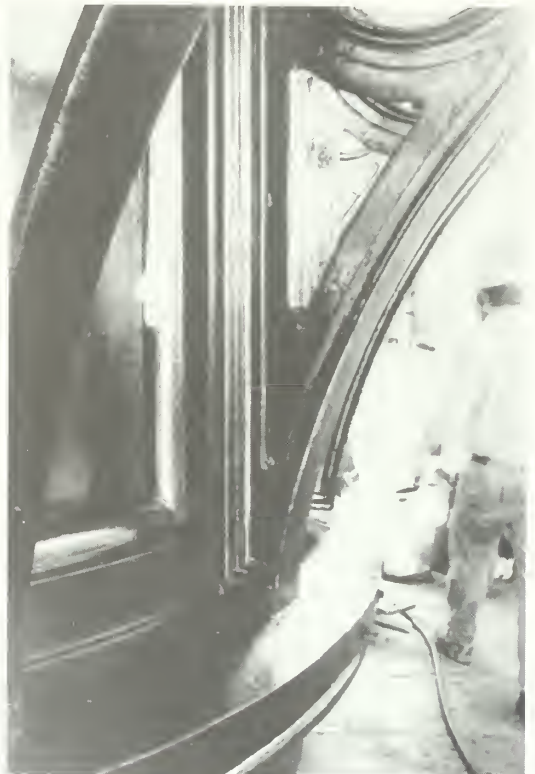
Figure 17. The cast-iron belt courses are repinned to new masonry beneath.

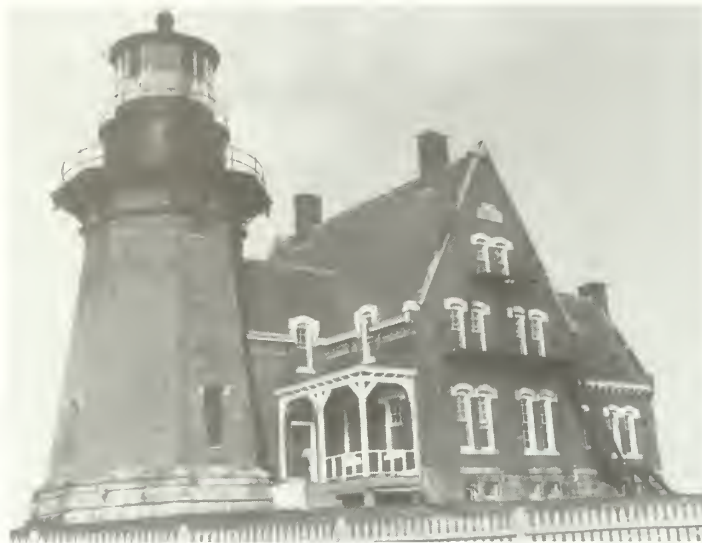
Figure 11. Block Island Southeast Light Station before the move.

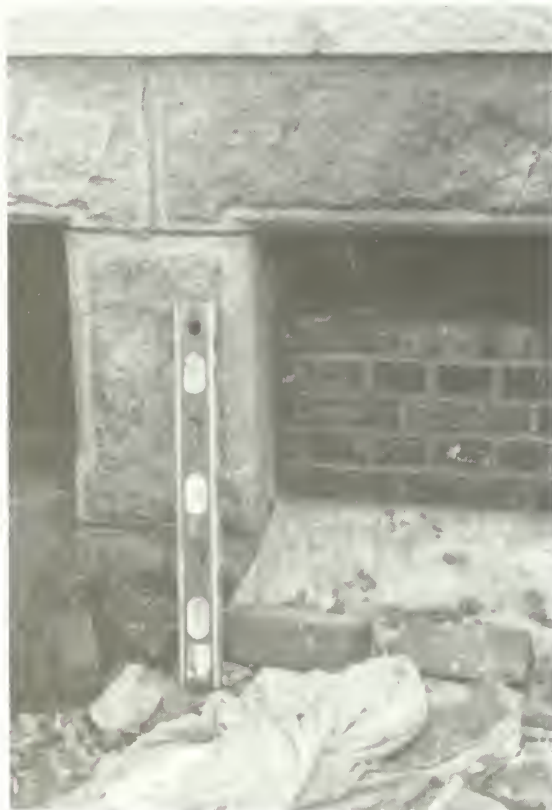
Figure 12. In preparation for the move, the cellar windows openings are temporarily bricked in to stabilize the masonry above the lift point.

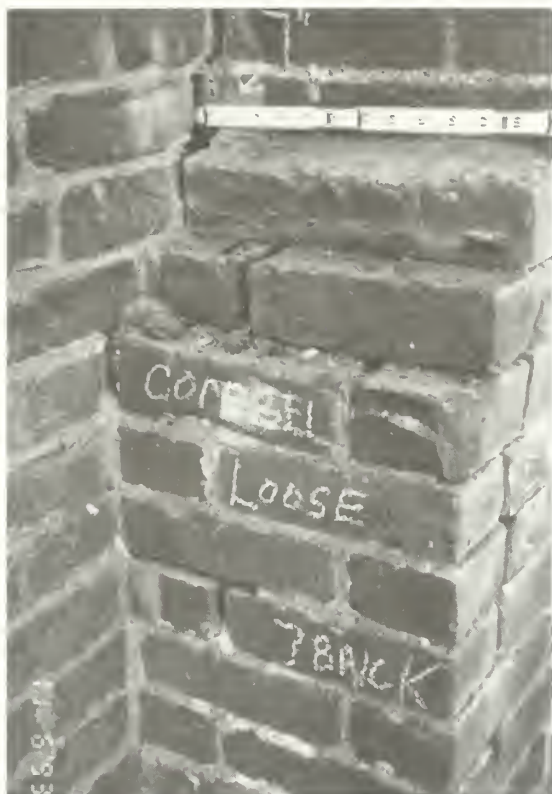
Figure 13. A complete structural survey of the building was performed and documented in order to perform the structural repairs necessary to move the building intact. All loose or eroded mortar joints were cut out and carefully pointed with a new mortar mix designed to closely resemble the original. All chimneys were braced and cabling installed around the perimeter to catch problem areas.

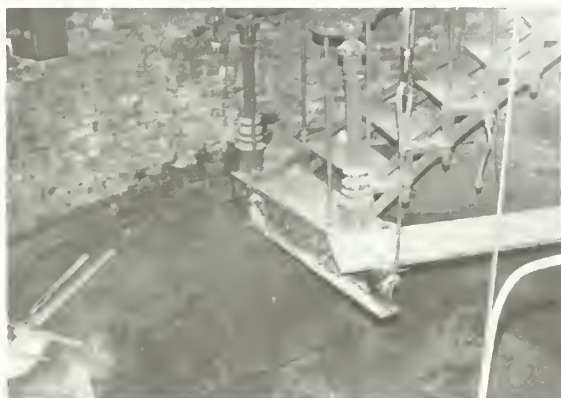
Figure 14. The concrete floor of the light tower was removed and earth excavated by hand in order to perform stabilization from the interior of the structure.

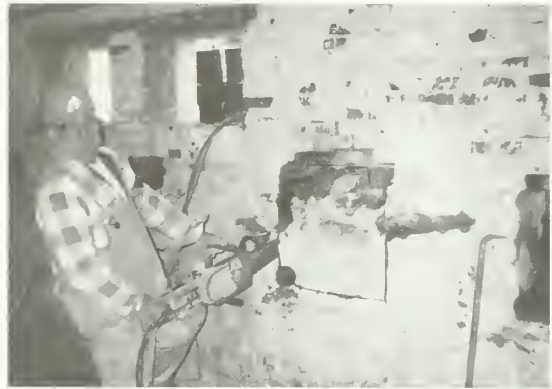
Figure 15. A hydraulic chain saw with industrial diamond teeth is being used to cut openings below the grade line for insertion of the steel beams.

through the original foundation, below grade level; then beams were inserted through the holes, in one side of the building and out the other. Multiple levels of beams were required. The lighthouse rested on an upper level of cross beams that were perpendicularly seated on four duplex main beams, which would house the hydraulic jacks. Thirty-eight hydraulic lifting/levelling jacks (capable of lifting 60 tons each) were installed to lift the lighthouse and to keep it level during the move. Thirty-eight 75-ton Hilman roller dollies were installed under the jacks. Once all the beams were in place, remaining portions of the foundation (the area between holes cut in the foundation) were removed. ICC worked in unison with Expert House Movers, a subcontractor experienced in moving large structures.

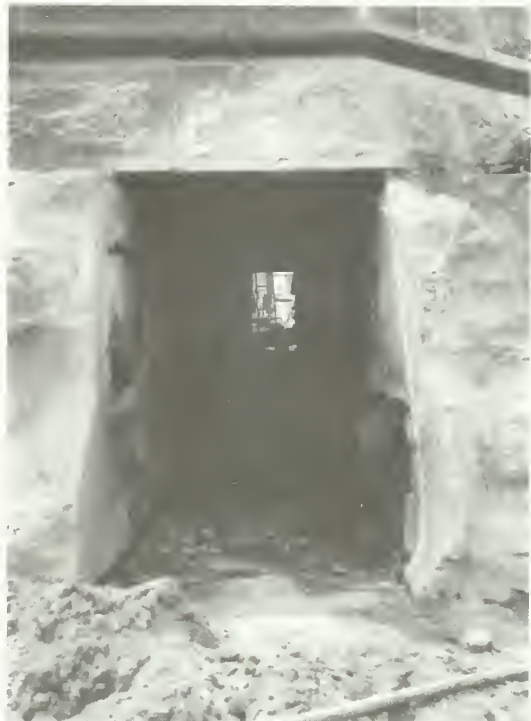
Figure 16. Close-up of the opening for the beam cut by the wire saw measuring 5 feet high by 3 feet, 6 inches wide. The depth of the cuts ranged from 18 inches to 16 feet for multiple wall cuts.

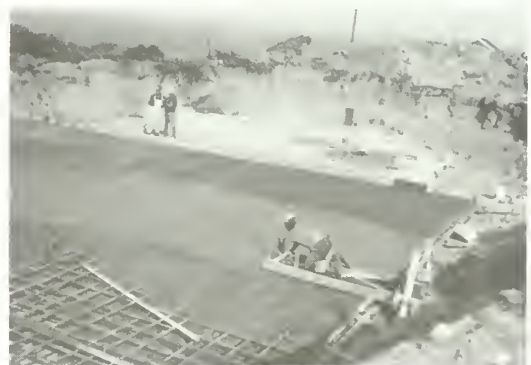
Figure 17. A foundation slab is being poured using 36 tons of rebar and 245 yards of concrete. This 18-inch-thick slab was designed to handle the dynamic load of the building travelling across the slab to its final position.

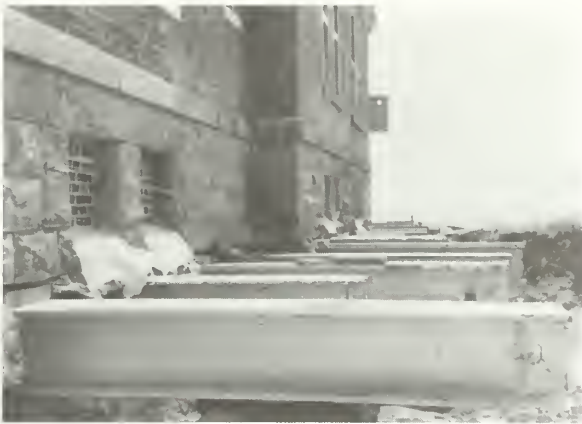
Figure 18. Large cross steel beams are inserted into the cut opening to form part of the grid that will carry the building.

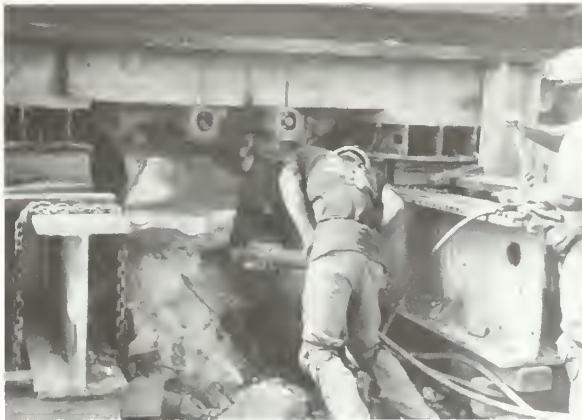
Figure 19. Once the initial lift was performed, the remaining foundation between the beams was removed.

Following the transfer of the lighthouse load from its foundation to the beam grid, all 38 hydraulic lifting jacks were activated in unison and the entire structure was raised vertically approximately 2 feet from its original elevation. The structure was then cribbed on oak timbers, tracks positioned below and parallel to the main beams, and the hydraulics for the jacks rerouted to three separate zones to allow for compensation on uneven surfaces during travel, i.e., no stress would be placed on the structure if a bump or soft spot was encountered, because the structure would roll like a ship rather than bend. By August 11, 1993, preparations were complete. The lighthouse was ready for the move.

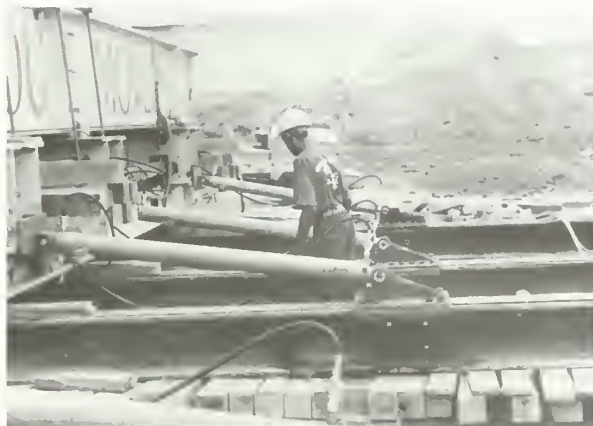
Figure 20. Four hydraulic rams set into the track steel pushed against the main steel to set the lighthouse in motion.

The move was accomplished by pushing the lighthouse along its newly installed track system in 5-foot increments with four hydraulic pushing rams (capable of pushing 30 tons each). After the lighthouse was pushed approximately 5 feet, all four pushing rams had to be retracted for the next 5-foot move. The lighthouse did not travel in a straight line from its original location to its new home. If this were done, loads on the network of beams under the lighthouse would have become too uneven. Instead, the move was accomplished in three separate stages (legs). Time was required between legs of the move for changes in the track system in preparation for the 90-degree change in direction the lighthouse was about to take.

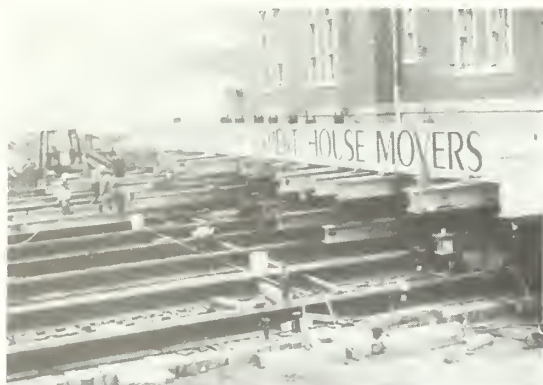
Figure 21. After the first leg of the journey was completed, the track steel was repositioned for a 90° turn.

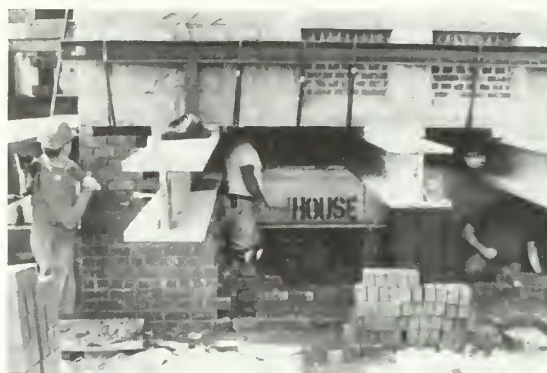
Figure 22. Construction of a new foundation around the support beams.

On August 24, 1993, Block Island Southeast Lighthouse reached its new home. It sat positioned with approximately 5 feet between the top of its new reinforced concrete slab foundation and the underside of remaining portions of its original masonry foundation. Solid brick was laid to fill the 5-foot gap (approximately 80,000 brick were required). Beams used to support the lighthouse during its journey were removed after brick was laid between the beams to carry the load. Wooden bracing and other temporary measures were removed; porches were installed; grading, landscaping, and final cleanup tasks completed. Once again, the Block Island Southeast Lighthouse rests a safe distance from the edge of Mohegan Bluffs, still facing in its original direction.

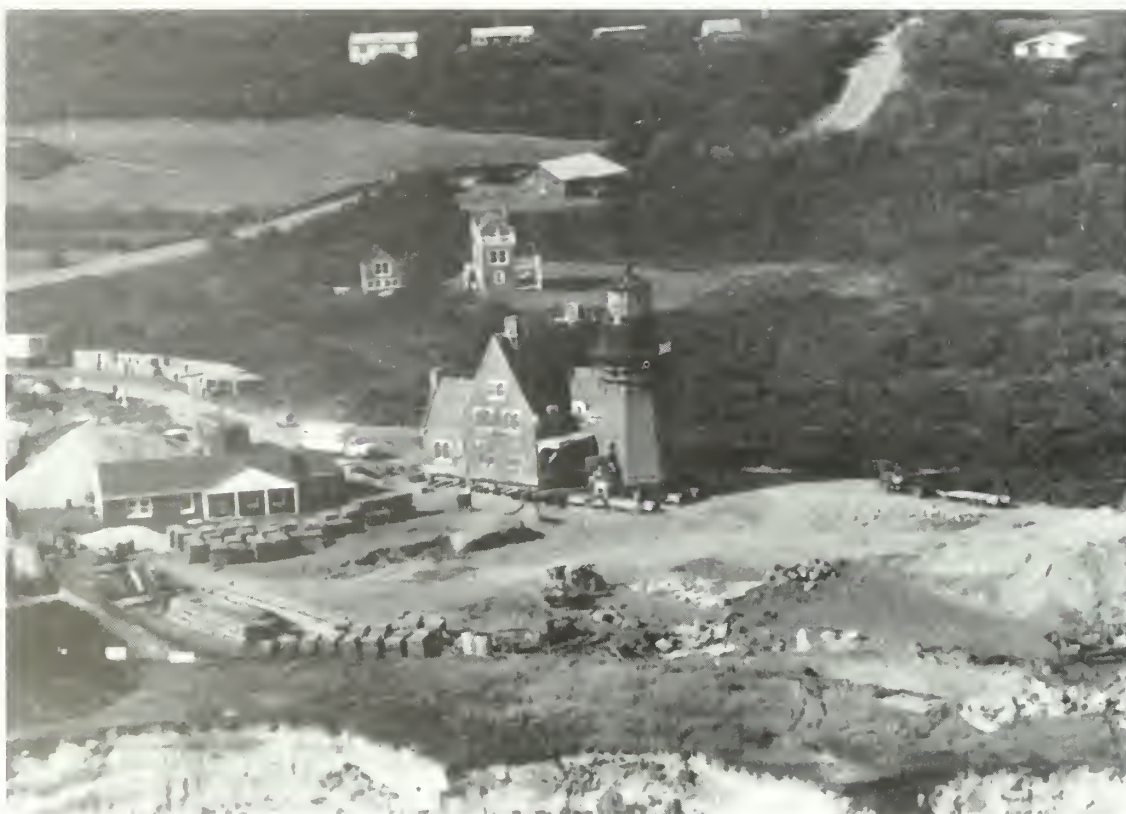
Figure 23. On August 23, 1993, the Block Island Southeast Light Station reached its new home.

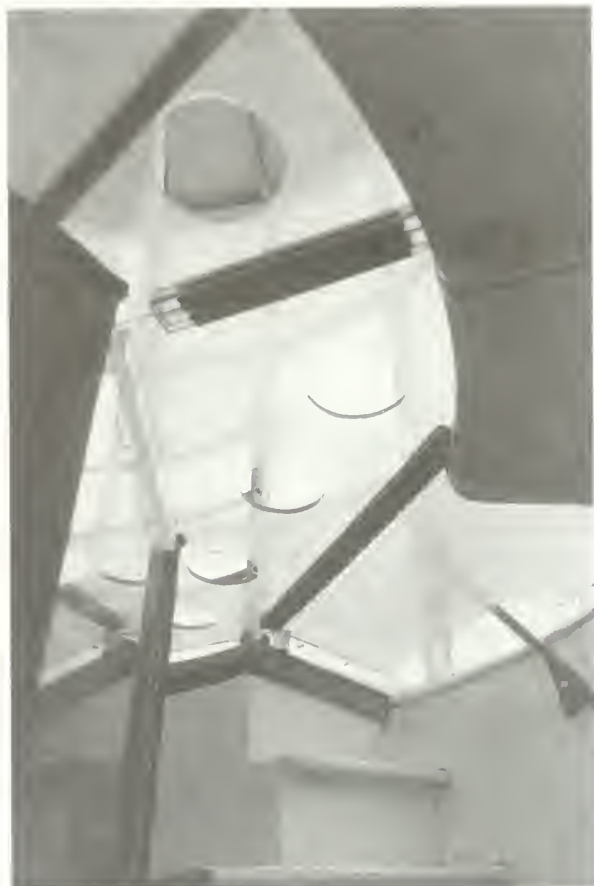
Figure 24. Visitors are prohibited from the Barnegat Lighthouse's lantern room; however, they can view it from the watch room through plexiglas sheets. While these protective sheets prevent access to the lantern room, they do collect dust and need periodic cleaning. In other lighthouses, a person is stationed in the watch room to prohibit access to the lantern room as well as control visitor behavior.

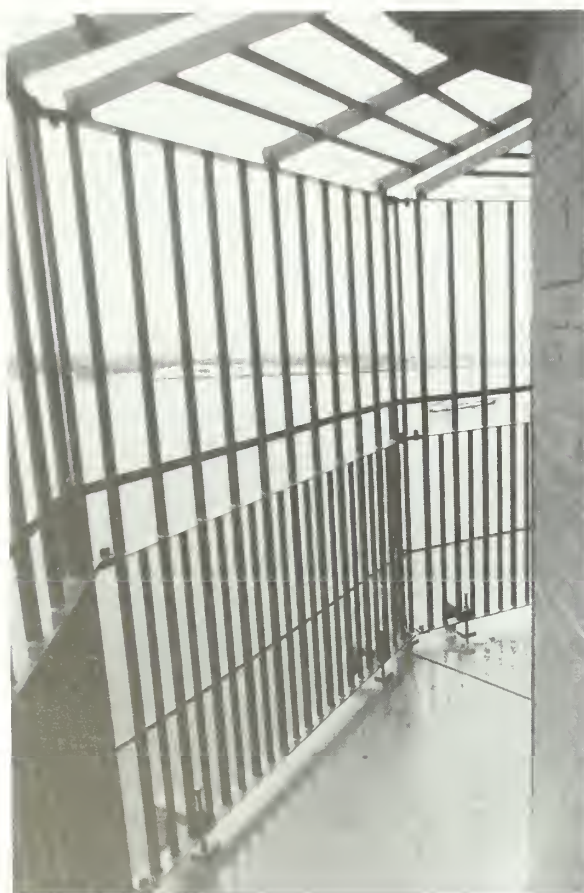
Figure 25. To protect visitors from falling or jumping from a lighthouse tower, a safety railing system or 'cage' is often built around the gallery decks. The cage at Barnegat Lighthouse was designed so that it has minimal impact on the historic structure and can be removed with little, if any, damage to the original fabric. Note that the cage is also enclosed to prevent climbing over the top.

method used by many lighthouse groups is to build a metal cage that fits around the gallery deck. The maximum space between pickets should be no more than four inches (BOCA, Building Officials & Code Administrators, International). The pickets need to completely extend to a structural element above or bend back to the tower/lantern wall so no one, even if deliberately climbing, could get over the top. One lighthouse suicide in 1995 was accomplished by climbing between overhead cage pickets with 9-inch spacing. Cages can be designed so they are attached reversibly to light towers without doing any permanent damage to the historic fabric of the structure.

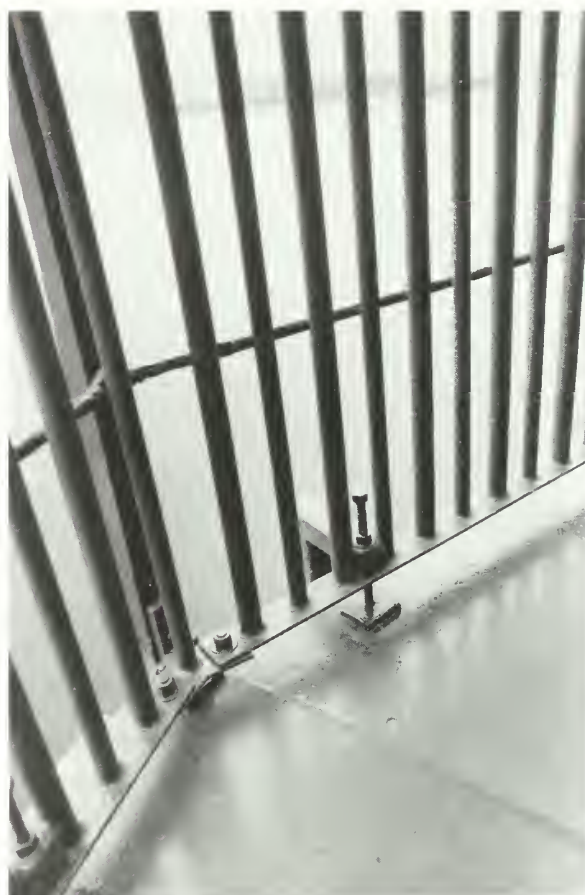
Figure 26. Note how the cage is clamped to the gallery deck, minimizing any impact on the structure's original fabric.
