Cape Hatteras Light Station Cultural Landscape Report

Cultural Landscape Report

Prepared by Susan Hart Vincent
Historic Land Design
Charlotte, North Carolina

2003

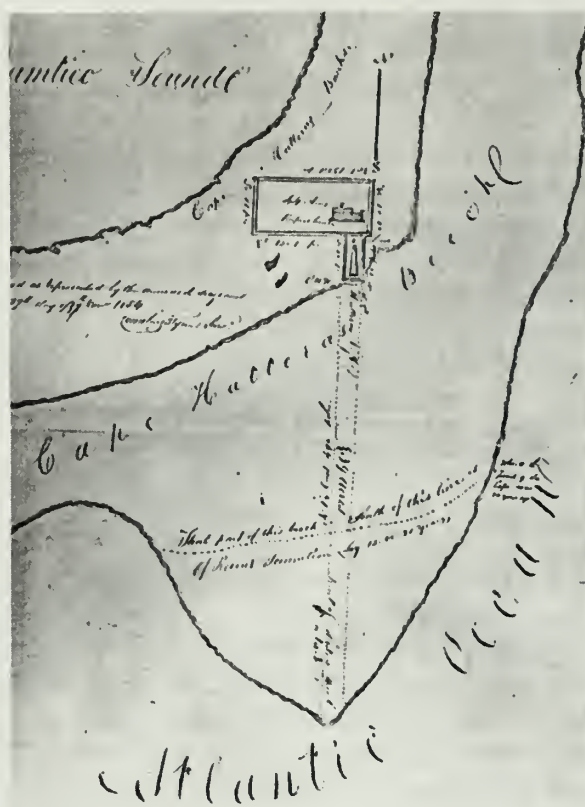
FIGURE 2. Cape Hatteras Light Station Survey of November 29, 1854, showing the 4-acre original tract and the 1828 40-acre tract, as found in Holland, 1968.

Eighteenth-century documentation reveals astonishing topographical changes taking place in the area of the Cape Hatteras Light. The 1854 survey (fig. 2) depicted a long dune line east of the lighthouse that paralleled the beach. In view of Nicholson's sketch (fig. 3), it appears the lighthouse stood atop this line of dunes, with the flat barren beach to the east.

The 1854 survey in figure 2 illustrates the quarters north of the lighthouse and within the forty-acre tract purchased in 1828. Although not shown in the survey, a smokehouse may have been built along with other necessary outbuildings.¹²

The survey showed the boundaries of the reservation enclosing a square area of approximately 40 acres. How the property holdings changed from forty-four acres to forty acres is not known. Bamber's boundaries are incongruous with the 1854 map in figure 2.

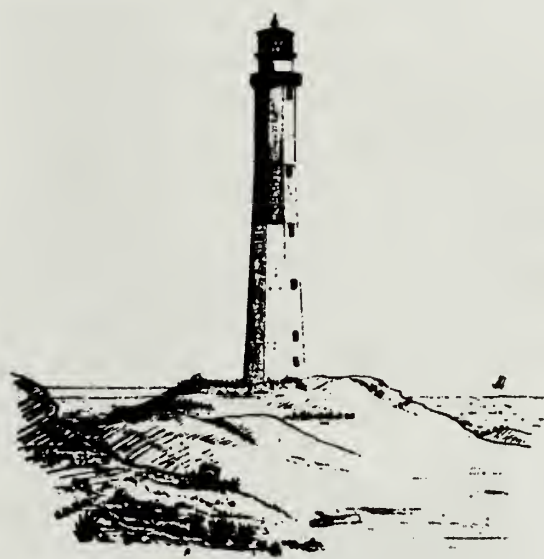
Illustration No. 1
OLD TOWER, CAPE HATTERAS N.C., OCT. 24, 1870
View from the West

*Height of sand hill above the general level of the beach 20 feet
From base to top of existing 1854*

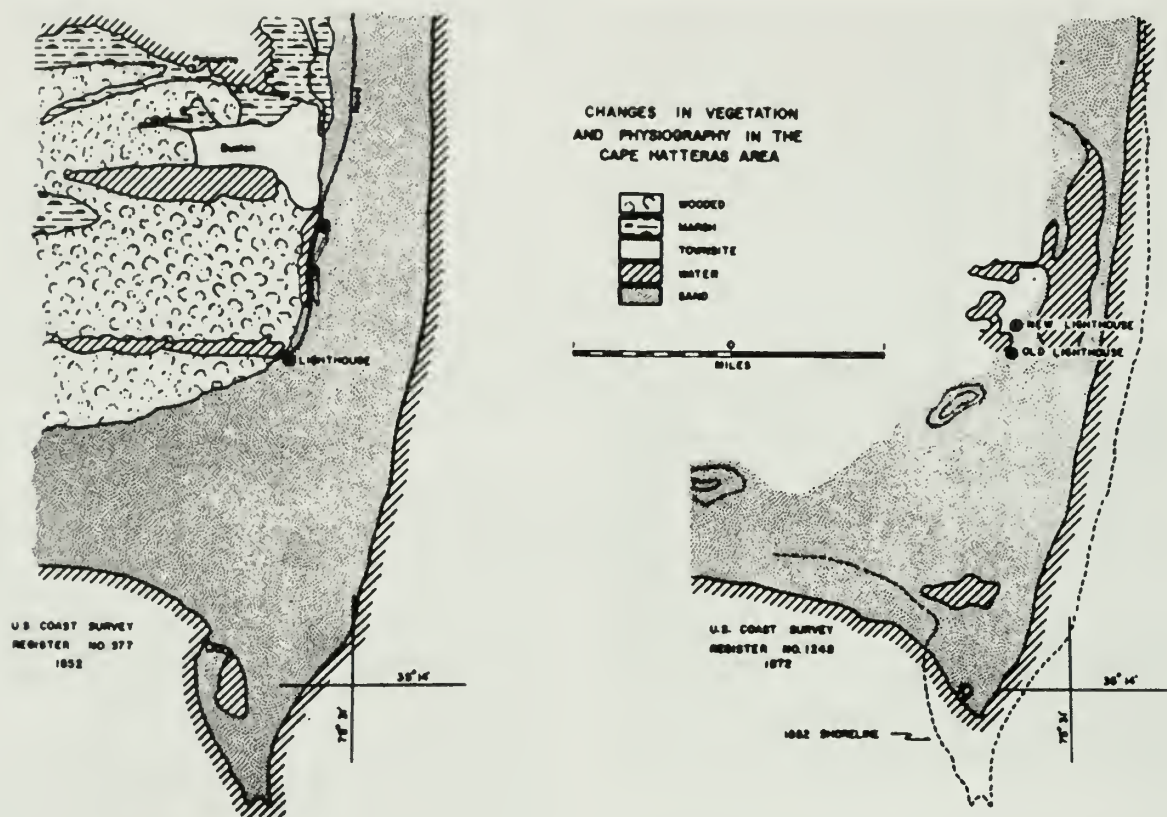
FIGURE 4. Physiographic changes in the Cape Hatteras area, 1852 - 1872.

of the light station. Another north-south pond ran parallel to the lighthouse road approximately one-half mile to the north. This pond may have been associated with Cape Creek, the eastern boundary of the station property (formerly Farrow's) that drained north to the Pamlico Sound. By 1872, the north-south pond had moved east and enlarged, leaving a thin piece of land between it and the ocean. The linear east-west pond also appears to have enlarged (fig. 4).

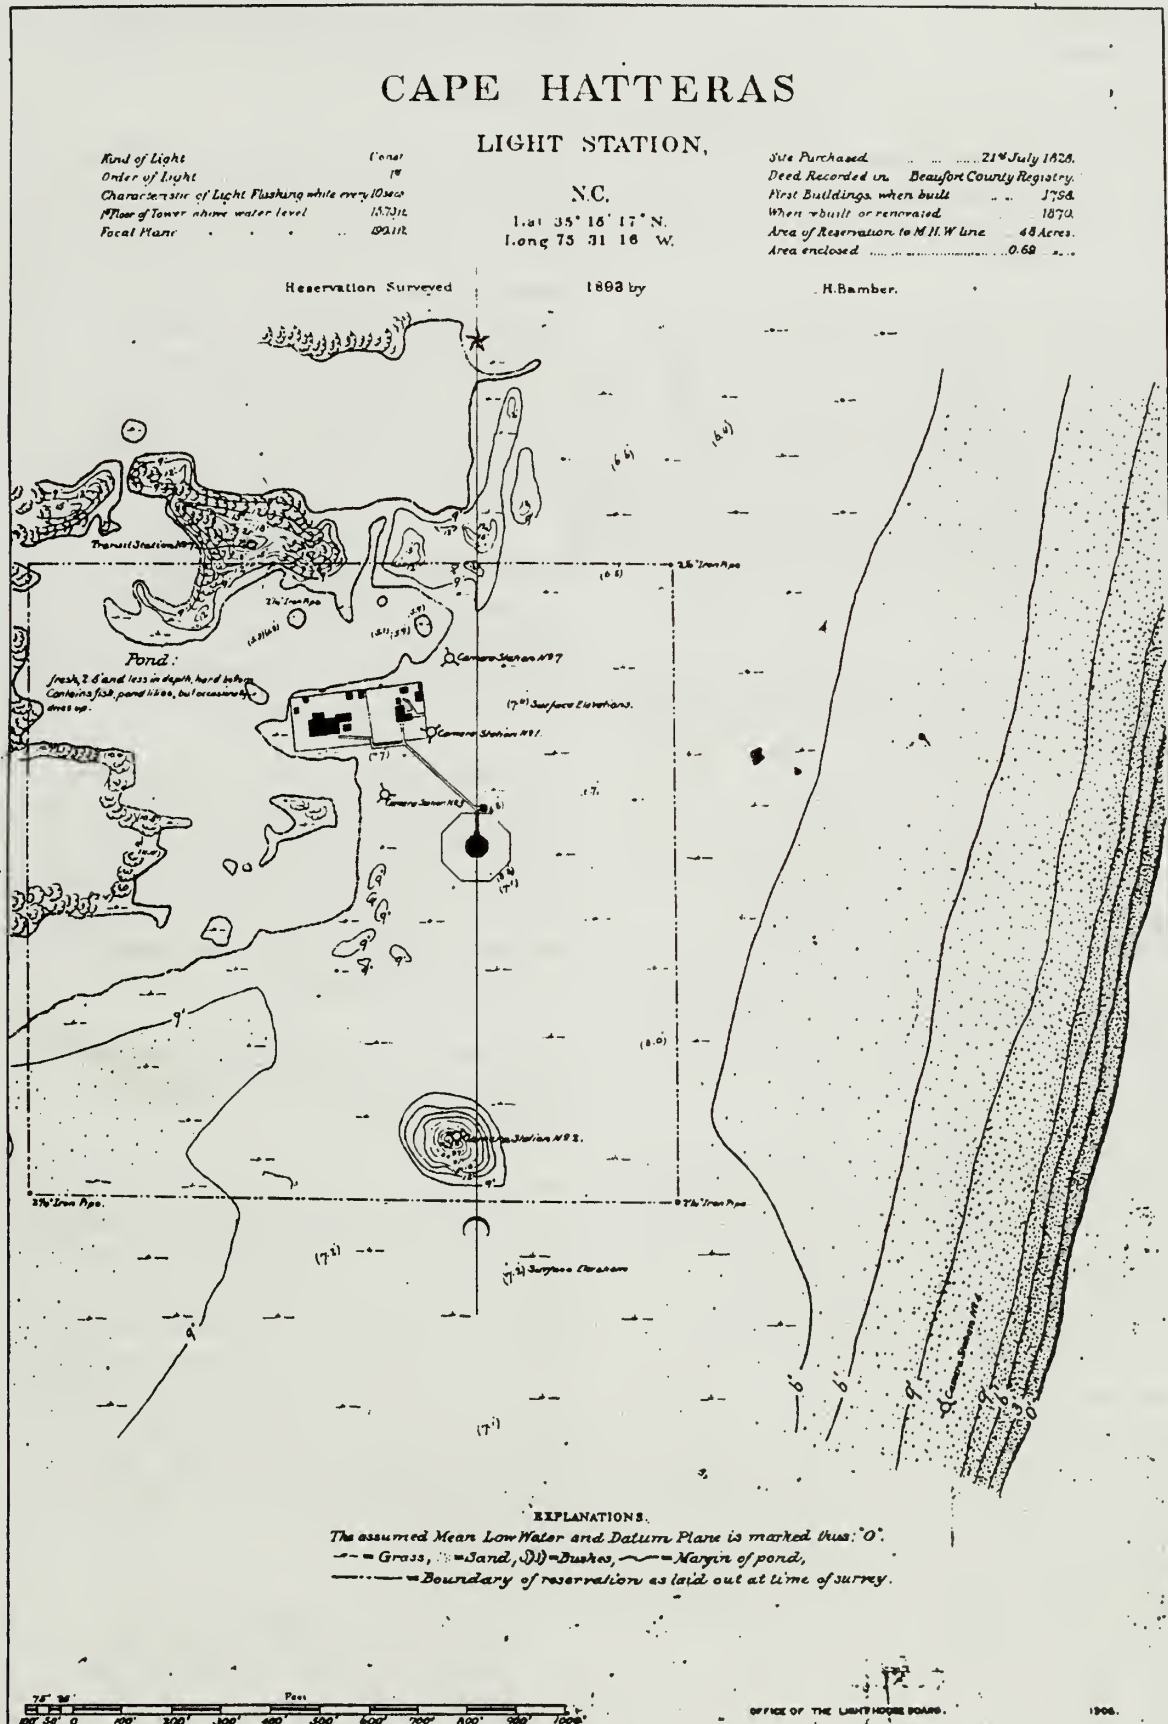
FIGURE 5. H. Bamber's 1893 Survey of Station Boundaries and Shore Line.

The 1870 light station was surveyed in 1893 by H. Bamber for the Office of the Lighthouse Board (fig. 5).

Despite the optimism of this report, the shoreline erosion near the lighthouse was increasing. The 1893 Bamber survey (fig. 5) indicated the water had moved to within approximately 1,300 feet of the new tower. In addition, photographs of the same period show a flat, open sandy beach south and southwest of the tower. In 1919, a low sand ridge, remnant of an old dune line, ran parallel with the shore about 500 feet east of the light. Soon after, the ocean overcame the dunes and washed to within 300 feet of the lighthouse.

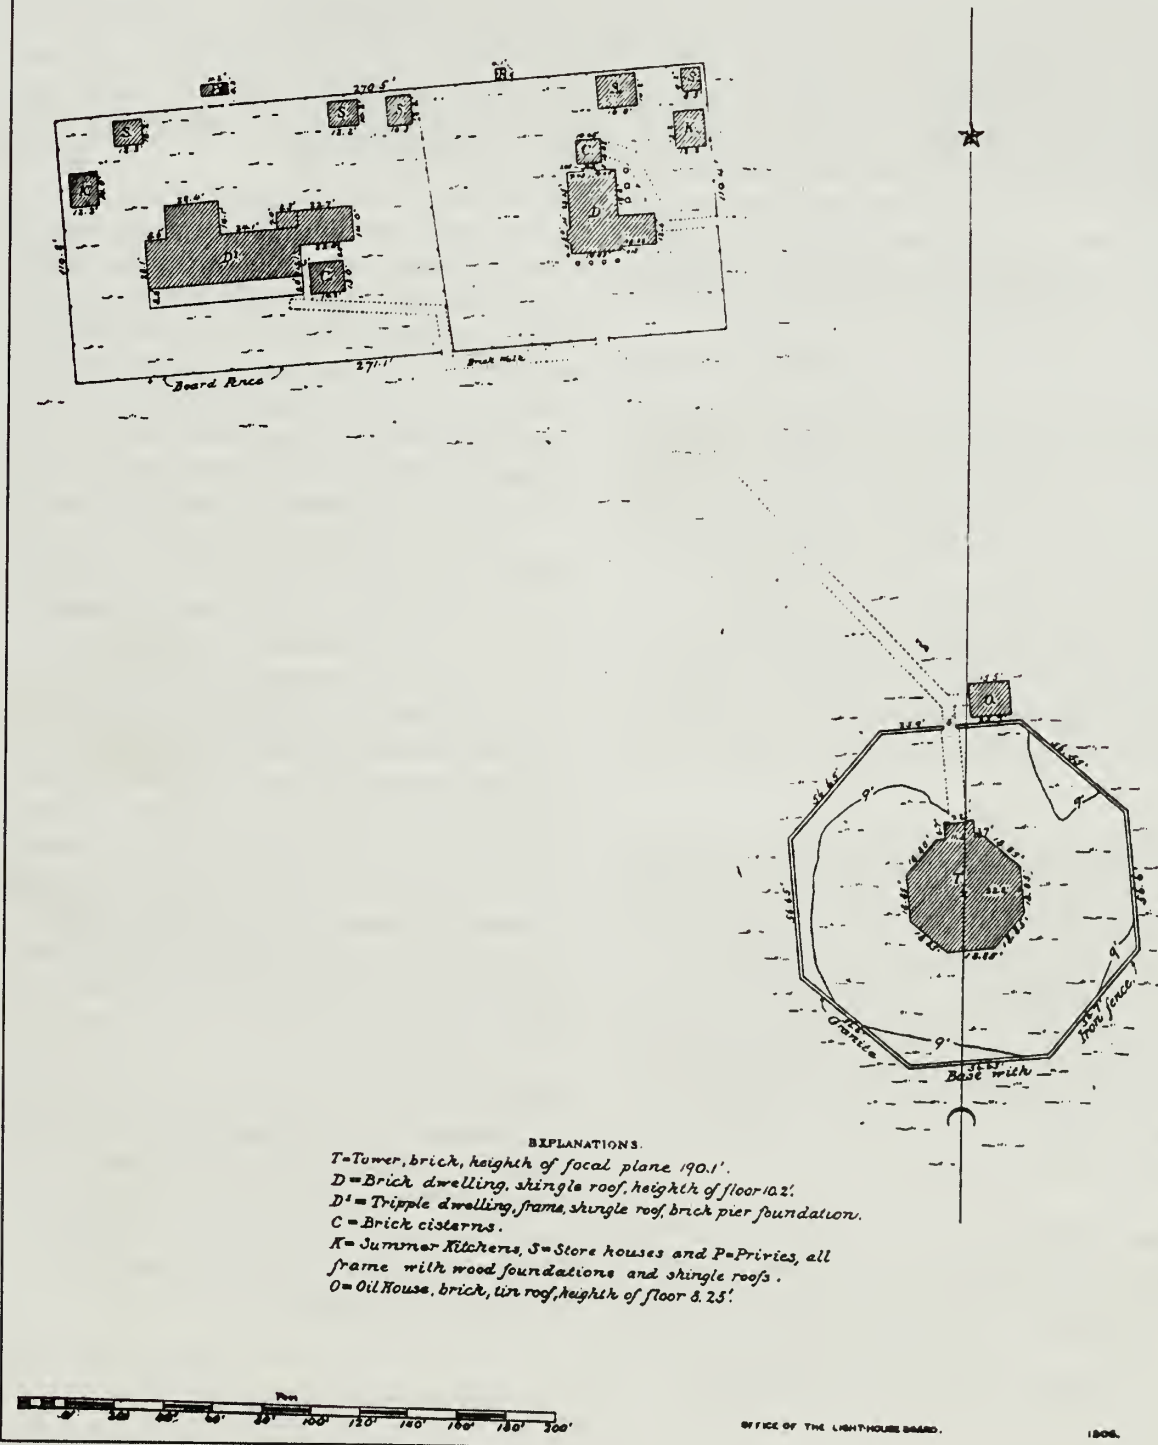
FIGURE 6. H. Bamber's 1893 Survey of Cape Hatteras Light Station, NC.

summer kitchen, three storage structures, a cistern, and double privy (fig. 6). All structures were painted white.

The principal keeper's wooden picket fence, constructed in 1870, was replaced in 1888. Although historical sources cite 400 feet of new fence being built, it appears that approximately 900 feet were needed to construct the white board fence that surrounded both dwellings in 1893 photographs.²⁰ The fence was approximately 110 by 270 feet, with a 110-foot segment dividing the two properties (fig. 6).

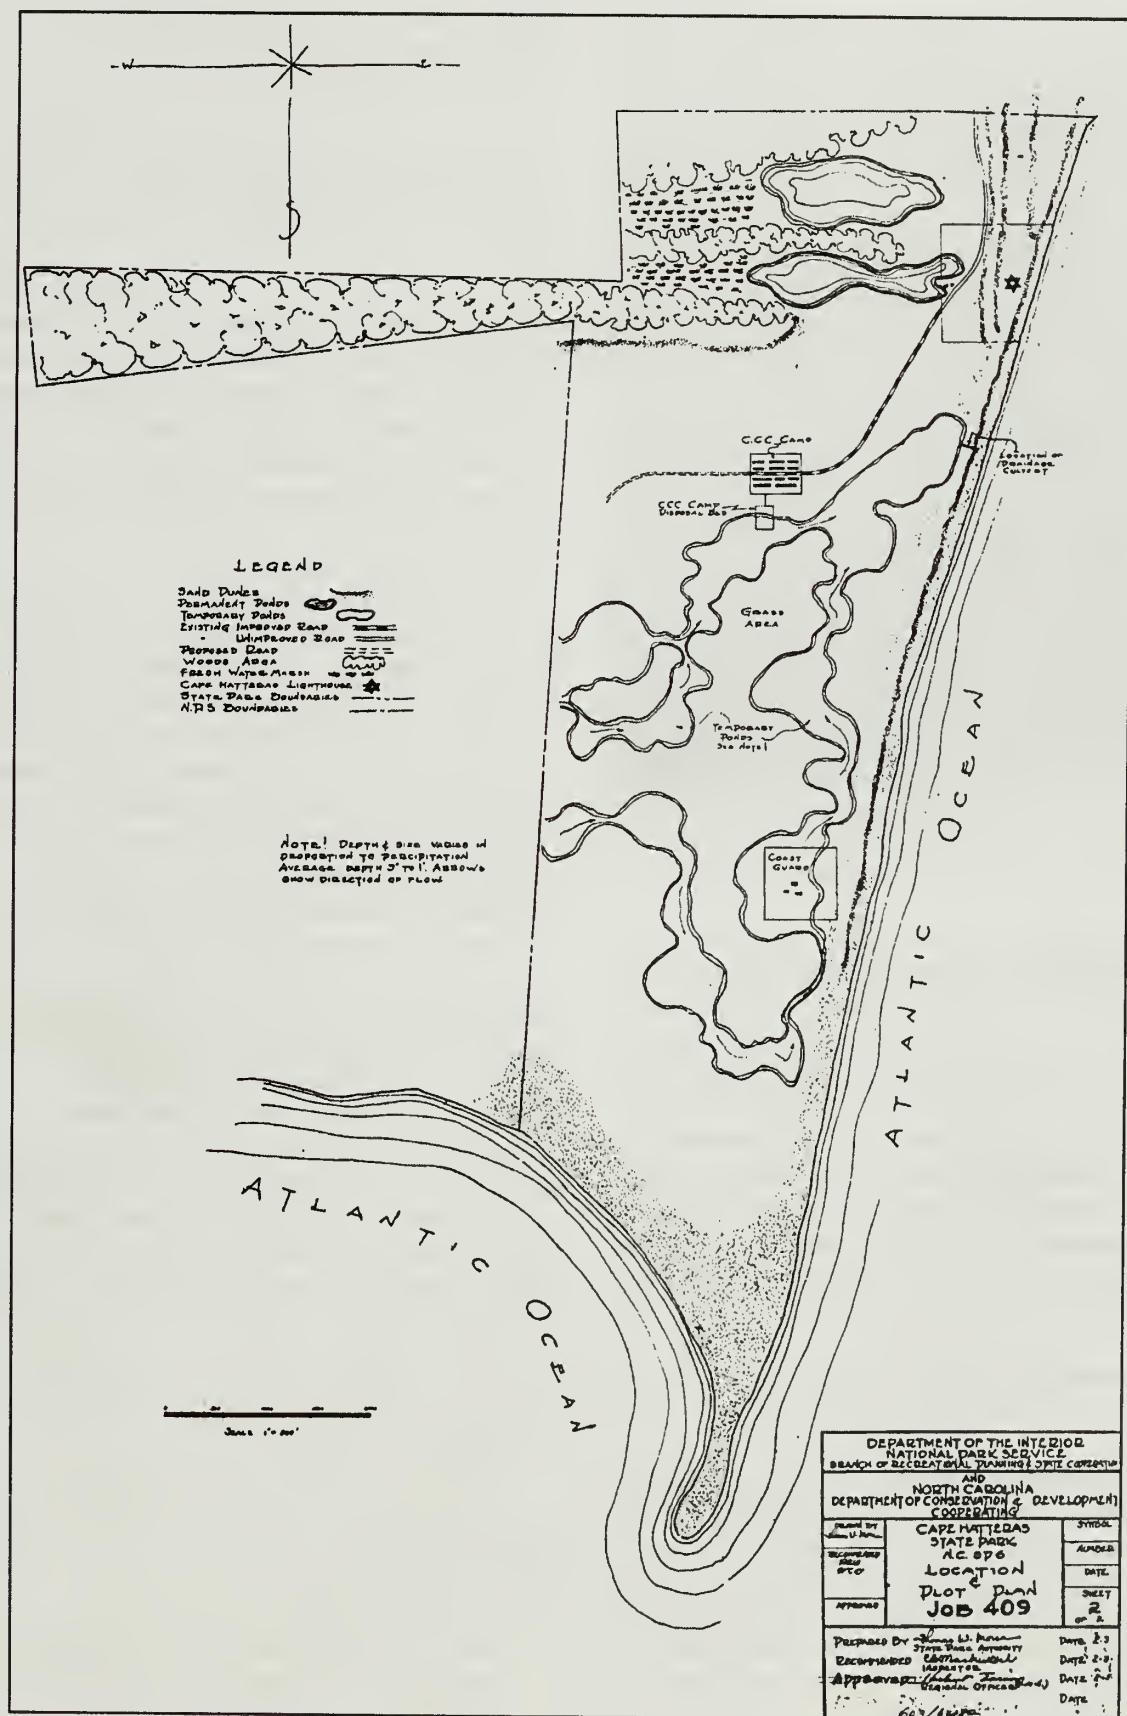
FIGURE 8. Cape Hatteras State Park, N.C. SP-6, 1937 Location and Plot Plan.

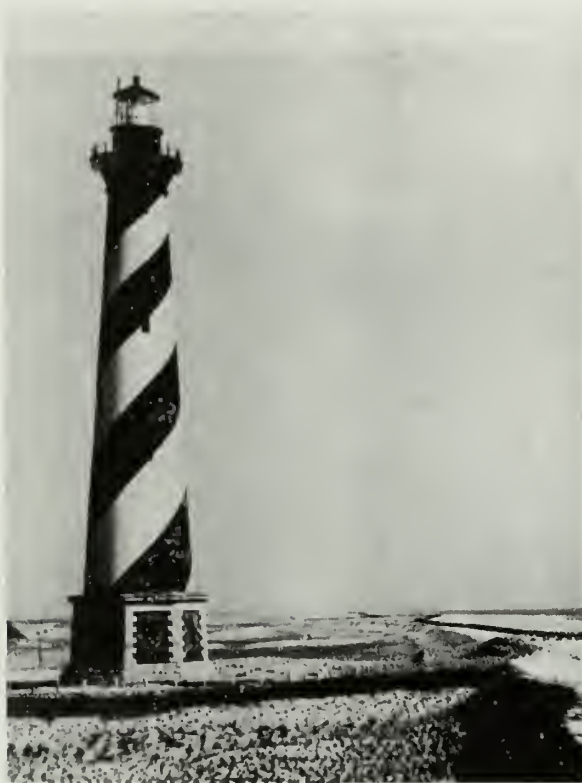
FIGURE 9. North view of Lighthouse and CCC brush fences and grass plantings. Lighthouse revetments can be seen along the beach, ca. 1935.

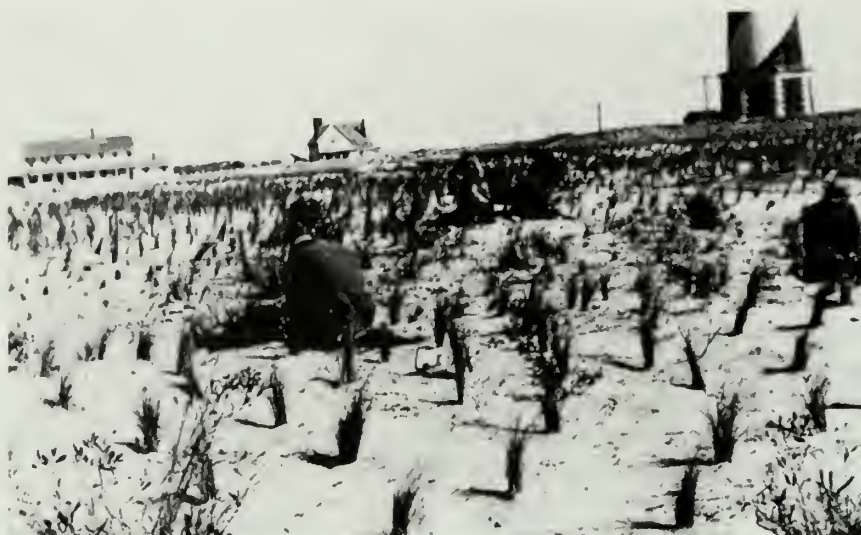
FIGURE 10. CCC grass planting, ca. 1935.

At Cape Hatteras State Park, CCC workers installed four miles of brush fences. Native grasses planted on twenty-two acres of dunes took root and began collecting sand. Approximately 18,000 shrubs and trees, including yaupon, American beauty bush (*Callicarpa americana*), loblolly pine (*Pinus taeda*), redbay, live oak, and wax myrtle were planted on nearby sand flats (fig. 10).²⁷

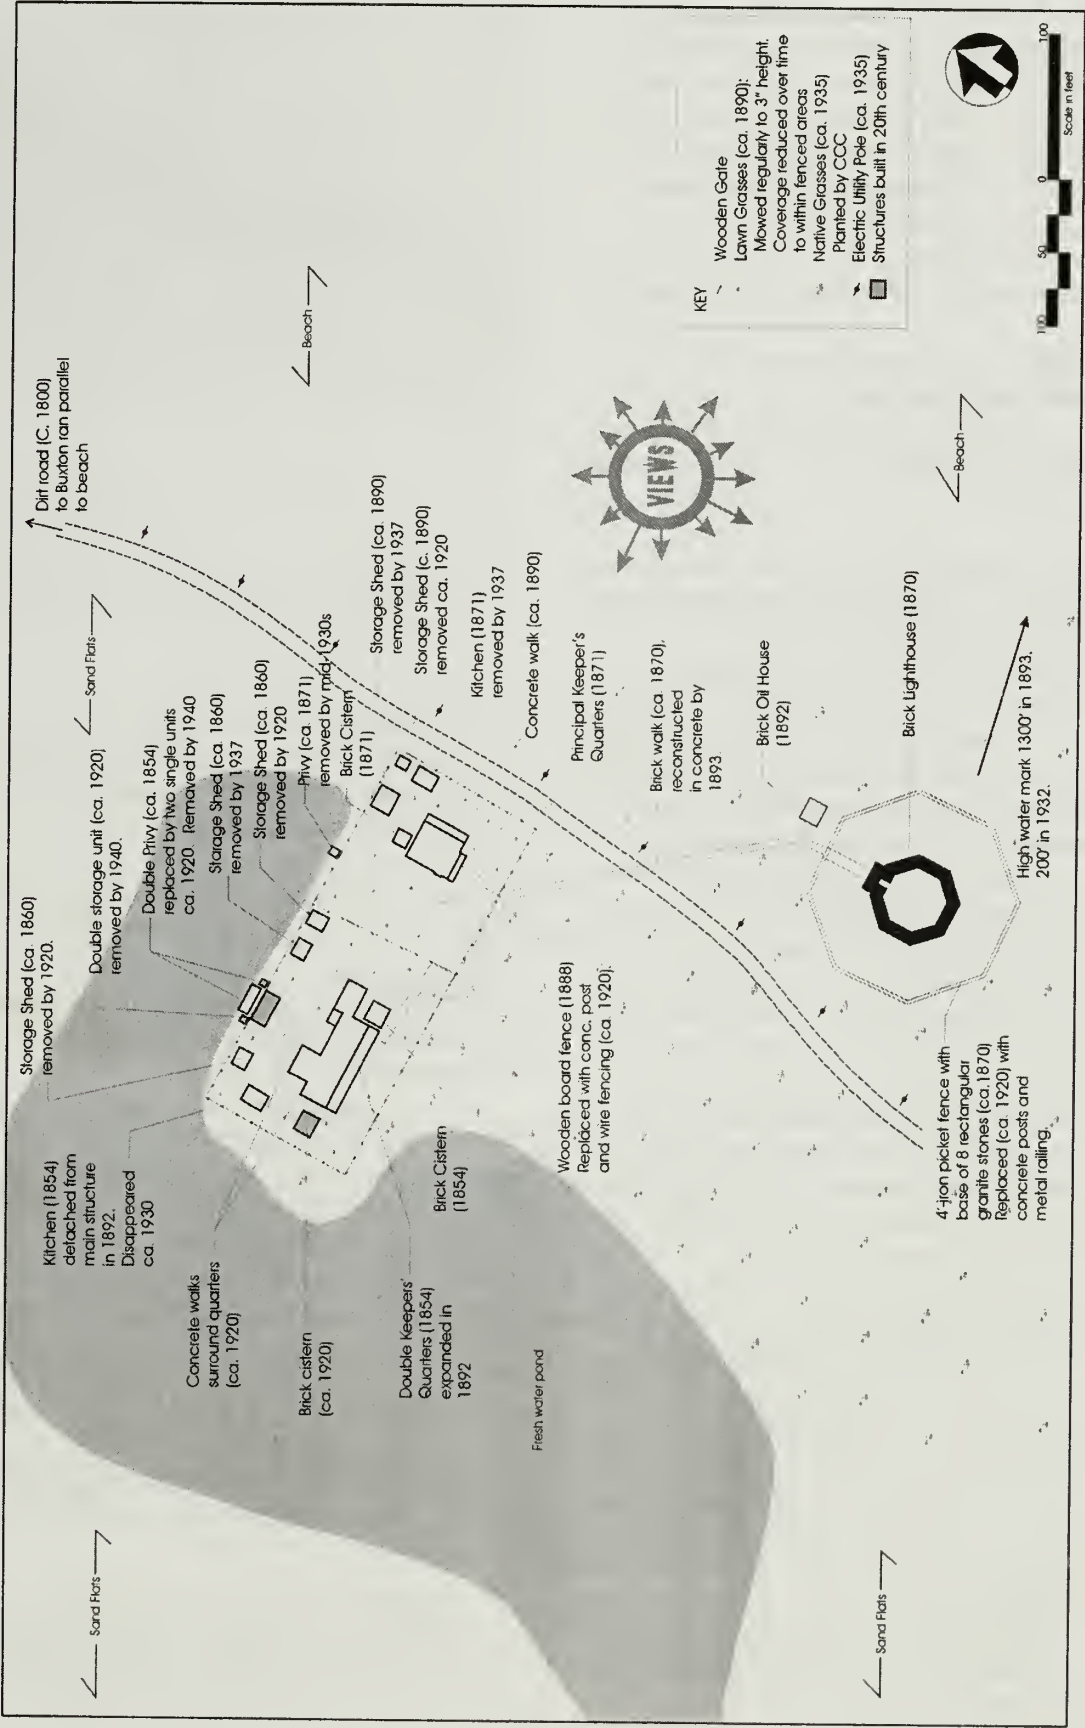
FIGURE 11. Cape Hatteras Light Station Historic Period (1870-1936).

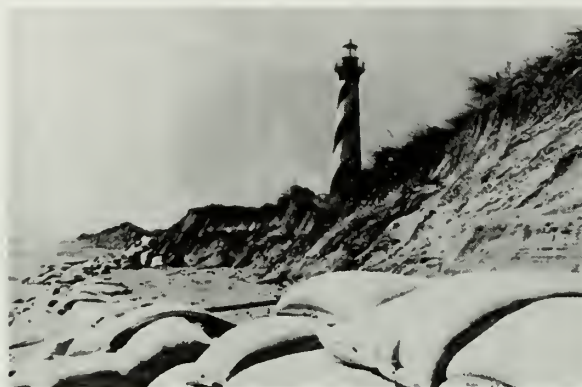
FIGURE 12. Sandbagging efforts in 1968 to protect the lighthouse.

The Mission 66 priority to repair the dune system illustrated the unstoppable changes in the shoreline. The dune system had started to fail. Although it had prevented over-wash during small storms, overall erosion was narrowing the

beaches. A reduced area of "run up" for waves increased turbulence and sand broken into finer particles would wash away. This created a steeper beach profile that magnified wave turbulence.

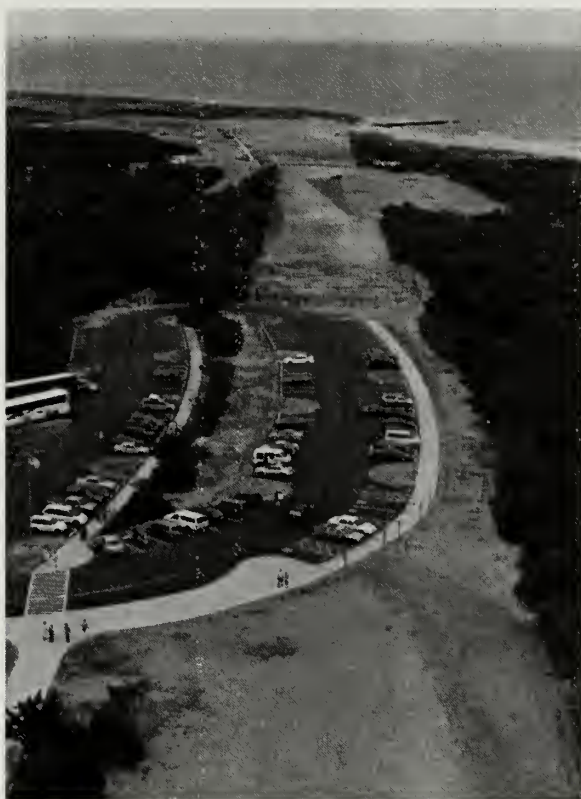
FIGURE 14. Northeast view of move corridor and old lighthouse site, May 2001.

Once all the structures were relocated, ICC removed the tracks and any debris that resulted as a byproduct of the move. The move corridor was back-filled and re-graded to resemble pre-move elevations (fig. 14).

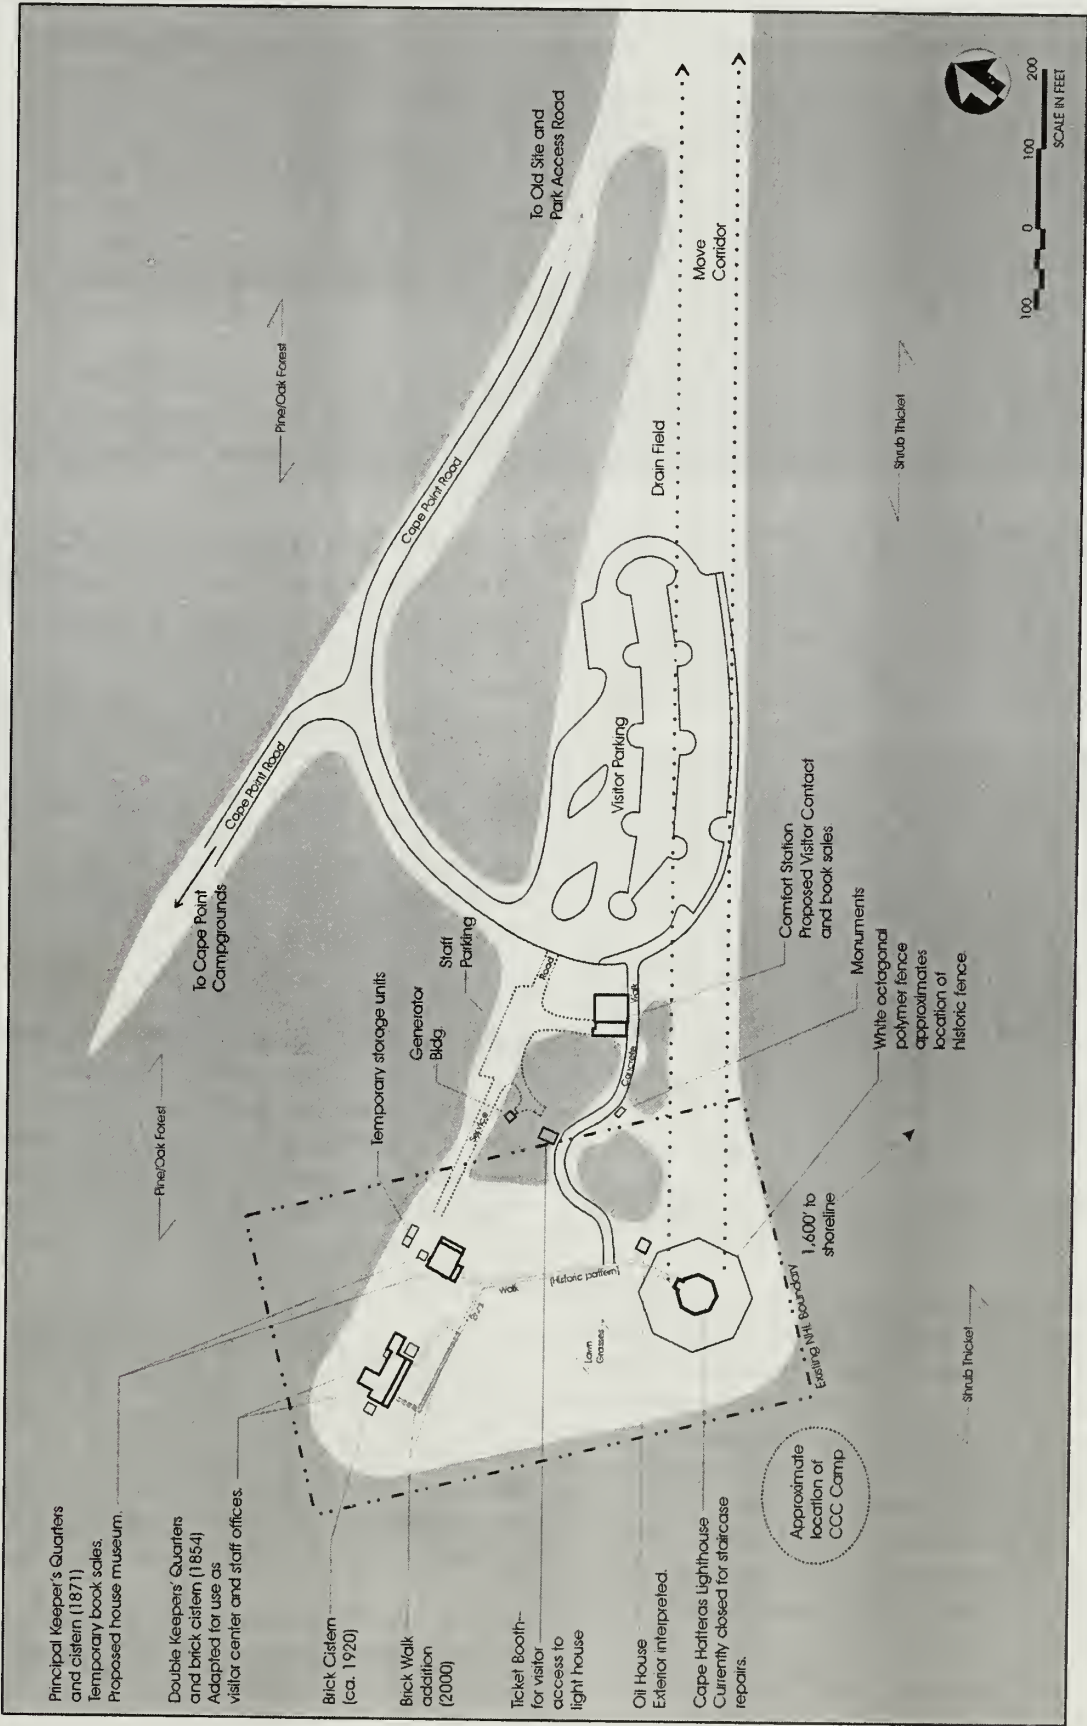
FIGURE 15. Existing Conditions Plan.

Existing conditions reflect the ongoing development of the site (fig. 15). Three phases of development were planned, of which two have been realized. Phase one involved the preparation and relocation of the light station complex to its new site. Phase two, completed in 2001, provided for site visitation and included the construction of a light station access road, a visitors parking area, a comfort station, a temporary ticket booth, and walkways. Clearing away trees in the historic zone and planting lawn grasses was also completed in this phase.

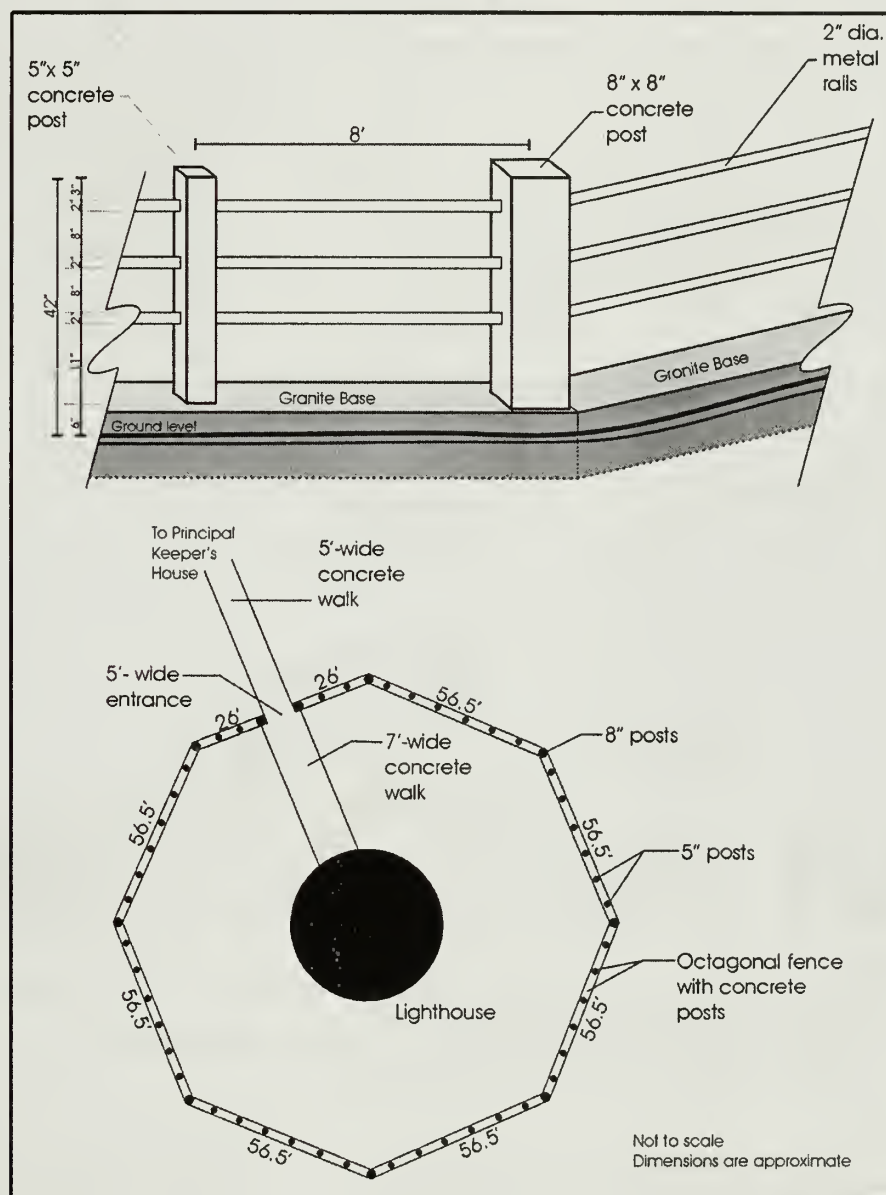
FIGURE 17. Lighthouse Fence Details.

- Maintain the exterior of extant keepers' quarters and cisterns white, which is consistent with the end of the historic period.
- Restore the historic concrete post and metal rail fence that surrounded the lighthouse at the end of the historic period. Use the original granite stones that supported an octagonal fence there throughout the historic period (fig. 17).
- Restore the historic concrete post and wire fence that surrounded the principal and double keepers' quarters at the end of the historic period. This is consistent with the period of significance in that a rectangular fence surrounded the quarters from 1888 to ca. 1950. Nine hundred yards of four-foot-tall welded wire fencing, with 8-inch-by-12-inch rectangles, can be specially made for approximately \$500 (fig. 18).²

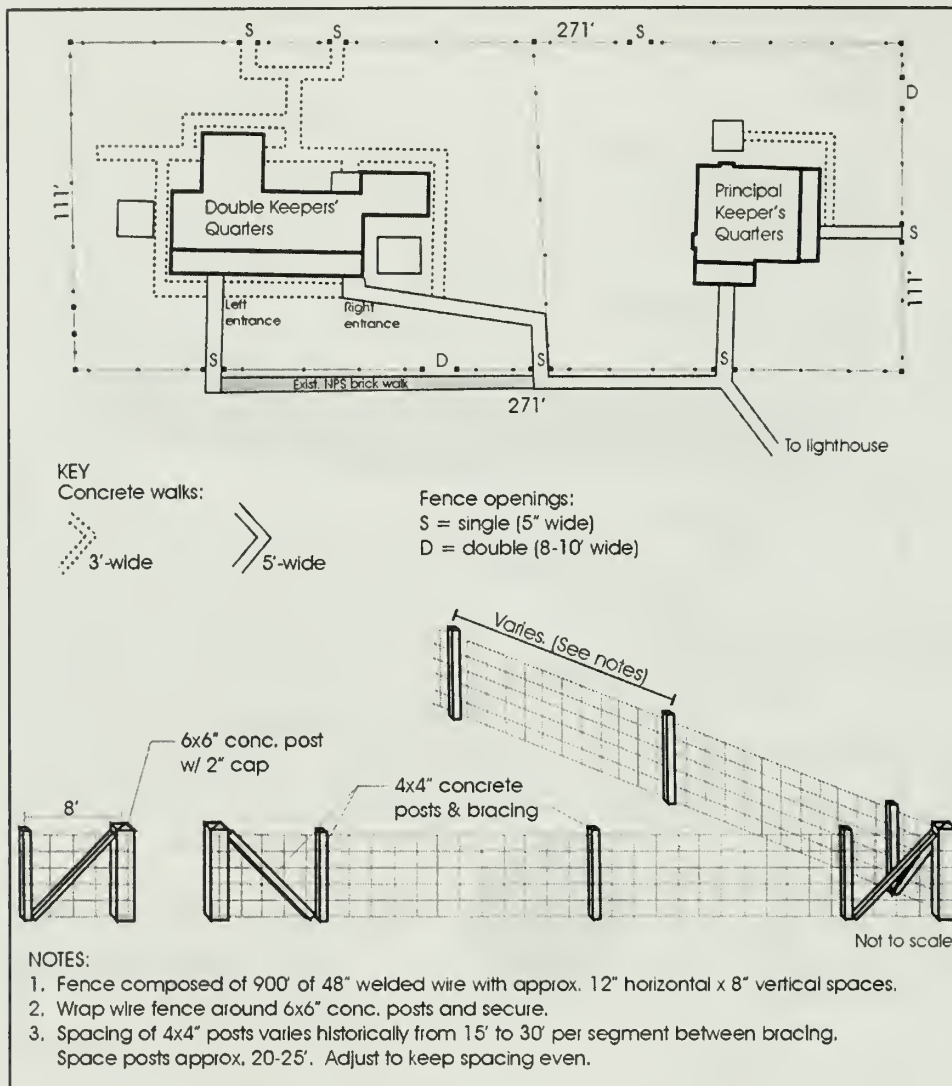
FIGURE 18. Keepers' Quarters Fence and Walk Details.

- Restore a five-foot-wide concrete walk from the east door of the principal keeper's house to the proposed fence. This walk is a visual contribution to circulation patterns and not to be used as a visitors entrance. Therefore, elevation changes to meet ADA requirements are not necessary (fig. 18).

- keepers' dwelling. Therefore, elevation changes to meet ADA requirements are not necessary. Provide interpretation at the terminus of these walks of the site's 19th-century outbuildings (fig. 18).

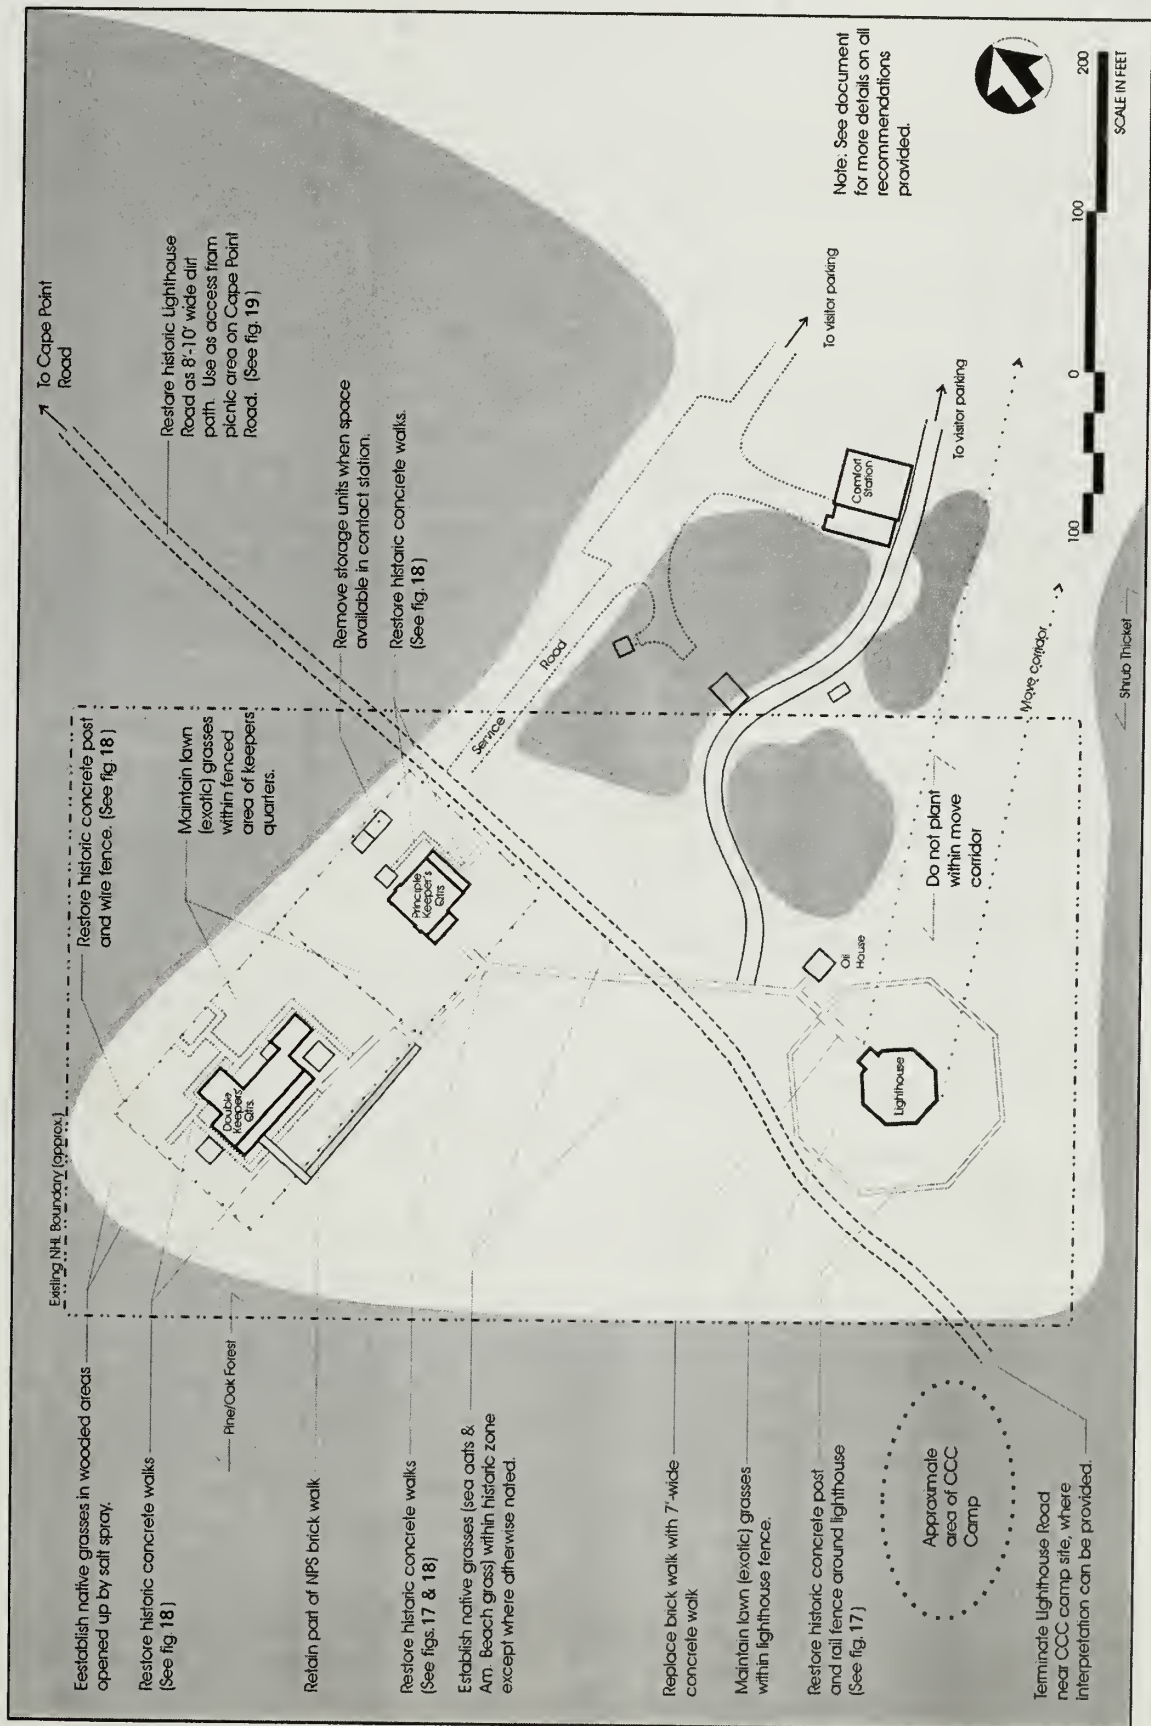
FIGURE 20. Lighthouse Complex Treatment Recommendations.
