Final Report

Characterization of Restoration Mortars For Fort Sumter National Monument and Degradation of Mortars by Sea Water And Frost Action

Denis A. Brosnan, Sr. Professor, Clemson University

April 19, 2012

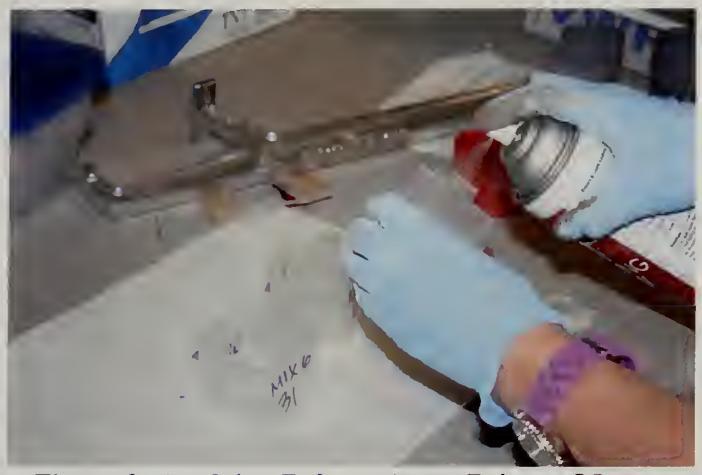
Figure 3: Applying Release Agent Prior to Mortar Insertion in Molds (Photograph No. 1868)

Mortar test specimens were produced as either 2" (0.78 cm) cubes or cylinders 4" (1.57 cm) diameter by 2" (0.78 cm) length. These were produced by slight tamping of mortar into molds using a small square Plexiglas ram to ensure good fill of the molds. Disposable polymer molds were lubricated using cooking spray prior to insertion of the mortar mix.

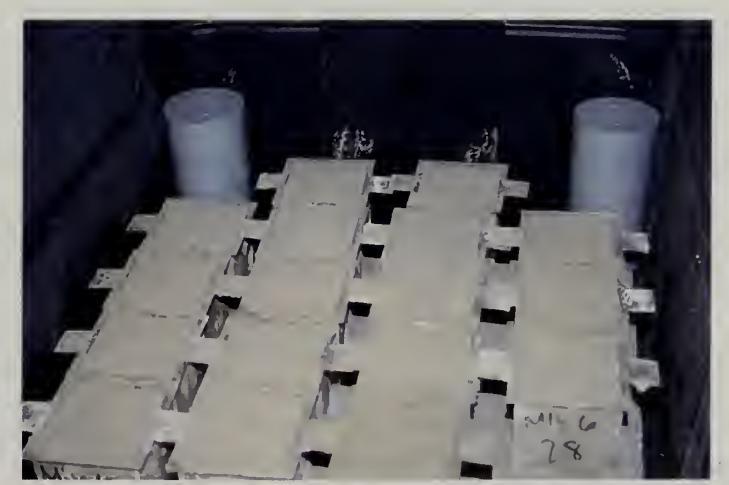
Figure 4: Curing Chamber for Initial Curing (Photograph No. 1882)

The mortars were initially cured at room temperature (70°F or 21°C) for a minimum of seven days at 100% relative humidity in polymer containers containing a large open pan of water (Figure 4). Mortars were then exposed to 100% relative humidity conditions at 120°F (49°C) with air recirculation and inspiration of ambient air to accelerate curing. The degree of curing was evaluated using a pH indicator solution on fracture faces according to the procedure of Weiss and Schork (Reference 6).

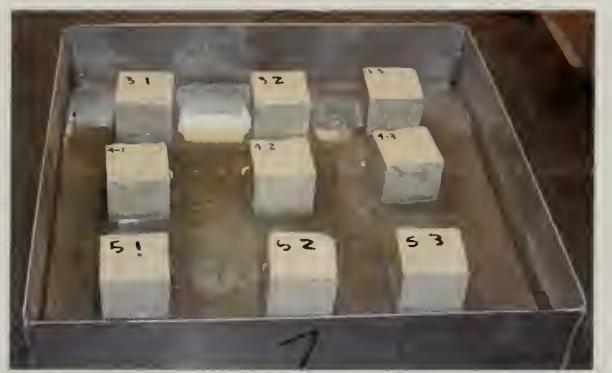
Figure 5: Specimens Immersed in Water prior to the C666 Test

One pan of specimens prior to cycling is shown in Figure 5. Pans were placed in the commercial freezer cabinet (Figure 6) and the testing procedure began. After freezing, typically three cycles per day were achieved. The tests were interrupted periodically for inspection of the specimens allowing them to equilibrate with room temperature.

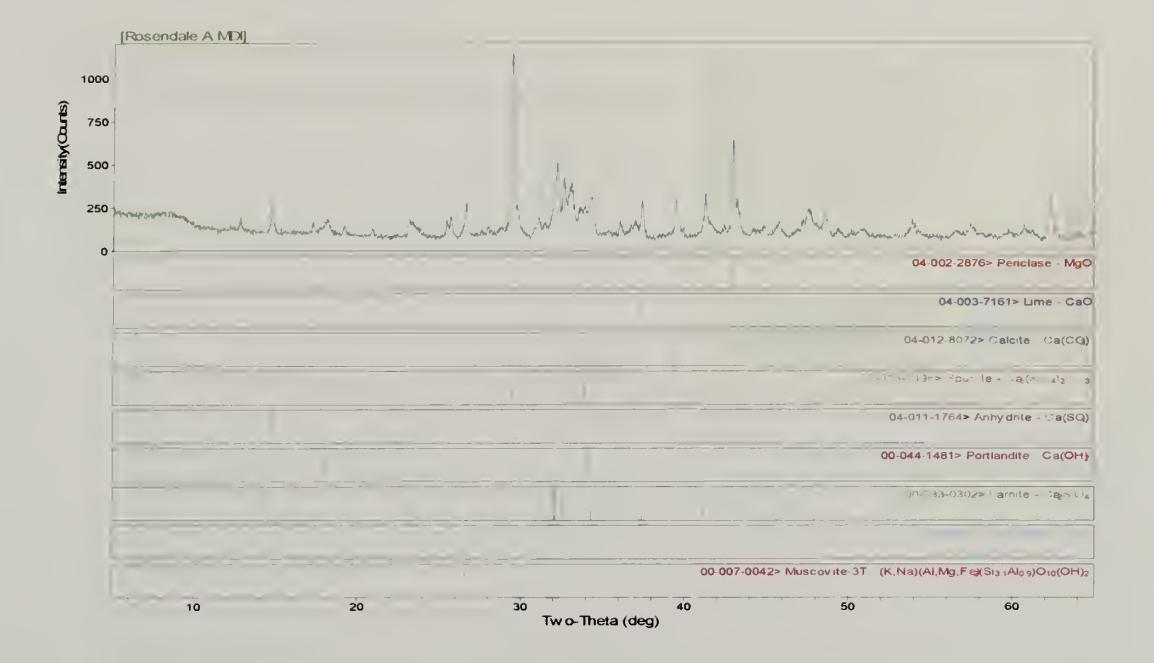
Figure 7: XRD Results for Rosendale Specimen A

The XRD data for Rosendale specimens is given in Figures 7-9. A semi-quantitative analysis was performed for Specimens B and C. The major differences between Specimens B and C was that B contained higher contents of periclase (MgO), portlandite $[Ca(OH)_2]$, and larnite (aka "belite" or 2CaOSiO₂) while Specimen C contained a significantly higher content of lime and calcite. Free or uncombined lime can cause flash sets in calcium aluminate cements, and this may contribute to the faster setting characteristic of Specimen C as compared to Specimen B. The shape of the XRD curves at low angles indicates the presence of a glass component in the cements, but the glass content was not quantified.

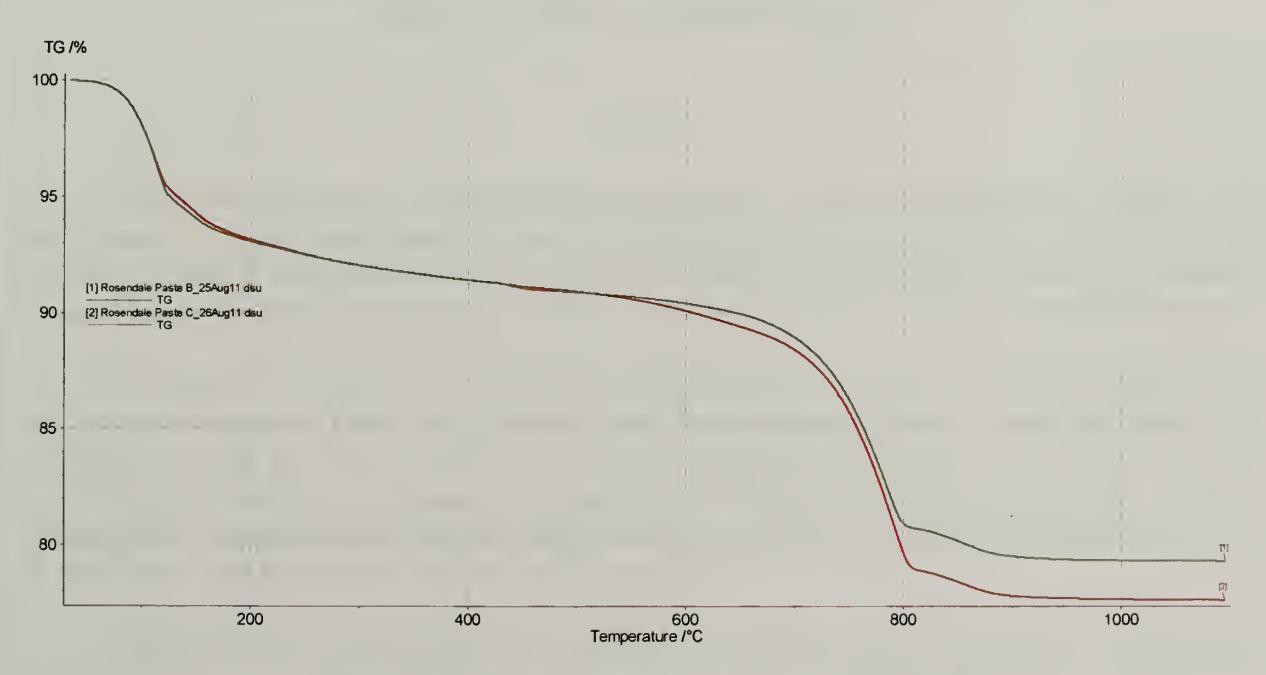
Figure 10: TGA of Cements B and C on Heating

Neat cement pastes (cement and water mixtures after setting) were produced from specimens B and C, allowed to harden, and thermogravimetric analysis (TGA) was obtained (Figure 10). Differences in the weight loss are likely attributable to the differences in calcite content, with Specimen C exhibiting the highest amount of calcite (Figures 8 and 9).

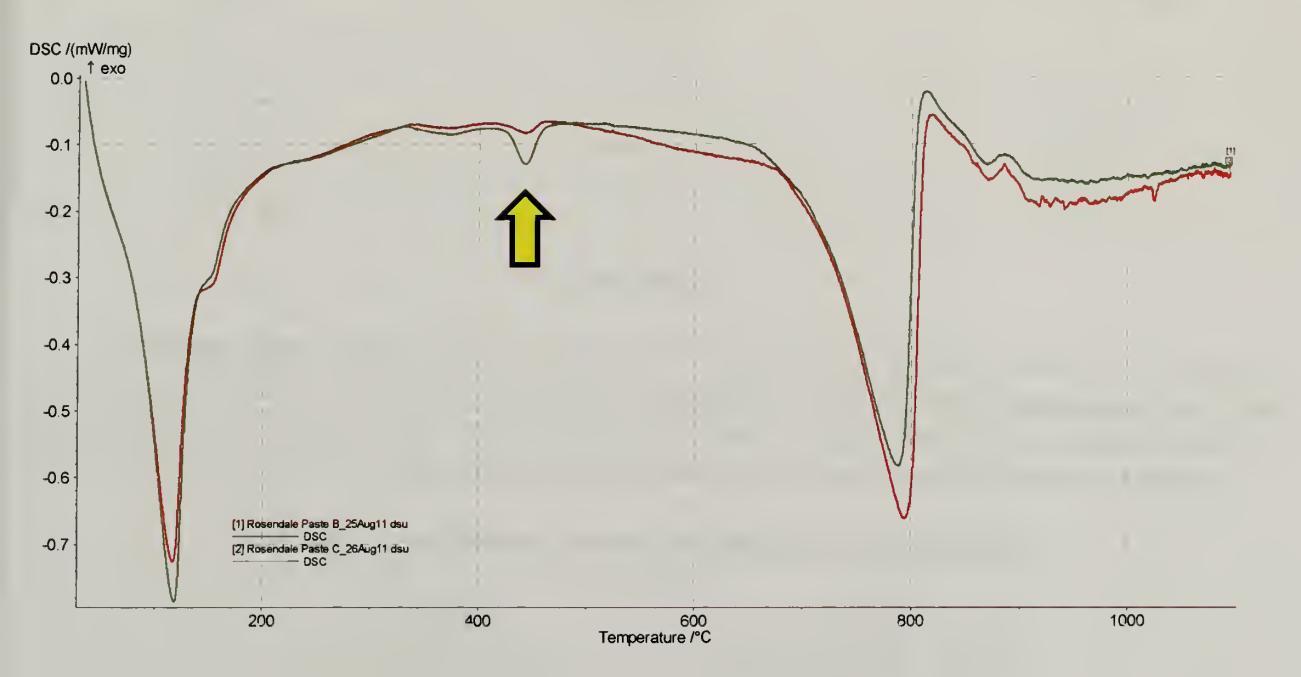
Figure 11: DTA of Specimens B and C

The differential thermal analysis (DTA) analysis for Specimens B and C in Figure 11 shows a notable difference in an endothermic reaction at about 440° C (arrow). This endotherm is associated with the thermal decomposition of portlandite or Ca(OH)₂. The DTA quantification is not in agreement with the semi-quantitative XRD analysis that showed Specimen B to contain more portlandite than Specimen C, suggesting a possible error in the XRD estimation.

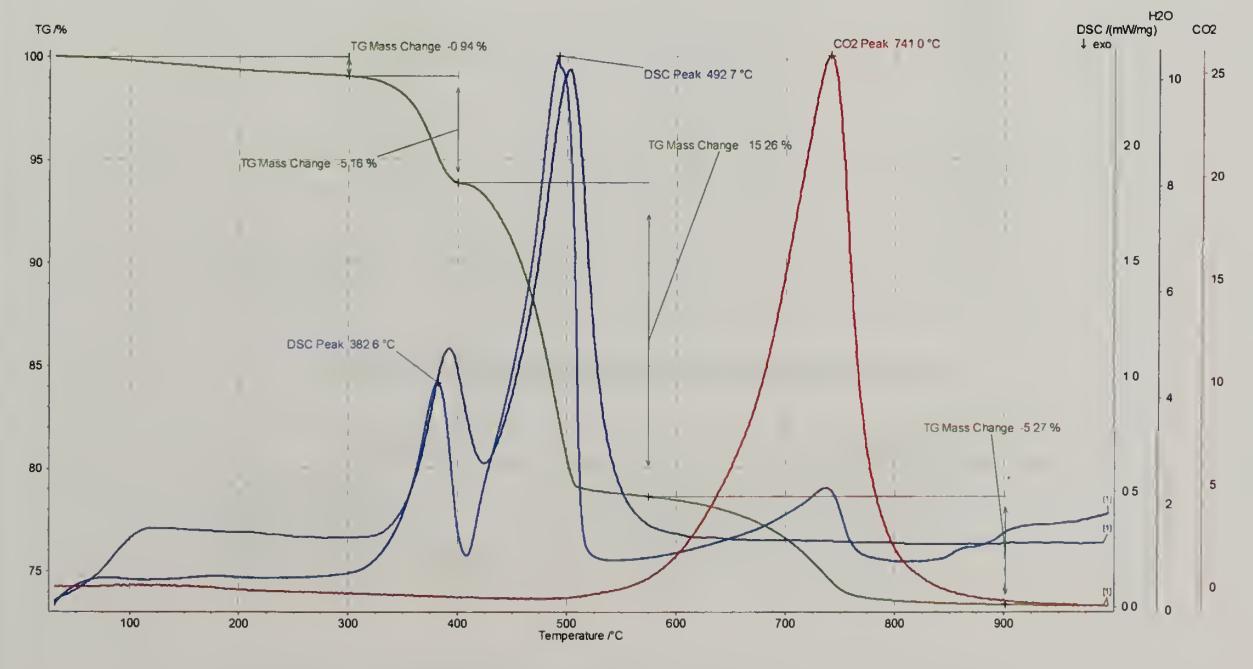
Figure 12: Simultaneous Thermal Analysis of Lime Putty

- Endothermic peak at 394°C with a weight loss of 10.8% and water vapor evolution resulting from decomposition of Mg(OH)₂.
- Endothermic peak at about 440°C resulting from decomposition of portlandite or Ca(OH)₂.
- Endothermic peak at 514°C with a weight loss of 11.2% resulting from decomposition of MgCO₃.
- Endothermic peak at 779°C with a weight loss of 5.5% and CO₂ evolution resulting from decomposition of CaCO₃.

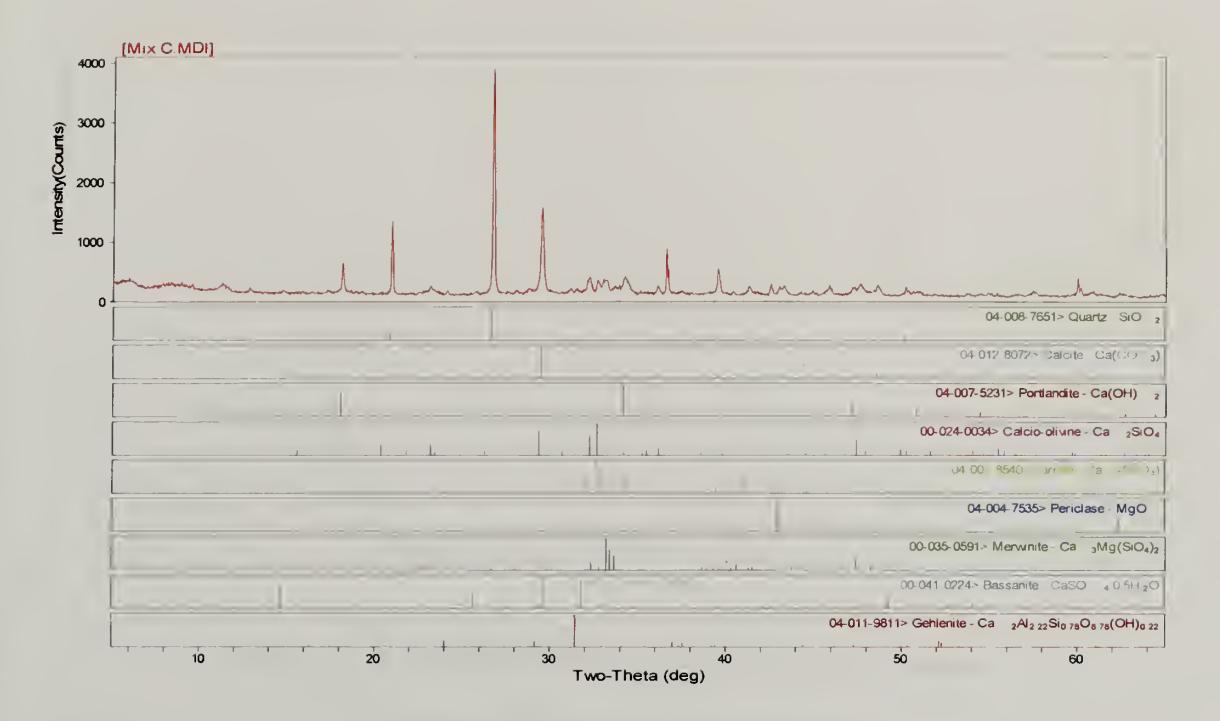
Figure 15: X-ray Diffraction Results for Mix C As-cured

The mineral phases in the mortar specimens as-cured were compared to phases reported in the literature and found in the cement characterization (above), with results presented in Table 23. The XRD traces and peak identifications of Mortars C, 1, and 2 are given in Figures 15-17.

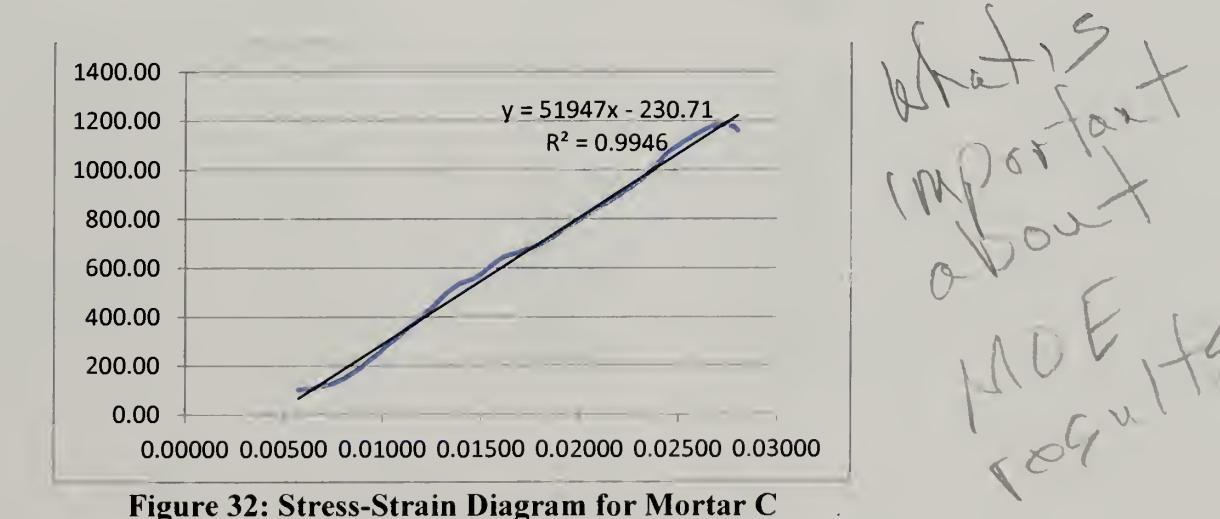
The stress-strain diagram for Mortar C is shown in Figure 32 where a linear regression analysis was found to determine the slope of the line over the range of loading of the specimen, where the slope is the Modulus of Elasticity value (coefficient of x). The data shows an initial higher slope (arrow) followed by a more uniform lower slope, i.e. there is a difference in initial MOE and average MOE, the latter obtained from the range of loading prior to failure. Some investigators might link the initial material response to a period of "crack initiation" and the continued response as due to a period of "crack propagation".

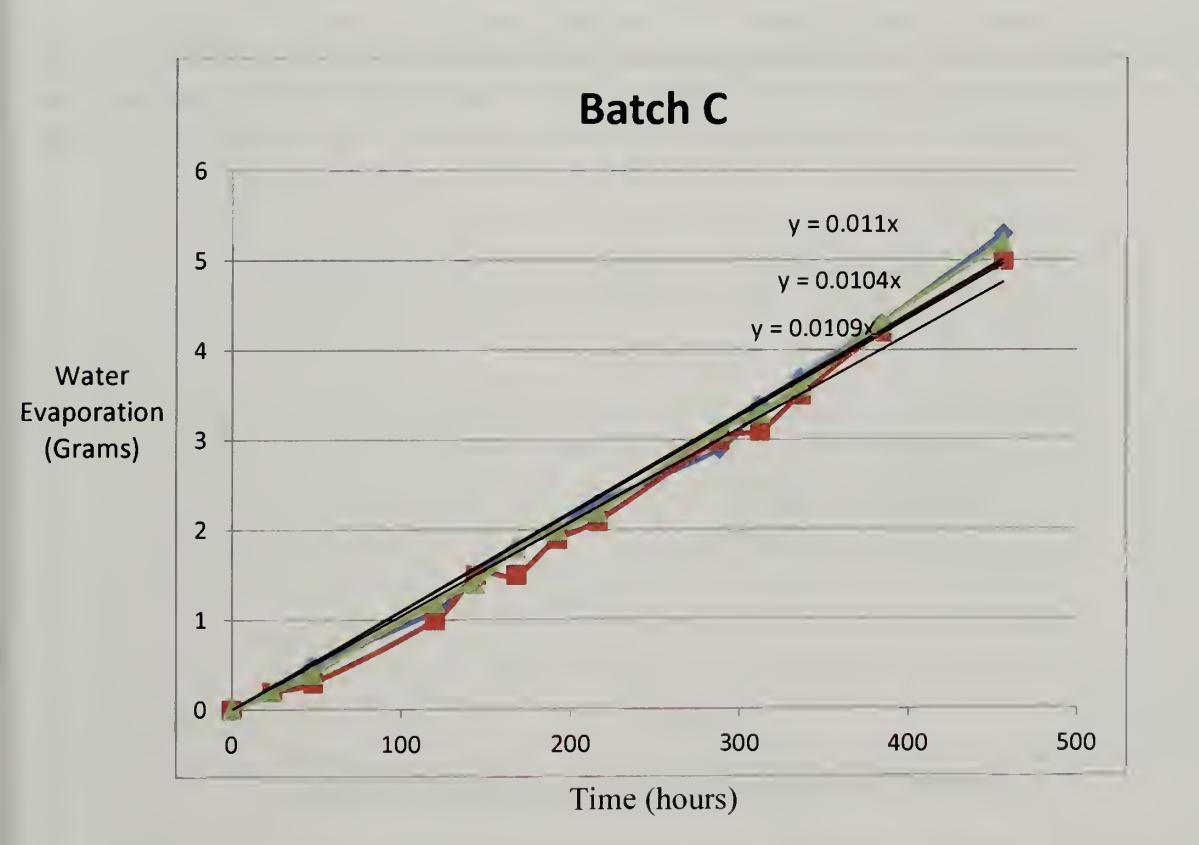
Figure 33: Water Evaporation Rate for Mix C

A typical experimental curve for Mix C with the open cup method is shown in Figure 33. The evaporation rate is linear with one plot for each of the three specimens, and the slope of each line (the coefficient of x) is the evaporation rate. The values were averaged, and the water vapor transmissions were calculated using the exposed areas of the specimens (Table 30).

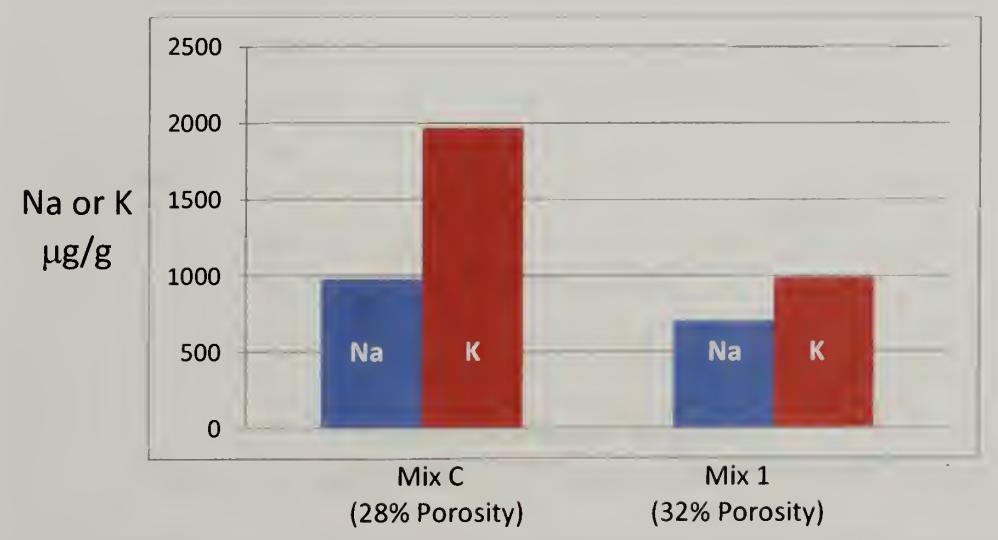
Figure 37: Alkali Solution at 90-days of Submersion for Mixes C and 1

The alkali release from Mix 1 is greater than that of Mix C. The 90-day soaking data is shown in Figure 37 comparing Mixes C and 1. It is interesting that Mix C has the highest alkali solution but the lowest calcium solution of the two cements. In other words, the cement content is apparently controlling the calcium and alkali releases, but they follow opposite dependencies on cement content.

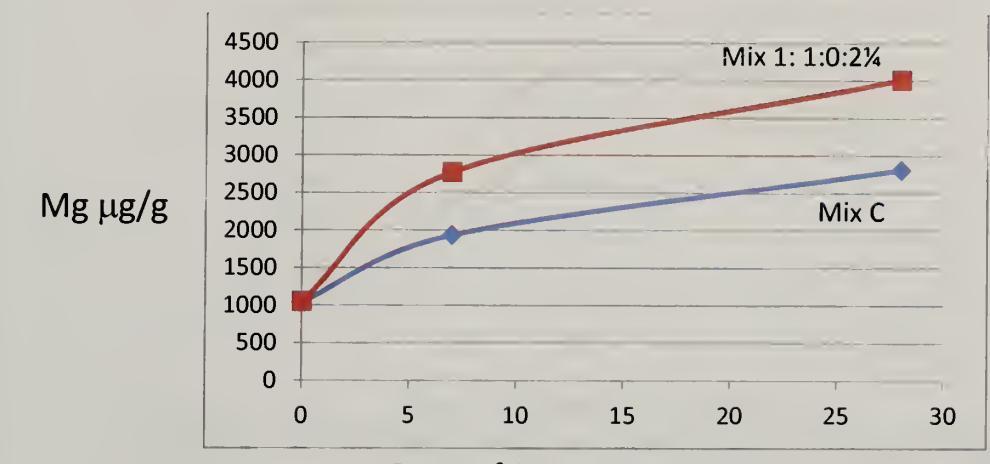
Days of Seawater Exposure Figure 38: Magnesium Adsorption by Mixes C and 1 through 60 Days

Magnesium exhibits absorption or "uptake" from sea water for Mixes C and 1 (Figure 38). In other words, the concentration of magnesium decreased within the leachate from an initial value during the soaking or leaching process. Both bricks and mortar at FSNM have exhibited magnesium elevation found in forensic analyses.

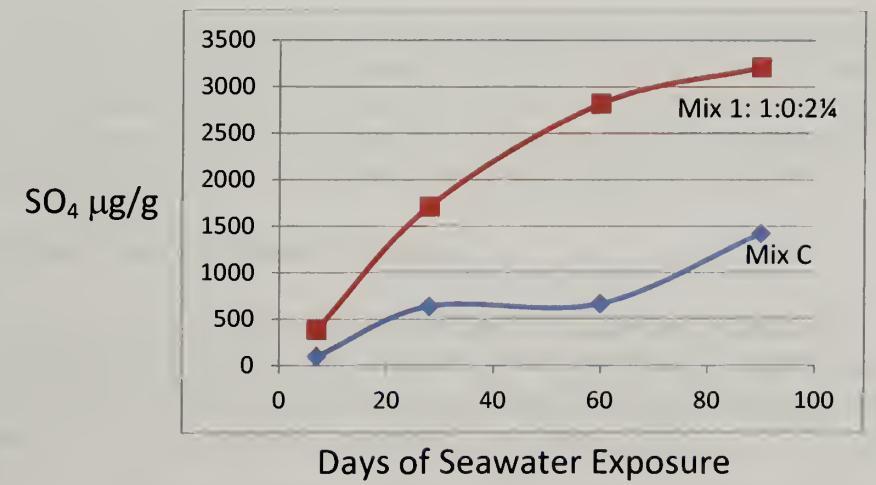
Figure 39: Sulfate Uptake in Cement-Sand Mortar (IC Data)

The up take or absorption of sulfate (SO_4) is an example of capture of anionic species by the cement-sand mortars (Figure 39). The magnitude capture and trend is similar for magnesium and sulfate (comparing Figures 38 and 39).

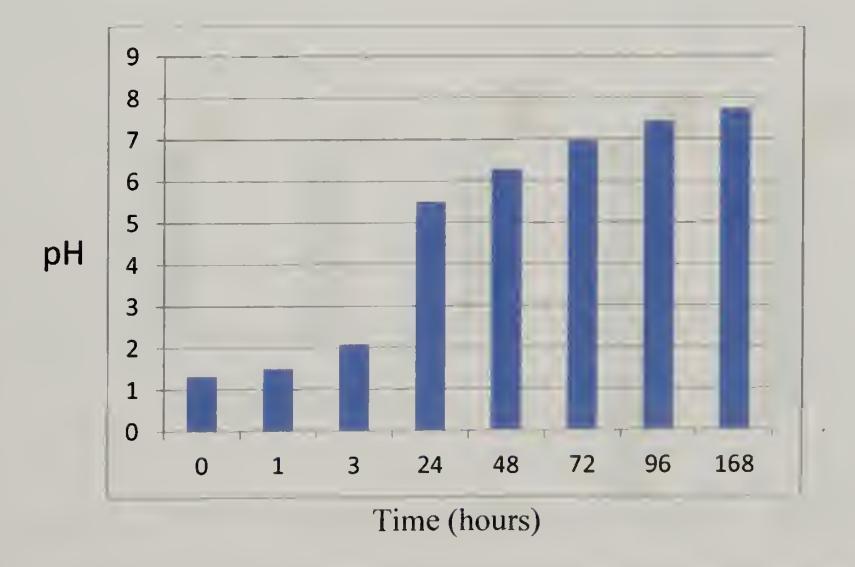
Figure 48: Change in pH With Immersion Time for Mix C in 7 Days

In all cases, the pH of leachate solutions increased from an initial value of 1.34 (zero immersion time) to the range of 7-8 in 7 days (Figure 48). All of the mixes tested exhibited similar behavior. Additions of lime to mortar mixes did not affect the pH change over time. The results simply show a process of neutralization by the mortar on the leachate solution – a process frequently observed when performing TCLP tests on concrete specimens.

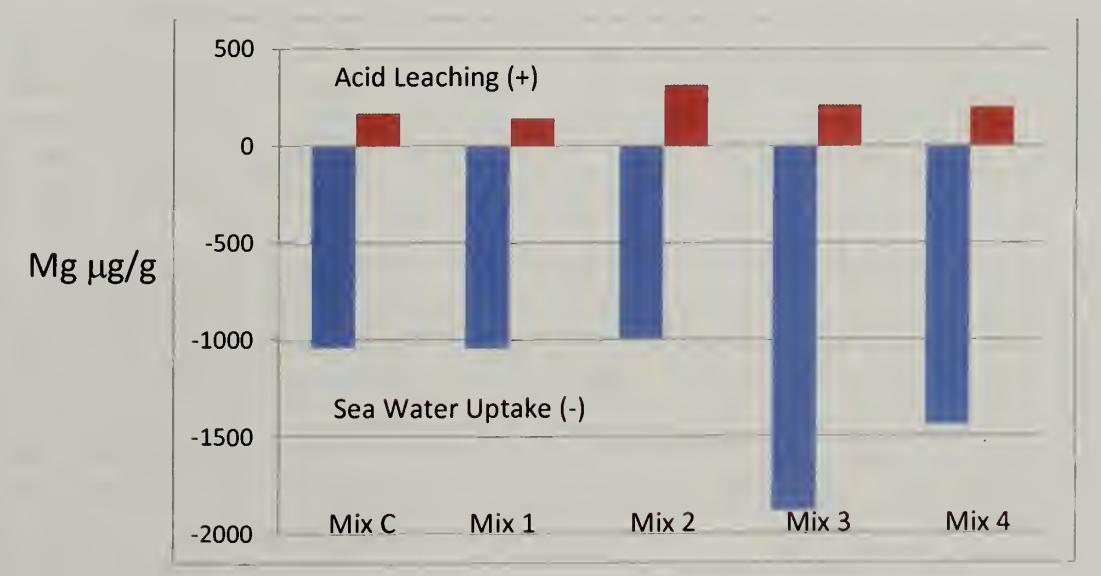
Figure 50: Opposite Behavior for Magnesium in Sea Water and Acid

Interestingly, acid immersion resulted in magnesium loss or leaching from mortar mixes that all exhibited magnesium uptake in sea water immersion (Figure 50). The same "flip-flop" in behavior was found with sulfur uptake in sea water and sulfur loss in dilute acid immersions. In contrast, sodium and potassium exhibited leaching in both sea water and acid.

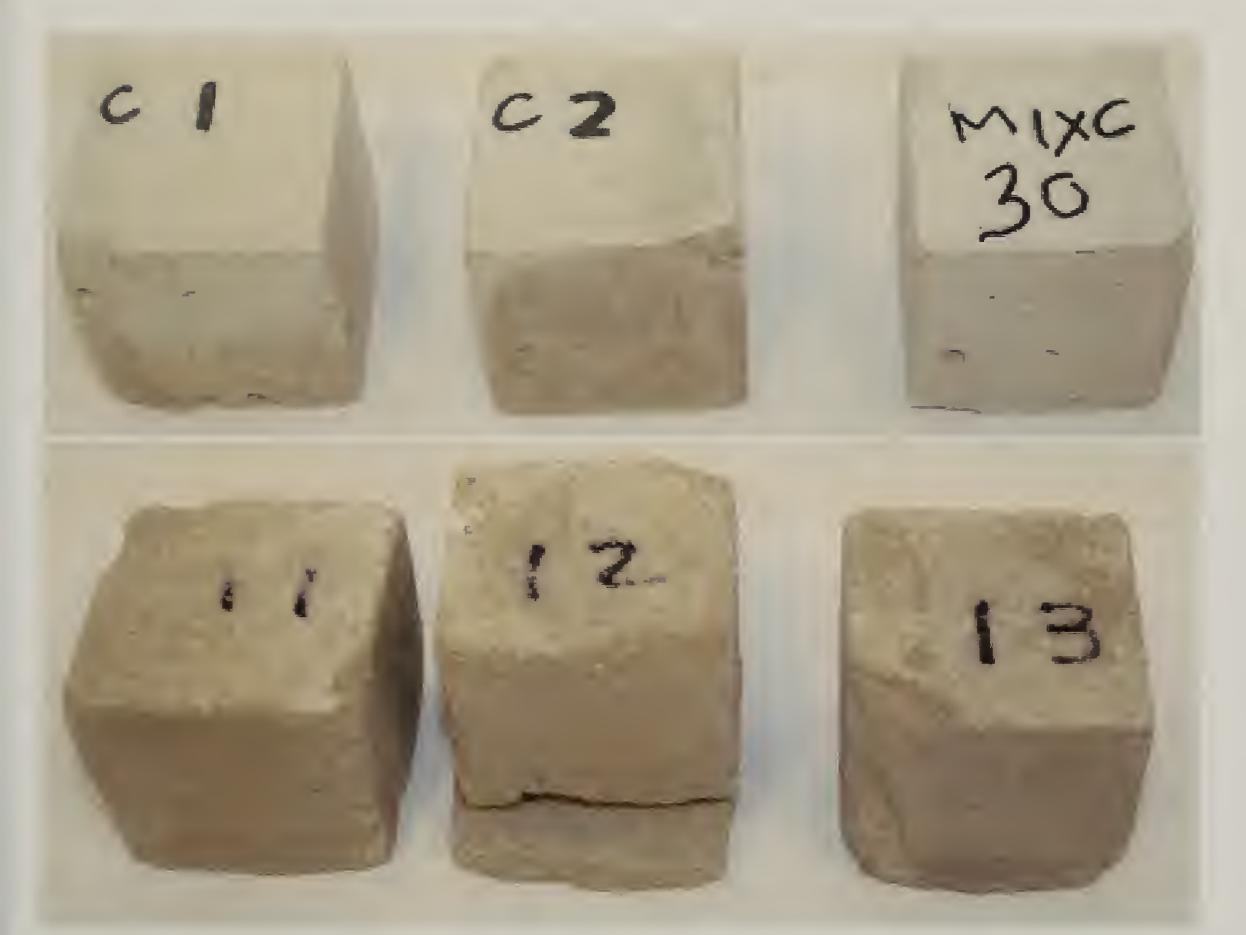
Figure 52: C666 Results for Mixes and 1 at 6 Cycles (Mixes Contain No Lime) Note: Mix 1 Judged as Failed; Mixes C judged as unaffected and continued in testing.

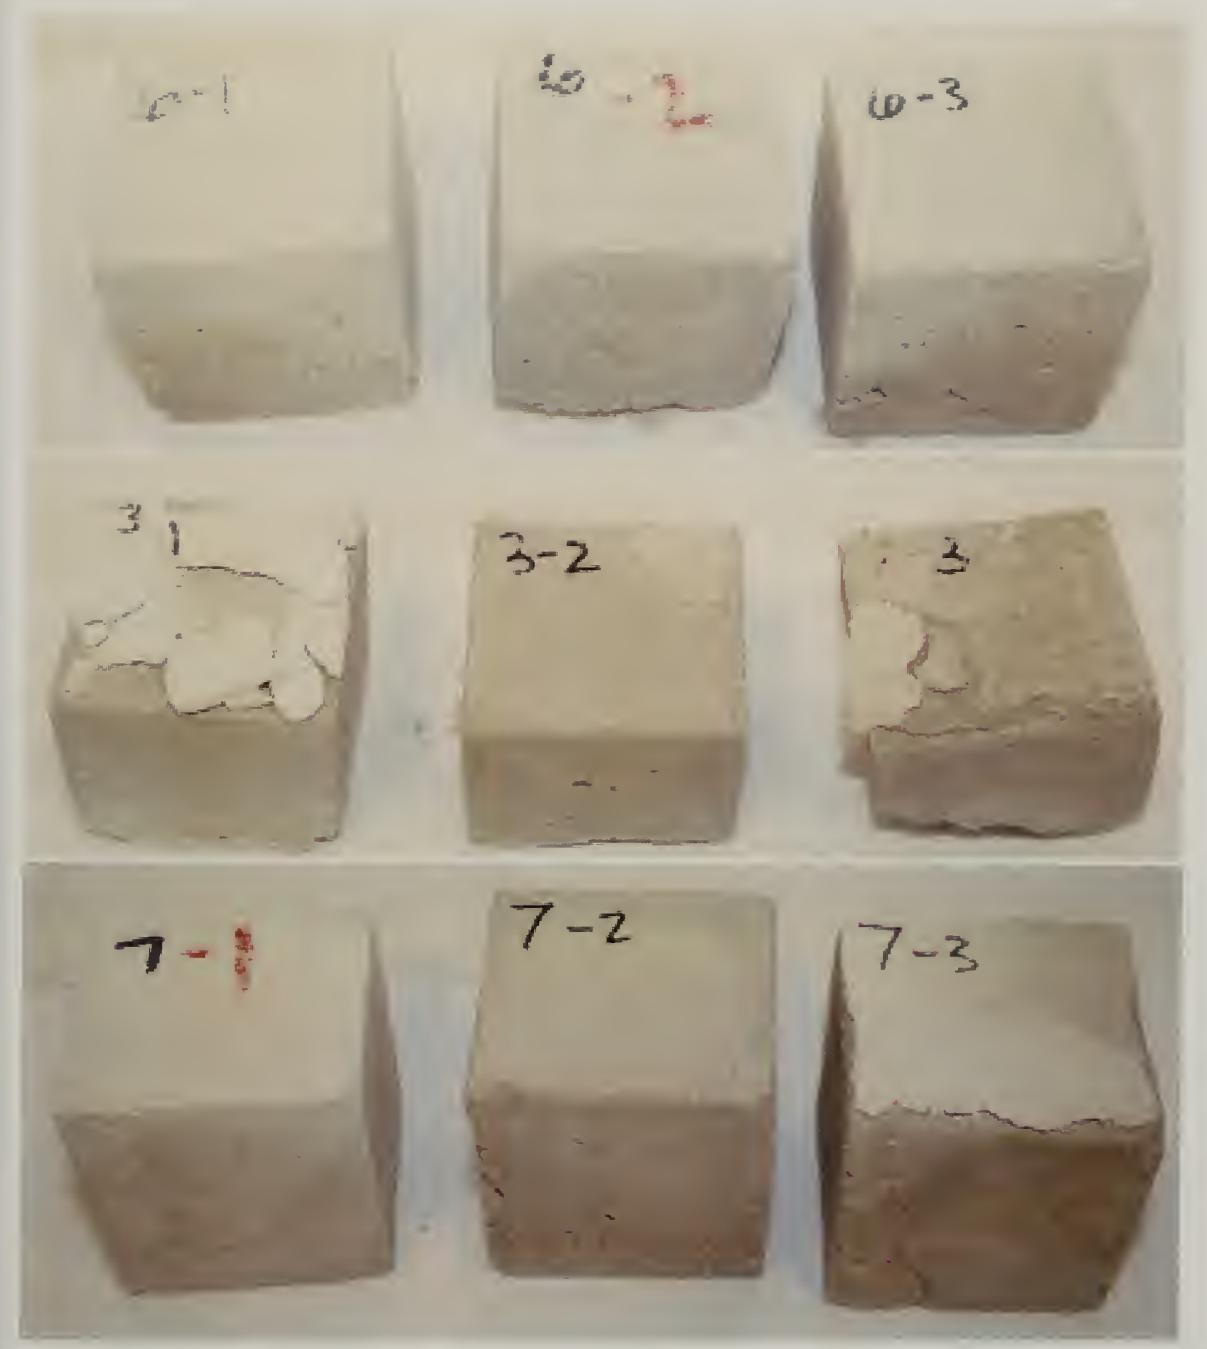
Figure 53: C666 Results for Mixes and 1 at 6 Cycles (All 1:1/2:11/2 at different water contents). Note: Mix 3 Judged as Failed; Mixes 6 and 7 Judged as damaged but continued in testing.

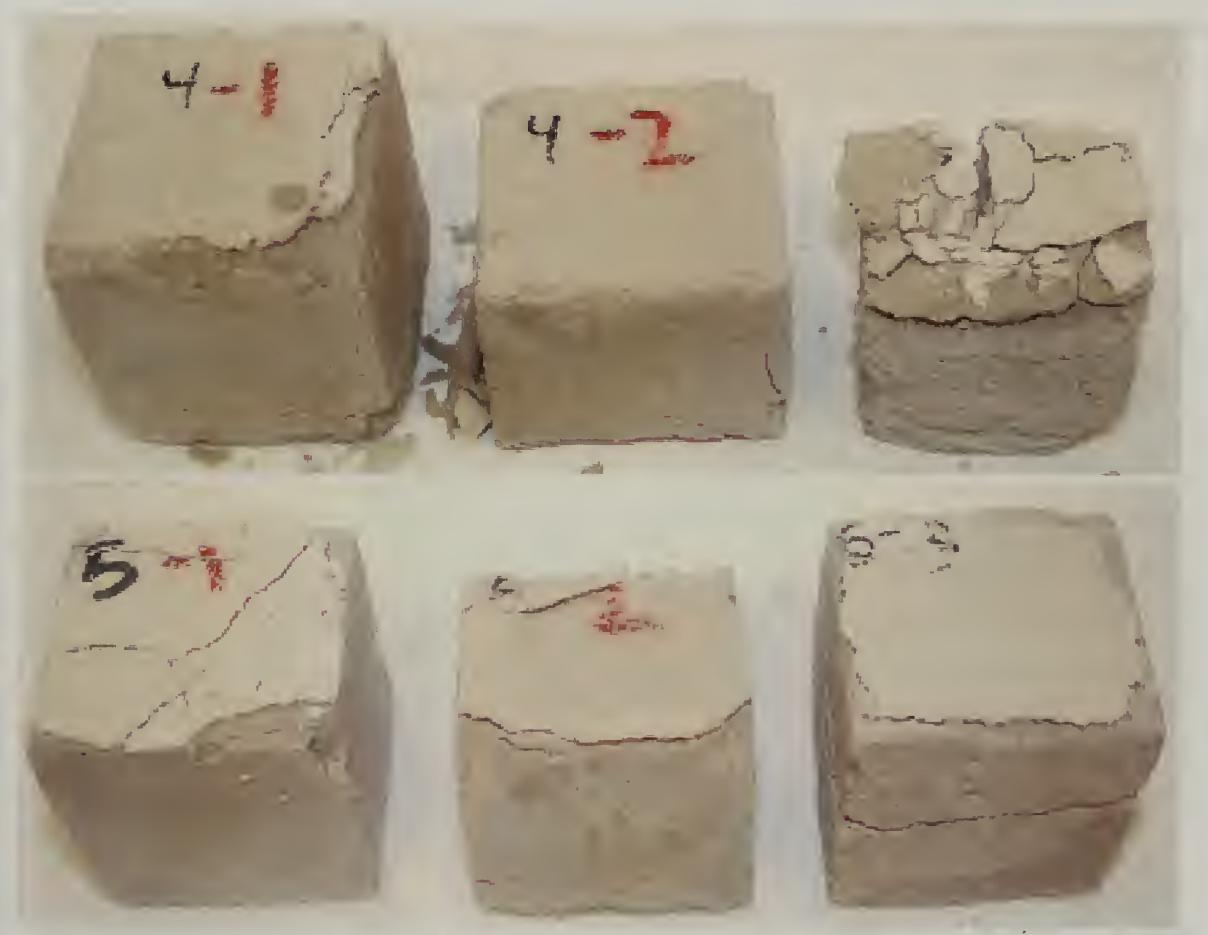
Figure 55: C666 Results for Mixes 4 and 5 (contain dolomitic lime) – Judged as Failed at Six Cycles

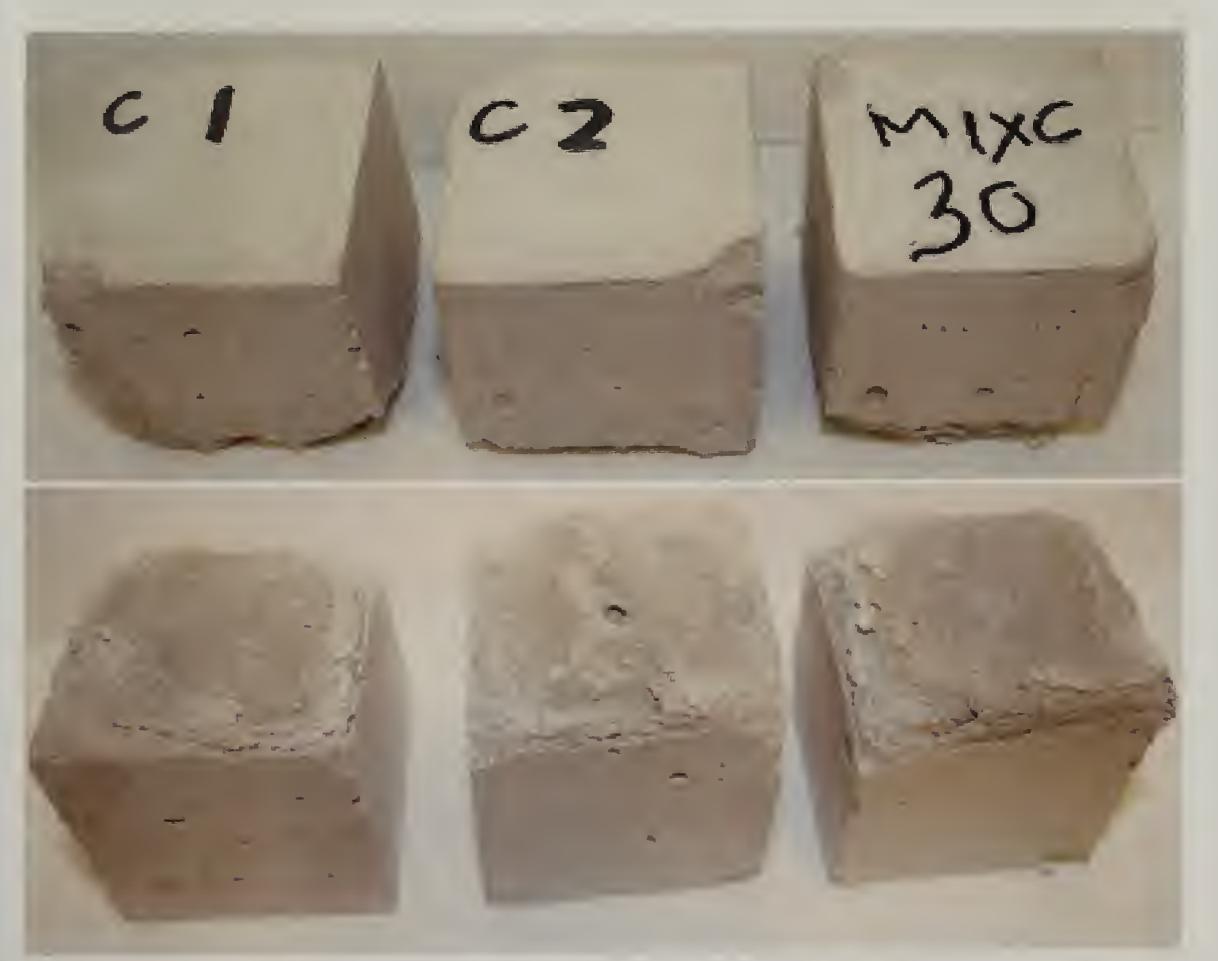
Figure 56: C666 Results for Mix C at 24 Cycles

Specimens C, 6, and 7 were subjected to additional C666 freezing and thawing cycles to obtain a total of 24 cycles. The results are summarized in Table 39, with the condition of mortar cubes shown in Figures 56-57. It was apparent that the specimens, in continued testing to 24 cycles, primarily exhibited cracking and delamination suggesting that the mechanism of failure changed or was exaggerated so that failure was primarily below the water/ice line or elevation.

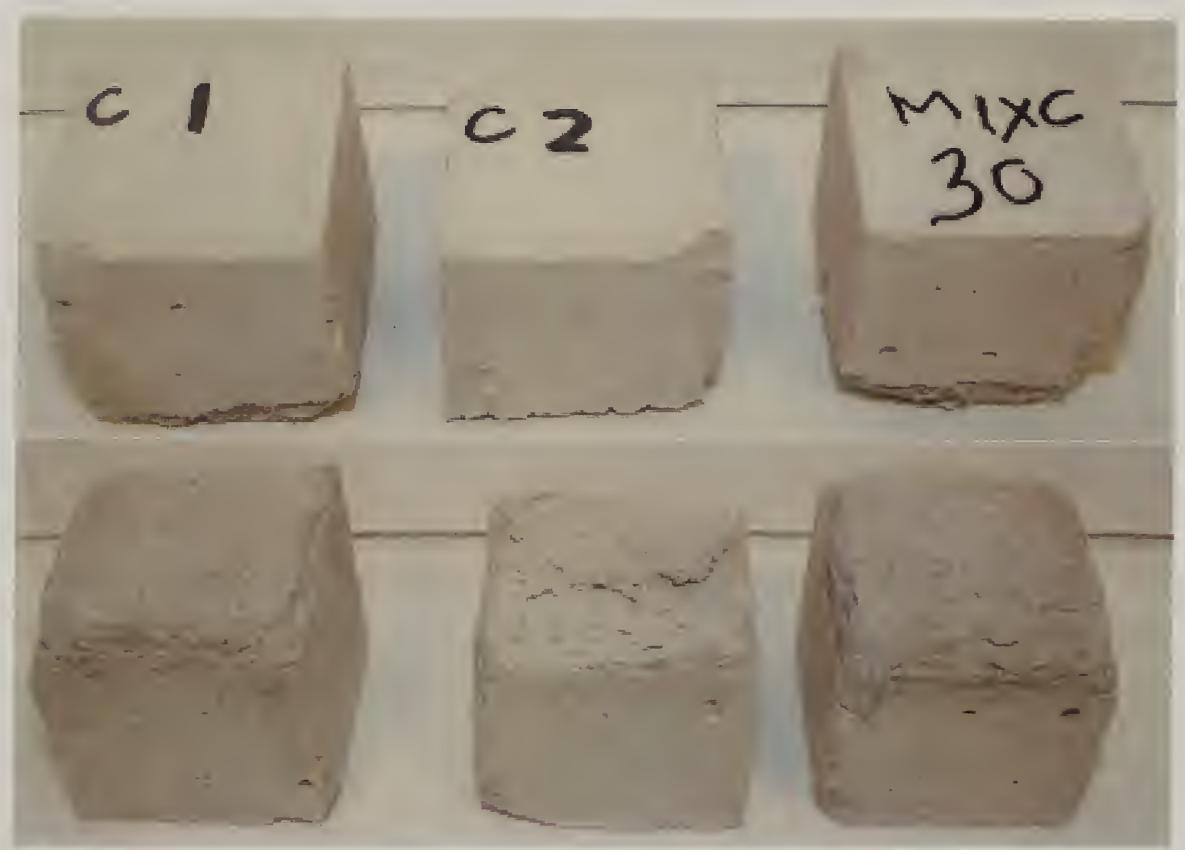
Figure 58: Mix C at 50 Cycles

•
Freezing and thawing tests continued for Mix C until a total of 50 cycles we and the test specimens after this regime are shown in Figure 58. At this point Mix rounding of the bottom corners and edges with delamination in progress, so the spec deemed as "failed" and testing was terminated.

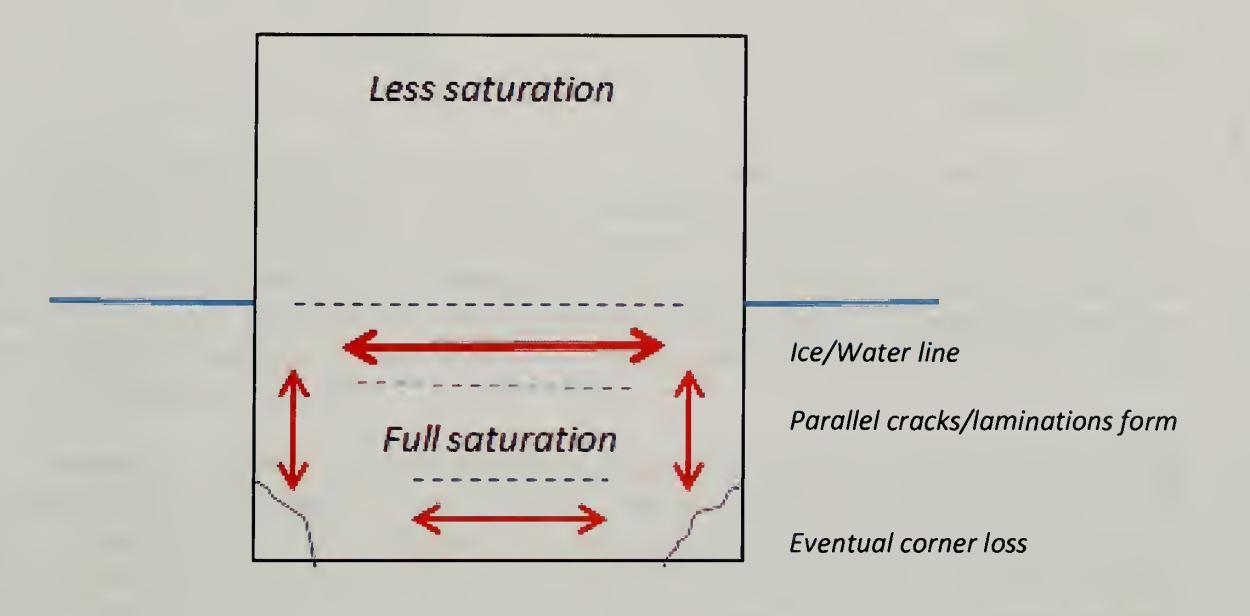
Figure 59: Stresses due to Expansions within a Mortar Cube during Freezing

The behavior of the specimens that survived six cycles and continued for additional cycles suggests that the expansion of water within the immersed portions of specimens contributed to the failure mechanism. It is well known that the volumetric expansion of water on freezing is about 11%. Water within the pores of a material will cause the material to expand on freezing⁴³ (in three dimensions). Thus, the immersed portion of the specimen undergoes a volume expansion on freezing relative to the portion of the specimen above the elevation of the water/ice line (as the top of the specimen is of lower saturation). The situation is illustrated in Figure 59, where the red arrows represent expansions within the material in this two dimensional representation.

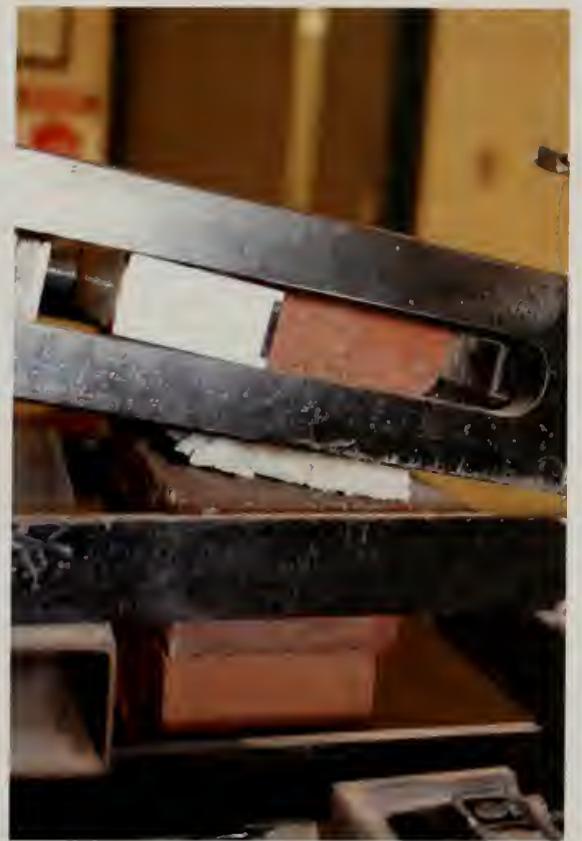
Figure 60: Bond Wrench Test of Masonry Prism With Restoration Mortar (File 2166)

One bond wrench test is shown in Figure 60 after one mortar joint has been tested to failure. After the test, the mortar is examined for mode of failure. The typical failure in this study was delamination of the mortar from the brick at the joint (Figure 61). Fragments of brick are shown in the separated mortar beds that were pulled away from the brick surface in the test. Flexural bond strength results are provided in Table 42. Both Mixes C and 2 exceed the minimum criterion in C1713.

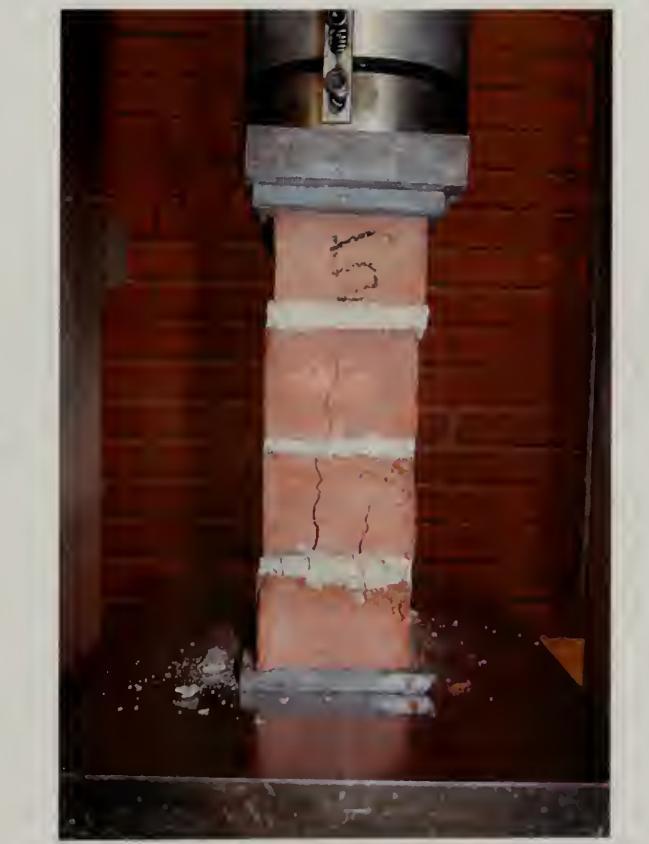
Figure 63: Failure in the Pier Compressive Test (File 2173)

The pier compression results are provided in Table 43 where the average is in the expected range of 1000-3000 lb/in^2 . The failure modes are primarily face shell separation. Failure modes are provided in Figure 64.
