# **Hydrologic Conditions and Hazards In the Kennicott River Basin Wrangell-St. Elias National Park and Preserve, Alaska**

U.S. GEOLOGICAL SURVEY  
Water-Resources Investigations Report 96-4296

Prepared in cooperation with the  
NATIONAL PARK SERVICE

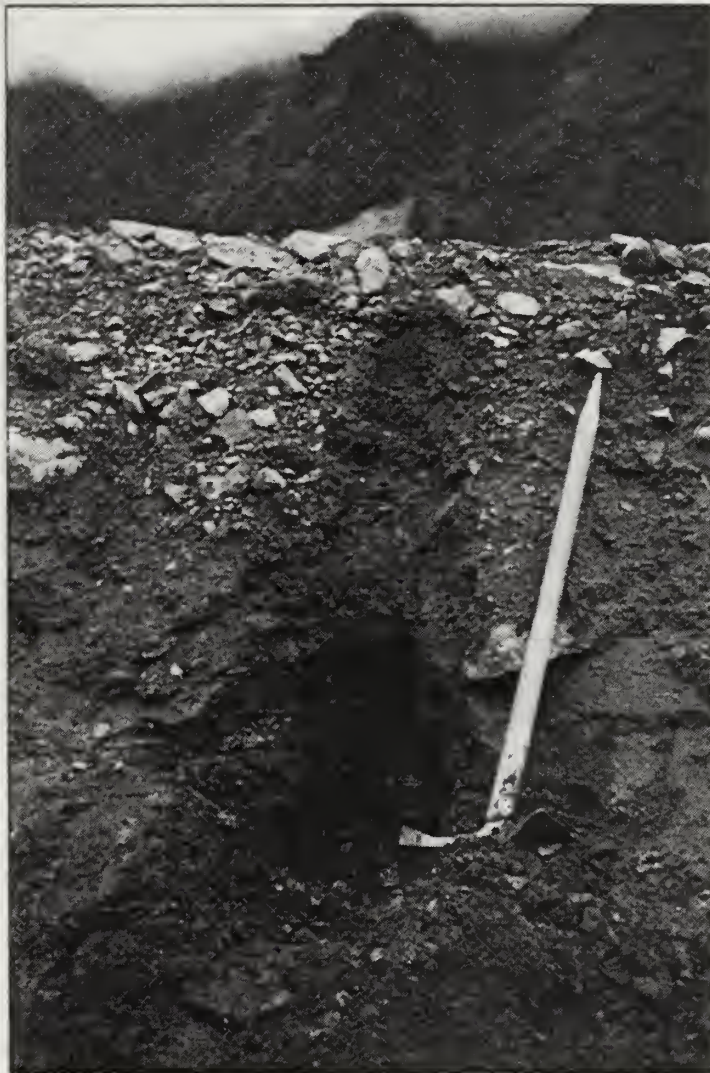
**Figure 8.** Hidden Creek Lake bed deposits capping fluvial gravels, August 31, 1994.

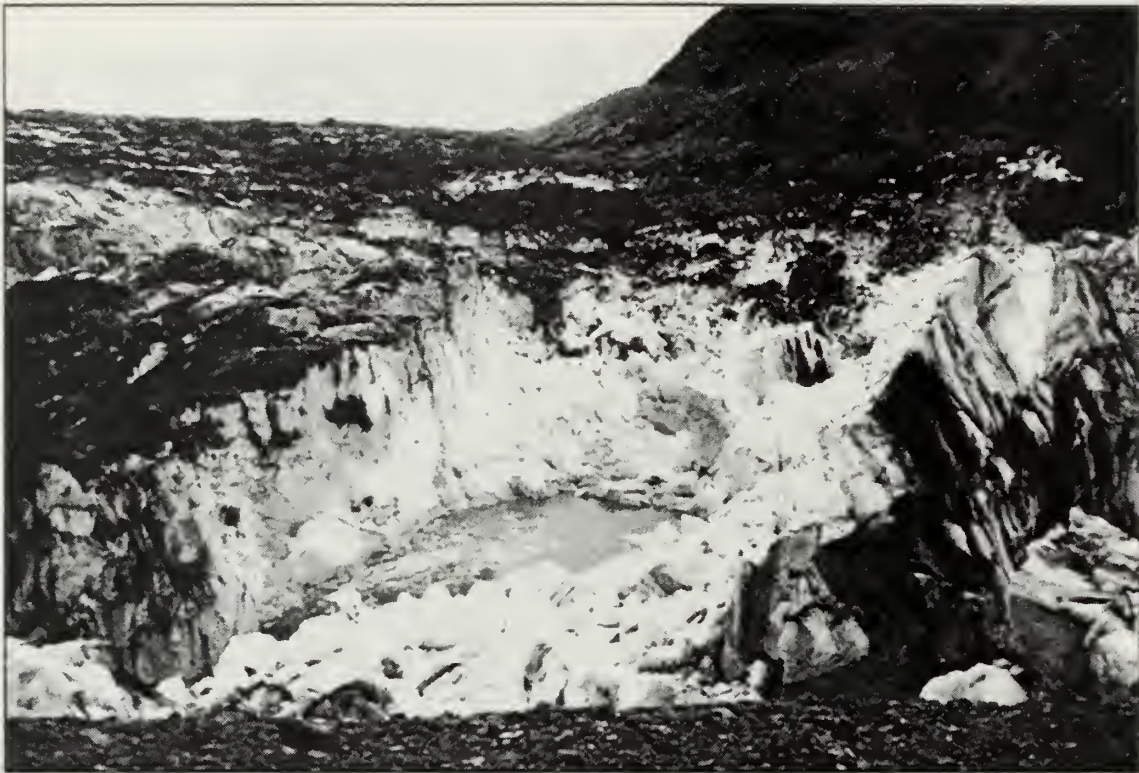
**Figure 9.** Large depression near the glacier margin, Hidden Creek Lake, August 31, 1994.

The *depression zone* is an oval-shaped depression between the 1860 moraine and the ice dam (figs. 7 and 9). It is covered and choked with large icebergs after the lake drains. This large depression was formed after Kennicott Glacier retreated from its side-valley moraine. Depression depth may exceed 350 ft near the ice dam, and contains a significant portion of the total lake volume (Friend, 1988). A small lake that was formed when the photograph was taken is shown in figure 9. This small lake had drained by the next morning, and began re-forming.

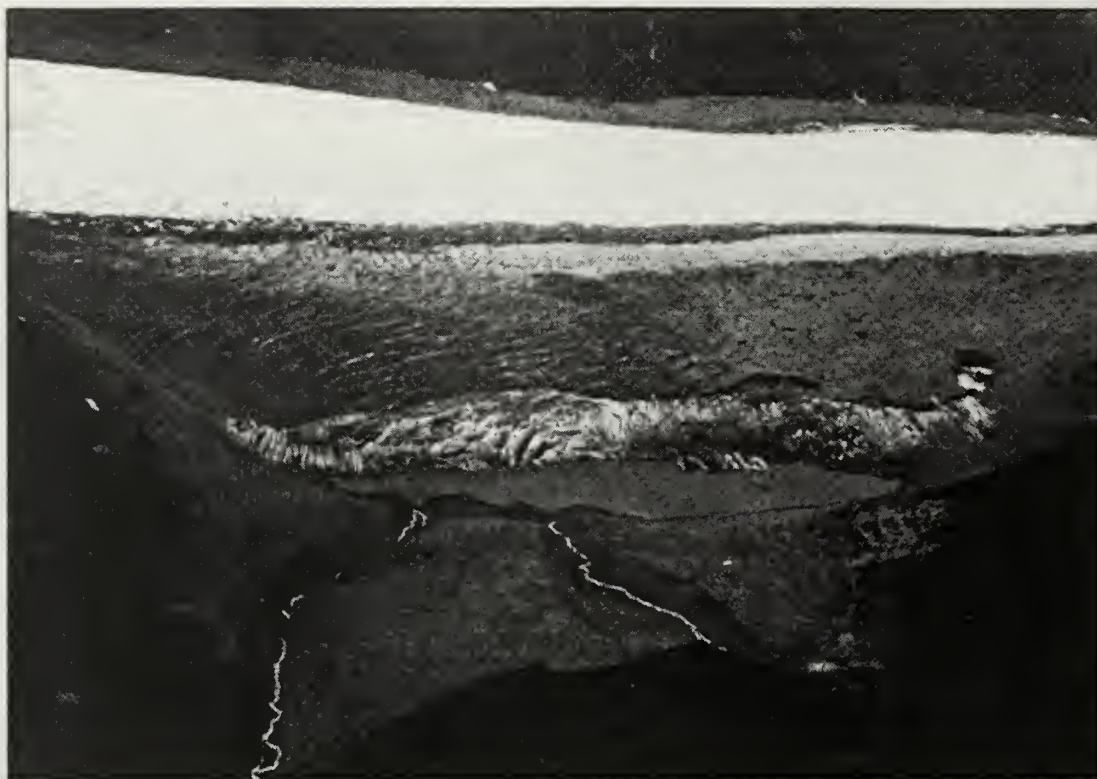
**Figure 11.** Erie Lake draining, July 16, 1994. (Note wash line and lightly vegetated strandlines.)

Erie Lake is the second largest glacier-dammed lake in the Kennicott basin (fig. 2, table 2). **Strandlines** indicate that recent maximum lake stages are lower than historical lake levels (fig. 11). The lake usually outbursts during July or early August, based on observations made in 1982, 1988, and 1993-95. The Erie Lake outburst occurred before the Hidden Creek Lake outburst in 1994, and after the Hidden Creek Lake outburst in 1995. Erie Lake drained in 3 days during the 1994 outburst. One of the **englacial** or **subglacial** conduits, observed during the 1994 outburst, is located at the up-glacier end of the lake, indicating a complex drainage system (Roger Elconin, Humboldt State University, written commun., 1994). A compilation of Erie Lake fill and drain information can be found in appendix 4.

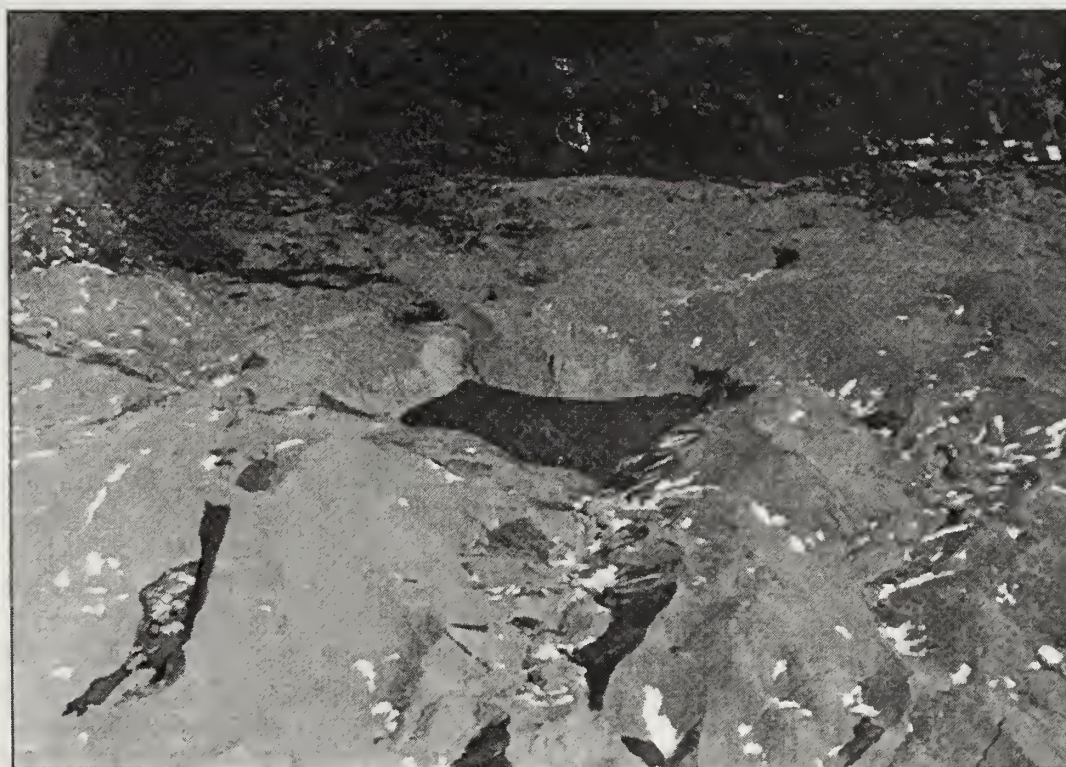
**Figure 14.** Bonanza Lakes near Kennecott mill site, May 12, 1994.

Bonanza Lakes consist of two small ponds located adjacent to the Kennecott Mining Company mill at Kennicott (figs. 2 and 14). In four of six years in which outburst can be defined, the outburst occurred in May or June. They remain empty throughout the summer.

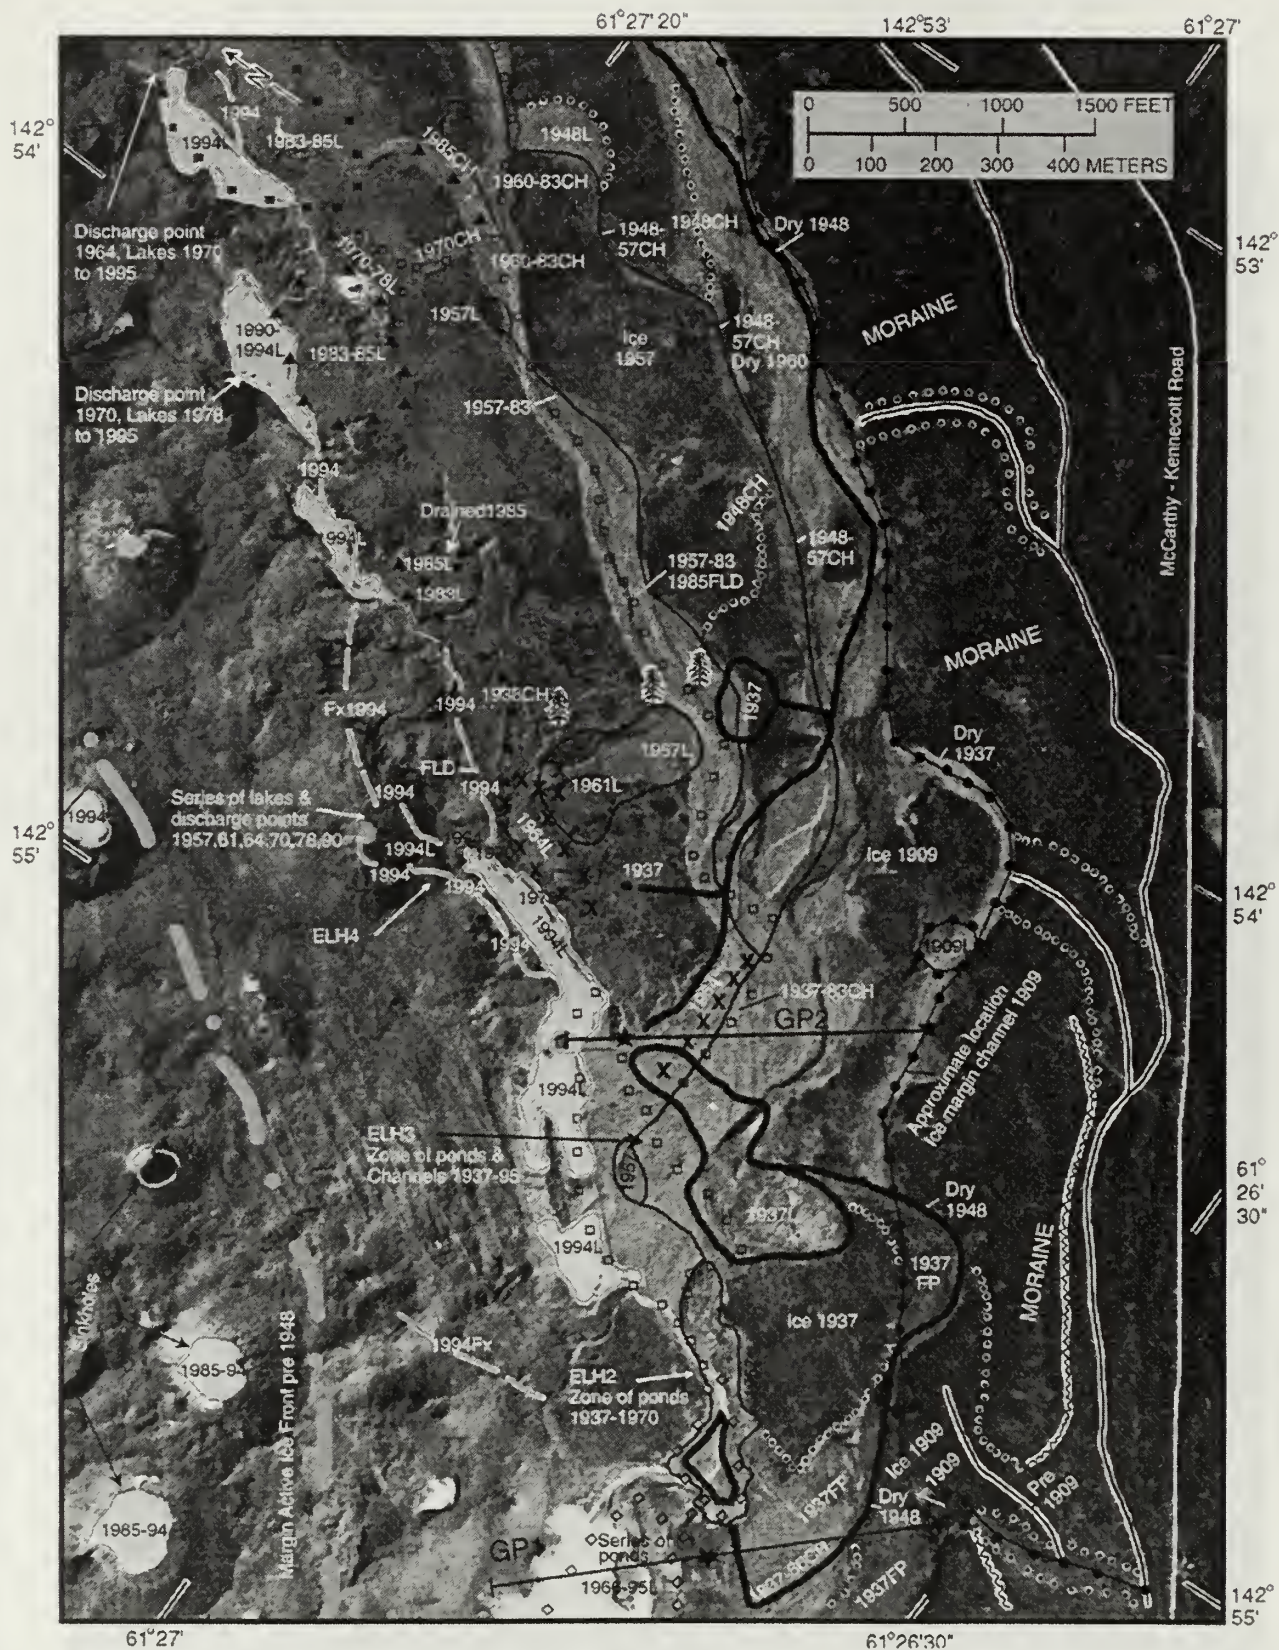
Figure 17. Kennicott Glacier and outwash history, lower east side.

The *karst* stage occurs below the active parts of the glacier within the moraine-covered stagnant ice areas (figs. 16-19), in which tension fractures indicative of ice movement are absent. Characteristically, the karst stage contains small and large sinkholes, which are quasi-stationary. Initially, these features are circular in plan view, and cone shaped, but as their perimeters melt and collapse, they become elongated, which suggests linear englacial or subglacial channel controlling mechanisms. Small ponds occur within the karst areas, some of which evolve from sinkholes and others from collapse zones. During glacier-dammed lake outbursts, these sinkholes and ponds fill, which suggests a connection with the internal drainage system of Kennicott Glacier. Englacial and subglacial conduits are active in the karst stage. As melting progresses, caverns and passages form and expand. They persist from year to year. Discharge from west lake/hole 3 (WLH3, fig. 19)—which lies within the karst area—increases during outbursts, suggesting that it is connected to the glacier's internal drainage system, whereas west lake/hole 4 (WLH4, fig. 19), situated in the active glacier, has a constant discharge during outburst floods. The karst area acts like a large sponge during outburst floods. Large volumes of flood water are temporarily retained in the karst area, especially during the initial stages of an outburst when caverns and ponds are filling with water.

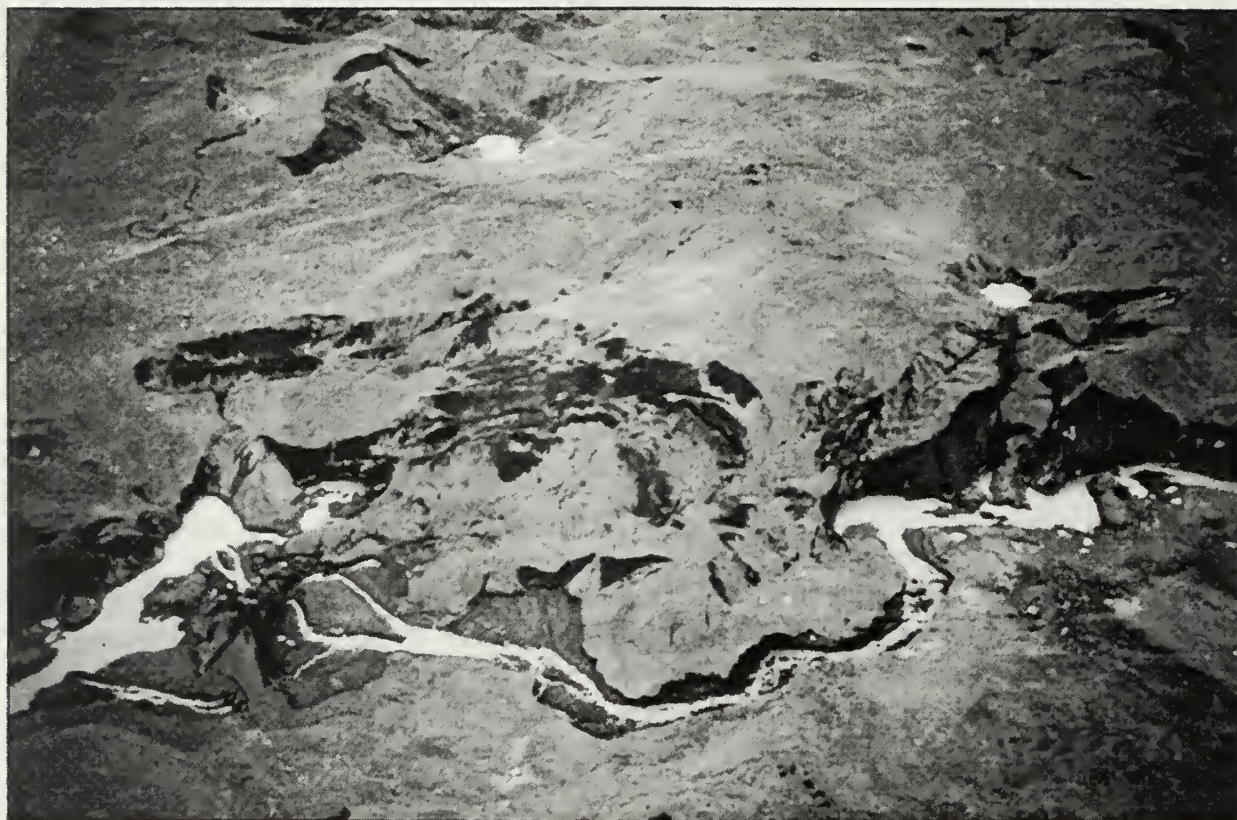
**Figure 22.** Channel downcutting near east lake/hole 4 resulting from the 1994 Hidden Creek Lake outburst flood.

A transition to the *active channel* stage occurs as the ice-margin lakes connect, undercutting the ice margin or downcutting through outwash deposits. Between 1909 and 1995, the active channel position has migrated toward the center of the valley (figs. 16-18), and streambed elevation has declined (fig. 21). Active channels carry water for periods ranging from a few years to more than 25 years (fig. 16). Some active channels are eventually separated from the glacier margin by islands of moraine-covered ice, as noted for the 1909 and 1937 ice locations (figs. 16 and 18). Eventually, the elevation of the active channel becomes higher than that of the glacier margin ponds. Downcutting and migration of active channels may occur rapidly in unconsolidated outwash sediments. For example, a channel downcut approximately 20 ft into unconsolidated outwash sediments in the east lake/hole 4 area during the 1994 Hidden Creek Lake outburst flood (fig. 22).
