WATER RESOURCES MANAGEMENT PLAN

Montezuma Castle and Tuzigoot
National Monuments, Arizona

SEPTEMBER 1992

WATER RESOURCES MANAGEMENT PLAN
MONTEZUMA CASTLE AND TUZIGOOT NATIONAL MONUMENTS

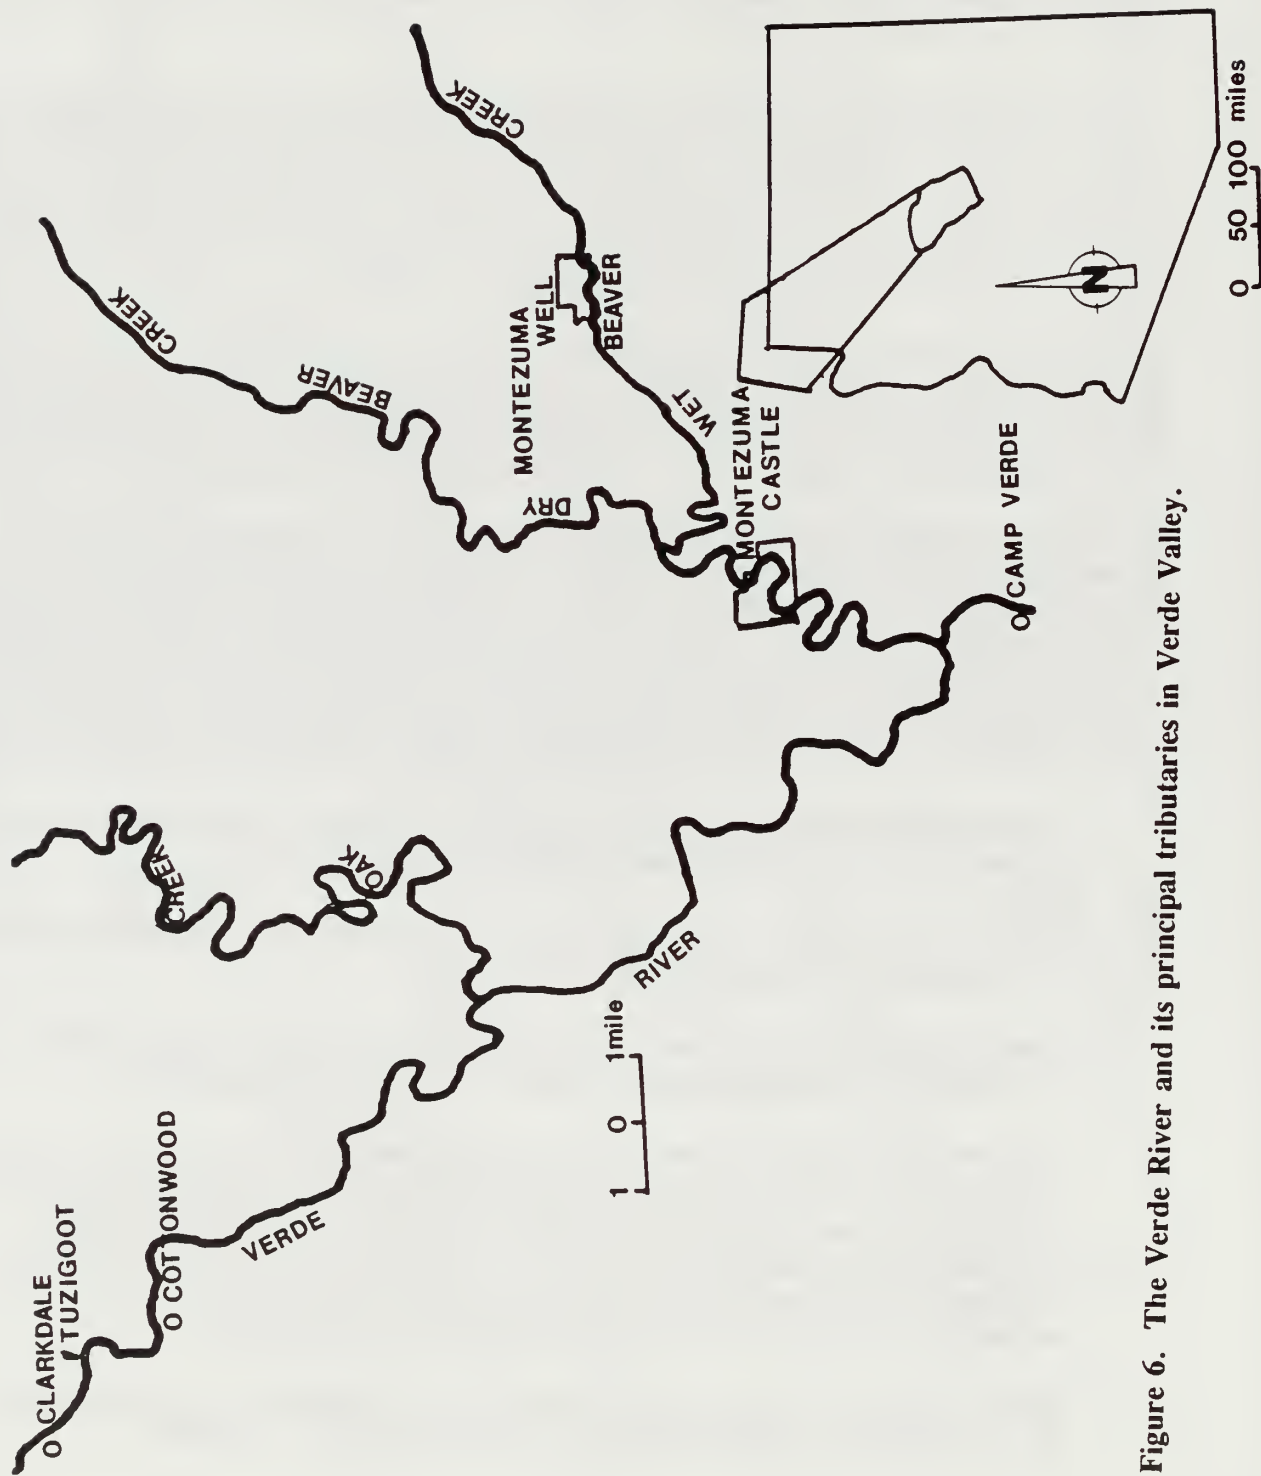
Figure 6. The Verde River and its principal tributaries in Verde Valley.

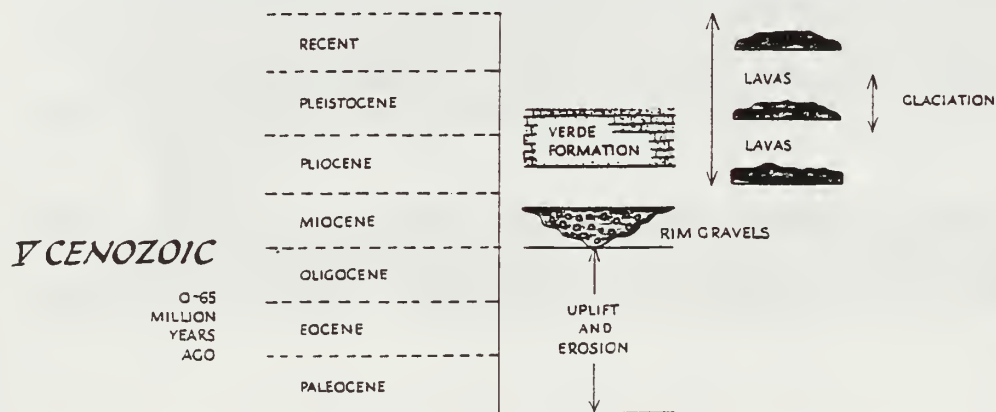
SAN FRANCISCO PEAKS – VERDE VALLEY

Figure 7. Geologic cross section of the Verde Valley Region.

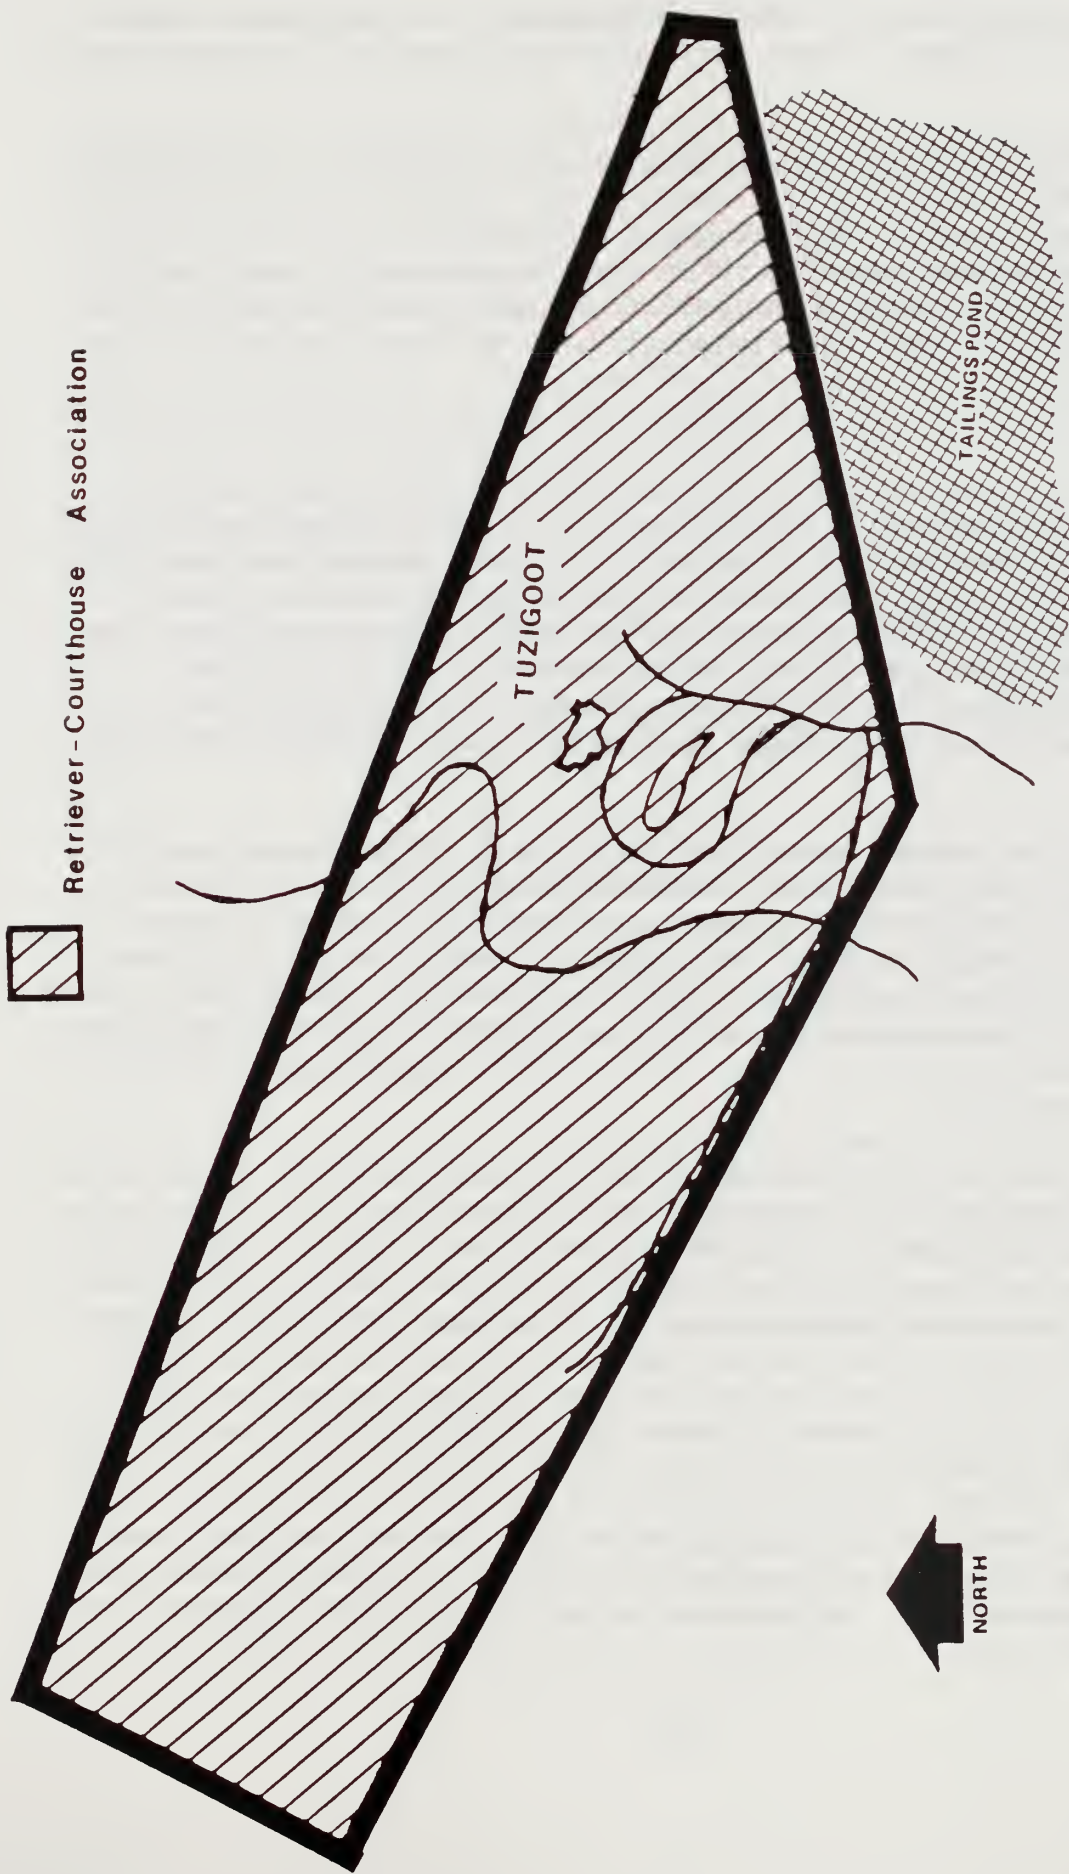
Figure 10. Soils map for Tuzigoot National Monument.
