# PRESERVATION Tech Notes

## TEMPORARY PROTECTION NUMBER 2

### Specifying Temporary Protection of Historic Interiors During Construction and Repair

Dale H. Frens, AIA  
Frens and Frens

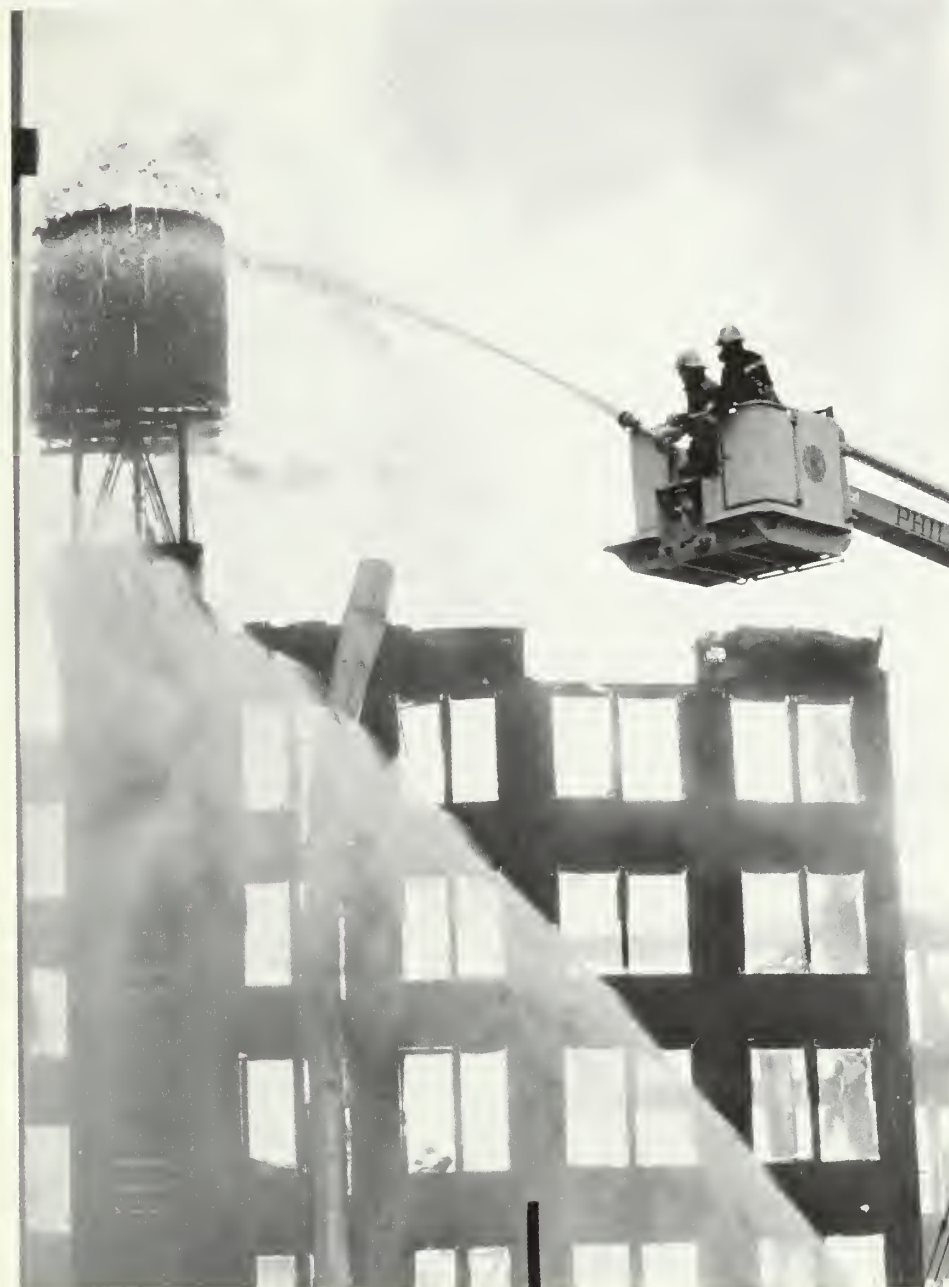
*Historic interiors and collections  
should be protected from potential  
damage during construction work*

Fire poses the greatest risk of sudden catastrophic loss during construction activities in existing buildings. Just one of numerous examples is the 1985 Harrison Court fire in Philadelphia, in which a block-long National Register warehouse building undergoing rehabilitation burned to the ground (*see cover photo*). The fire was caused by sparks from cutting torches that were being used during selective interior demolition work.

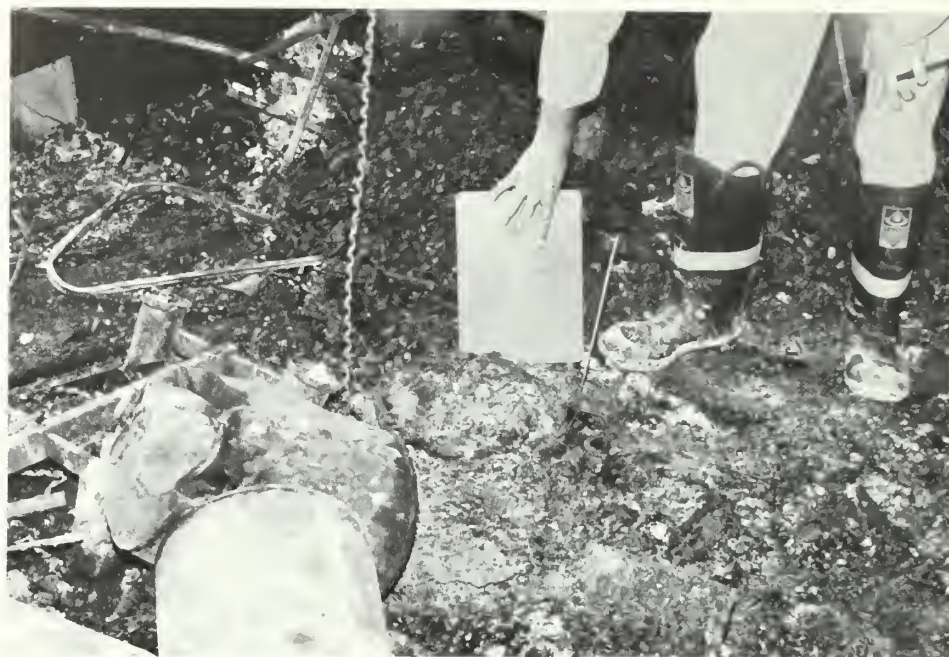
**Figure 1.** The spontaneous combustion of cloth rags that had been used in applying a common finishing wax caused over \$1 million damage to a historic government office building in 1991. Remains of the trash can where the rags had been stored overnight is indicated by the fireman's notepad. After the cause of the fire was determined, a standard specification provision was developed for future contracts requiring the contractor to remove all material contaminated with finishing products from the site at the end of the day.

struction activities, including new construction, NFPA 241 should be a reference standard in any selective demolition specification, and a foundation for addressing fire safety on building rehabilitation sites. Additional guidance is available in NFPA 914: *Rehabilitation and Adaptive Reuse of Historic Structures*. When these are utilized as reference standards, the historic building owner should obtain and enforce their recommendations (*see figure 1*).

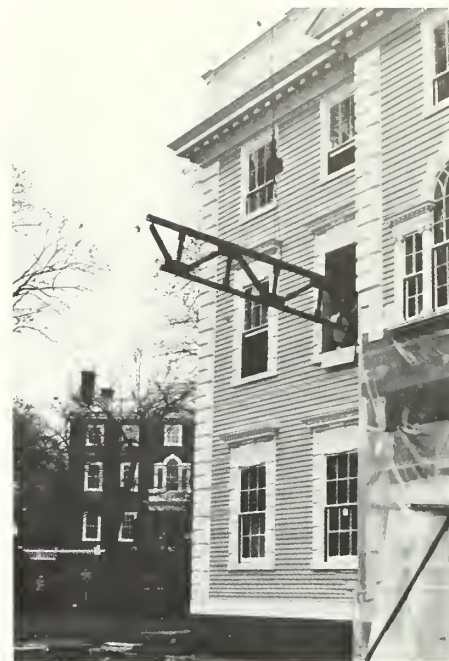
Figure 2. Because of the fire risks, open flame cutting and welding deserves careful attention both in the preparation of specifications and during the work. As much welding as possible should be done off site. For example, at the Nightingale-Brown House, several large trusses were assembled off site, then carefully hoisted through a window for installation. Photo: Irving B. Haynes and Associates.

ment. For smaller projects, the construction fireman or other designated people should be assigned the responsibility of inspecting of each cutting and welding location frequently during the day (see figure 2).

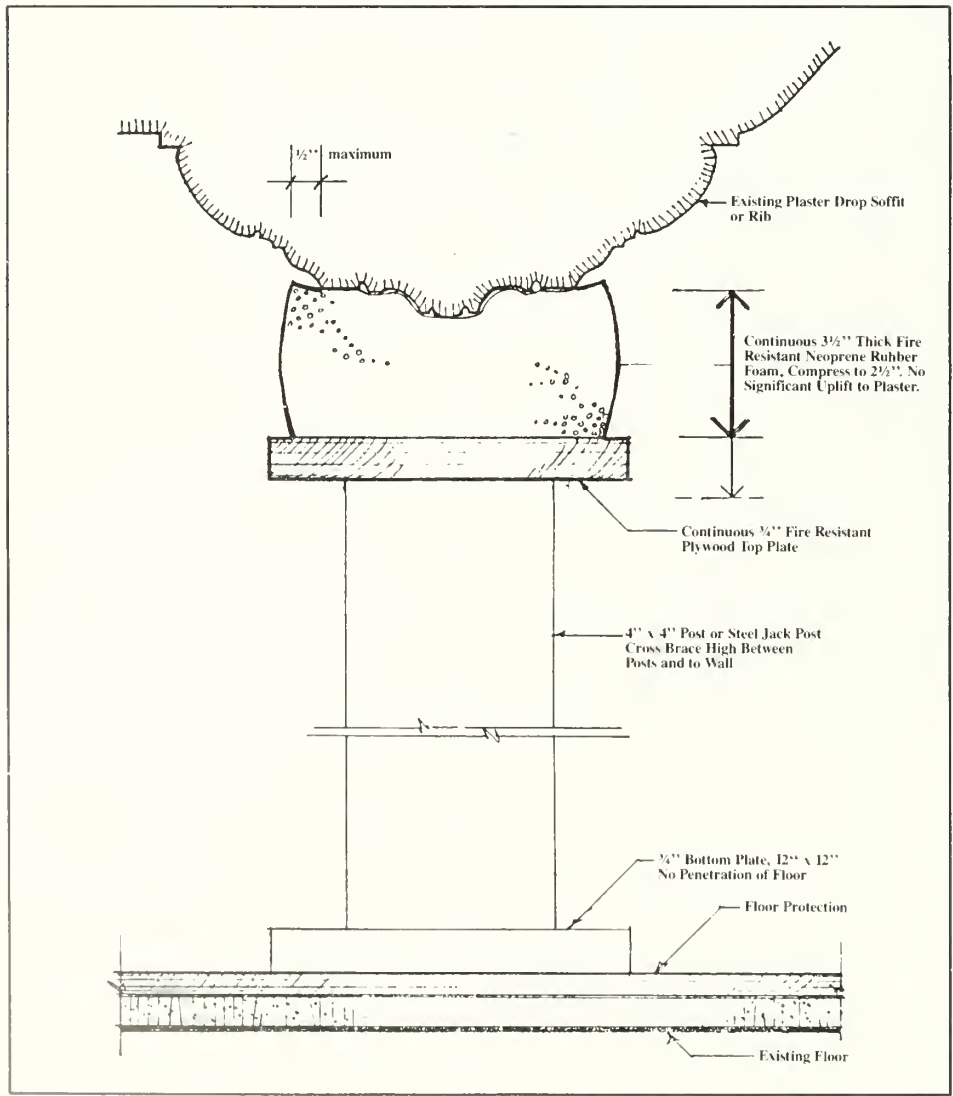
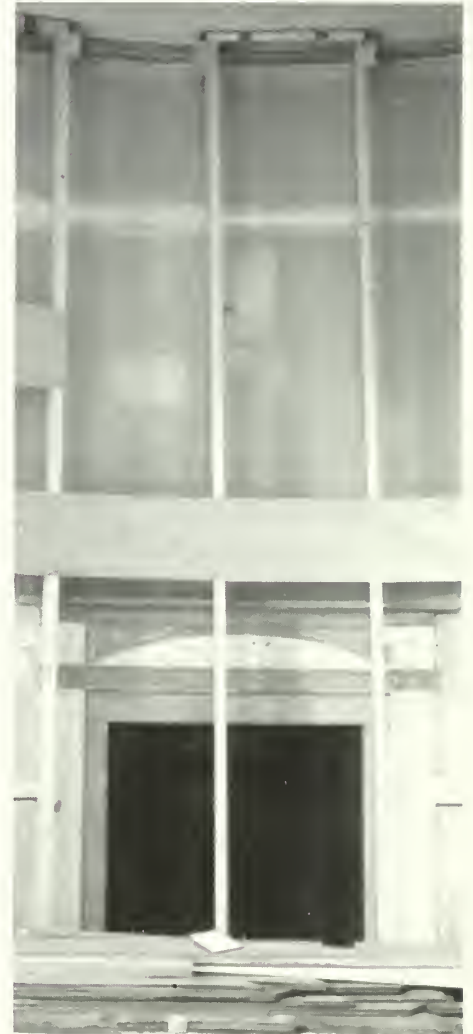
Figure 3. Vibrations generated during construction may necessitate the installation of temporary support for such fragile features as plaster ceiling cornices and soffits. Drawing: Villard Houses — courtesy of Emery Roth & Sons Architects, P.C. Photo: The Octagon, Lonnie Hovey, AIA.

Important architectural features which are easily removed should be stored off site, if possible, to protect them from vandalism, theft and damage during construction. Lighting fixtures, fireplace mantels, and interior doors are typical examples. Less movable architectural material or finishes such as wallpaper are often best retained in place but may require custom-designed protective measures developed and monitored by a conservator (see figure 3).

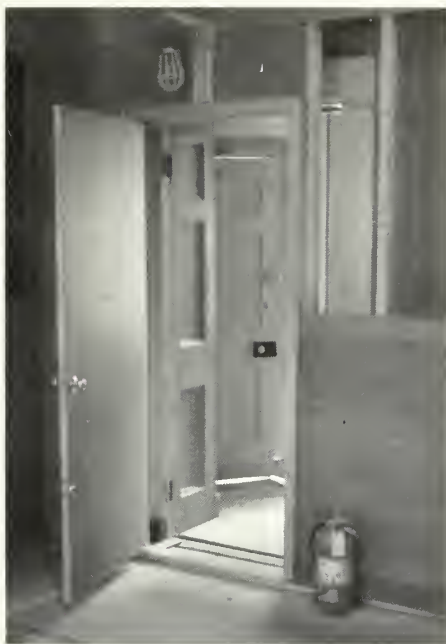
Figure 4. Temporary protection during construction can involve covering historic features, such as floors and walls, as well as using temporary doors to control the passage of workers and the inevitable dust and dirt. Prominently located fire extinguishers are mandatory. Photo: Lonnie Hovey, AIA, The Octagon.

of such spaces. Spaces with restricted access should be identified by the planning team and indicated in the construction documents in order to allow the contractor to include any associated costs in his price proposal (see figure 4).

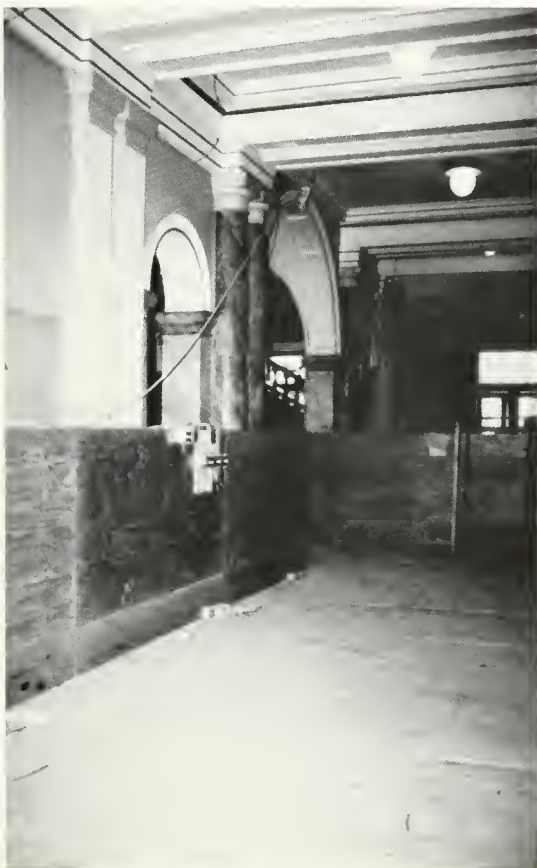
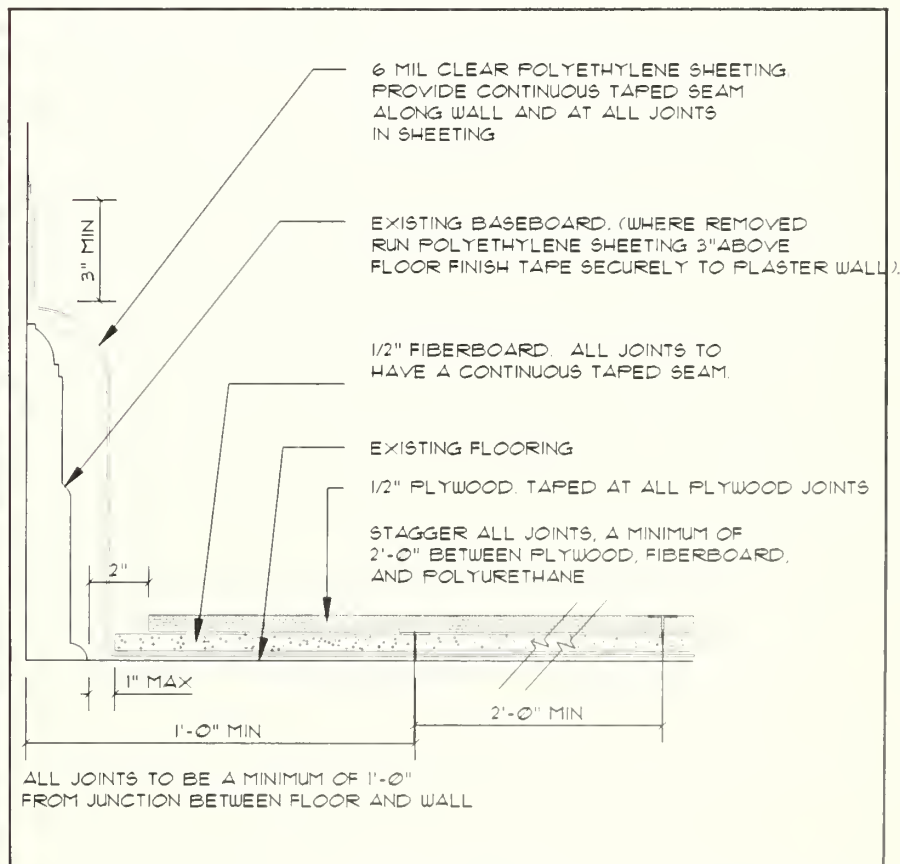
Figure 5. To provide for adequate floor protection in the New Jersey State Capitol, this area was swept clean, then covered with polyethylene sheeting to protect against spills and dirt abrasion. Fiberboard (1/2" thick) was placed over floors and the joints sealed with tape. Finally 1/2" plywood was laid with all joints taped. This floor protection system has been successful over many years of use and is recommended in major construction areas, and where tile, marble, parquet wood, or other historic flooring is involved. Photo and drawing: Ford Farewell Mills and Gatsch Architects.

Flooring should be protected from damage caused by abrasion, falling objects,

dust and dirt, and spilled liquids (see figure 5). If work in, or traffic through, a particular space does not involve one or more of these risks, temporary protection may be reduced. Damage caused by abrasion can be controlled by means of protective coverings such as canvas tarps or resilient wood fiber panels. Canvas tarps should overlap and be taped at all joints. Resilient wood fiber panels should be carefully fitted with tight seams and laid continuously wall to wall. Joints should be taped to avoid displacement of the panels after setting. For added safety, resilient panels left exposed should also be fire-retardant treated to achieve a UL Class A listing for flame spread and smoke developed. Such a readily available product is N.C.F.R Homasote.

For greater protection from physical force, a layer of plywood can be applied over the Homasote panel underlayment, with joints staggered to stabilize the assembly. In this double layer assembly, the top plywood should be treated with a fire-retardant, but the underlayment need

not be. Where protection from spilled liquids is required, a layer of polyethylene sheeting should be applied between the Homasote panels and the plywood top layer. Care should be taken in planning the protection assembly to ensure that moisture from spilled liquids is not trapped against the historic flooring. Otherwise, the staining, splitting, wood-grain raising, or stone-finish destruction could potentially go undetected for months while concealed from view under the protection assembly. Care should also be taken to avoid sheet coverings such as building felt, which could potentially stain the historic flooring.

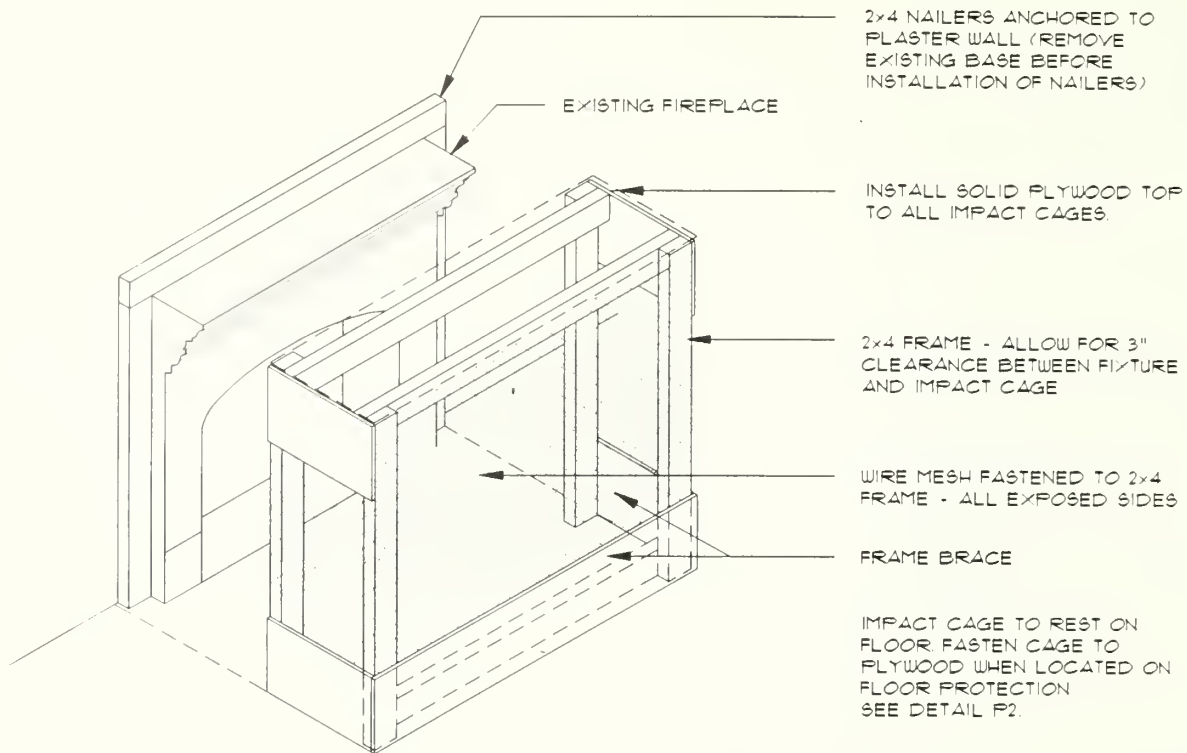
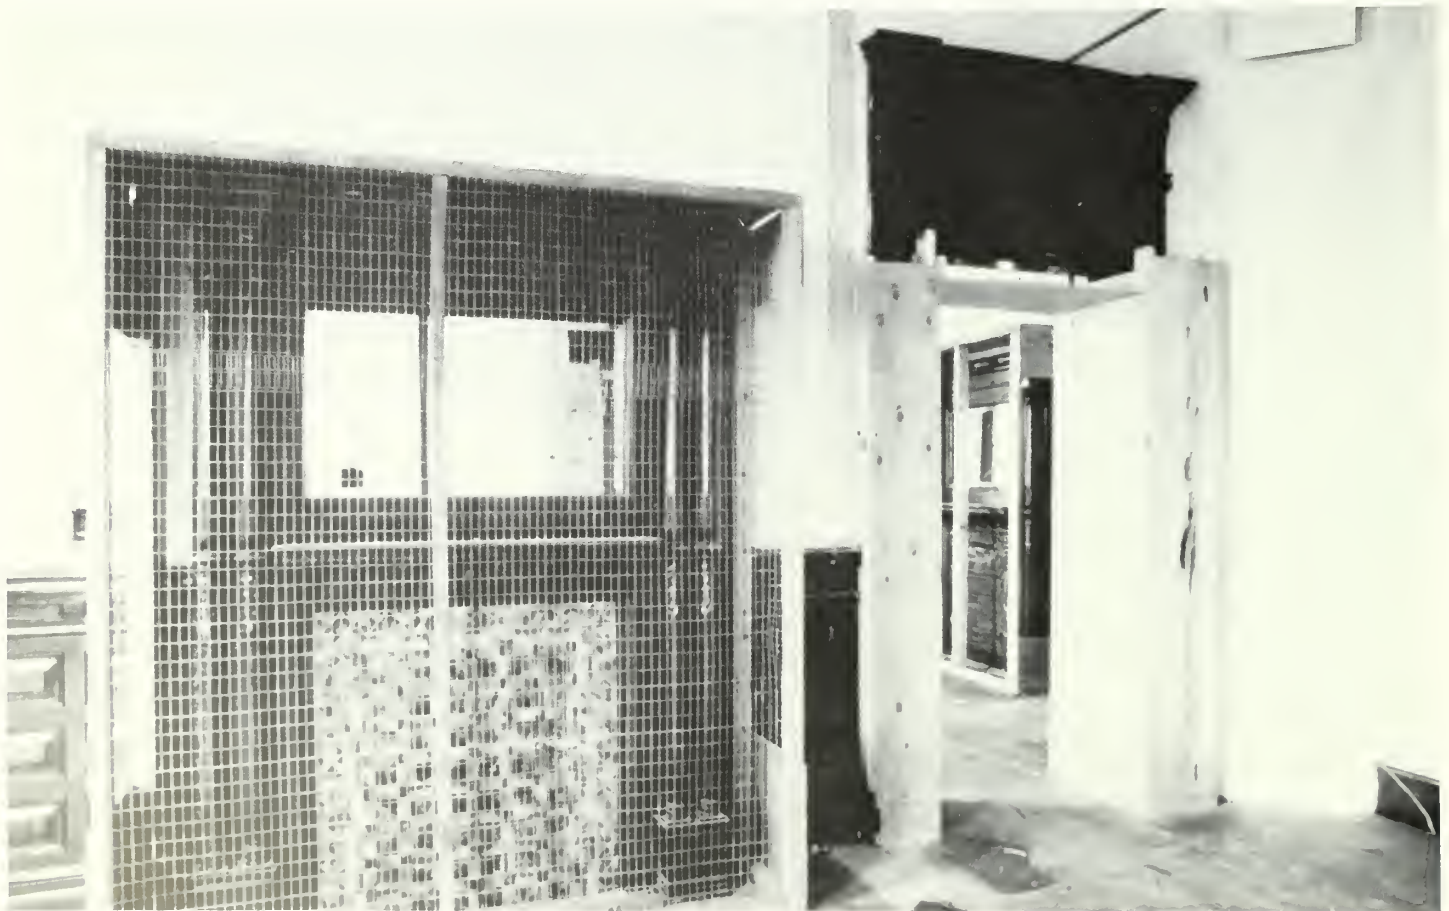
Figure 6. A self-supporting impact cage utilizing wood and wire mesh protects the fireplace. In this project, the long construction process required bidders to have visible access to features such as the fireplace. The wire mesh also facilitated monitoring during the lengthy construction. Photo and drawing: Ford Farewell Mills and Gatsch Architects.

Historic stairways, balustrades, balconies, fireplaces, door surrounds, window surrounds, and other components will also need to be protected from construction damage by combining the techniques described for floors and walls (see figure 6). Horizontal surfaces should be protected as floors, and vertical assemblies treated as walls, with the major difference being the complexity of the framing required.

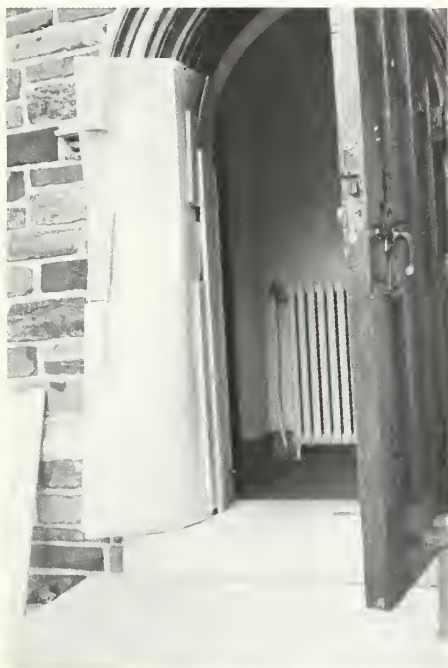
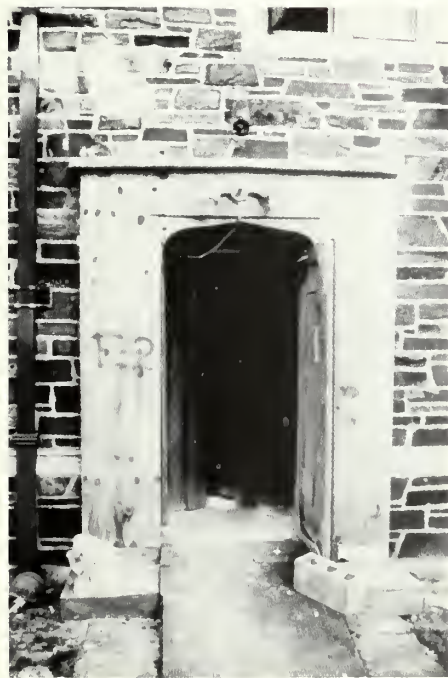
**Figure 7.** A contractor’s solution to protecting the limestone door surround consisted of thin foam sheeting, secured with wood nailed to the masonry. This protection was rejected as inadequate by the architect, and a full plywood enclosure constructed. In the architect’s solution, it should be noted that a temporary door is used while the original door is stored for safe keeping during construction. Photo: Ford Farewell Mills and Gatsch Architects.

The above notwithstanding, architects routinely specify temporary facilities including temporary utilities, temporary construction and support facilities, and security and protection services. For preservation projects, it is recommended that temporary protection of historic interiors during construction be specified in a separate Division 1 specification section entitled “Special Project Procedure” or “Restoration Project Procedures” to ensure that required provisions are not overlooked by bidders because they appear in the often lengthy Section 01500 — Temporary Facilities. Under competitive bidding circumstances, bidders logically seek to minimize the cost to the project for providing temporary facilities, including temporary protection of historic interiors. By creating a separate section in a price proposal, the bidder will be inclined to treat the “special project procedures” as an added cost rather than a part of the temporary facilities required for any alteration project. The contractor’s project manager can thus anticipate making reasonable expenditures for providing specified temporary protection during construction. To ensure the adequacy of temporary protection measures in projects involving a construction manager, temporary protection is often best provided by the construction manager, who normally works for the owner on a cost-plus-fee basis (*see figure 7*).
