PRAIRIE GULLY EROSION
IN THE REDWOOD CREEK BASIN, CALIFORNIA

REDWOOD NATIONAL PARK
RESEARCH AND DEVELOPMENT

TECHNICAL REPORT
NOVEMBER 1985

SEDIMENT BUDGET PROJECT

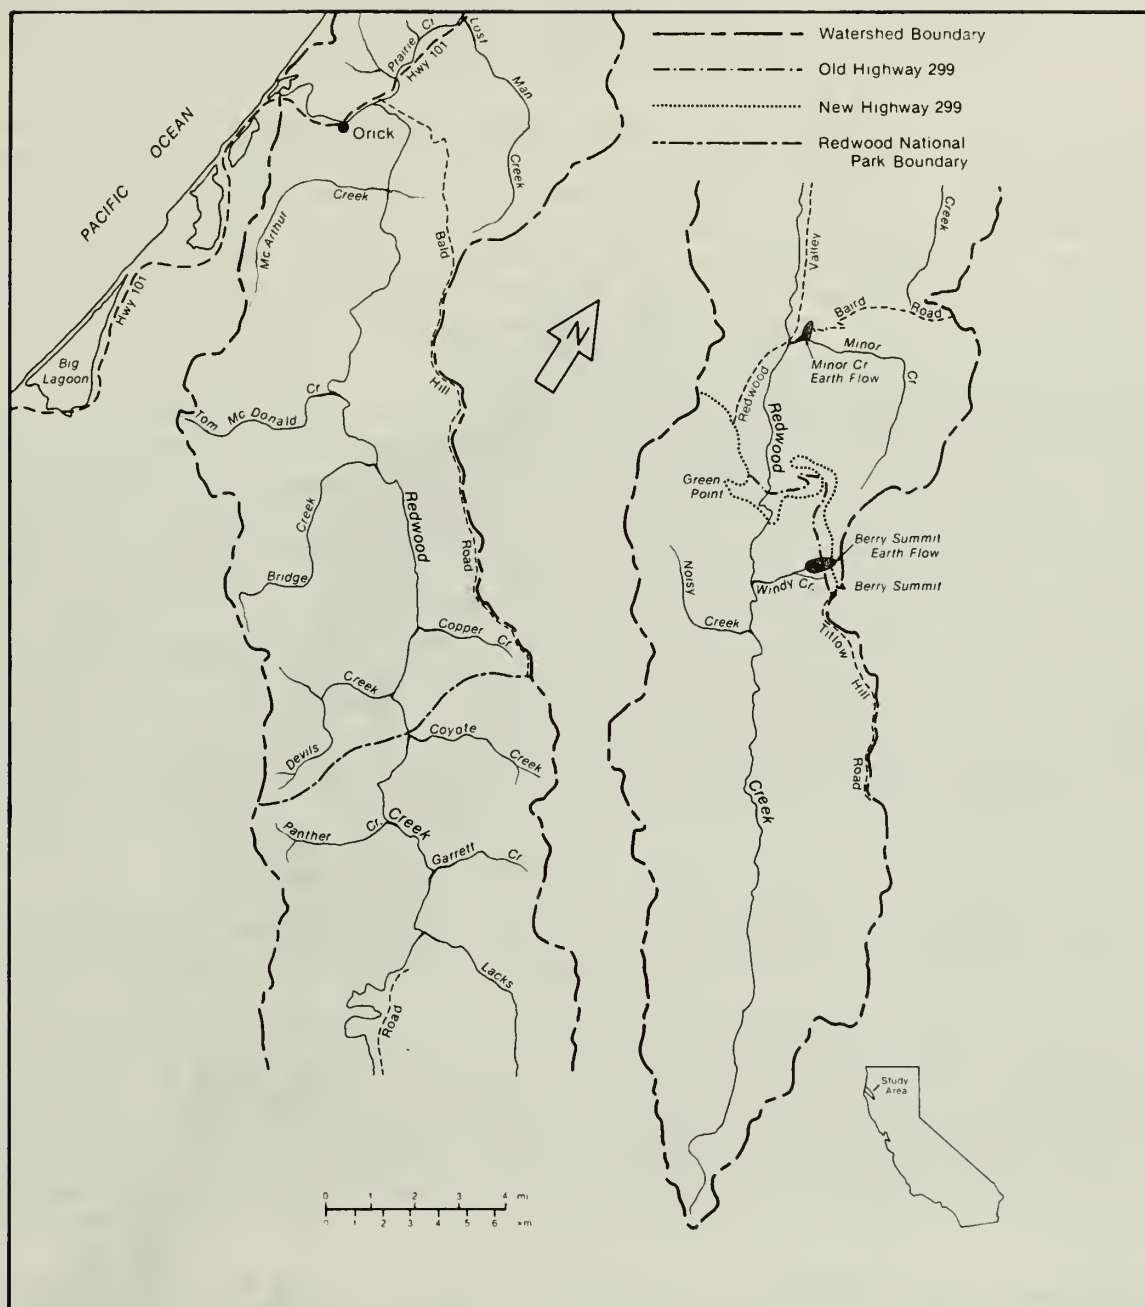
Figure 1: Redwood Creek basin. The dividing point between the lower and middle basins is Redwood National Park Boundary. The dividing point between the middle and upper basins is new Highway 299.

unusually elongate, being approximately 100 km long and 6 to 8 km wide in most places (Figure 1). Average annual precipitation varies from about 2,500 mm on the ridgetops to about 1,600 mm in the valley bottom. Five major storms (1955, 1964, 1972 [2], and 1975) occurred in the basin during the study period, each producing instantaneous peak discharges of $1,415 \pm 142 \text{ m}^3/\text{s}$ ($50,000 \pm 5,000 \text{ m}^3/\text{s}$) at the U.S. Geological Survey gaging station at Orick (Harden *et al.*, 1978).

For the purposes of this report, the Redwood Creek basin was roughly divided into thirds (Figure 1). The lower, middle, and upper thirds contain 5.4, 22.3, 23.4 km² of grassland respectively (Best, 1984). Almost all of the grasslands (referred to as prairie) lie on the east side of the Redwood Creek basin (Figure 2). In the lower basin, prairies are continuous along the eastern watershed divide, with occasional tongues extending downslope. These are bordered by Douglas-fir forests, with lesser amounts of hardwood and redwood. In the middle and upper sections of the basin, prairies are more numerous. They occur on all sections of the slope, and are most often bordered by oak woodlands.

Major roads are individually identified on Figure 1. Bald Hill, Titlow Hill, and Redwood Valley Roads are all two-lane, paved, and well maintained roads. Baird Road is a two-lane rocked road, and is also well maintained. Old Highway 299 is two-lane and paved, but most of the road crossing prairie areas has not been maintained since August 1971, when the new Highway 299 was completed. New Highway 299 is a well maintained, three-lane state highway with extensive cut and fill slopes.

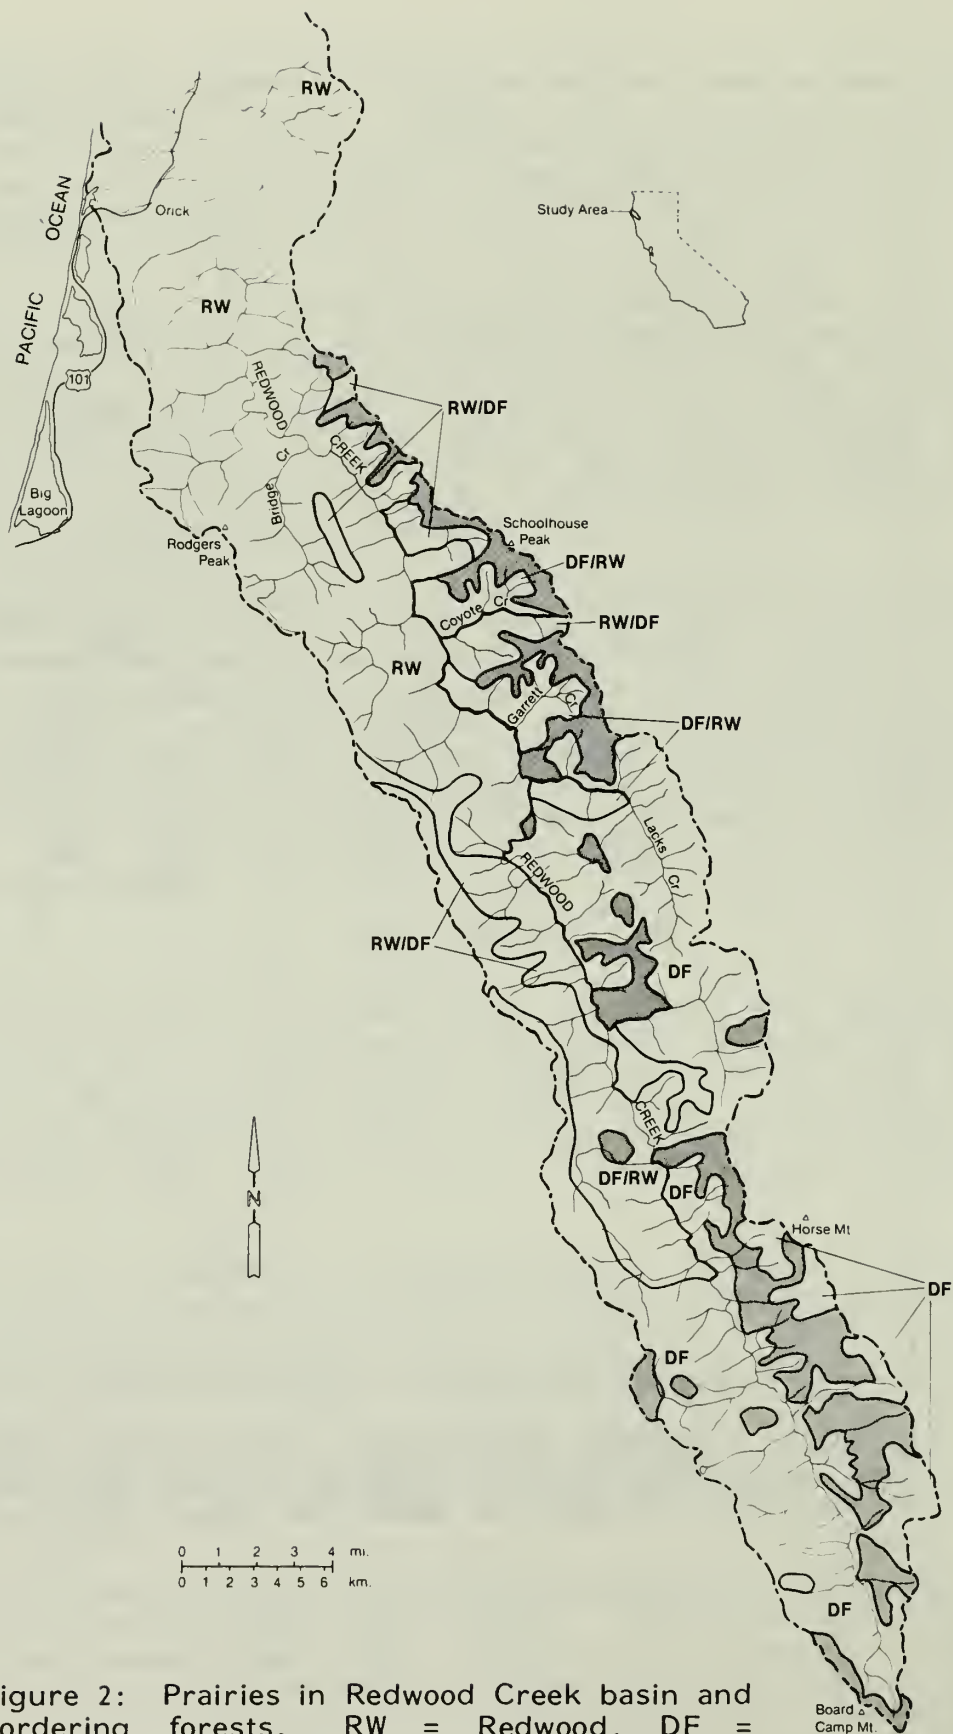
Figure 2: Prairies in Redwood Creek basin and bordering forests. RW = Redwood, DF = Douglas Fir. Stippled areas are prairies.

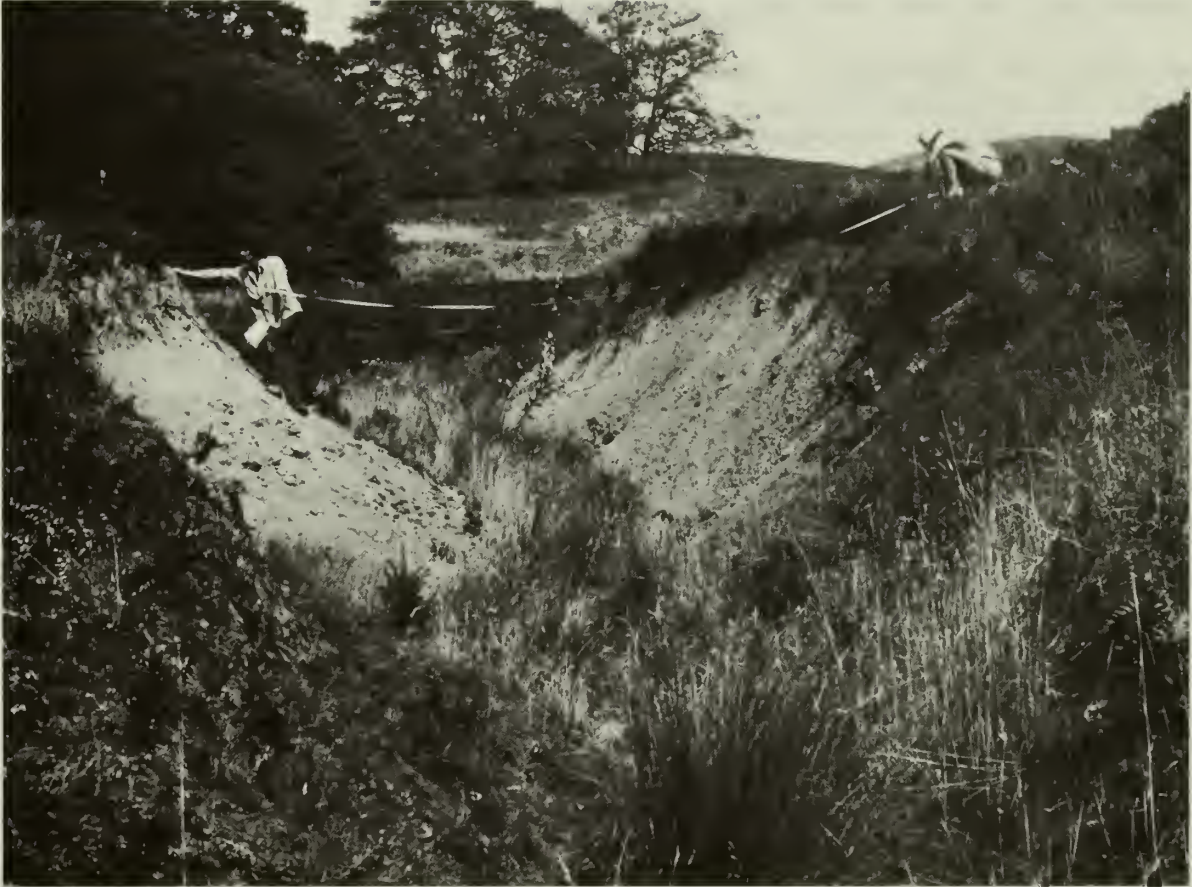
Figure 3: The author (right) and Dave Best measure the top width of a gully in the prairies of Redwood National Park.

In order to determine a relationship between top width and cross-sectional area, 155 cross-sections were measured on 24 gullies in the field (Figure 3). This represents 3.7 percent of the total number of gullies measured on aerial photographs. The sampling procedure was made as unbiased as possible by measuring cross-sections at regular length intervals along a gully and by sampling as many different areas of the basin as possible, given time and access constraints. Figure 4 shows the correlation between top width and cross-sectional area, along with the linear regression equations. Two regression lines were calculated because of the apparent change in gully characteristics when the top width was either greater or less than 3 m. The regression line for gullies with a top width less than or equal to 3 m has a coefficient of determination (r^2) equal to 0.58, indicating a wide variability in shapes among the smaller gullies. The regression line for gullies with a top width greater than 3 m has an r^2 of 0.86, indicating a greater degree of uniformity among larger gullies.

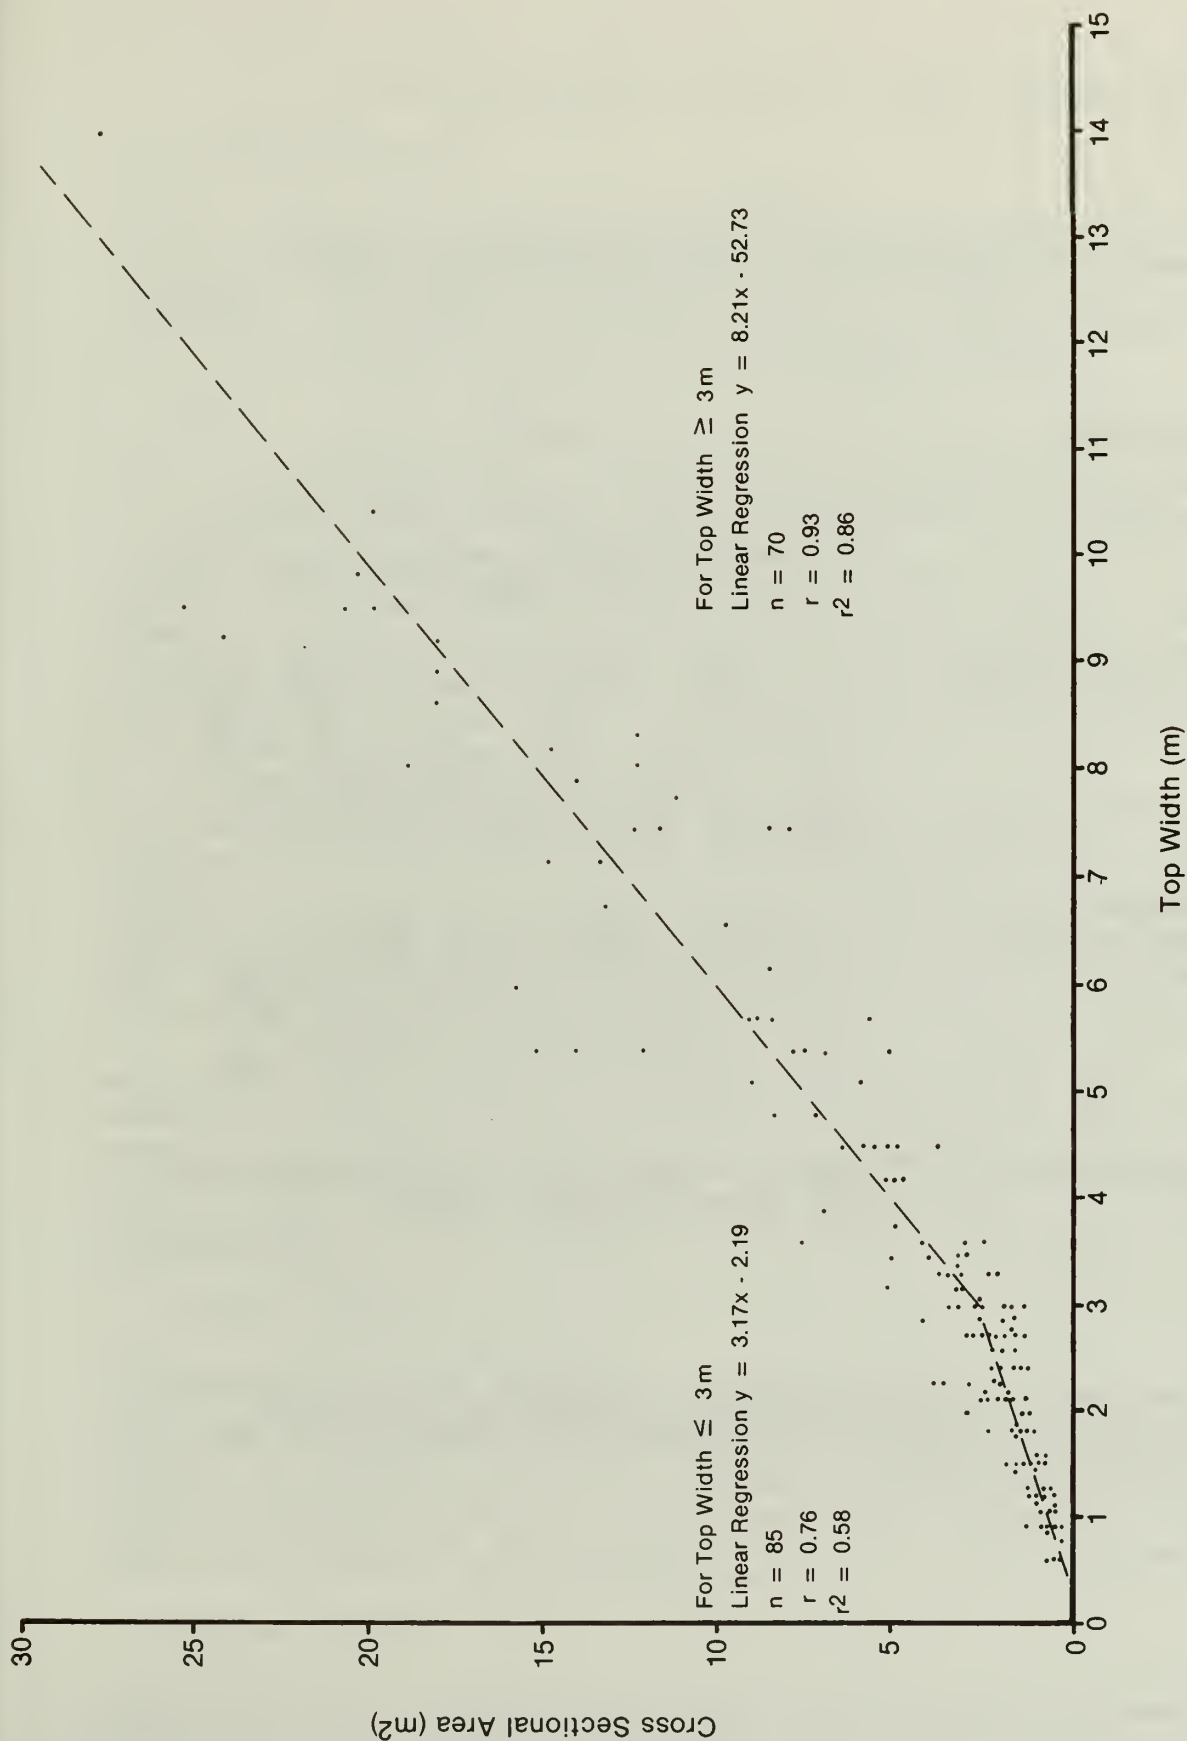
Figure 4: Correlation between top width and cross-sectional area of gullies. Two linear regression lines were calculated because of apparent change of slope characteristics when top width is greater than or less than 3m.

The appropriate regression equation was applied to the top width measurement of each gully to obtain a cross sectional area which was then multiplied by length to obtain a volume.

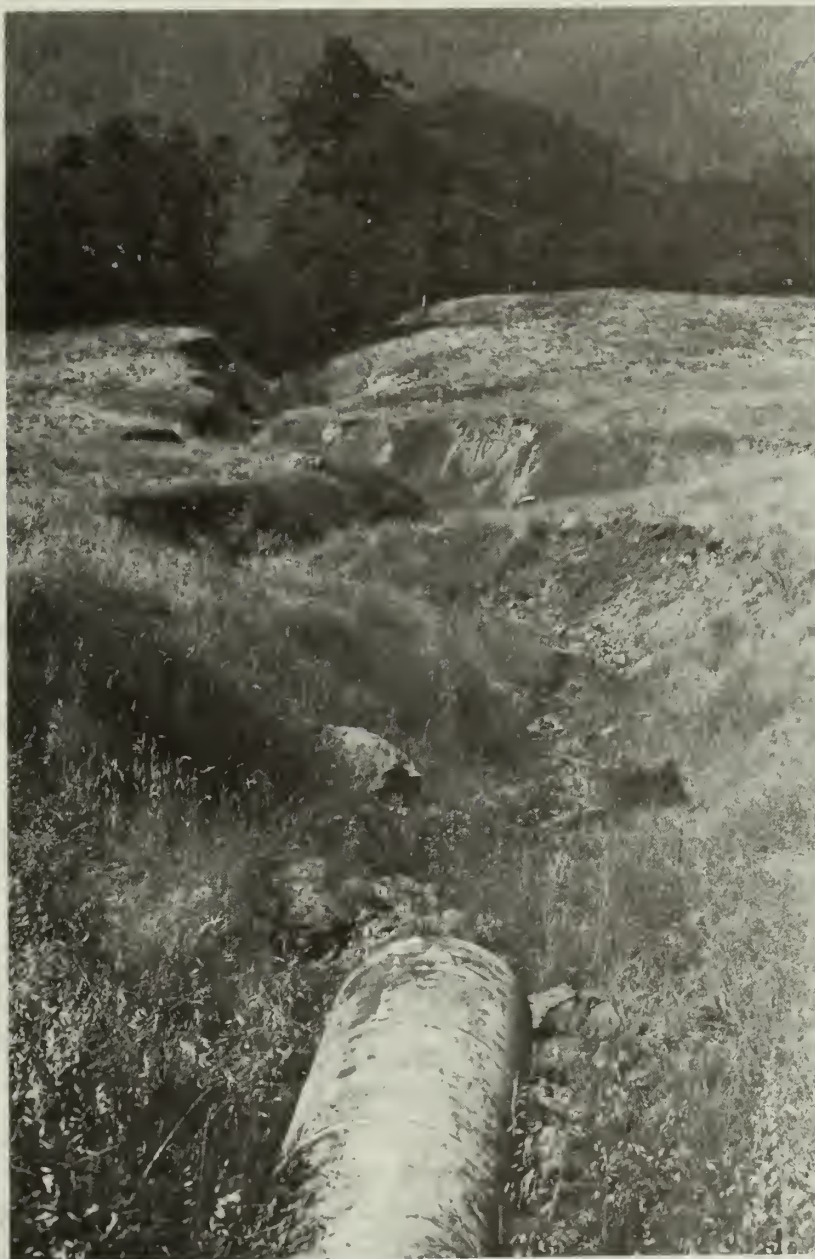
Figure 5: Lack of a protective vegetative mat and an intense concentration of water diverted off roads can cause gullying to occur on gradients as low as 10 percent. Note that this gully formed on a topographic high point rather in a swale.

and variable. Therefore, an "average" gradient number is not very meaningful. Field observations suggest that the gradient at the point of gully initiation may be more important than average slope. Often a gully is initiated on a steeper slope and remains roughly the same size as the slope lessens. Accurately quantifying slope at the point of gully formation would require extensive field work and is beyond the scope of this study. Best (personal communication, 1983), in studying logged conifer regions of the Redwood Creek basin, found that little gully formation occurred on slopes less than 20 percent. Above 20 percent, there was a very poor correlation between increasing slope and increasing gully formation. The exception to this was on roads, where gullying occurred on gradients as low as 10 percent. Presumably this reflects the intense concentration of water often diverted onto roads and inboard ditches and the lack of a protective vegetative mat (Figure 5).

with inboard ditches then overloading existing stream crossings, and (3) by misplacing culverts which may focus stream power on unprotected areas (Figure 5). In addition, the interception and alteration of subsurface flow by cut and fill slopes may have more significant effects on gully initiation.

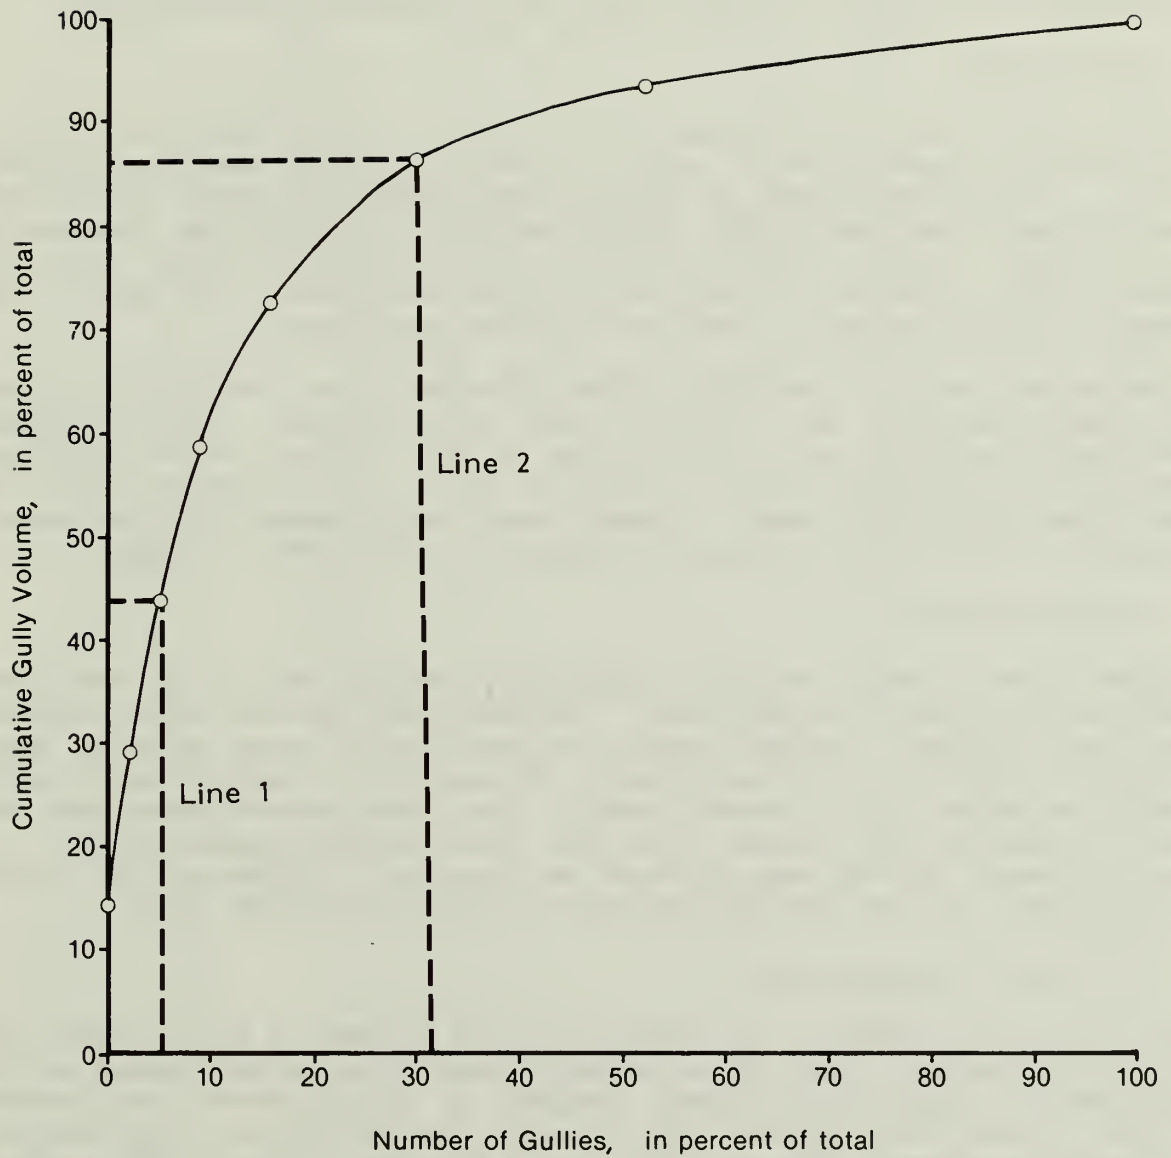
Figure 6: Sediment volume contribution by number of gullies in percent of total.

It can be seen from Figure 6 that a few very large gullies dwarf the smaller ones in terms of sediment volume contribution. The 32 largest gullies (5 percent of the total number) accounted for 43 percent of the total volume (see line 1) and 30 percent of the gullies accounted for over 85 percent of the total volume (see line 2). Among gullies with volumes of 2,800 m³ (100,000 ft³) or greater, two-thirds are road-related or probably road-related.

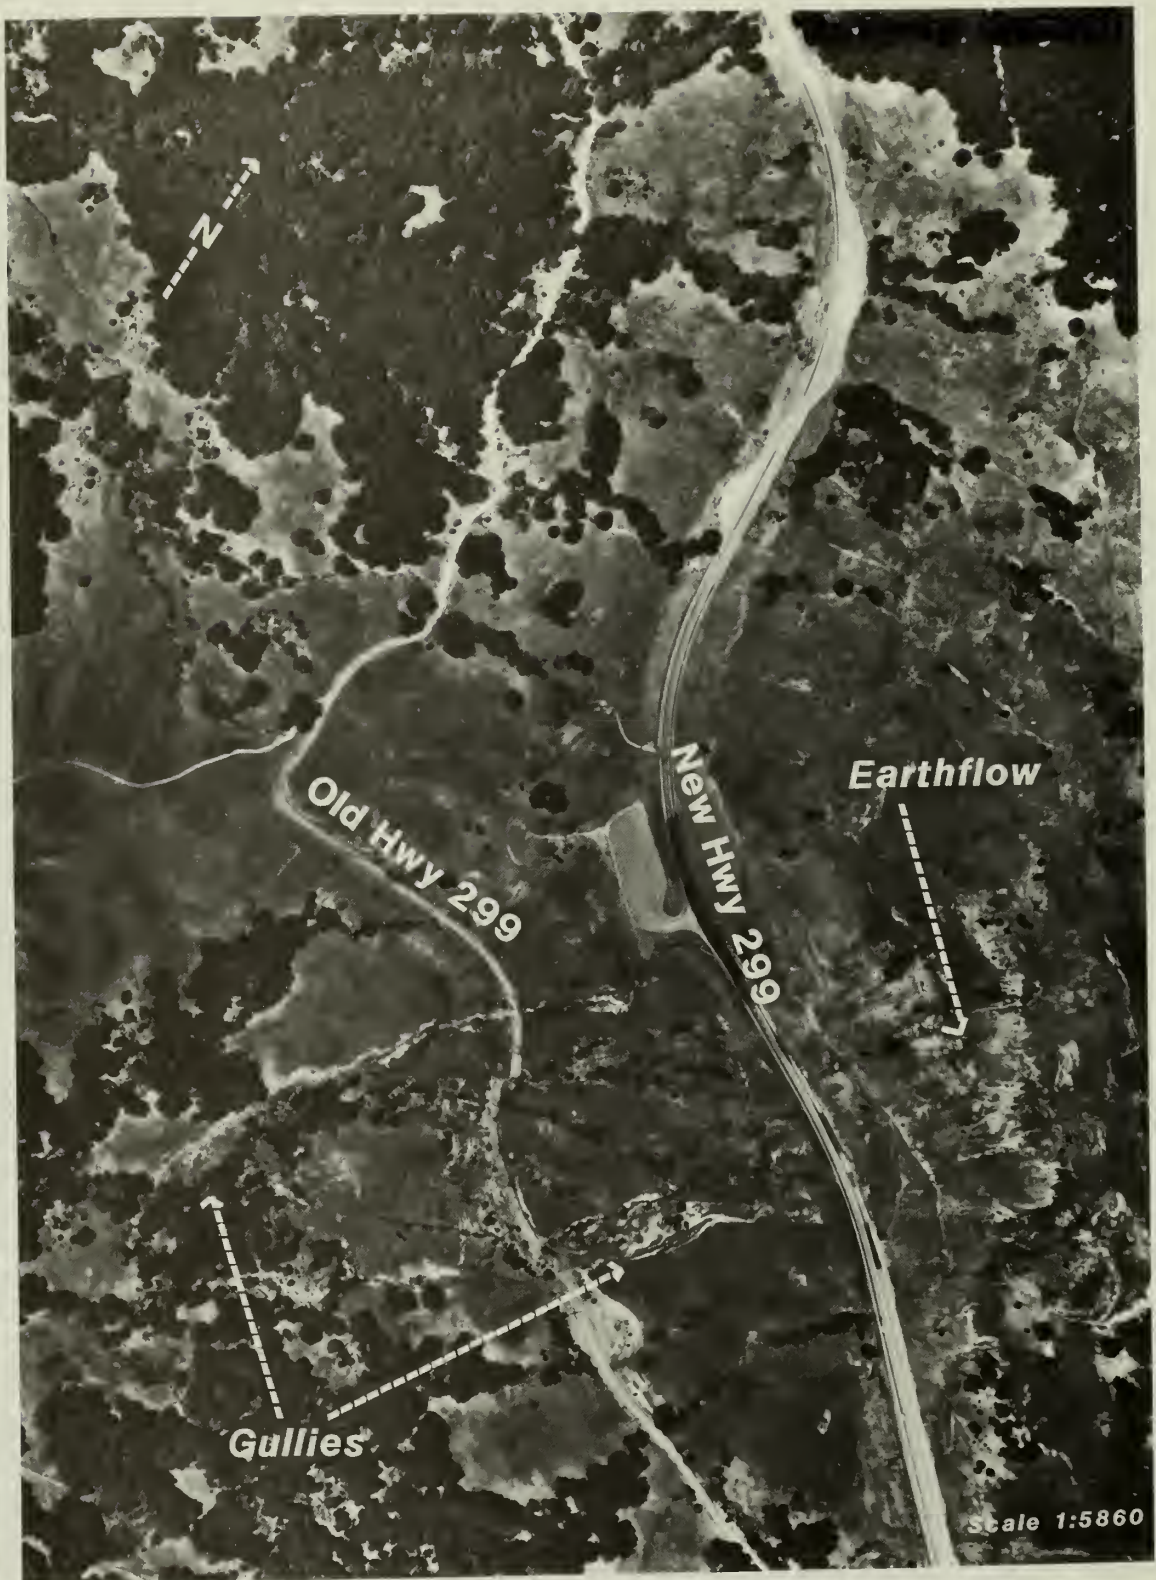
Figure 7: Earthflow and large gullies near Berry Summit on old and new Highway 299.

Both old and new Highway 299 have very high volumes of gully erosion per km of road length. Much of the erosion comes from gullies incised on the large earthflow near Berry Summit (Figure 7). Large gullies were present in 1954, where old Highway 299 crossed the earthflow. New 299 was constructed upslope of the old 299 in 1971. Between 1971 and 1978, several

large gullies formed in the earthflow between the two roads. A few new gullies also formed below old Highway 299 during this time period, possibly because the old highway was no longer being maintained. Numerous small gullies are now present in the section of the earthflow above new Highway 299, which appeared stable prior to highway construction. At Green Point (Figure 1), on the west side of the basin, new Highway 299 has again apparently triggered earthflow movement (along with a large incised gully) above the road.

Almost all of the gully erosion associated with old Highway 299 occurs on the Berry Summit earthflow. New 299, however, has initiated many gullies even in relatively stable prairie areas (Figure 6). This reflects the extremely large cuts and fills and subsequent alteration of hillslope drainage patterns involved in constructing the new highway.
