Final Report
April 1995

**Historical Flow Regimes And Canyon Bottom Vegetation
Dynamics At Walnut Canyon National Monument, Arizona**

Prepared by
Peter G. Rowlands¹ and Charles C. Avery²
Principal Investigators
and
Nancy J. Brian¹ and Heidemarie Johnson³
Research Associates

Prepared for
Water Rights Branch, Water Resources Division,
National Park Service, Fort Collins, Colorado
Under National Park Service, Western Regional Office
Work Order No. CA-8026-8-0002

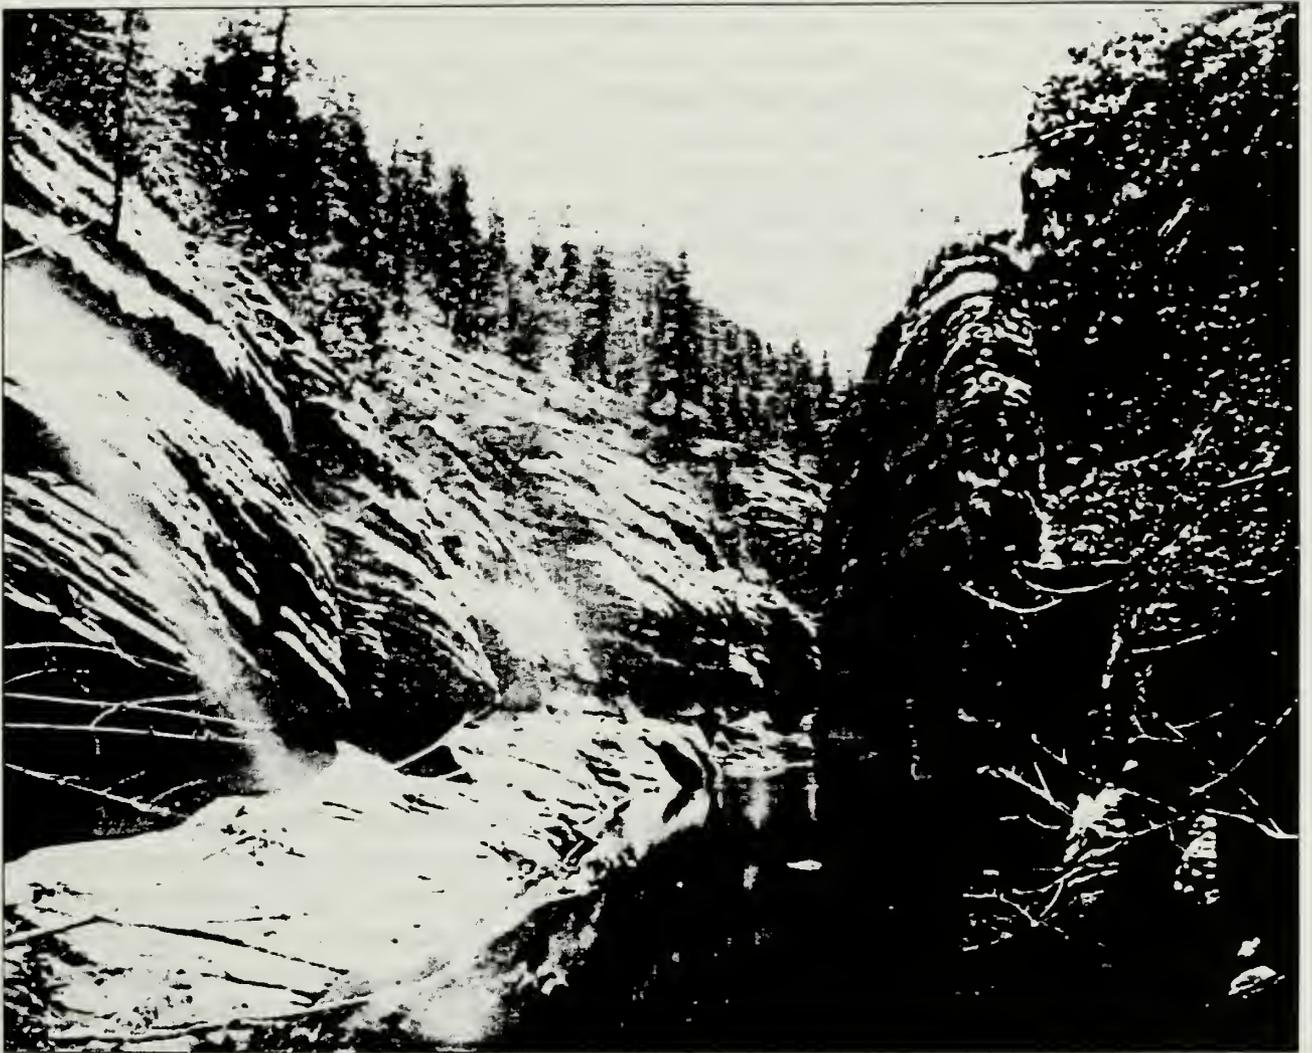
Figure 8. Photograph of a pool at Walnut Canyon, dated 1897 from the Smithsonian Institution.
