# historic structure report

a history of the buildings and  
structures of faraway ranch

## CHIRICAHUA FARAWAY RANCH

NATIONAL MONUMENT/ARIZONA

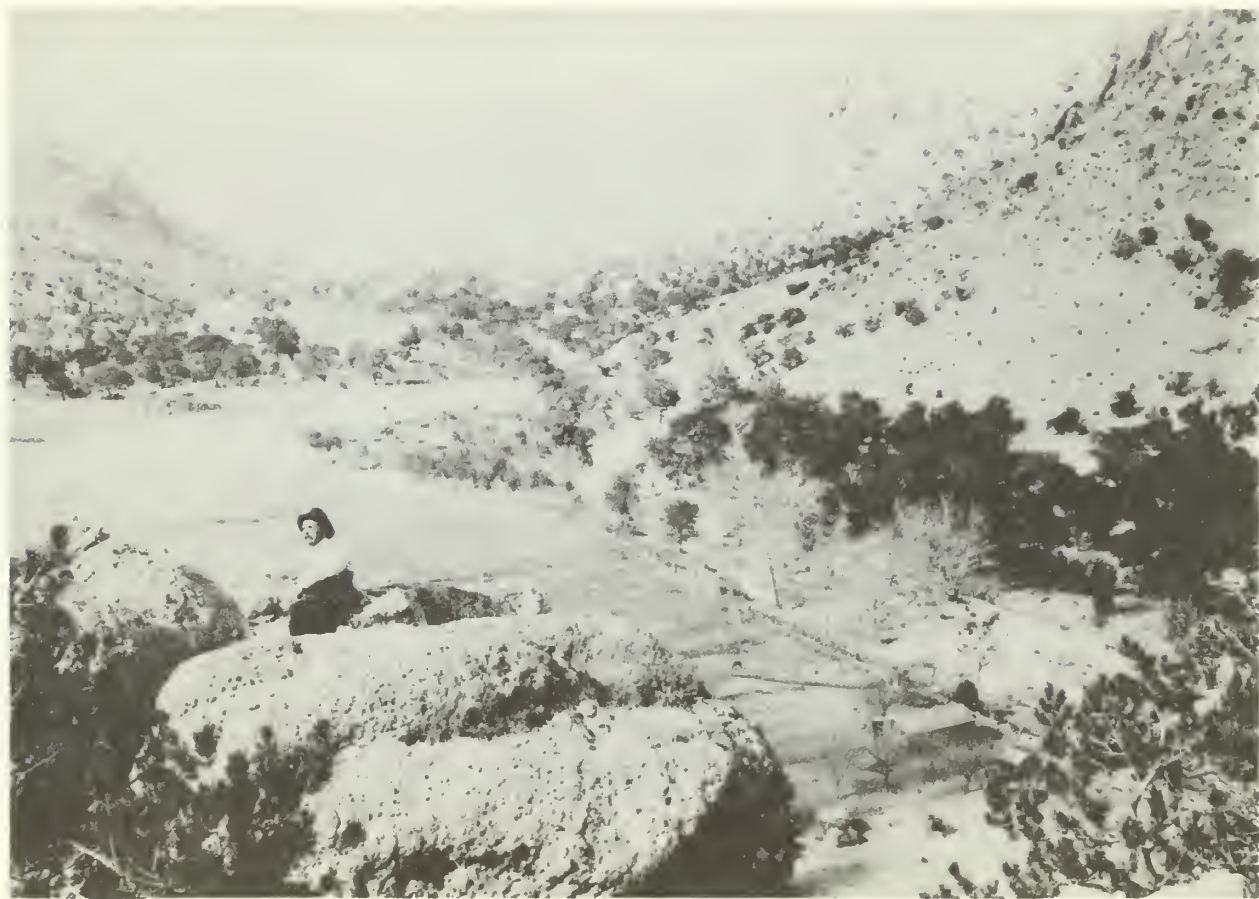
ILLUSTRATION NO. 8

Main House (section of cellar on east side), ca. 1908  
(Erickson-Riggs Collection)

Nothing is said about the type of wood employed to build the box-like addition, but the several photographs reveal that it consisted of boards with battens. The gabled roof of the cellar was also made of milled planks with battens to cover the cracks between them.

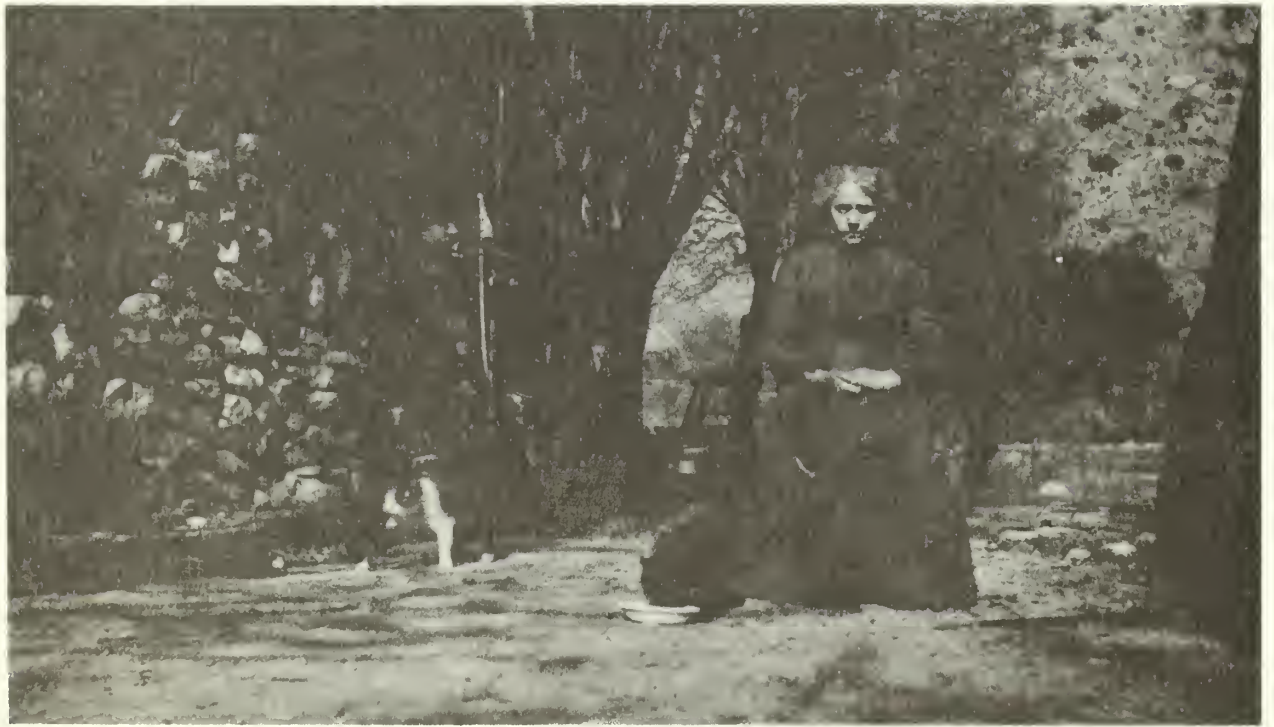
ILLUSTRATION NO. 9

Main House (adobe construction) ca. 1915  
(Erickson-Riggs Collection)

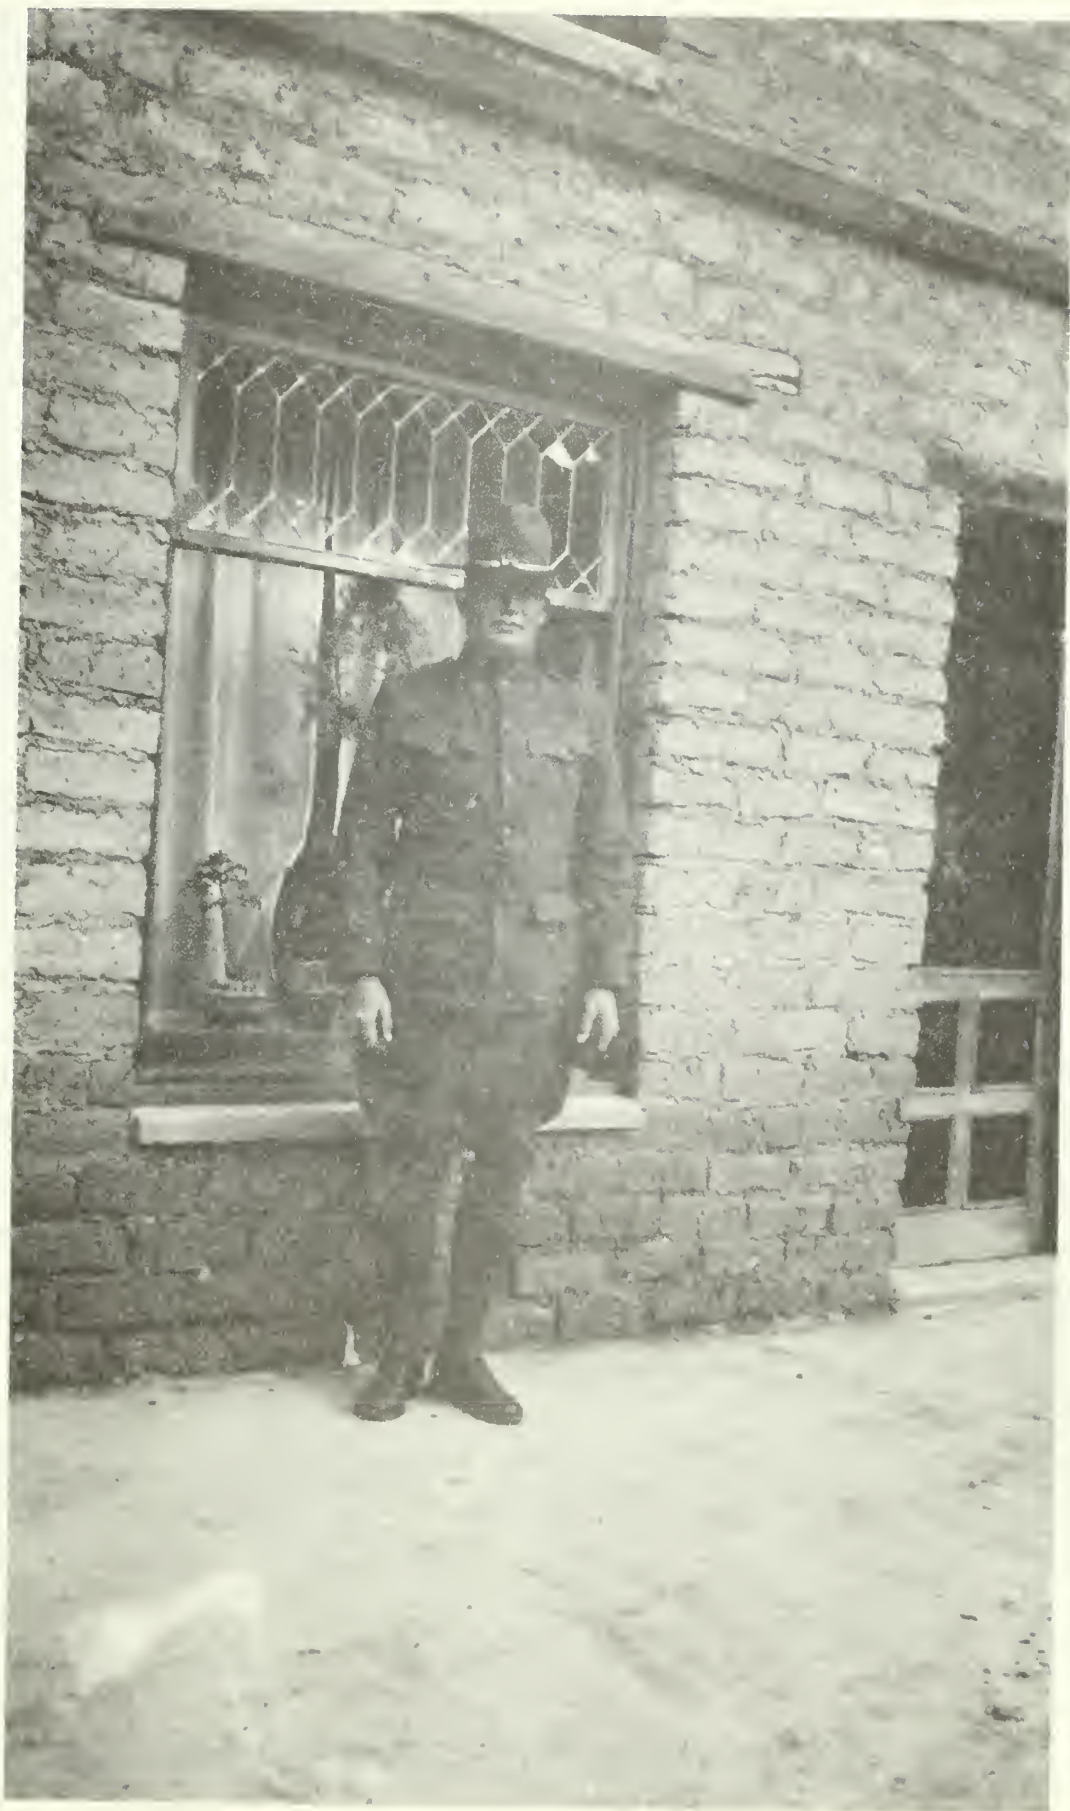
ILLUSTRATION NO. 11

Main House (adobe construction), ca. 1918  
(Erickson-Riggs Collection)

A third photograph taken of Lillian and Hildegard in front of the remodeled structure has this caption on the back, "Lillian and Hildegard Erickson in front of House about 1918." Judging from the attire these women were wearing, there can be no mistake in the date of the caption (Illustration No. 11).

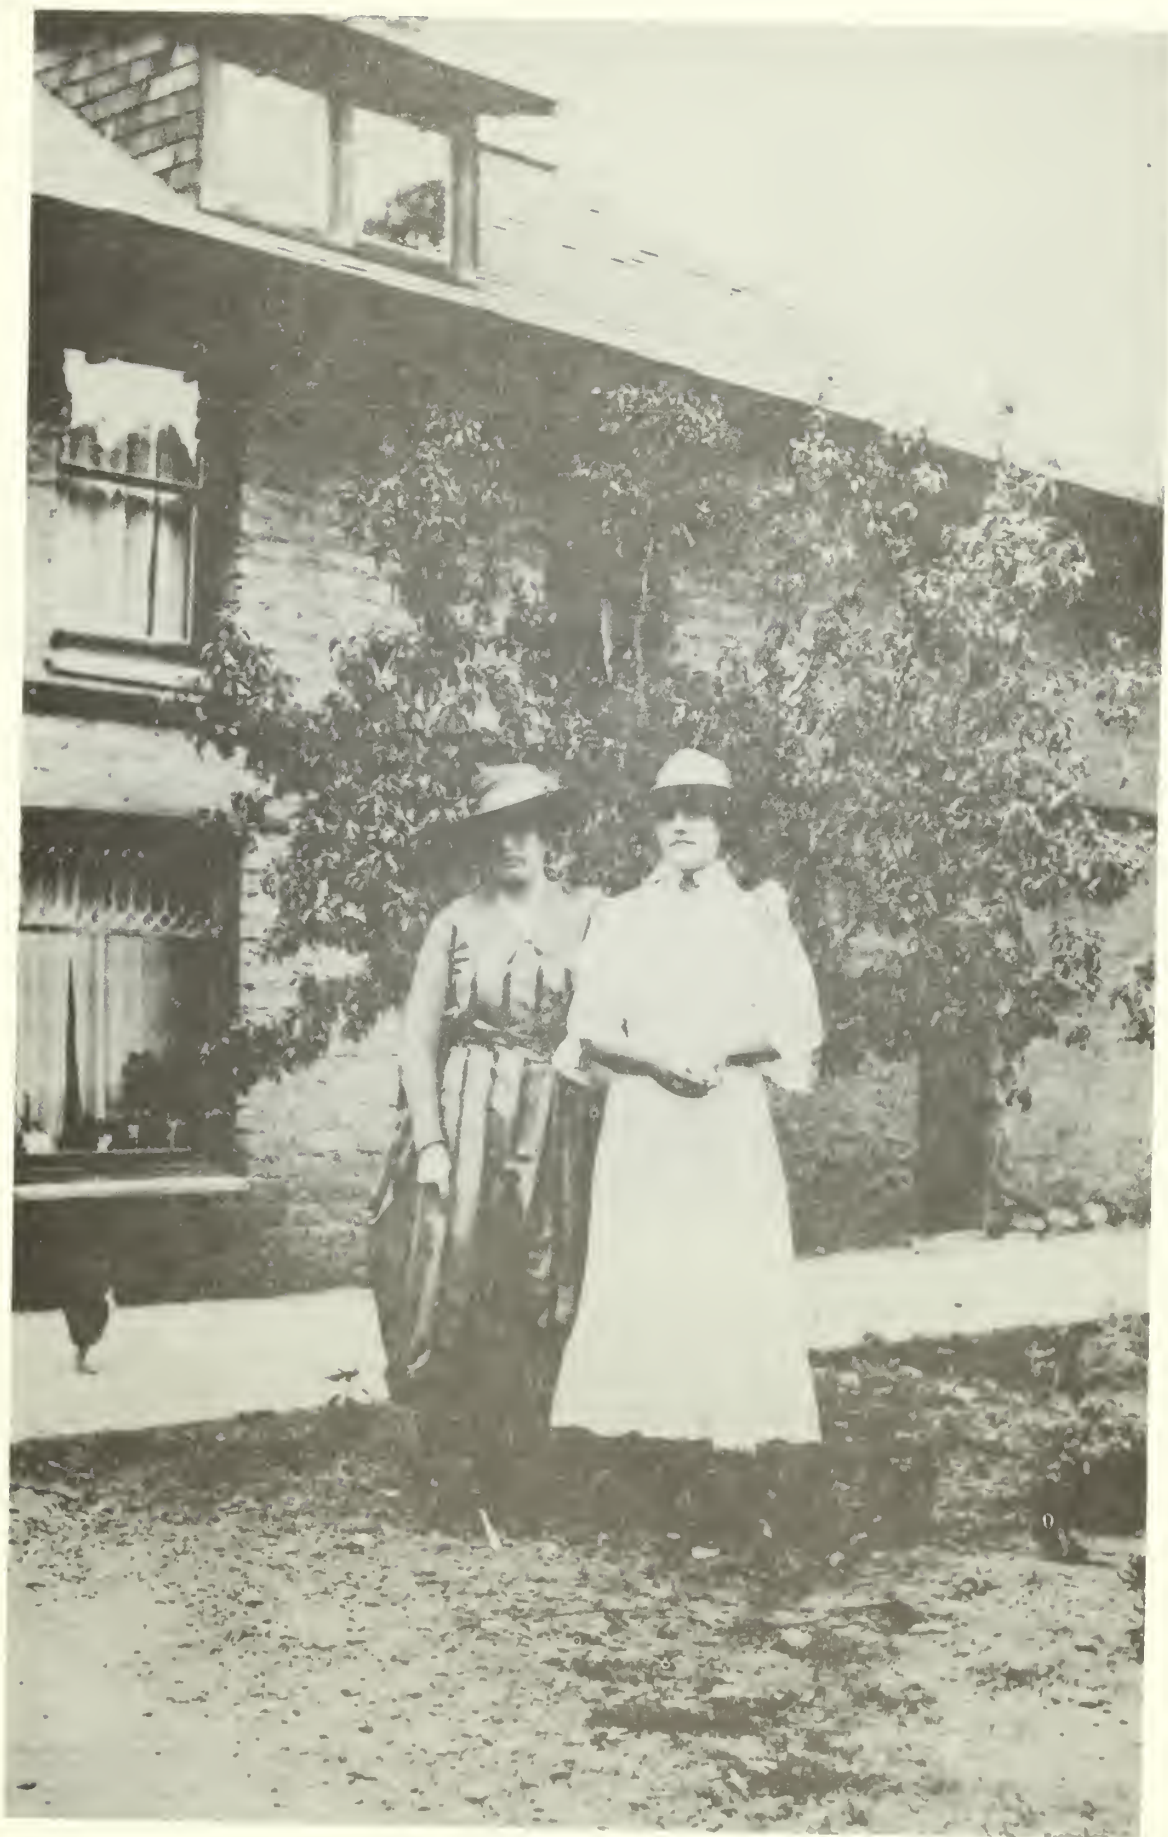
ILLUSTRATION NO. 12

Main House (adobe section), 1920  
(Erickson-Riggs Collection)

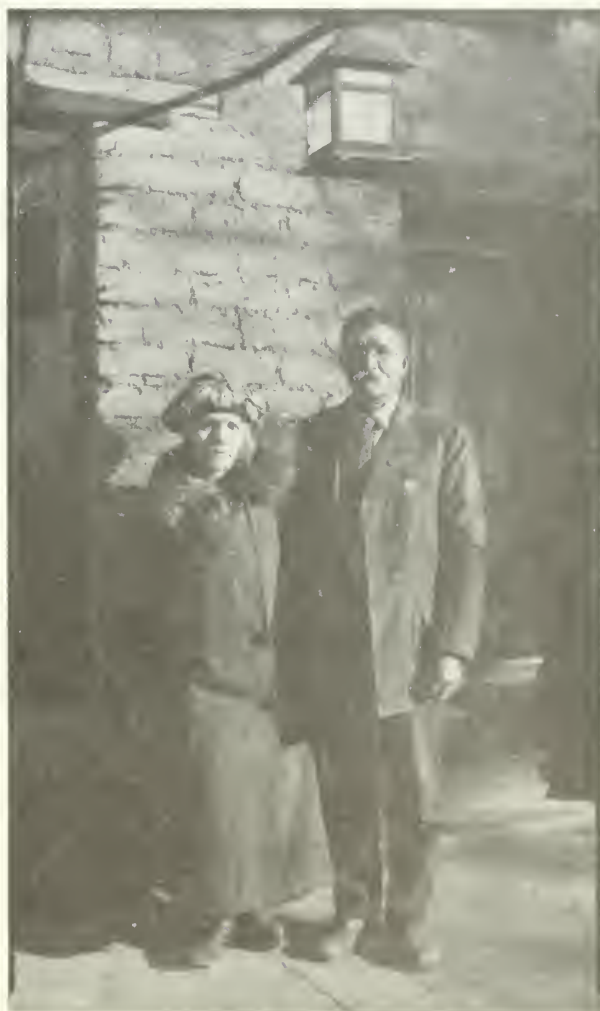
ILLUSTRATION NO. 16

Stafford Cabin (second Addition or lean-to), ca. 1900  
(Erickson-Riggs Collection)

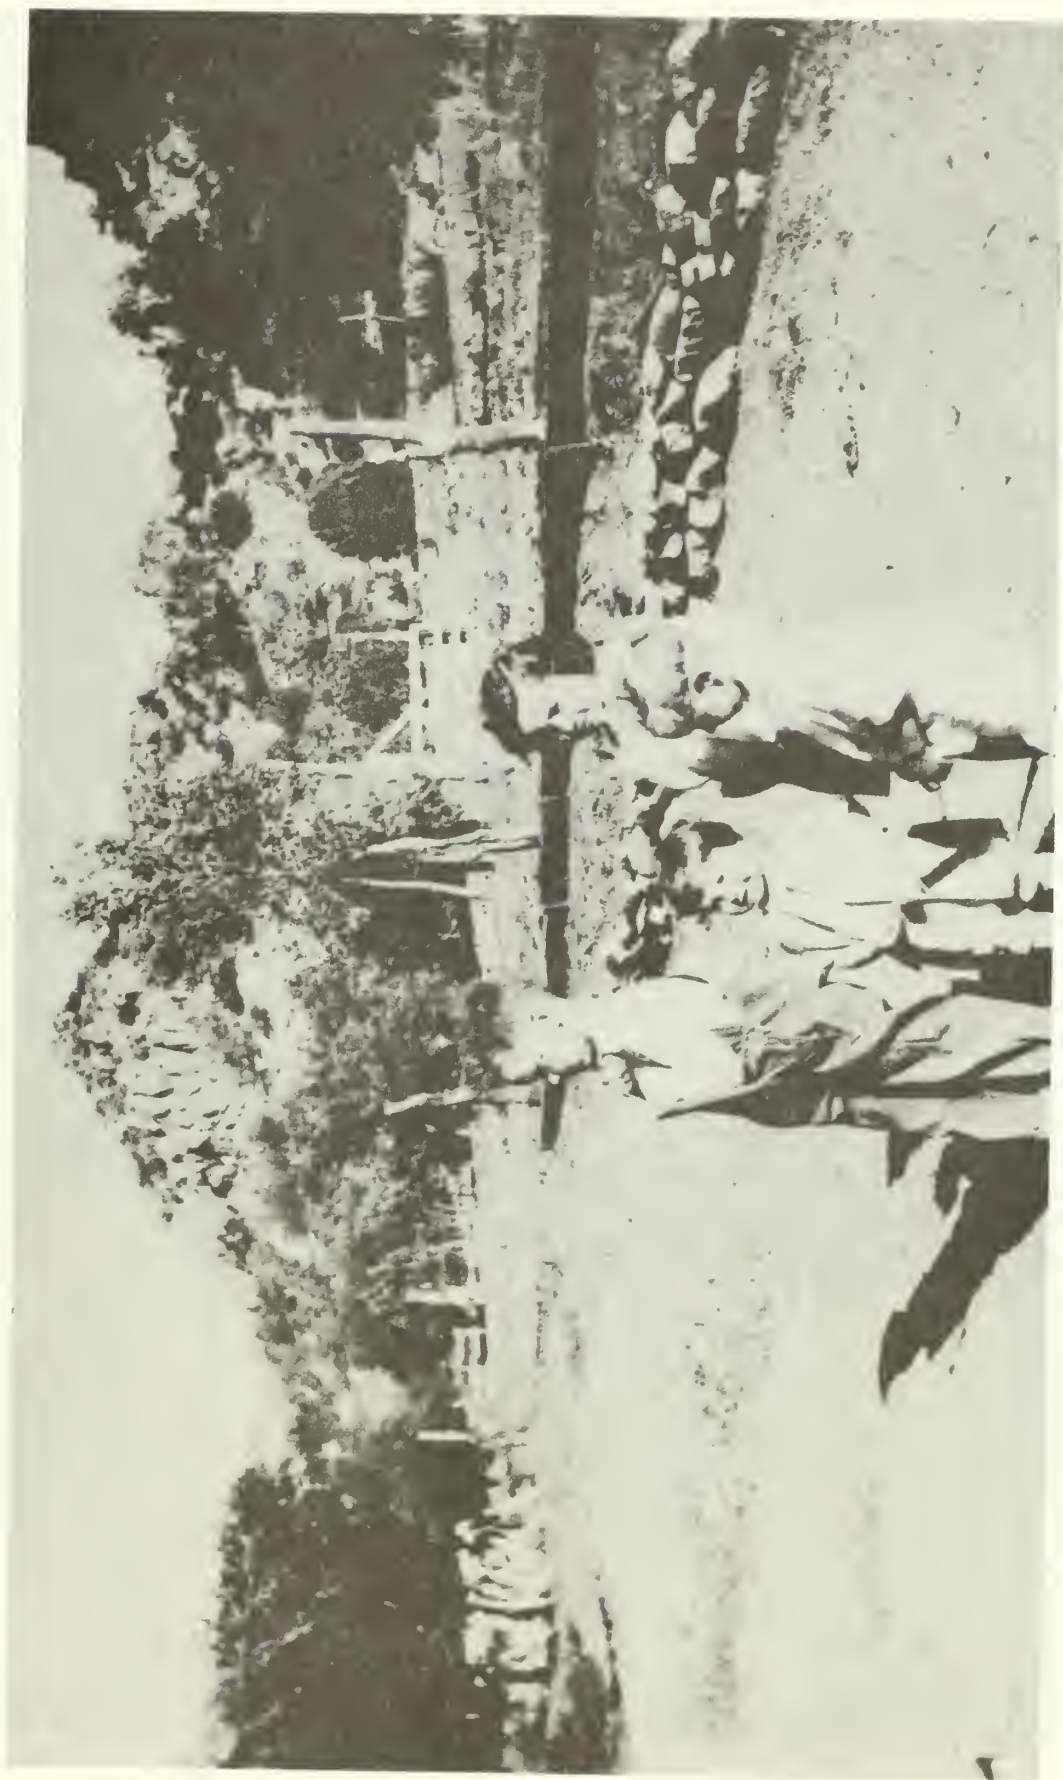
ILLUSTRATION NO. 40

Gate, low stone wall, and other barriers, ca. 1930s  
(Erickson-Riggs Collection)
