INVENTORY OF  
SIGNIFICANT  
STRUCTURES

ARCHITECTURAL CHARACTER GUIDELINES

SEQUOIA &  
KINGS CANYON  
NATIONAL  
PARKS

Laura Soullière Harrison  
Architectural Historian  
National Park Service  
Southwest Regional Office  
February, 1989

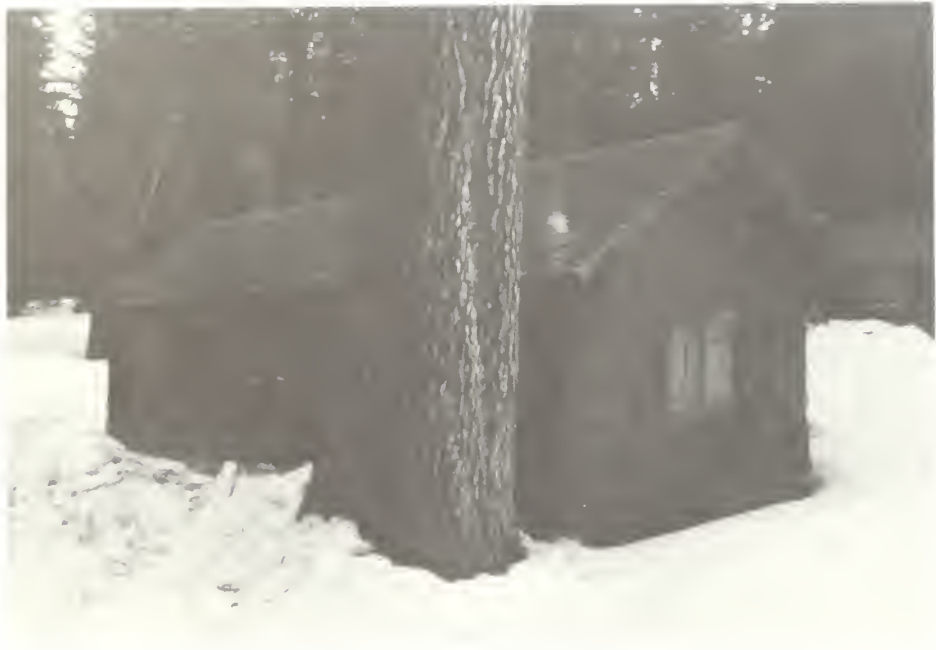
**Building:** Grant Grove Village Cabin 5-6

This cottage, too, is part of the complex of identical rustic cottages of Grant Grove Village. Again, the group of cottages is more important than the individual structures. The building's character-defining features are: the shake exterior walls; the wood-shingle gable roof with double-coursing every fifth row; the paired, six-light casement windows; the bracketed and beveled outlookers; the traditional brown color with lichen-green trim; and the building's placement in the informal layout of the group.

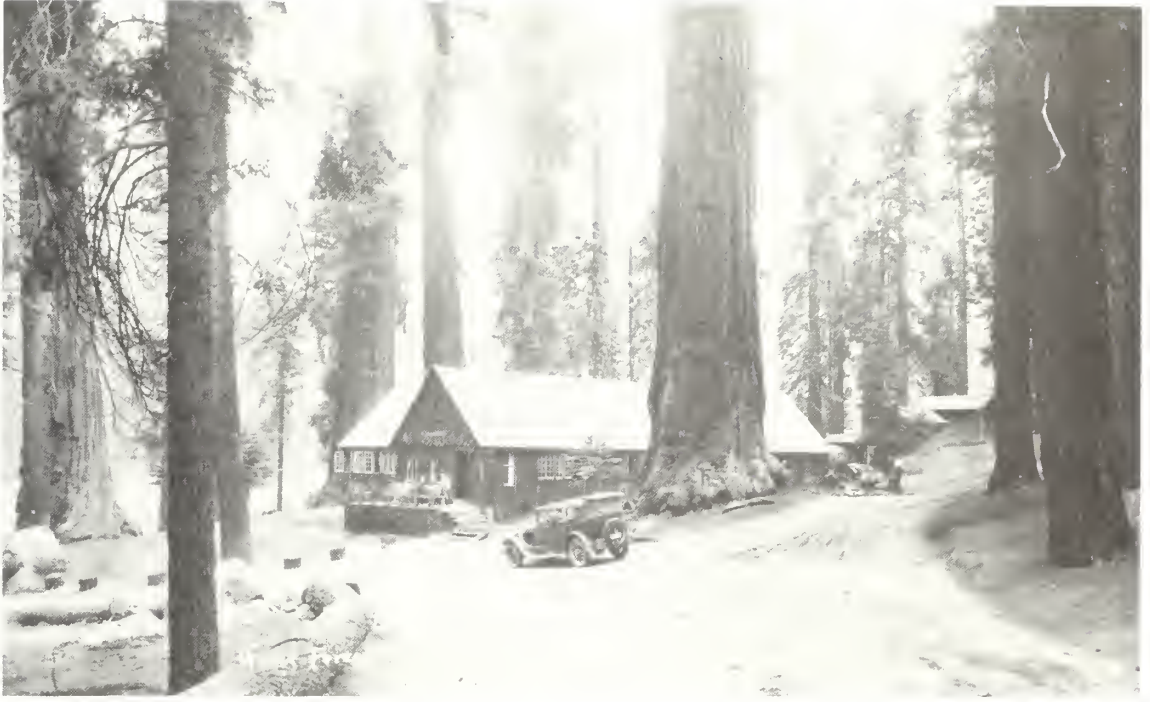
The main building of Giant Forest Lodge (circa 1920) sported a shake roof and Sequoia bark siding. The bright green paint around the window frames and mullions duplicated the green lichen that frequently appeared on adjacent fir trees. Although this building had a simple, functional form, its exterior materials tied the building with its setting.

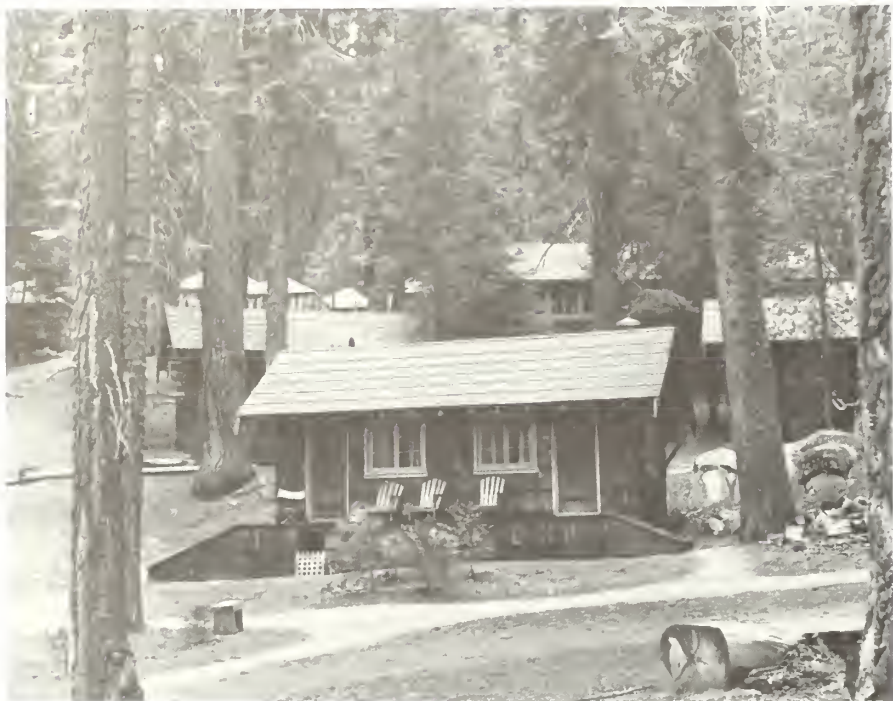
The concessioner offered a variety of overnight accommodations in Giant Forest. The small duplexes (above) dated from 1921. Their shake exteriors, lichen-green trim, wood-shingled roofs, and wrought-iron door hardware were carefully repeated in cottage after cottage. Architect Herbert Maier designed these buildings. The cleaner lined cottages of the mid-1930s (below) had enough architectural variety to defy boredom. Vertical siding defined the corners. Horizontal siding covered the remaining wall spaces. The shingle pattern added even more texture.

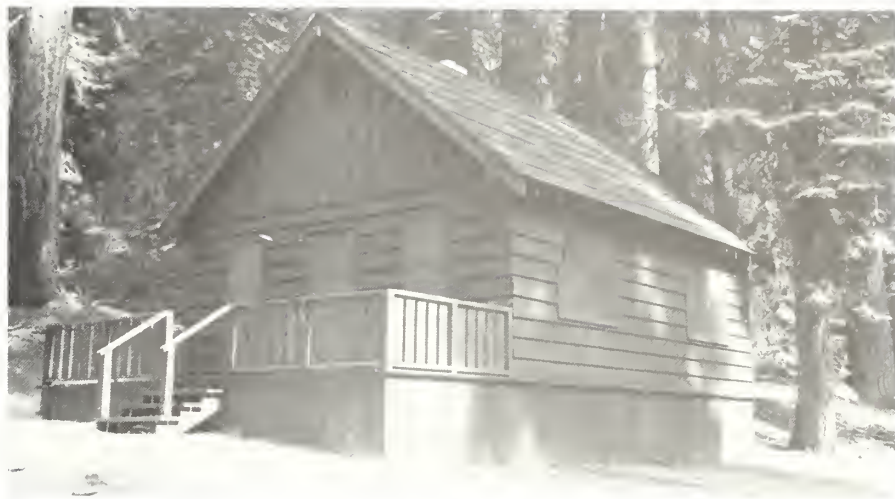
Other buildings at the 7,000-foot elevation possessed a decidedly rustic air. The vertical board-and-batten siding in the gable ends provided a counterpoint to the wide, horizontal boards of the principle siding. The buildings possessed both style and practicality. Above is B-89, a seasonal residence at Wolverton. Below is the Lodgepole Fire Dormitory.

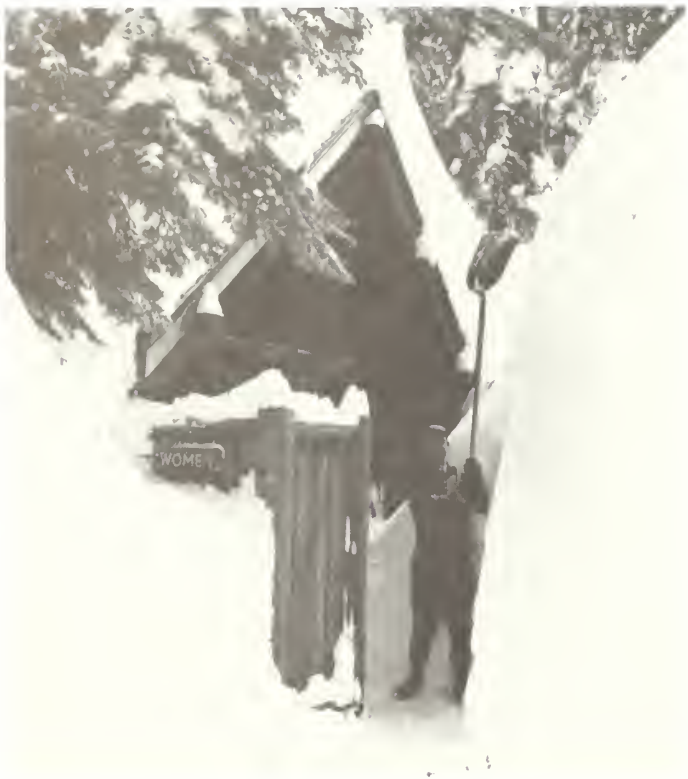
Heavy snows have caused considerable stress to buildings in the higher elevations. In 1952 (above), 1969 (below), and 1983, record snows buried buildings under tons of snow.

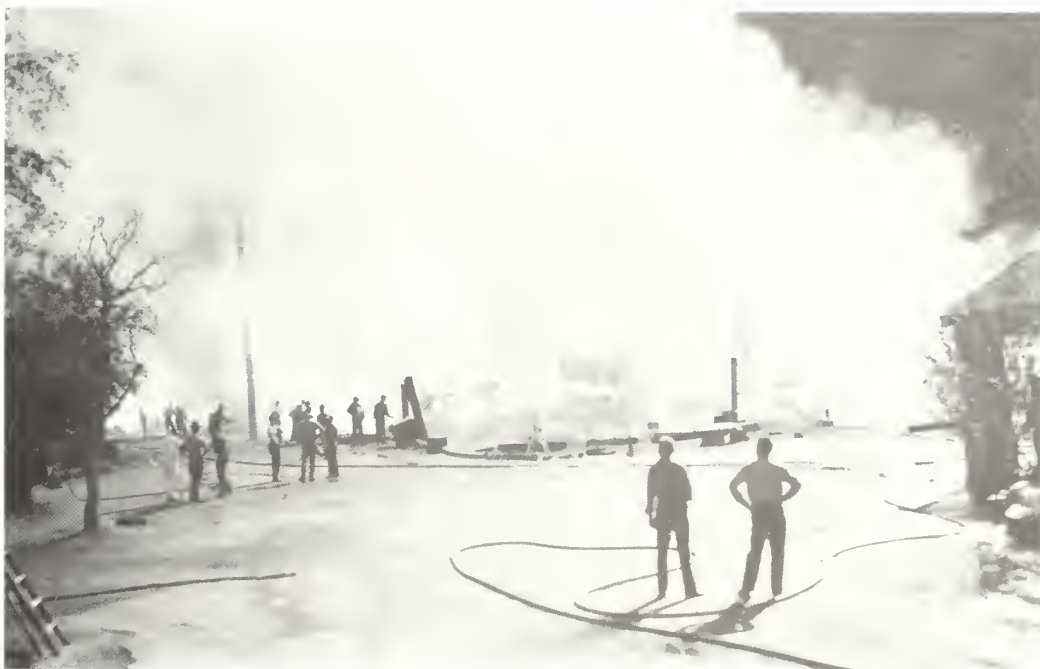
The Ash Mountain fire of November 11, 1939 destroyed several maintenance buildings and could have taken most of the woodframe headquarters development with it. Luckily conditions for spread of fire were minimal on that day. Even so, the hot drafts from the fire blew roof shingles a mile away. As a result of this fire, all new construction in Ash Mountain had to be fireproof.

I think it essential that we cease immediately the construction of buildings in the Ash Mtn. area consisting of shake sidewalls and shingles on the roof. We found large quantities of partly burned shakes and shingles as much as a mile away from Ash Mtn. If conditions for spread of fire had been favorable on that particular day, the entire Middle Fork of the Kaweah River Valley would perhaps have been burned out. It is therefore recommended that all existing residence plans for the Ash Mtn. area be revised to provide for a reasonable fire resistant roof and stucco side walls.<sup>12</sup>

A letter to the Regional Director four months later also recommended that any maintenance buildings in Ash Mountain be constructed of reinforced concrete.<sup>13</sup> Thus the preference for California cottages and wood-frame maintenance buildings succumbed to the harsher realities of nature in the Sierra foothills.

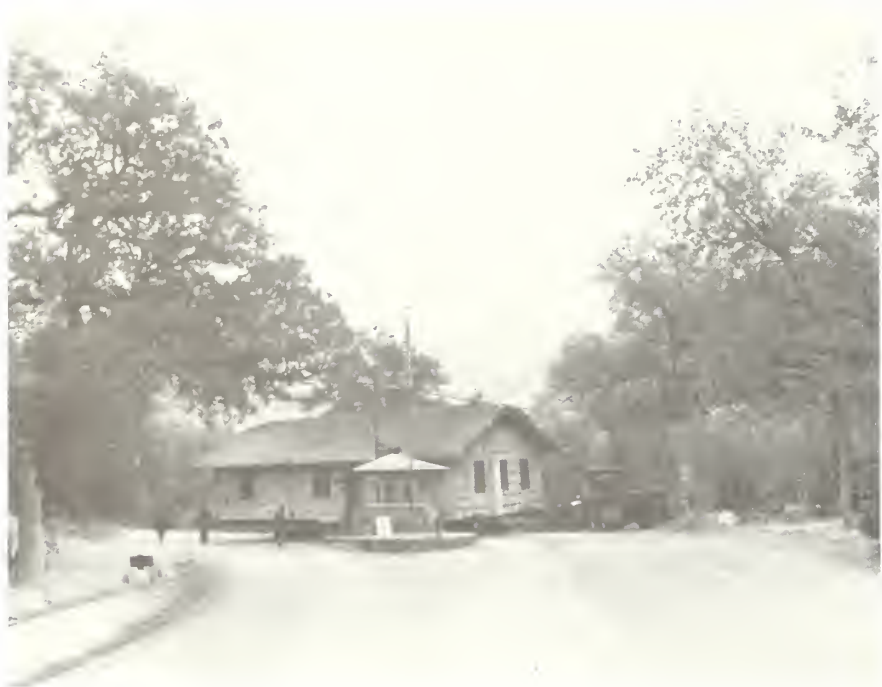
Moving buildings is a tradition in Sequoia and Kings Canyon. Among the many benefits of the post-and-block foundation is its lightness on the land. The building can be picked up easily and transported to another location. The building leaves a minimal scar.

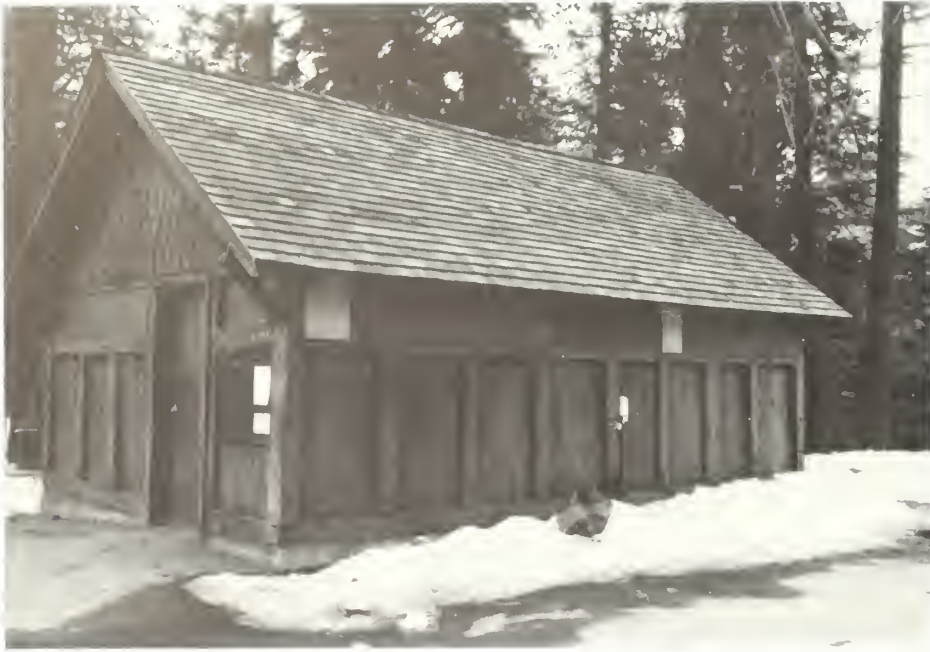
**Building:** Azalea Campground Comfort Station B-257

The building possessed a handcrafted look because of the hewn timbers and puncheons. The building has a wonderful rough texture that relates it to the texture of the surrounding forest.
