Meridian Hill Park Cultural Landscape Report Volume 2: Treatment

National Park Service - National Capital Region
Contract #: 1443X300094034
architrave, p.c. architects, Washington, D.C.

30 November 2001

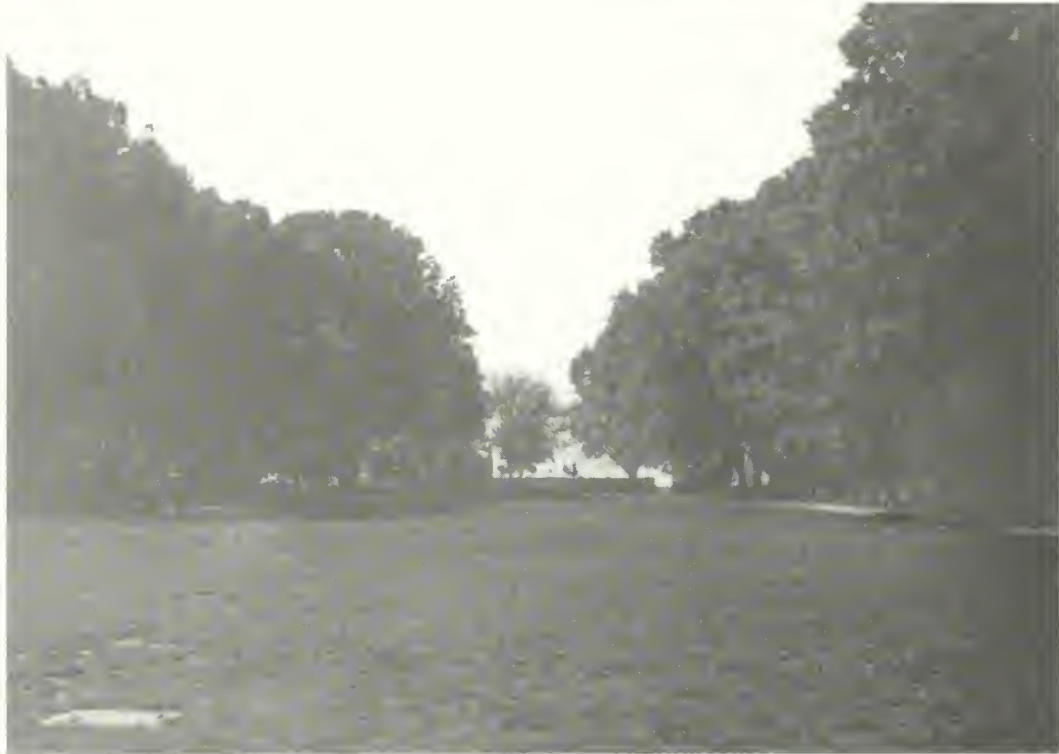
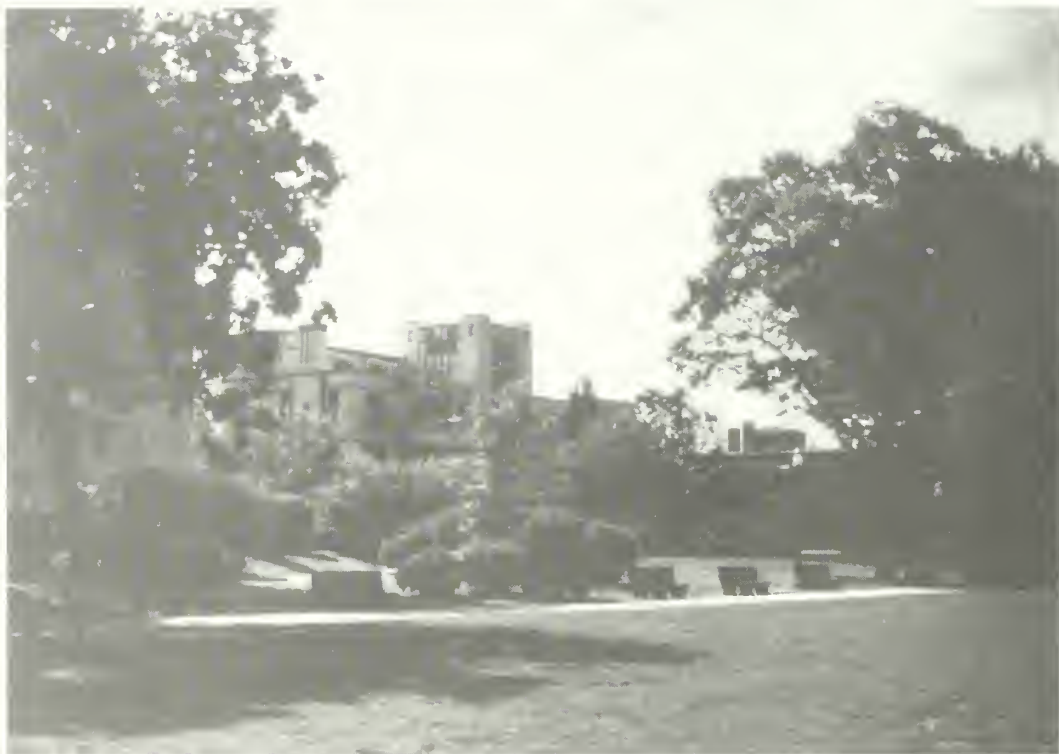
Above: This view south along the main axis of the park through the mall toward the great terrace overlook shows how effectively the mature oaks behind the mall walkways contain and define the mall space.

Below: However, as seen in this image, the loss of two of these mature trees leaves a substantial gap in that edge definition.

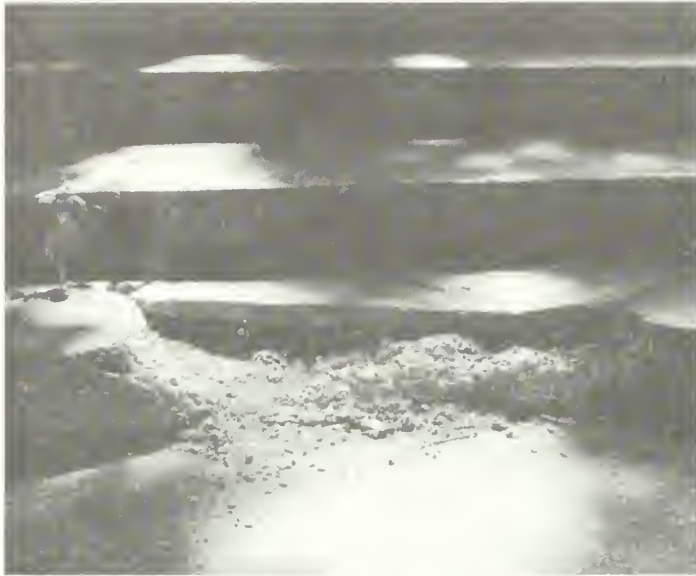
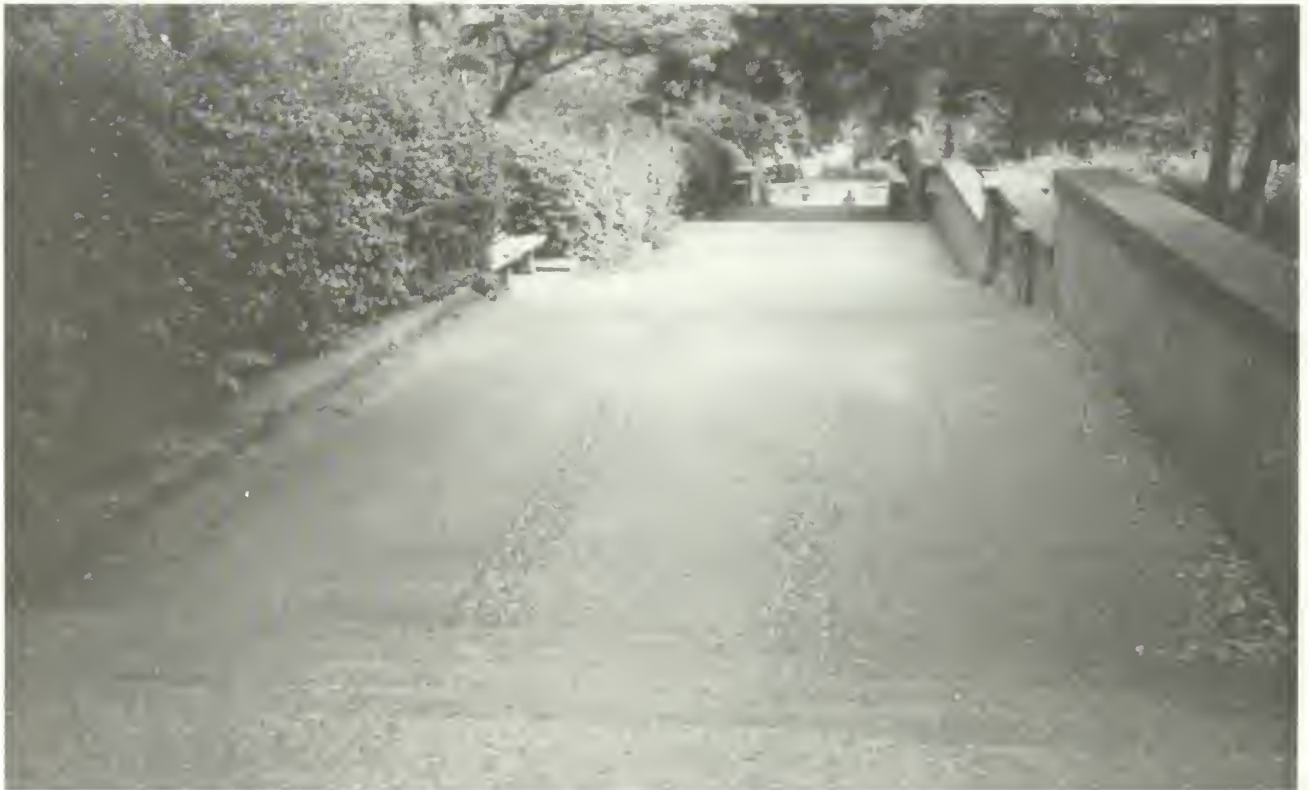
Below left: Corroboration that the method called for in the specifications for pouring pavement in two layers is provided in this picture of the deteriorated steps at the upper 16th Street entrance.

Above and above right: While the colors are not seen in these pictures, the tonal and textural differentiation created by polychromy in the concrete aggregate is nonetheless visible. It is critical that the colors and types of aggregates used in the historic concrete in the park be matched exactly in any new or repair concrete work.

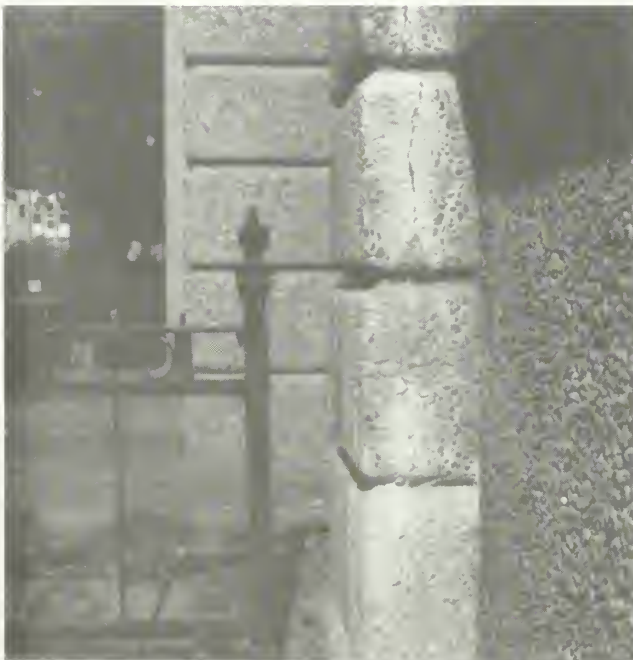
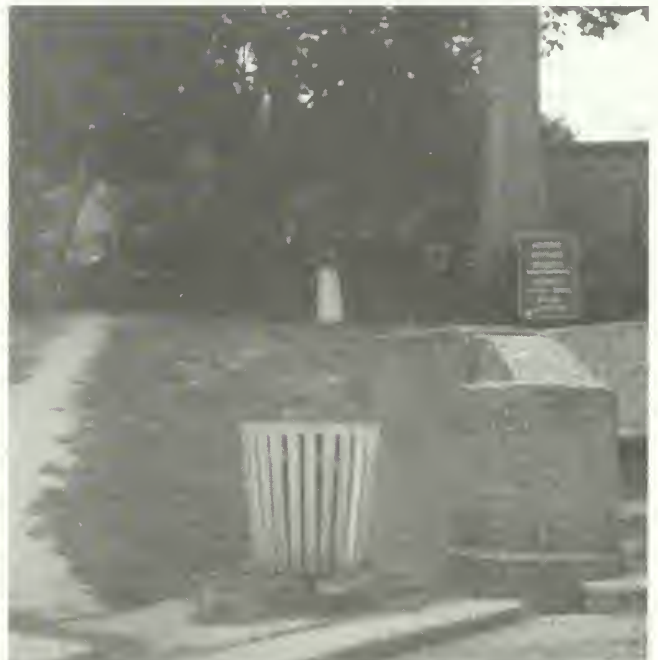
Fountain basin with missing lip and severe deterioration at main 16th Street entrance.

(above left) An example of cracks and efflorescence, on the northern wall of the park, looking west from the children's play area. This fence finial is the only one still in place on the fence at this play area.

(above right) This picture illustrates the agglomeration that has occurred in the park since its official opening in 1936. Intrusive and non-original elements include the signage, the replacement drinking fountain, the tulip- type trash receptacle, and the informal path. This view is taken from the entrance at 15th and W Streets looking toward the lower plaza.

- all cracks and spalls in walls, piers, and paving
- the lip of the western bowl fountain on the great terrace
- damaged stairs
- heaved and deteriorated paving
- all locations of exposed reinforcing steel

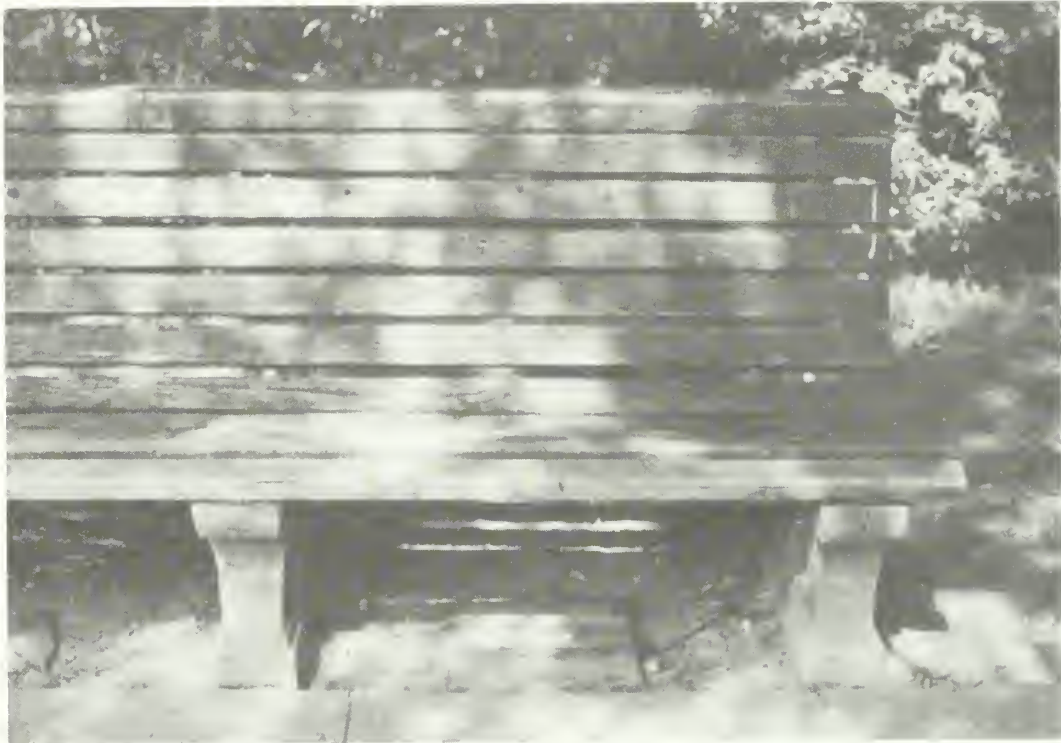
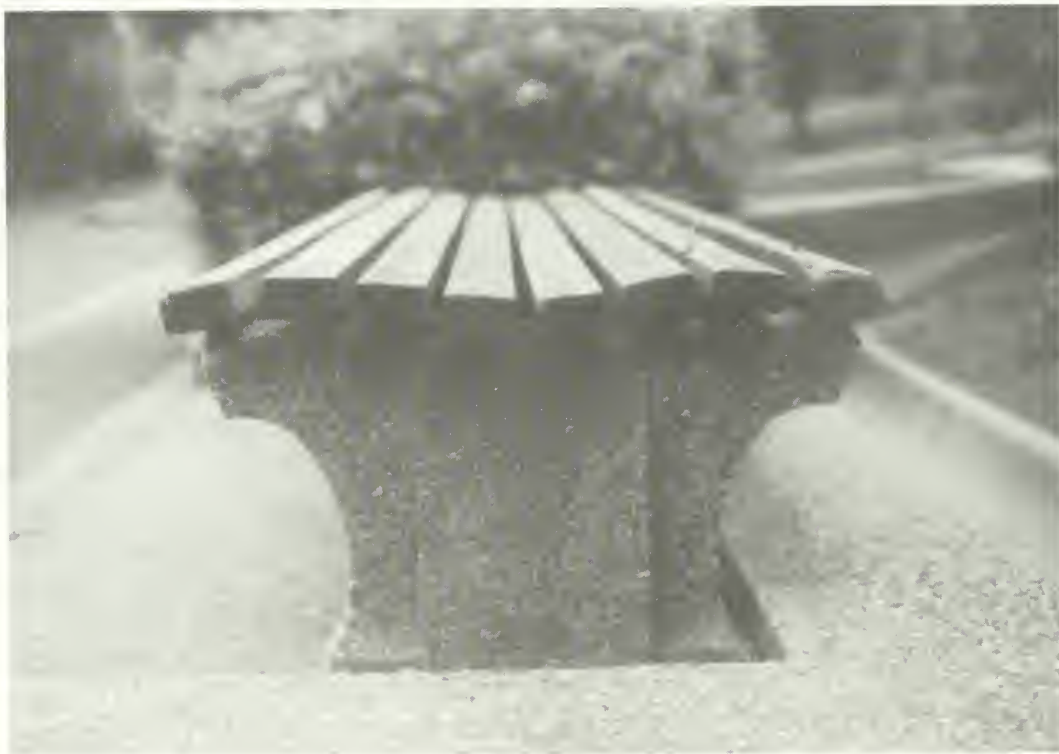
The original bench slat attachment detail on these contoured benches is both elegant and difficult to maintain. It is critical to develop a practical method of attachment that is consistent with the historic character of the benches.
