AMISTAD NATIONAL RECREATION AREA,
TEXAS

WATER RESOURCES SCOPING REPORT

Technical Report NPS/NRWRD/NRTR-2001/295

September, 2001

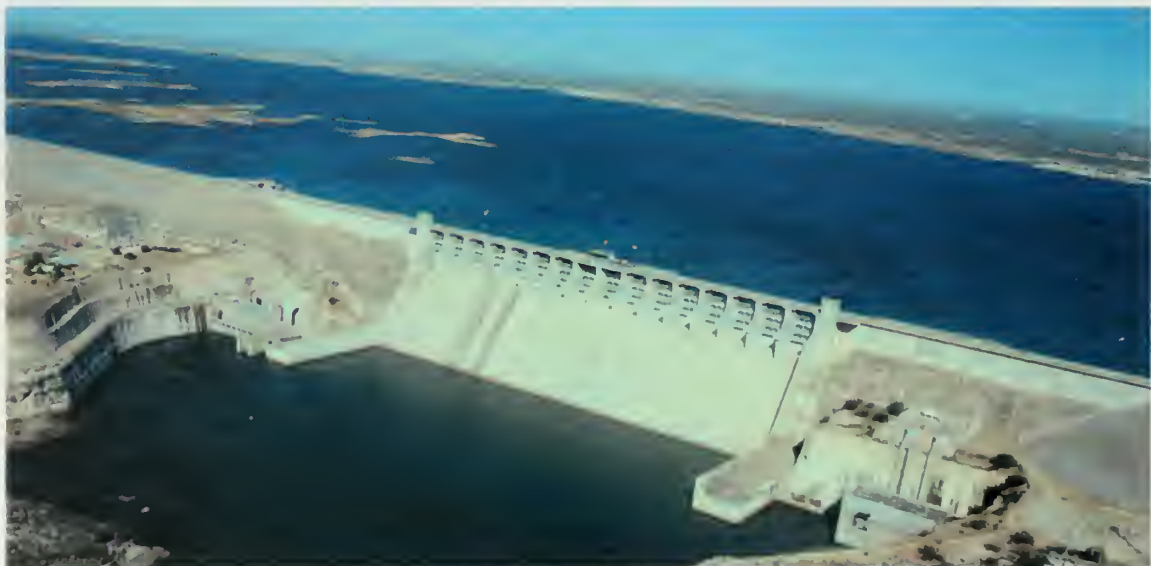
Figure 2. Amistad Dam

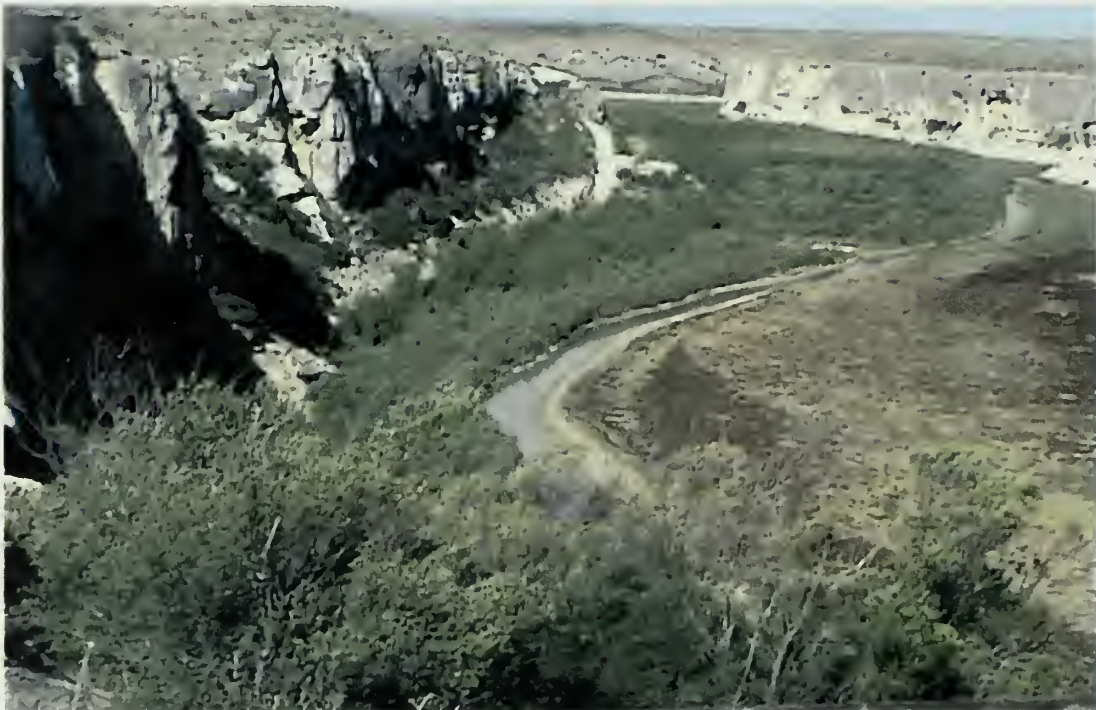
Figure 5. Pecos River just above Confluence with Rio Grande.

Amistad NRA manages 16 miles (25.8 km) of the Pecos River. From the boundary to the reservoir conservation pool of 1,117 feet (340 m), the Pecos River flows for 3 miles (4.8 km). The Pecos River gauging station, near Langtry, is located at an elevation of 1,136 feet (346 m). Since 1995, the Pecos River has been free flowing for a total of 9 miles (14.9 km) from the boundary to Deadman's Canyon. Below Deadman's Canyon, the Pecos River is lined by steep limestone canyon walls and slows to a 6 mile (9.7 km) long pool to the US 90 bridge (Figure 4). Sediment deposition in the lower Pecos along with low reservoir water levels has formed the pool environment above the US 90 bridge. When the lake level is low, as at present, the Pecos flows from the US 90 bridge to the confluence with the Rio Grande for approximately one mile (1.6 km), forming a narrow shallow incised channel (Figure 5).

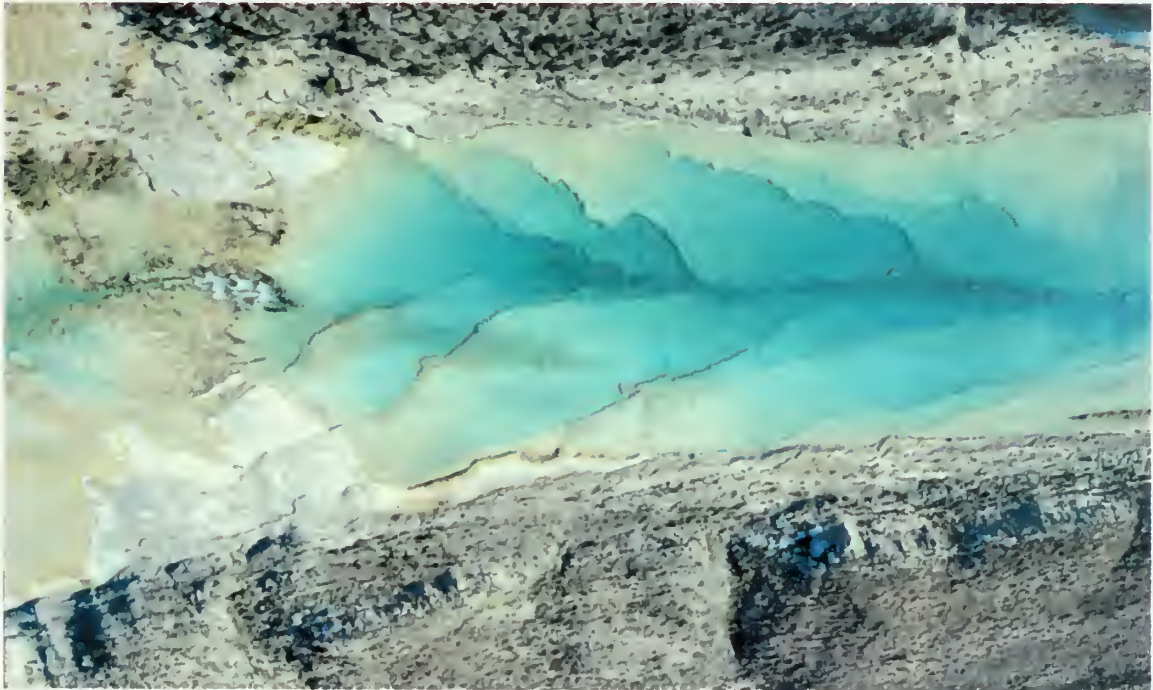
Figure 6. Aerial Close up of Devils River Channel

The Devils River flows over a base structure of limestone shelves, forming swift narrow runs alternating with calm braided channels and slow flowing pools (Figure 6). Pecan, oak and sycamore are found along the riverbanks (Figure 7). Salt cedar has not become a nuisance exotic species in this system, due to the semi-annual high flows, which scour shorelines and benefit native plant regeneration.

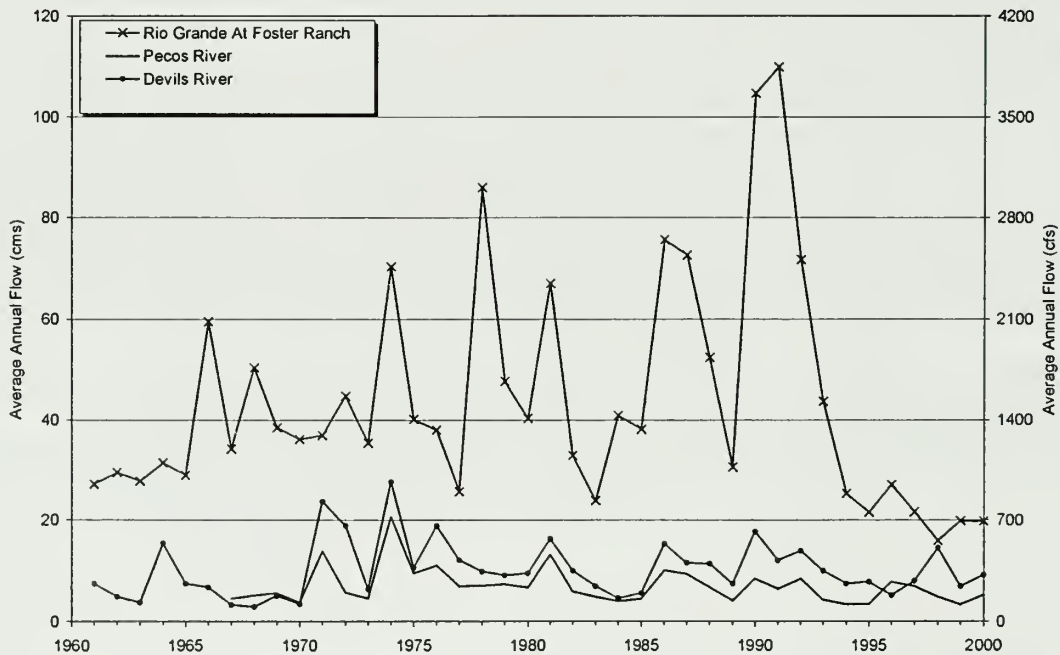
Figure 1. Annual Mean Flow of the Major Tributaries to Amistad Reservoir.

Flow from the Rio Grande (Rio Bravo), Pecos River and the Devils River; account for more than 70% of the estimated inflows to Amistad Reservoir. The remaining third of reservoir inflows are contributed primarily from springs, the largest being Goodenough Spring, which was inundated when the reservoir filled. Early streamflow records show that Goodenough Spring averaged almost 62,000 cubic feet per second (cfs) (1,750 cubic meters per second (cms)). Other springs are located along the Devils River below the gauging station and around the circumference of the reservoir as described in the previous section. In response to localized rainstorms, several ungauged Mexican arroyos also flow into the reservoir.

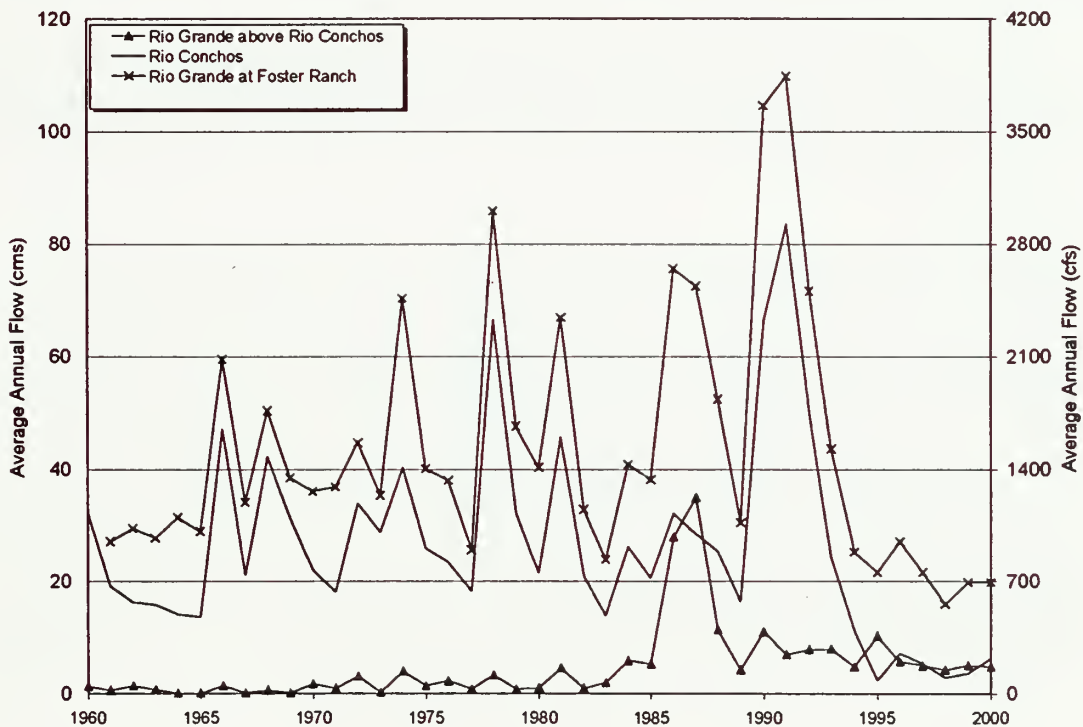
Figure 10. Average annual flows of the Rio Conchos, Rio Grande above the Rio Conchos and Rio Grande at Foster Ranch (just above Amistad Reservoir).

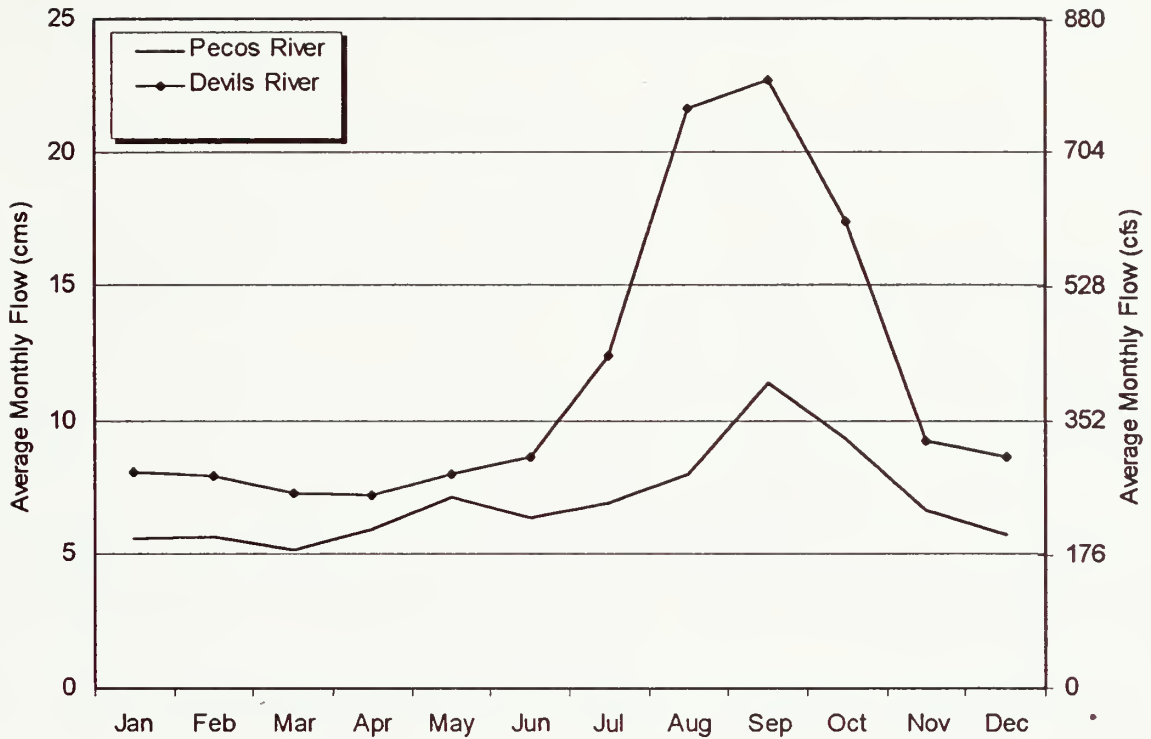
Figure 11. Average Monthly Flow of Pecos and Devils Rivers (1968-1999).

Base flows, originating from springs, average from 106 to 247 cfs (3 to 7 cms). Unlike the other inflows to Amistad Reservoir, base flows appear to be steady over the past 40 years. However, flows could decrease if groundwater use increases in this watershed.

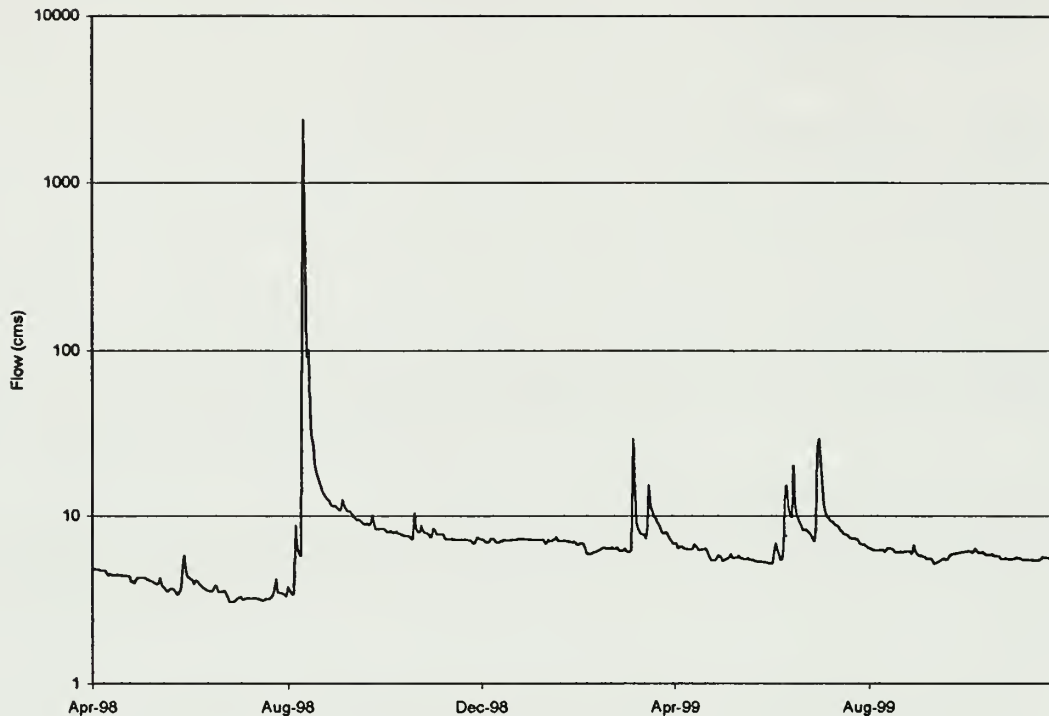
Figure 12. Increase in Devils River Base Flow Following a Large Rain Event in September, 1998.

Peak flows are very flashy, with a typical high flow often lasting only a few days. In 1998, a tropical storm stalled over the Del Rio area resulted in a peak flow of 83,341 cfs (2360 cms). In addition, the river had higher base flows for close to a year following the storm (Figure 12). Large storms apparently recharge the limestone aquifer in the watershed, producing higher spring and groundwater flow to the Devils River for months and possibly years after a large rain event.

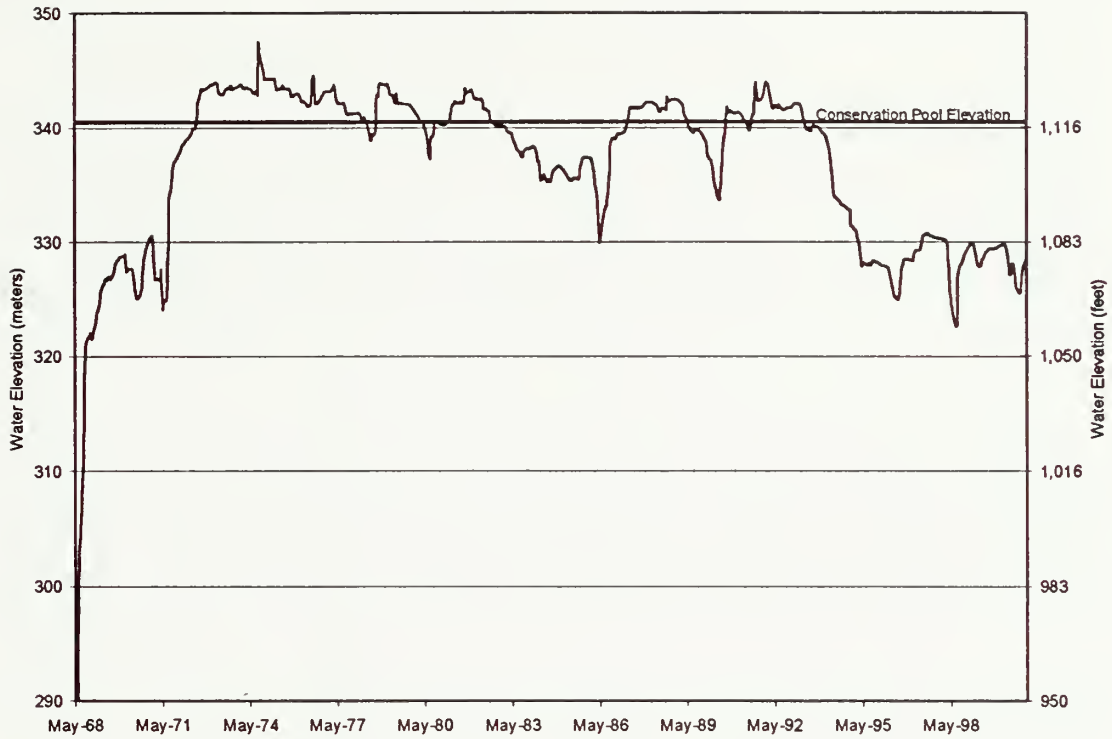
Figure 13. Water Level Elevation of Amistad Reservoir.

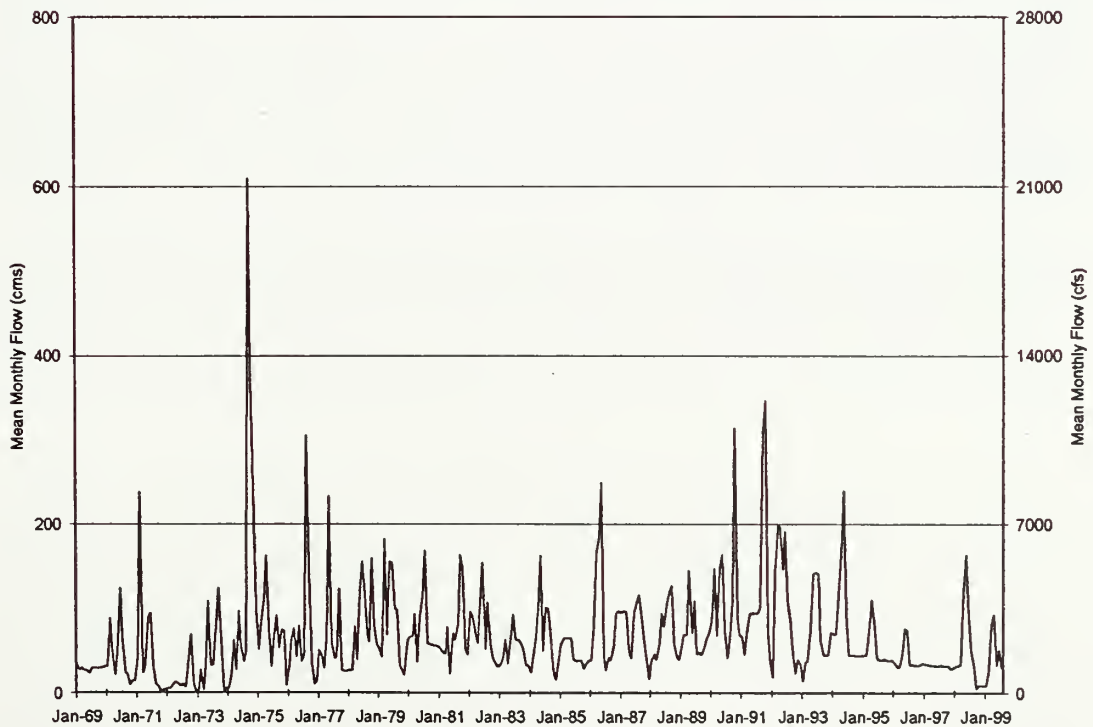
Figure 14. Average Monthly Outflow from Amistad Dam (in cms) from 1969 to Present

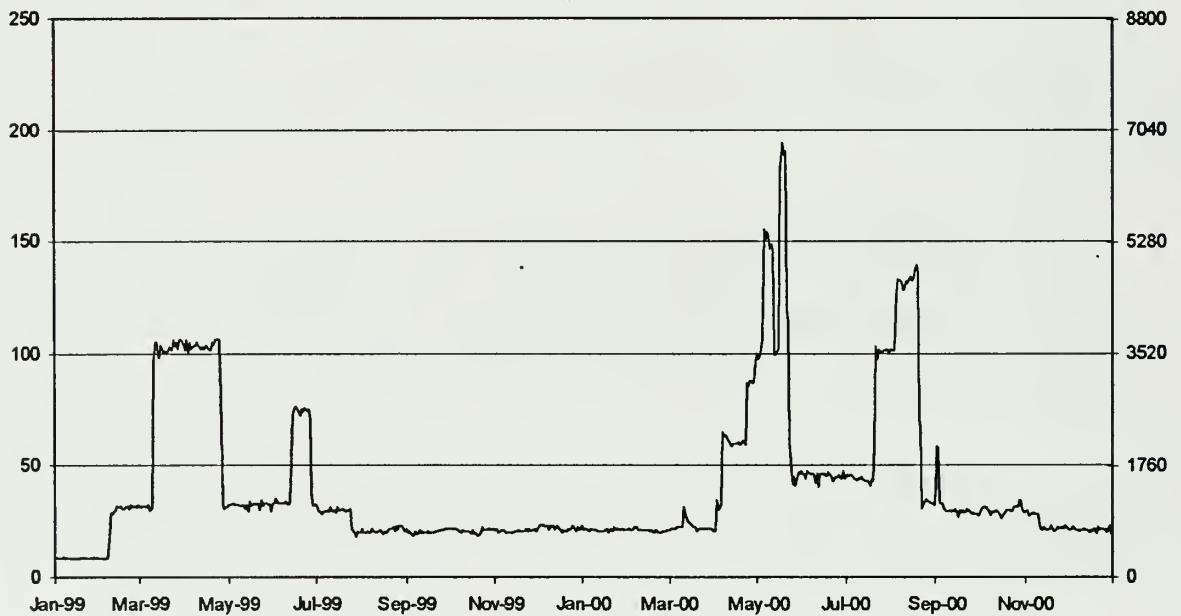
Figure 15. Average daily Amistad Dam Outflows (in cms) for 1990 through 1999.

Outflows through Amistad dam typically are highest during the irrigation season from spring through early summer. The largest flood since the reservoir was completed occurred in September 1974. Several other smaller floods occurred in the late 1970's and the early 1990's (Figure 14). A 1998 tropical storm caused flooding in San Felipe Creek, which flows into the Rio Grande near the town of Del Rio. Reservoir releases have decreased significantly since 1994 due to the decreased flow from the Rio Grande. Figure 15 illustrates the abruptness of the water releases. This unnatural hydrograph is undoubtedly affecting the riparian area directly below Amistad Dam. The abrupt increase and decrease of flow will tend to inhibit the formation and maintenance of channel point bars and riparian areas, and so decreases the aquatic and riparian habitat in this section of the Rio Grande.

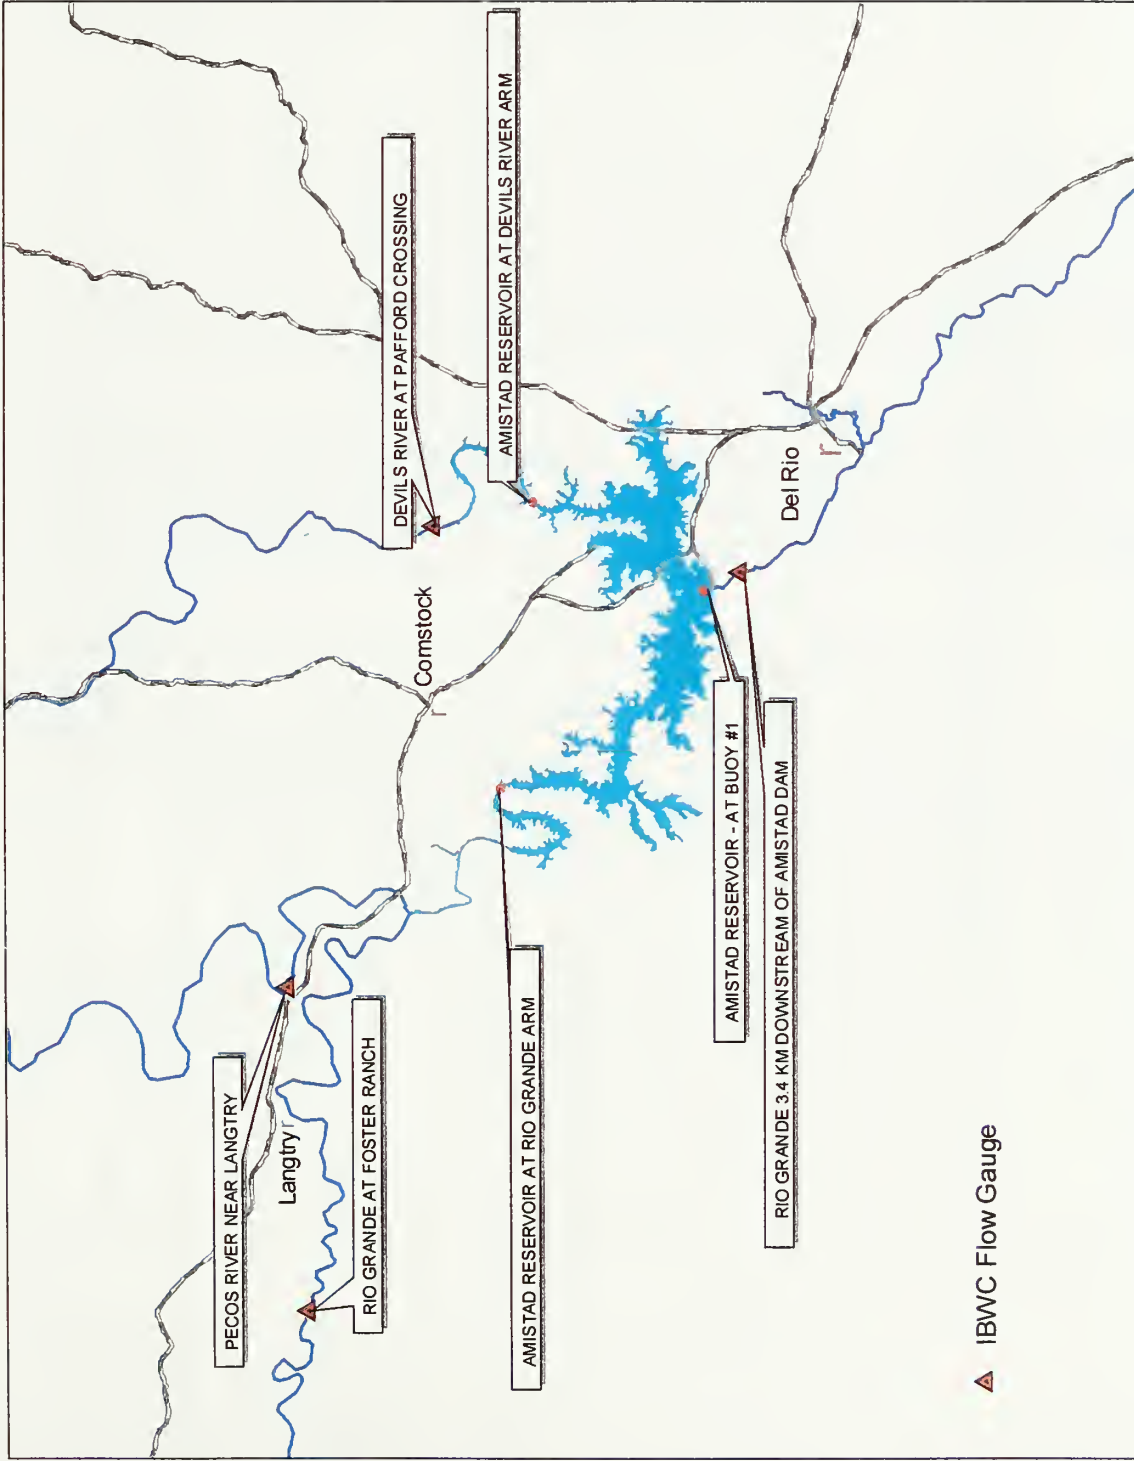
Figure 16. Map of Water Quality and Stream Flow Gauging Stations in the Amistad Area.

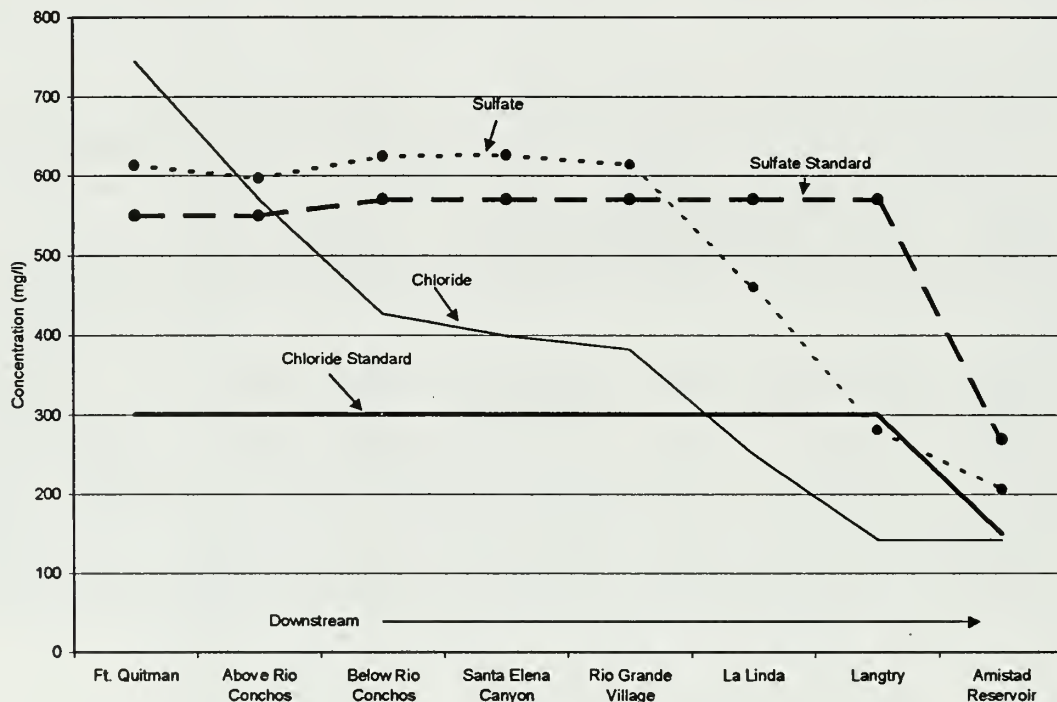
Figure 17. Average Sulfate and Chloride Concentrations (1995-2000) for the Rio Grande Above Amistad. (IBWC, 2001)

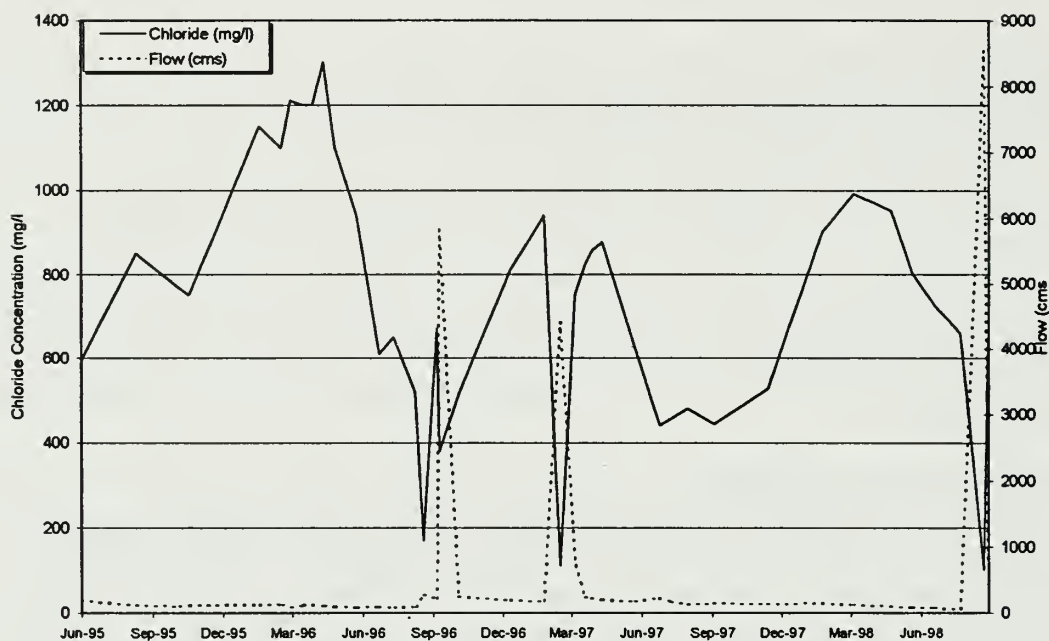
Figure 18. Chloride Concentrations and Streamflow in the Pecos River at Langtry. (from IBWC, 2001)

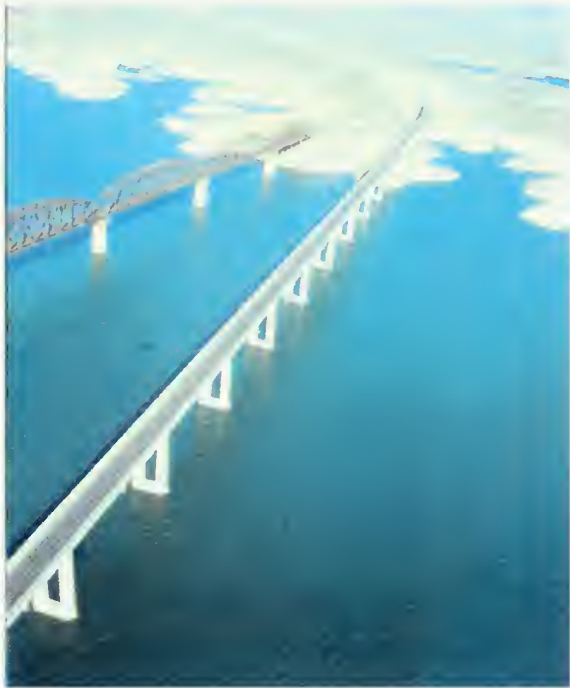
Figure 22. Railroad and Hwy 90 Bridges Crossing Amistad Reservoir

There is potential for both petroleum and hazardous material spills in the vicinity of the International Amistad Reservoir. US 90, a major east-west thoroughfare, parallels the reservoir along most of its length, crossing the reservoir at three locations: Governor's Landing, Evans Creek, and the Pecos River Arm. The Union Pacific Railroad also has a major rail line which generally parallels US 90 crossing the reservoir at both Governor's Landing and at the Pecos High Bridge (Figure 22). US 277/377, a north-south artery connecting Mexico with Interstate 10 crosses the reservoir via a bridge in the vicinity of San Pedro Canyon. A major petroleum or hazardous materials spill at any of these crossings or along drainages tributary to the reservoir has potential to adversely affect the waters within Amistad NRA. Response to third-party spills at these locations would likely come from Val Verde County Emergency Services, the Texas Highway Patrol, the TNRCC, and/or the Union Pacific Railroad.
