DEVILS TOWER NATIONAL MONUMENT  
Wyoming

ENVIRONMENTAL ASSESSMENT/GENERAL MANAGEMENT PLAN/  
DEVELOPMENT CONCEPT PLAN

Devils Tower National Monument  
Crook County  
Wyoming

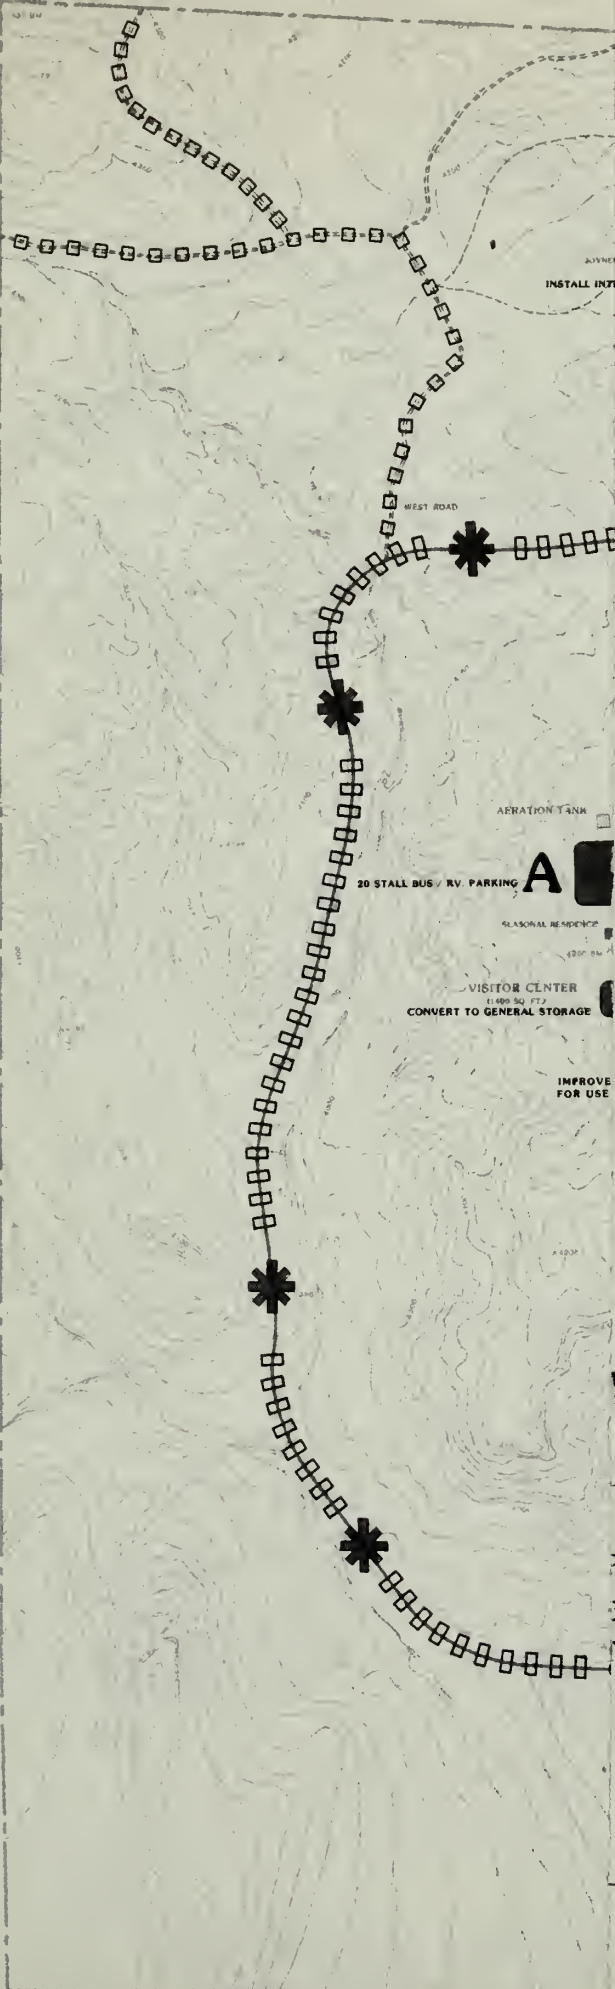
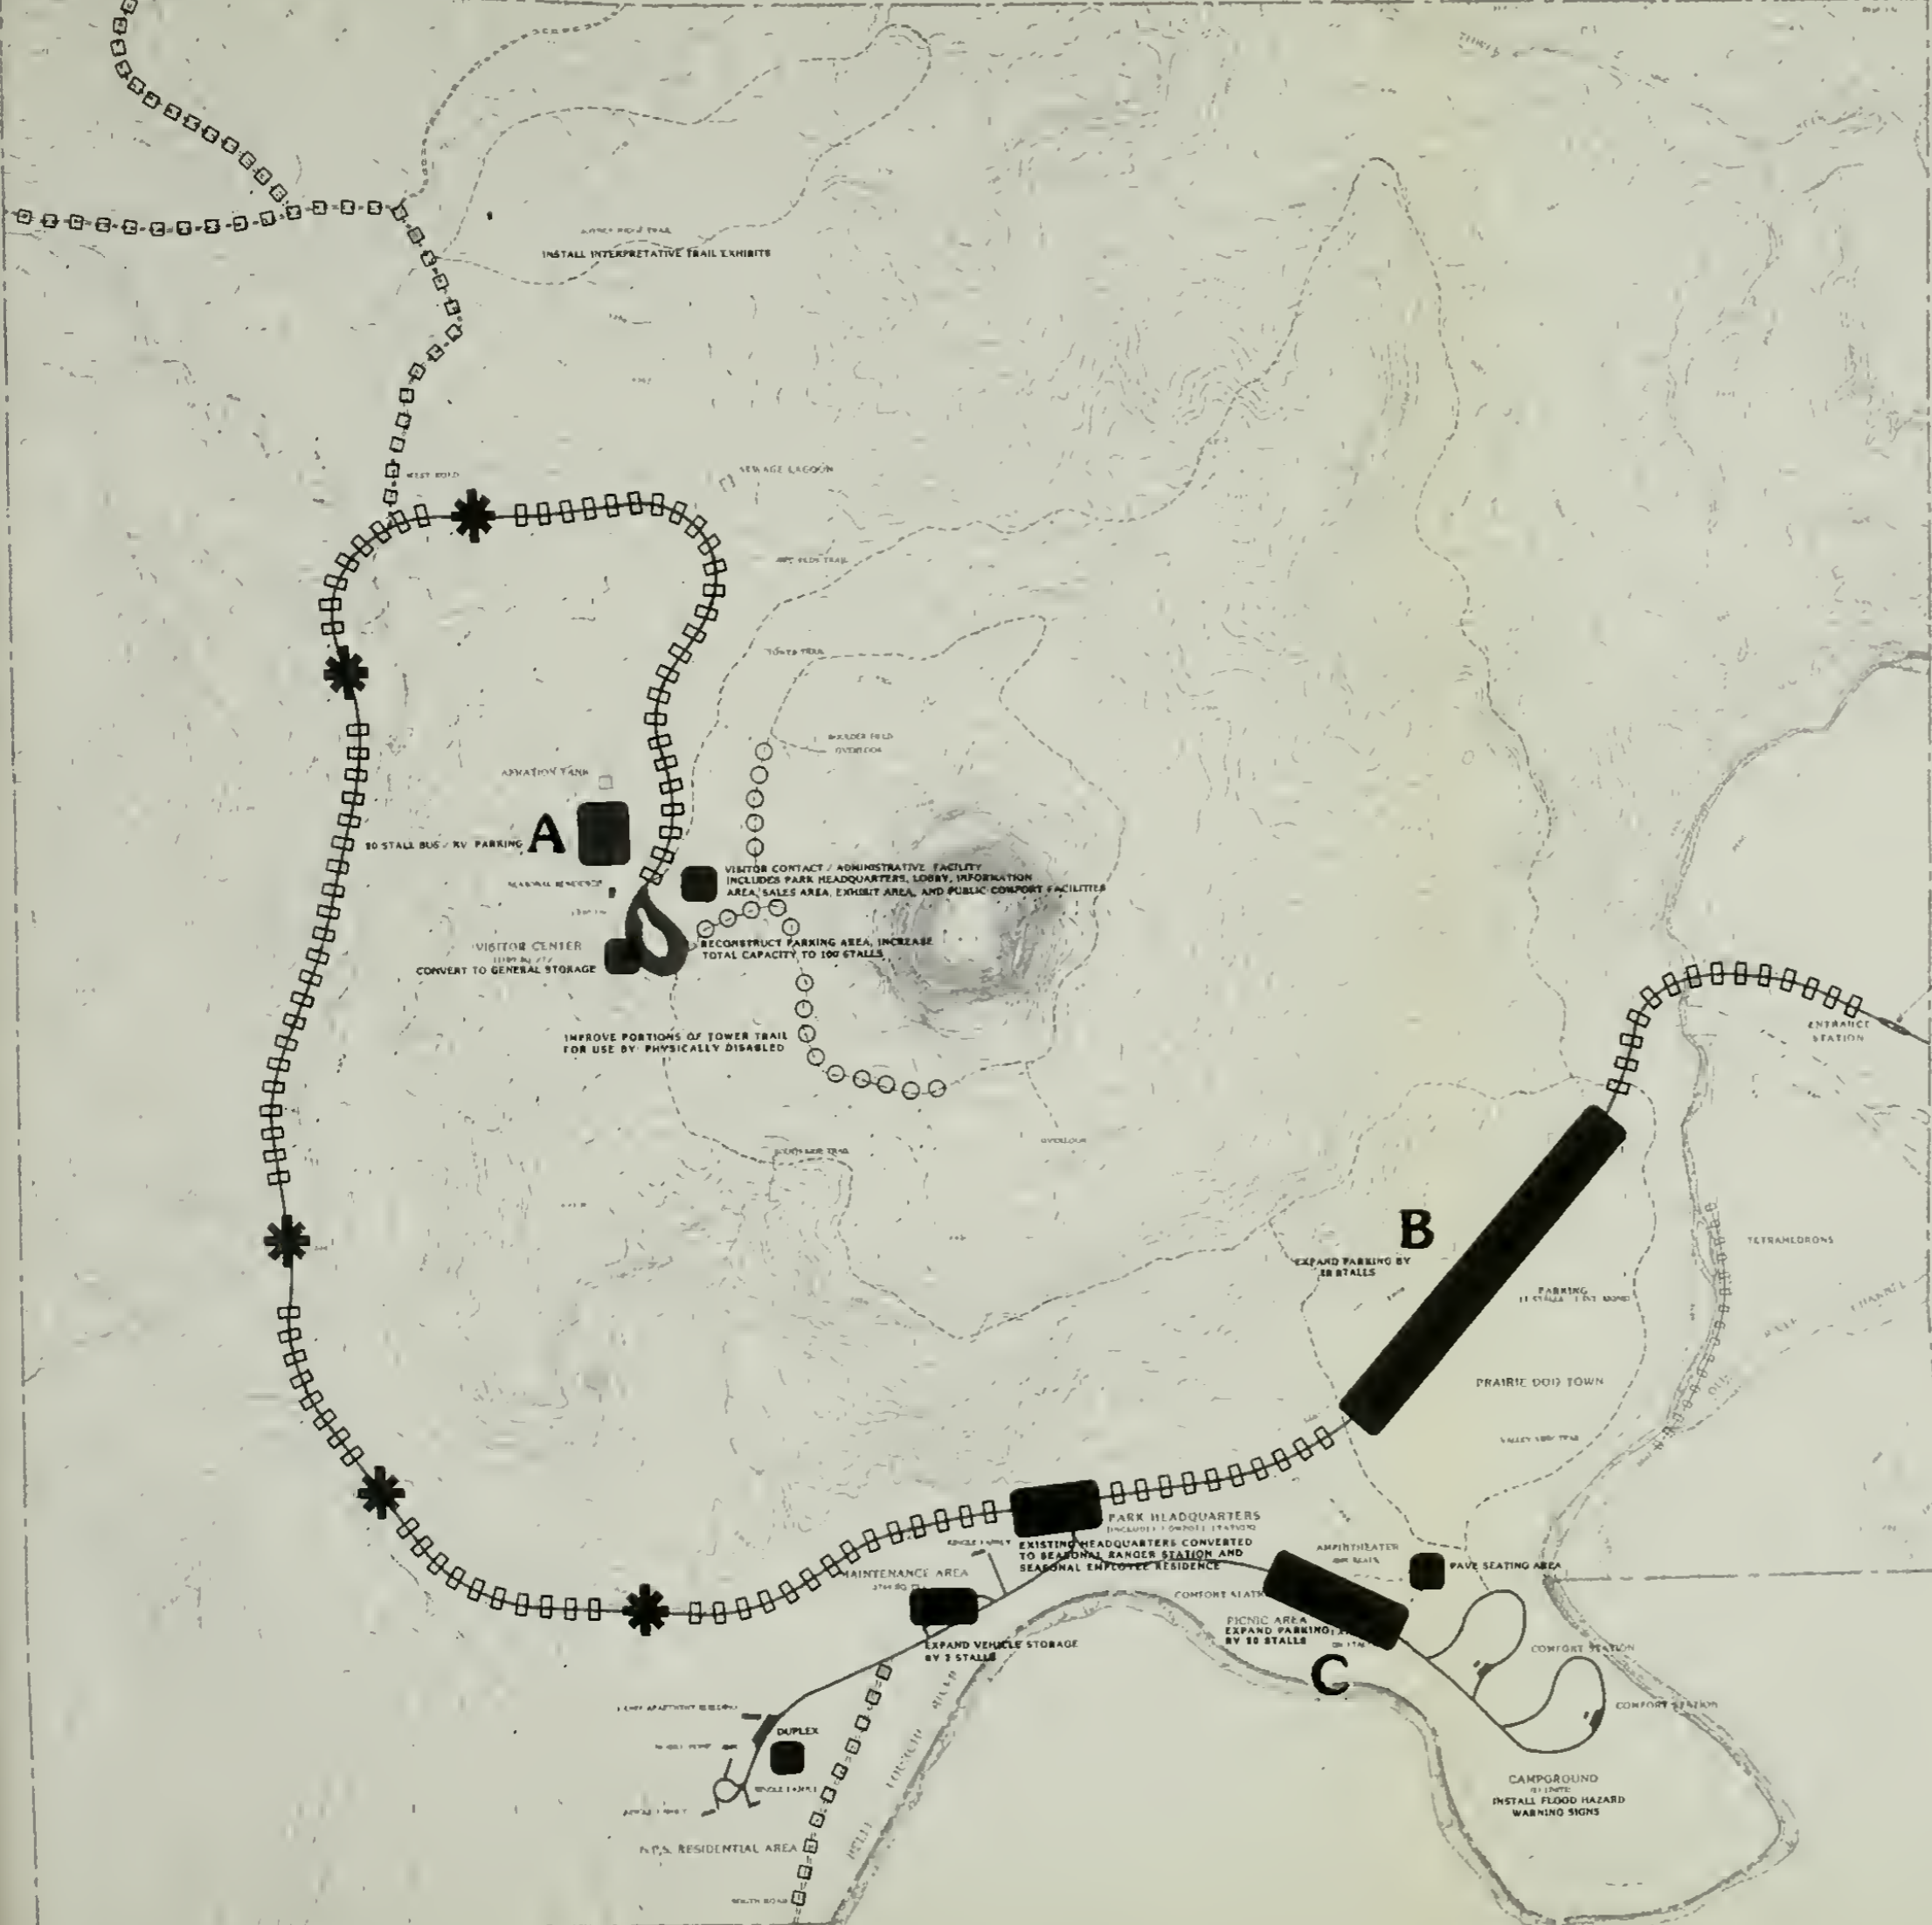
**MAP III.2**  
**PROPOSED GENERAL DEVELOPMENT**  
**DEVILS TOWER NATIONAL MONUMENT**  
**GENERAL MANAGEMENT PLAN**  
 UNITED STATES DEPARTMENT OF THE INTERIOR  
 NATIONAL PARK SERVICE

RECONSTRUCT MAIN PARK ROAD FOLLOWING RECOMMENDATIONS IN THE 1980 FEDERAL HIGHWAY ADMINISTRATION SURVEY (ACTIONS PREVIOUSLY PROGRAMED)

- RECONSTRUCT MAIN PARK ROAD FOLLOWING RECOMMENDATIONS IN THE 1980 FEDERAL HIGHWAY ADMINISTRATION SURVEY (ACTIONS PREVIOUSLY PROGRAMMED)
- CHIP & SEAL ROAD SURFACE
- DEVELOPMENT ZONE
- A** DEVELOPMENT ZONE DETAIL REFERENCE (SEE MAP III.3)
- PHOTO PULLOFF SEE CONCEPT DEVELOPMENT (SEE MAP III.3)
- IMPROVEMENTS TO TOWER TRAIL FOR USE BY THE PHYSICALLY DISABLED

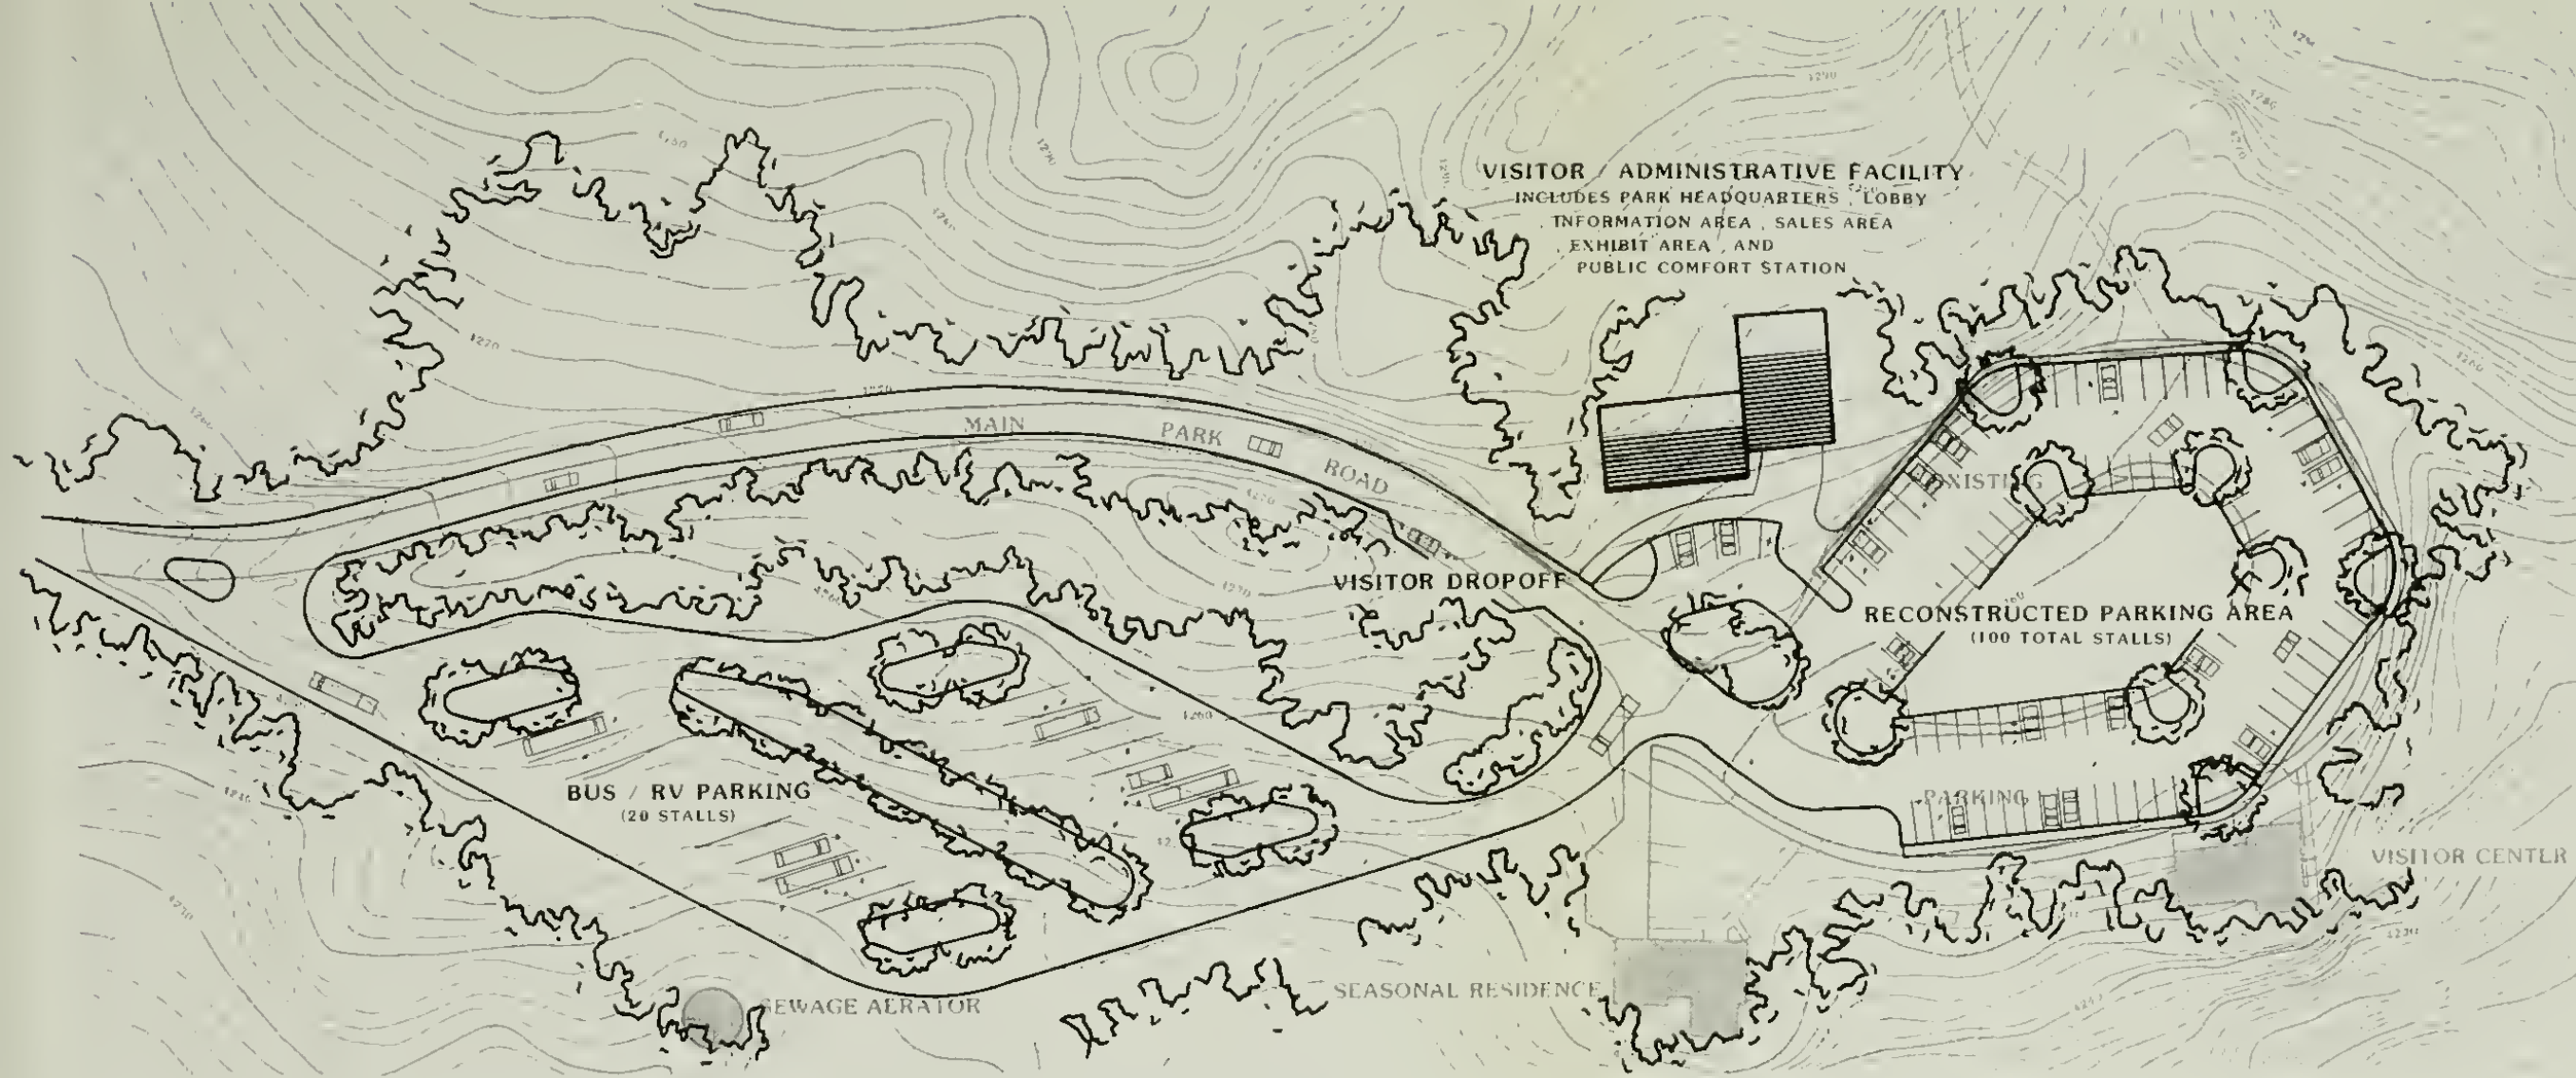
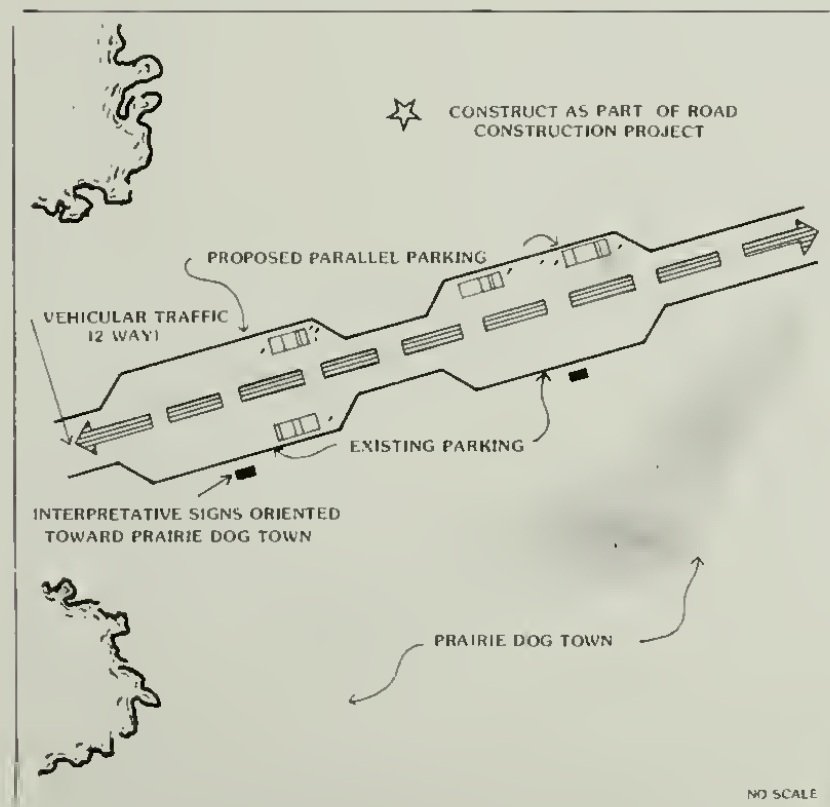
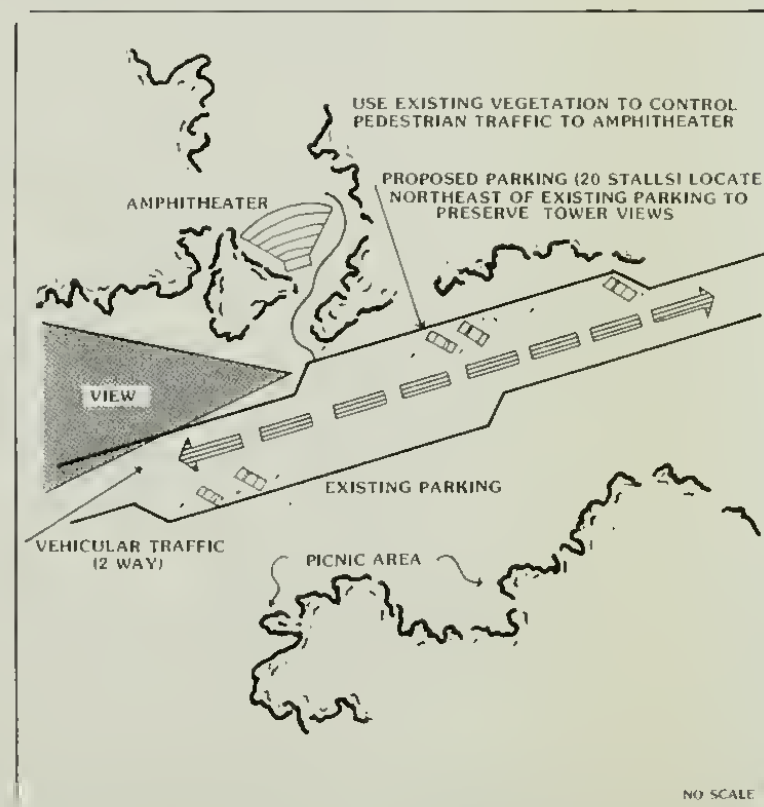
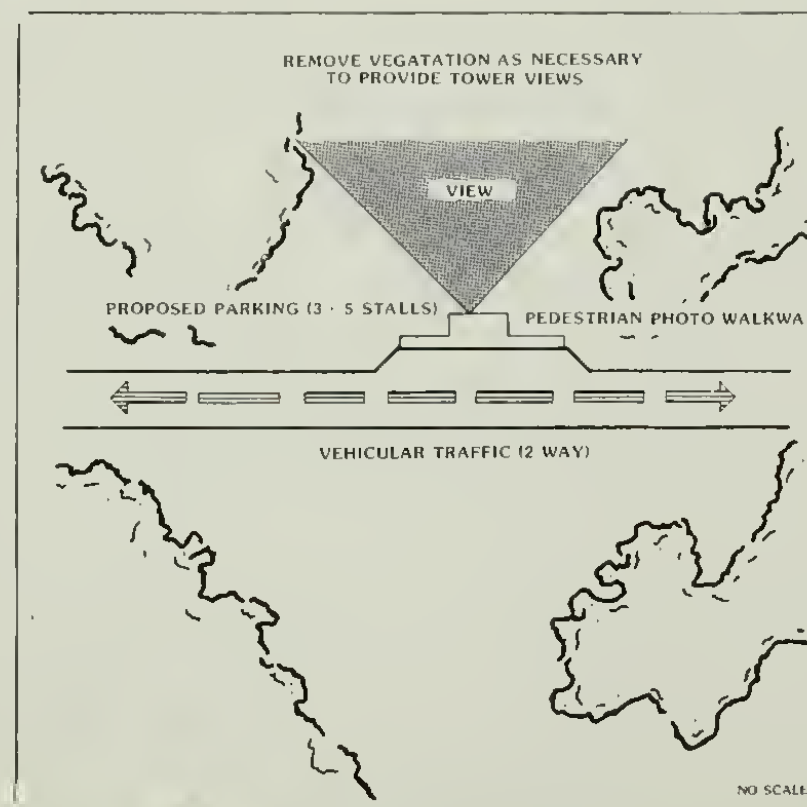
**MAP III .3**  
**PROPOSED TOWER**  
**BASE / DEVELOPMENT CONCEPTS**

**A - TOWER BASE DEVELOPMENT CONCEPT**

**B - PRARIE DOG TOWN PARKING CONCEPT**

**C - PICNIC / AMPHITHEATER PARKING CONCEPT**

**TYPICAL PHOTO PULLOFF**

Historically, visitors have pulled off the main park road along strategic points to photograph the tower. This use poses safety hazards for many visitors. Five vehicle pull-outs with a capacity of two to three vehicles each are constructed for visitors taking tower photographs. Some vegetative manipulation is necessary to provide vistas and confined views of the tower.

Picnic Area/Amphitheater - This area presently contains a 20 stall parking lot and seating for about 200 visitors. Seating capacity is more than adequate at the amphitheater; however, vegetation growing in this facility provides habitat for rattlesnakes posing a potential safety hazard. Park staff is unable to continually treat vegetation to remove this habitat. To increase operation efficiency and eliminate potential hazards, the amphitheater surface is paved. Many visitors drive to the amphitheater from the private campground, and the picnic area is used for group functions. When existing parking stalls are full, visitors park in unauthorized areas resulting in vegetative and soil degradation. Parking is expanded by 20 stalls to minimize these adverse environmental effects.

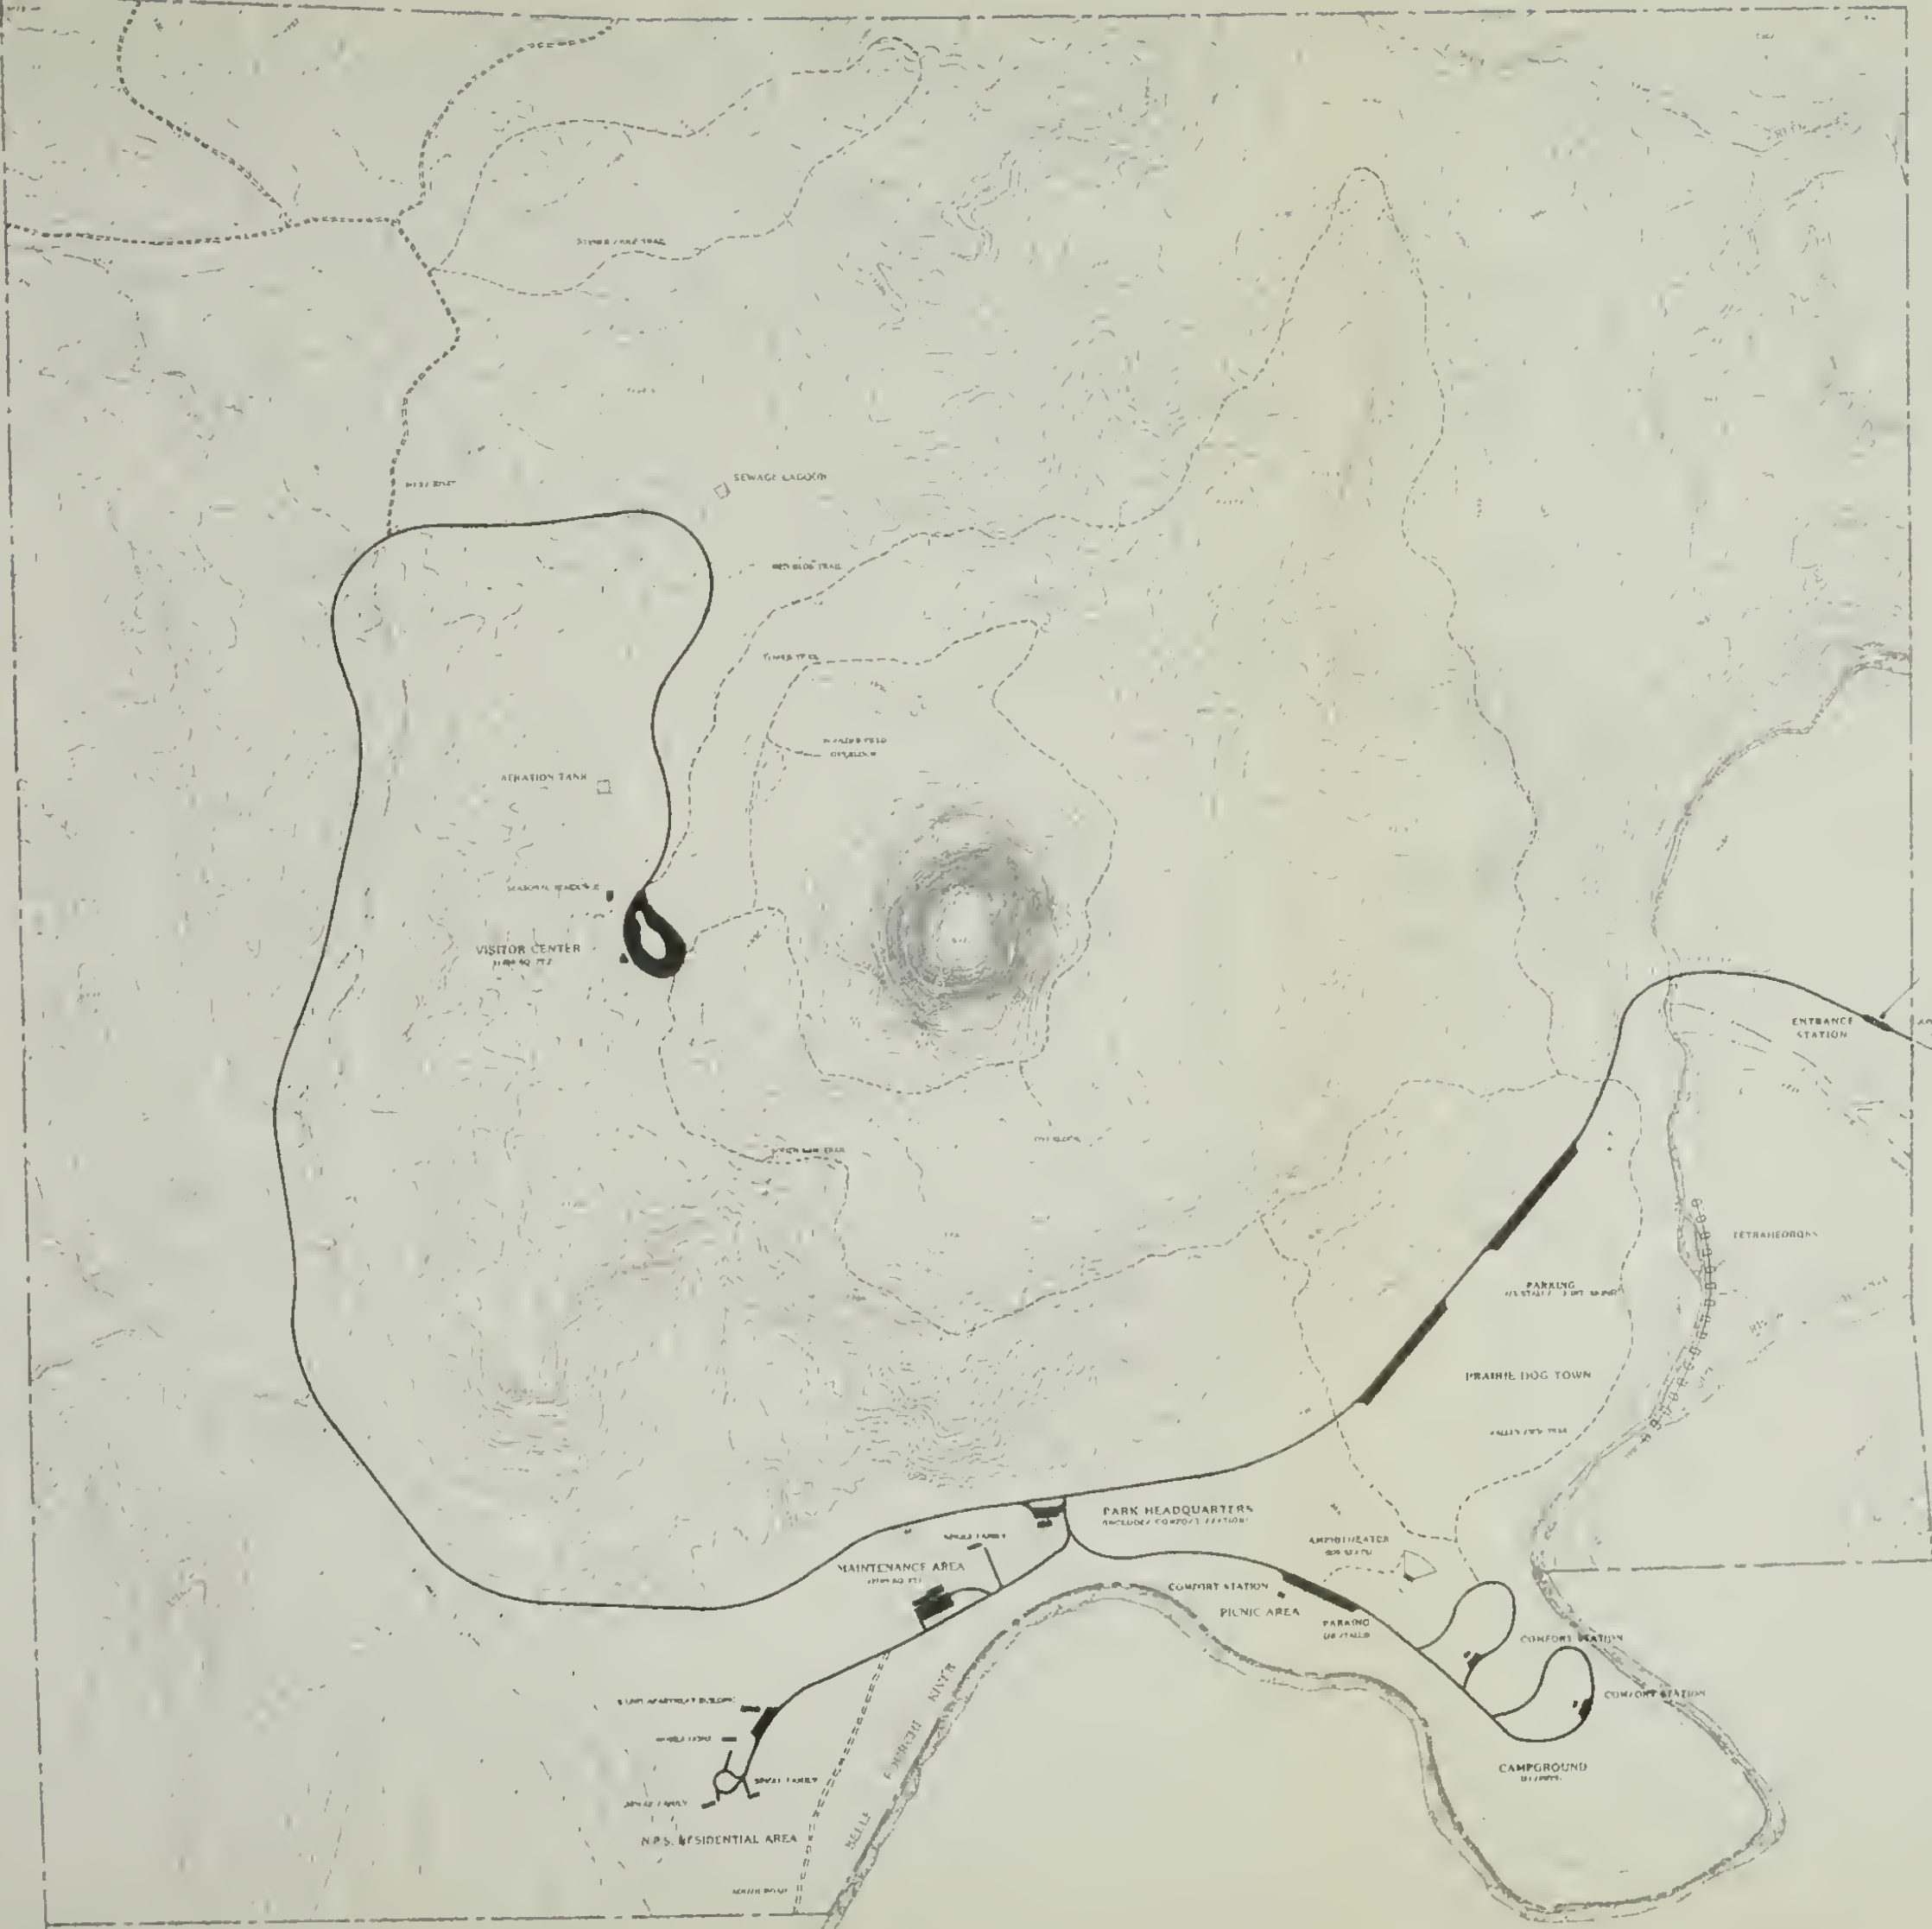
**MAP IV .1**  
**ALTERNATIVE I**  
**DEVILS NATIONAL TOWER MONUMENT**  
**GENERAL MANAGEMENT PLAN**  
 UNITED STATES DEPARTMENT OF THE INTERIOR  
 NATIONAL PARK SERVICE

**PROPOSED ACTIONS**

NONE

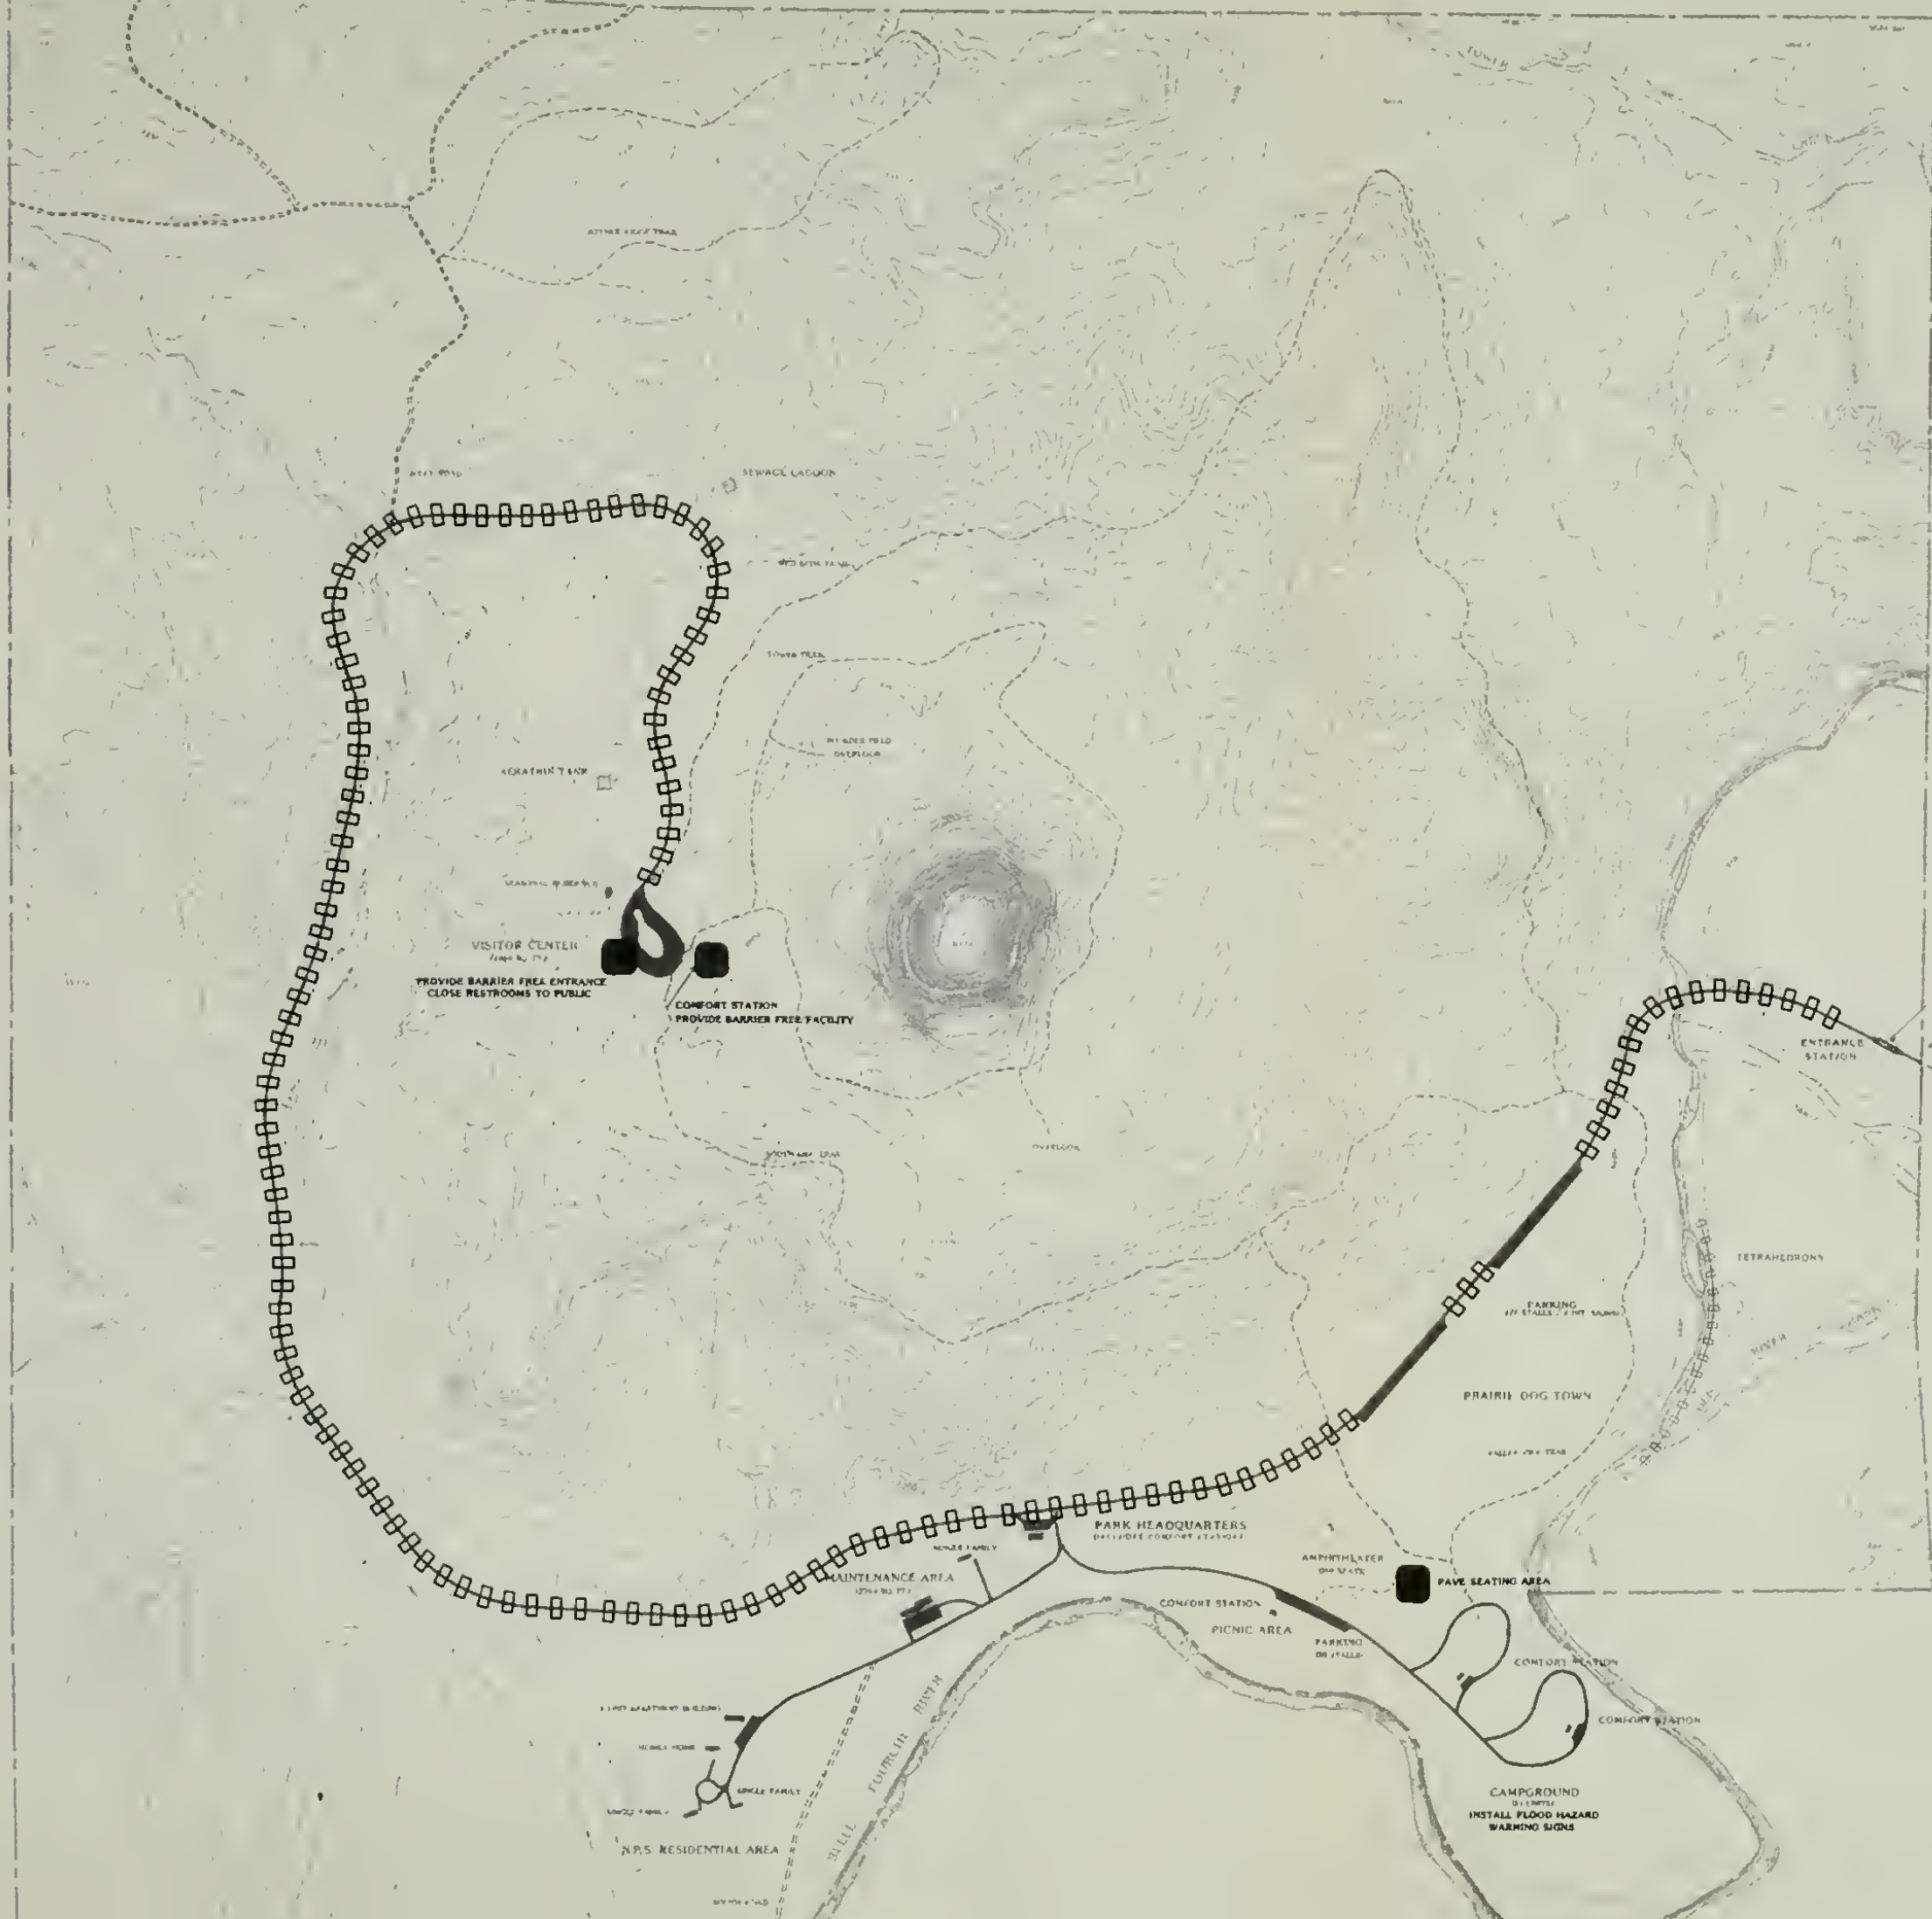
**MAP IV .2**  
**ALTERNATIVE II**  
**DEVILS NATIONAL MONUMENT**  
**TOWER MONUMENT**  
**GENERAL MANAGEMENT PLAN**  
 UNITED STATES DEPARTMENT OF THE INTERIOR  
 NATIONAL PARK SERVICE

- LEGEND**
- EXISTING CONDITIONS**
- PARK BOUNDARY
  - PAVED ROADS
  - GRAVEL ROADS
  - TRAILS
  - CONTOUR LINE
  - STRUCTURE
  - TETRAHEDRON
- PROPOSED ACTIONS**
- RECONSTRUCT MAIN PARK ROAD FOLLOWING RECOMMENDATIONS IN THE 1980 FEDERAL HIGHWAY ADMINISTRATION SURVEY (ACTIONS PREVIOUSLY PROGRAMED)
  - DEVELOPMENT ZONE

- Chip and seal the south and west woods.
- Expand prairie dog town parking by 20 vehicles and construction of 3 additional interpretive signs.
- Expansion of the headquarters by 600 square feet.
- Signing campground warning visitors of potential flood hazards and flood levels.
- Expand picnic area parking by 20 vehicles.
- Existing visitors center is expanded by 2,500 square feet and a separate comfort station is provided which is accessible to and usable by the physically disabled.
- Construct new 20 vehicle bus/RV lot.
- Partially reconstruct the 1.25 mile Tower Trail for use by the physically handicapped.
- Expand water storage and distribution and sewer treatment systems.
- Cost for these improvements is \$1,658,000, appendix B includes detailed cost estimates.

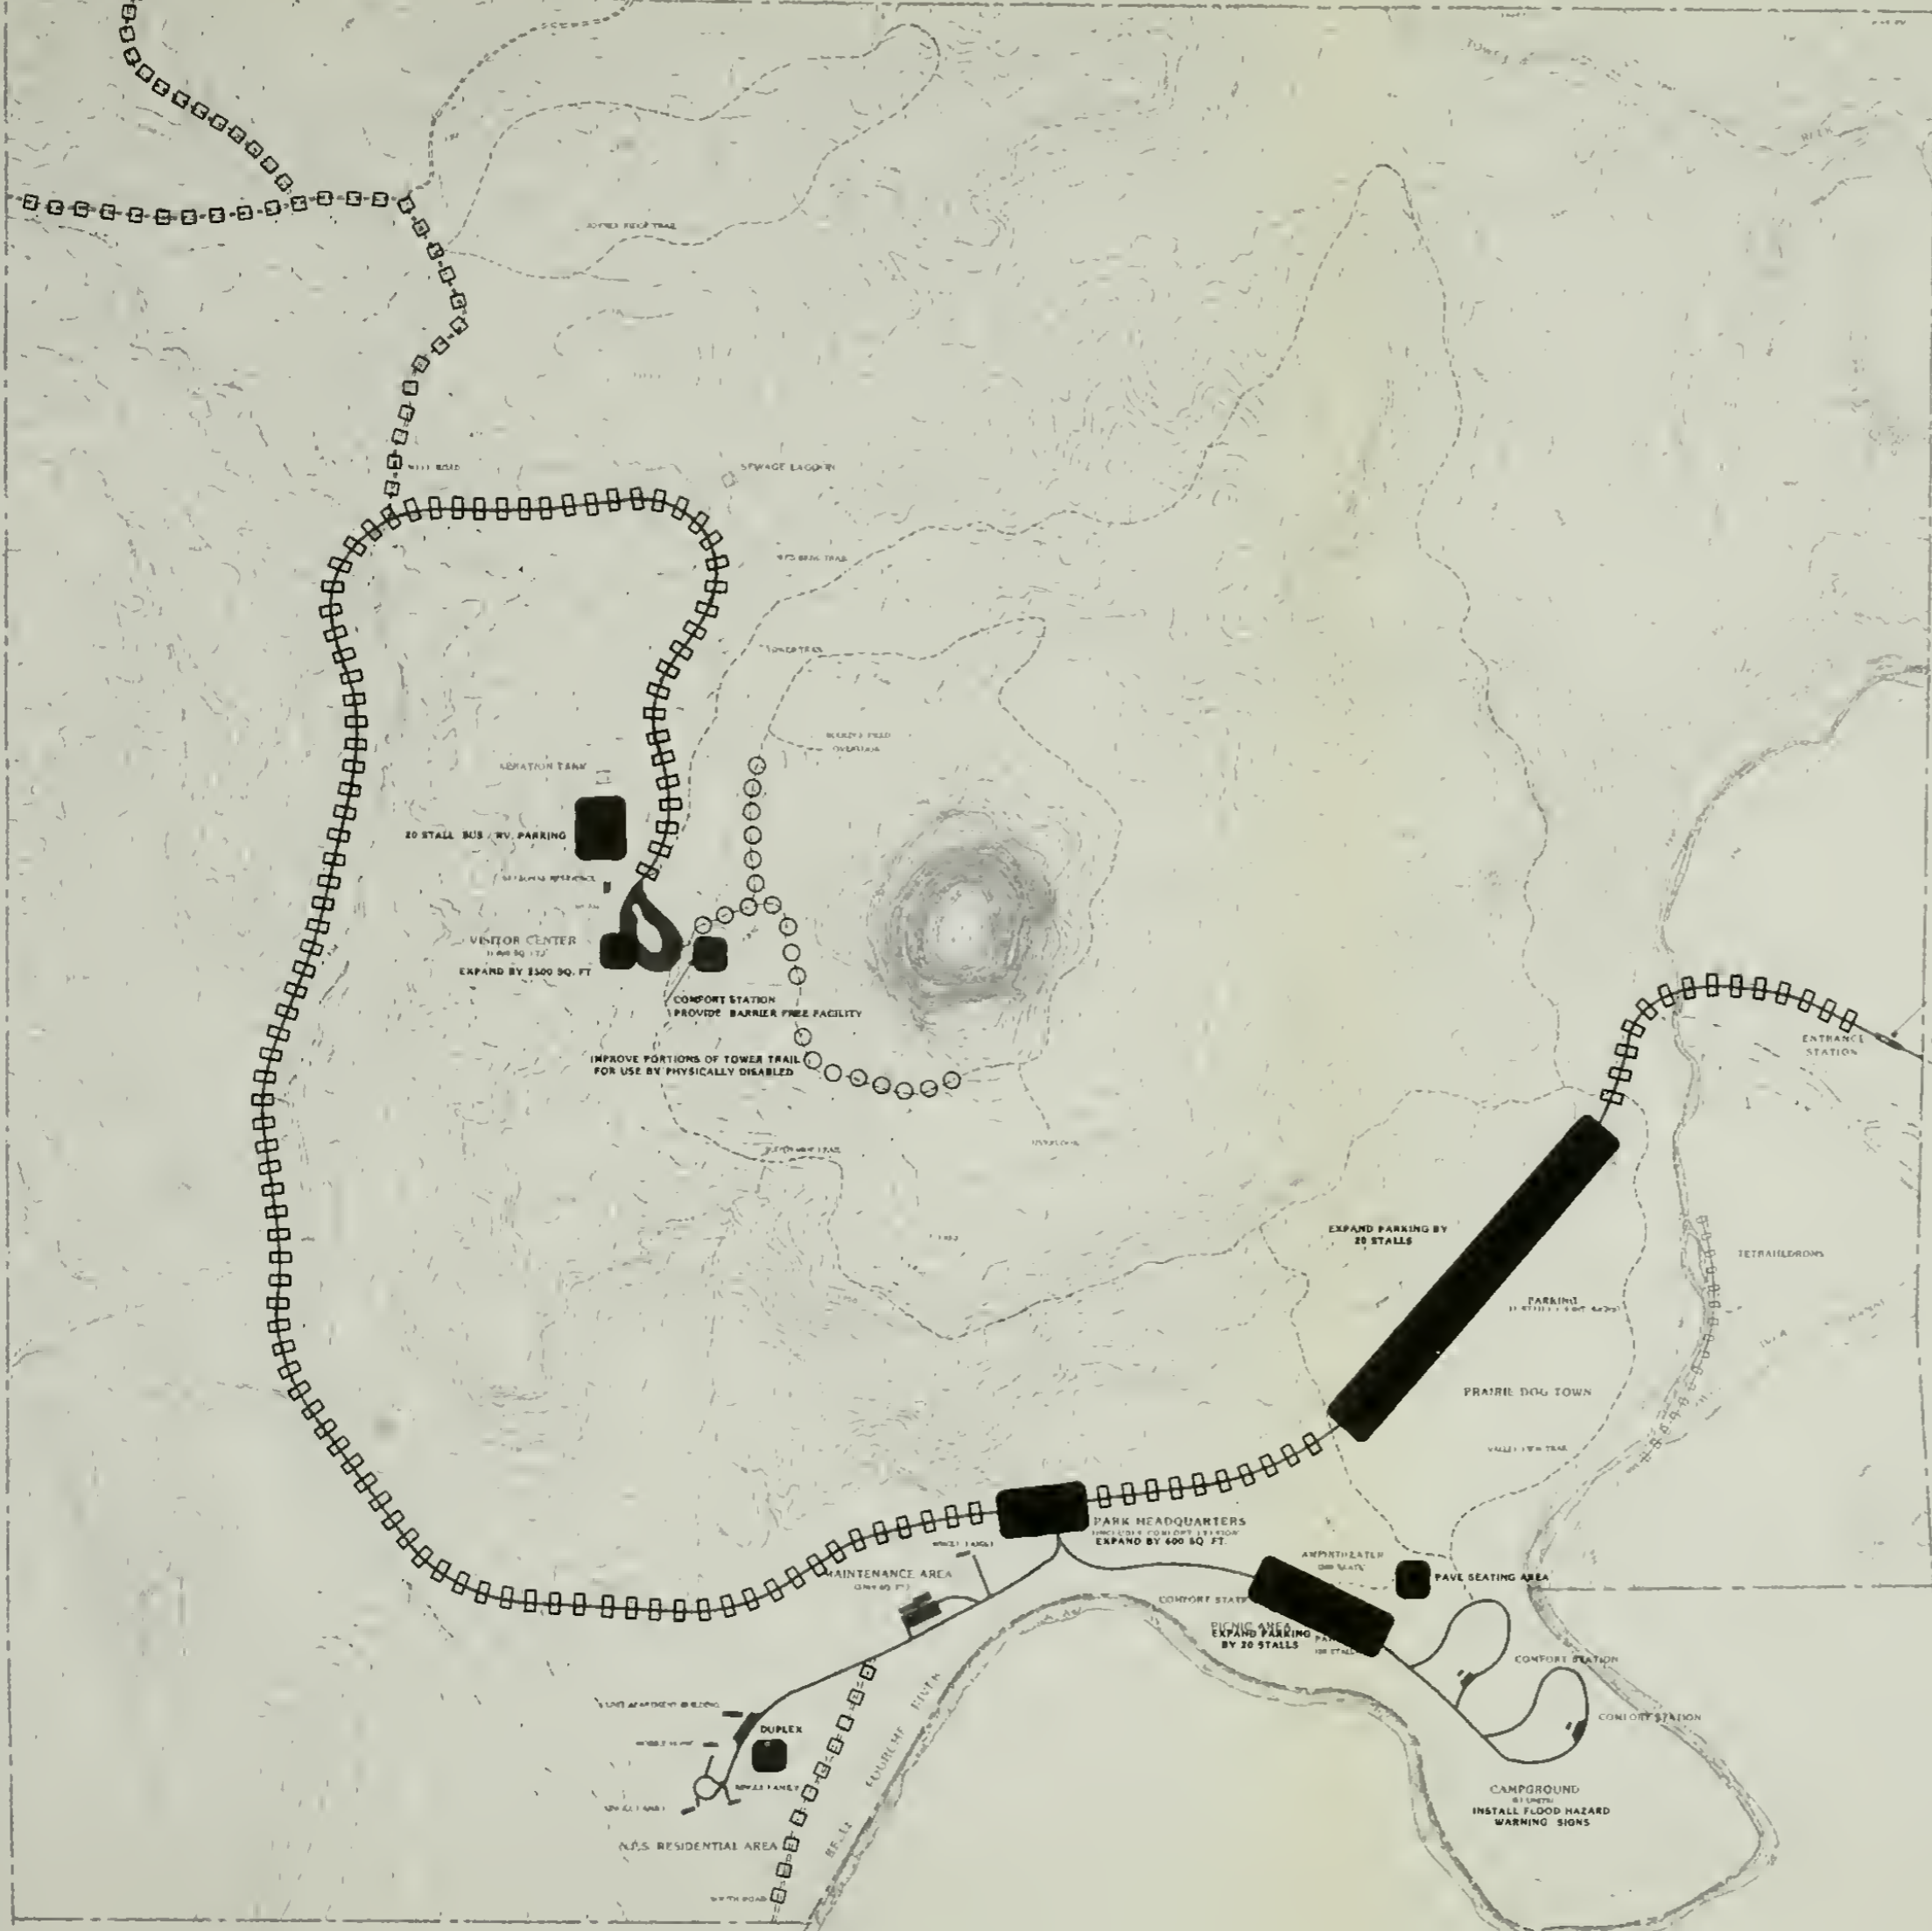
LEGEND	
EXISTING CONDITIONS	
	PARK BOUNDARY
	PAVED ROADS
	GRAVEL ROADS
	TRAILS
	CONTOUR LINE
	STRUCTURE
	TETRAHEDRON
PROPOSED ACTIONS	
	RECONSTRUCT MAIN PARK ROAD FOLLOWING RECOMMENDATIONS IN THE 1980 FEDERAL HIGHWAY ADMINISTRATION SURVEY (ACTIONS PREVIOUSLY PROGRAMED)
	CHIP & SEAL ROAD SURFACE
	DEVELOPMENT ZONE
	IMPROVEMENTS TO TOWER TRAIL FOR USE BY PHYSICALLY DISABLED

- Pave the south and west roads.
- Five vehicle pullouts for photography with 4-5 parking spaces at each.
- The existing visitors center is closed and converted to storage and a seasonal ranger station, included are public restrooms on the main floor with provisions that allow use by the physically disabled. New 11,500 square foot visitors/administrative facility is constructed near the entrance station. Also included are 200 stalls of single vehicle parking and 30 stalls of bus/RV parking.
- The current park headquarters is converted to seasonal employee residences.
- Cost for improvements is \$5,281,000, appendix B includes detailed cost estimates.
