DEVILS TOWER NATIONAL MONUMENT  
Wyoming

ENVIRONMENTAL ASSESSMENT/GENERAL MANAGEMENT PLAN/  
DEVELOPMENT CONCEPT PLAN

Devils Tower National Monument  
Crook County  
Wyoming

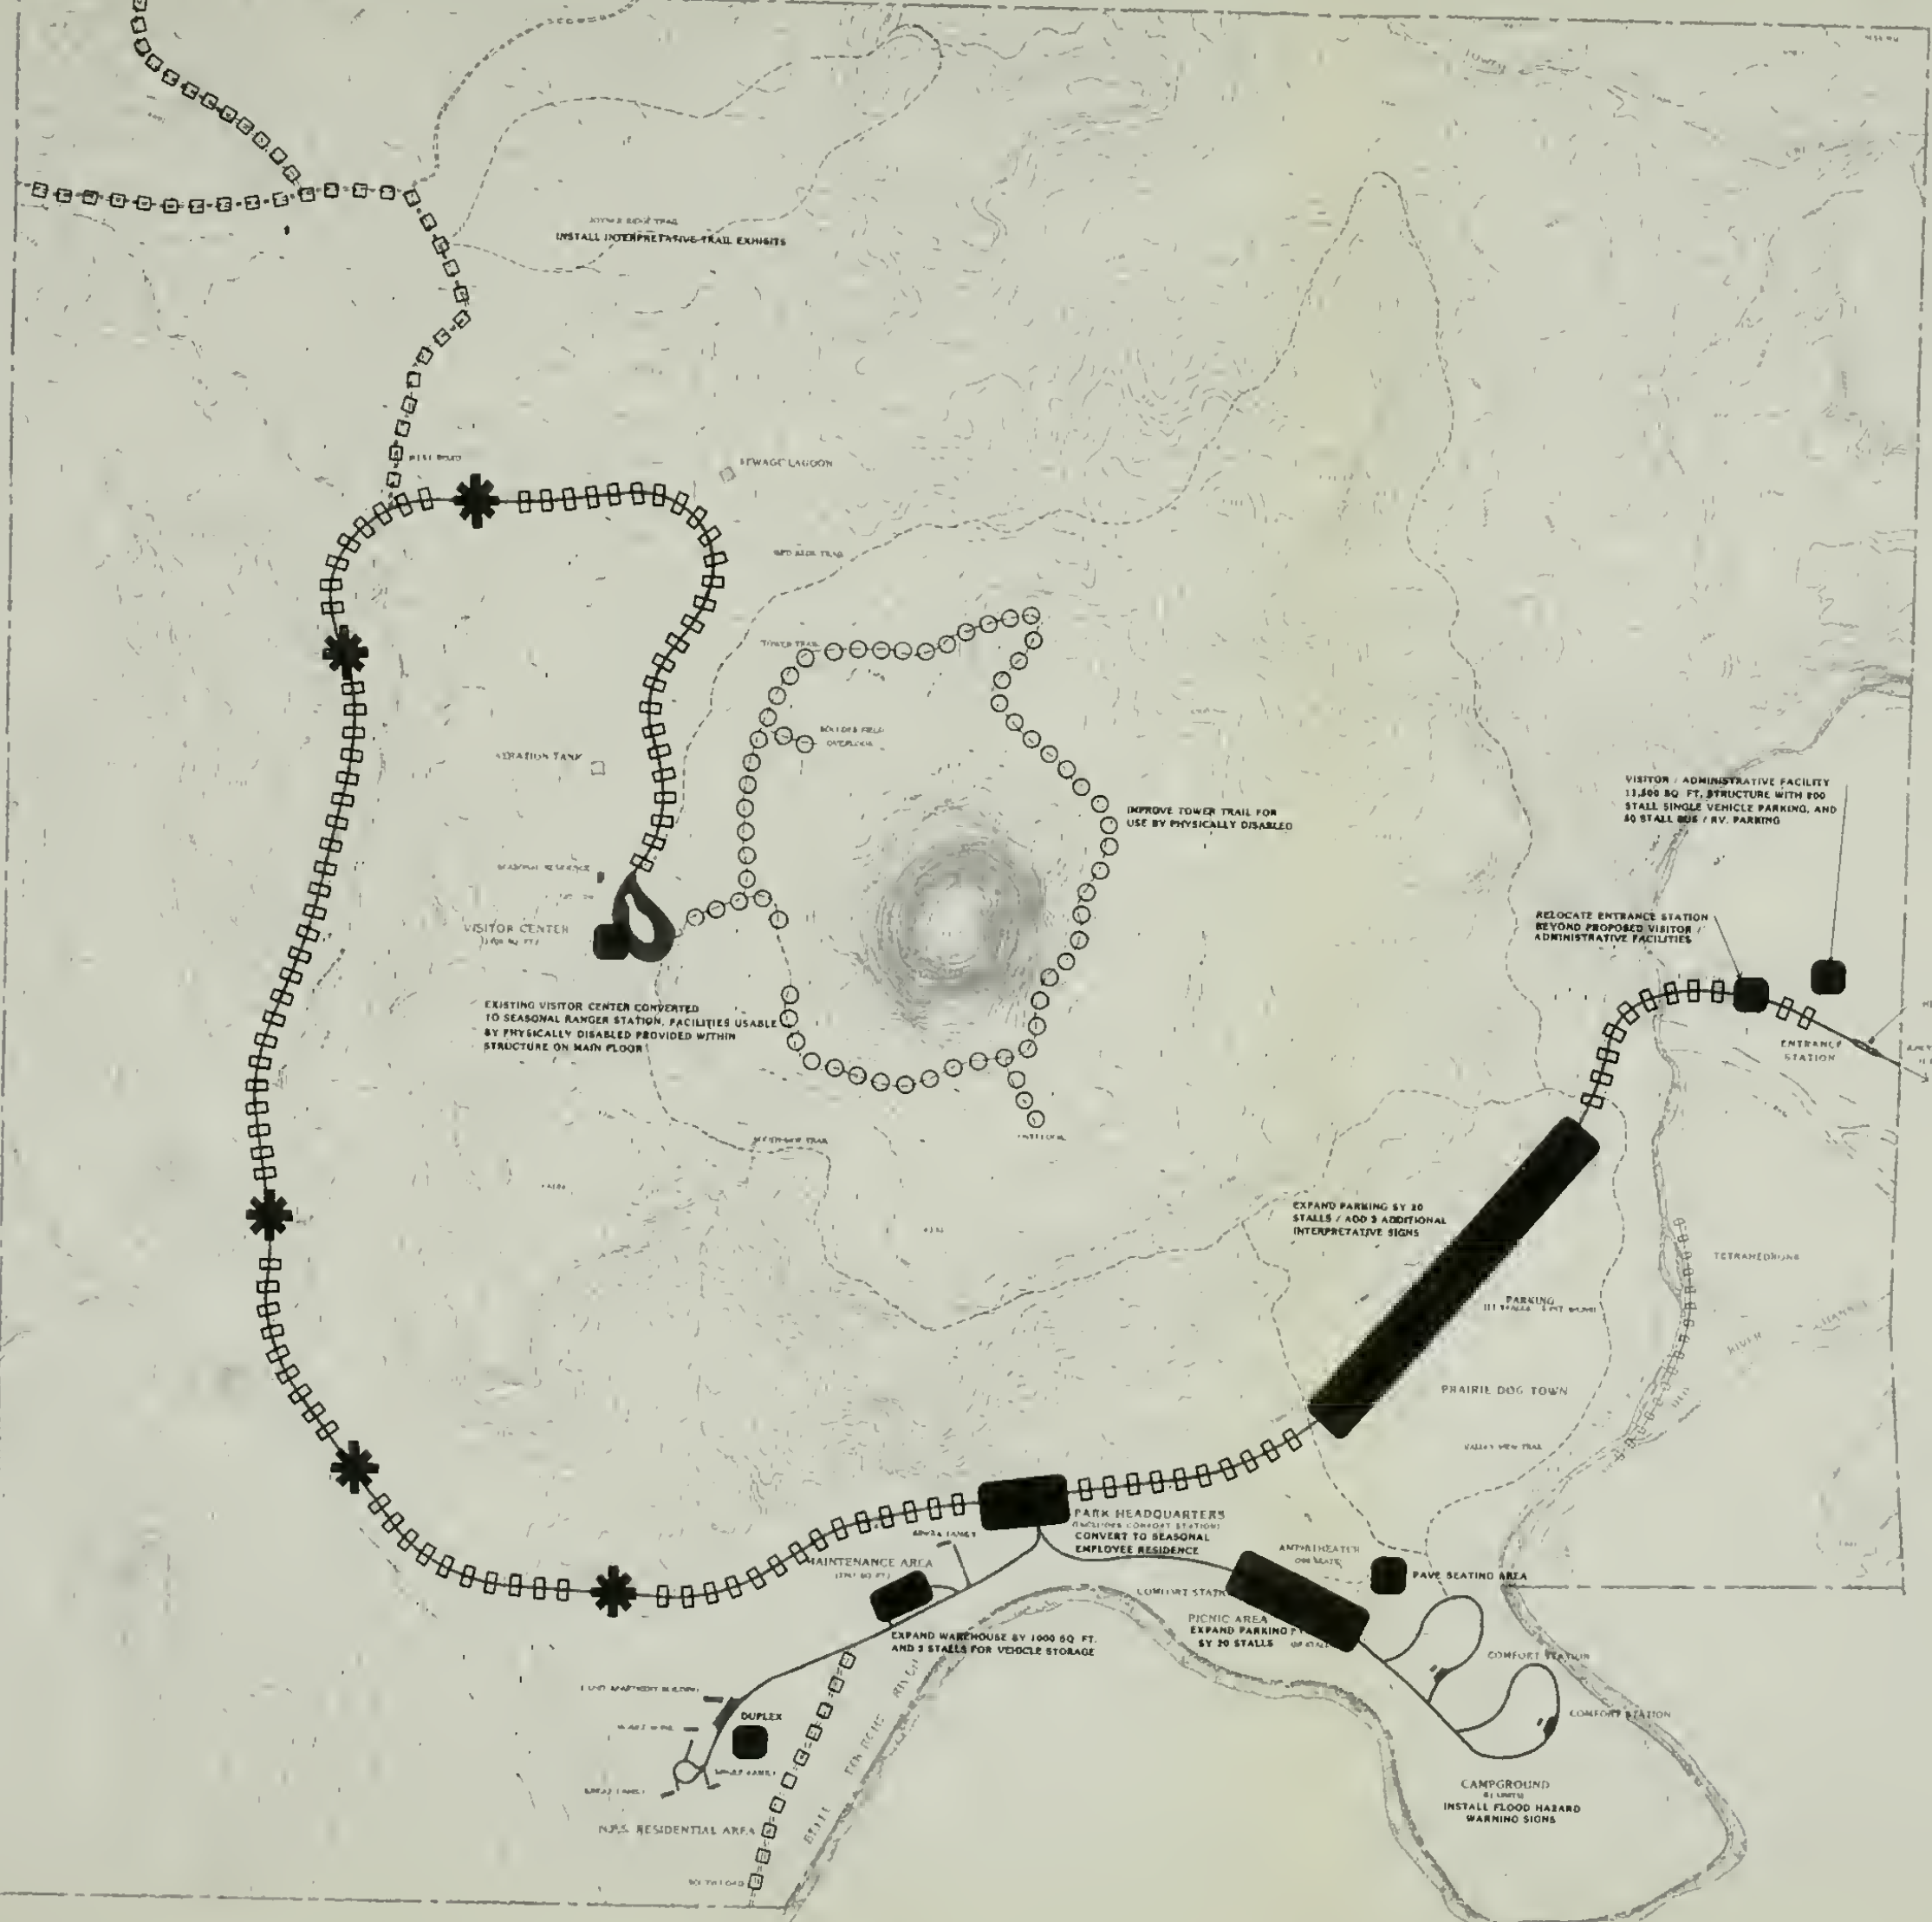
<b>EXISTING CONDITIONS</b>	
	PARK BOUNDARY
	PAVED ROADS
	GRAVEL ROADS
	TRAILS
	CONTOUR LINE
	STRUCTURE
	TETRAHEDRON
<b>PROPOSED ACTIONS</b>	
	RECONSTRUCT MAIN PARK ROAD FOLLOWING RECOMMENDATIONS IN THE 1980 FEDERAL HIGHWAY ADMINISTRATION SURVEY (ACTIONS PREVIOUSLY PROGRAMED)
	PAVE ROAD
	DEVELOPMENT ZONE
	PHOTO PULLOFF
	IMPROVE TOWER TRAIL FOR USE BY PHYSICALLY DISABLED

- Pave the south and west roads.
- Five vehicle pullouts for photography with 4-5 parking spaces at each.
- The existing visitors center is closed and converted to storage and a seasonal ranger station, included are public restrooms on the main floor with provisions that allow use by the physically disabled. New 11,500 square foot visitors/administrative facility is constructed near the entrance station. Also included are 200 stalls of single vehicle parking and 30 stalls of bus/RV parking.
- The current park headquarters is converted to seasonal employee residences.
- Cost for improvements is \$5,281,000, appendix B includes detailed cost estimates.

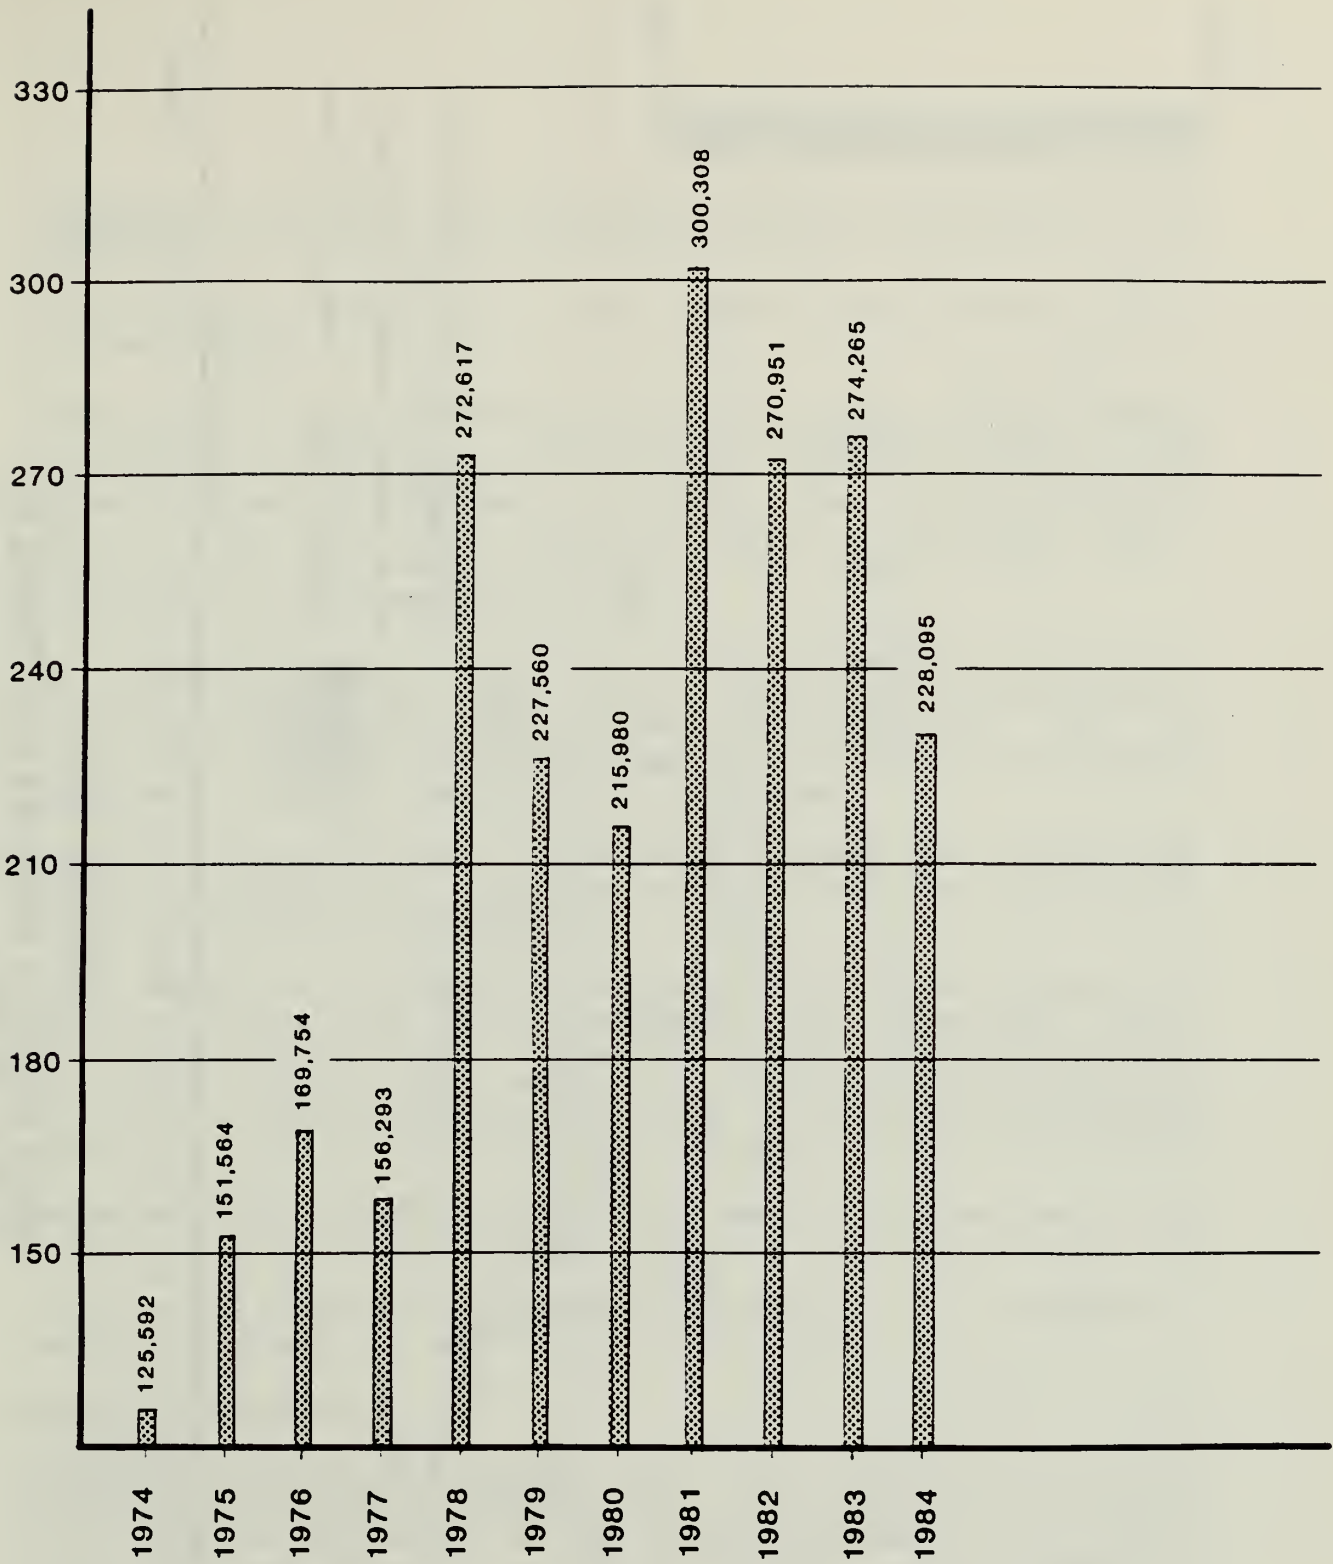
FIGURE V .3

ANNUAL VISITATION

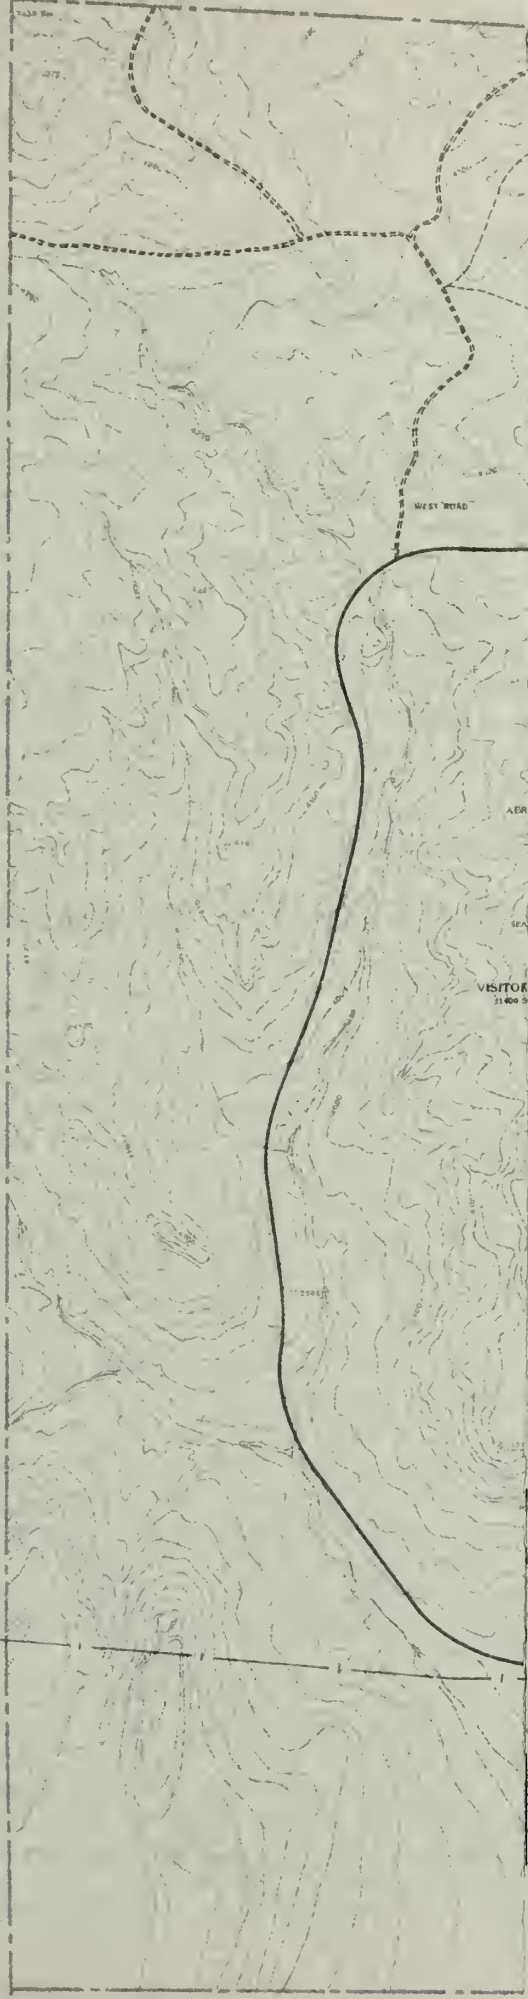
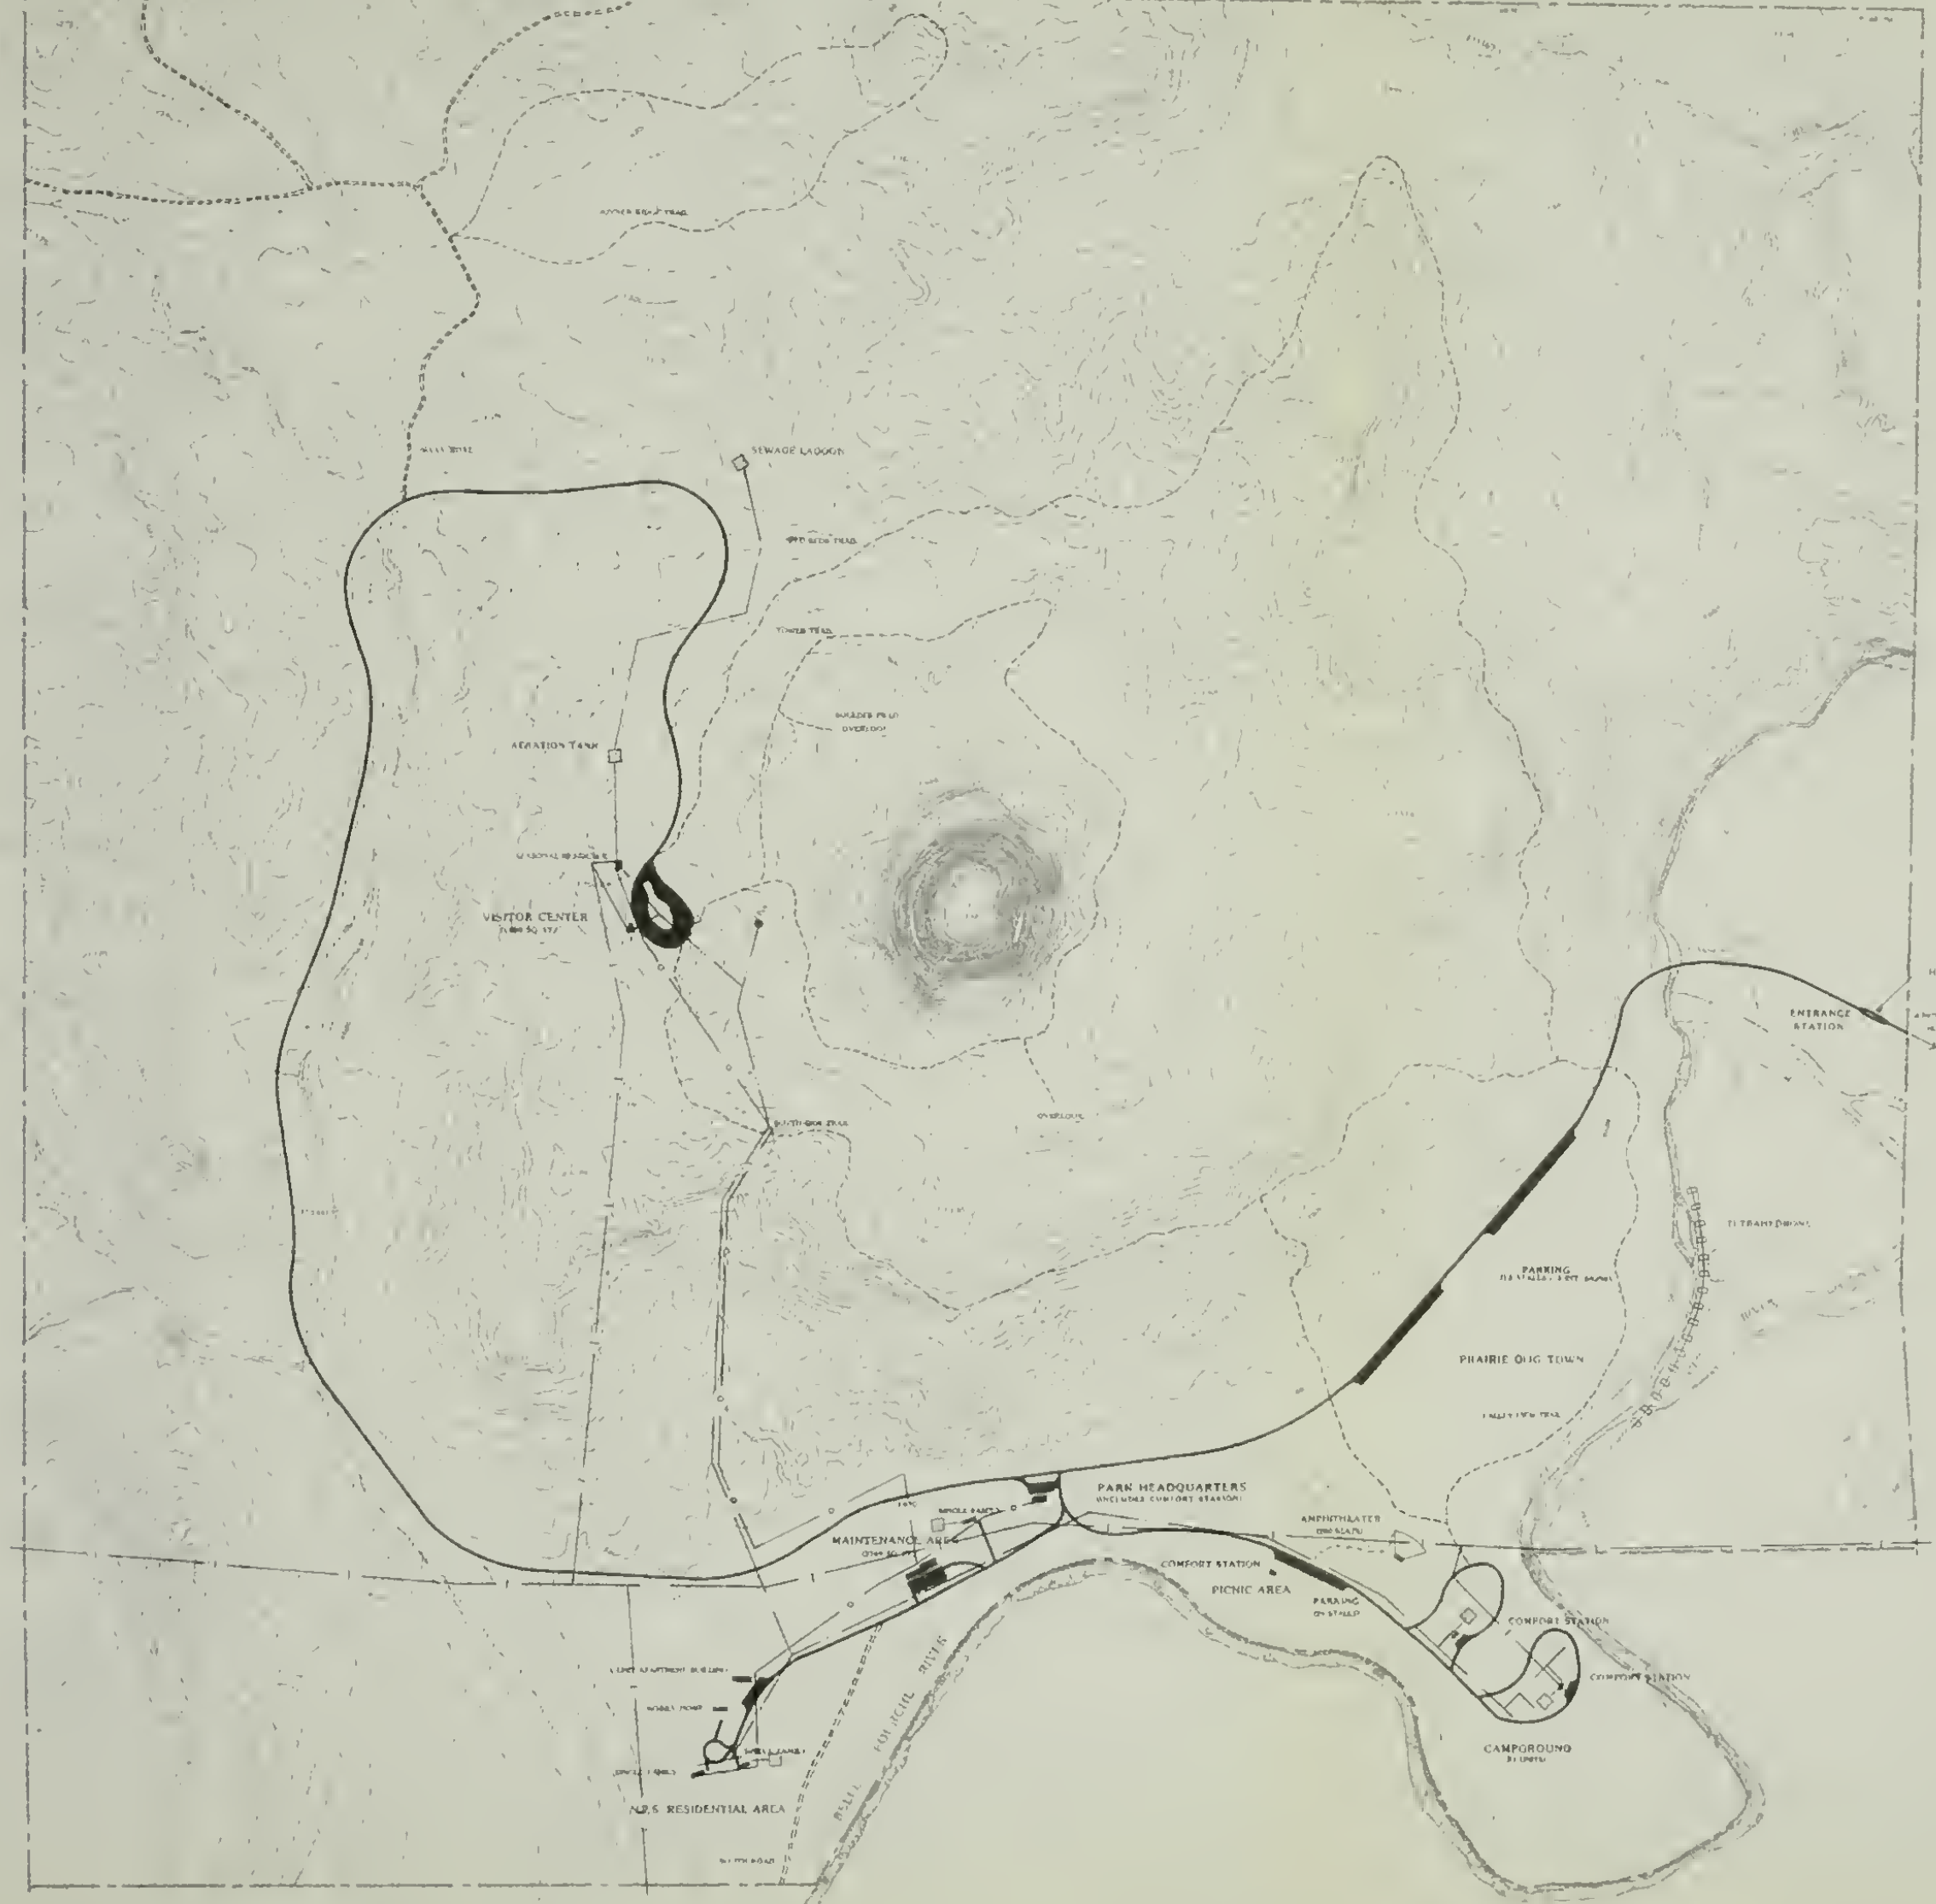
**MAP V.2**  
**EXISTING CONDITIONS**  
**DEVILS TOWER**  
**NATIONAL MONUMENT**

- OVERHEAD POWERLINE
- WATER DISTRIBUTION LINE
- BURIED RADIO LINE
- SEWER COLLECTION SYSTEM

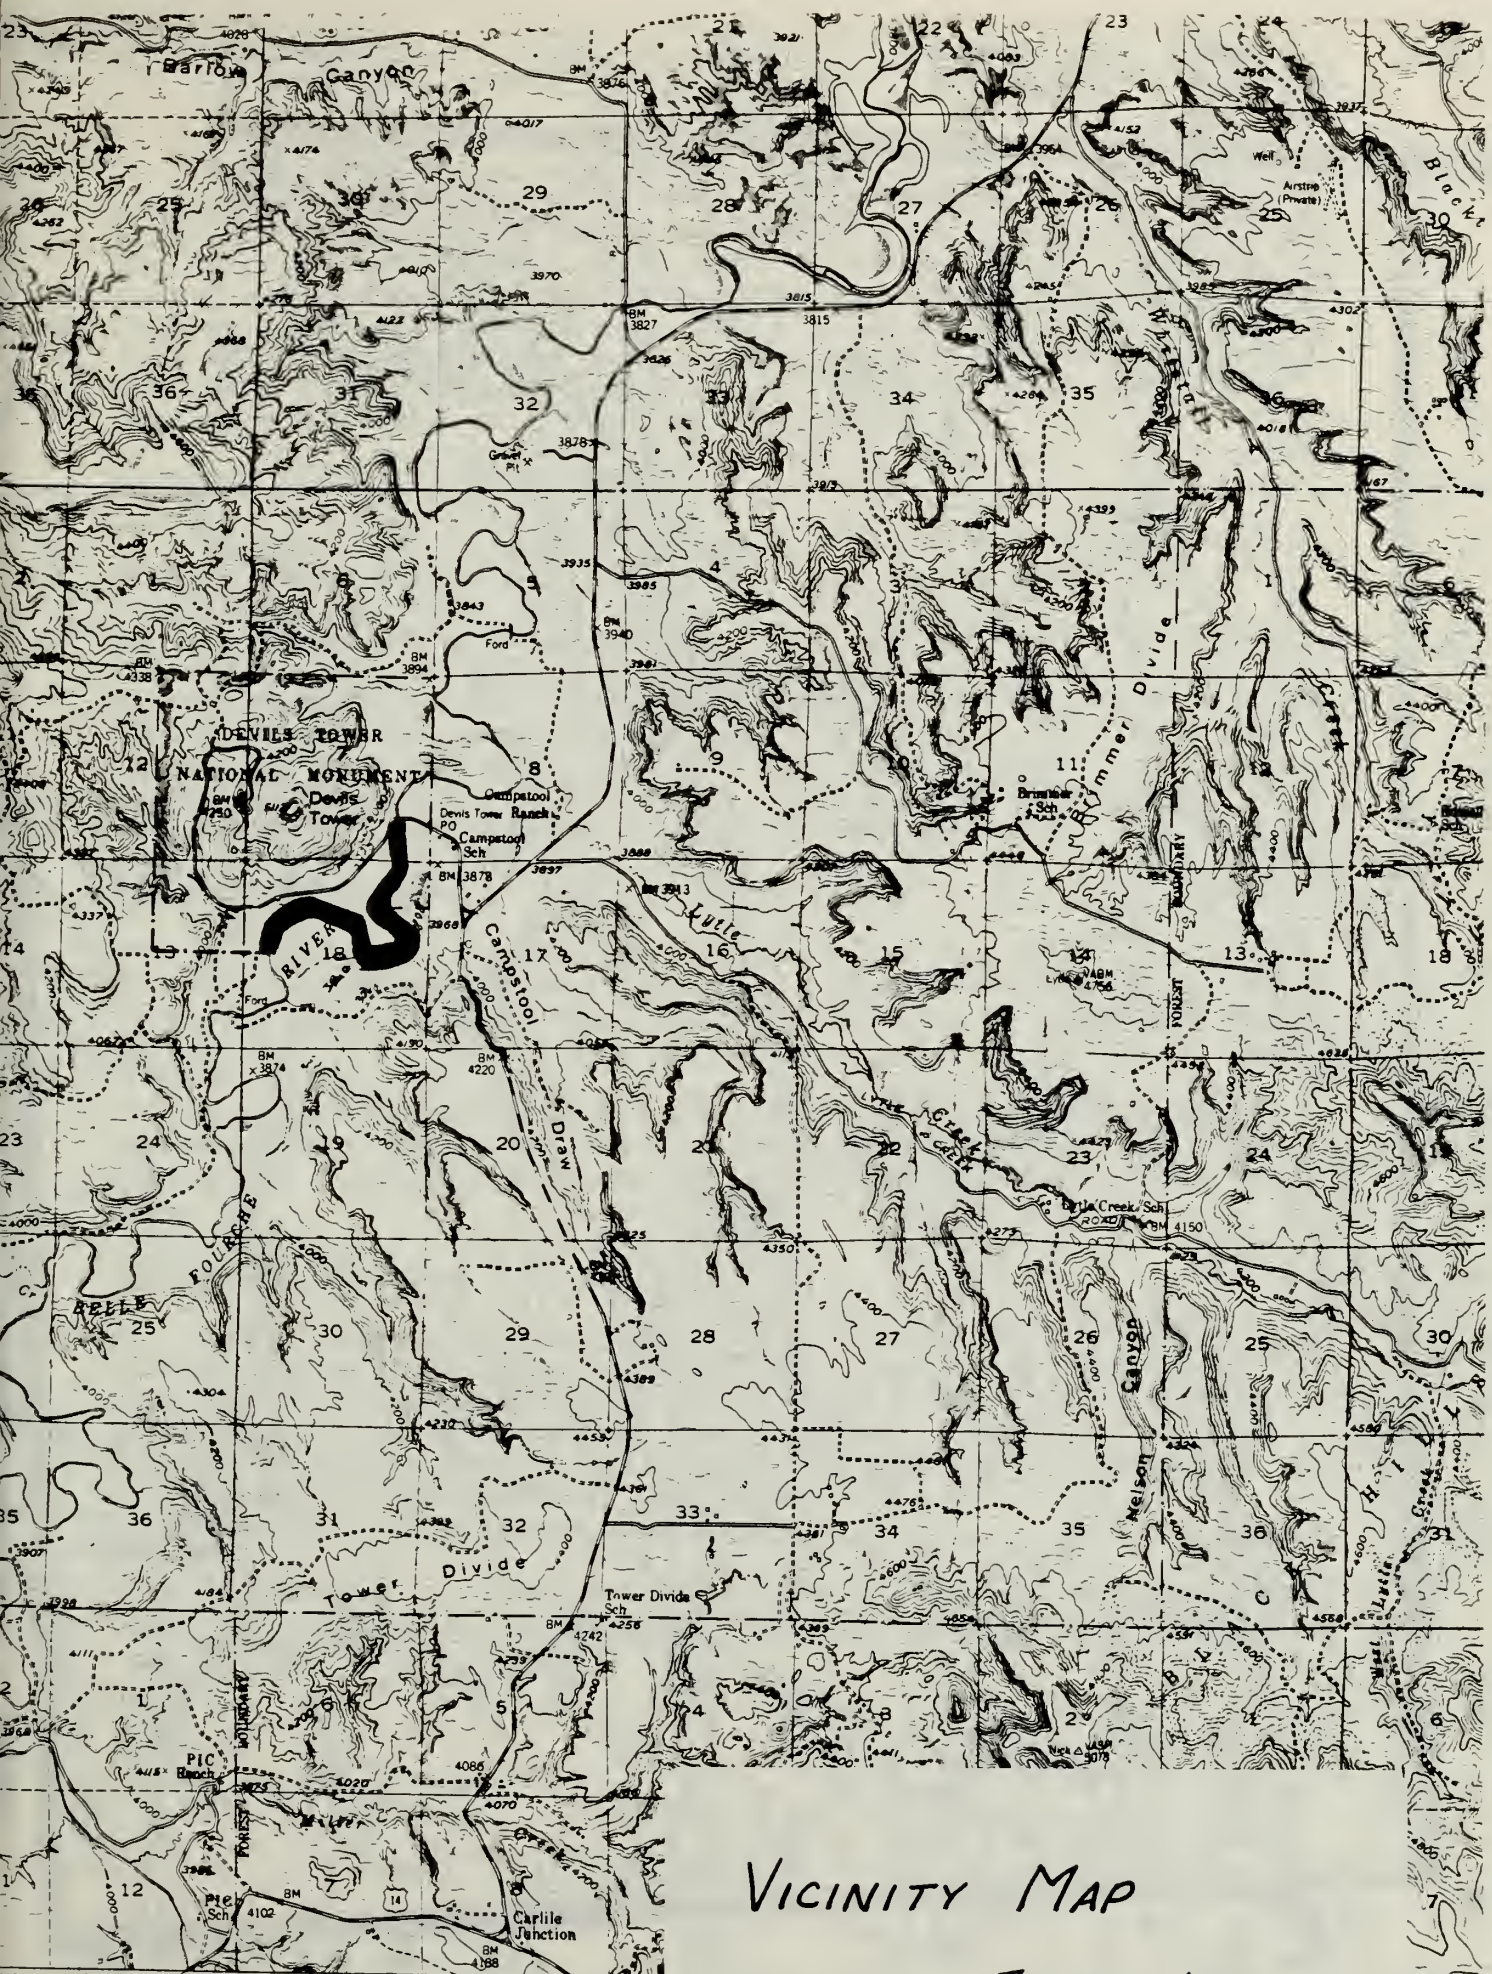
FIGURE 1

VICINITY MAP

This Special Flood Hazard Report covers an area within the Devils Tower National Monument along the Belle Fourche River. The study area started 800 feet upstream of the Belle Fourche River bridge inside the Park and extended to the south Park boundary, a distance of approximately 2.0 miles. The area of study is shown on the Vicinity Maps (Figures 1 and 2).

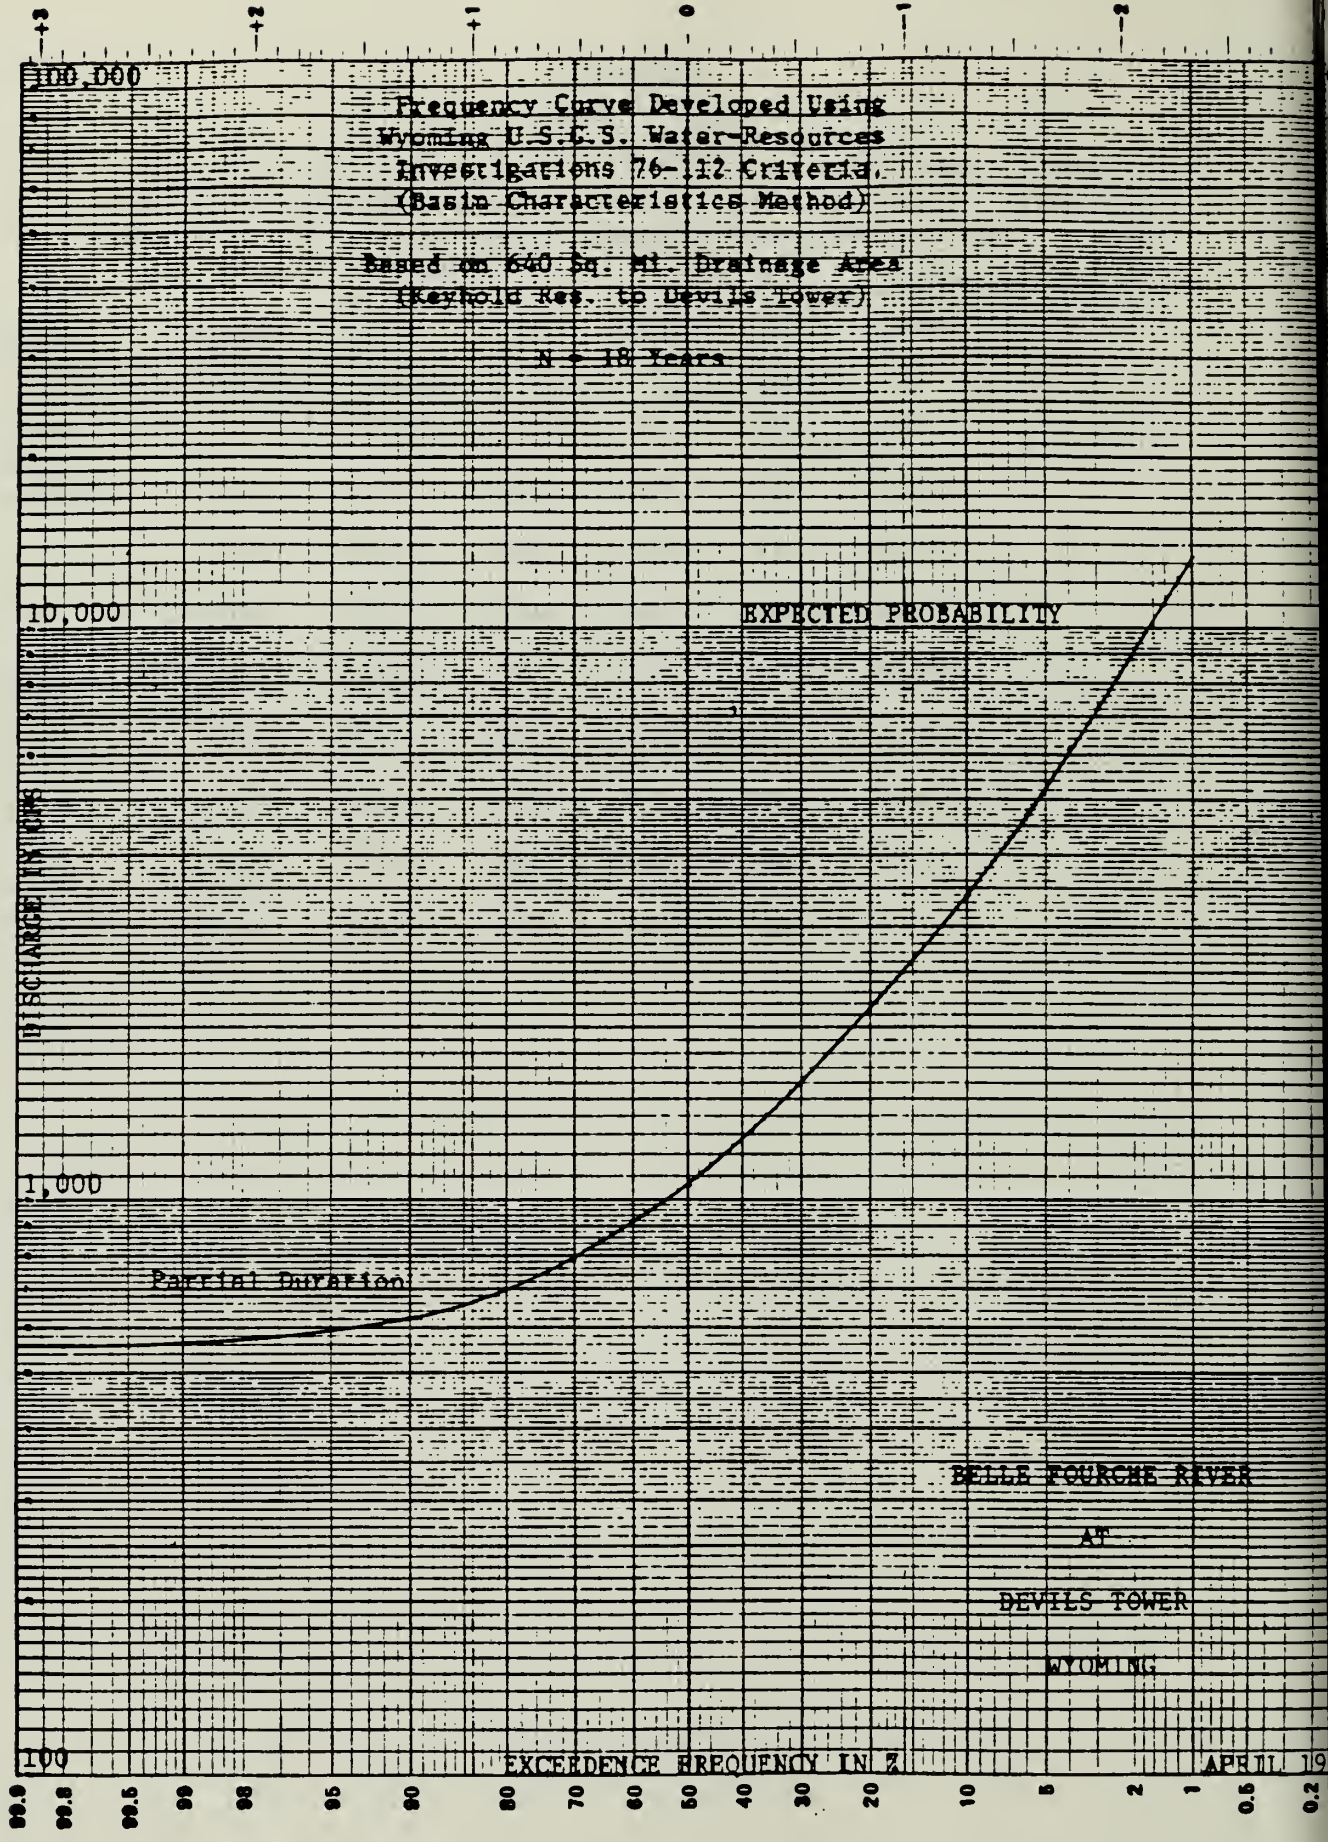
Attachment

500 - YEAR FLOOD

KEYHOLE DAM FAILURE

Eight (8) cross-sections were surveyed in June 1984 on the Belle Fourche River inside the park. The location of each cross-section was specified by the NPS. The surveying was performed by the Wyoming Water Research Center of the University of Wyoming at Laramie (Reference 1).

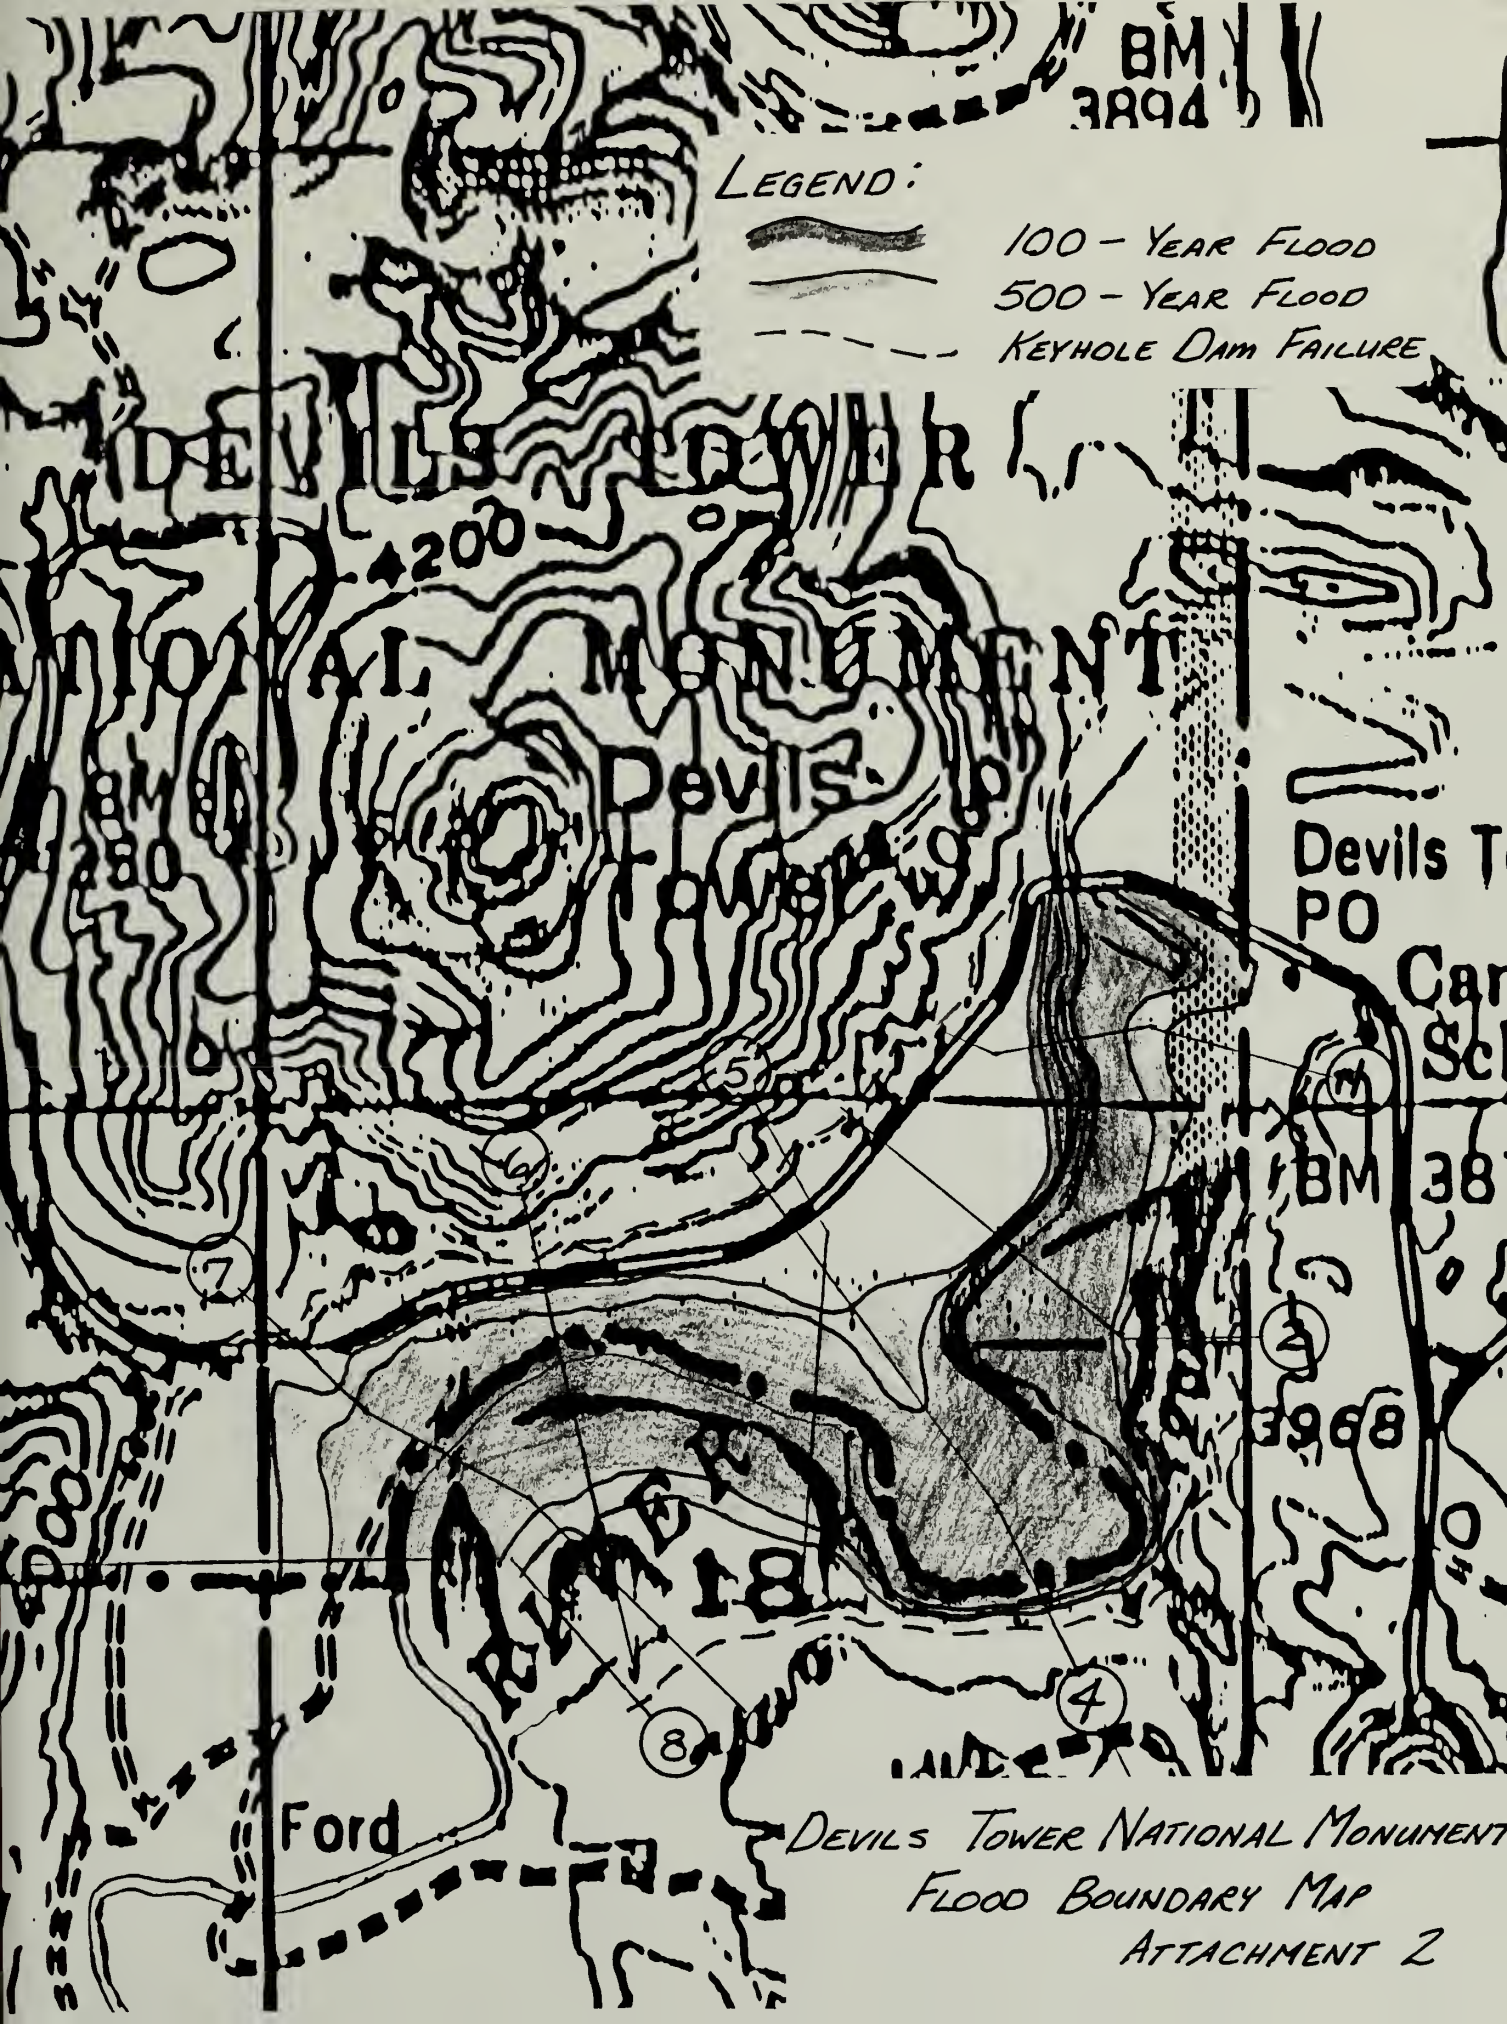
ATTACHMENT 2

FLOOD BOUNDARY MAP
