CULTURAL LANDSCAPE REPORT

for
Perry's Victory and International Peace Memorial
Put-in-Bay, Ohio

National Park Service, 1994

by
Historical Landscape Architect Sherda K. Williams
Midwest Regional Office

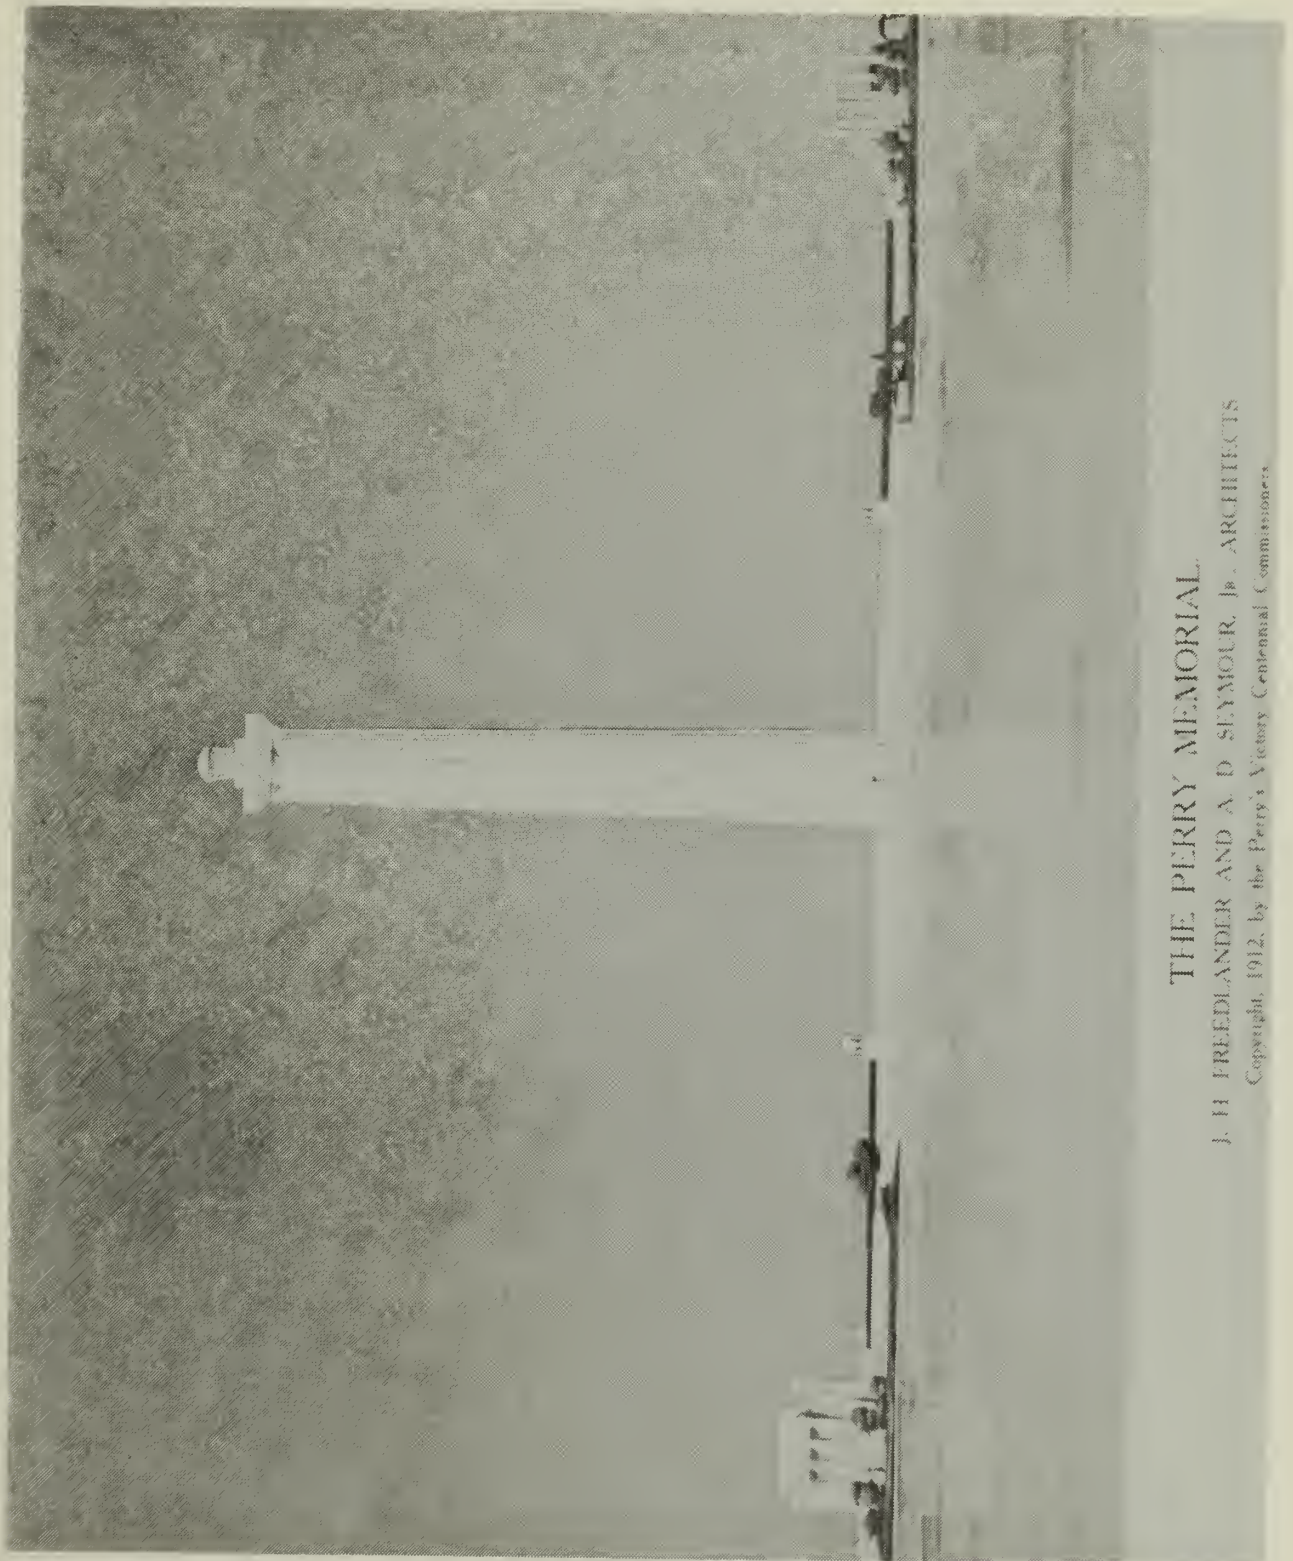
Fig. 8 Freedlander's competition drawing, 1912. The original of this drawing has not been located [from *Official Souvenir Program of the Perry's Victory Centennial, 1813-1913*].

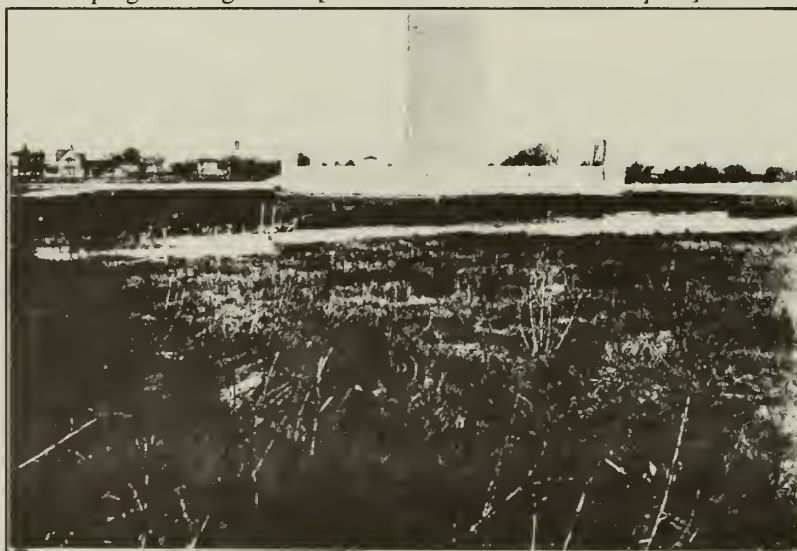
Fig. 10 The Memorial after completion of column and plazas and before landscaping of the grounds [1926 *Commission Annual Report*].

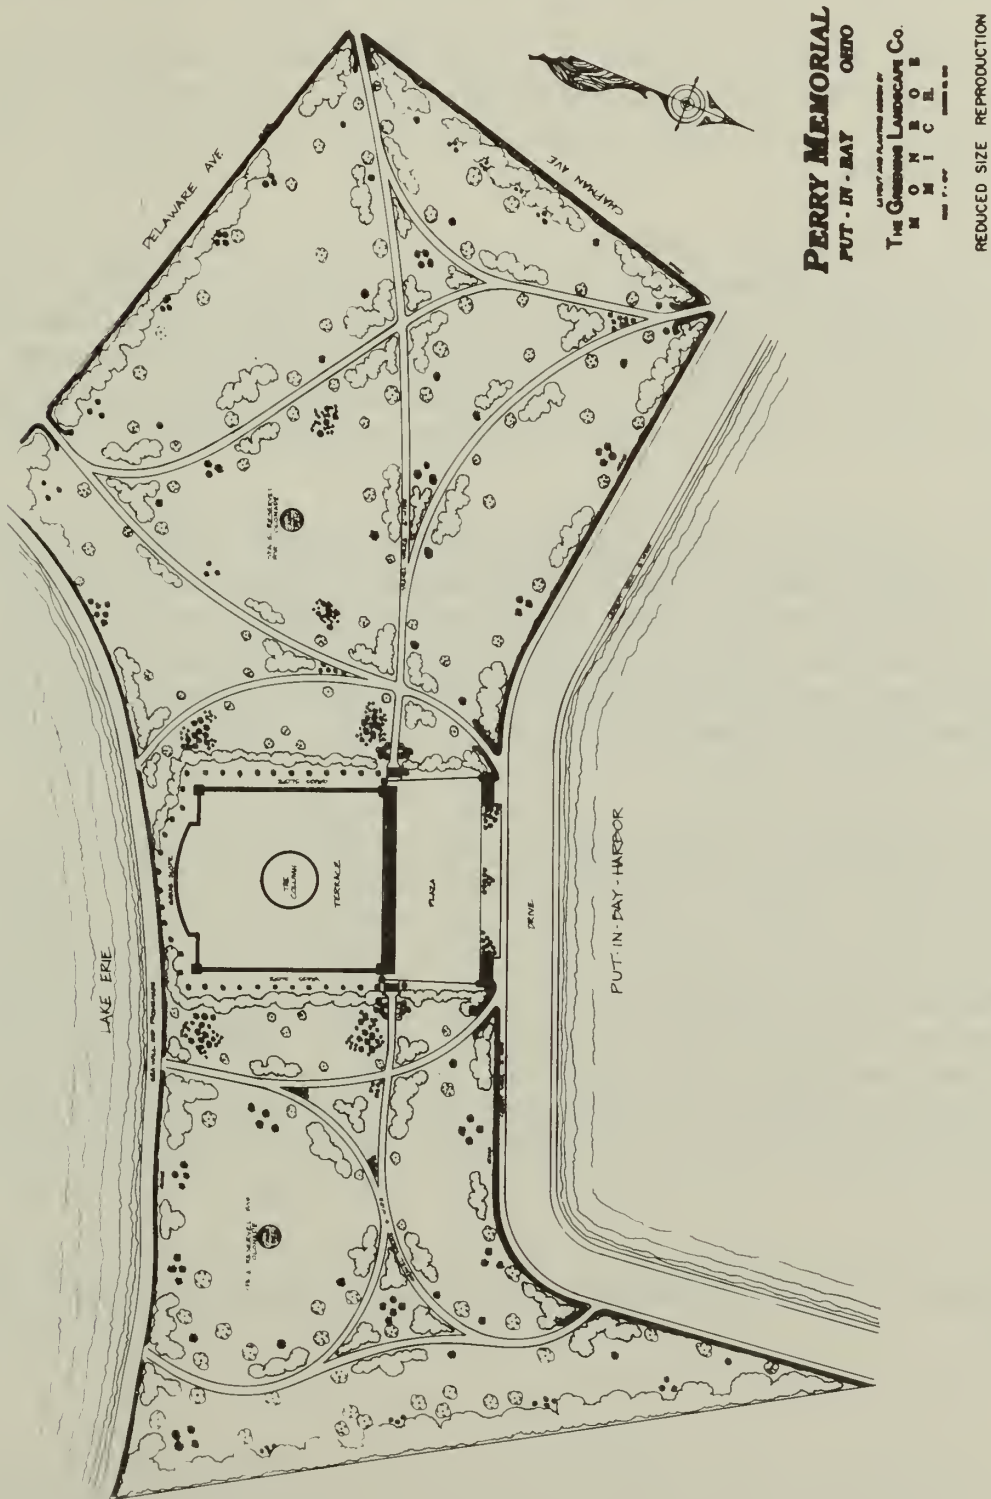
Fig. 13 Greening's proposed landscaping plan, 1921 [copied from the original by NPS/DSC staff].

Greening gave the project a great deal of thought and submitted a design in October 1921. He intended to create an arboretum of carefully selected varieties of plants and trees which would at once become a wonderful educational feature for the study of hardy flowers, trees, and plants. He included a collection of shrubs that would be in bloom during June, July and August. The varieties of plants and trees would be marked with botanical and common names for natural study. The design was extremely ambitious including 7,466 trees, evergreens, shrubs, roses, hedges, and perennial flowers.³⁵

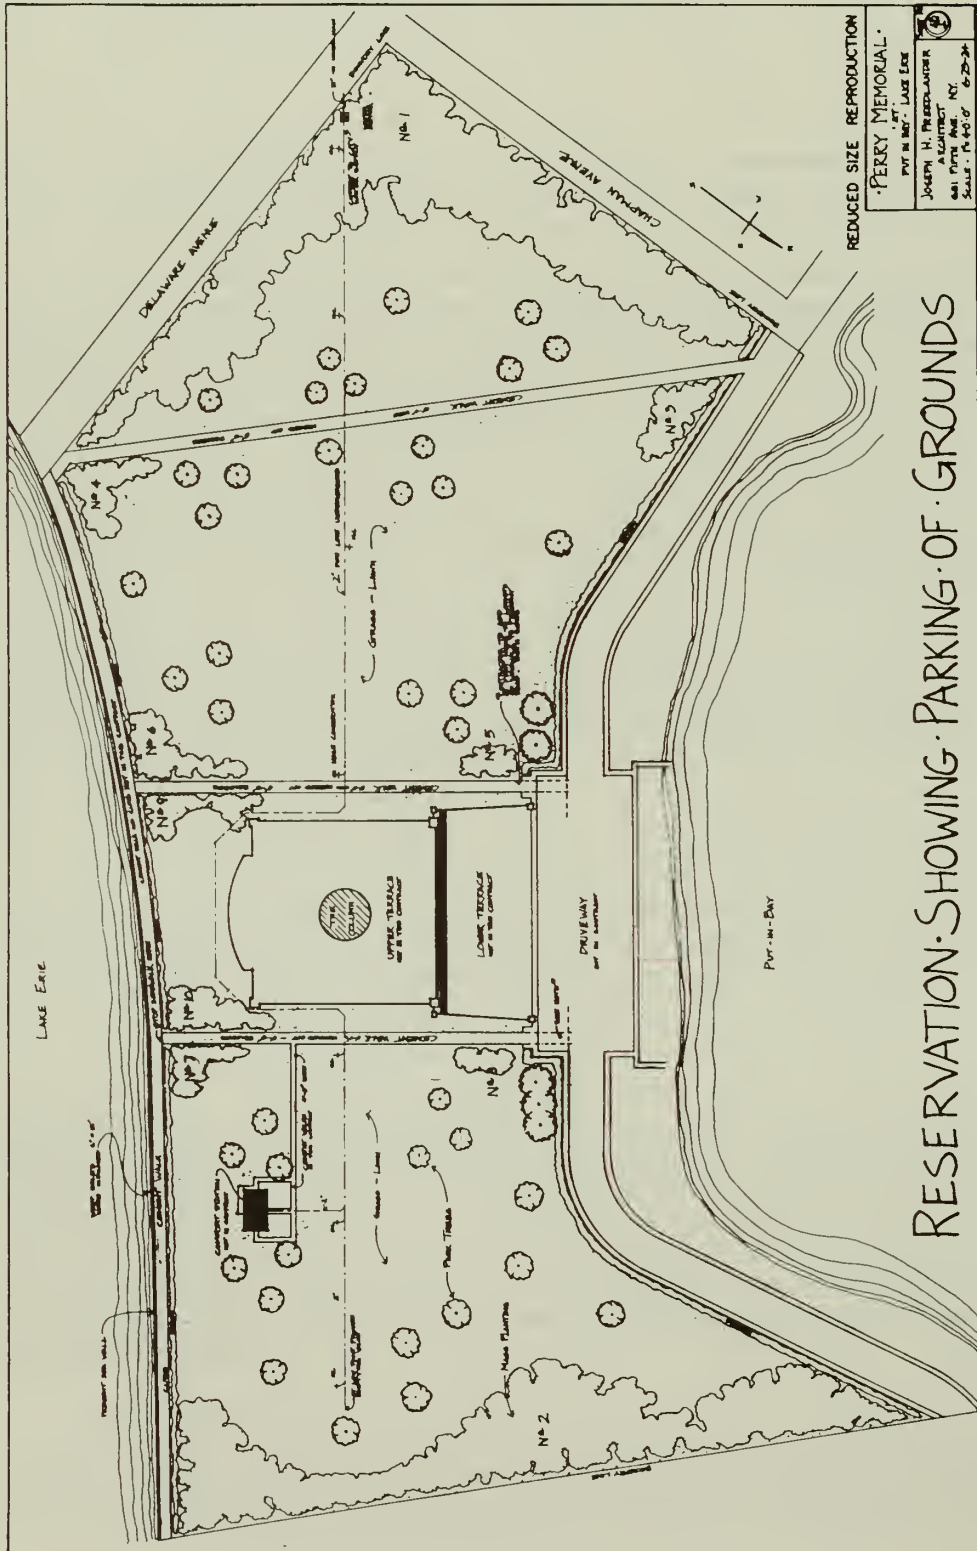
Fig. 14 Freedlander's second plan, 1924 [copied from original by NPS/DSC staff].

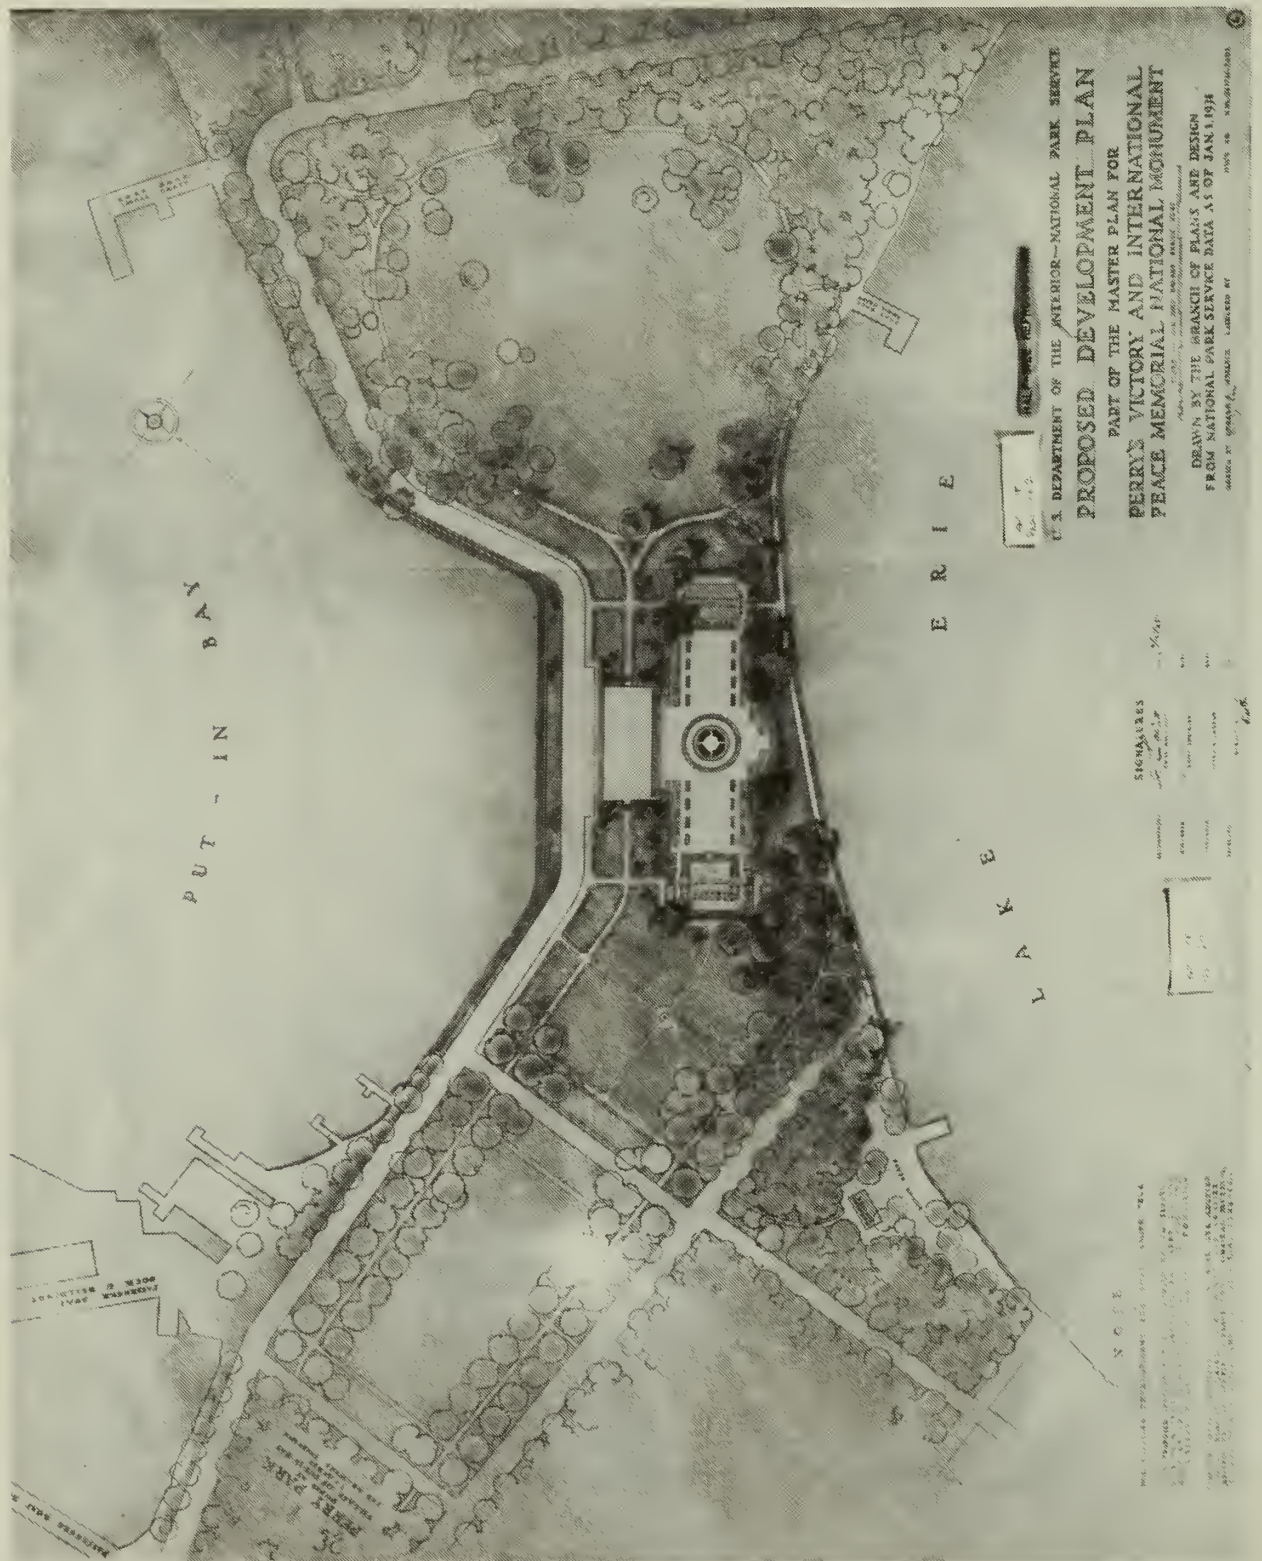
Fig. 19 The "Development Plan" proposed by George Wallace of the National Park Service, 1938 [copied from the original by NPS/DSC staff].

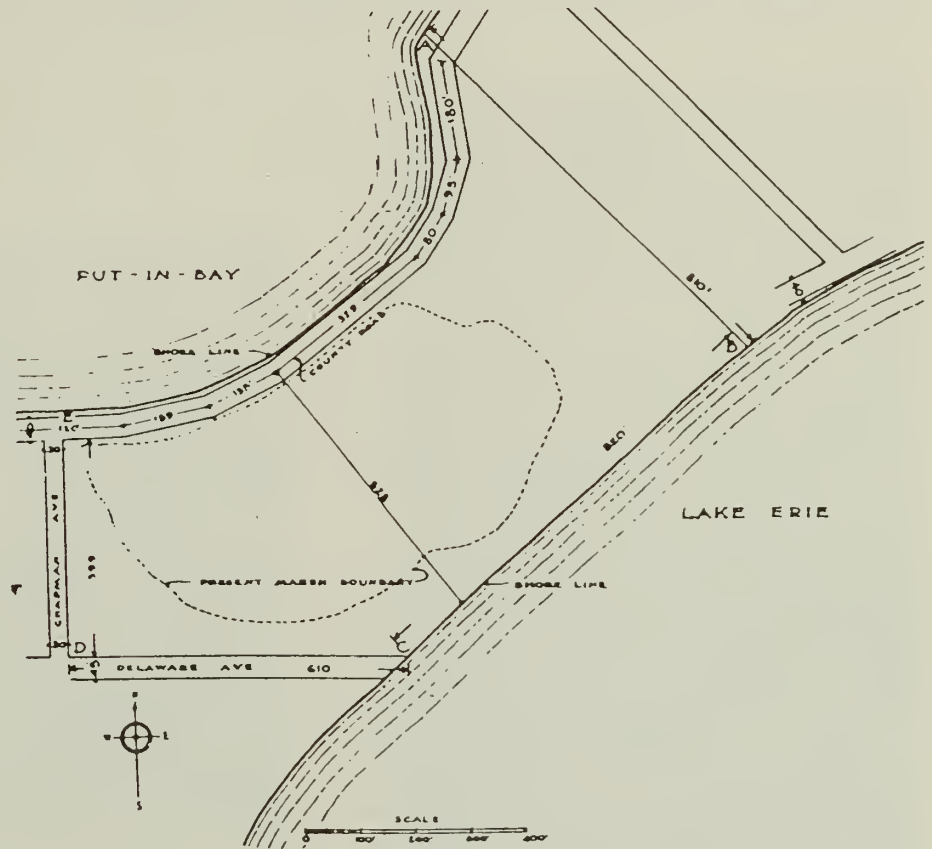
Fig. 23 Original survey map indicating the extent of "Chapman's Marsh."

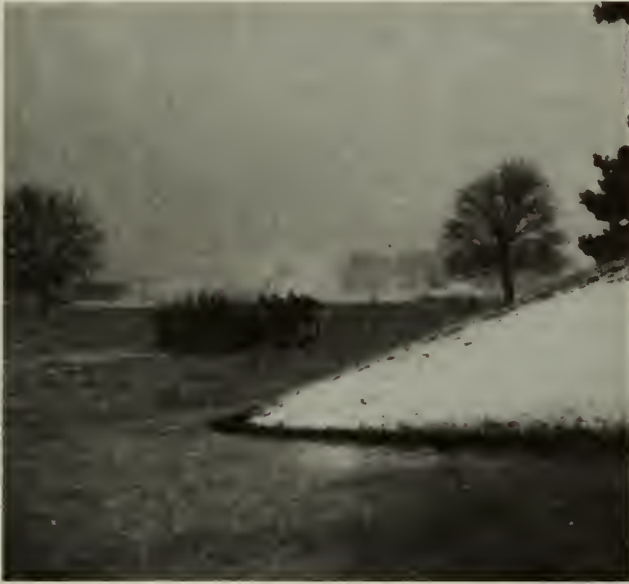
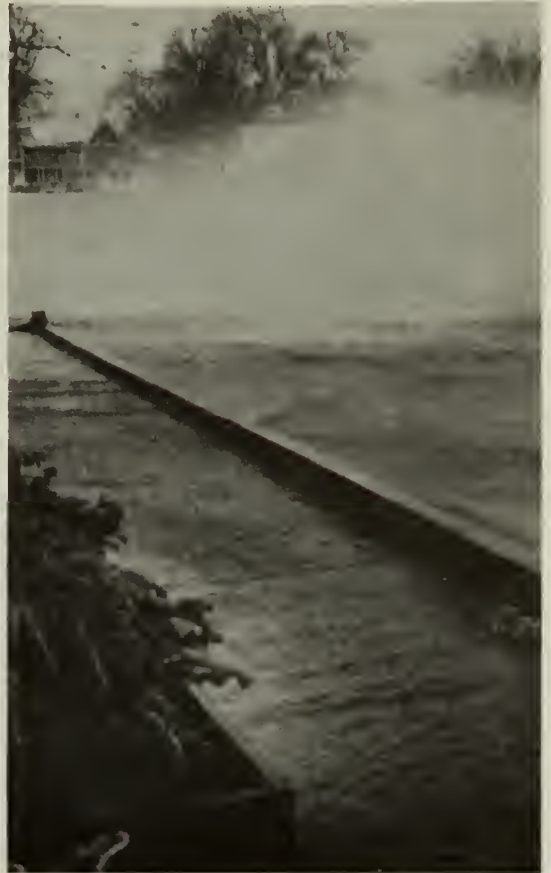
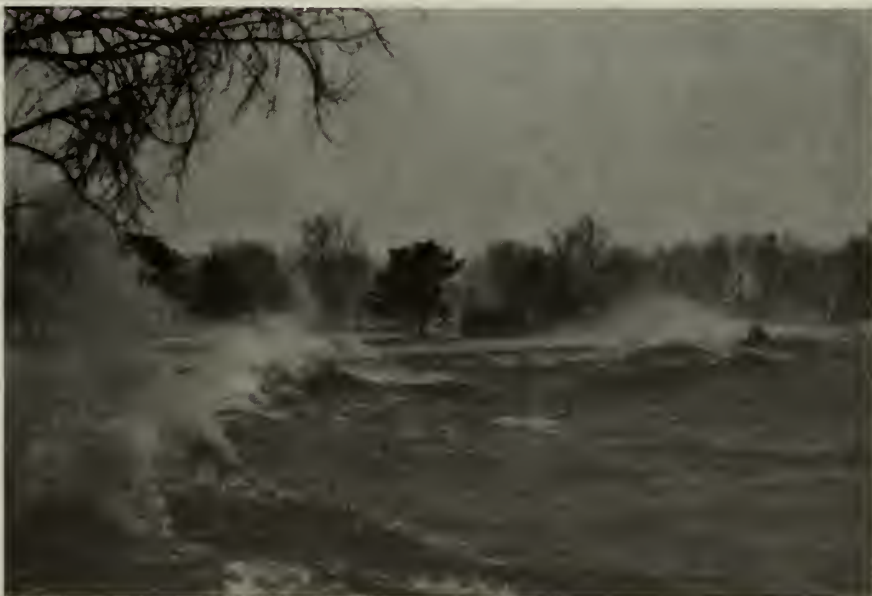
Fig. 24 Photographs from the 1970s illustrate conditions during a typical spring storm. Waves breaking over the north seawall completely covered State Road 357 and drove lake water across the Memorial grounds [by park staff].

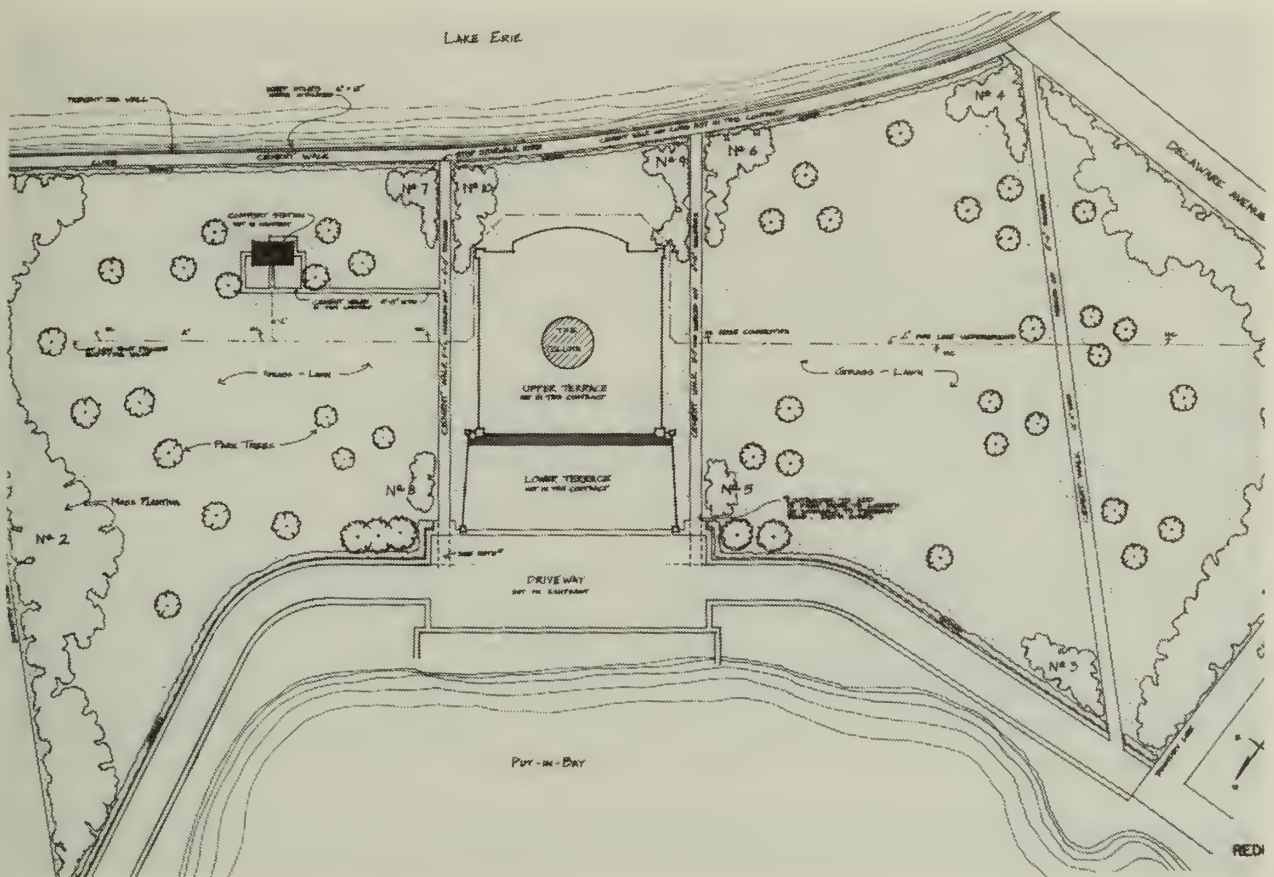
Fig. 27 Detail of Freedlander's second design for the Memorial landscape, 1924 [copied from original by NPS/DSC staff].

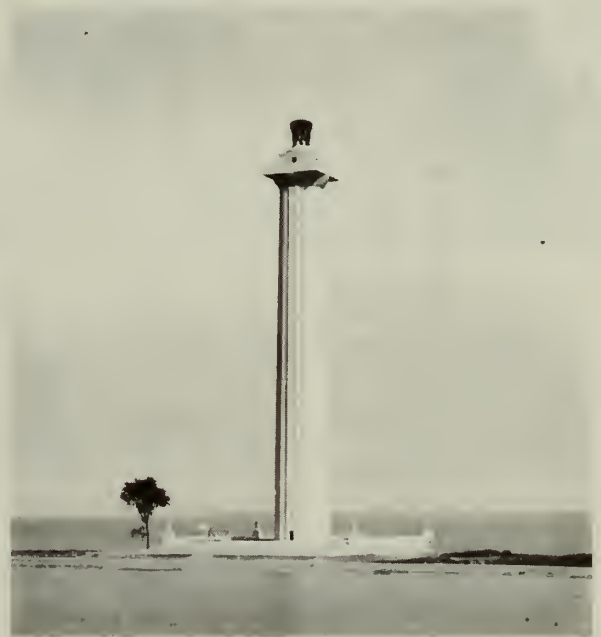
Fig. 29 A photograph showing the sloping terrace which had been completed around the lower plaza, but not around the upper terrace, 1915 [13-8-24].

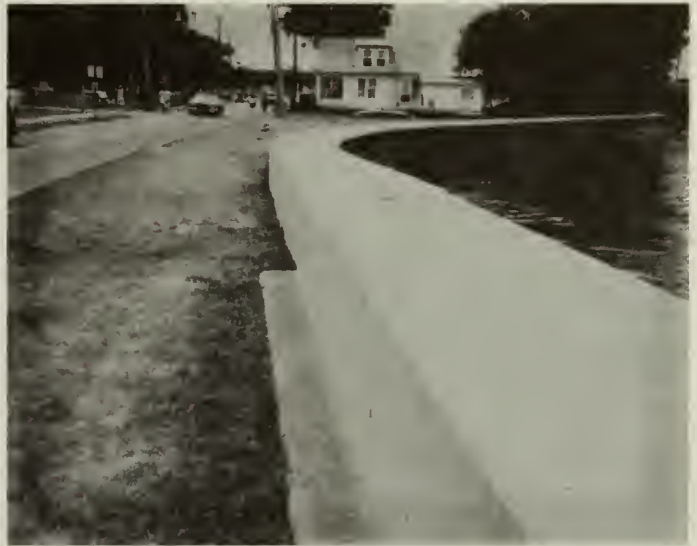
Fig. 32 View of the north seawall constructed over the earlier 1934-35 seawall [by author].

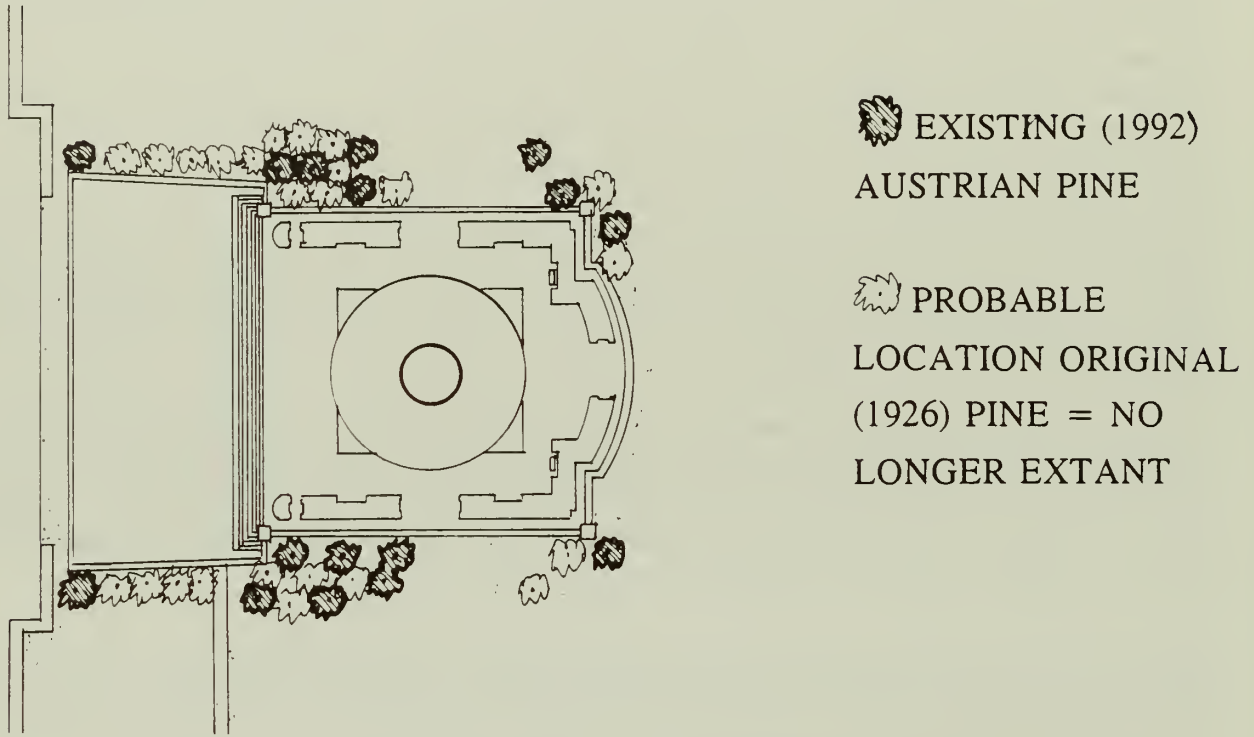
Fig. 34 Probable placement of the forty original Austrian pines planted in 1926 [by author].

building" which appears to be the current Park office [18],²³ and five went to the grounds of the Hotel Victory (no longer extant) on the southwest end of South Bass Island. No written documentation was found to indicate when the other thirteen pines were removed.

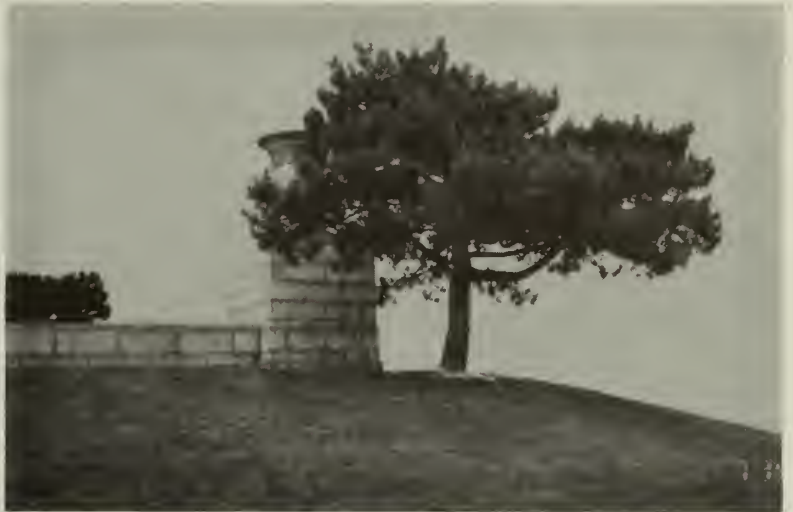
Fig. 35 The pruned top of the Austrian pine at the southwest corner gives the appearance of being stunted [by author].

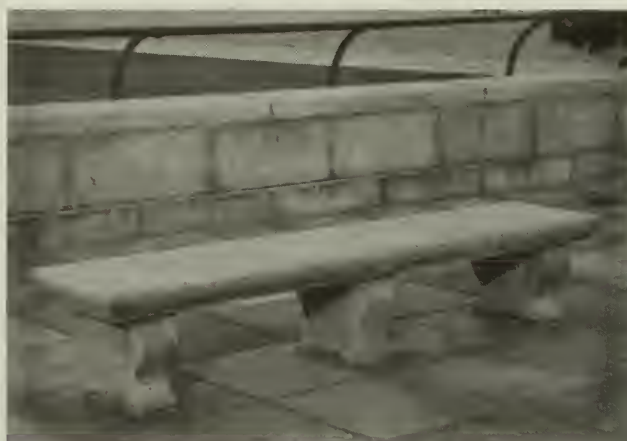
Fig. 38 One of the nine historic benches located on the upper plaza [by author].

the plaza are inscribed with the name of the flagships involved in the 1813 Battle of Lake Erie, a detail that bolsters the commemorative nature of the Memorial. The nine benches (six 6-foot long and three 8-foot long) were probably not installed until after the 1925 paving work on the plazas was completed. Their design and locations are consistent with those shown on Freedlander's 1912 "Sheet No. 12," *Perry Memorial at Put-in-Bay, Lake Erie* construction document. The urns and benches are original features and are intact in location, design, setting, materials, workmanship, feeling and association.
