STREAM CHANNEL ADJUSTMENTS FOLLOWING LOGGING ROAD REMOVAL IN REDWOOD NATIONAL PARK

TECHNICAL REPORT
DECEMBER 1987

Redwood National Park Watershed Rehabilitation
Technical Report Number 23

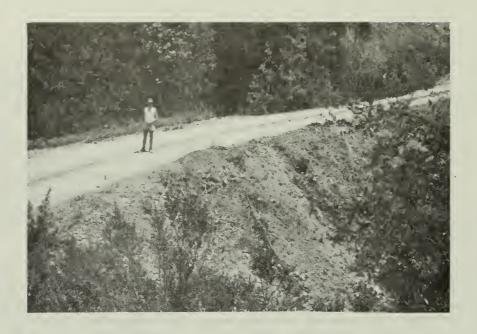
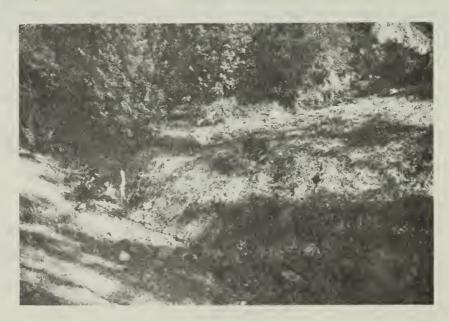
Figure 2. Logging road stream crossing before (A) and after (B) excavation. Excavation has uncovered cobbles and boulders that composed the original stream bed.

When roads are constructed across streams, a large amount of fill material (soil) is bulldozed into the stream channel to build the road bed up to grade. A major part of the ongoing watershed restoration program includes the removal of this road fill material from skid trail and haul road stream crossings (Figure 2). Excavation of road fill from stream crossings is given high priority because of the relatively high potential for significant erosional damage. For example, during extreme runoff events, plugged culverts may divert streamflow and cause gullying of hillslopes and road beds while saturated stream crossings can fail as destructive debris torrents.

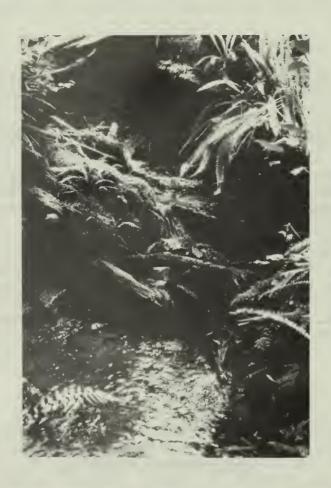
Figure 4. Small stream in an undisturbed, old-growth setting. Note that organic debris accumulations form steps in the stream's longitudinal profile.

accumulates in channels to form discrete "dams", or steps, in the longitudinal profile (Figure 4). By exaggerating the variability in local channel gradient, organic debris steps cause much of a stream's potential energy to be expended at localized points along the profile. Energy dissipation by vertical waterfalls over organic steps results in less energy available for channel erosion and sediment transport (Heede 1972, Curry 1976, Swanson and Lienkaemper 1978, and Marston 1982).

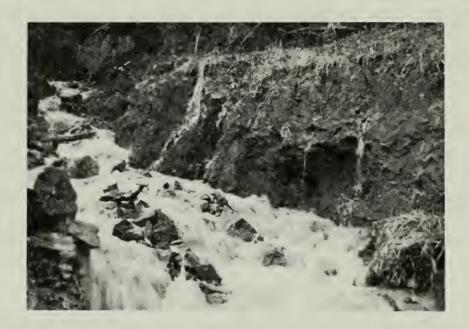
Figure 10. Left bank in Reach 6 following the storm of December 15, 1982. At the time this photo was taken (December 17, 1982), bank slumping continued to supply fine sediment to the channel, precluding or masking the development of a channel bed armor layer.

the field between Reach 6 and the other 23 reaches was the extremely saturated condition and resultant instability of streambanks along the upper portion of the reach (see Figure 10). It was noted during frequent visits to the study reaches that the streambanks adjacent to Reach 6 continued to slough and supply fine sediment to the channel well after stormflows had receded. In other reaches, banks appeared less mobile, allowing more opportunity for lag development by winnowing away of fines while storm discharges receded. From these observations, it was concluded that Reach 6 could be considered anomalous with respect to channel armoring due to the persistence of bank sloughing.

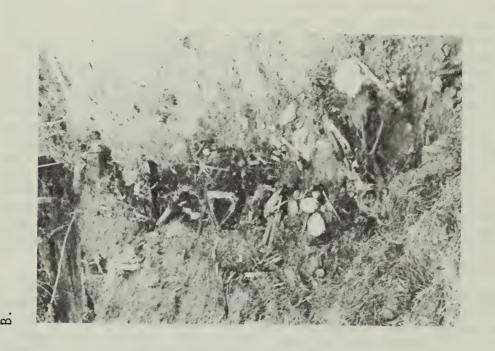
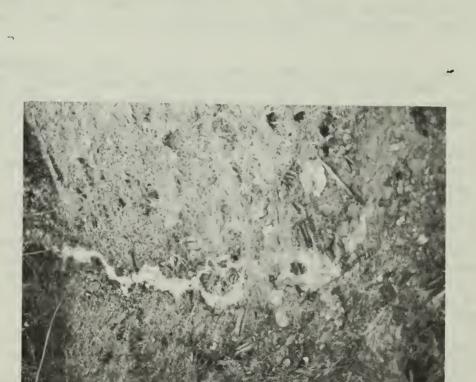
Figure 12. Before (A) and after (B) season photos of Reach 23 showing development of numerous steps composed of organic debris accumulations. Percent stream drop composed of organic steps (%ORGDROP) in this reach was relatively high at 45.5%.

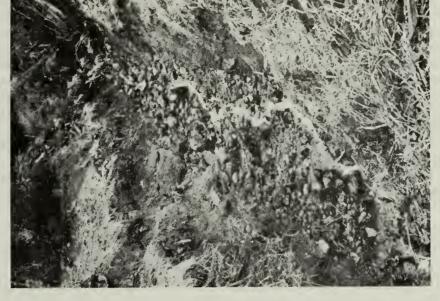
Before (A) and after (B) season photos of Reach 5 showing extensive scour and channel levelopment. Percent stream elevation drop composed of organic steps (%ORGDROP) was low (6.9%), as was the percent streambank material composed of boulders and cobbles the severe erosion occurring in this reach. bed armor development. (%B+C), accounting for Figure 13.
