Historic Furnishings Report

EXTERIOR FURNISHINGS OF LOWER TOWN HARPERS FERRY

HARPERS FERRY
National Historical Park/West Virginia

by
Sarah H. Heald
Staff Curator

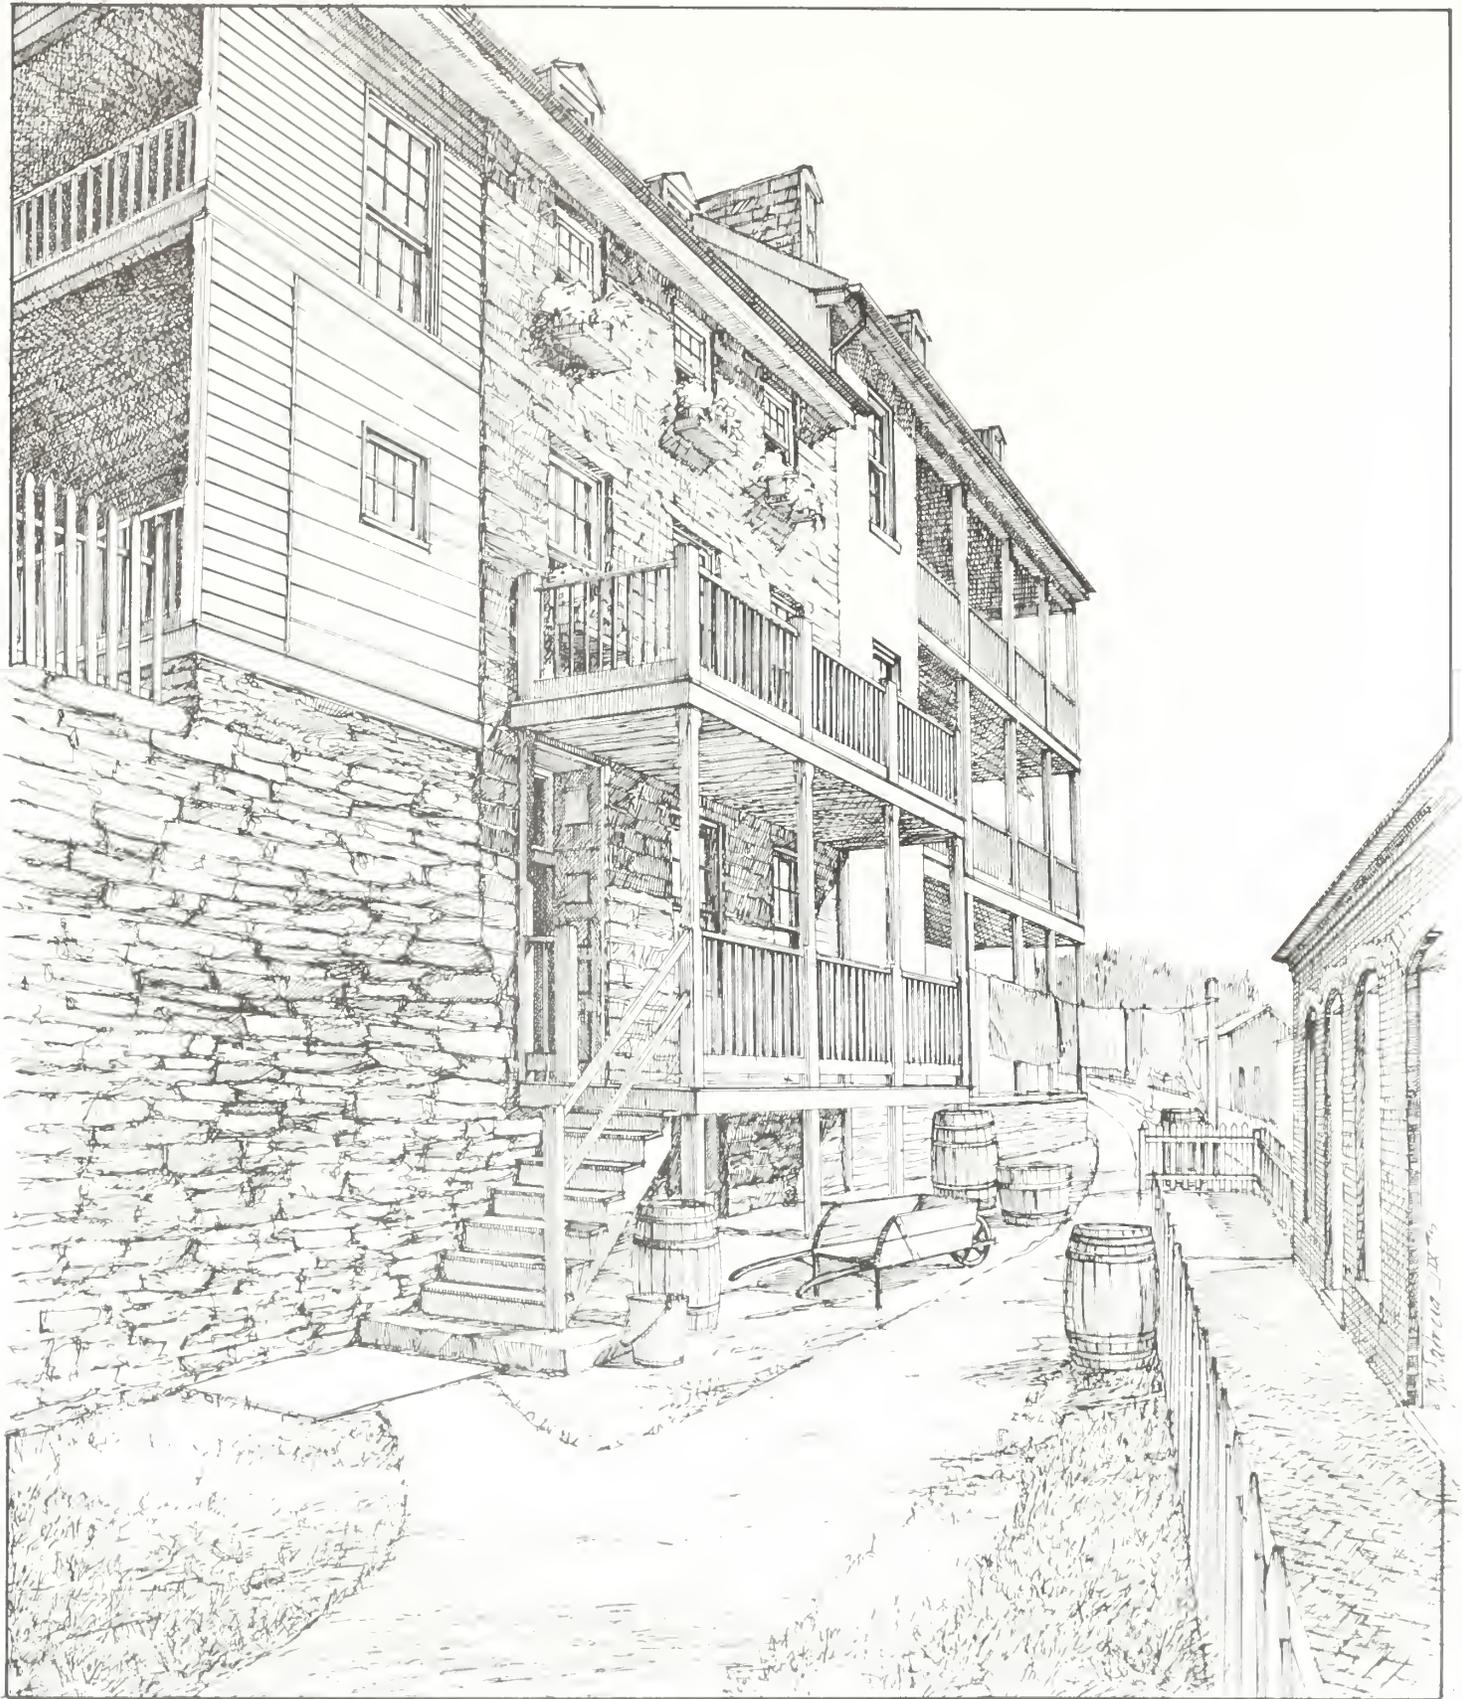
Marmion Row and Public Way

Object and Location	Documentation	Recommendation and Installation Consideration
CHAIRS, 2, rod-back style (on front porch of building 1-A, by footbridge)	Figure 7.	Reproduce.
WHEELBARROW (beside building 1-A on lower Public Walk)	Figure 8.	Reproduce.
CLOTHESLINE stretched in a diagonal direction from building 1-B porch column across Public Walk to pole, with sheets or blanket	Figures 8 and 16.	Reproduce. Attach textiles to line so they cannot be moved by visitors; maintenance staff will need to move it temporarily when mowing.
WOODEN BARRELS, 4 whole and 1 half barrel (not identical), beside 1-B and 1-C on lower Public Walk (1 of the barrels should be near the base of the clothes line pole; 2 barrels and the half barrel should be between the path and building 1-C; and 1 between the path and the fence)	Figures 8 and 13.	Reproduce. Remove white picket fence that is perpendicular to east side of 1-A and along length of path after building 3 ends (this fence should be relocated to be more clearly associated with back patio of building 3). Work with landscape architects to remove existing stepping stones and install a broad footpath based on historic photographs.

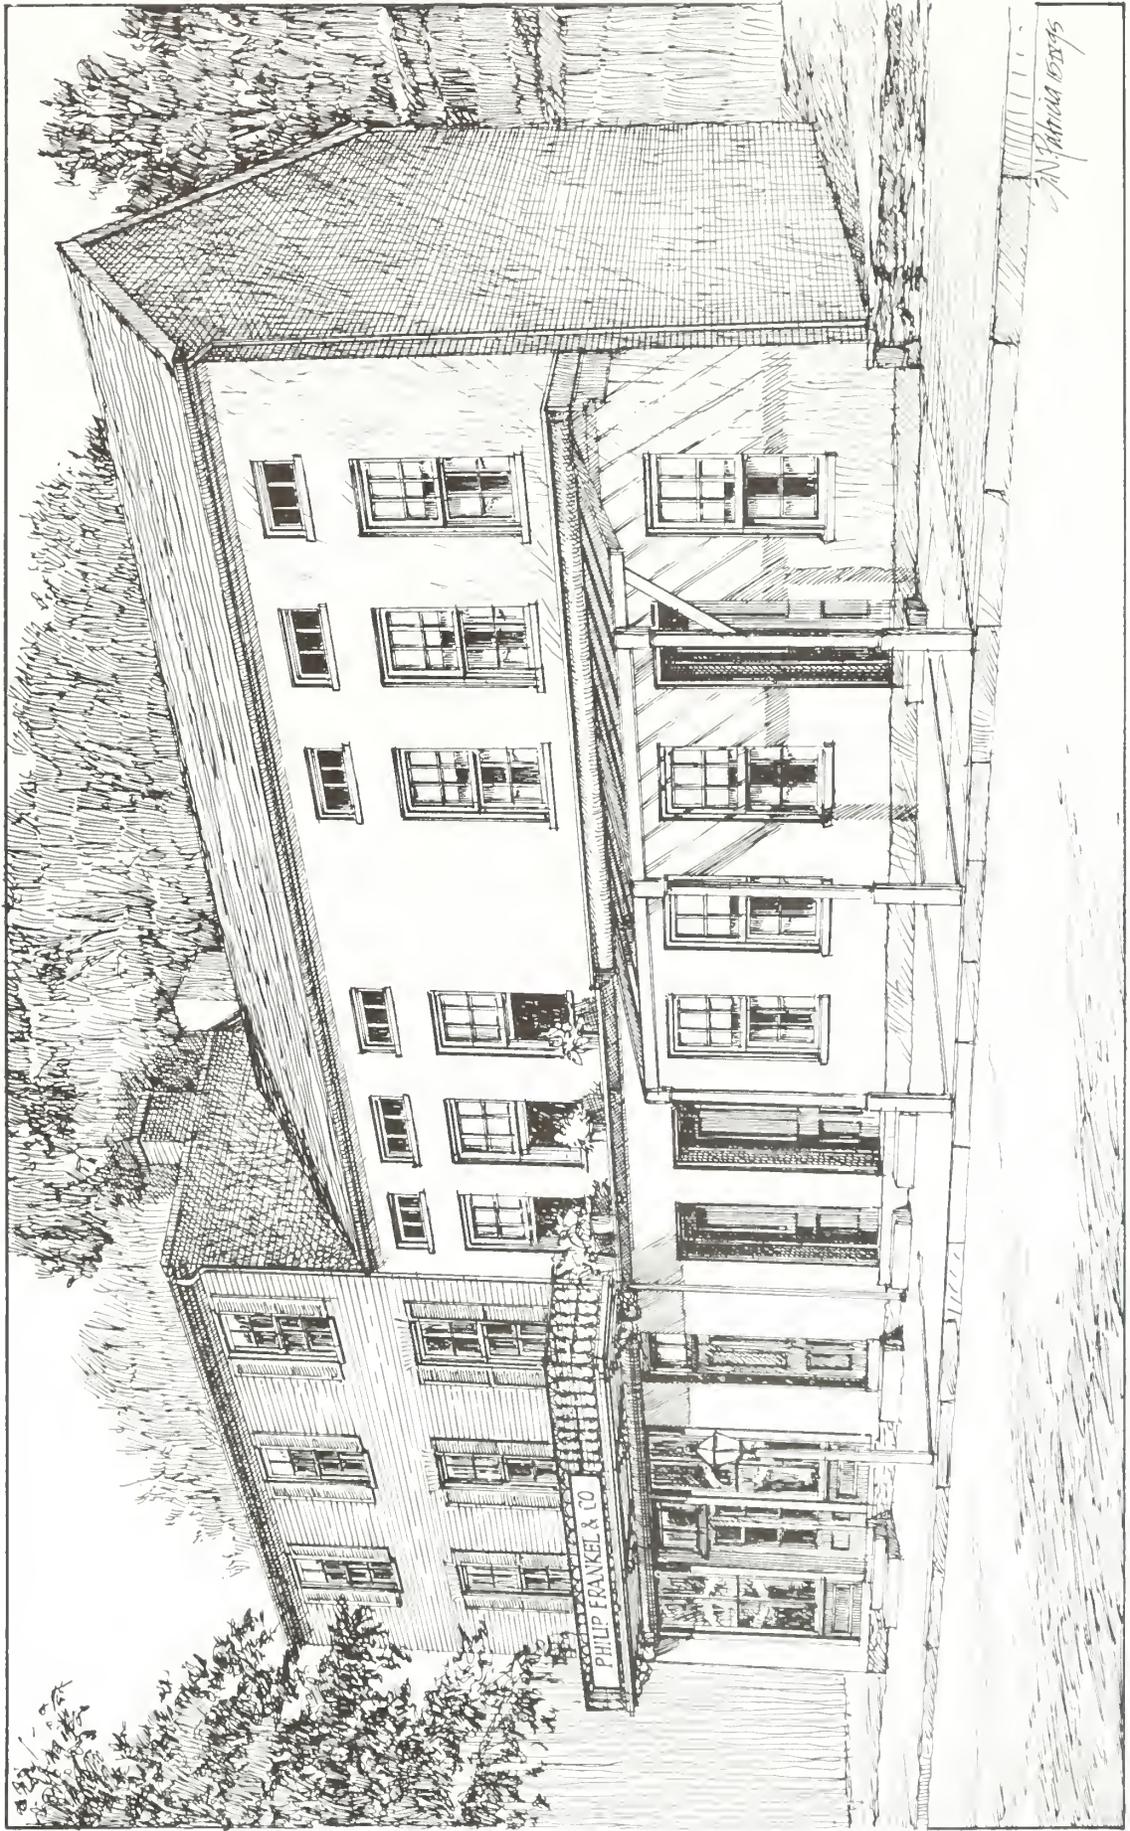
West Side of Shenandoah Street, South of High Street: Buildings 48, 45, 44, 43, 40, 38

Object and Location	Documentation	Recommendation and Installation Consideration
<p>WINDOW TREATMENTS</p> <p><u>Building 48</u></p> <p>First floor: 6 roller shades with full length, double panel curtains</p> <p>Second floor: 1 roller shade and 6 short-style curtains</p>	<p>Rented by an armorer and family in 1859.</p>	<p>Year round park residence. Reproduce. Storage of park materials should be moved away from the windows so it is not visible from the street.</p>
<p>WINDOW TREATMENTS</p> <p><u>Building 45</u></p> <p>Second floor: 6 roller shades with tassels and full length, double panel curtains; 3 rollers shades</p> <p>Third floor: 2 short style curtains, 2 empty</p>	<p>Upper floors rented to two families in 1859.</p>	<p>Reproduce. Storage of park materials should be moved away from the windows so it is not visible from the street.</p>
<p>CHAIRS, 4, rod-back and captain's style (on second floor porch of building 45)</p>	<p>"An adjourn to the porch [of Stipes' boarding house] follows the repast, when conversation supervenes," <i>The James E. Taylor Sketchbook</i>, p. 37.</p>	<p>Reproduce.</p>

<p>CHAIRS, 2, rod-back and captain's styles (on second and third floor porches of building 43)</p>	<p>"An adjourn to the porch [of Stipes' boarding house] follows the repast, when conversation supervenes," <i>The James E. Taylor Sketchbook</i>, p. 37.</p>	<p>Reproduce.</p>

<p>AWNING and FRAME, on building 40</p>	<p>Stores containing window clothing displays often had awnings to protect their merchandise from damage caused by heat and sunlight. Figure 15 shows numerous awnings on buildings along this side of Shenandoah Street.</p>	<p>Reproduce.</p>
<p>AWNING and FRAME, on building 38</p>	<p>Figures 5, 9, and 10.</p>	<p>Reproduce. Interior lighting must be added for archeology exhibition since awning will obstruct natural light in the exhibition.</p>
<p>WOOD PILE, approx. 2 ft. long and 1/2 ft. high (on second floor back porch of building 38)</p>	<p>The upper floors of building 38 were dwellings. Both wood and coal were used to fuel stoves in Harpers Ferry in second half of the nineteenth century.</p>	<p>Acquire cut wood.</p>
<p>BARRELS, 2, and BENCH (behind building 38)</p>	<p>Half of building 38 contained a grocery in 1859.</p>	<p>Reproduce.</p>
<p>FLOWER POTS with geraniums (on ledge of building 38, left side below second floor window sills)</p>	<p>Figure 5.</p>	<p>Reproduce.</p>

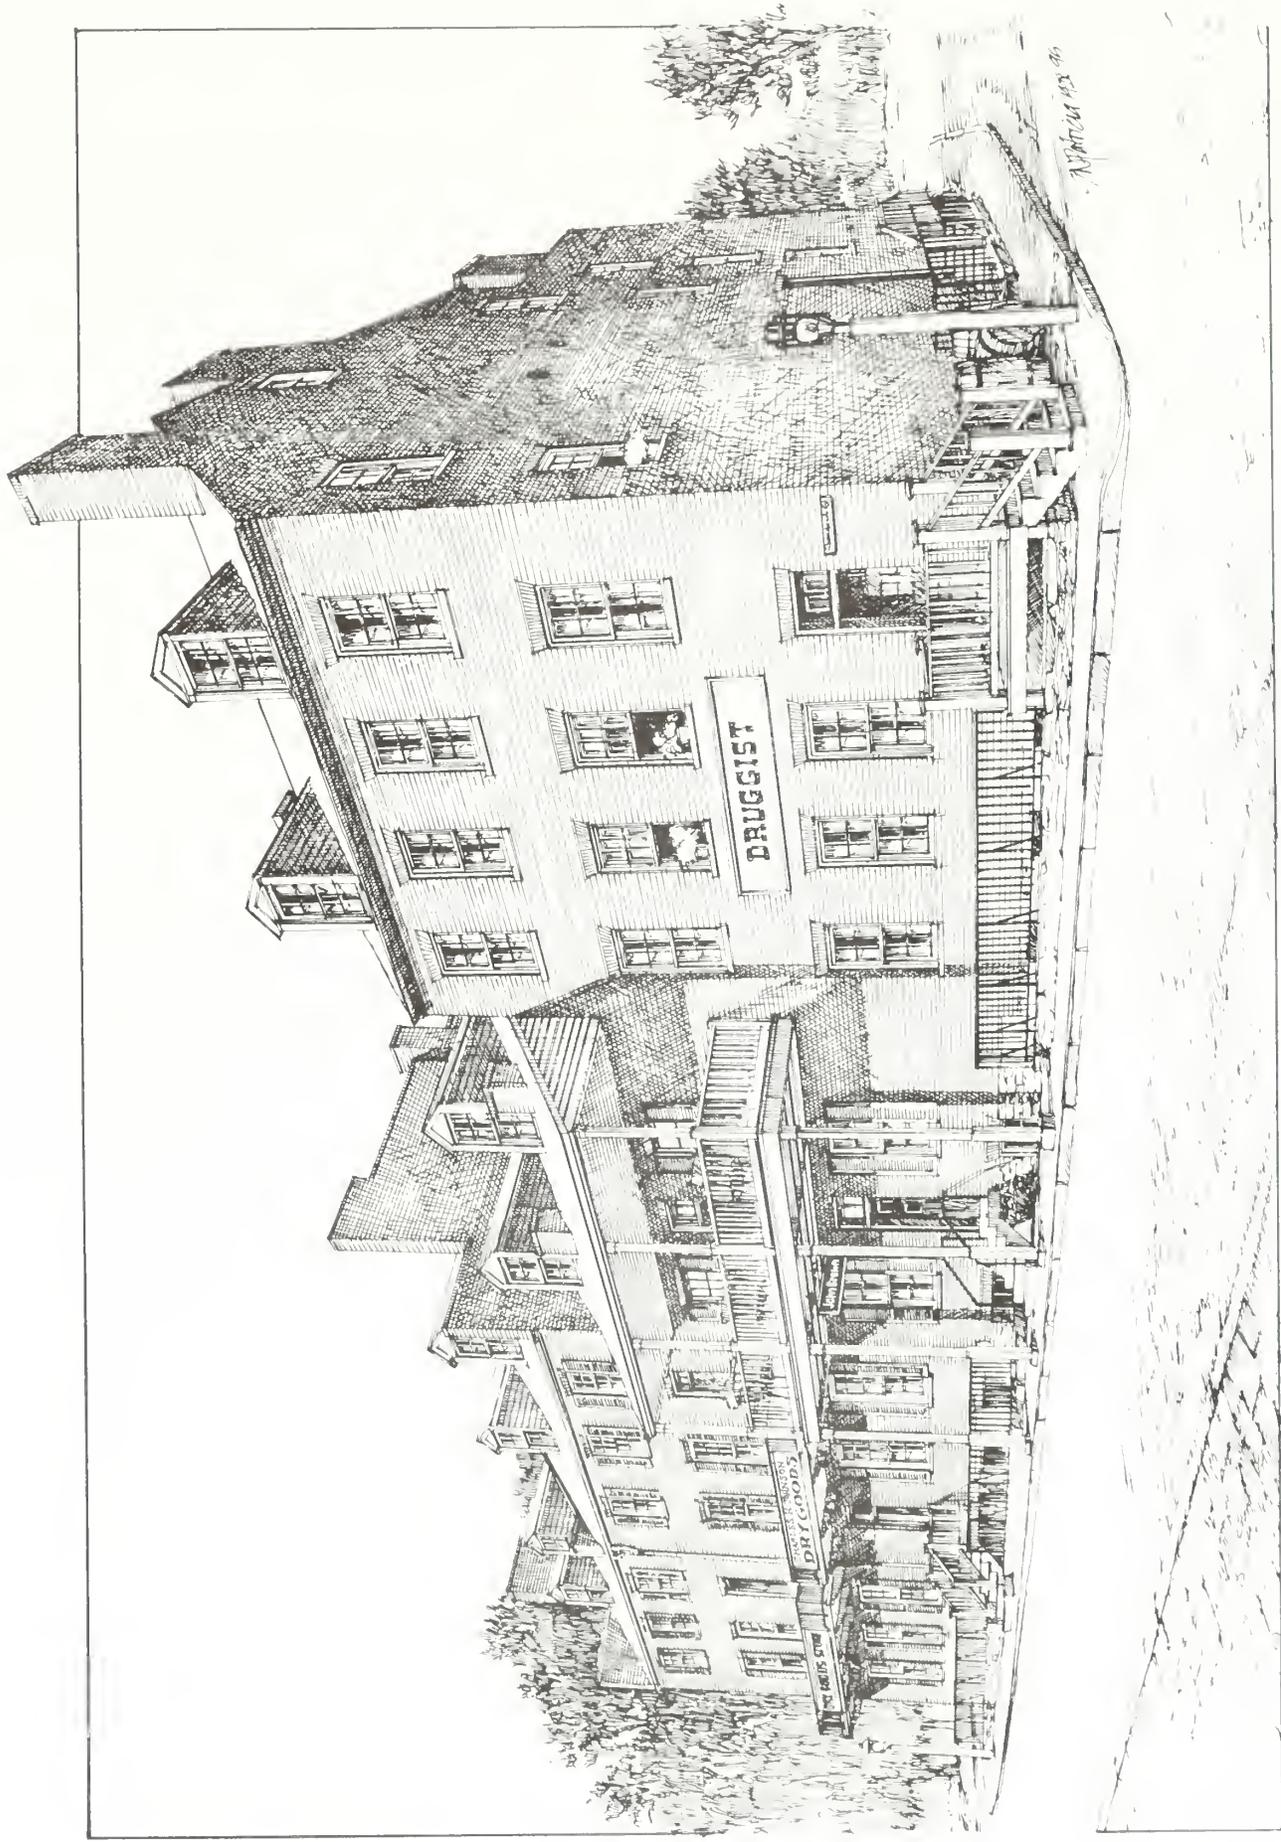
West Side of Shenandoah Street, North of High Street: Buildings 12, 11, 10, and 9

Object and Location	Documentation	Recommendation and Installation Consideration
SIGN, <i>Dry Goods Store</i> (on second floor porch rail, building 12)	A dry goods store was in building 12 in 1859. Store advertisements in <i>Spirit of Jefferson</i> , March 5, 1859.	Reproduce.
WOOD PILE, approx. 3-1/2 ft. long and 2 ft. high (along wall behind building 11)	Building 11 contained a dry goods store on the ground level and dwellings on the upper floors. Both wood and coal were used to fuel stoves in Harpers Ferry in second half of the nineteenth century.	Acquire cut wood.
HORSE CART, two-wheeled behind building 10 (location as shown in illustration)	Buildings 8 through 12 all had commercial businesses on their ground level in 1859; figure 25.	Reproduce. Indoor storage during winter will increase the longevity of this vehicle.
Commercial CRATES and BARRELS (crates stacked between cart and rear of building 10 along wall with building 11; barrels along same wall, behind building 11, and on opposite side of courtyard)	Buildings 8, 9, 10, 11, and 12 housed dry goods stores and a clothing store in 1859; <i>Virginia Free Press</i> , May 29, 1856, p. 2, col. 6.	Reproduce.

CARRIAGE behind building 8 (location as shown in illustration)	John Ridenour advertised a buggy for sale in early 1854. <i>Virginia Free Press</i> , Jan. 5, 1854, p. 3, c. 1.	Reproduce. Indoor storage during winter will increase the longevity of this vehicle.
WAGON behind building 8 and next to building 7	John G. Ridenour's dry goods store was in building 8 in 1859.	Use HAFE wagon (unnumbered). Indoor storage during winter will increase the longevity of this vehicle.

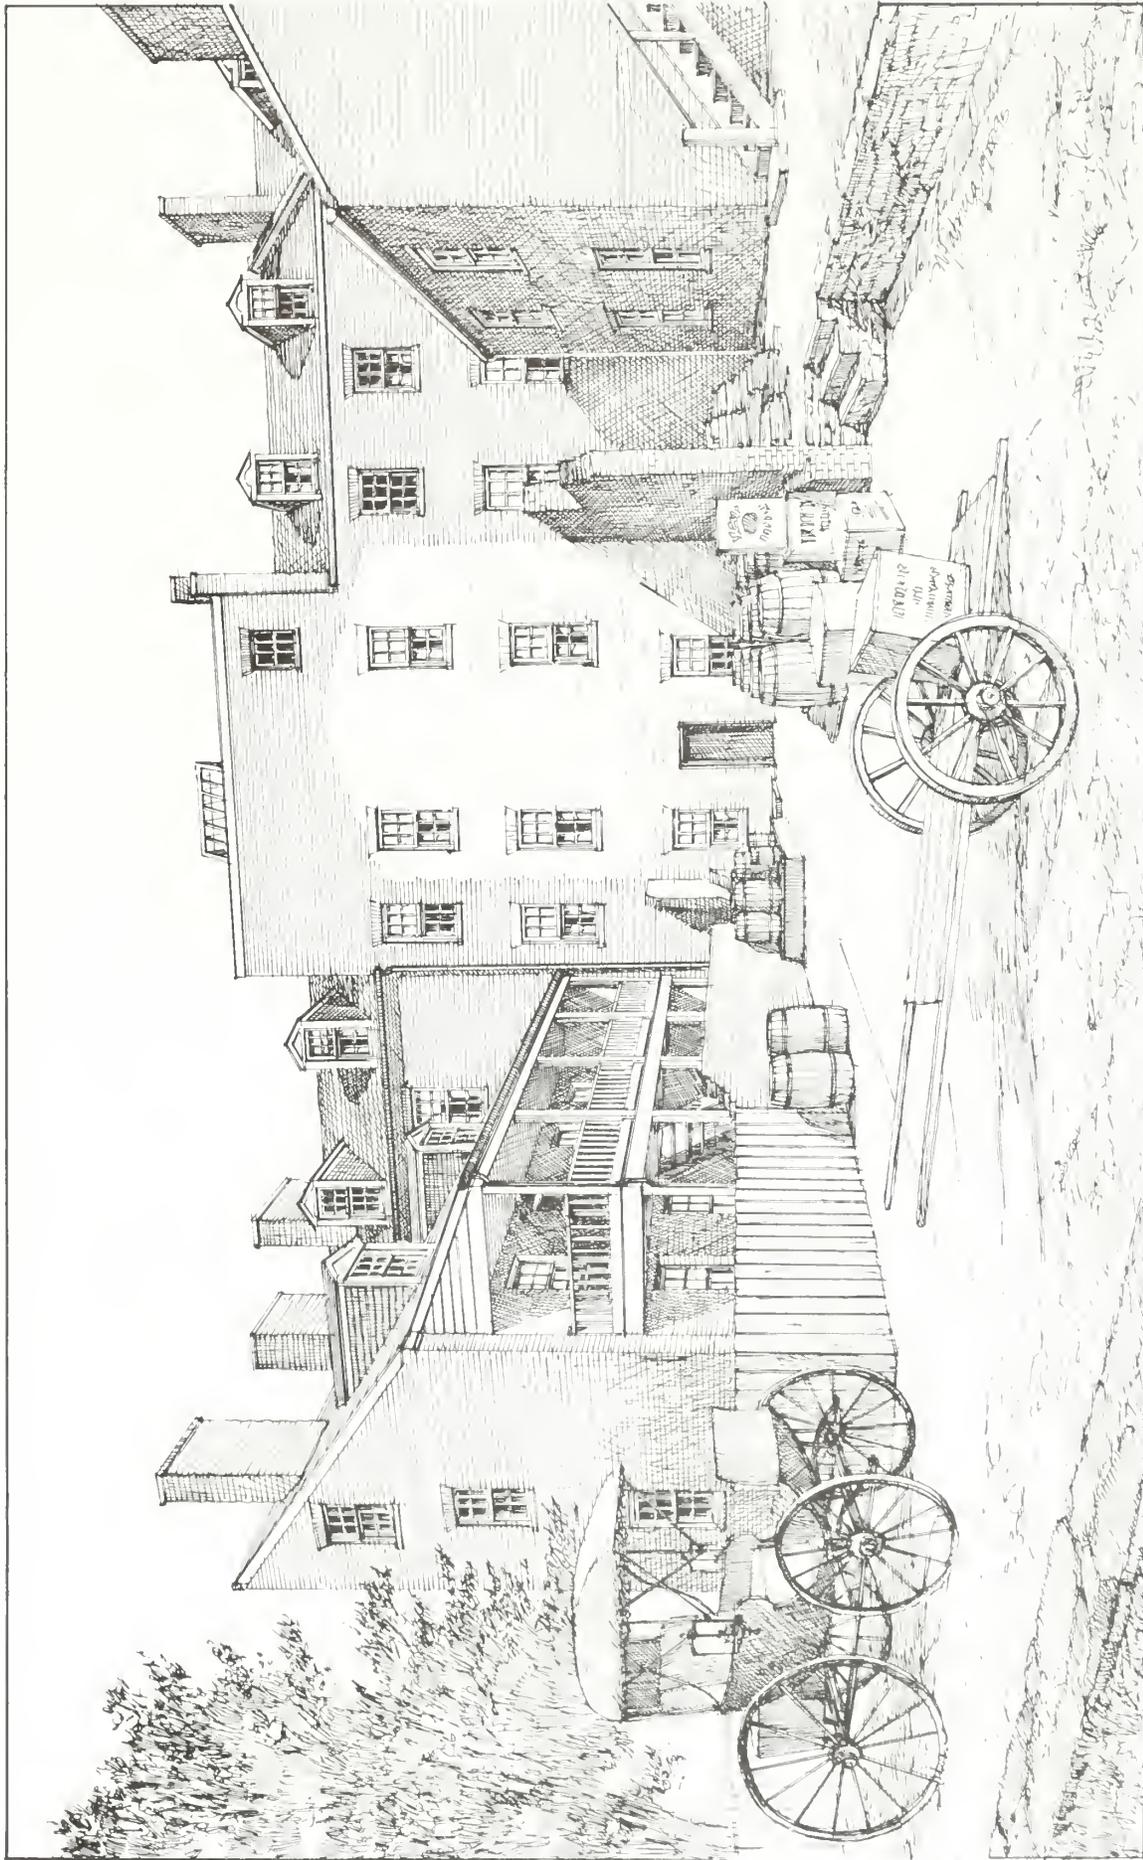
Backyards of Buildings , 9, 10, and 11

SIGN, <i>Charles H. Johnson / DRY GOODS</i> (on second floor porch of building 11)	Store advertisements in <i>Virginia Free Press</i> , April 24, 1856; May 29, 1856; August 6, 1857; April 8, 1858; and <i>Spirit of Jefferson</i> , March 5, 1859. Dry goods merchant Charles H. Johnson operated a store here in 1859.	Reproduce.
CHAIRS, 3, rod-back and captain's styles (on second floor porch of building 10)	"An adjourn to the porch [of Stipes' boarding house] follows the repast, when conversation supervenes," <i>The James E. Taylor Sketchbook</i> , p. 37.	Reproduce. Remove "Isaac Fouke" and "Harpers Ferry" sign on second floor porch, building 10. (There is no evidence for signs like these hanging here. The attorney Issac Fouke had an office in Charles Town and he operated the Wager House Hotel. If he had a Harpers Ferry office in 1859 it most likely would have been at the hotel.)
Commercial CRATES (along fence behind building 8)	John G. Ridenour's dry goods store was in building 8 in 1859.	Reproduce. Crates may be arranged to conceal recycling bins but historic sizes and configuration should be retained.

POTTED GERANIUMS (on sill of window on second floor of building 9, on Potomac Street side)	Figure 12.	Reproduce. Use artificial flowers that will be replaced annually.
BARRELS, 4 (on corner of Shenandoah and Potomac streets, beside building 9)	Figure 3.	Reproduce.
SIGN, <i>DRUGGIST</i> (between first and second floor windows of building 9)	Building 9 contained a store of unknown type in 1859. From 1845-1855 it was a drug store.	Reproduce.
WELL PUMP (where pump is currently located)	Figure 11.	Reproduce and paint.

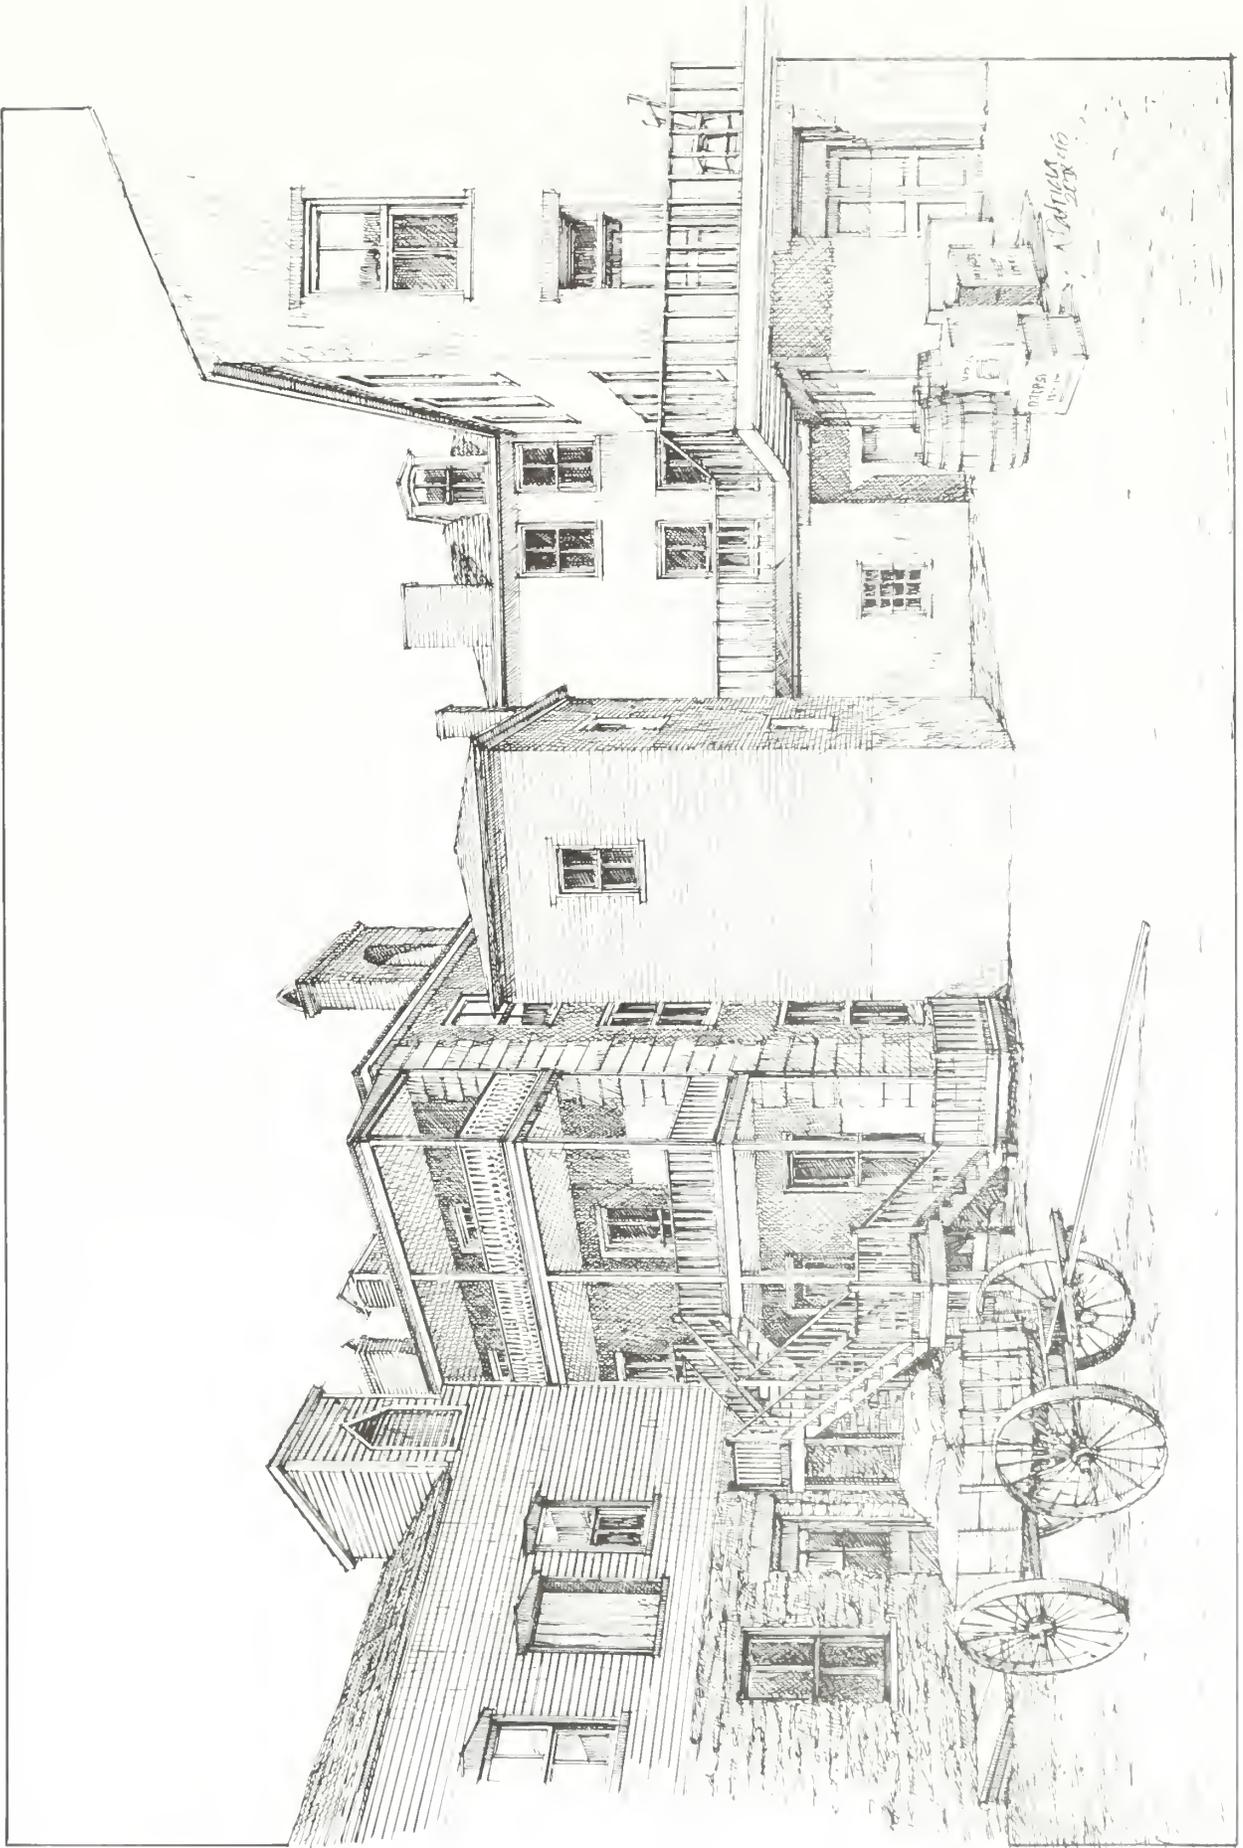
Backyards of Buildings 33, 34, and 35

<p>WINDOW TREATMENTS</p> <p><u>Building 35</u></p> <p>First floor: 1 roller shade; 4 roller shades with short style curtains</p> <p>Second floor: 9 roller shades with sill-length double panel calico curtains; 3 roller shades; 2 roller shades with short style calico curtains</p> <p>Third floor: 5 roller shades with sill-length double panel calico curtains; 7 roller shades with short style curtains</p> <p>Fourth floor: 2 short style curtains</p>	<p>Building 35 was vacant in 1859. It had been the Master Armorer's quarters from 1818 to 1858.</p>	<p>Reproduce. Storage of park materials should be moved away from the windows so it is not visible from the street.</p>
<p>CHAIR, 1, rod-back style (on second floor rear porch of building 35)</p>	<p>In 1864, building 35 housed Mrs. Stipes' boarding house; Gibson estate (see note, p. 17).</p>	<p>Reproduce. Restoration includes adding a second floor porch on the back of building 35.</p>

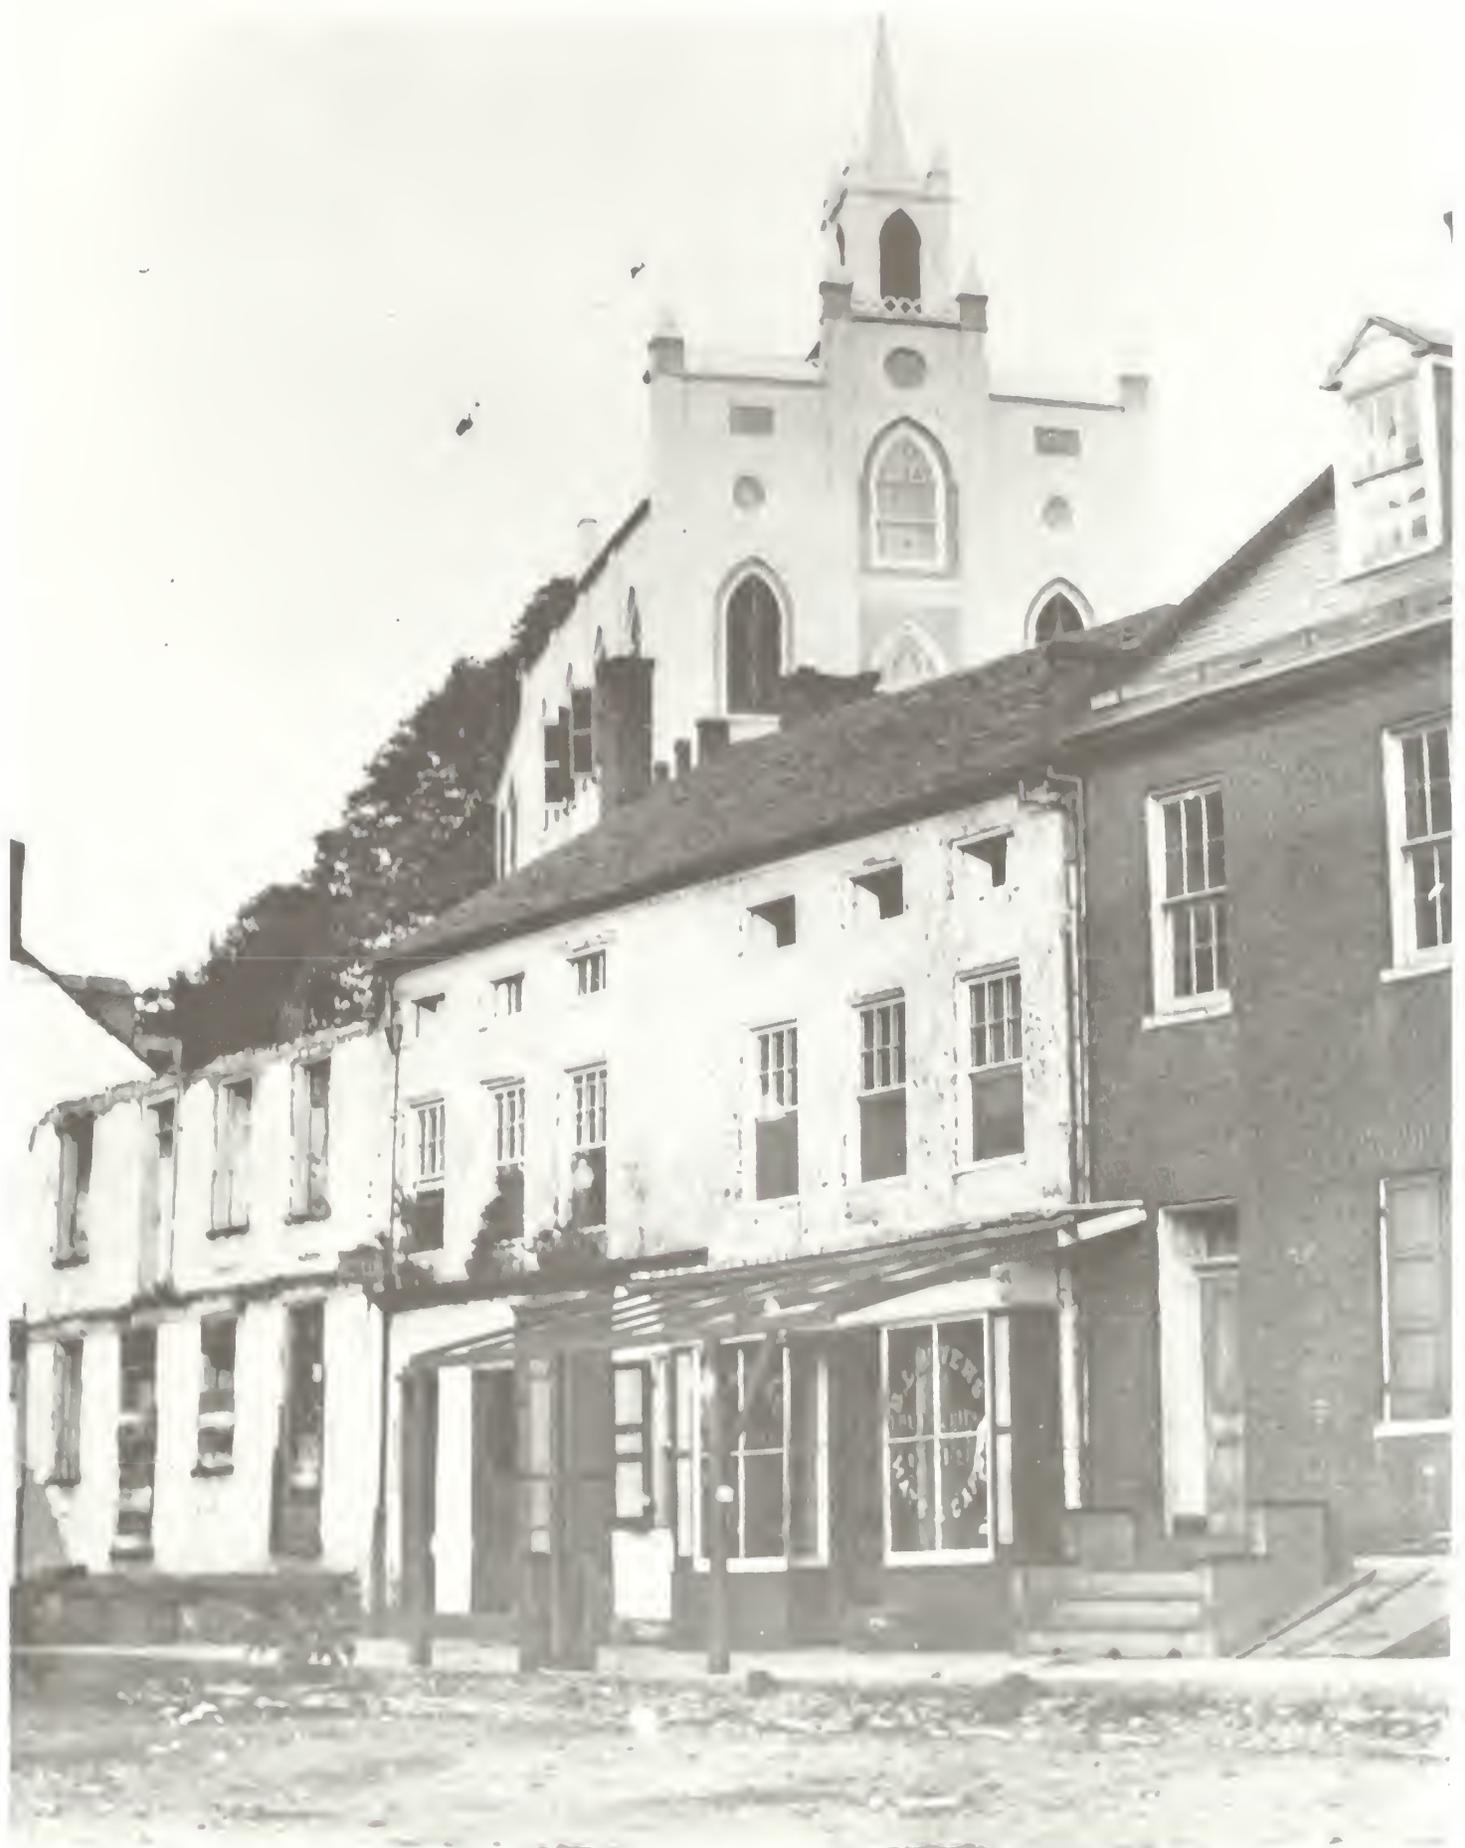
Figure 5. Shenandoah Street, ca.1865-81. The front of buildings 38 and 40, and the side of building 43 can be seen. The brick building on the right is no longer standing. Neg. no. HF-35. Courtesy of Harpers Ferry National Historical Park library.

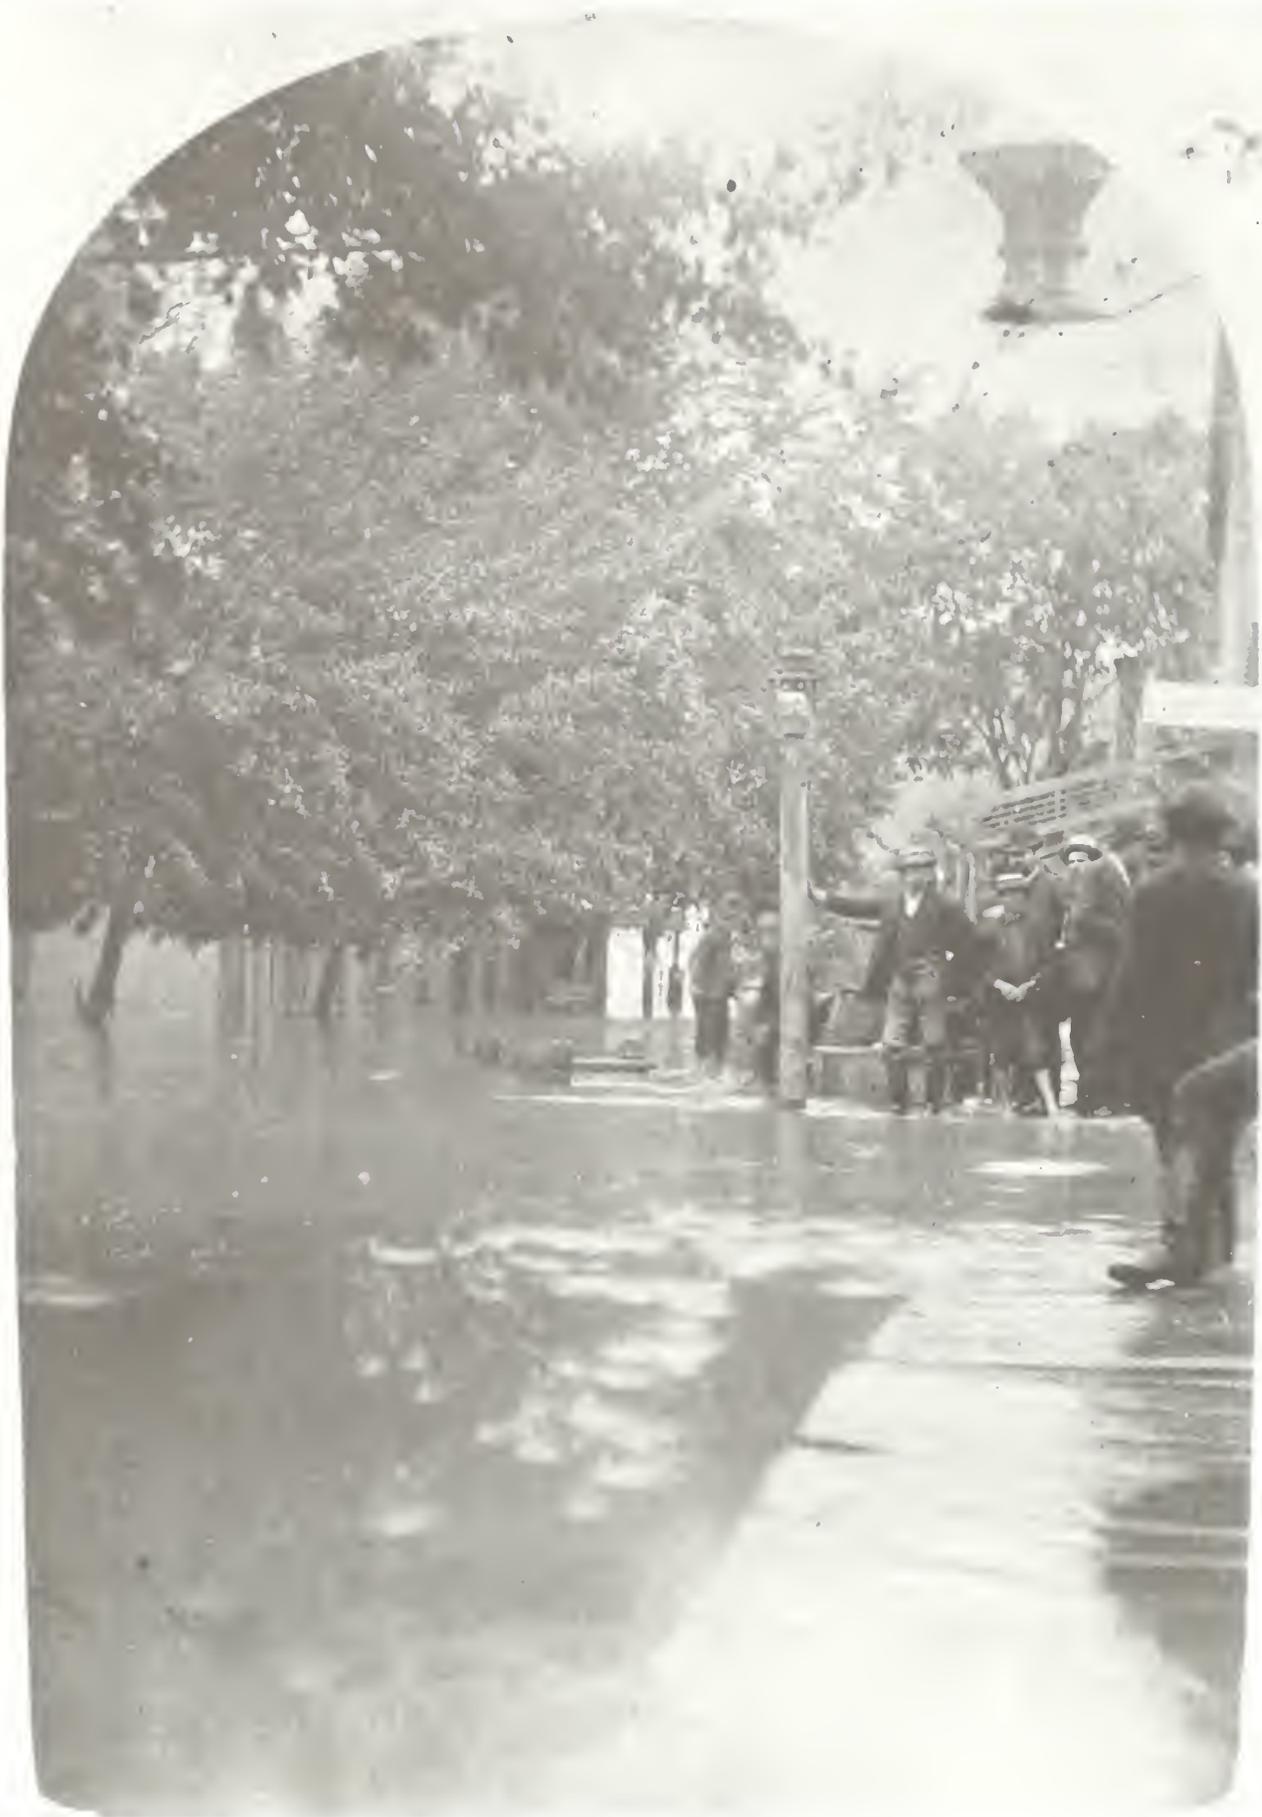
Figure 9. Shenandoah Street, west end, during the flood of 1889. Awning frame is on building 38. Neg. no. HF-722. Courtesy of Harpers Ferry National Historical Park library.

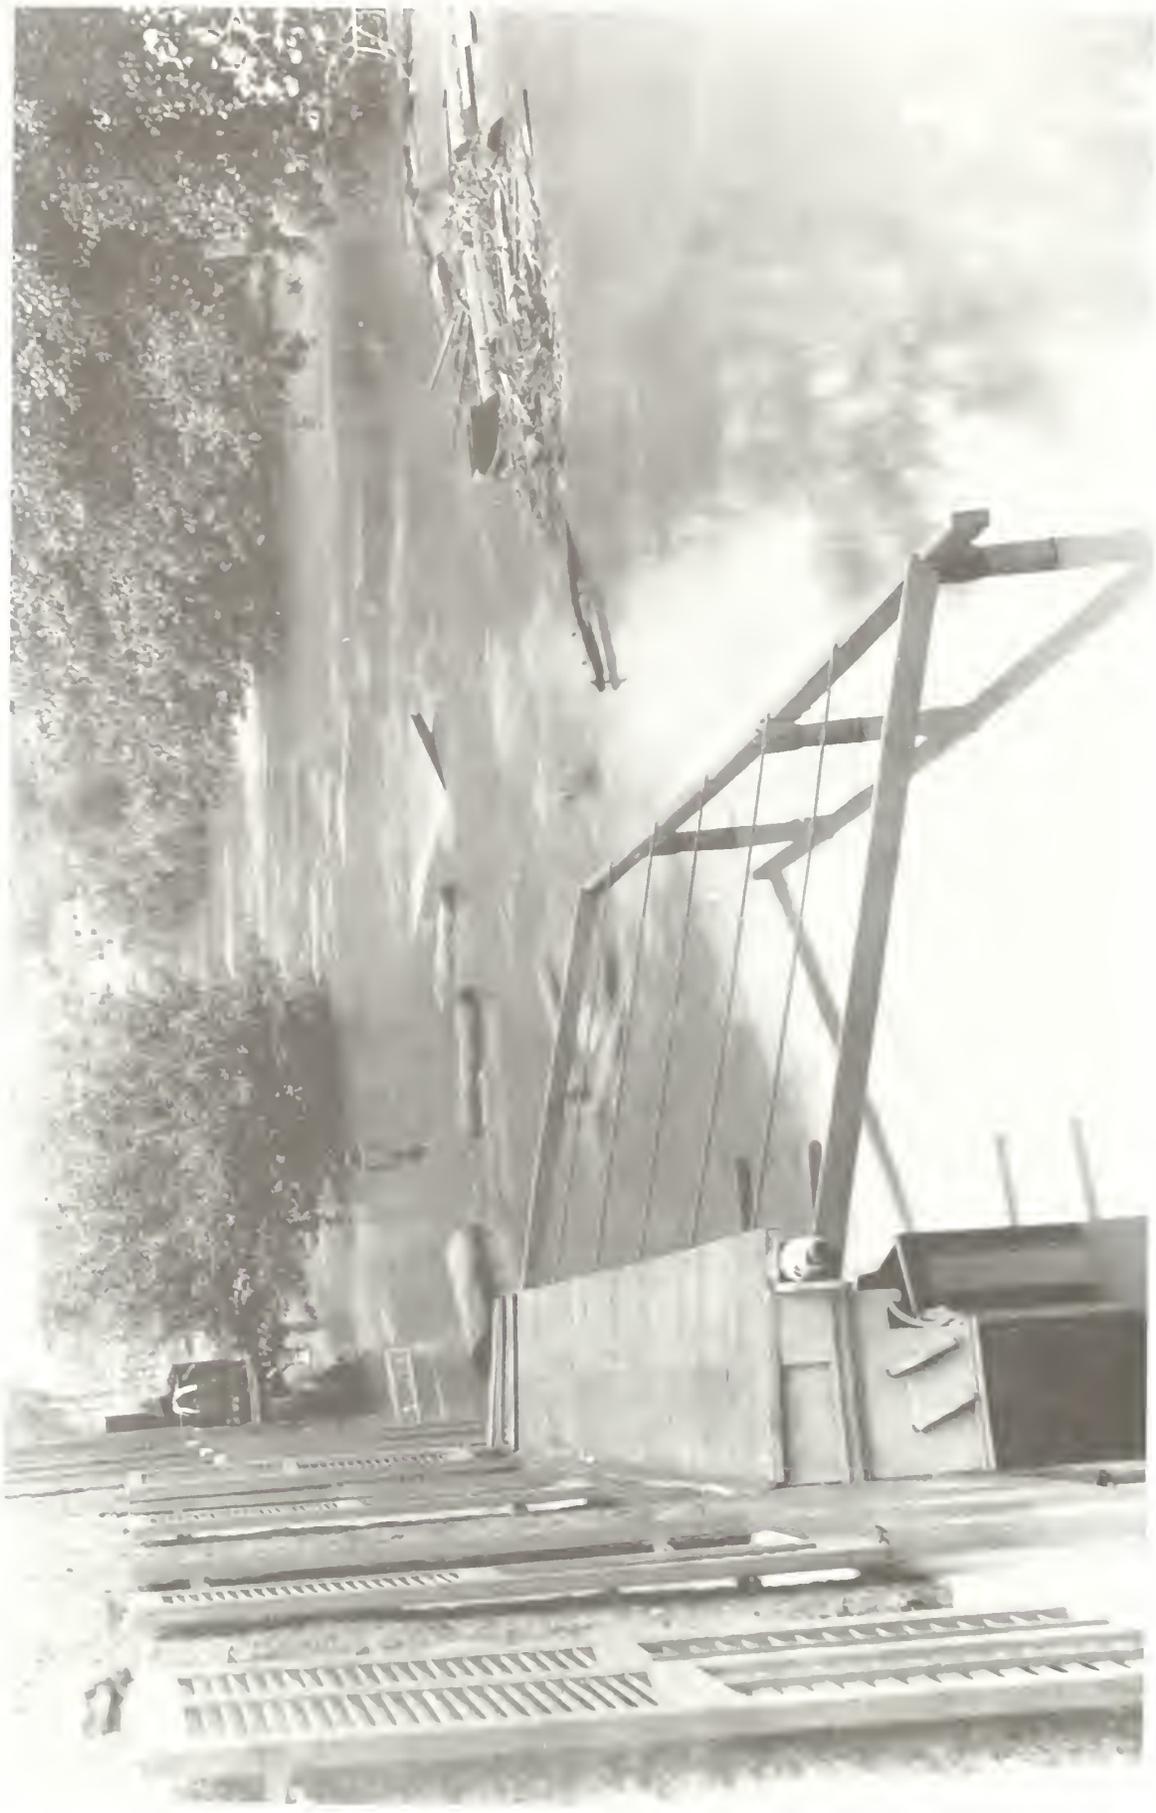
Figure 10. East Shenandoah Street during the flood of 1889. Awning frame on building 38 is the same one shown in figure 9. Neg. no. HF-610. Courtesy of Harpers Ferry National Historical Park library.
