Historic Furnishings Report

EXTERIOR FURNISHINGS OF LOWER TOWN HARPERS FERRY

HARPERS FERRY
National Historical Park/West Virginia

by
Sarah H. Heald
Staff Curator

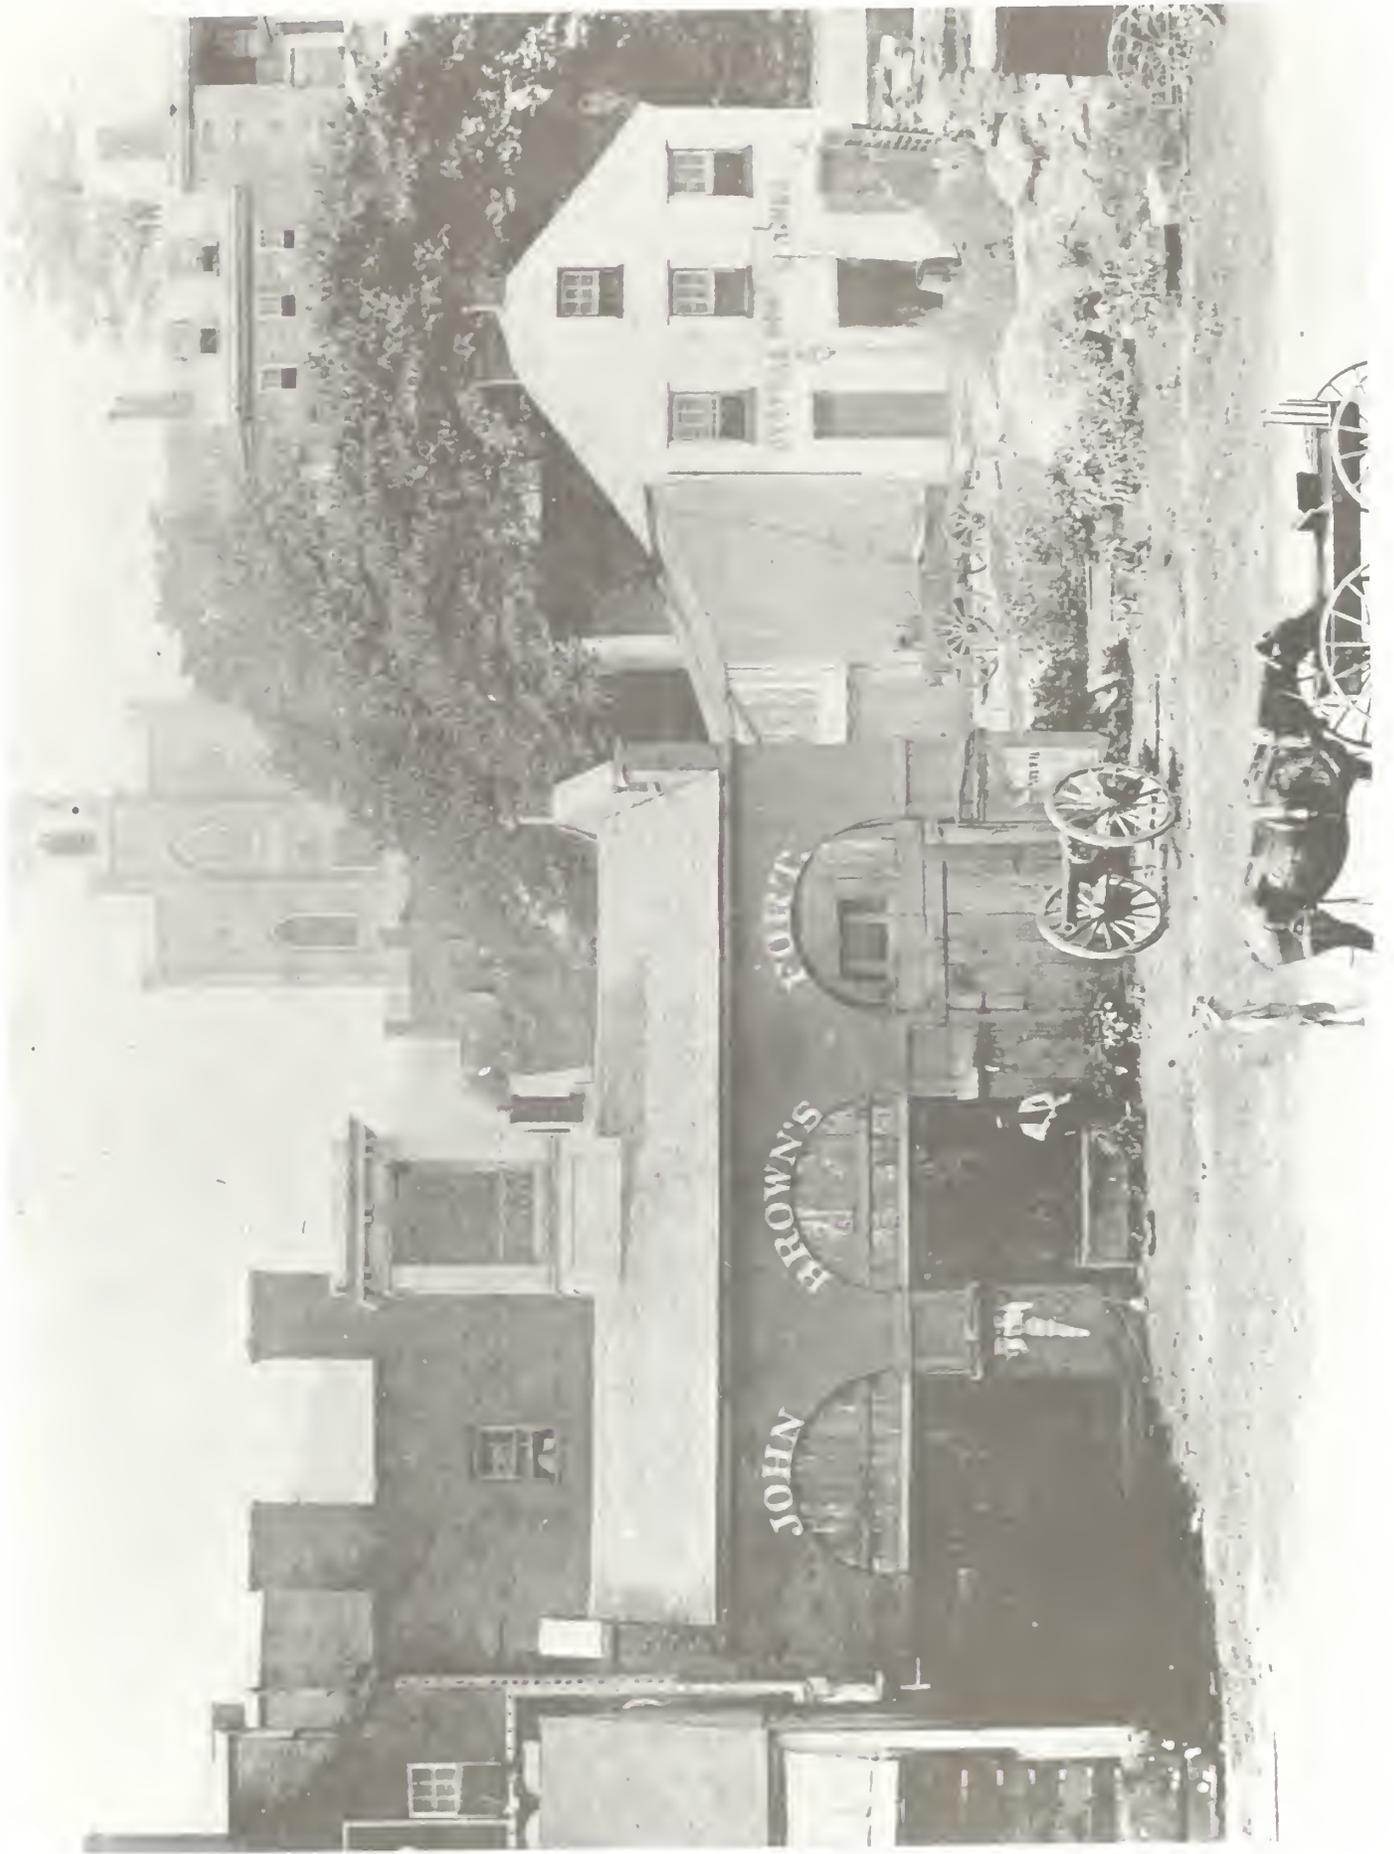
Figure 15. Shenandoah Street, ca.1894. From *Lost Examples of Colonial Architecture*, by John Mead Howell. Neg. no. HF-446. Courtesy of Harpers Ferry National Historical Park library.

Installation of the full array of exterior furnishings outside building 44 per figure 15 would cause undesirable clutter in front of the building which currently houses the public restrooms. A wall-mounted wayside exhibit inside the doors in the

restroom hallway would highlight figure 15 so that visitors may see a historic image of how the front of the building appeared when it was Cassell's store in the late nineteenth century.
