Meridian Hill Park Cultural Landscape Report Volume 2: Treatment

Meridian Hill Park

Cultural Landscape Report

Volume 2: Treatment

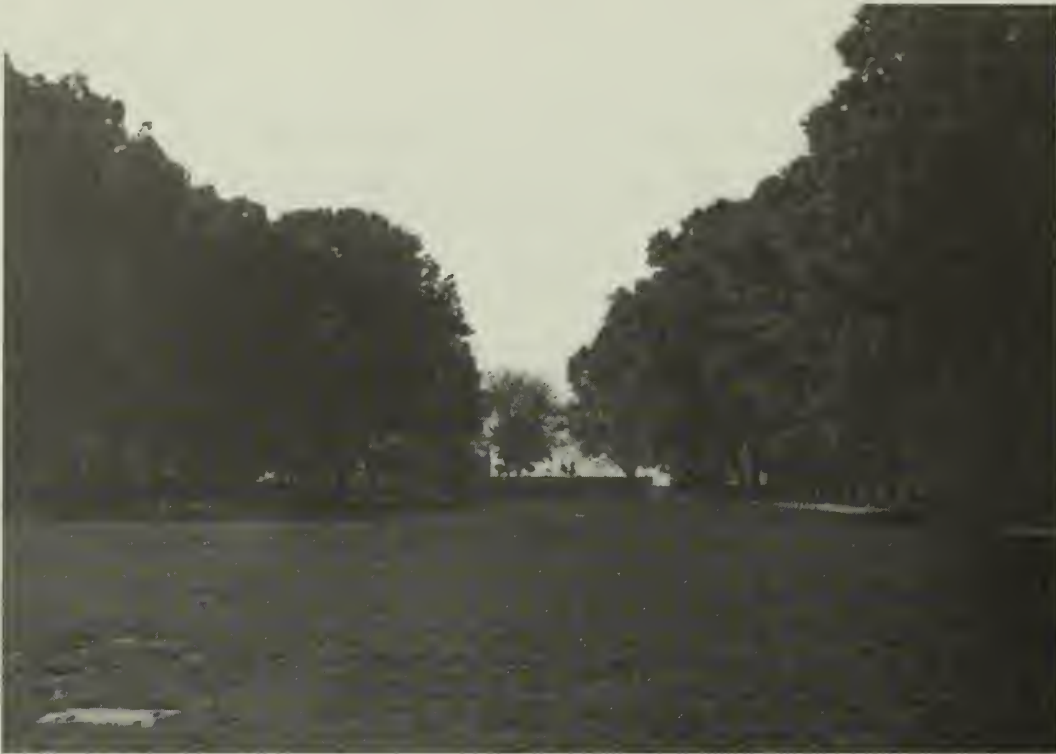
Above: This view south along the main axis of the park through the mall toward the great terrace overlook shows how effectively the mature oaks behind the mall walkways contain and define the mall space.

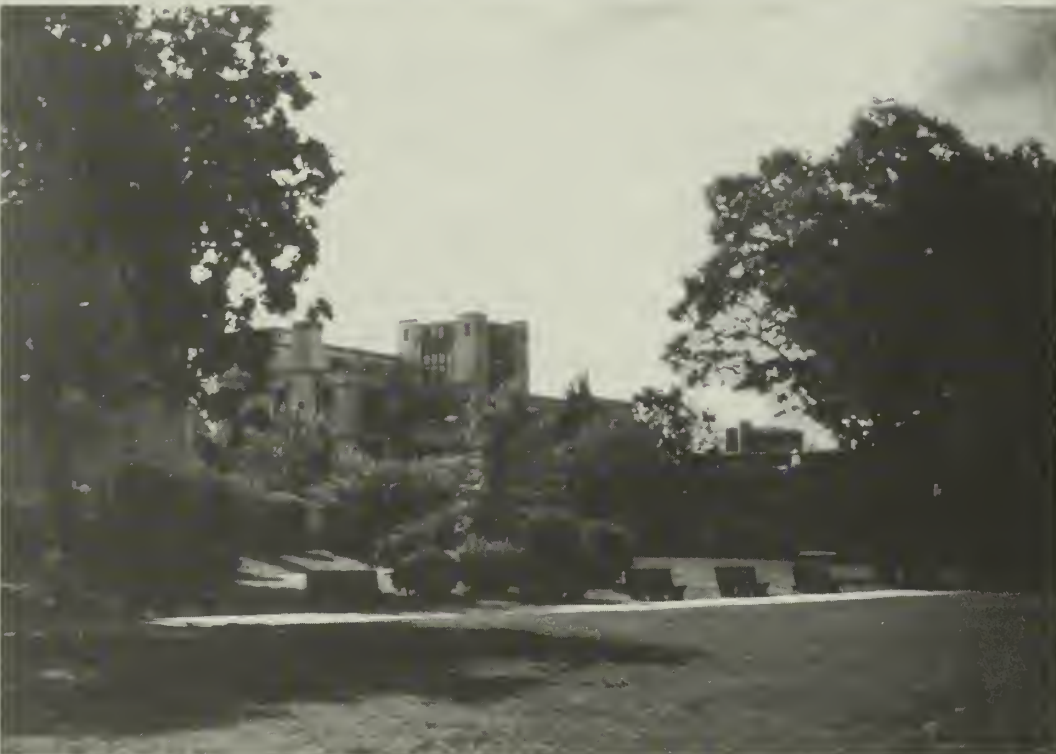
Below: However, as seen in this image, the loss of two of these mature trees leaves a substantial gap in that edge definition.

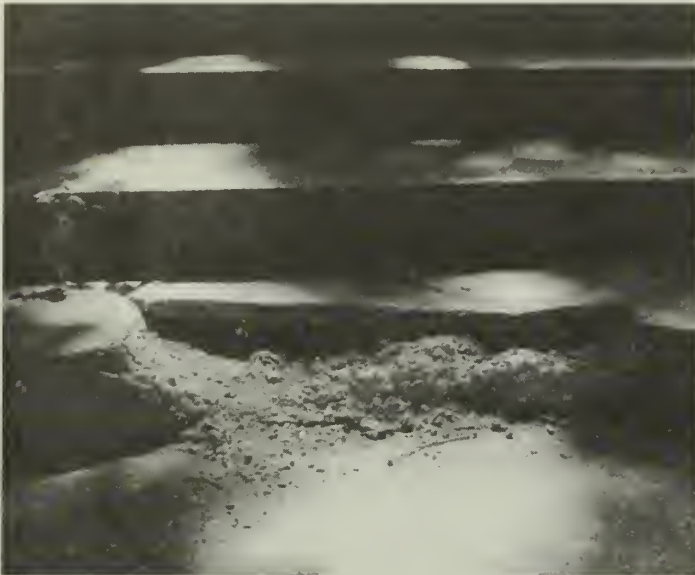
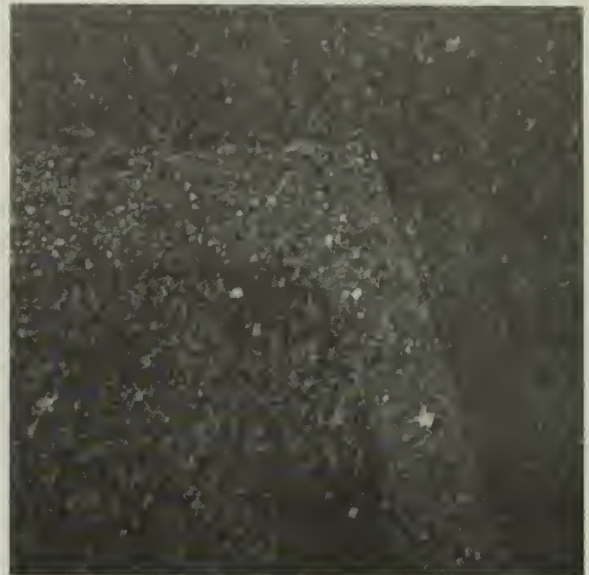
Above and above right: While the colors are not seen in these pictures, the tonal and textural differentiation created by polychromy in the concrete aggregate is nonetheless visible. It is critical that the colors and types of aggregates used in the historic concrete in the park be matched exactly in any new or repair concrete work.

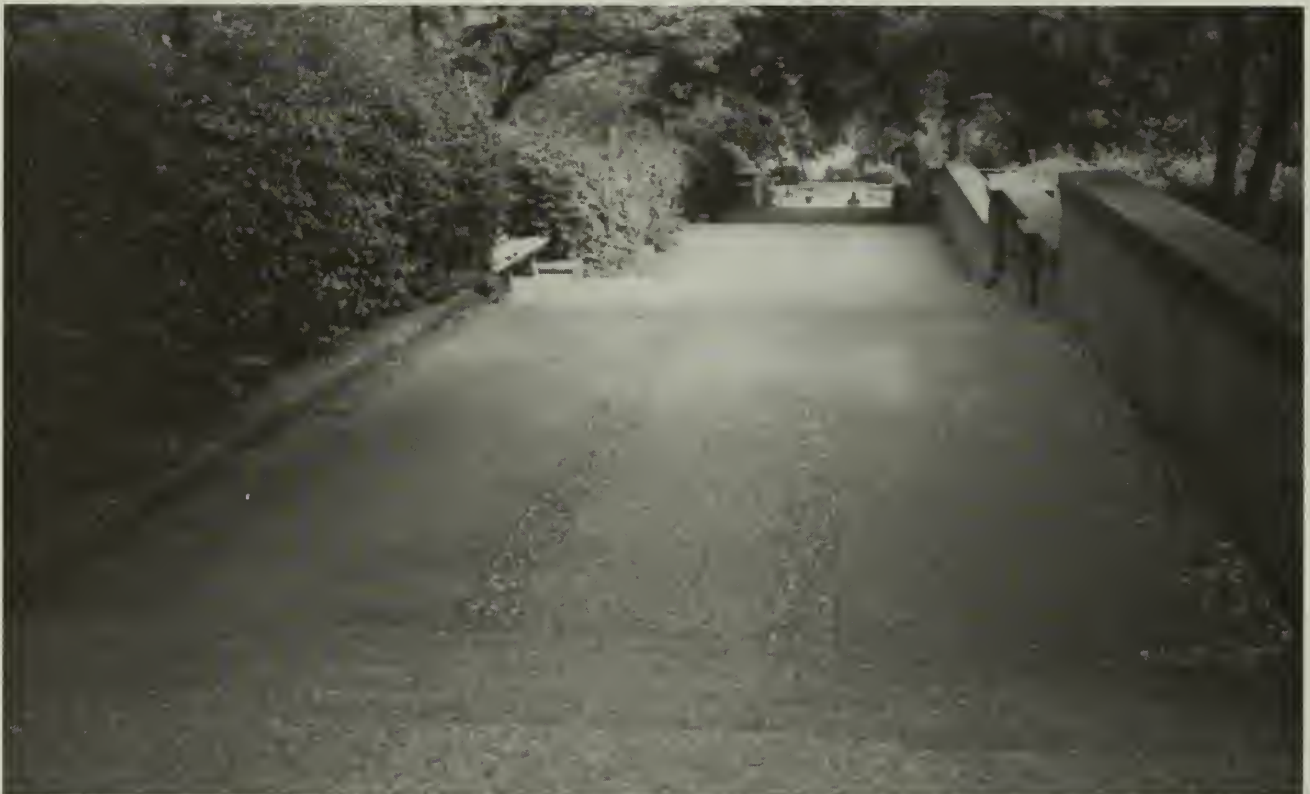
Below left: Corroboration that the method called for in the specifications for pouring pavement in two layers is provided in this picture of the deteriorated steps at the upper 16th Street entrance.

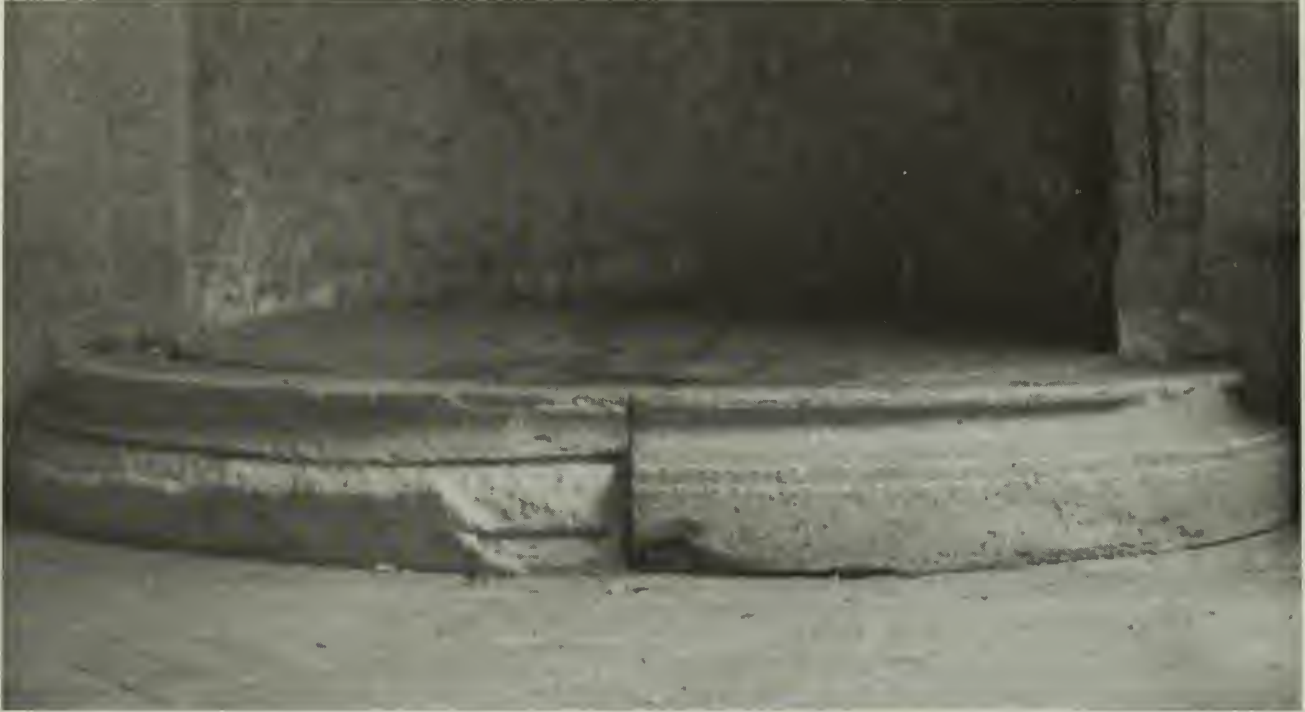
Fountain basin with missing lip and severe deterioration at main 16th Street entrance.

- all cracks and spalls in walls, piers, and paving
- the lip of the western bowl fountain on the great terrace
- damaged stairs
- heaved and deteriorated paving
- all locations of exposed reinforcing steel

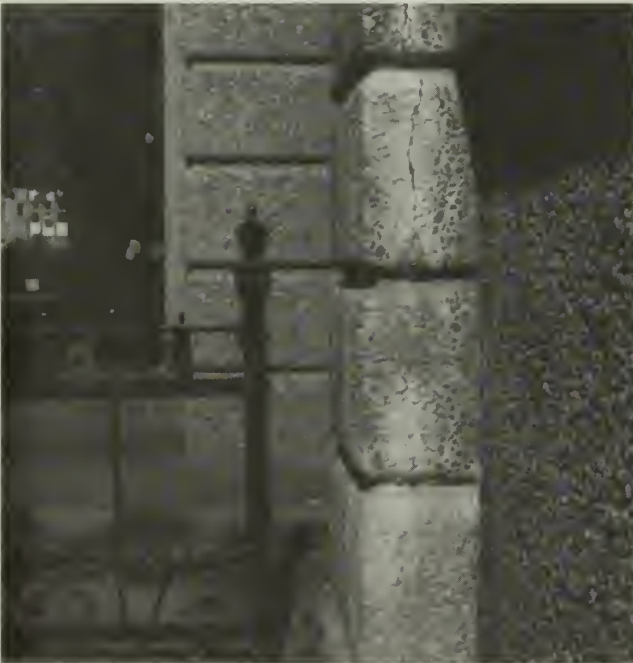
(above left) An example of cracks and efflorescence, on the northern wall of the park, looking west from the children's play area. This fence finial is the only one still in place on the fence at this play area.

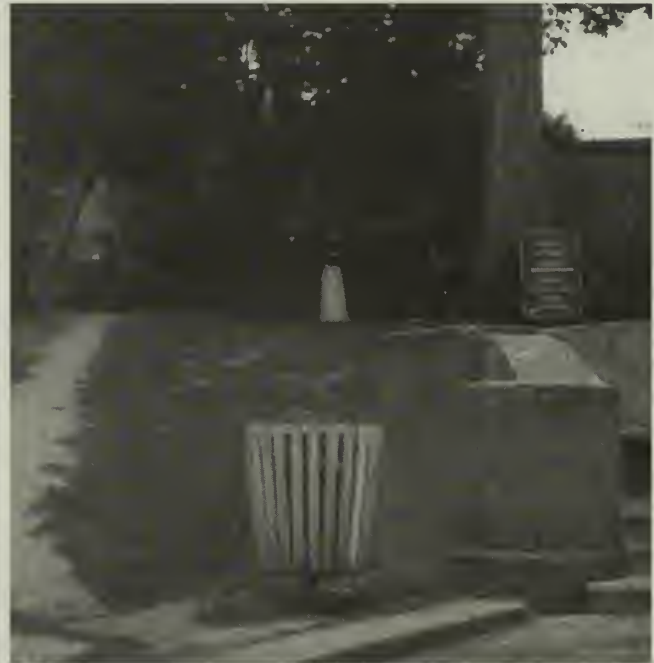
(above right) This picture illustrates the agglomeration that has occurred in the park since its official opening in 1936. Intrusive and non-original elements include the signage, the replacement drinking fountain, the tulip- type trash receptacle, and the informal path. This view is taken from the entrance at 15th and W Streets looking toward the lower plaza.

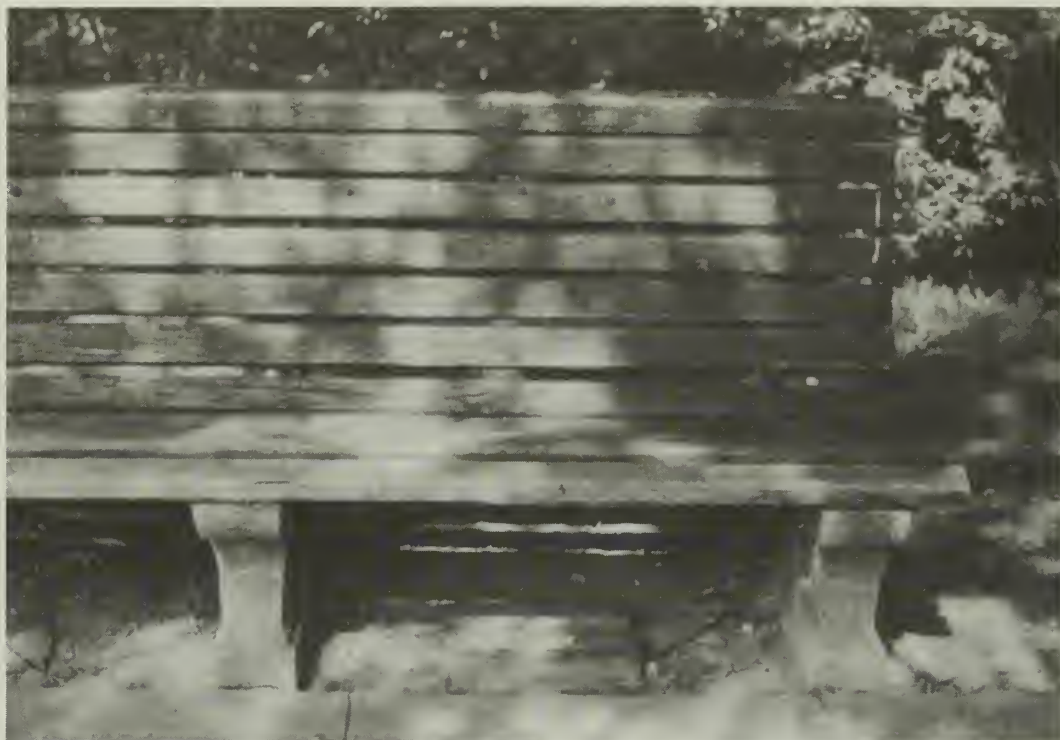
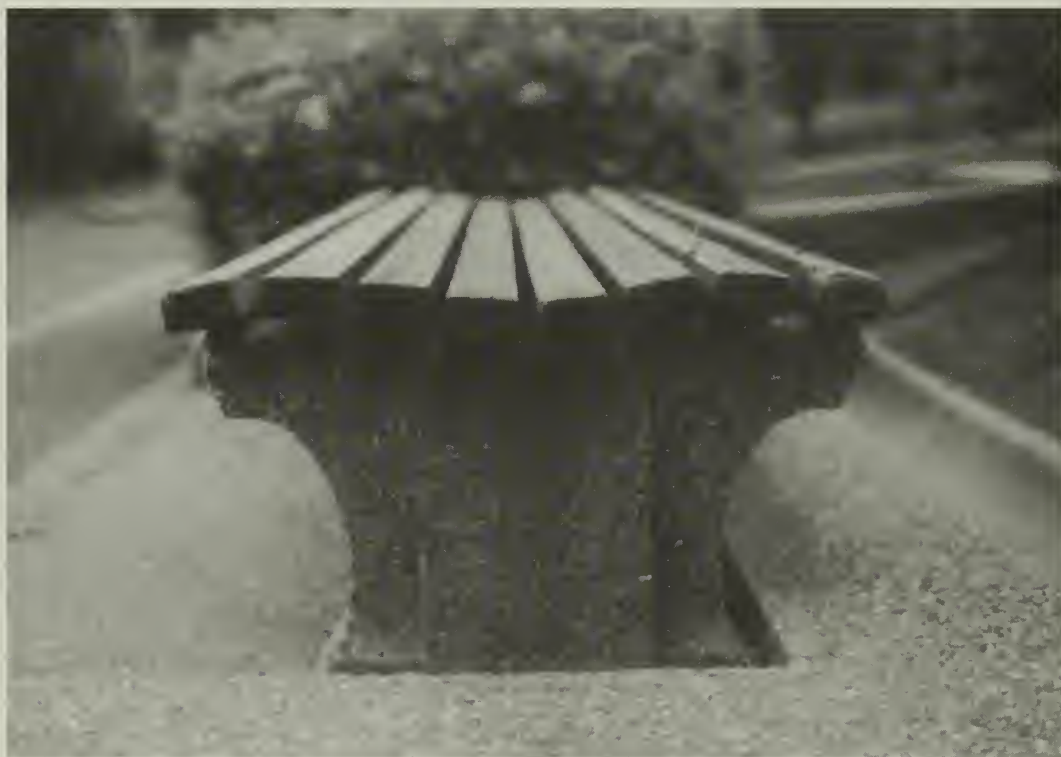
The original bench slat attachment detail on these contoured benches is both elegant and difficult to maintain. It is critical to develop a practical method of attachment that is consistent with the historic character of the benches.

Benches: Many benches are missing slats: these and inappropriate replacements would be replaced to match the original materials, sizes, shapes, and finishes. A new attachment system developed to facilitate maintenance could be implemented in this treatment alternative. If it is, the contoured profile of bench slats would be restored on those benches where it has been flattened.

Benches: Any site the age of this one shows accumulated repair strategies. The original benches had an ingenious system for attaching wood slats to the complexly curved bases. Unfortunately, over time, parts of that original system have been replaced with substitute bolts, nuts, and washers. Also, the original system required removal of the entire wood slat structure to replace a single slat. Either the original system should be fully restored on all the benches and park maintenance personnel trained in its operation and provided with parts, or a new system designed that is consistent with today's maintenance demands.
