Reclamation Research Plans For Alaska National Park System Units

**RECLAMATION RESEARCH PLANS FOR
ALASKA NATIONAL PARK SYSTEMS UNITS**

April 1986

U.S. NATIONAL PARK SERVICE

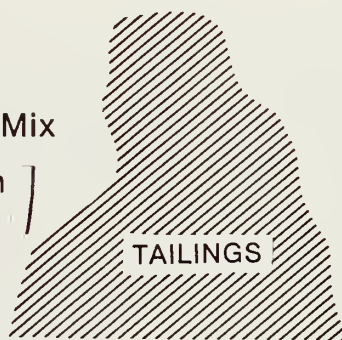
Figure 2.2-3
EXPERIMENTAL RECLAMATION PLOT DESIGN FOR
THE NELSON PROSPECT AND RADOVAN GULCH
SITES, WRANGELL-ST ELIAS NATIONAL PARK, ALASKA

- F_1 Fertilizer
- F_2 No Fertilizer
- P_1 Grass/Legume Seed Mix
- P_2 Natural Revegetation (control)
