CULTURAL LANDSCAPE REPORT FOR POPLAR GROVE NATIONAL CEMETERY

PETERSBURG NATIONAL BATTLEFIELD

SITE HISTORY

EXISTING CONDITIONS

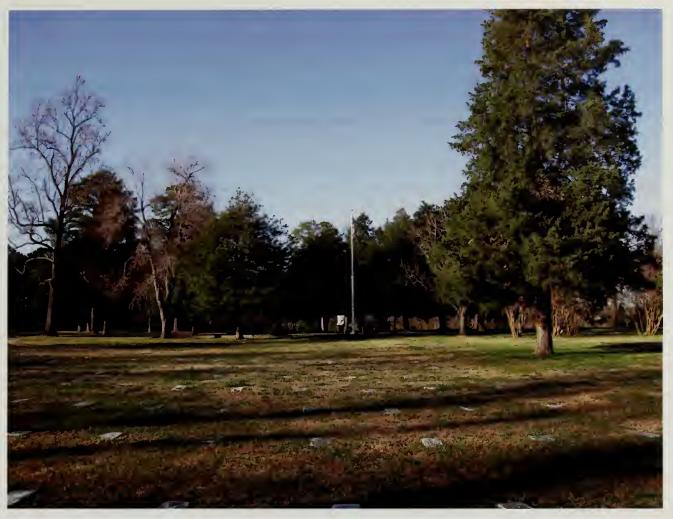
Figure 0.4: Recent view (2006) of Poplar Grove National Cemetery looking northwest across the burial grounds toward the center flagstaff. (SUNY ESF.)

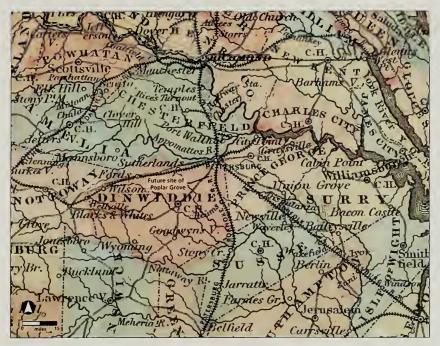
Figure 1.3: A 1854 map of Virginia showing Petersburg as a transportation nexus. (Detail, G. W. Colton, *Virginia*, Published by J. H. Colton & Company, 1856.)

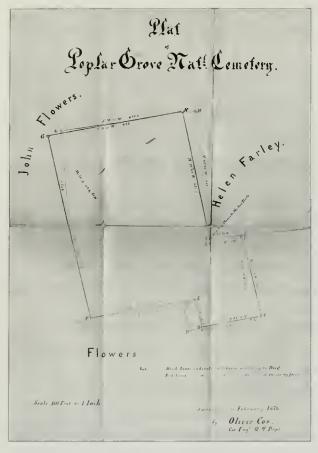
Figure 1.45: Survey of Poplar Grove National Cemetery made in February 1876 showing discrepancy between boundaries plotted in the original deed (dark line), and the actual boundary represented by the perimeter fence (lighter line). (Records of the Quartermaster General, Entry 576, Poplar Grove National Cemetery Records, box 57, National Archives I.)

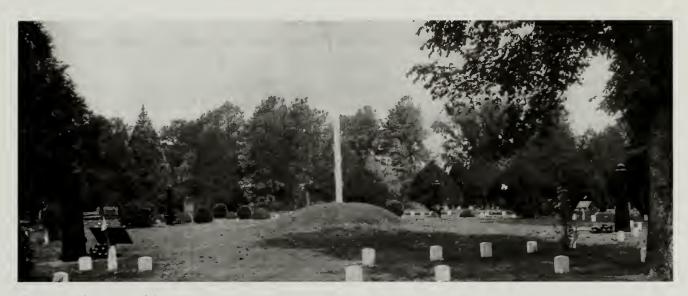
Figure 1.48: Photograph of the center of the cemetery taken in c.1895 showing the turf drives, looking northwest with one of the radial drives in the foreground. This photograph also shows the flagstaff mound (by this time without plantings), gun monuments, and numerous clipped shrubs that were maintained at this time. The iron tablet next to the gun at left contained text from the 1867 national cemetery act. (From The Artwork of Petersburg, Virginia, 1903.)

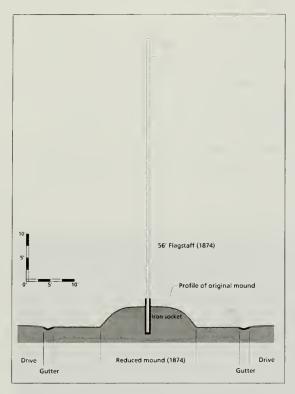
Figure 1.49: Section showing the scale of the reduced mound and flagstaff in 1874 compared to the original mound. (SUNY ESF.)

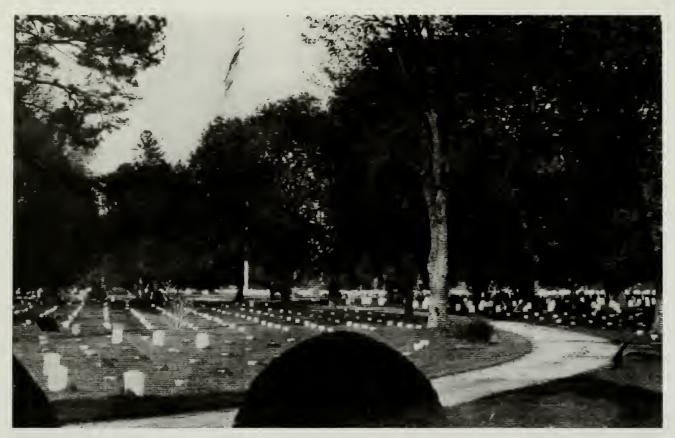
Figure 1.57: View from the rostrum looking northeast along the main drive toward the new iron flagstaff, c.1914. This photograph shows one of the Bivouac of the Dead tablets along the main drive at the right. The dark mounds in the foreground are sheared boxwood shrubs. (War Diary of Luman Harris Tenney 1861-1865, 1914).

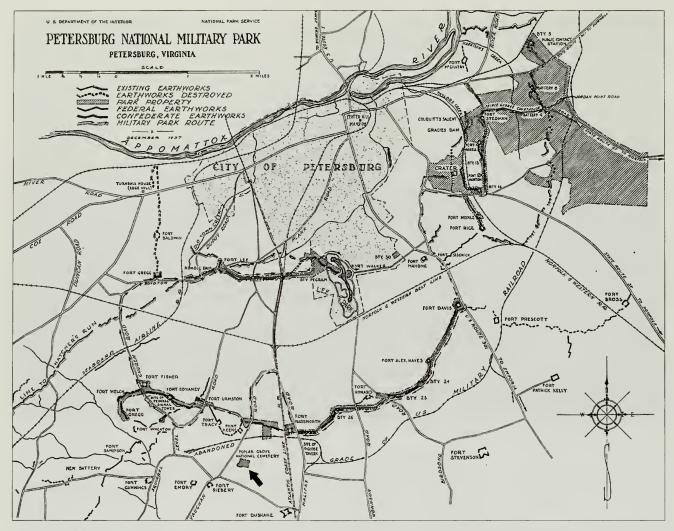
Figure 1.58: Map of Petersburg
National Military Park showing
general intent of original
c.1926 park plan, from a 1937
map showing subsequent
park development. The black
arrow points to Poplar Grove.
Hatched areas represent federal
government lands. (RG 79,
Records of the National Park
Service, Entry 31, Poplar Grove
National Cemetery, box 2704,
National Archives II, annotated by
SUNY ESF.)

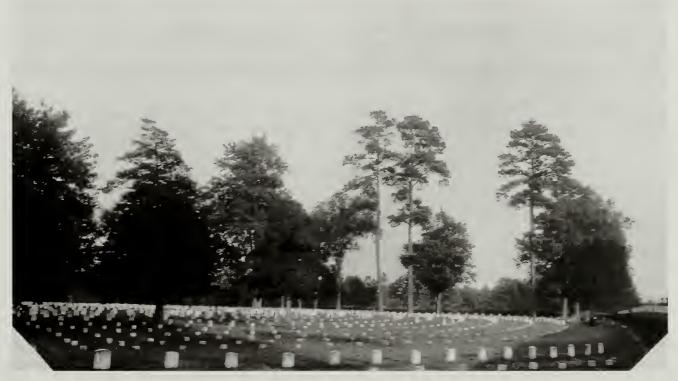
Figure 1.63: Photograph of
Poplar Grove taken from the near
the rostrum looking east along
the ivy-covered inclosure wall,
from a tree inspection report,
February 1932. The caption in
the report reads: "Characteristic
pines and hollies at Poplar Grove,
Petersburg, Va." (RG 92, Entry
1891, Office of the Quartermaster
General, Correspondence,
Geographic File, 1922-1935, box
1773, National Archives II.)

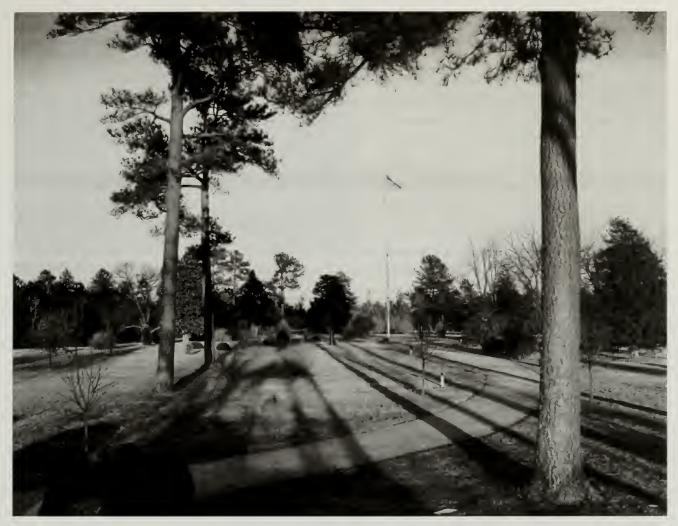
Figure 1.68: A 1939 photograph looking northeast toward the flagstaff from the rostrum showing the change in character with conversion of the headstones and blocks into flat markers. Several of the markers are visible at the lower right. Note the remaining tablets and gun monuments. (Copyright The Library of Virginia, from Virginia Room Exhibit at the 1939 World's Fair, image /WF/05/06/017. jpg.)

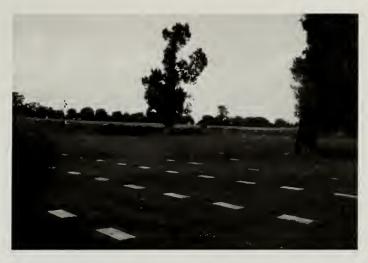
Figure 1.69: Replacement flat markers at Yorktown National Cemetery installed in c.1940, looking northeast from a recent photograph, 2006. In the background is the Revolutionary War battlefield. (SUNY ESF.)

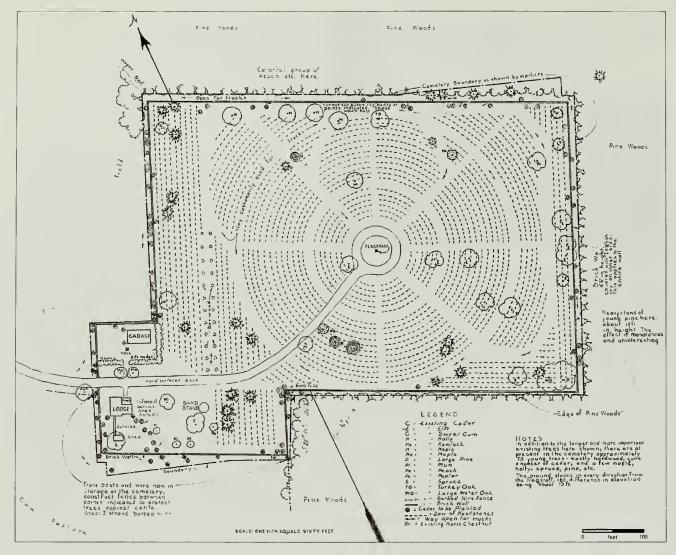
Figure 1.70: "Proposed Planting at Poplar Grove National Cemetery," 1937. The plan for planting 115 red-cedar trees also documented existing conditions except for young trees planted in 1931. (National Park Service Branch of Plans and Design, 29 May 1937, drawing PETE 325-8041, National Park Service Technical Information Center.)

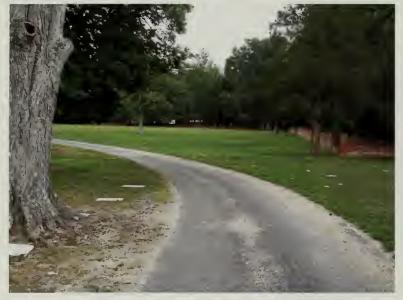
Figure 2.24 (top): Characteristic turf drive and walks, looking northwest toward the main drive in Division A between sections e and d (Blocks II and III). The wider space is a drive, the narrower space between the rows of grave markers are walks. (SUNY ESF, 2006.)

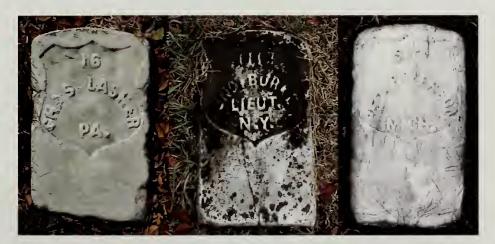
Figure 2.29: Representative first-generation recessed-shield headstones installed in 1877 and transformed into flat markers in 1934. These photographs illustrate characteristic chipping, cracking, weathering, and staining. The bases were cut or broken off. (Petersburg National Battlefield, 2005.)

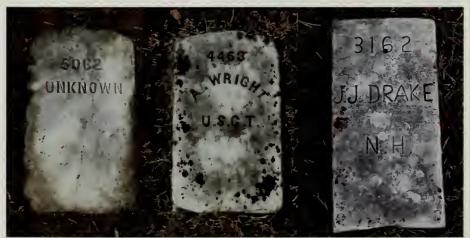
Figure 2.36: Examples of nongovernment headstones installed after 1877, showing variations in profile and inscriptions. (Petersburg National Battlefield, 2005.)

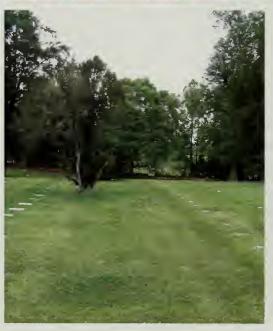
Figure 2.39 (top): A large white-cedar, also known as false cypress, in Block XI, looking northeast. The tree is probably more than one hundred years old. The adjoining tree is a red maple, one of the youngest trees in the cemetery. (SUNY ESF, 2006.)

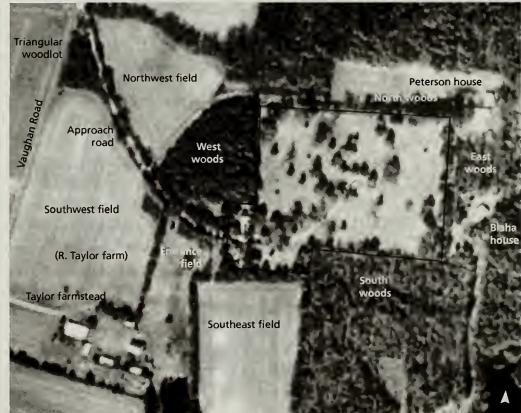
Figure 3.2: Existing natural systems and spatial organization characteristics in the setting of Poplar Grove National Cemetery, shown on 1994 aerial photograph. These conditions approximate existing conditions. (Detail, USGS aerial photograph, 1994, annotated by SUNY ESF.)

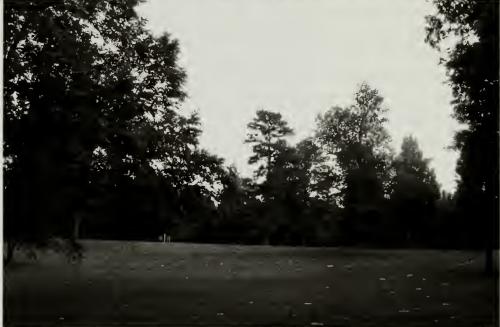
Figure 3.4: Existing view of the burial grounds looking in the same direction as figure 3.3., illustrating changes to the landscape from alteration of the grave markers in 1934. (SUNY ESF, 2006.)

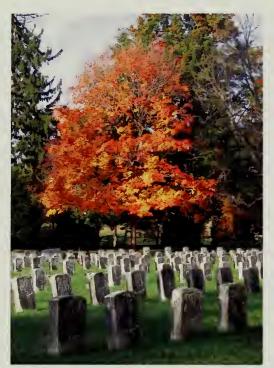
Figure 4.3: Recent photograph of Antietam National Cemetery showing level of maintenance at a National Park Service-administered national cemetery. Note the difference in maintenance of the headstones compared with figures 4.1 and 4.2. (Undated photograph by Keith Snyder, image 20060829 152450, Antietam National Battlefield website, www.nps. gov/anti/historyculture/antietamnational-cemetery-part-2.htm.)

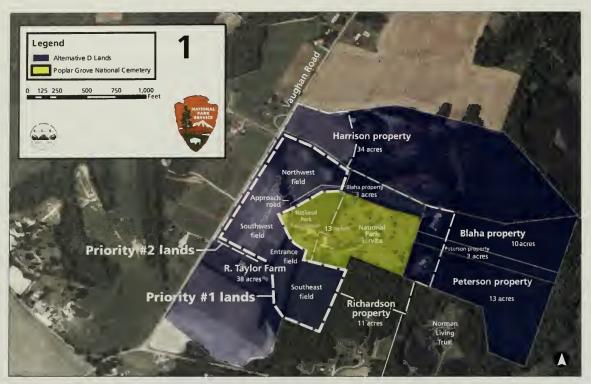
Figure 4.5: Alternative D lands for protection, General Management Plan for Petersburg National Battlefield (2004), showing lands required for protection of the cemetery setting. Ownership is shown as of 2008. (National Park Service, annotated by SUNY ESF.)

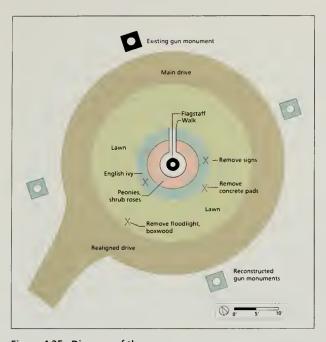
Figure 4.25: Diagram of the central circle showing proposed treatment in tasks BG Tasks 5 and 6. This drawing also shows the realigned circular loop of the main entrance drive as recommended in BG Task 4. (SUNY ESF.)

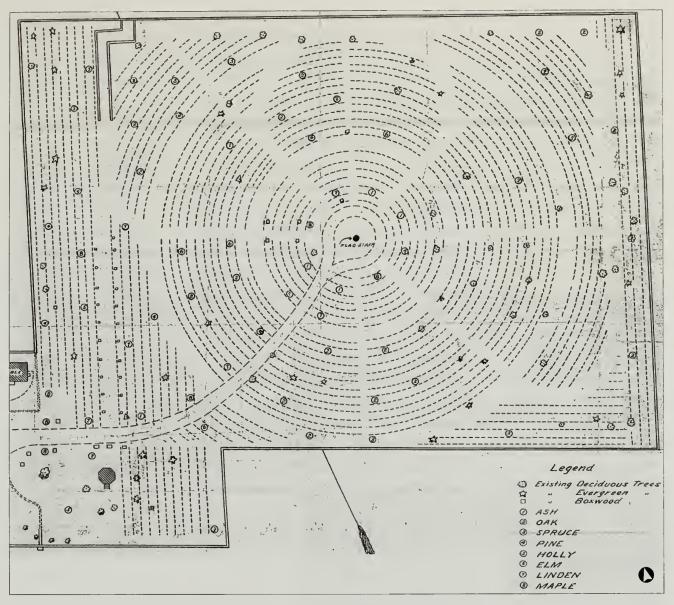
Figure 4.26: The 1931 War
Department planting plan for
Poplar Grove that serves as
the basis for reestablishing the
historic character of specimen
trees and shrubs within the burial
grounds in BG tasks 7 and 8.
The ash specified was European
mountain ash; oak, pin oak; pine,
Austrian pine; spruce, Norway
spruce; and maple, Norway
maple. This plan does not identify
the species of preexisting trees.
(Detail of fig. 1.62, National
Archives.)
