## TEMPORARY PROTECTION NUMBER 2

### Specifying Temporary Protection of Historic Interiors During Construction and Repair

Dale H. Frens, AIA  
Frens and Frens

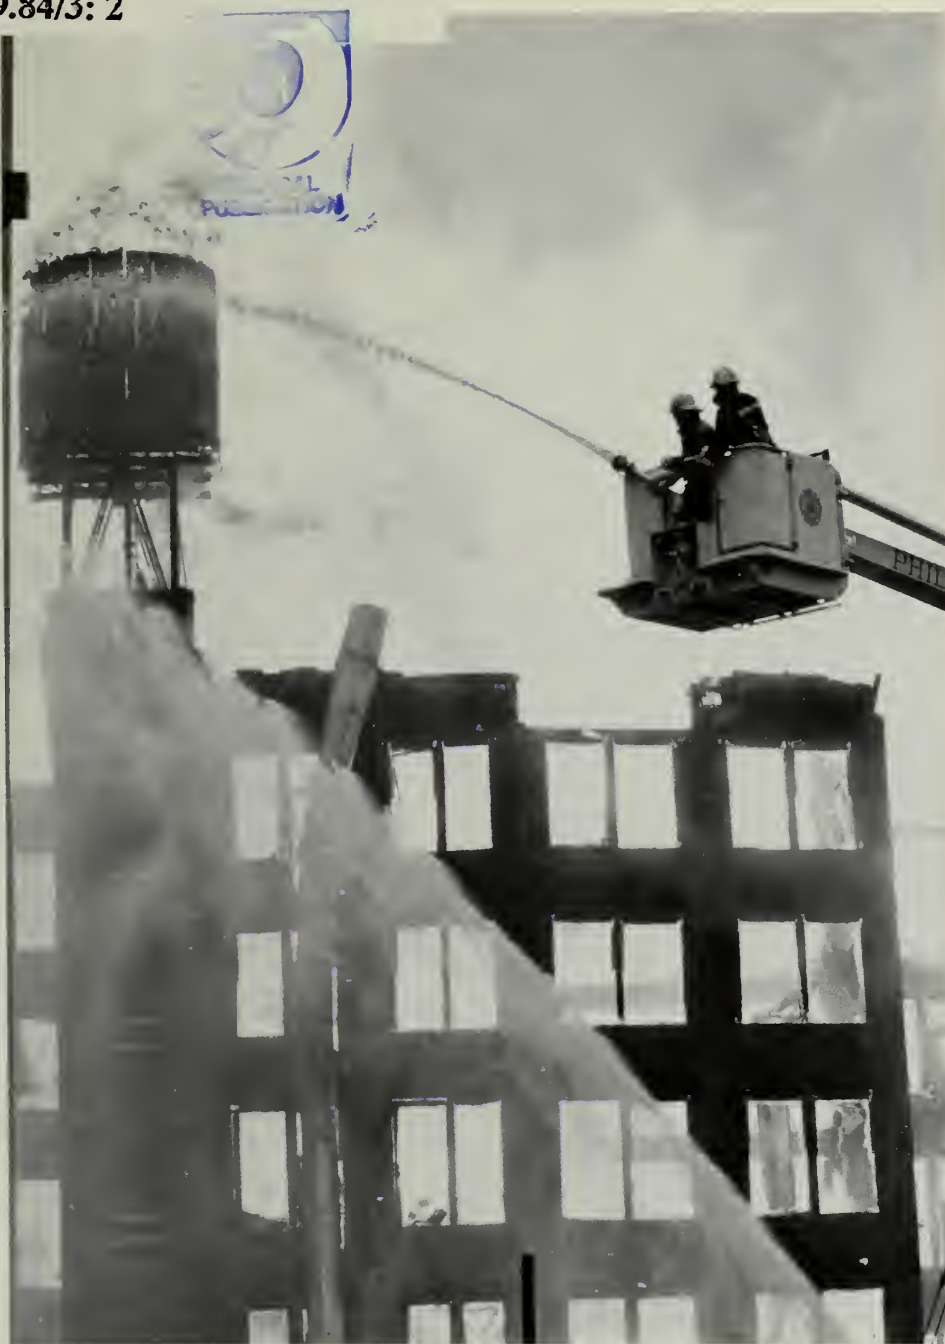
*Historic interiors and collections  
should be protected from potential  
damage during construction work*

Fire poses the greatest risk of sudden catastrophic loss during construction activities in existing buildings. Just one of numerous examples is the 1985 Harrison Court fire in Philadelphia, in which a block-long National Register warehouse building undergoing rehabilitation burned to the ground (*see cover photo*). The fire was caused by sparks from cutting torches that were being used during selective interior demolition work.

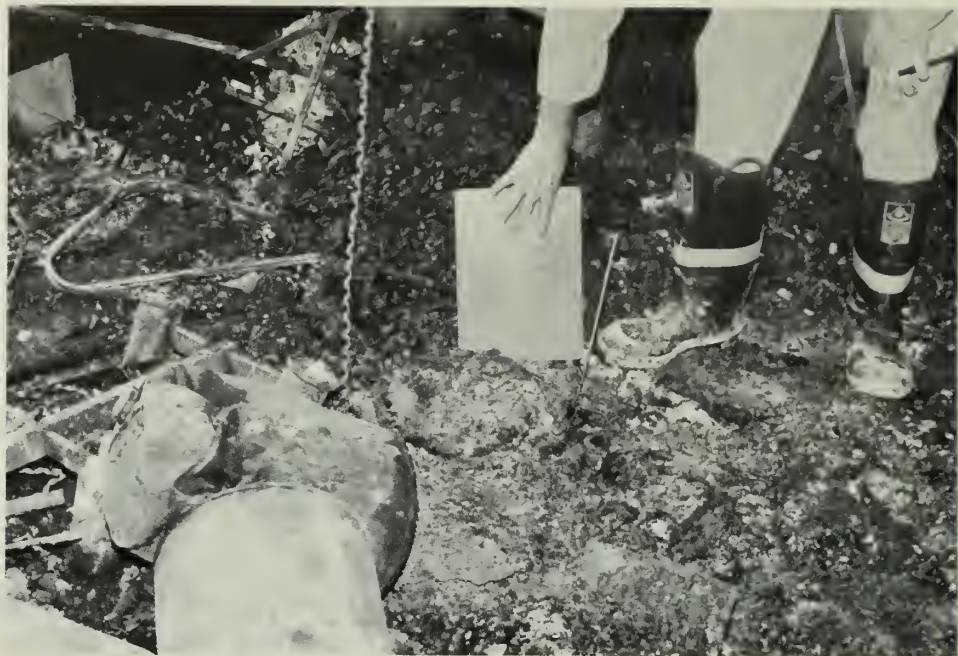
Figure 1. The spontaneous combustion of cloth rags that had been used in applying a common finishing wax caused over \$1 million damage to a historic government office building in 1991. Remains of the trash can where the rags had been stored overnight is indicated by the fireman's notepad. After the cause of the fire was determined, a standard specification provision was developed for future contracts requiring the contractor to remove all material contaminated with finishing products from the site at the end of the day.

struction activities, including new construction, NFPA 241 should be a reference standard in any selective demolition specification, and a foundation for addressing fire safety on building rehabilitation sites. Additional guidance is available in NFPA 914: *Rehabilitation and Adaptive Reuse of Historic Structures*. When these are utilized as reference standards, the historic building owner should obtain and enforce their recommendations (*see figure 1*).

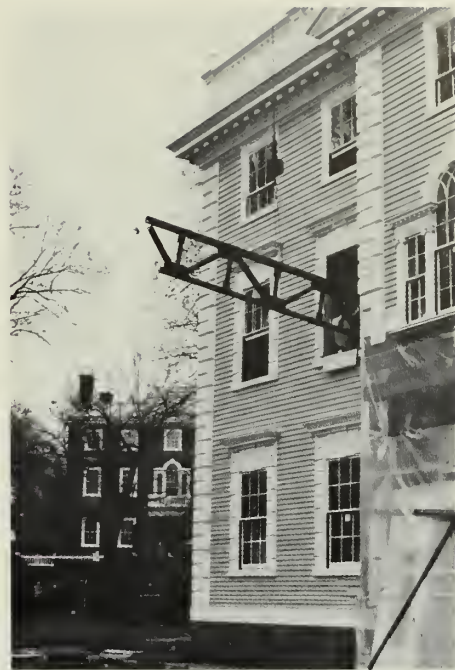
Figure 2. Because of the fire risks, open flame cutting and welding deserves careful attention both in the preparation of specifications and during the work. As much welding as possible should be done off site. For example, at the Nightingale-Brown House, several large trusses were assembled off site, then carefully hoisted through a window for installation. Photo: Irving B. Haynes and Associates.

ment. For smaller projects, the construction fireman or other designated people should be assigned the responsibility of inspecting of each cutting and welding location frequently during the day (see figure 2).

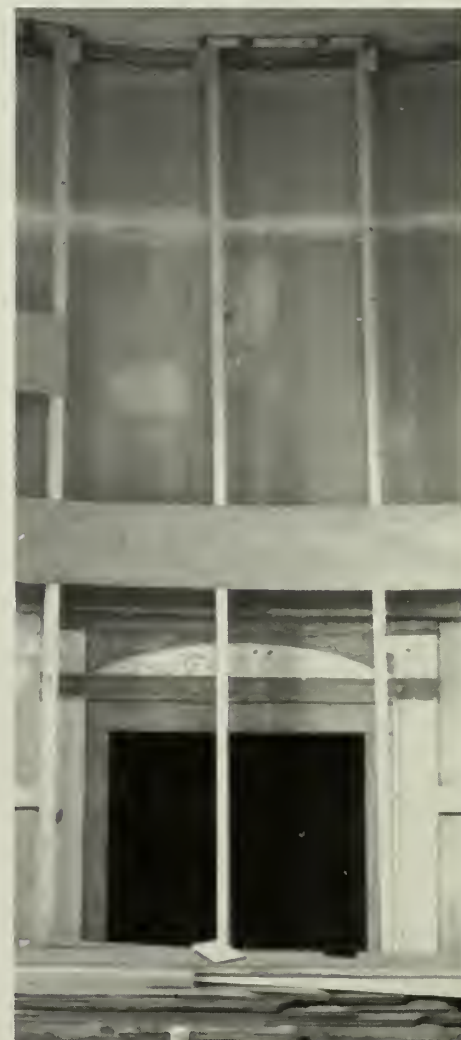
Figure 3. Vibrations generated during construction may necessitate the installation of temporary support for such fragile features as plaster ceiling cornices and soffits. Drawing: Villard Houses — courtesy of Emery Roth & Sons Architects, P.C. Photo: The Octagon, Lonnie Hovey, AIA.

Important architectural features which are easily removed should be stored off site, if possible, to protect them from vandalism, theft and damage during construction. Lighting fixtures, fireplace mantels, and interior doors are typical examples. Less movable architectural material or finishes such as wallpaper are often best retained in place but may require custom-designed protective measures developed and monitored by a conservator (see figure 3).

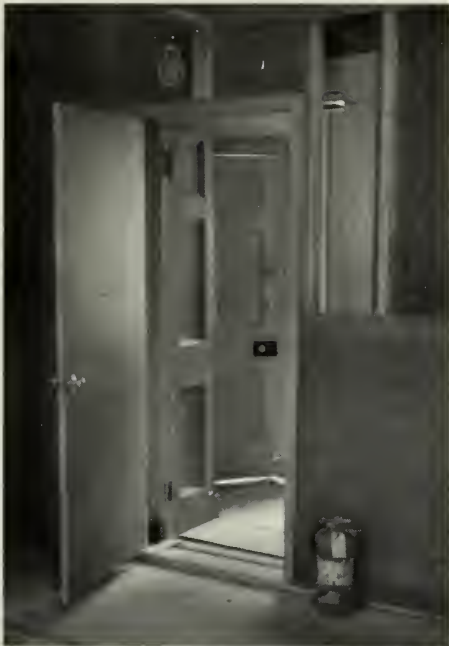
Figure 4. Temporary protection during construction can involve covering historic features, such as floors and walls, as well as using temporary doors to control the passage of workers and the inevitable dust and dirt. Prominently located fire extinguishers are mandatory. Photo: Lonnie Hovey, AIA, The Octagon.

of such spaces. Spaces with restricted access should be identified by the planning team and indicated in the construction documents in order to allow the contractor to include any associated costs in his price proposal (see figure 4).

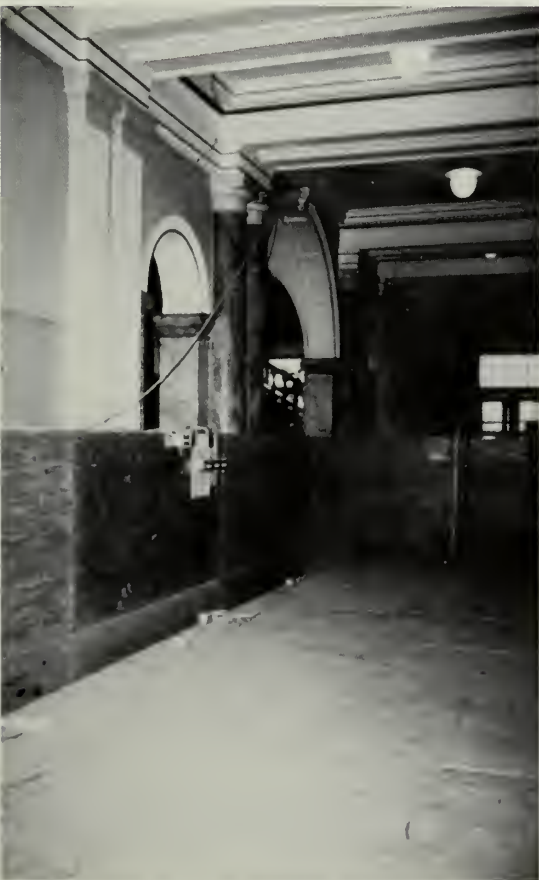
Figure 5. To provide for adequate floor protection in the New Jersey State Capitol, this area was swept clean, then covered with polyethylene sheeting to protect against spills and dirt abrasion. Fiberboard (1/2" thick) was placed over floors and the joints sealed with tape. Finally 1/2" plywood was laid with all joints taped. This floor protection system has been successful over many years of use and is recommended in major construction areas, and where tile, marble, parquetry wood, or other historic flooring is involved. Photo and drawing: Ford Farewell Mills and Gatsch Architects.

Flooring should be protected from damage caused by abrasion, falling objects,

dust and dirt, and spilled liquids (see figure 5). If work in, or traffic through, a particular space does not involve one or more of these risks, temporary protection may be reduced. Damage caused by abrasion can be controlled by means of protective coverings such as canvas tarps or resilient wood fiber panels. Canvas tarps should overlap and be taped at all joints. Resilient wood fiber panels should be carefully fitted with tight seams and laid continuously wall to wall. Joints should be taped to avoid displacement of the panels after setting.

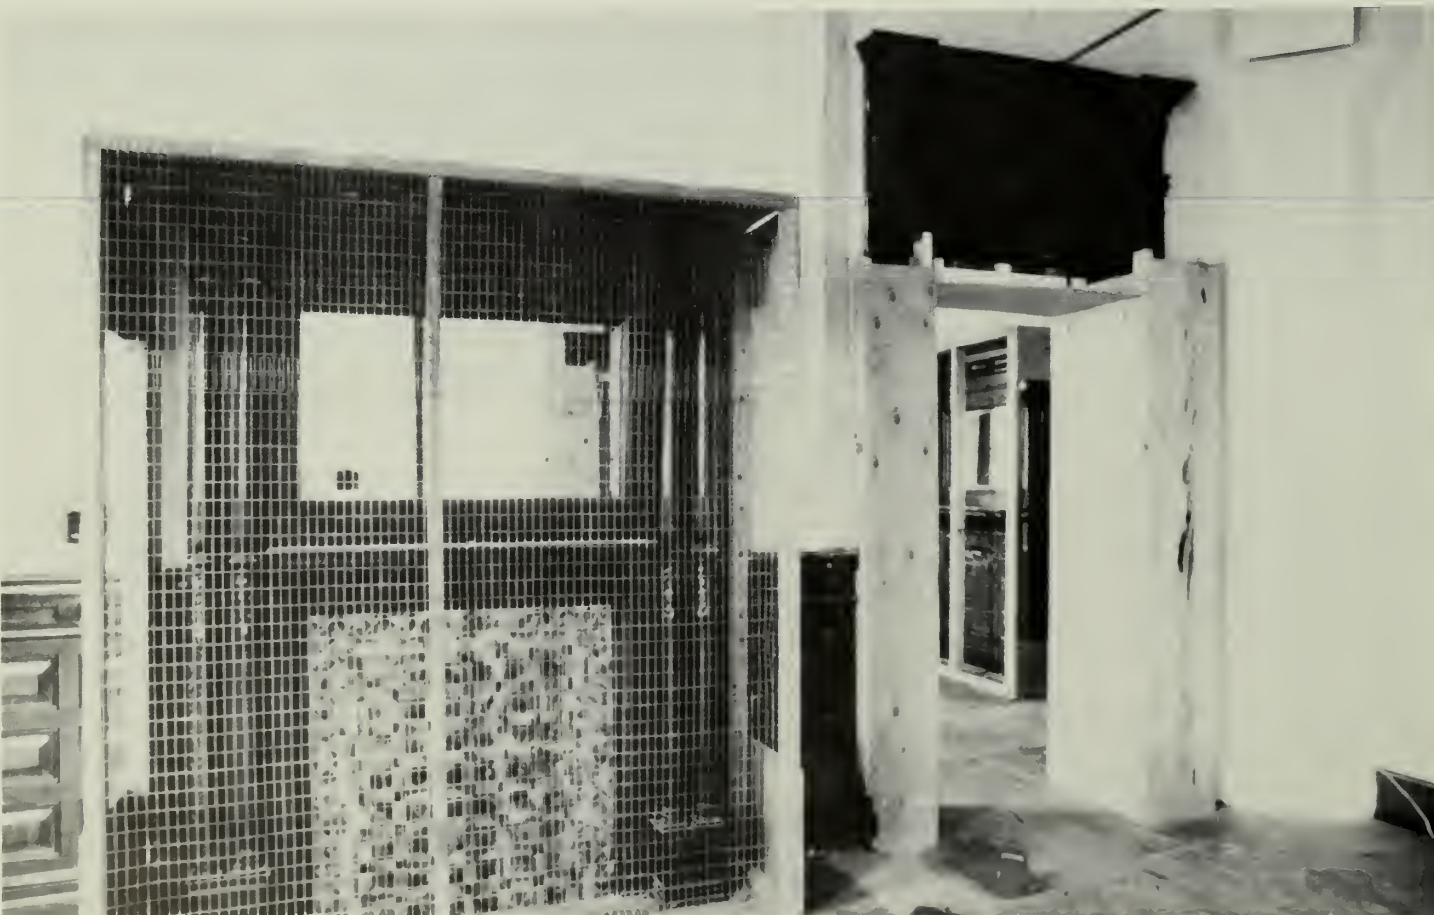
Figure 6. A self-supporting impact cage utilizing wood and wire mesh protects the fireplace. In this project, the long construction process required bidders to have visible access to features such as the fireplace. The wire mesh also facilitated monitoring during the lengthy construction. Photo and drawing: Ford Farewell Mills and Gatsch Architects.

Historic stairways, balustrades, balconies, fireplaces, door surrounds, window surrounds, and other components will also need to be protected from construction damage by combining the techniques described for floors and walls (see figure 6). Horizontal surfaces should be protected as floors, and vertical assemblies treated as walls, with the major difference being the complexity of the framing required.

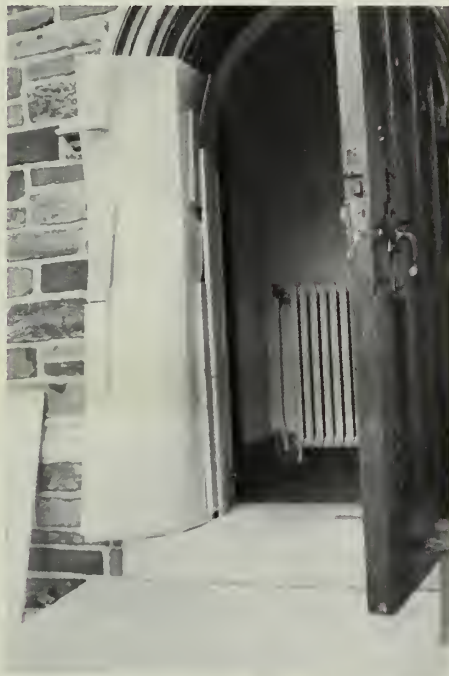
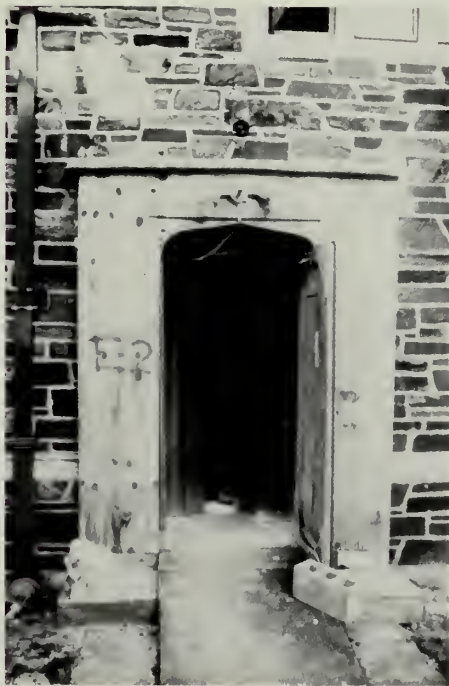
**Figure 7.** A contractor’s solution to protecting the limestone door surround consisted of thin foam sheeting, secured with wood nailed to the masonry. This protection was rejected as inadequate by the architect, and a full plywood enclosure constructed. In the architect’s solution, it should be noted that a temporary door is used while the original door is stored for safe keeping during construction. Photo: Ford Farewell Mills and Gatsch Architects.

The above notwithstanding, architects routinely specify temporary facilities including temporary utilities, temporary construction and support facilities, and security and protection services. For preservation projects, it is recommended that temporary protection of historic interiors during construction be specified in a separate Division 1 specification section entitled “Special Project Procedure” or “Restoration Project Procedures” to ensure that required provisions are not overlooked by bidders because they appear in the often lengthy Section 01500 — Temporary Facilities. Under competitive bidding circumstances, bidders logically seek to minimize the cost to the project for providing temporary facilities, including temporary protection of historic interiors. By creating a separate section in a price proposal, the bidder will be inclined to treat the “special project procedures” as an added cost rather than a part of the temporary facilities required for any alteration project. The contractor’s project manager can thus anticipate making reasonable expenditures for providing specified temporary protection during construction. To ensure the adequacy of temporary protection measures in projects involving a construction manager, temporary protection is often best provided by the construction manager, who normally works for the owner on a cost-plus-fee basis (see figure 7).
