Planning for Exterior Work on the First Parish Church

Portland, Maine

Using Photographs as Project Documentation

A Preliminary Survey of the Building

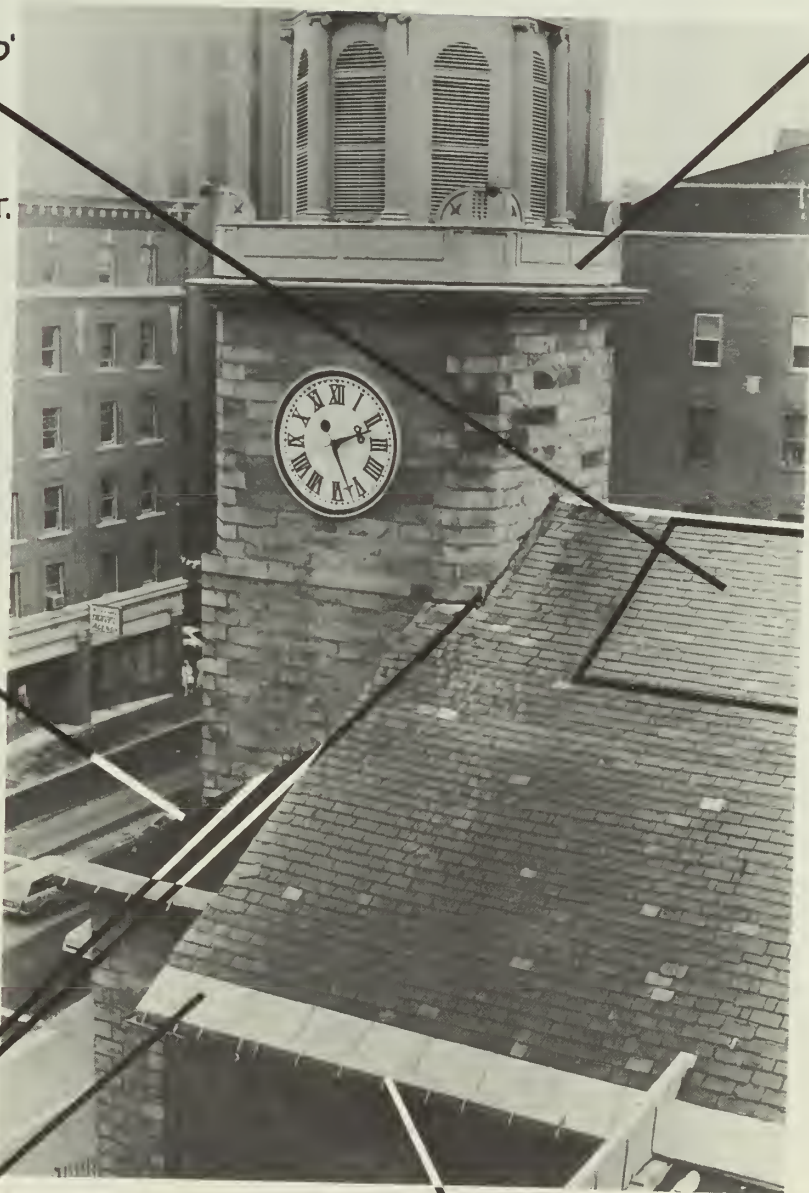
Fig. 1. Deterioration of Roofing and Flashing.

The existing slate roof has undergone numerous repairs over the years and therefore includes several different colors and sizes of slate. Most repairs have been limited to replacement of individual slates, except near the tower where an approximately 15' x 30' section was replaced with green slate (Fig. 1:a) in what was evidently an early, rather sizeable repair job on the main roof (see also Fig. C). Comparison of what we assume is an original slate with other slate samples indicates that the original slate was Welsh purple. We would estimate that only 20–30% of the existing slate can be re-used; the remaining 70–80% will have to be new slate. Obviously, when laying old and new slate side by side, a close color and size match are desirable. New slate will also be required for the two small hipped roof surfaces on either side of the tower, at present covered with black asphalt shingles (Fig. 1:b). Some holes, leaks and previous patching attempts are evident in the roof sheathing when viewed from the attic space. We estimate that 10–15% of the existing roof sheathing will have to be removed and replaced. Other areas of concern are the flashing and counter-flashing. Completely new flashing and counter-flashing will be required at the rear chimney and wherever any roof surface abuts the masonry tower (Fig. 1:c). The existing eave flashing appears to be in good condition (Fig. 1:d). A related flashing item is the re-hanging of several sections of gutter in order to facilitate better drainage (Fig. 1:e). A new metal ridge roll for the main roof and metal hip rolls for the two small hip roofs adjacent to the tower would also be required. Replacement of the existing attic ventilation system at the main roof ridge is also advisable.¹ Inspection of the existing copper roof at the base of the steeple (Fig. 1:f) for any cracks in the seams or joints is recommended. Several water-stained areas were noted in the sheathing beneath this surface which may indicate a leak. Re-soldering of suspect seams should eliminate any current water penetration (see Part 2 specifications, Slate Roofing 06500 and Flashing 07600).

¹The present attic ventilation system consists of a roof ventilator approximately 16" in diameter placed centrally on the main roof ridge, directly over a ceiling grate with an undetermined amount of free area. It would appear that the prime purpose of this roof ventilator is not to ventilate the attic, but to exhaust air from the main sanctuary space. Positive ventilation of attic spaces is recommended to prevent condensation and subsequent rot of wooden framing or sheathing elements. At present, no such rot appears to exist; however, introduction of cellulose insulation on top of existing lath and framing may present a problem of moisture absorption or retention sometime in the future. Therefore, an investigation of appropriate alternatives with respect to ventilating the attic space is recommended.

a. APPROXIMATE 15'x30'
PATCH OF INAPPRO-
PRIATE GREEN
SLATE REQUIRING
TOTAL REPLACEMENT.
PATCH IS VISIBLE
IN 1865 PHOTO.

b. HIP ROOF SURFACES
COVERED IN INAP-
PROPRIATE BLACK
ASPHALT SHINGLES
REQUIRING TOTAL
REPLACEMENT

d. EXISTING EAVE FLASHING
IN GOOD CONDITION

e. SECTIONS OF GUTTER
NEED REHANGING

In reference to Fig. 1 (Deterioration of Roofing and Flashing), because no absolute photographic evidence of the 1826 roof ridge detail exists and

in view of the building's early roof repairs, another approach was selected in conjunction with the roofing contractor, Mr. C. Gordon LaRose, Portland Roofing Co., South Portland, Maine: a slate comb roof on the main roof and slate fantail hips on the two small roofs adjacent to the tower (see Part 2 specifications, Slate Roofing 06500).

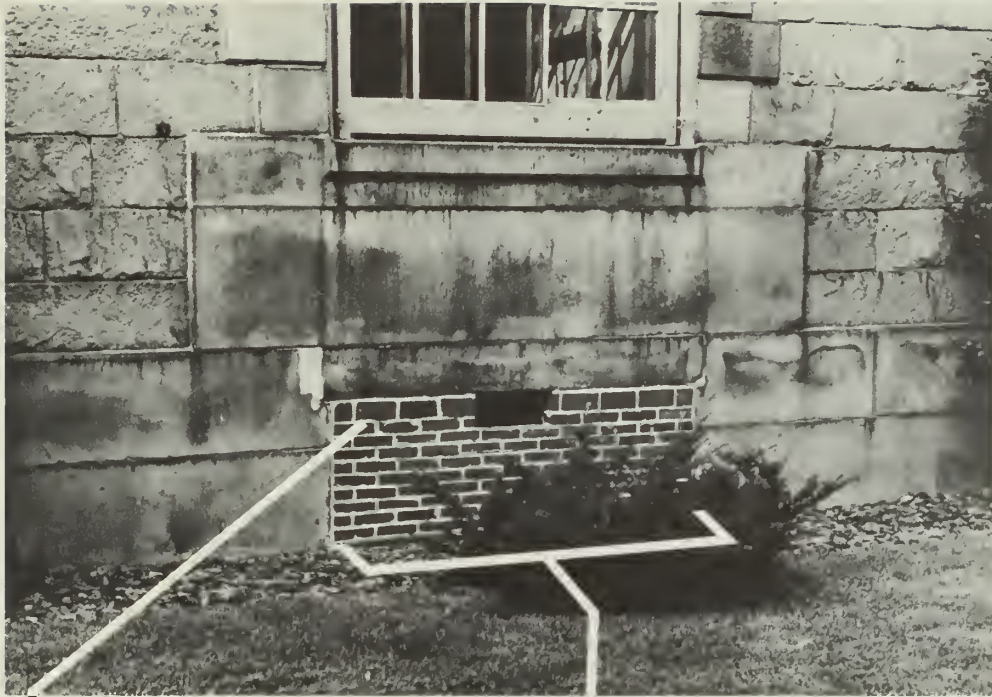
Fig. 2. Below-grade Water Penetration at Basement Window Openings.

The three exterior wall penetrations at basement level were originally doorways to the three storage areas below the church. Within the recent past, each of these openings was closed by the insertion of concrete block and brick masonry, then backfilled with dirt (Fig. 2:a). It would appear, however, that no effort was made to mechanically seal the joints below-grade between the existing stone and the infill material. As a result, sizable amounts of water are penetrating the wall at isolated points below-grade. The water penetration is cause for concern. If the dampness is not removed through ventilation, it may well lead to future deterioration of both wood and masonry materials. We therefore recommend that the immediate area outside of each basement opening be excavated (Fig. 2:b) in order to install proper waterproofing membranes over the below-grade infill material and neighboring existing masonry (see Part 2 specifications, Dampproofing 07150 and related Site Improvements 02700).

a. ORIGINAL BASEMENT
DOOR OPENING FILLED
WITH CONCRETE BLOCK
AND BRICK - THEN
BACKFILLED WITH DIRT

b. BELOW GRADE AREA
TO BE EXCAVATED FOR
WATERPROOFING
TREATMENT

At the foundation on the west wall, existing masonry block walls will be excavated and dampproofed. Existing shrubs will be removed and replanted upon completion of dampproofing and roofing work.

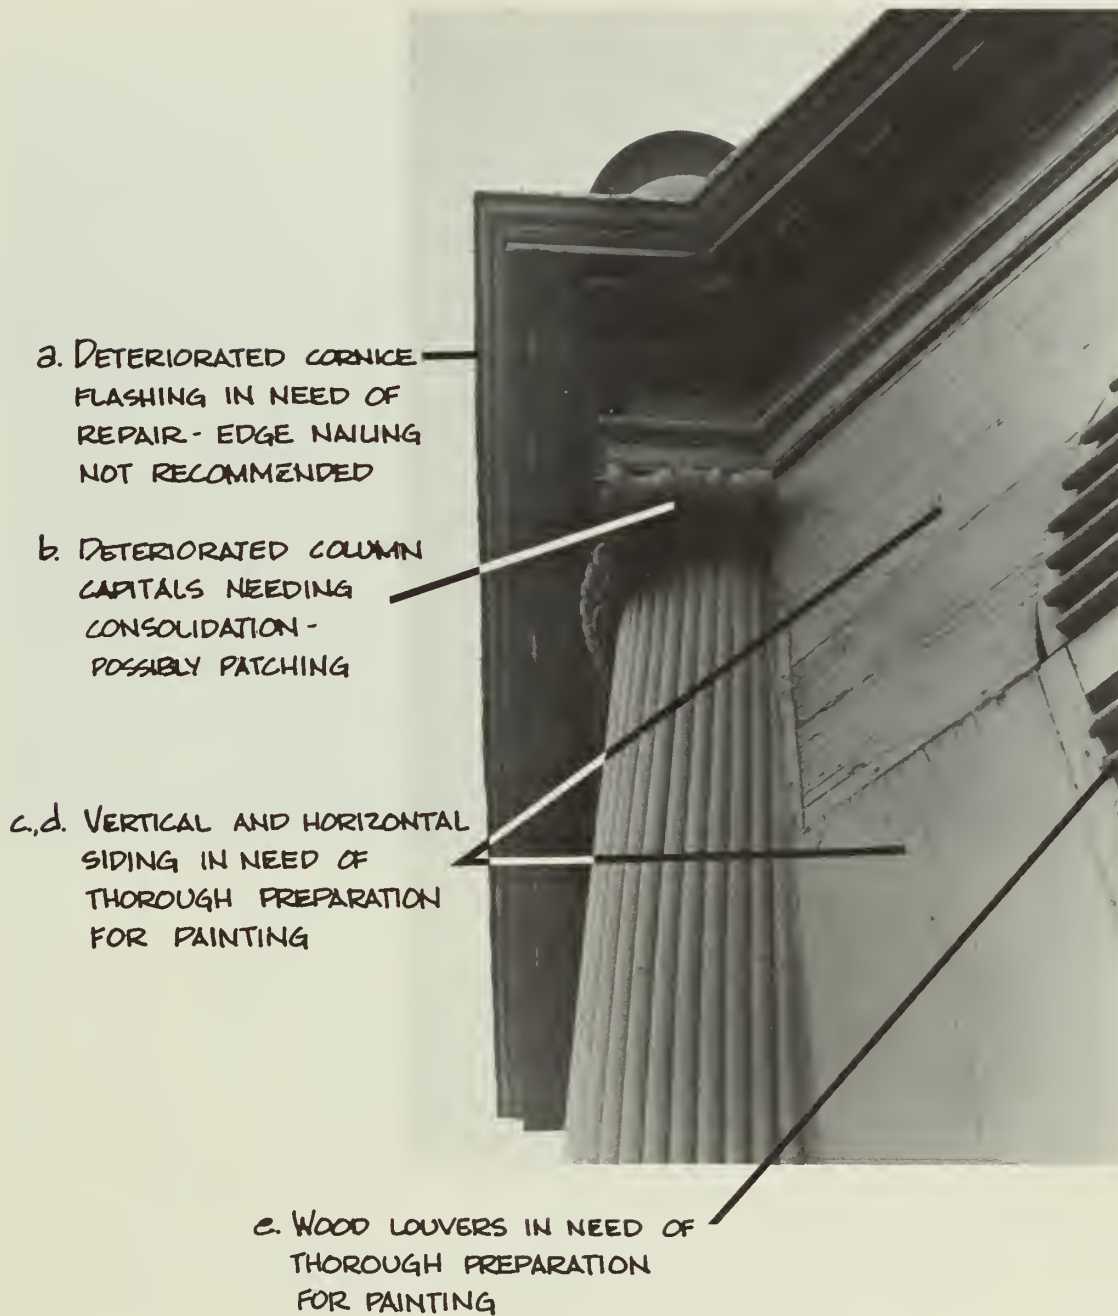
Fig. 3 Cornice Deterioration at the Urn Level of the Steeple.

The cornice flashing, edge-nailed into the crown moulding (Fig. 3:a) is no longer serving its intended function of throwing water away from the cornice below. Instead, the many open nail holes provide an avenue for moisture penetration. Therefore, it is strongly recommended that all existing cornice flashing at this level be replaced and that all new flashing be detailed in such a manner as to avoid edge-nailing. Additional deterioration, including some large holes, is evident at several locations in the cornice soffit and should be repaired. Many of the Ionic column capitals also show weathering and deterioration at their upper surfaces (Fig. 3:b). Where possible, these areas should be consolidated and patched; the worst areas may require piecing-in of new wood. The vertical (Fig. 3:c) and horizontal sheathing (Fig. 3:d) needs a thorough scraping in preparation for painting, in addition to localized patching or caulking of open areas in the wood. The wood louvers (Fig. 3:e) require similar preparation prior to painting (see Part 2 specifications, Rough Carpentry 06100 and Flashing 07600).

- J. Continuous around steeple at base of dome below urns; and around steeple bell deck, raise eave flashing and insert underneath a four inch wide copper strip. Isolate from incompatible metal if necessary to prevent electrolysis with 15 pound felt. Renail assembly through sound existing metal into wood backing. NOTE: This flashing treatment is specified in order to stabilize the existing deteriorated and leaking material. Future corrective measures should involve detailing the flashing to avoid edge-nailing, possibly requiring the replacement of the entire dome roof.

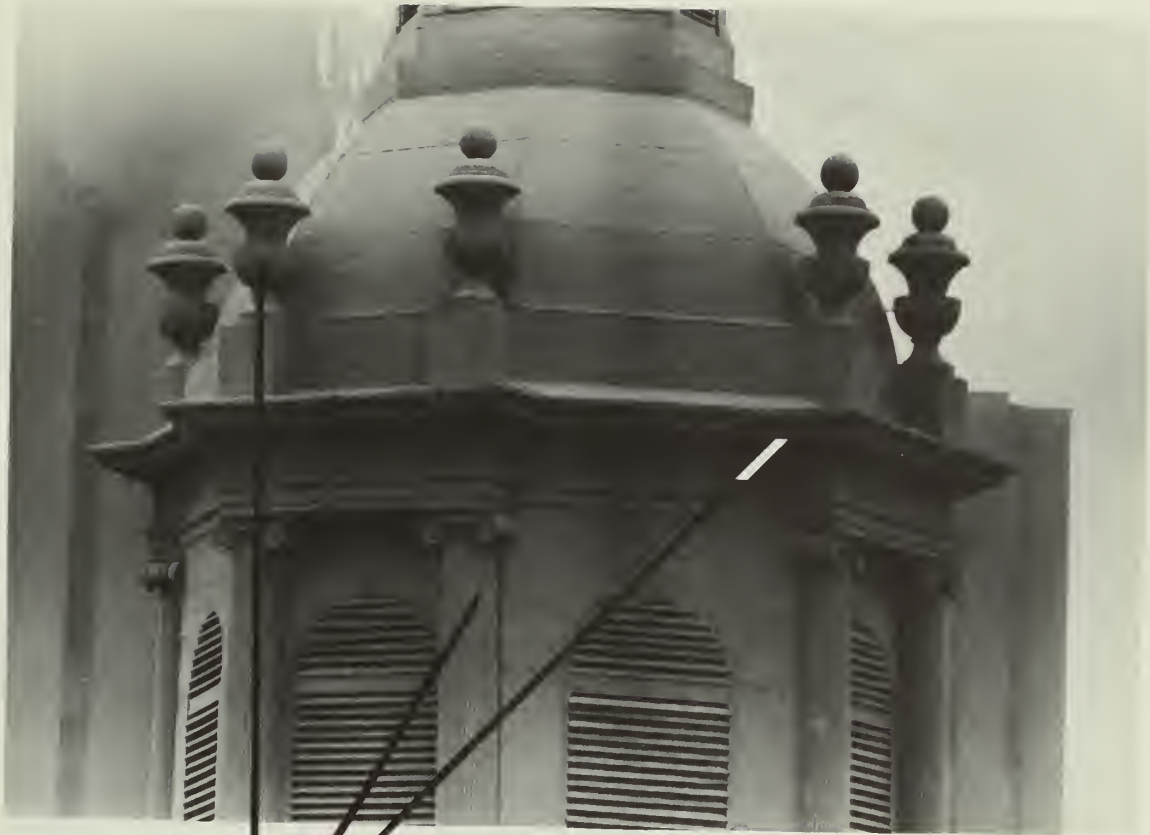
Fig. 4 Paint Failure on Wood Elements of Steeple.

The majority of steeple woodwork² exhibits weathering and loss of paint coverage and adhesion. For the continued life of these elements, we recommend a thorough scraping, sanding, and caulking of all areas of the steeple woodwork followed by the priming of all bare wood and two coats of a premium housepaint (see Part 2 specifications, Painting 09900).

²The space enclosed by the cupola and the curving, metal-covered roof below appears not to be ventilated. Visual inspection from the access hatch above the bell revealed the interior wood surfaces of this space to be quite damp. To prevent any chance of rot developing, we recommend investigating ways of unobtrusively ventilating this space.

GENERAL WEATHERING AND LOSS
OF PAINT ON STEEPLE WOODWORK
REQUIRING THOROUGH PREPARATION
AND REPAINTING

- A. Thoroughly scrape all wood components on the steeple down to and including clock faces. Extreme care shall be taken not to damage existing or new wood surfaces by using appropriate devices. Scrape front wood doors and frames.
- B. Remove loose paint from all metal components on the steeple exclusive of gold flaked parts. Do not damage metal sheeting or joints.
- C. Thoroughly scrape all shutters as noted in Section 06100 Rough Carpentry and hang as directed by Owner at completion of painting process.
- D. Touch sand to smooth and even surface and dust. After prime coat has been applied, fill remaining holes with wood putty.
- E. Existing painted and new surfaces shall be thoroughly cleaned before beginning painting work with detergents.

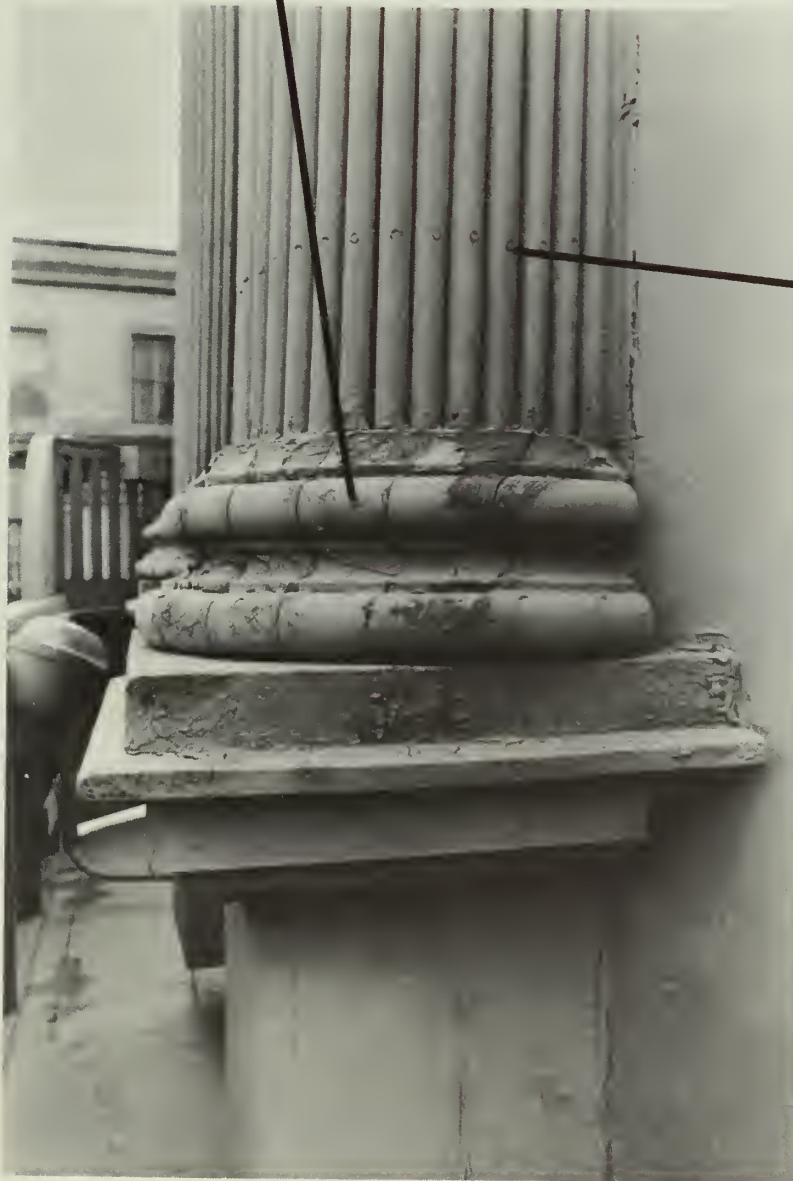
Fig. 5. Delamination of Column Bases at Lower Steeple Roof Deck.

The column bases, which appear to be of recent vintage, are separating at their lamination points (Fig. 6:a). Further inspection should be made to ascertain the probable age of these elements, which would then determine whether the existing bases need expensive regluing and consolidation, or if entirely new bases should be fabricated. The unusual reeding above appears to be fastened with wire nails, indicating 20th century building material (Fig. 6:b); however, close examination of a ca. 1895 photograph of the church (Fig. F) seems to show similar reeding, which would tend to suggest that the existing material was fabricated in a manner approximating that of the earlier material (see Part 2 specifications, Rough Carpentry 06100).

2. SEPARATION OF COLUMN BASES REQUIRING
EITHER REPAIR OR REPLACEMENT

b. COLUMN REEDING
FASTENED WITH
WIRE NAILS

- E. Fabricate new column bases for the above noted locations conforming to profile of existing wood bases. Parts shall each be fabricated from a single piece of thoroughly dry stock as specified and conform to American Woodworkers Institute Standards for custom grade work. Secure in proper position on columns.

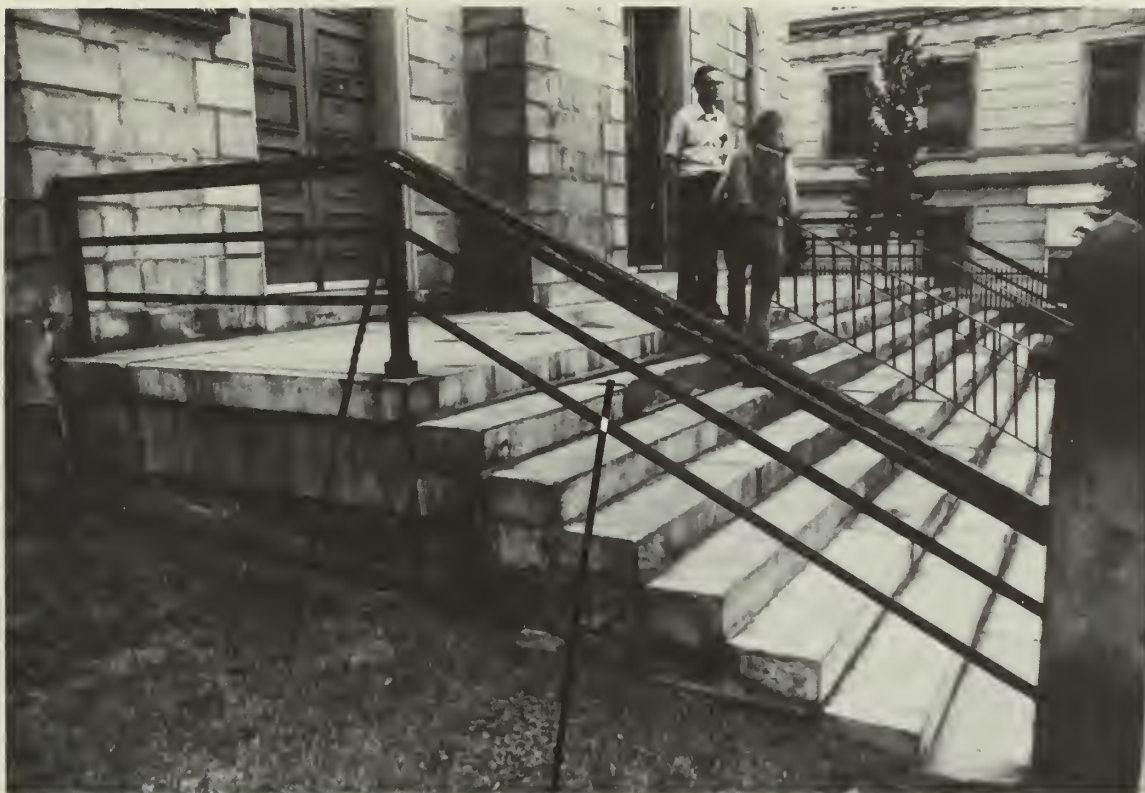
Fig. 6. Uneven Settlement of Main Entry Stairs.

For the most part, the stone stairs appear to be in reasonably good condition. A few slabs have twisted or rotated, opening large gaps between the slabs (Fig. 6:a). These gaps may be allowing water to penetrate under the slabs where it could possibly be leaching mortar away from the supporting spur walls below (Fig. 6:b). We believe that the present condition of the stairs does not warrant immediate attention; however, it should be pointed out that one or two of the slabs could present a problem to an elderly person or to someone who fails to notice the uneven settlement. Repairs to the stair slabs and the supporting walls below could possibly best be effected by removal of the uppermost large stone sections. Once all stone is re-set in position, all joints should be grouted and caulked with a suitable non-staining material to prevent future moisture penetration (see Part 2 specifications, Mortar 04100 and Brick Masonry 04210).

a,b. TWISTED OR ROTATED SLABS CAUSING
POSSIBLE WATER PENETRATION AND
MORTAR LEACHING - NEEDS FUTURE
ATTENTION

- A. Jack up large platform stone at doors. Make front edge continuous with adjacent slabs. Remove unsound mortar and brick from supporting walls. Replace with new brick and/or mortar to provide continuous bearing for stone.

- B. Under remaining large platform stones, remove any unsound mortar and/or brick and repair with new material to provide sound bearing surfaces.
- C. Remove all unsound mortar and/or brick from step supporting walls and repair with new material. Alter spacing of supports as necessary to provide 1 inch minimum horizontal lap of stone steps when they are placed in final position.

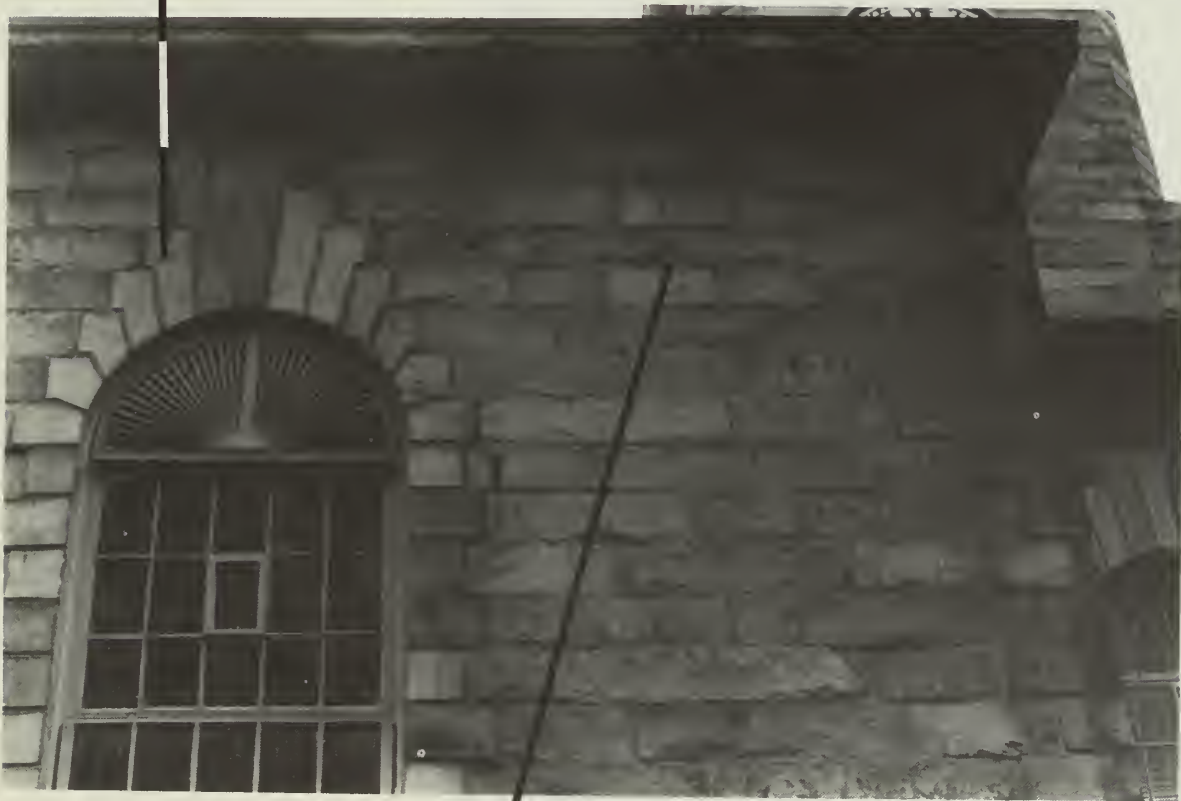
Fig. 7. Uneven Weathering of Mortar Joints.

³We also recommend that an attempt be made to examine the mortar joints of the church which are now covered by the construction of the parish house. It may be possible, by lifting one of the sash on the parish house side of the church (Fig. F), to see undisturbed mortar joints from the original period of construction. The discovery of these joints could possibly be of great assistance in determining future repointing materials and techniques.

- a. RAISED MORTAR JOINTS
DIRECTLY UNDER THE EAVES

- b. UPPER MORTAR JOINTS OF
LIGHTER COLOR THAN THOSE
BELOW

NOTE: PRIOR TO ANY REPOINTING WORK,
AN ANALYSIS OF EXISTING MORTAR
COMPOSITION AND PROFILE IS
RECOMMENDED

No specifications have been provided for Fig. 7 (Uneven Weathering of Mortar Joints) and Fig. 8 (Exfoliation of Stone at Center Doorway) as per Mr. Hecker's recommendations, because further investigation and/or monitoring of these areas must be conducted prior to the development of additional items of work.

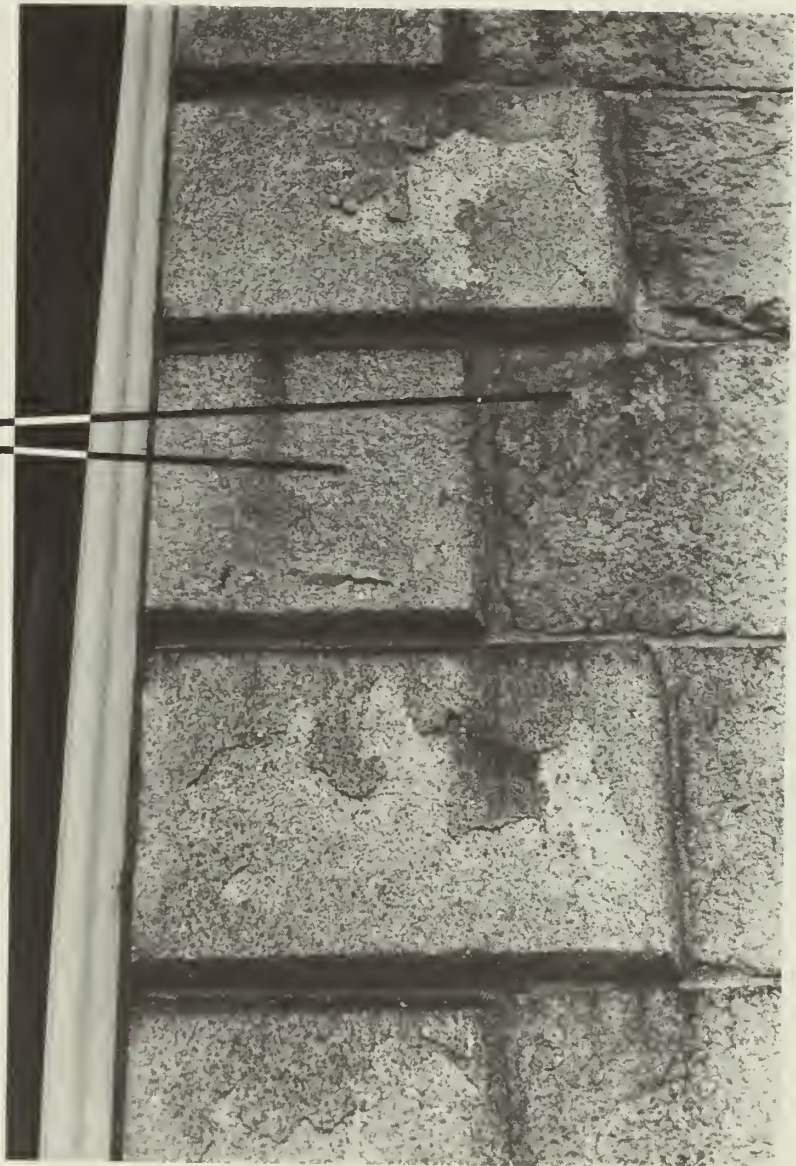
The weathering crust which has formed on the doorway quoins (Fig. 8:a) and adjacent masonry (Fig. 8:b) is exfoliating due to a combination of factors. The Portland urban environment imposes many stresses upon stone which include a higher level of sulfates and carbon dioxide in the atmosphere, frequent freeze-thaw cycles, street salting during the winter, a salt water environment, and winter and summer fog sequences. Unfortunately, little can be done to prevent additional weathering crusts from forming and exfoliating. Even in an ideal climate, most stones exhibit formation of a weathering crust, but at a much slower rate.

a,b WEATHERING CRUST
FORMED ON THE
DOORWAY QUOINS
AND ADJACENT
MASONRY
