PRESERVATION **9** BRIEFS

Holding the Line: Controlling Unwanted **Moisture in Historic Buildings**

Sharon C. Park, AIA

U.S. Department of the Interior National Park Service **Cultural Resources** Heritage Preservation Services

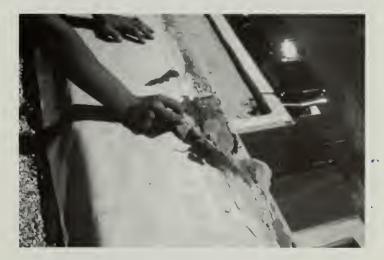
Fig. 1. Moisture problems, if not properly corrected, will increase damage to historic buildings. This waterproof coating trapped moisture from the leaking roof, causing portions of the masoury parapet to fail. Photo: NPS Files.

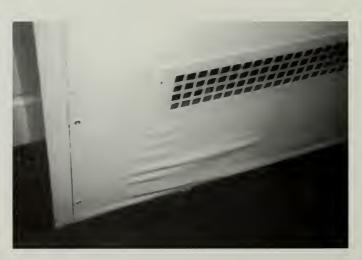
Fig. 3. The deterioration of this wooden cover was a sign that water was leaking from the fan coil unit behind. Photo: author.

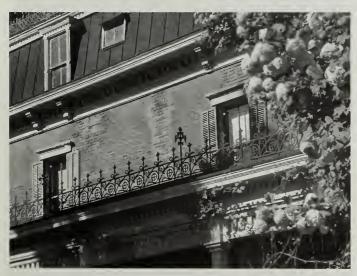
Fig. 4. Deferred maintenance often leads to blocked gutters and downspouts. This cracked gutter system allowed moisture to penetrate the upper exterior wall, erode mortar joints, and rot fascia boards. Photo: NPS files.

Above grade exterior moisture generally results from weather related moisture entering through deteriorating materials as a result of deferred maintenance, structural settlement cracks, or damage from high winds or storms (see fig. 4). Such sources as faulty roofs, cracks in walls, and open joints around window and door openings can be corrected through either repair or limited replacement. Due to their age, historic buildings are notoriously "drafty," allowing rain, wind, and damp air to enter through missing mortar joints; around cracks in windows, doors, and wood siding; and into uninsulated attics. In some cases, excessively absorbent materials, such as soft sandstone, become saturated from rain or gutter overflows, and can allow moisture to dampen interior surfaces. Vines or other vegetative materials allowed to grow directly on building materials without trellis or other framework can cause damage from roots eroding mortar joints and foundations as well as dampness being held against surfaces. In most cases, keeping vegetation off buildings, repairing damaged materials, replacing flashings, rehanging gutters, repairing downspouts, repointing mortar, caulking perimeter joints around windows and doors, and repainting surfaces can alleviate most sources of unwanted exterior moisture from entering a building above grade.

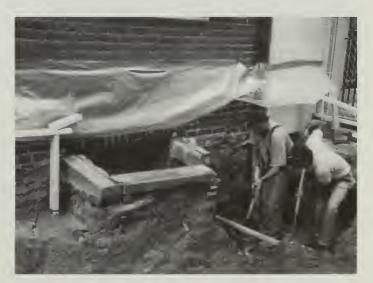
Fig. 5. Excavating this foundation revealed that the downspout pipe had corroded at the "u-trap" and was leaking moisture into the soil. Openings around the horizontal water supply line and cracks in the wall allowed moisture to penetrate the basement in multiple locations. Photo: author.

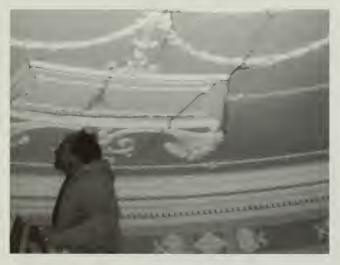
Fig. 6. Uninsulated plumbing pipes close to the exterior wall froze and cracked, wetting this ornamental plaster ceiling before the water supply line could be shut off. As a result, limited portions of the ceiling needed reattaching. Photo; author.

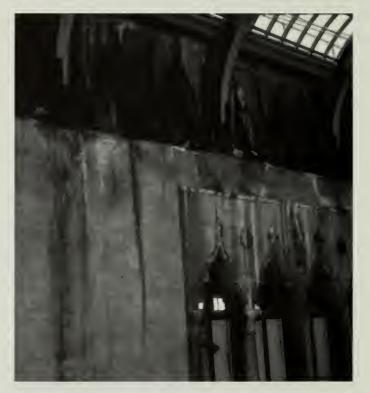
Fig. 7. Condensation dripping from the large overhead courtyard skylight was damaging the masonry in this museum. A new skylight with thermal glazing was installed, replacing the deteriorated single-glazed unit. A new climate control system monitors interior temperature and humidity. Photo: © Isabella Stewart Gardner Museum, Boston.

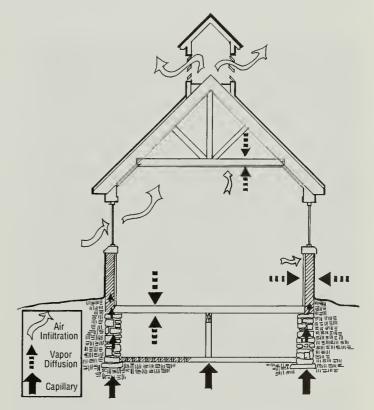
Fig. 9. The dynamic forces that move air and moisture through a building are important to understand particularly when selecting a treatment to correct a moisture problem. Air infiltration, capillary action, and vapor diffusion all affect the wetting and drying of materials. Drawing; NPS Files.

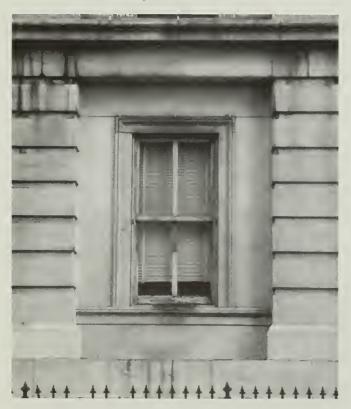
Fig. 10. Infiltration of damp air can occur around loose-fitting or deteriorated window sash and through cracks or open joints in building exteriors. Photo: Ann Brooks Prueher.

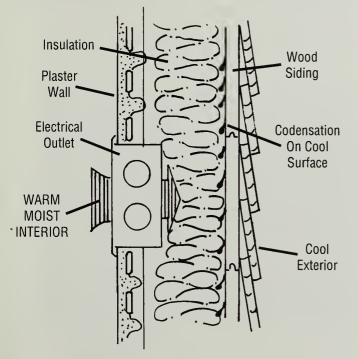
Fig. 12. Vapor diffusion can result in damp air migrating into absorbent materials and condensing on colder surfaces, thereby wetting insulation, damaging electrical conduits, and causing deterioration of the wooden framing. Drawing: NPS Files.

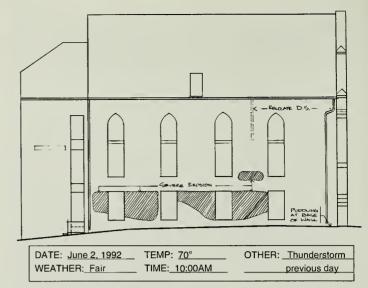
Fig. 13. Using sketch plans and elevation drawings to record the moisture damage along with the date, time, and weather conditions will show how moisture is affecting buildings over time. Drawing: Courtesy, Quinn Evans Architects.

Surveying moisture damage must be systematic so that relative changes can be noted. Tools for investigating can be as simple as a notebook, sketch plans, binoculars, camera, aluminum foil, smoke pencil, and flashlight. The systematic approach involves looking at buildings from the top down and from the outside to the inside. Photographs, floor plans, site plan, and exterior elevations — even roughly sketched — should be used to indicate all evidence of damp or damaged materials, with notations for musty or poorly ventilated areas. Information might be needed on the absorption and permeability characteristics of the building materials and soils. Exterior drainage patterns should be noted and these base plans referred to on a regular basis in different seasons and in differing types of weather (see fig. 13).

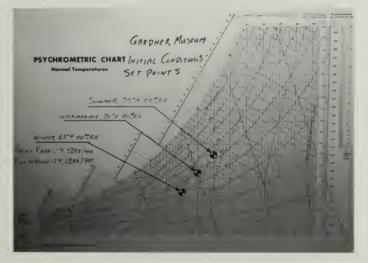
Fig. 15. Psychrometric charts quantify the amount of relative humidity a building can tolerate before dewpoint condensation occurs. This is important when the range of temperature and humidity are critical to both collections management and historic building preservation. Chart: Landmark Facilities Group.

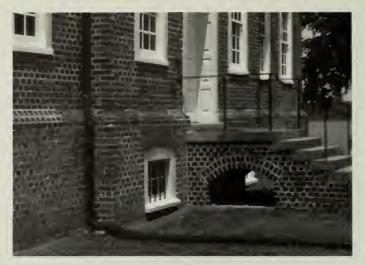
Fig. 17. In testing a theory for the cause of basement wetness, the owner used long black extender pipes to direct roof run-off away from the foundation. This test established that the owner did not need expensive waterproofing of the foundation, but a better drainage system. Photo: Baird M. Smith.

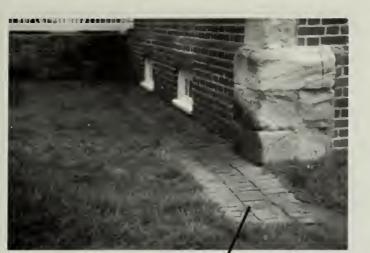
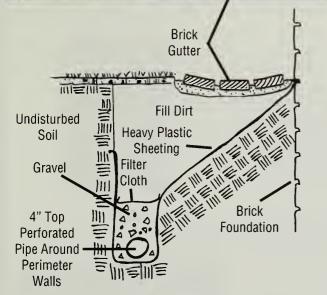
Fig. 18. This detail drawing shows a sub-surface perimeter drain in conjunction with a historic brick ground gutter system to help control roof run-off moisture from entering the historic foundation. Detail: Courtesy, Gunston Hall Plantation. Photo: Elizabeth Sasser.

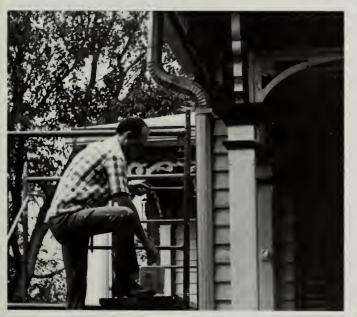
Fig. 19. Maintaining gutters and downspouts in good operable condition, repairing exteriors to keep water out, redirecting damaging moisture away from foundations and controlling interior moisture and condensation are all important when holding the line on moisture deterioration. Photo: Nebraska State Historical Society.

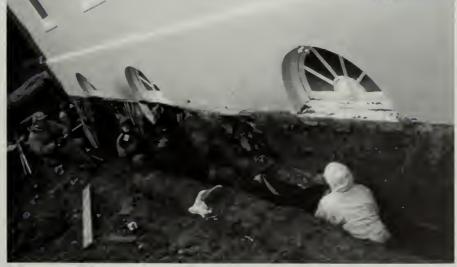
I. Critically damp foundation walls were protected with a layer of bentonite clay to reduce moisture penetration. This work was in combination with new downspouts that were connected to drainage boots that deposited captures roof run-off away from the foundation. Photo: Courtesy, Larry D. Dermody and the National Trust for Historic Preservation.

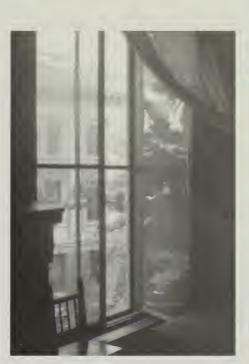
F. Triple glazed windows replaced the originals to control condensation. Photo: © Isabella Stewart Gardner Museum, Boston.
