EXCAVATION AND REPAIR OF SUN TEMPLE MESA VERDE NATIONAL PARK

EXCAVATION AND REPAIR OF SUN TEMPLE.

By J. WALTER FEWKES, *Bureau of American Ethnology.*

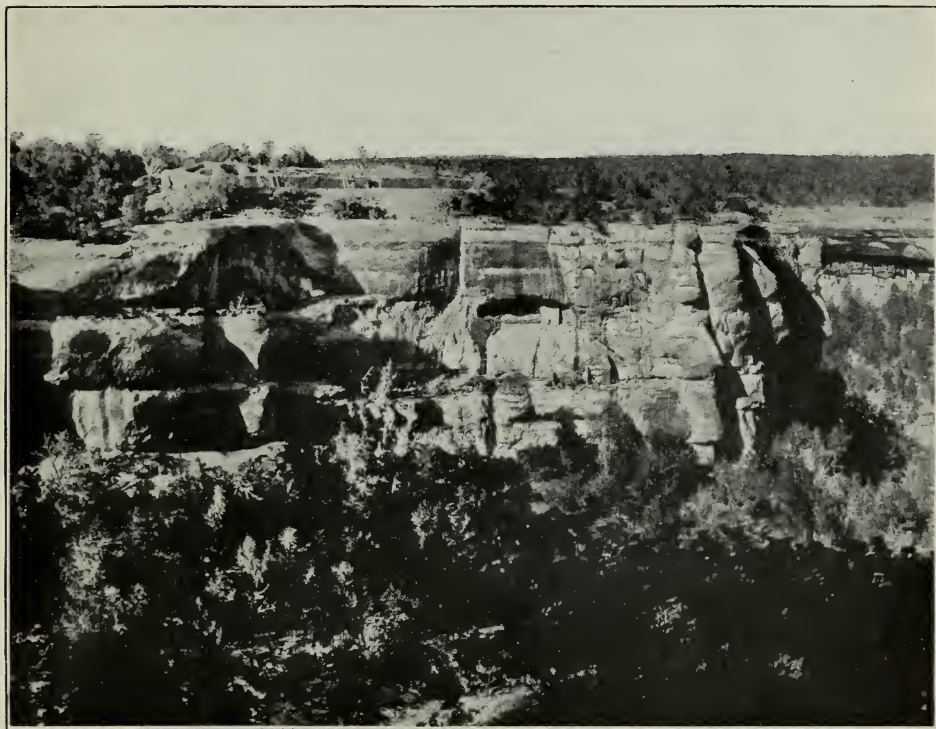
FIG. 2.—VIEW OF SUN TEMPLE AND CLIFF PALACE.

The ruin was purposely constructed in a commanding situation (fig. 2) in the neighborhood of large inhabited cliff houses. It sets somewhat back from the edge of the canyon, but near enough to

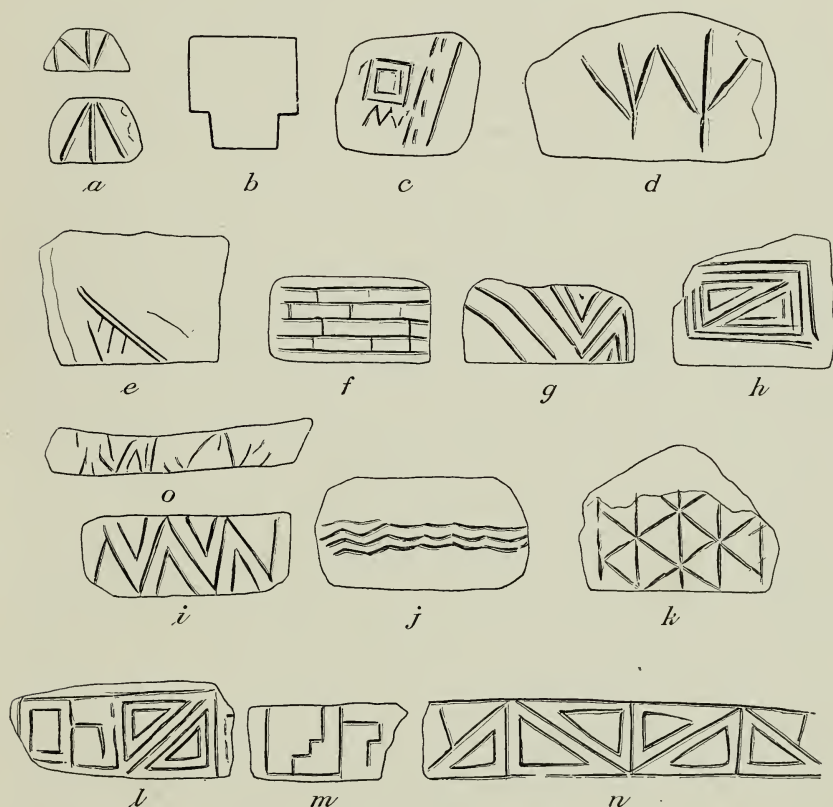
FIG. 4.—TYPICAL DESIGNS ON STONES FROM THE WALLS.

A figure (fig. 4*c*) representing a ladder leaning against a wall is incised on the left-hand side of the entrance to room *o*. On one side, near it, is an outline of a T-shaped door (fig. 4*b*), above which

is a cross, not very deeply cut in the rock. Near the top of the inner wall of room *g*, on the west side, there is an incised figure (fig. 4*h*), commonly found on pottery and on the inner wall of the southwest corner of the plaza another pattern is obscurely indicated.

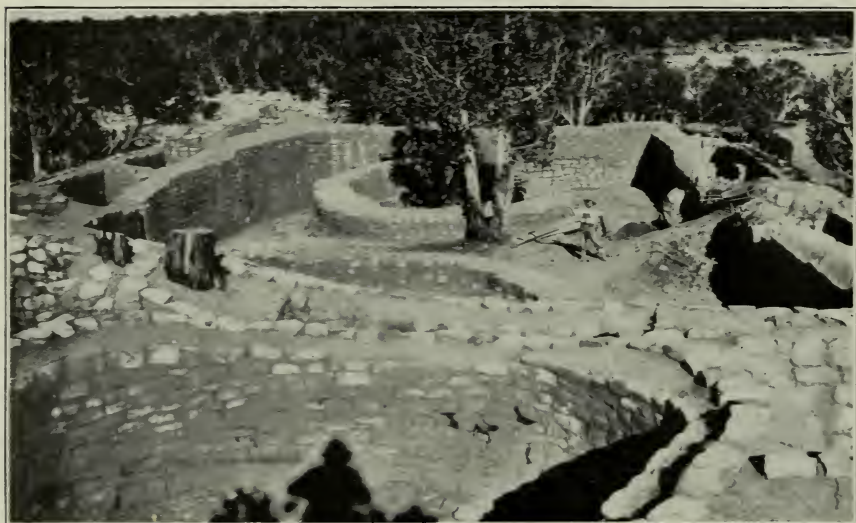
FIG. 5.—INTERIOR OF RUIN. LOOKING EAST. SHOWING CEDAR STUMP.

The surfaces of the walls of many rooms (fig. 5) have been rubbed smooth, the marks of pecking on individual stones not being as well

shown as on the facing of the outer walls. Roots of trees formerly growing on the ruin have made their way between the courses of stone and can still be seen in the walls.

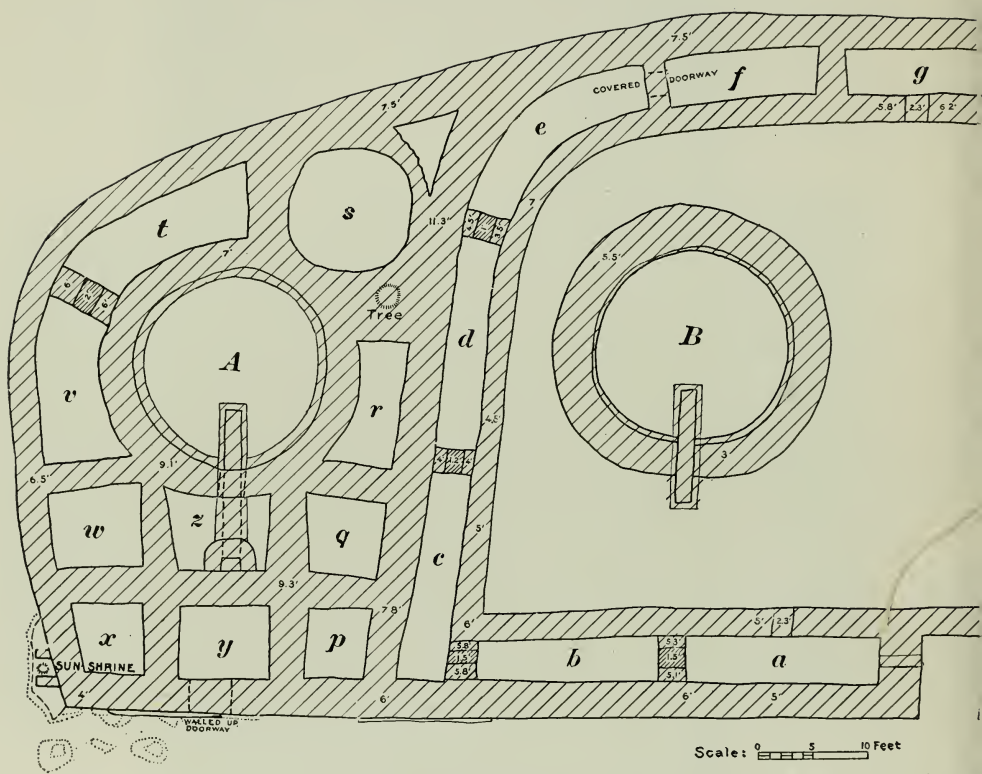
FIG. 7.—GROUND PLAN OF SUN TEMPLE, MESA VERDE NATIONAL MONUMENT

The ground plan, shown in figure 7, has been well compared to the letter D. The building is formed of two sections, the larger of which taken separately is also D-shaped and may be called the original building, while the smaller, forming the west end, is of later (?) construction and may be known as the Annex. The south wall, which is straight, is common to both original building and Annex and extends from the southeast corner of the ruin directly east-west 121.7 feet. The portion of this wall from the recess to the east corner has exactly the same length as that to the junction of the original building with the Annex. The western end of the original building, on the south

The width of the ruin at its widest portion is 64 feet. The walls average 4 feet in thickness, and are composed of a central core made of rubble and adobe, with two facings made of well-dressed rock, which, however, were not tied into the core and present a serious architectural defect.

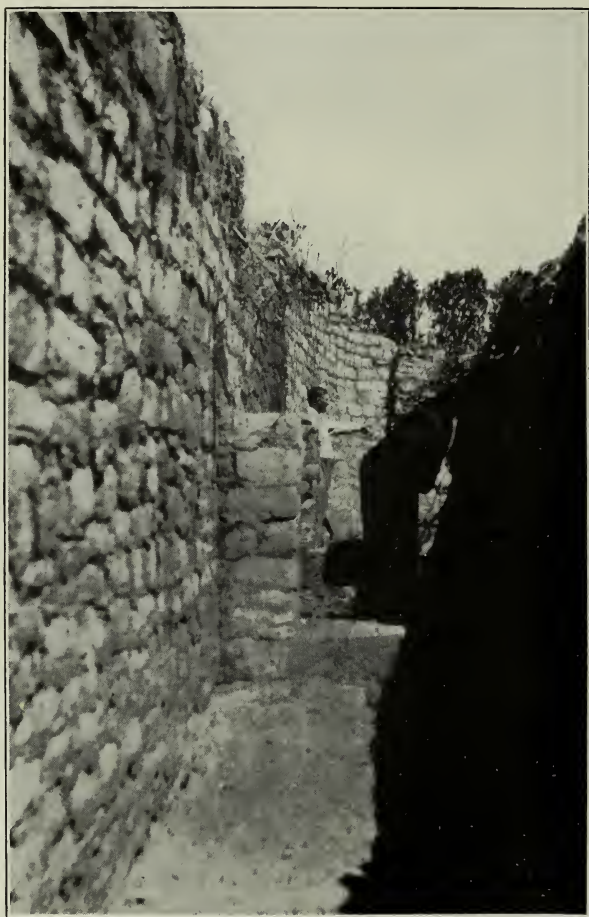
FIG. 8.—WEST WALL OF ROOMS *d* AND *e*, SHOWING DOORWAY.

t-v. The lintels which remained were much decayed and sagged under the weight of the wall above them, so much so that a brace of modern construction was introduced to support them. The lintel that held up the covered doorway of room *r* and that which supported the floor of room *z* above the trench leading into kiva A, were partially intact, but most of the lintels had to be replaced by modern beams, the originals being much decayed (fig. 8).

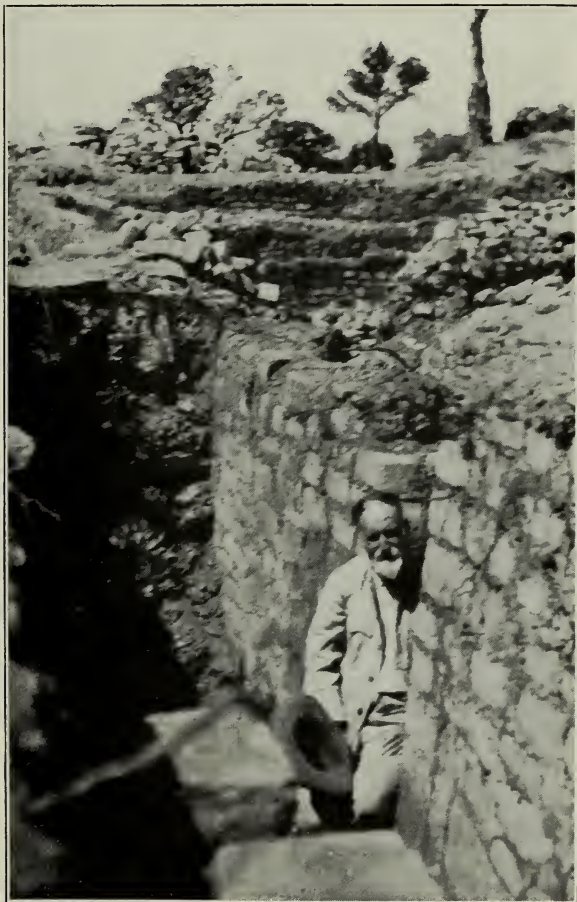
FIG. 9.—WEST END OF ROOM *o*, PARTLY EXCAVATED.

Four of the rooms surrounding the plaza were entered directly by doorways; one of these led into room *a*, others into rooms *g*, *k*, and *o*. The thresholds of the doorways are commonly constructed of large, flat, well-trimmed stones. On each side of the doorway are pilasters (fig. 9) the walls of which are upright and the corners made of good masonry (fig. 9). Evidently all the doorways once had wooden lintels

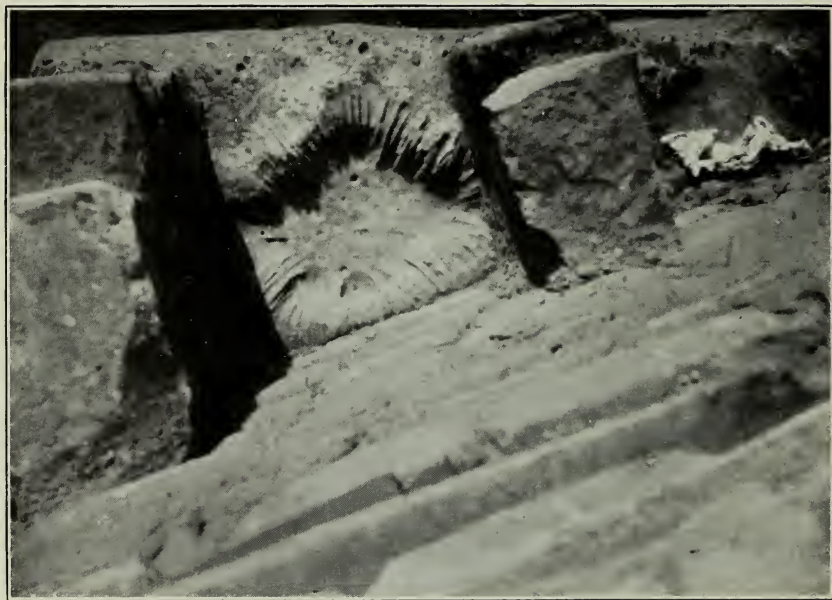
FIG. 10.—SUN SHRINE FROM ABOVE.

One of the most remarkable structures built on the outside walls of the building is near the southwest corner of the Annex. This corner stands on a solid rock that projects about $1\frac{1}{2}$ or 2 feet above the otherwise level foundation of the wall. This cornerstone or foundation of the corner wall protrudes 2 feet beyond the building, and on its upper surface is a fossil with central depressed zone with sharp radiating ridges. The figure (fig. 10) is not artificial,¹ but is possibly helped out by artificial means. A natural object with these charac-

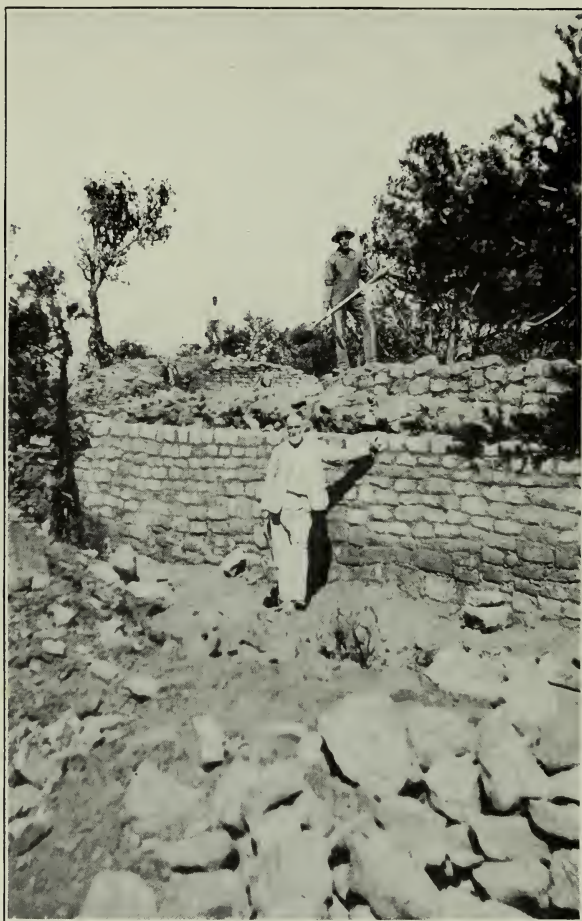
FIG. 11.—PART OF SOUTH WALL, PARTLY EXCAVATED.

The unnecessarily large quantity of adobe in the joints is a weakness, for it allowed water, whether rain or melting snow, to penetrate between the courses of stones or between the facing and the core. When the water froze the walls were broken apart. This is especially

The main causes of destruction of this ruin were not vandals, as at Cliff Palace, but the elements, especially water. After it was abandoned the tops of the walls were exposed to the sky and unprotected either from snow or rain which sometimes falls in torrents. The snow was particularly damaging, for the water from the melting snow percolated between the facings and the core of the wall, and subsequently froze, forcing the facing of the wall away from the central core until it fell. That this was the main cause of deterioration is shown by the fact that as a rule the outer facing of the surrounding wall was more nearly obliterated to a lower level than the inner, and as a rule the core projected often a foot above faces of the wall. The deleterious cause which early led to the overtopping and destruction of walls would be even more potent when they were excavated. Some means had to be devised to prevent a continuation of their destruction (fig. 11).

Although the walls of the building were so massive that they remained intact to the height of the top of the mound, they were partially held up by an accumulated débris. The removal of earth and fallen rocks weakened them so much that some provision had to be made to counteract this loss of support. In order to prevent the

water from melting snow from penetrating the walls, or the rain from percolating between the core of the wall and its facing, I placed a cap of cement on the tops of all the walls. The inner facing of the outer walls, as a rule, stood a few courses of stone higher than the outer, and it was necessary to add masonry to bring the outer wall to the level of the core and inner facing. Having leveled the top of

the wall, I covered it with small, angular fragments of stone, placing these fragments highest in the middle or over the core. Over this roof-like covering was spread a thick layer of adobe. The top of the wall was thus made in a way to shed water. Over this roof of adobe was spread a layer of Portland cement, 2 inches thick, mixed in proportion of 1 to 5, care being taken to use this cement freely in point-

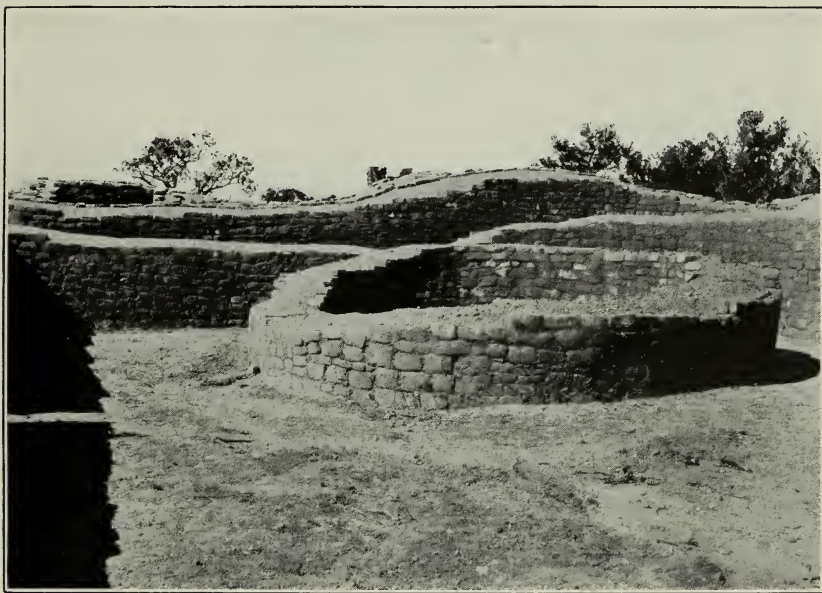
FIG. 14.—WEST END OF PLAZA, SHOWING KIVA B AND STUMP OF OLD CEDAR.

mound. No one can tell the length of this interval in years. We have, however, knowledge of the lapse of time since the mound had accumulated enough soil on its surface to support growth of large trees. In the Annex, between rooms *r* and *s*, near the summit of the highest wall, which is 11 feet 3 inches high, there grew a juniper or red cedar of great antiquity, alive and vigorous when I began work. This tree undoubtedly sprouted after the desertion of the building, and grew after a mound had developed from fallen walls. Its roots penetrated into the adjacent rooms and derived nourishment from the soil filling them. Necessarily when these roots were cut off, thereby killing the tree, I was obliged to fell it, but the stump remains, cut off about a foot above the ground (fig. 14). Three hundred and

sixty annual rings were counted on a section of this tree by Mr. Gordon Parker, supervisor of Montezuma National Forest. Its heart is decayed, but its size suggests other rings and that a few more years can be added to its age. It is not improbable that this tree began to grow on the top of the Sun Temple mound shortly after the year 1540 when Coronado first entered New Mexico, but how great an interval elapsed during which the walls fell to form the mound in which it grew, and how much earlier the foundations of the ruined walls were laid no one can tell. A conservative guess of 250 years is allowable for the interval between construction and the time the cedar began
