Environmental Assessment  
Reconstruction of Park Routes 12, 13, and 112  
and  
Associated Visitor Use Areas \*

environmental assessment  
reconstruction of park routes 12, 13, and 112  
associated visitor use areas

august 1991

**JOSHUA TREE NATIONAL MONUMENT • CALIFORNIA**

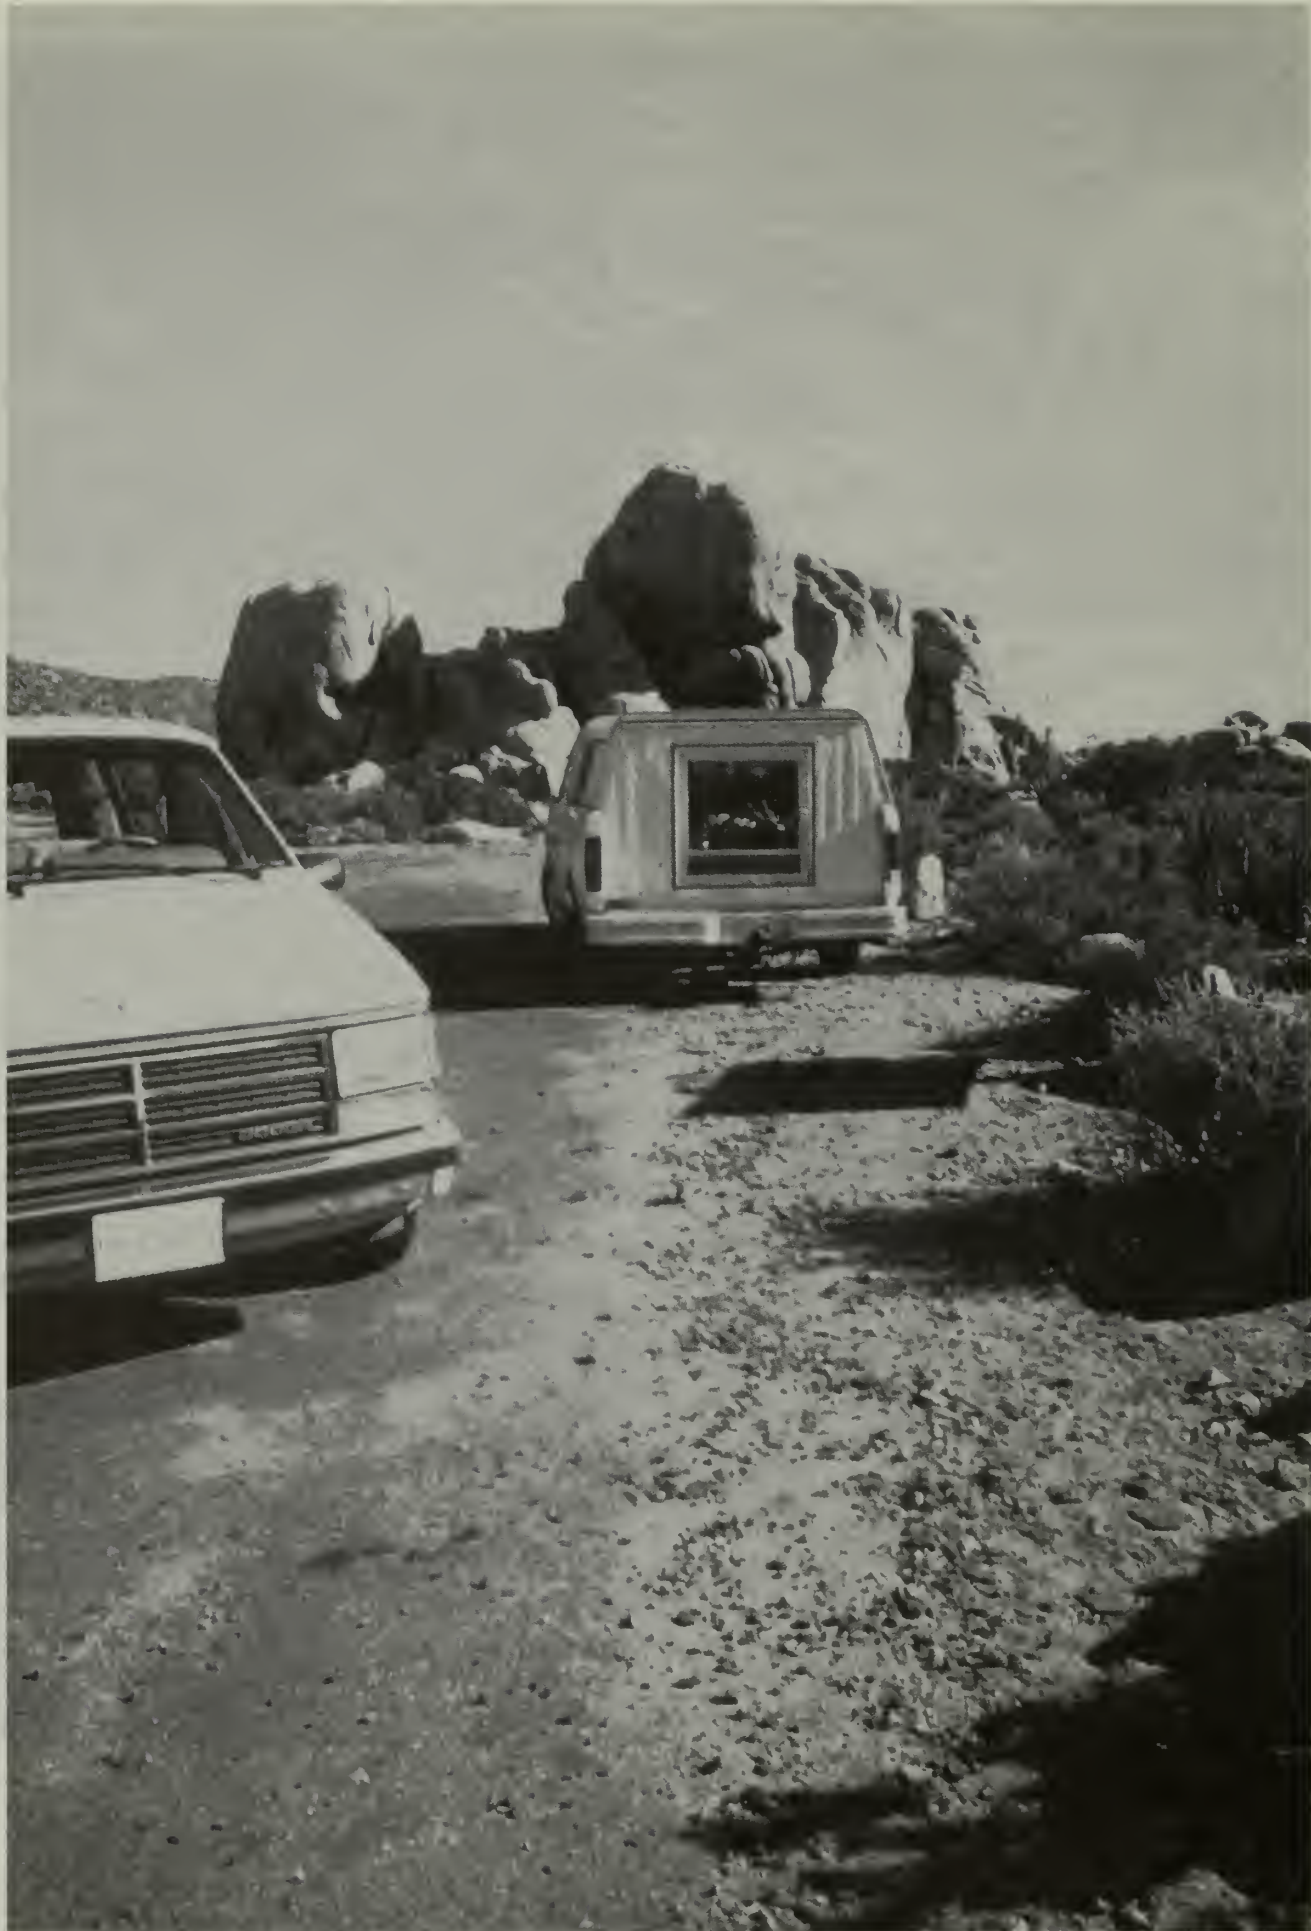
INFORMAL EXPANSION OF PARKING AREAS CAUSED BY USE EXCEEDING CAPACITY

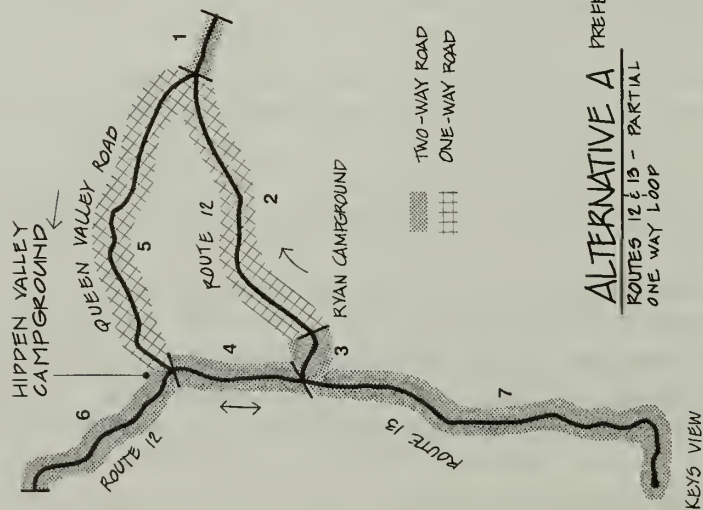
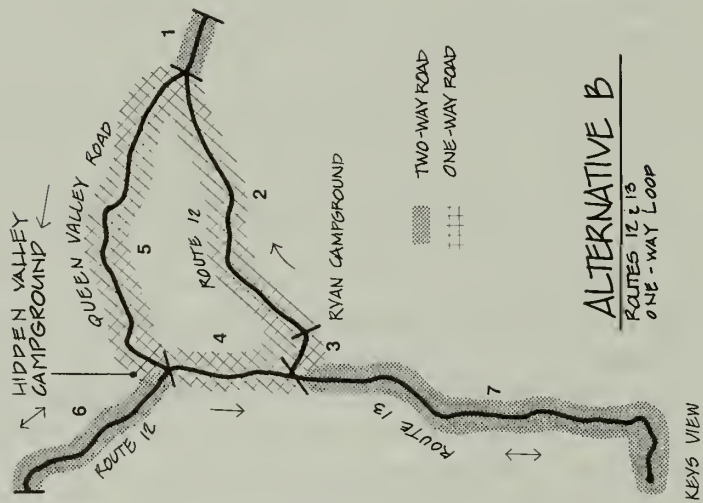
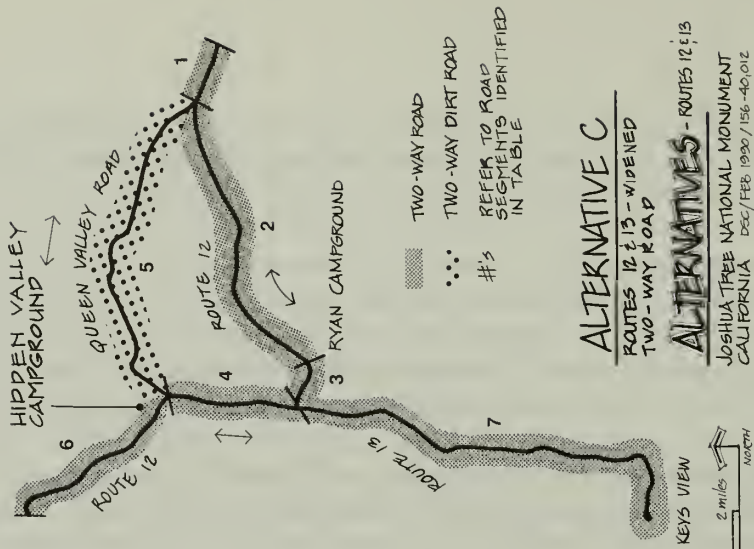
**ALTERNATIVES - ROUTES 12 & 13**  
 JOSHUA TREE NATIONAL MONUMENT  
 CALIFORNIA DEC/FEB 1990 / 156-40.012

## ALTERNATIVES

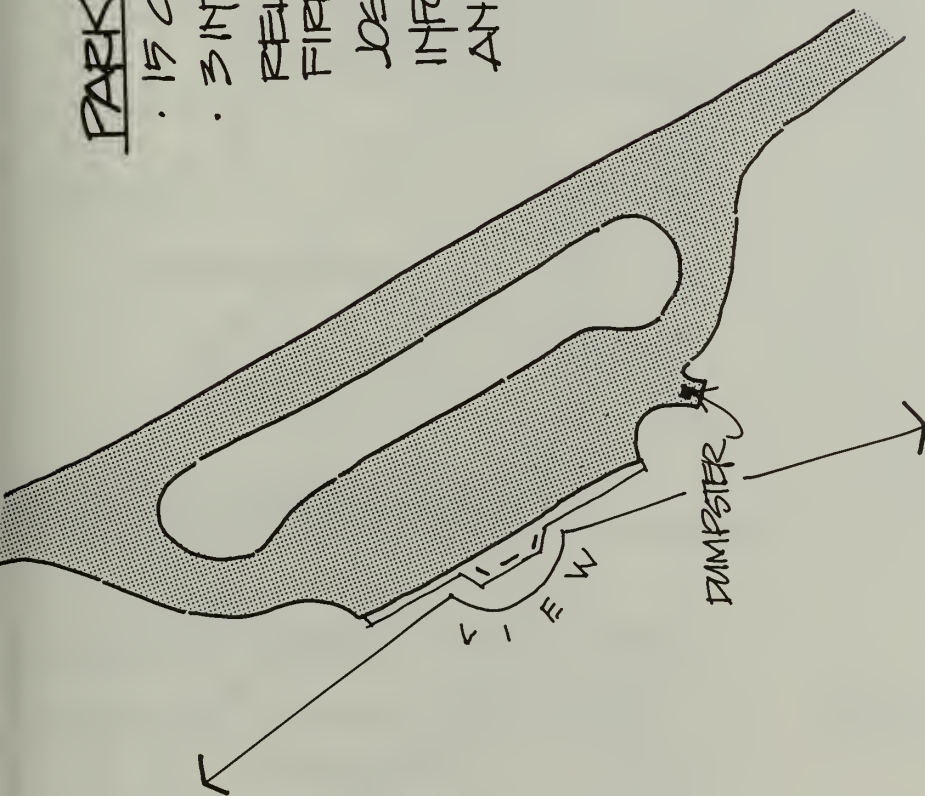
## PARKING

- 15 CARS / 3 RV'S
- 3 INTERPRETIVE EXHIBITS RELATING TO THE ROLE OF FIRE IN DESERT ECOSYSTEMS, JOSHUA TREES, AND GENERAL INFORMATION ON DESERT LANDSCAPE AND PURPOSE OF THE PARK.

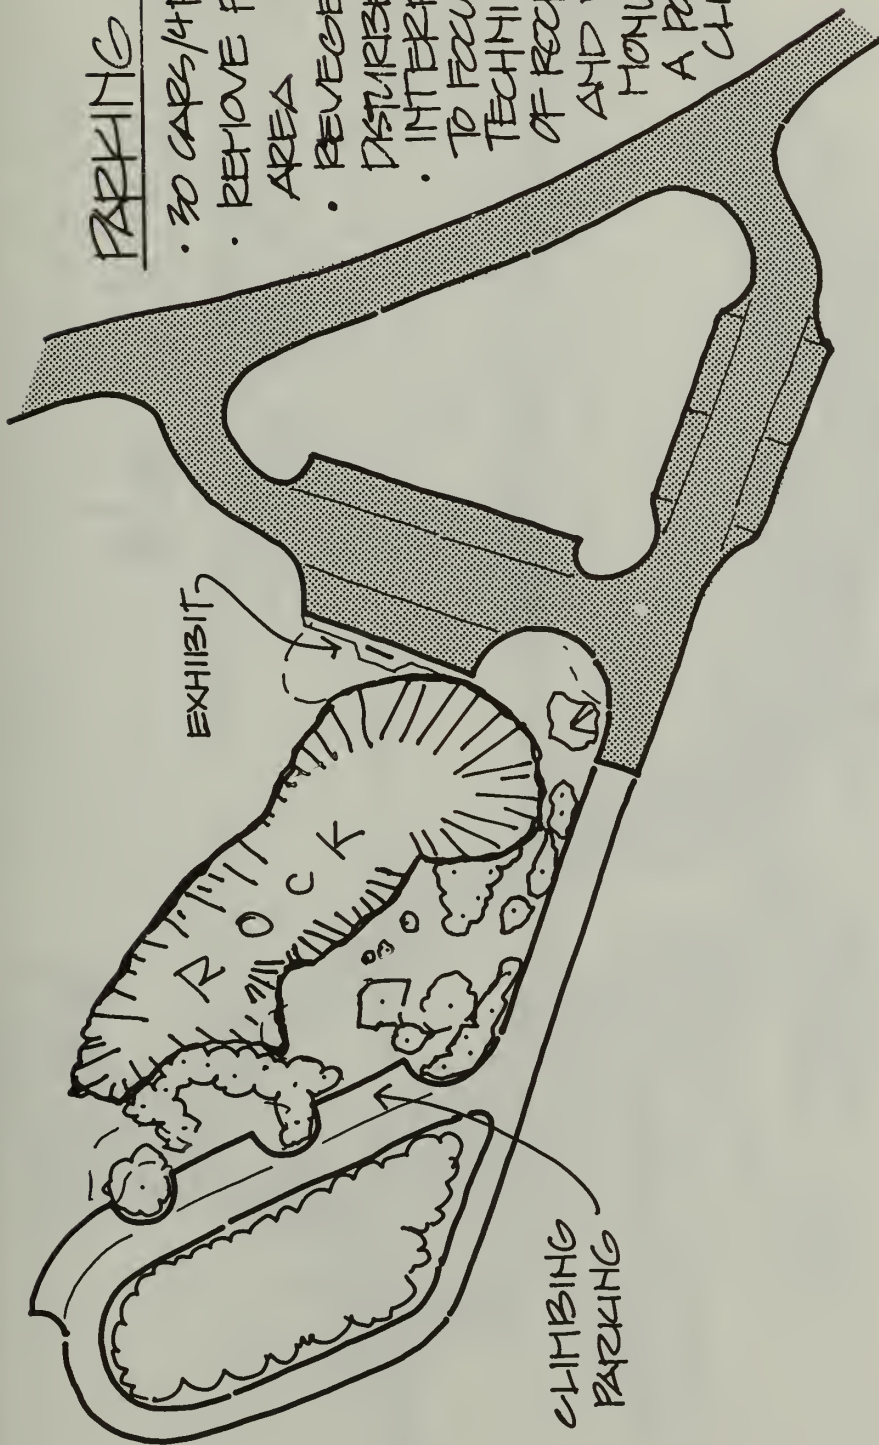
## 2. ROCK CLIMBING EXHIBIT CONCEPTUAL PLAN JOSHUA TREE NATIONAL MONUMENT CALIFORNIA

- 30 CARS/4RY
- REMOVE PICNIC AREA

- REVEGETATE DISTURBED AREAS
- INTERPRETATION TO FOCUS ON TECHNICAL ASPECTS OF ROCK CLIMBING AND WHY THE MONUMENT IS SUCH A POPULAR ROCK-CLIMBING AREA.

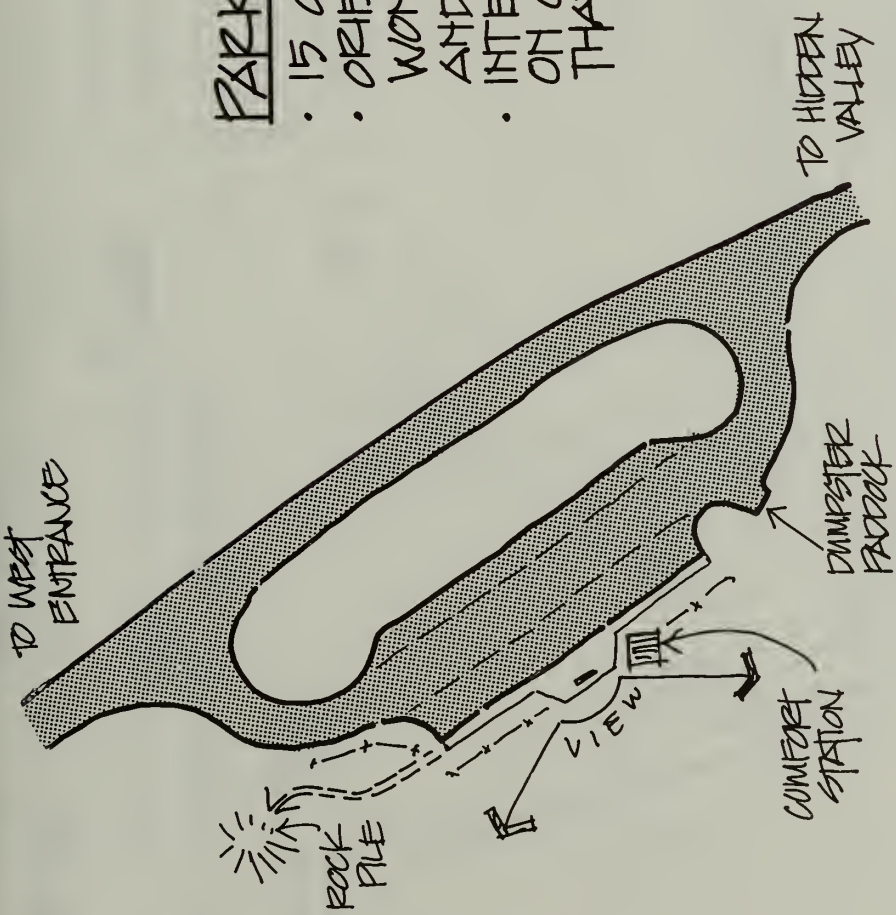
## PARKING AREA

- 15 CARS / 3 RV'S
- ORIENTATION RELATING TO WONDERLAND OF ROCKS AREA AND PARK ROADS IN GENERAL.
- INTERPRETIVE EXHIBIT TO FOCUS ON GEOLOGY OF ROCK PILES THAT ARE PROMINENT IN THIS AREA.

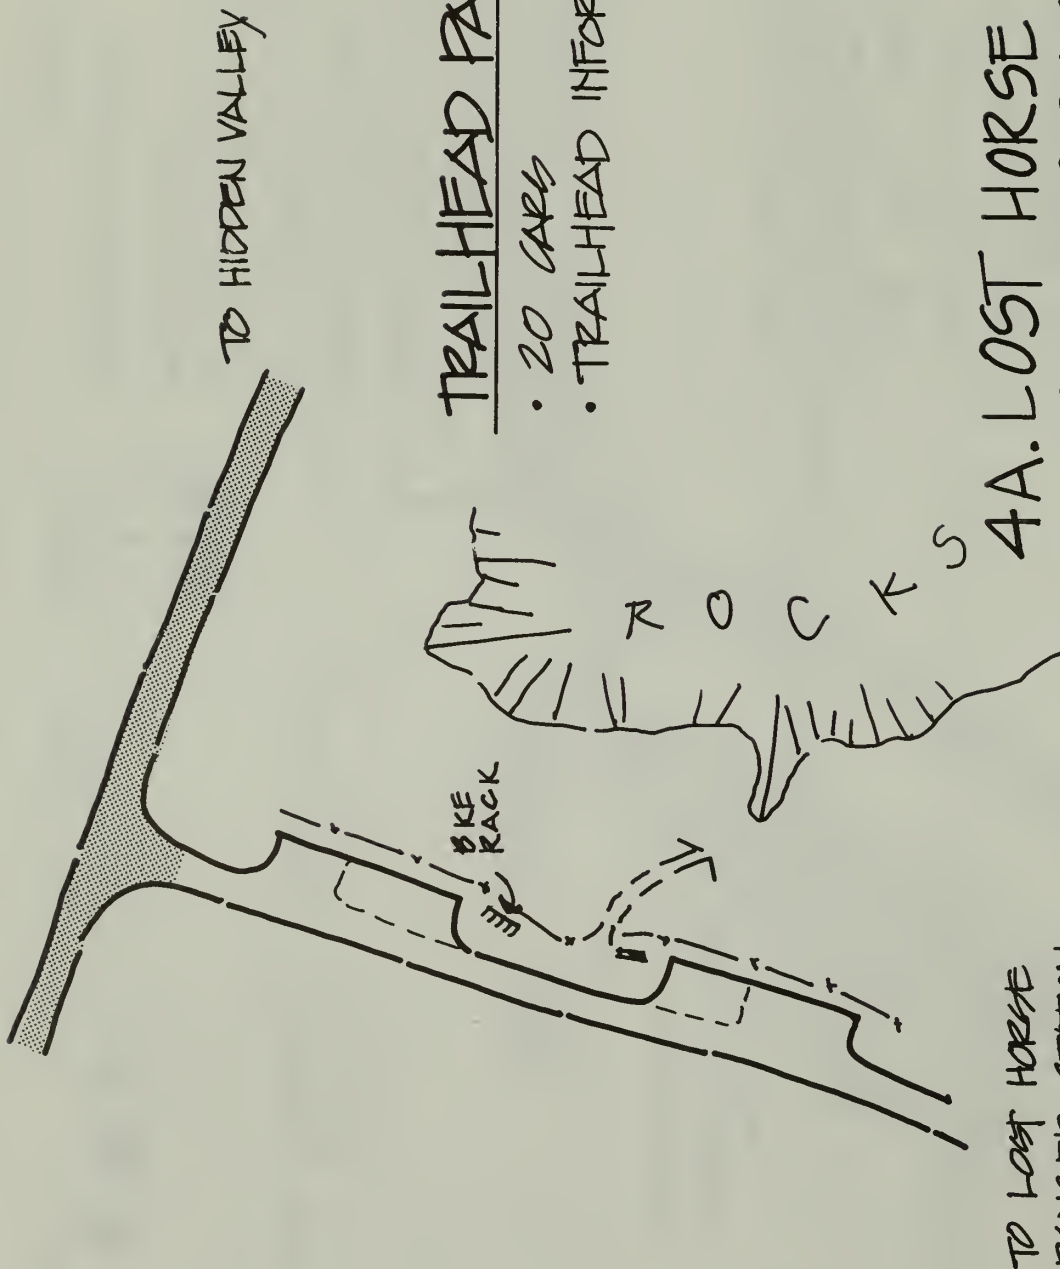
## TRAILHEAD PARKING

- 20 CARS
- TRAILHEAD INFORMATION

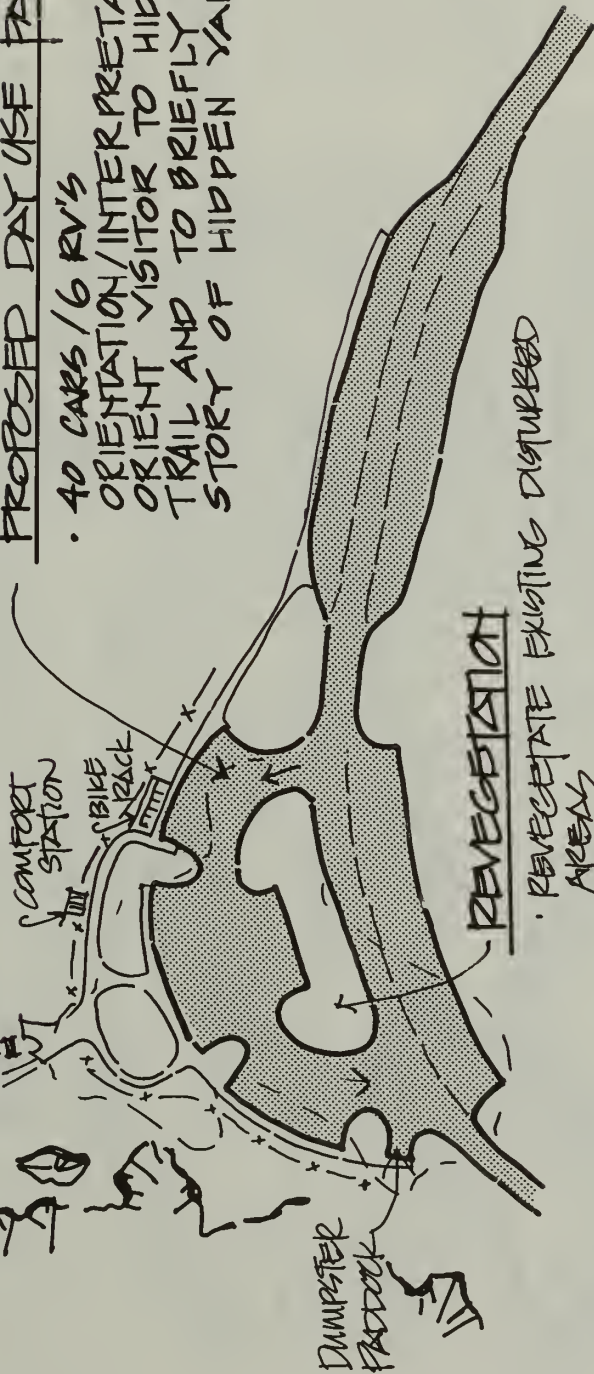
## PROPOSED DAY USE PARKING

- 40 CARS/6 RV'S
- ORIENTATION/INTERPRETATION TO ORIENT VISITOR TO HIDDEN VALLEY TRAIL AND TO BRIEFLY INTERPRET STORY OF HIDDEN VALLEY

## REVEGETATION

- REVEGETATE EXISTING DISTURBED AREAS

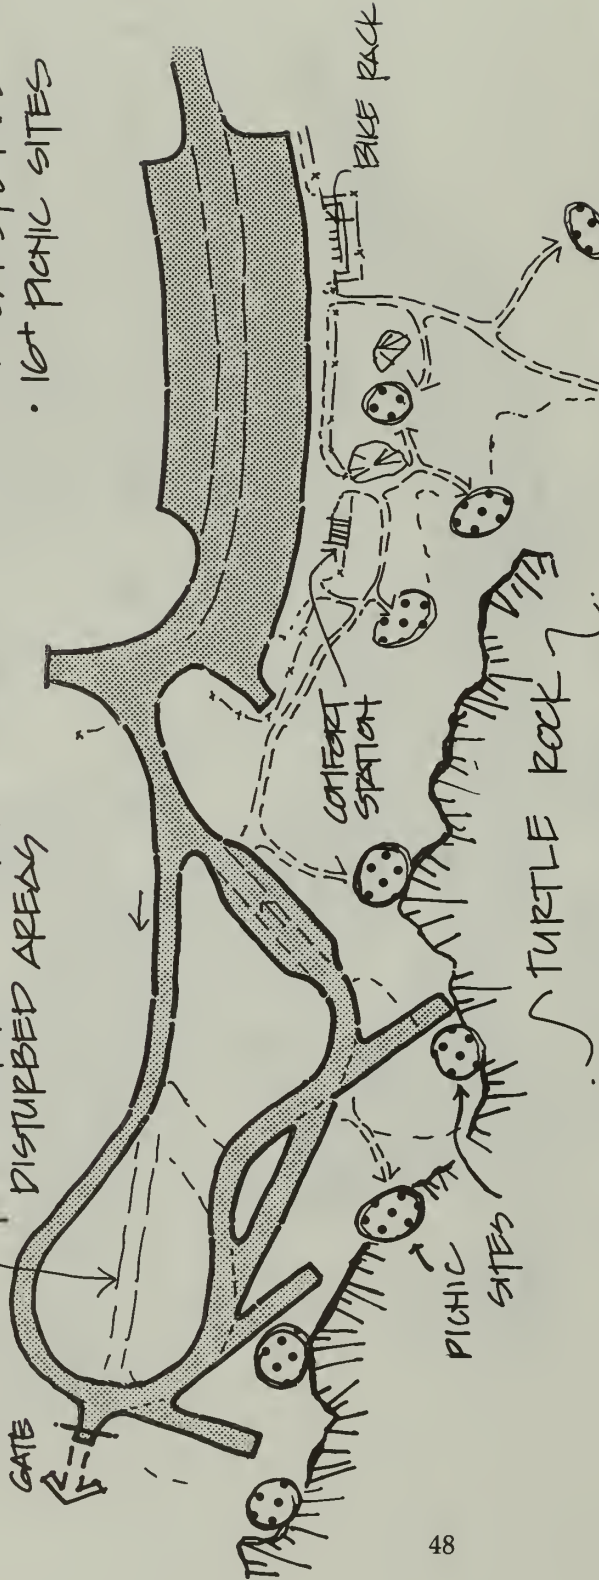
- 40 CARS/6 RV's
- 16+ PICNIC SITES

TO  
LOST HORSE  
GATE  
← REVEGETATE EXISTING  
DISTURBED AREAS

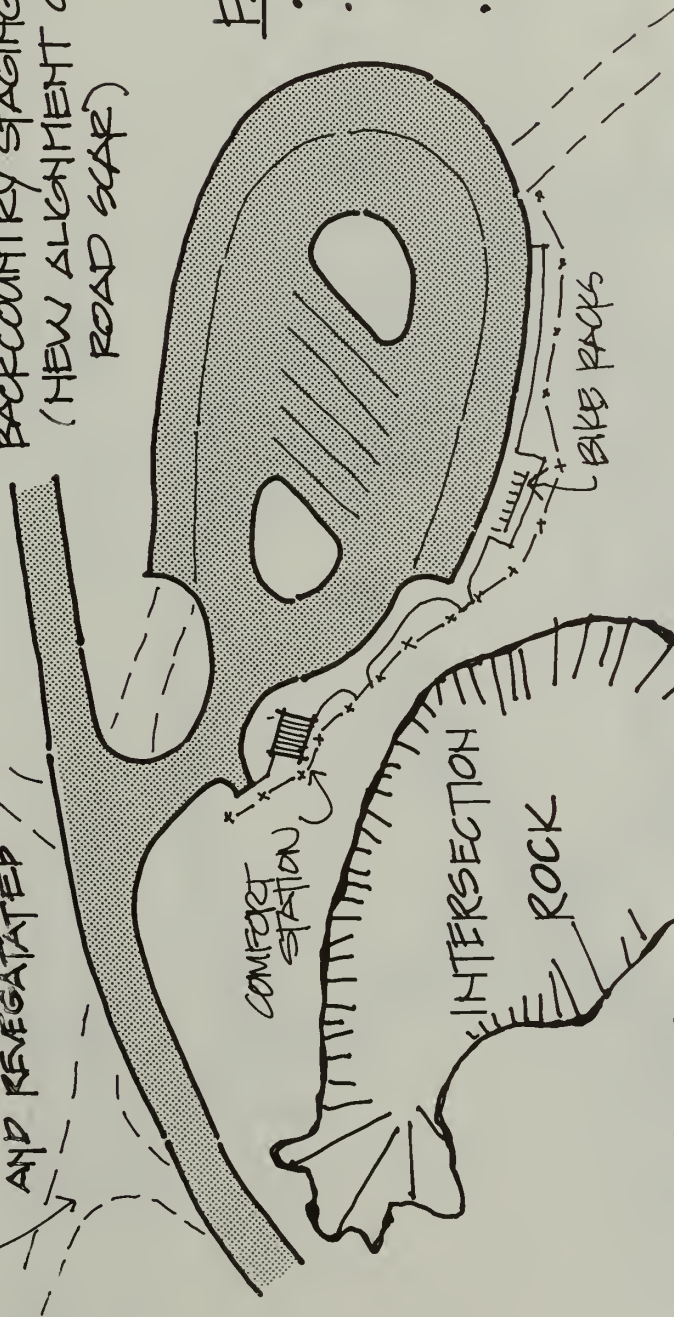
## 9A. INTERSECTION ROCK CONCEPTUAL PLAN JOSHUA TREE NATIONAL MONUMENT CALIFORNIA

## PARKING

- 50 CARS / 6 RV'S
- REVEGETATE  
EXISTING  
DISTURBED AREA
- PROVIDE COMFORT  
STATION AND BIKE  
RACKS

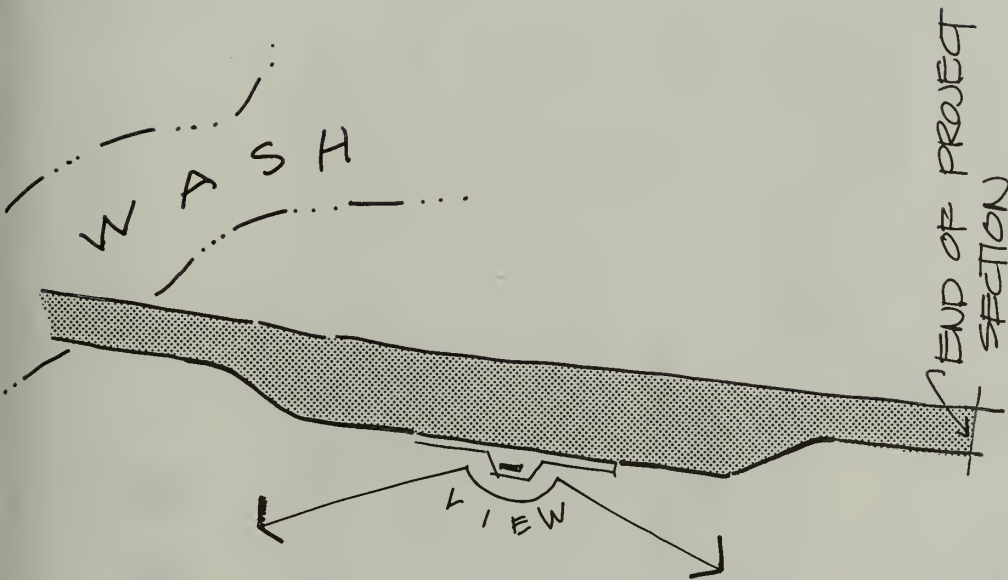
## PARKING

- 5 CAR / 2 RV
- EXHIBIT TO INTERPRET 4 OR 5 SPECIES OF MOJAVE DESERT PLANTS FOUND AT THIS SITE.

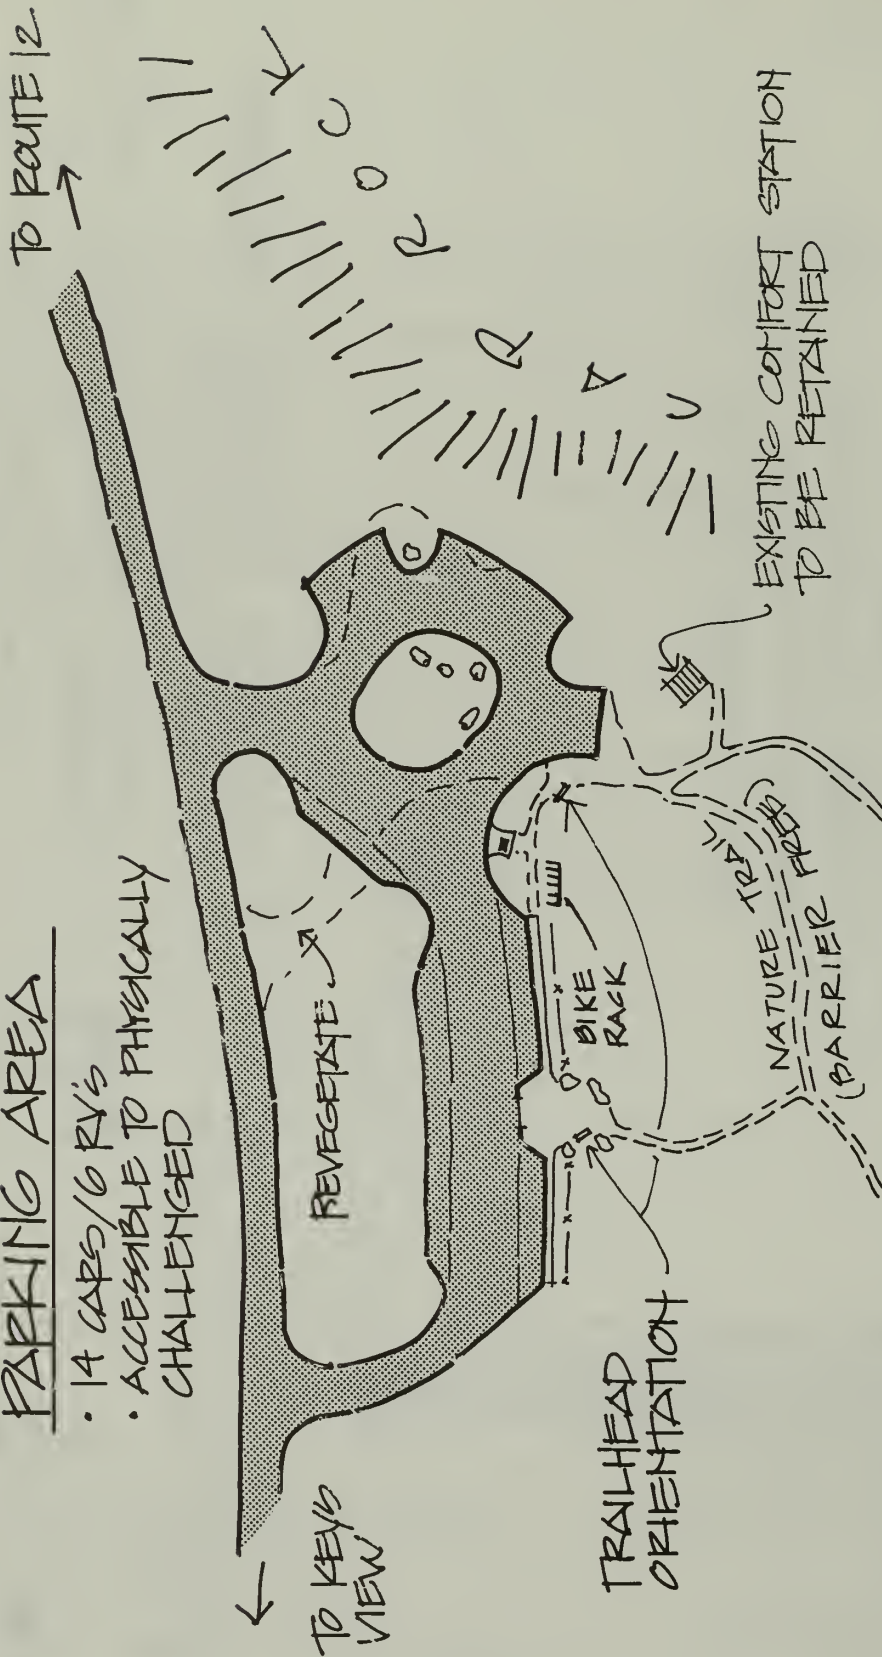
## PARKING AREA

- 14 CARS/6 RV's
- ACCESSIBLE TO PHYSICALLY CHALLENGED

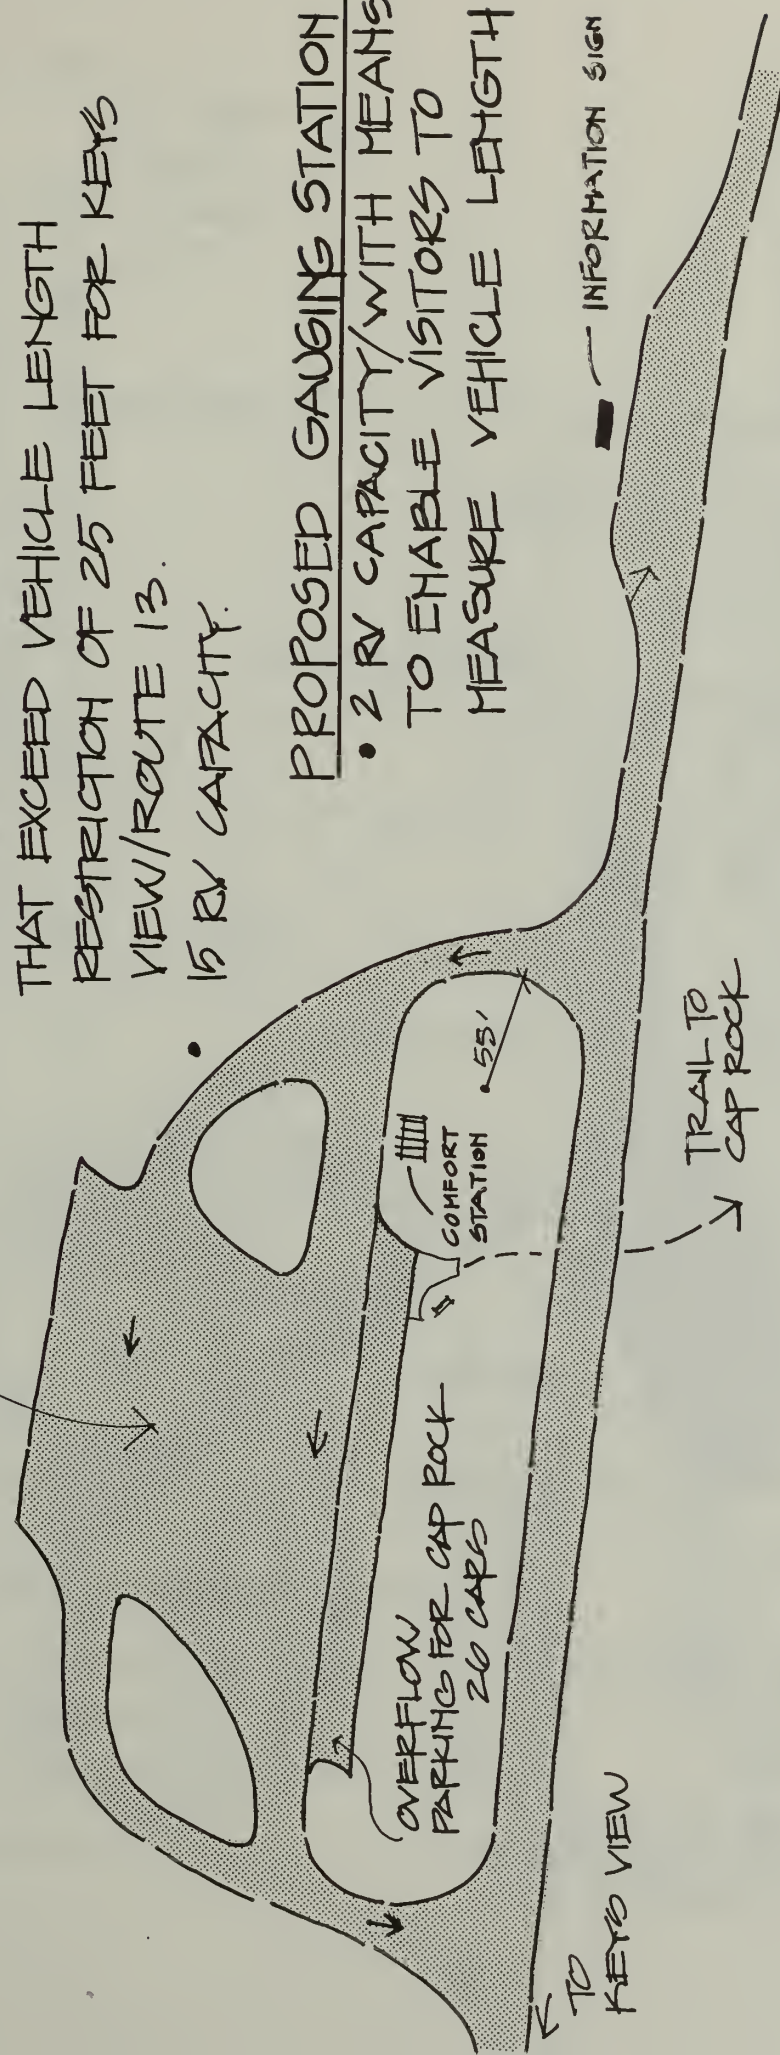
# RV/ TRAILER DROP PARKING AREA

- FOR TEMPORARY PARKING OF OVERSIZE VEHICLES OR TRAILERS THAT EXCEED VEHICLE LENGTH RESTRICTION OF 25 FEET FOR KEYS VIEW/ROUTE 13.
- 15 RV CAPACITY.

## PROPOSED GAUGING STATION

- 2 RV CAPACITY/ WITH MEANS TO ENABLE VISITORS TO MEASURE VEHICLE LENGTH

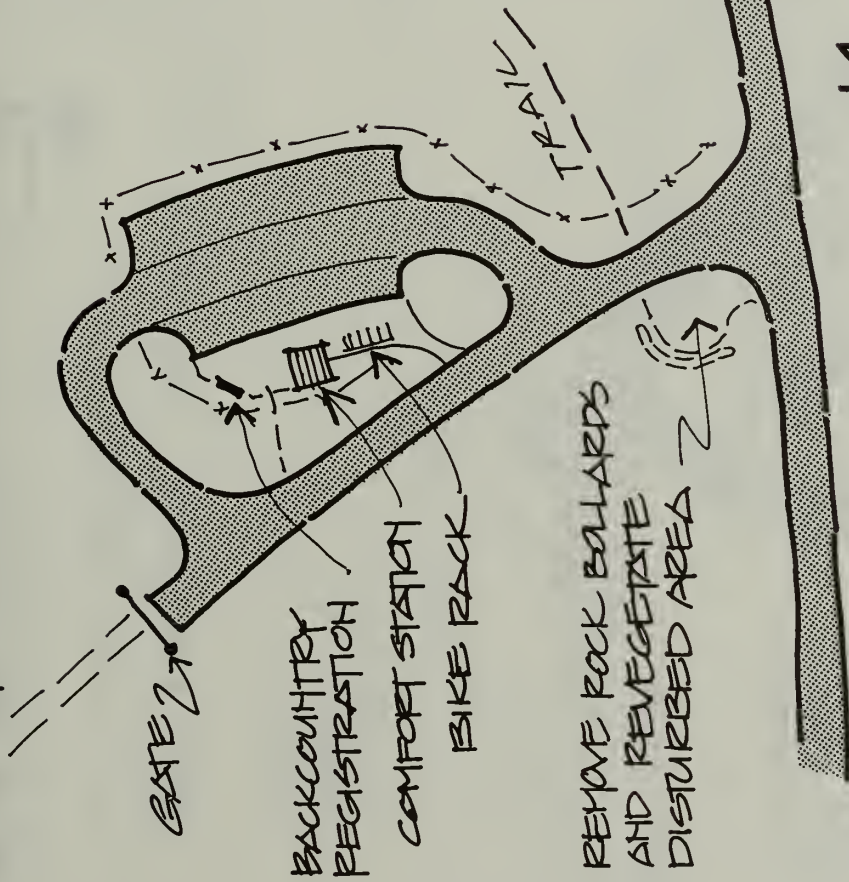
## TRAILHEAD PARKING

- 25 VEHICLES
- BACKCOUNTRY REGISTRATION

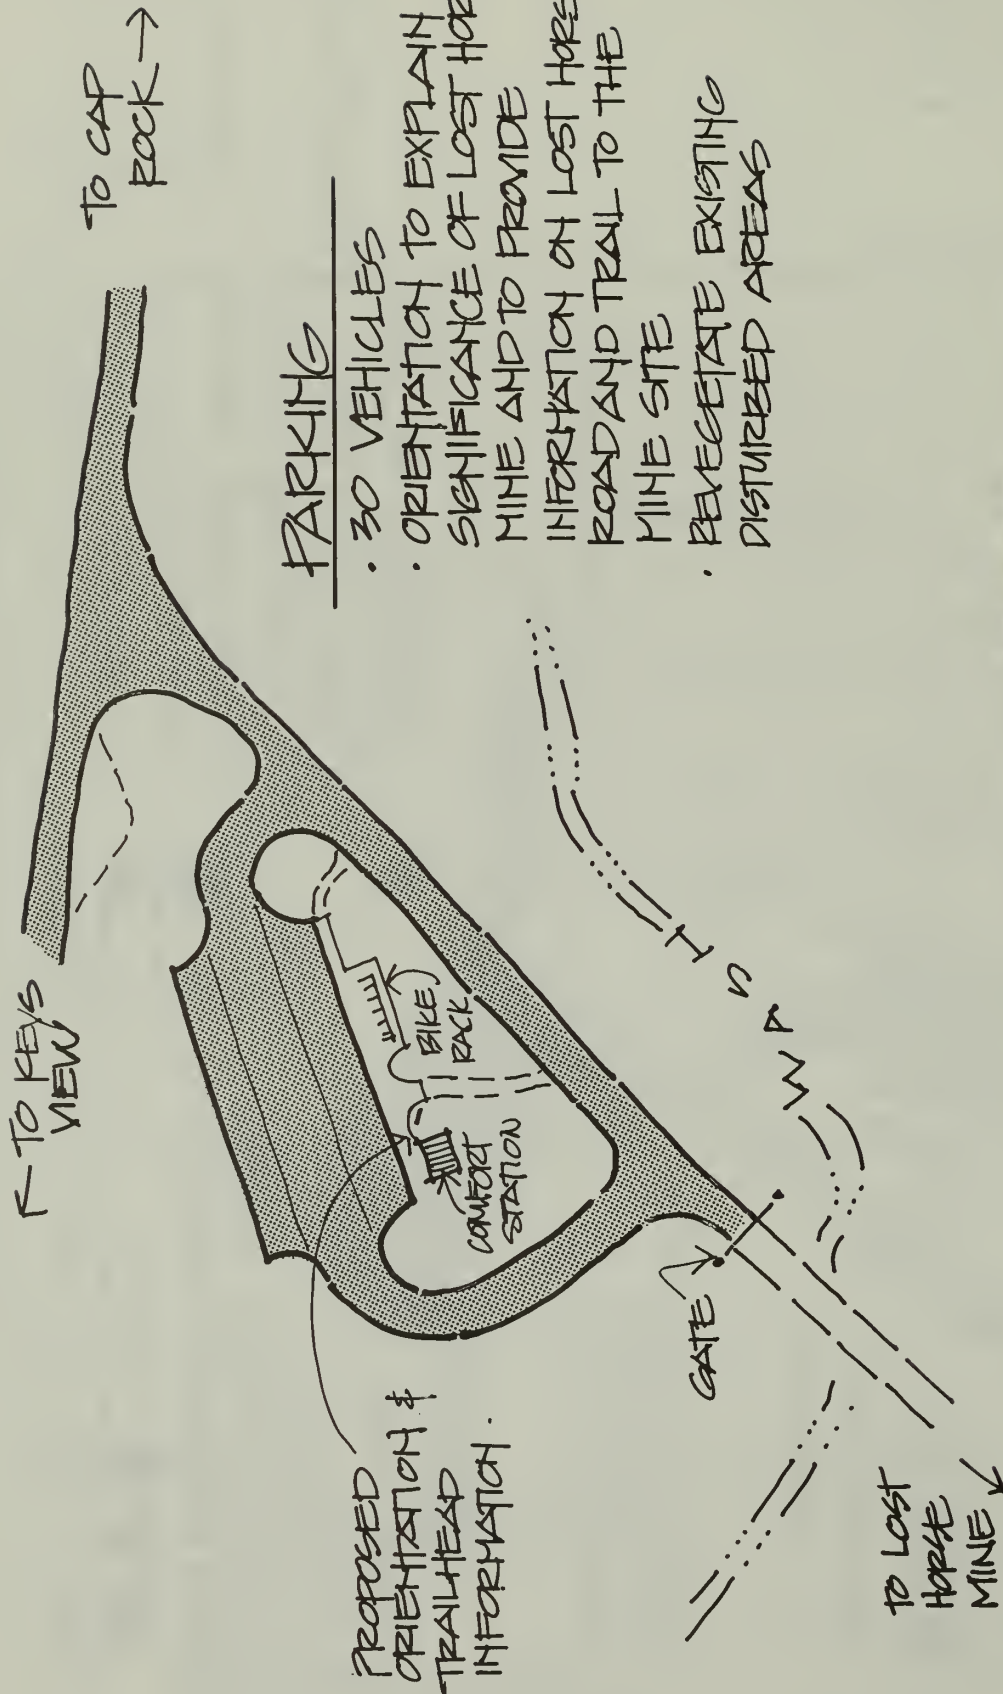
## PARKING

- 30 VEHICLES
- ORIENTATION TO EXPLAIN SIGNIFICANCE OF LOST HORSE MINE AND TO PROVIDE INFORMATION ON LOST HORSE ROAD AND TRAIL TO THE MINE SITE
- REVEGETATE EXISTING DISTURBED AREAS

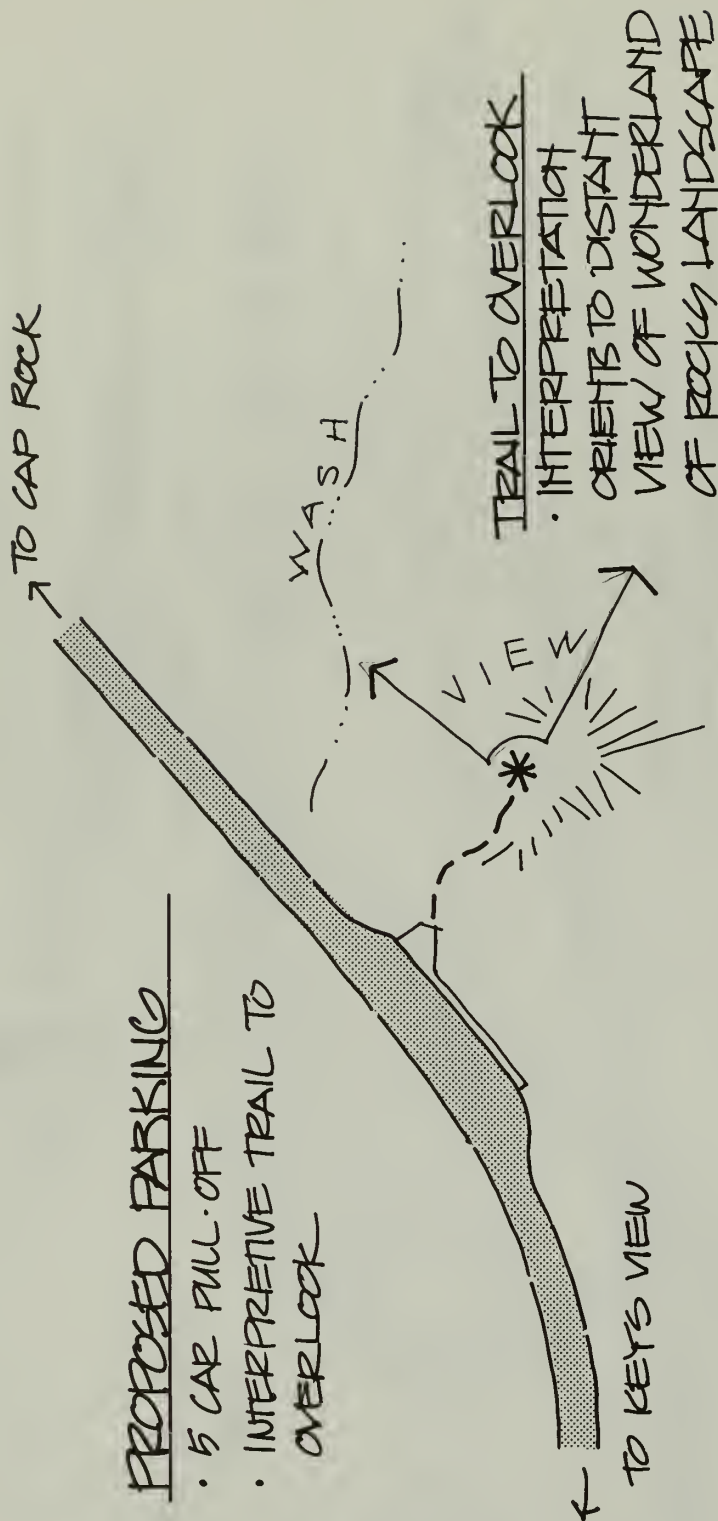
# PROPOSED PARKING

- 5 CAR FULL-OFF
- INTERPRETIVE TRAIL TO OVERLOOK

TRAIL TO OVERLOOK  
 • INTERPRETATION  
 ORIENTS TO DISTANT  
 VIEW OF WONDERLAND  
 OF ROCKS LANDSCAPE

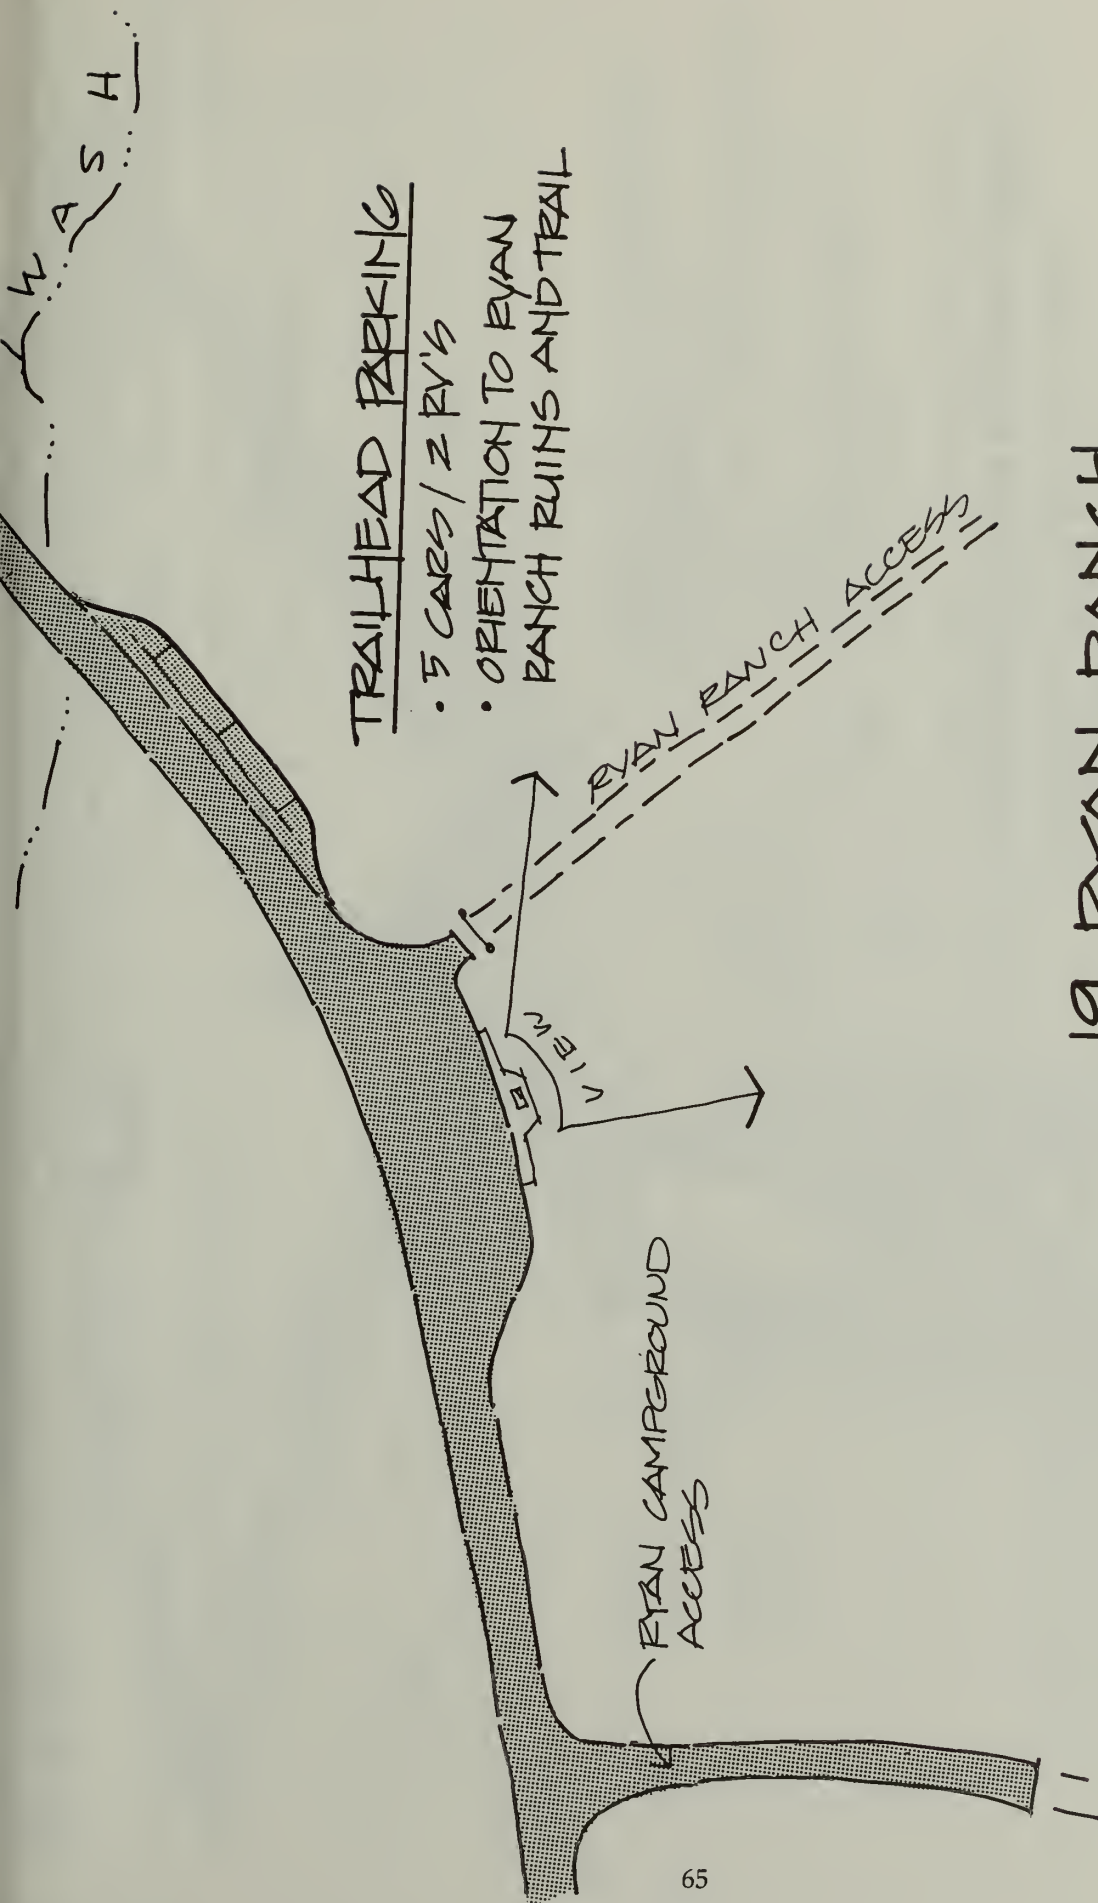
## TRAILHEAD PARKING

- 5 CARS / 2 RV'S
- ORIENTATION TO RYAN RANCH RUINS AND TRAIL

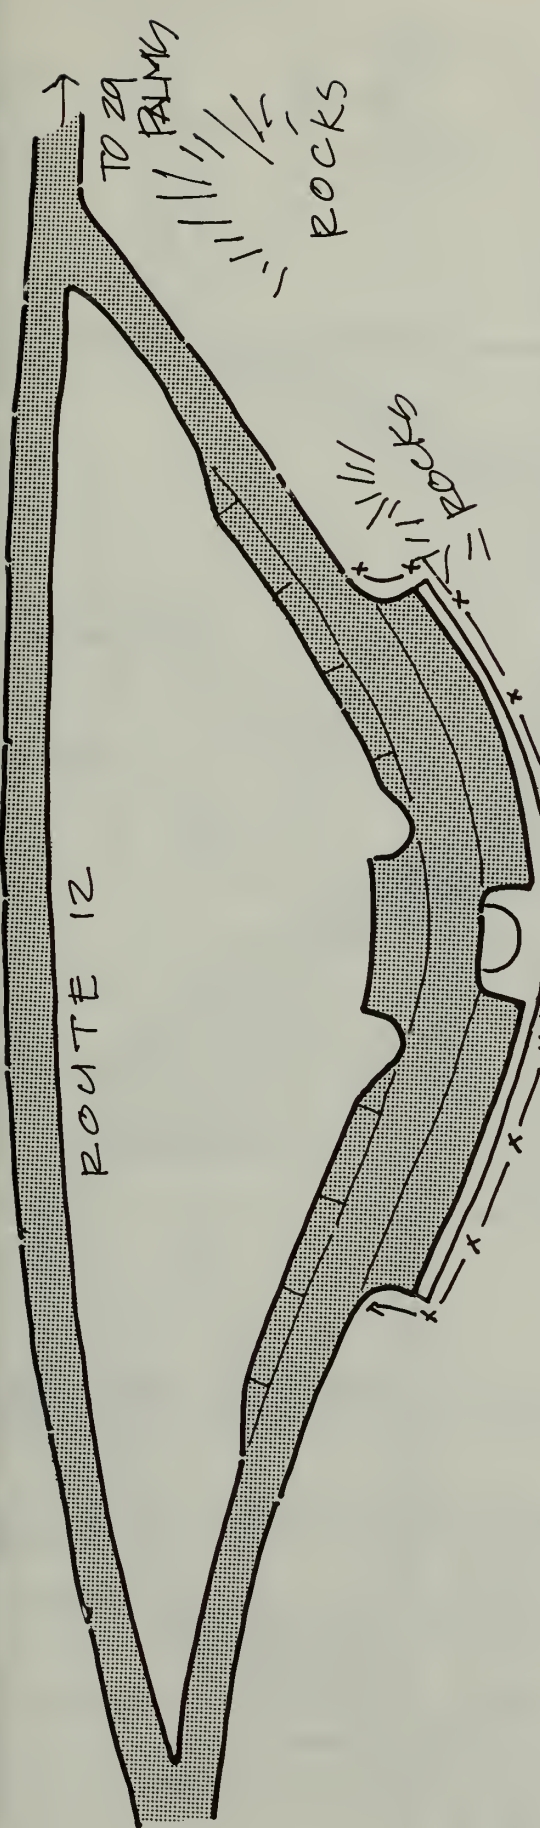
## TRAILHEAD PARKING

- 40 CARS/6 RV's
- MAXIMIZE USE OF DISTURBED AREA
- IMPROVE TRAILHEAD ORIENTATION

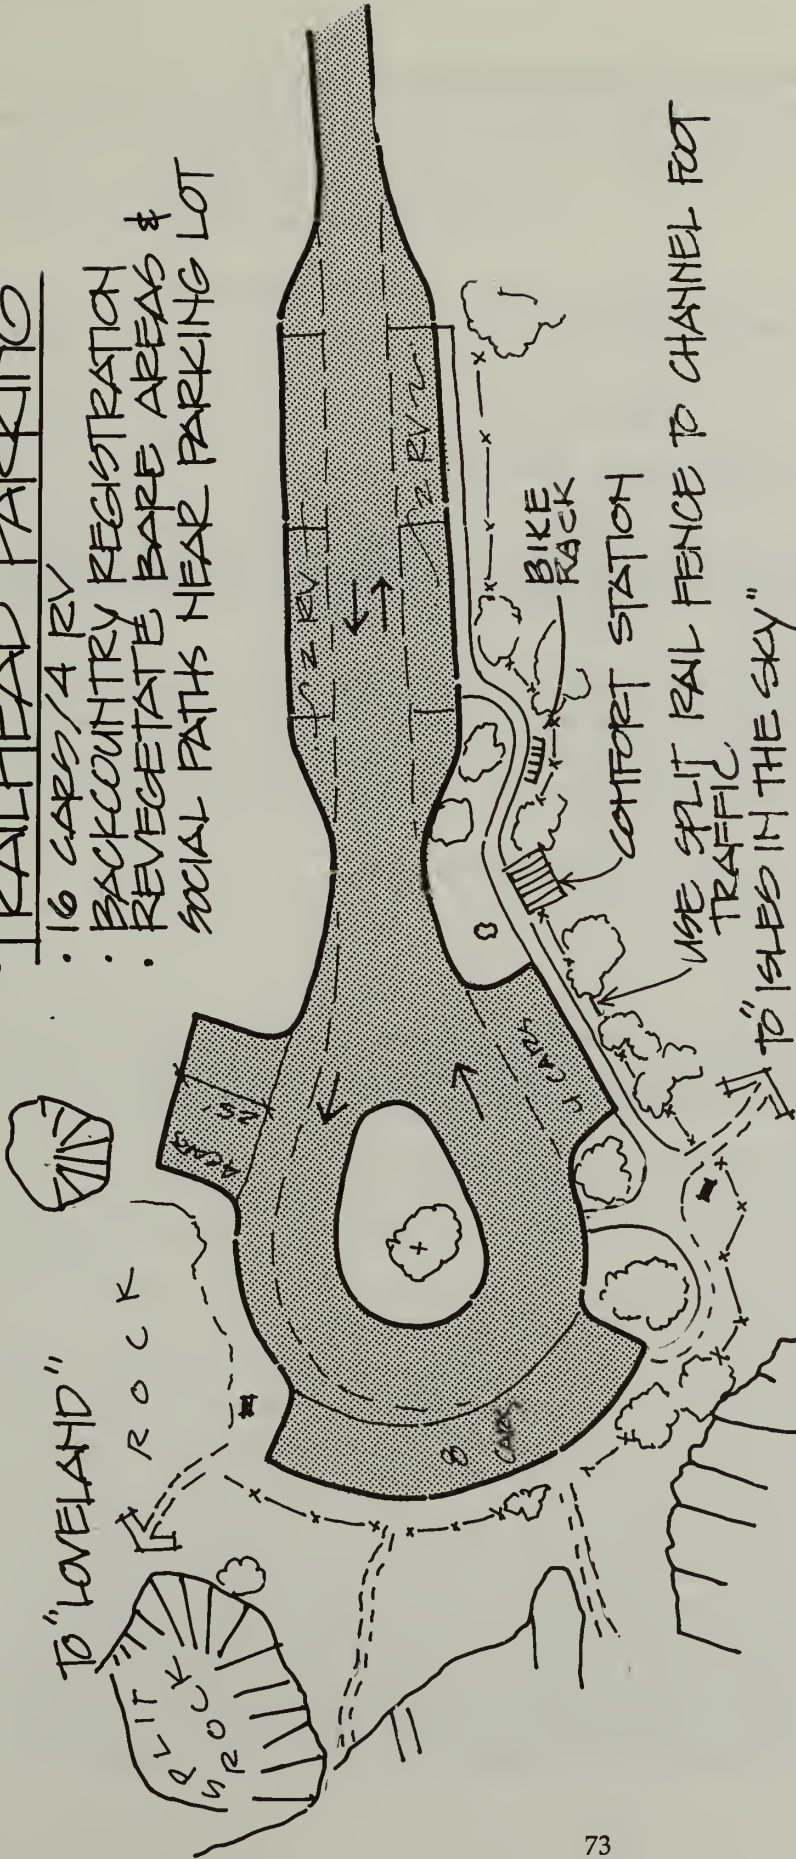
## 29. SPLIT ROCK CONCEPTUAL PLAN JOSHUA TREE NATIONAL MONUMENT CALIFORNIA

# TRAILHEAD PARKING

- 16 CARS / 4 RV
- BACKCOUNTRY REGISTRATION
- REVEGETATE BARE AREAS & SOCIAL PATHS NEAR PARKING LOT
