Environmental Assessment  
Reconstruction of Park Routes 12, 13, and 112  
and  
Associated Visitor Use Areas \*

environmental assessment  
reconstruction of park routes 12, 13, and 112  
associated visitor use areas

august 1991

**JOSHUA TREE NATIONAL MONUMENT • CALIFORNIA**

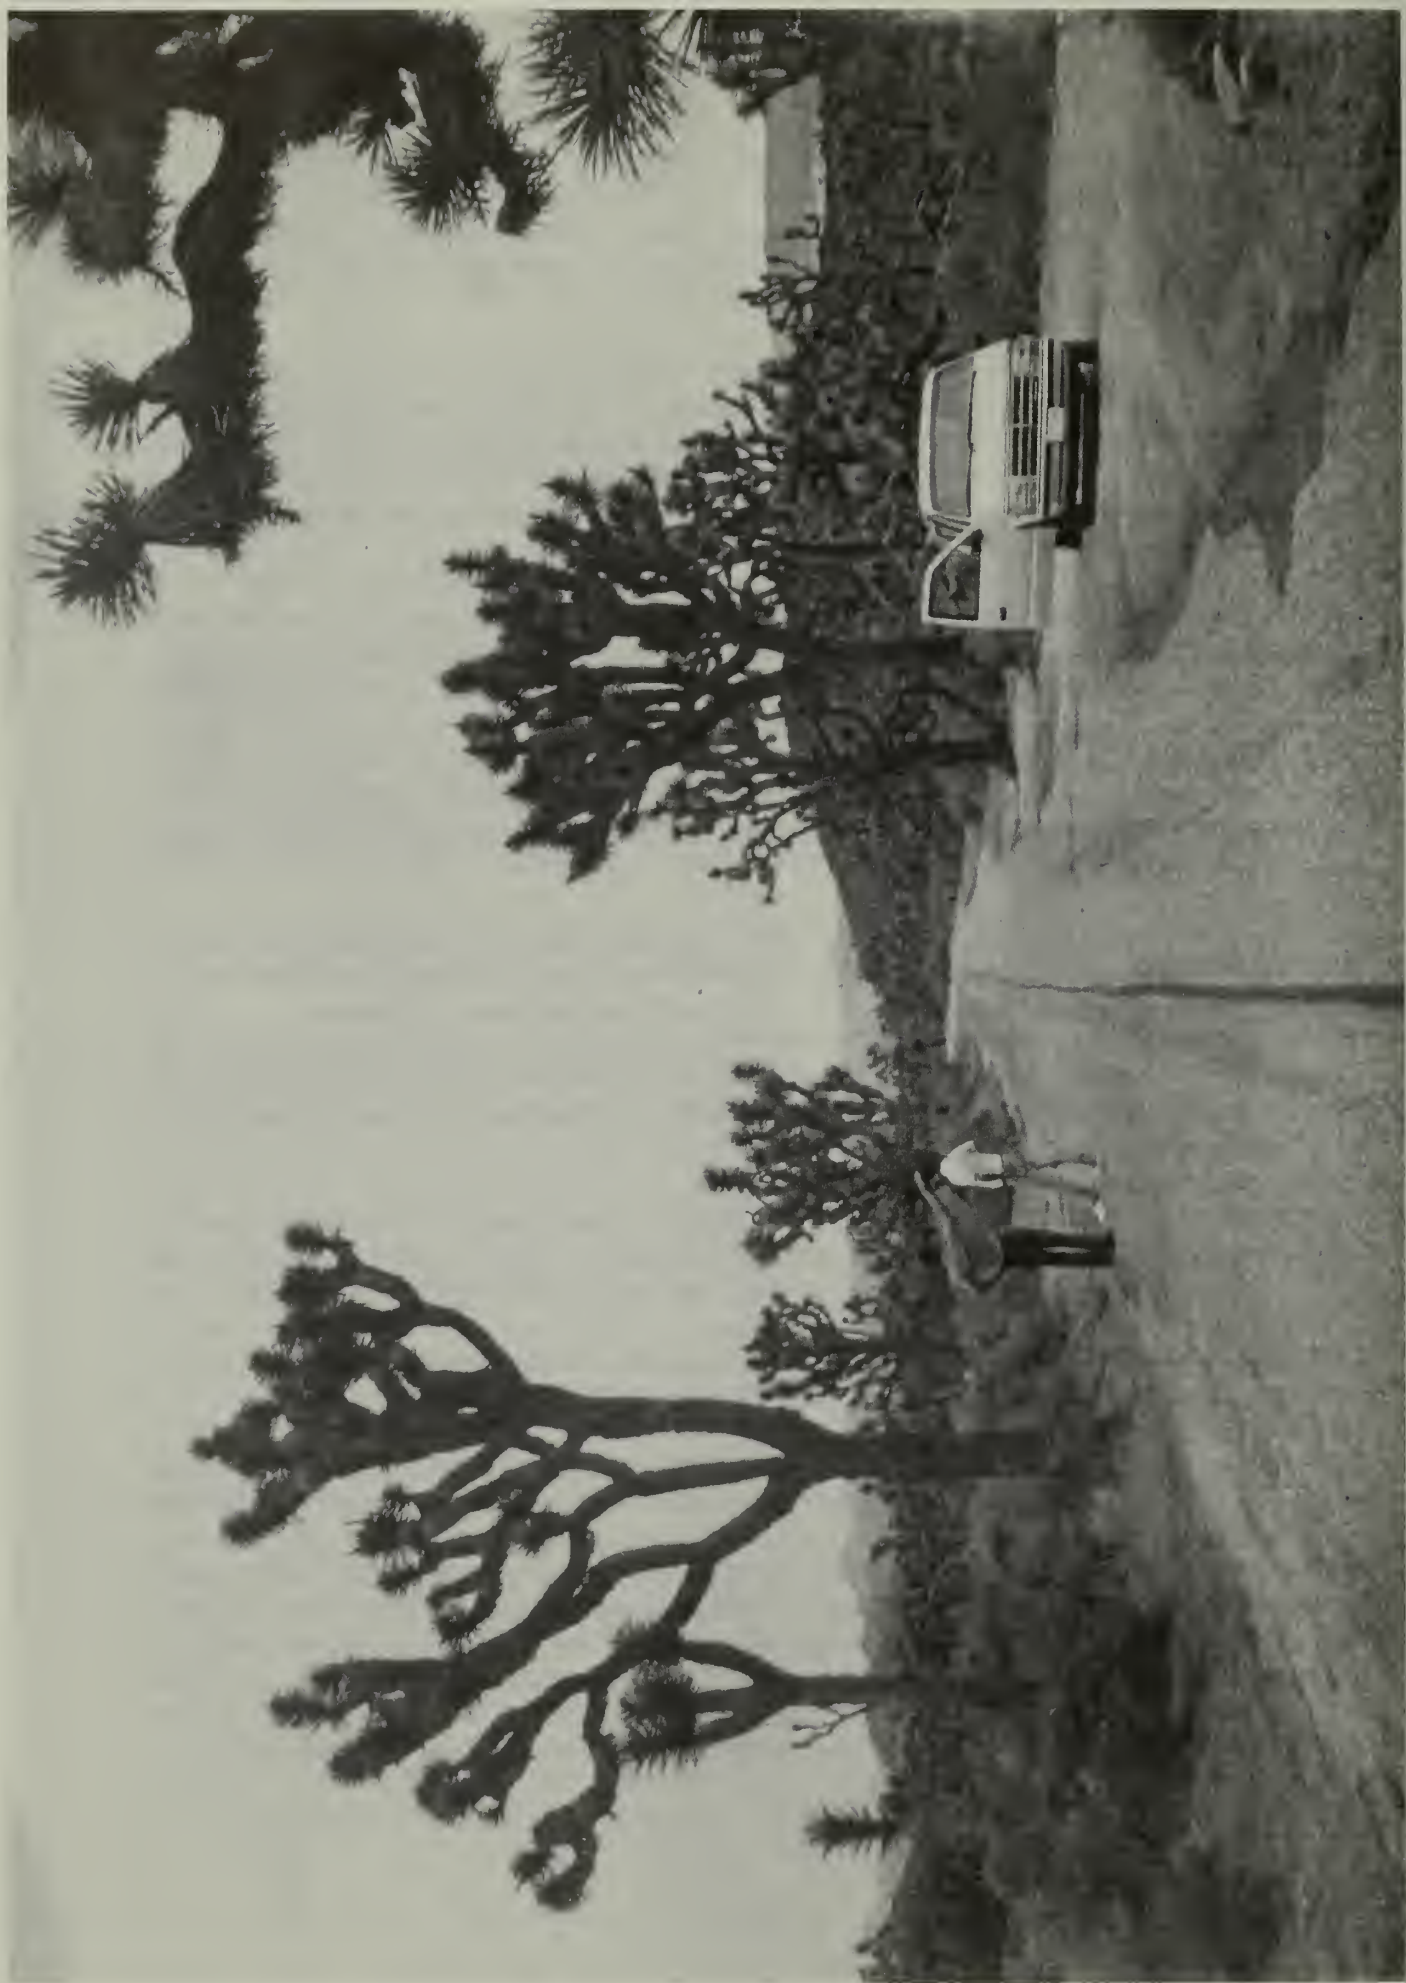
EXISTING ROADWAY

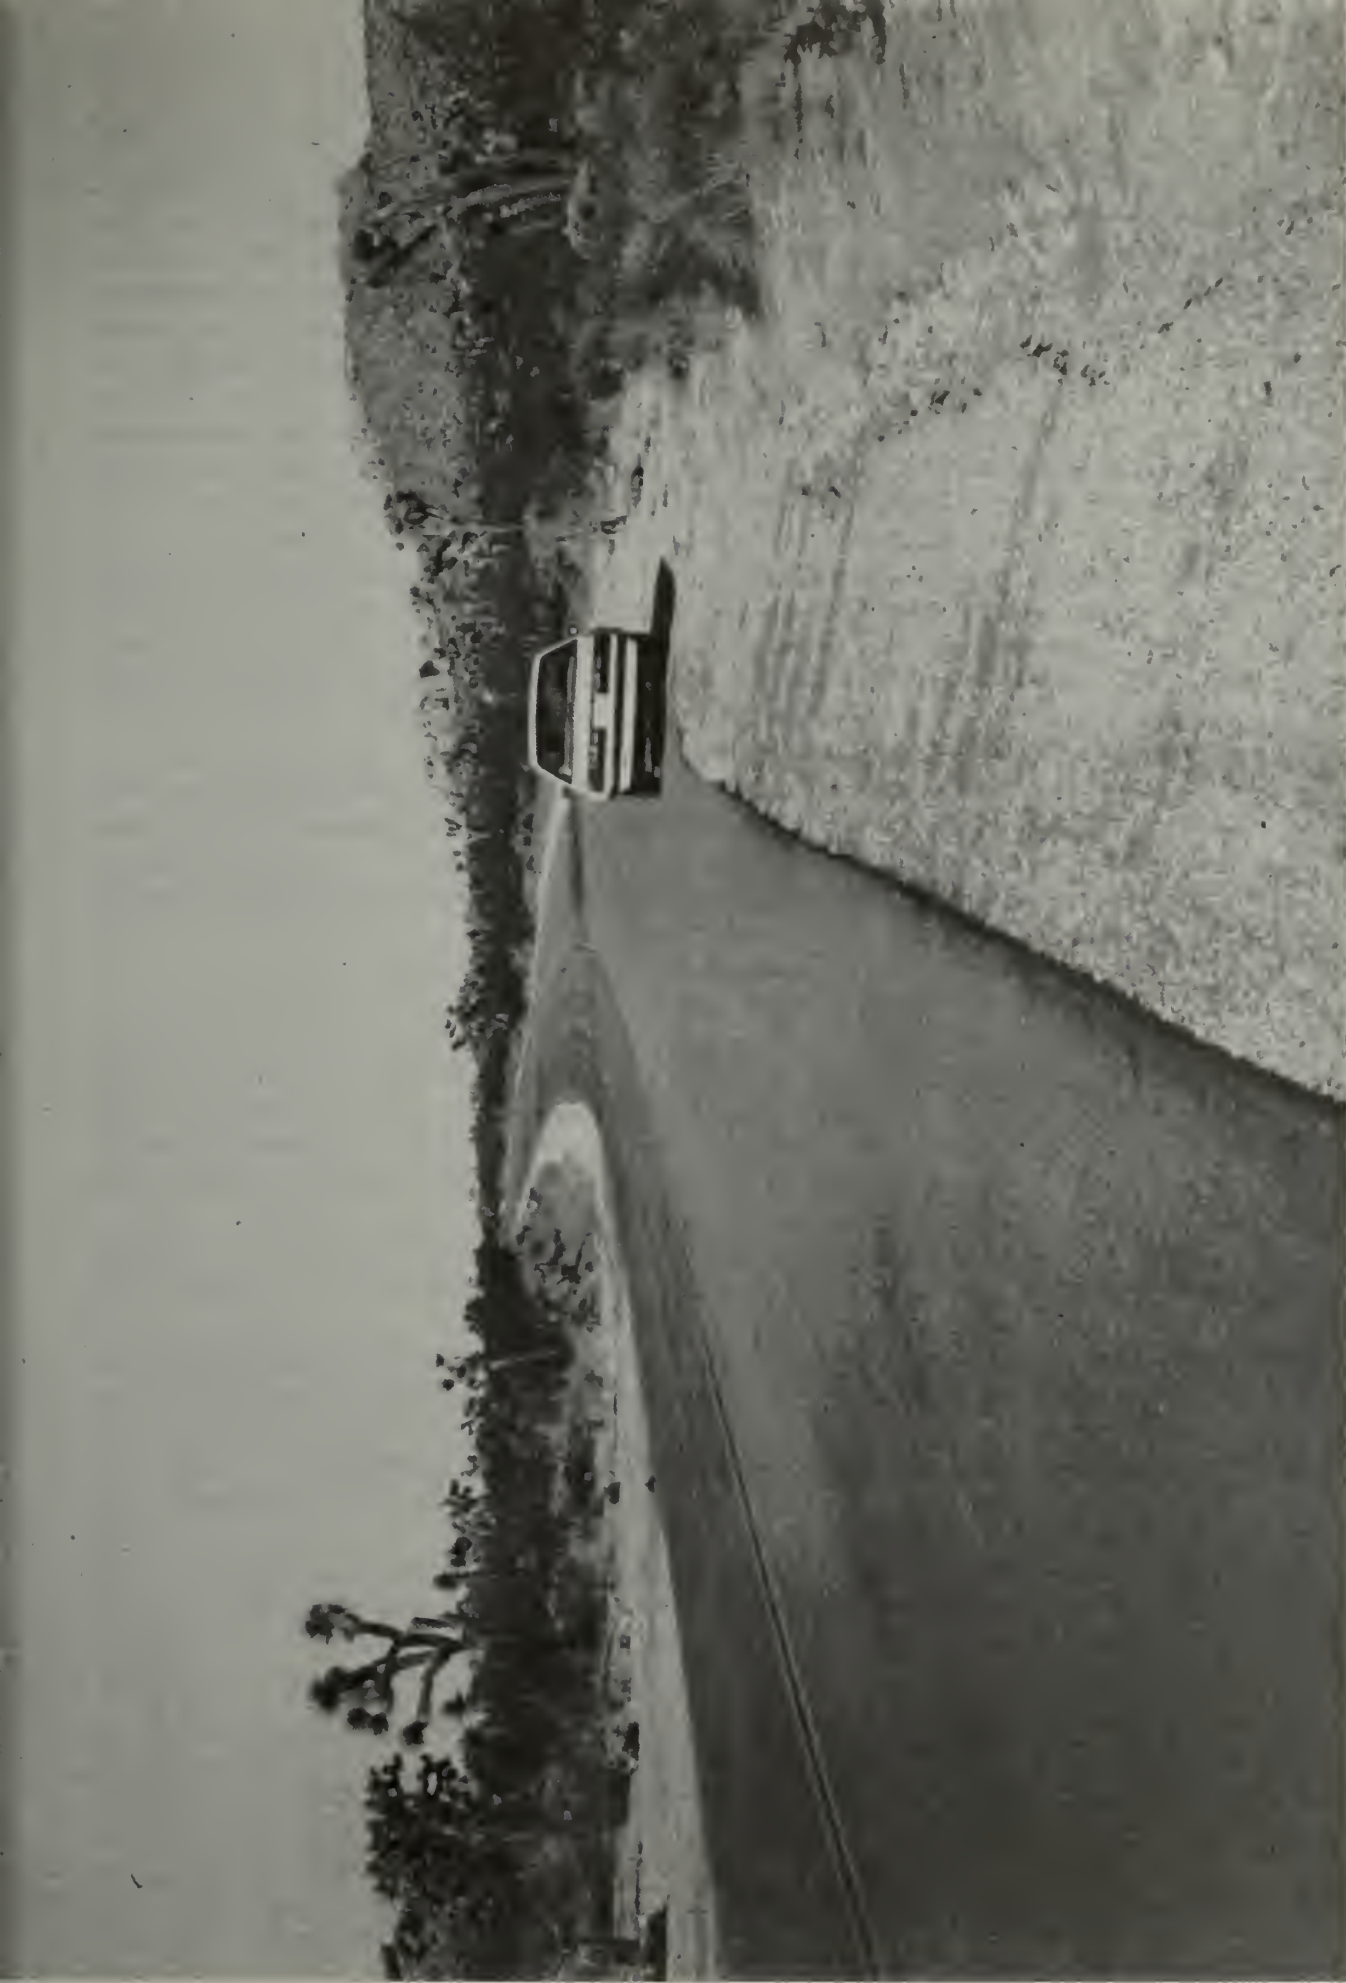
RECENTLY RECONSTRUCTED SECTION OF ROUTE 12
