Historic Structures Report
Architectural & Historical Data Section

Clubhouse, Brown Cottage, Moorhead Cottage,
and Clubhouse Annex

**SOUTH FORK FISHING
& HUNTING CLUB**

ST. MICHAEL • PENNSYLVANIA

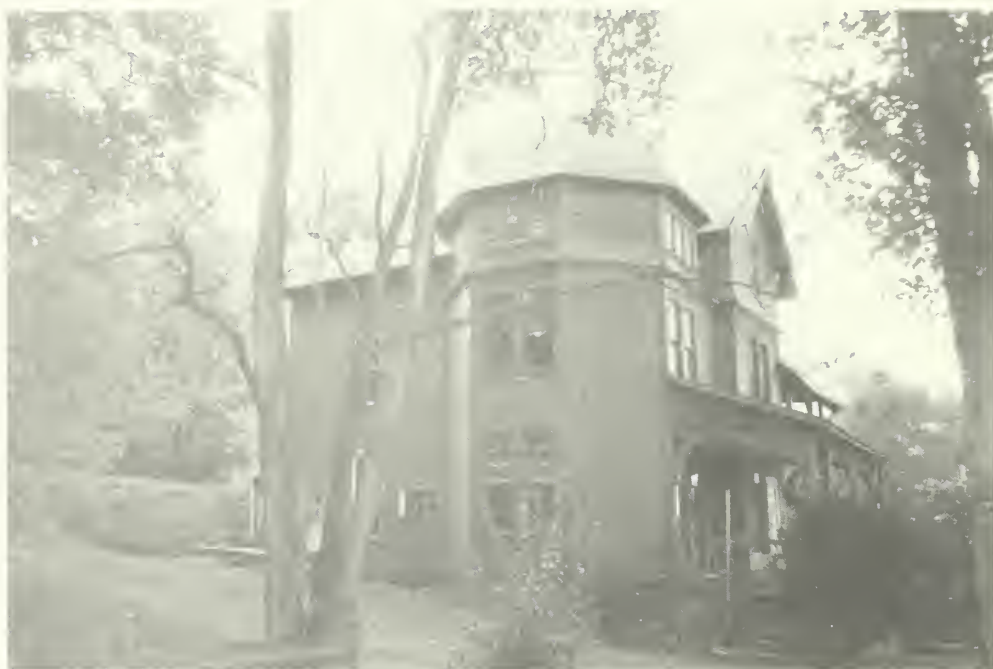
Photo E-1 South elevation of Cottage No. 3 (Moorhead).
1992

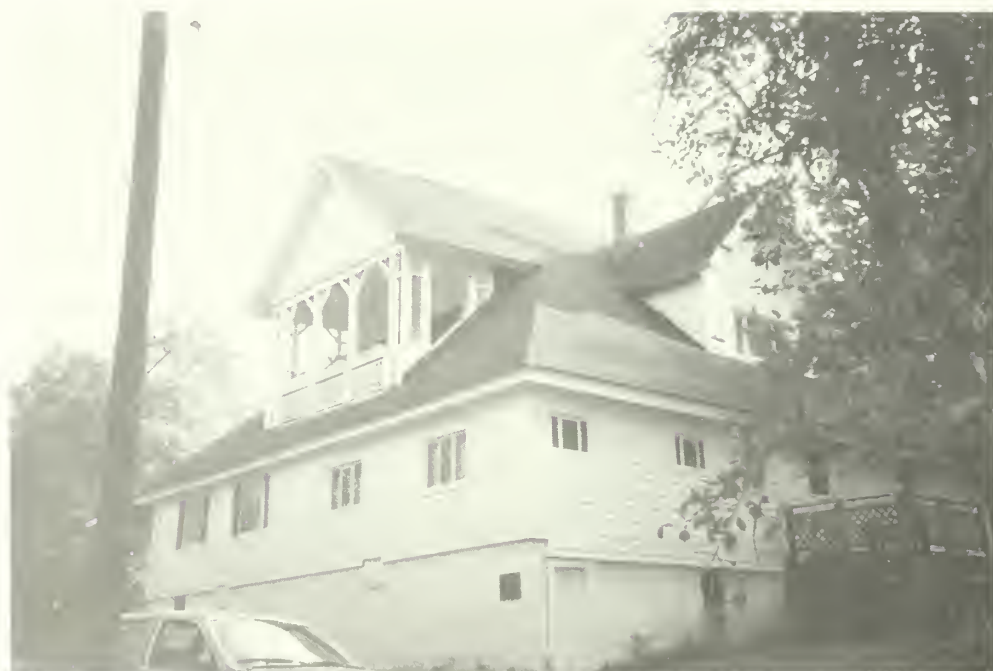
Photo E-2 East elevation of Cottage No. 2.
1992

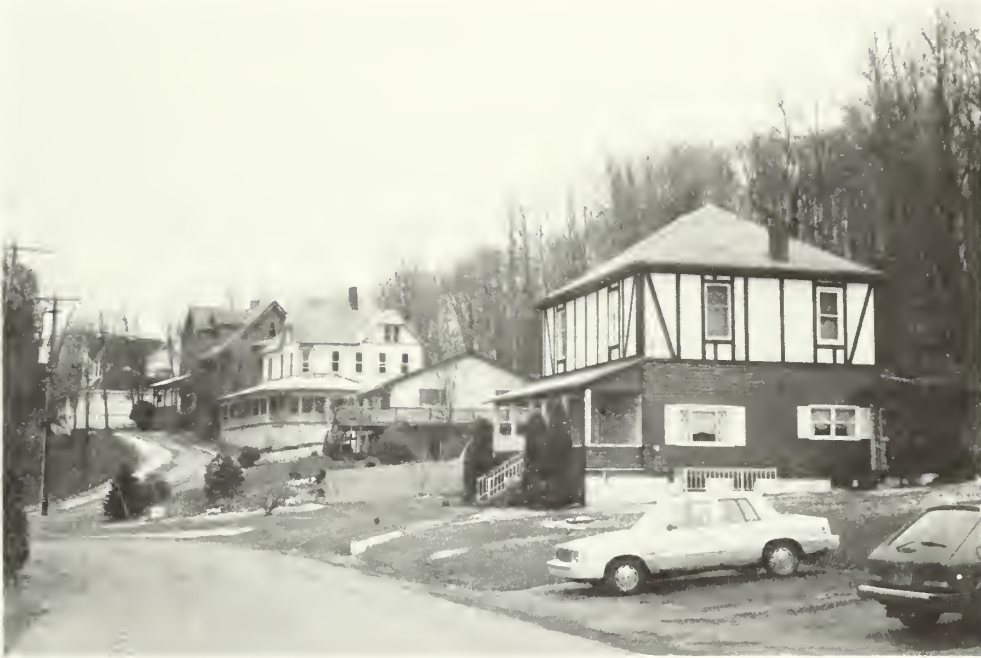
Photo E-3 Looking south past the heavily remodeled Cottage No. 6 in the foreground, and the site of Cottage No. 5, to Cottages Nos. 4, 3, and 2 in the background.
1992

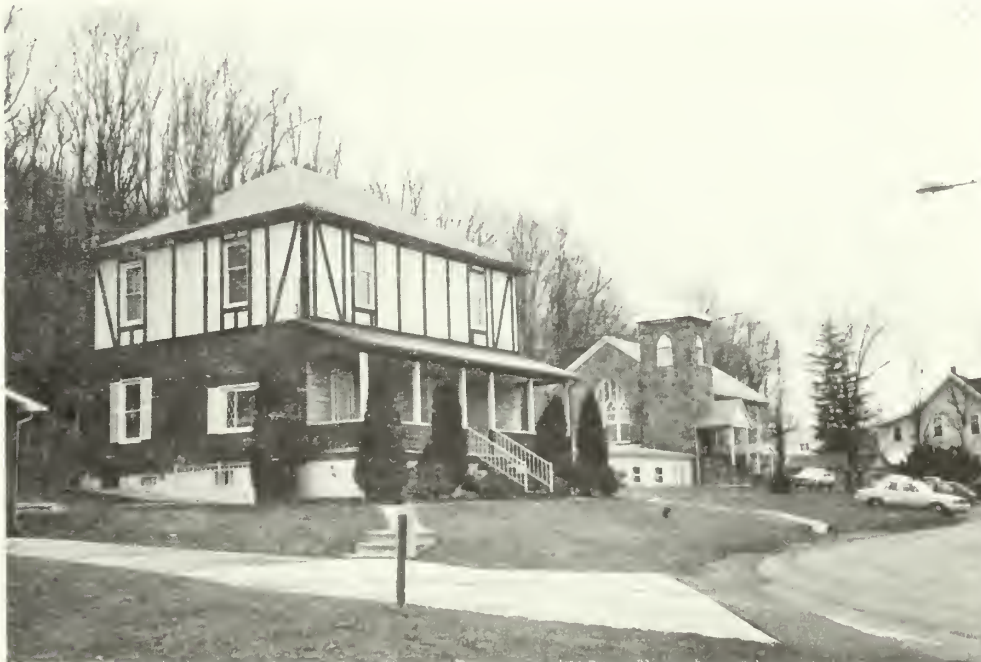
Photo E-4 Looking north past Cottage No. 6 in the foreground to the church on the site of Cottages No. 7 and 8. Cottage No. 9 is partially visible to the right of the photograph.
1992

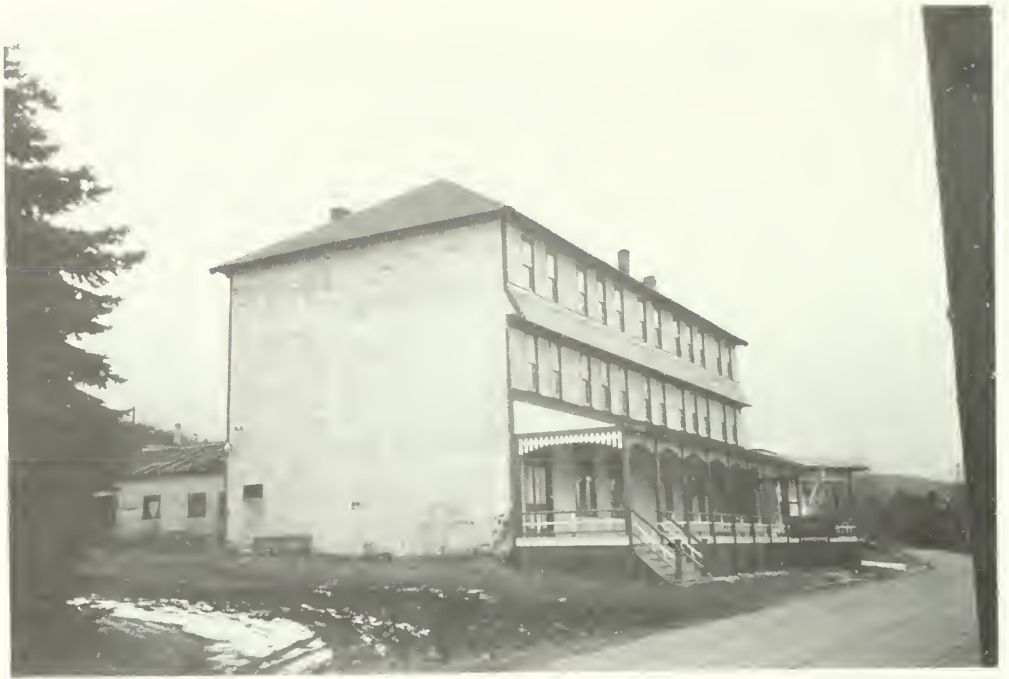
Photo E-9 View of east and south elevations.
Clubhouse 1992

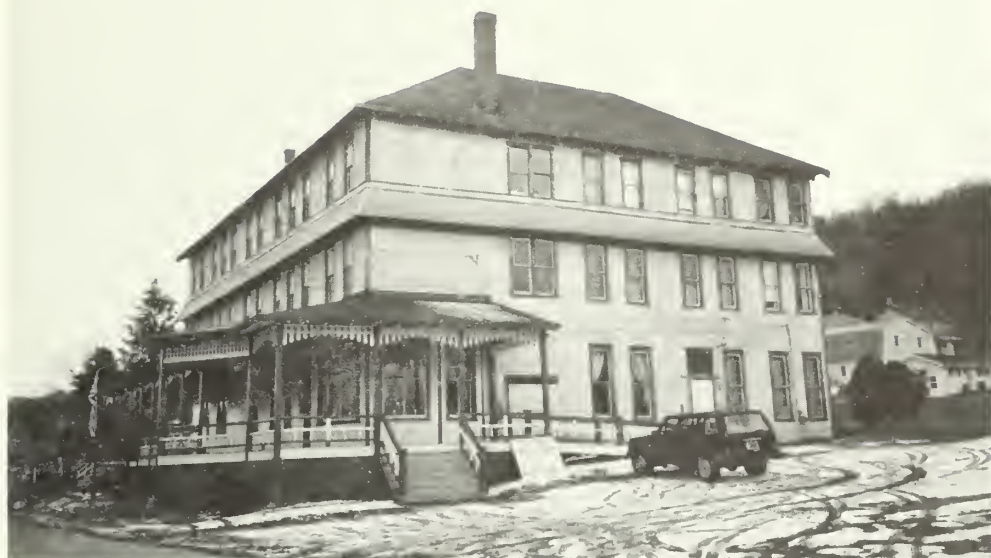
E-11 View of east and north elevations.
Clubhouse 1992

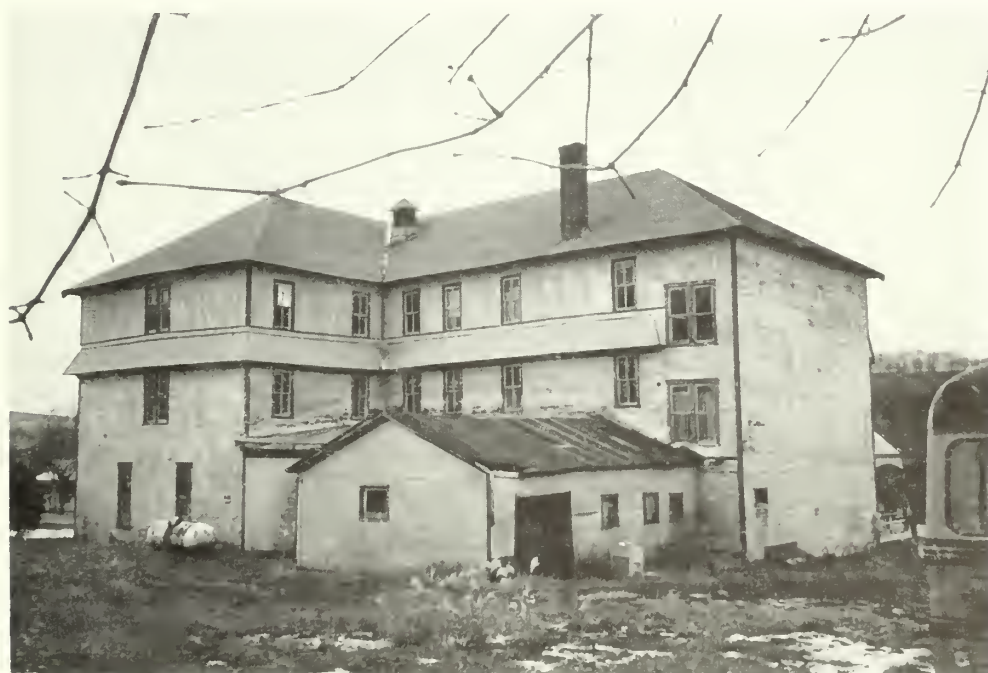
E-12 View of west and south elevations.
Clubhouse 1992

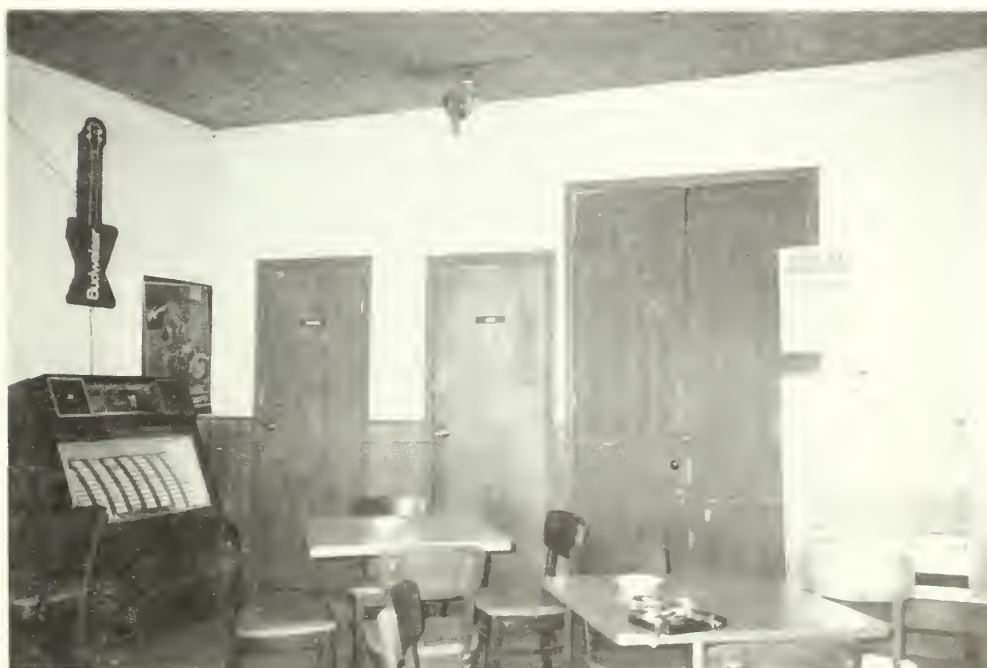
c E-15 West wall of room 102. Although the wall is new, the double doors are
original and have been relocated.
Clubhouse 1992

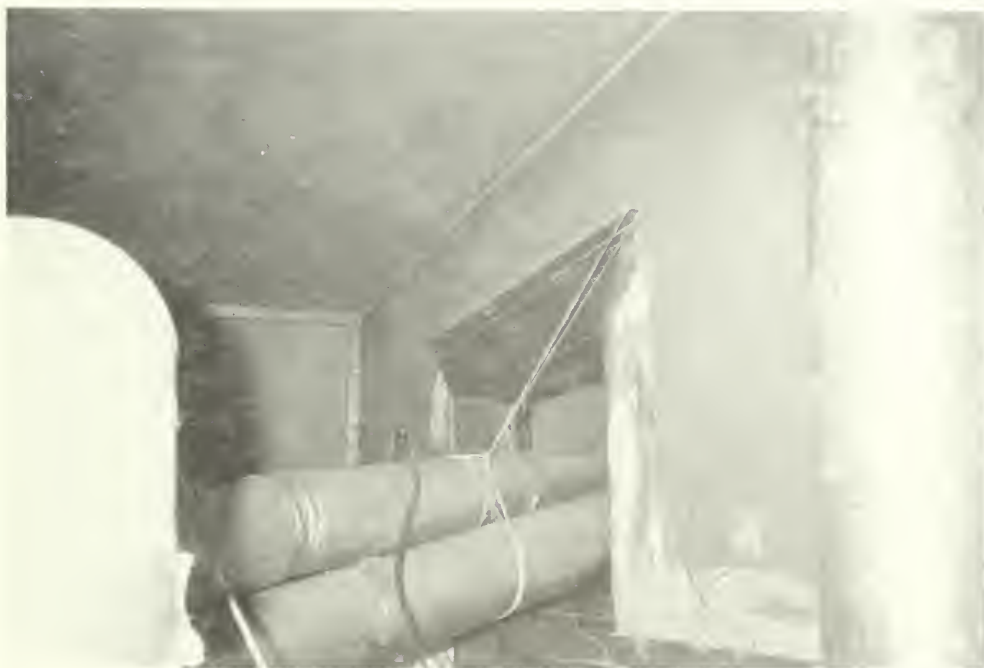
E-18 View above existing kitchen ceiling of room 107, looking northeast at east
wall of original center hall and door opening.
Clubhouse 1992

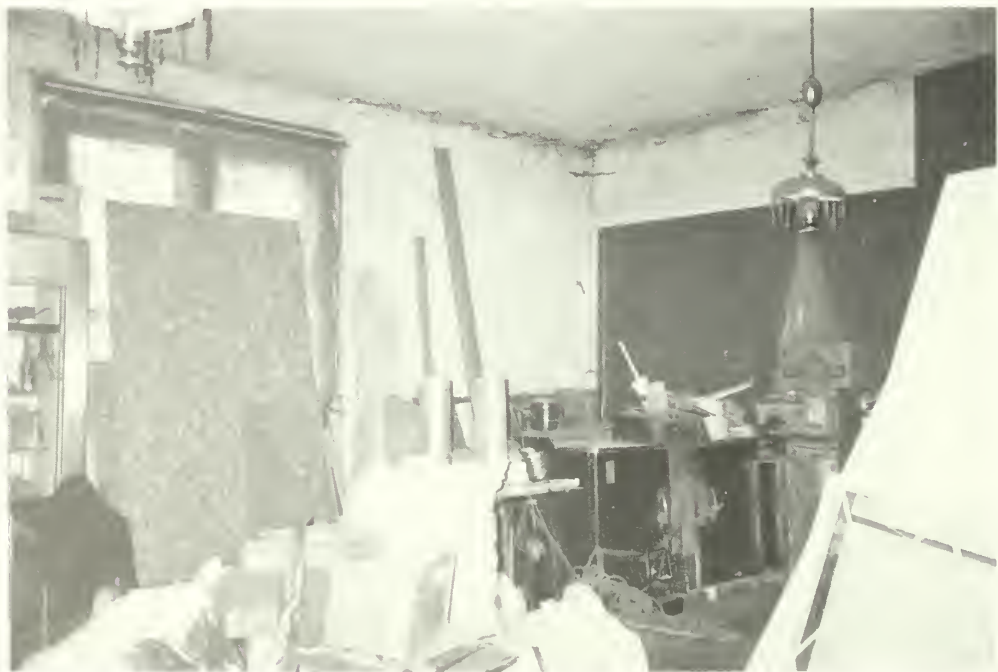
Photo E-20 Looking northwest in room 114 towards window in west wall and newer, large cased opening in north wall. Clubhouse 1992

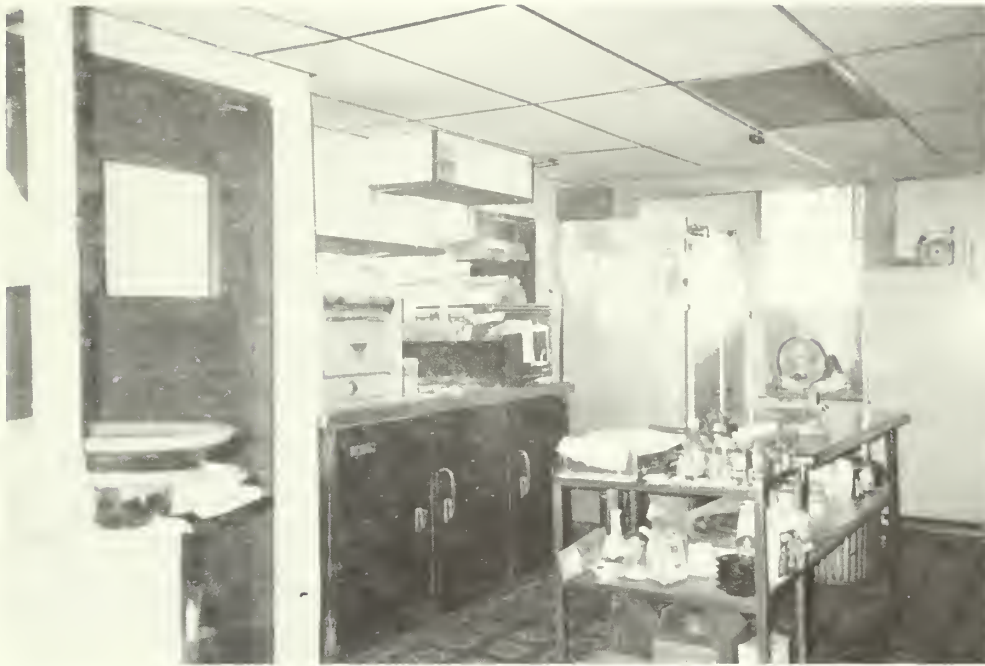
to E-21 Existing first floor kitchen in room 107, looking northeast.
Clubhouse 1992

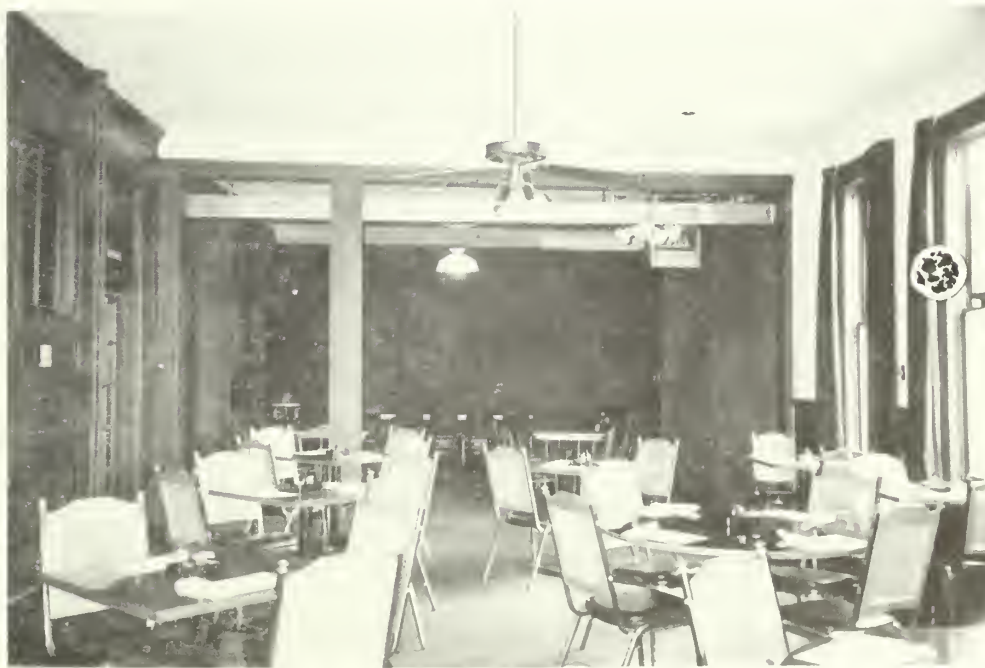
to E-22 Looking west from room 109 into room 113. The off-centered column was
originally enclosed in a wall dividing these two rooms.
Clubhouse 1992.

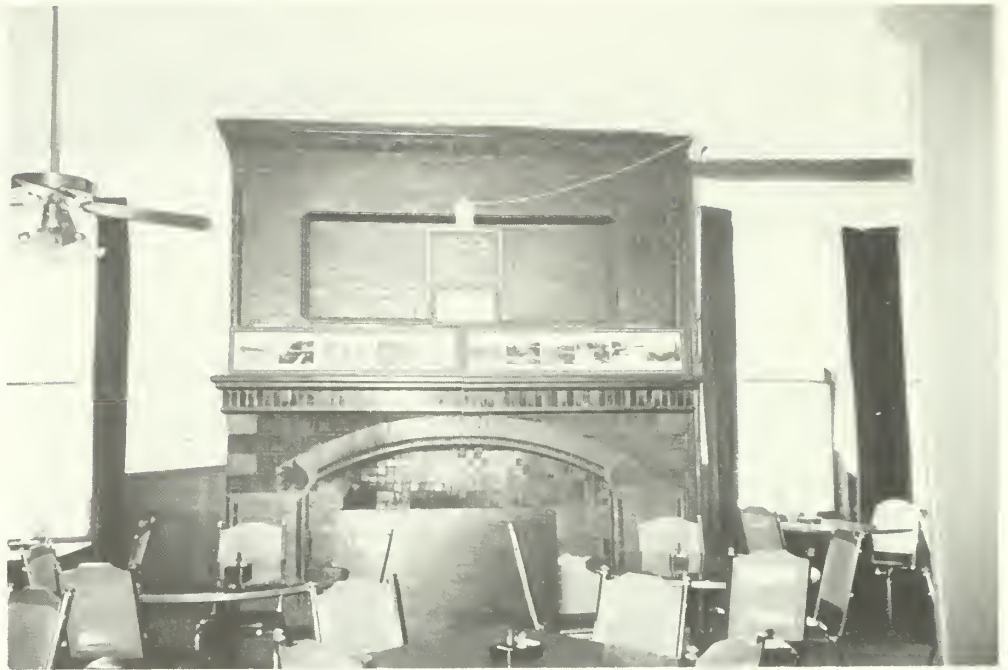
Photo E-23 View of fireplace and chimney on north wall of room 109.
Clubhouse 1992

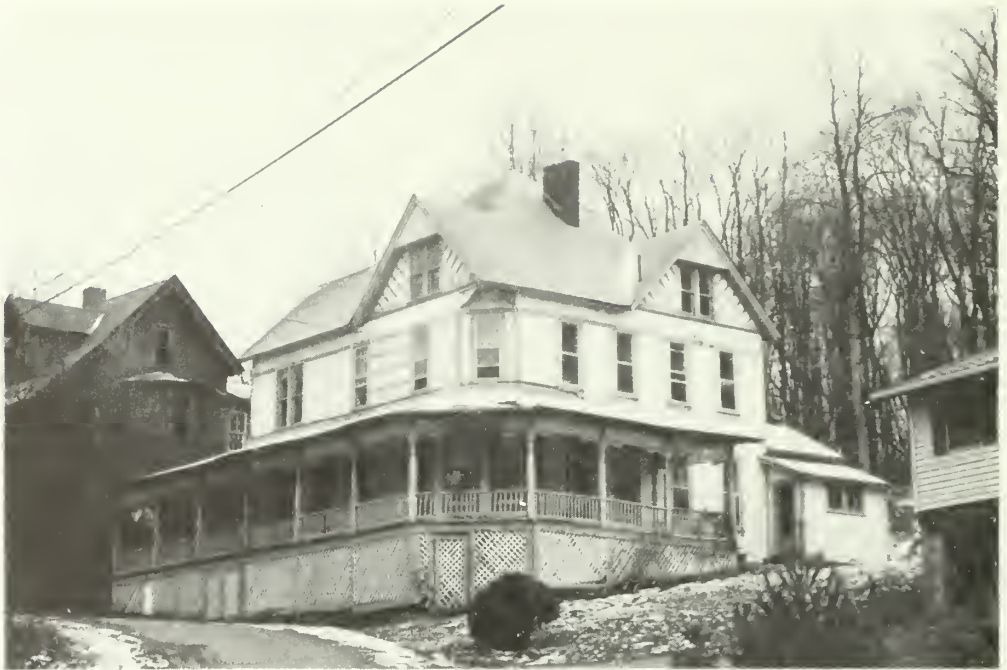
The exterior of the building remains much as it appeared originally. (Photos E-32 through E-35) Alterations to the exterior are limited to three window changes, the addition of a door, relocation of the porch steps, removal of the shutters, and removal of an eyelid dormer on the east roof slope. Although it has been suggested that the one story kitchen wing at the rear of the house is a later addition to the house,³ no physical evidence exists to support the theory. A small rectangular concrete foundation is located at the uphill western edge of the site opposite the rear entrance on the west facade. Local residents recall the concrete foundations for outhouses installed by the mining company.⁴

Photo E-32 View of east and north elevations.
Brown Cottage 1992

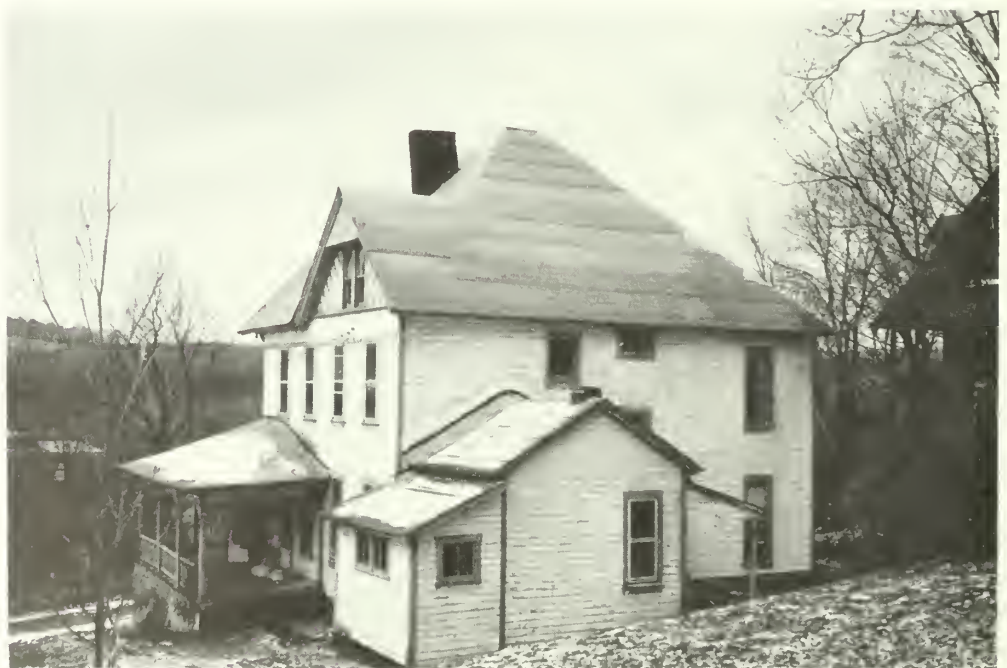
Photo E-33 View of north and west elevations.
Brown Cottage 1992

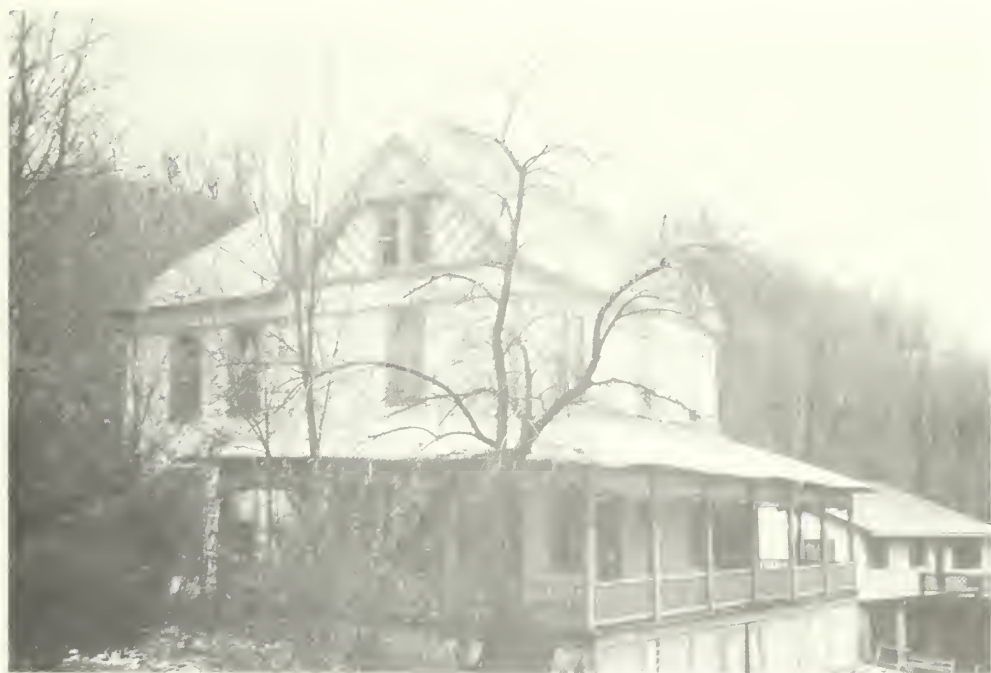
E-34 View of south and east elevations.
Brown Cottage 1992

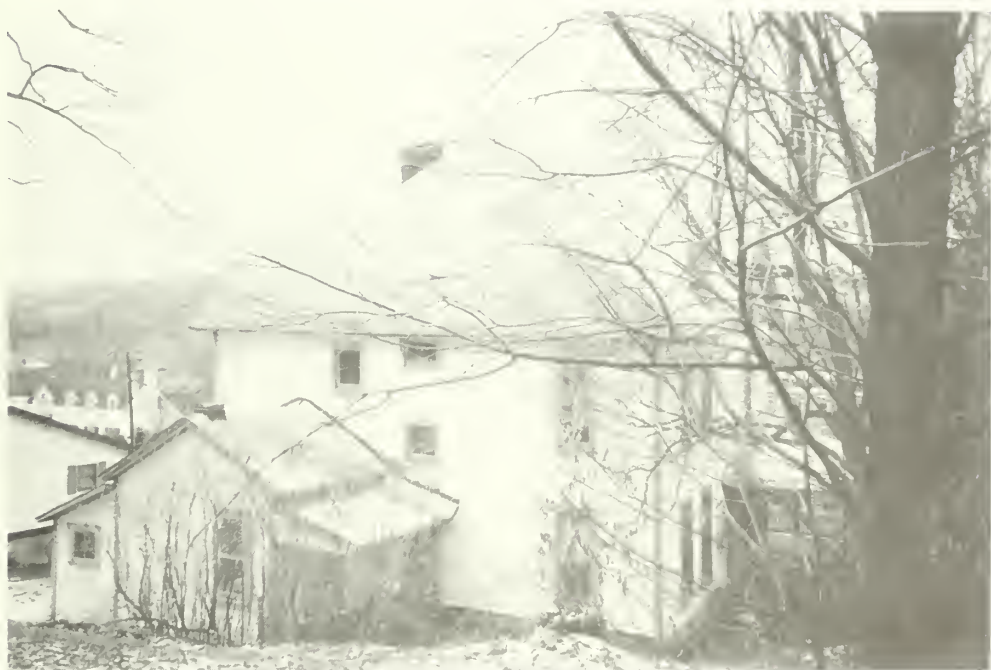
E-35 View of west elevation. Note foreshortened windows on elevation of main building.
Brown Cottage 1992

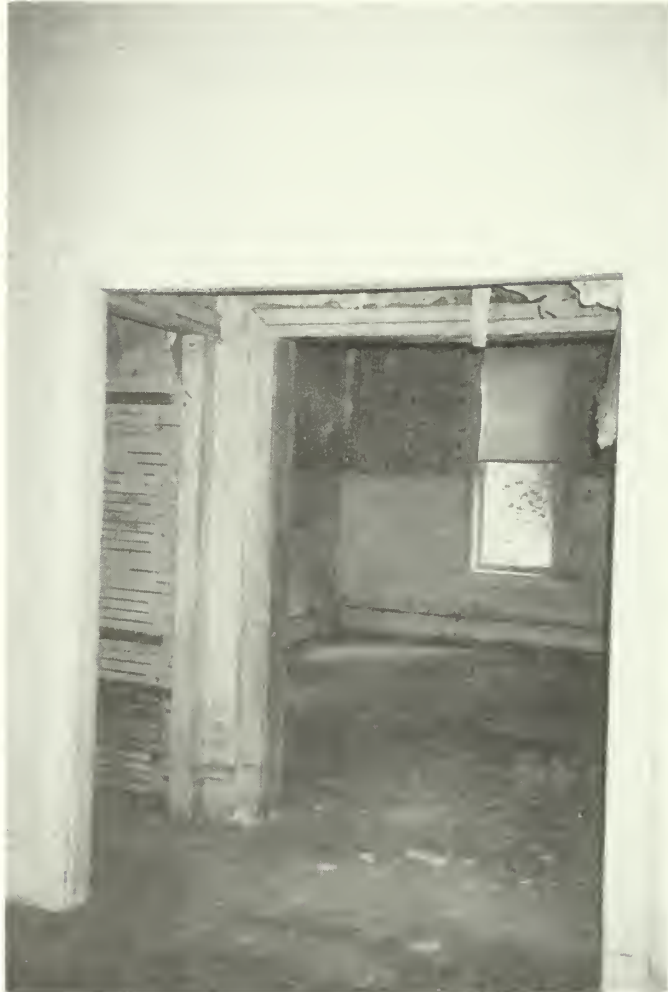
Photo E-39 Looking southwest at altered area between rooms
105 and 103.
Brown Cottage 1992

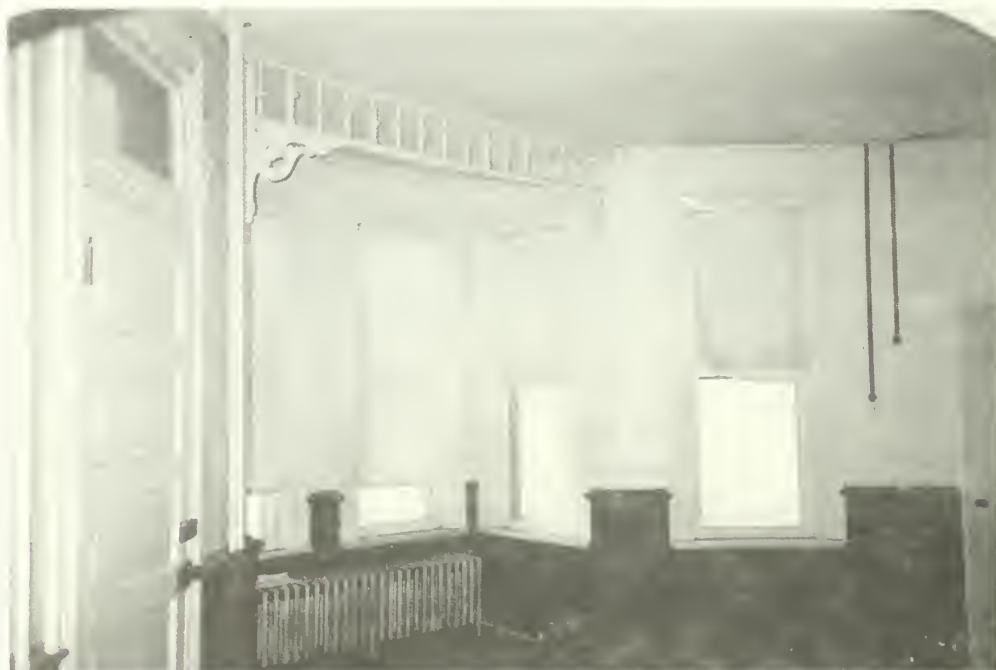
Photo E-42 Northeast bay with decorative wood bracket in room 106.
Brown Cottage 1992

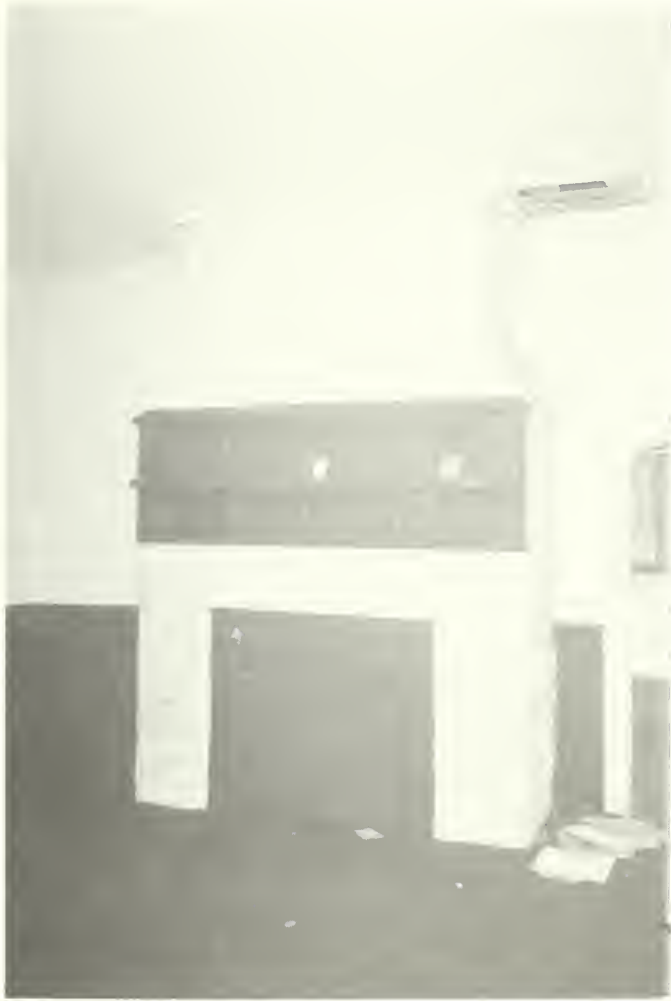
Photo E-43 Chimney and fireplace on west wall of room 106.
Brown Cottage 1992

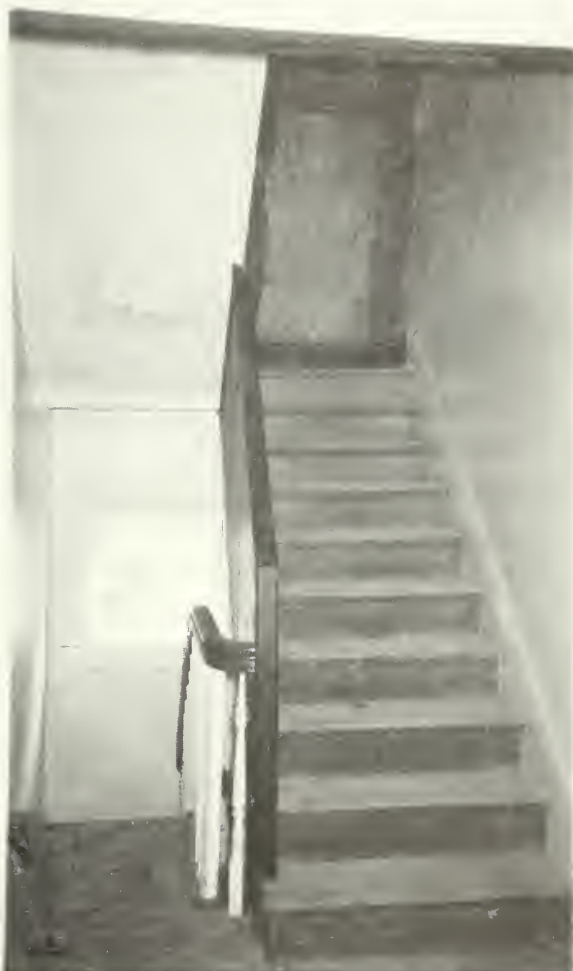
Photo E-47 Second floor view of the main stair from the hall
(room 200), looking west.
Brown Cottage 1992

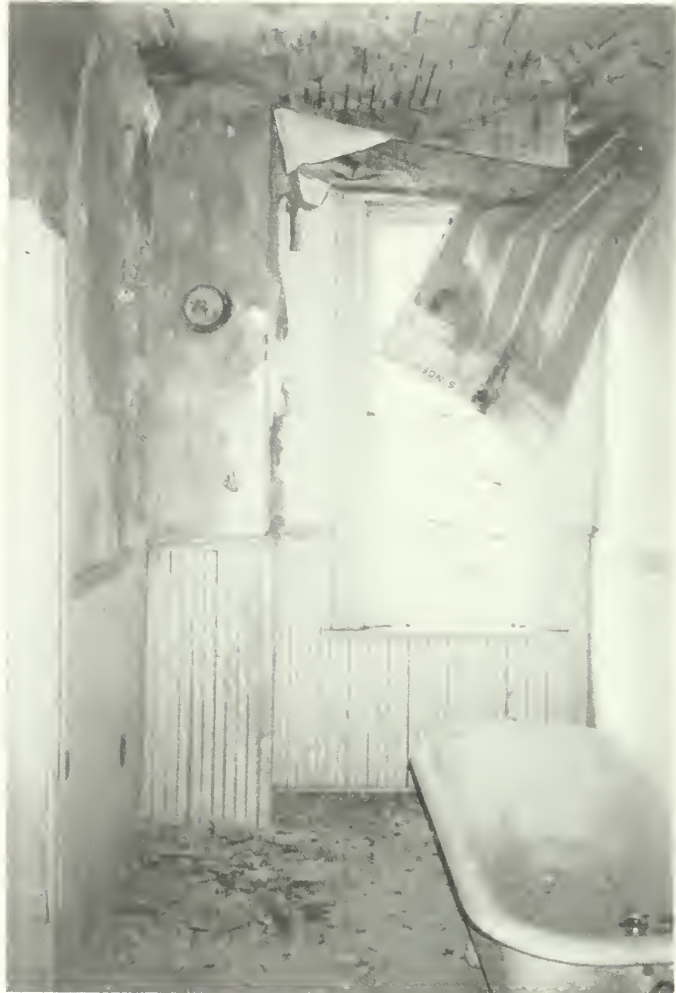
Photo E-48 Room 203, looking south. The bathtub stored in this room is not original to the room.
Brown Cottage 1992

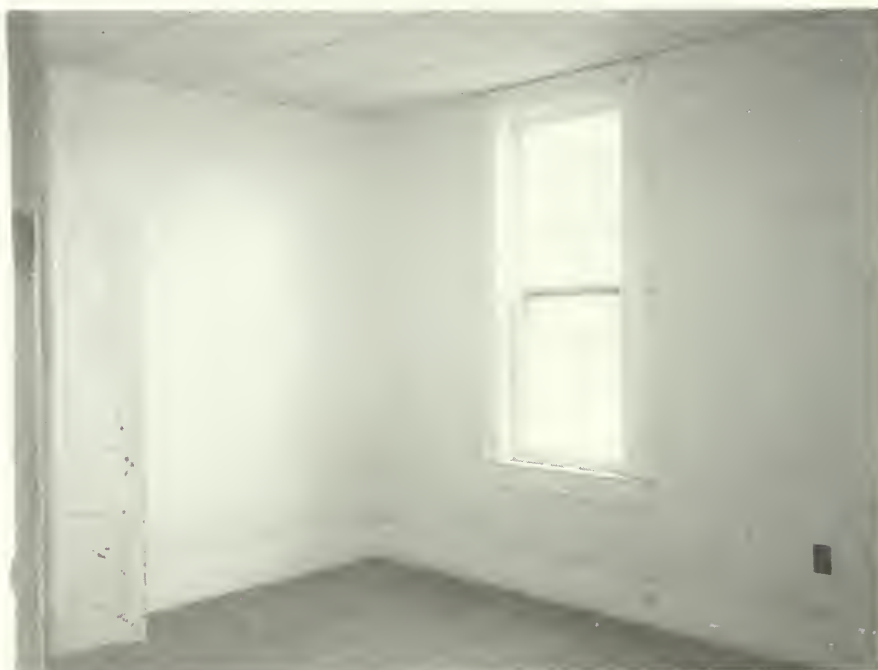
Photo E-52 Northwest corner of room 208. The door to the left leads to the newer stair
to the third floor.
Brown Cottage 1992

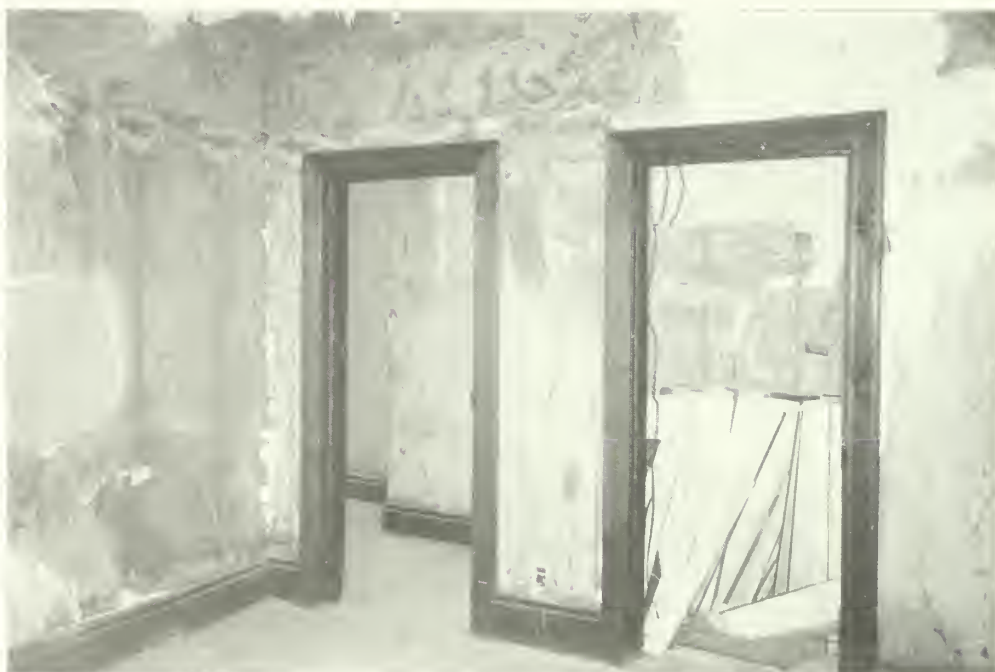
Photo E-56 Northwest corner of room 302. Ghost of former doorway is faintly visible in wall in hallway beyond left doorway.
Brown Cottage 1992

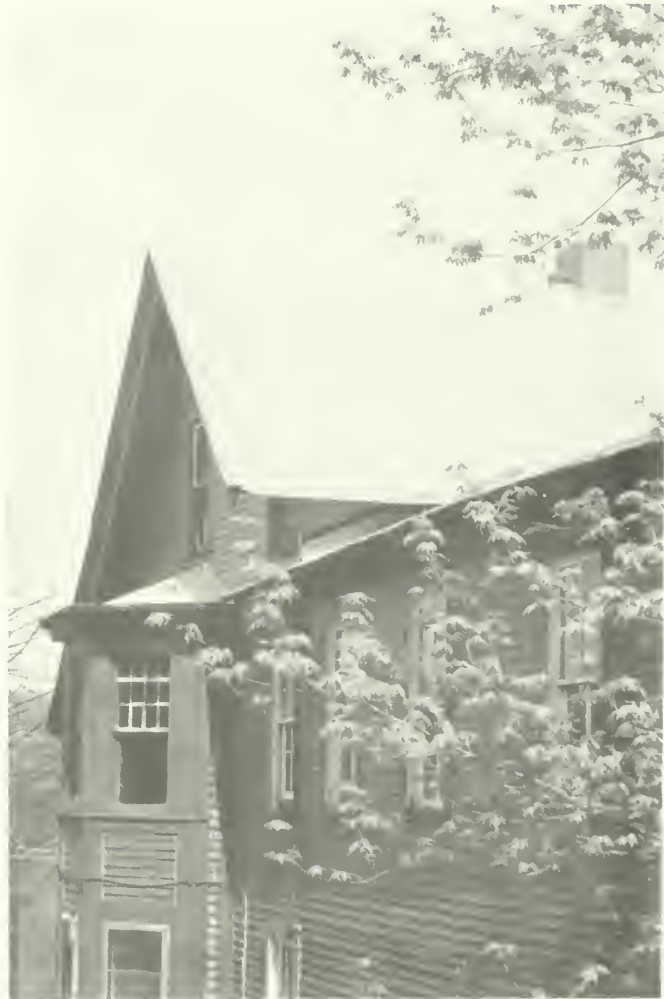
Photo E-64 North facade showing original wood shiplap siding visible at the eave of the main roof and in the return of the bay area.
Moorhead Cottage 1992

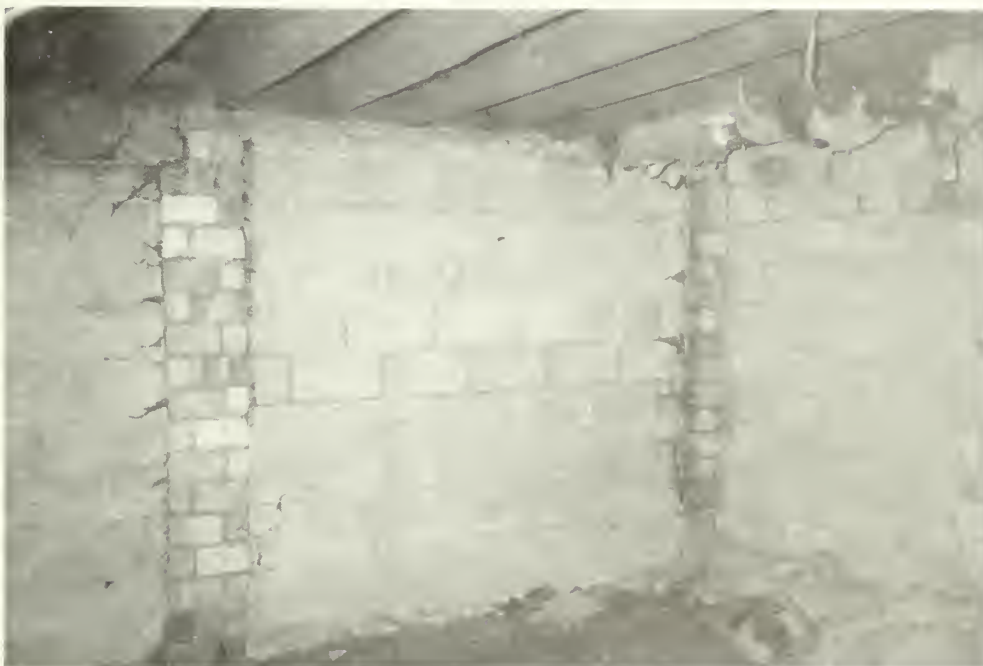
E-70 Northeast corner of room B01 indicating masonry pier and infill structural system.
Moorhead Cottage 1992

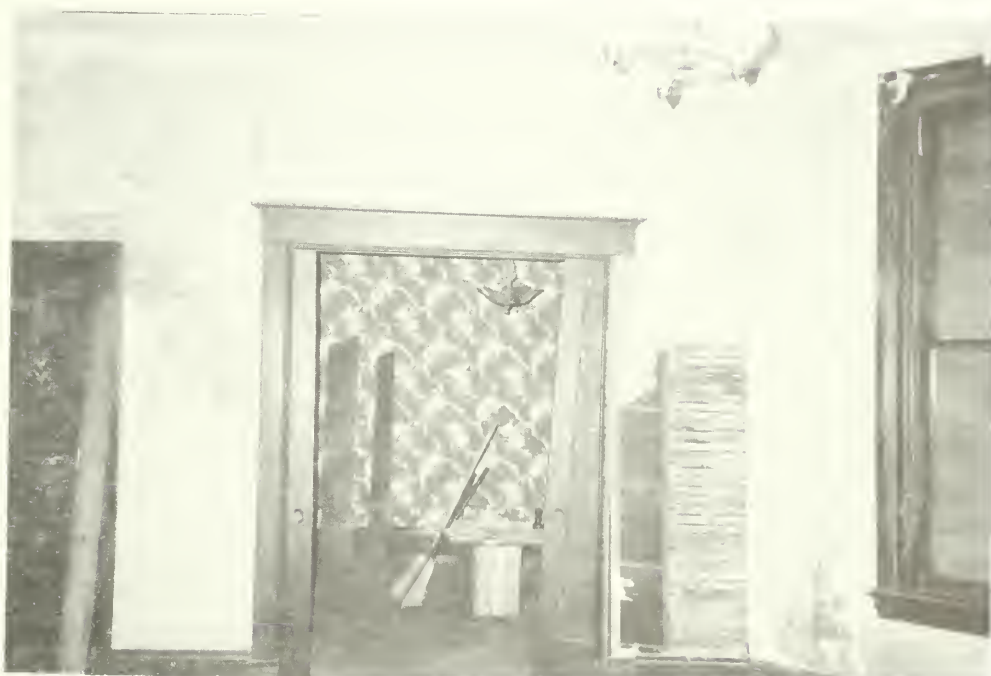
c E-73 North wall of room 102 showing early twentieth century pocket doors and alterations to wall.
Moorhead Cottage 1992

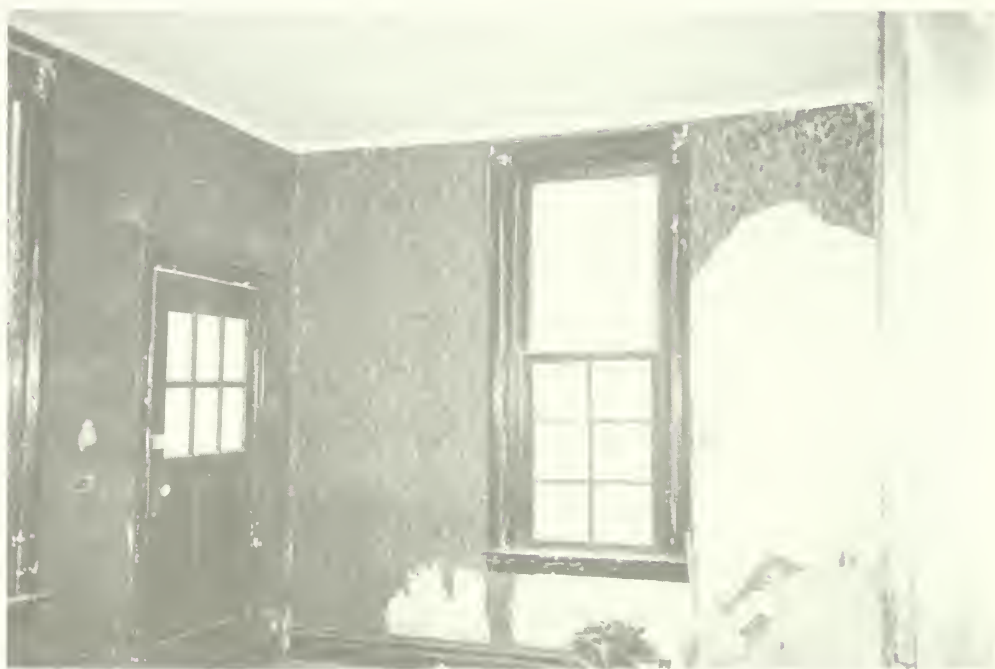
Photo E-75 Southwest view of room 103 showing window and door alterations.
Moorhead Cottage 1992

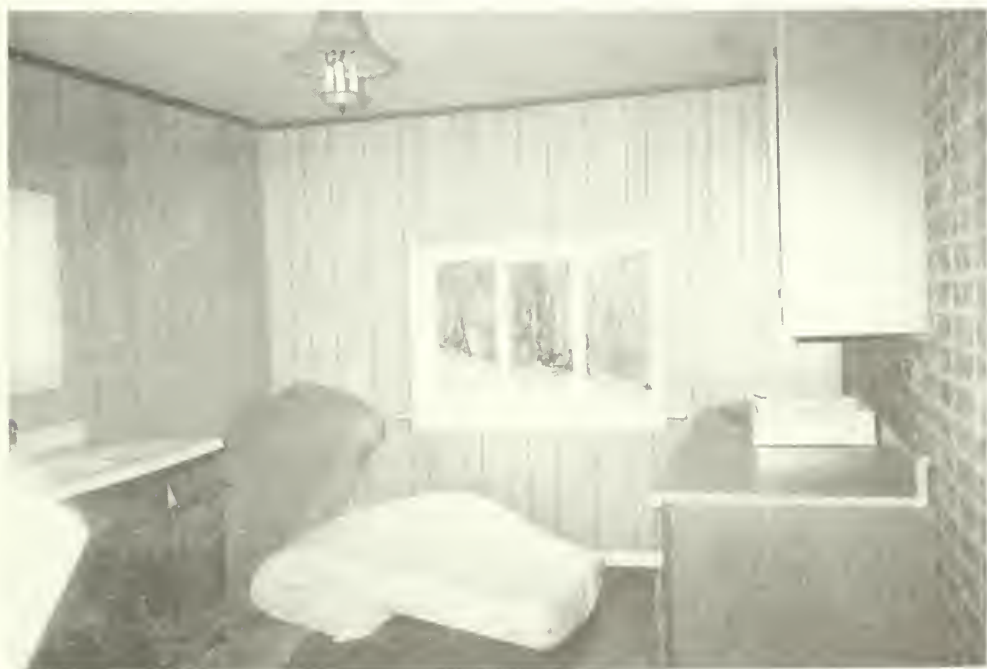
to E-79 South wall of room 106 showing paneling at stairway installed from another location. The window to the right of the stair replaces an original door. Moorhead Cottage 1992

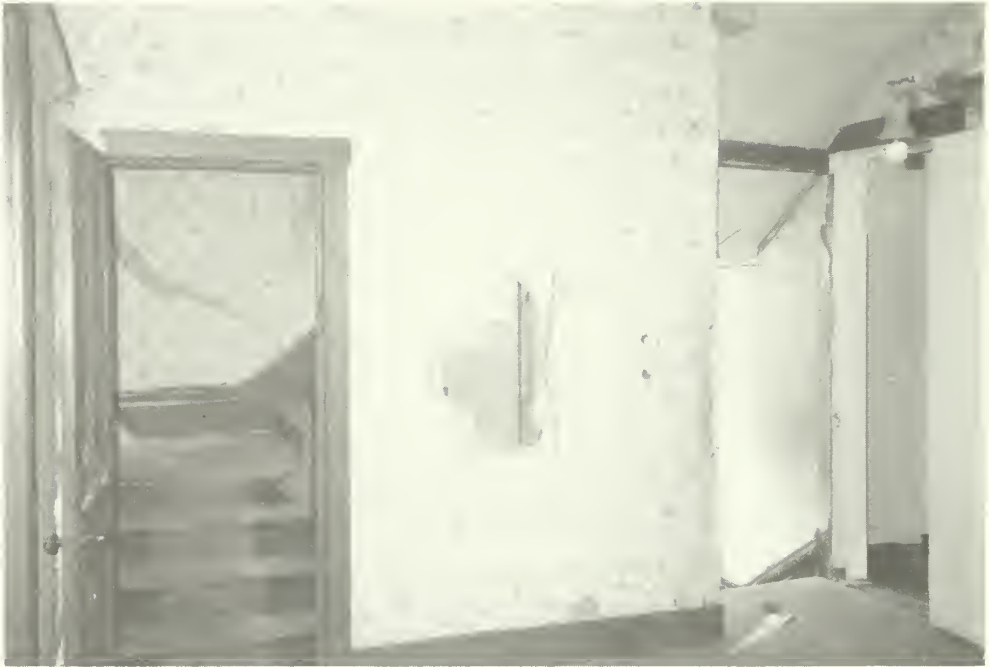
Photo E-81 View of enclosure added over main stair at second floor.
Moorhead Cottage 1992

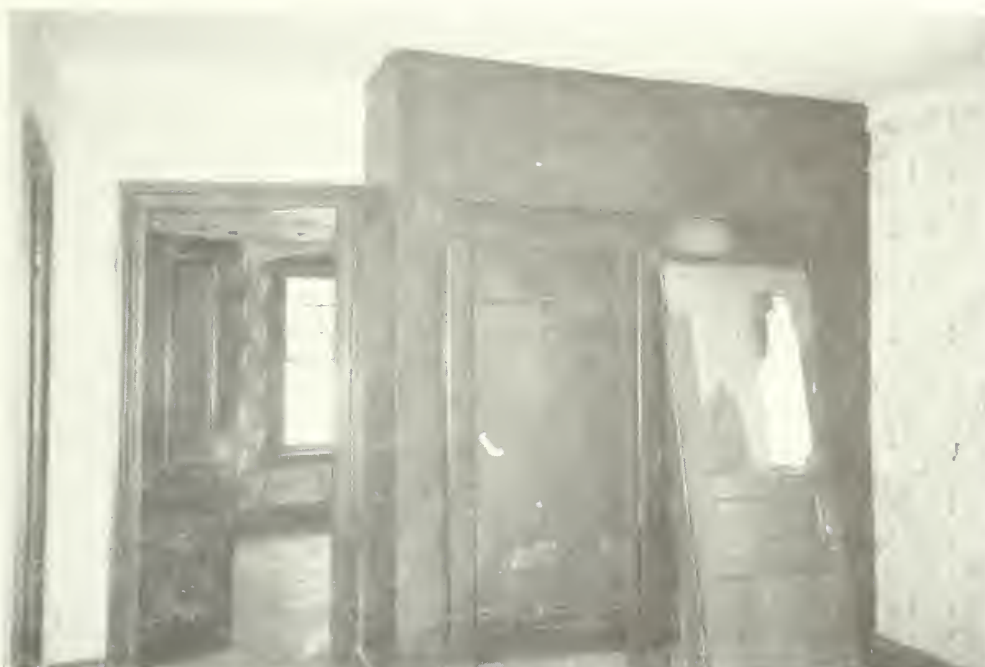
E-86 East wall of room 203 with view through doorway to room 202. The closet is an addition to the room.
Moorhead Cottage 1992

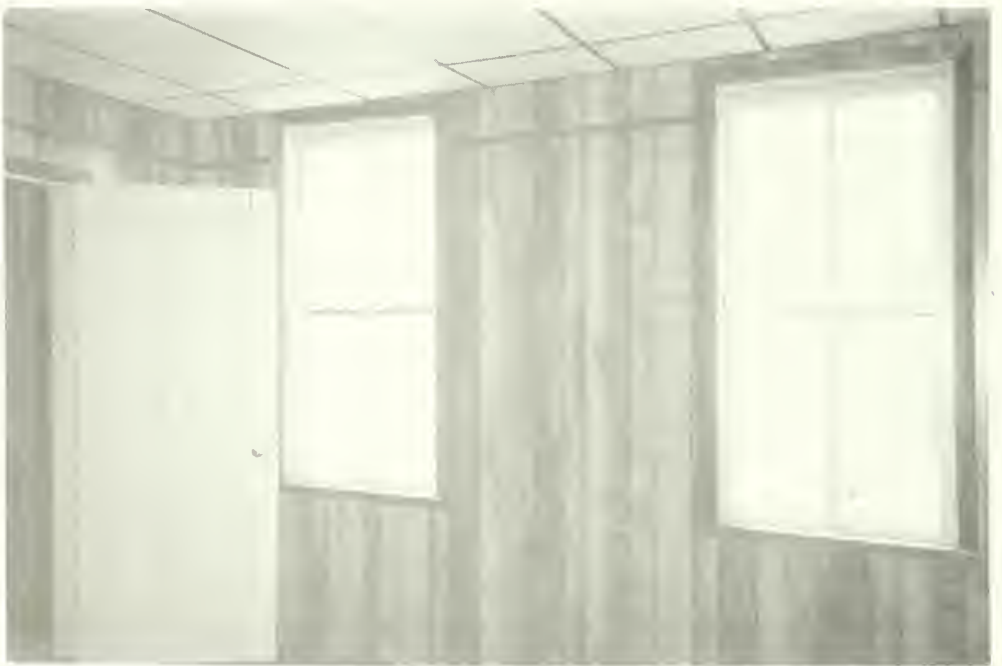
Photo E-88 North bay and northeast corner of room 204, showing colored glass in upper sashes of bay and modern paneling.
Moorhead Cottage 1992

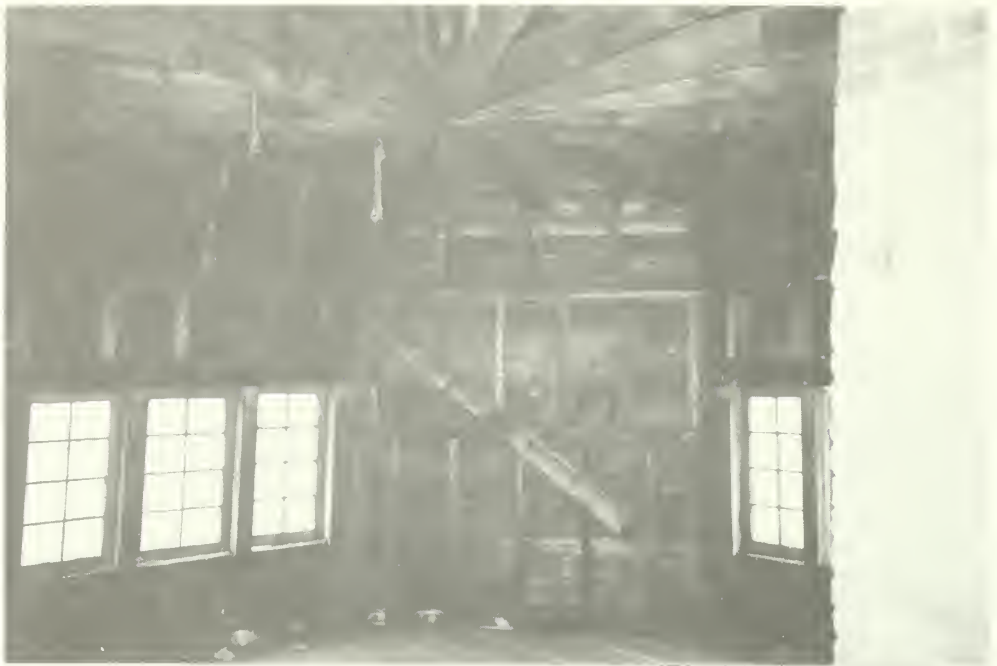
Photo E-91 South wall of room 304 with view to hall 300. Closet to the left is a later addition.
Moorhead Cottage 1992
