Historic Structures Report
Architectural & Historical Data Section

Clubhouse, Brown Cottage, Moorhead Cottage,
and Clubhouse Annex

**SOUTH FORK FISHING
& HUNTING CLUB**

ST. MICHAEL • PENNSYLVANIA

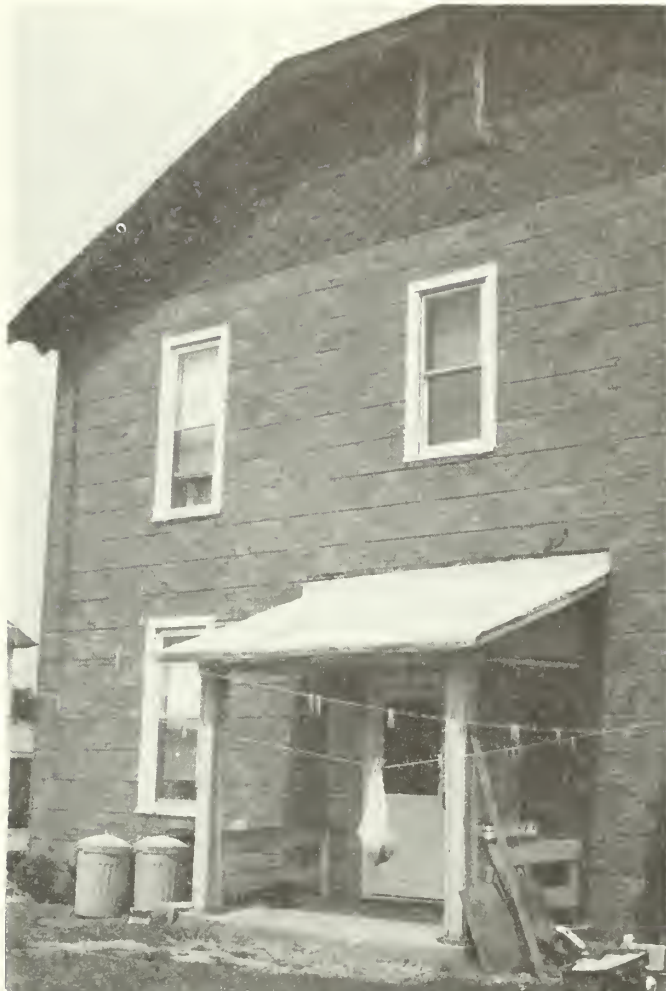
Photo E-96 Detail of west elevation showing original wood siding flanking rear door.
Clubhouse Annex 1992
