FURE'S CABIN

HISTORIC STRUCTURE REPORT

KATMAI NATIONAL PARK & PRESERVE

PREPARED BY

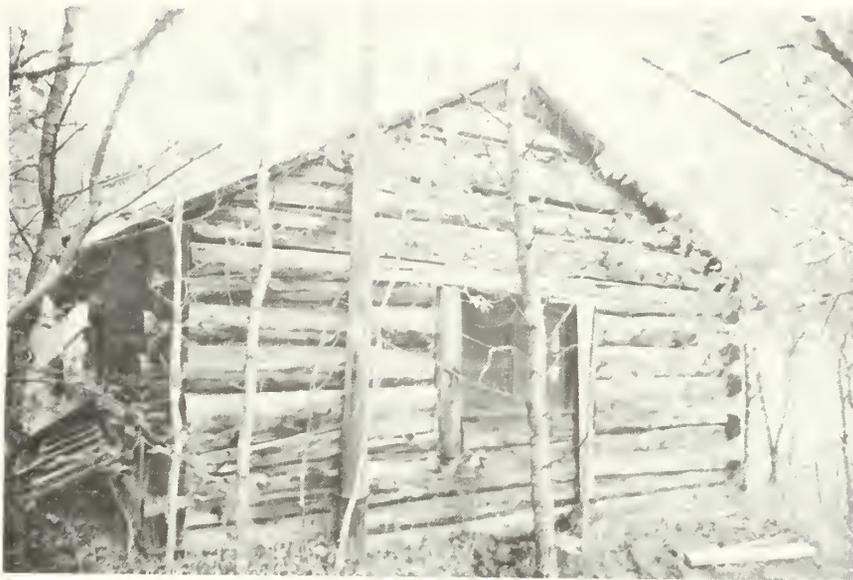
Photograph 3
West Elevation: Note Deteriorated Condition of
Roof Planks
6/82 D. Snow

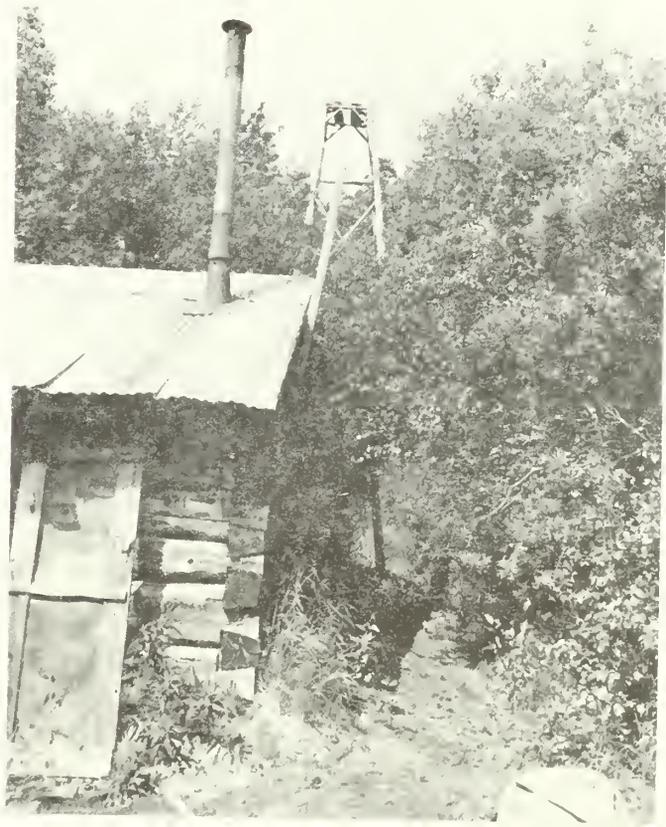
Photograph 16
Roof Plank Edge at North End of
West Elevation
6/28/83 D.C. Anderson

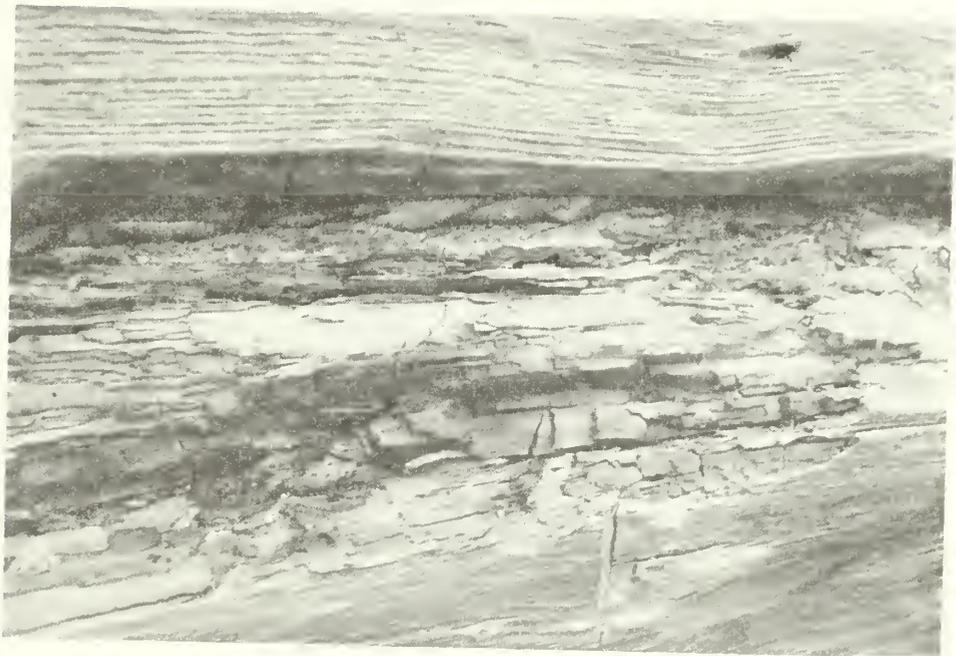
Photograph 48
North Elevation of Cabin Above Window:
Note isolated Dry Rot
6/82 D. Snow
