historic structure report  
units 2, 3, and 4  
volume 4  
part 3

ELLIS ISLAND  
STATUE OF LIBERTY

**HISTORIC STRUCTURES REPORT  
UNITS 2, 3 AND 4**

**Volume 4  
Part Three**

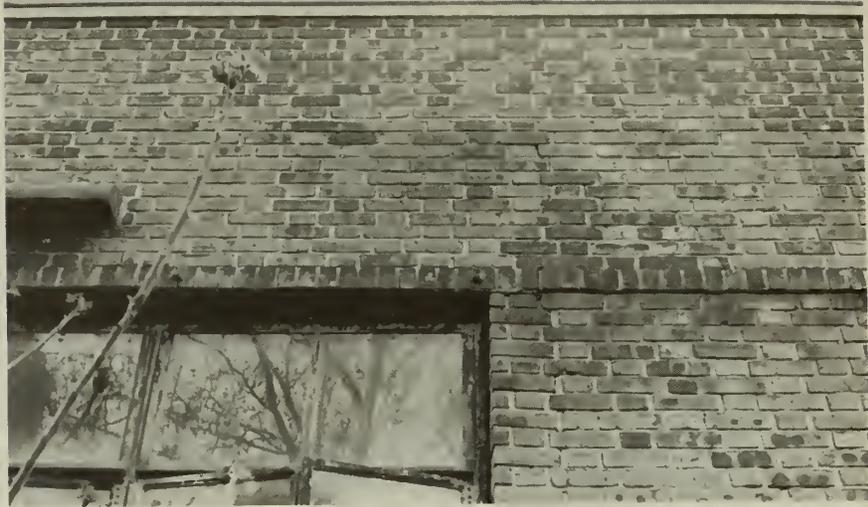
The copper flashing which protects the terra cotta roof coping is torn and missing in some areas with two small areas of flashing on the roof face of the parapet also missing. Composition roof surfaces are in fair condition with bubbling along the seams of the roofing felt and water accumulation in the southeast corner of the south wing. The chimney located in the southern portion of the roof area of the central block has been coated with tar.

3. Terra cotta roof coping with copper flashing.

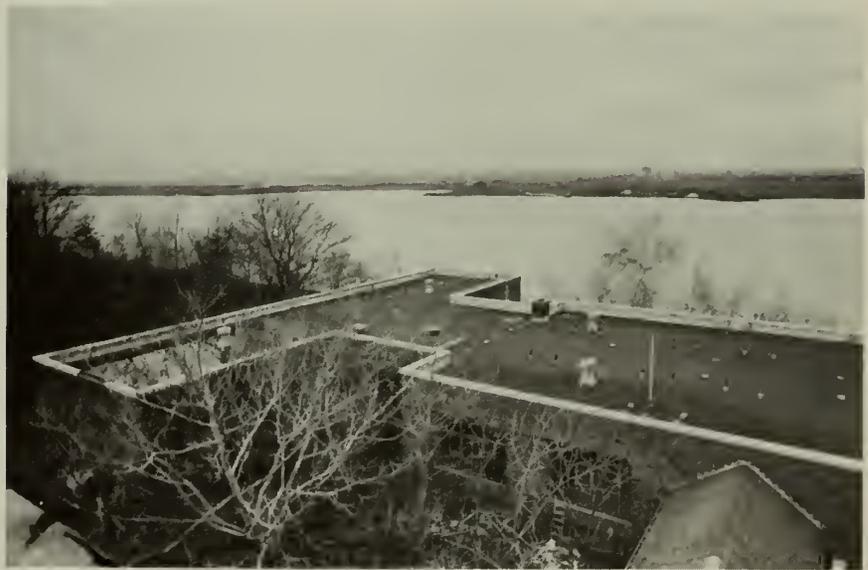
8. Roof, southern half.

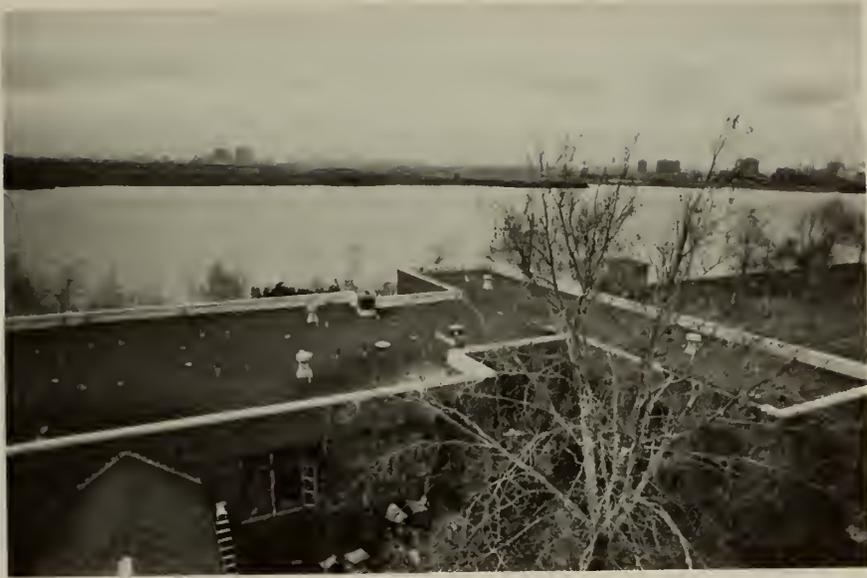
9. Roof, northern half.

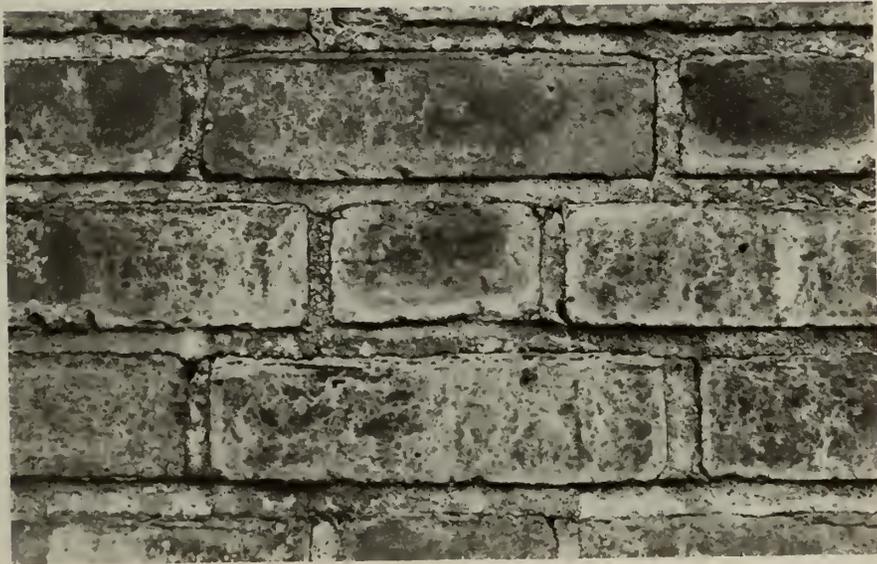
As with the ferry house, brick surfaces of the immigrant building suffer from areas of fairly extensive general detachment and flaking loss of surface glaze exposing brick subsurfaces. Cracking occurs in one area of the east elevation of the central block. Areas of mortar deterioration and separation of mortar from bricks occur randomly. This appears to be most severe above the window lintel header coursing. Efflorescence occurs on all elevations (photo 10).

10. Efflorescence, north facade.

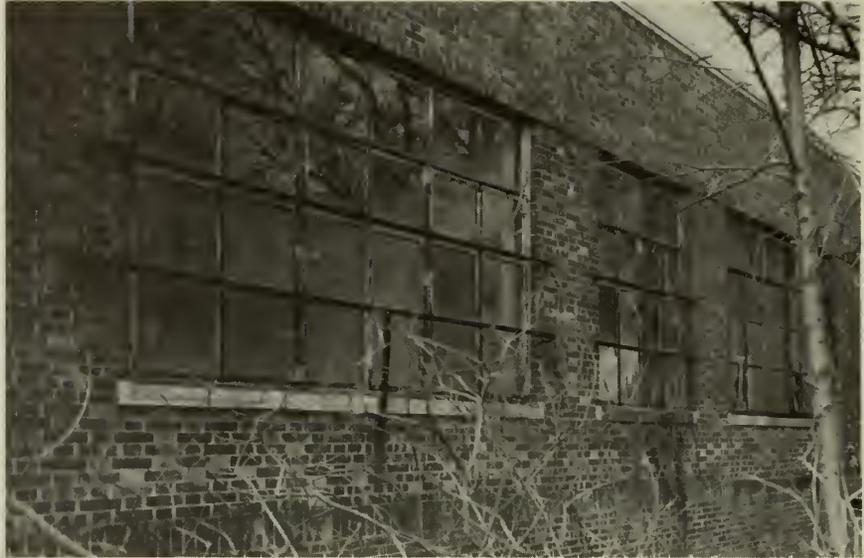
Terra cotta surfaces exhibit general erosion through weathering with some chipping and random areas of loss as in a portion of a window sill face on the east elevation. Iron staining occurs in patches on most terra cotta sill surfaces with carbon staining appearing in mortar joints and on upper surfaces of window sills (see photo 4). Biological staining as well as areas of dark water staining appears on most elevations, occurring primarily below the window sill level. Steel window sash and frames exhibit general surface pitting and rusting, and display remnants of cream, aluminum and turquoise colored overpaint, now rust stained and generally lifting. Window glass suffers from general to random areas of cracking, breakage and loss (photo 11). Metal doors on the east, west and south elevations exhibit rusting of metal surfaces resulting in some loss (see photo 6). The original metal french doors of the north elevation of the north wing have been replaced by two wood paneled doors, which are unlike and are themselves in severely deteriorated condition (photo 12). Metal as well as some wood grilles have been installed below some windows in the brick base with wood grilles exhibiting some deterioration and loss (photos 13 and 14). Various surface alterations are visible on most elevations such as the attachment of wood and metal fasteners and bars to brick surfaces. Metal bars have been bolted to the face of the brick across two window openings on the south elevation (photo 15).

15. Windows with bars, south facade.

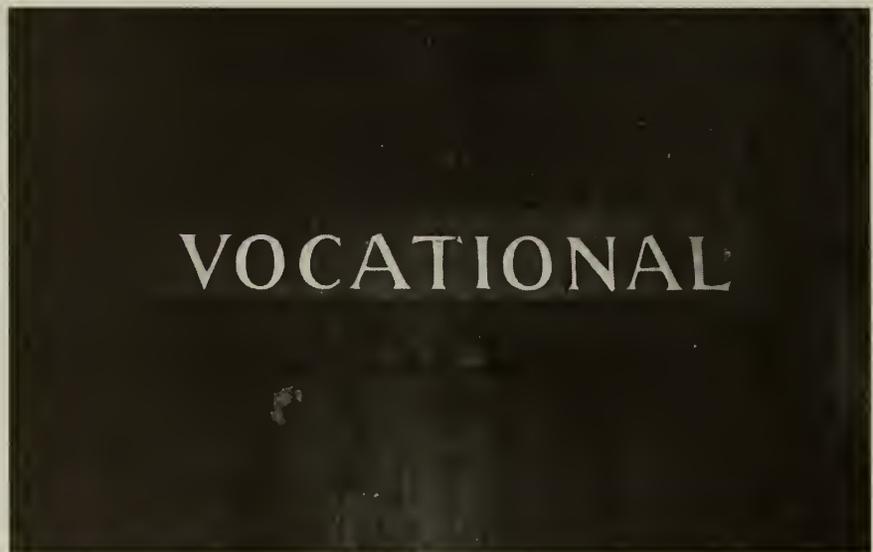
16. Stenciling, door to room 101A.

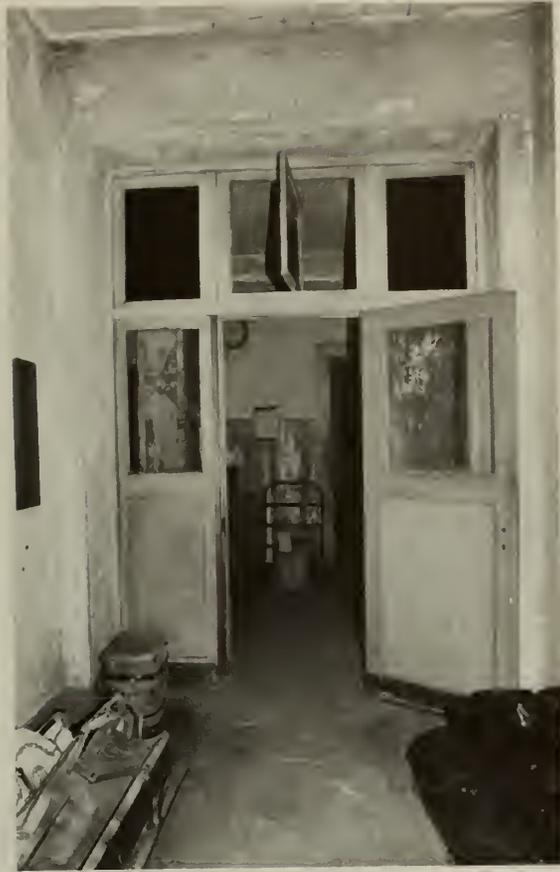
17. Door to H106.

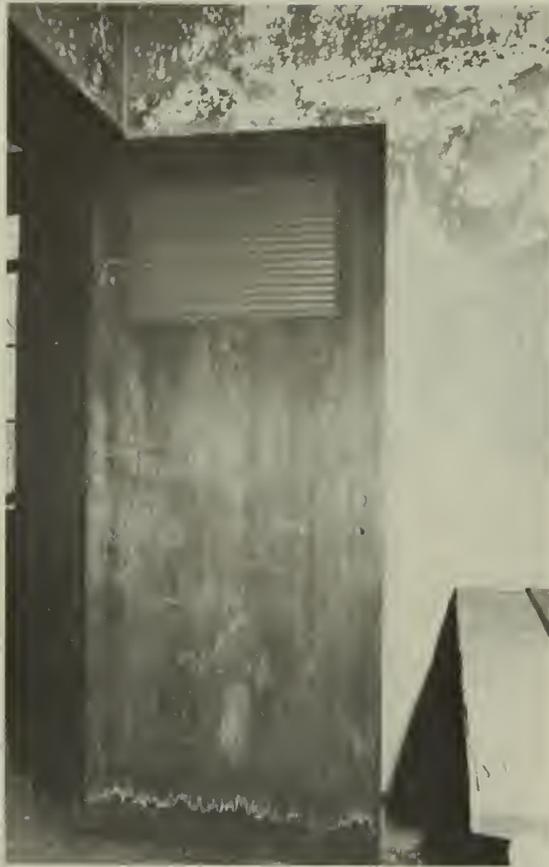
18. Typical dormitory door.

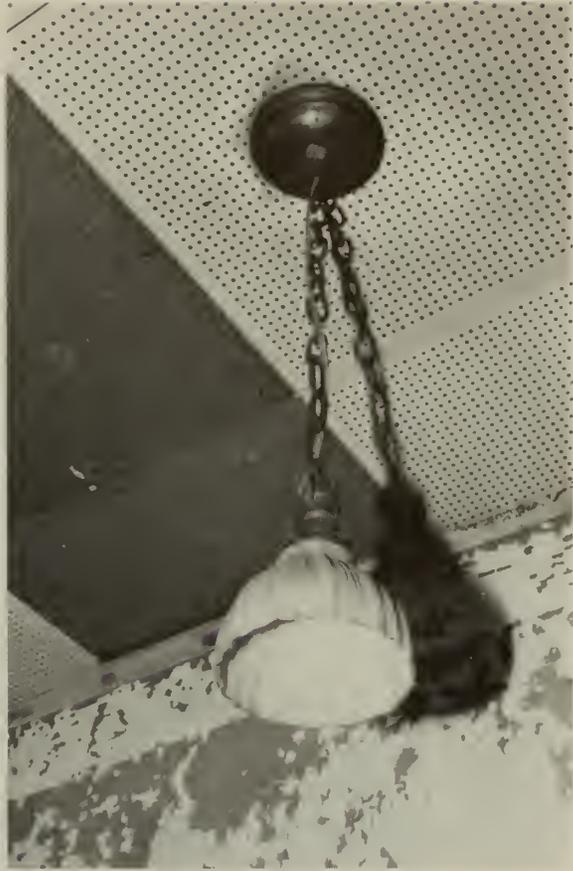
19. Typical chain-hung light fixture.

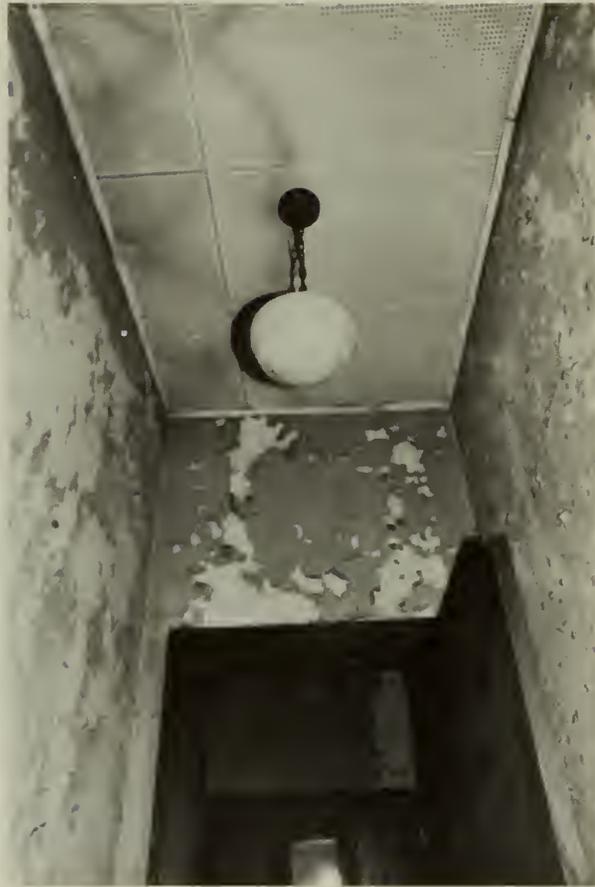
20. Original light fixture.

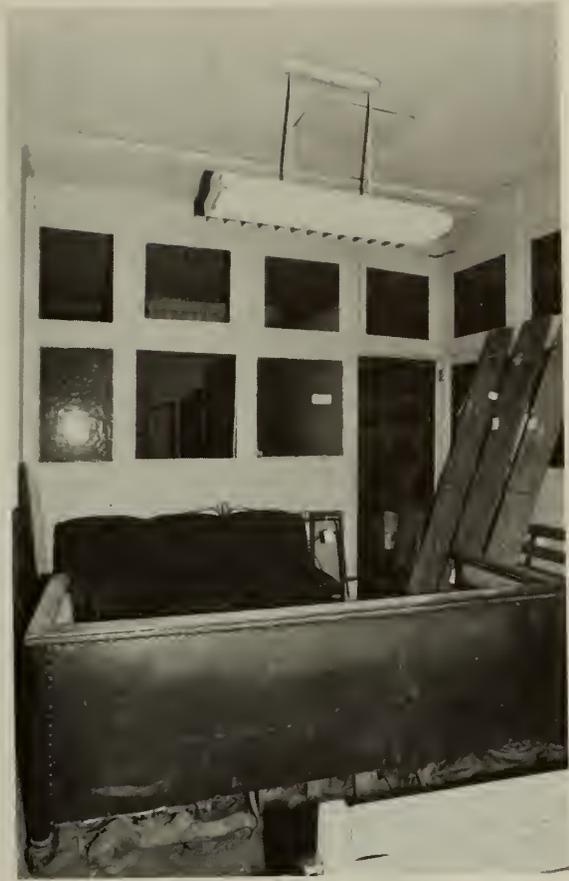
21. Partition wall, room 101D.

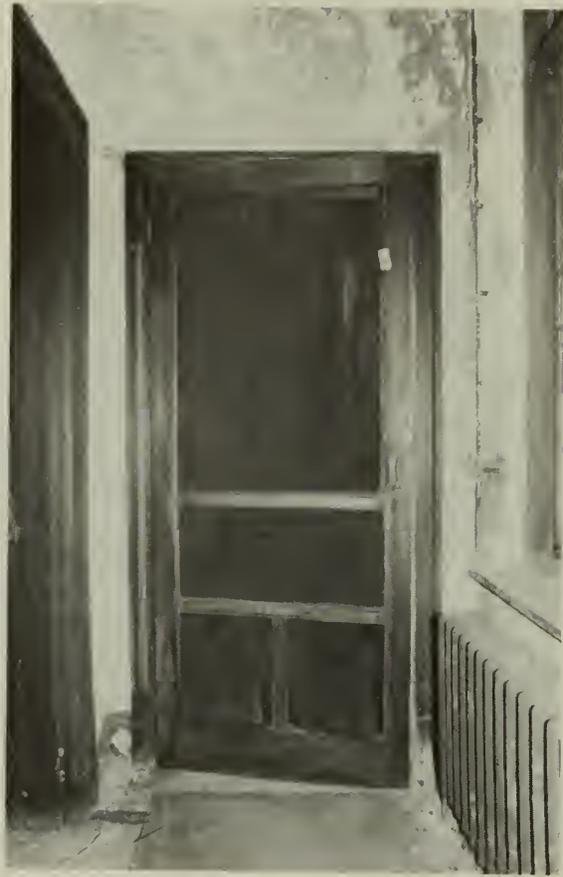
22. Screen door, H104.

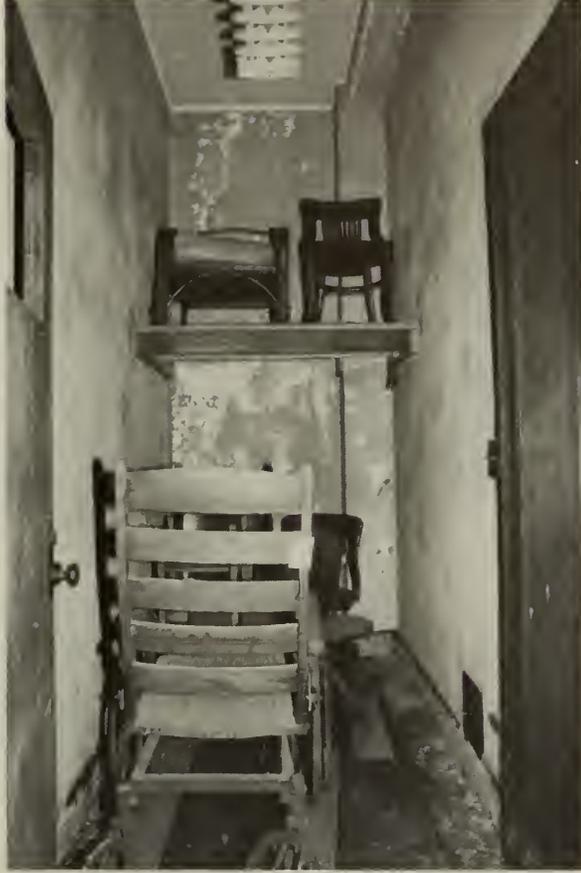
23. Typical locker room.

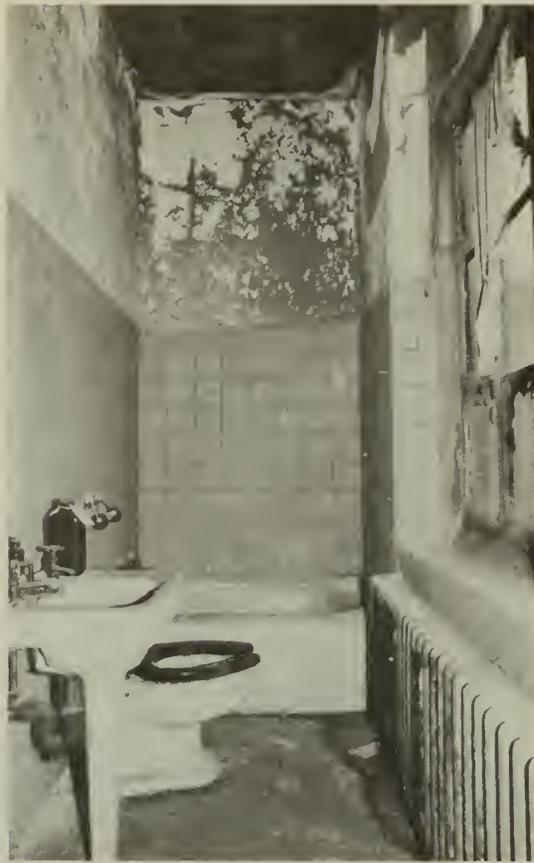
24. Typical bathroom.

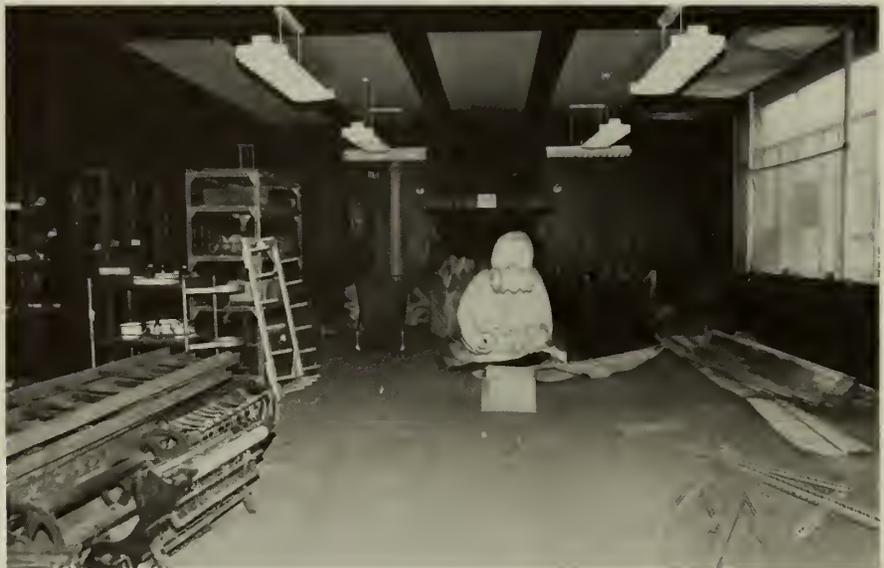
25. Room 111, view south.

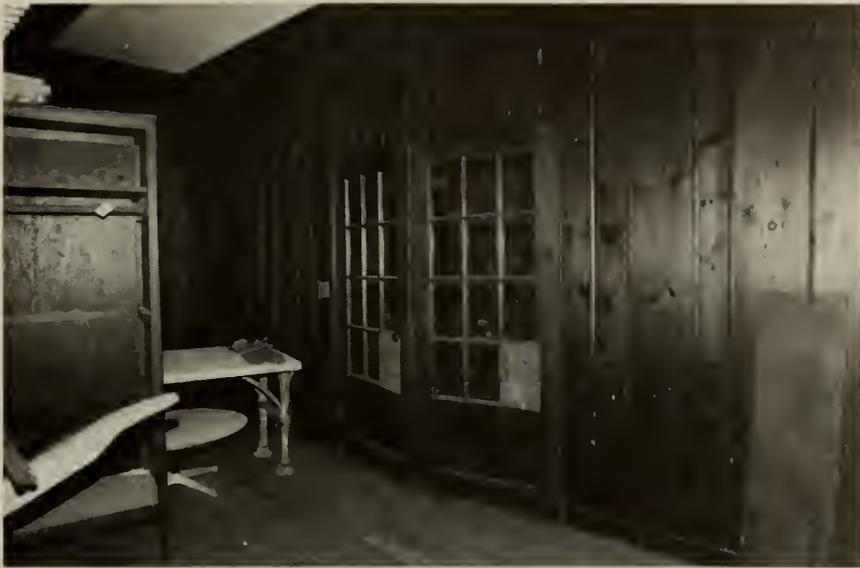
26. Wood paneling and double doors, room 111.

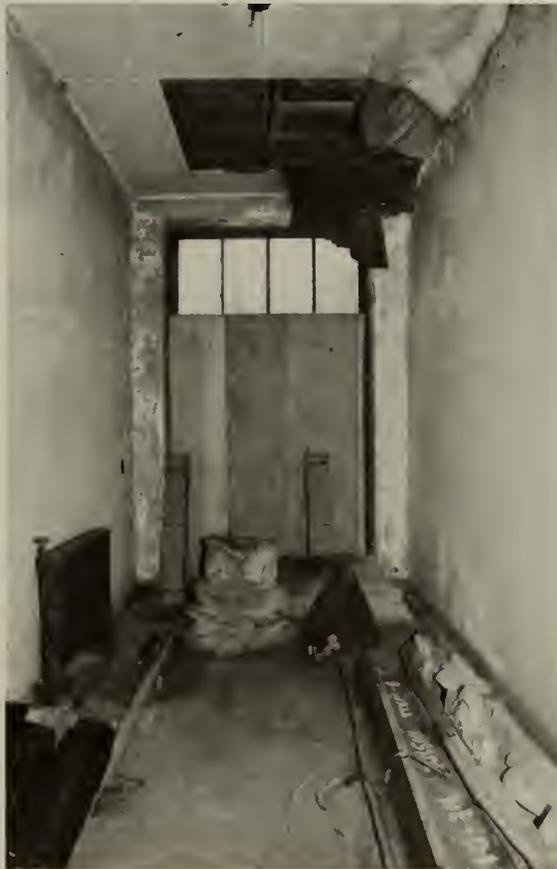
27. Water-damaged acoustical ceiling panels, H106.

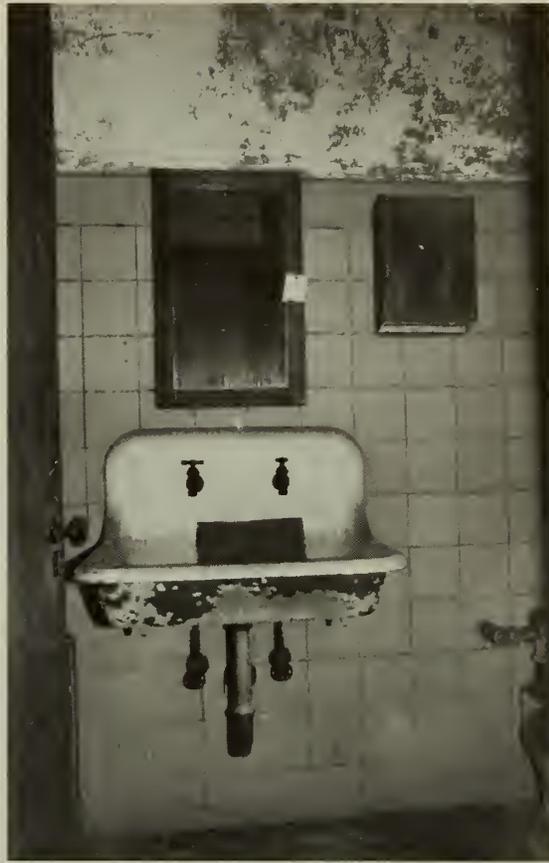
30. Extant bathroom mirror and paper towel dispenser.

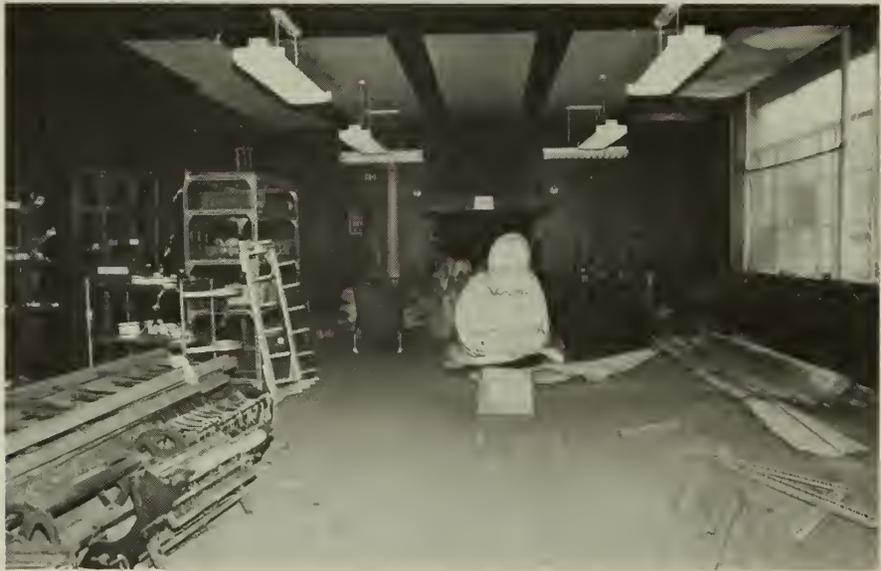
31. Room 111, view south.

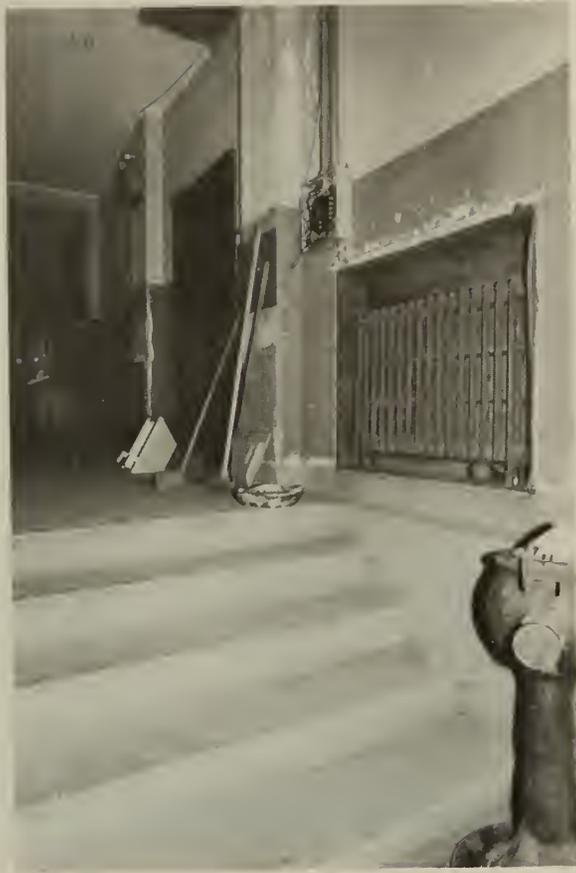
32. Stairs, hallway H101.

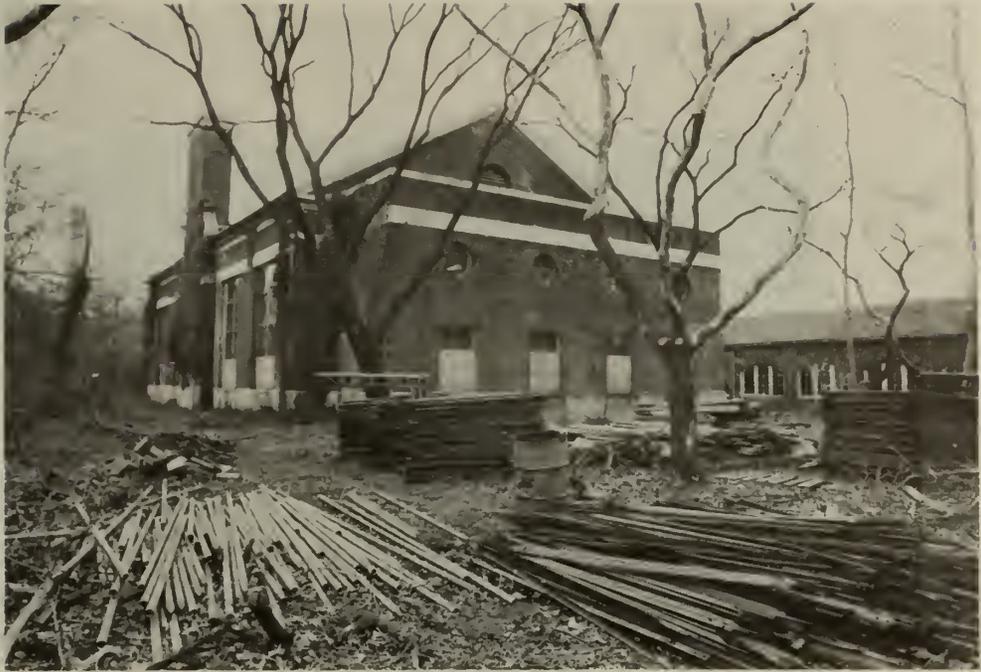
1. North facade.

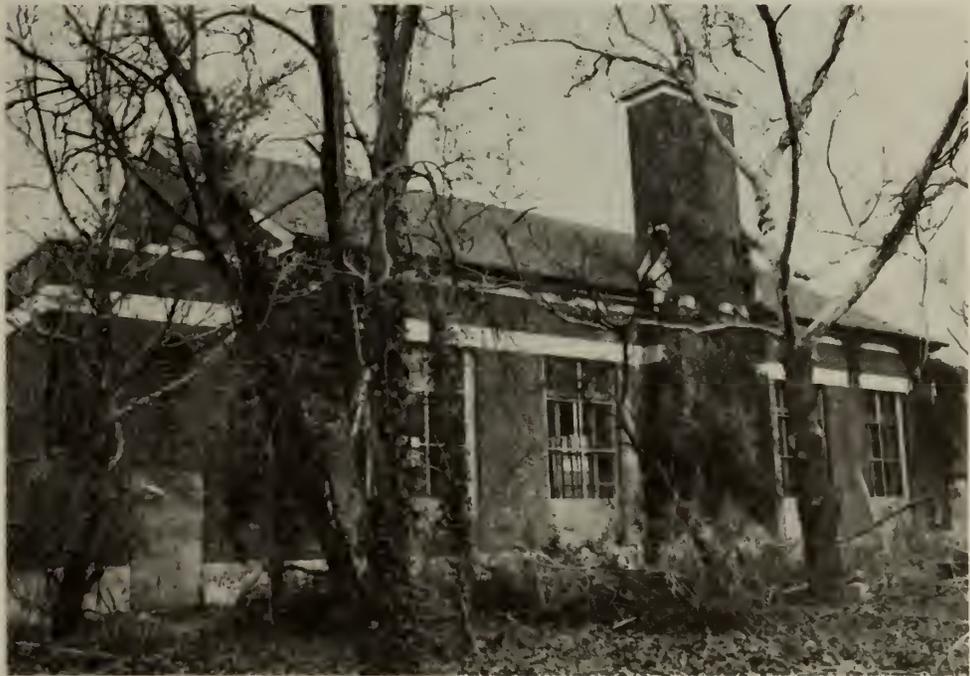
2. East facade.

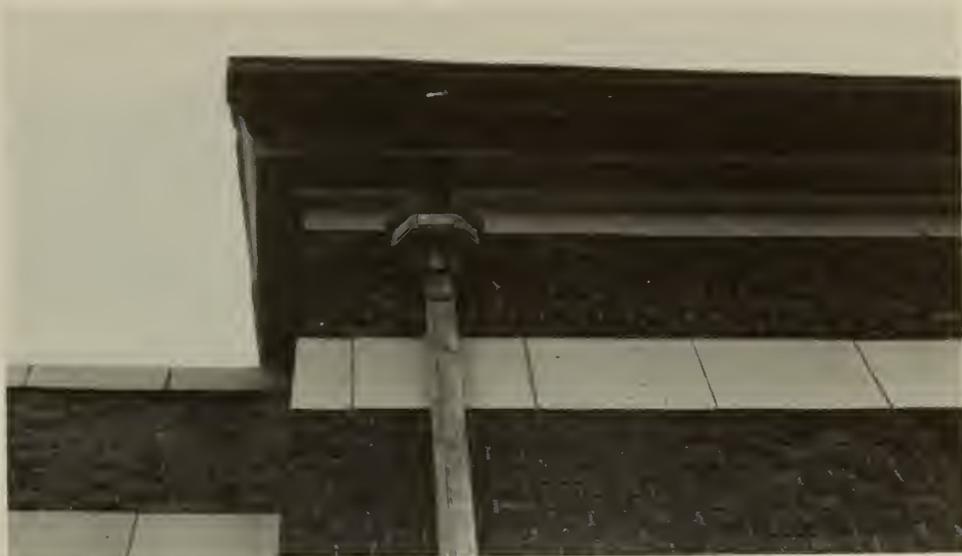
6. Lead-coated copper downspout, top.

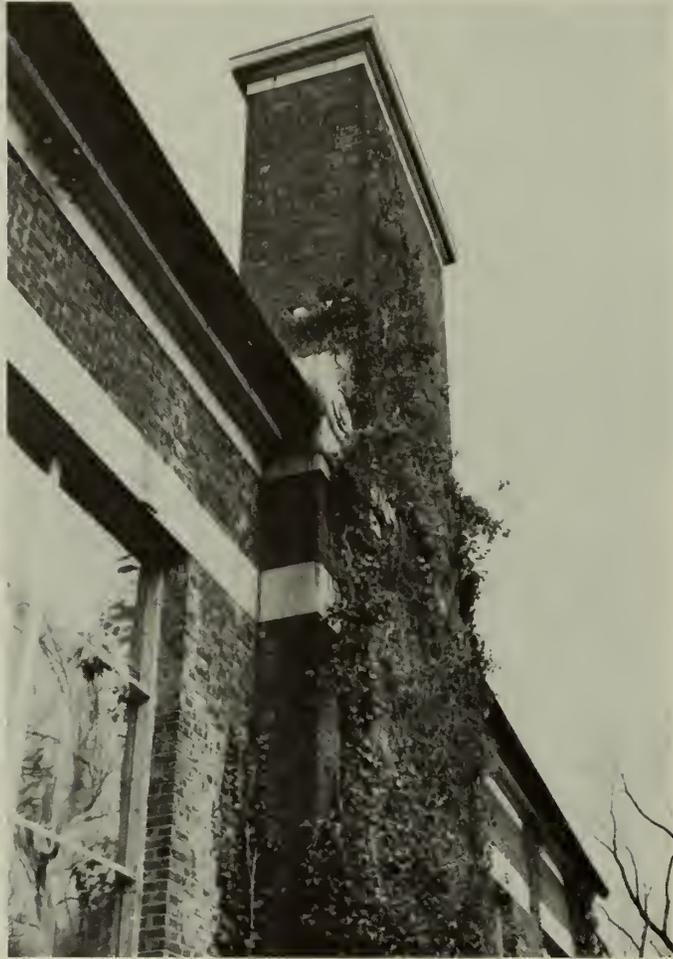
24. Vine-cover, east facade.

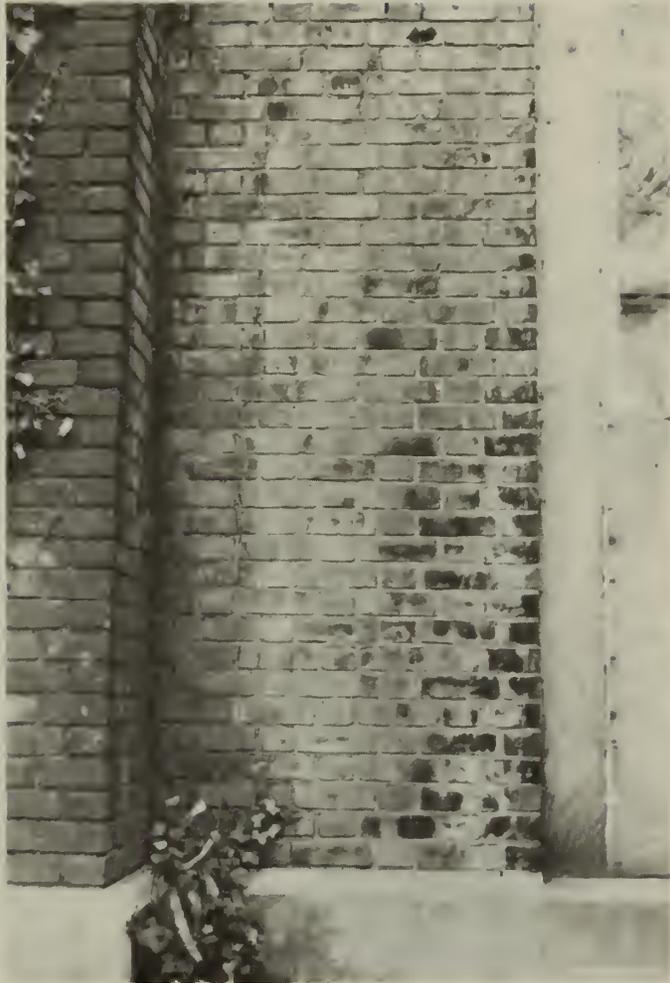
25. Efflorescence, east facade.

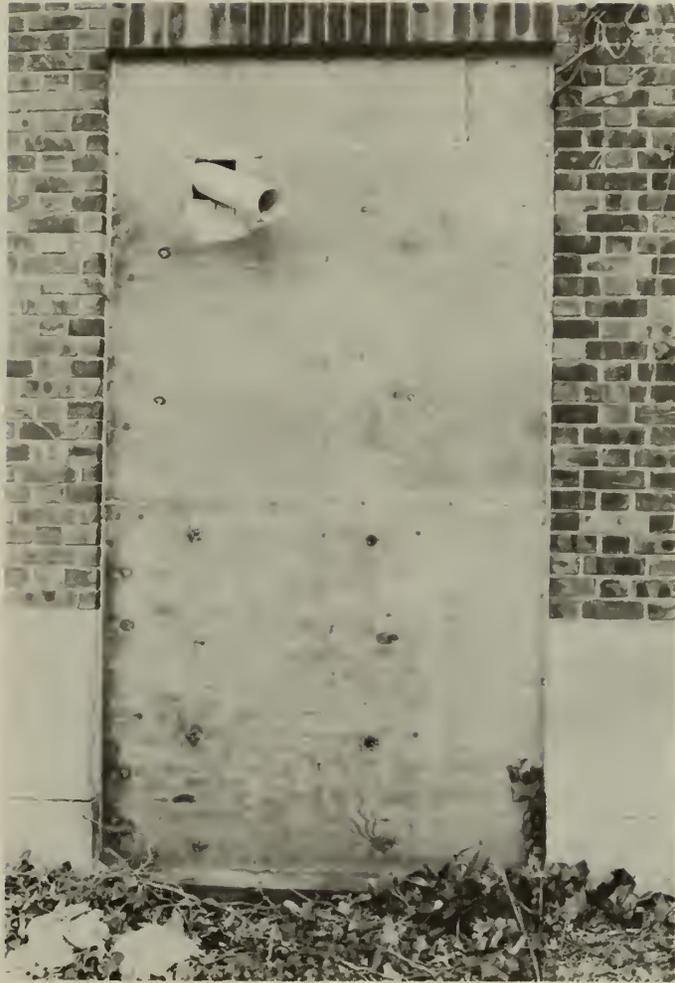
31. Pipe protruding from infilled door,  
east facade.

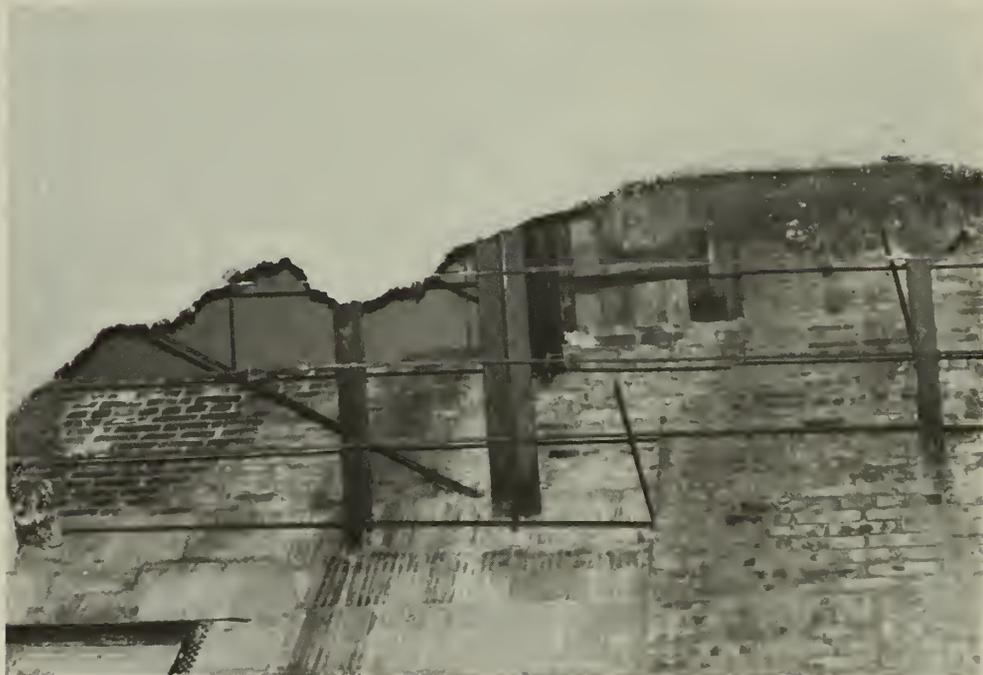
56. Plaster loss, ceiling of recreation room.

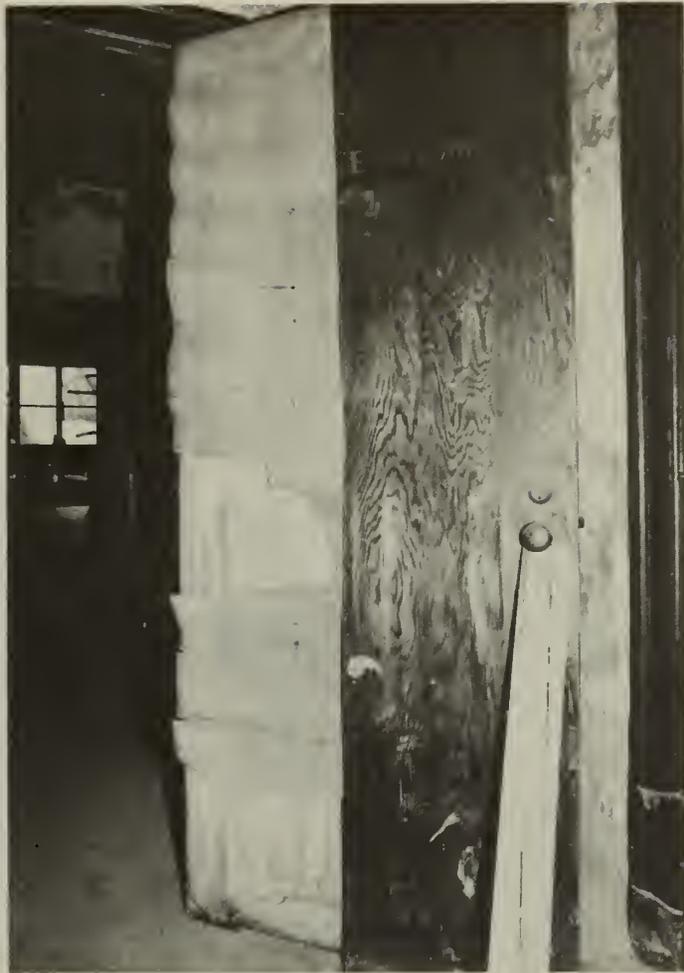
57. Delamination of door.

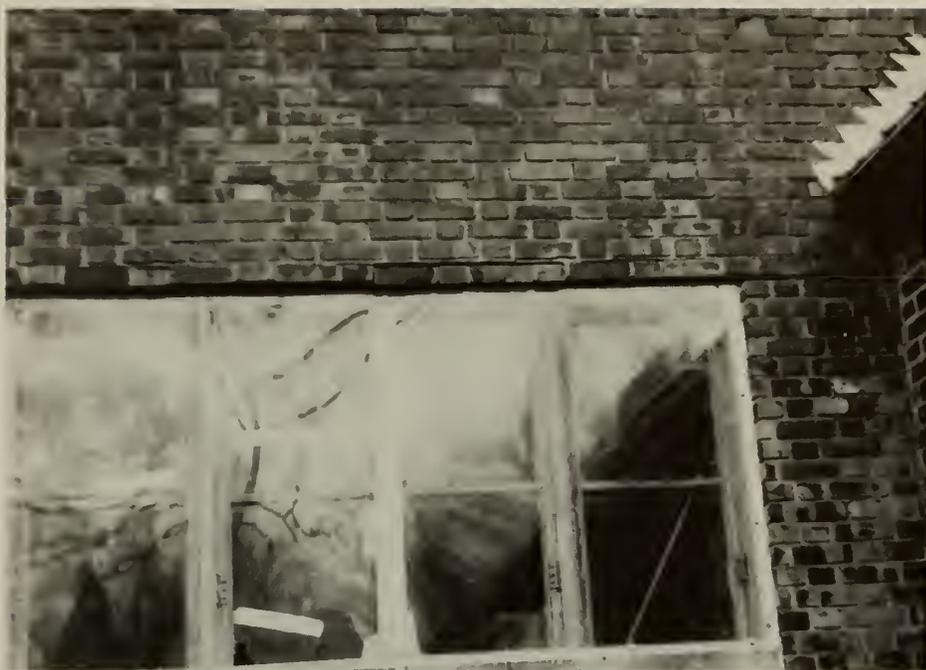
61. Horizontal cracks above lintel, north facade, west link.

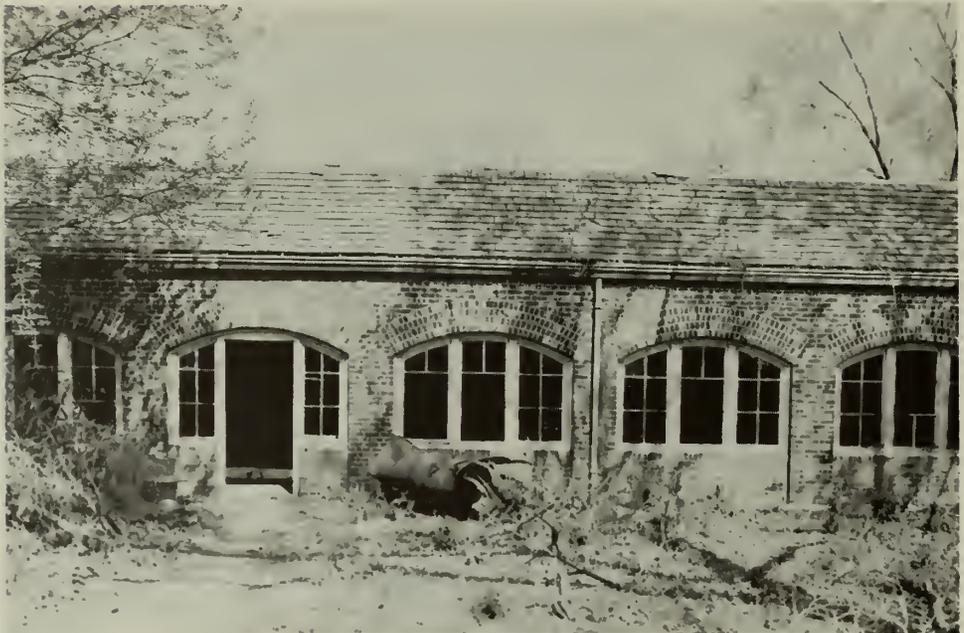
Wood doors exhibit some deterioration and loss with the door to the office building on Island 3 having lost its upper sash, and the wood doors of 8A which exit to the north and south, exhibiting weathered surfaces, alterations, deterioration and loss of parts. The vertical board double door exiting to the south between the hospital outbuilding and the psychopathic ward has lost its west half (photo 16).

15. Missing sash, east elevation, C-8C.

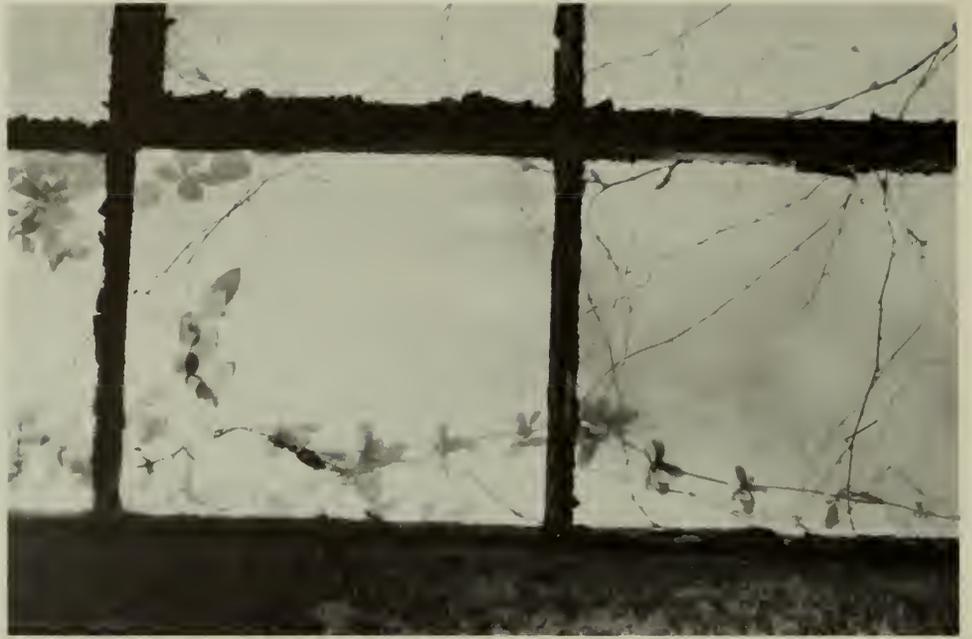
The exterior of corridor 9 is in fair condition. The exterior walls' aggregate stucco (pebble dash) finish is in generally fair to good condition with occasional areas of cracking as on the north facade of the covered way 9E section of corridor 9 as it turns to connect with the west entrance of the staff house. Fine cracking also appears under some window sills. Areas of loss of pebble aggregate occur randomly over the length of corridor 9. Patches of loss also appear on a pilaster of the south elevation of 9C. Rust staining of the stucco finish is evident under deteriorating metal window sash.

18. Corroded metal sash, C-9D.

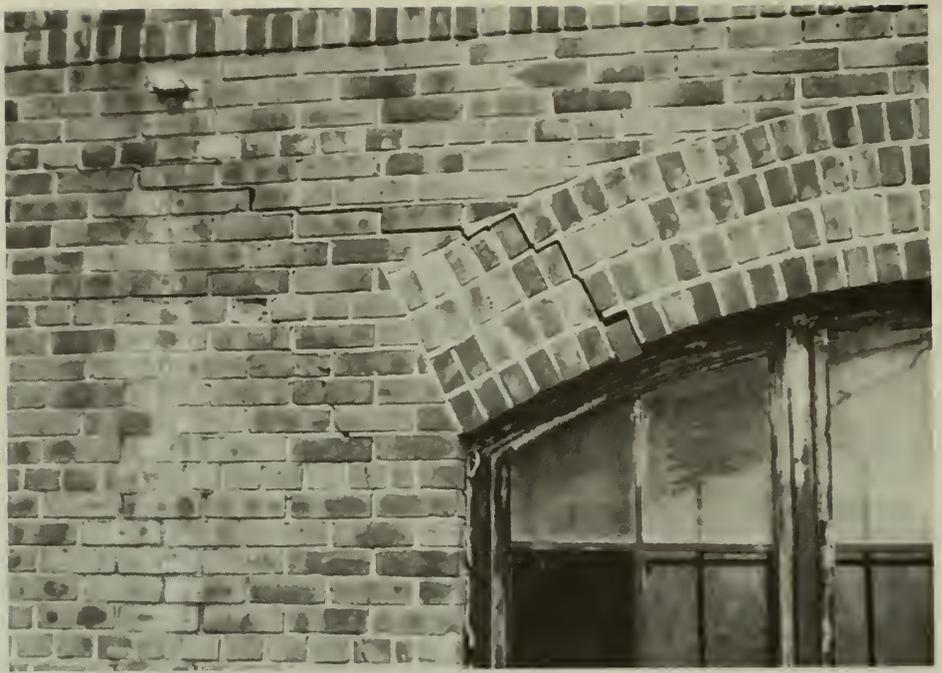
The exterior of covered way 7 is in generally fair condition. Brick surfaces of all elevations exhibit random areas of mortar deterioration and loss. Cracking occurs occasionally, as at the upper southeast corner of the north pavilion, the juncture of the west elevation of 7A with the north elevation of 7B and the juncture of the east elevation of 7A with the south pavilion. Efflorescence is evident on all elevations and is particularly severe on the west elevation of covered way 7A between the connector to the immigrant building, 7B, and the south pavilion. Dark water staining appears in conjunction with green biological staining in the area of removed gutters. The concrete base exhibits cracking, general deterioration and severe rust staining under most metal sash windows.

25. Cracking at brick joints, C-7B.

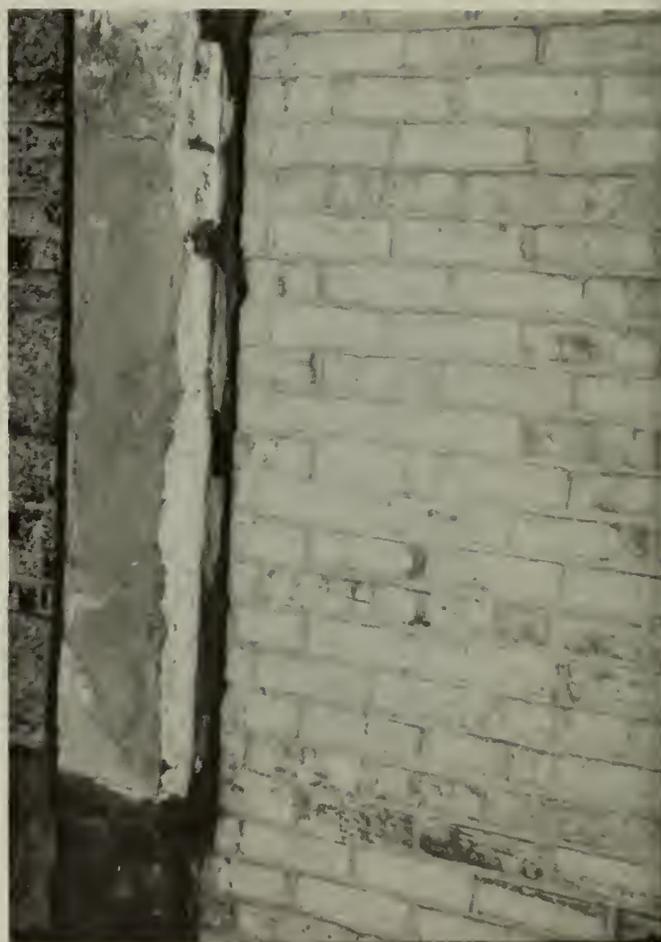
37. Gap at junction between walls of C-8C and C-9A.

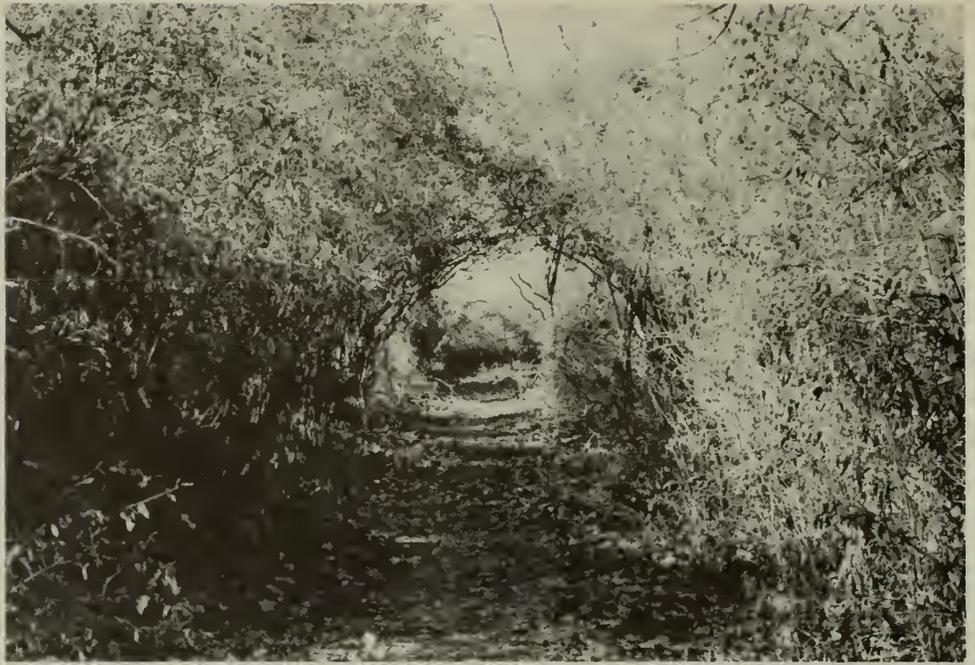
7. Overgrown path between Island 2 and 3.

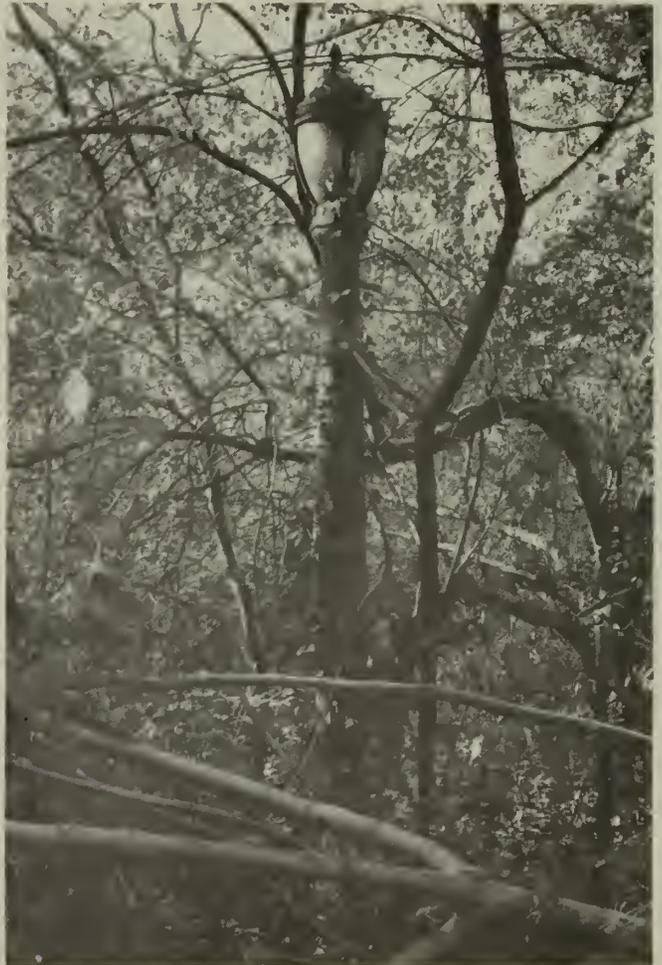
8. Concrete lamp post near measles ward D.

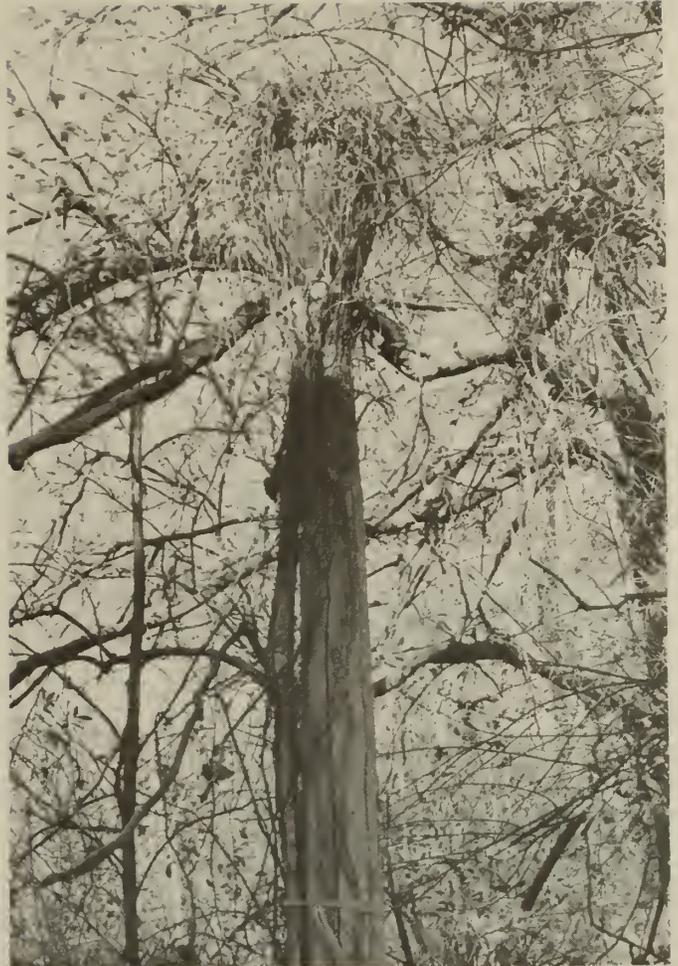
9. Concrete lamp post behind new hospital extension.

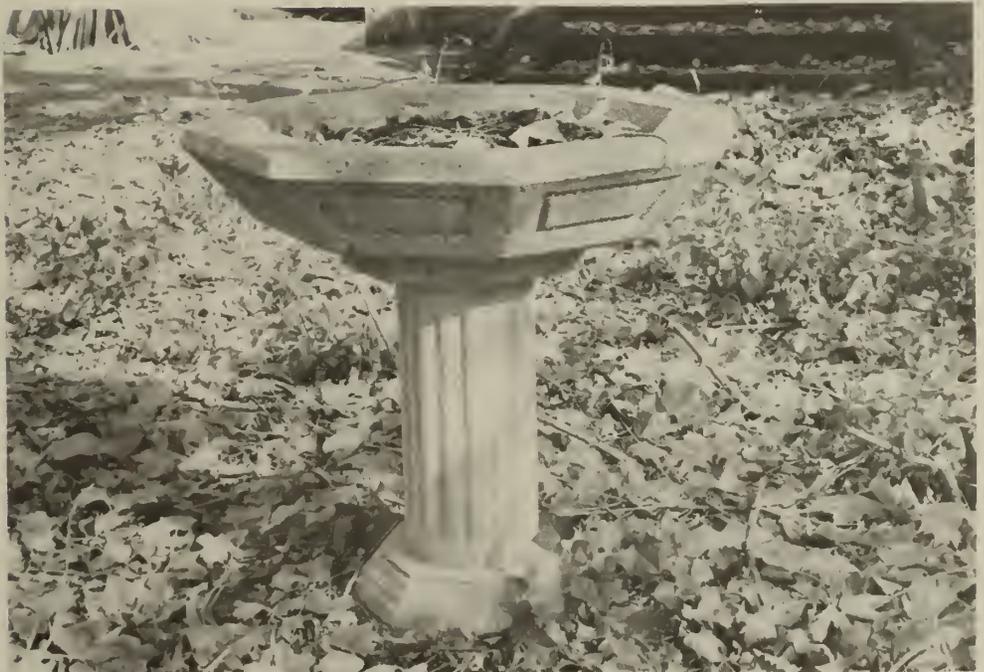
10. Bird bath at rear of Island 2 administration building.
