ELLIS ISLAND STATUE OF LIBERTY NATIONAL MONUMENT

HISTORIC STRUCTURES REPORT UNIT ONE BUILDINGS

Volume 2 Part One

Beyer Blinder Belle/ Anderson Notter Finegold

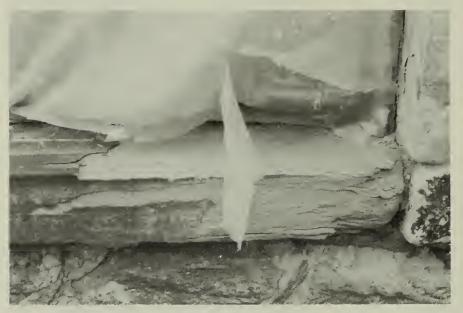
44. Exfoliation, bluestone window sill, south elevation.

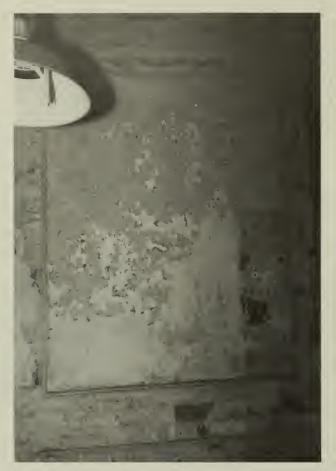
25. Room 115- west wall panel, location of 1930's mural under paint layers.

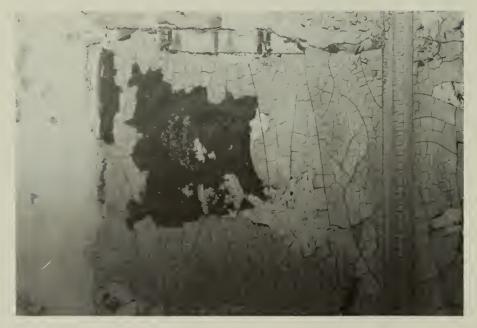
26. Detail of above- portion of hand-painted mural revealed under layers of paint- ear of corn visible in upper portion of area.

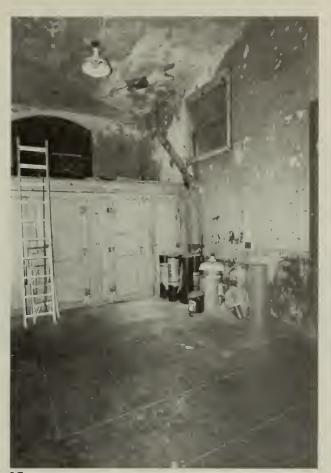
Room 111- concrete flooring and cement concrete wainscot, typical in eastern half of the building.

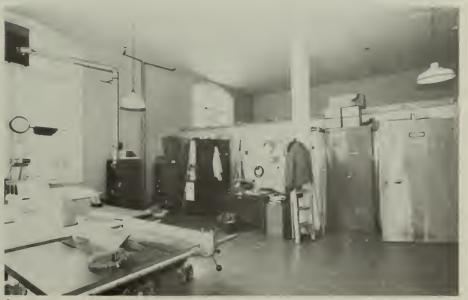
Room 101- looking southwest to recently formed rooms-105 and 106.

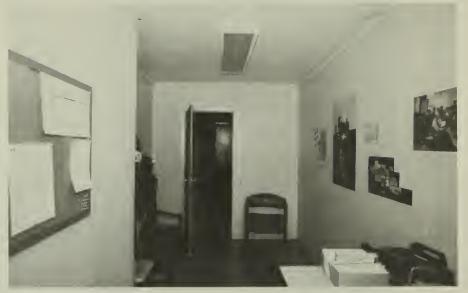
Room 106- plywood partitions forming a National Park Service office.

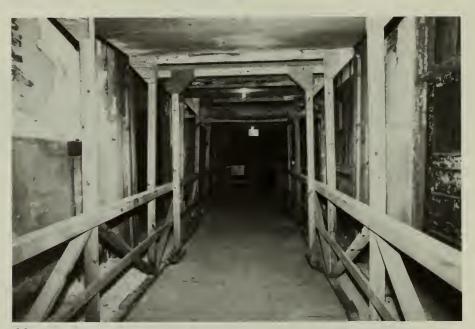
30. Hallway 105- temporary wood railings and overhead protection.

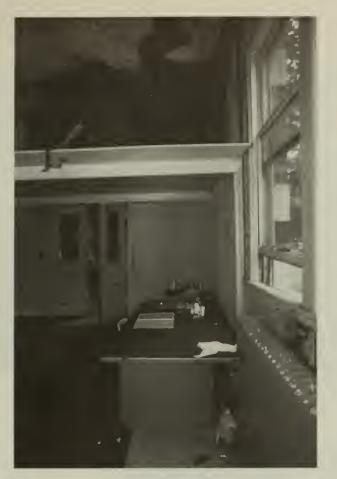
31. Room 118- subdivision of room with gypsum board wall partitions.

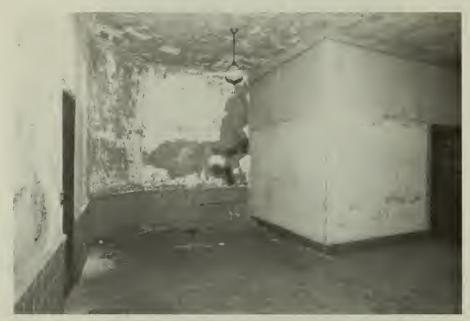
Room 203- masonite partitions in northeast corner. Buff tile floor and wainscot installed in 1935.

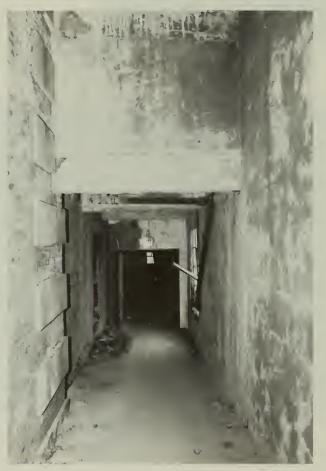
34. Hallway 201- north hallway looking west into the bakery and carpentry shop.

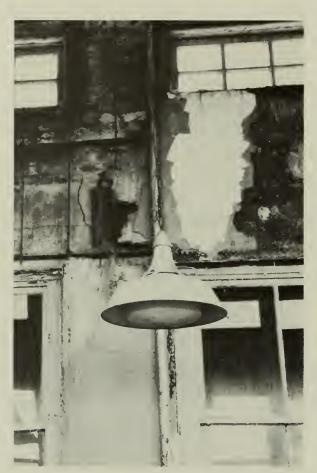
Chain-suspended RLM with globe, c. 1935, room 119.

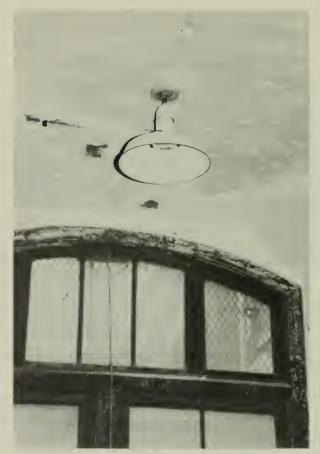
2. Ceiling mounted RLM-type, room 111.

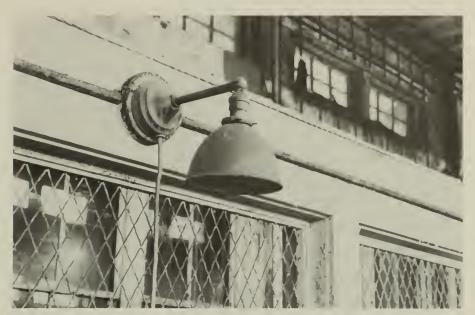
Partition-mounted counter lamp- metal directional shade, c. 1940's, room 119.

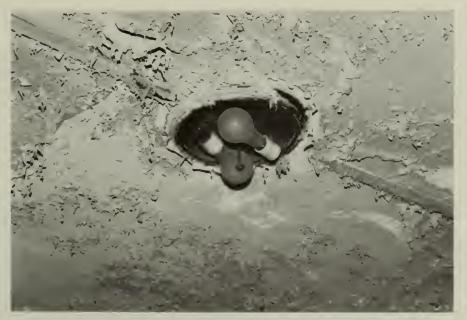
4. Double lamp ceiling mount, missing shade, H104.

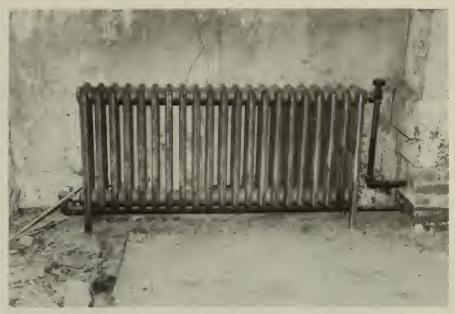
Existing piping cannot be reused due to its advanced state of deterioration. Some asbestos insulation has been removed. Radiators probably could be reused after thorough cleaning. The fans and exhaust hood could be reused in an historical restoration though their functional value is limited.

7. Sectional radiator, 4-leg, H201.

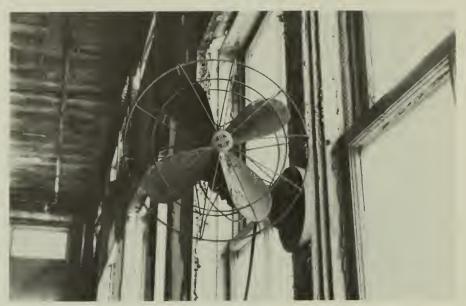
9. Wall-mounted rotary fan, room 119.

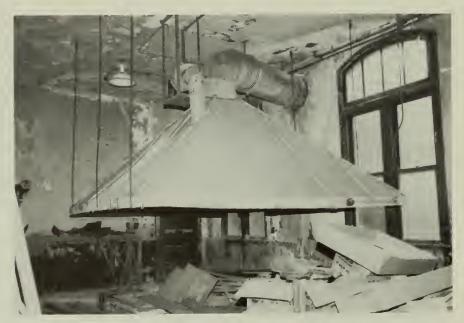
10. Ceiling suspended laundry room copper exhaust hood.

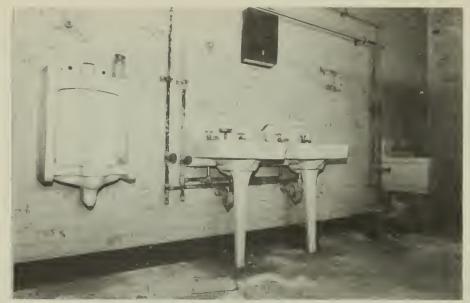
All water and sanitary piping requires replacement. Existing fixtures probably could be reused after cleaning.

11. Urinal, sinks and slop sink, c. 1940's, room 204.

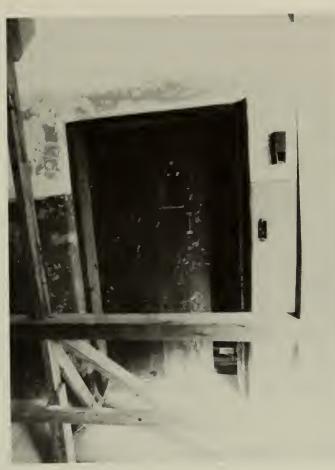
14. Elevator door, H105.

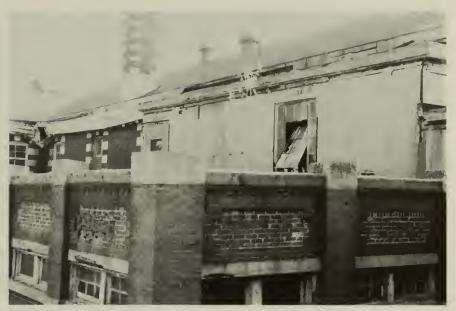
The exterior walls are generally in good condition except for the north wall where some horizontal cracks have formed near the roof. In addition the gutter and cornice at the north and south walls have partially separated from their wall attachments and are in a state of collapse (photos 1-3).

3. North facade, western end. Deterioration and sag of copper cornice.

Cracks in the exterior were caused by either beam flange corrosion or expansion and contraction resulting from freeze-thaw cycles. Flange corrosion may lead to further deterioration on the wall if not halted. Remedial measures include the removal of outside brick, determining the extent of damage and executing necessary reinforcing, cleaning, corrosion proofing and painting. In the case of thermally caused cracks, patching and rebuilding or installing expansion joint material is recommended.

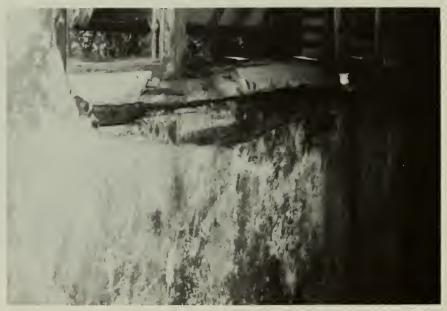
The white ceramic tile floor in room 201 has many cracks in a random pattern that were probably caused by building movement due to temperature changes (photo 8). The ceiling in this room has a large opening through which the roof construction can be seen. No structural deficiencies could be seen in this room. Rooms 202, 203 and 204 also have no visible structural problems. The ceramic tile floor showed little or no cracking. The corner wall furring had been broken open and some of the wall has been damaged by water coming in the missing window. Hall 201 is an enclosed ramp. The exterior stucco wall of this addition is in considerable distress. There are numerous cracks and large horizontal open slots under the windows (photo 9 and 10).

10. Corrosion of steel sill plate and concrete spalling typical in north wall of H201.

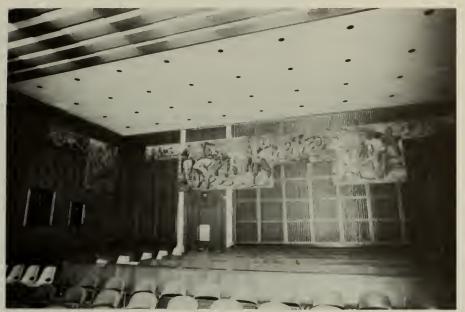
11. View of the mural in courtroom #3.

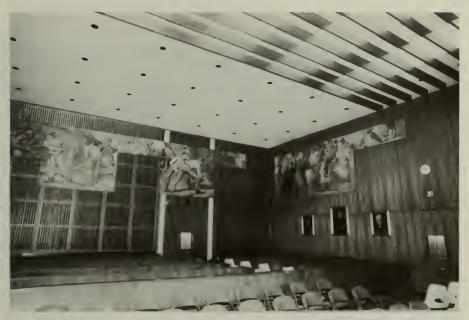
12. View of the mural in courtroom #3.

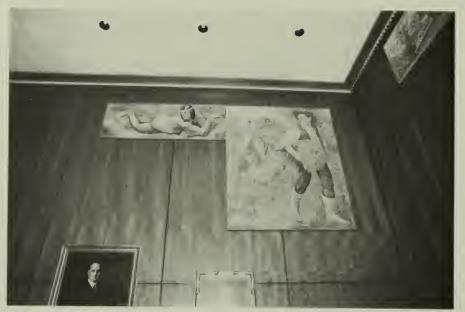
Indian and farmers. The missing scene of pioneers in covered wagons was most likely located between these two panels.

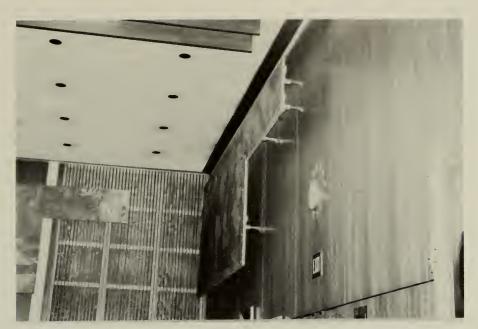
31. The mural is mounted on wood panels that are suspended from the wall on metal brackets.

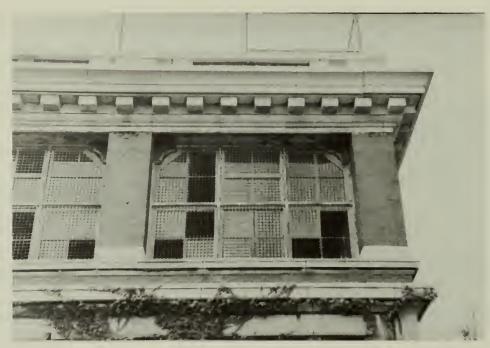
Metal window muntins and frames are severely corroded and warped. Some sash is missing and much of the glass is broken or no longer extant (photos 17-19). Many of the wood sash windows are rotted. The light court skylights are in poor condition with several missing mullions and panes of glass.

Second floor window, east elevation of north projection.

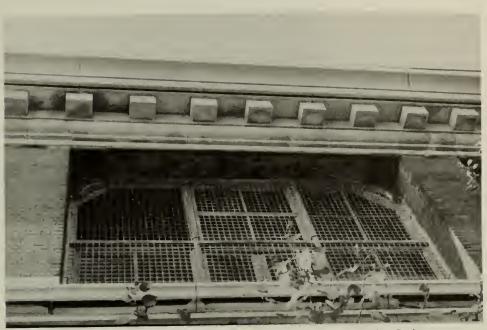
All metal members, including riveted spandrel beams, window guards, chain link fence and the exterior stair (on the east elevation) are all severely corroded (photo 19).

19. Second floor window, exposed riveted spandrel beam, north projection.

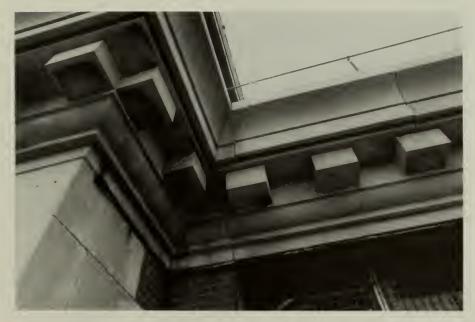
40. Open mortar joints, cornice, east elevation.

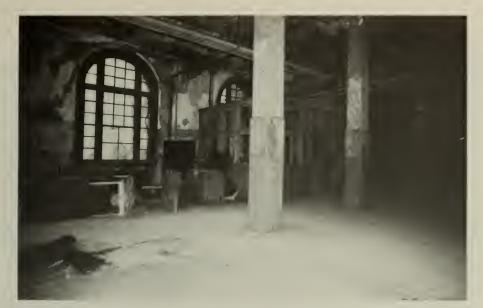
8. Room 114- finishes of concrete flooring, cement plaster wainscot and freestanding columns encased with galvanized iron.

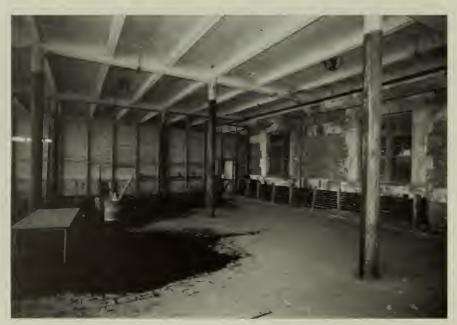
15. Room 210- view east toward partition wall and original exterior wall (at right).

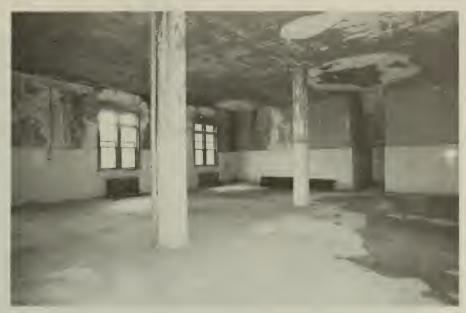
16. Room 324- view southwest.

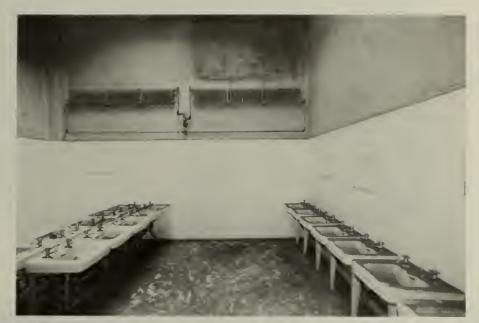
20. Room 322- wash room with skylight, finishes in good condition.

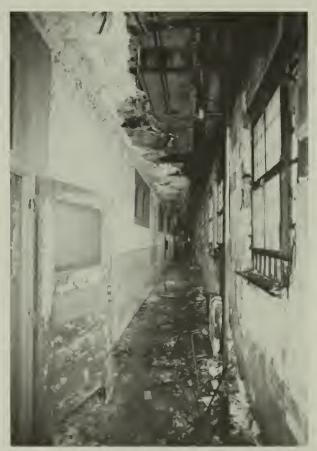
22. Hallway 201- view north, hung ceiling destroyed, severe deterioration of materials on exterior light court wall (right).

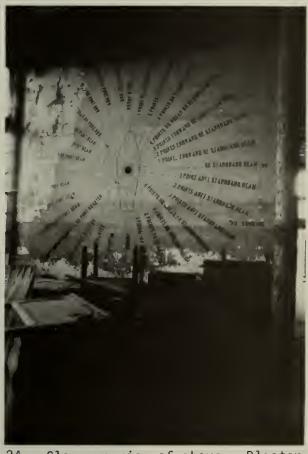
24. Close-up view of above. Plaster deteriorating.

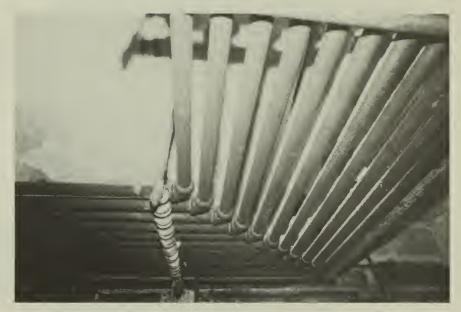
17. Exposed steam pipe clusters, ceiling suspended, (typical in north porch), ca. 1914.

None of the existing piping can be feasibly reused due to its advanced state of deterioration. Asbestos insulation is being removed at the present time. Radiators and pipe clusters probably could be reused after thorough cleaning, depending on metal thickness. Unit ventilators are in a severe state of disrepair. The various wallmounted fans have limited functional value.

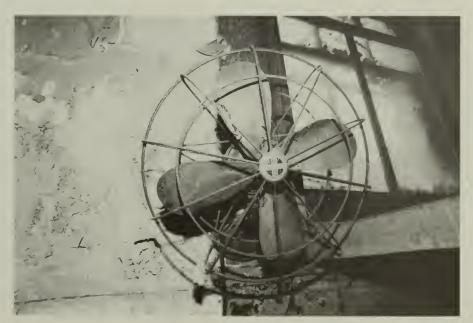
19. Wall-mounted propoeller fan.

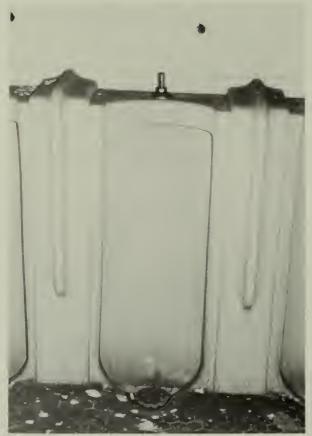
22. Urinal, room 320.

All water and sanitary piping requires replacement. Existing fixtures have historical value and should be reused after inspection and cleaning. Plumbing fixture types are depicted in photos 22-38.

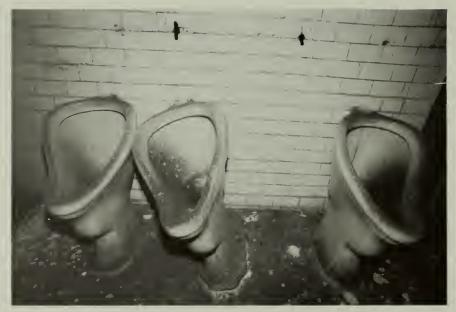
23. Urinal, room 213, ca. 1920's.

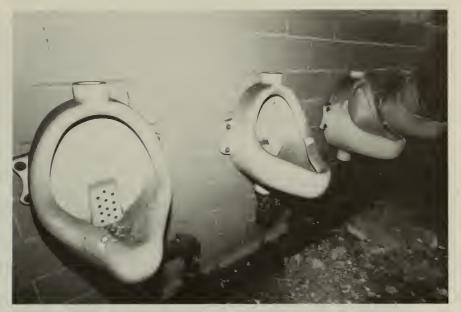
24. Wall-mounted urinal, room 109, ca. 1939.

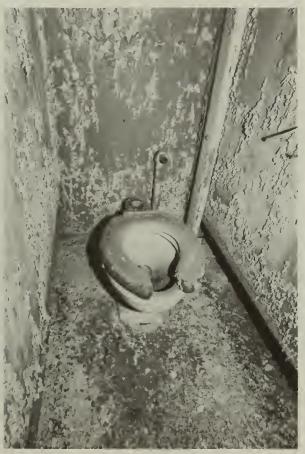
25. Typical toilet, room 109, ca. 1939.

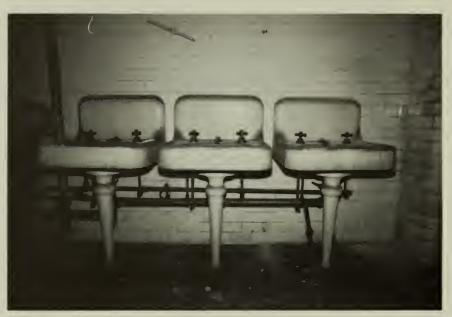
26. Typical pedestal sink installed between 1900-1924, room 204.

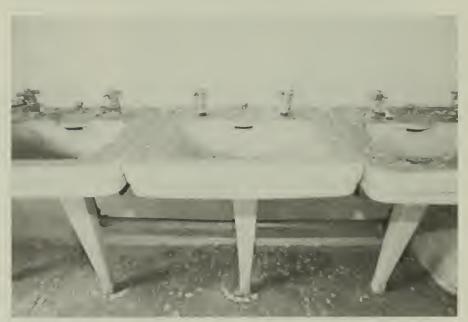
27. Typical pedestal sink, room 317, ca. 1930's.

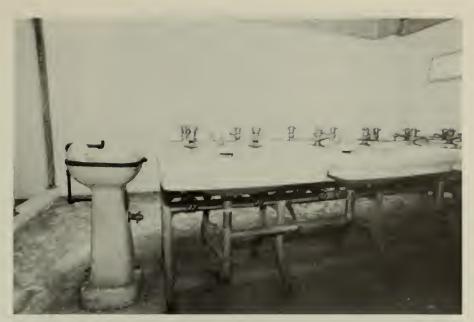
28. Freestanding attached sinks and drinking fountain, room 322, ca. 1932.

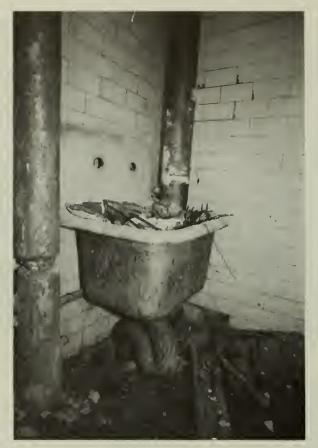
30. Slop sink, room 203.

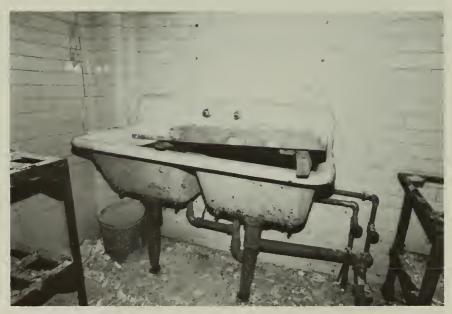
31. Slop sink, room 108.

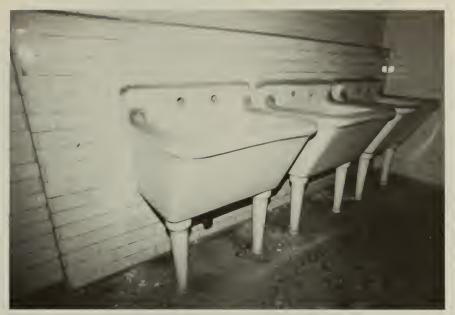
32. Porcelain slop sinks, room 207.

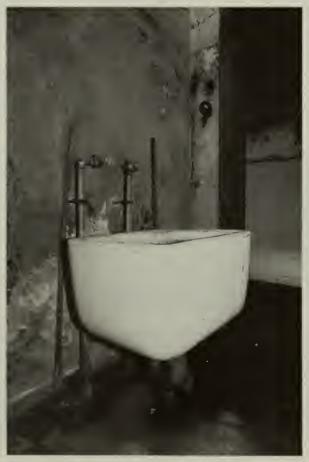
33. Slop sink, room 303.

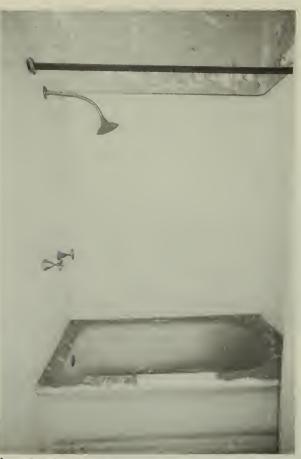
34. Bathtub and shower head, women's bath, room 309.

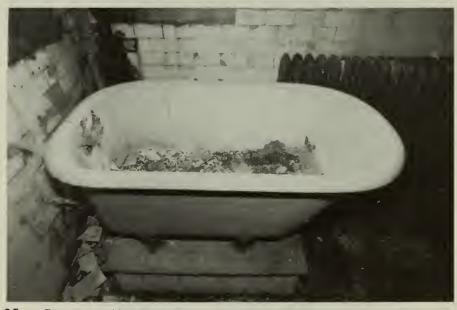
35. Freestanding bathtub, room 305, ca. 1924.

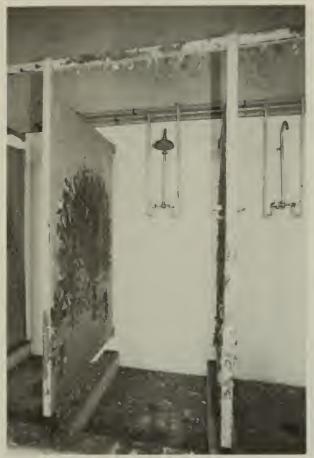
36. Aluminum partitions and tile floor and walls of showers, room 317, 1932.

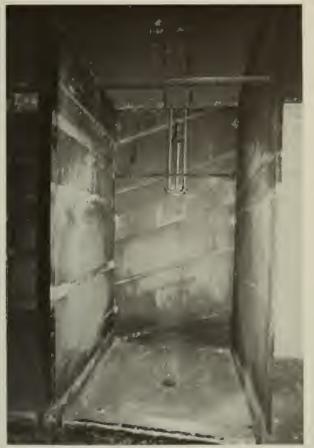
37. Aluminum enclosed shower, room 207, 1935.

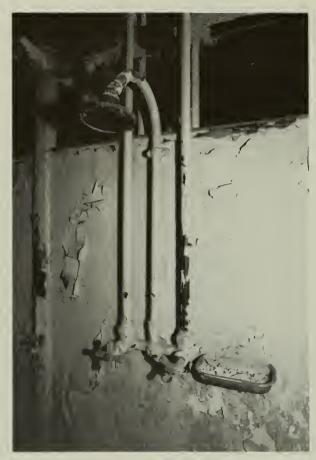
38. Aluminum stall-less shower, room 110, 1939.

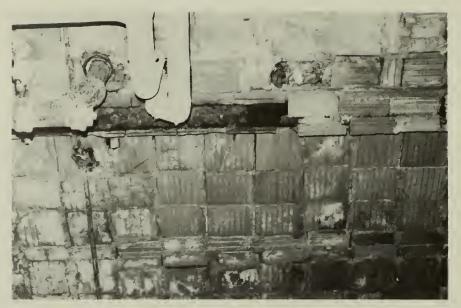
The first floor of the original building has some corroded beam soffits causing clay tile fireproofing to drop off (photos 1 and 2). In the southeast corner of room 103 the ceramic tile floor is cracking in a north-south direction at the columns (photo 3). In addition, the tile wainscots on the columns have extensive cracking. The interior courtyard roof beams are considerably corroded.

First floor ceiling, corroded beam soffits and missing tile.

Rusting of both slab reinforcing and steel beams should be arrested by cleaning, rust-proofing and painting. Analysis should be done of the corroded areas

after a more thorough inspection and members reinforced if required. Corrosion of beam flanges in the south wall should be halted to prevent further wall deterioration which could result in a decrease of floor support capability. Outside brick should be removed to ascertain the extent of damage and necessary reinforcing cleaning, corrosionproofing and painting should be done.

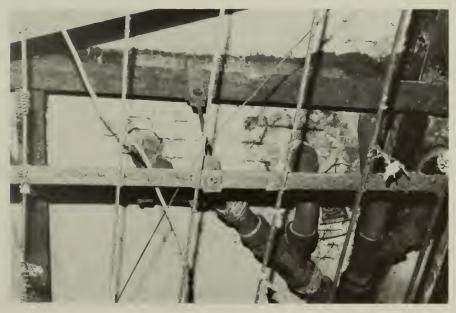
Some second floor hung-ceiling construction has broken out and corroded columns and beams are visible (photo 4). A portion of the slab soffit has fallen off and corroded triangle mesh is exposed. There are roof leaks allowing entry of water at several locations.

Second floor hung ceiling, corroded beams and exposed metal lath.
